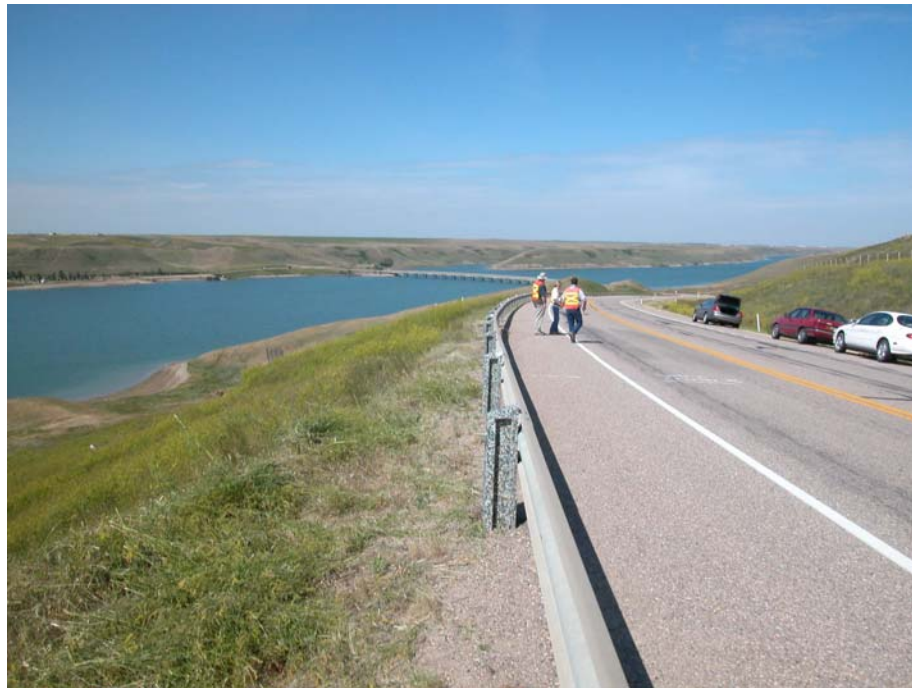
**Photo 1** (upper left) July 2003  
Facing west along the guardrail above the slide scarp. Despite the shallow slumping along the guardrail between May and July 2003, the guardrail alignment does not appear to have been disturbed.

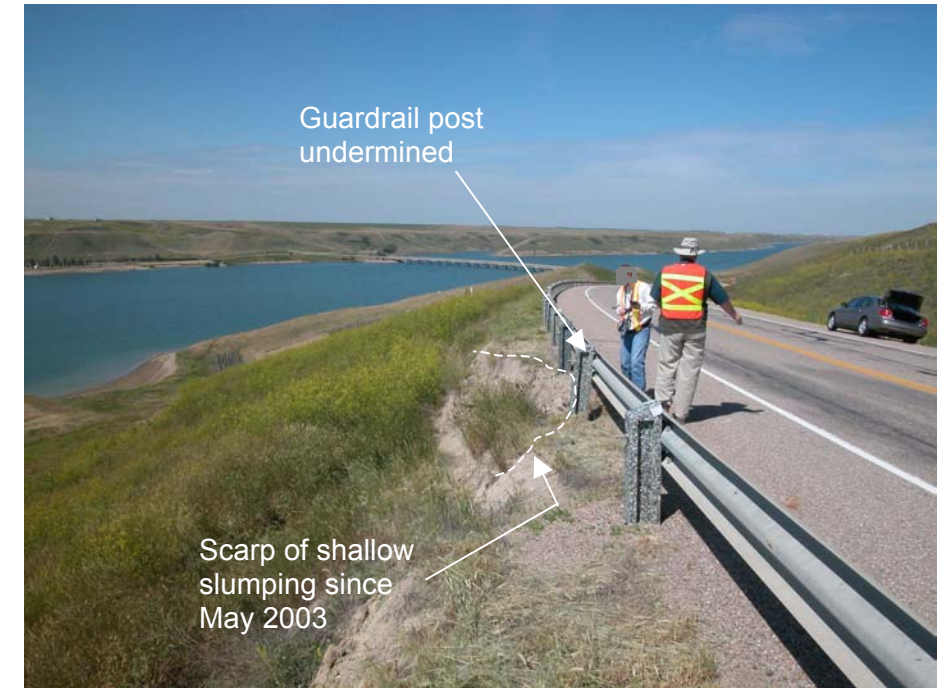
**Photo 2** (upper right) July 2003  
Closer view of the area where shallow slumping occurred along the scarp of the slide area. One of the guardrail posts has been undermined by the movement, and the two adjacent posts are very close to becoming undermined.

This area is roughly centered within the overall, deep-seated landsliding. The new slope inclinometer (SI 2002-1) that was installed to monitor for retrogression of the deep-seated movement through the road alignment is located in the upslope ditch of the road, just off the right edge of the photo (adjacent to the parked car).

Guardrail post undermined

Scarp of shallow slumping since May 2003

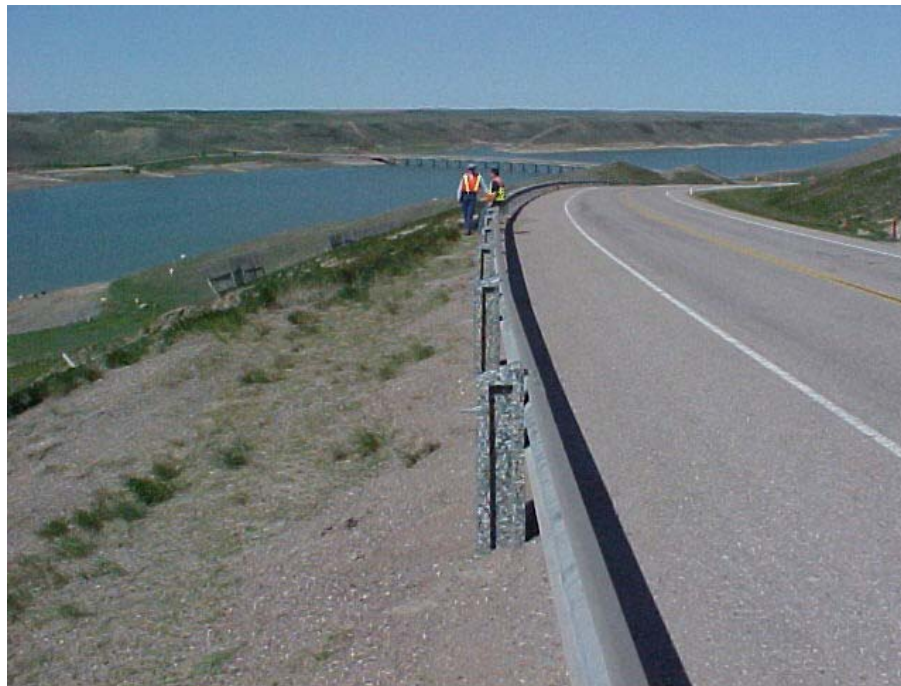
**Photo 3** (lower left) May 2002  
Same area as Photos 1 and 2, as seen during the May 2002 site inspection.

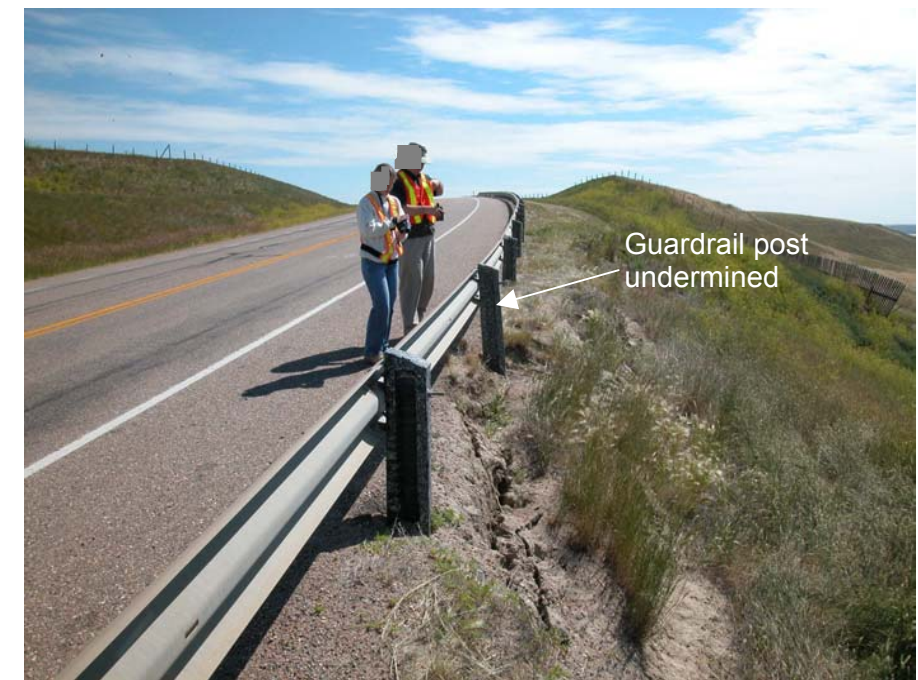
**Photo 4** (lower right) July 2003  
Facing east across the recent shallow slumping area. The road surface has not been damaged, despite the proximity of the slumping.

Guardrail post undermined

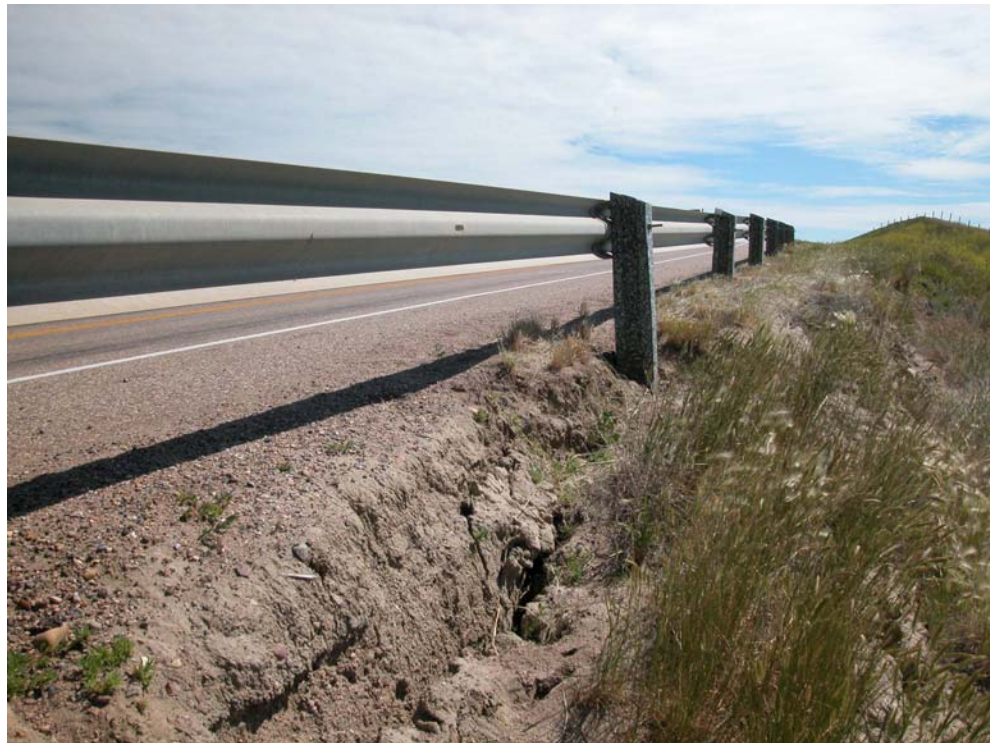
**Photo 5** (upper left) July 2003  
 Close-up of the undermined guardrail post shown in Photos 2 and 4. The adjacent posts (on either side) are close to becoming undermined as well. The exposed soil on the oversteepened slope face in this area should be regraded and covered with erosion control matting, as discussed in the Recommendations section of the text.

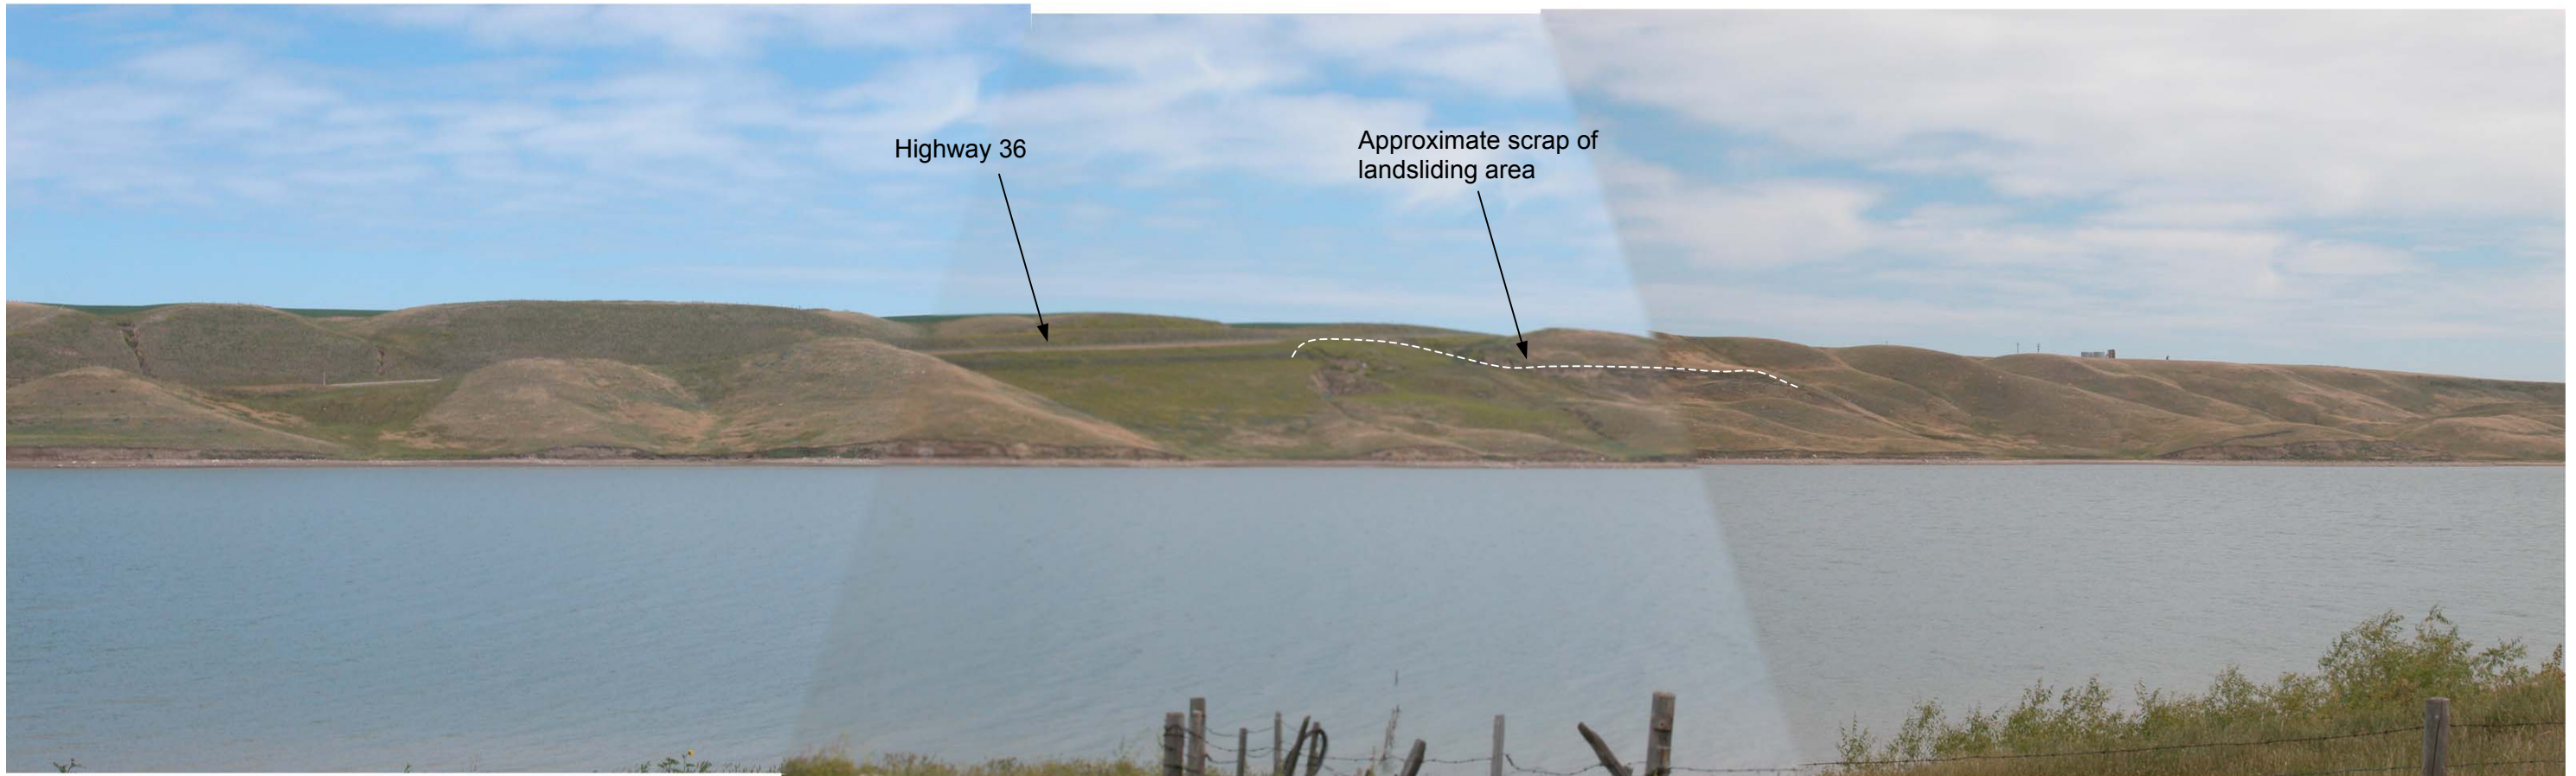
**Photo 6** (bottom) July 2003  
 General view of the Chin Coulee site, as seen from the campsite and picnic area across the reservoir.
