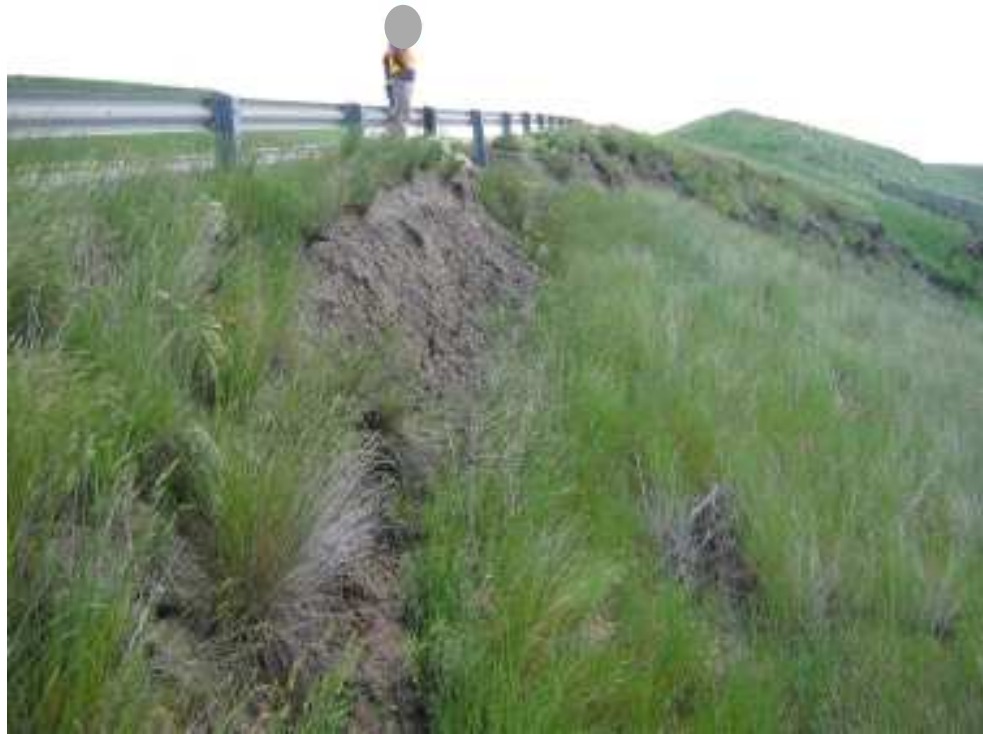
Photo S5-1 (upper left) – June 2005 – facing east across the shallow slumping area that is undermining the guardrail along the downslope edge of the road. Possible additional cracking since the 2004 inspection was noted but the overall state of the slumping did not appear to have changed significantly.

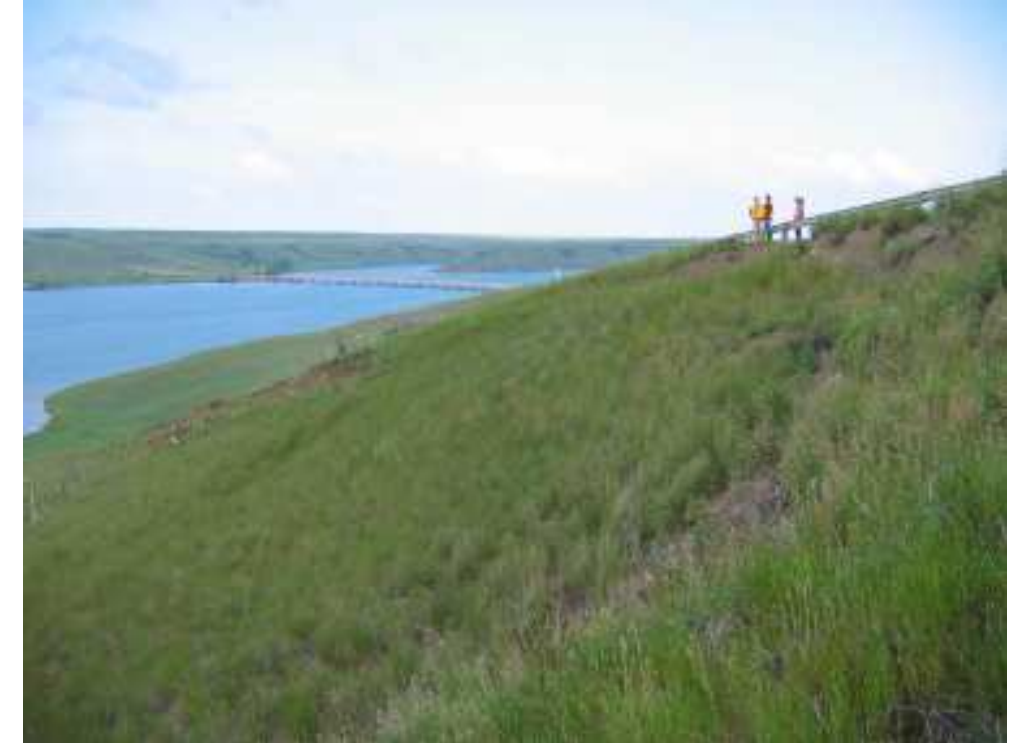
Photo S5-2 (upper right) – June 2005 – facing west across the shallow slumping area below the road.

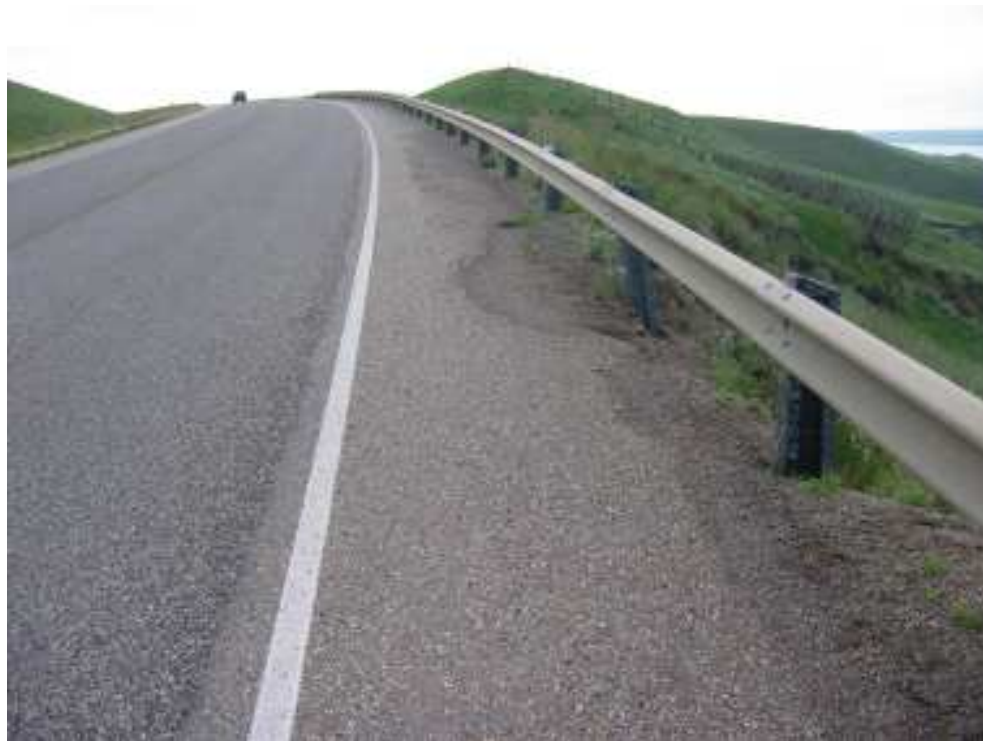
Photo S5-2 (lower left) – June 2005 – facing east along eastbound lane. Note the settlement in the shoulder next to the guardrail.

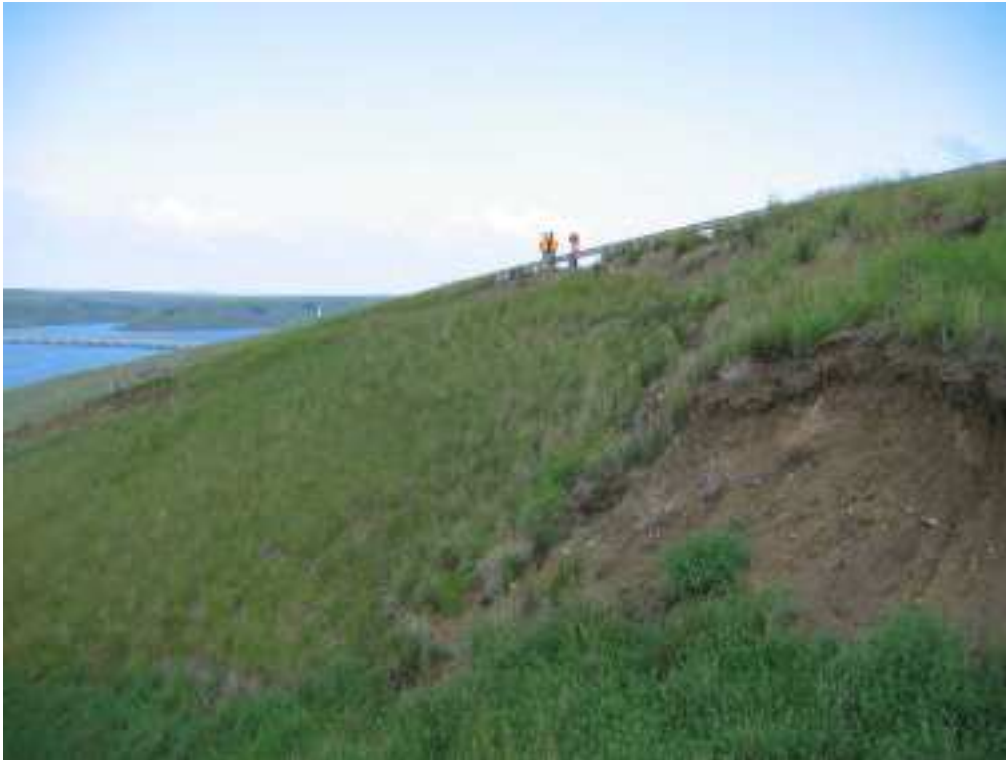
Photo S5-4 (left) – shallow slumping on slope downslope of the road.

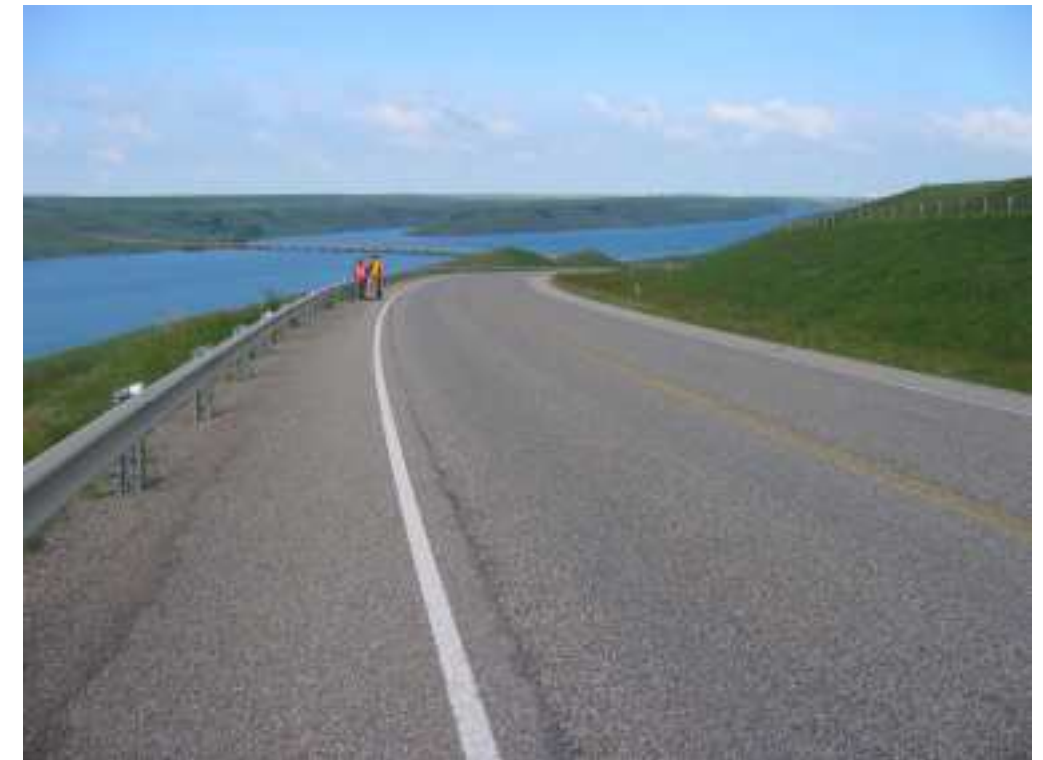
Photo S5-5 (right) – facing west along road. No new cracking visible since the last annual inspection.
