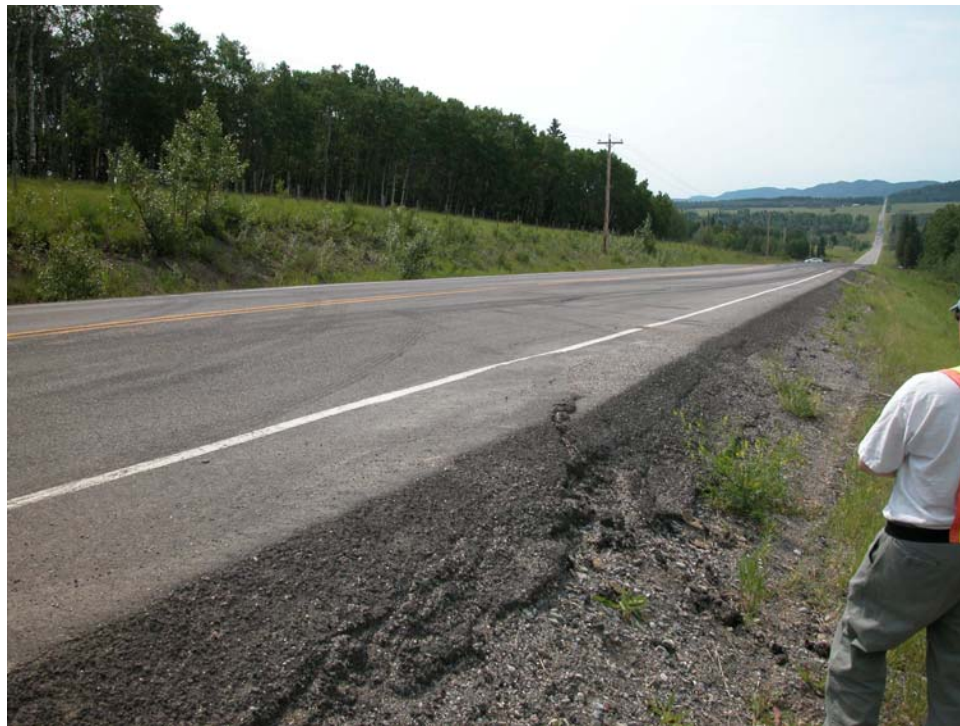
Photo 1 (upper left)
Facing south across the settlement and cracking area at the north end of the site. The cracking and settlement in this area has not changed significantly since the May 2002 inspection.

Downslope movement zones around the base of the road fill in this area were previously identified in the instruments that were installed here in 2001. These instruments are no longer functioning (either paved over or sheared off).

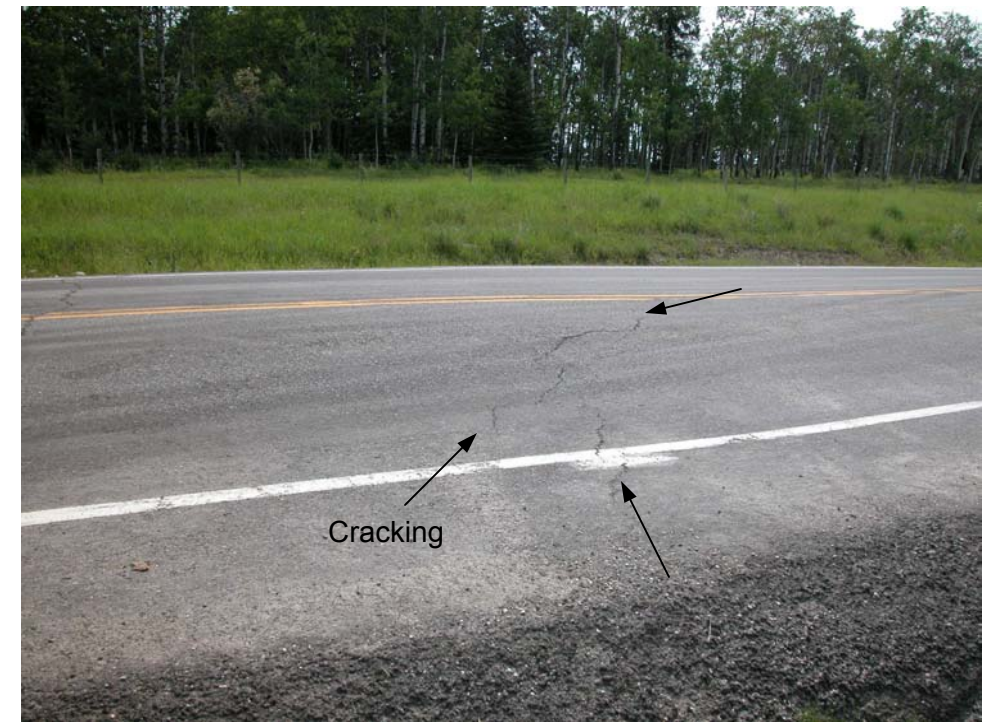
Photo 2 (upper right)
Another view of the cracking in the southbound lane, north end of the site.

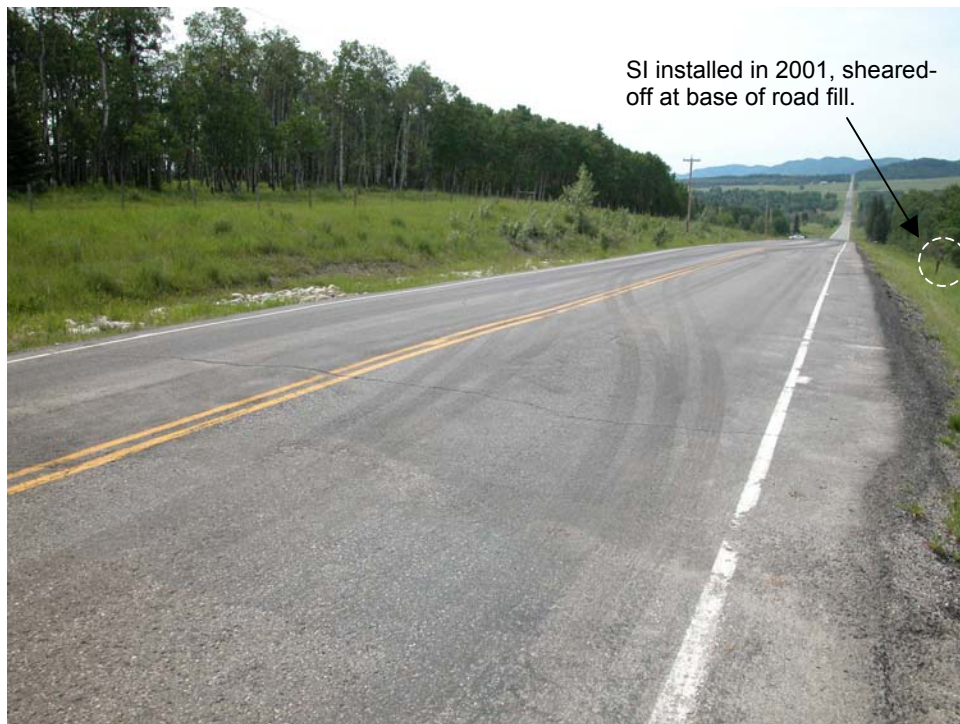
Photo 3 (lower left)
Another view of the cracking in the southbound lane, north end of the site.

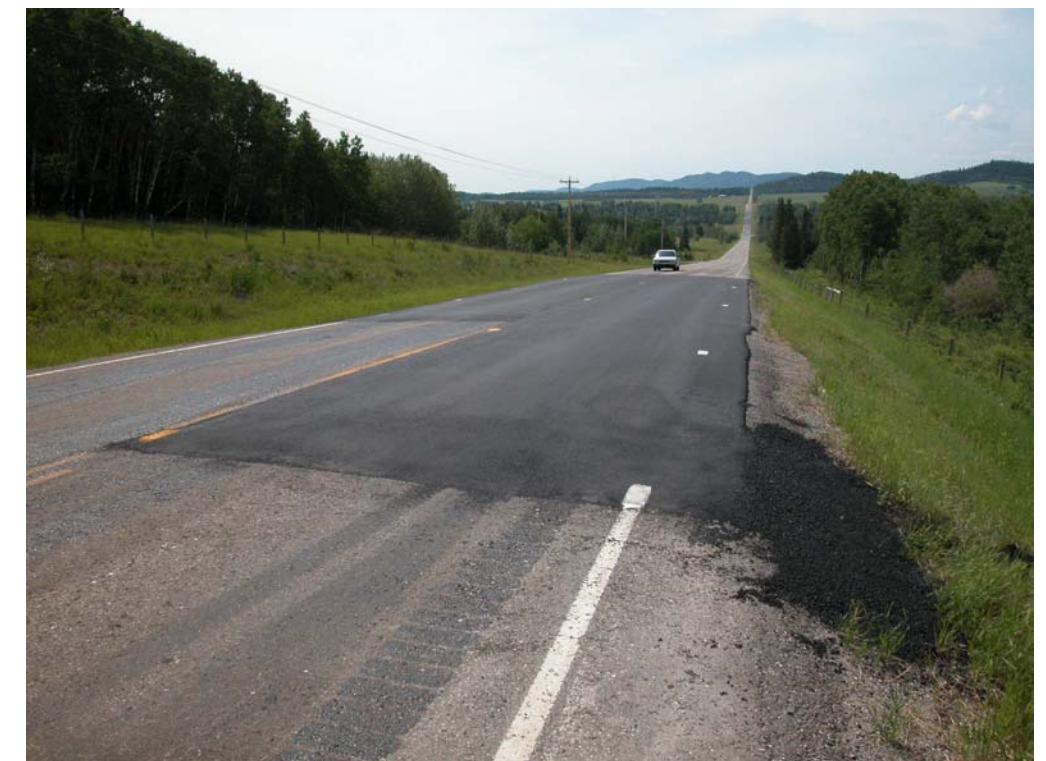
Photo 4 (lower right)
Facing south across the recently repaved southern cracking and settlement area at this site. The instruments that were installed in the fall of 2002 in this area have measured ongoing slope movement towards the southwest. The rate of slope movement has been moderate, and cracking of the road surface has resulted. This repaving has “reset” the road surface with respect to cracking, but unfortunately prevented any observations the magnitude and extent of additional cracking since the previous site inspection in May 2002.

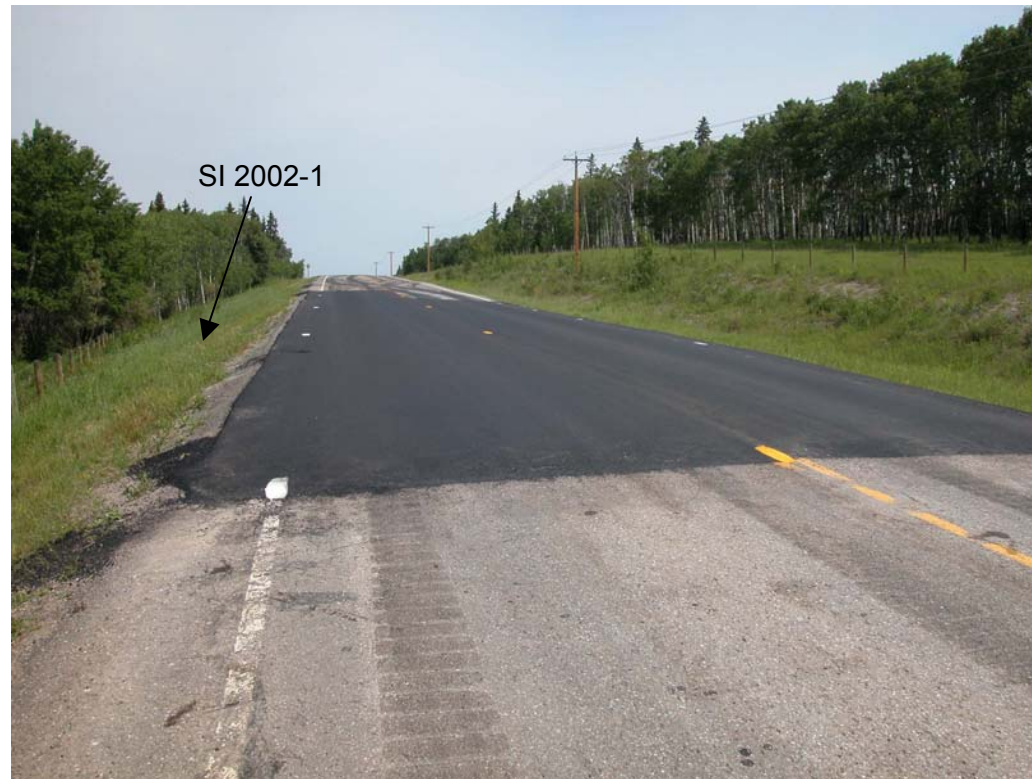
Photo 5 (left)

Facing north across the southern cracking and settlement area. Any future remedial measures for this site should incorporate both this area and the northern cracking and settlement area – a total length of approximately 180 m along the road.
