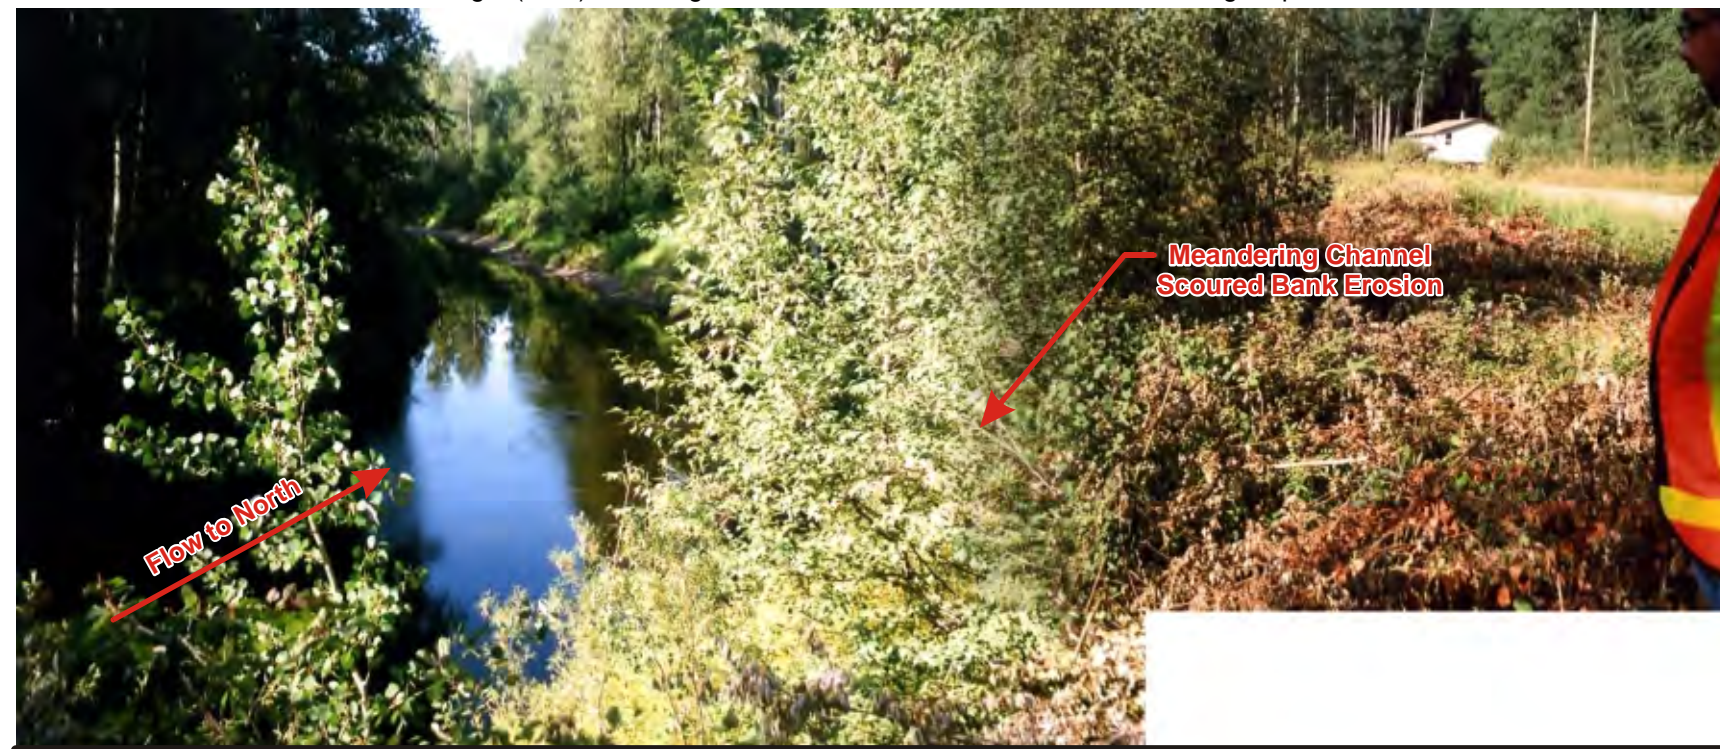
Photo 1

**Looking south away from Hwy 2:50 junction**

- Drift Pile River running north (on left of photo) (on east side) beside local road
- On left (east) side, top of eroded bank at about 7m setback to edge of local road
- On right (west) side, edge of local road is offset about 14m from a dugout pond

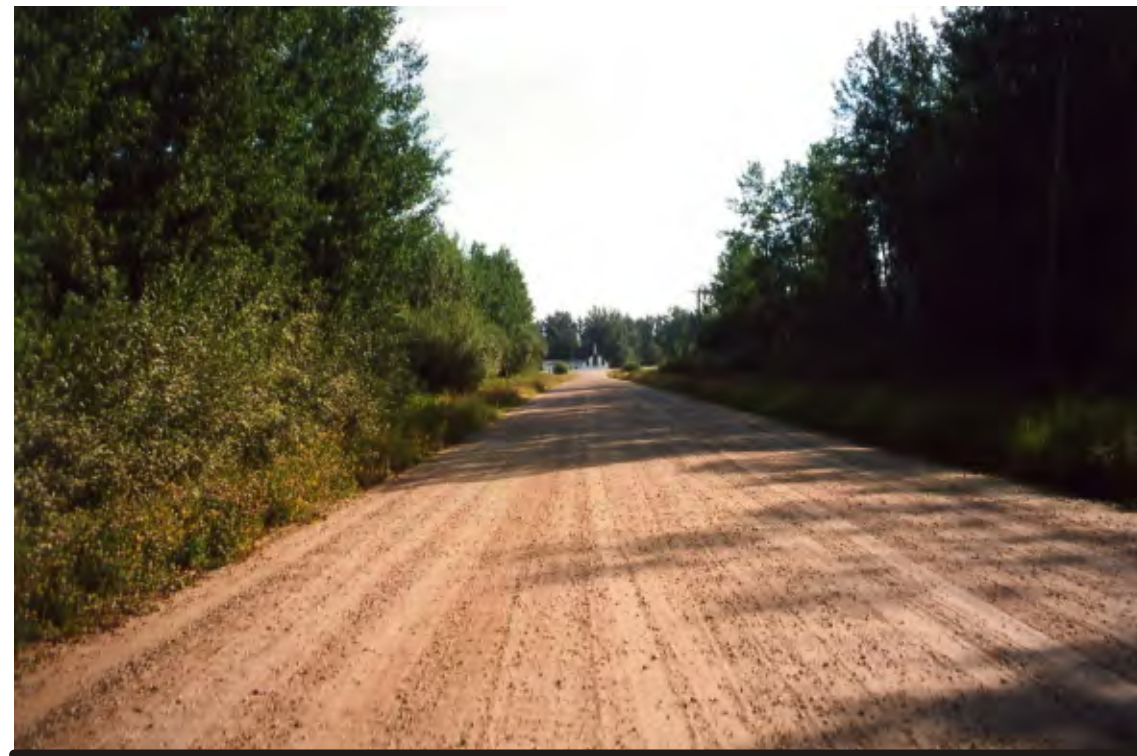
Photo 2

**Looking south upstream from top of setback**

- A meander scour bank is being eroded to encroach towards the roadway
- Roadway on right side of photo

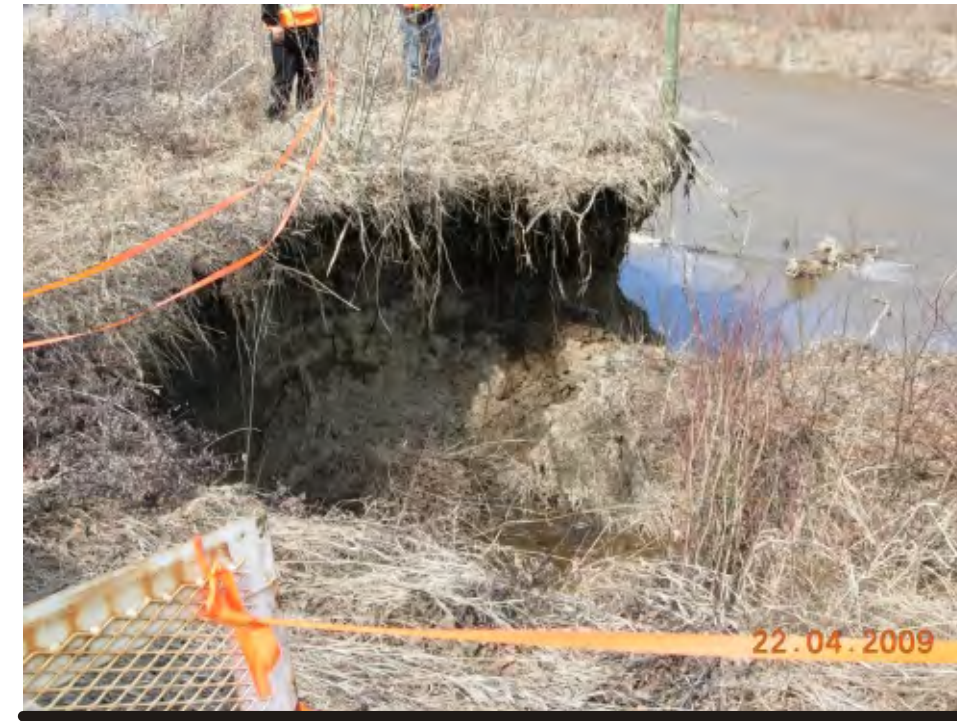
**Photo 1**  
Looking east at river bank scour location

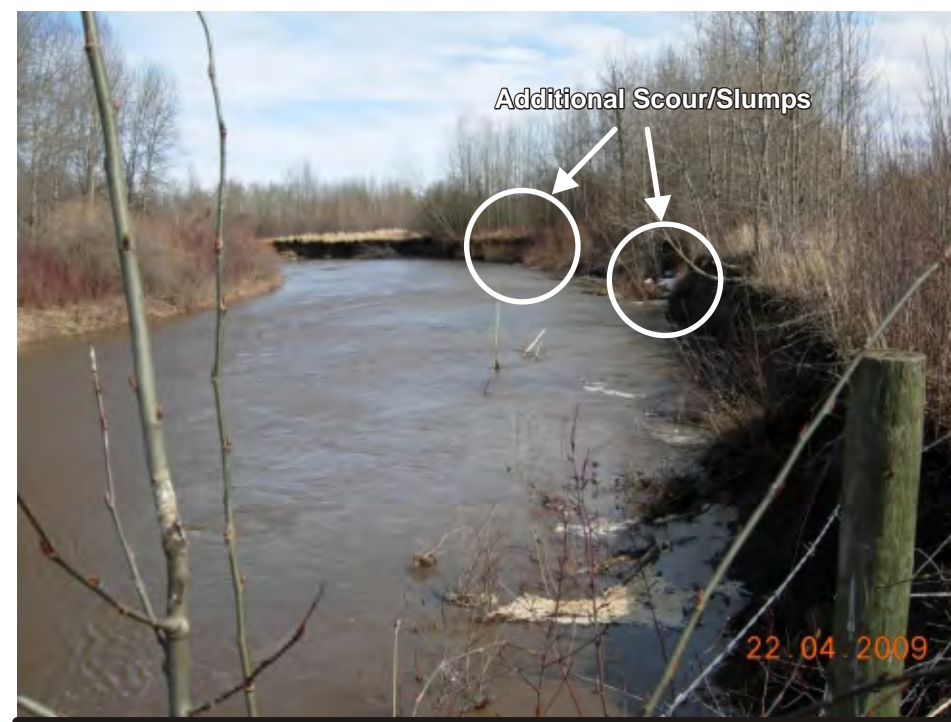
**Photo 2**  
Looking north at scour location

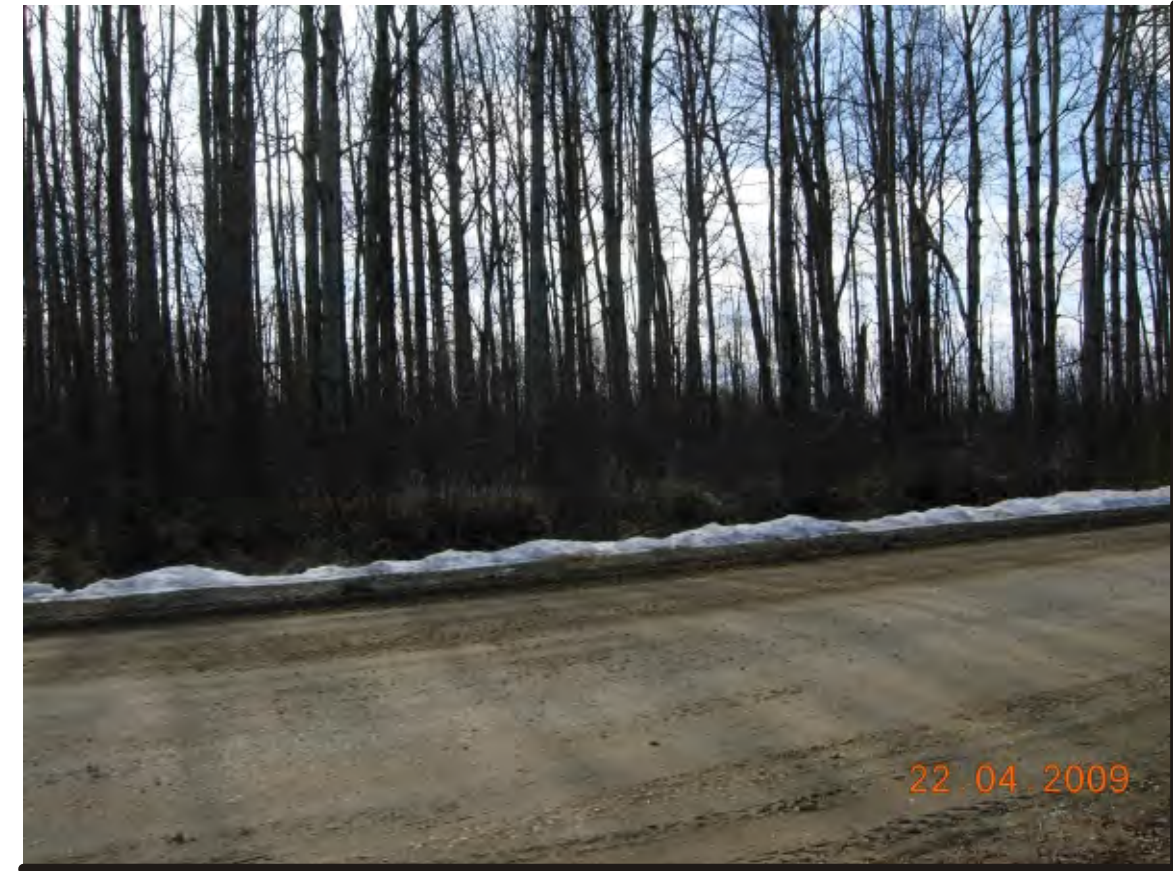
**Photo 4**  
**Looking northwest at scour location**  
- Crest of scour within 3 m of edge of roadway  
- Area barricaded and demarcated to notify motorists of reduced setback distance and to minimize public access into area
