**SH 29a
Page 1 of 2**

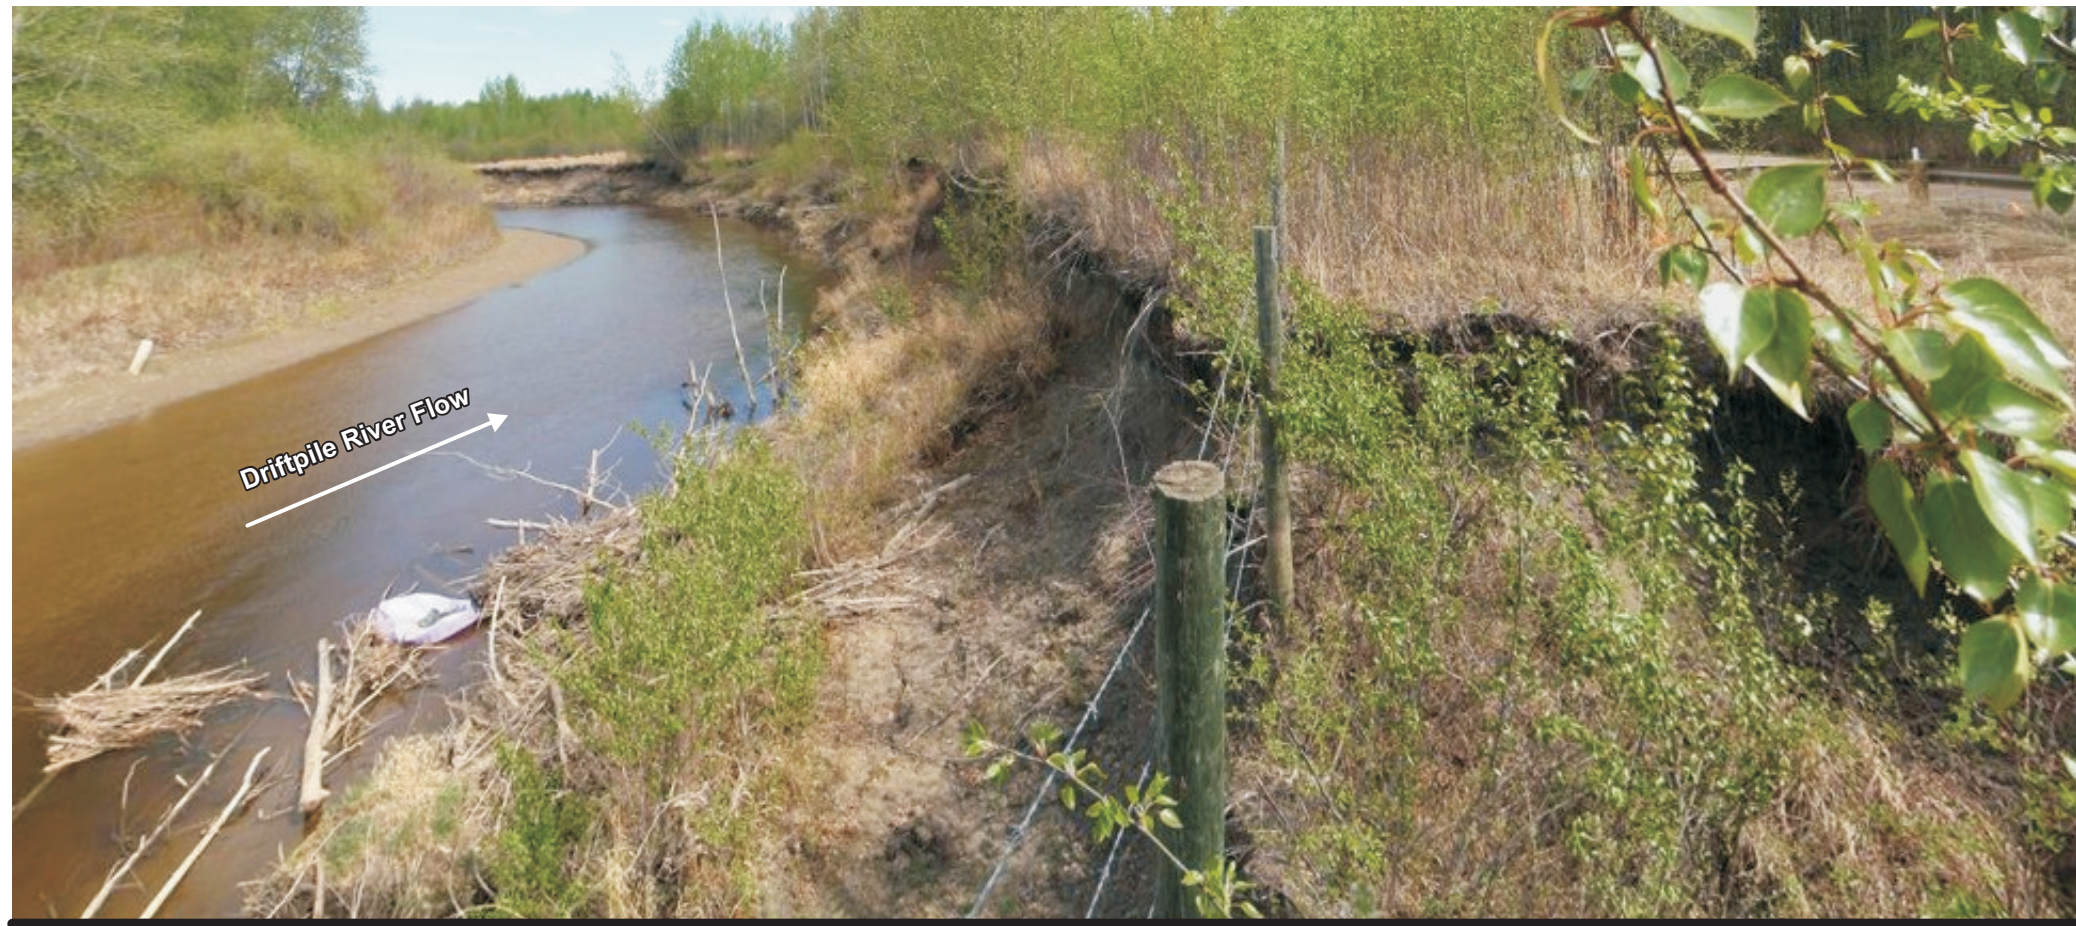
Photo 1

Looking east downstream

Scouring bank of the meandering Drift Pile river channel
has effected this bowl location of retrogression of slumping

Shape of escarpment seems no obvious deterioration from previous year.

Bowl width (about 12m), depth (about 10m inland towards roadway), setback (about 3m from scarp to road edge)

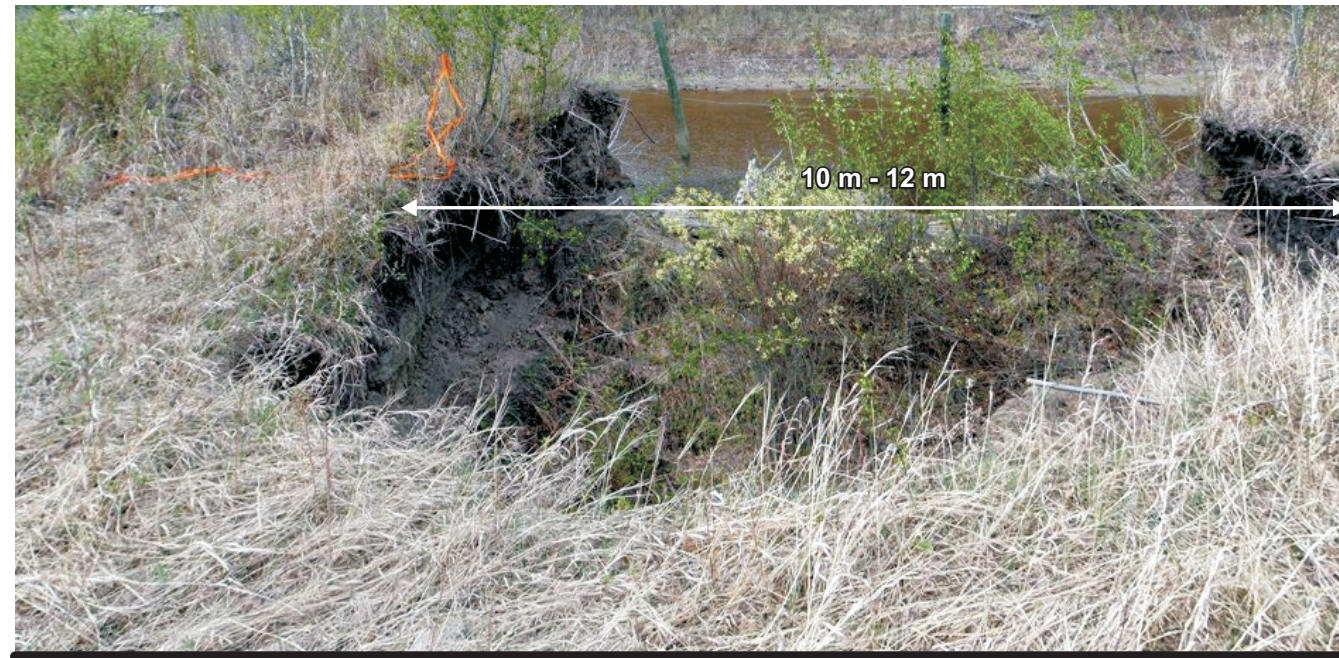
Photo 2
Another view of escarpment bowl

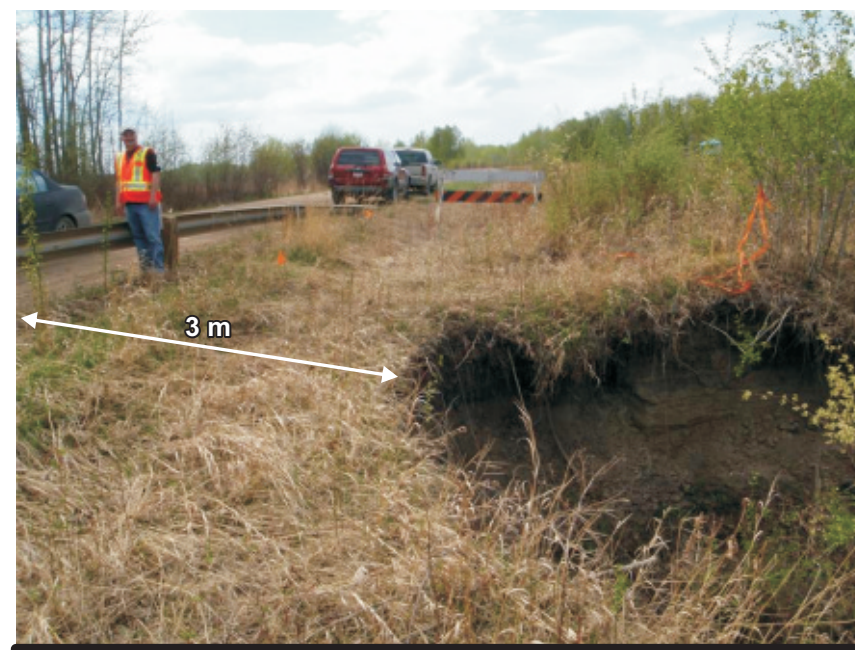
Photo 2a
Another view of escarpment bowl
