**Application of Best Management Practices (BPMs) to Erosion and Sediment Control on Alberta Highways (Good and Bad/Failed Installations)**

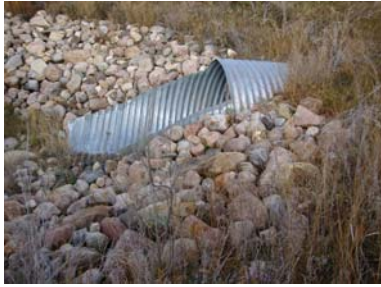
<p align="center">H595:02 Culvert outlet area with energy dissipator being protected by riprap</p>

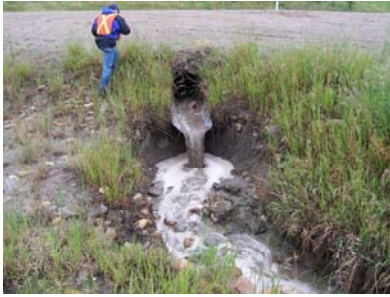
<p align="center">H986:01 Erosion of culvert outlet and removal of large riprap protection</p>

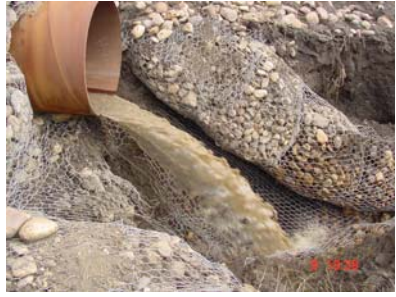
<p align="center">Erosion and undermining of gabion structure resulting in collapse and scour</p>
<p>Rolled Erosion Control Blankets (BMP 13)</p>

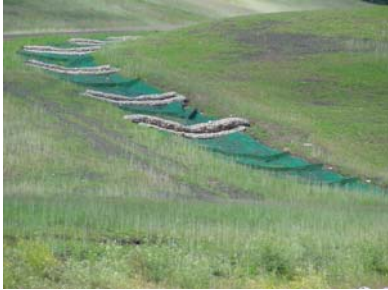
<p align="center">H43:12 Iosegun River Installation of gabion basket check structure and permanent RECP</p>

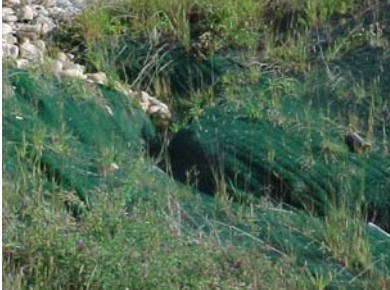
<p align="center">H43:12 Chicadee Creek Erosion of soil under permanent RECP</p>	
<p>Gabion Wall (BMP 2)</p>

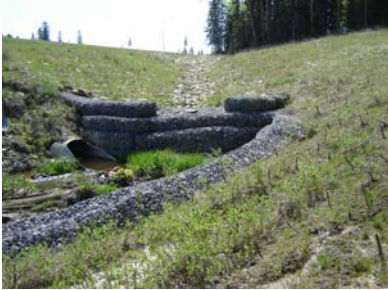
<p align="center">H11:08 Rocky Mountain House Rebuilt of failed gabion wall</p>

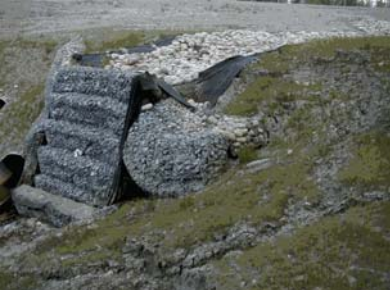
<p align="center">H11:08 Rocky Mountain House Poor installation of gabion wall resulting in failure</p>	
<p>Gabion-lined Channel (BMP 2)</p>

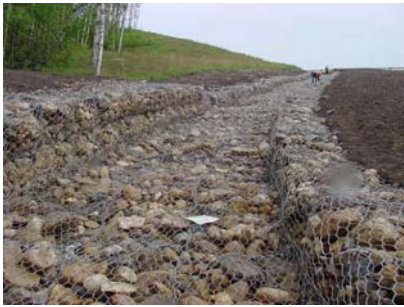
<p align="center">H63:12 Supertest Hill Rebuilt of gabion-lined channel</p>

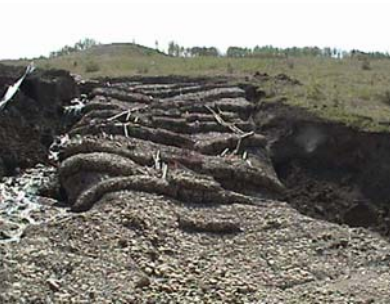
<p align="center">H986:01 Failed gabion structure</p>

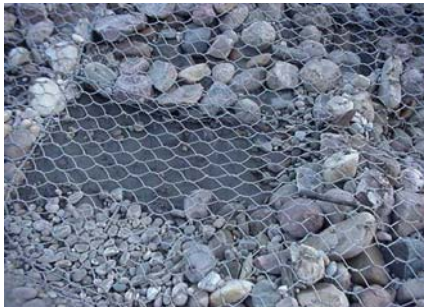
<p align="center">Rock size too small resulting in large void</p>

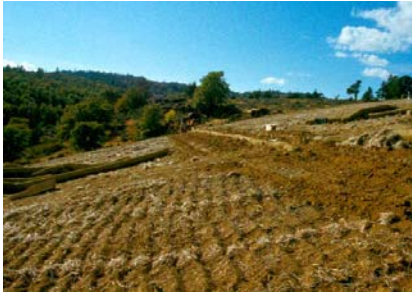
<p align="center">Track-walk up and down slope – strongly recommended</p>

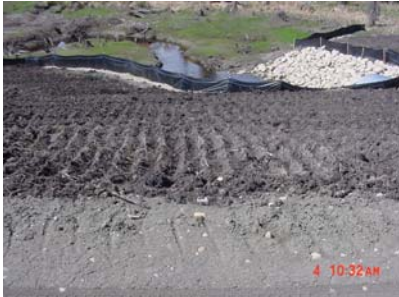
<p align="center">H43:10 Slope tracking along slope – not recommended</p>	
Silt Fence (BMP 1)

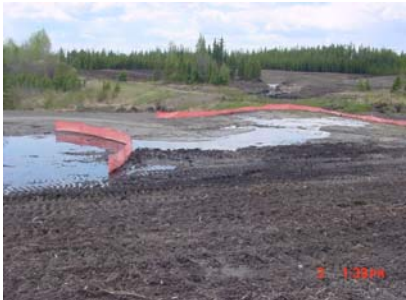
<p align="center">H43:10 "Smile" shape</p>

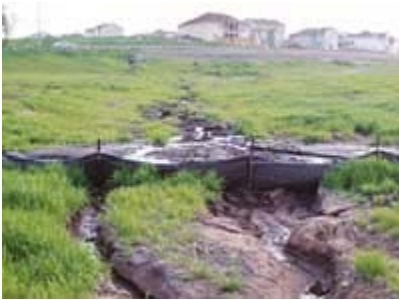
<p align="center">Formation of gullies below silt fence</p>	
Silt Fence (BMP 1)

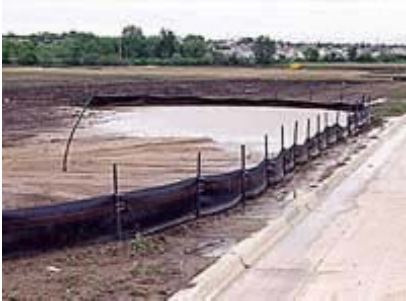
<p align="center">"J" hook</p>

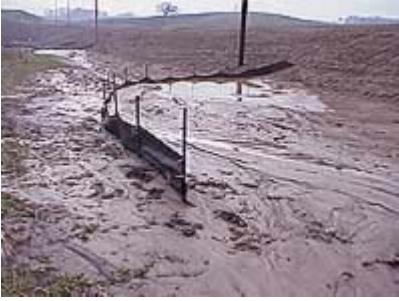
<p align="center">Silt needs to be removed</p>

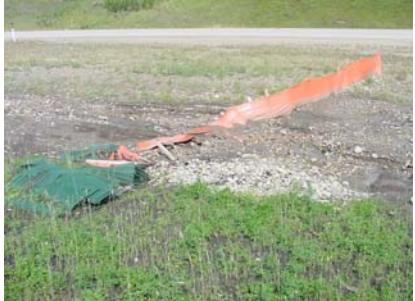
<p align="center">H43:12 Silt fence not intercepting flow – need repair</p>
Rolled Erosion Control Blankets (BMP 13)

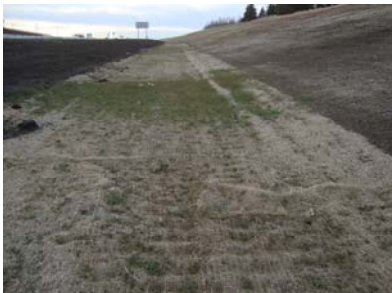
<p align="center">H16/H21 Interchange Installation of straw RECP in ditch</p>

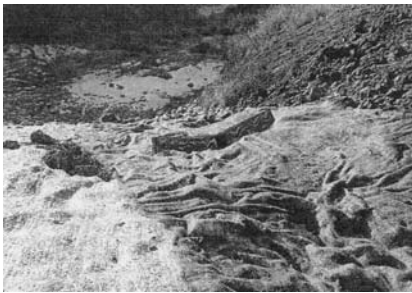
<p align="center">Improper blanket installation</p>

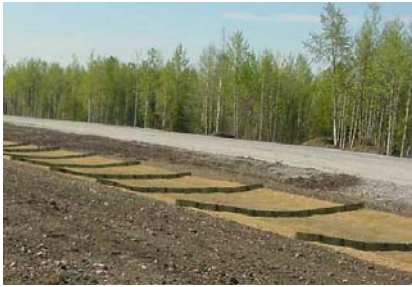
<p align="center">H43:10 Good installation of permeable barriers properly spaced</p>

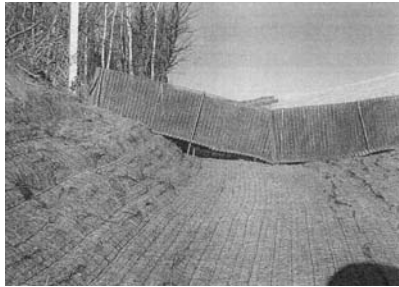
<p align="center">Improper installation of permeable barrier</p>

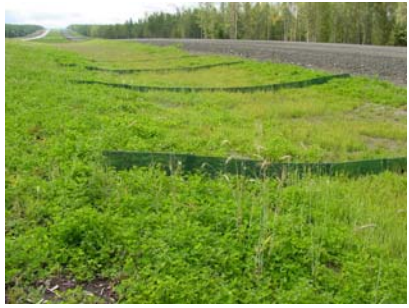
<p align="center">H43:10 Vegetation has established - permeable barriers may be removed</p>
Synthetic Permeable Barriers (BMP 10)

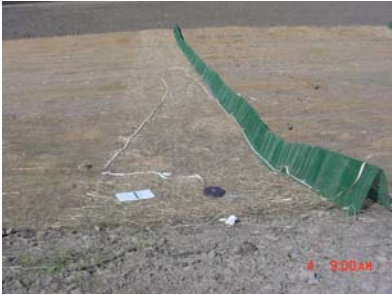
<p align="center">H43:10 Proper installation of permeable barriers with erosion control matting below</p>

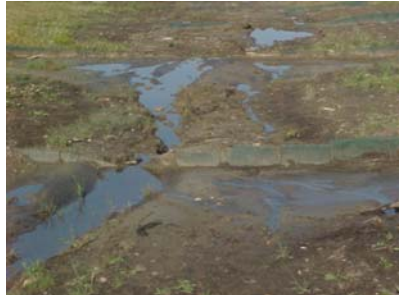
<p align="center">H43:12 Two Creeks Erosion of ditch below barriers and overtopping of water due to high silt accumulation</p>

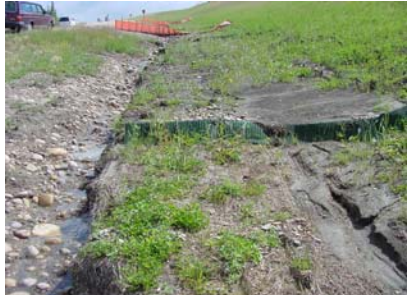
<p align="center">H43:12 Iosegun River Non-removal of silt resulting in switch over of water course</p>
Rock Ditch Creek (BMP 3)

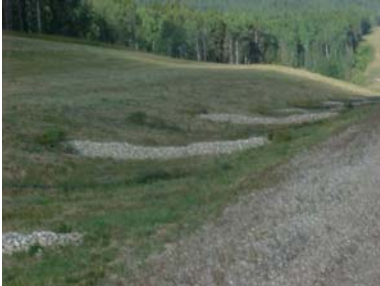
<p align="center">H43:12 Iosegun River Rock ditch check</p>

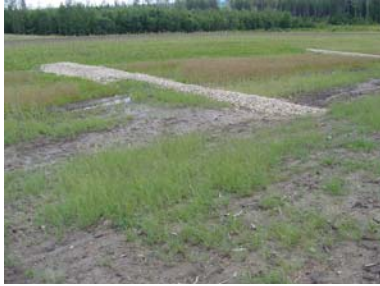
<p align="center">H43:12 Iosegun River Collection of silt on uphill side of rock ditch check</p>

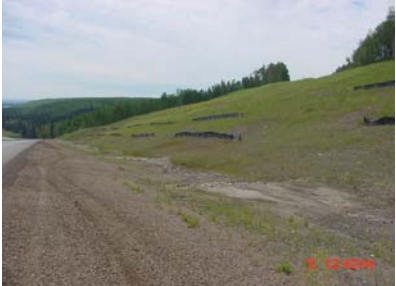
<p align="center">H63:12 Poplar Creek Accumulation of silt on uphill side of rock ditch check</p>

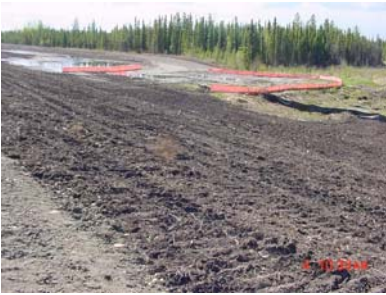
<p align="center">H43:10 "Smile" shape</p>

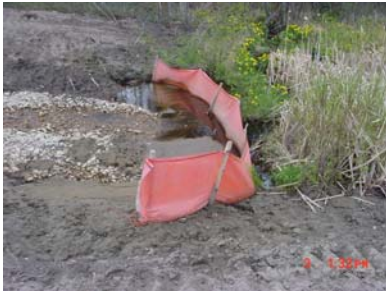
<p align="center">H43:12 Silt fence works but need a little repair</p>
