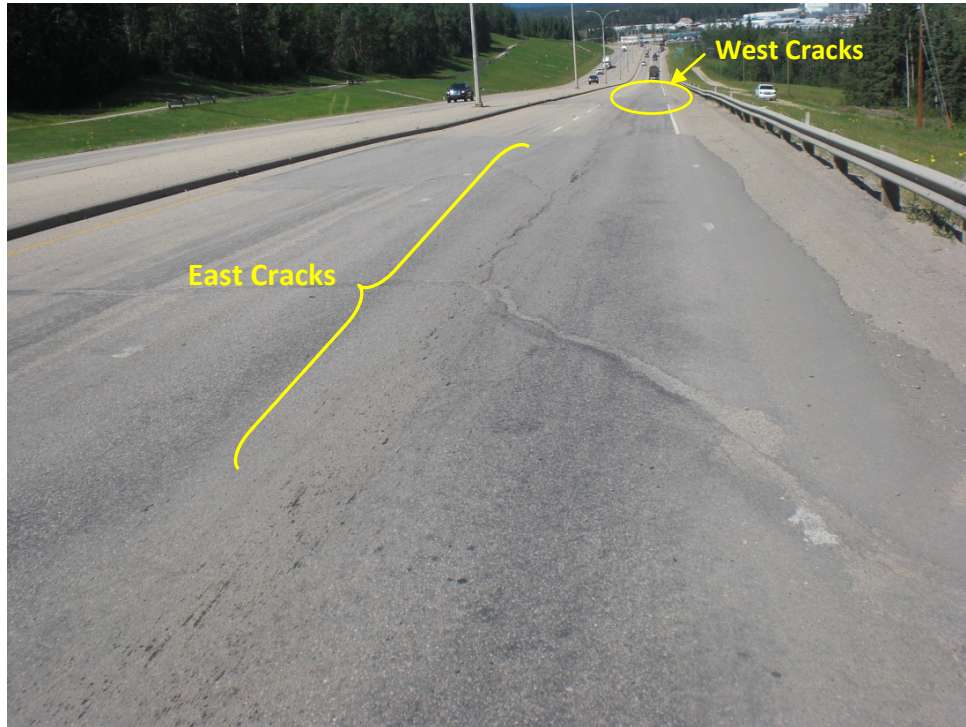
Photo 1: East crack (note west crack in distance).

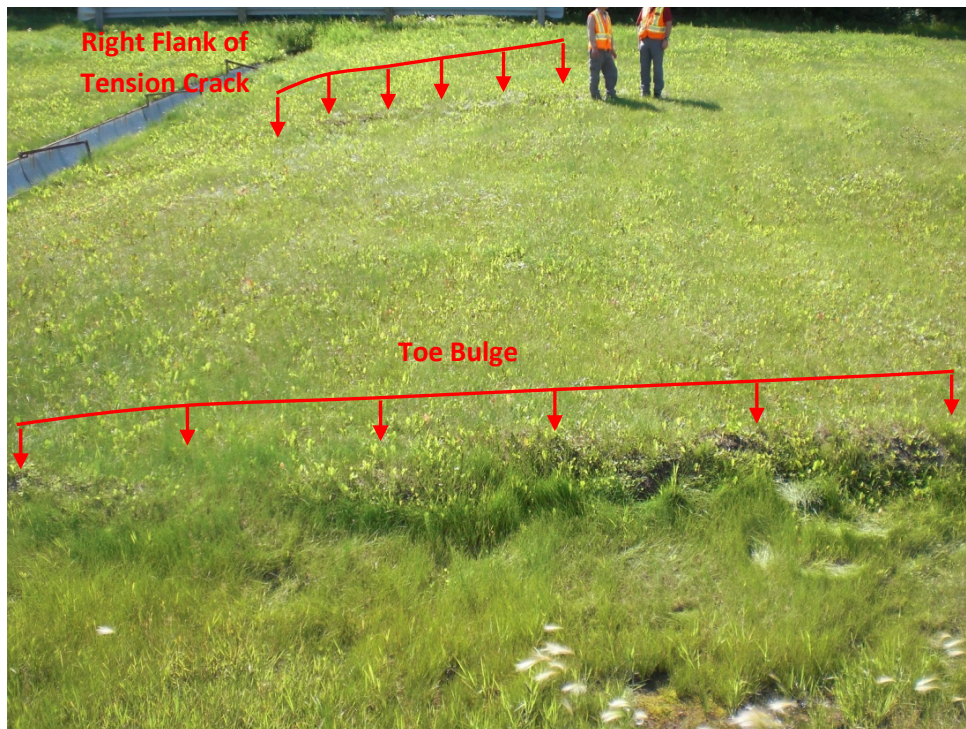
Photo 2: Tension crack and toe bulge, south of Highway 43.

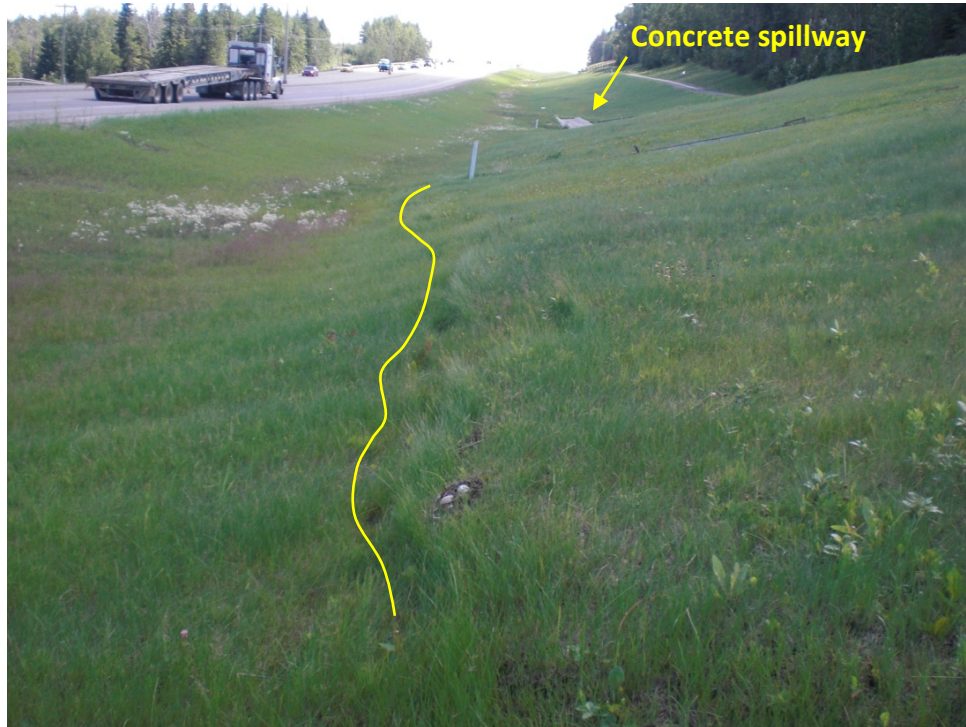
Photo 3: Toe bulge on south side of highway, facing east.

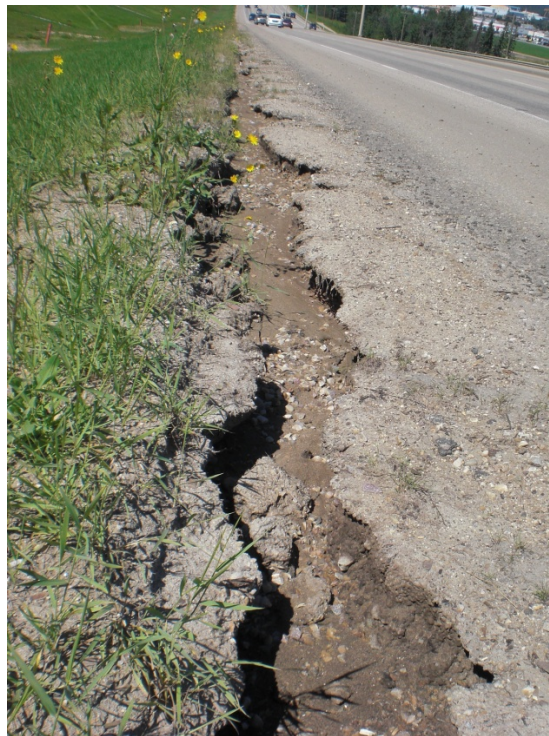
Photo 4: Erosion along outside shoulder of eastbound lanes.

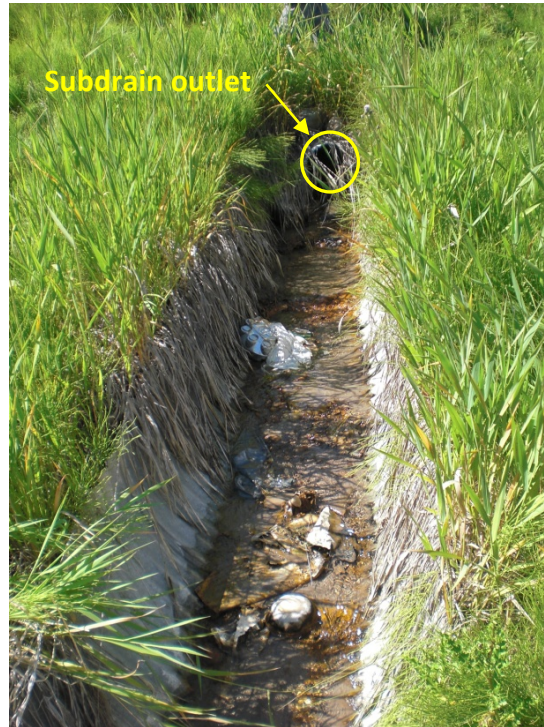
Photo 5: Subdrain outlet and debris accumulation in half-round culvert.

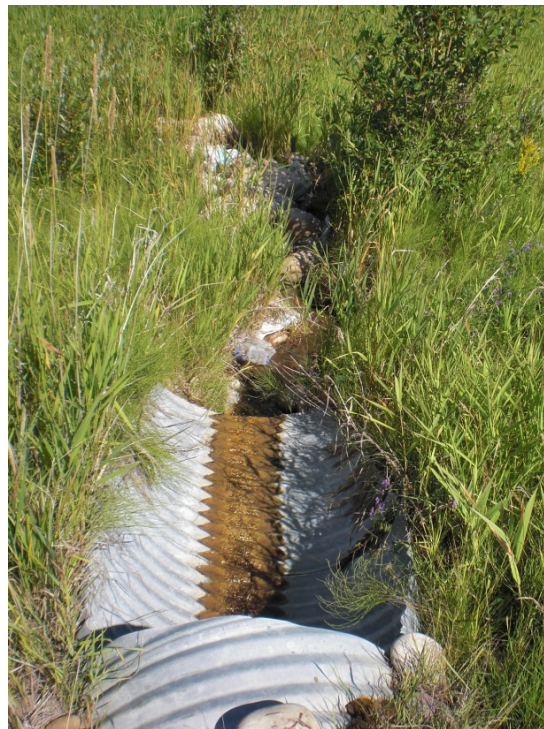
Photo 6: Debris collecting at culvert outlet at approximately station 1+600.

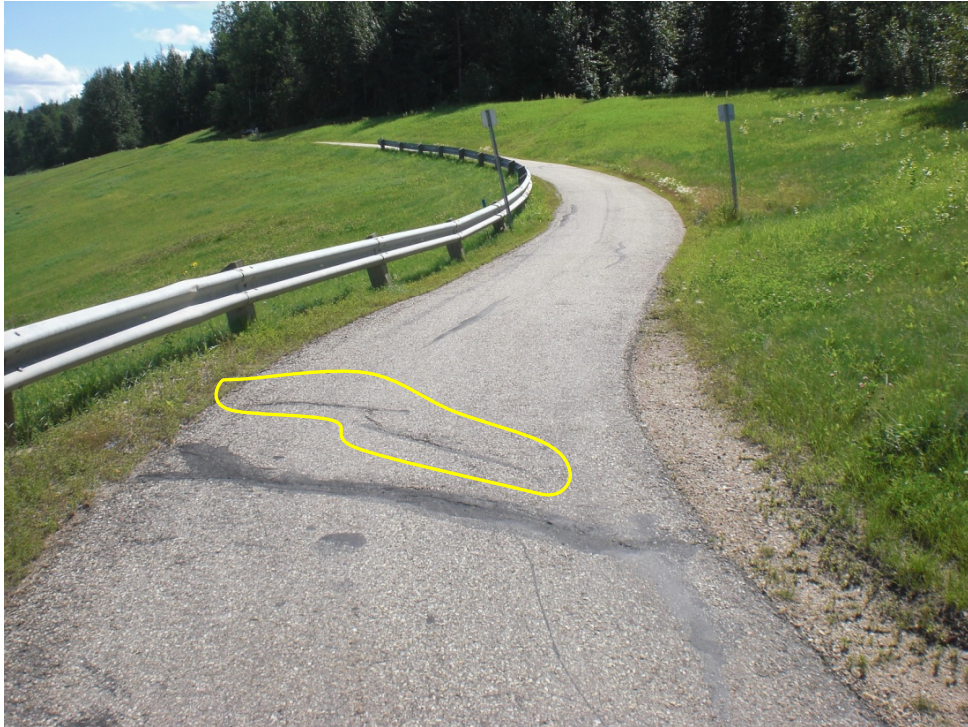
Photo 7: Crack in paved trail above bin wall reflecting through seal.
