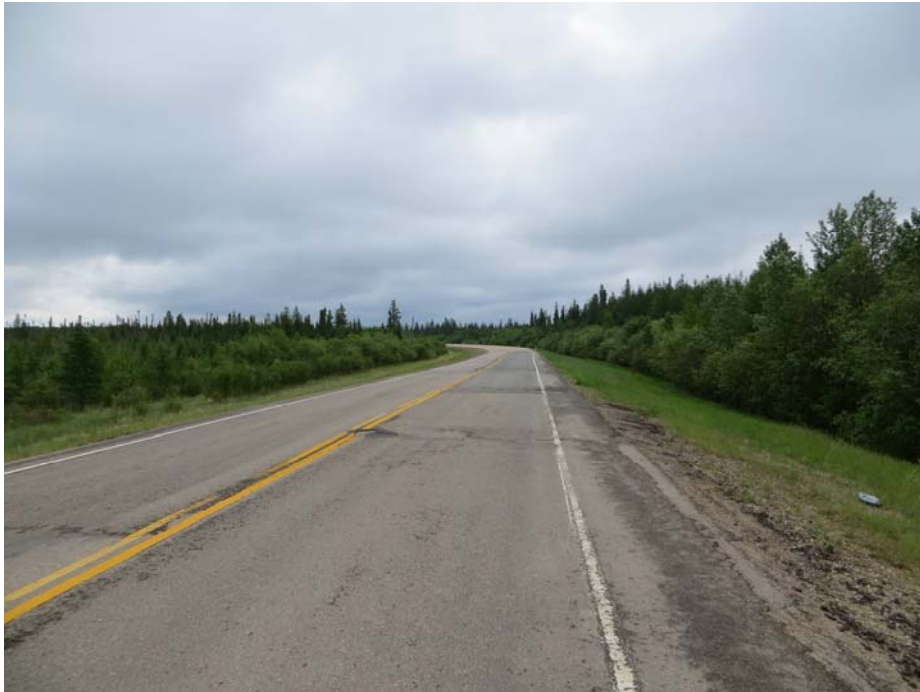
**Photo #1** Looking east at the highway surface. Existing patch defines the limits of the repair

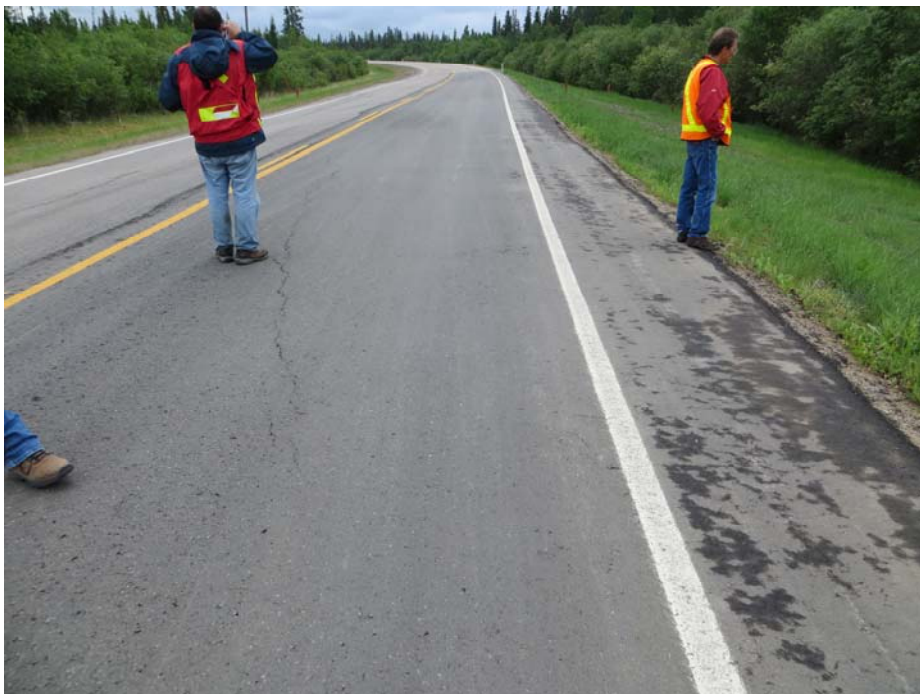
**Photo #2** Looking east from the western flank of the landslide at a reflective diagonal crack in the highway EBL

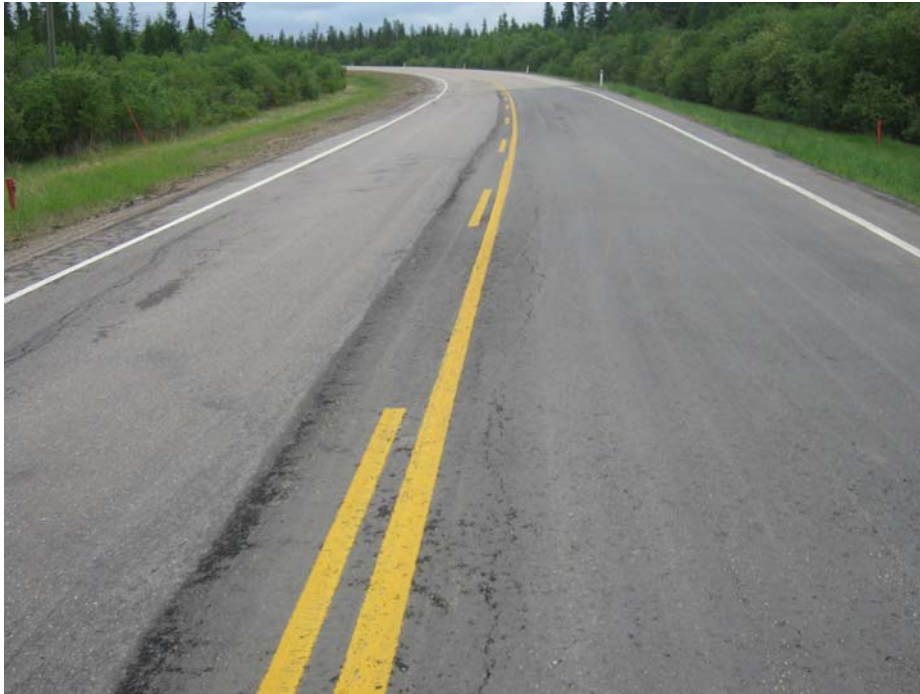
**Photo #3** Looking east from the middle of the landslide at longitudinal reflective crack on the highway EBL

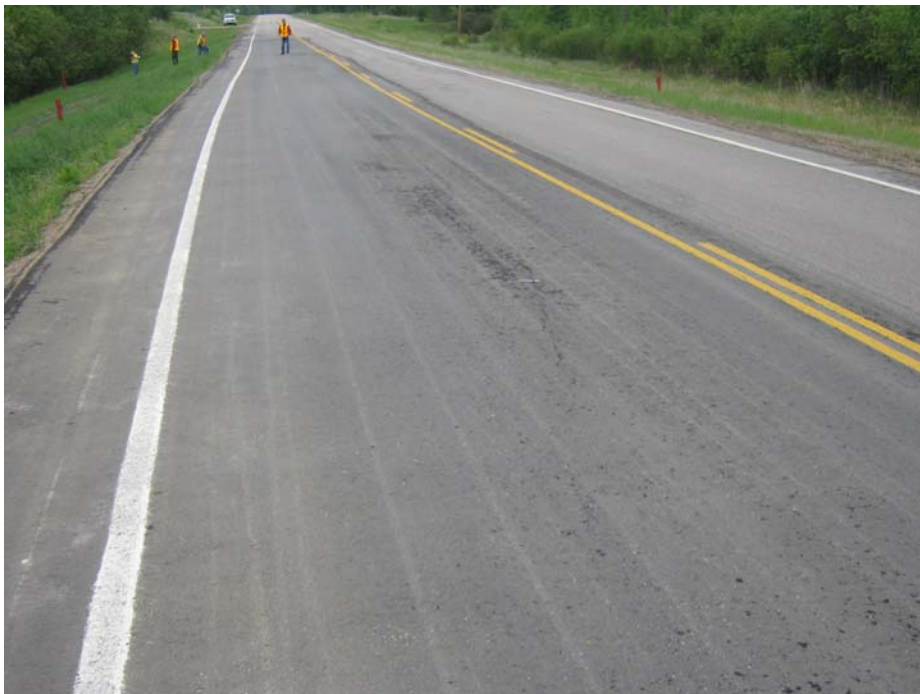
**Photo #4** Looking west from the eastern limit of the landslide at a diagonal reflective crack; note the dip on the highway EBL surface near the western limit of the patched area

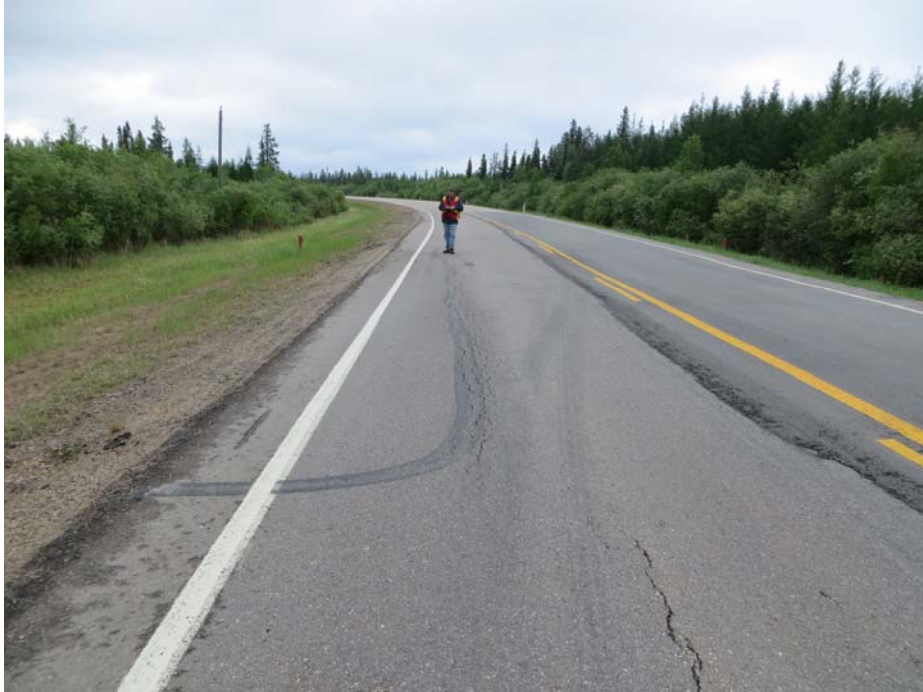
**Photo #5** Looking east at open longitudinal cracks on the highway WBL

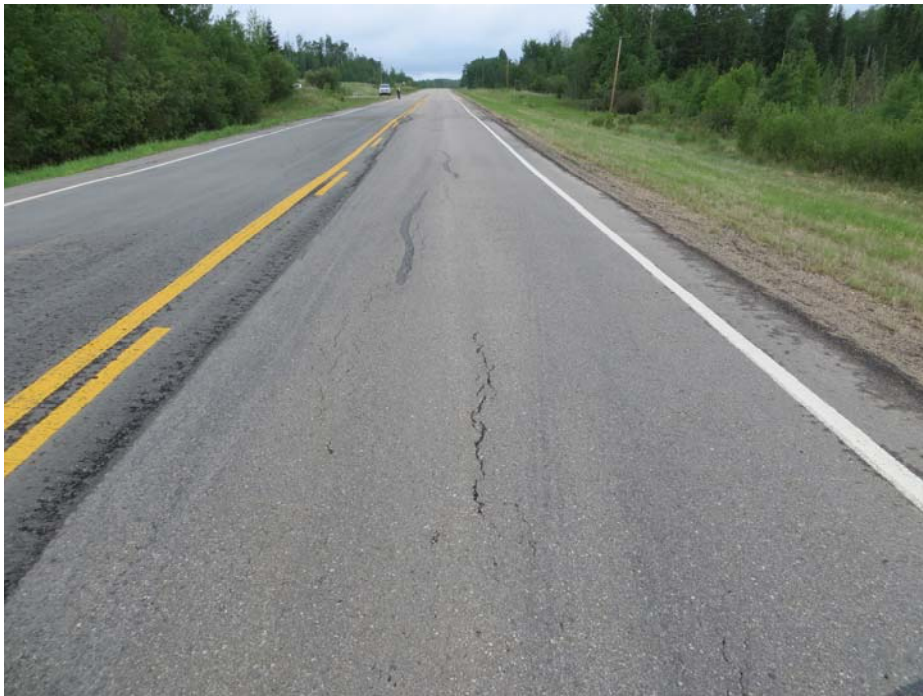
**Photo #6** Looking west at additional set of longitudinal cracks on the highway WBL
