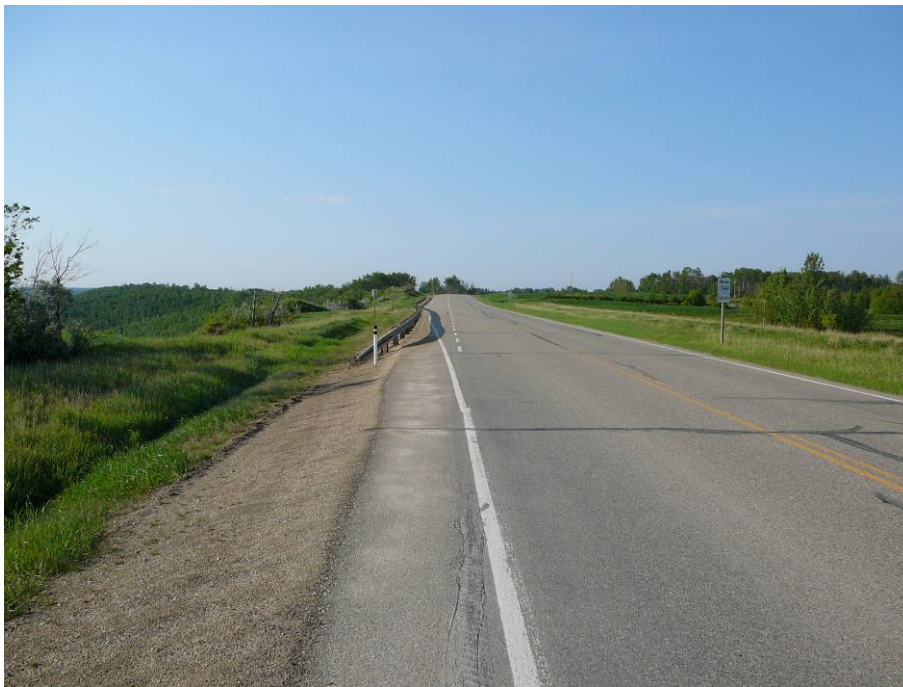
Photo 1.

View looking south along Hwy 744, showing the lay-by, starting at the guardrail at the left of the picture.

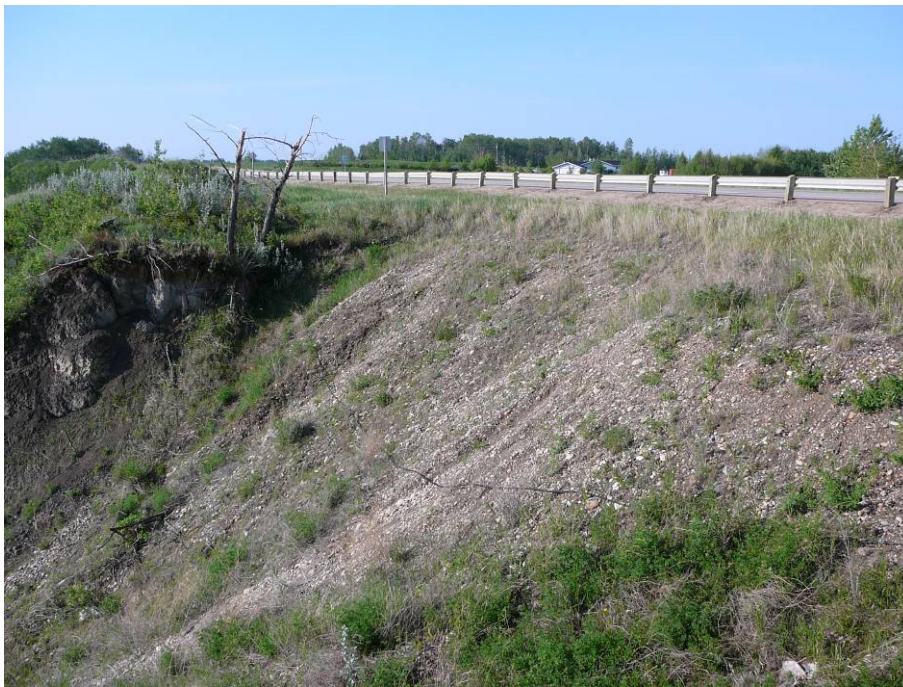
Photo 2.

Slide 1 at the north end of the site. There is no fresh slide movement visible from the crest of the slope. This slide area was repaired by re-grading and improving drainage some time prior to 2004.

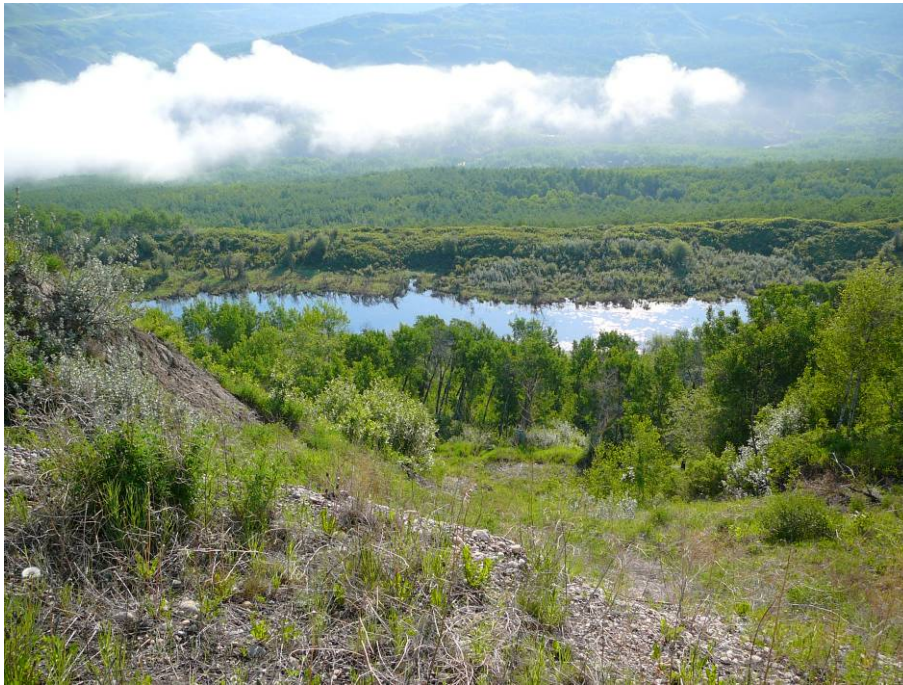
Photo 3.

Looking down-slope (eastwards) at Slide 1. No significant changes since the inspection in 2007. Note the water in the sag pond above the Heart River.

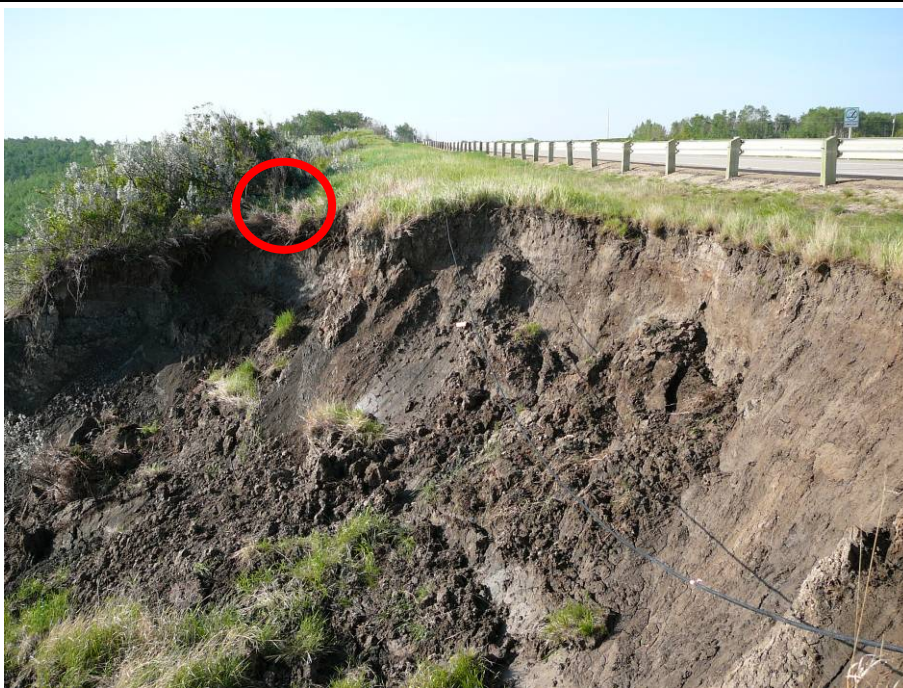
Photo 4.

Looking south along the backscarp of Slide 2. The backscarp shows fresh movement, and has expanded laterally, but has only retrogressed by around 20 cm since the last inspection in 2007. The indistinct scarp on the south side of the slide (circled) has a roughly 0.75 m vertical offset.

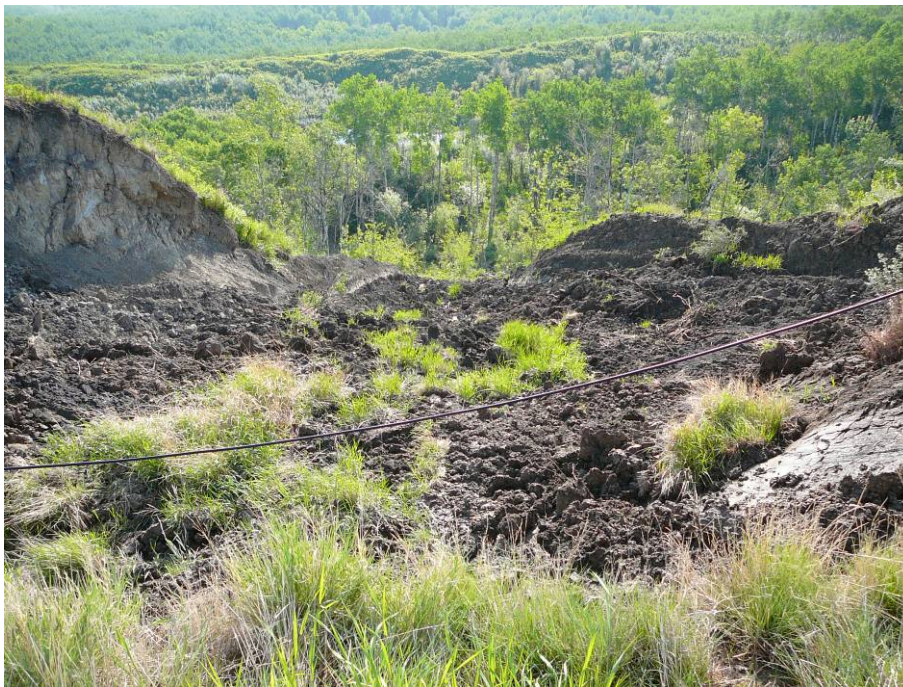
Photo 5.

Looking down-slope at Slide 2. There is fresh movement in the slide bowl, and water ponded in the debris.

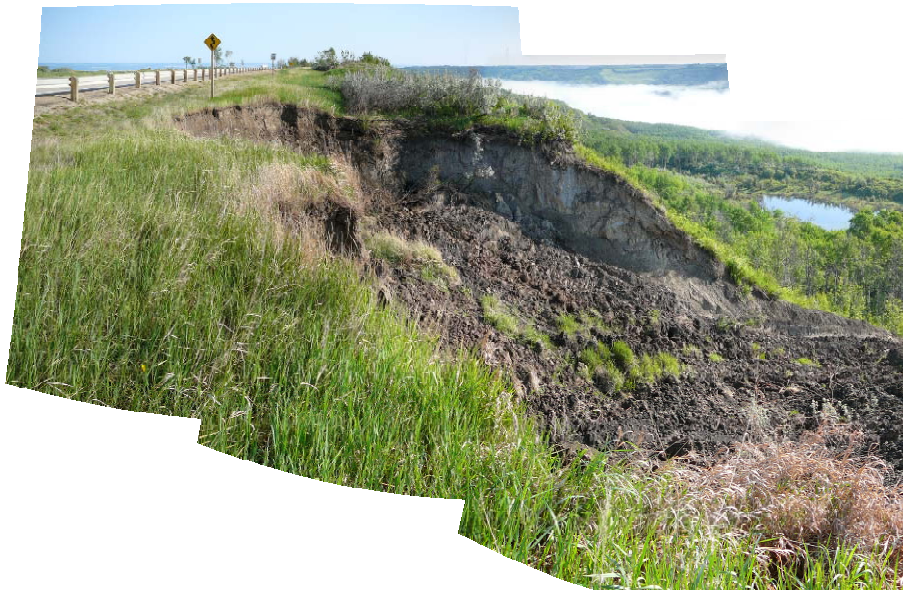
Photo 6.

Looking northwards at Slide 2 showing fresh debris in the slide bowl.

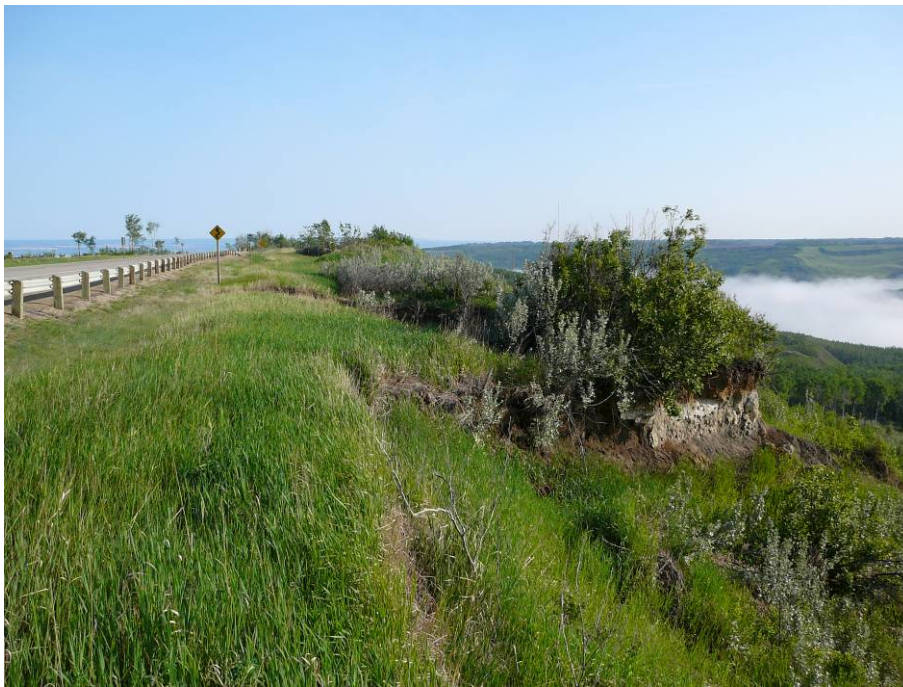
Photo 7.

Backscarp of Slide 3 – no fresh movement at the backscarp, but the area of fresh movement noted down-slope is still there.

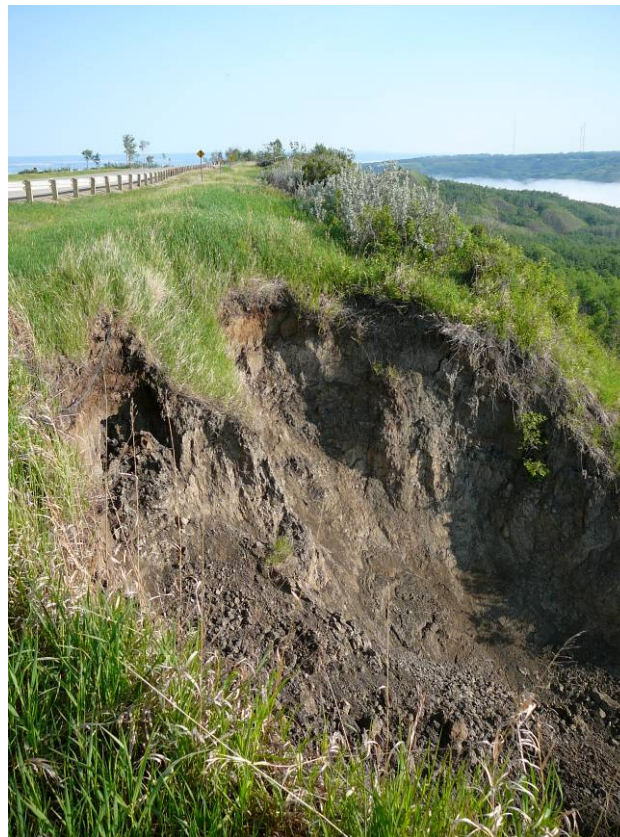
Photo 8.

Backscarp of Slide 4 with fresh movement since the 2007 inspection. The backscarp is roughly 5 m high and 17 m wide, and appears to have retrogressed by up to 0.5 m.

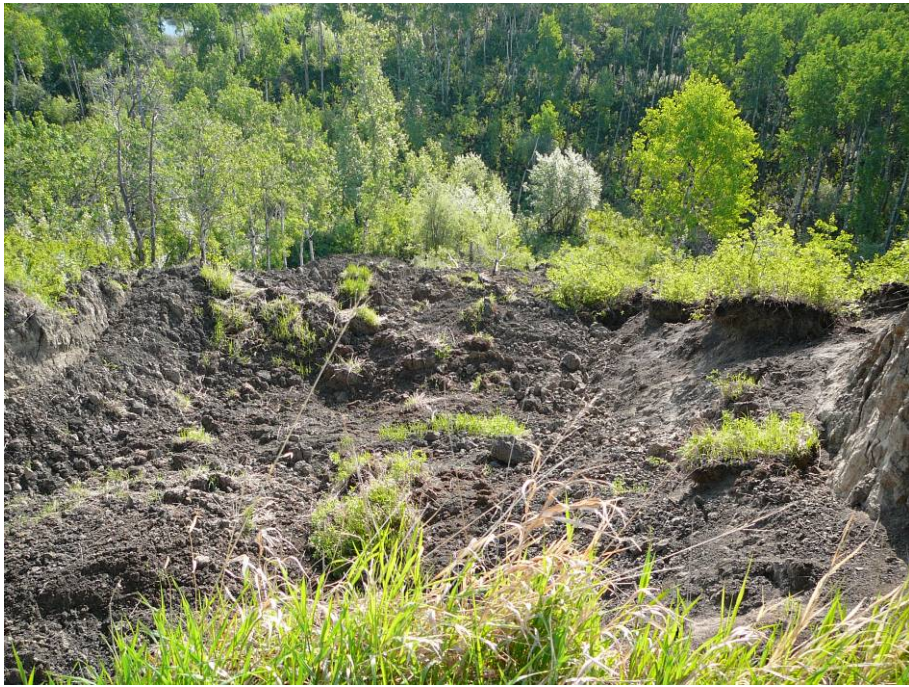
Photo 9.

Looking downhill from
the backscarp of
Slide 4.
