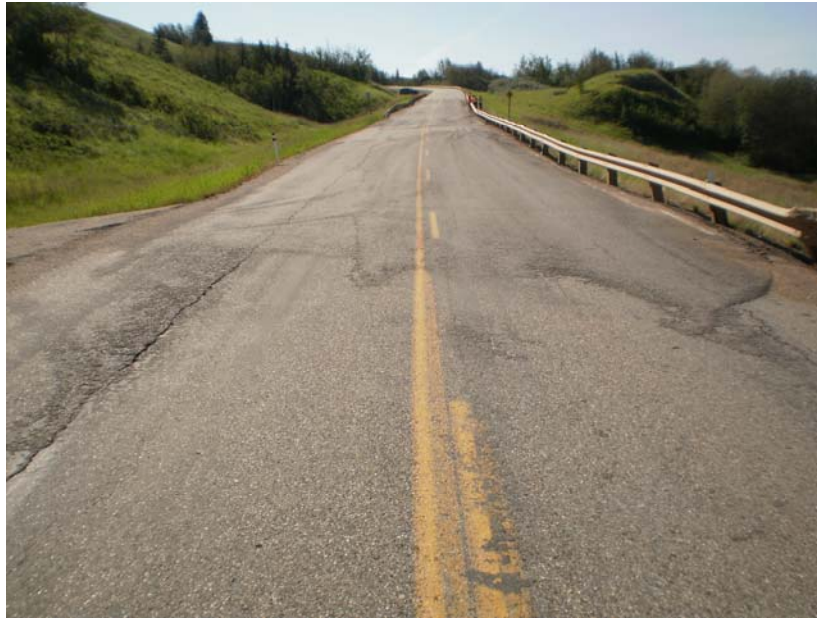
Photo 1 - Looking east along the highway over the Grimms Creek site area.
Note the ACP patches and the dip in the highway.

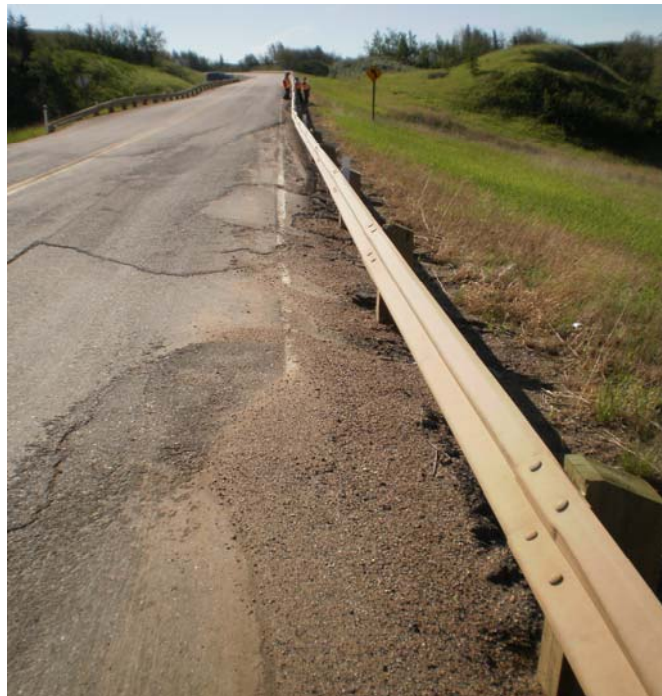
Photo 2 – Looking east along the downstream embankment and guardrail.

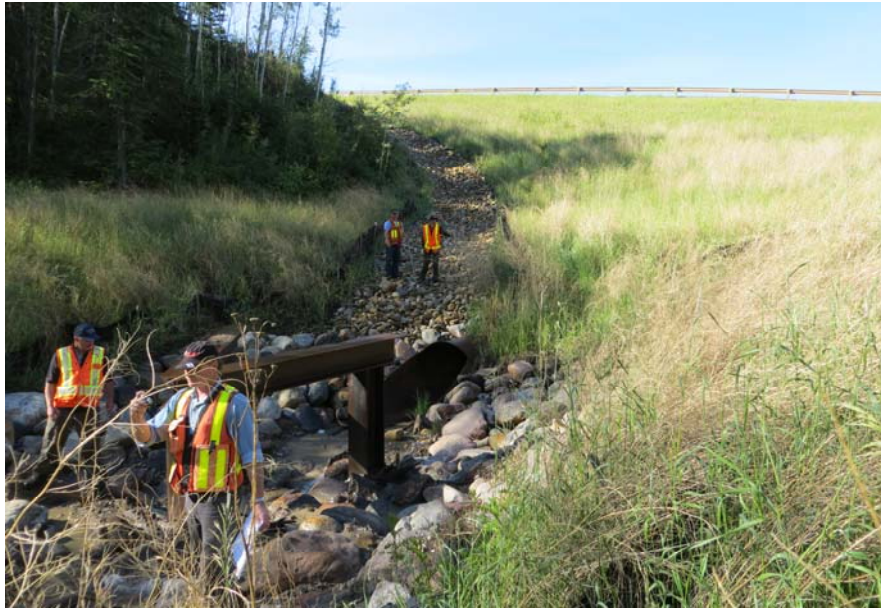
Photo 3 - Looking southeast at the culvert inlet area.

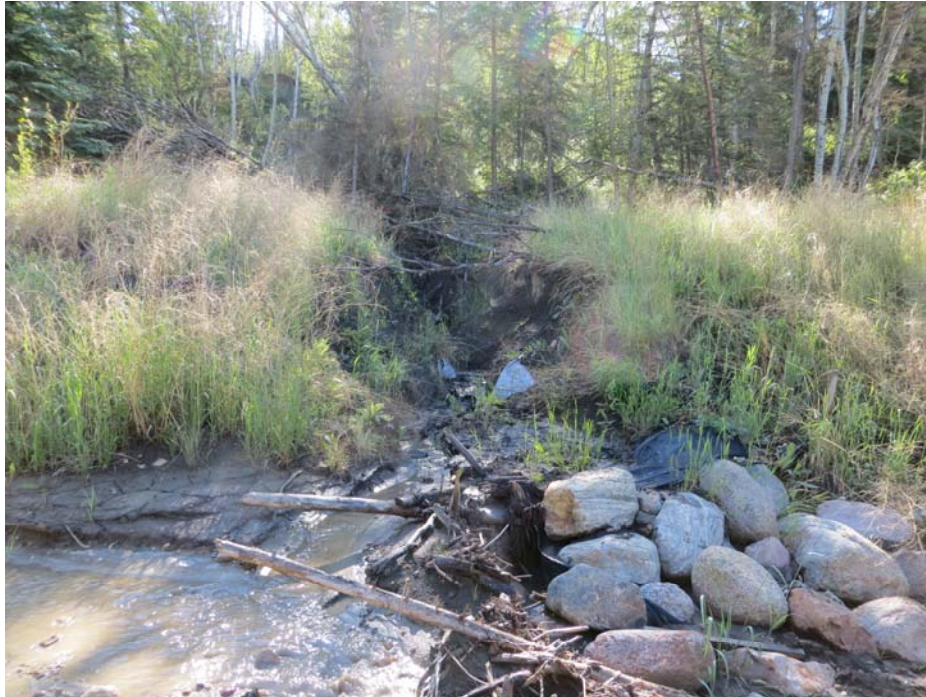
Photo 4 - Looking east at a 10 m long x 1.5 m deep erosion gully that has enlarged on the east side of the channel in front of the culvert inlet.

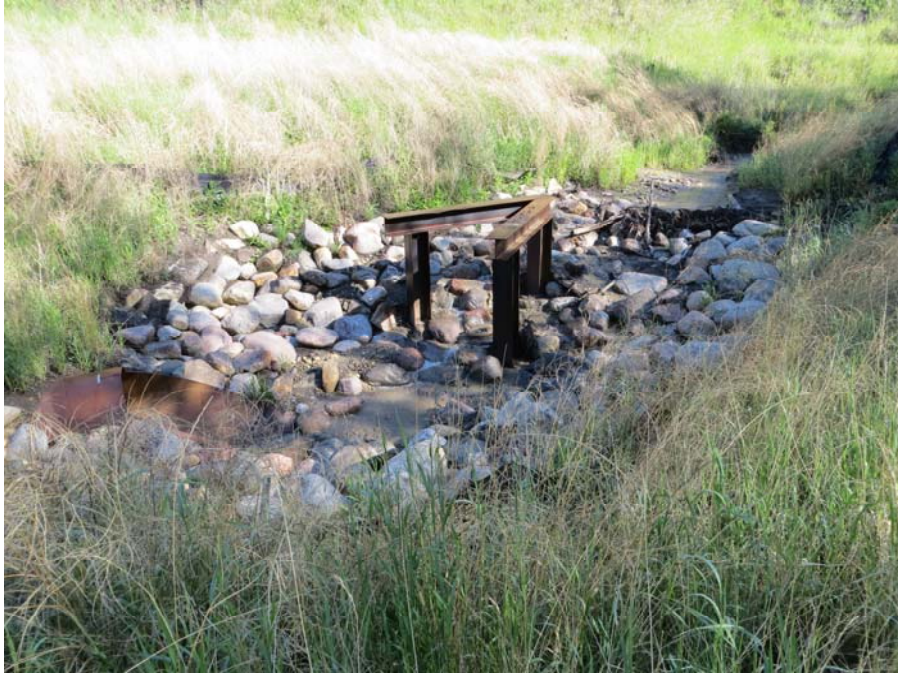
Photo 5 - Looking north along the eroded channel upstream of the culvert inlet.

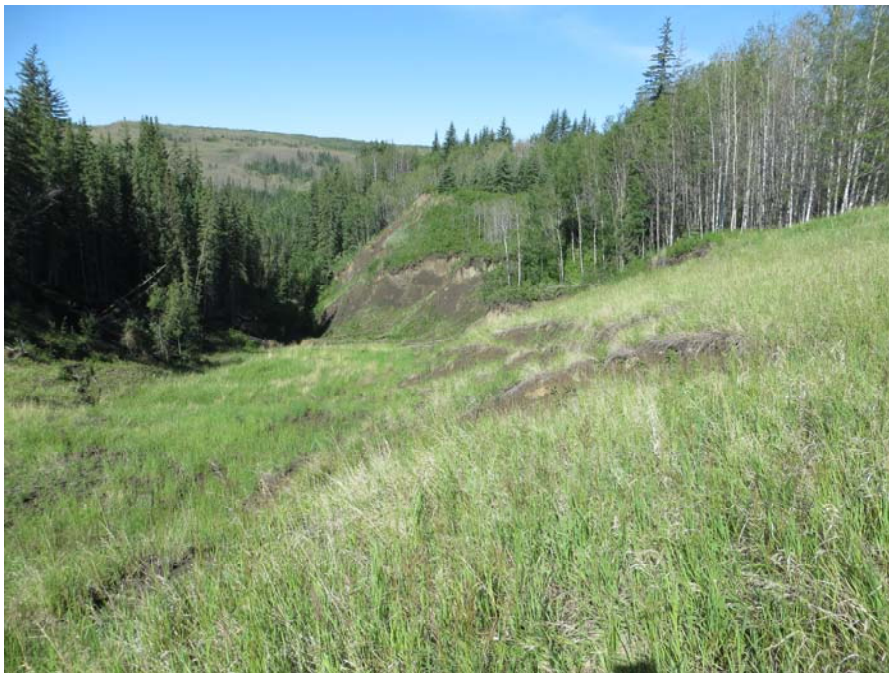
Photo 6 – Looking southwest across the downstream highway embankment at the previous culvert outlet area.

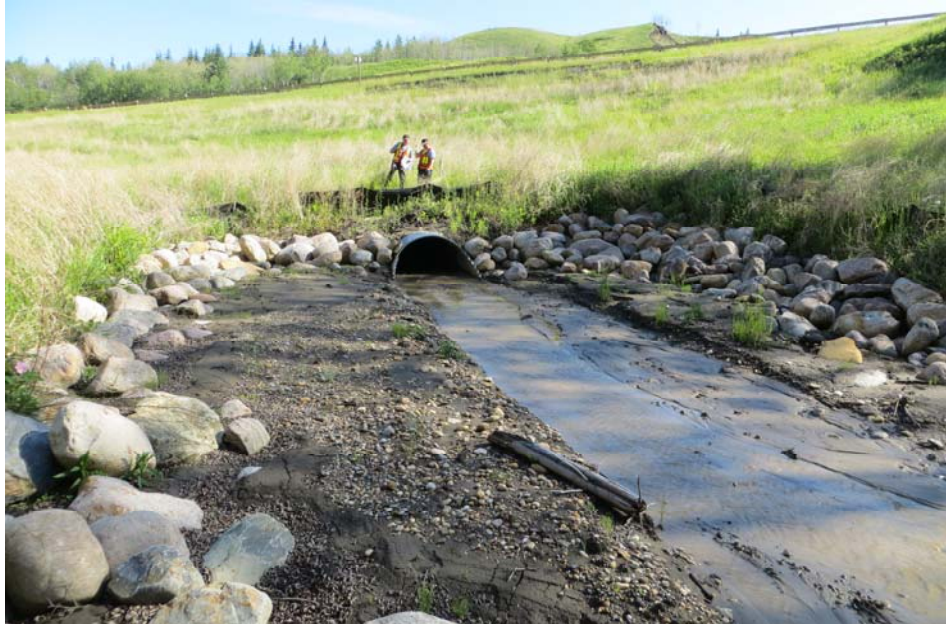
Photo 7 - Looking northwest at the new culvert outlet. It is about 50% full of sediment.

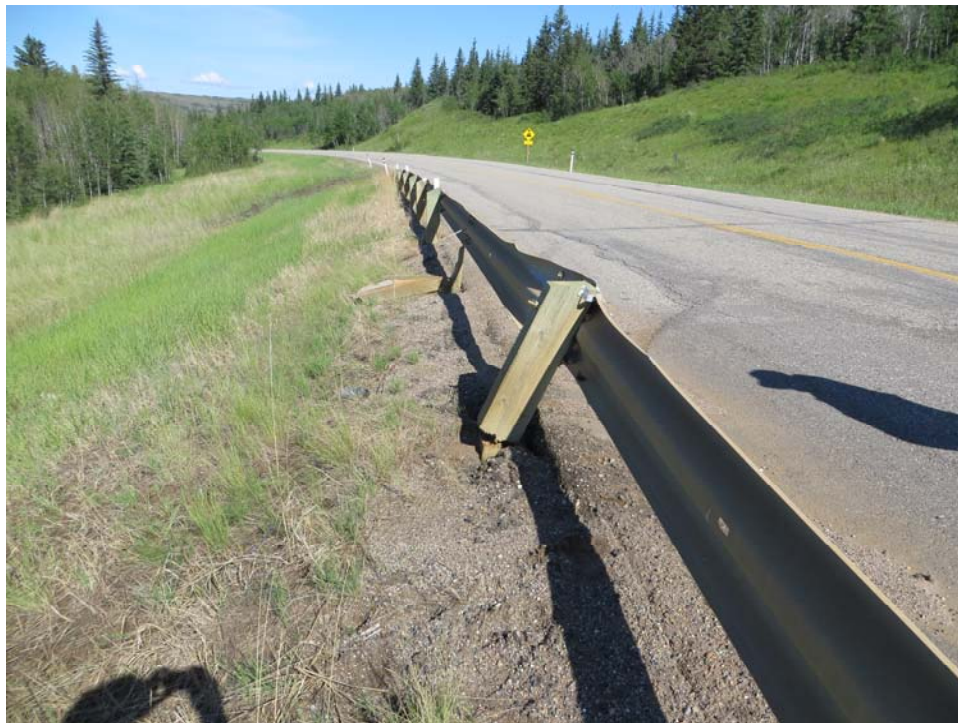
Photo 8 - Looking west along the south guardrail that is damaged.
