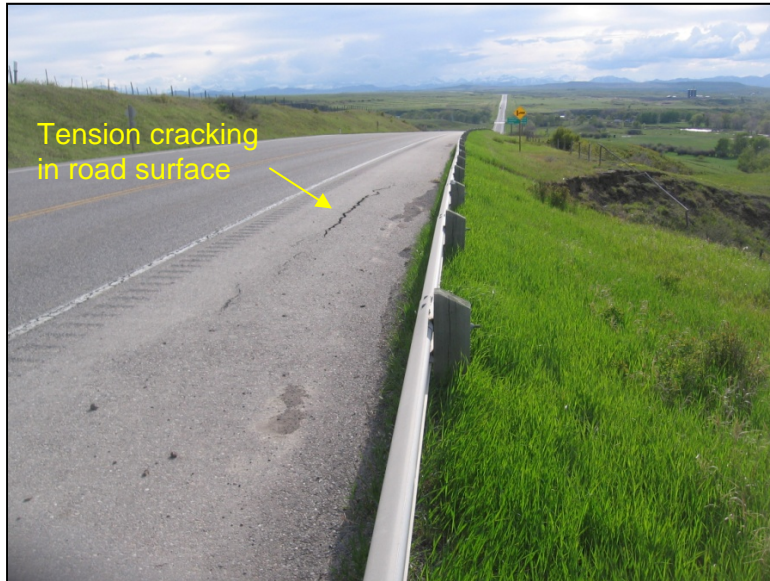
Photo 1 (June 1, 2011)
Facing westbound along the highway with the position of the recent tension cracking along the north shoulder as marked. The landsliding in the valley slope is visible on the right hand side of the photo, just downslope of the highway.

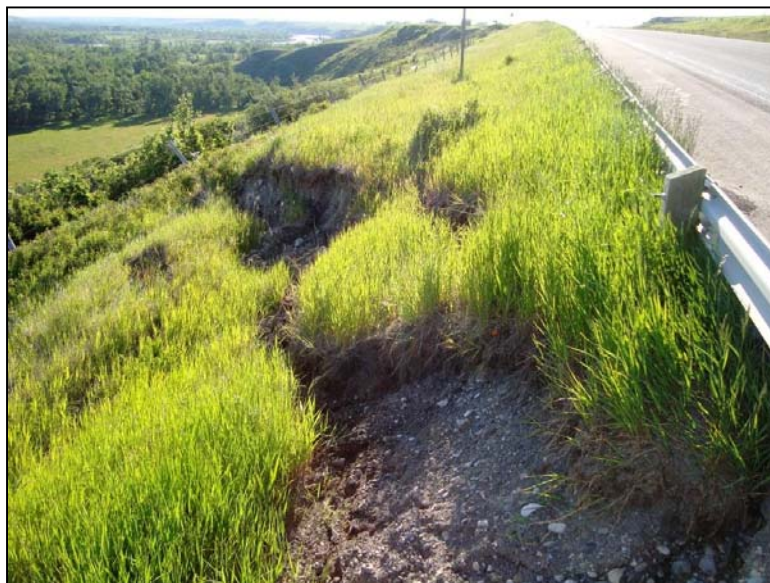
Photo 2 (June 21, 2011)
Facing east along the north/downslope edge of the road at the landslide headscarp. The headscarp has fresh soil exposed, and is immediately adjacent to the road surface.

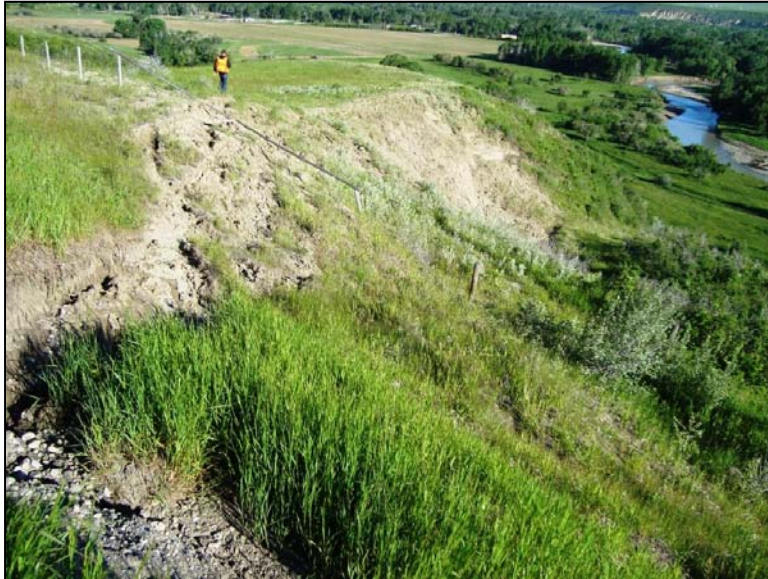
Photo 3 (June 21, 2011)
Facing northwest from the north edge of the road at the landslide headscarp. The west flank of the landslide is active. The slide is well developed, with slide movement likely ongoing for many years and having displaced the fenceline north of the road, as shown in this photo.

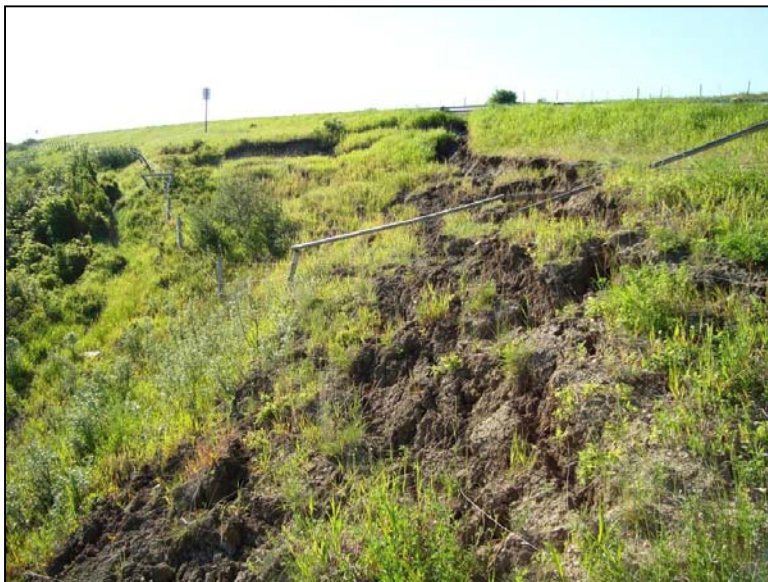
Photo 4 (June 21, 2011)
Facing southeast from the west flank of the landslide. Recent slide activity is visible (note also the displaced fenceline)

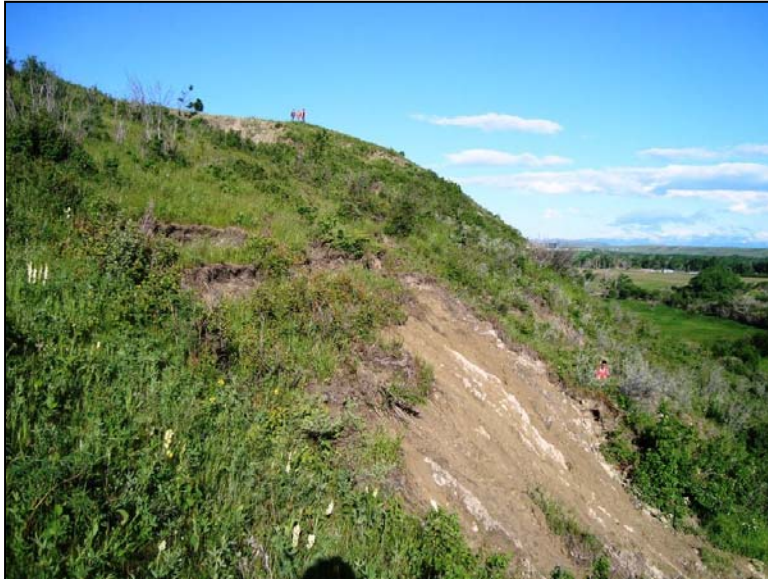
Photo 5 (June 21, 2011)
Facing west at an active secondary scarp on the slide mass. A large increment of movement occurred here recently. Slide activity appears to extend to a bedrock outcropping slightly below this location.

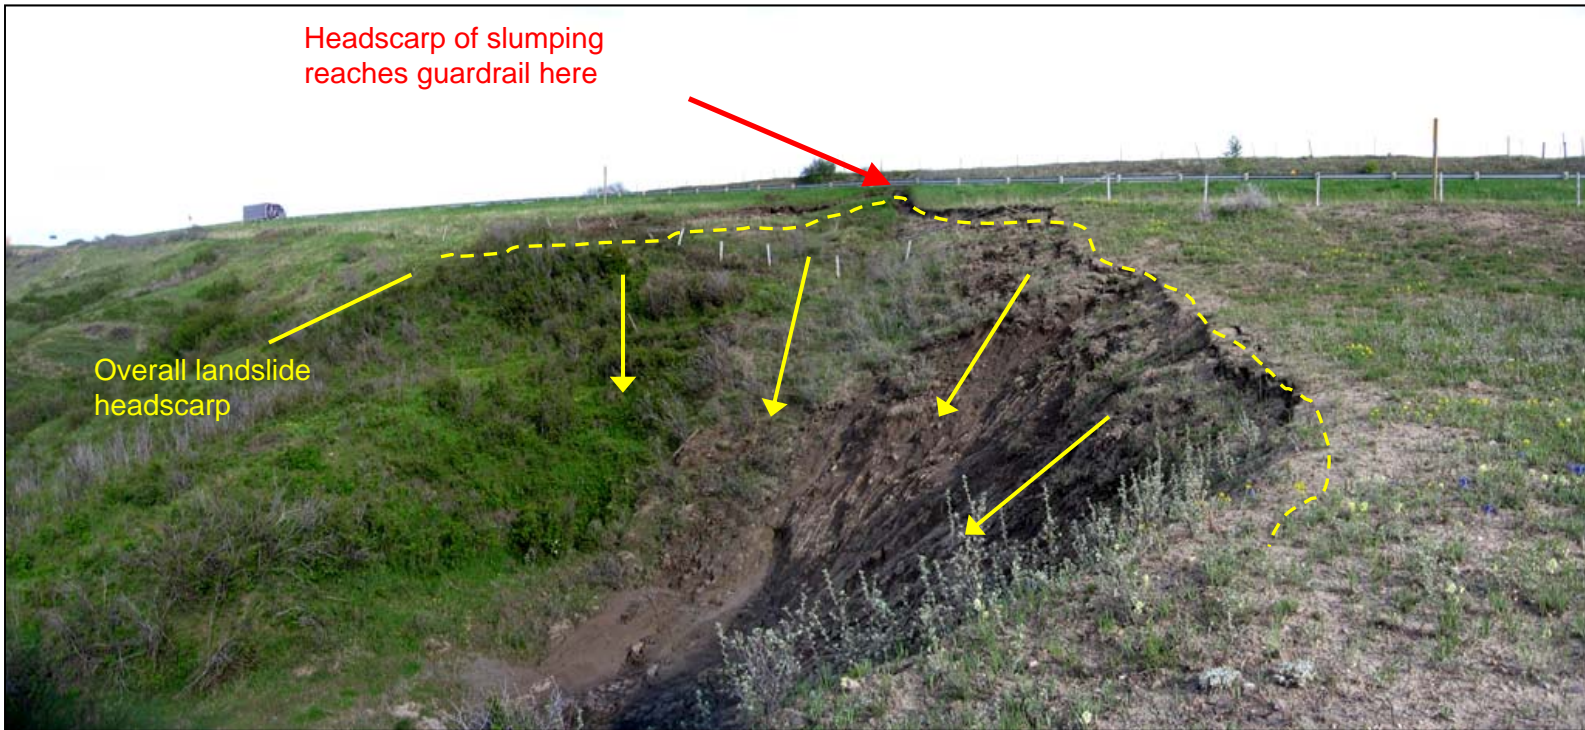
Photo 6 (June 1, 2011)

Facing upslope towards the upper portion of the landslide mass on the valley slope below the highway. The approximate location of the overall landslide headscarp is marked, as well as the point where the headscarp and gully erosion has reached the guardrail as of June 2011.
