## **ALBERTA TRANSPORTATION LANDSLIDE RISK ASSESSMENT**

### **SECTION A: GEOTECHNICAL FILE REVIEW**

#### **NORTH CENTRAL REGION - ATHABASCA**

**SITE NC72: HWY 2:46 GRADUATION ROCK BACKSLOPE SLUMP  
(km 42.5)**

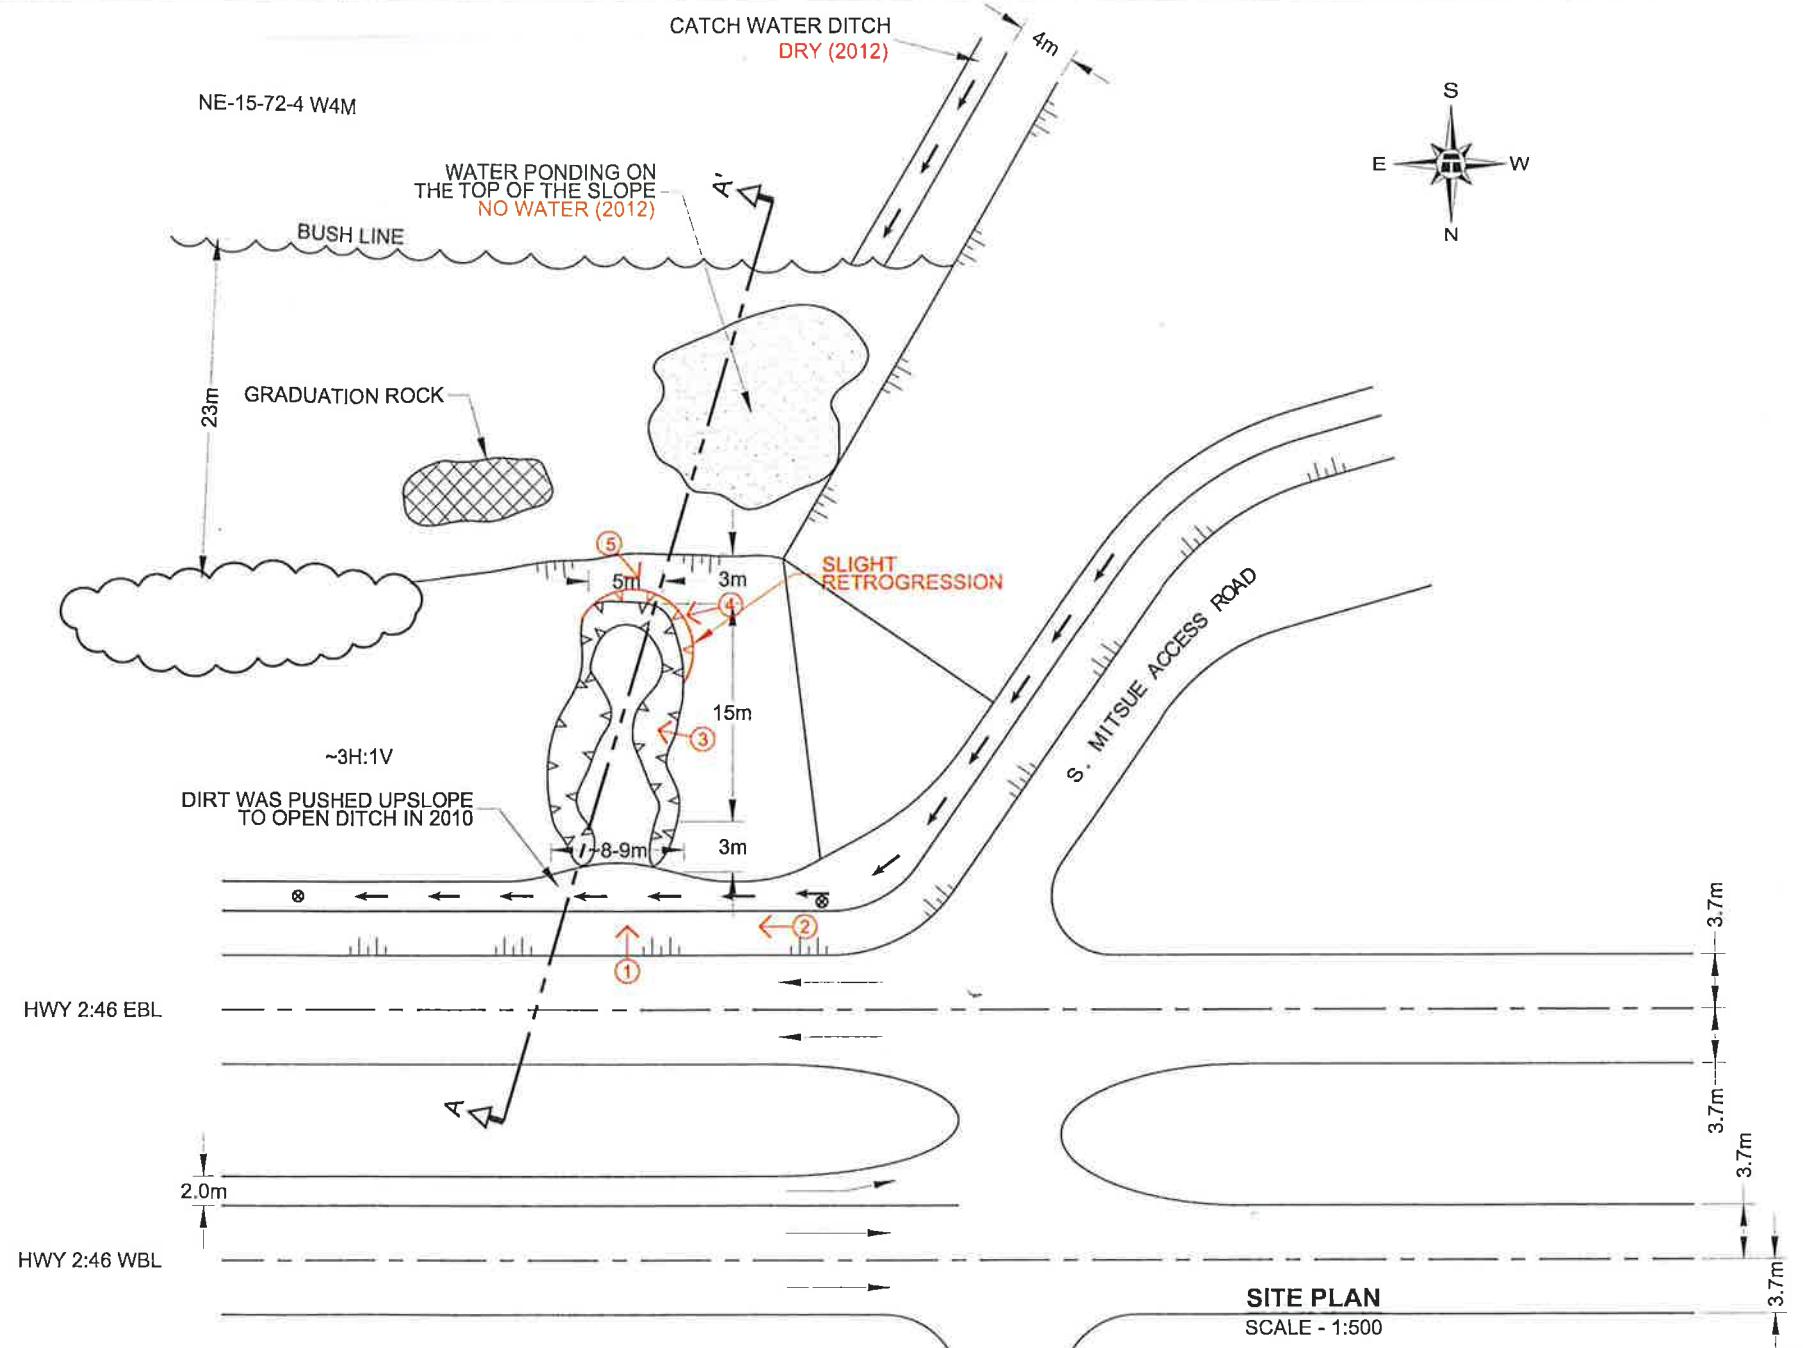
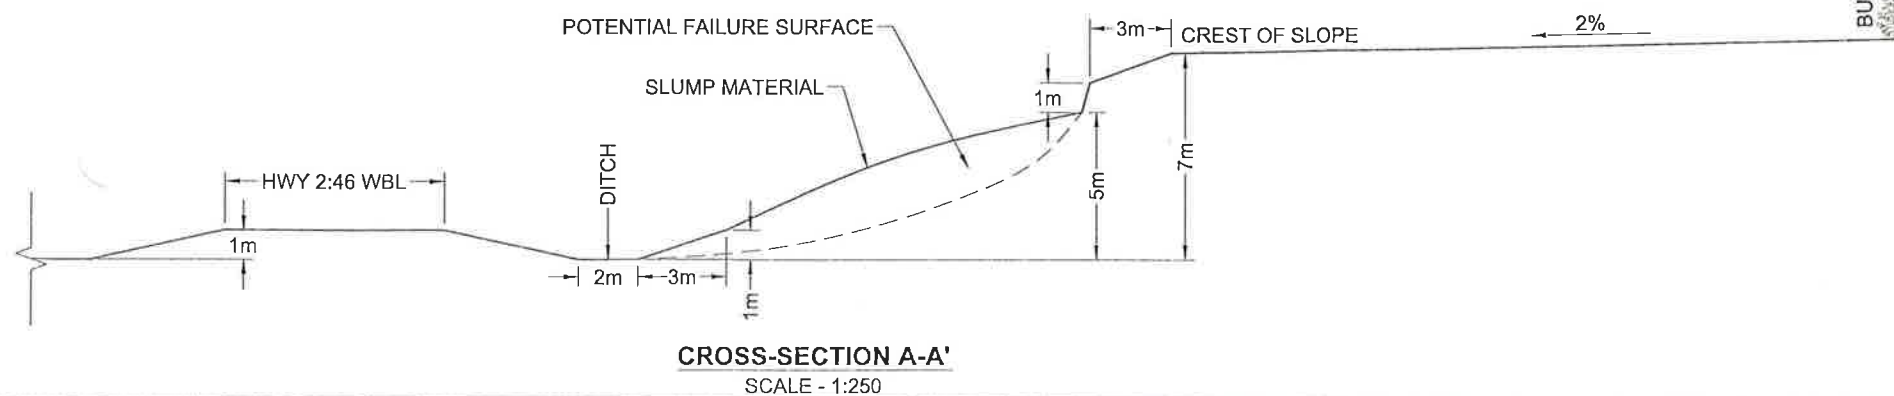
FIGURE NC72-1

A slump failure occurred within the south back slope of the highway at this location. The slump is about 5 to 8 m wide (parallel to highway) and 16 m long (parallel to slope surface). The slump debris kept accumulating in the highway east ditch and continued to impede surface drainage in the ditch. The slump failure did not appear to affect the highway surface. Details of the slide main features and a cross section are shown on Figure NC72-1.

Site inspection visits indicated that the existing catch water ditch on the top of the slope has been recharging the highway back slope. Presence of high ground water levels and highly erodible silty sand soils are the main trigger for the slump failure.

The site was added to the North Central Annual GeoHazard Assessment program and a site reconnaissance was carried out in June 2012. A slight retrogression of the headscarp cracks were observed. Some erosion was observed within the slump mass. The catch water ditch was dry during this site reconnaissance. The ditch flow was unimpeded. Vegetation grew within the slump mass.
