# **ALBERTA TRANSPORTATION NORTH CENTRAL REGION INSTRUMENTATION MONITORING RESULTS**

**FALL 2020**

**SITE NC004-1: HWY 55 / HWY 813 INTERSECTION (ATHABASCA)**

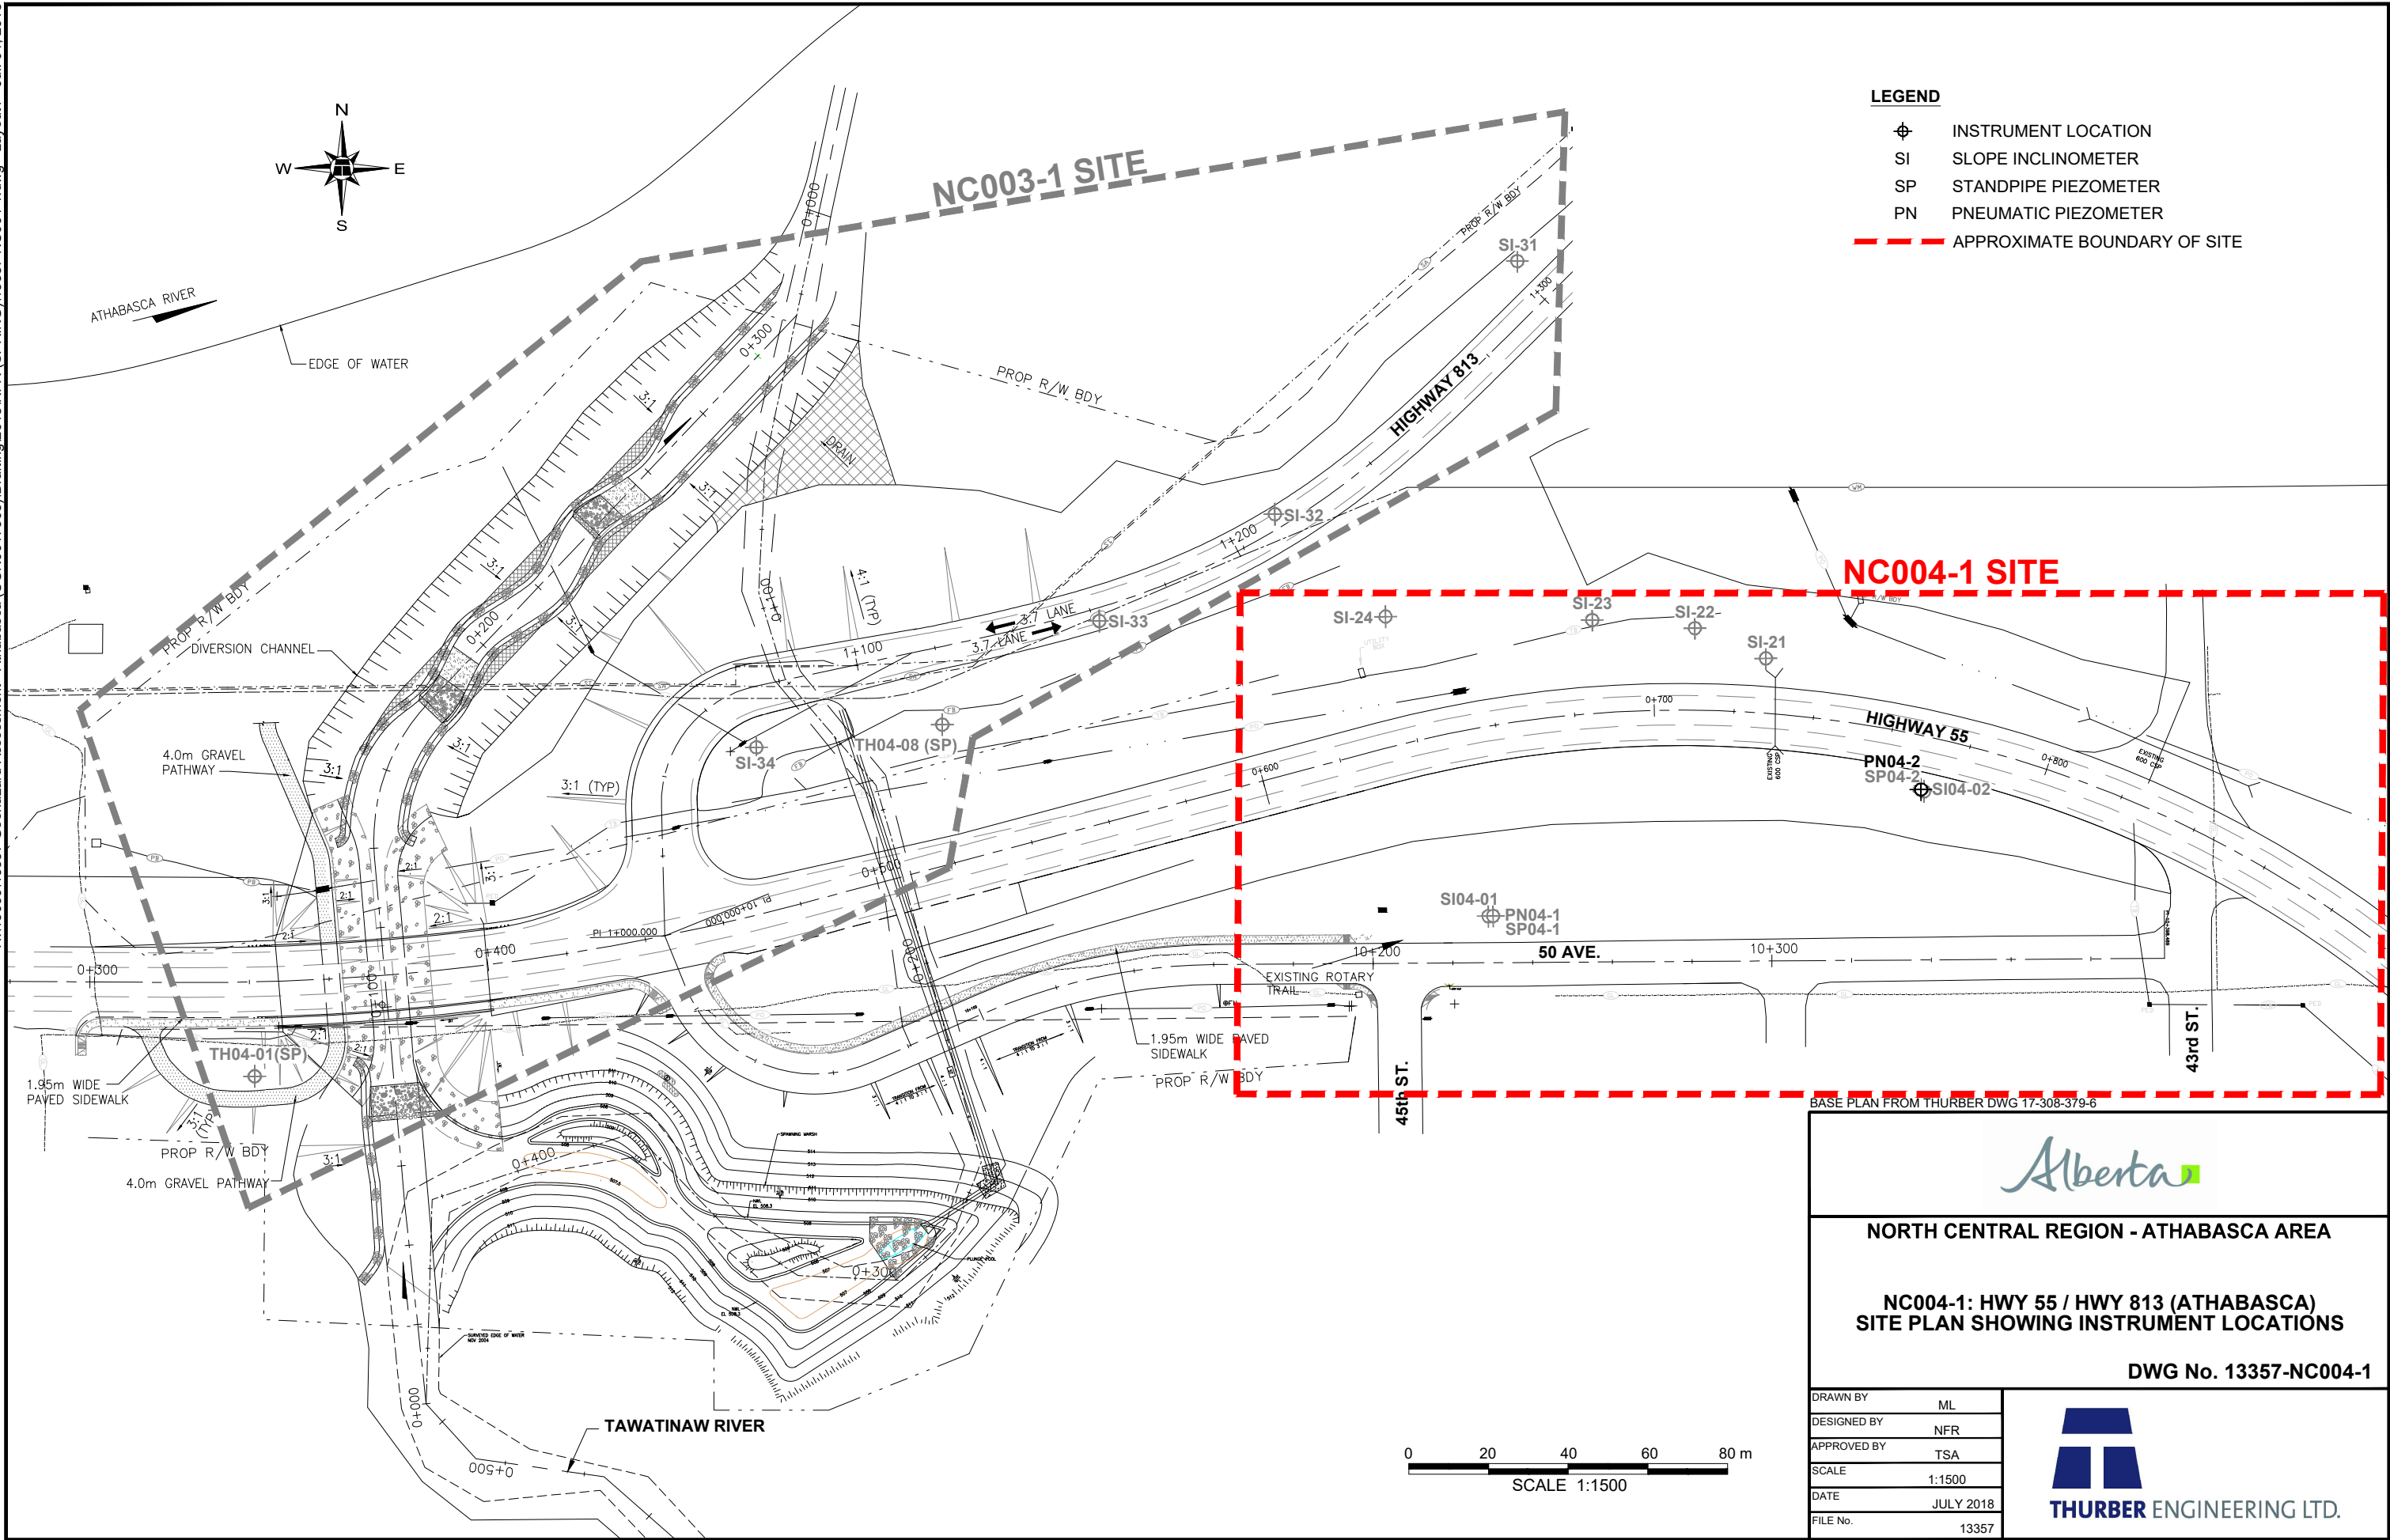
Figure 13357-NC004-1 in section D provides a sketch of the approximate location of the monitoring instrumentation for this site.
