**GEOHAZARD ASSESSMENT PROGRAM**  
**NORTH CENTRAL REGION – ATHABASCA**  
**2020 CALL OUT INSPECTION**

| Site Number | Location | Name | Hwy | km |
|---|---|---|---|---|
| NC XX | 35 km Northwest of the Junction of Hwy 2:46 and Hwy 44:04 | <b>Hwy 2:46 Bridge File 79193 North Embankment Landslide</b> | 2:46 | 38.77 |

| | Date | PF | CF | Total |
|---|---|---|---|---|
| Current Inspection: | June 19, 2020 | 13 | 5 | 65 |

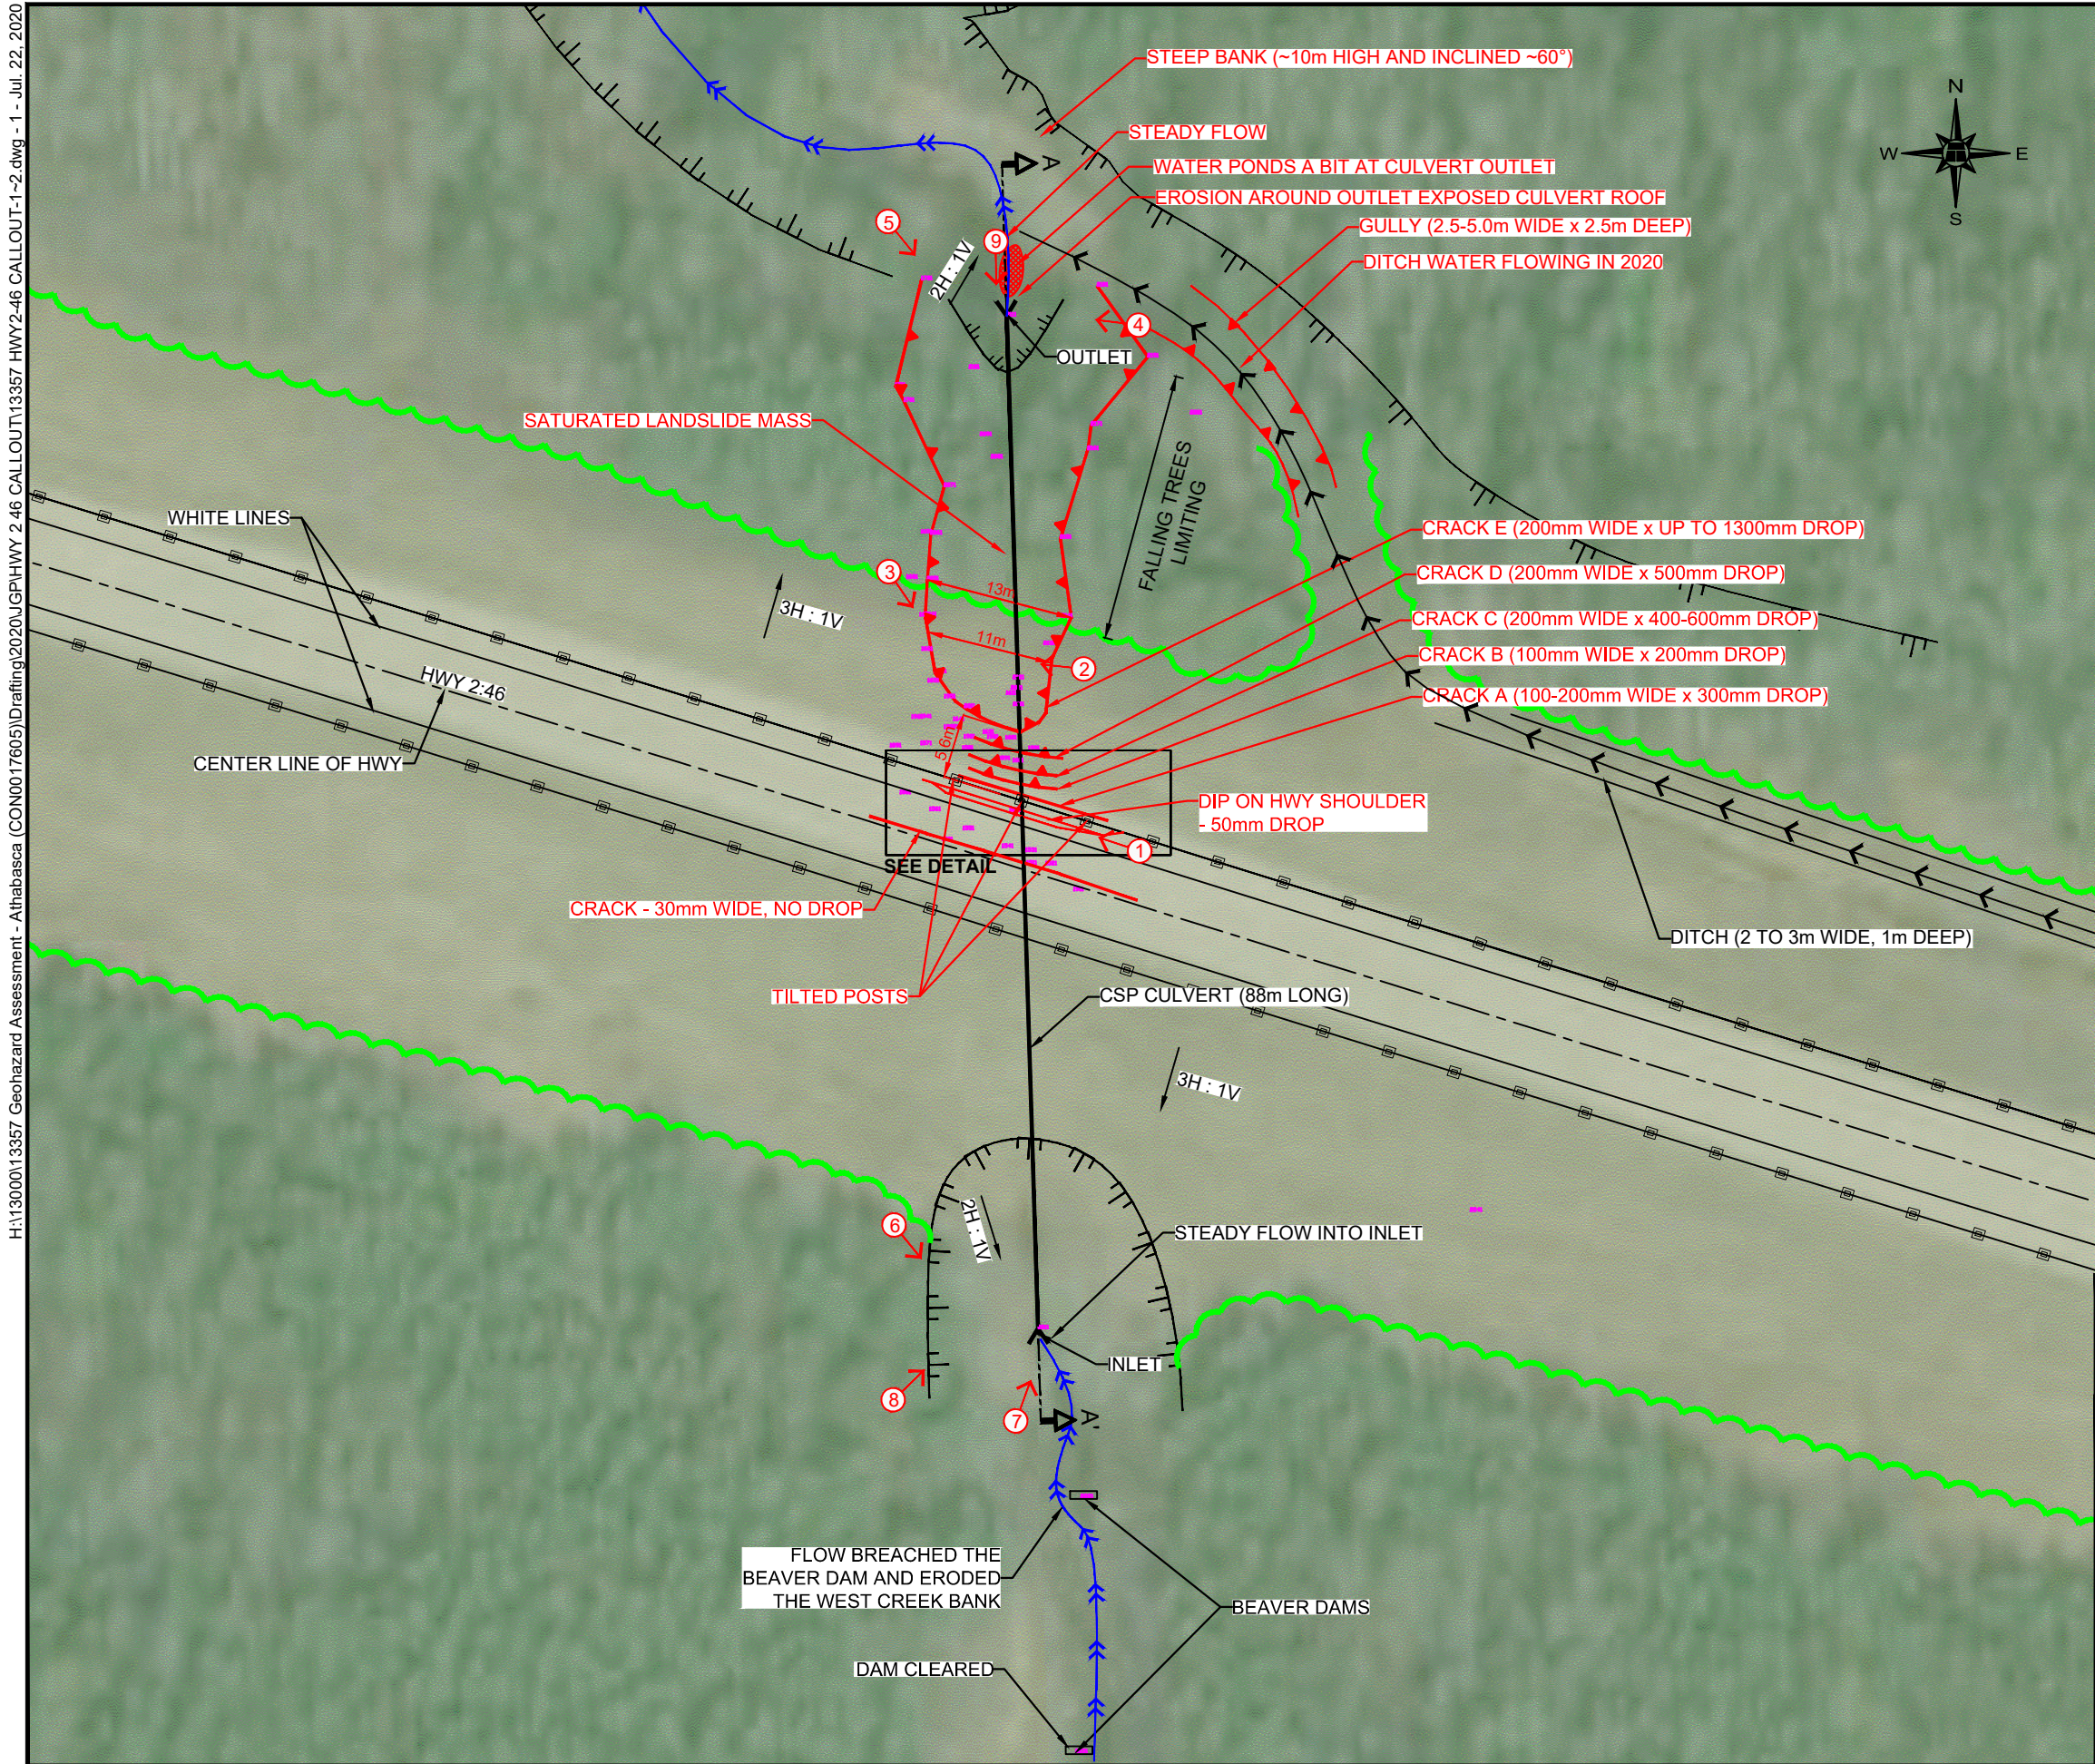
**FIGURE 1**

| Observations: | Description | Worse? |
|---|---|---|
| <input checked="" type="checkbox"/> Slope Movement | Head scarp on the north embankment side slope with 1.3 m drop located approximately 5.6 m from the edge of pavement; four tension cracks above the head scarp as shown on Figure 1 having a width up to 200 mm and depth up to 600 mm | <input type="checkbox"/> |

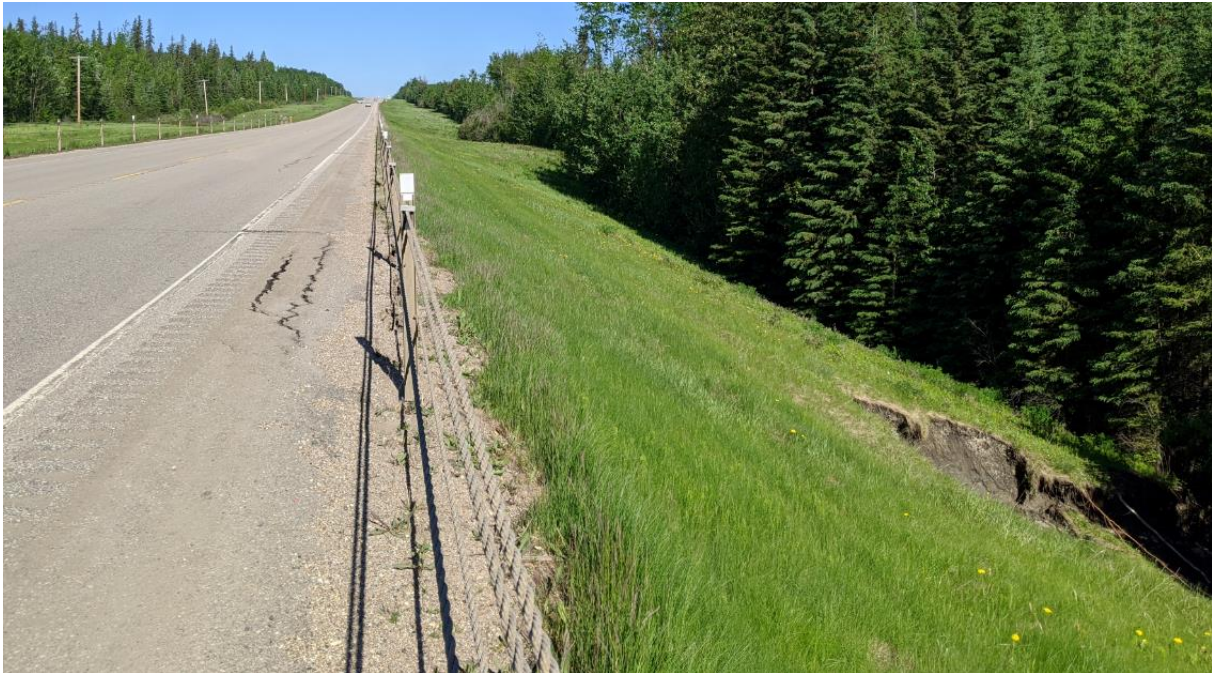
| Observations: | Description | Worse? |
|---|---|---|
| <input checked="" type="checkbox"/> Pavement Distress | A 50 mm dip in the highway WBL shoulder above the landslide area; 15 m long, 50 mm deep open cracks within the dip | <input type="checkbox"/> |

Photo No. 1 – Looking at WBL landslide; note the presence of open tension cracks on the highway shoulder; main head scarp crack of landslide is about 5.6 m from the edge of pavement

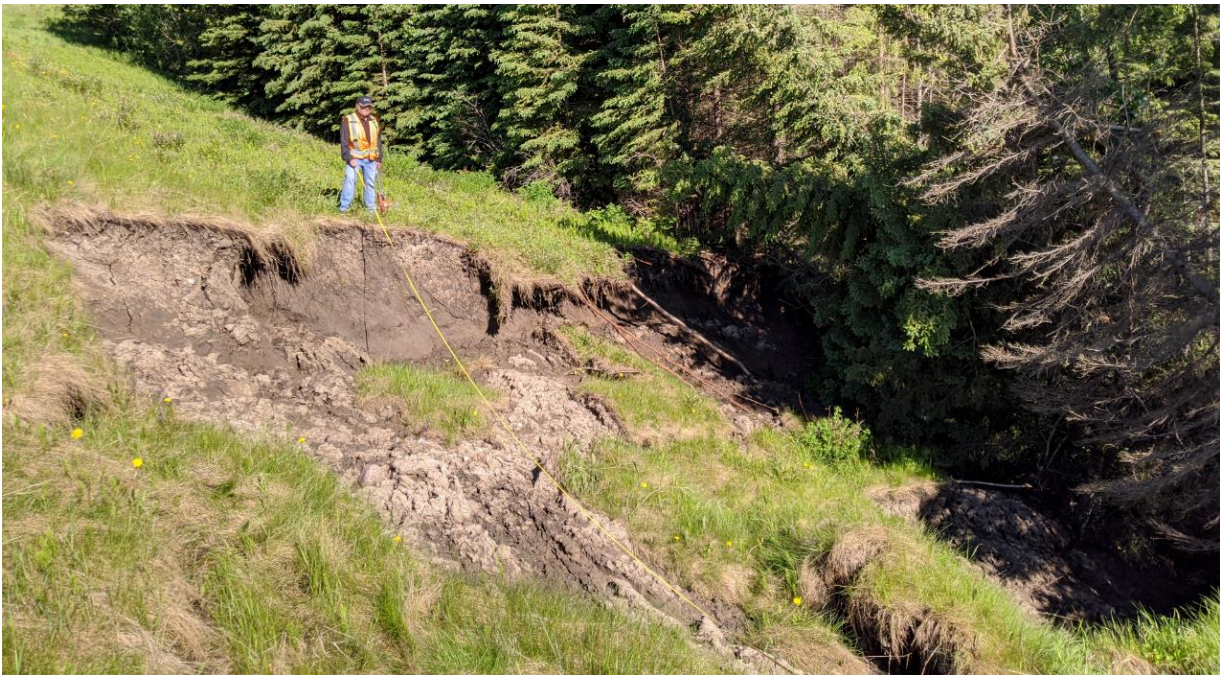
Photo No. 2 – Looking west at the north embankment landslide's head scarp and western flank; note the presence of fallen and tilting trees, and seepage along the western flank; landslide mass was noted to be wet at the time of the inspection.

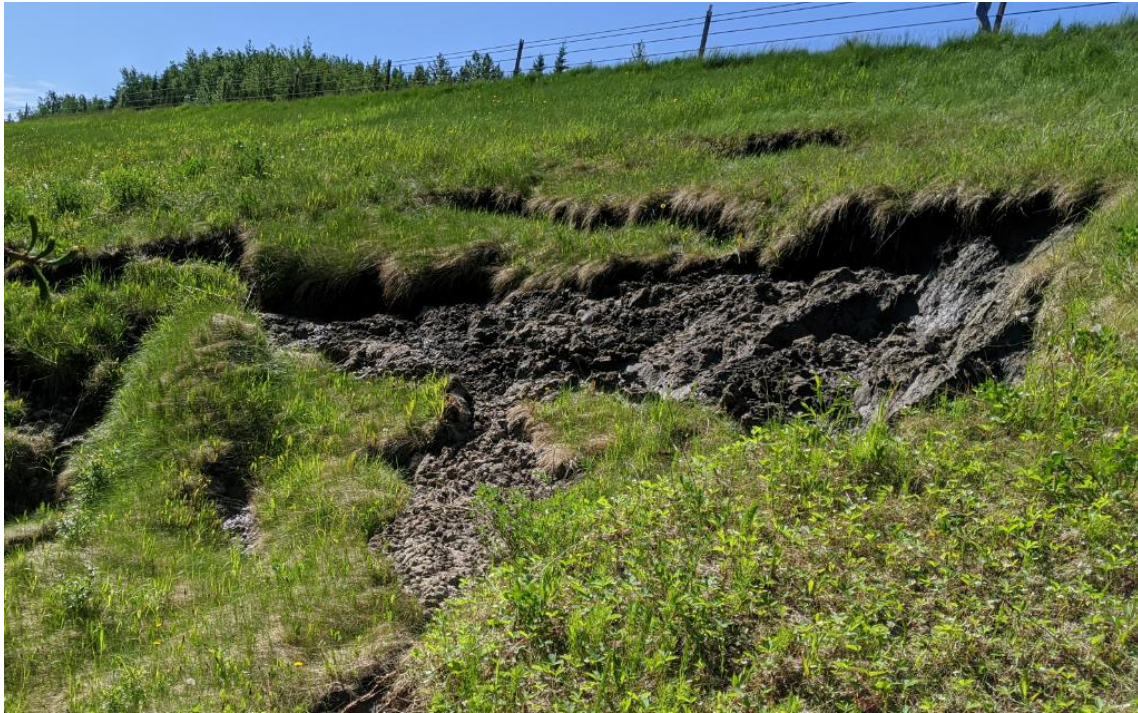
Photo No. 3 – Looking southeast at the landslide’s head scarp and eastern flank; note the presence of multiple tension cracks within the slope downslope of the highway location

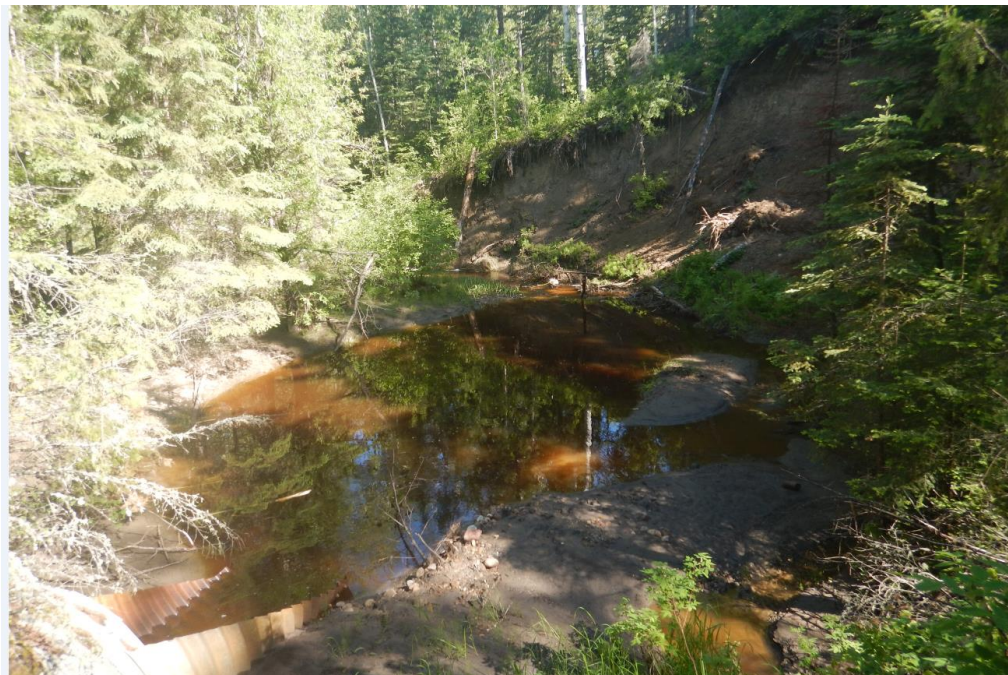
Photo No. 4. Looking northwest at the CSP culvert outlet; note silt accumulation as well as fallen trees near the culvert outlet

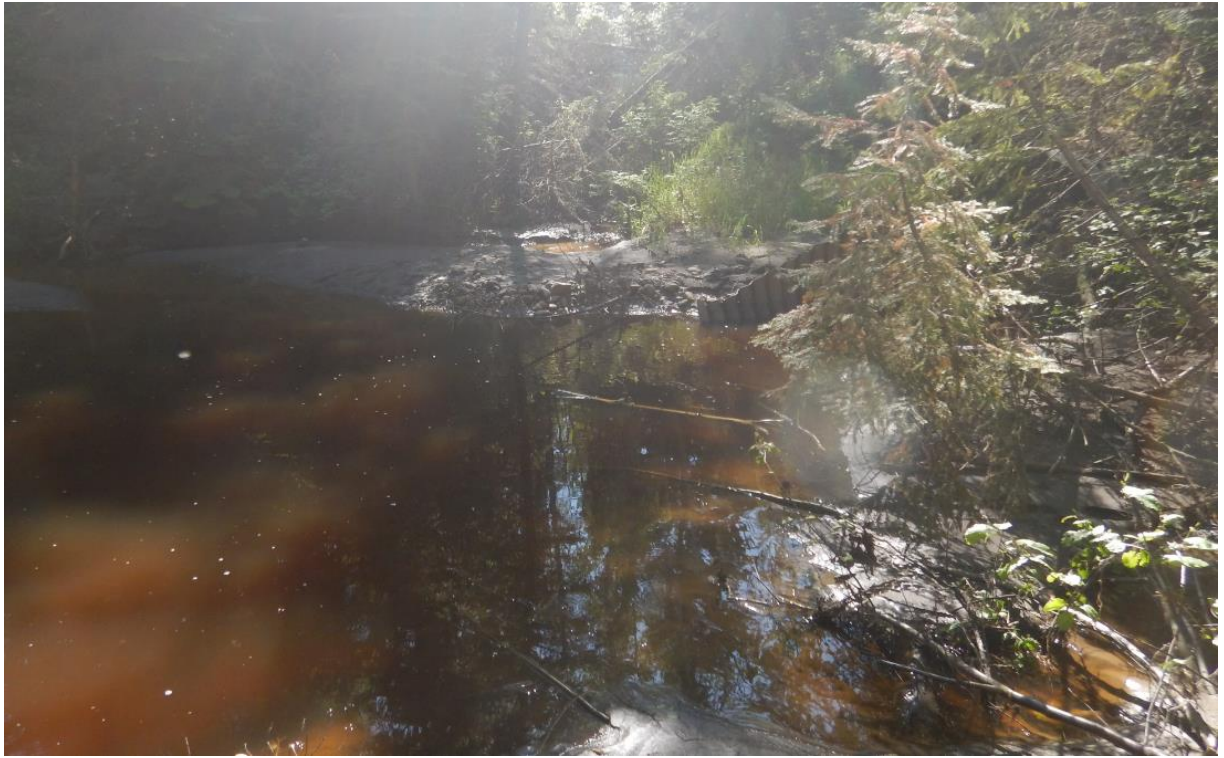
Photo No. 5 – Looking east; water ponding a bit around culvert outlet location

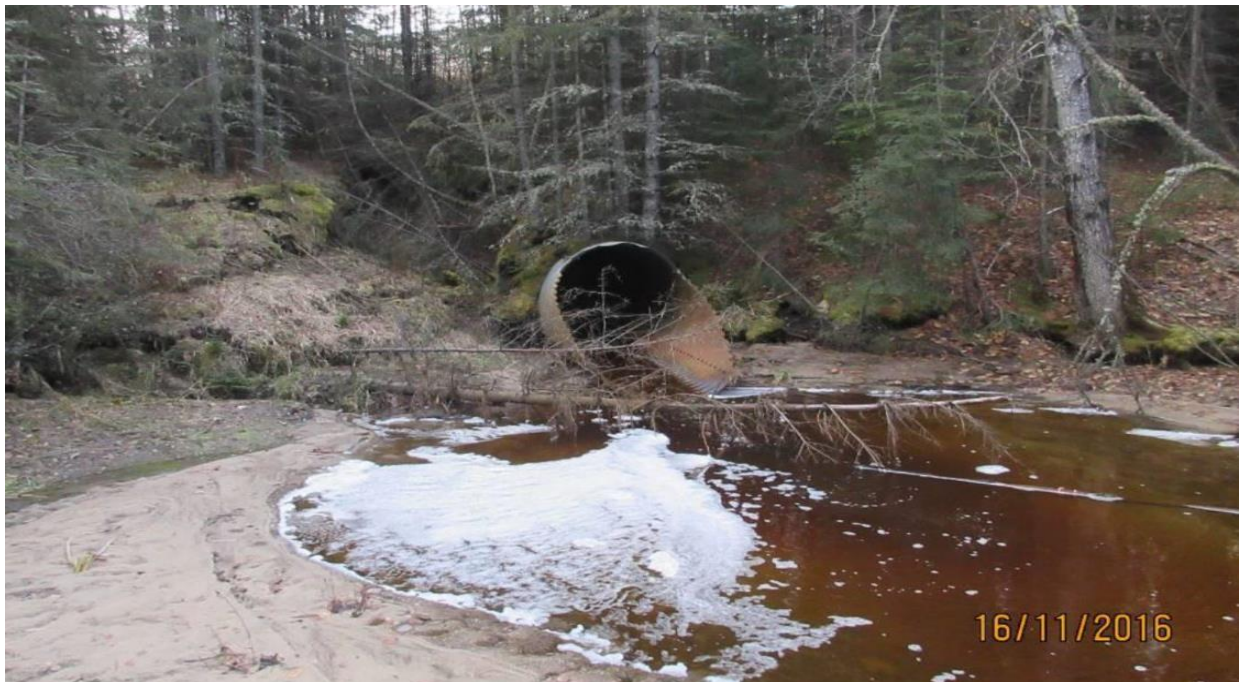
Photo No. 5a (Taken by AT in 2016) – Erosion and debris at the culvert outlet; note the absence of riprap at the culvert outlet location

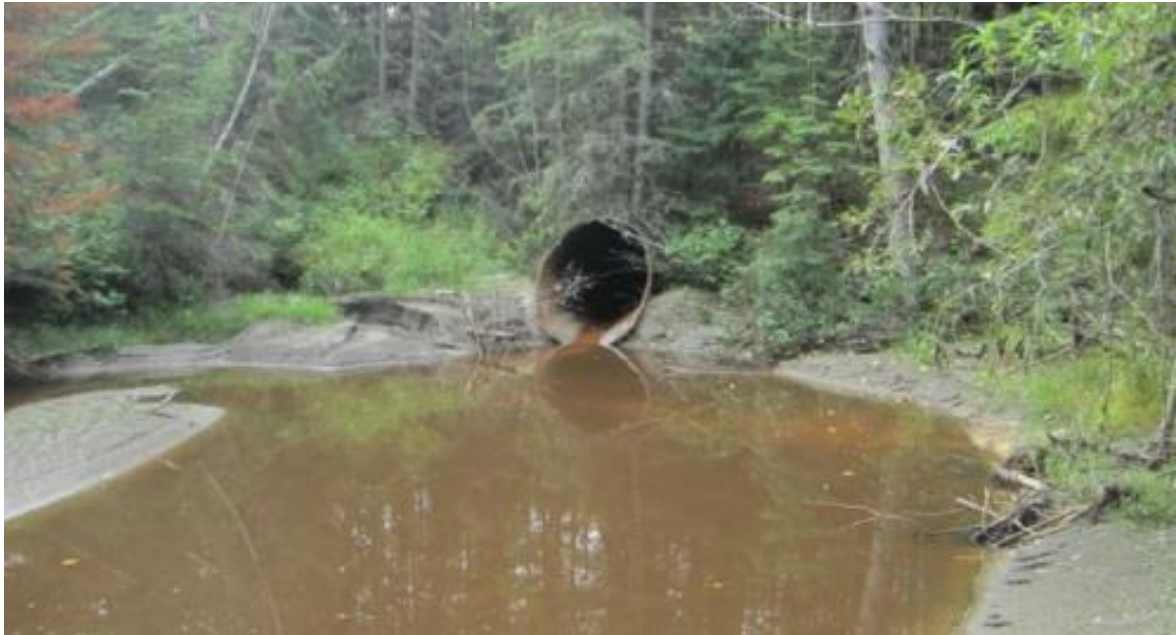
Photo No. 5b (Taken by AT in 2018) – Erosion and debris around culvert outlet; culvert outlet heaved by about 300 mm above the creek bed

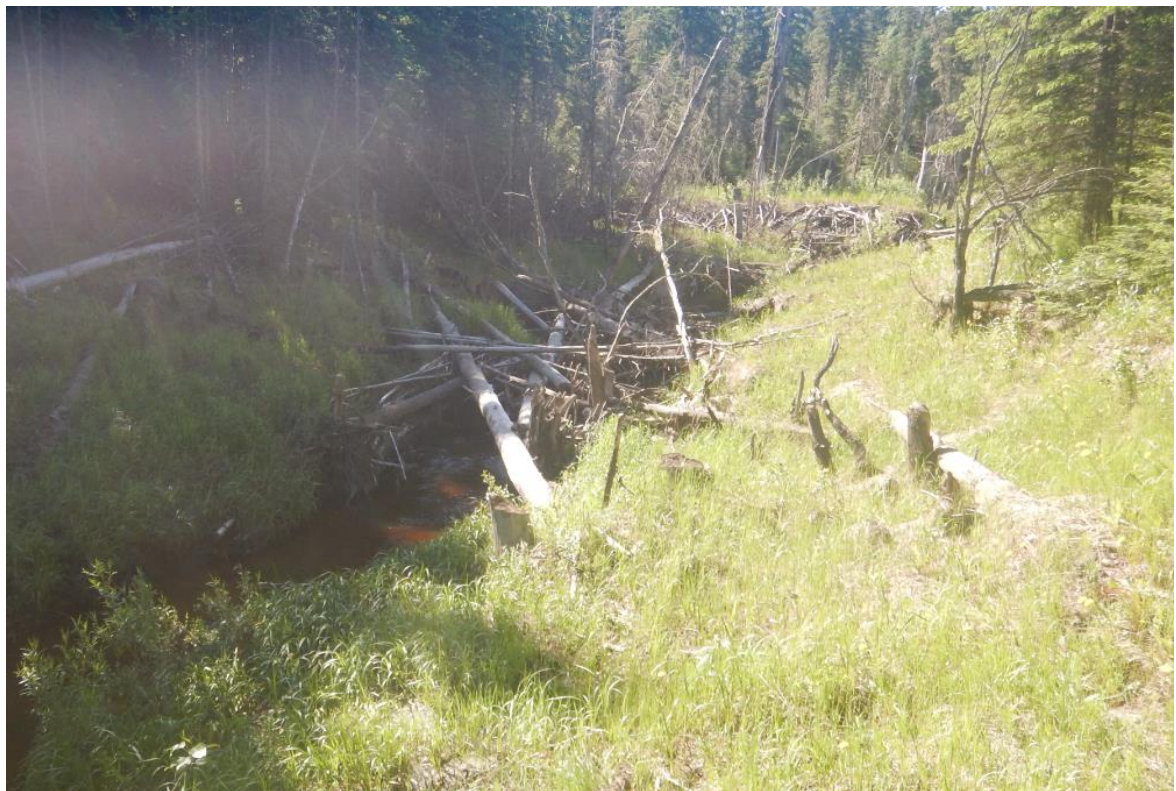
Photo No. 6 – Two beaver dams noted upstream of the culvert inlet

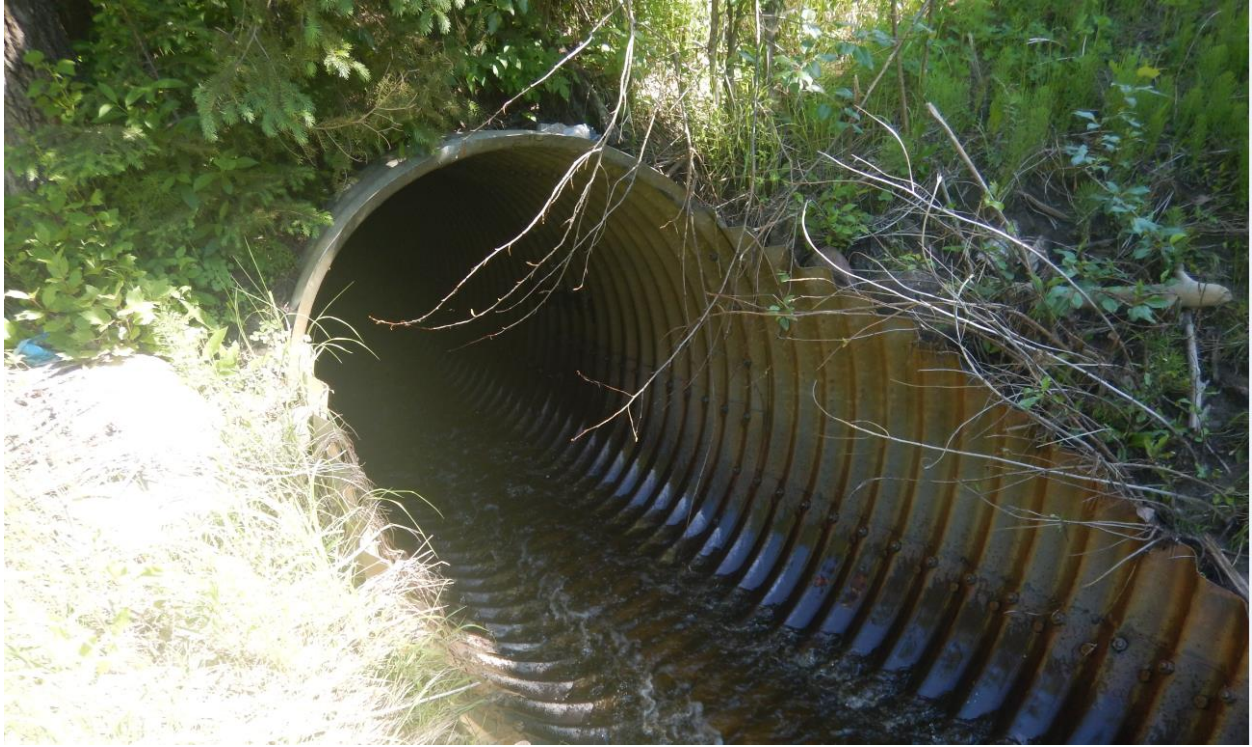
Photo No. 7 – Looking at CSP Culvert Inlet (1.9 m diameter); scattered riprap was noted at inlet location

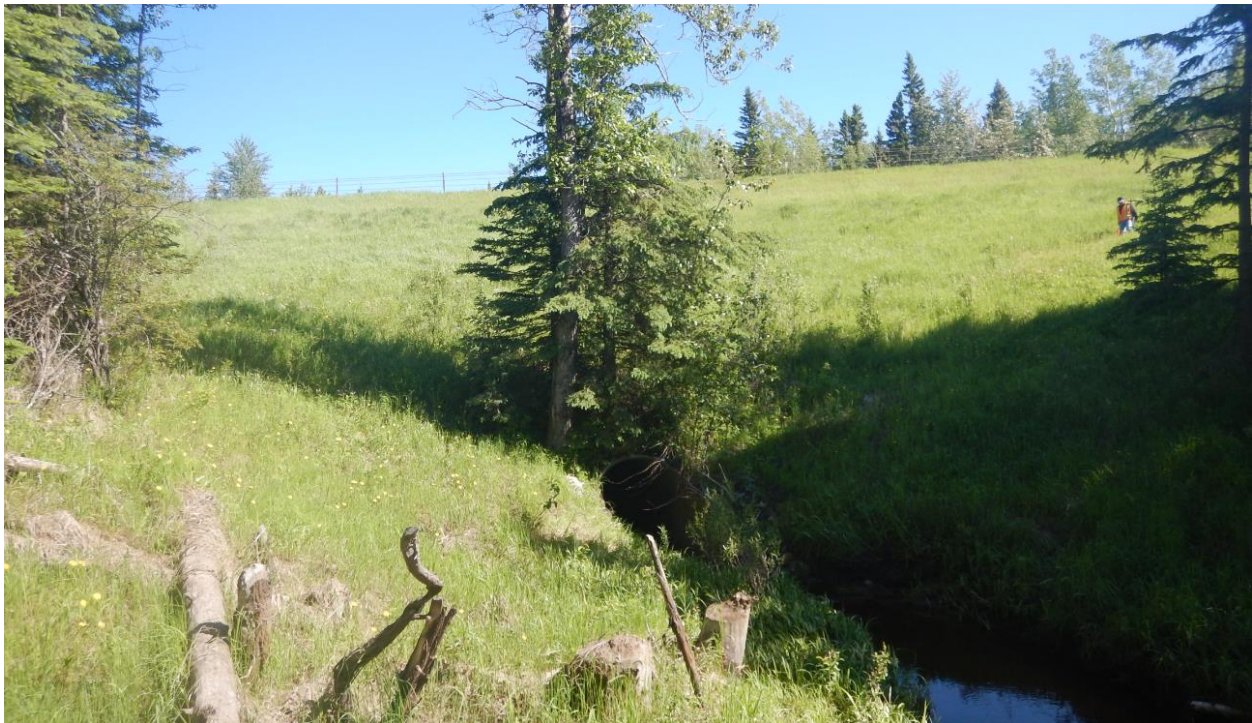
Photo No. 8. Looking north at the south side slope of the highway embankment

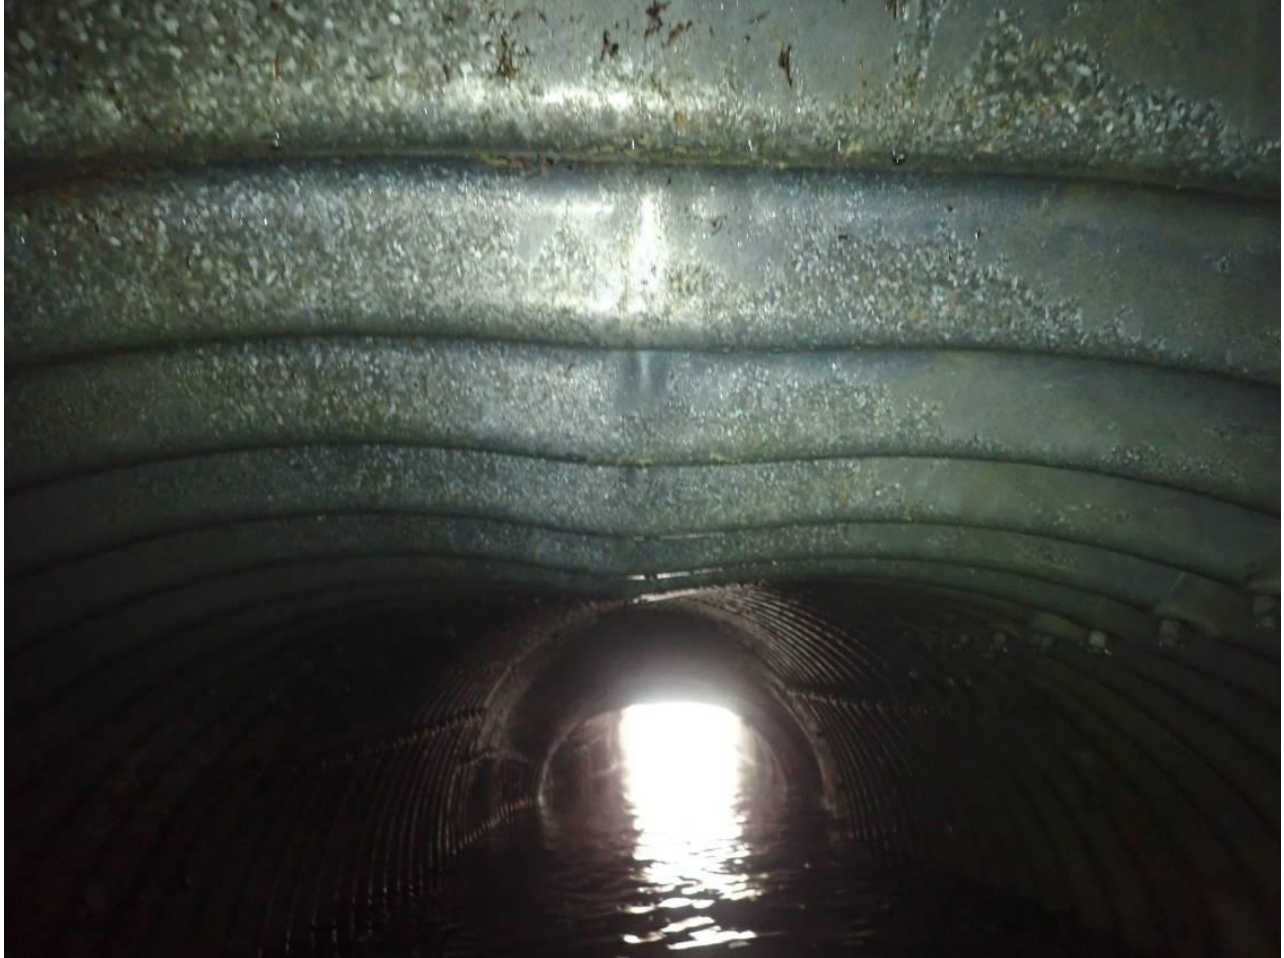
| Observations: | Description | Worse? |
|---|---|---|
| <input checked="" type="checkbox"/> Bridge/Culvert Distress | The bridge inspection reports indicated that the culvert had bolts cracked near the inlet, the roof was damaged at rings 29, 30, and 31 with a reverse curvature close to the outlet. Silt accumulated at the bottom of these rings, but the inspector was unable to take measurements at these locations. The report also indicates that the culvert outlet heaved by about 300 mm. | <input type="checkbox"/> |

Photo No. 9 – Looking inside CSP Culvert outlet; note reverse curvature in the roof (Photograph was taken by AT during bridge culvert inspection completed on June 3, 2020). This is approximately 27 to 30 m from the culvert outlet location.

It is understood that the existing pipe will be replaced in 2028. Hence, the most feasible intermediate term solution to maintain the integrity of the highway and the current pipe is to (a) excavate and replace the landslide mass with gravel, and (b) replace the damaged 30 m long section of the pipe below embankment fill. The existing gully will need to be re-shaped and armoured during this work to reduce the likelihood of future erosion issues within the embankment. Armoring the culvert inlet and outlet locations should also be completed during the repair.
