ALBERTA TRANSPORTATION AND  
ECONOMIC CORRIDORS GRMP  
NORTH CENTRAL (ATHABASCA AND FORT  
McMURRAY DISTRICTS)  
INSTRUMENTATION MONITORING - FALL 2025

| Site Number | Location | Name | Hwy | km |
|---|---|---|---|---|
| NC006 | HWY 2:46 C1 47.6 | Mitsue Lake Recreation Area | 2:46 | km 47.6 |

| <b>Current Monitoring:</b> | 22-Sep-2025 | <b>Previous Monitoring</b> | 31-May-2025 |

**ALBERTA TRANSPORTATION AND ECONOMIC CORRIDORS GRMP (CON0022163)  
NORTH CENTRAL (ATHABASCA AND FORT McMURRAY DISTRICTS)  
INSTRUMENTATION MONITORING RESULTS**

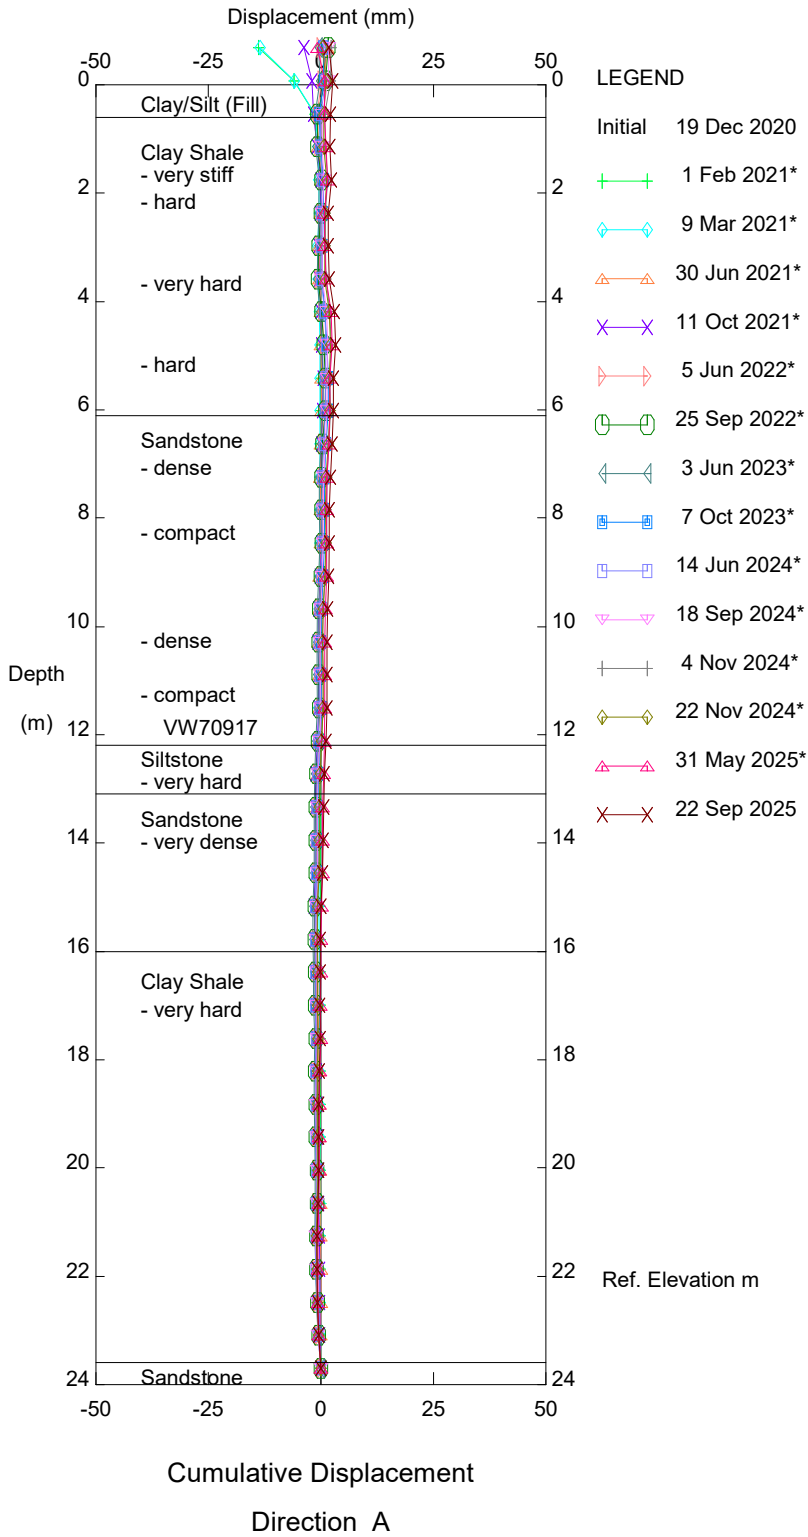
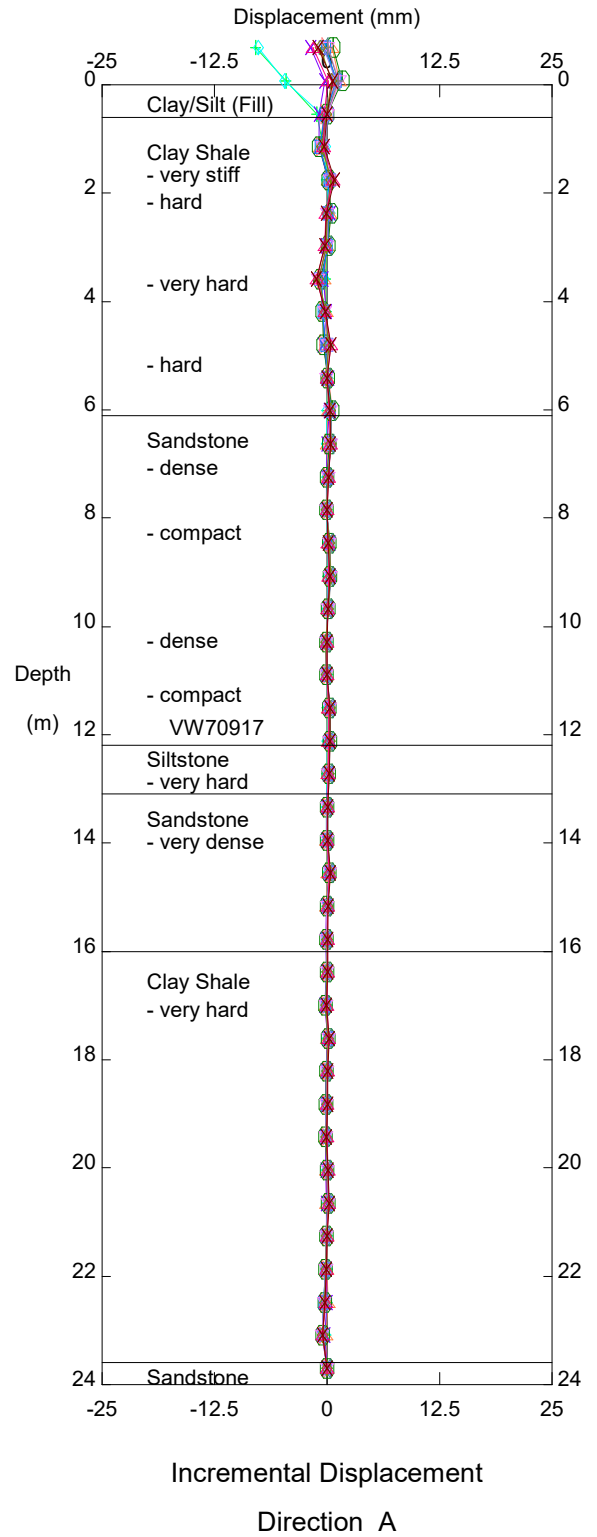
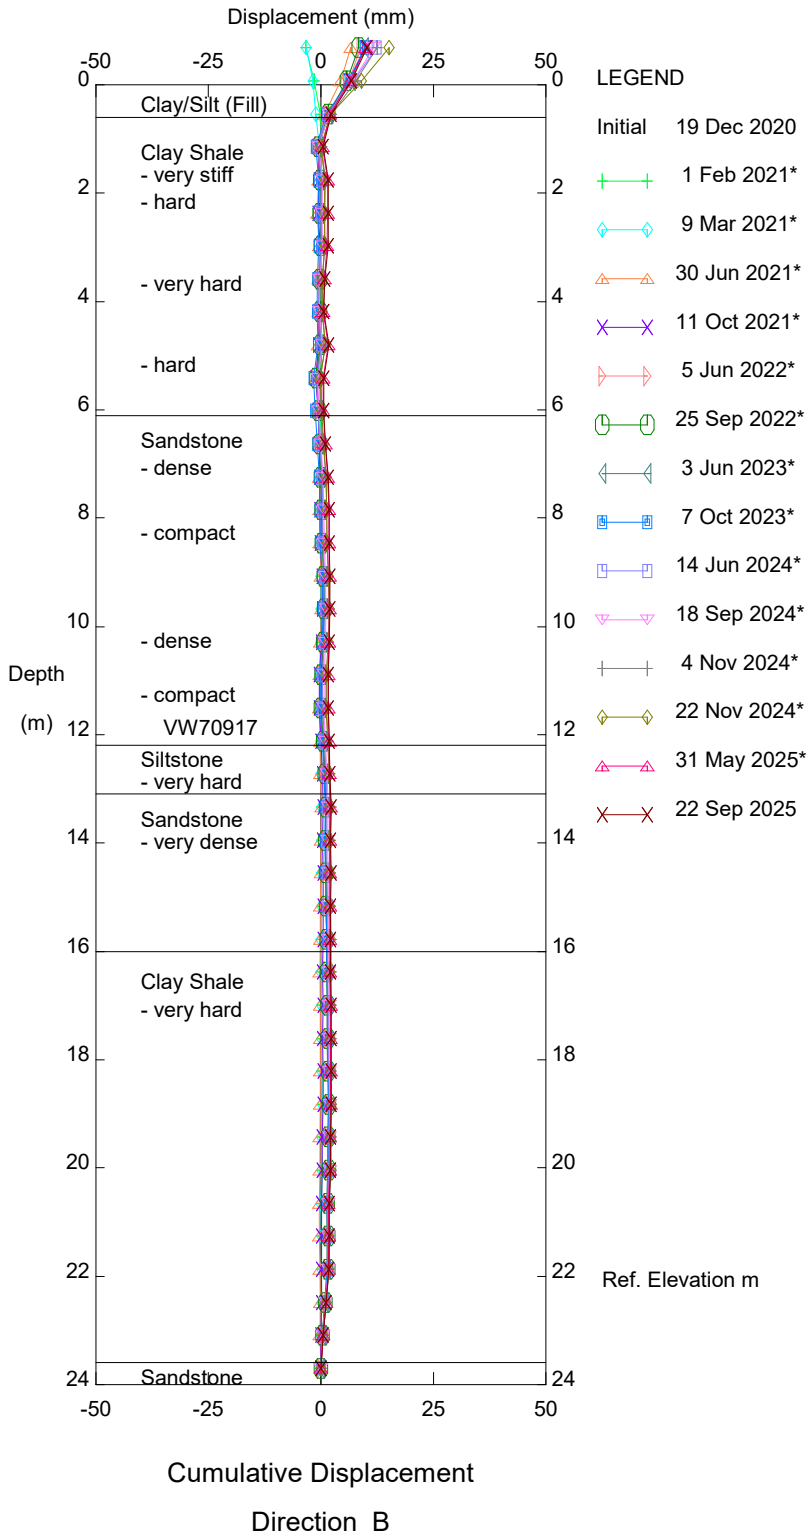
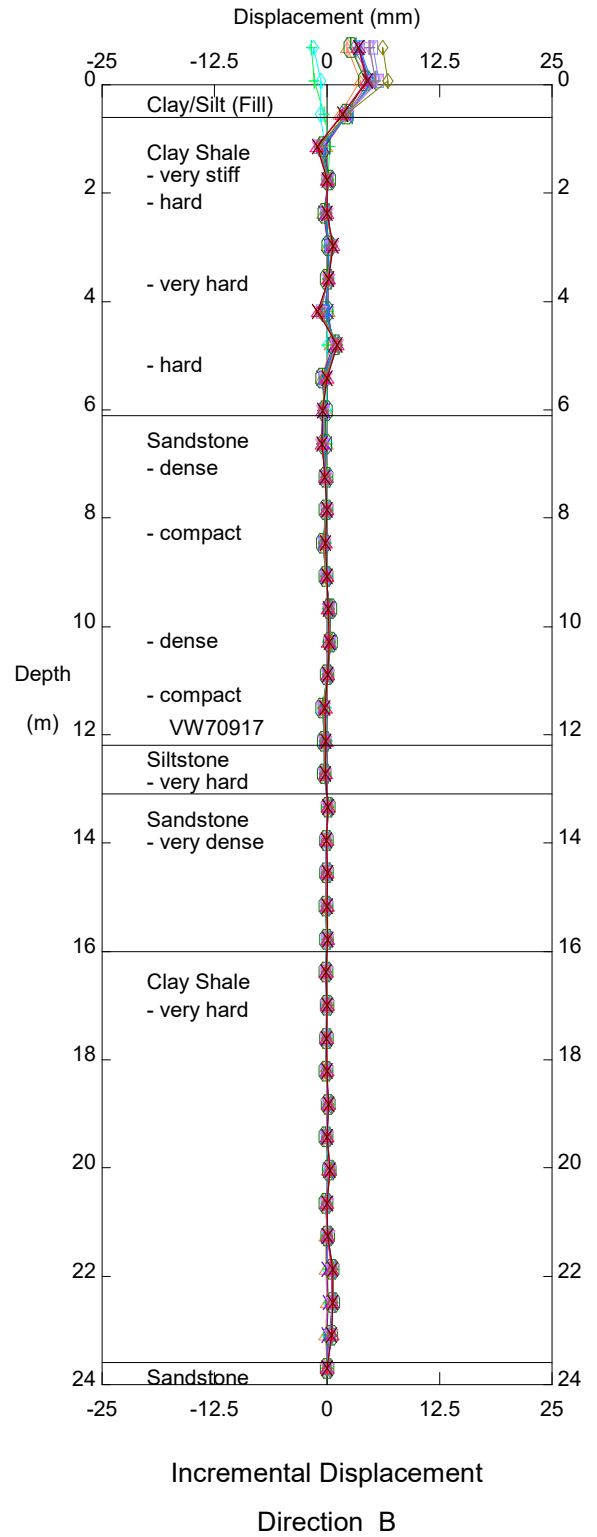
NC006 - Hwy 2:46 Mitsue Lake (km 47.6), Inclinator SI20-1

| INSTRUMENT # | DATE INITIALIZED | TOTAL CUMULATIVE RESULTANT MOVEMENT AND DEPTH OF MOVEMENT TO DATE (mm) | MAXIMUM RATE OF MOVEMENT (mm/yr) | CURRENT STATUS OF SI | DATE OF PREVIOUS READING | INCREMENTAL MOVEMENT SINCE PREVIOUS READING (mm) | CURRENT RATE OF MOVEMENT (mm/yr) | CHANGE IN RATE OF MOVEMENT SINCE PREVIOUS READING (mm/yr) |
|---|---|---|---|---|---|---|---|---|
| SI20-1 | December 21, 2020 | No discernible movement | N/A | Operational | May 31, 2025 | N/A | N/A | N/A |

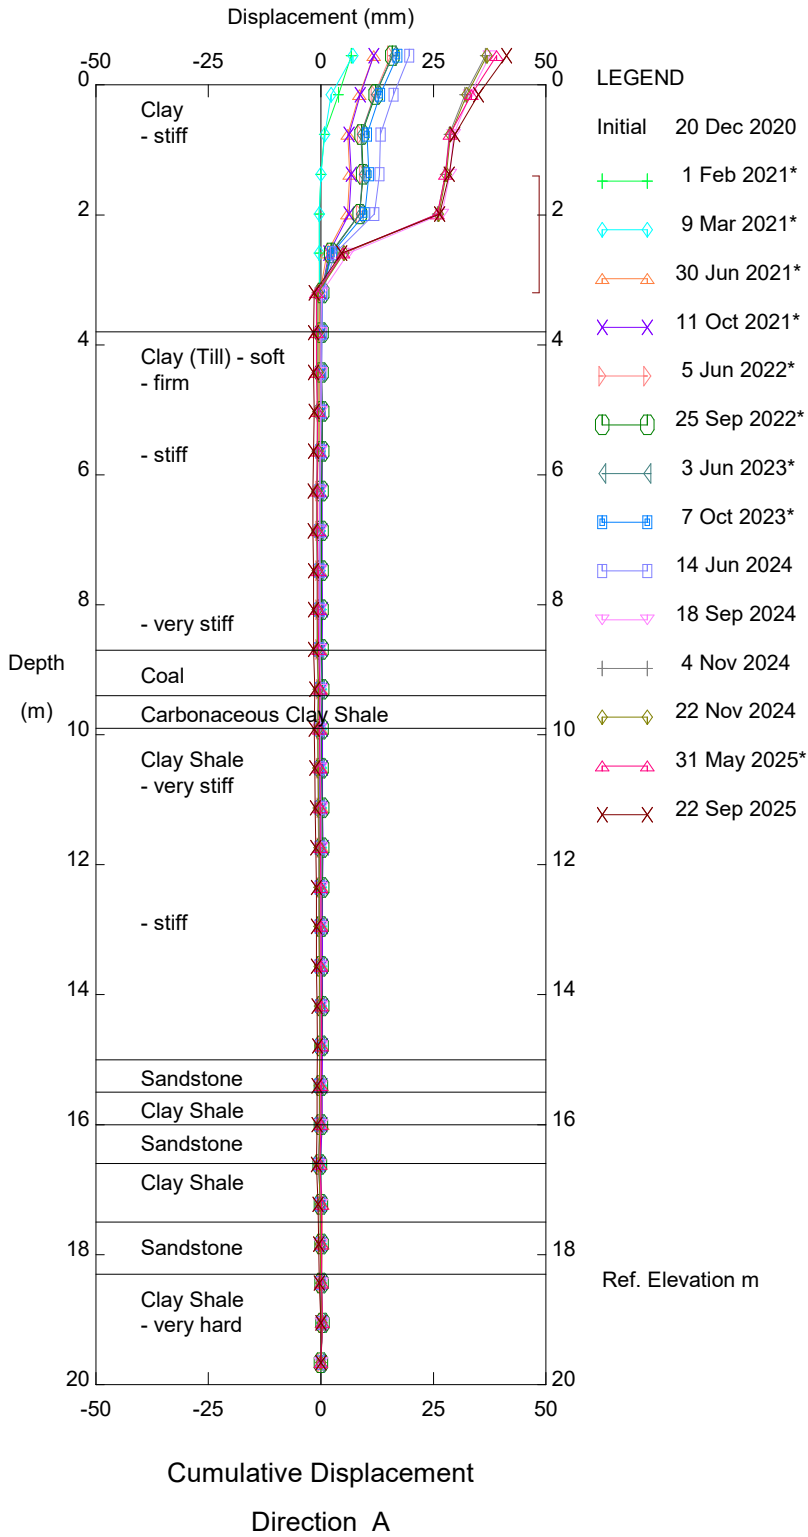
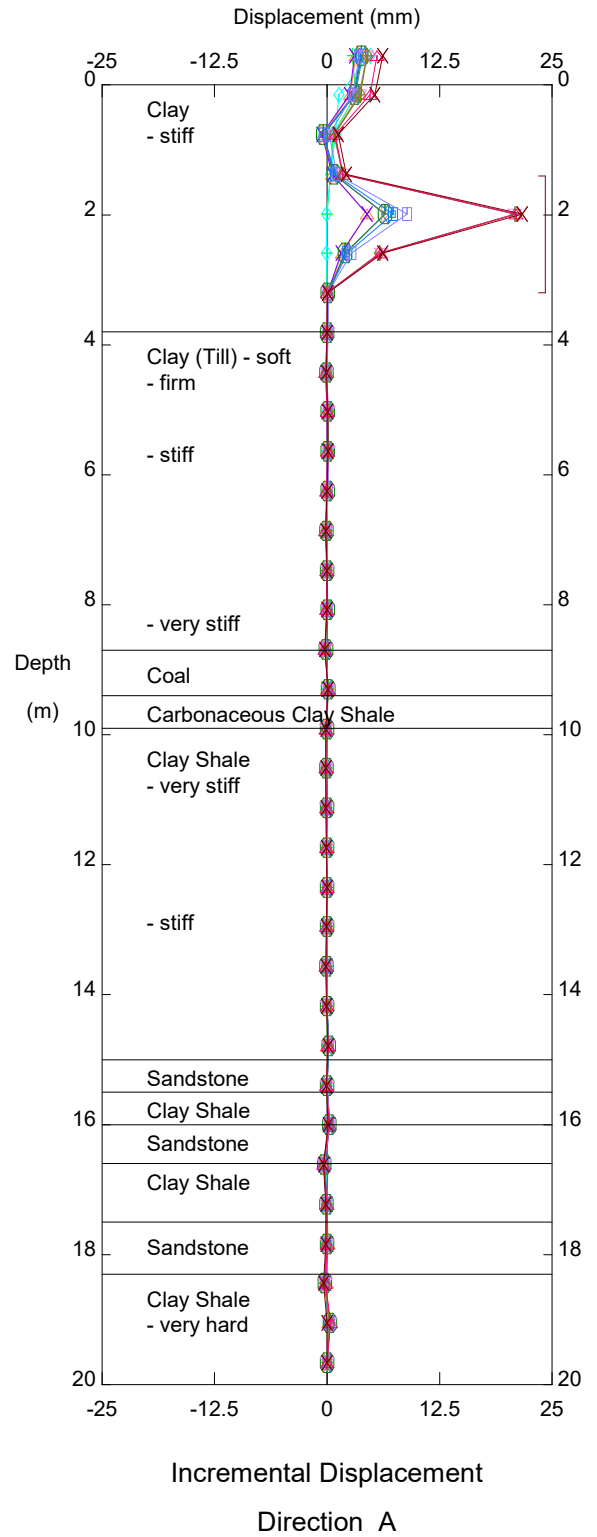
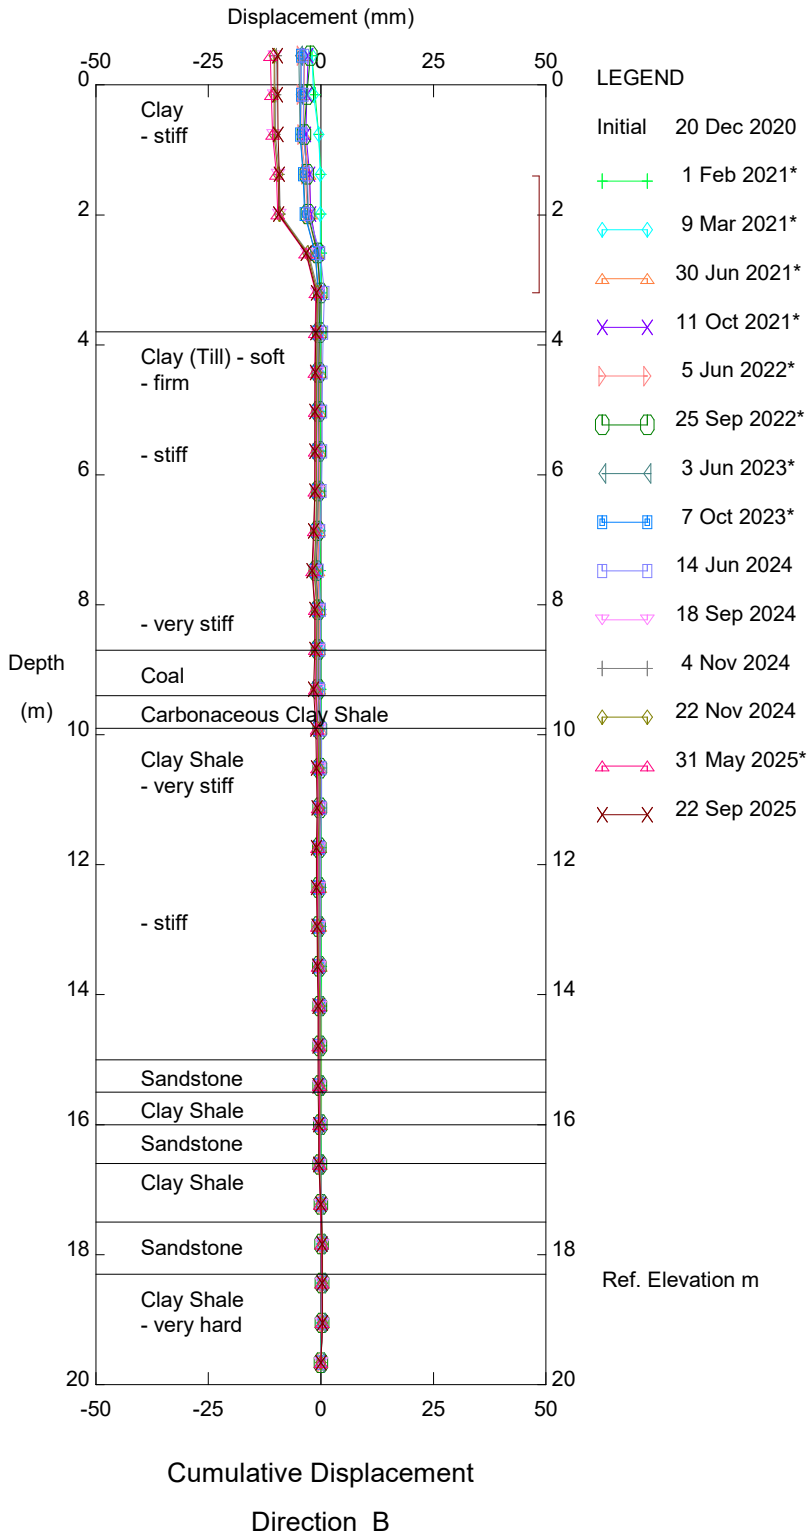
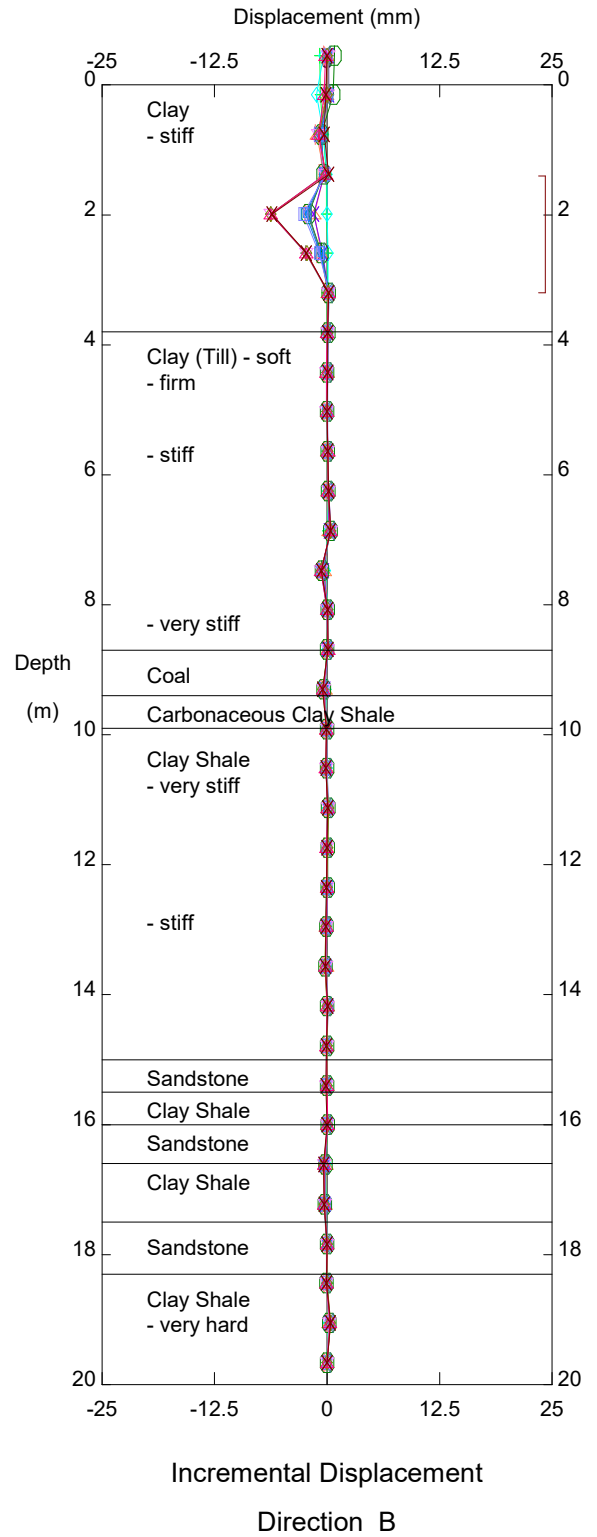
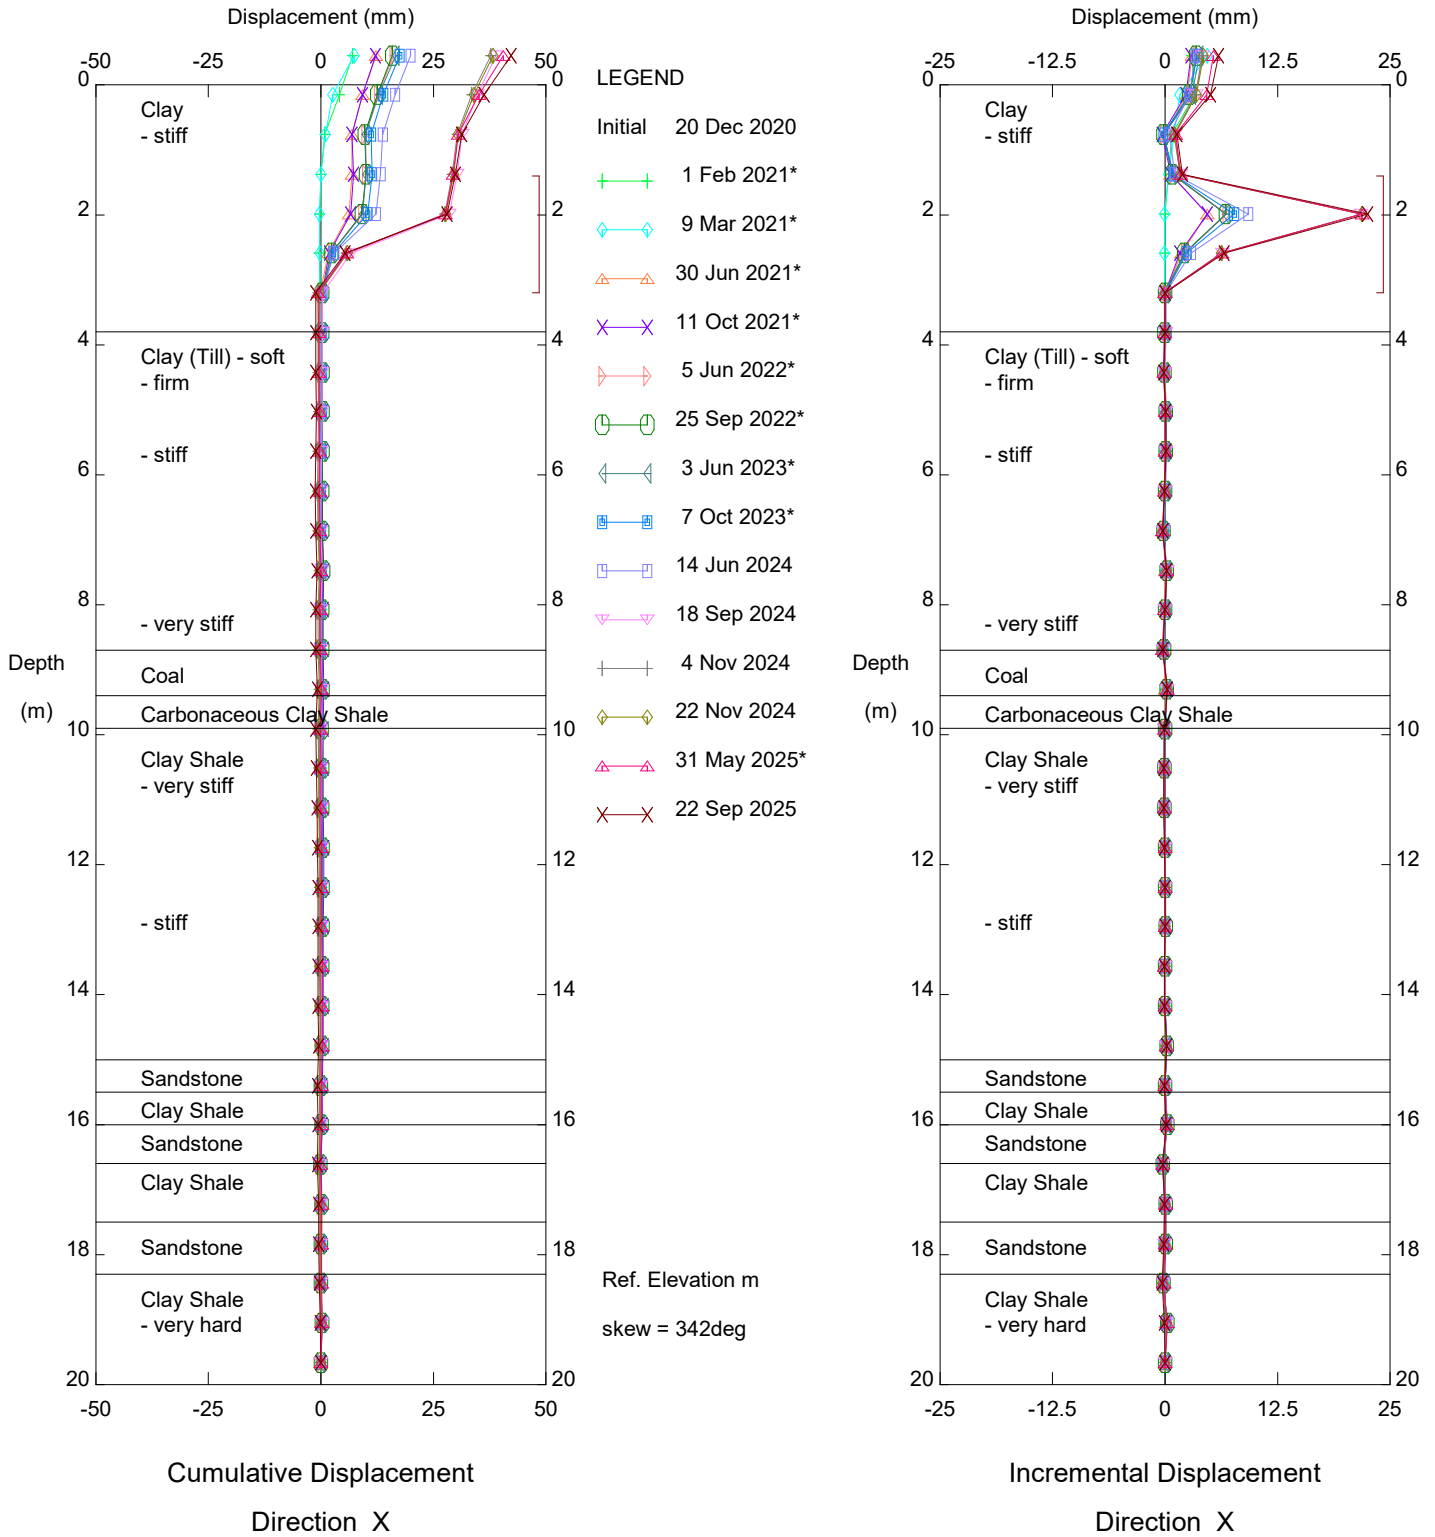
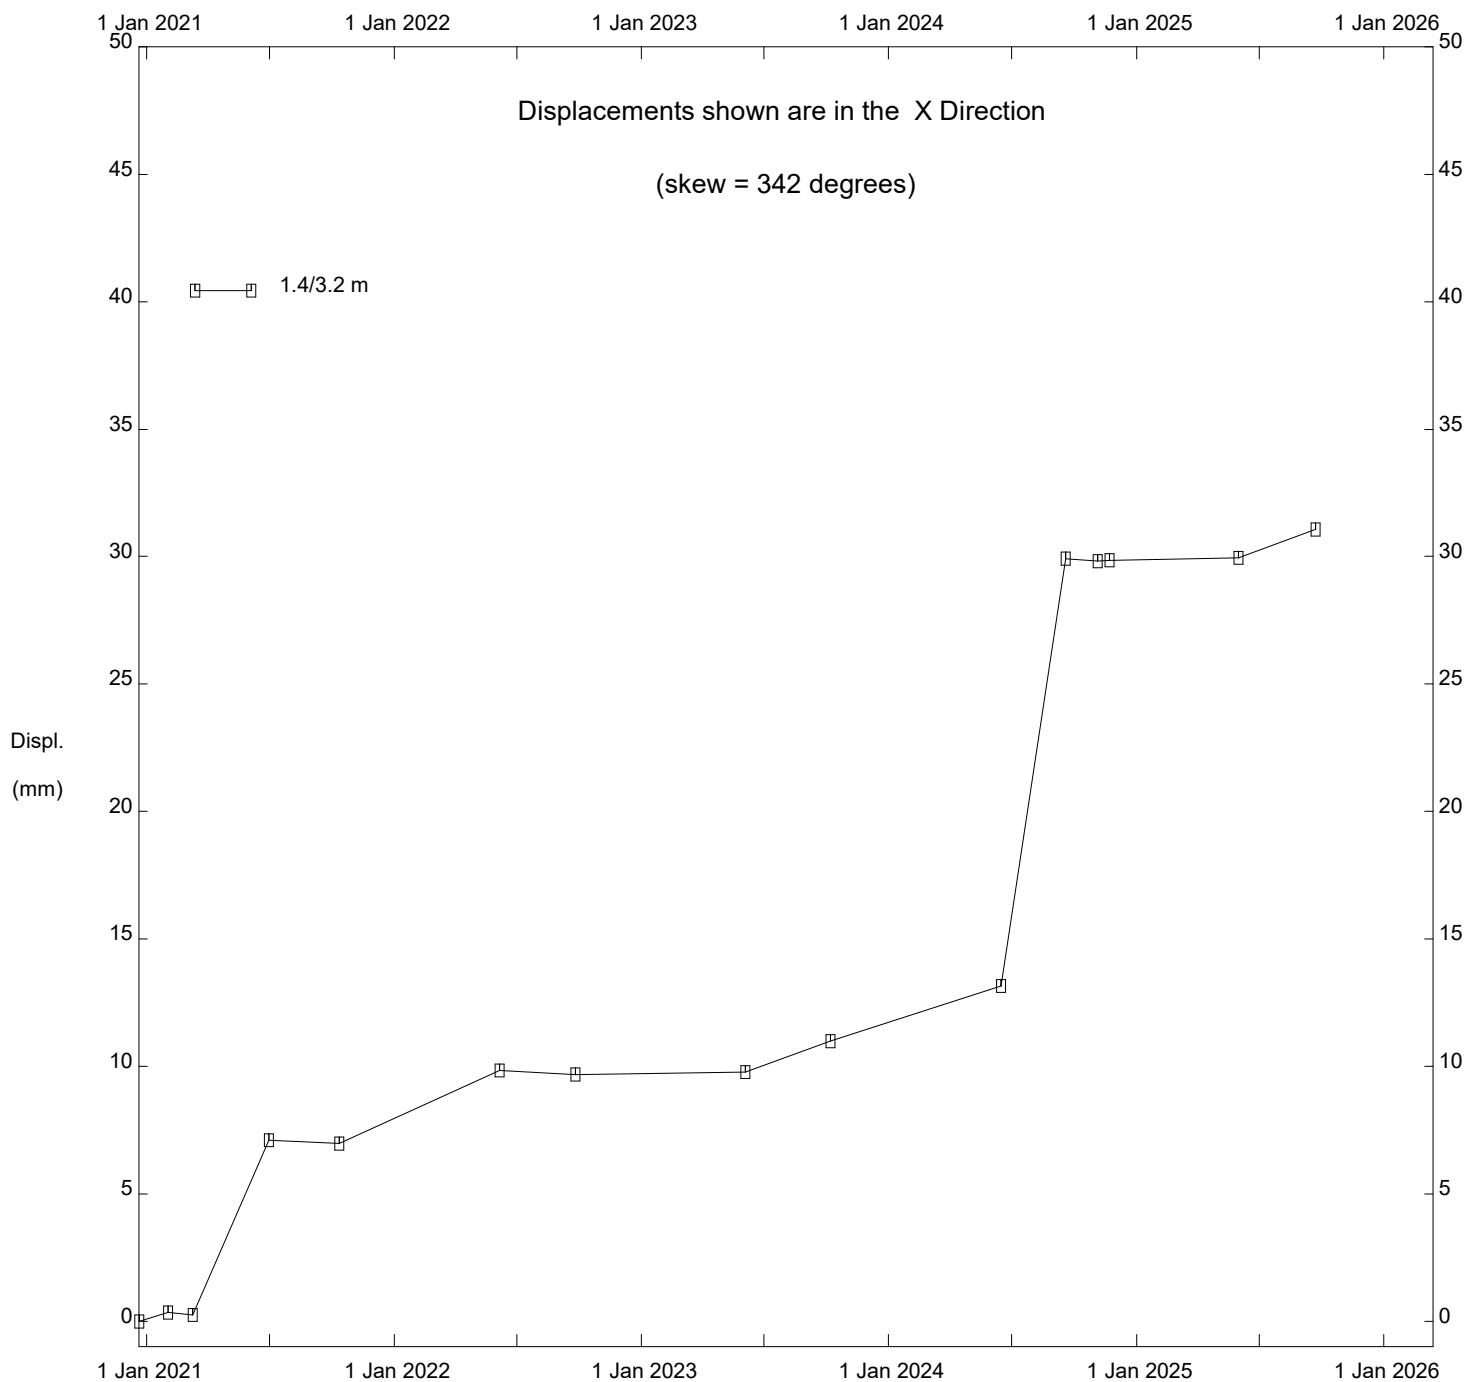
NC006 - Hwy 2:46 Mitsue Lake (km 47.6), Inclinometer SI20-3

| Discussion | |
|---|---|
| <b>Interpretation of Monitoring Results:</b> | <p>SI20-1, installed in the south ditch of the highway, has shown no discernible movement since initialization. SI20-3, installed downslope of SI20-2 within the bush, showed a rate of movement of 3.6 mm/yr over 1.4 m to 3.2 m depth since the spring of 2025 readings. This corresponds to an increase in the rate of movement by 3.5 mm/yr. SI20-4, installed further downslope of SI20-3 within the bush, has shown no discernible movement since initialization.</p> <p>SI24-7, installed downslope of the pile wall, and SI24-8, installed between the highway surface and the pile wall, each showed no discernible movement since the spring of 2025 readings.</p> <p>Vibrating wire piezometers VW20-3A, VW20-3B, VW20-4A, and VW20-4B showed decreases in groundwater level of 0.59 m, 0.05 m, 0.72, and 0.58 m, respectively, since the spring of 2025 readings. Vibrating wire piezometer VW20-1 showed an increase in groundwater level of 0.36 m since the spring of 2025 readings.</p> |

| INSTRUMENT # | DATE INITIALIZED | TOTAL CUMULATIVE RESULTANT MOVEMENT AND DEPTH OF MOVEMENT TO DATE (mm) | MAXIMUM RATE OF MOVEMENT (mm/yr) | CURRENT STATUS OF SI | DATE OF PREVIOUS READING | INCREMENTAL MOVEMENT SINCE PREVIOUS READING (mm) | CURRENT RATE OF MOVEMENT (mm/yr) | CHANGE IN RATE OF MOVEMENT SINCE PREVIOUS READING (mm/yr) |
|---|---|---|---|---|---|---|---|---|
| SI20-3 | December 20, 2020 | 31.1 over 1.4 m to 3.2 m depth in 348° direction | 63.8 in September 2024 | Operational | May 31, 2025 | 1.1 | 3.6 | 3.5 |

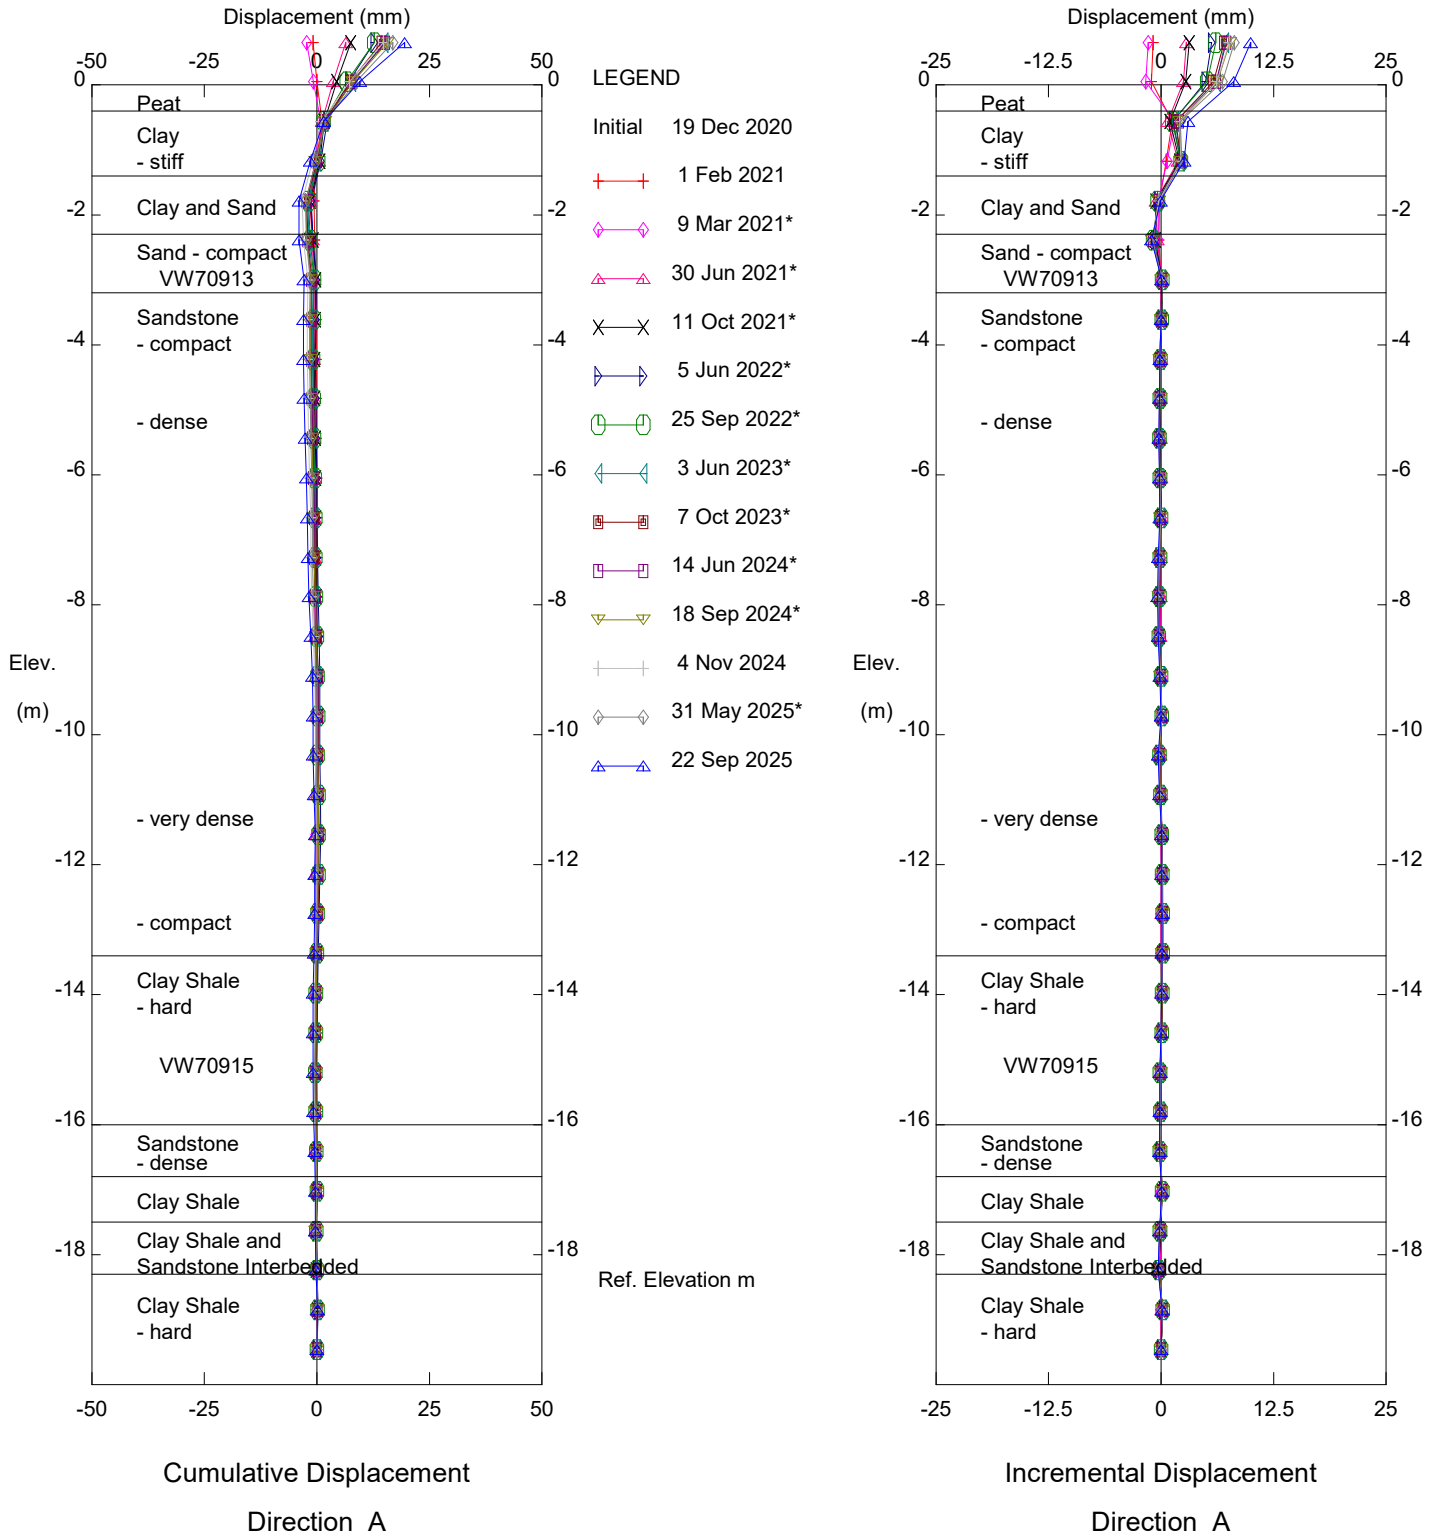
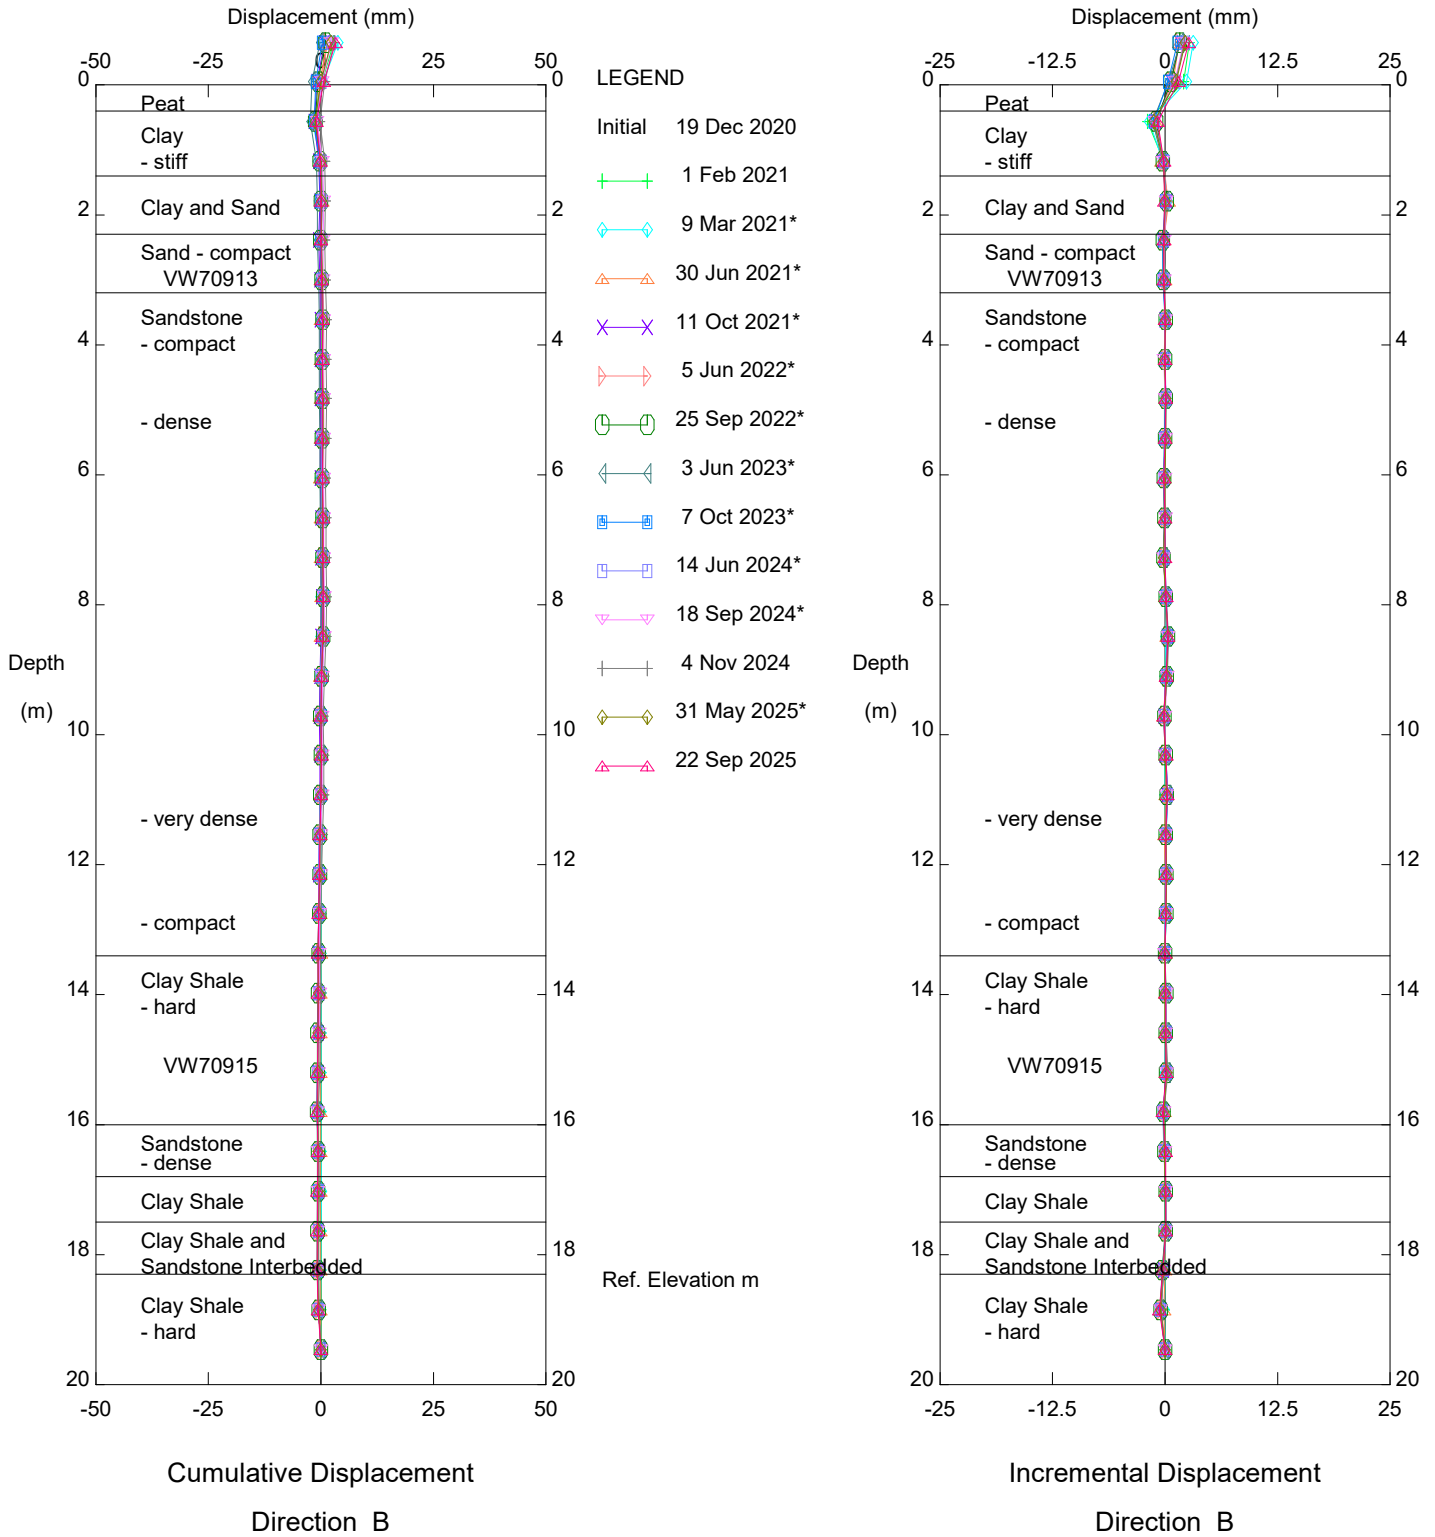
NC006 - Hwy 2:46 Mitsue Lake (km 47.6), Inclinator SI20-4

| INSTRUMENT # | DATE INITIALIZED | TOTAL CUMULATIVE RESULTANT MOVEMENT AND DEPTH OF MOVEMENT TO DATE (mm) | MAXIMUM RATE OF MOVEMENT (mm/yr) | CURRENT STATUS OF SI | DATE OF PREVIOUS READING | INCREMENTAL MOVEMENT SINCE PREVIOUS READING (mm) | CURRENT RATE OF MOVEMENT (mm/yr) | CHANGE IN RATE OF MOVEMENT SINCE PREVIOUS READING (mm/yr) |
|---|---|---|---|---|---|---|---|---|
| SI20-4 | December 19, 2021 | No discernible movement | N/A | Operational | May 31, 2025 | N/A | N/A | N/A |
