ALBERTA TRANSPORTATION AND  
ECONOMIC CORRIDORS GRMP  
NORTH CENTRAL (ATHABASCA AND FORT  
McMURRAY DISTRICTS)  
INSTRUMENTATION MONITORING - FALL 2025

| Site Number | Location | Name | Hwy | km |
|---|---|---|---|---|
| NC006 | HWY 2:46 C1 47.6 | Mitsue Lake Recreation Area | 2:46 | km 47.6 |

| <b>Current Monitoring:</b> | 22-Sep-2025 | <b>Previous Monitoring</b> | 31-May-2025 |

**ALBERTA TRANSPORTATION AND ECONOMIC CORRIDORS GRMP (CON0022163)  
NORTH CENTRAL (ATHABASCA AND FORT McMURRAY DISTRICTS)  
INSTRUMENTATION MONITORING RESULTS**

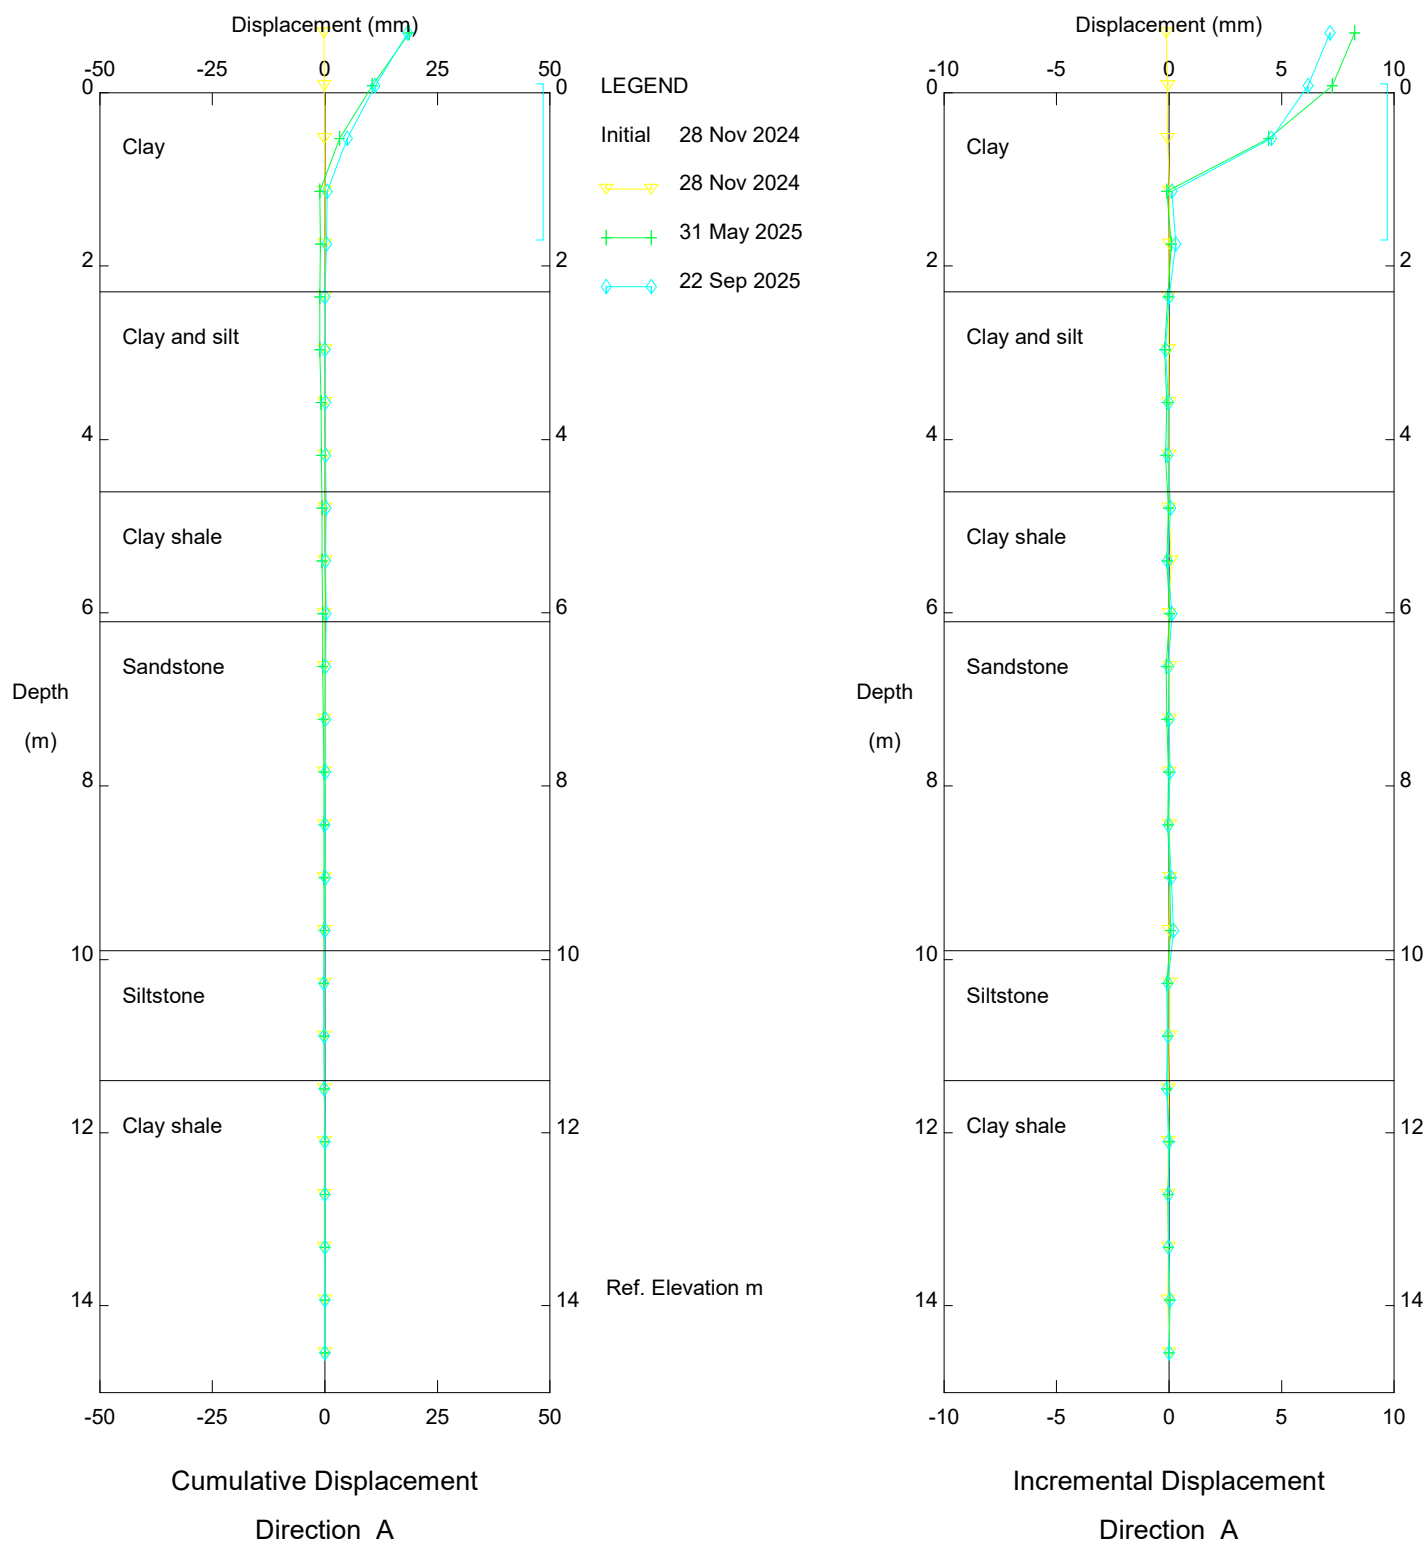
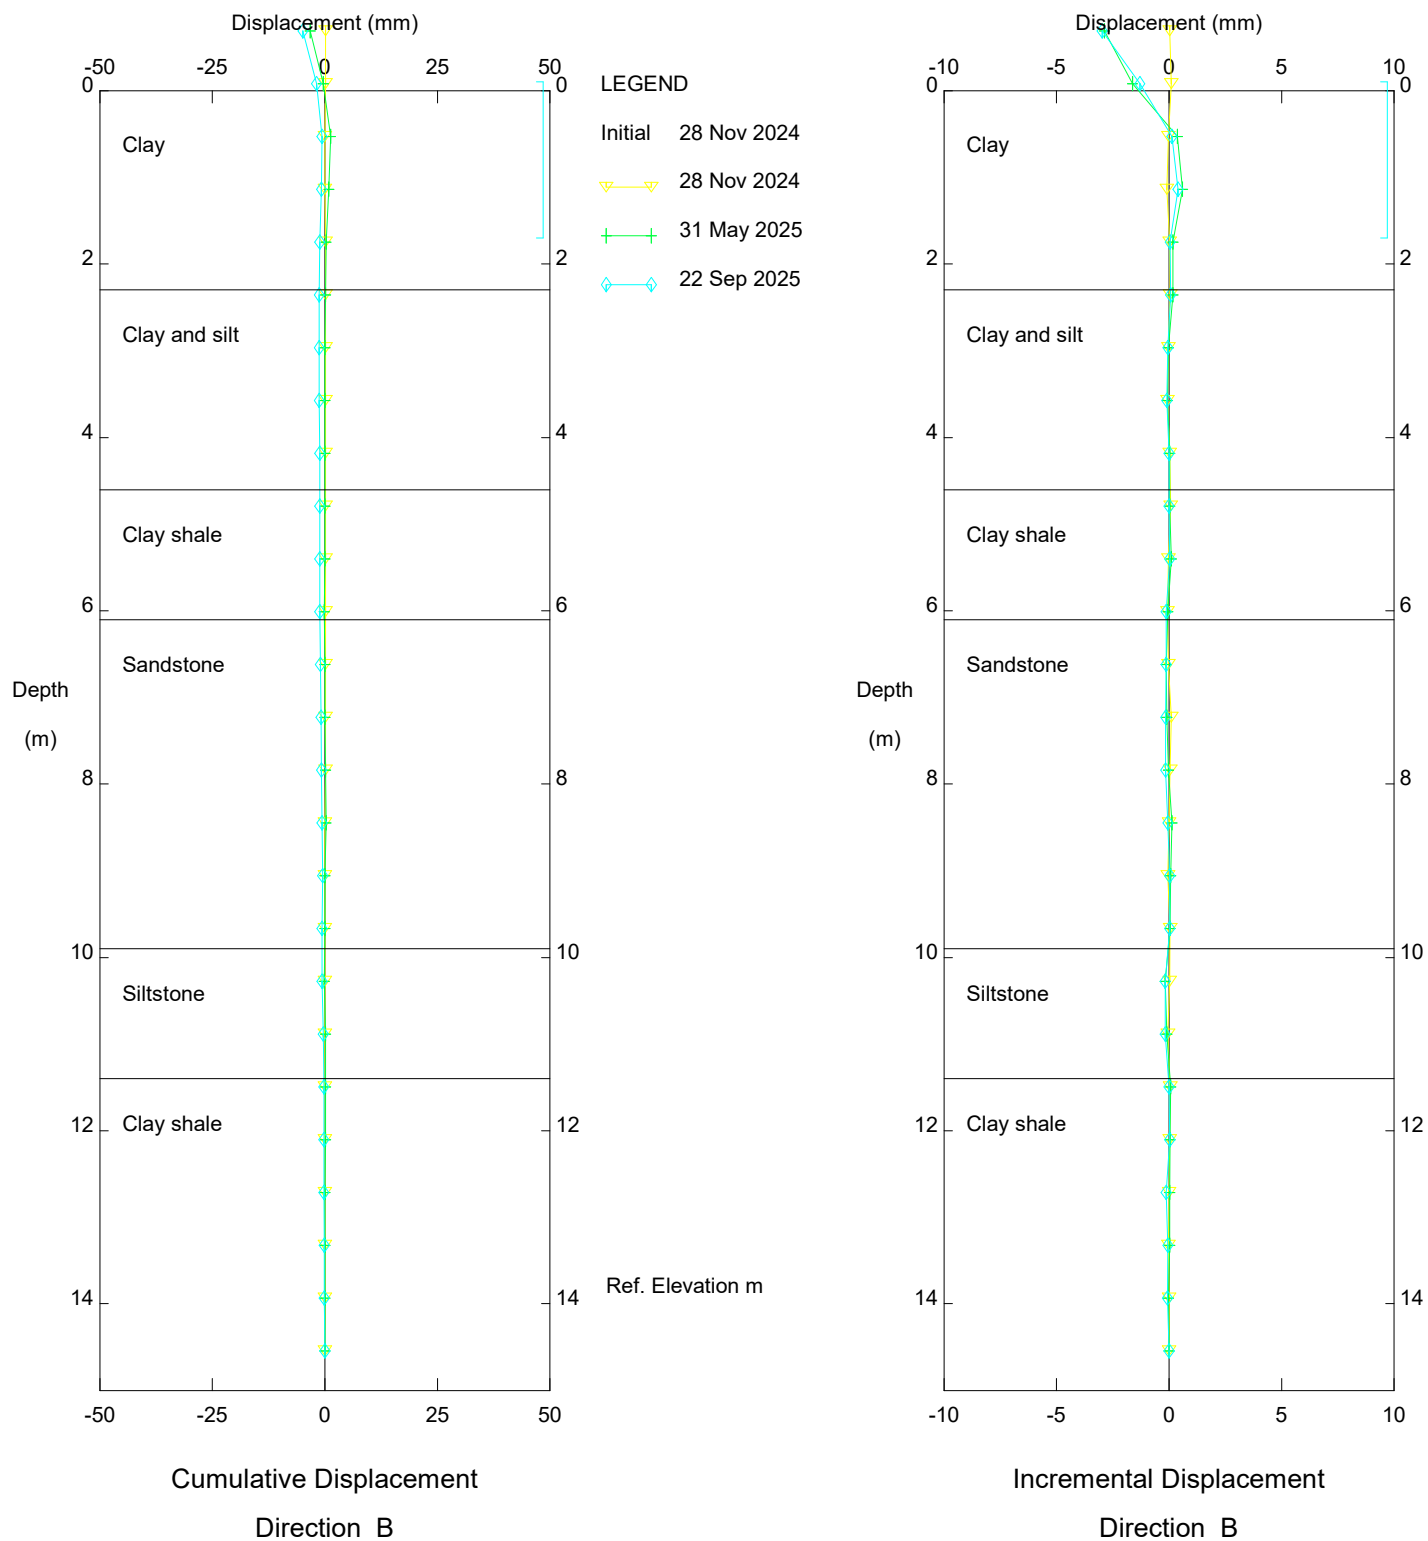
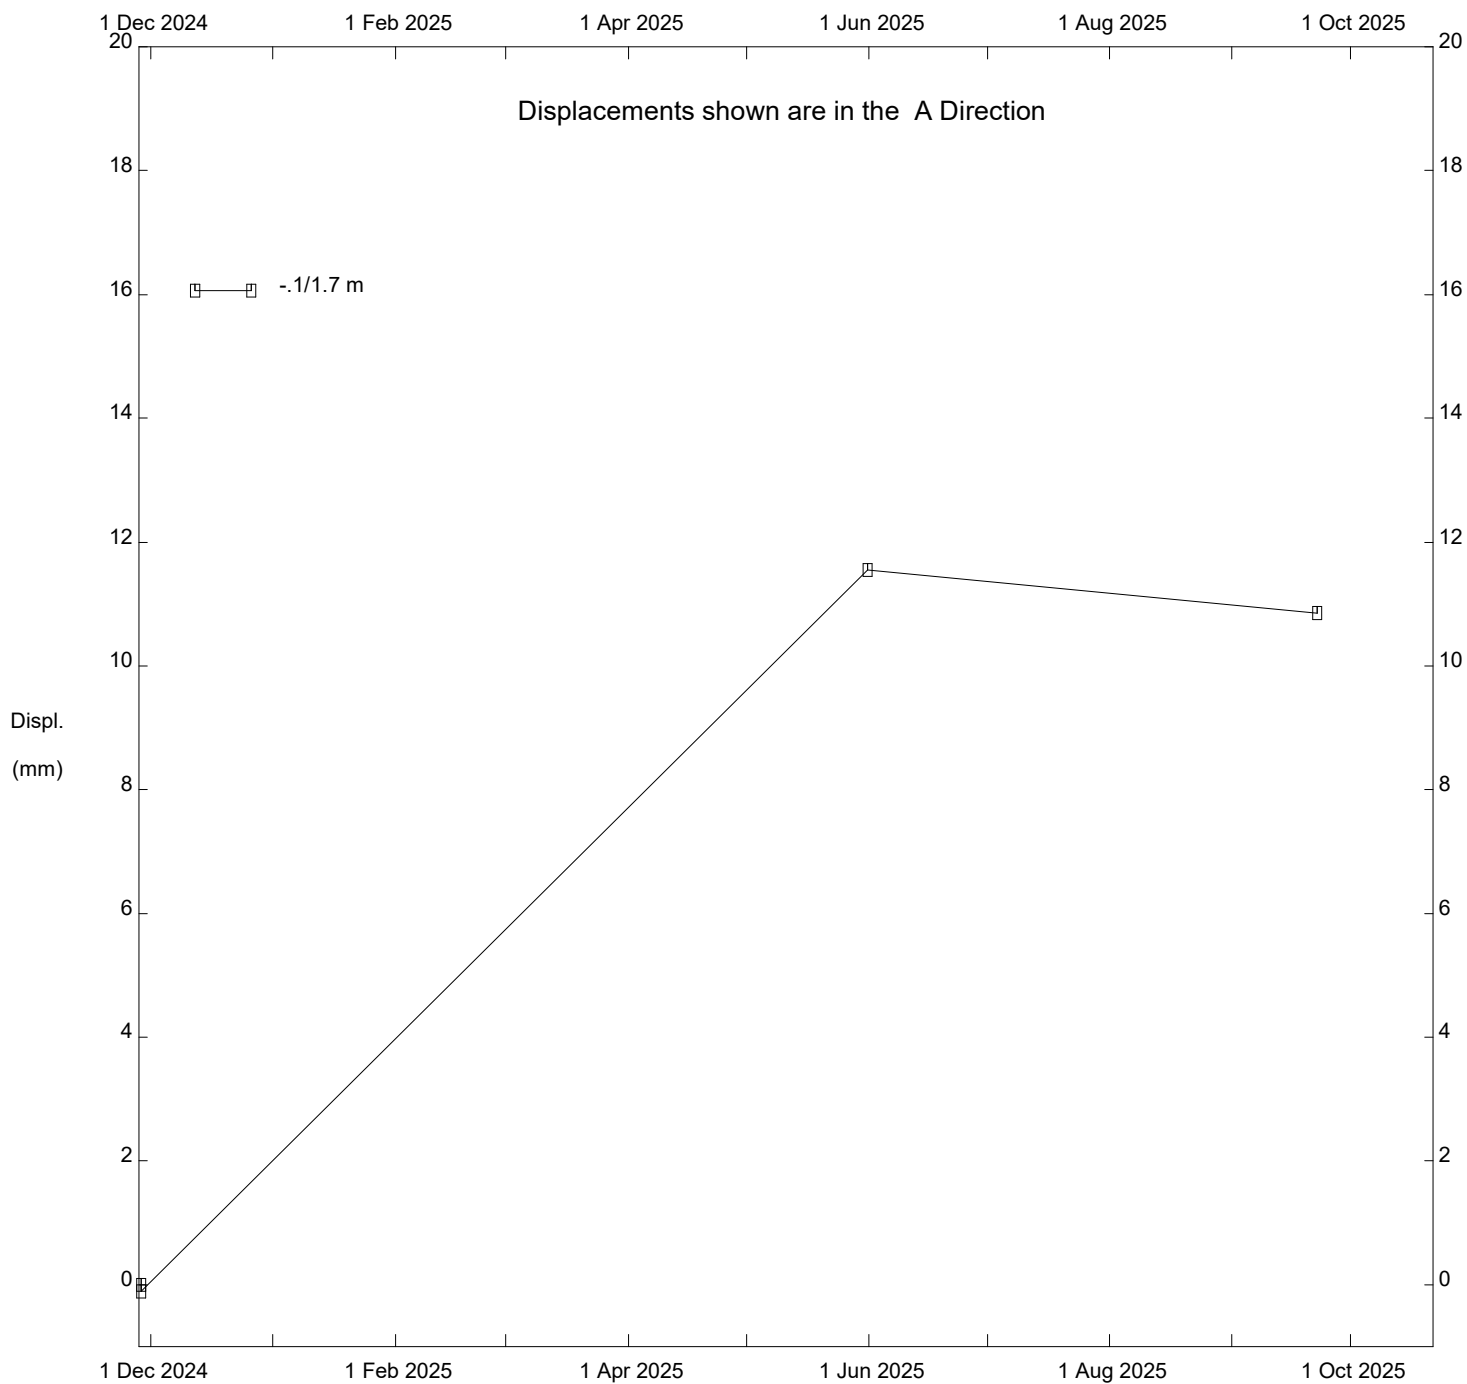
NC006 - Hwy 2:46 Mitsue Lake (km 47.6), Inclinometer SI24-7

| INSTRUMENT # | DATE INITIALIZED | TOTAL CUMULATIVE RESULTANT MOVEMENT AND DEPTH OF MOVEMENT TO DATE (mm) | MAXIMUM RATE OF MOVEMENT (mm/yr) | CURRENT STATUS OF SI | DATE OF PREVIOUS READING | INCREMENTAL MOVEMENT SINCE PREVIOUS READING (mm) | CURRENT RATE OF MOVEMENT (mm/yr) | CHANGE IN RATE OF MOVEMENT SINCE PREVIOUS READING (mm/yr) |
|---|---|---|---|---|---|---|---|---|
| SI24-7 | November 28, 2024 | 10.8 over 0.0 m to 1.7 m depth in the 7° direction | 23.1 in May 2025 | Operational | May 31, 2025 | No Discernible Movement | N/A | -25.4 |

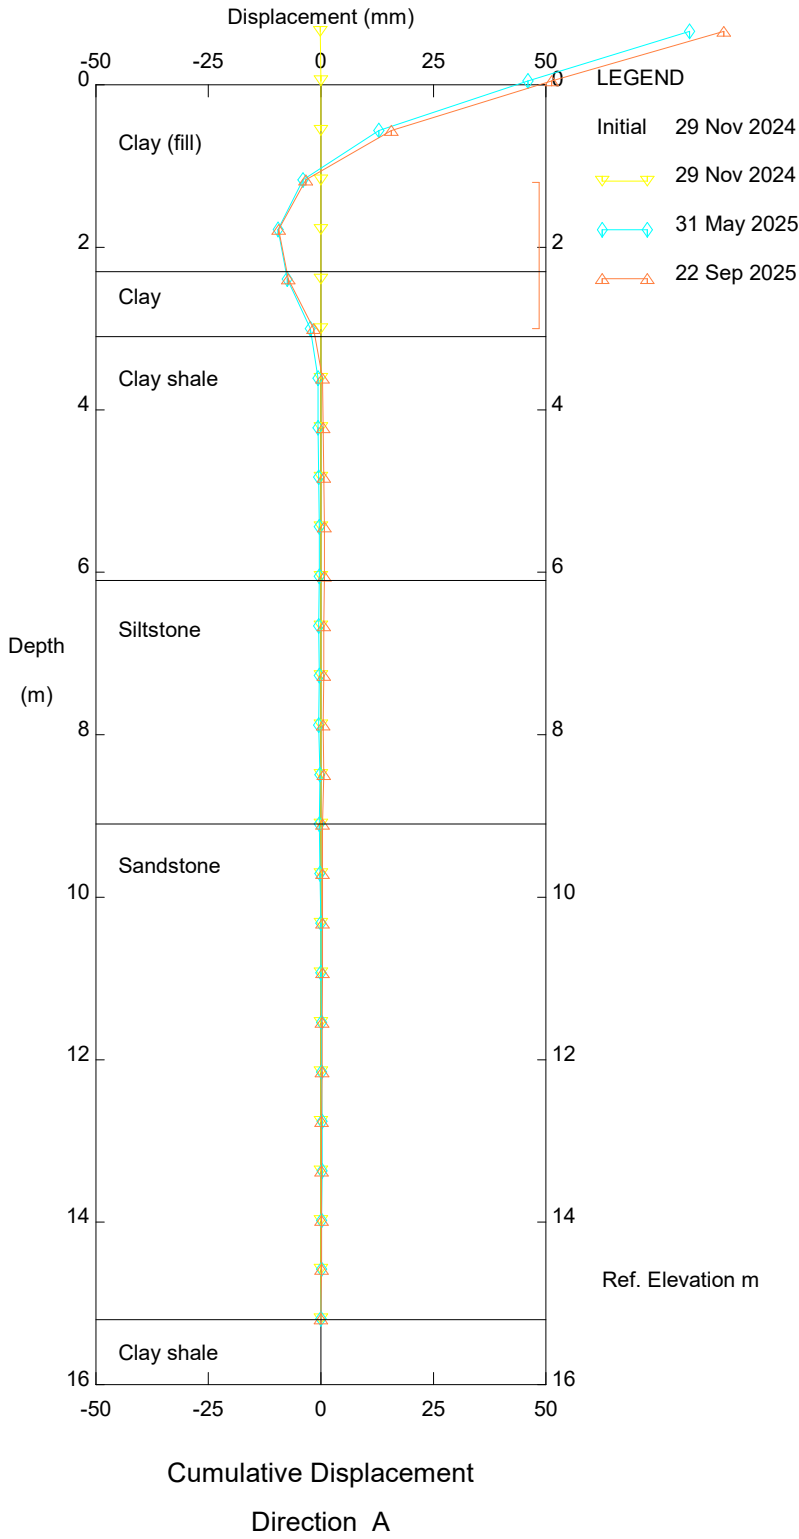
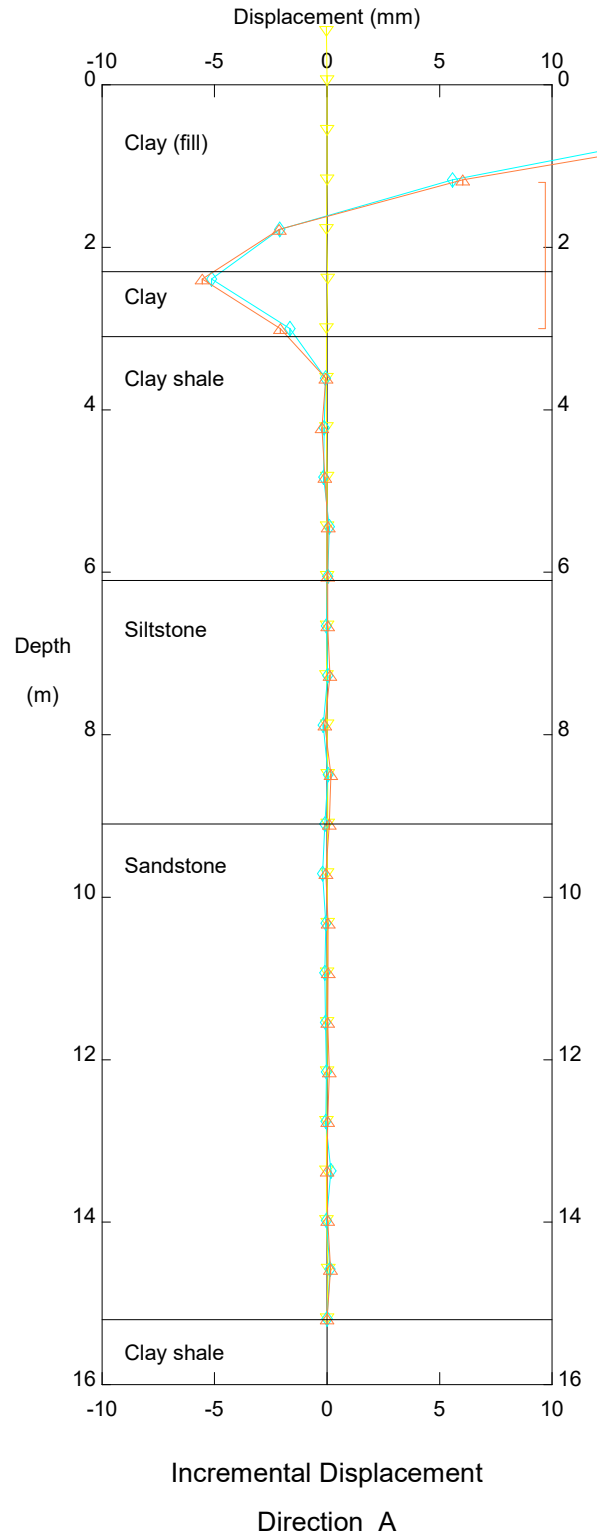
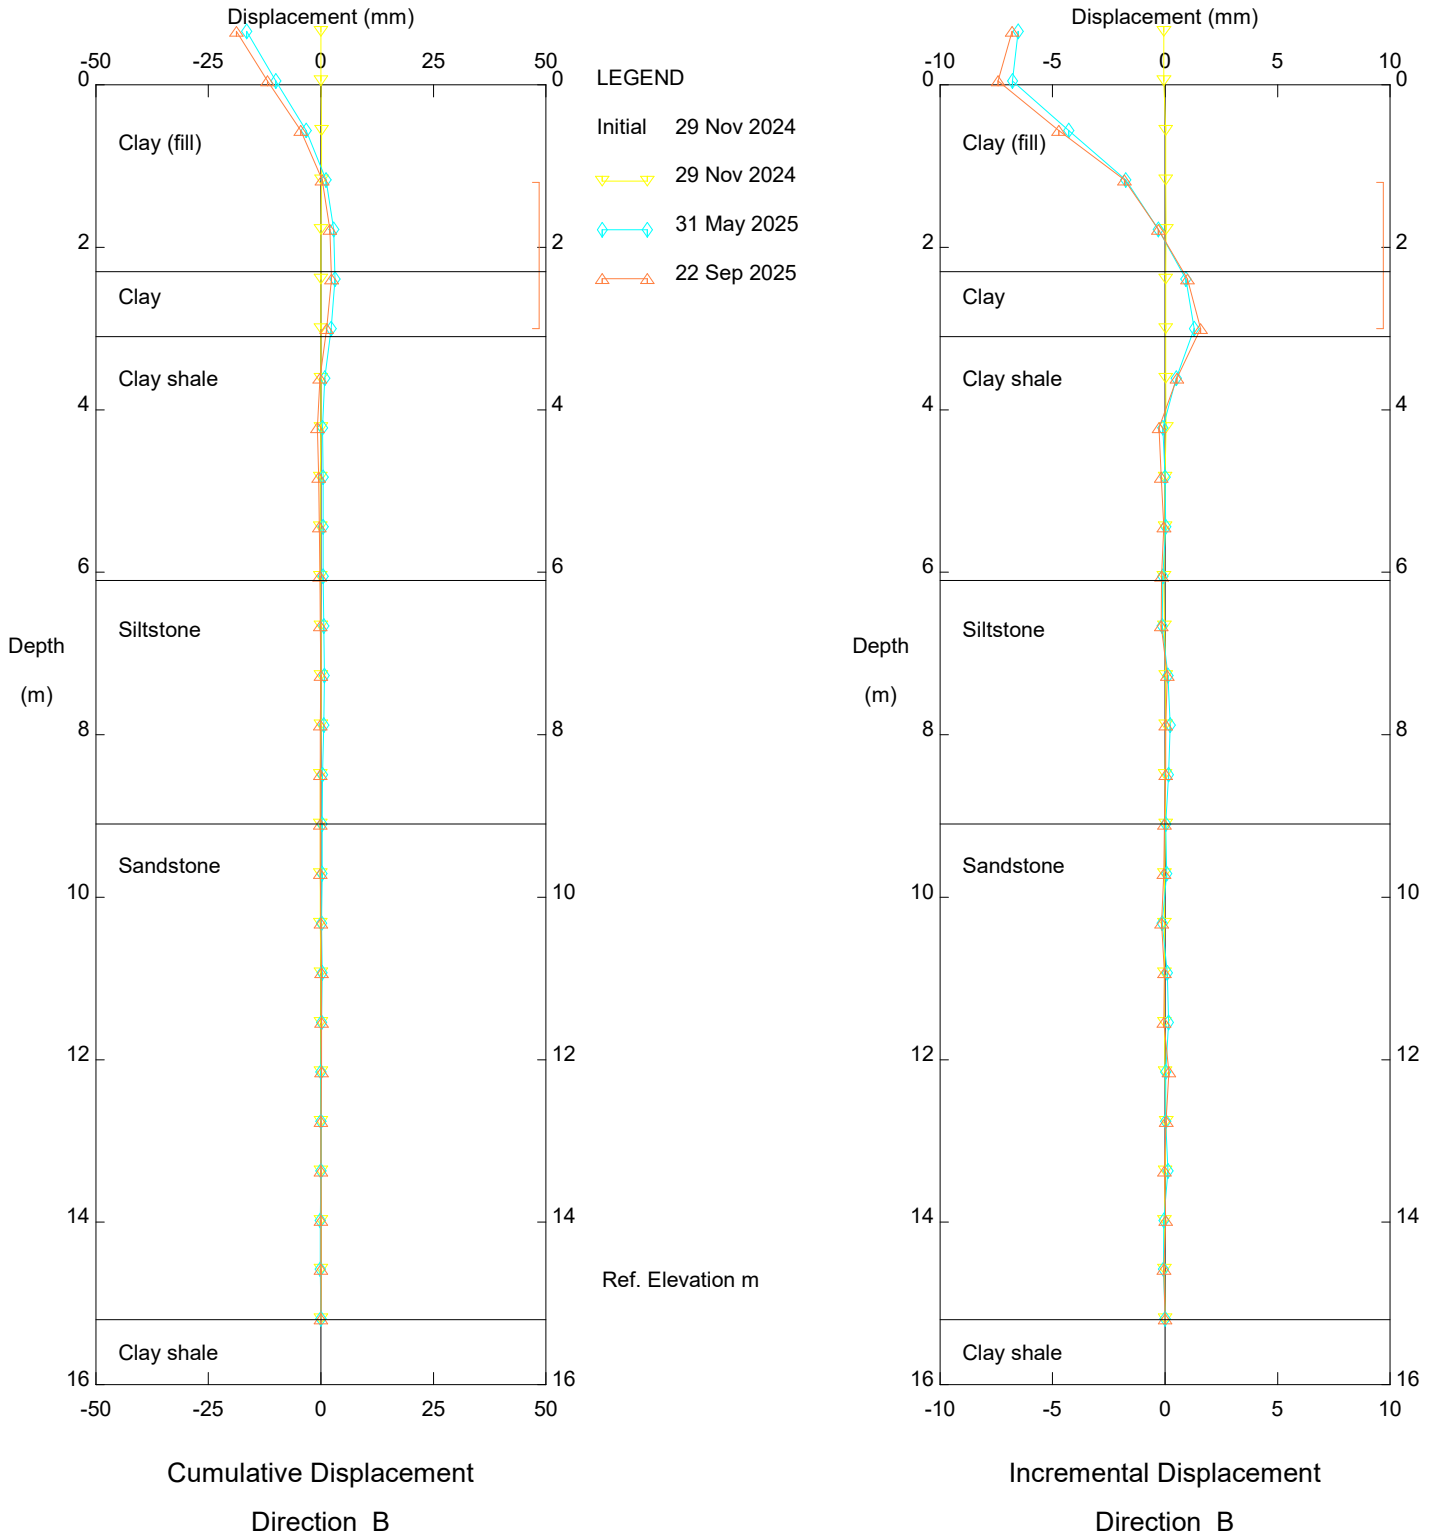
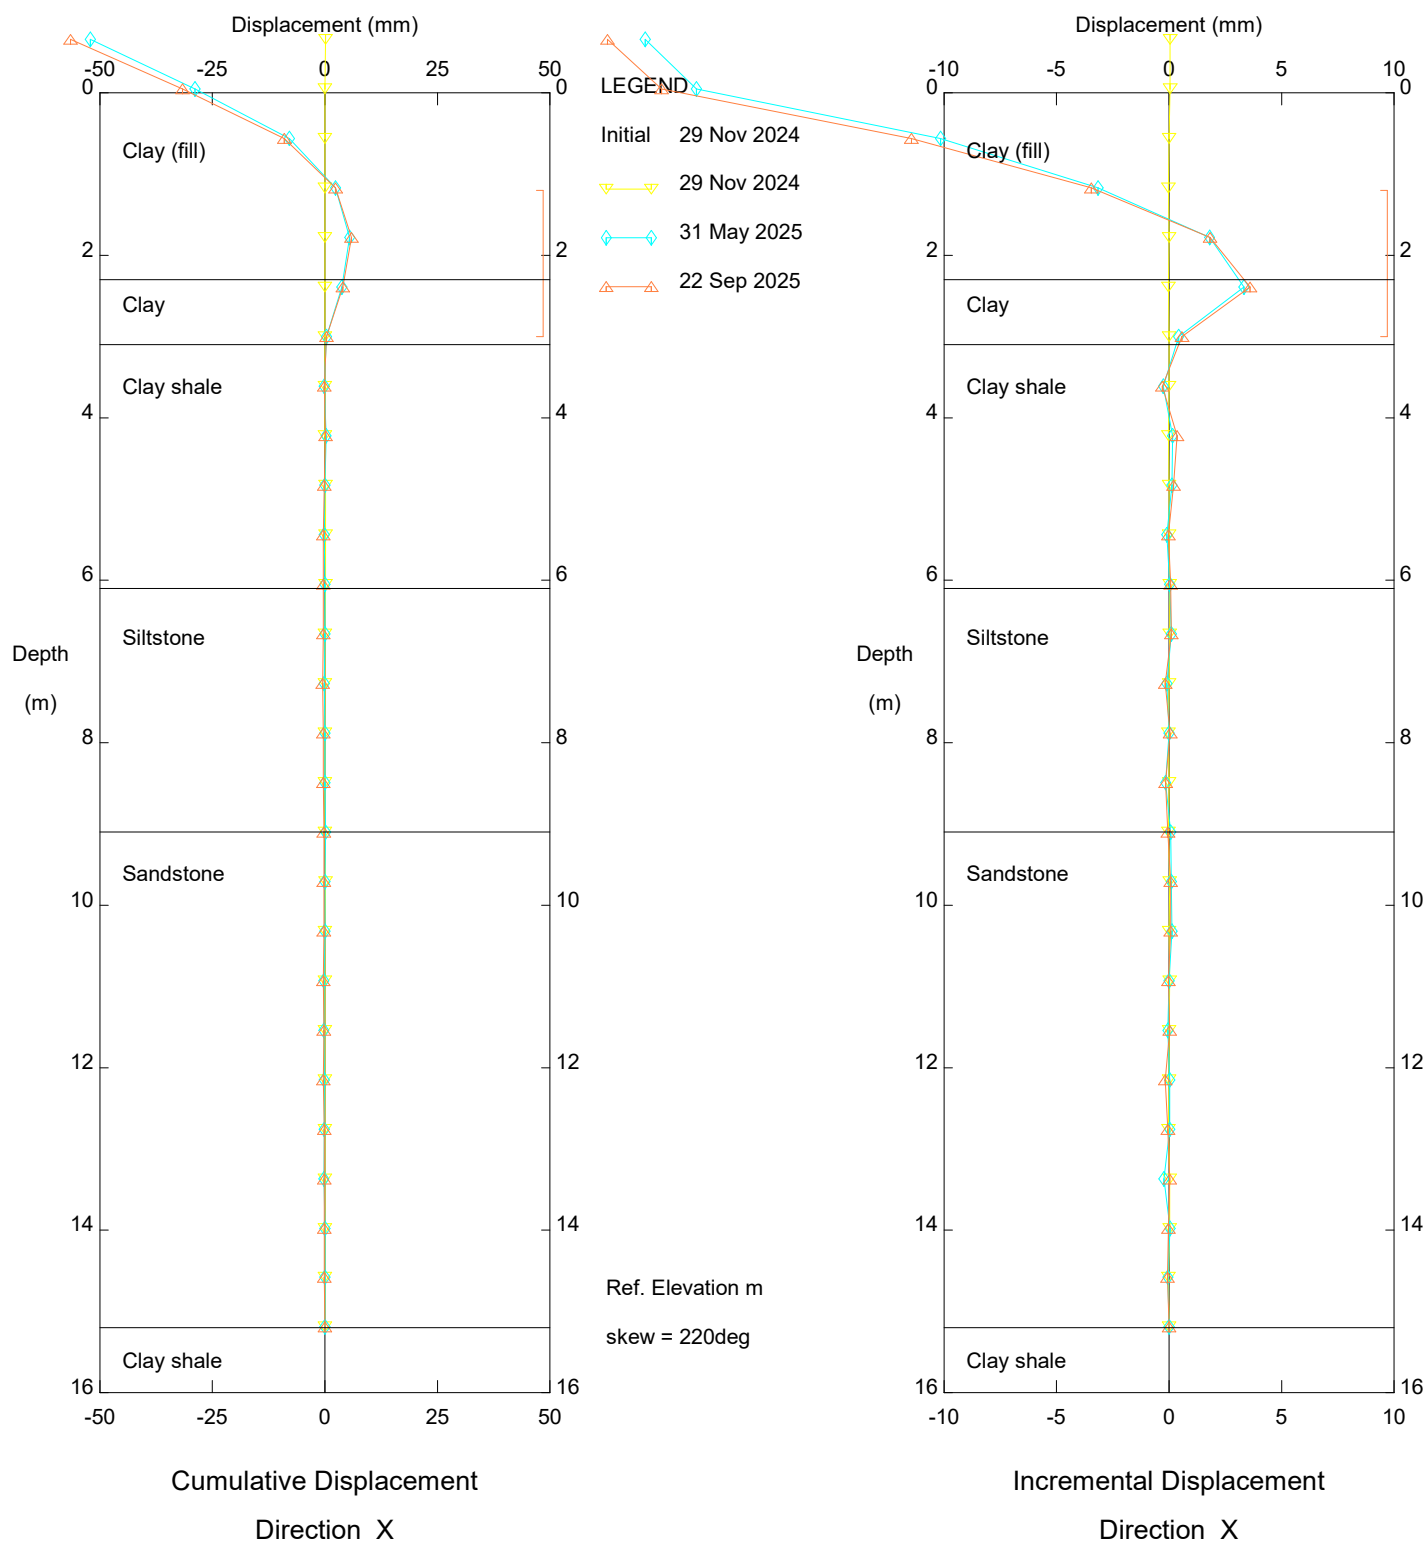
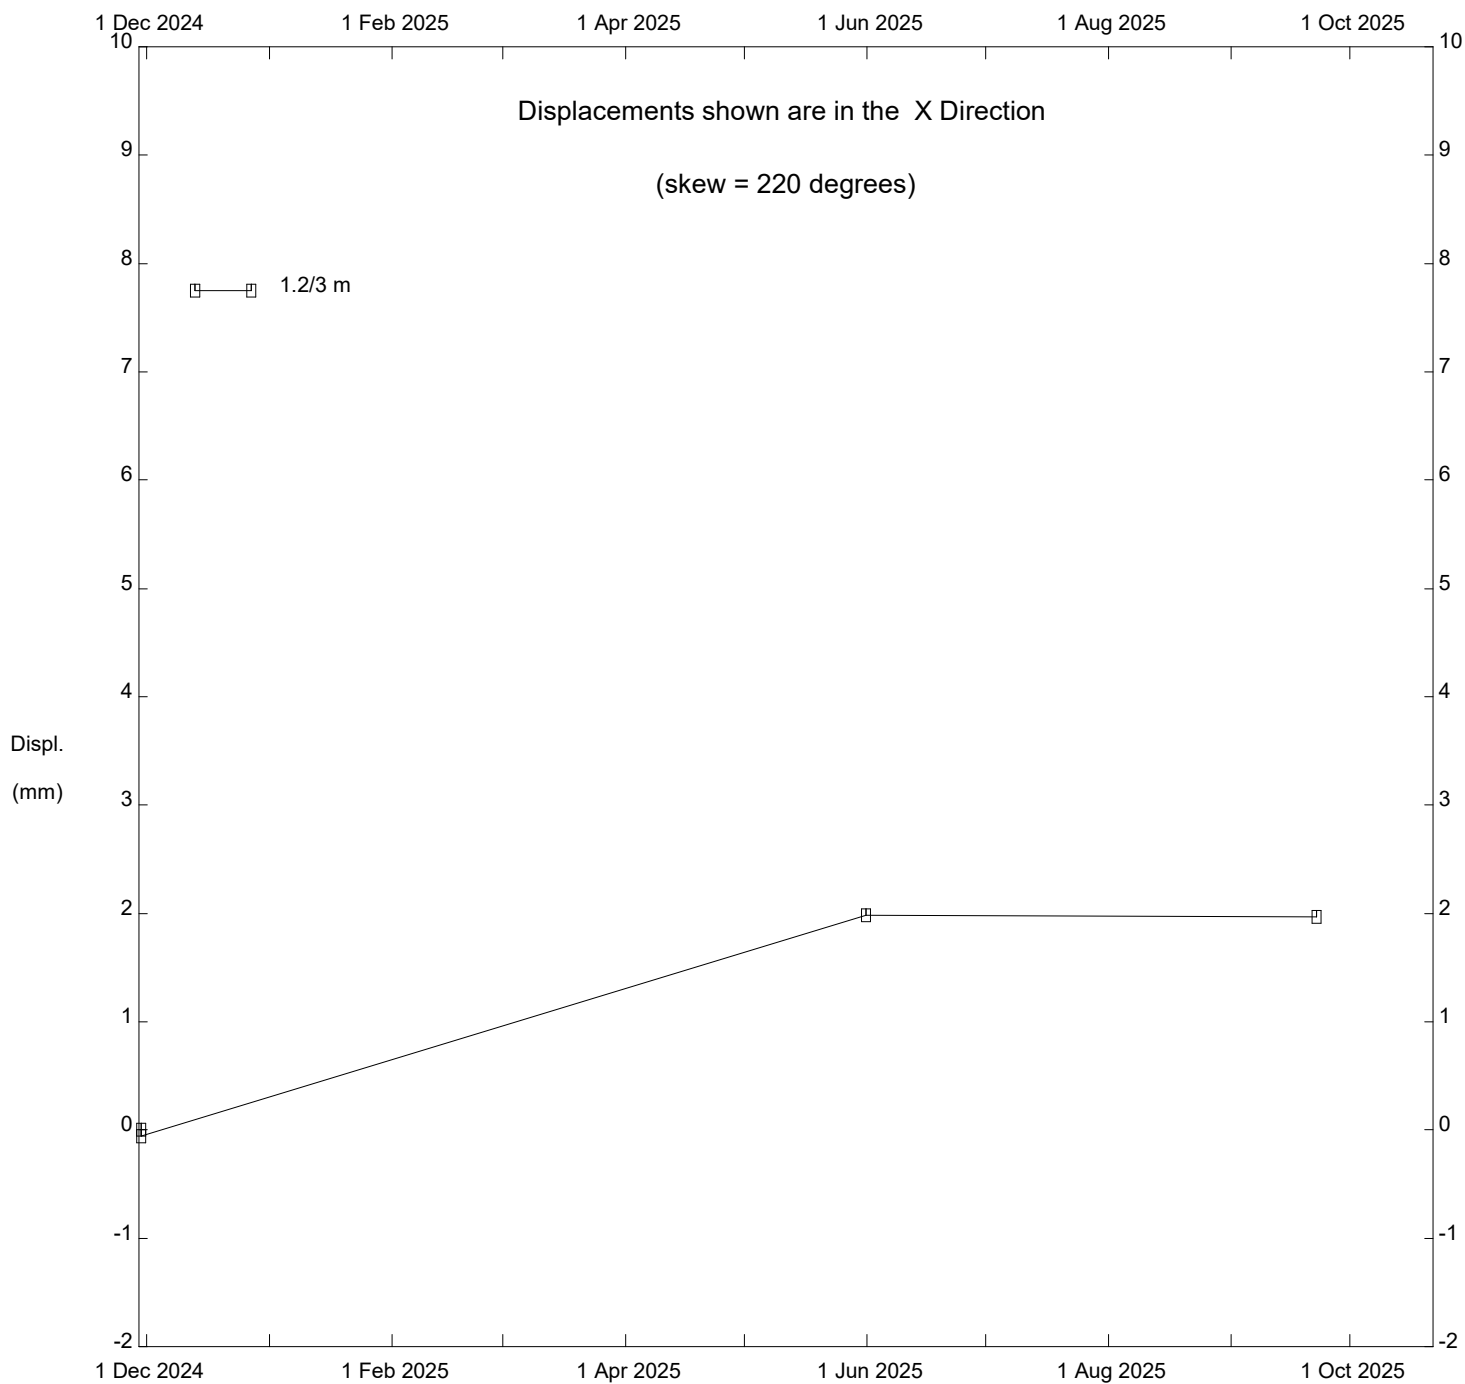
NC006 - Hwy 2:46 Mitsue Lake (km 47.6), Inclinometer SI24-8

| INSTRUMENT # | DATE INITIALIZED | TOTAL CUMULATIVE RESULTANT MOVEMENT AND DEPTH OF MOVEMENT TO DATE (mm) | MAXIMUM RATE OF MOVEMENT (mm/yr) | CURRENT STATUS OF SI | DATE OF PREVIOUS READING | INCREMENTAL MOVEMENT SINCE PREVIOUS READING (mm) | CURRENT RATE OF MOVEMENT (mm/yr) | CHANGE IN RATE OF MOVEMENT SINCE PREVIOUS READING (mm/yr) |
|---|---|---|---|---|---|---|---|---|
| SI24-8 | November 29, 2024 | 2.0 over 1.2 to 3.0 m in the 201° direction | 4.1 in May 2025 | Operational | May 31, 2025 | No Discernible Movement | N/A | -4.2 |

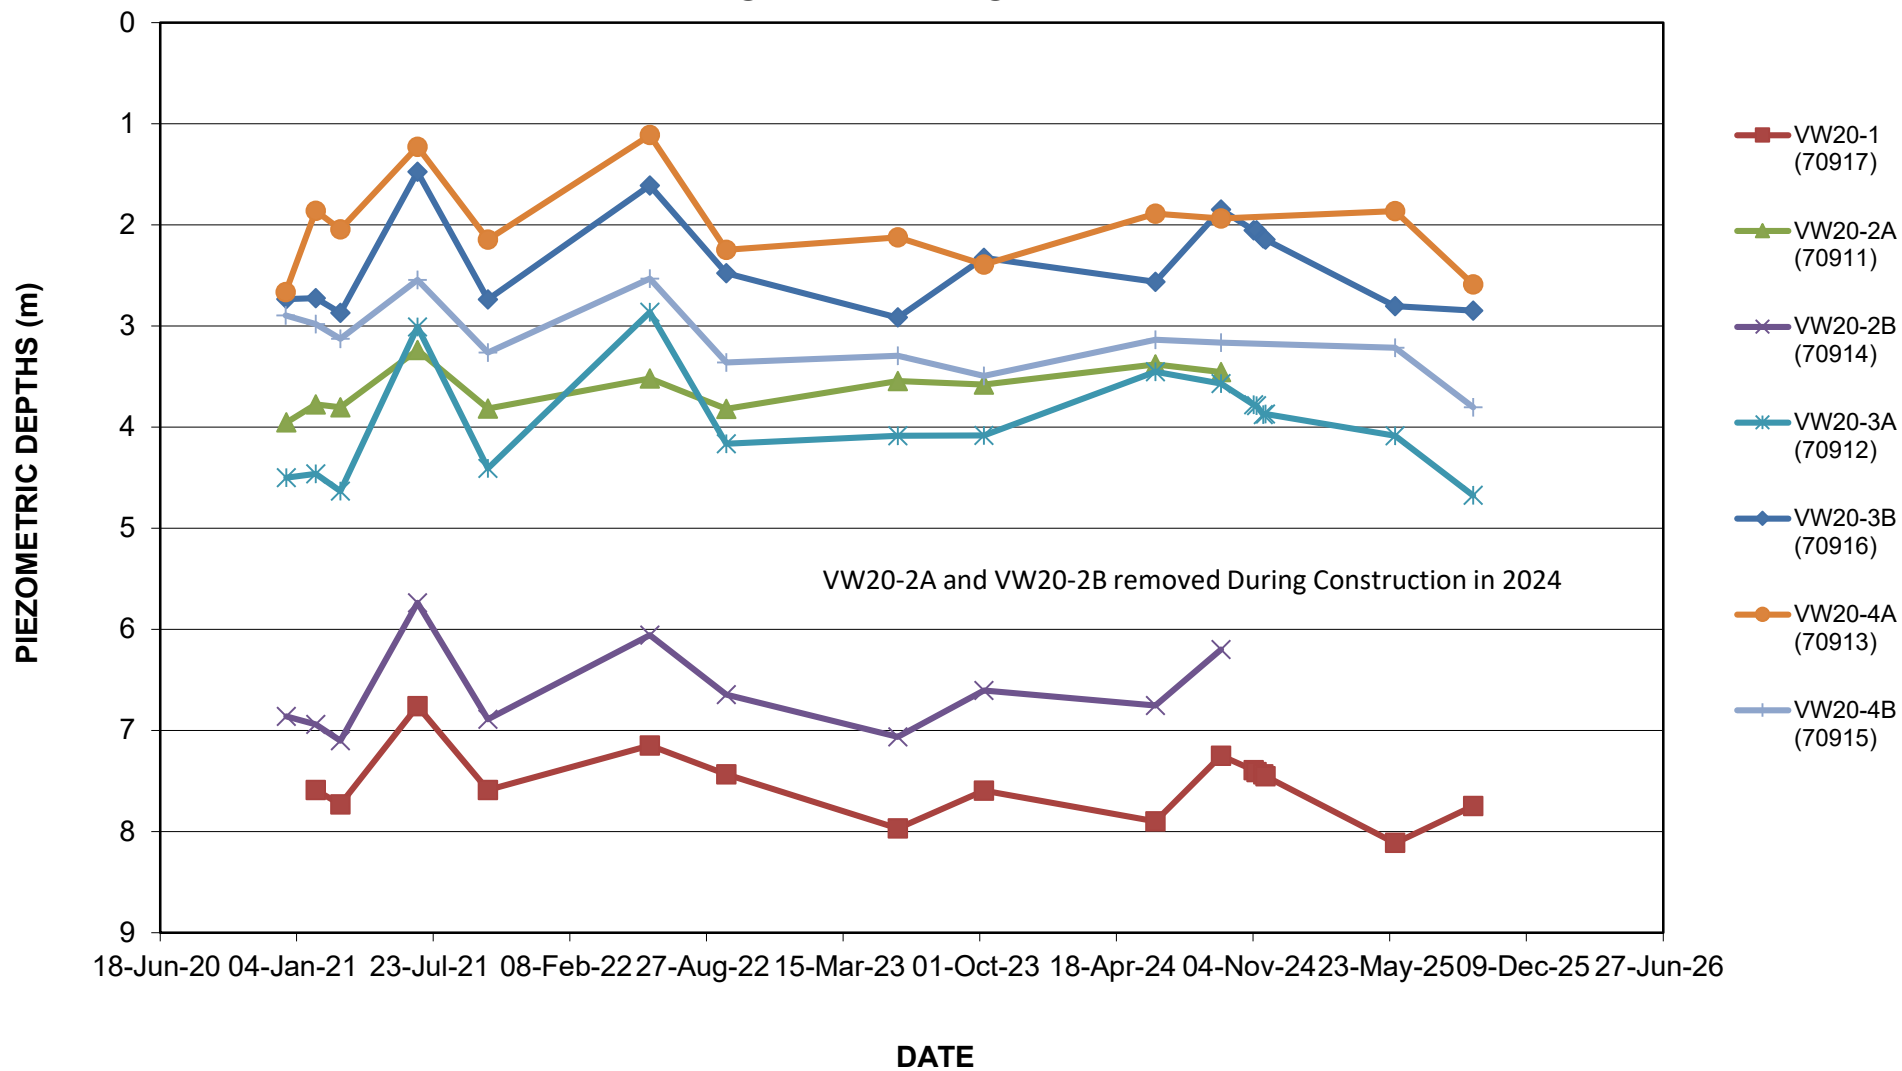
**FIGURE NC006-1**  
**HWY 2:46 MITSUE LAKE SLIDE (KM 47.6)**  
**VIBRATING WIRE PIEZOMETER DATA**

| Discussion | |
|---|---|
| <b>Interpretation of Monitoring Results:</b> | <p>SI20-1, installed in the south ditch of the highway, has shown no discernible movement since initialization. SI20-3, installed downslope of SI20-2 within the bush, showed a rate of movement of 3.6 mm/yr over 1.4 m to 3.2 m depth since the spring of 2025 readings. This corresponds to an increase in the rate of movement by 3.5 mm/yr. SI20-4, installed further downslope of SI20-3 within the bush, has shown no discernible movement since initialization.</p> <p>SI24-7, installed downslope of the pile wall, and SI24-8, installed between the highway surface and the pile wall, each showed no discernible movement since the spring of 2025 readings.</p> <p>Vibrating wire piezometers VW20-3A, VW20-3B, VW20-4A, and VW20-4B showed decreases in groundwater level of 0.59 m, 0.05 m, 0.72, and 0.58 m, respectively, since the spring of 2025 readings. Vibrating wire piezometer VW20-1 showed an increase in groundwater level of 0.36 m since the spring of 2025 readings.</p> |

| | Overall, the measured groundwater levels are within the historically maximum groundwater levels for the site. |
