**ALBERTA TRANSPORTATION AND  
ECONOMIC CORRIDORS GRMP  
NORTH CENTRAL (ATHABASCA AND FORT  
MCMURRAY DISTRICTS)  
2025 SITE INSPECTION**

| Site Number | Location | Name | Hwy | km |
|---|---|---|---|---|
| NC006 | 11 Km East of Slave Lake | Mitsue Recreation Area | 2:46 | 47.33 |

| | Date | PF | CF | Total |
|---|---|---|---|---|
| <b>Current Inspection:</b> | May 13, 2025 | 6 | 5 | 30 |

| <b>Primary Site Issue</b> | Active landslide causing severe deterioration to highway conditions. |

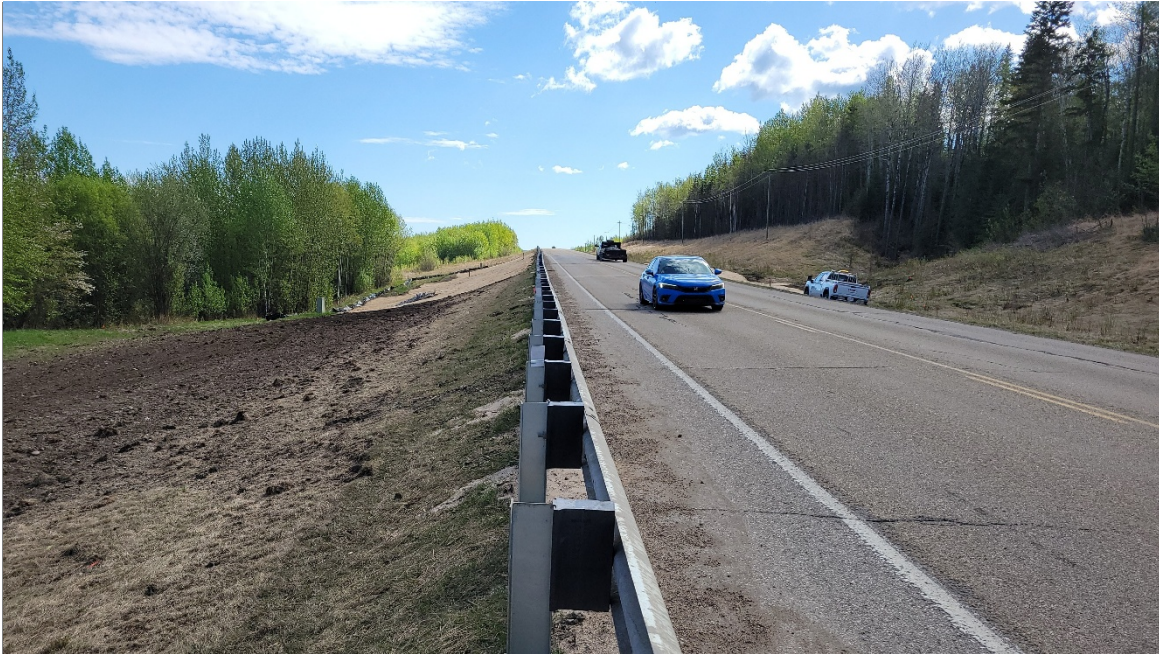
| <b>Observations:</b> | <b>Description</b> | <b>Worse?</b> |
|---|---|---|
| <input checked="" type="checkbox"/> Other | The bench and settlement cracks, used to be downslope of the highway surface, were regraded as part of the 2024 pile wall construction and are no longer visible. | <input type="checkbox"/> |

**Photo 1. Looking east toward the highway side slope area regraded as part of the 2024-25 pile wall construction.**

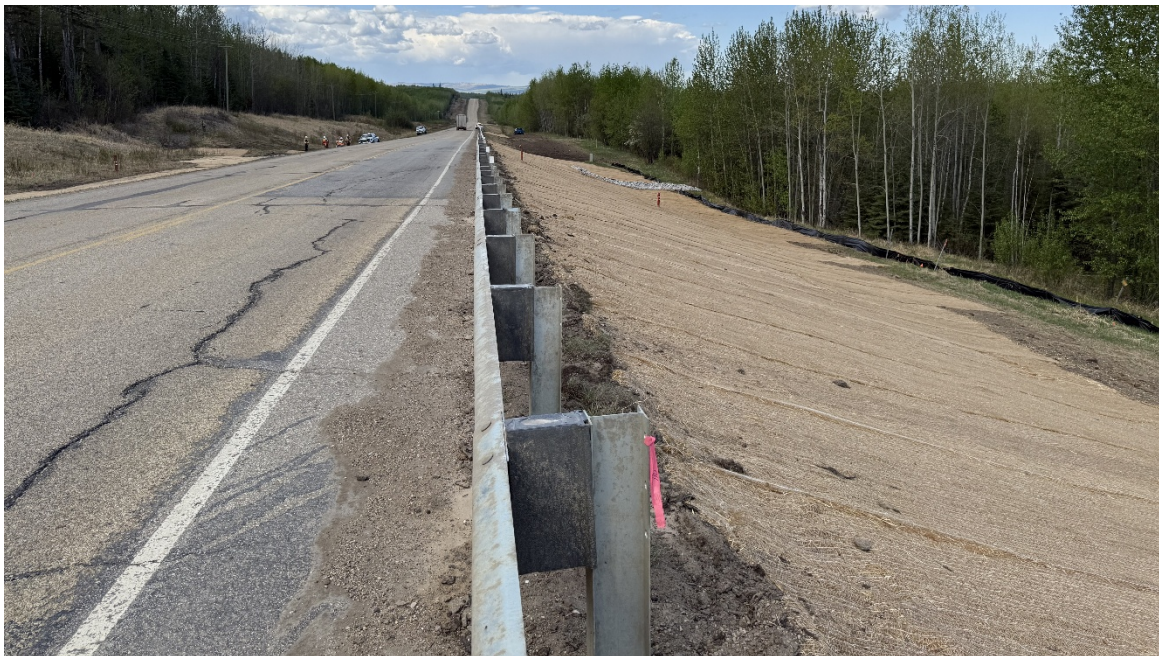
**Photo 2. Looking west at the flank of the landslide area and the west edge of the 2021 ACP patch.**

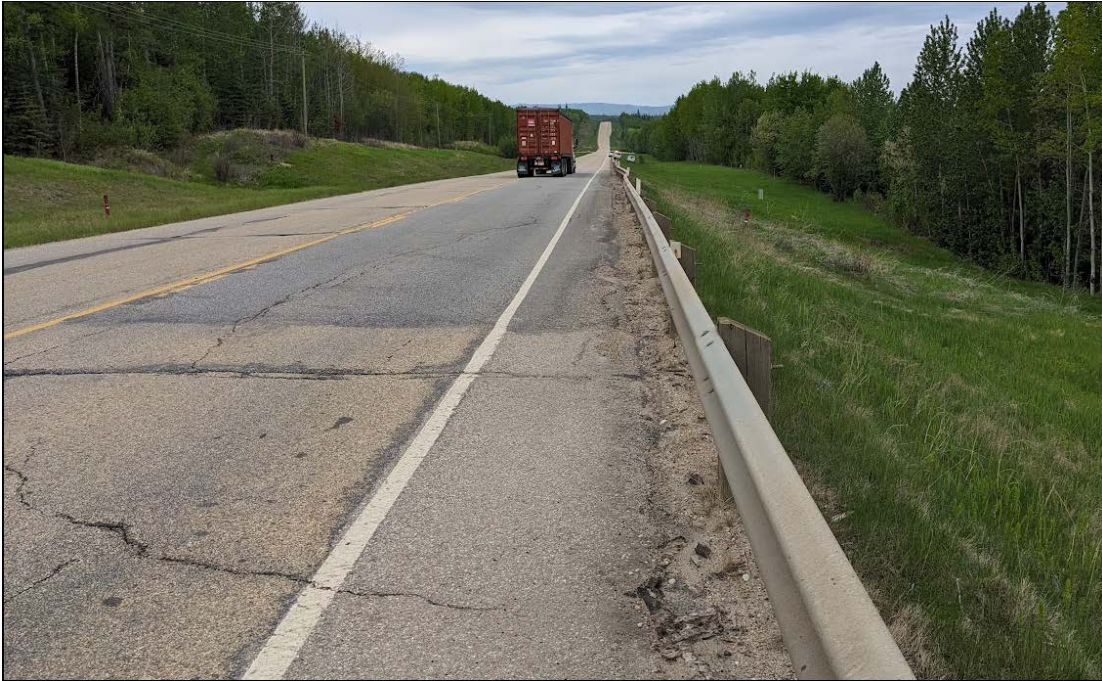
**Photo 3A (2024 Inspection).** Looking west at the edge of the 2021 ACP patch. Reflective cracks are visible through the ACP patch.

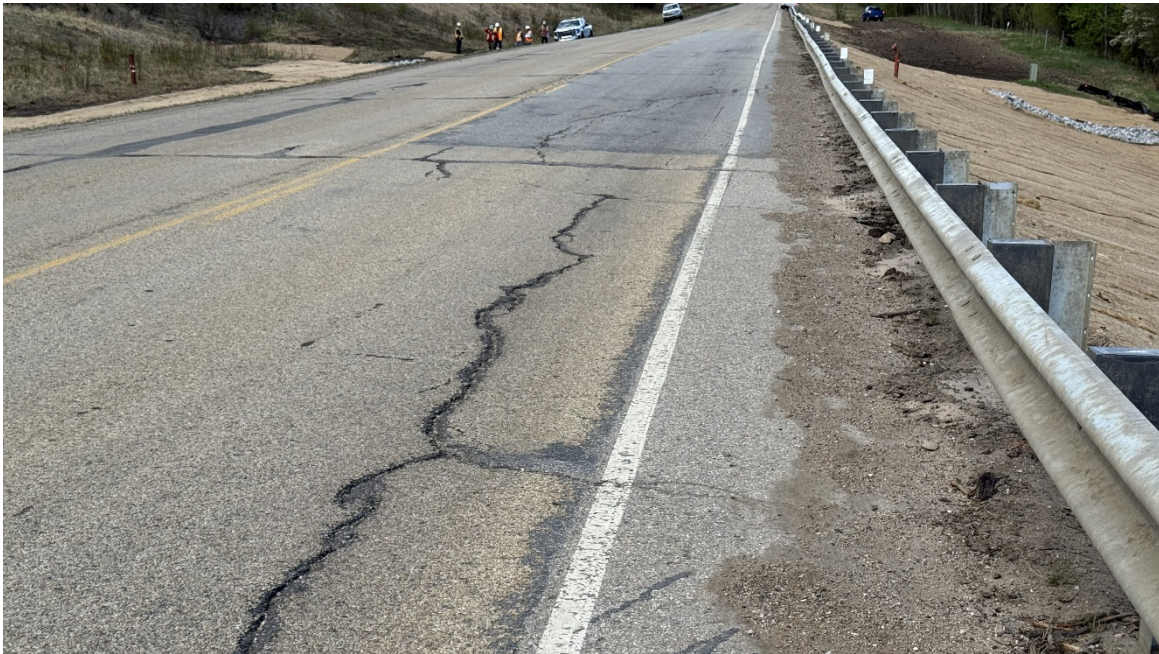
| <b>Observations:</b> | <b>Description</b> | <b>Worse?</b> |
|---|---|---|
| <input checked="" type="checkbox"/> Slope Movement | Reflective landslide cracks within the 2021 ACP patch area have widened; diagonal cracks within the landslide area are up to 150 mm wide with up to 30 mm drop across the crack surfaces; tension cracks downslope of the highway and the previously observed toe roll are no longer visible due to regrading work completed as part of 2024 pile wall construction. | <input type="checkbox"/> |

**Photo 3B.** (Same location as Photo 3A viewed during the current inspection). Note that the guardrail was replaced during the 2024-25 pile wall construction.

The ACP overlay, scheduled for 2025, should eliminate the existing dip on the highway surface and provide a smooth ride to the highway motorists. If delayed, the local MCI should consider sealing the visible landslide cracks on the highway surface.

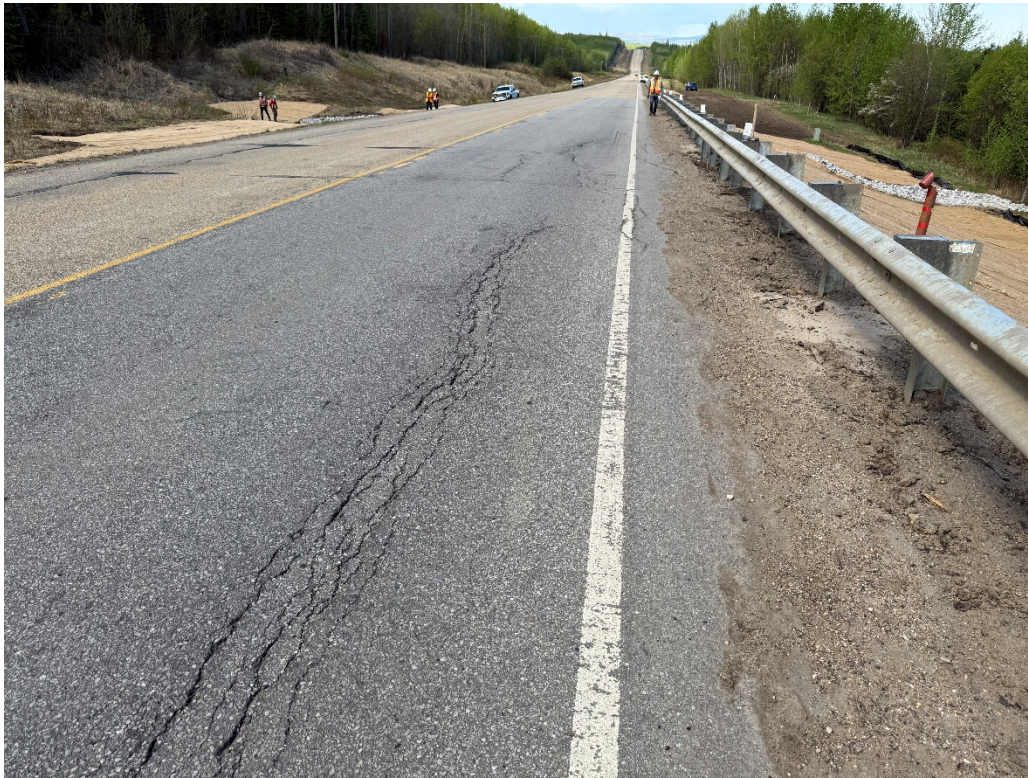
**Photo 4. Looking west at longitudinal cracks on the highway.**

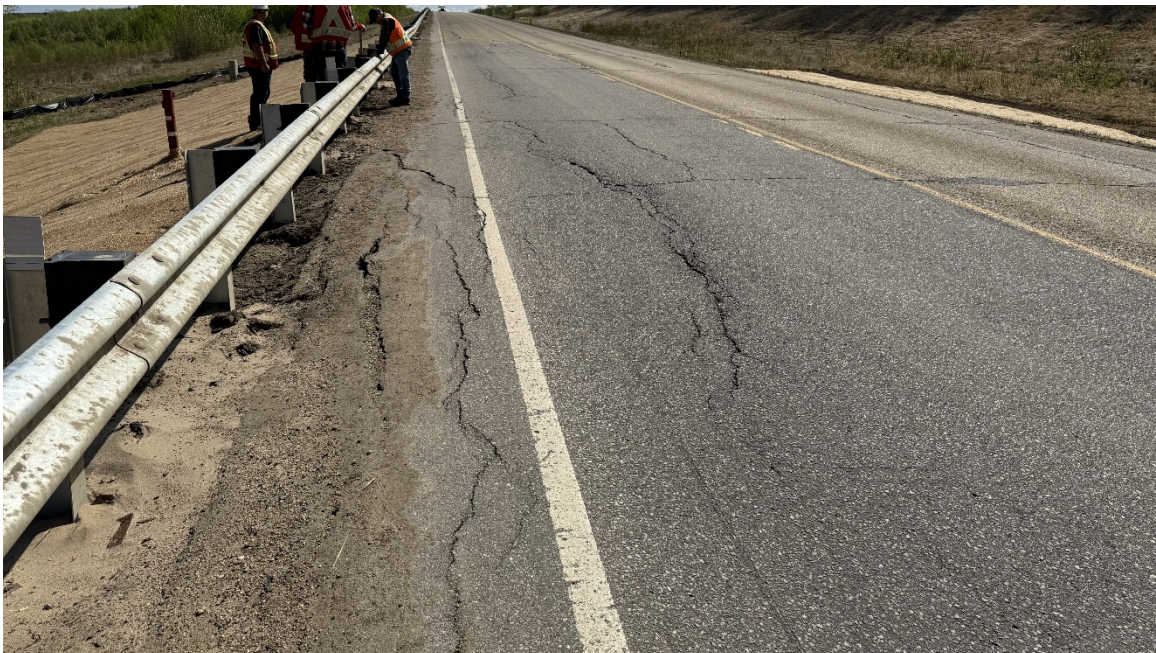
| <b>Observations:</b> | <b>Description</b> | <b>Worse?</b> |
|---|---|---|
| <input checked="" type="checkbox"/> Pavement Distress | 25 mm dip noted on the middle portion of the 2021 ACP patch. | <input type="checkbox"/> |

**Photo 5. Looking east at the most severe area of pavement distress within the slide. The dips and cracks have not shown substantial change since construction of the pile wall in 2024.**

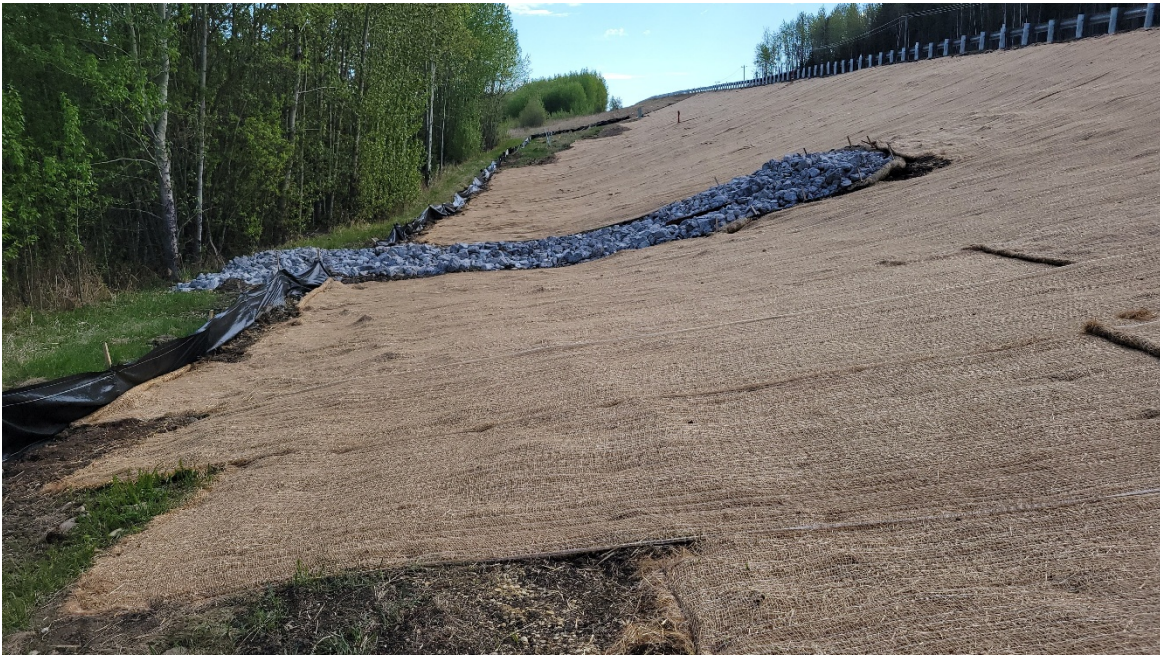
**Photo 6. Looking east at the regraded downslope area. The inlet for the new 900 mm diameter SWSP culvert as well as the associated Class 1M riprap channel are visible in the foreground. Regraded slope area has been covered with Type C erosion control matting.**

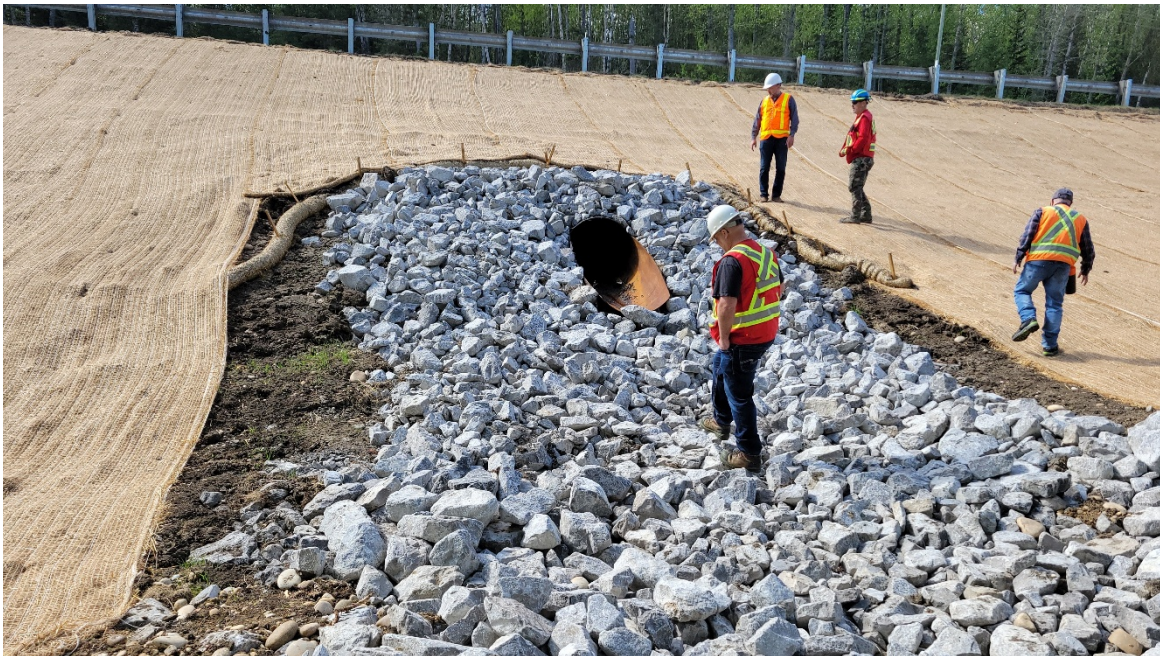
| <b>Observations:</b> | <b>Description</b> | <b>Worse?</b> |
|---|---|---|
| <input checked="" type="checkbox"/> Seepage | Minor flow in the new culvert. | <input type="checkbox"/> |

**Photo 7. Outlet of new 900 mm diameter SWSP culvert and Class 1M riprap channel.**

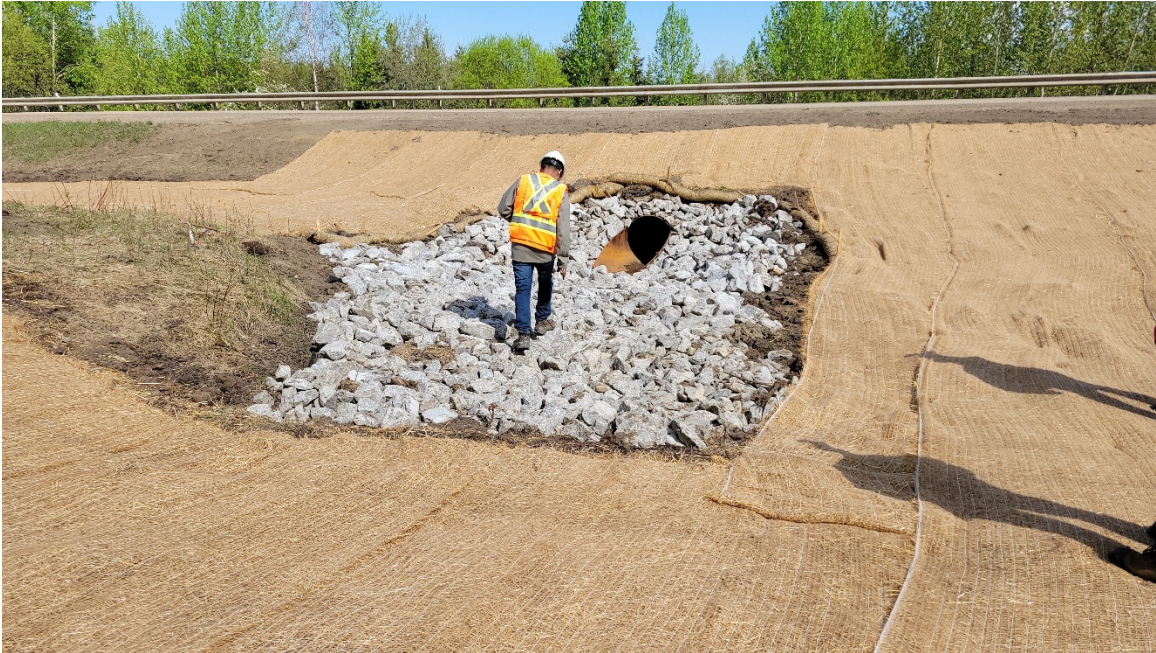
**Photo 8. Inlet side of new 900 mm diameter SWSP culvert and riprap bowl.**

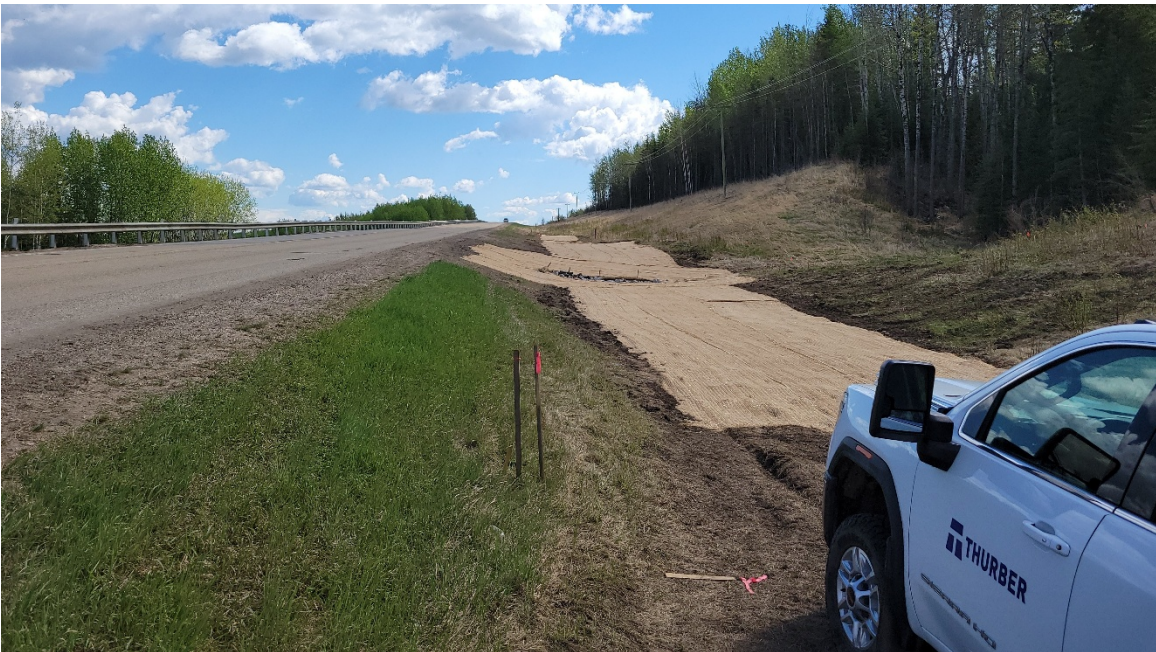
**Photo 9. Looking east at the regraded upslope ditch area. Type C erosion control blanket has been placed in the ditch. The inlet to the new 900 mm diameter SWSP culvert is visible near the middle of the photo. |**
