ALBERTA TRANSPORTATION AND  
ECONOMIC CORRIDORS GRMP  
NORTH CENTRAL (ATHABASCA AND FORT  
McMURRAY DISTRICTS)  
INSTRUMENTATION MONITORING - SPRING 2025

| Site Number | Location | Name | Hwy | km |
|---|---|---|---|---|
| NC006 | HWY 2:46 C1 47.6 | Mitsue Lake Recreation Area | 2:46 | km 47.6 |

| <b>Current Monitoring:</b> | 31-May-2025 | <b>Previous Monitoring</b> | 18-Sep-2024 |

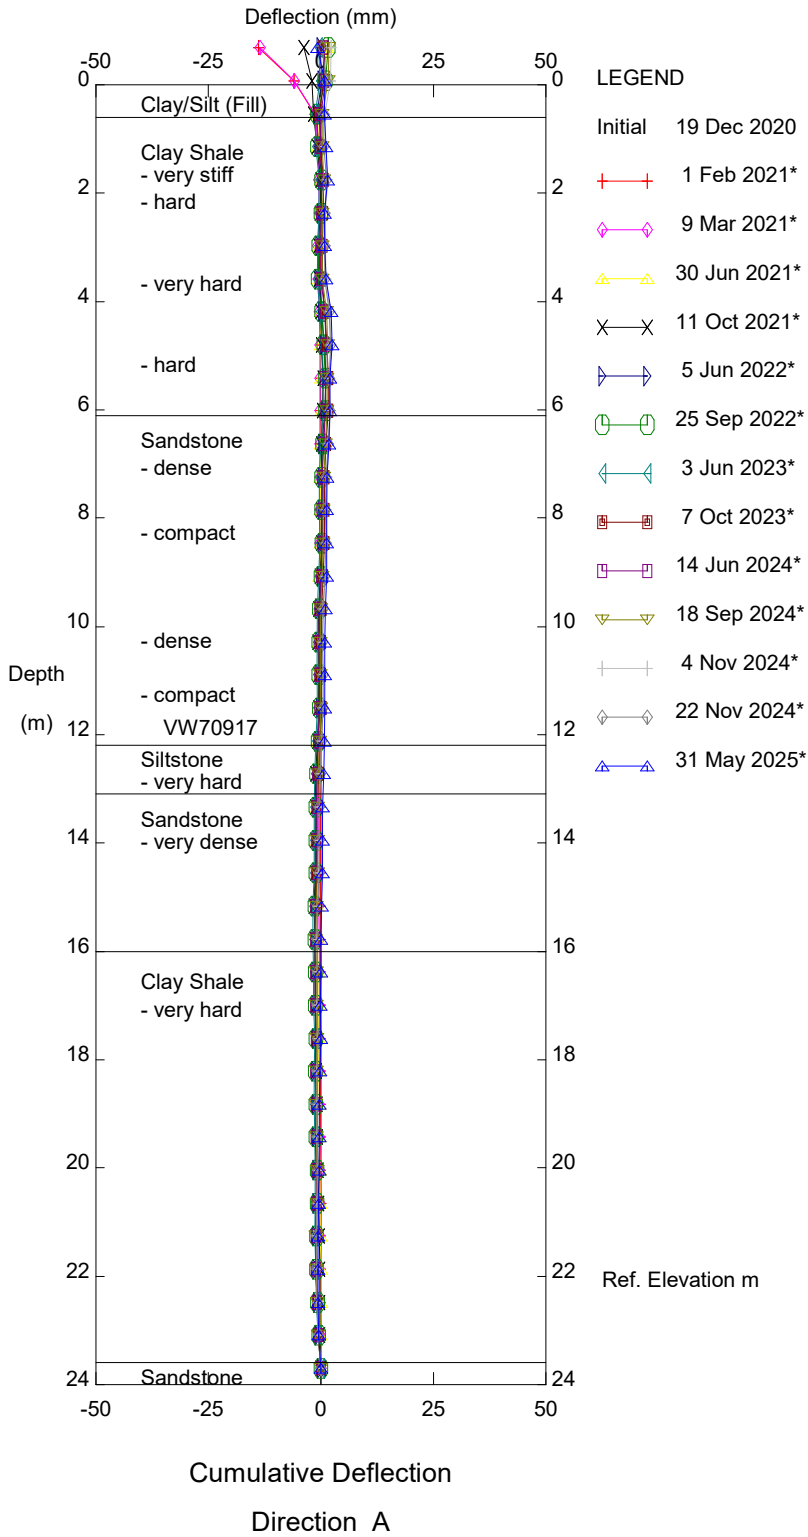
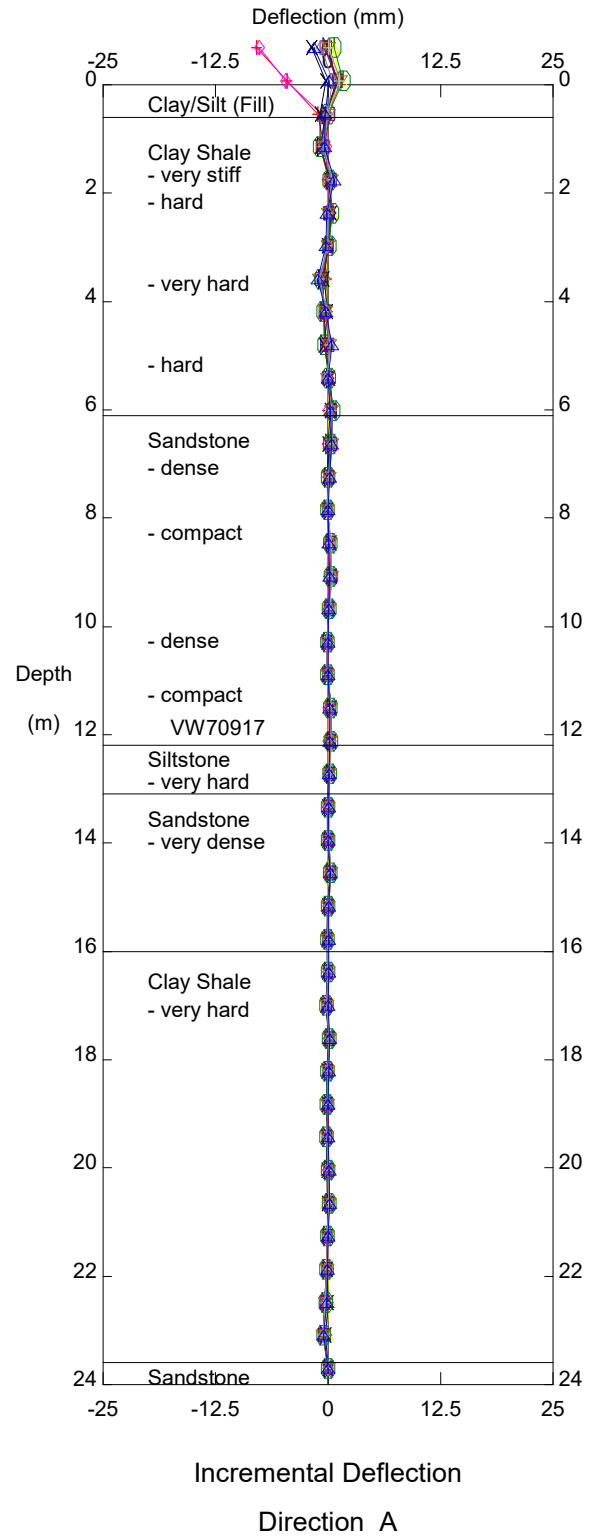
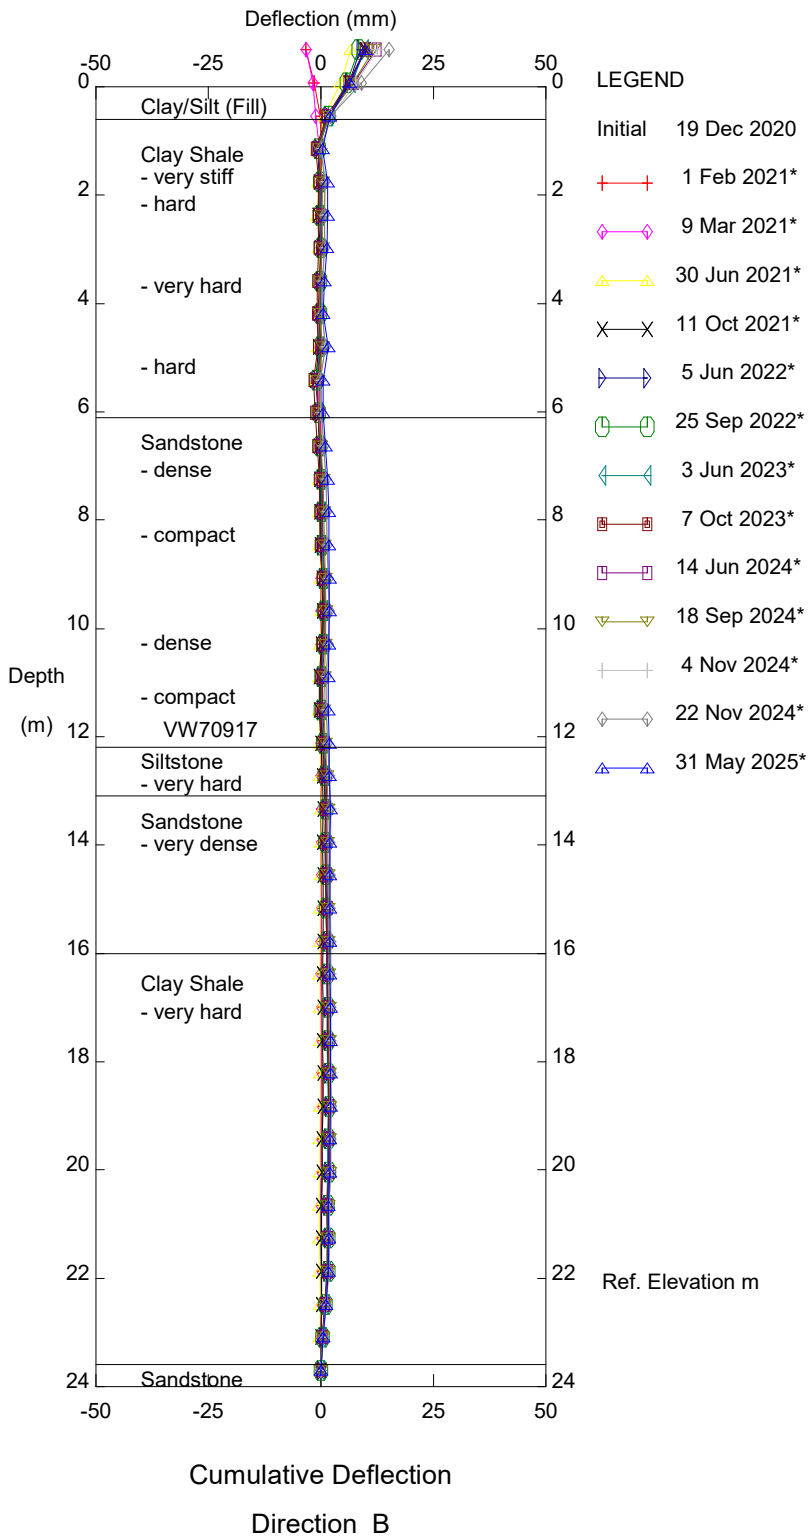
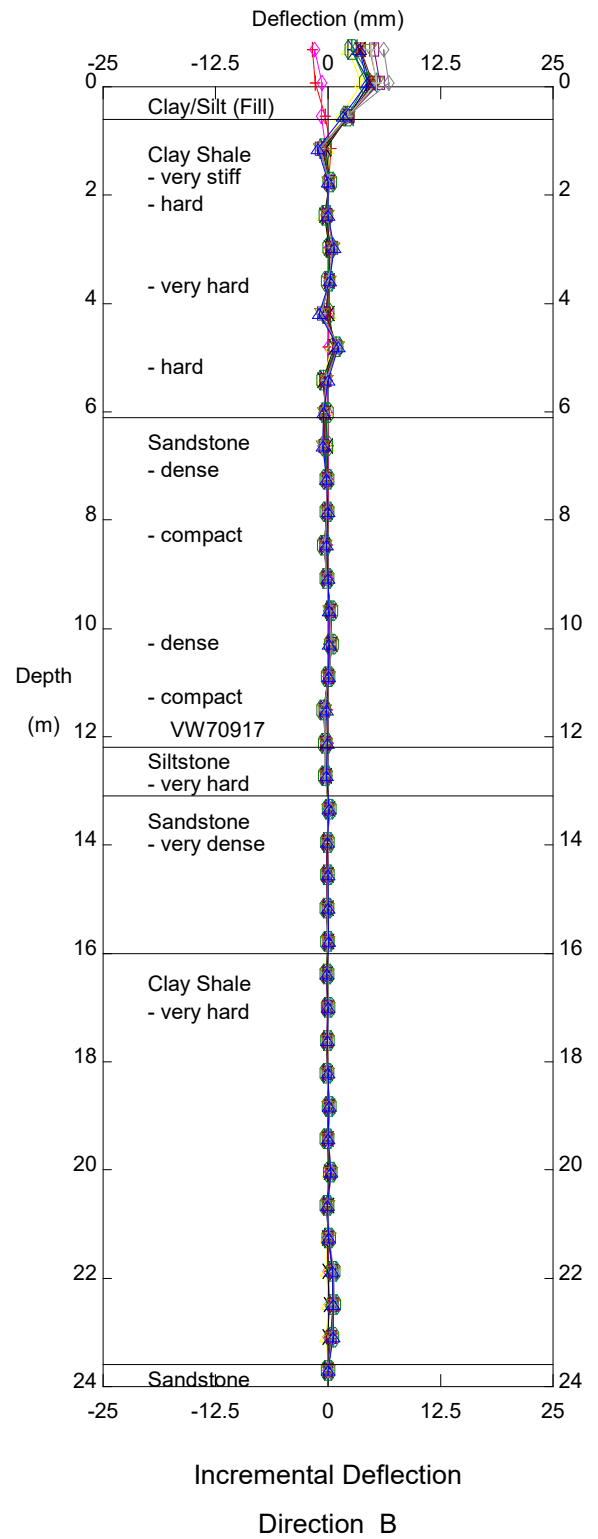
NC006 - Hwy 2:46 Mitsue Lake (km 47.6), Inclinometer SI20-1

| Discussion | |
|---|---|
| <b>Interpretation of Monitoring Results:</b> | <p>SI20-1, installed in the south ditch of the highway, has shown no discernible movement since initialization. SI20-3, installed downslope of SI20-2 within the bush, showed a rate of movement of less than 0.1 mm/yr over 1.4 m to 3.2 m depth since the fall of 2024 readings. This corresponds to a decrease in rate of movement of 63.7mm/yr. SI20-4, installed further downslope of SI20-3 within the bush, has shown no discernible movement since initialization.</p> <p>Slope Inclinometers SI24-7 and SI24-8 were initialized after the fall of 2024 readings. SI24-7, installed downslope of the pile wall, showed a rate of movement of 23.1 mm/yr over 0 to 1.7 m depth since it was initialized in November, 2024. SI24-8, installed between the highway surface and the pile wall, showed a rate of movement of 4.1 mm/yr over 1.2 to 3 m depth since it was initialized in November, 2024. It is likely that the grading activities occurred during the construction of the remedial measures impacted the movement rates and patterns of the new slope inclinometers.</p> |

| INSTRUMENT # | DATE INITIALIZED | TOTAL CUMULATIVE RESULTANT MOVEMENT AND DEPTH OF MOVEMENT TO DATE (mm) | MAXIMUM RATE OF MOVEMENT (mm/yr) | CURRENT STATUS OF SI | DATE OF PREVIOUS READING | INCREMENTAL MOVEMENT SINCE PREVIOUS READING (mm) | CURRENT RATE OF MOVEMENT (mm/yr) | CHANGE IN RATE OF MOVEMENT SINCE PREVIOUS READING (mm/yr) |
|---|---|---|---|---|---|---|---|---|
| SI20-1 | December 21, 2020 | No discernible movement | N/A | Operational | September 18, 2024 | N/A | N/A | N/A |

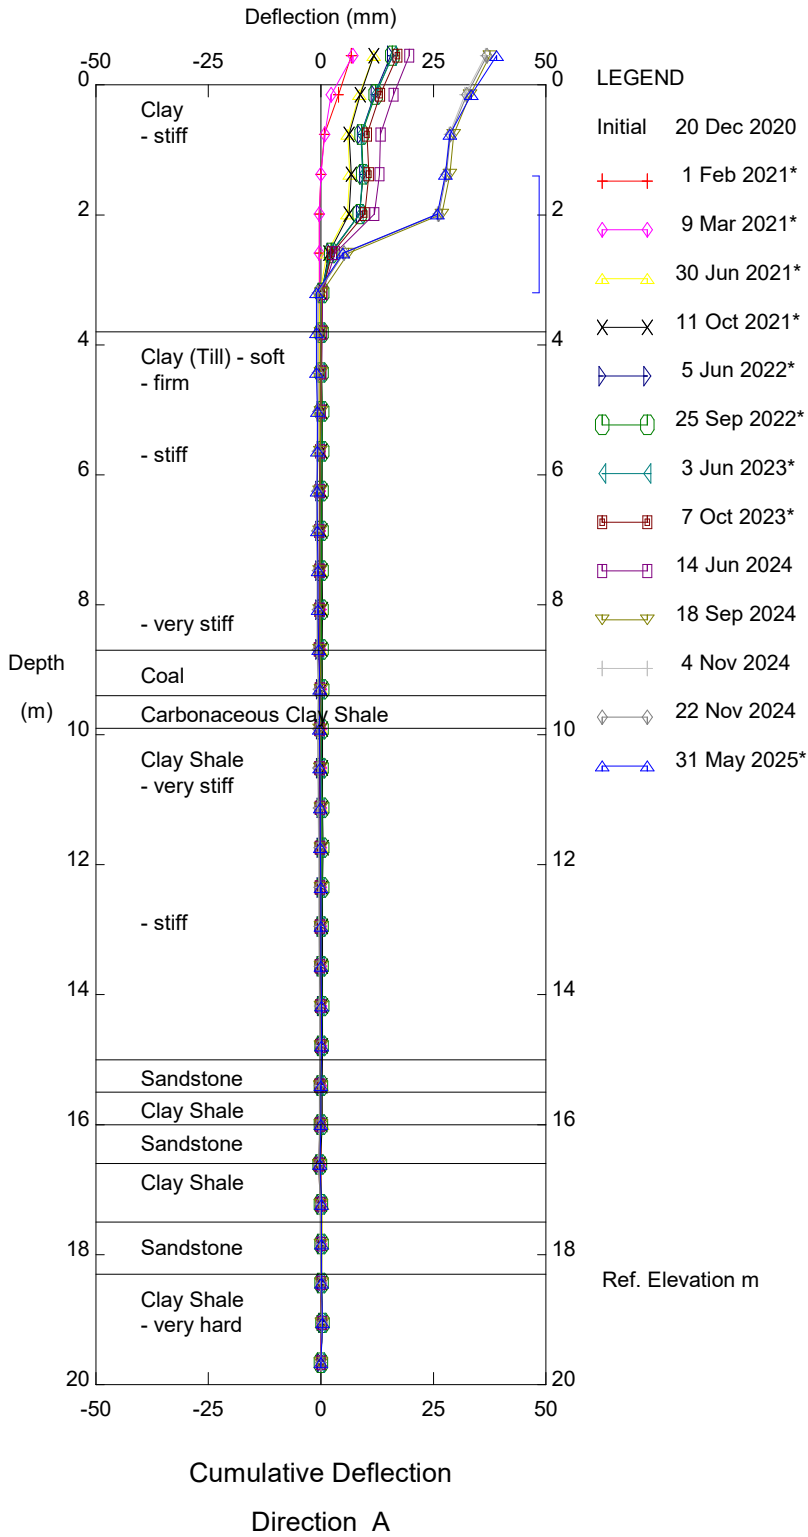
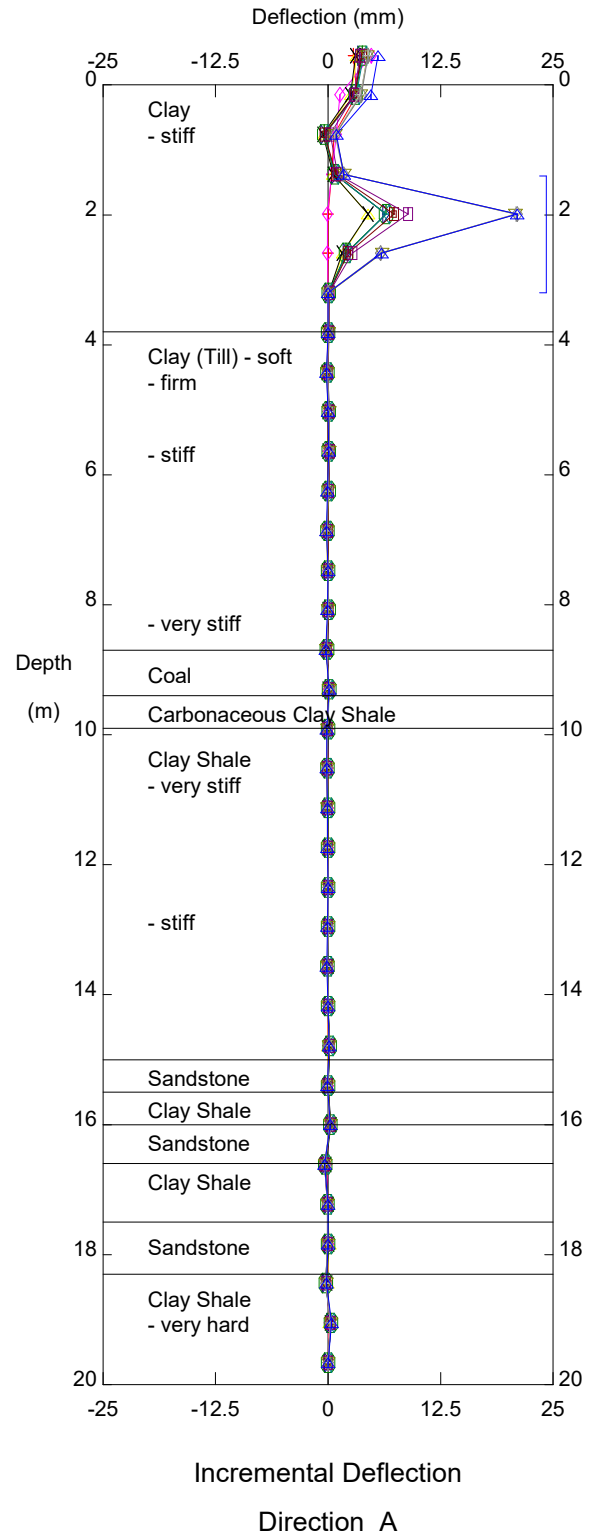
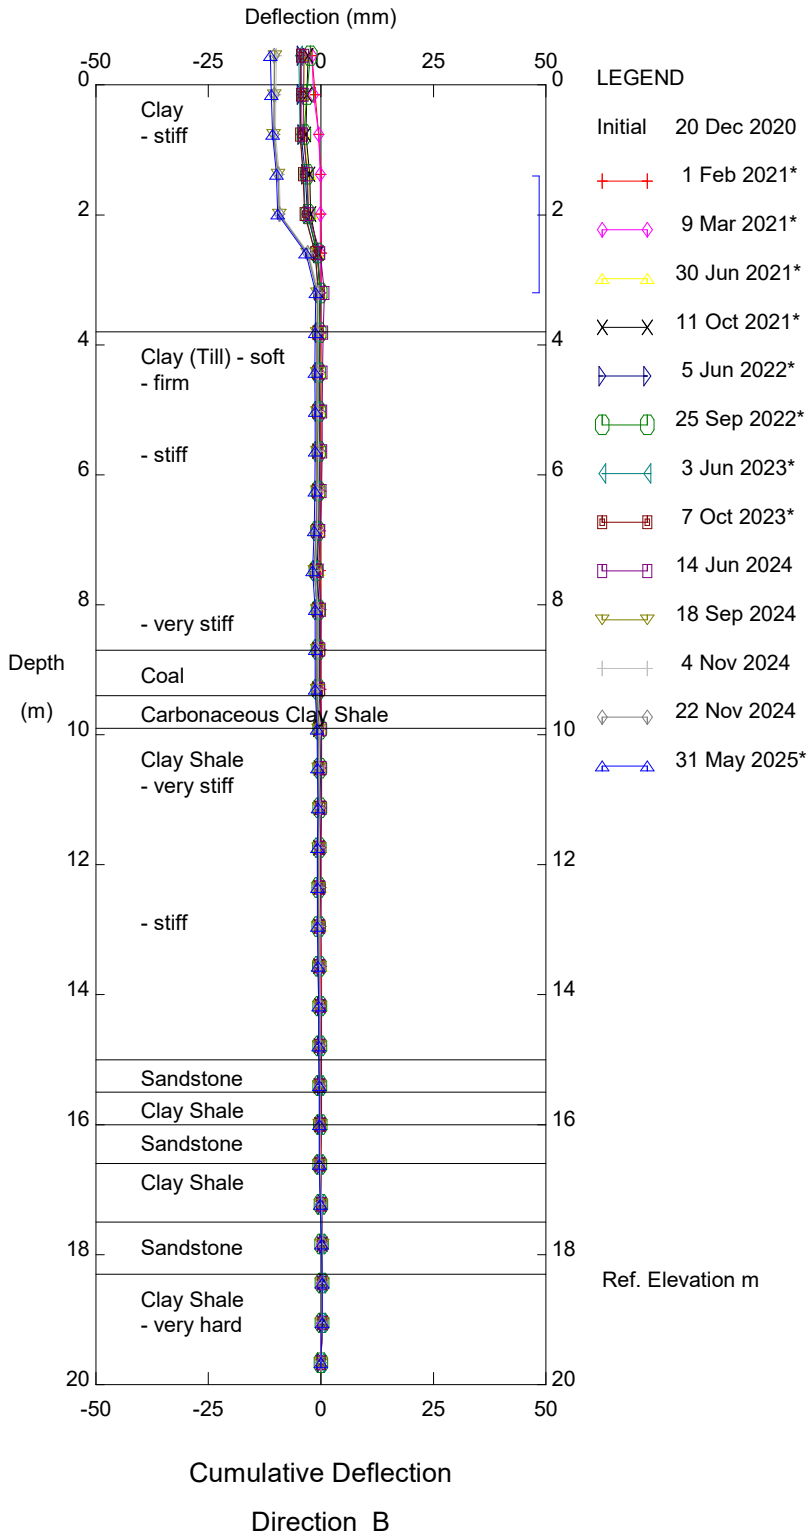
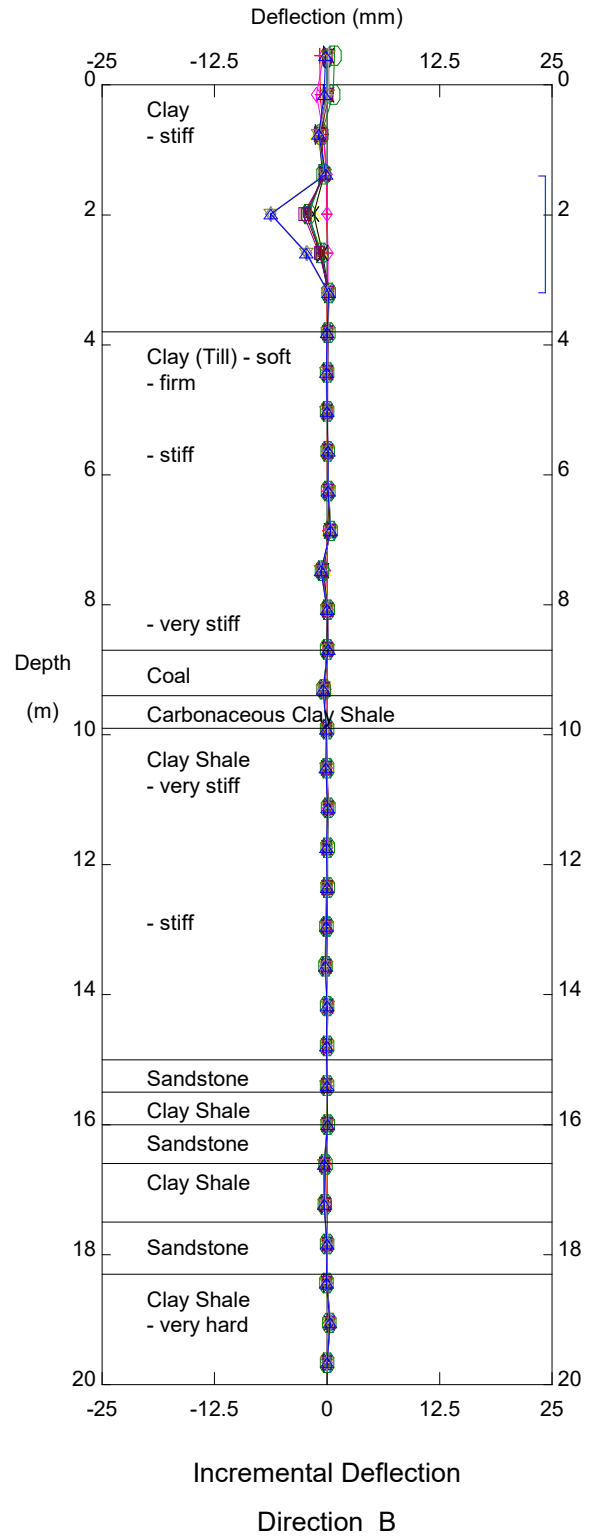
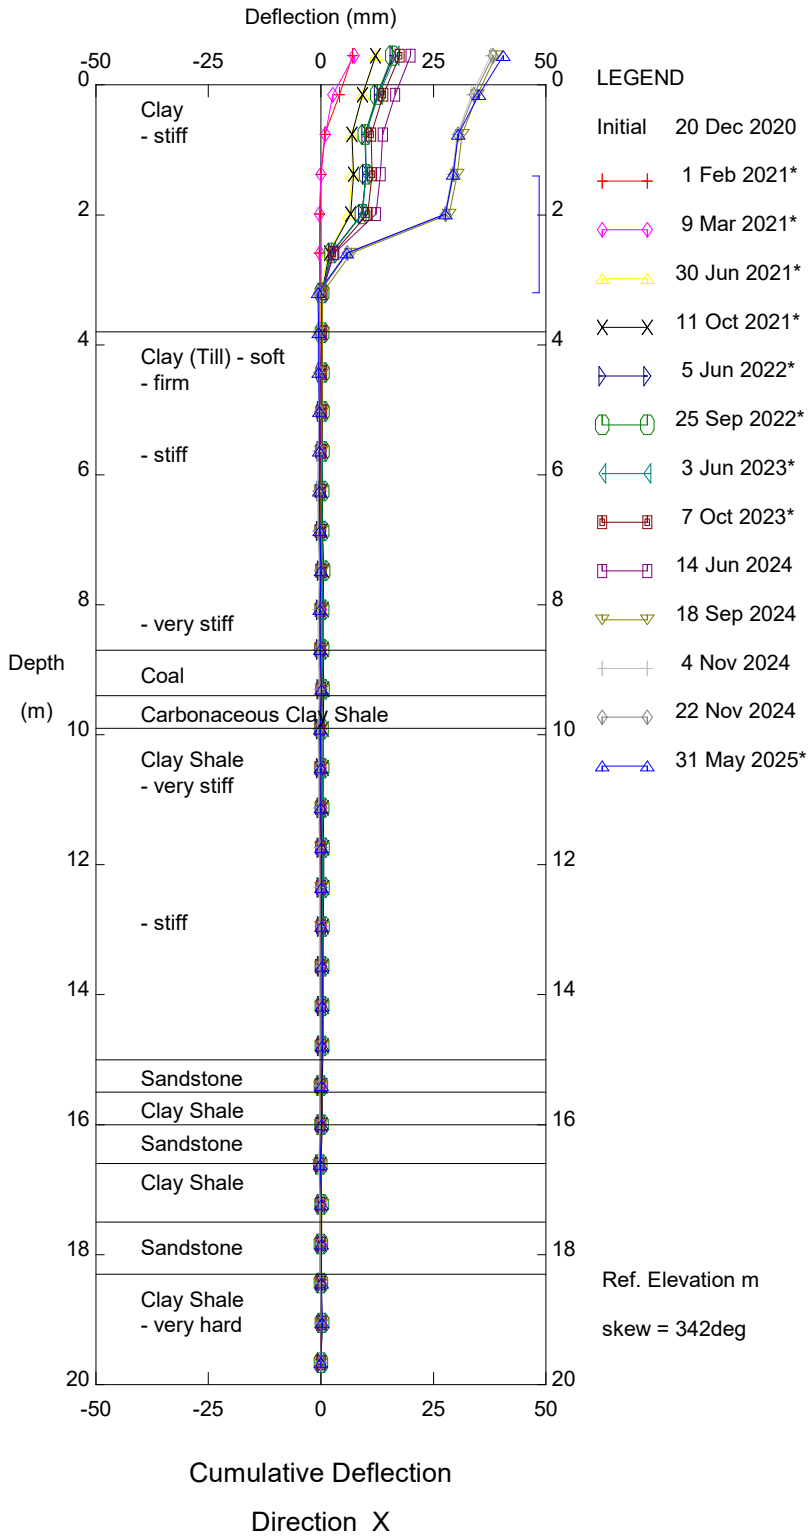
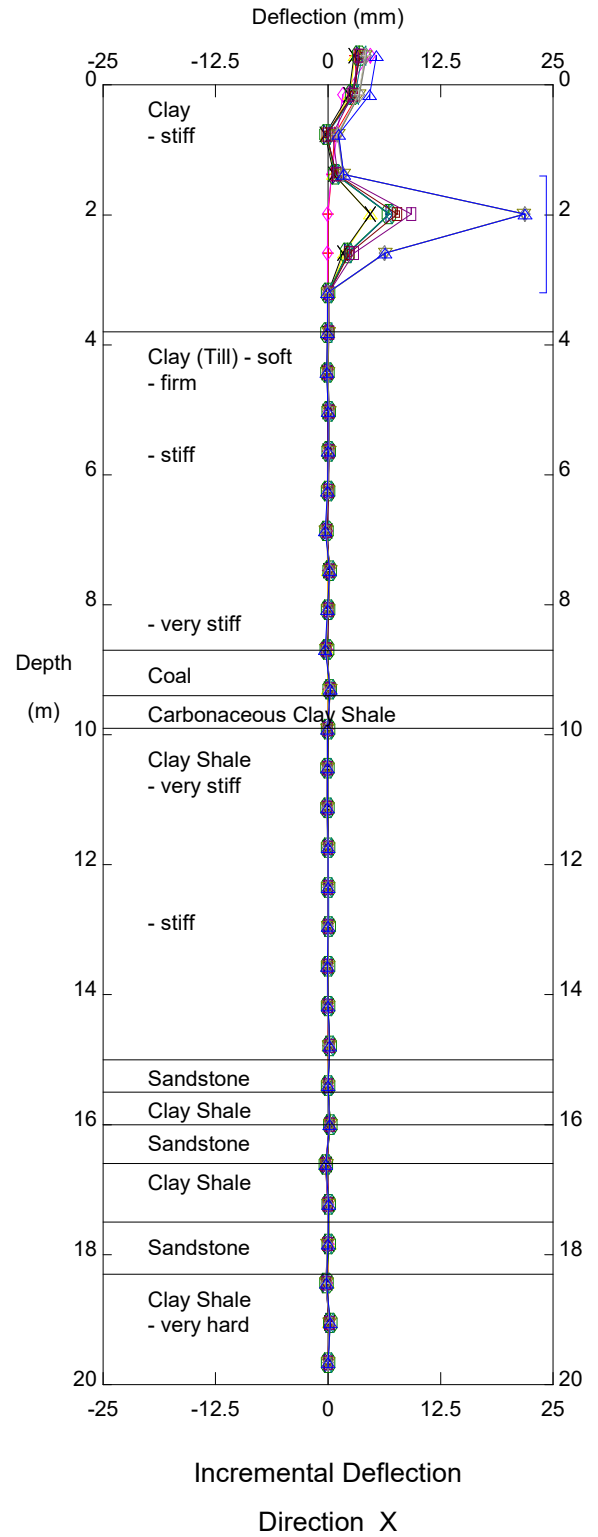
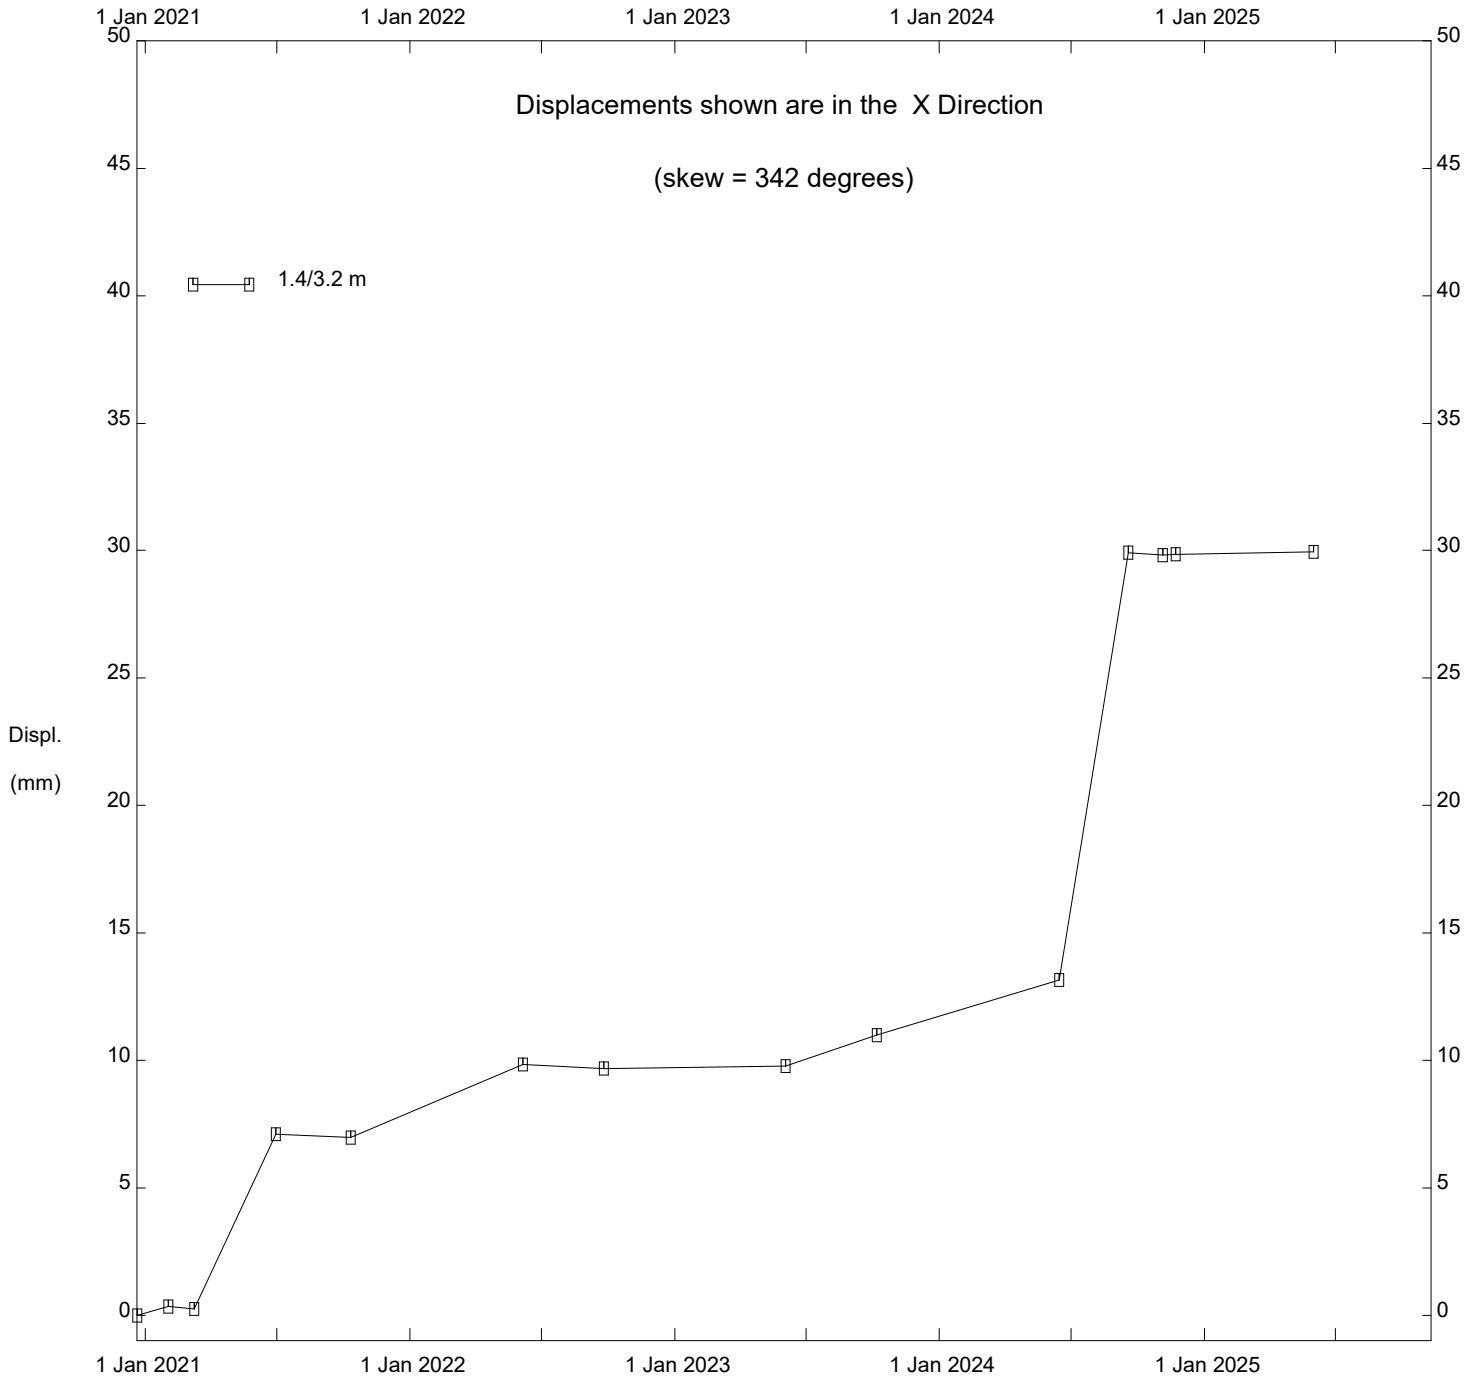
NC006 - Hwy 2:46 Mitsue Lake (km 47.6), Inclinometer SI20-3

| INSTRUMENT # | DATE INITIALIZED | TOTAL CUMULATIVE RESULTANT MOVEMENT AND DEPTH OF MOVEMENT TO DATE (mm) | MAXIMUM RATE OF MOVEMENT (mm/yr) | CURRENT STATUS OF SI | DATE OF PREVIOUS READING | INCREMENTAL MOVEMENT SINCE PREVIOUS READING (mm) | CURRENT RATE OF MOVEMENT (mm/yr) | CHANGE IN RATE OF MOVEMENT SINCE PREVIOUS READING (mm/yr) |
|---|---|---|---|---|---|---|---|---|
| SI20-3 | December 20, 2020 | 29.9 over 1.4 m to 3.2 m depth in 348° direction | 63.8 in September 2024 | Operational | September 18, 2024 | <0.1 | <0.1 | -63.7 |

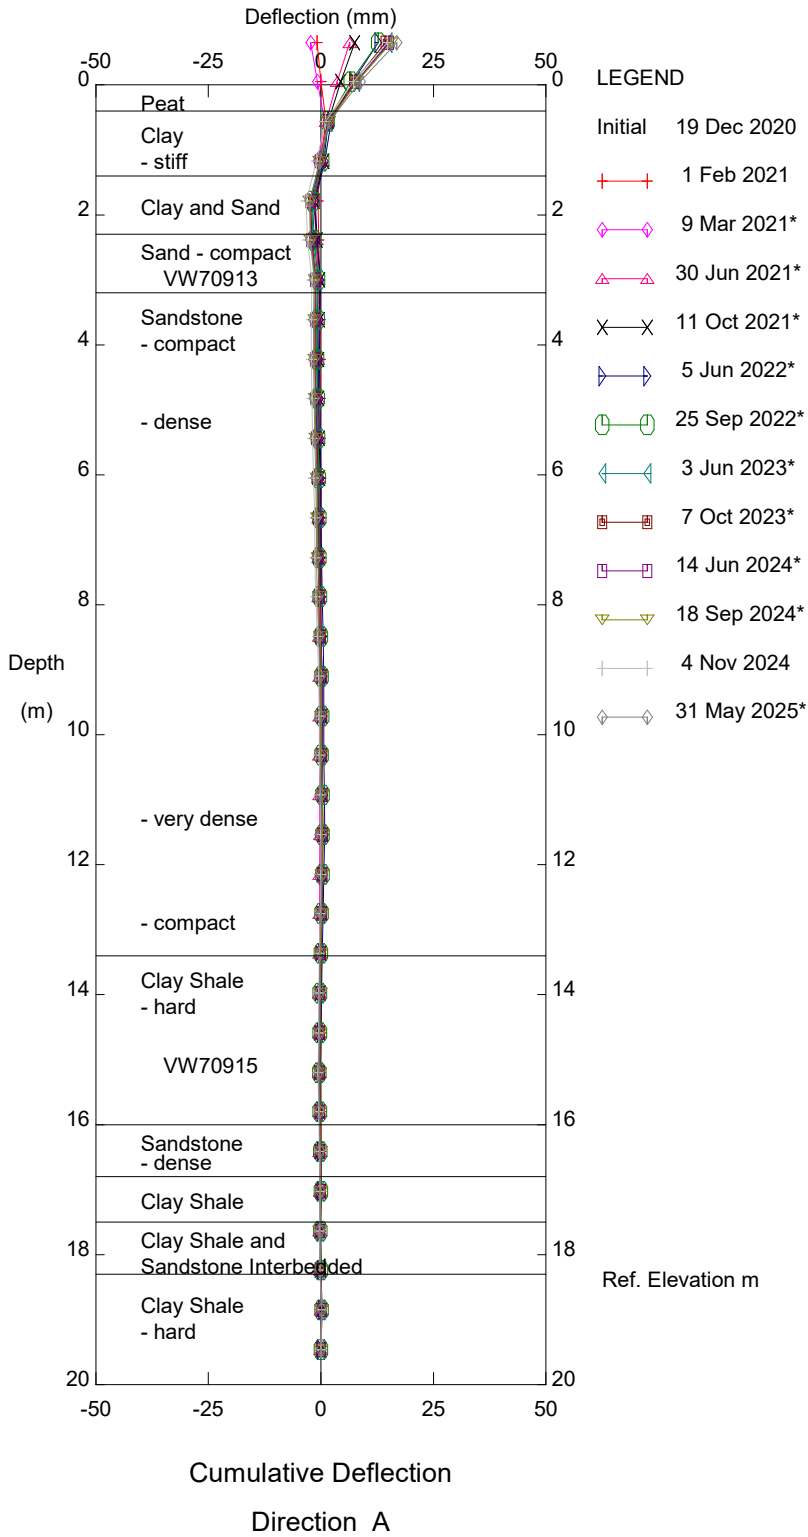
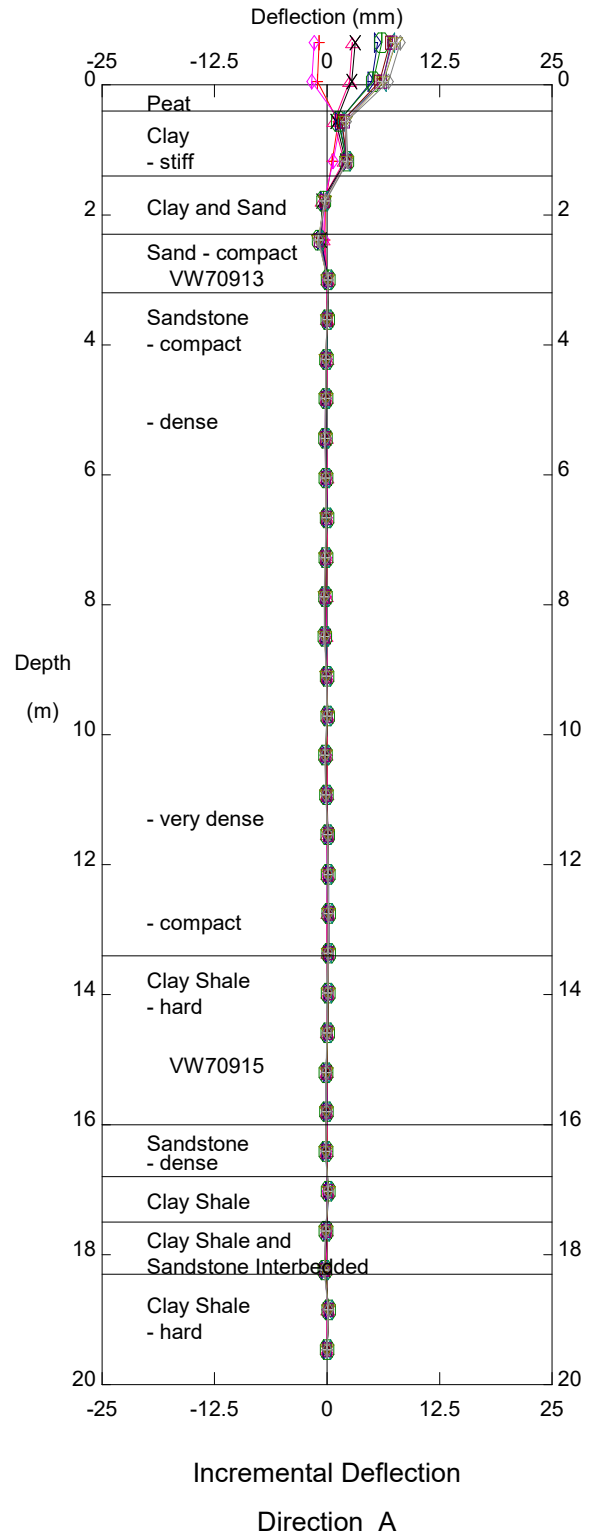
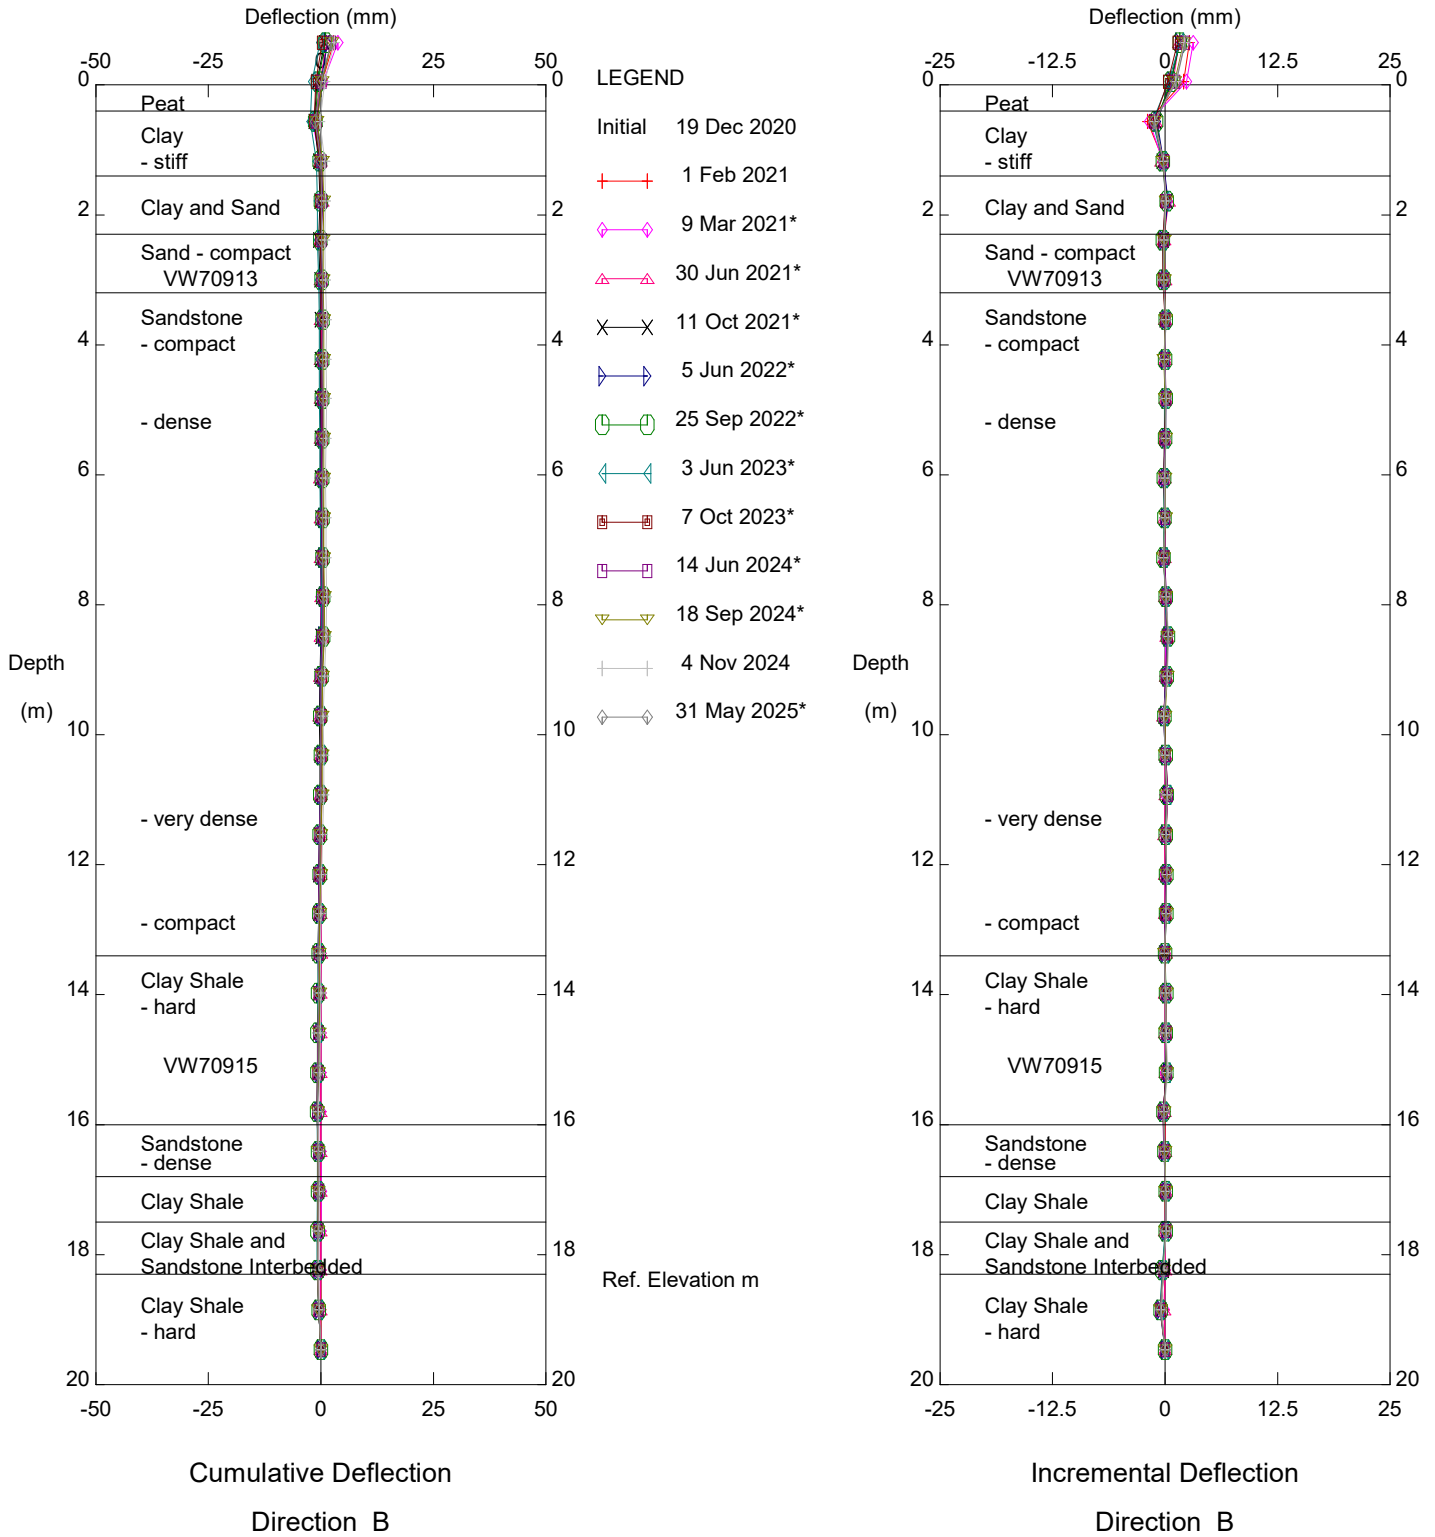
NC006 - Hwy 2:46 Mitsue Lake (km 47.6), Inclinometer SI20-4

| INSTRUMENT # | DATE INITIALIZED | TOTAL CUMULATIVE RESULTANT MOVEMENT AND DEPTH OF MOVEMENT TO DATE (mm) | MAXIMUM RATE OF MOVEMENT (mm/yr) | CURRENT STATUS OF SI | DATE OF PREVIOUS READING | INCREMENTAL MOVEMENT SINCE PREVIOUS READING (mm) | CURRENT RATE OF MOVEMENT (mm/yr) | CHANGE IN RATE OF MOVEMENT SINCE PREVIOUS READING (mm/yr) |
|---|---|---|---|---|---|---|---|---|
| SI20-4 | December 19, 2021 | No discernible movement | N/A | Operational | September 18, 2024 | N/A | N/A | N/A |
