ALBERTA TRANSPORTATION AND  
ECONOMIC CORRIDORS GRMP  
NORTH CENTRAL (ATHABASCA AND FORT  
McMURRAY DISTRICTS)  
INSTRUMENTATION MONITORING - SPRING 2025

| Site Number | Location | Name | Hwy | km |
|---|---|---|---|---|
| NC006 | HWY 2:46 C1 47.6 | Mitsue Lake Recreation Area | 2:46 | km 47.6 |

| <b>Current Monitoring:</b> | 31-May-2025 | <b>Previous Monitoring</b> | 18-Sep-2024 |

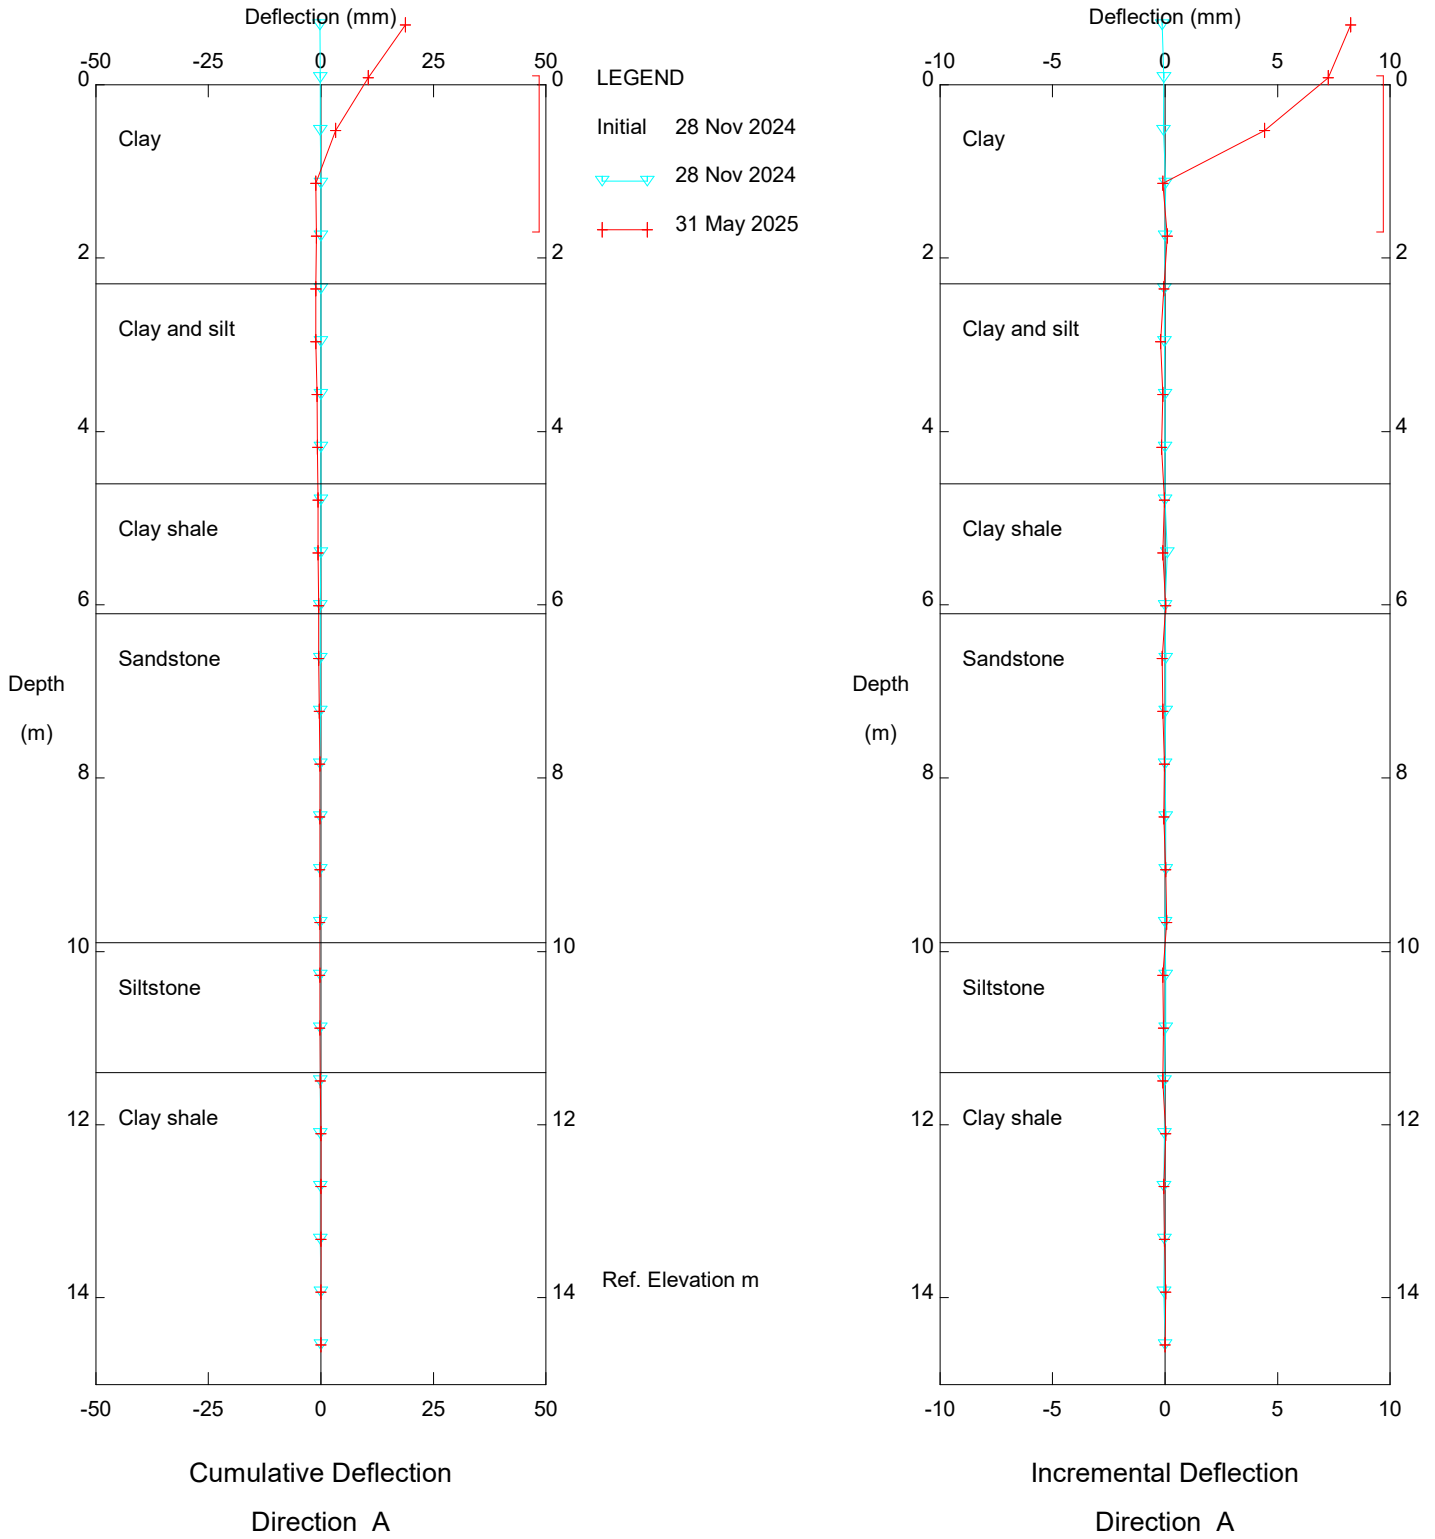
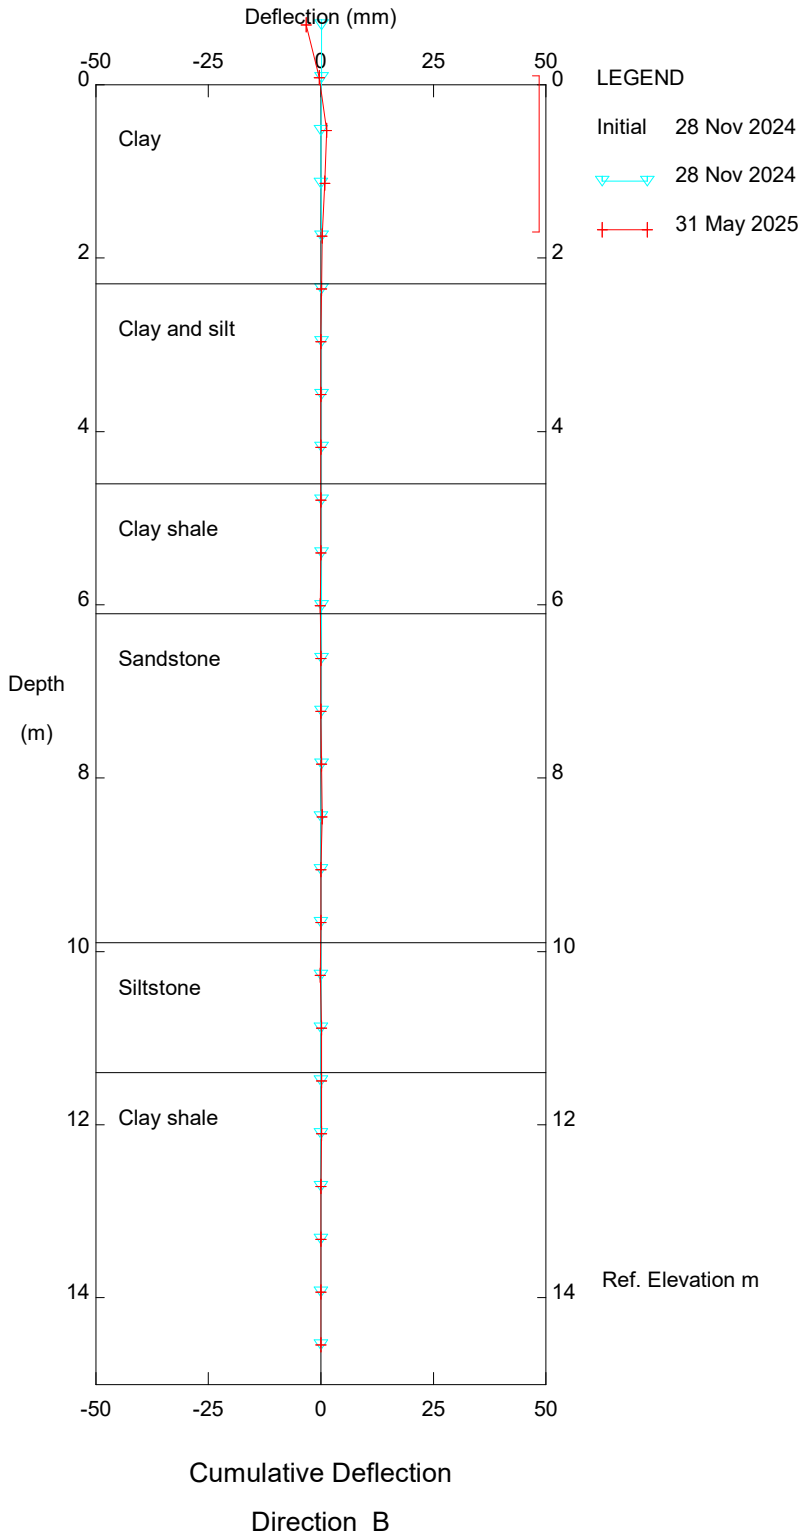
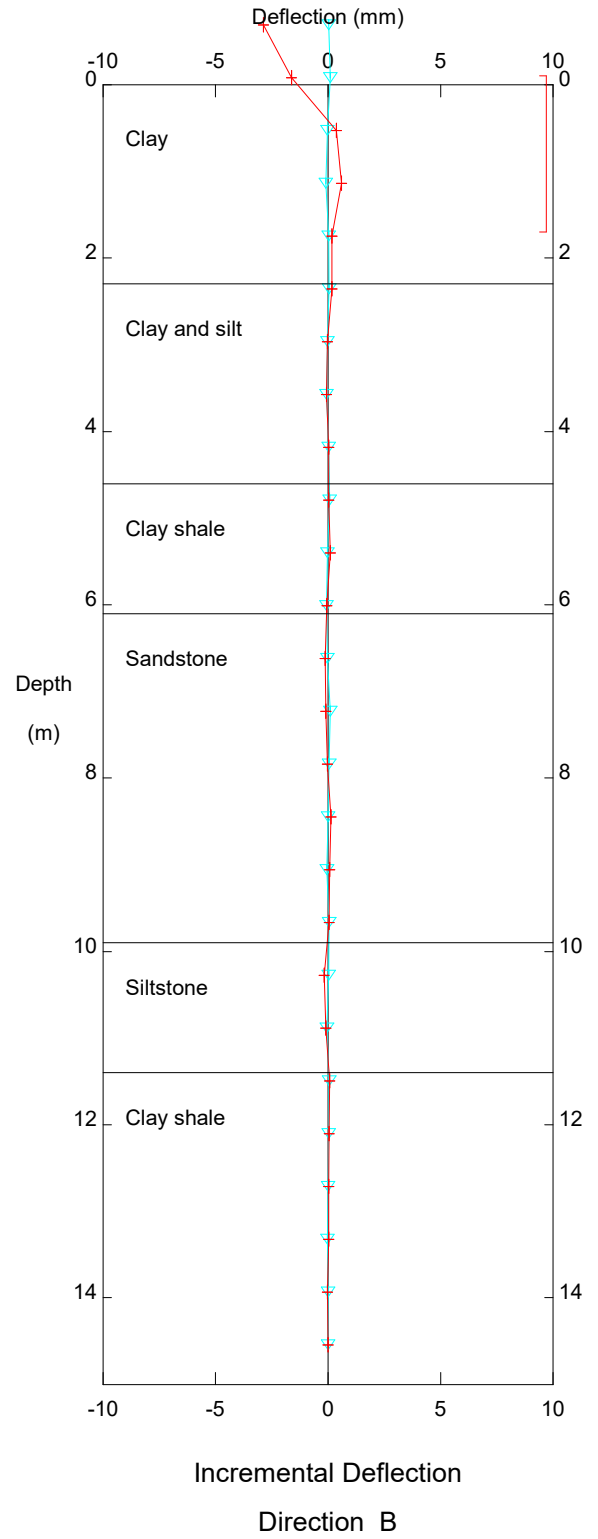
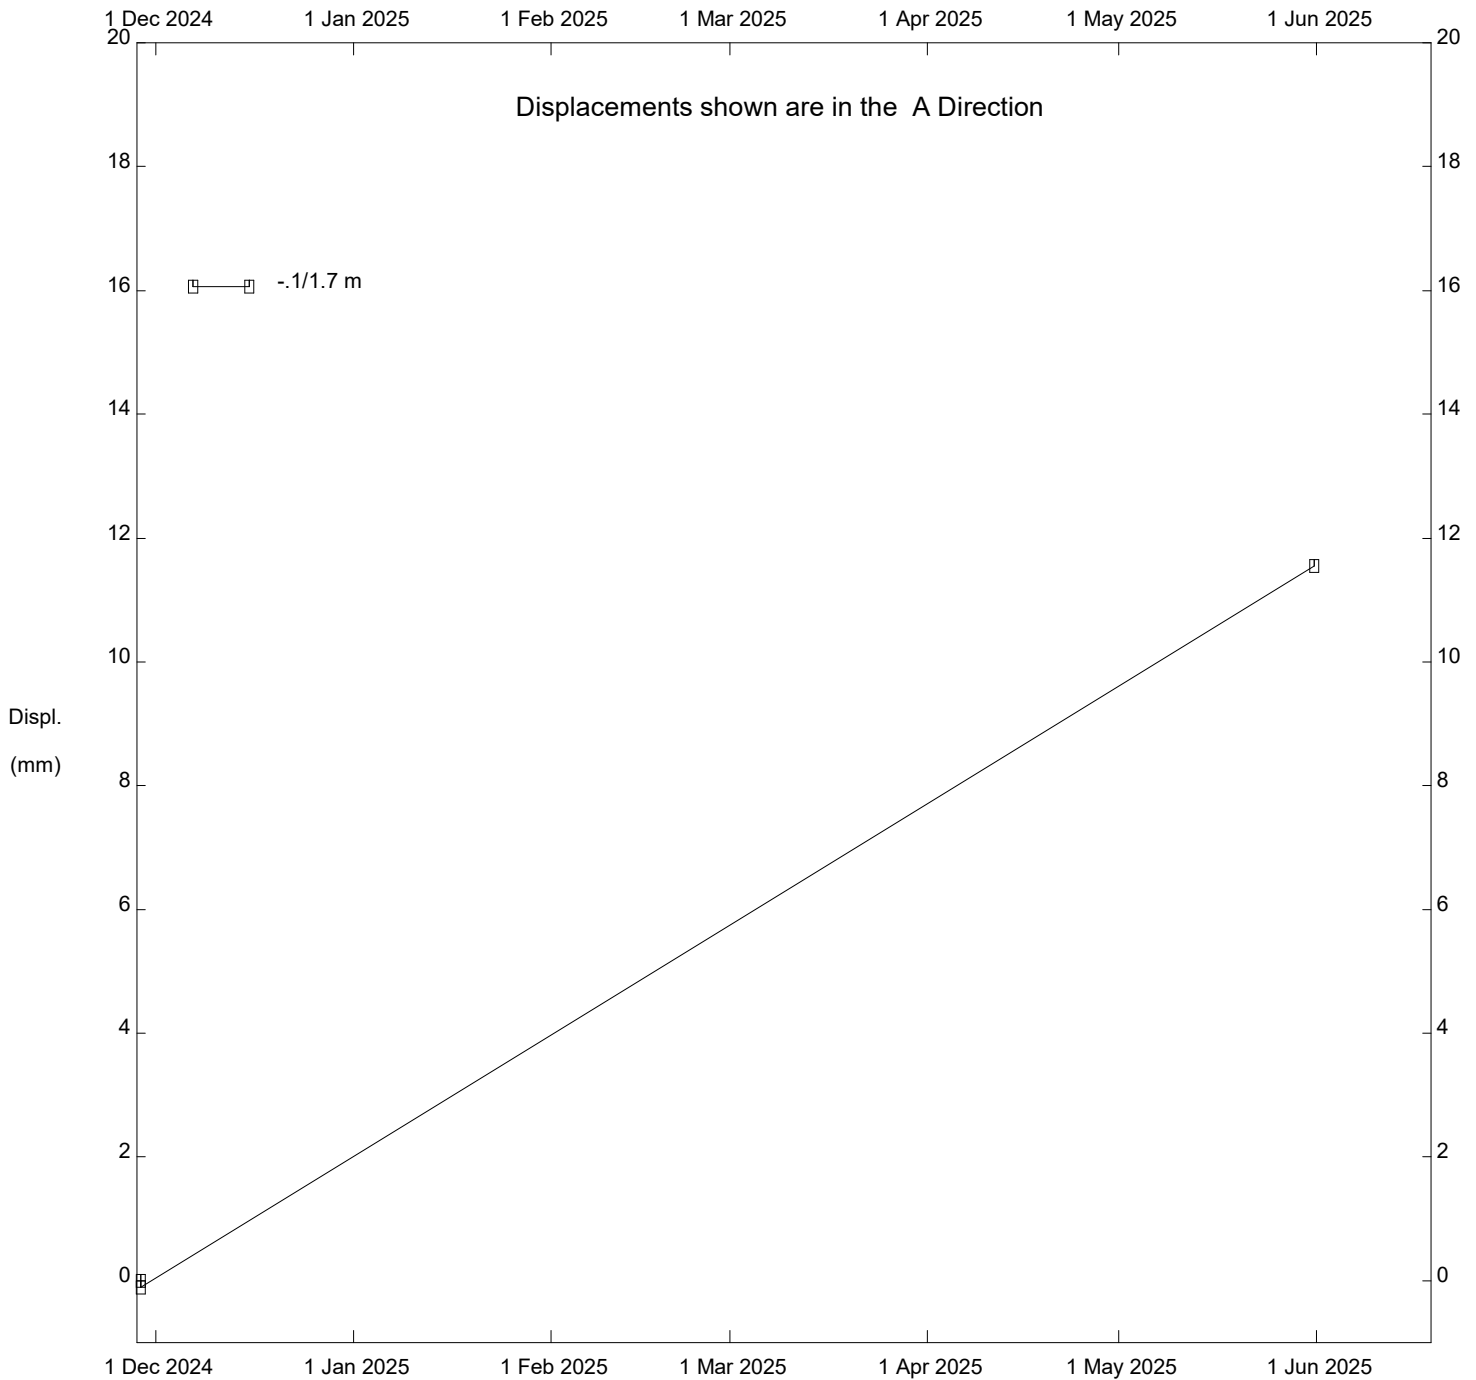
NC006 - Hwy 2:46 Mitsue Lake (km 47.6), Inclinometer SI24-7

| INSTRUMENT # | DATE INITIALIZED | TOTAL CUMULATIVE RESULTANT MOVEMENT AND DEPTH OF MOVEMENT TO DATE (mm) | MAXIMUM RATE OF MOVEMENT (mm/yr) | CURRENT STATUS OF SI | DATE OF PREVIOUS READING | INCREMENTAL MOVEMENT SINCE PREVIOUS READING (mm) | CURRENT RATE OF MOVEMENT (mm/yr) | CHANGE IN RATE OF MOVEMENT SINCE PREVIOUS READING (mm/yr) |
|---|---|---|---|---|---|---|---|---|
| SI24-7 | November 28, 2024 | 11.6 over 0.0 m to 1.7 m depth in the 7° direction | 23.1 in May 2025 | Operational | November 28, 2024 | 11.7 | 23.1 | 23.1 |

| <b>Future Work:</b> | The instruments should be read again in the fall of 2025. The zones and the rates of movements in SI24-7 and SI24-8 should be confirmed in the next reading cycle. |

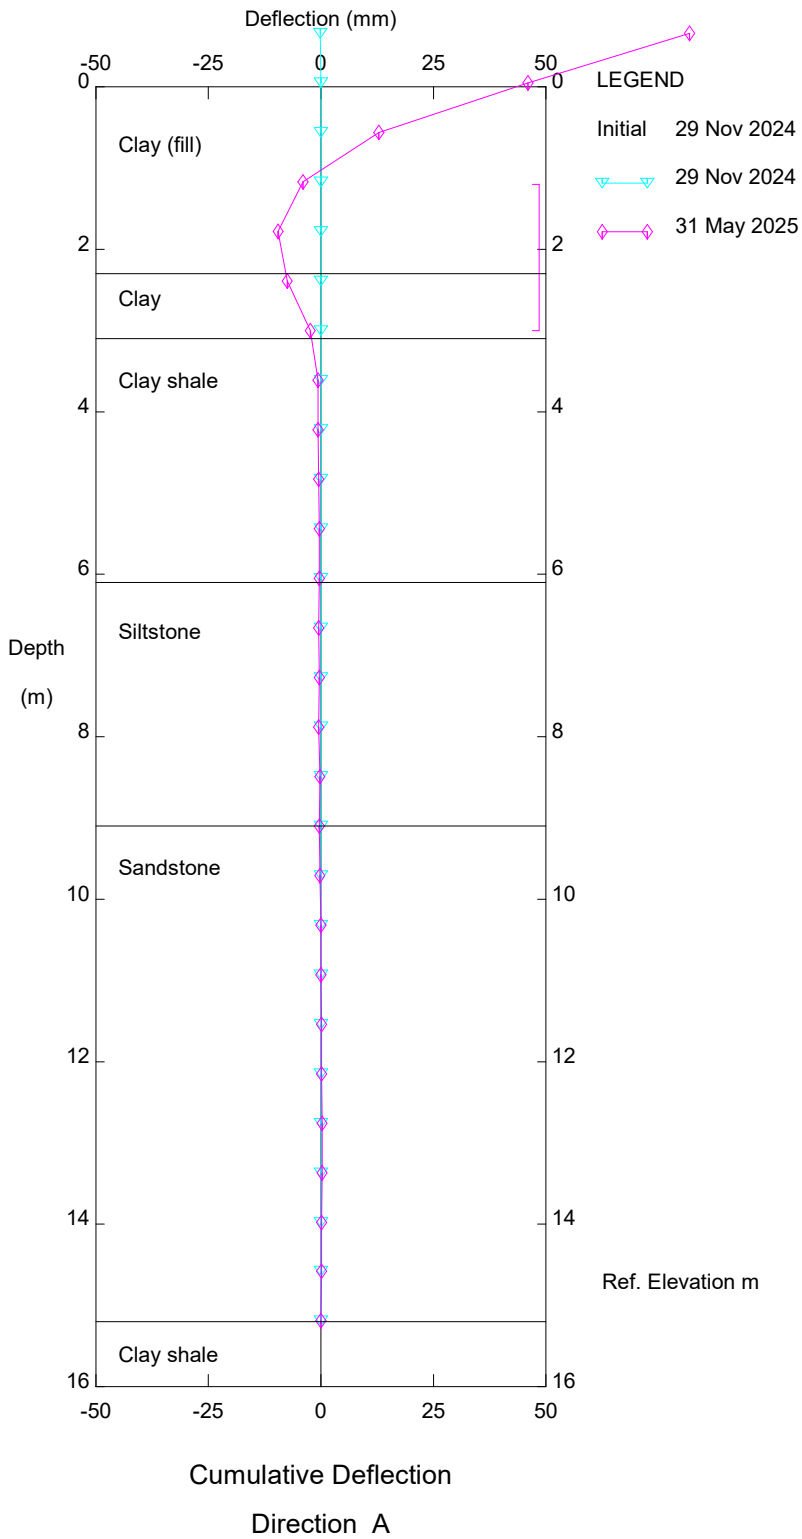
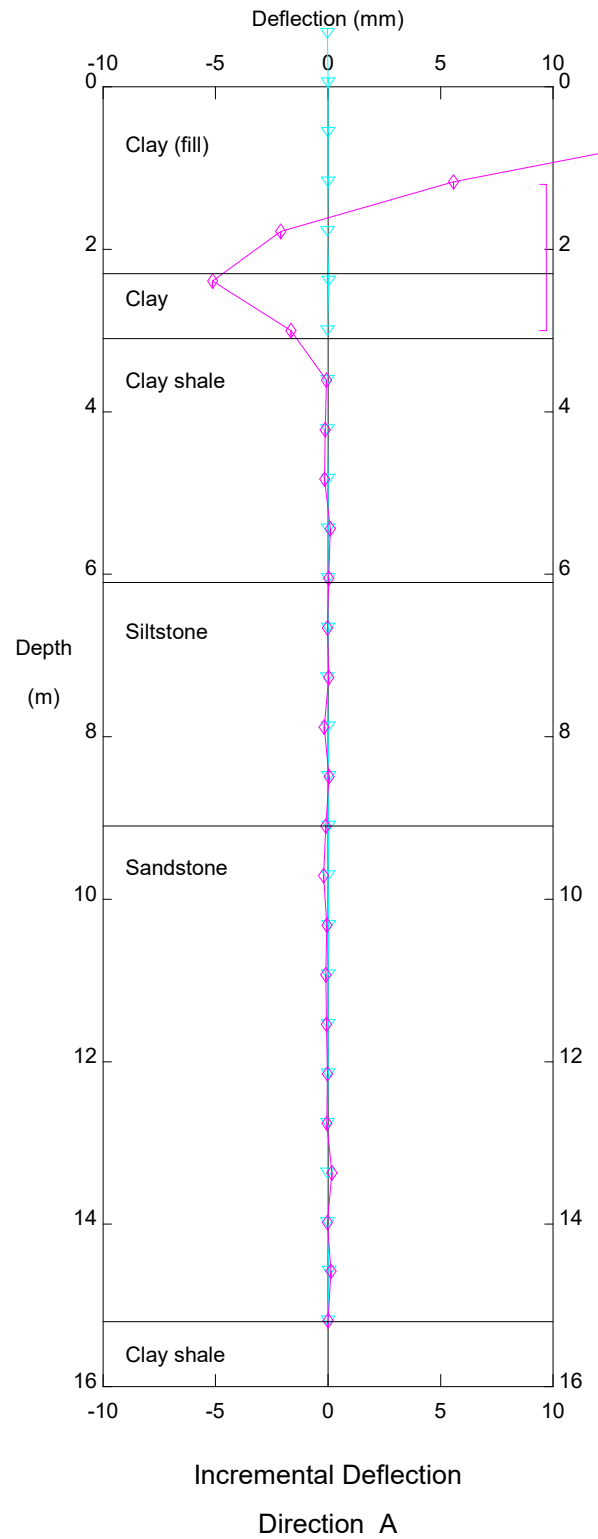
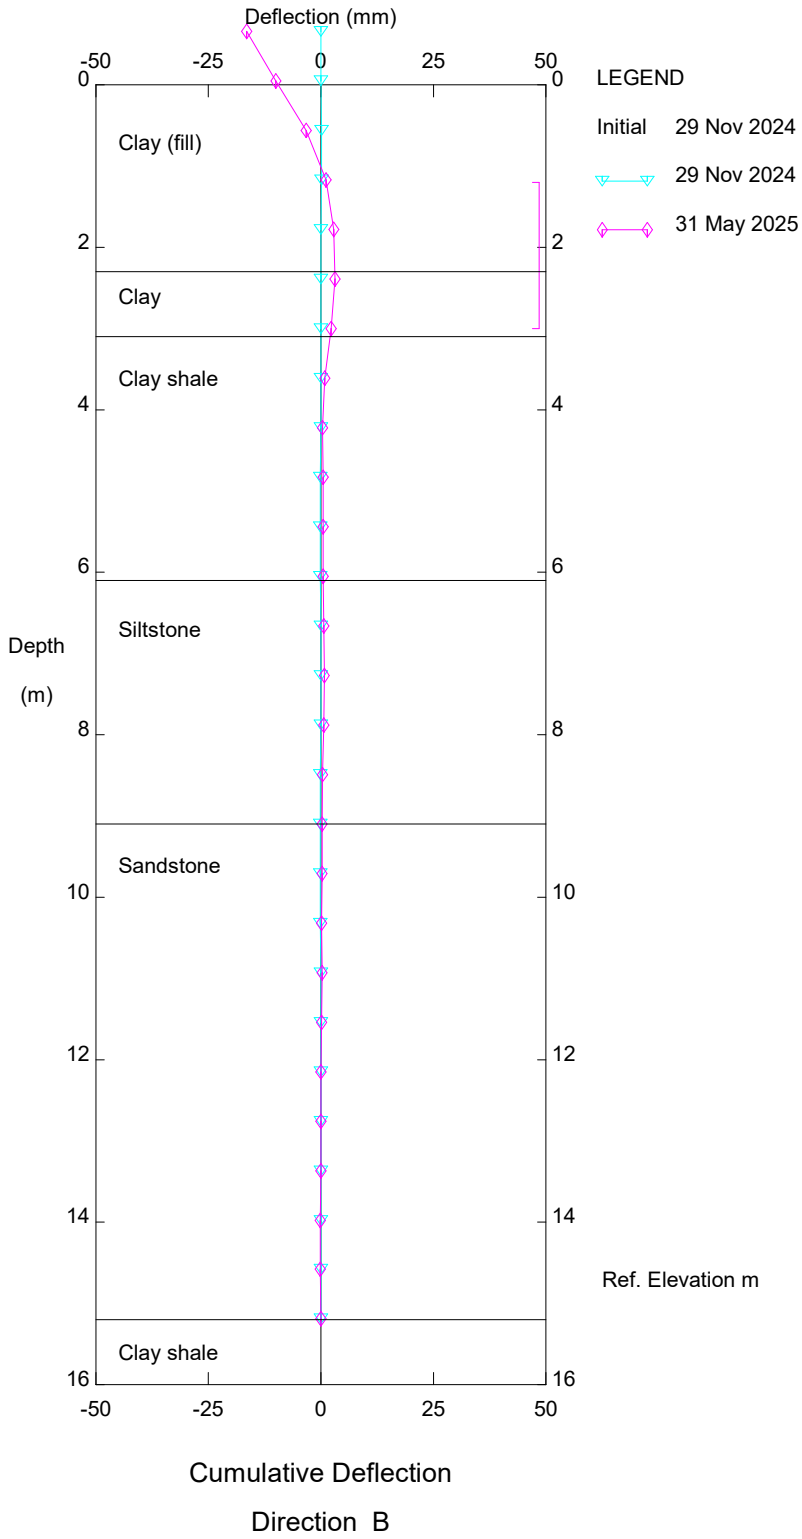
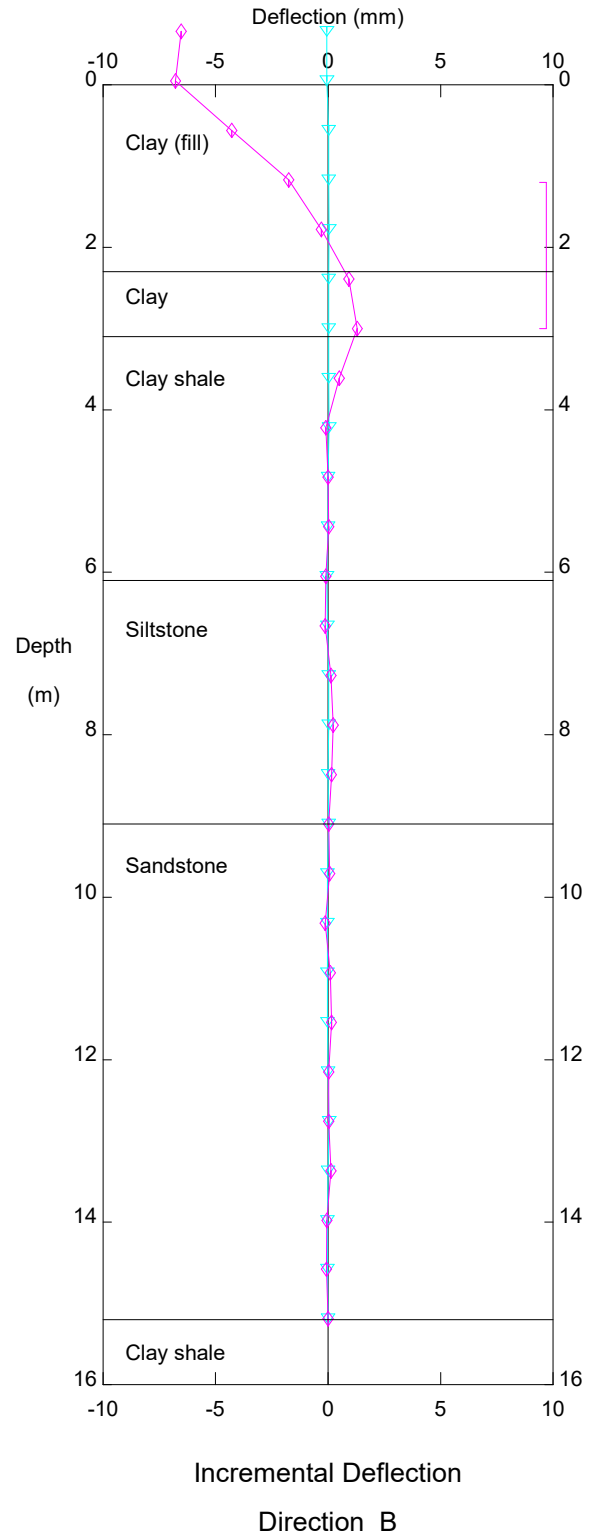
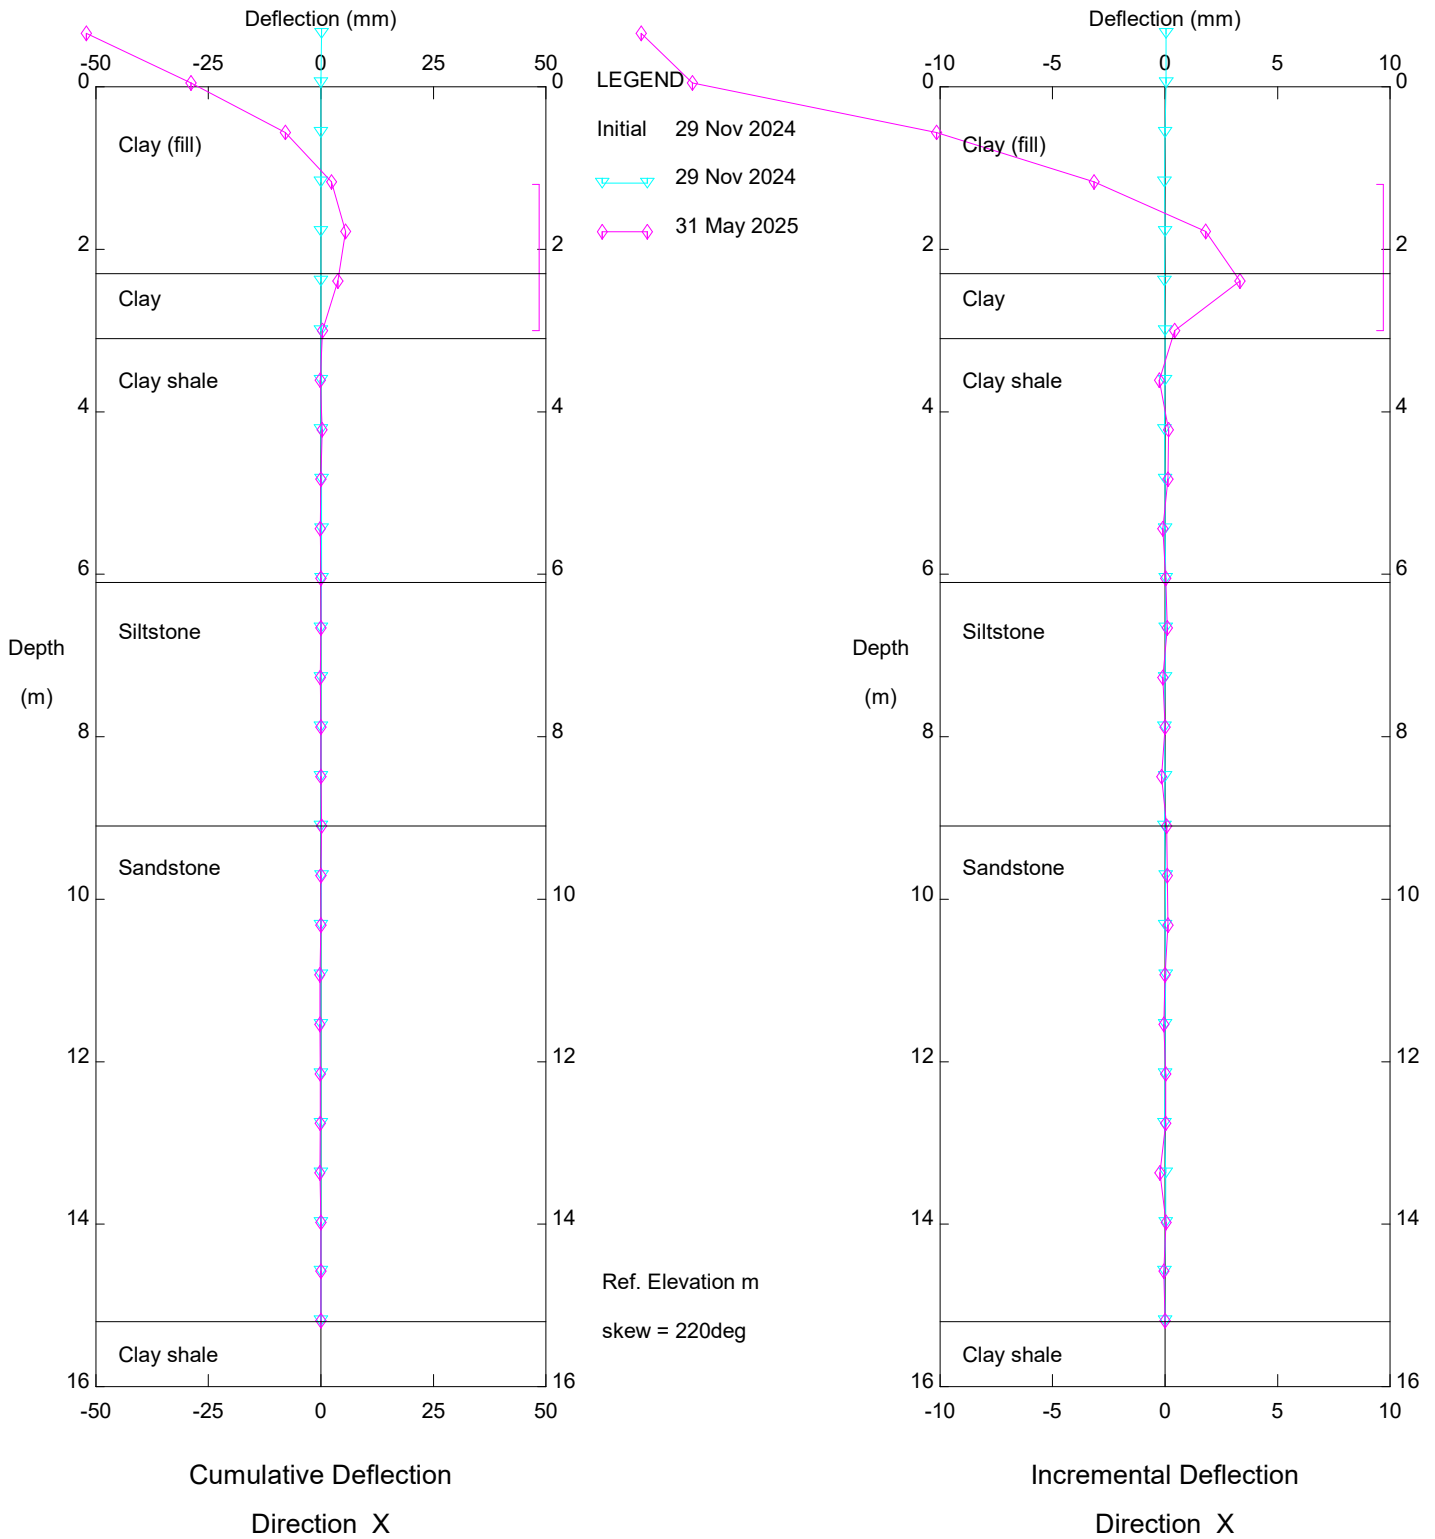
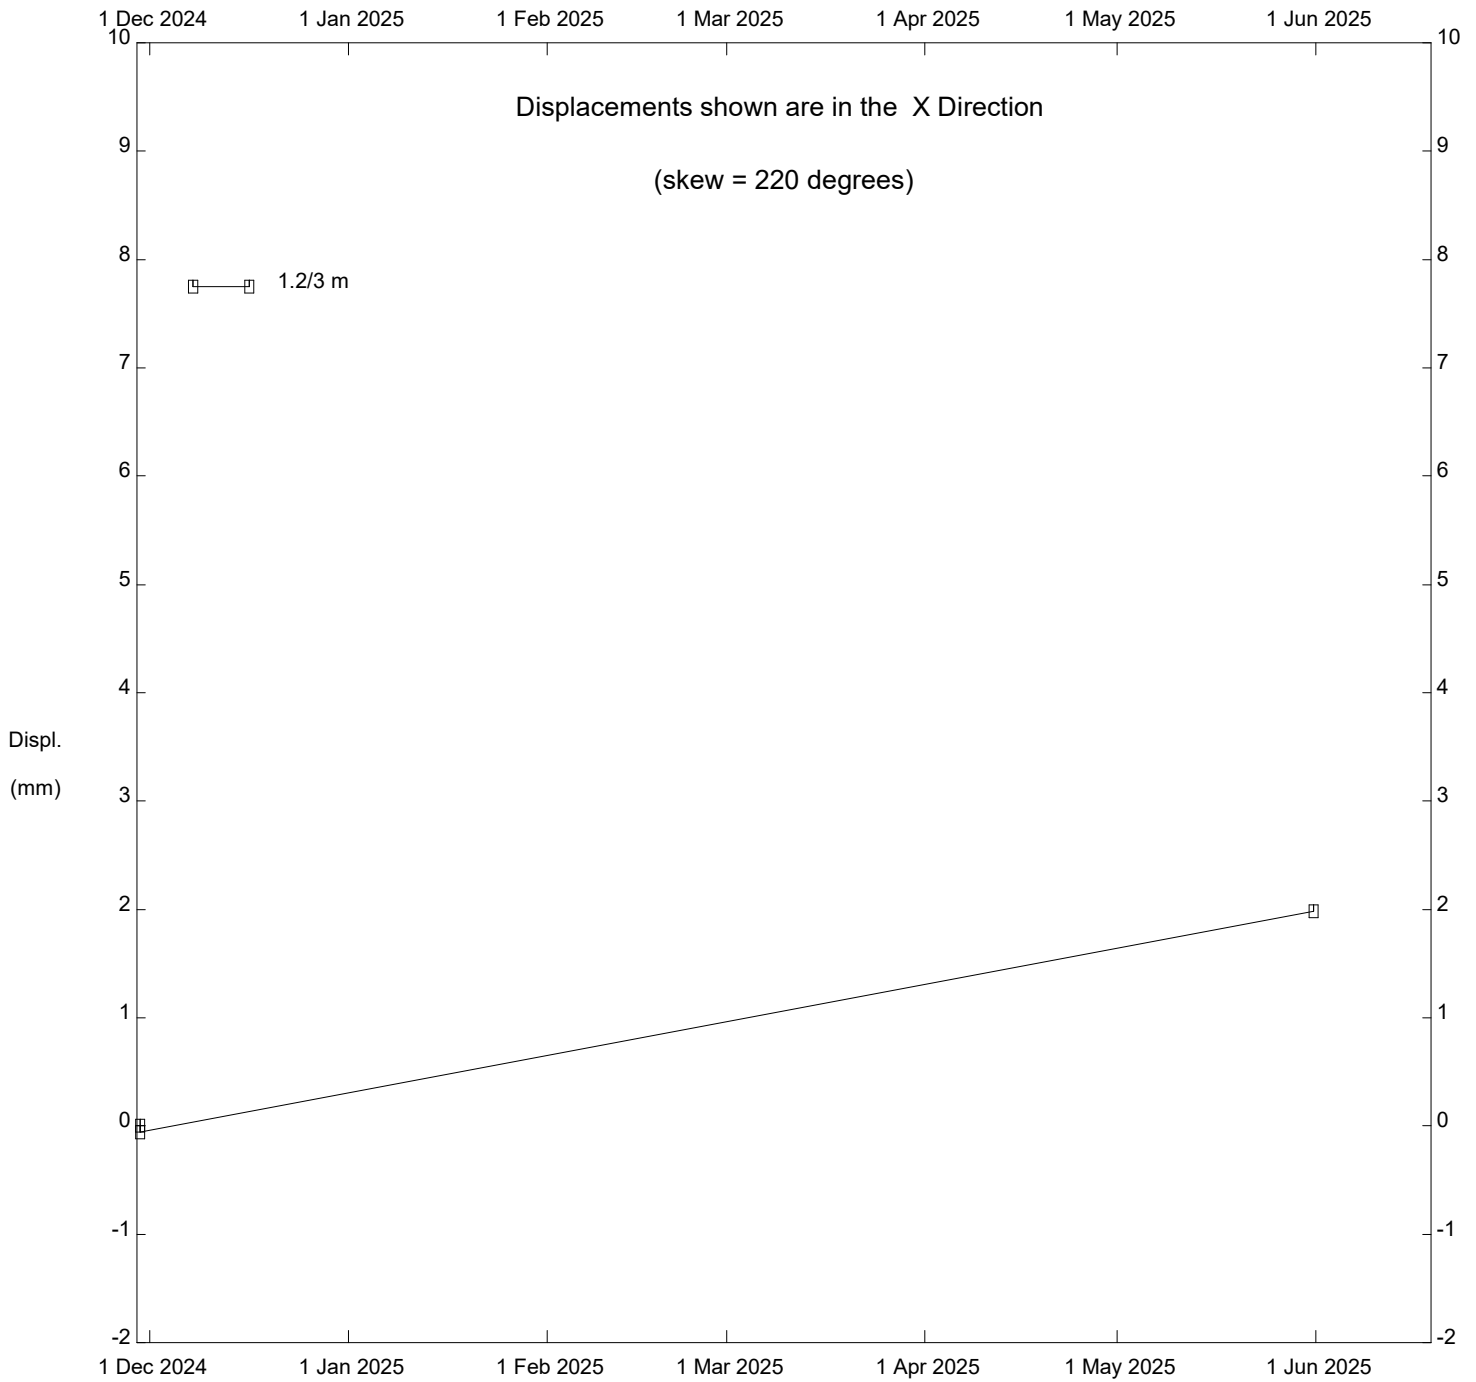
NC006 - Hwy 2:46 Mitsue Lake (km 47.6), Inclinometer SI24-8

| INSTRUMENT # | DATE INITIALIZED | TOTAL CUMULATIVE RESULTANT MOVEMENT AND DEPTH OF MOVEMENT TO DATE (mm) | MAXIMUM RATE OF MOVEMENT (mm/yr) | CURRENT STATUS OF SI | DATE OF PREVIOUS READING | INCREMENTAL MOVEMENT SINCE PREVIOUS READING (mm) | CURRENT RATE OF MOVEMENT (mm/yr) | CHANGE IN RATE OF MOVEMENT SINCE PREVIOUS READING (mm/yr) |
|---|---|---|---|---|---|---|---|---|
| SI24-8 | November 29, 2024 | 2.0 over 1.2 to 3.0 m in the 201° direction | 4.1 in May 2025 | Operational | November 29, 2024 | 2.0 | 4.1 | 4.1 |

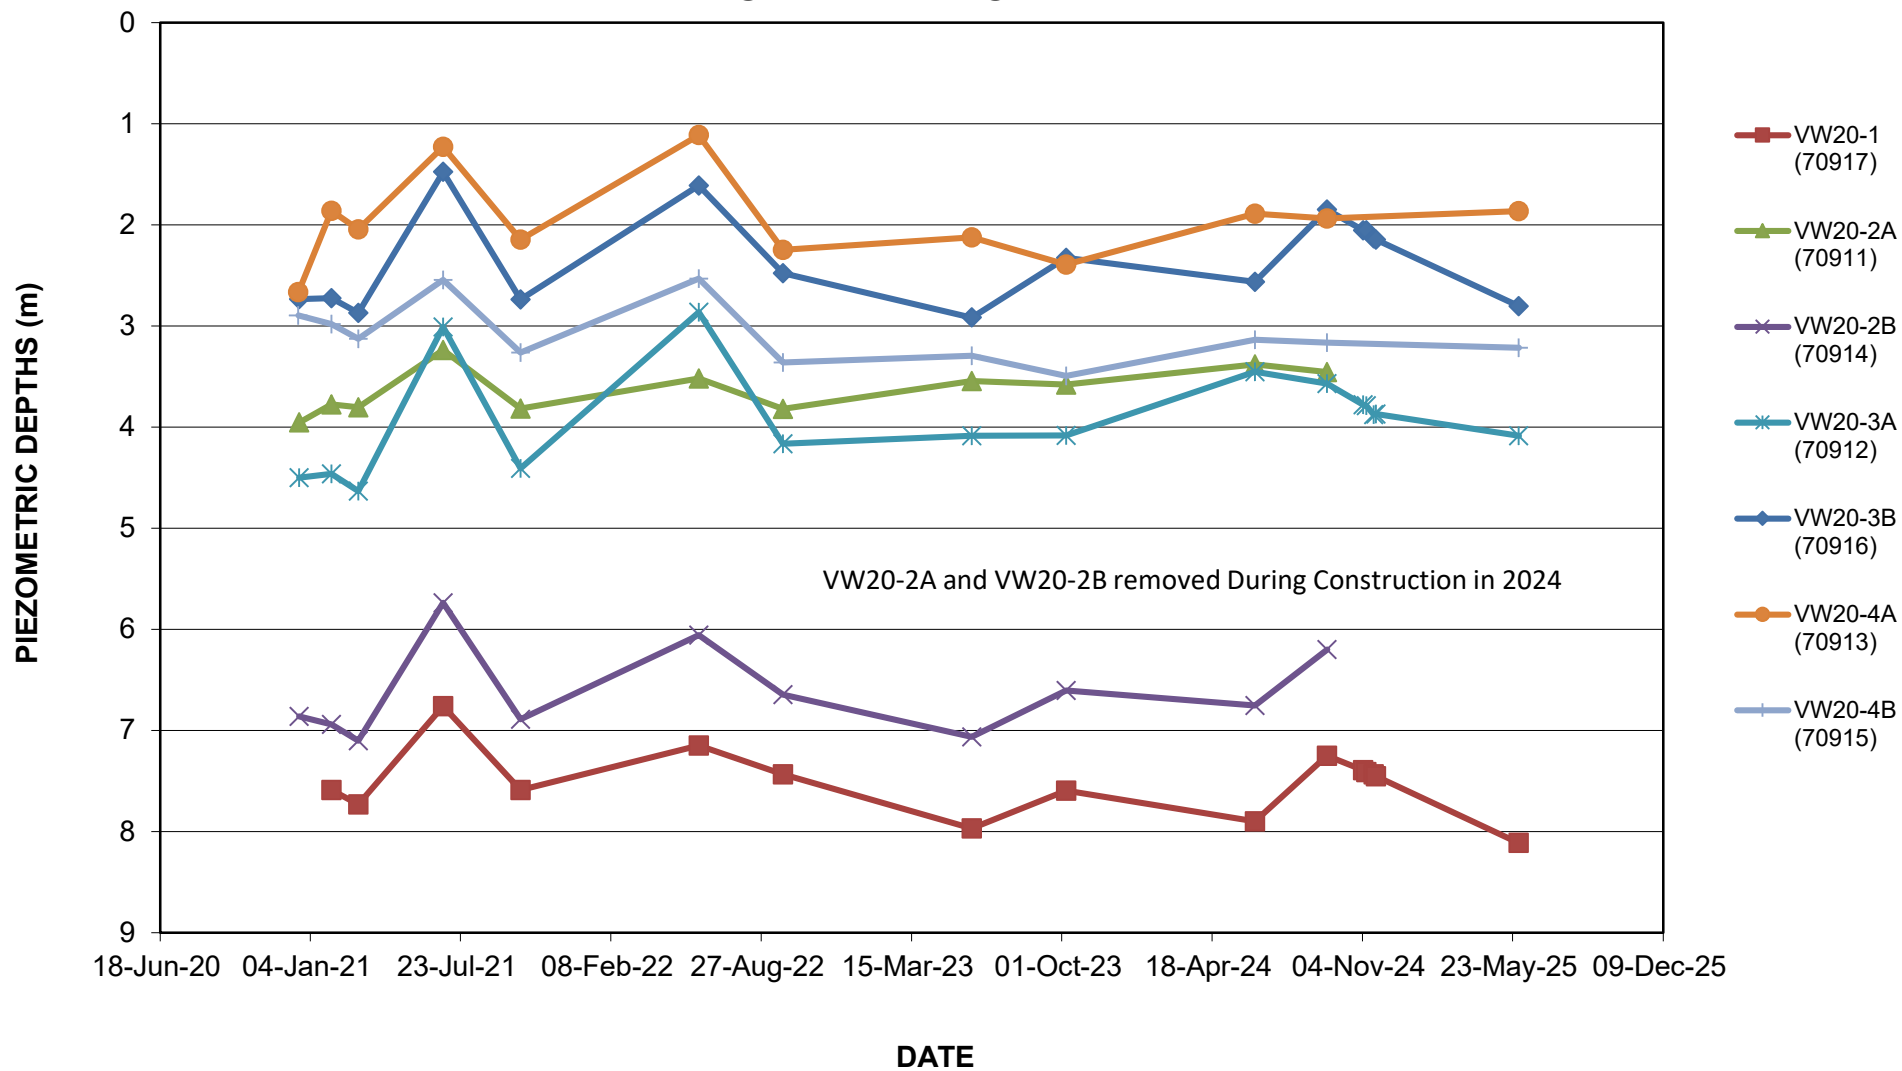
**FIGURE NC006-1**  
**HWY 2:46 MITSUE LAKE SLIDE (KM 47.6)**  
**VIBRATING WIRE PIEZOMETER DATA**

| | <p>Vibrating wire piezometers VW20-1, VW20-3A, VW20-3B, and VW20-4B showed decreases in groundwater level of 0.86 m, 0.52 m, 0.95 m and 0.05 m, respectively, since the fall of 2024 readings. VW20-4A showed an increase in groundwater level of 0.07 m since the fall of 2024 readings.</p> <p>Overall, the measured groundwater levels are within the historically maximum groundwater levels for the site.</p> |
