**ALBERTA TRANSPORTATION AND  
ECONOMIC CORRIDORS GRMP  
NORTH CENTRAL (ATHABASCA AND FORT  
McMURRAY DISTRICTS)  
2025 SITE INSPECTION**

| Site Number | Location | Name | Hwy | km |
|---|---|---|---|---|
| NC102<br>(previously known as NC24B and NC24D) | Adjacent to Hwy 41, N. of Junction Hwy 29 at km 8.8 | Kehiwin Lake | 41.23 | 8.7 |

| | Date | PF | CF | Total |
|---|---|---|---|---|
| Current Inspection: | May 15, 2025 | 6 | 3 | 18 |

NC102: HWY 41:23 KEHIWIN LAKE (km8.8)  
SITE PLAN SHOWING FEATURES AND  
INSTRUMENT LOCATIONS

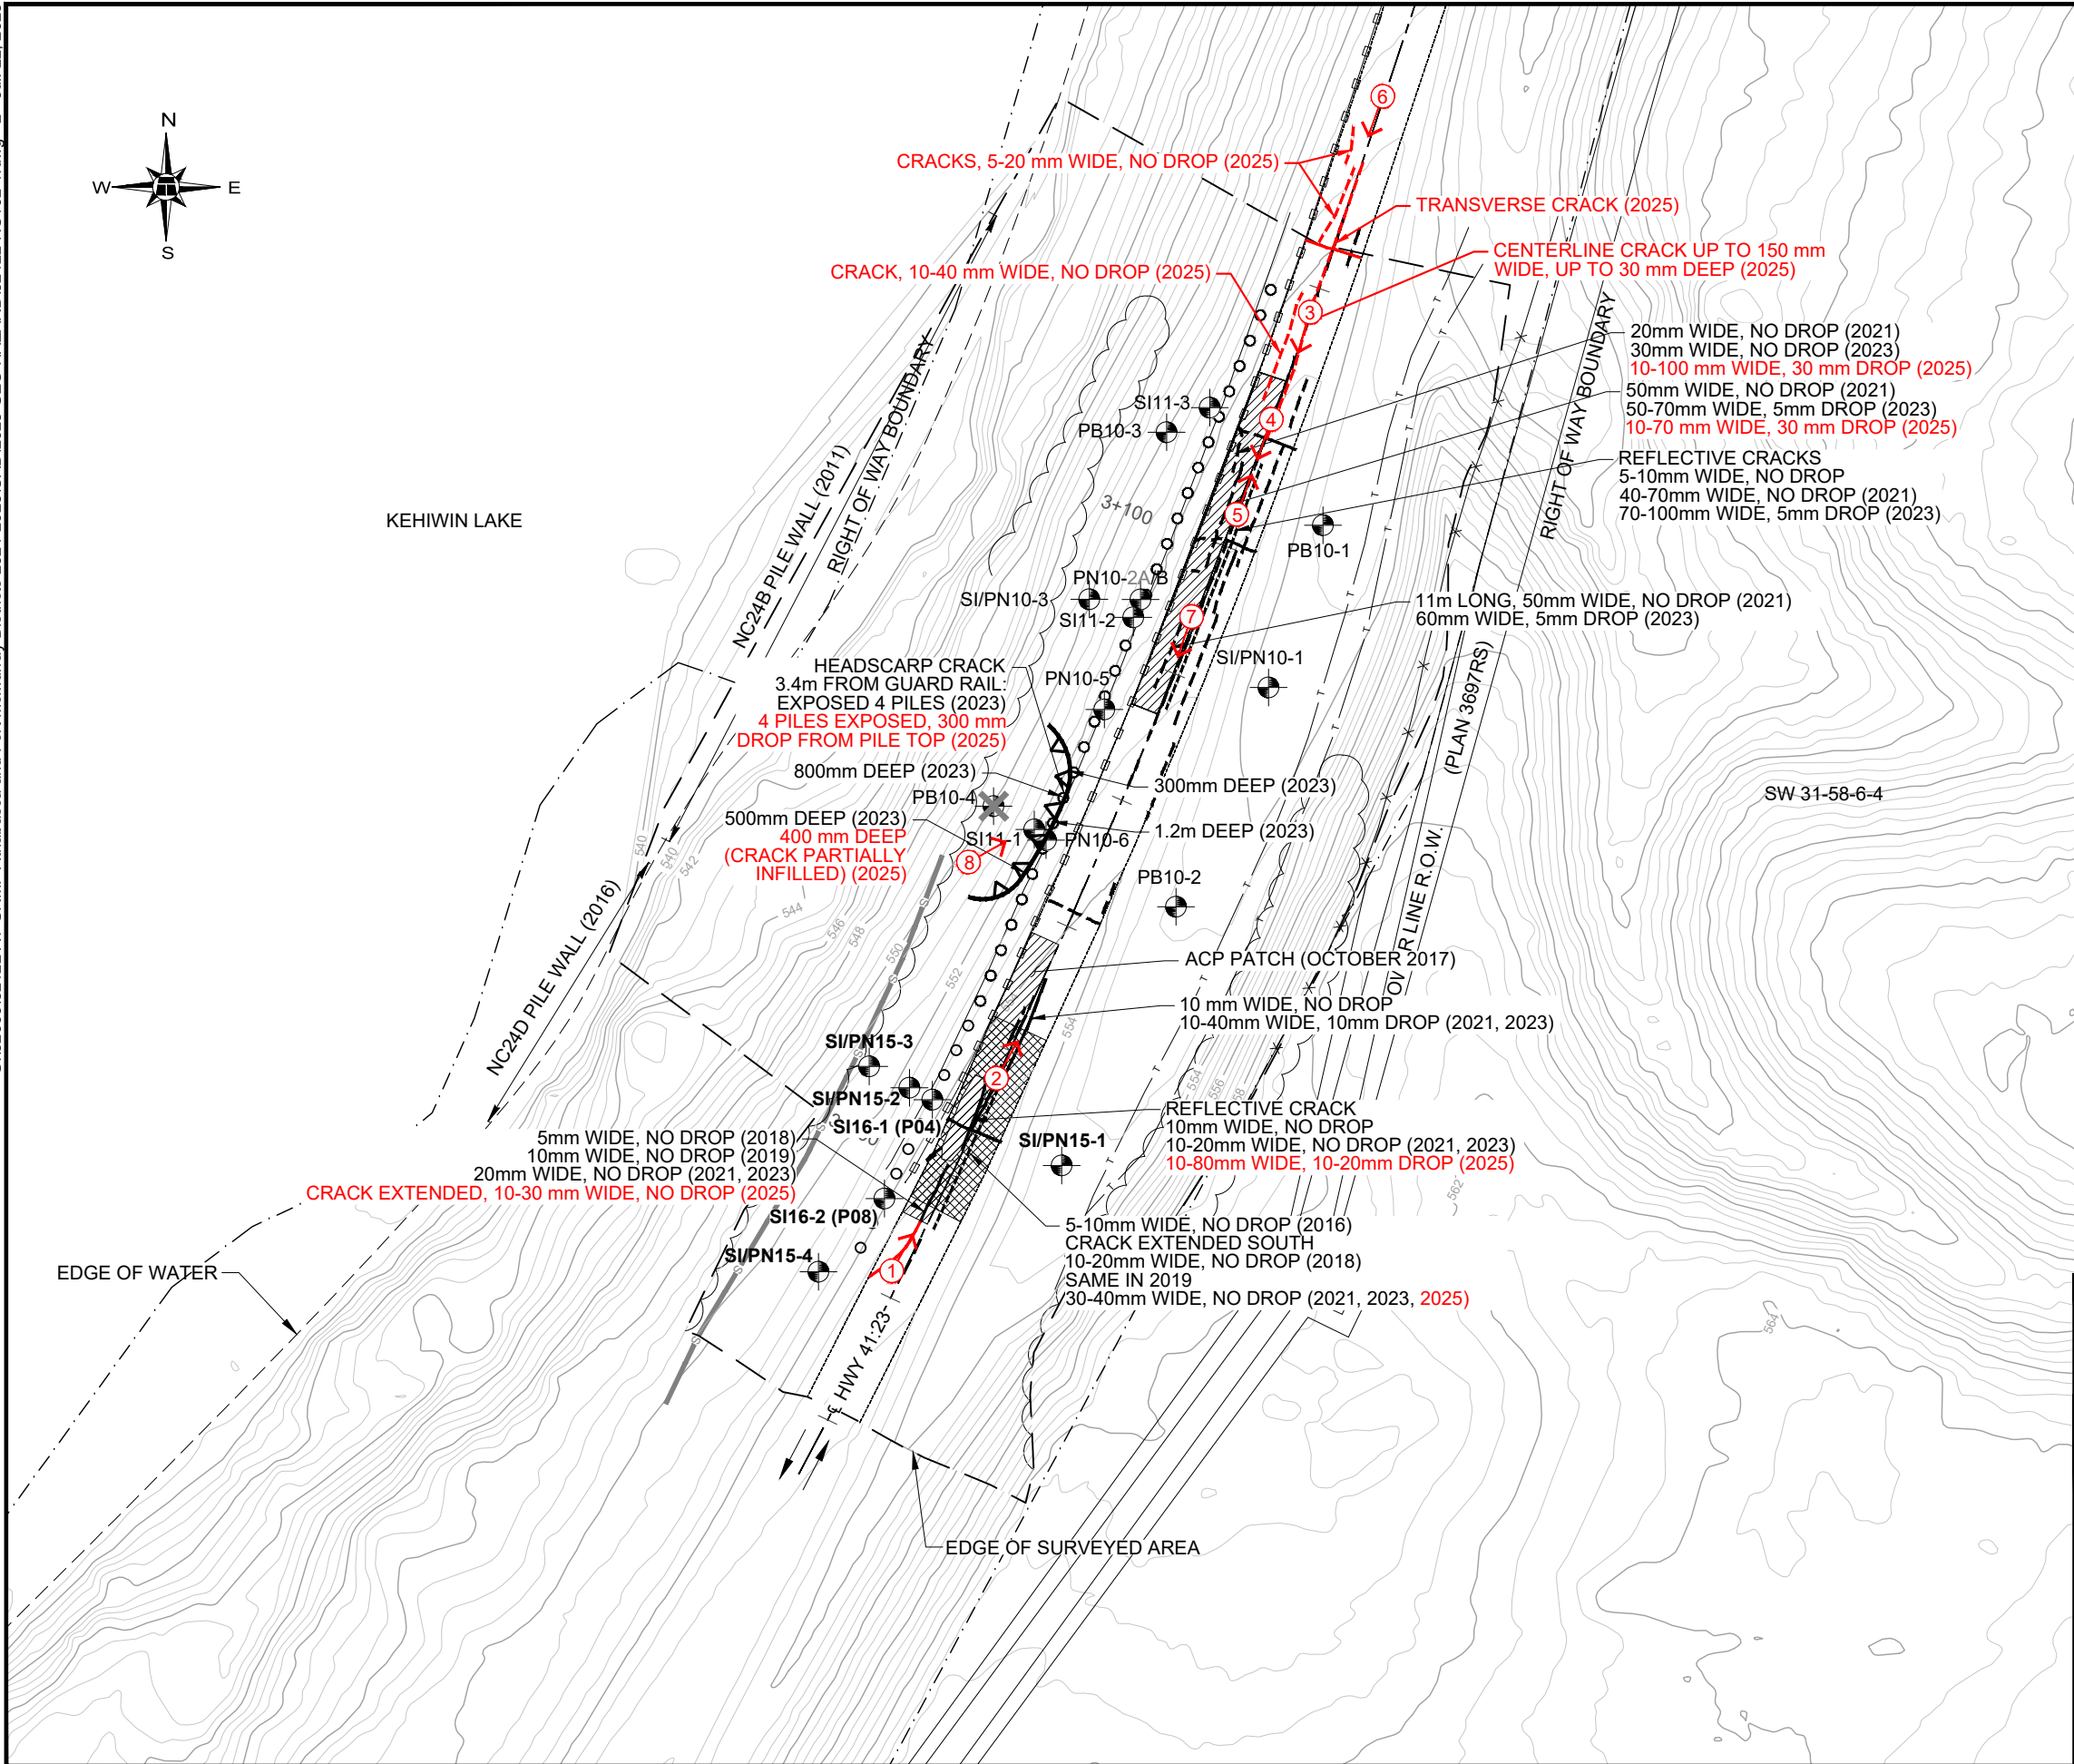
DWG NO. 32122-NC102-1

| Observations: | Description | Worse? |
|---|---|---|
| <input checked="" type="checkbox"/> Slope Movement | 10 to 150 mm wide reflective cracks with up to 30 mm drop on the highway surface above NC24B wall; 10 to 80 mm wide cracks with up to 20 mm drop above NC24D pile wall. A 0.4 m deep scarp crack, located about 3.4 m from guardrail exposing 4 piles from the NC24B Pile Wall near SI11-1. | <input checked="" type="checkbox"/> |

The NC24B and NC24D pile walls have been effective in stabilizing the landslide movements. The reflective landslide cracks appeared on the highway surface above both walls will continue to open and widen over time until the pile walls mobilize the full magnitudes of the landslide stabilizing forces.

In general, open cracks on the highway surface above the pile walls should be sealed to reduce groundwater infiltration into the landslide masses.

The local MCI should watch for the development of any new cracks on the highway lanes, particularly upslope of SI15-4 location (i.e., SI located outside the pile wall extent).

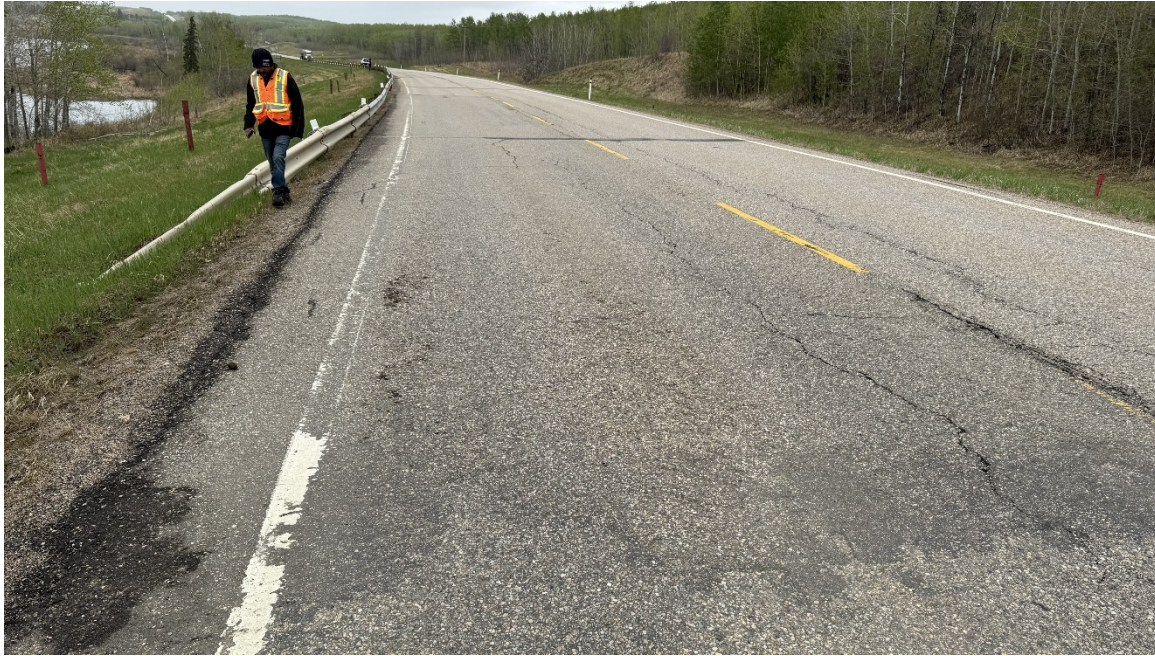
**Photo 1. Looking north at the 2017 ACP patch placed on the highway surface at the NC102 pile wall location; no visible dip on highway surface.**

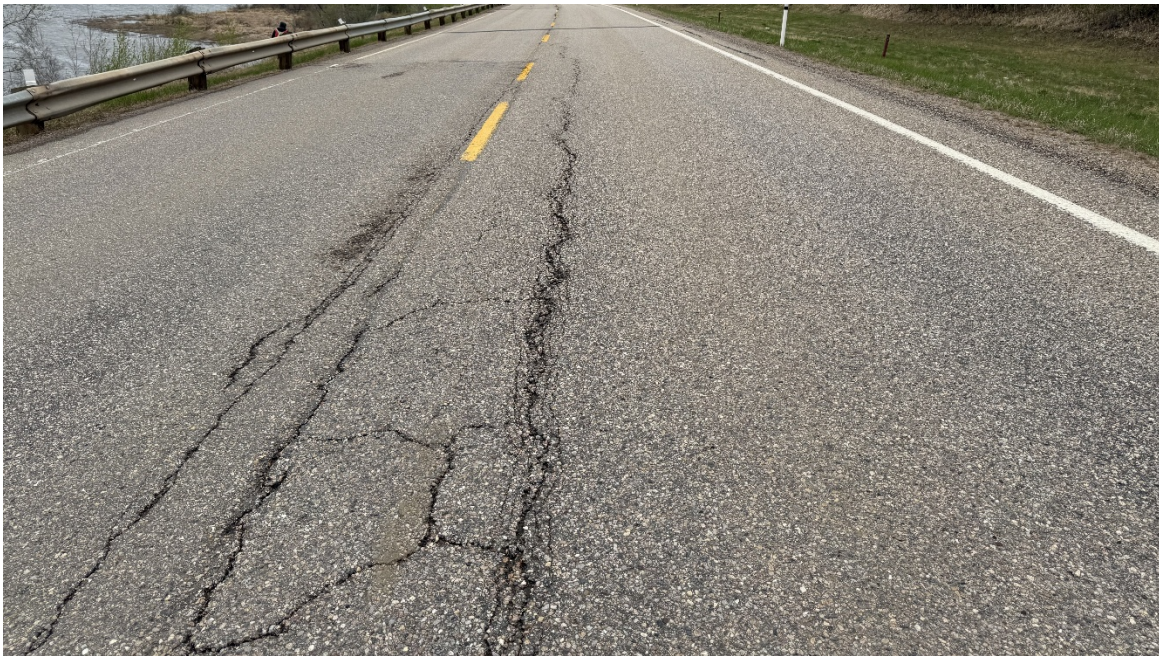
**Photo 2. Looking north at reflective cracks in the highway surface at the NC102 pile wall location. Cracks are 10-80 mm wide, with a 10-20 mm drop.**

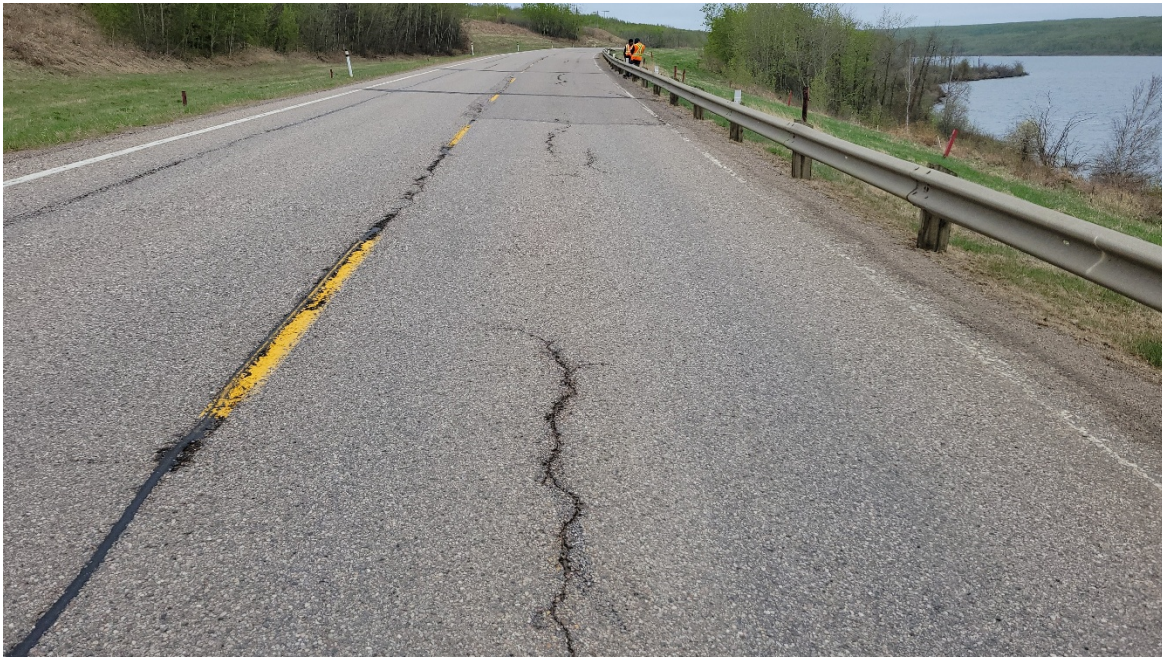
**Photo 3. Looking south at reflective cracks through north 2017 ACP patch.**

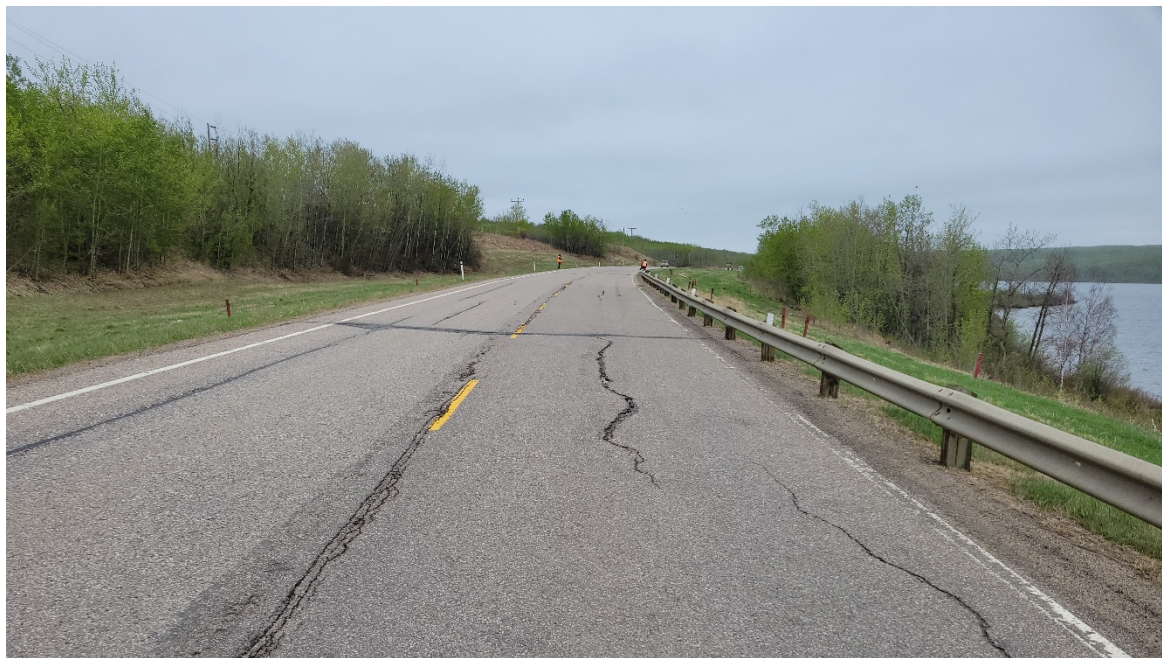
**Photo 4. Looking south at reflective cracks in north ACP patch. Reflective crack in middle of southbound lane is 10-70 mm wide with a 30 mm drop.**

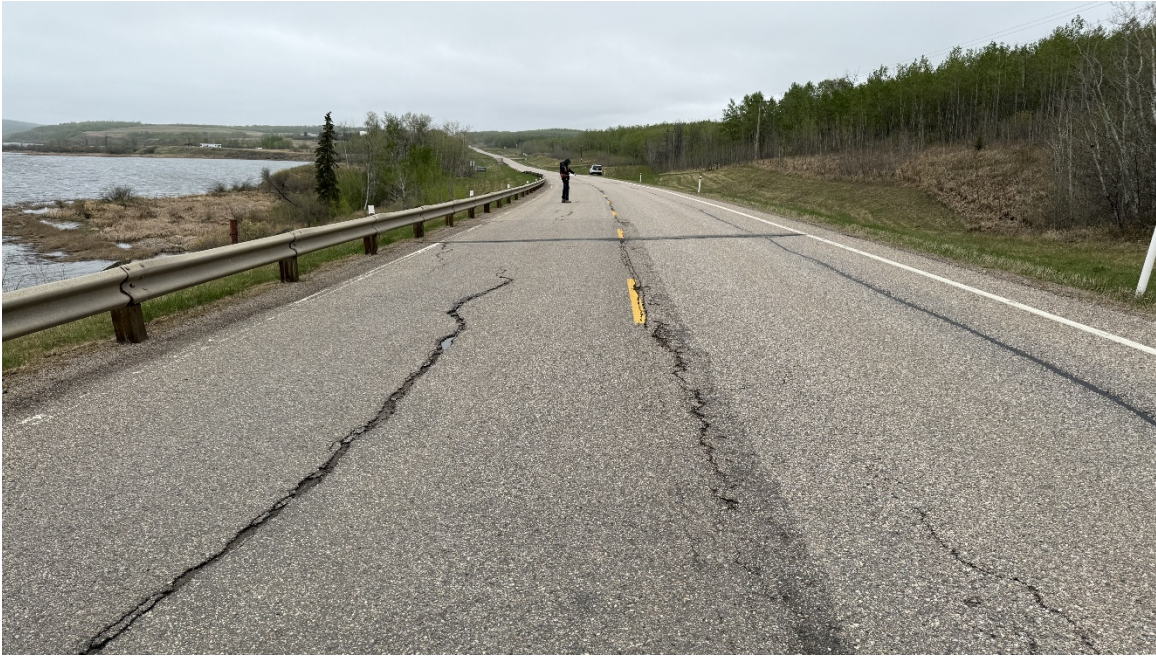
**Photo 5. Looking north at reflective cracks near north end of NC102 pile wall. Reflective crack in middle of southbound lane is up to 100 mm wide with 30 mm drop. Centerline crack is up to 150 mm wide with a 30 mm drop.**

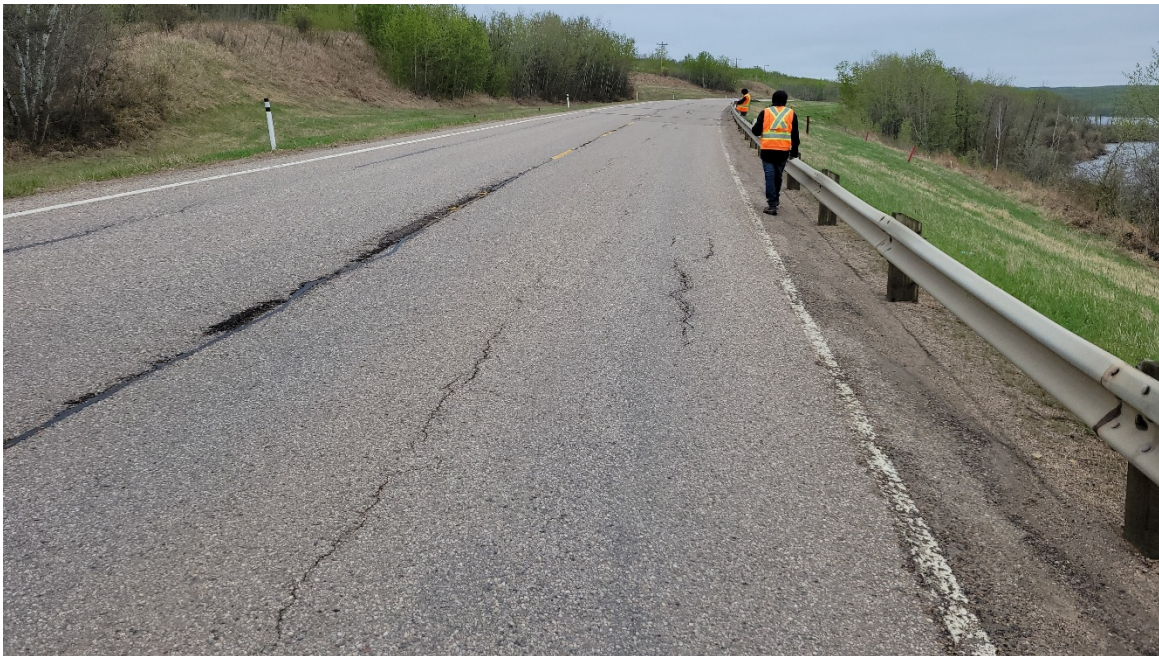
**Photo 6. Looking south at 5 to 20 mm wide reflective cracks with no drop on the southbound lane, up to 150 mm wide and 30 mm deep along centerline.**

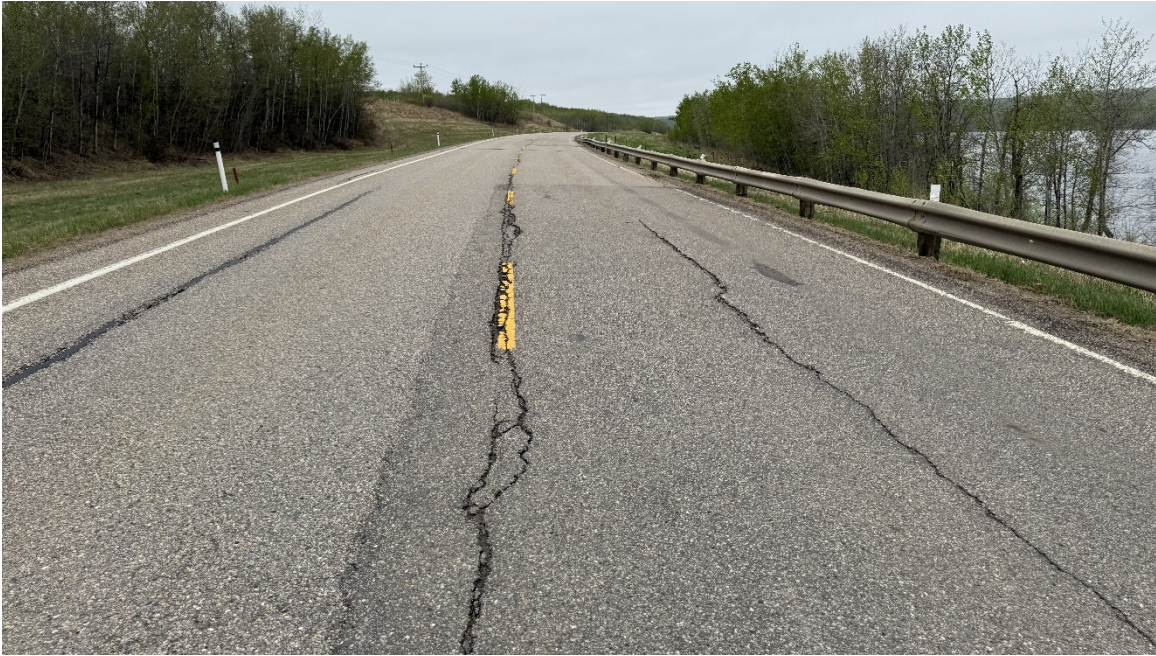
**Photo 7. Looking south at 60 to 100 mm wide reflective cracks with up to 5 mm drop.**

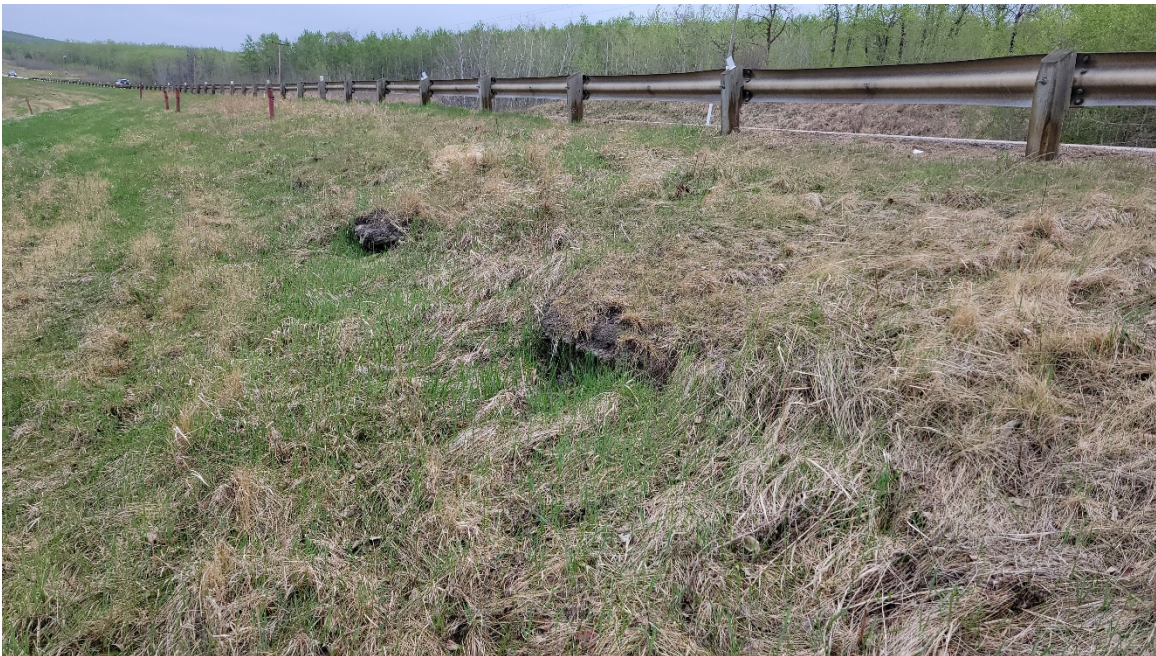
The design of the NC24B pile wall accounted for partial loss of the downslope soil mass (i.e., up to 4 m). Hence, the integrity of the wall should not be impacted due to the exposure of the concrete piles unless the downslope mass drops by more than 4 m. However, the slump developed downslope of the wall may get bigger and deeper in the future, and the head scarp crack may potentially expose more piles. Future loss of the exposed soils between the spaced piles, if occurs for example due to repeated freeze/thaw cycles or saturation of soils after a heavy rainfall event, may eventually impact the integrity of the highway due to progressive loss of soils the wall and the highway.

**Photo 8. Looking at the tops of exposed concrete piles. The cracks in front of the piles are 300 mm deep.**

The slump area around the exposed four piles should be monitored and any cracks on the side slopes or the highway above this location should be sealed.

It is recommended that fill be brought to site to slightly grade/contour the slump area and cover the exposed four piles. The fill should be lightly compacted around the exposed piles.
