ALBERTA TRANSPORTATION AND  
ECONOMIC CORRIDORS GRMP  
NORTH CENTRAL (ATHABASCA AND FORT  
McMURRAY DISTRICTS)  
INSTRUMENTATION MONITORING- SPRING 2025

| Site Number | Location | Name | Hwy | km |
|---|---|---|---|---|
| NC102<br>(NC024-2) | HWY 41:23 C1 8.88 | Kehiwin Lake | 41:23 | Km 8.8 |

**ALBERTA TRANSPORTATION AND ECONOMIC CORRIDORS GRMP (CON0022163)  
NORTH CENTRAL (ATHABASCA AND FORT McMURRAY DISTRICTS)  
INSTRUMENTATION MONITORING RESULTS**

**SITE NC102 (NC024-2): HWY 41:23 KEHIWIN LAKE (km 8.8)**

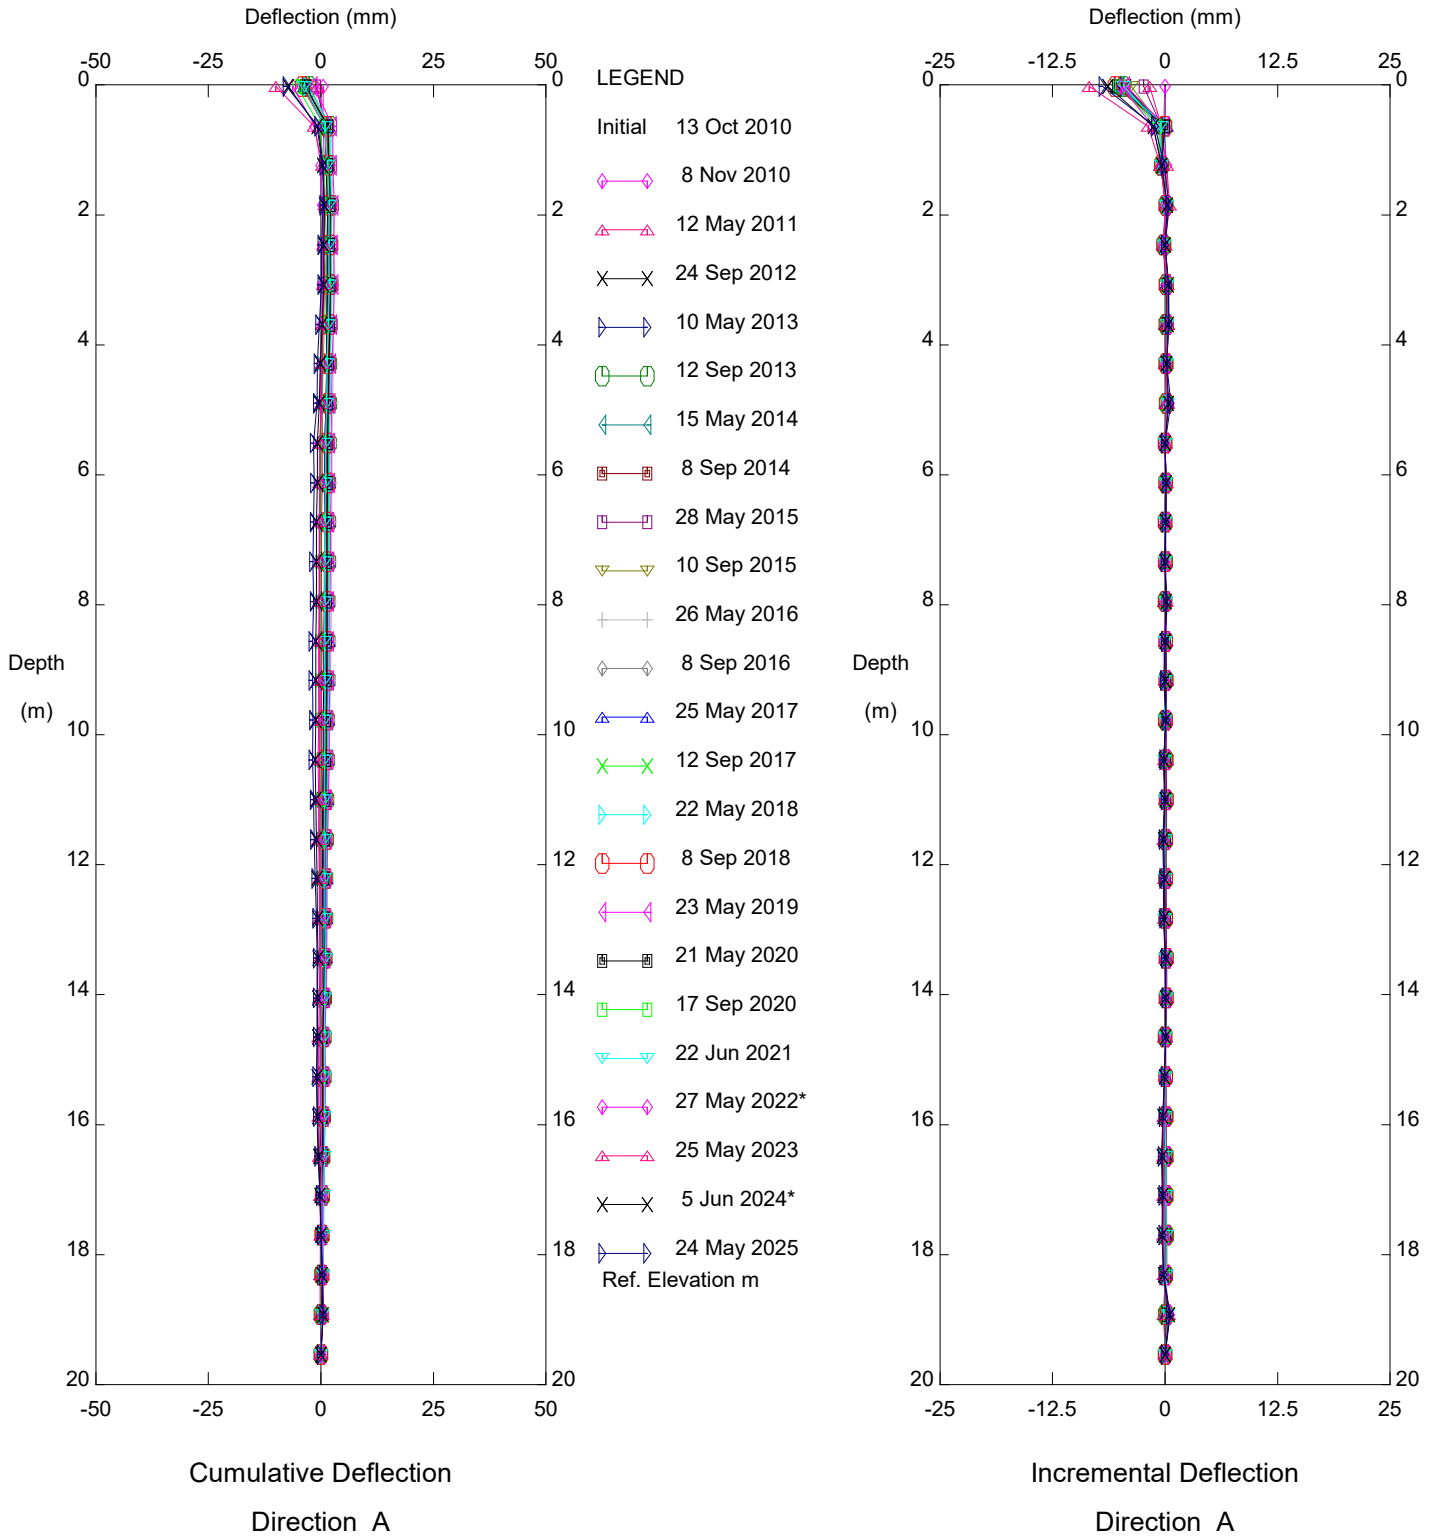
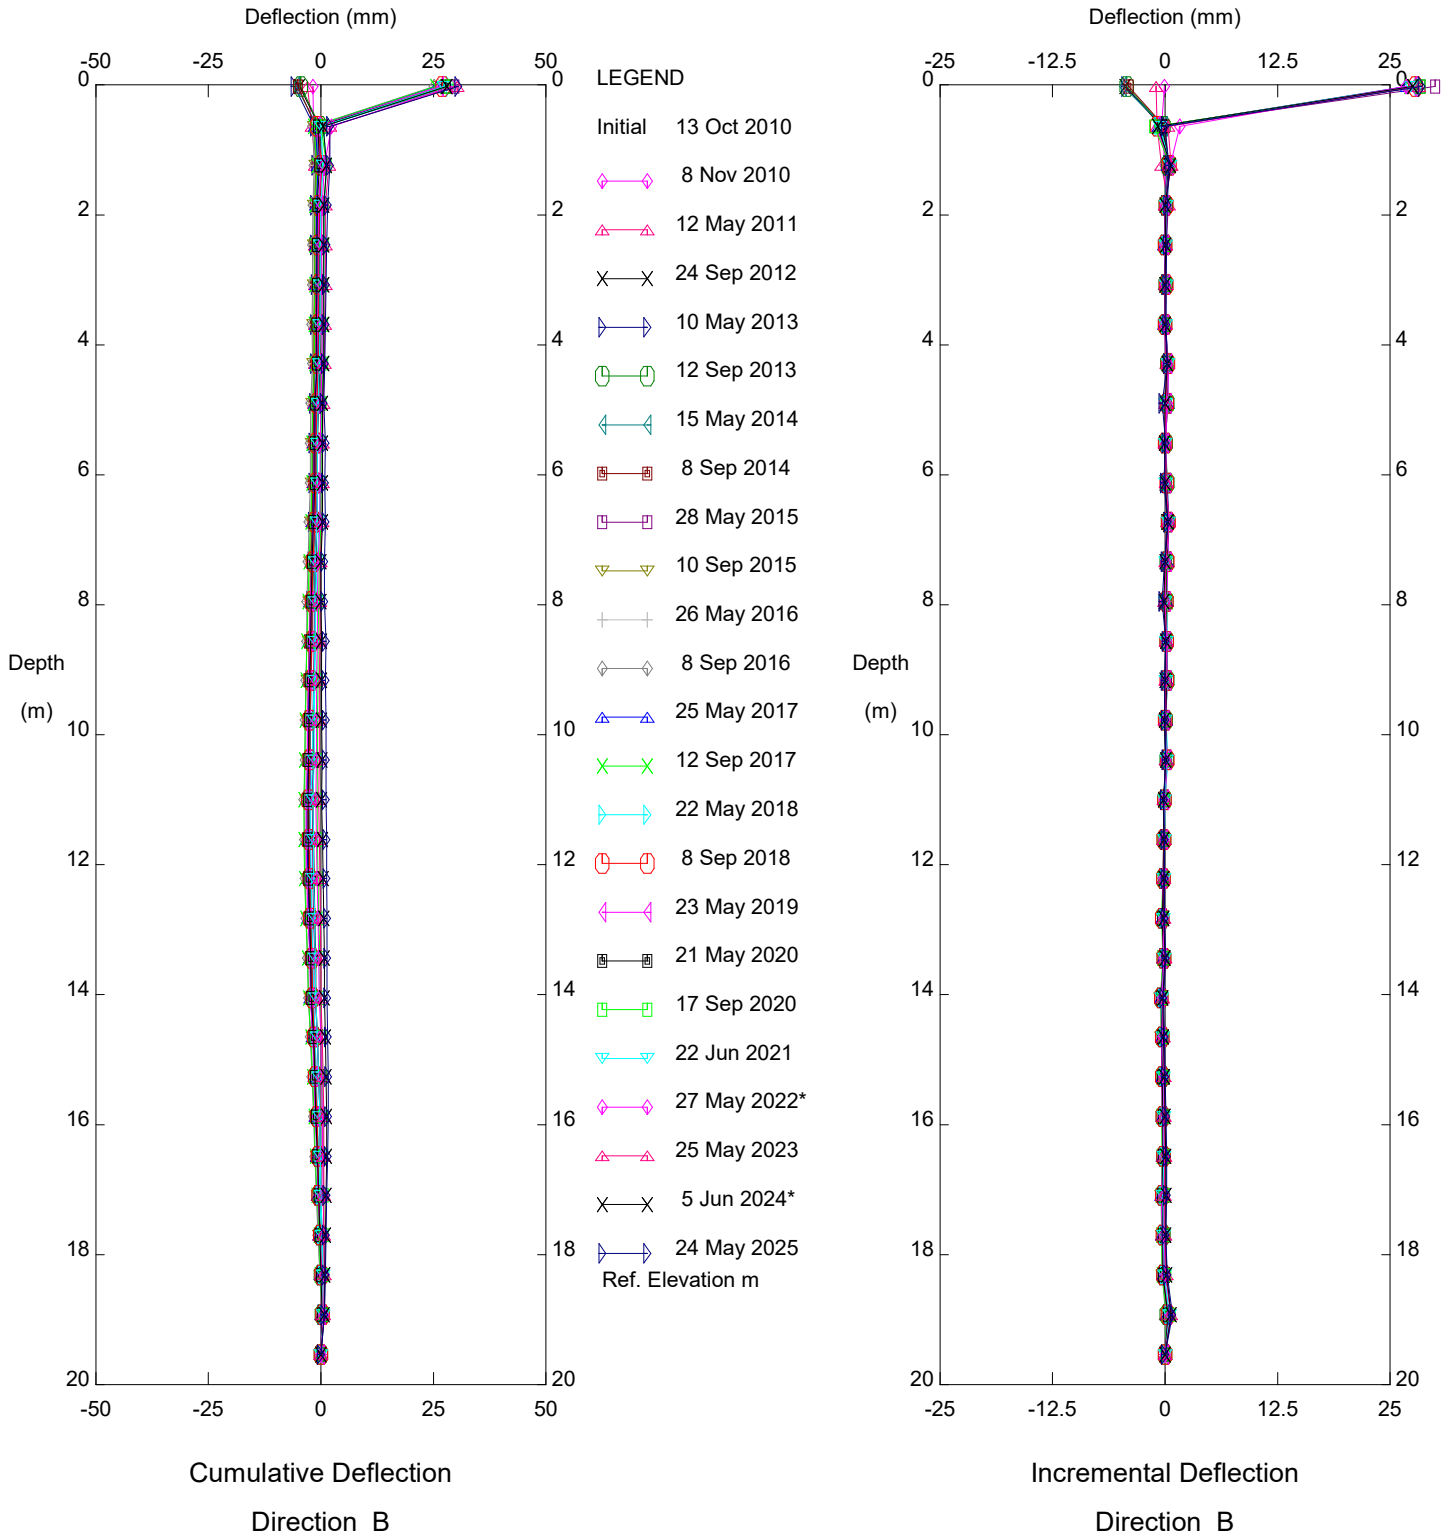
Hwy 41:23 Kehiwin Lake (NC102), Inclinometer SI10-1

| Discussion | |
|---|---|
| <b>Interpretation of Monitoring Results:</b> | <p>Slope inclinometer SI10-1, installed in the highway east ditch upslope of the NC24B pile wall, continued to show no discernible movement. SI10-3 installed downslope of the NC24B pile wall, showed a rate of movement of 0.5 mm/yr over 0.0 m to 2.4 m of depth since the spring of 2024 readings.</p> <p>SI11-1 through SI11-3 were installed in piles P7, P16 and P24, respectively, of the NC24B pile wall. SI11-1 to SI11-3 showed no discernible movement since the spring of 2024 readings.</p> <p>SI11-1 and SI11-2 have shown total pile head movements of 1.9 mm and 1.8 mm, respectively, since installation. SI11-3 has shown a total pile head movement of 0.1 mm in the upslope direction since installation (i.e., likely reflecting probe accuracy).</p> |

| INSTRUMENT # | DATE INITIALIZED | TOTAL CUMULATIVE RESULTANT MOVEMENT AND DEPTH OF MOVEMENT TO DATE (mm) | MAXIMUM RATE OF MOVEMENT (mm/yr) | CURRENT STATUS OF SI | DATE OF PREVIOUS READING | INCREMENTAL MOVEMENT SINCE PREVIOUS READING (mm) | CURRENT RATE OF MOVEMENT (mm/yr) | CHANGE IN RATE OF MOVEMENT SINCE PREVIOUS READING (mm/yr) |
|---|---|---|---|---|---|---|---|---|
| SI10-1 | October 13, 2010 | No discernible movement | No discernible movement | Operational | June 5, 2024 | No discernible movement | N/A | N/A |

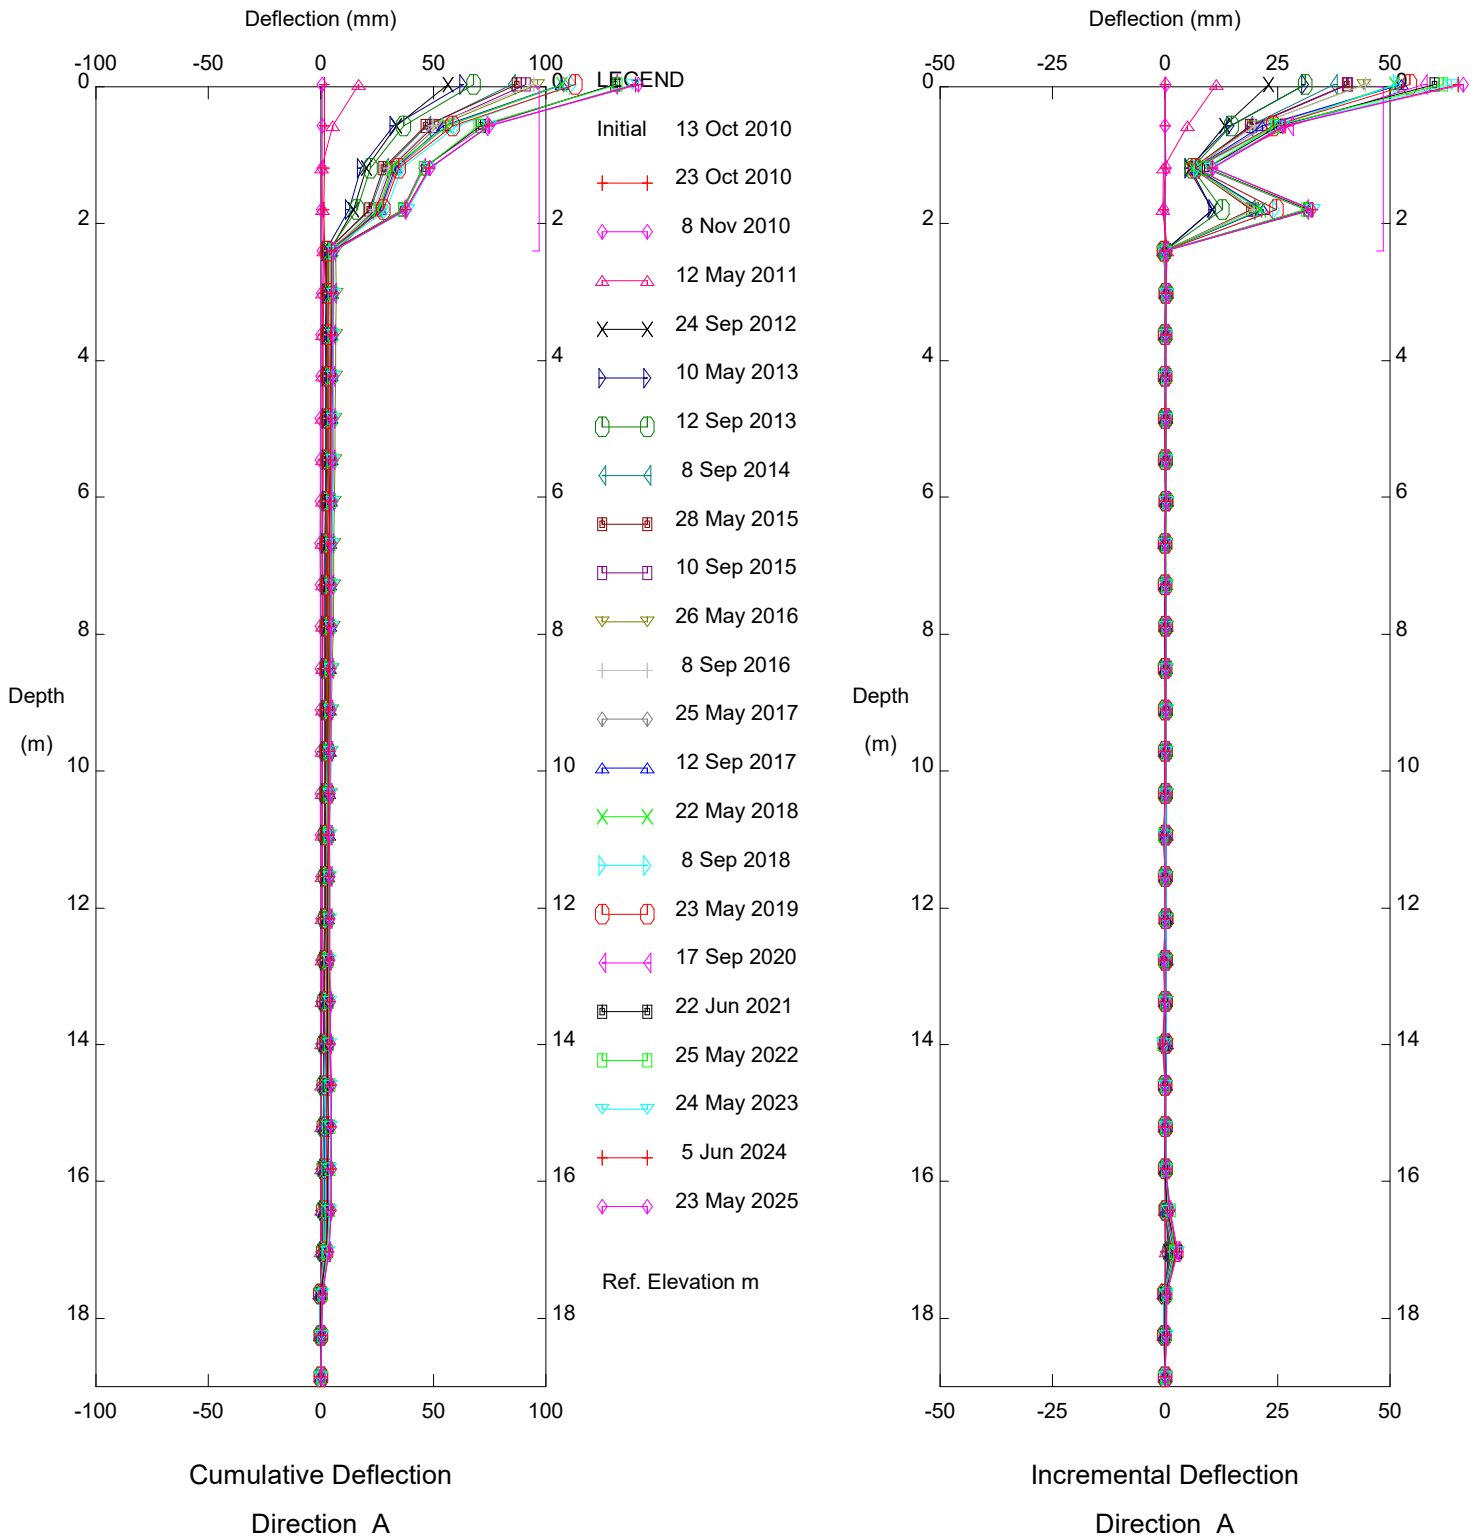
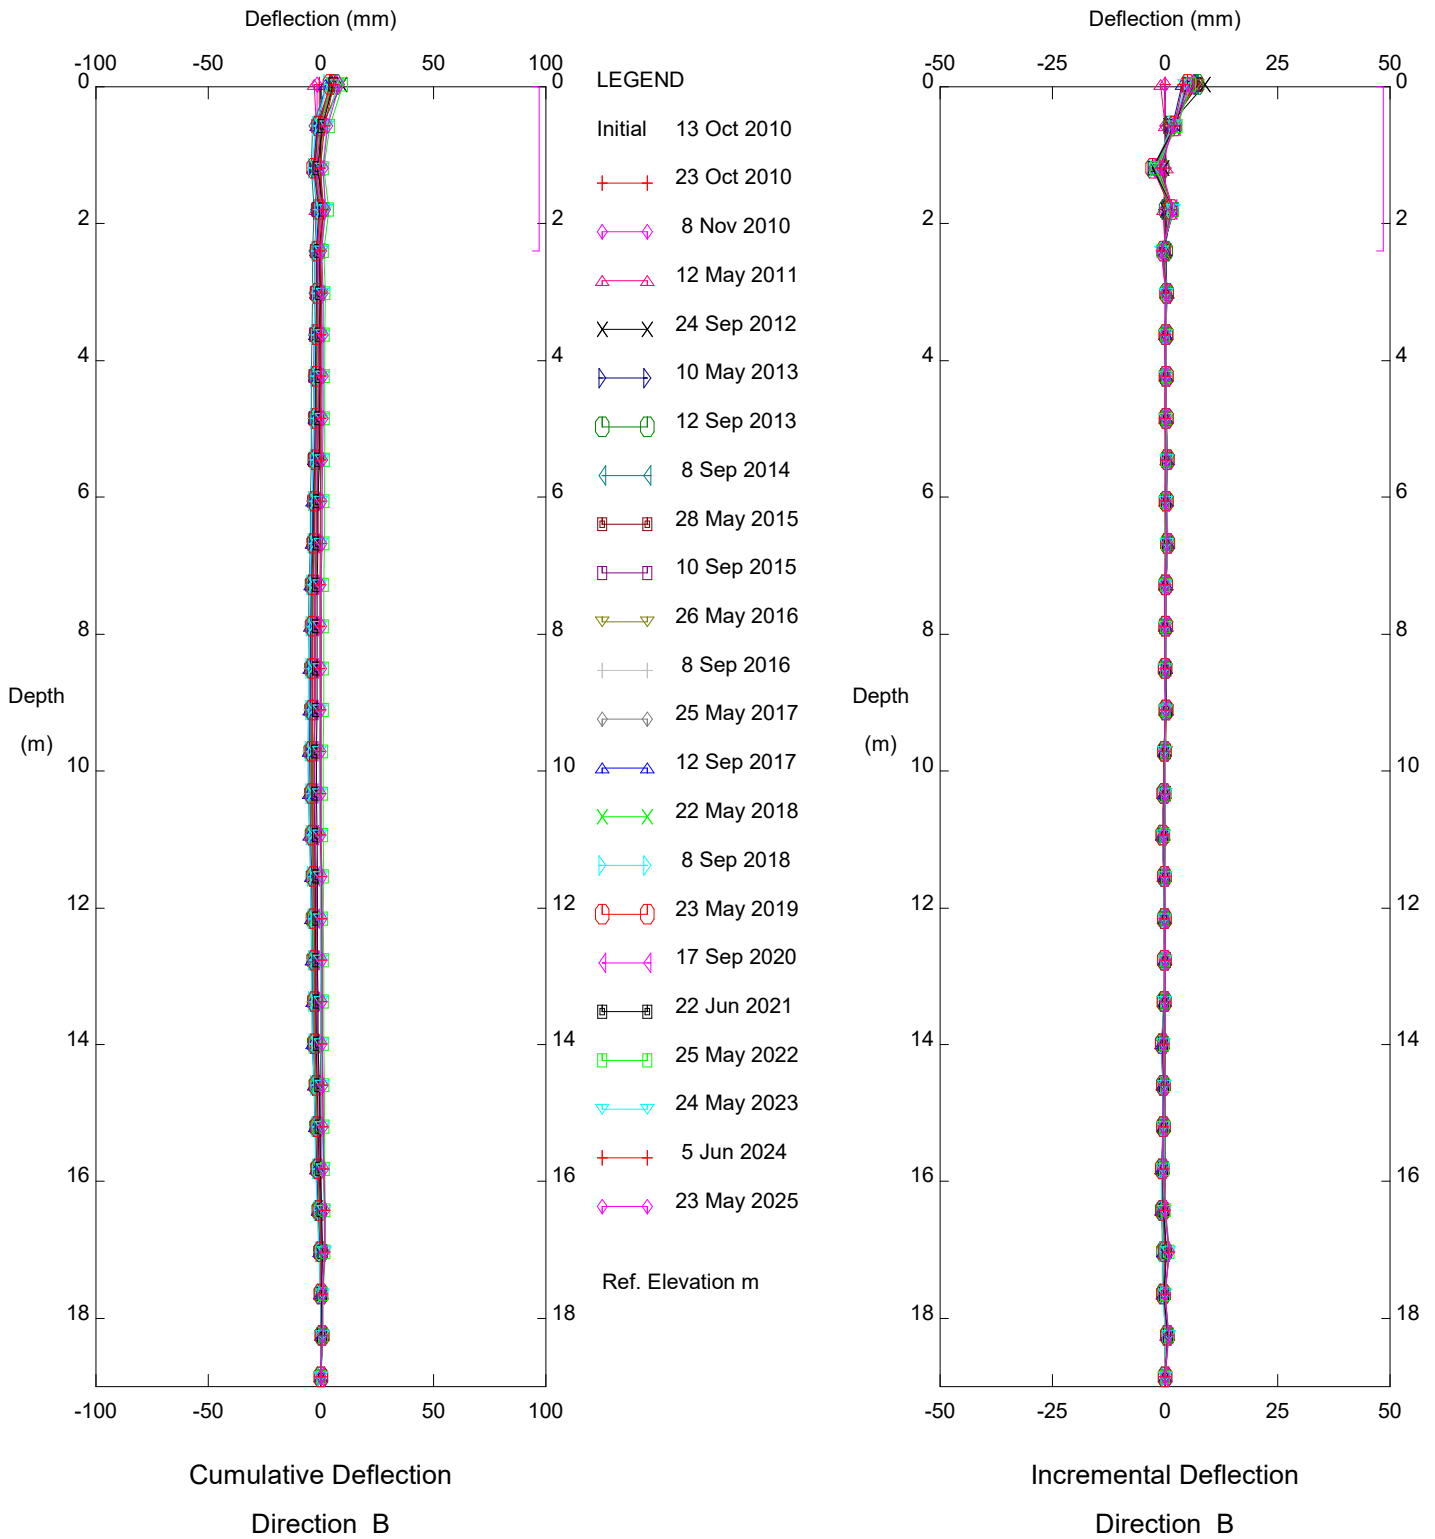
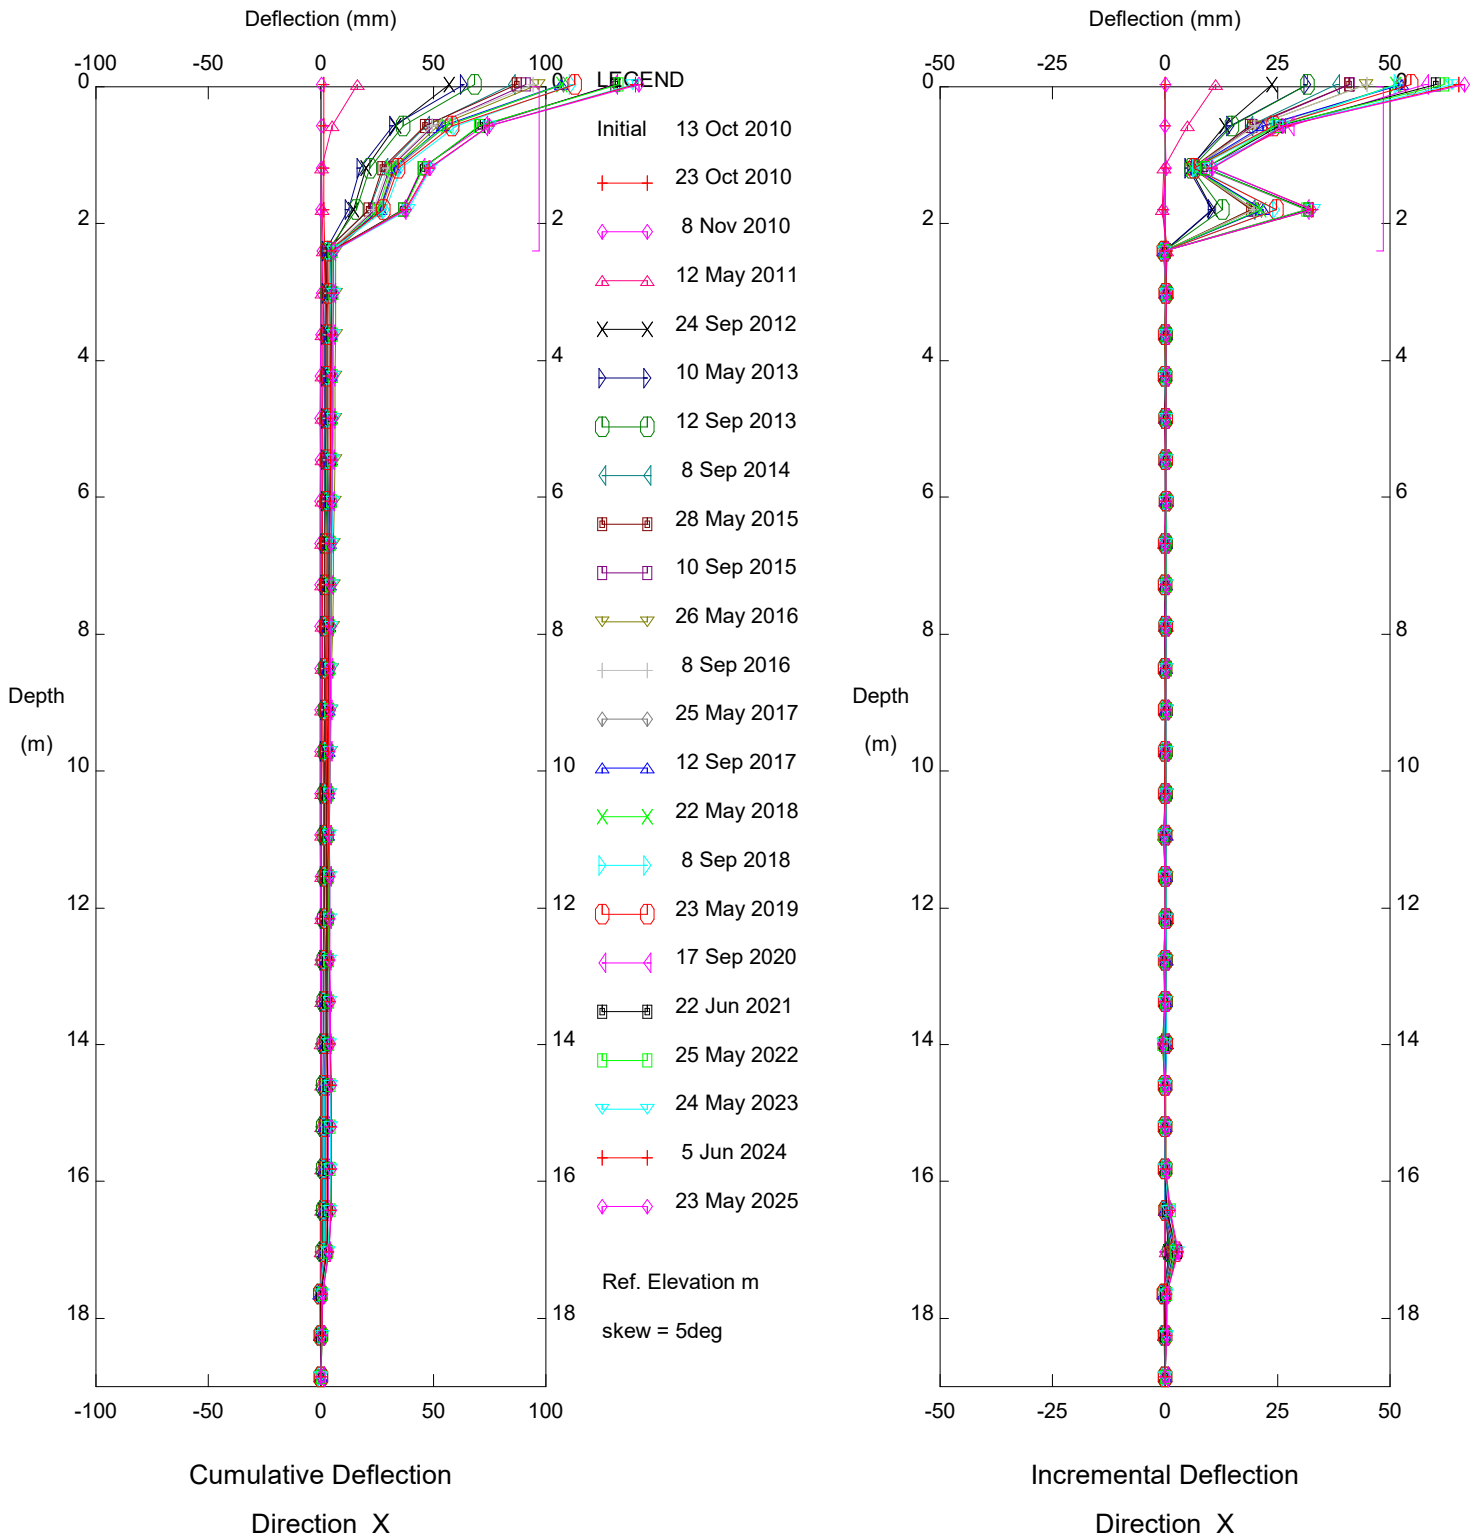
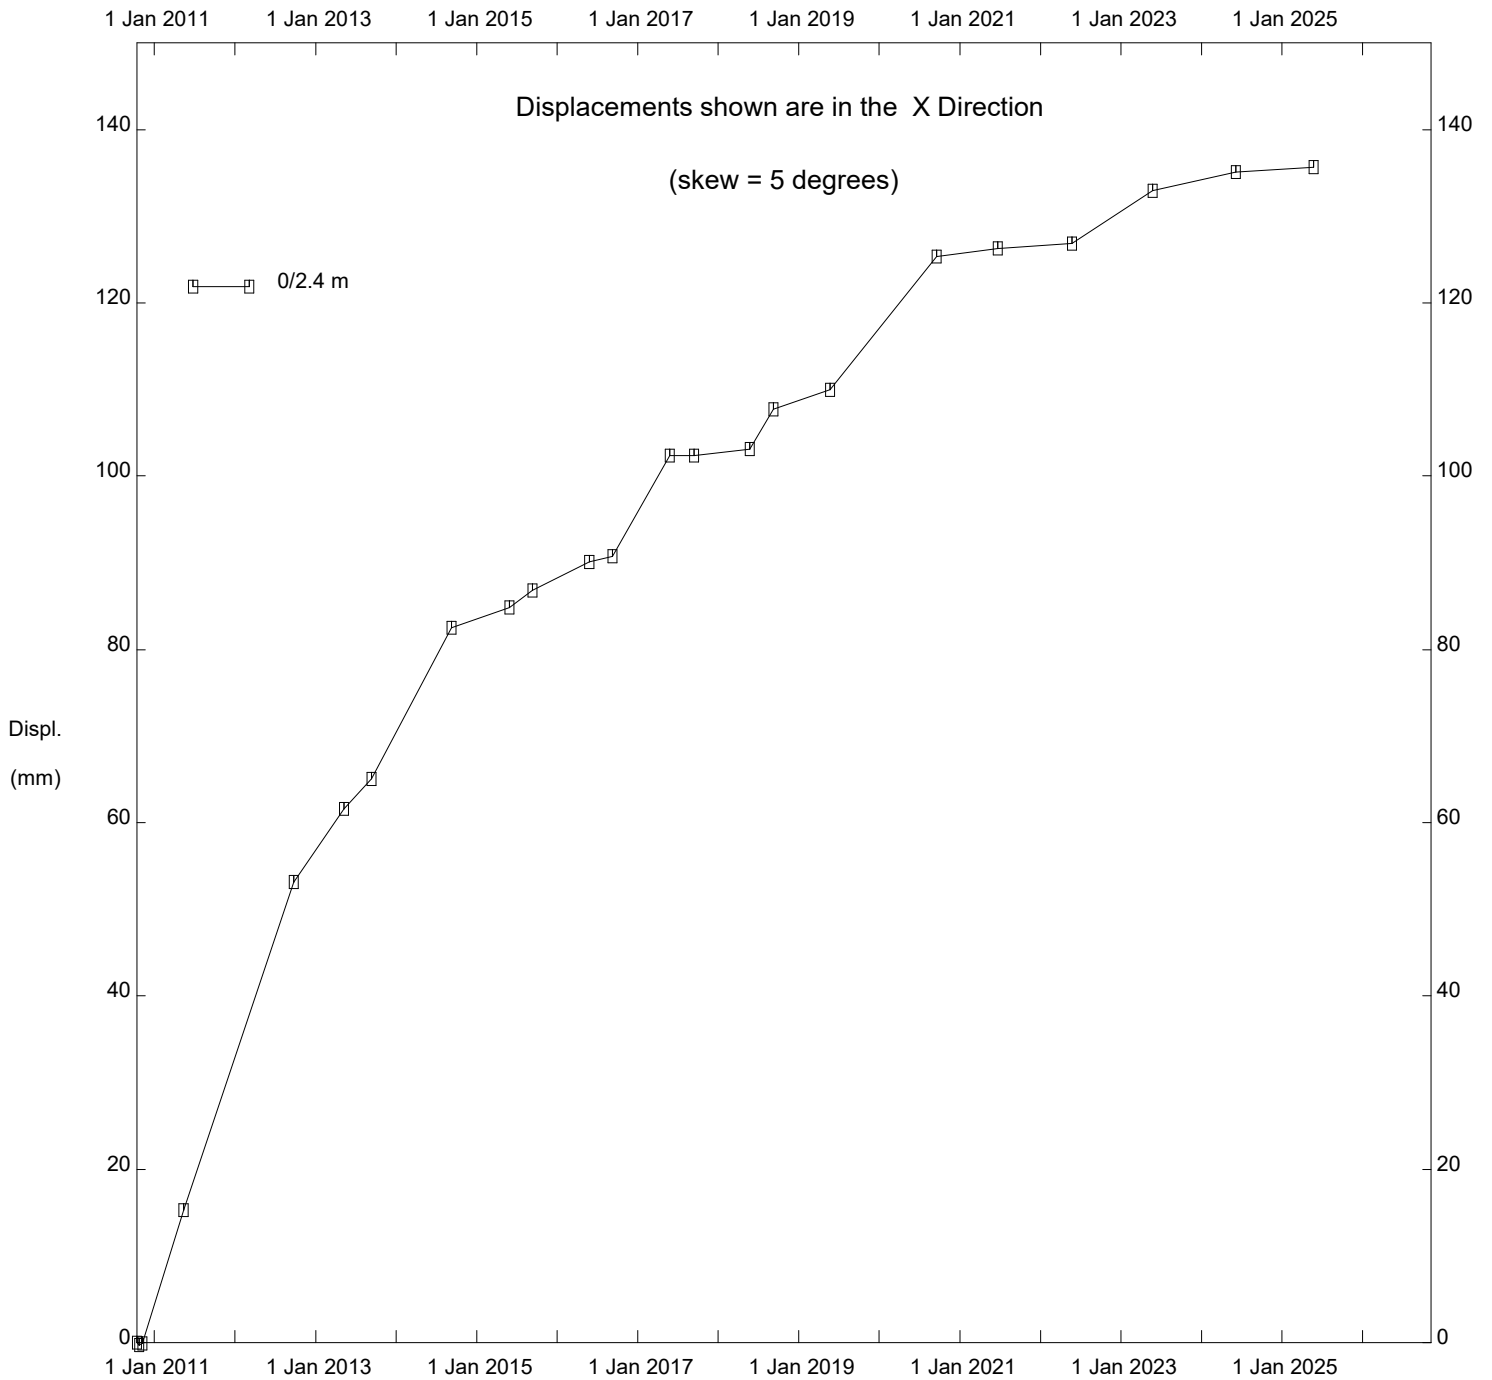
Hwy 41:23 Kehiwin Lake (NC102), Inclinometer SI10-3

| INSTRUMENT # | DATE INITIALIZED | TOTAL CUMULATIVE RESULTANT MOVEMENT AND DEPTH OF MOVEMENT TO DATE (mm) | MAXIMUM RATE OF MOVEMENT (mm/yr) | CURRENT STATUS OF SI | DATE OF PREVIOUS READING | INCREMENTAL MOVEMENT SINCE PREVIOUS READING (mm) | CURRENT RATE OF MOVEMENT (mm/yr) | CHANGE IN RATE OF MOVEMENT SINCE PREVIOUS READING (mm/yr) |
|---|---|---|---|---|---|---|---|---|
| SI10-3 | October 13, 2010 | 135.6 over 0.0 m to 2.4 m depth in 323° direction | 30.3 in May 2011 | Operational | June 5, 2024 | 0.5 | 0.5 | -1.6 |

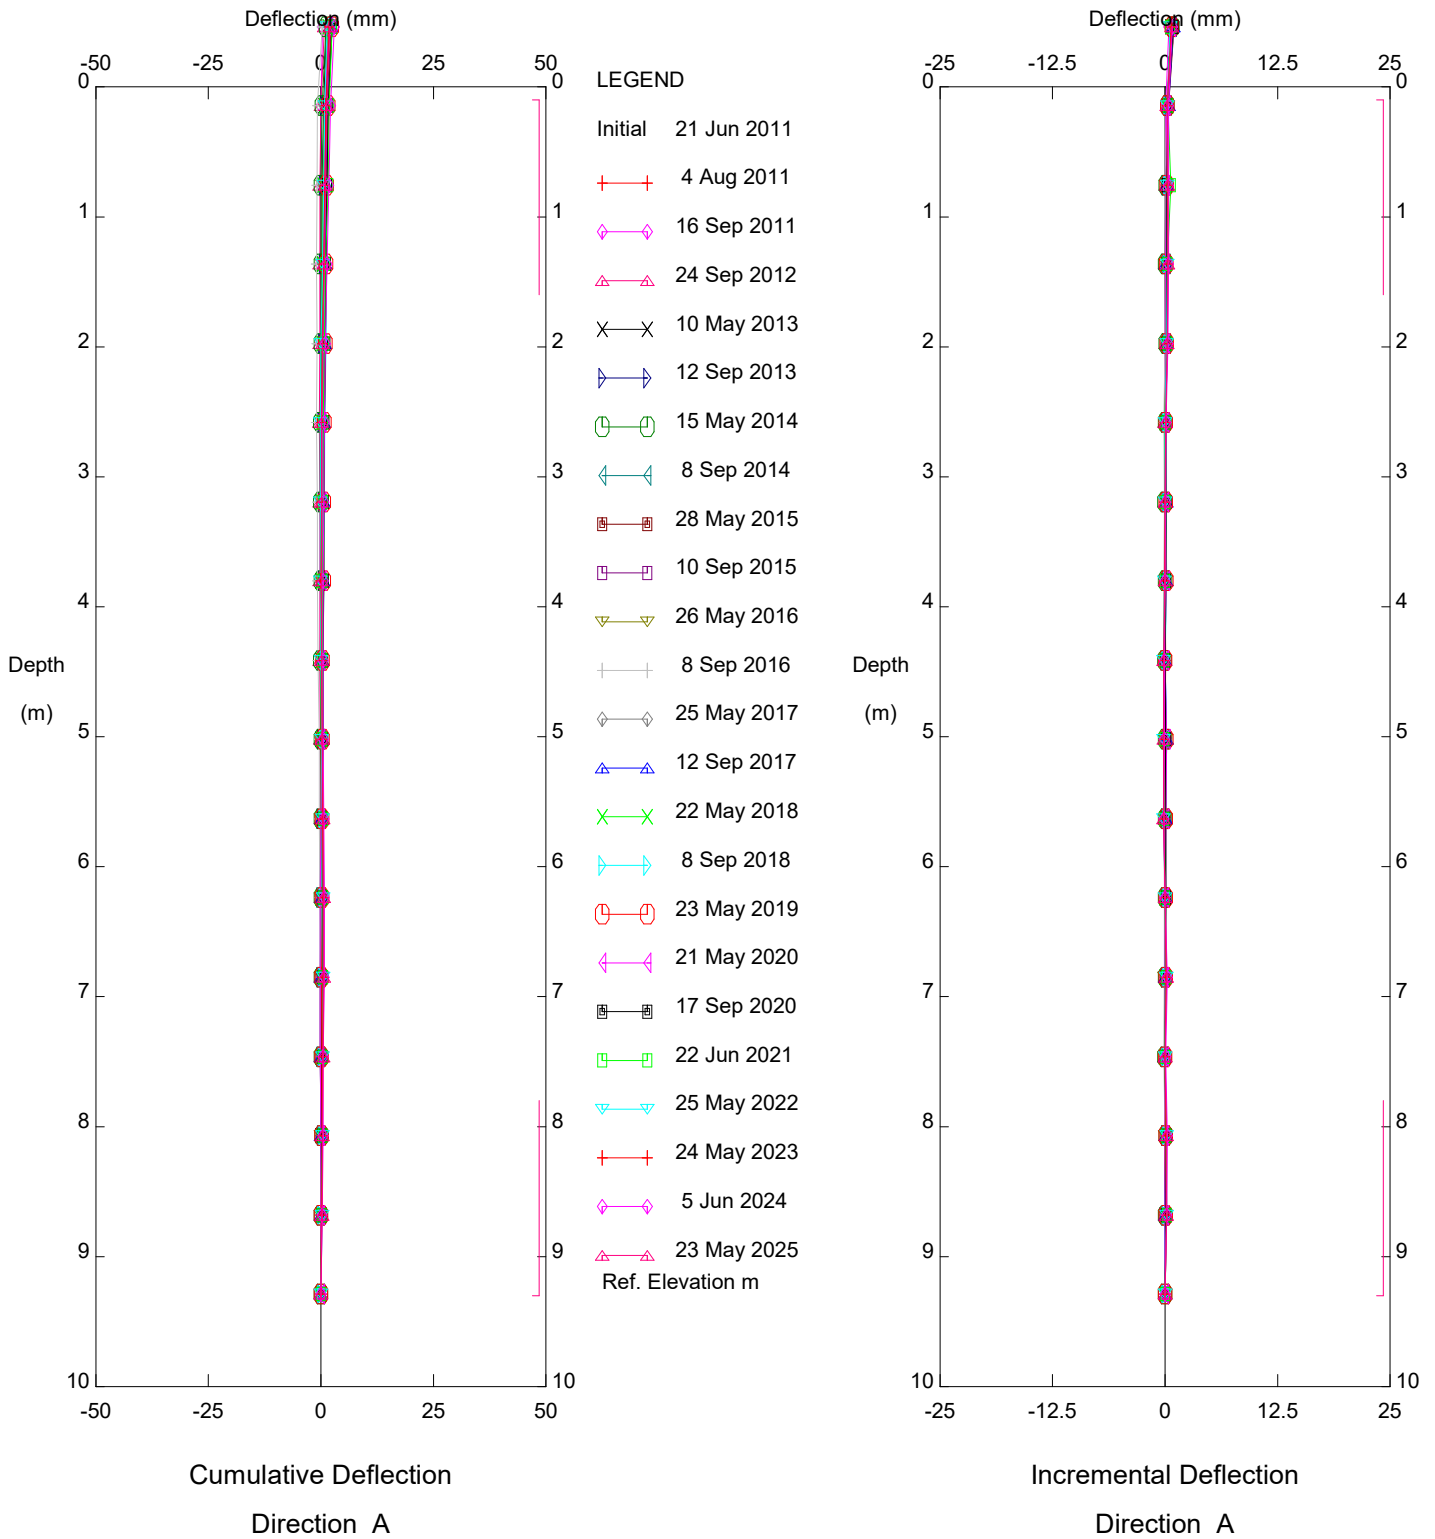
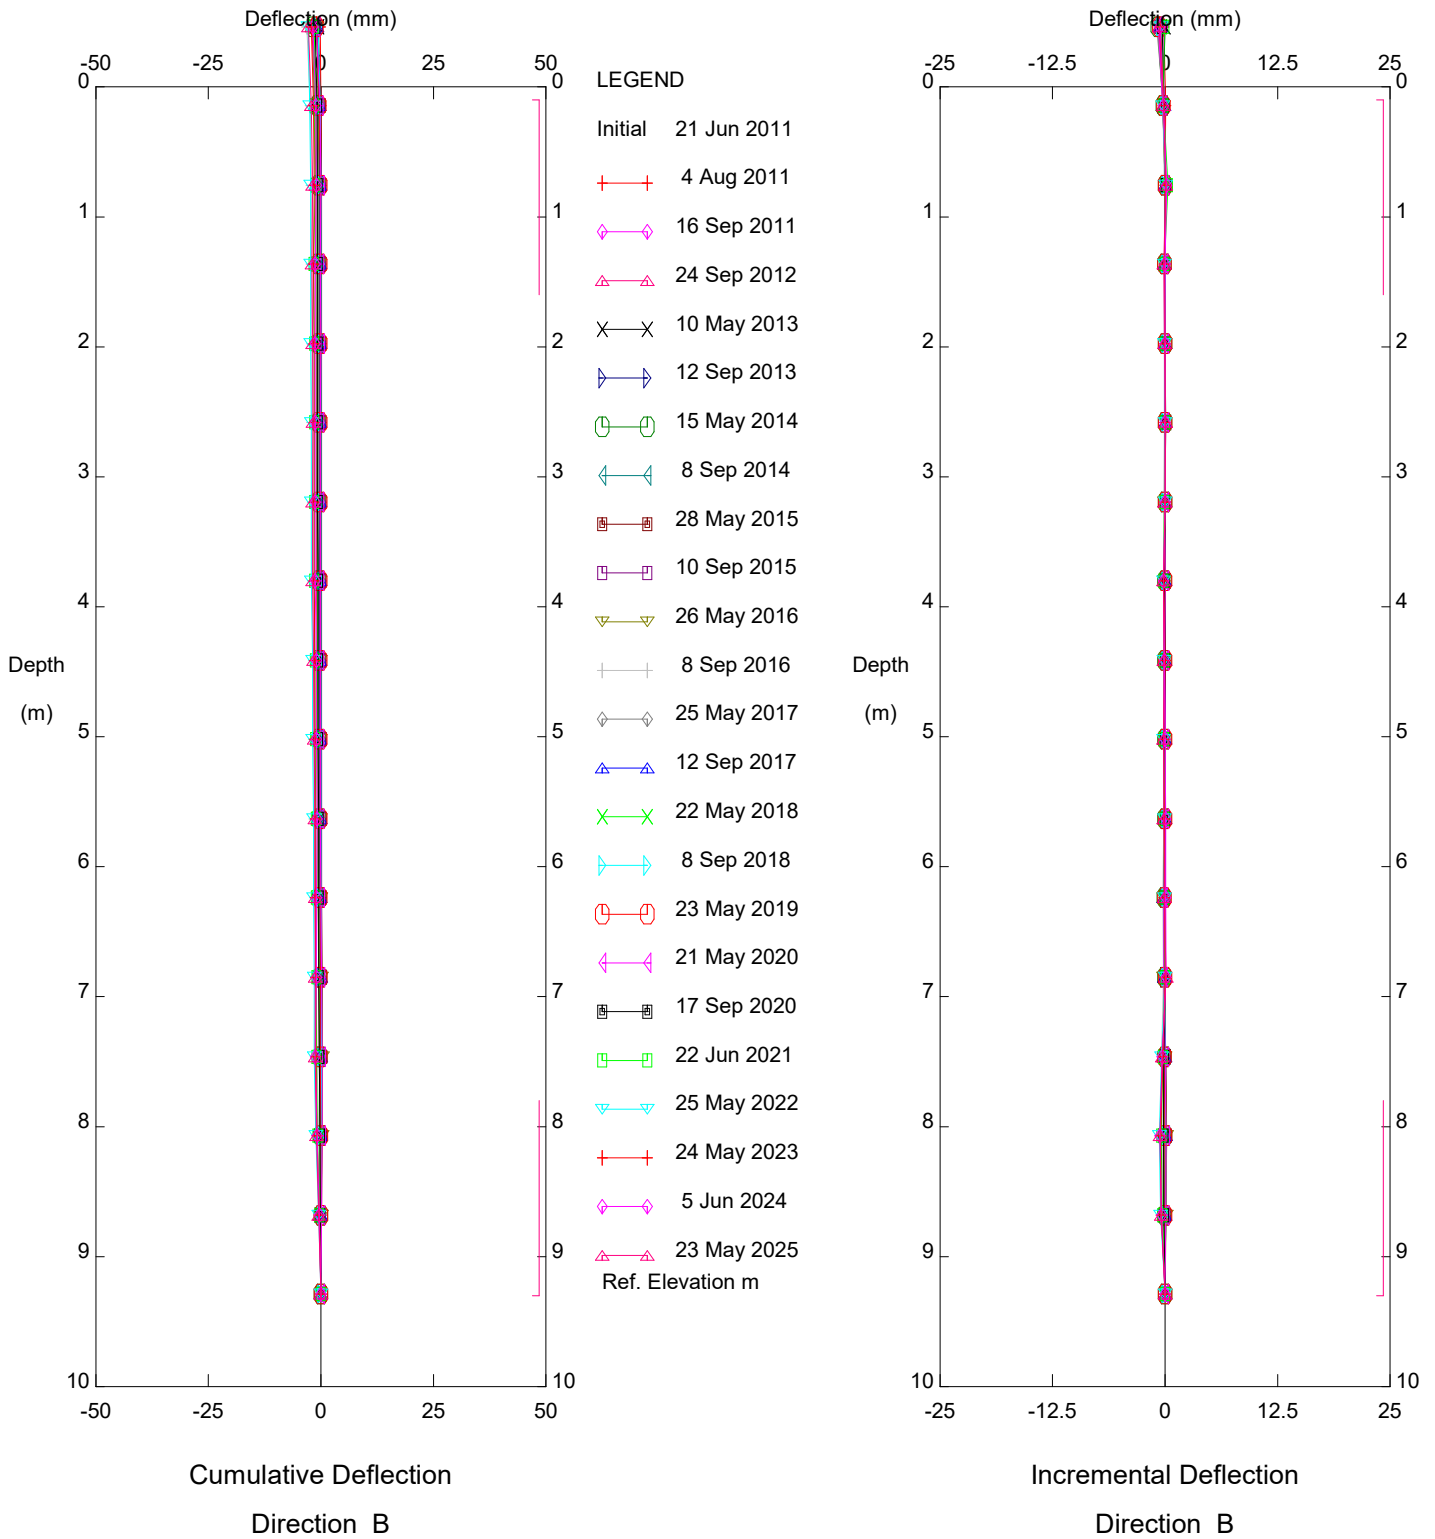
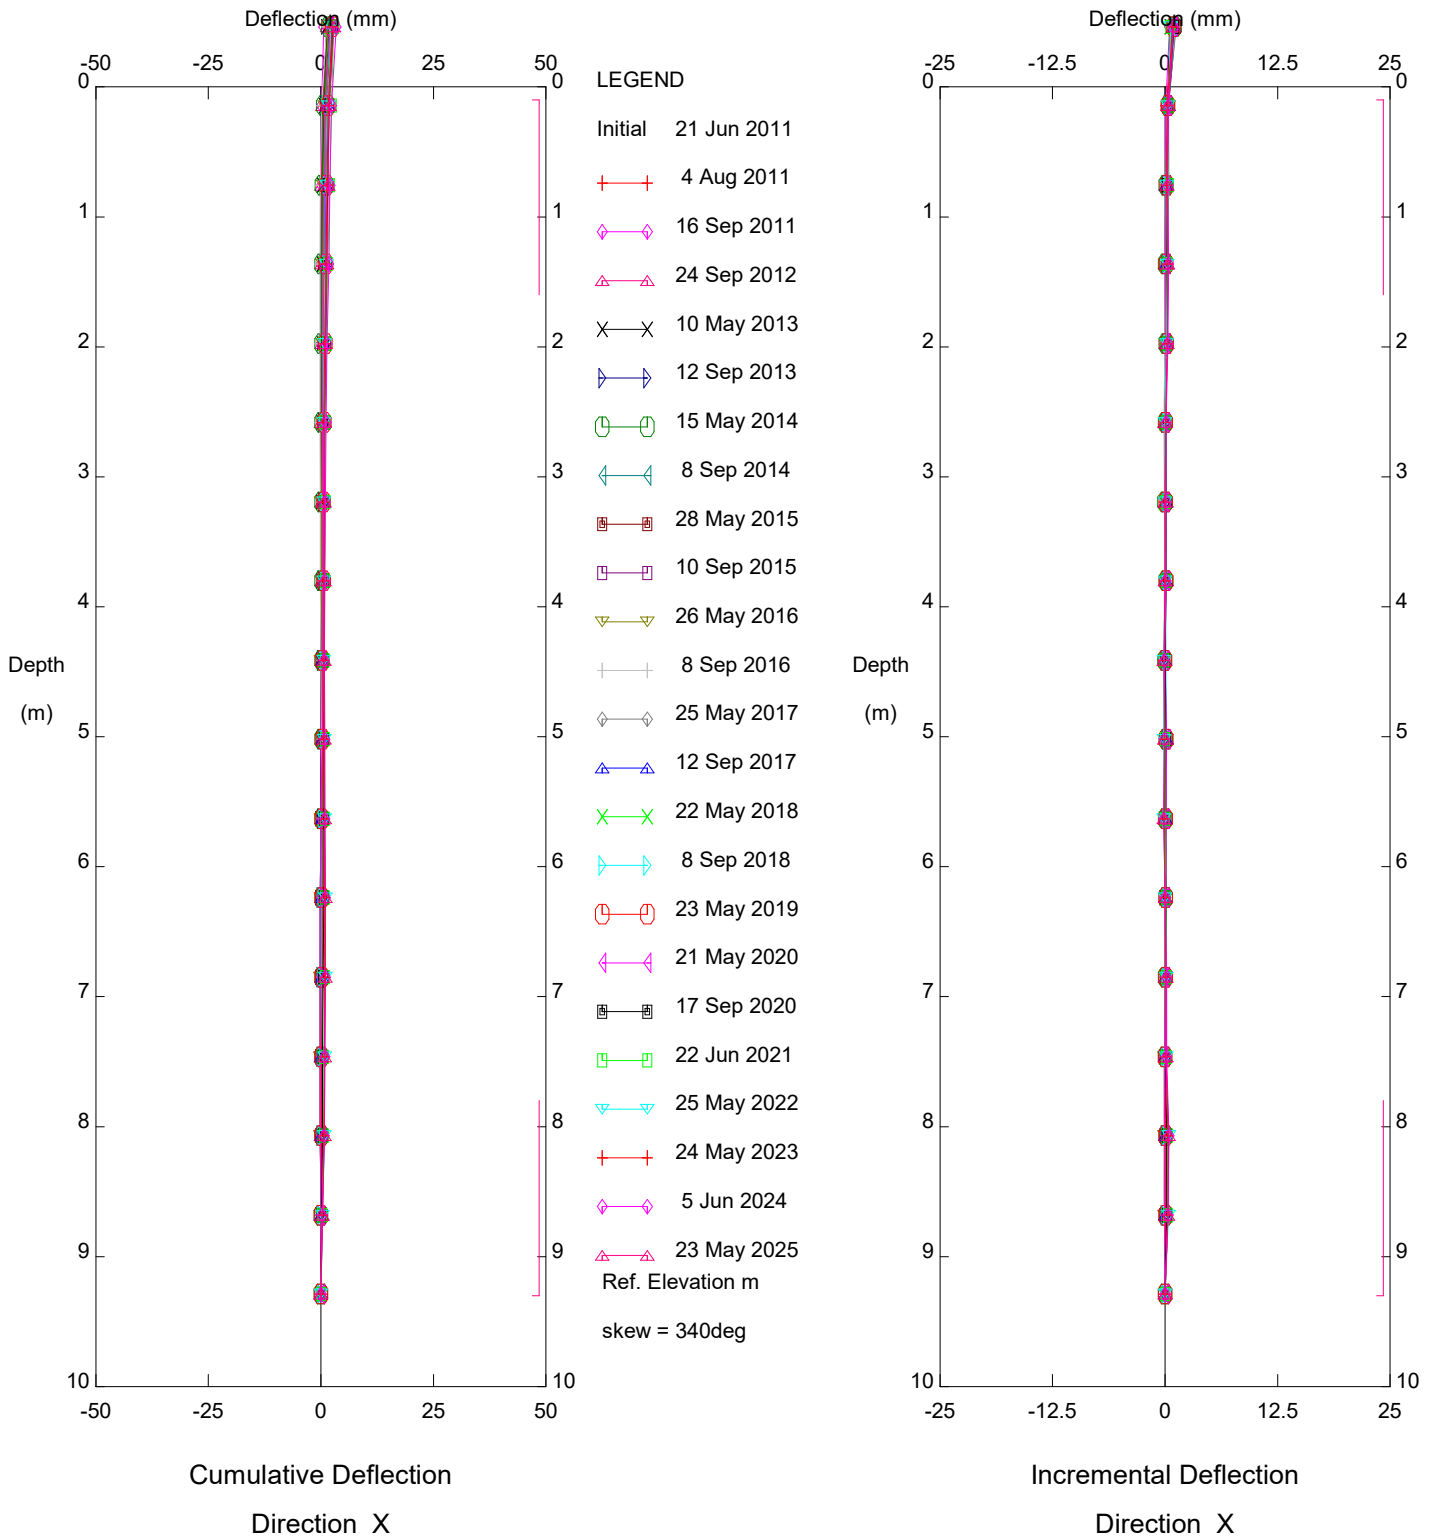
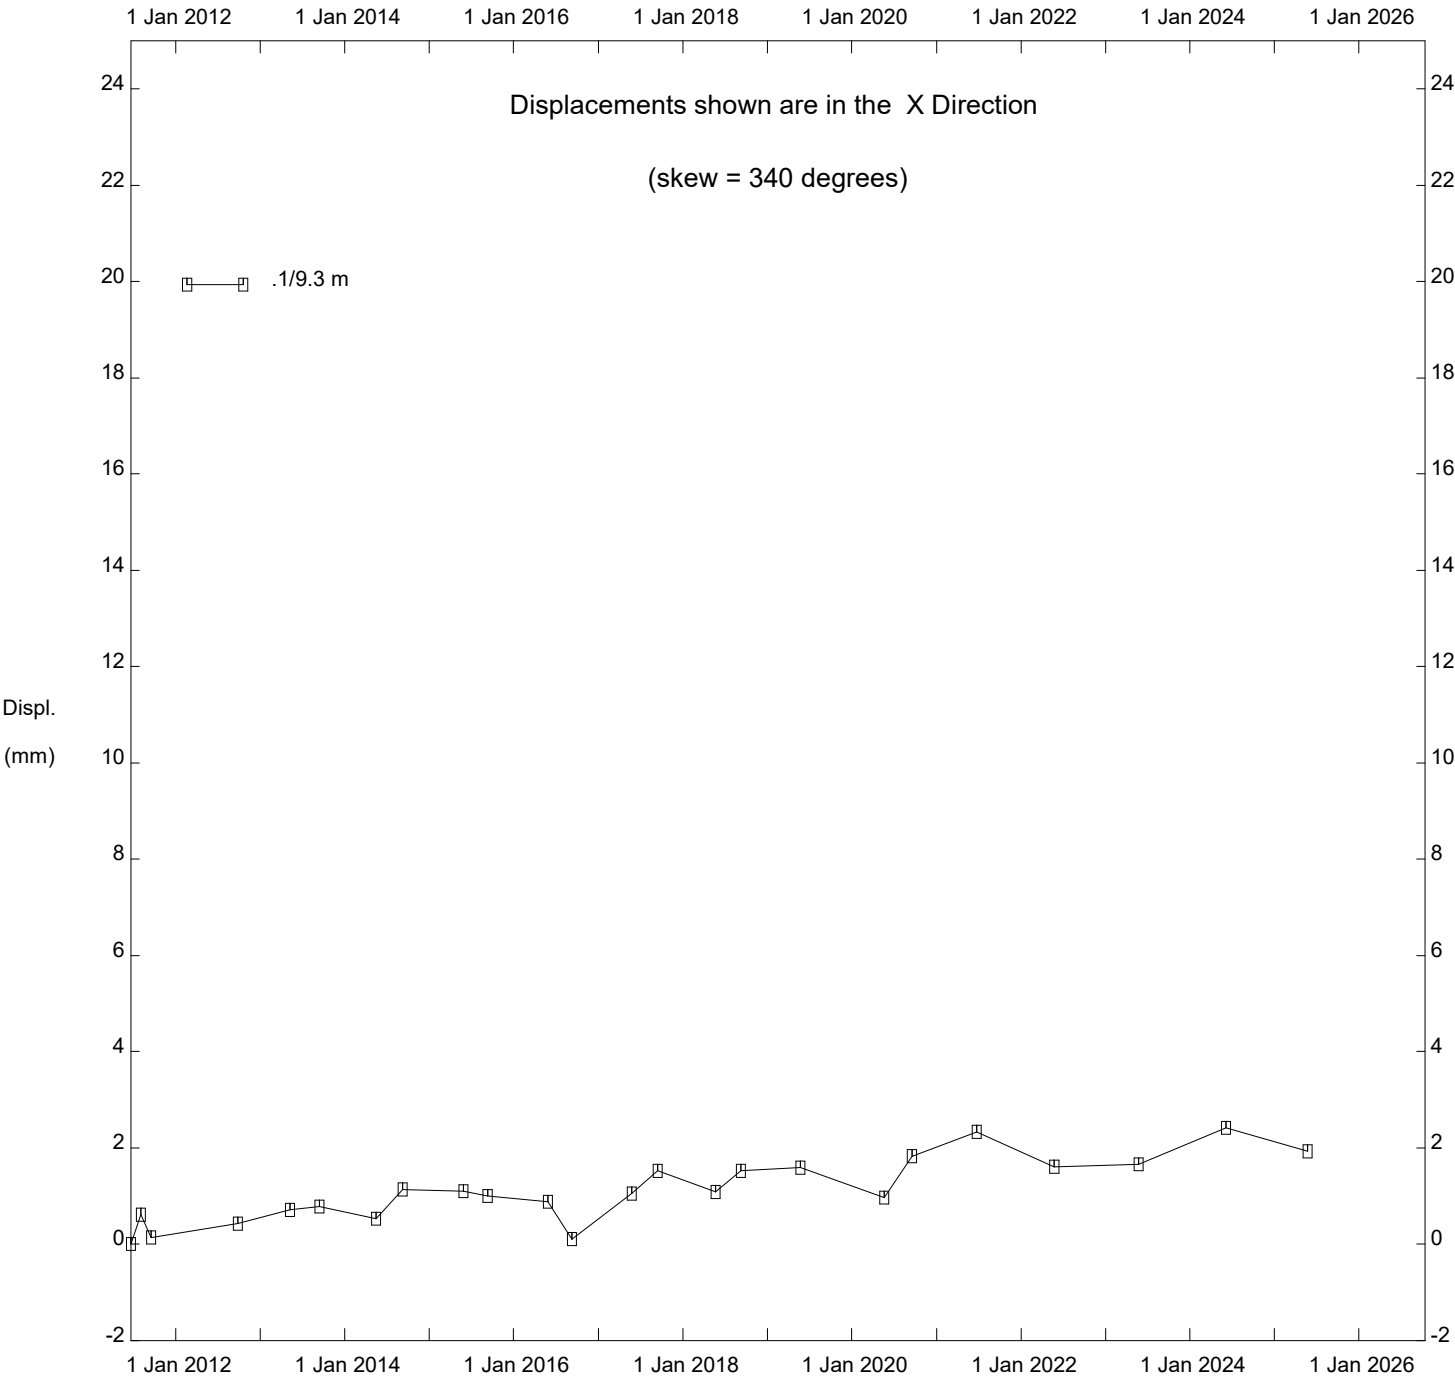
Hwy 41:23 Kehiwin Lake (NC102), Inclinometer SI11-1 (P7)

| INSTRUMENT # | DATE INITIALIZED | TOTAL CUMULATIVE RESULTANT MOVEMENT AND DEPTH OF MOVEMENT TO DATE (mm) | MAXIMUM RATE OF MOVEMENT (mm/yr) | CURRENT STATUS OF SI | DATE OF PREVIOUS READING | INCREMENTAL MOVEMENT SINCE PREVIOUS READING (mm) | CURRENT RATE OF MOVEMENT (mm/yr) | CHANGE IN RATE OF MOVEMENT SINCE PREVIOUS READING (mm/yr) |
|---|---|---|---|---|---|---|---|---|
| SI11-1 (P7) | June 21, 2011 | 1.9 over 0.1 m to 9.3 m depth in 275° direction | 5.1 in August 2011 | Operational | June 5, 2024 | No discernible movement | N/A | -1.2 |
