ALBERTA TRANSPORTATION AND  
ECONOMIC CORRIDORS GRMP  
NORTH CENTRAL (ATHABASCA AND FORT  
McMURRAY DISTRICTS)  
INSTRUMENTATION MONITORING- SPRING 2025

| Site Number | Location | Name | Hwy | km |
|---|---|---|---|---|
| NC102<br>(NC024-2) | HWY 41:23 C1 8.88 | Kehiwin Lake | 41:23 | Km 8.8 |

**ALBERTA TRANSPORTATION AND ECONOMIC CORRIDORS GRMP (CON0022163)  
NORTH CENTRAL (ATHABASCA AND FORT McMURRAY DISTRICTS)  
INSTRUMENTATION MONITORING RESULTS**

**SITE NC102 (NC024-2): HWY 41:23 KEHIWIN LAKE (km 8.8)**

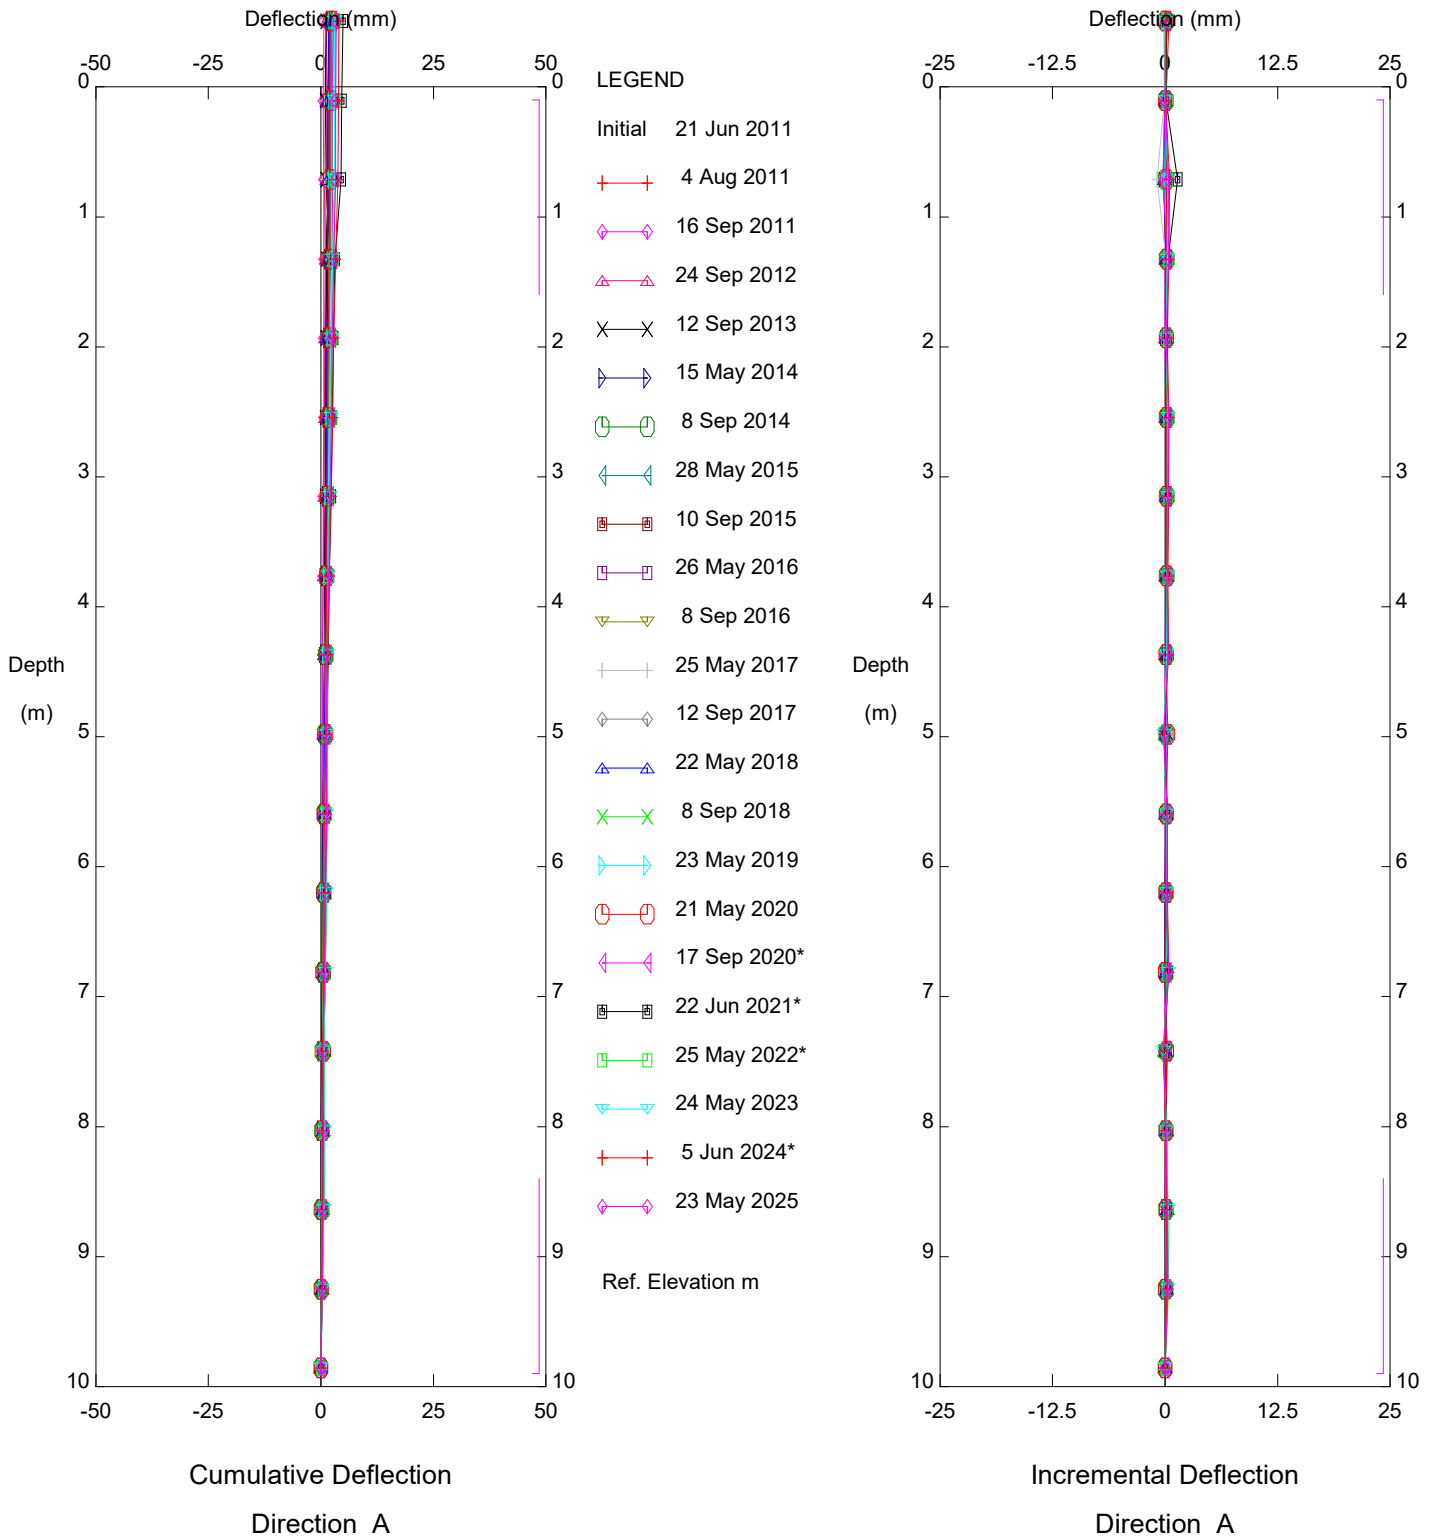
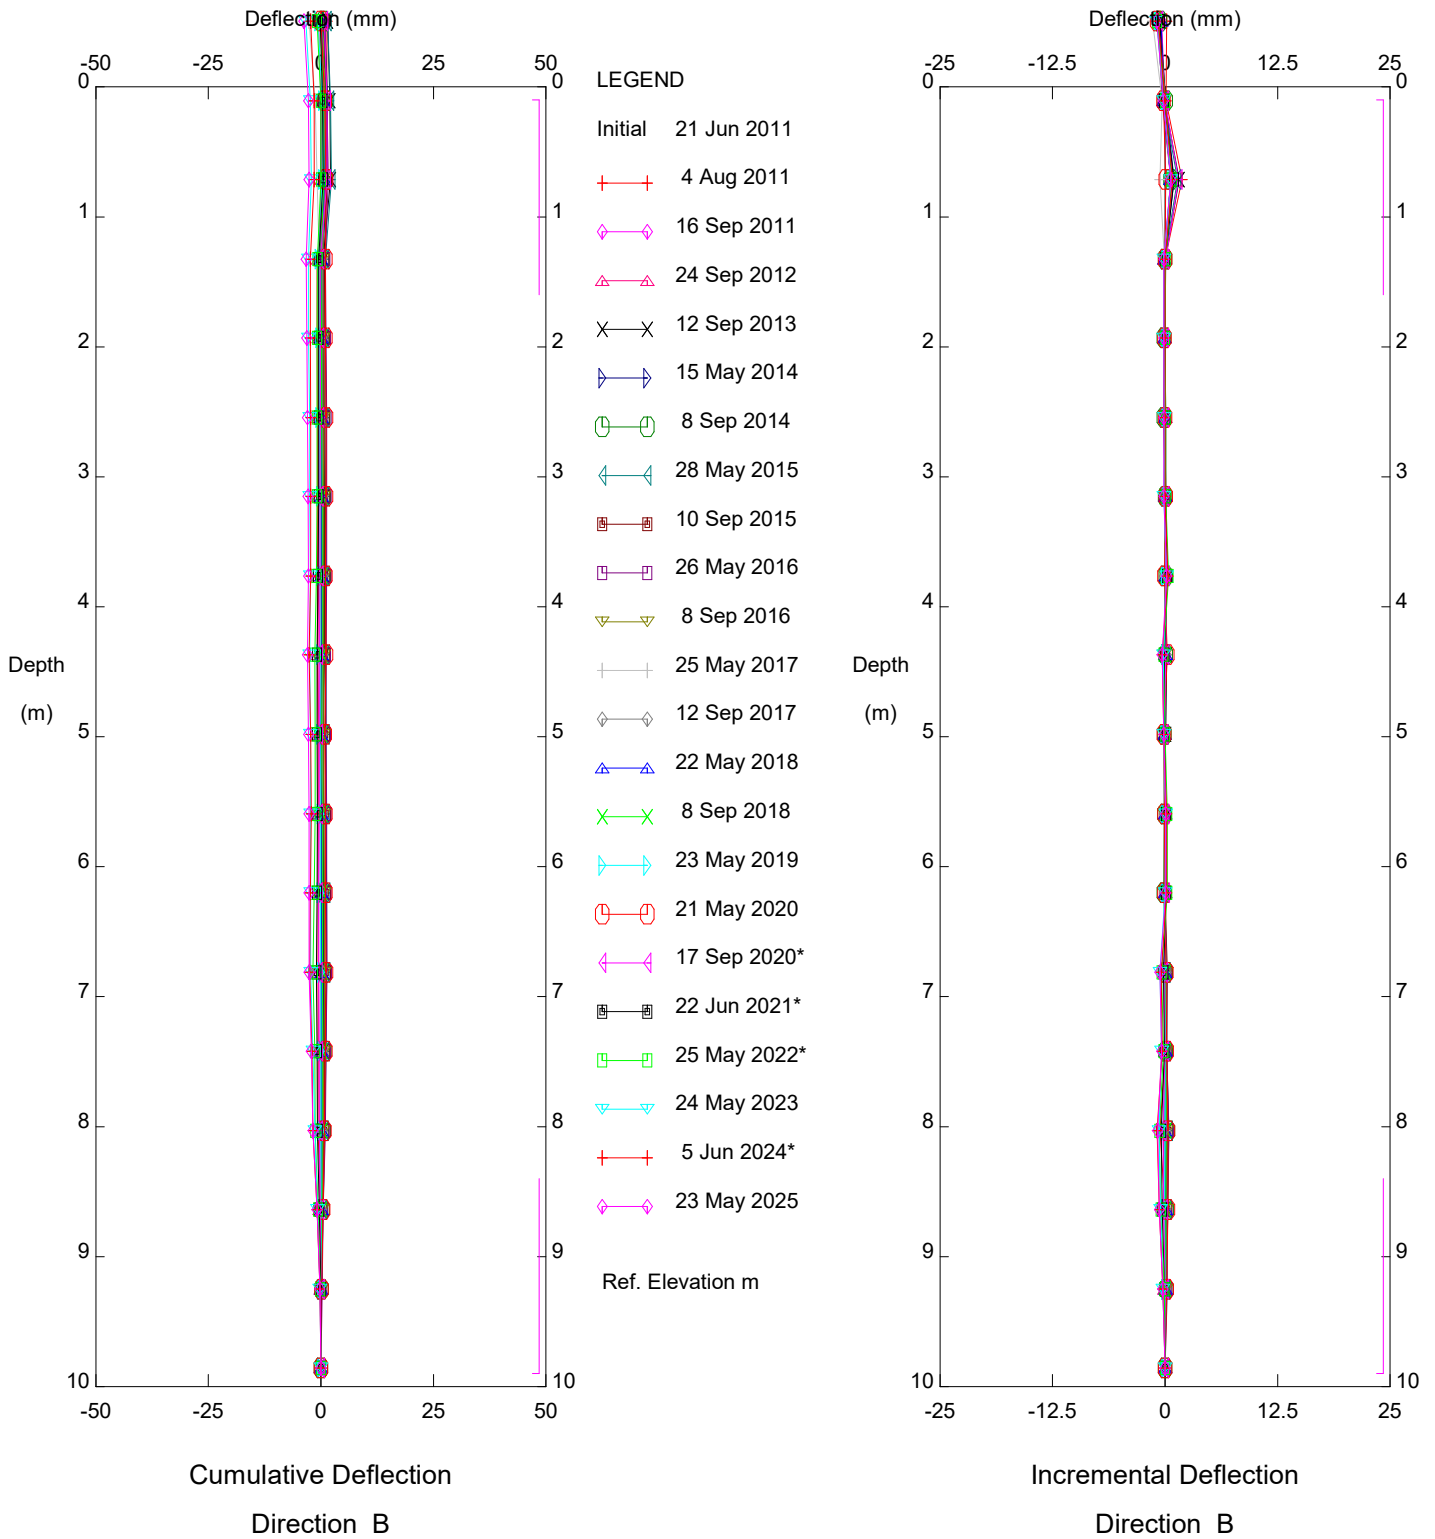
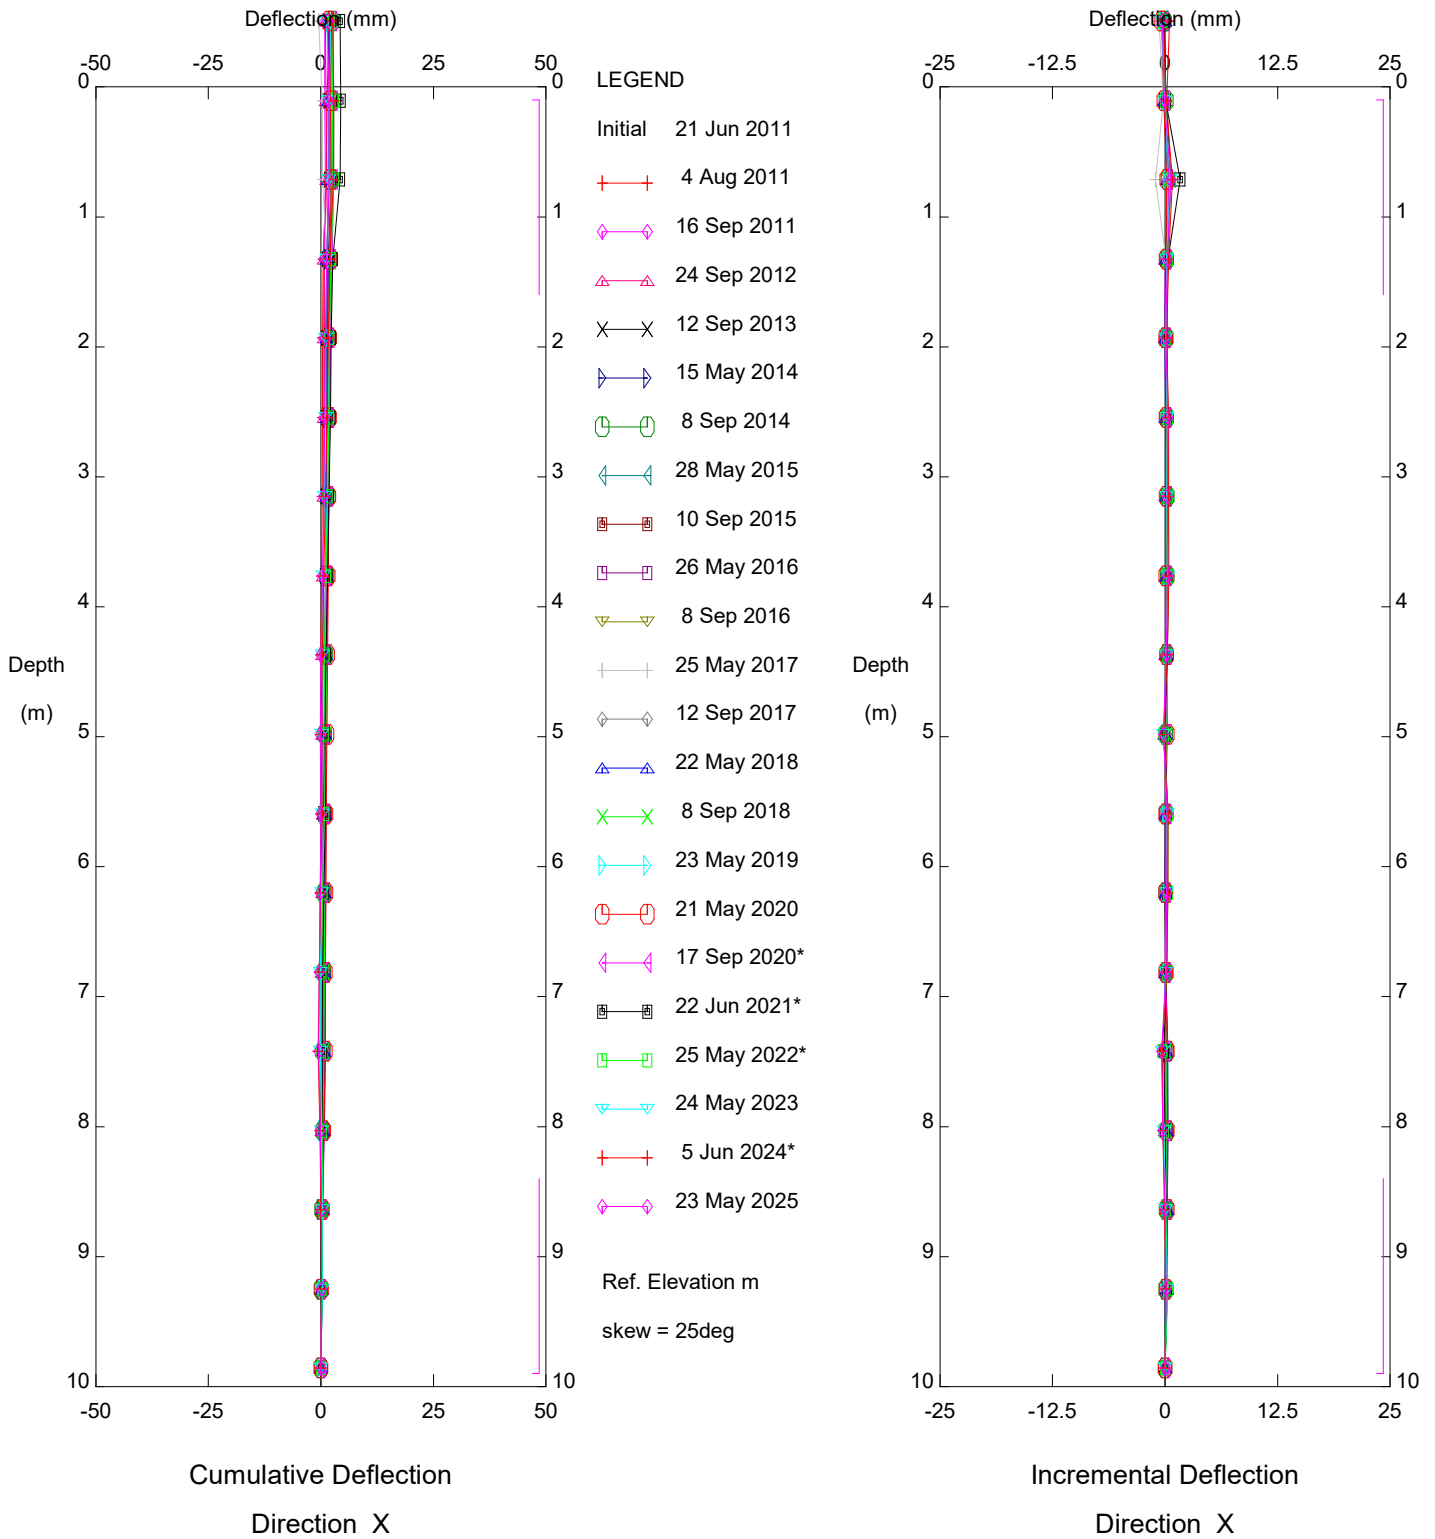
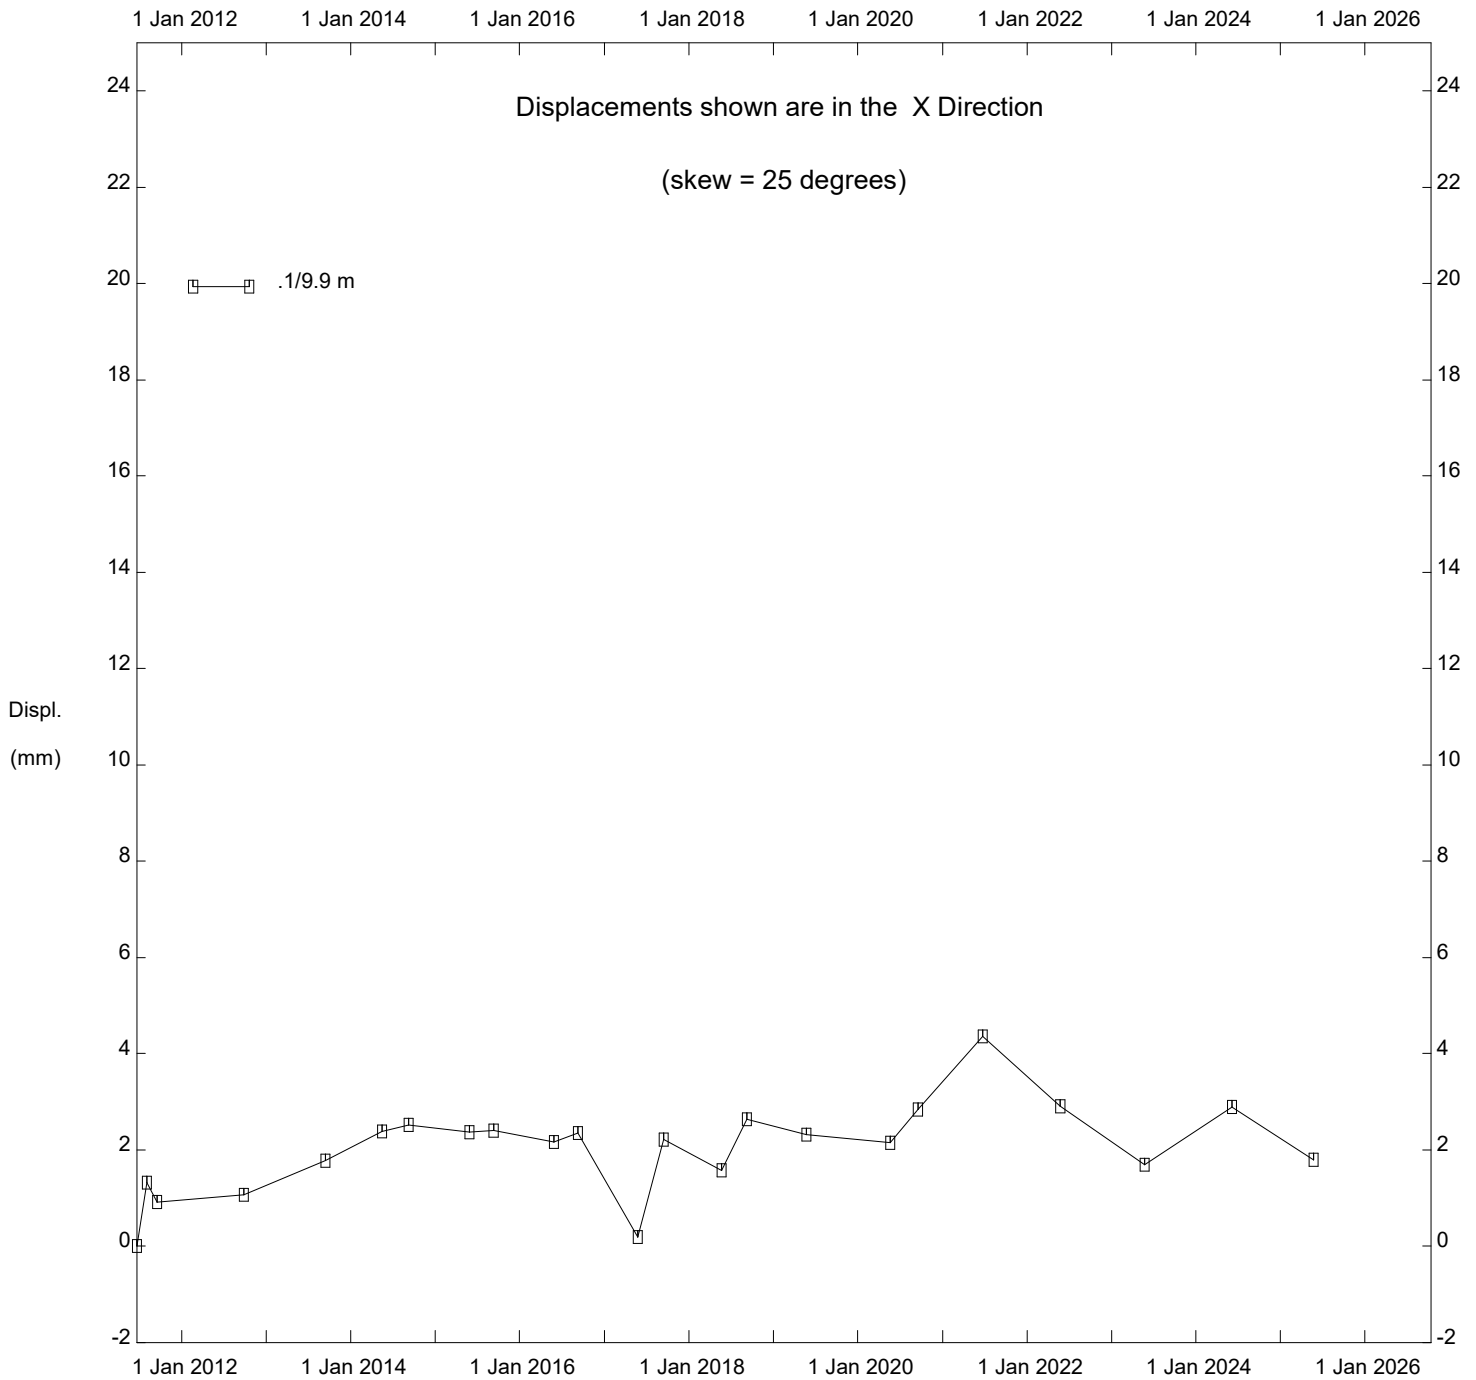
Hwy 41:23 Kehiwin Lake (NC102), Inclinometer SI11-2 (P16)

| INSTRUMENT # | DATE INITIALIZED | TOTAL CUMULATIVE RESULTANT MOVEMENT AND DEPTH OF MOVEMENT TO DATE (mm) | MAXIMUM RATE OF MOVEMENT (mm/yr) | CURRENT STATUS OF SI | DATE OF PREVIOUS READING | INCREMENTAL MOVEMENT SINCE PREVIOUS READING (mm) | CURRENT RATE OF MOVEMENT (mm/yr) | CHANGE IN RATE OF MOVEMENT SINCE PREVIOUS READING (mm/yr) |
|---|---|---|---|---|---|---|---|---|
| SI11-2 (P16) | June 21, 2011 | 1.8 over 0.1 m to 9.9 m depth in 346° direction | 11.0 in August 2011 | Operational | June 5, 2024 | No discernible movement | N/A | -2.3 |

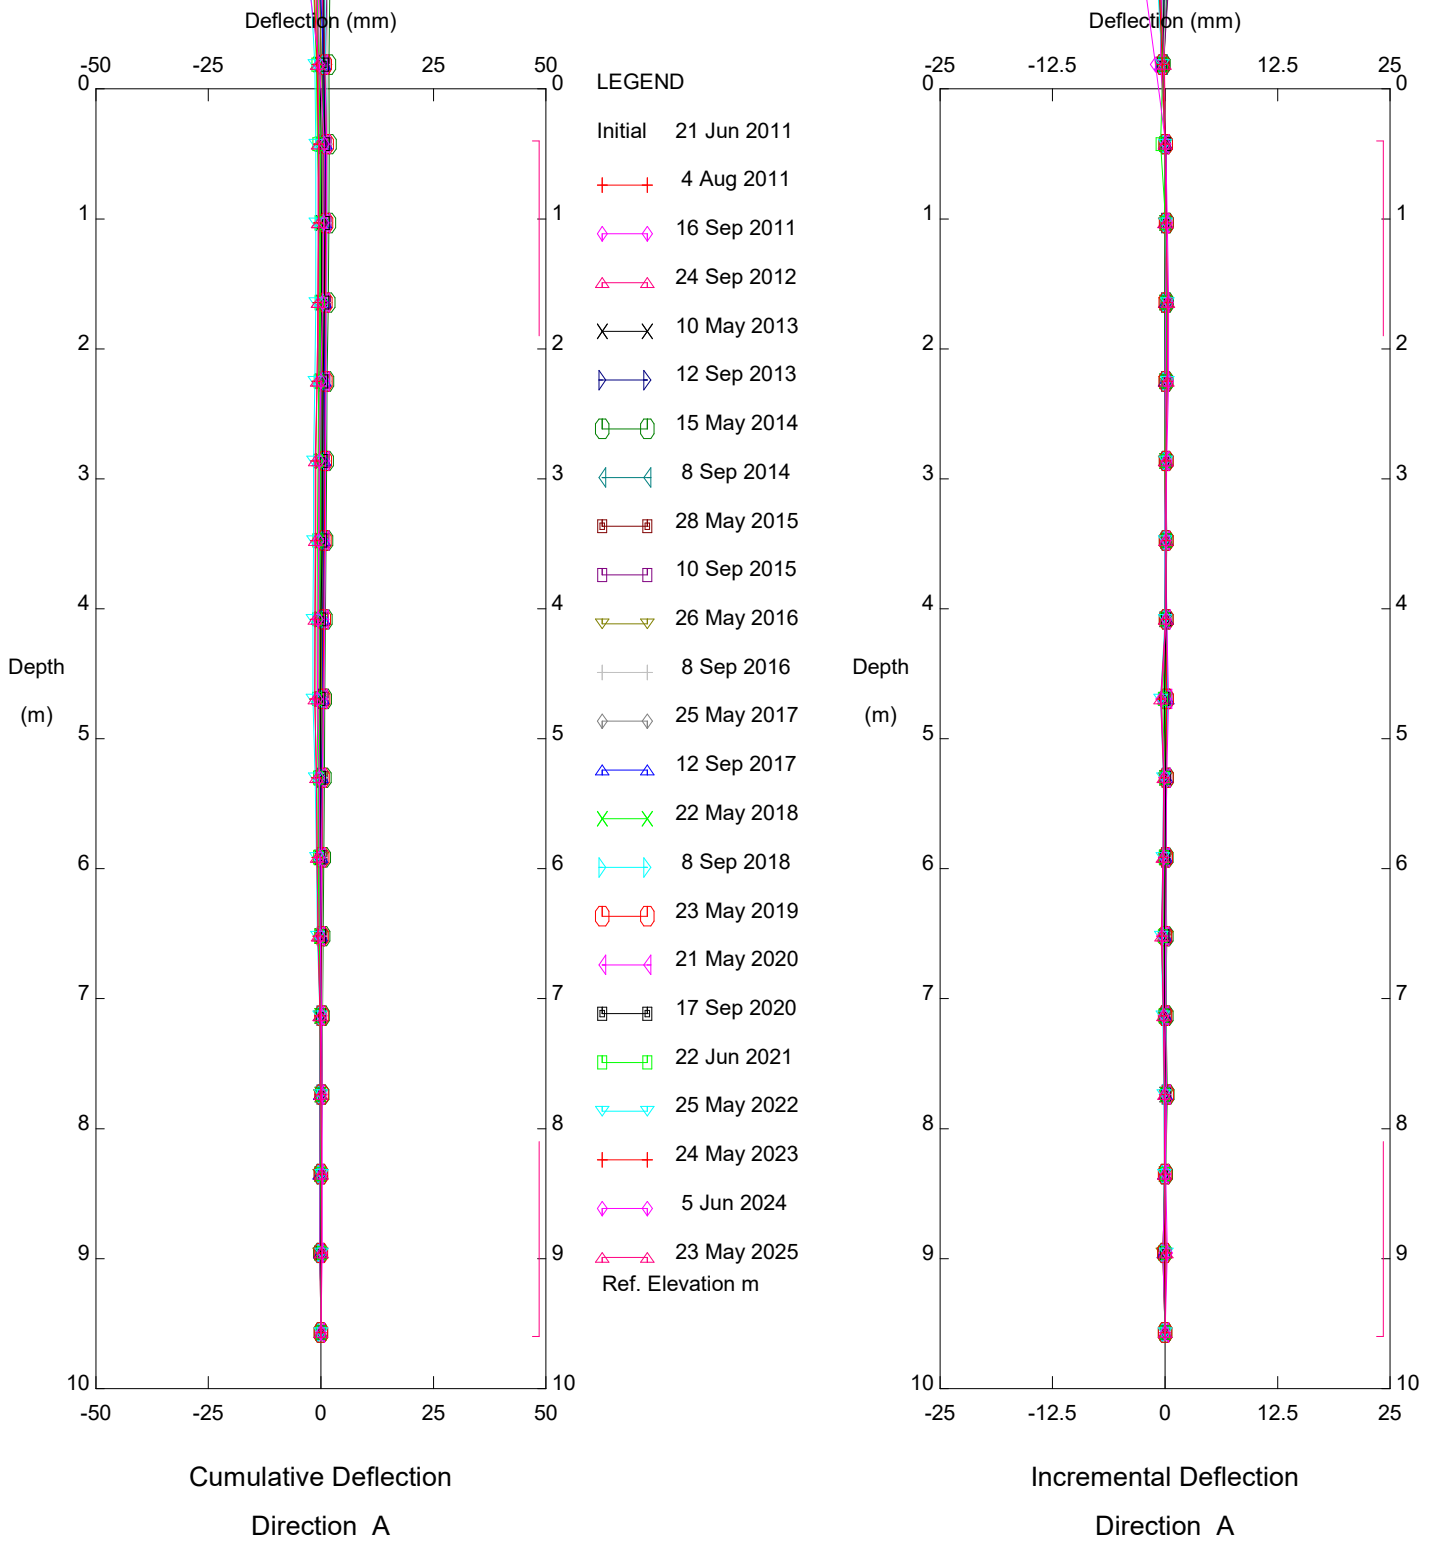
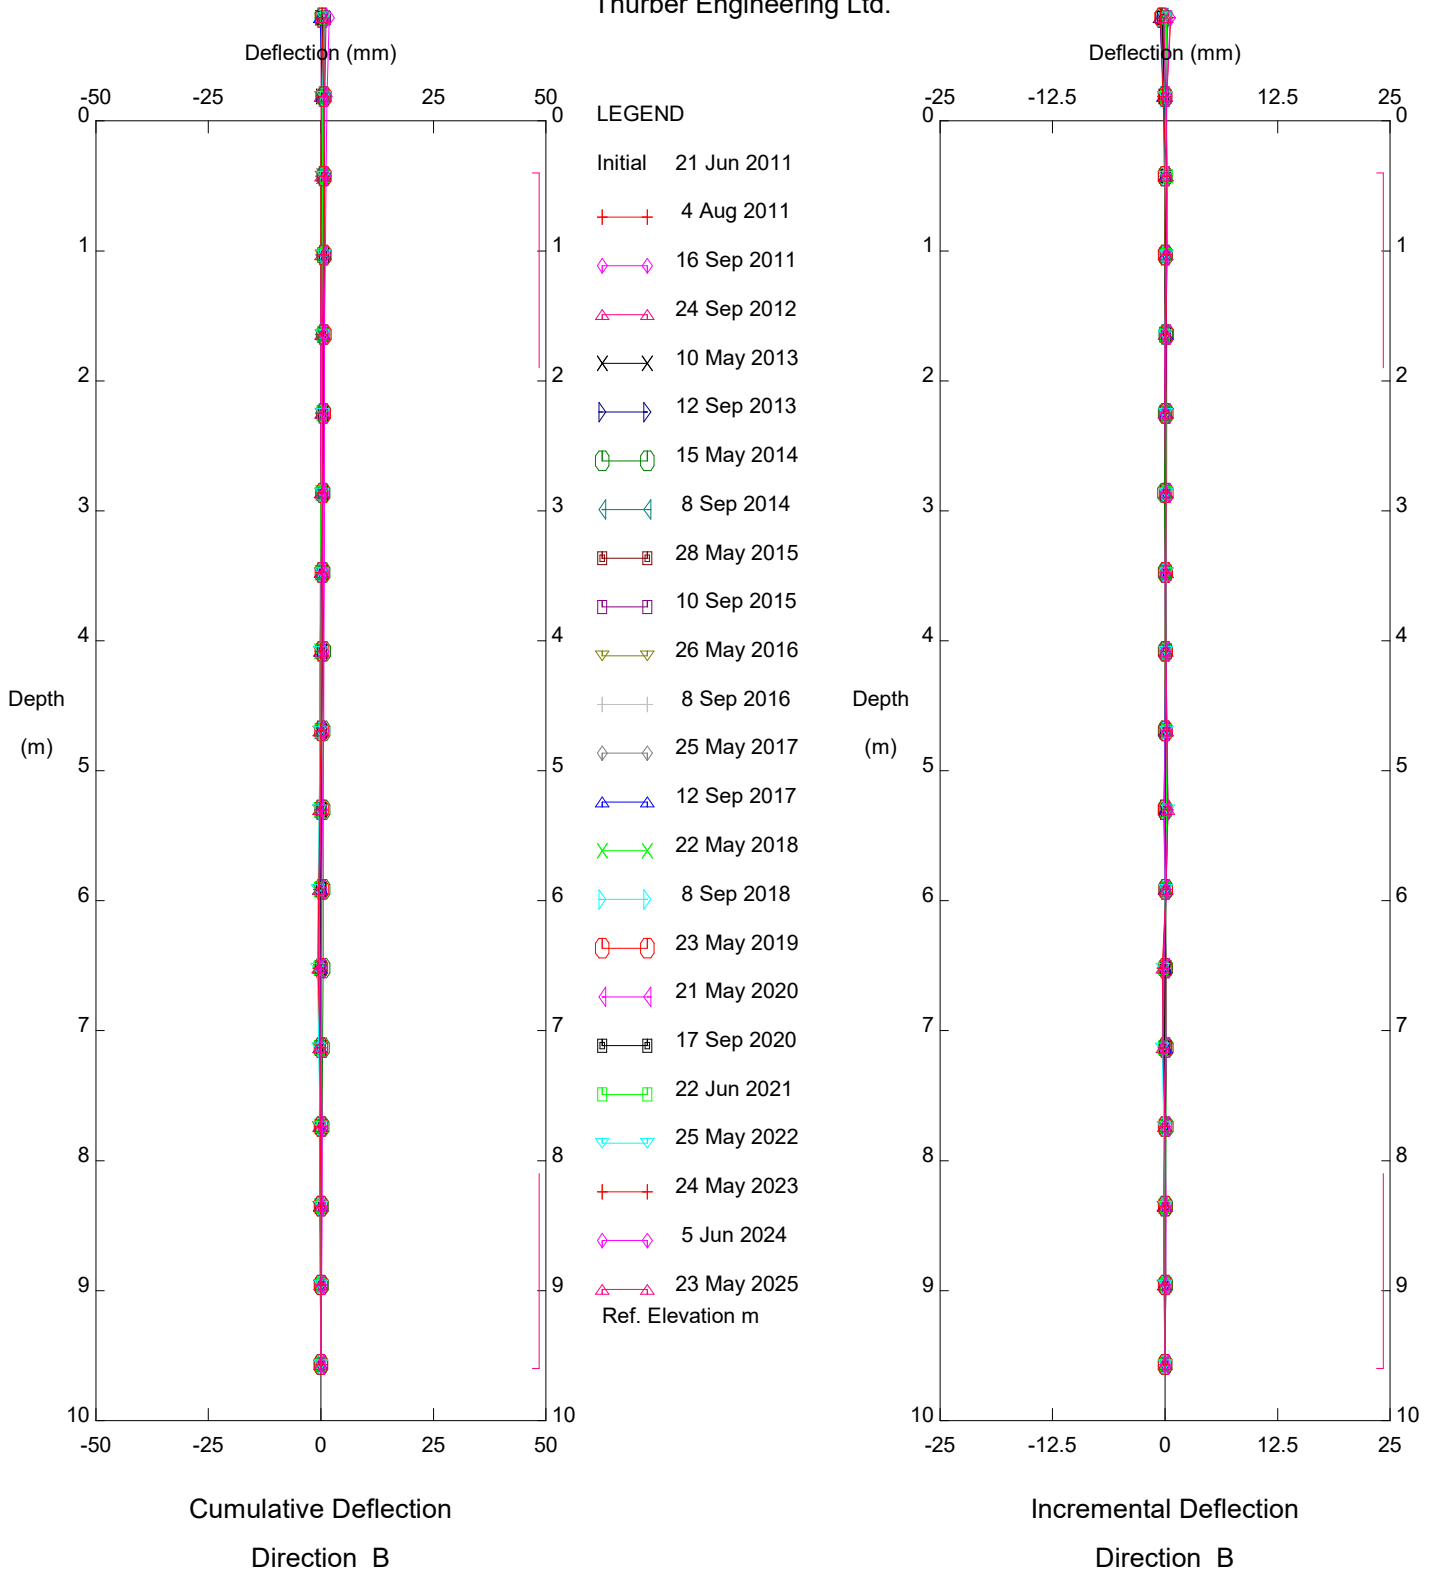
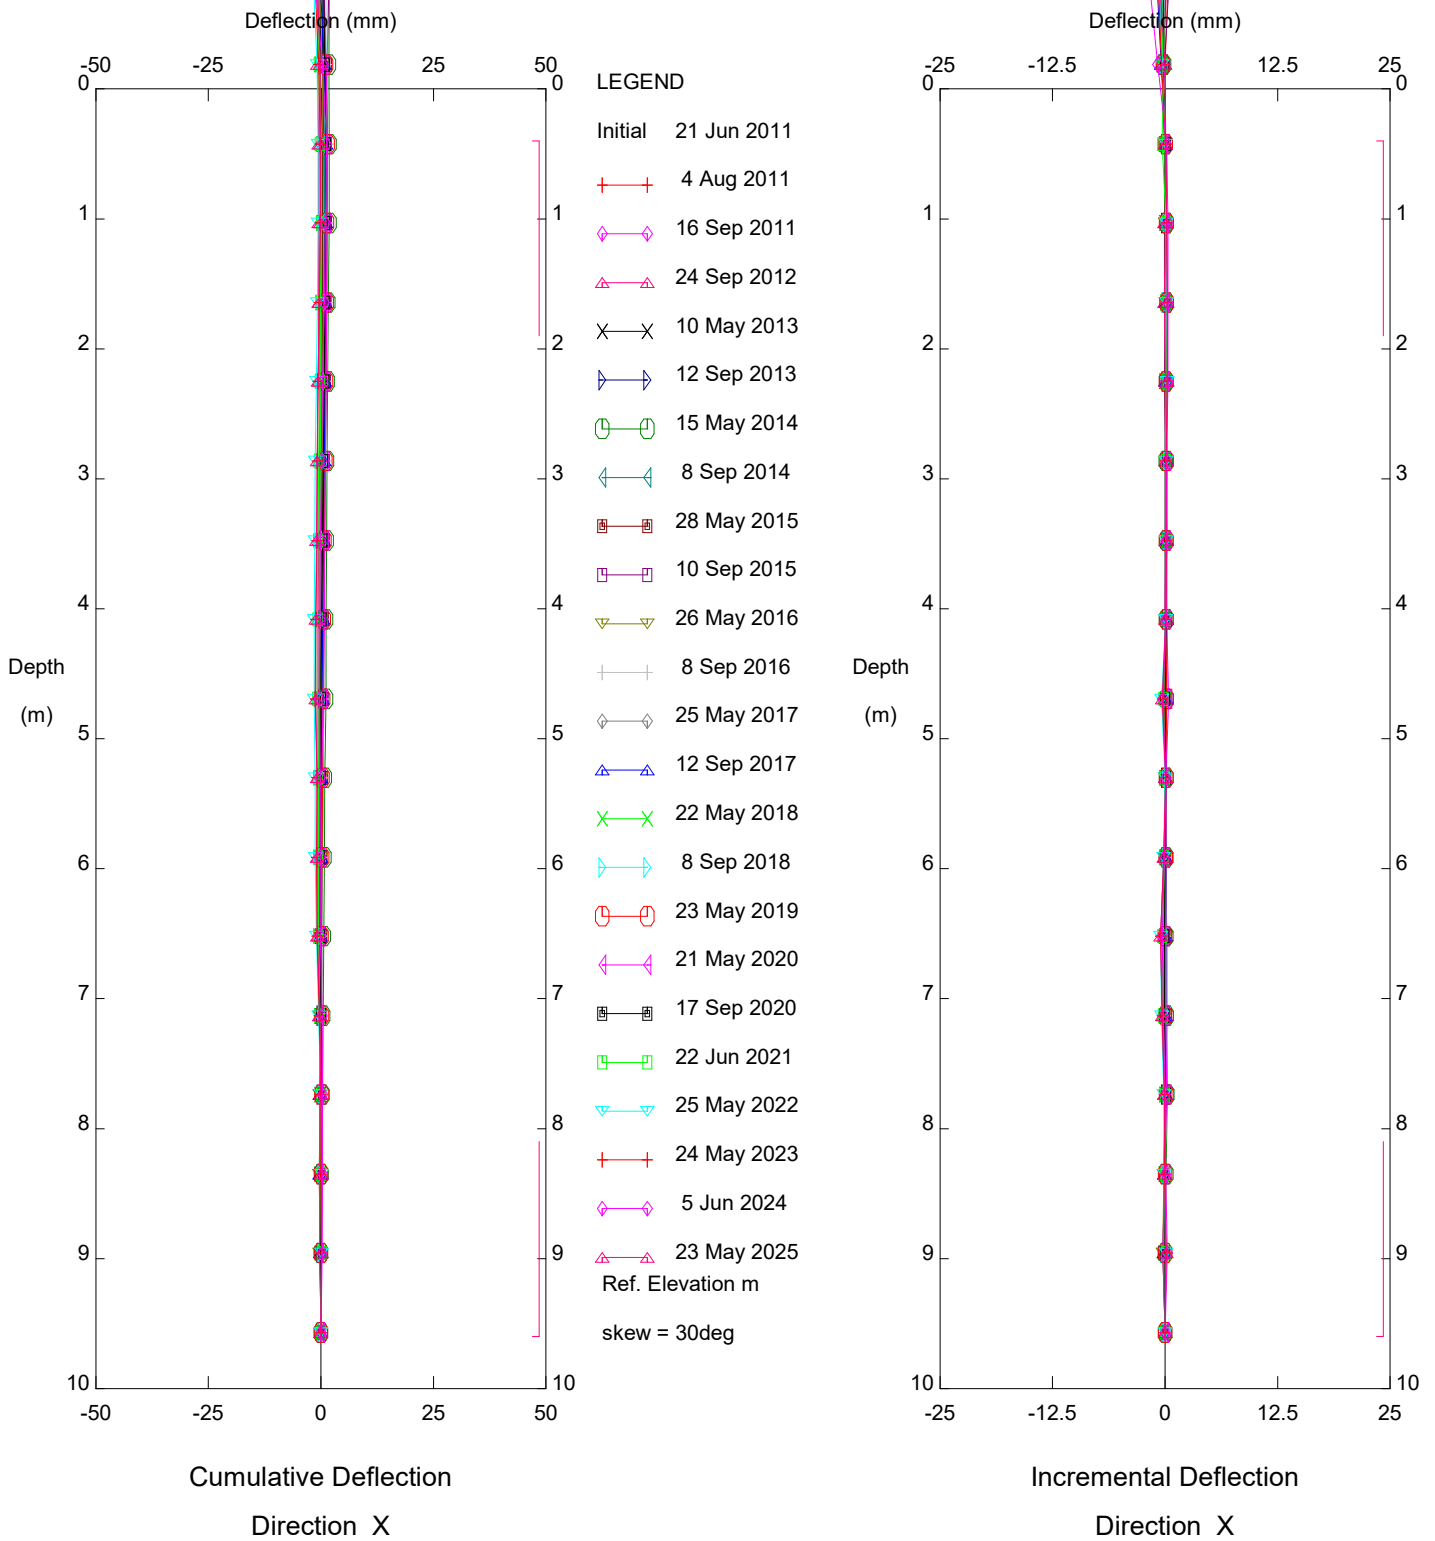
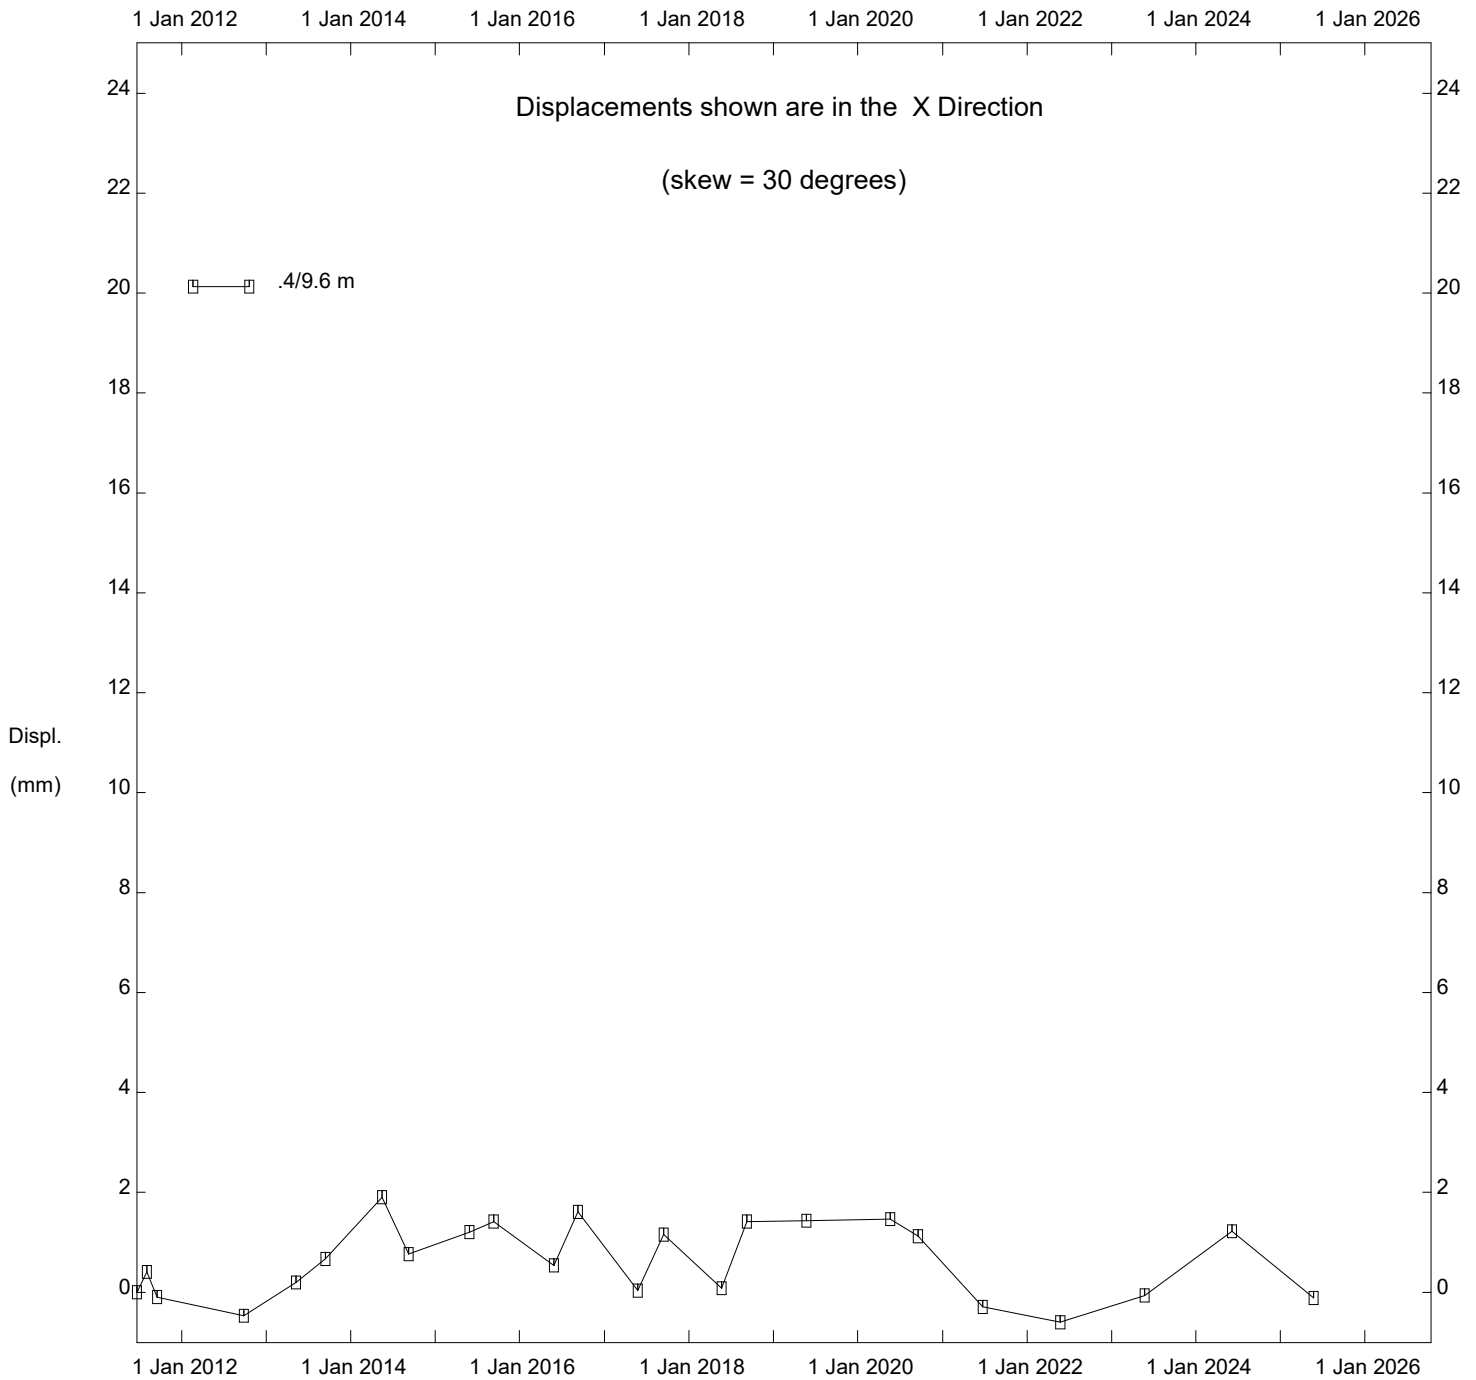
Hwy 41:23 Kehiwin Lake (NC102), Inclinometer SI11-3 (P24)

| INSTRUMENT # | DATE INITIALIZED | TOTAL CUMULATIVE RESULTANT MOVEMENT AND DEPTH OF MOVEMENT TO DATE (mm) | MAXIMUM RATE OF MOVEMENT (mm/yr) | CURRENT STATUS OF SI | DATE OF PREVIOUS READING | INCREMENTAL MOVEMENT SINCE PREVIOUS READING (mm) | CURRENT RATE OF MOVEMENT (mm/yr) | CHANGE IN RATE OF MOVEMENT SINCE PREVIOUS READING (mm/yr) |
|---|---|---|---|---|---|---|---|---|
| SI11-3 (P24) | June 21, 2011 | -0.1 over 0.4 m to 9.6 m depth in 358° direction | 4.5 in September 2018 | Operational | June 5, 2024 | No discernible movement | N/A | -2.6 |

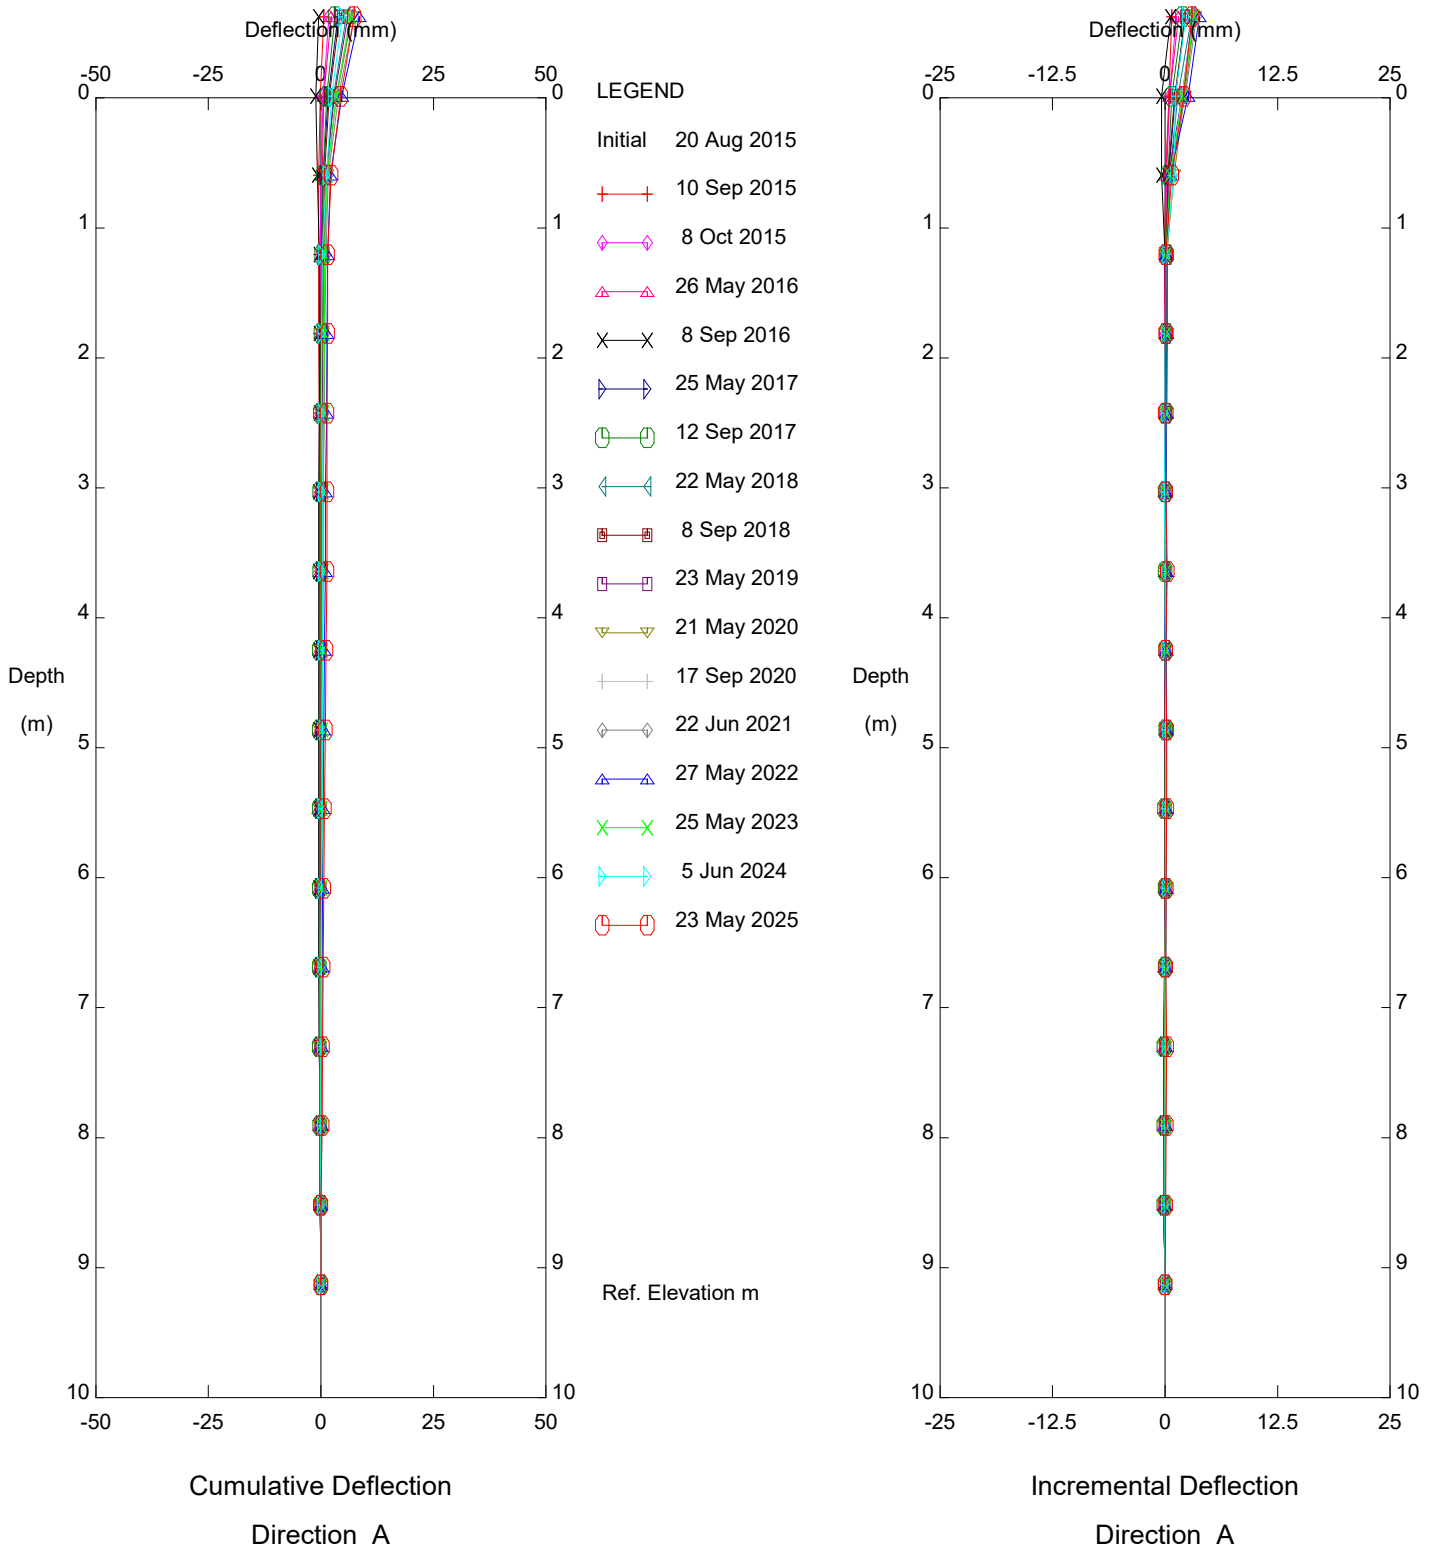
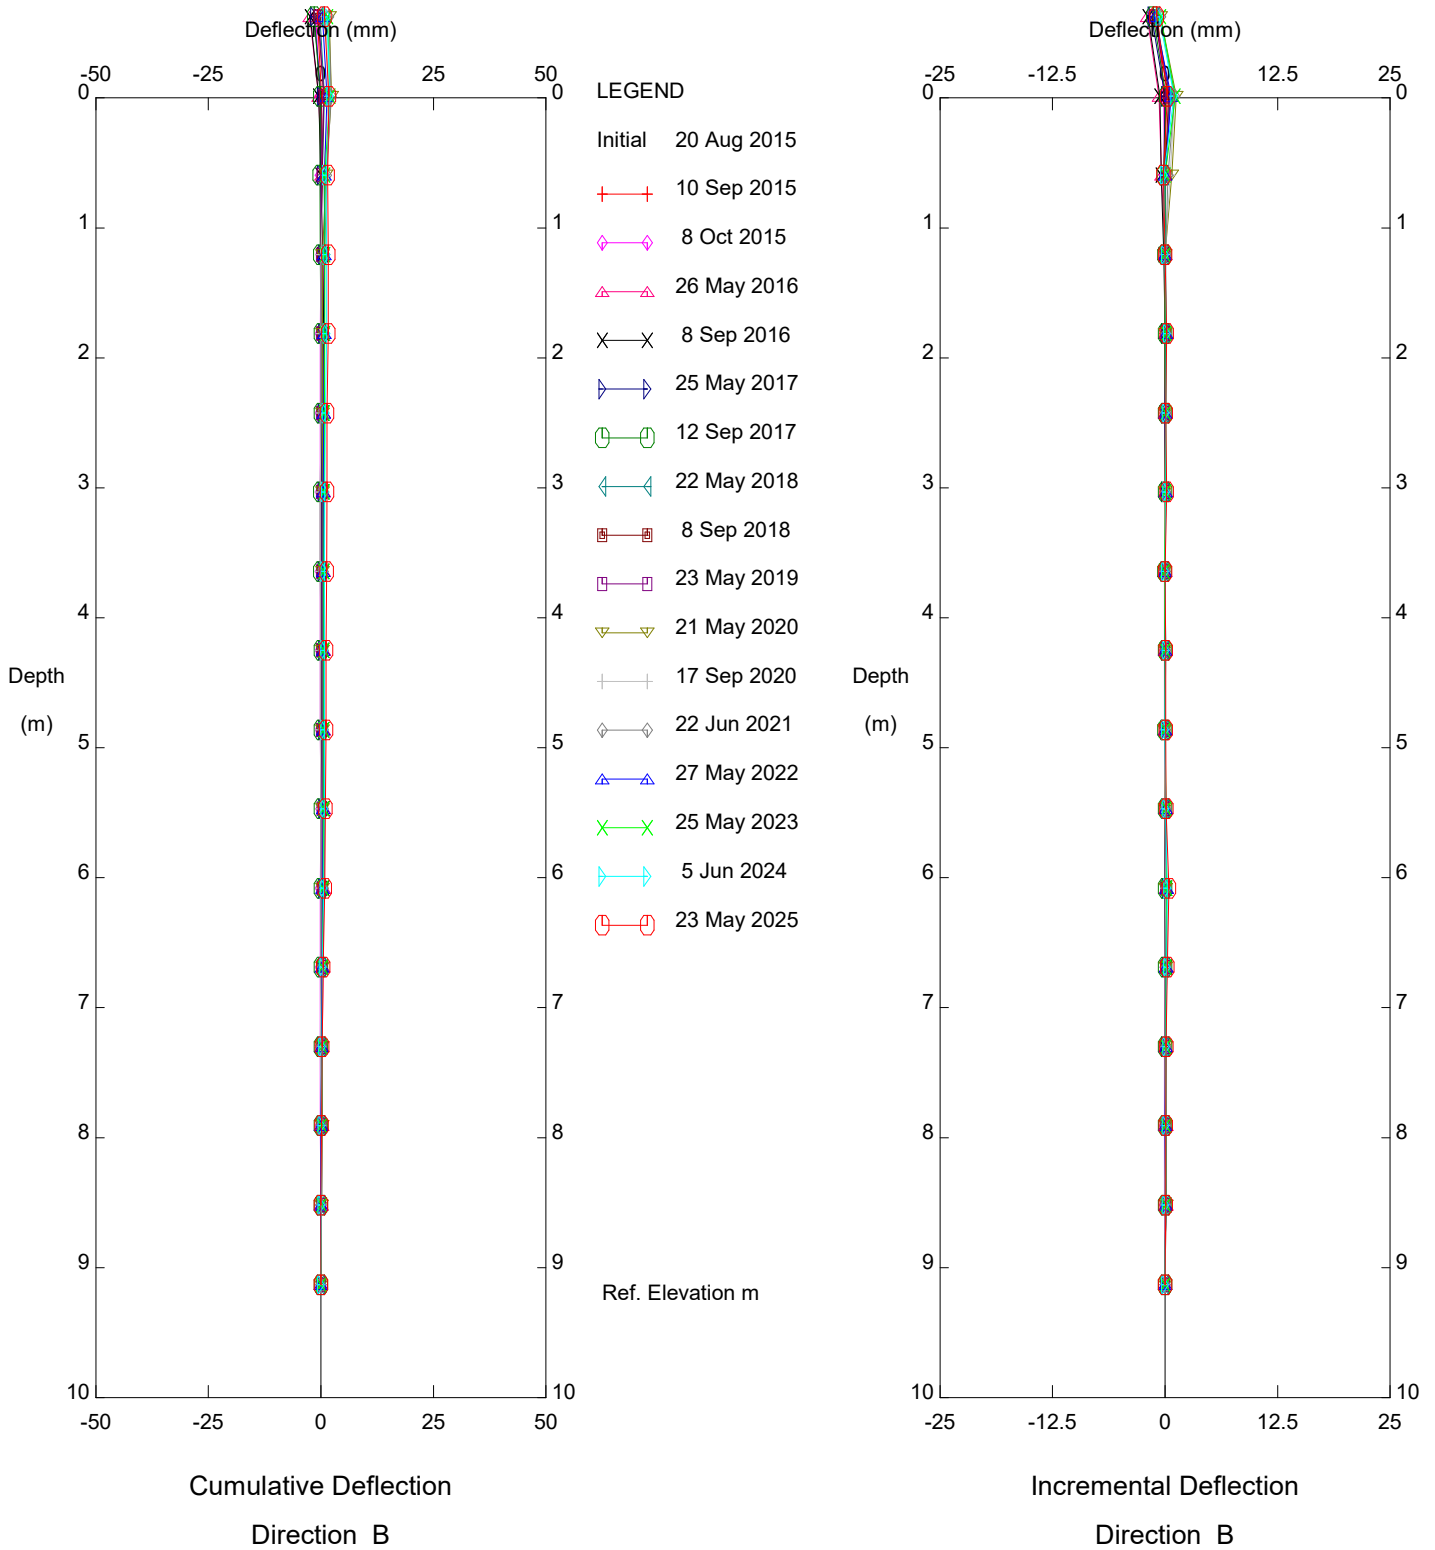
Hwy 41:23 Kehiwin Lake (NC102), Inclinometer SI15-1

| | <p>Slope inclinometer SI15-1, installed in the highway east ditch upslope of the NC24D pile wall, has shown no discernible movement since initialization. SI15-2, installed immediately downslope of the NC24D pile wall, showed a rate of movement of 0.3 mm/yr over 3.0 m to 4.8 m depth since the spring of 2024 readings. SI15-4, installed near the west edge of the highway to the south of the NC24D pile wall, showed a rate of movement of 0.4 mm/yr over 1.6 m to 3.4 m depth and a rate of movement of 0.5 mm/yr over 3.4 m to 4.7 m depth since the spring of 2024.</p> <p>SI16-1, installed in the 2016 pile wall (NC24D), showed no discernible movement over the length of the pile from 0.0 m to 12.2 m depth since the spring of 2024 readings. SI16-1 has shown a total pile head movement of 4.3 mm to date. SI16-2, also installed in the 2016 pile wall, showed a rate of movement of less than 1 mm/yr over the length of the pile from 0.0 m to 12.2 m depth since the spring of 2024 readings. SI16-2 has shown a total pile head movement of 4.3 mm to date.</p> <p>Pneumatic piezometers PN10-1, PN10-3, PN10-6, and PN15-4 showed decreases in groundwater level of 0.09 m, 0.09 m, 0.15 m, and 0.03 m, respectively, since the spring of 2024 readings. PN10-5, PN15-1, PN15-2, and PN15-3 showed increases in groundwater levels of 0.05 m, 0.06 m, 0.16 m, and 0.15 m, respectively, since the spring of 2024 readings.</p> <p>Standpipe piezometer PB10-1 showed an increase in groundwater level of 0.72 m since the spring of 2024 readings. Standpipe piezometer PB10-4 showed a decrease in groundwater level of 0.05 m since the spring of 2024 readings.</p> <p>In general, the pile walls appear to have performed well since the completion of construction.</p> |

| INSTRUMENT # | DATE INITIALIZED | TOTAL CUMULATIVE RESULTANT MOVEMENT AND DEPTH OF MOVEMENT TO DATE (mm) | MAXIMUM RATE OF MOVEMENT (mm/yr) | CURRENT STATUS OF SI | DATE OF PREVIOUS READING | INCREMENTAL MOVEMENT SINCE PREVIOUS READING (mm) | CURRENT RATE OF MOVEMENT (mm/yr) | CHANGE IN RATE OF MOVEMENT SINCE PREVIOUS READING (mm/yr) |
|---|---|---|---|---|---|---|---|---|
| SI15-1 | August 20, 2015 | No discernible movement | No discernible movement | Operational | June 5, 2024 | N/A | N/A | N/A |
