ALBERTA TRANSPORTATION AND  
ECONOMIC CORRIDORS GRMP  
NORTH CENTRAL (ATHABASCA AND FORT  
McMURRAY DISTRICTS)  
INSTRUMENTATION MONITORING- SPRING 2025

| Site Number | Location | Name | Hwy | km |
|---|---|---|---|---|
| NC102<br>(NC024-2) | HWY 41:23 C1 8.88 | Kehiwin Lake | 41:23 | Km 8.8 |

**ALBERTA TRANSPORTATION AND ECONOMIC CORRIDORS GRMP (CON0022163)  
NORTH CENTRAL (ATHABASCA AND FORT McMURRAY DISTRICTS)  
INSTRUMENTATION MONITORING RESULTS**

**SITE NC102 (NC024-2): HWY 41:23 KEHIWIN LAKE (km 8.8)**

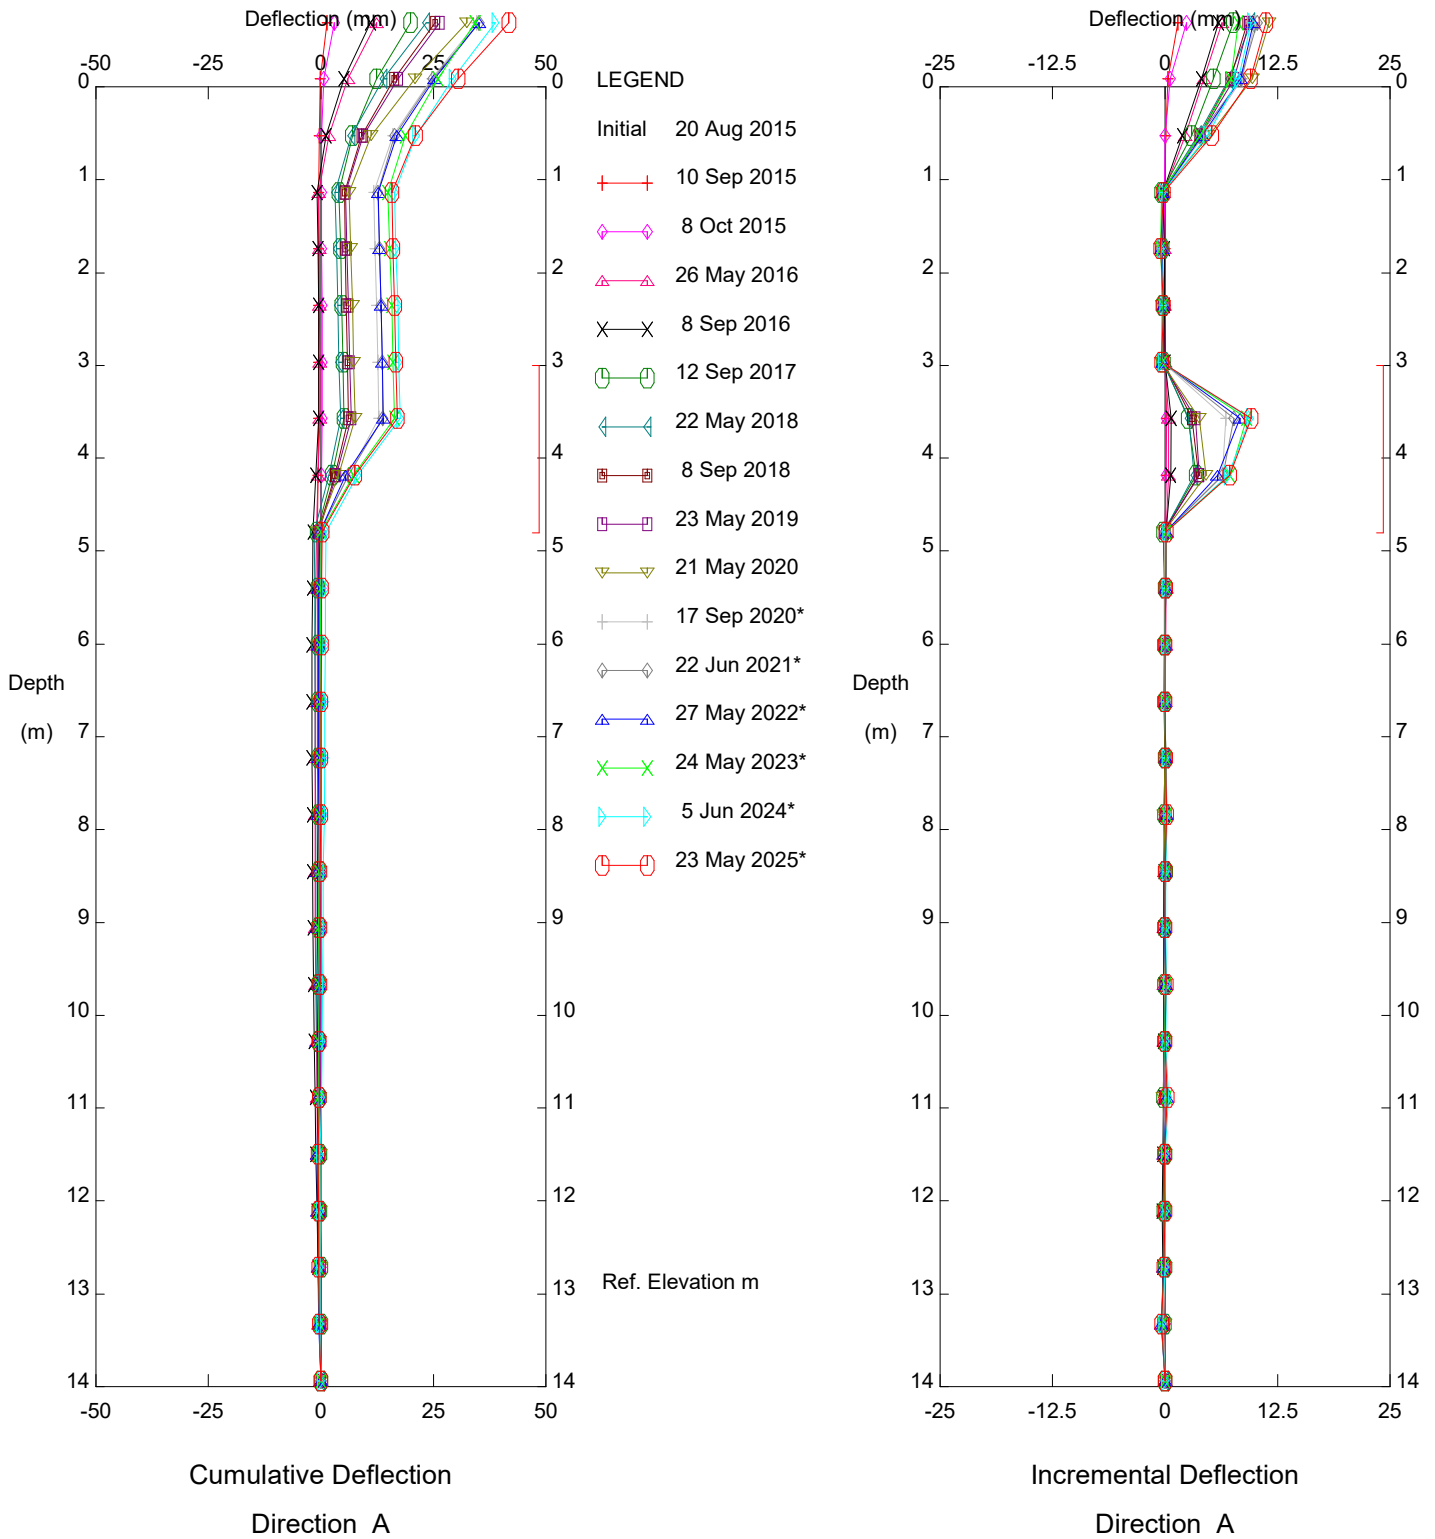
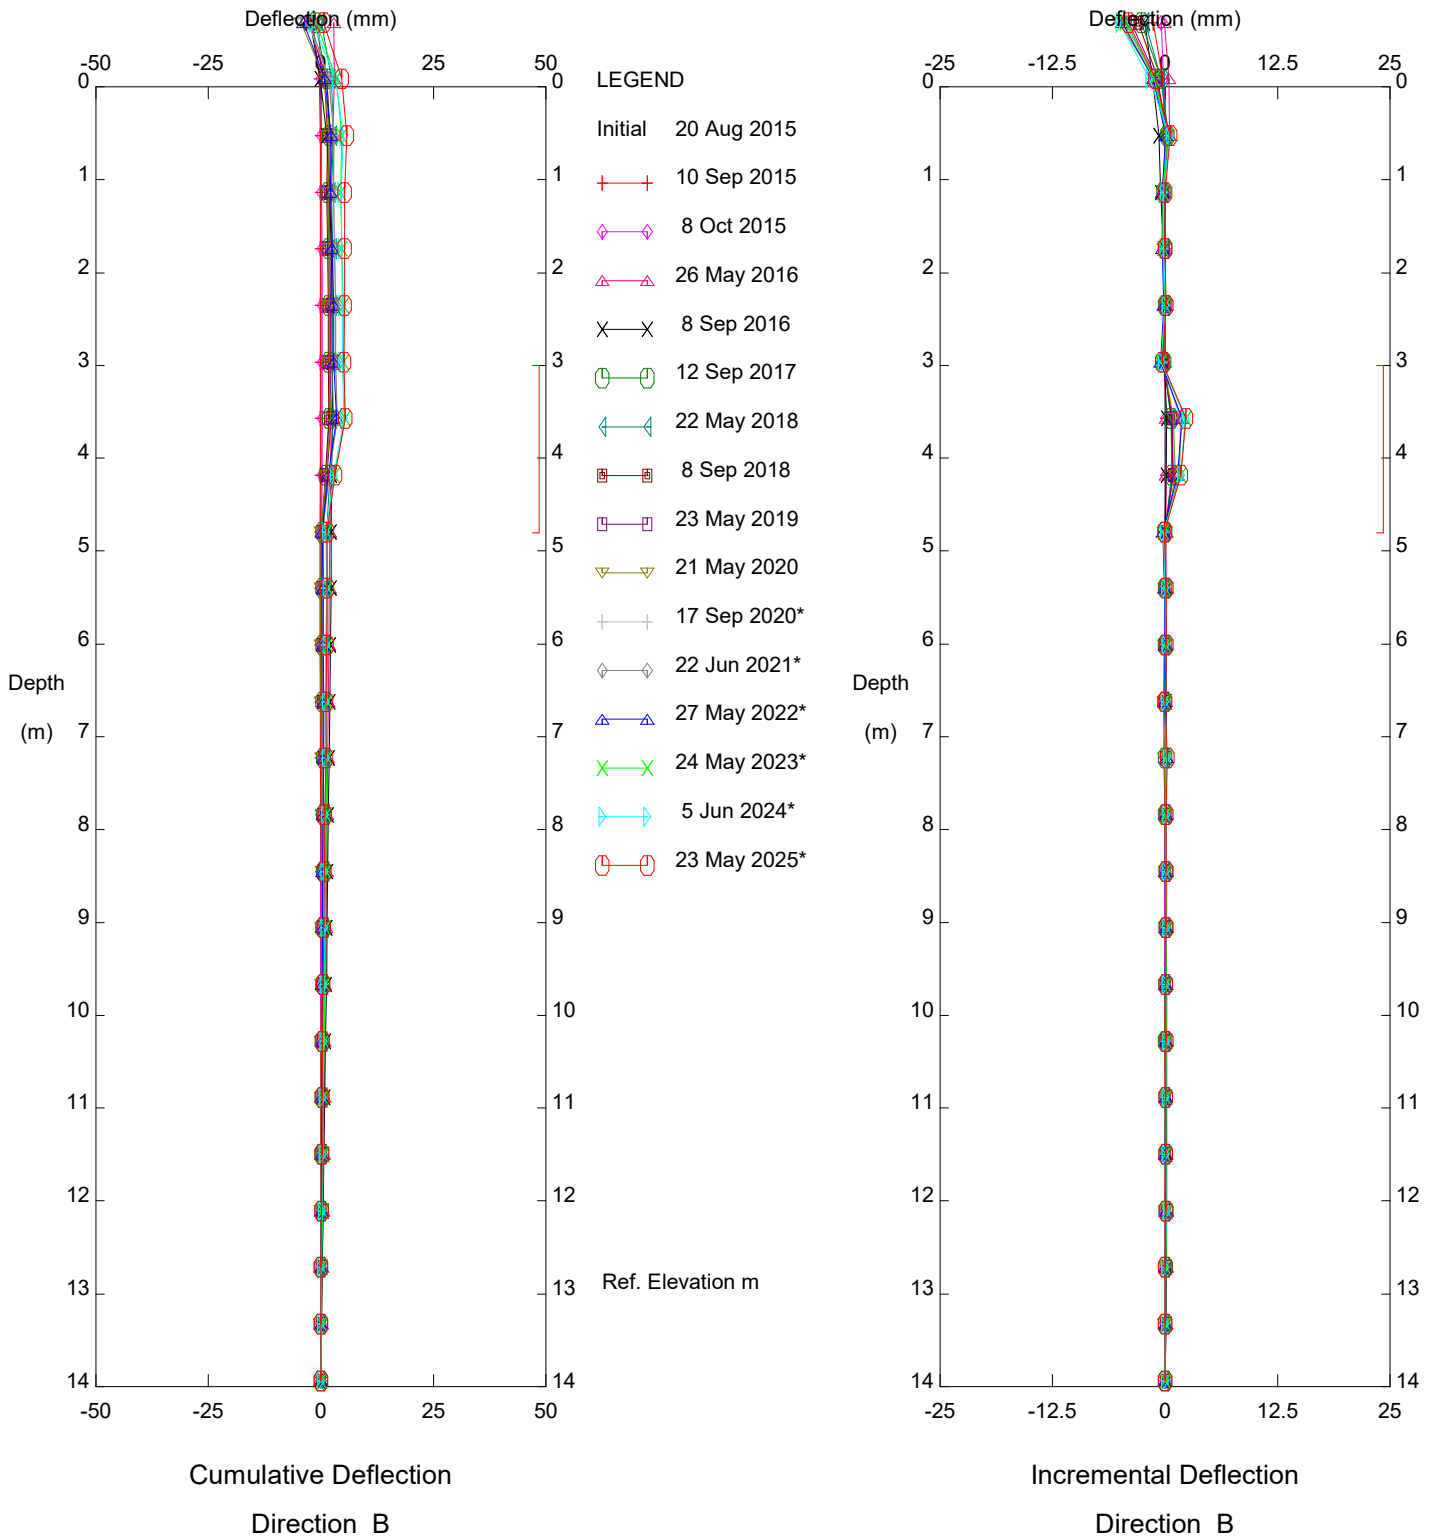
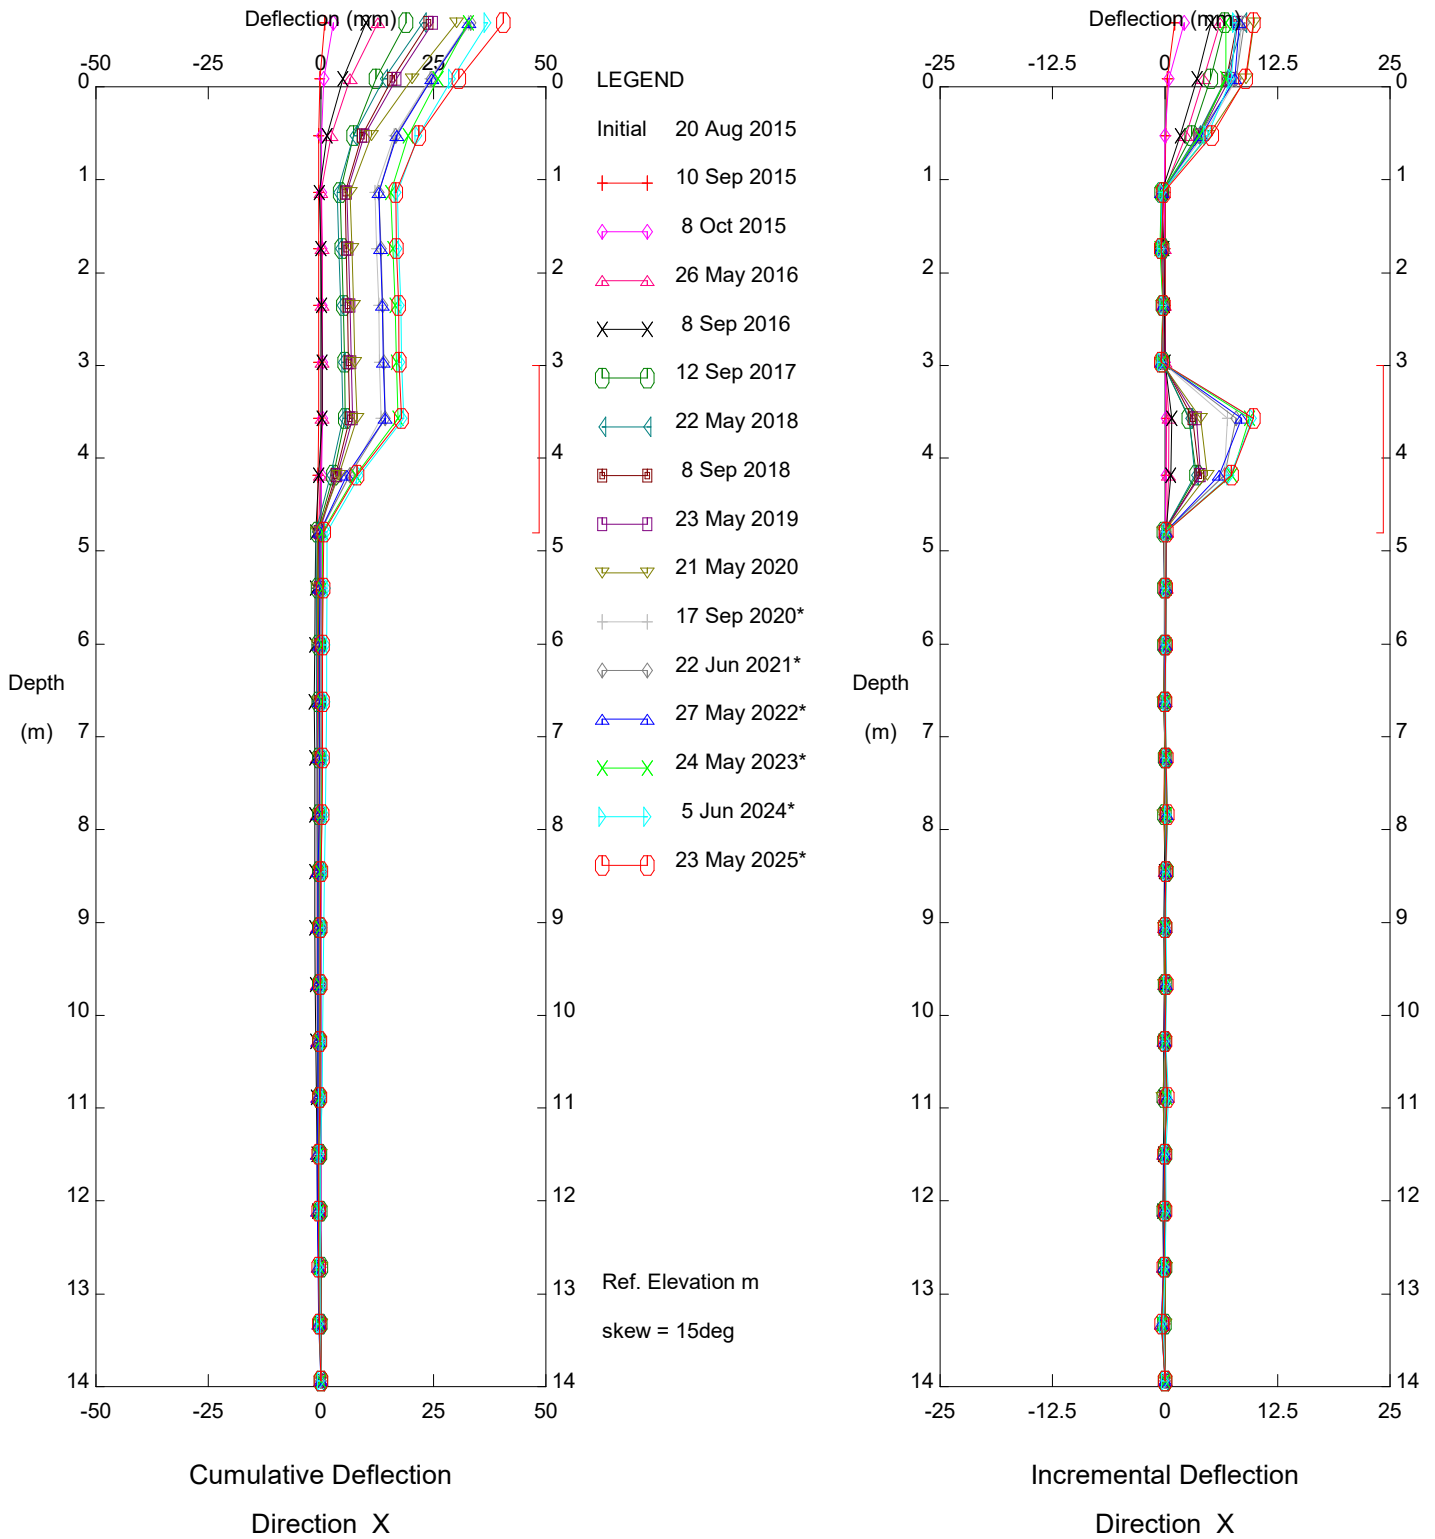
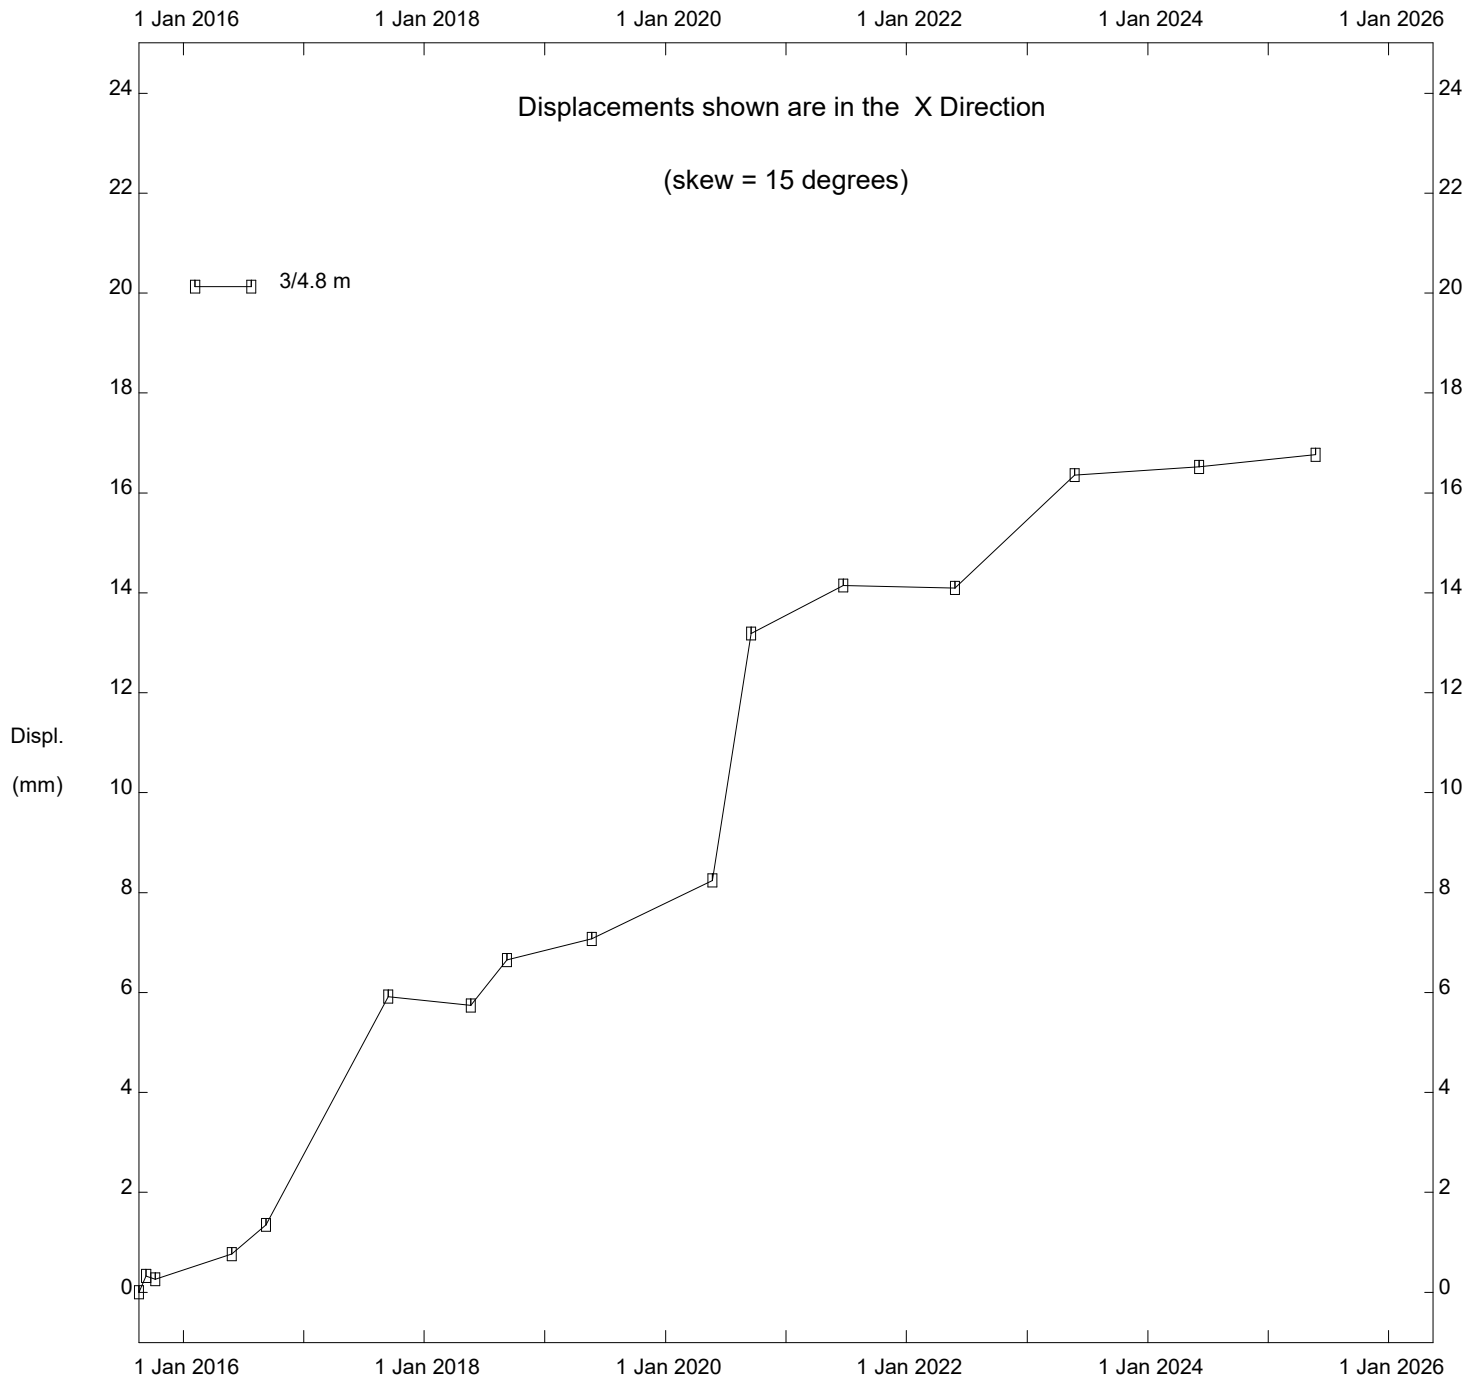
Hwy 41:23 Kehiwin Lake (NC102), Inclinometer SI15-2

| INSTRUMENT # | DATE INITIALIZED | TOTAL CUMULATIVE RESULTANT MOVEMENT AND DEPTH OF MOVEMENT TO DATE (mm) | MAXIMUM RATE OF MOVEMENT (mm/yr) | CURRENT STATUS OF SI | DATE OF PREVIOUS READING | INCREMENTAL MOVEMENT SINCE PREVIOUS READING (mm) | CURRENT RATE OF MOVEMENT (mm/yr) | CHANGE IN RATE OF MOVEMENT SINCE PREVIOUS READING (mm/yr) |
|---|---|---|---|---|---|---|---|---|
| SI15-2 | August 20, 2015 | 16.8 over 3.0 m to 4.8 m depth in 328° direction | 15.4 in September 2020 | Operational | June 5, 2024 | 0.2 | 0.3 | 0.1 |

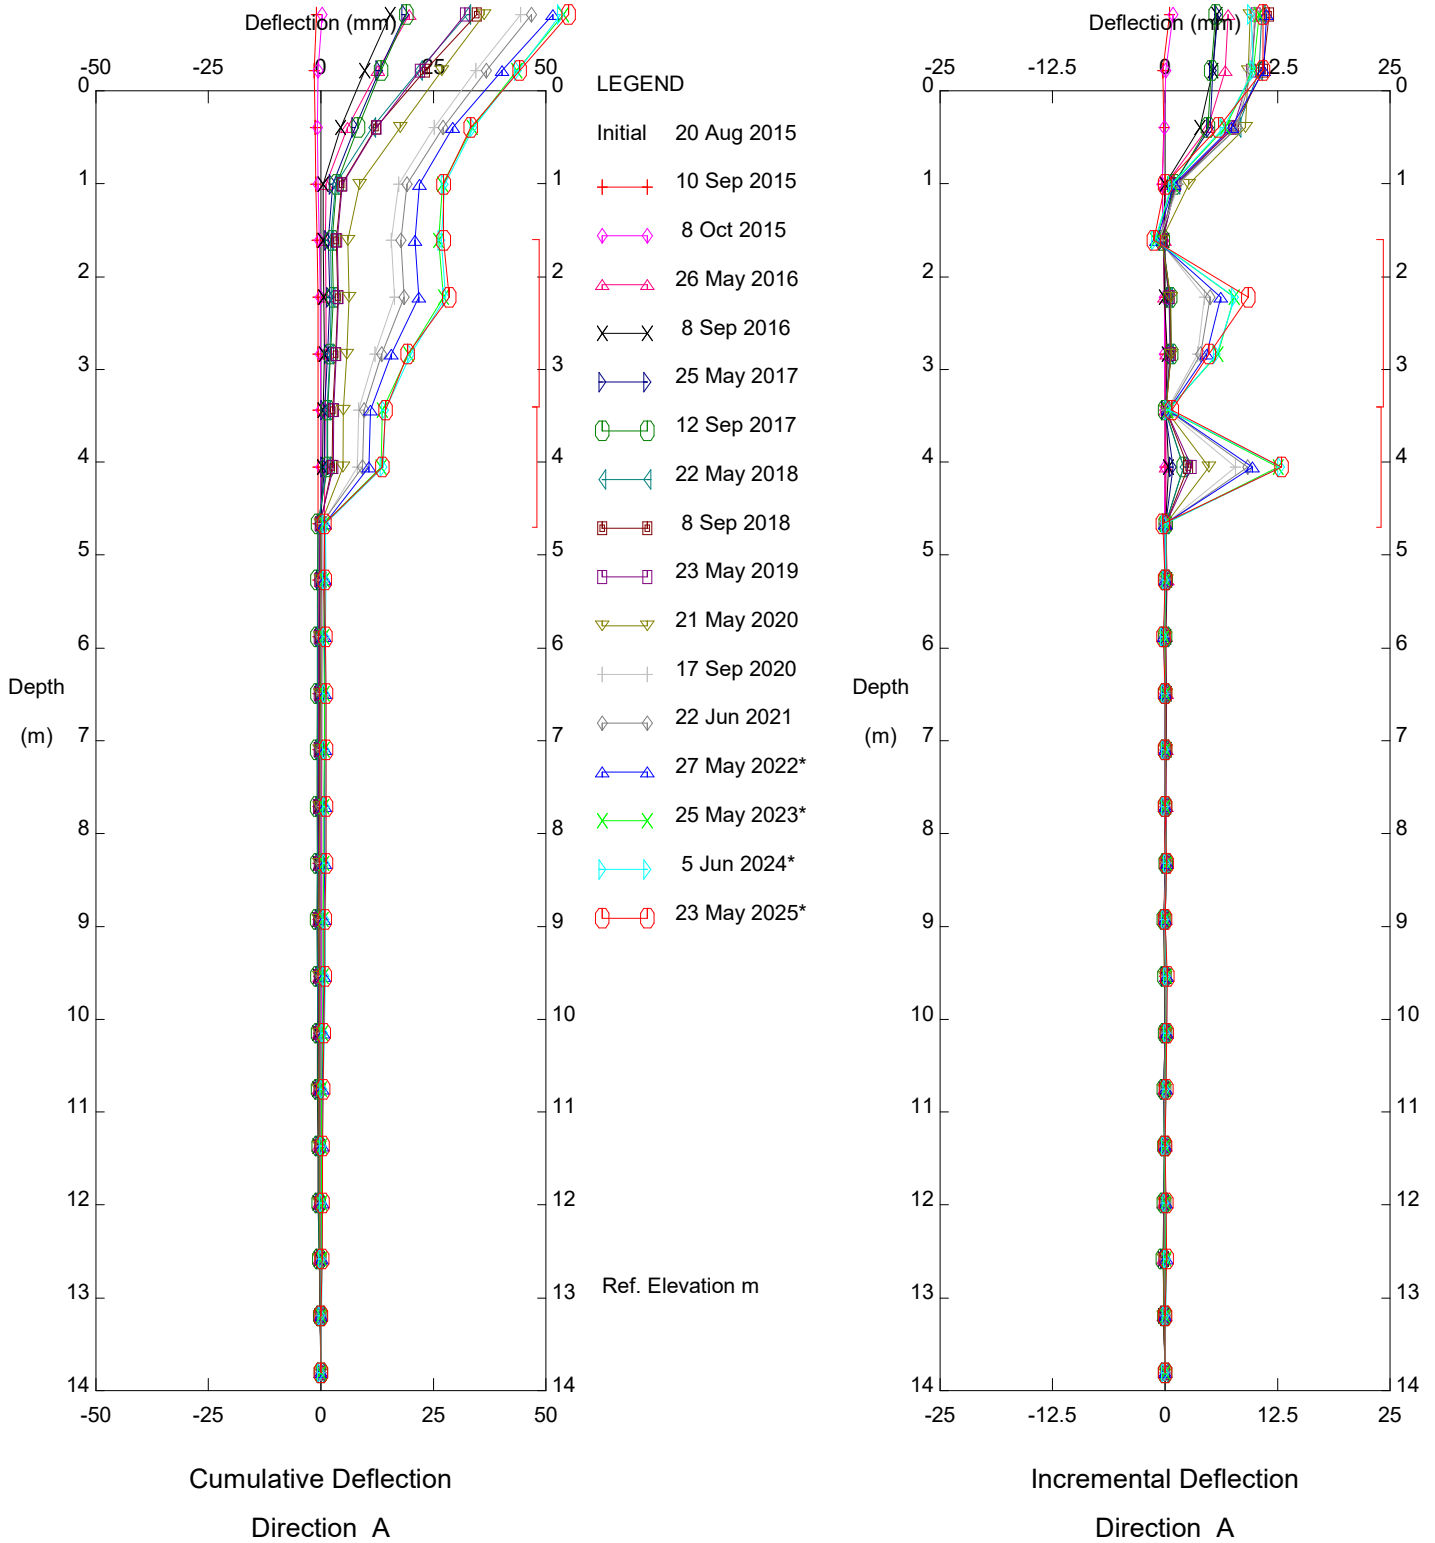
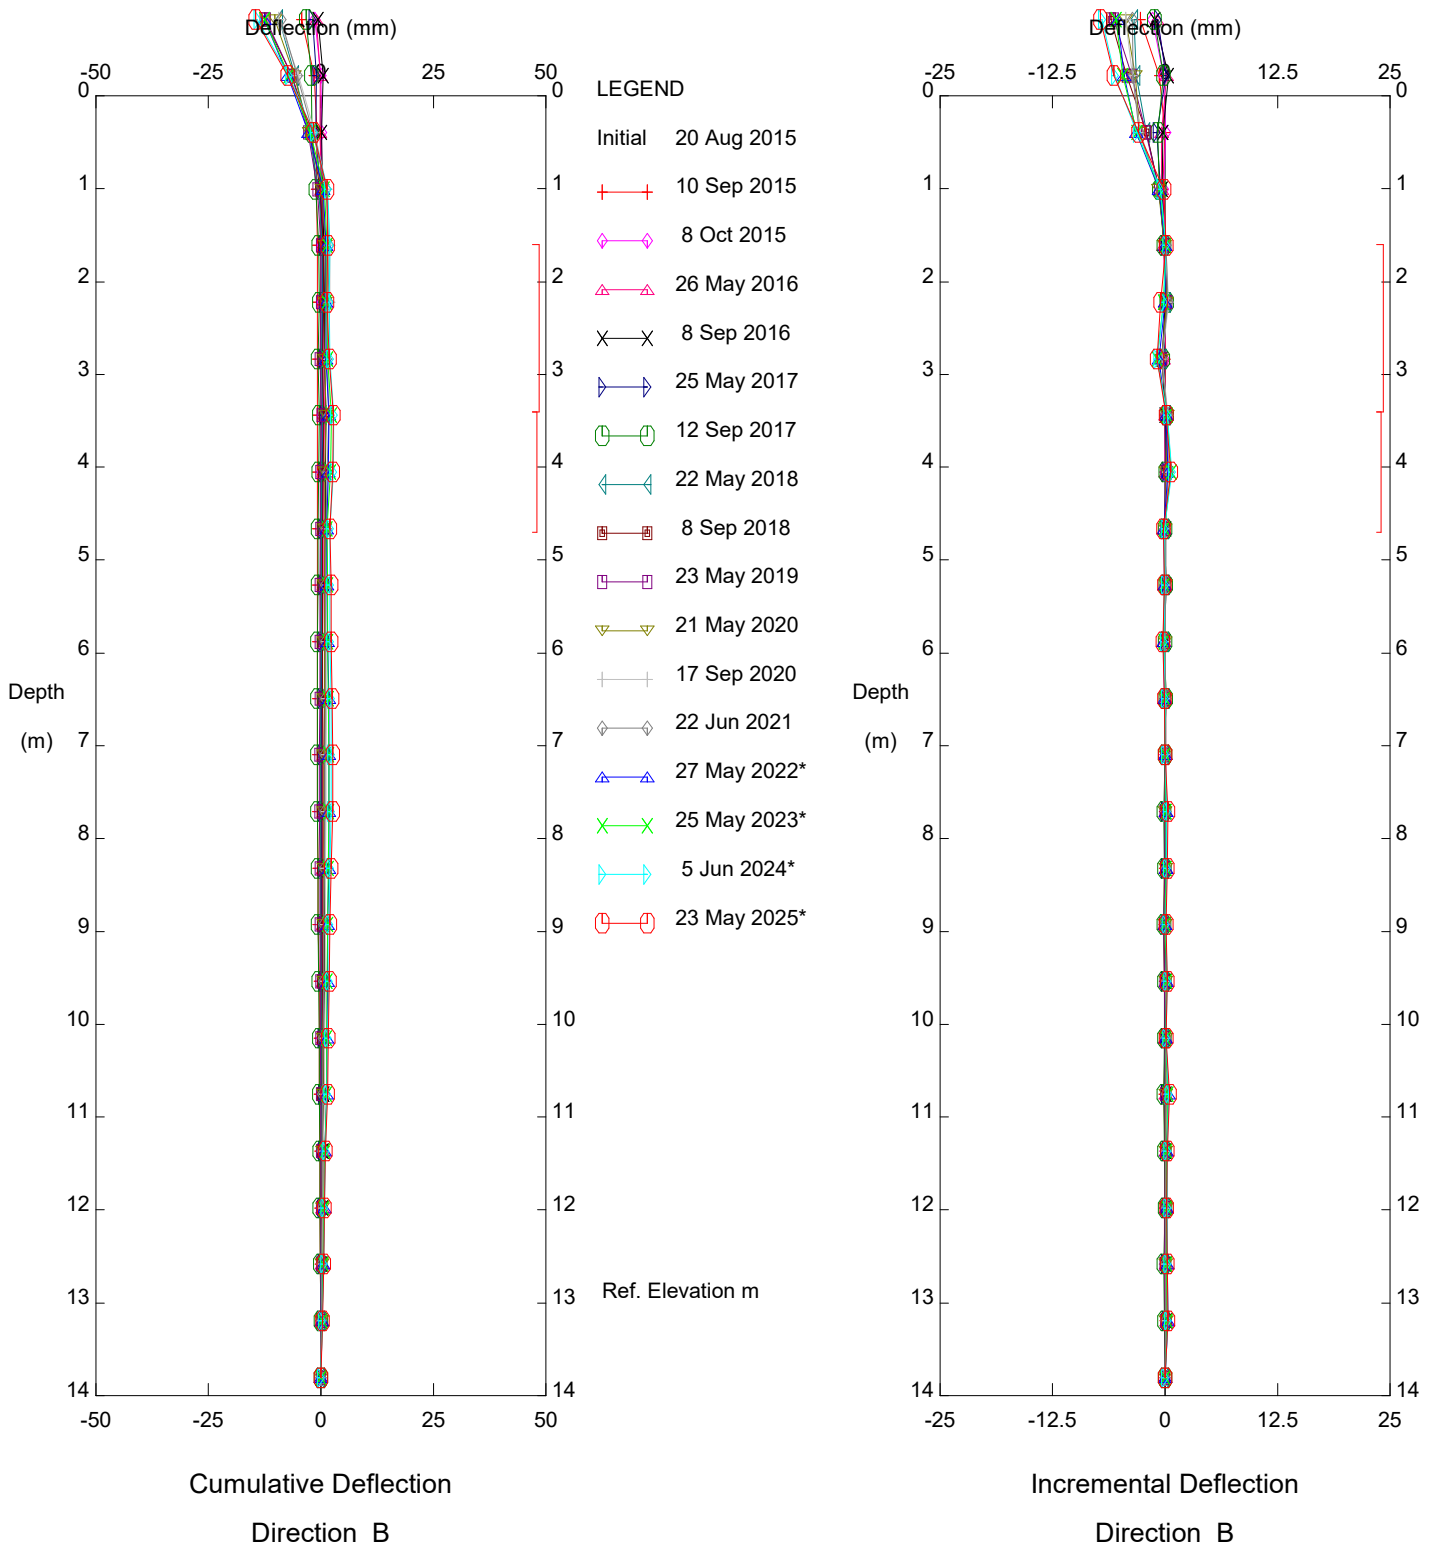
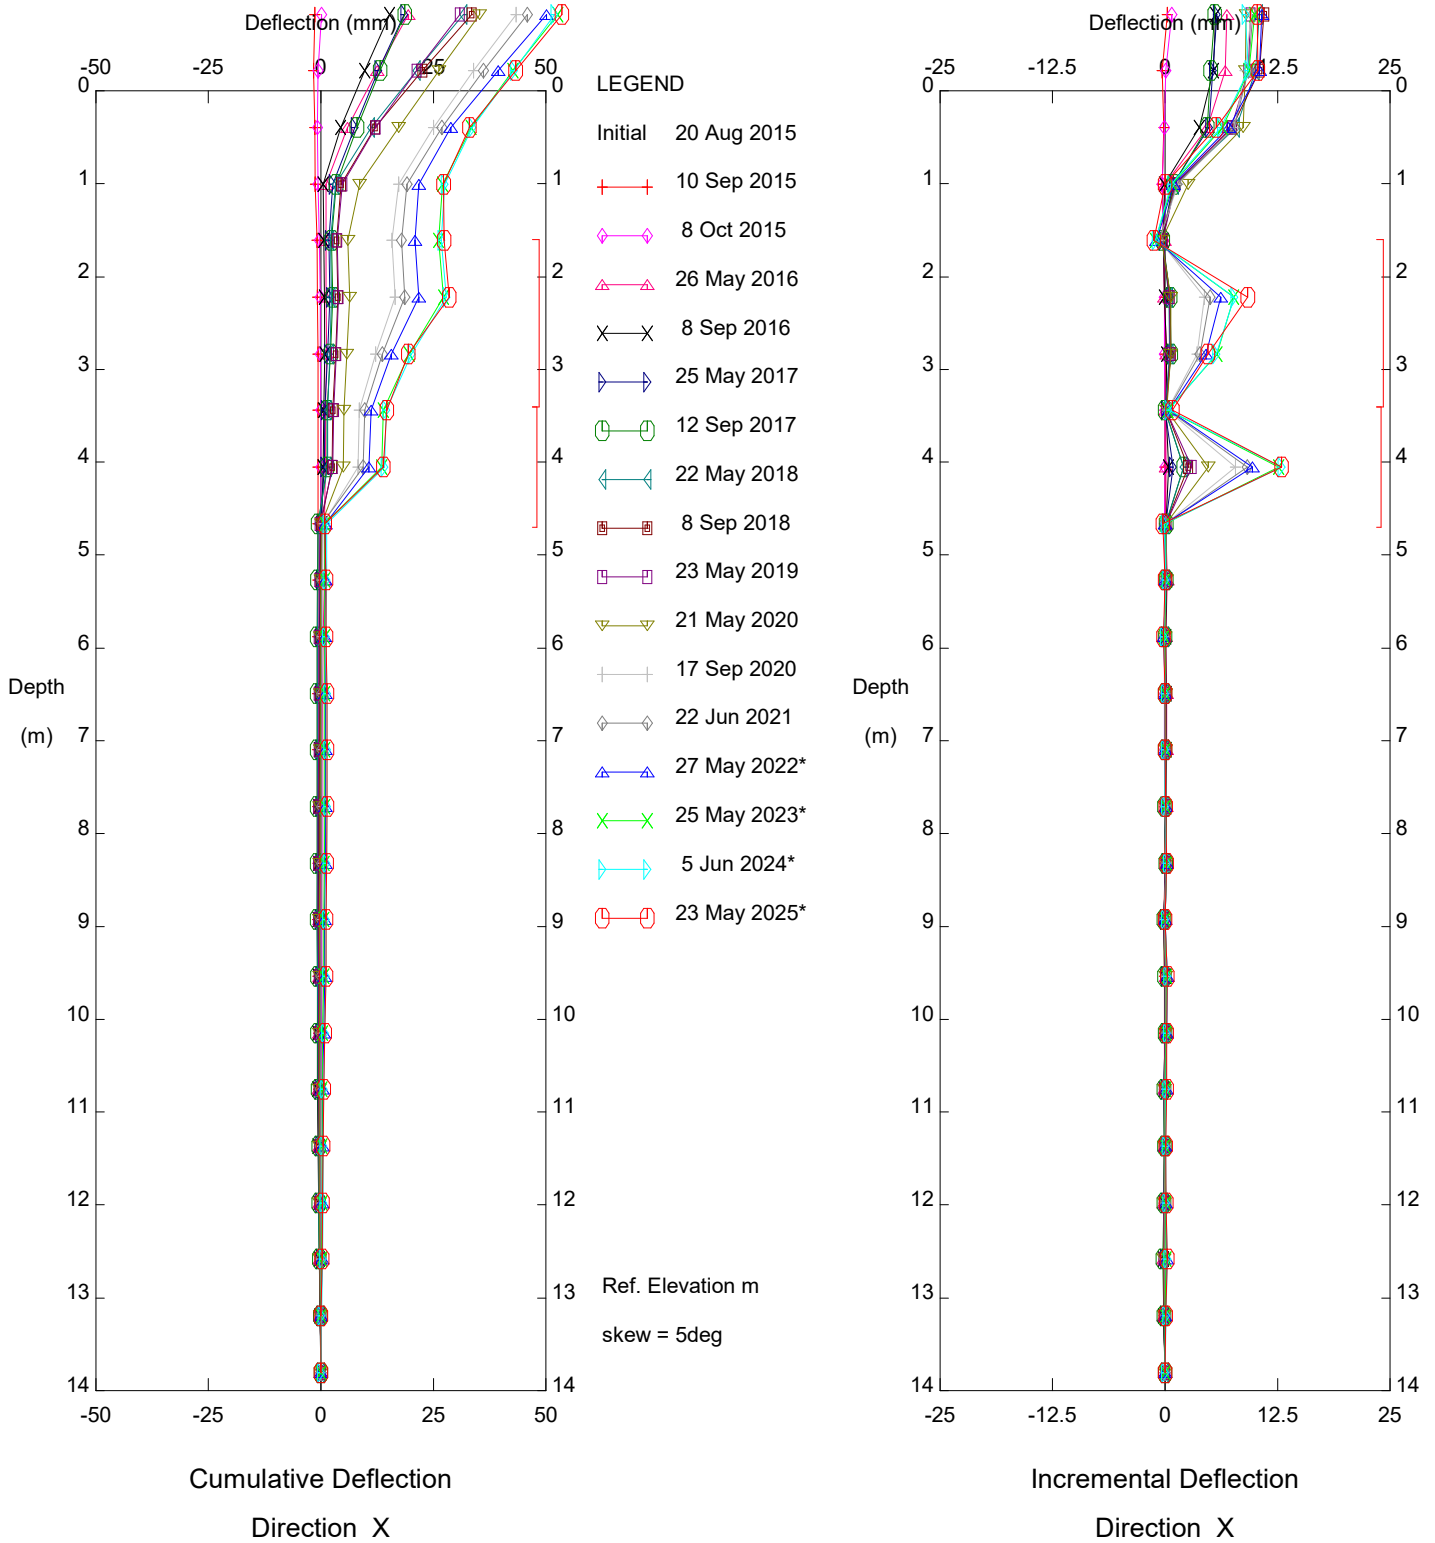
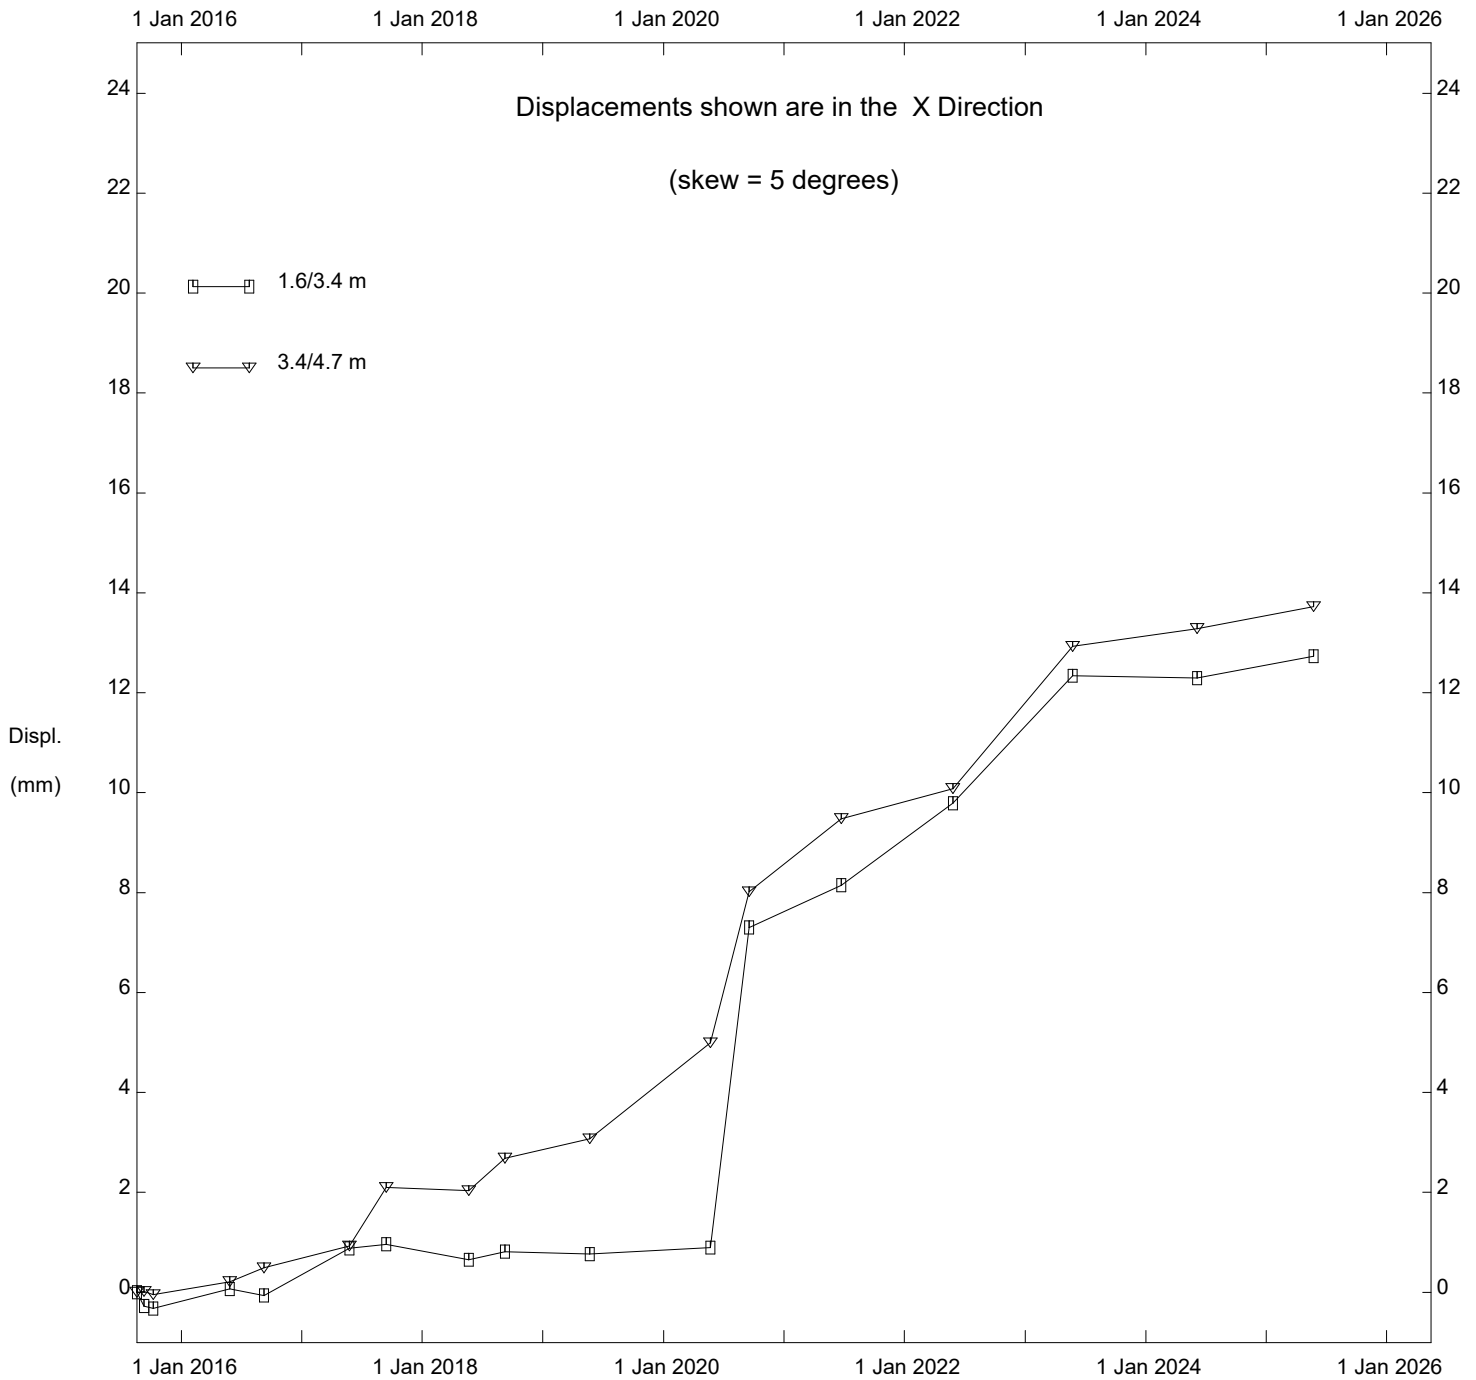
Hwy 41:23 Kehiwin Lake (NC102), Inclinometer SI15-4

| INSTRUMENT # | DATE INITIALIZED | TOTAL CUMULATIVE RESULTANT MOVEMENT AND DEPTH OF MOVEMENT TO DATE (mm) | MAXIMUM RATE OF MOVEMENT (mm/yr) | CURRENT STATUS OF SI | DATE OF PREVIOUS READING | INCREMENTAL MOVEMENT SINCE PREVIOUS READING (mm) | CURRENT RATE OF MOVEMENT (mm/yr) | CHANGE IN RATE OF MOVEMENT SINCE PREVIOUS READING (mm/yr) |
|---|---|---|---|---|---|---|---|---|
| SI15-4 | August 20, 2015 | 12.7 over 1.6 to 3.4 m depth in 328° direction | 19.6 in September 2020 | Operational | June 5, 2024 | 0.4 | 0.4 | 0.5 |
| | | 13.7 over 3.4 to 4.7 m depth in 328° direction | 9.3 in September 2020 | | | 0.5 | 0.5 | 0.1 |
