ALBERTA TRANSPORTATION AND  
ECONOMIC CORRIDORS GRMP  
NORTH CENTRAL (ATHABASCA AND FORT  
McMURRAY DISTRICTS)  
INSTRUMENTATION MONITORING- SPRING 2025

| Site Number | Location | Name | Hwy | km |
|---|---|---|---|---|
| NC102<br>(NC024-2) | HWY 41:23 C1 8.88 | Kehiwin Lake | 41:23 | Km 8.8 |

**ALBERTA TRANSPORTATION AND ECONOMIC CORRIDORS GRMP (CON0022163)  
NORTH CENTRAL (ATHABASCA AND FORT McMURRAY DISTRICTS)  
INSTRUMENTATION MONITORING RESULTS**

**SITE NC102 (NC024-2): HWY 41:23 KEHIWIN LAKE (km 8.8)**

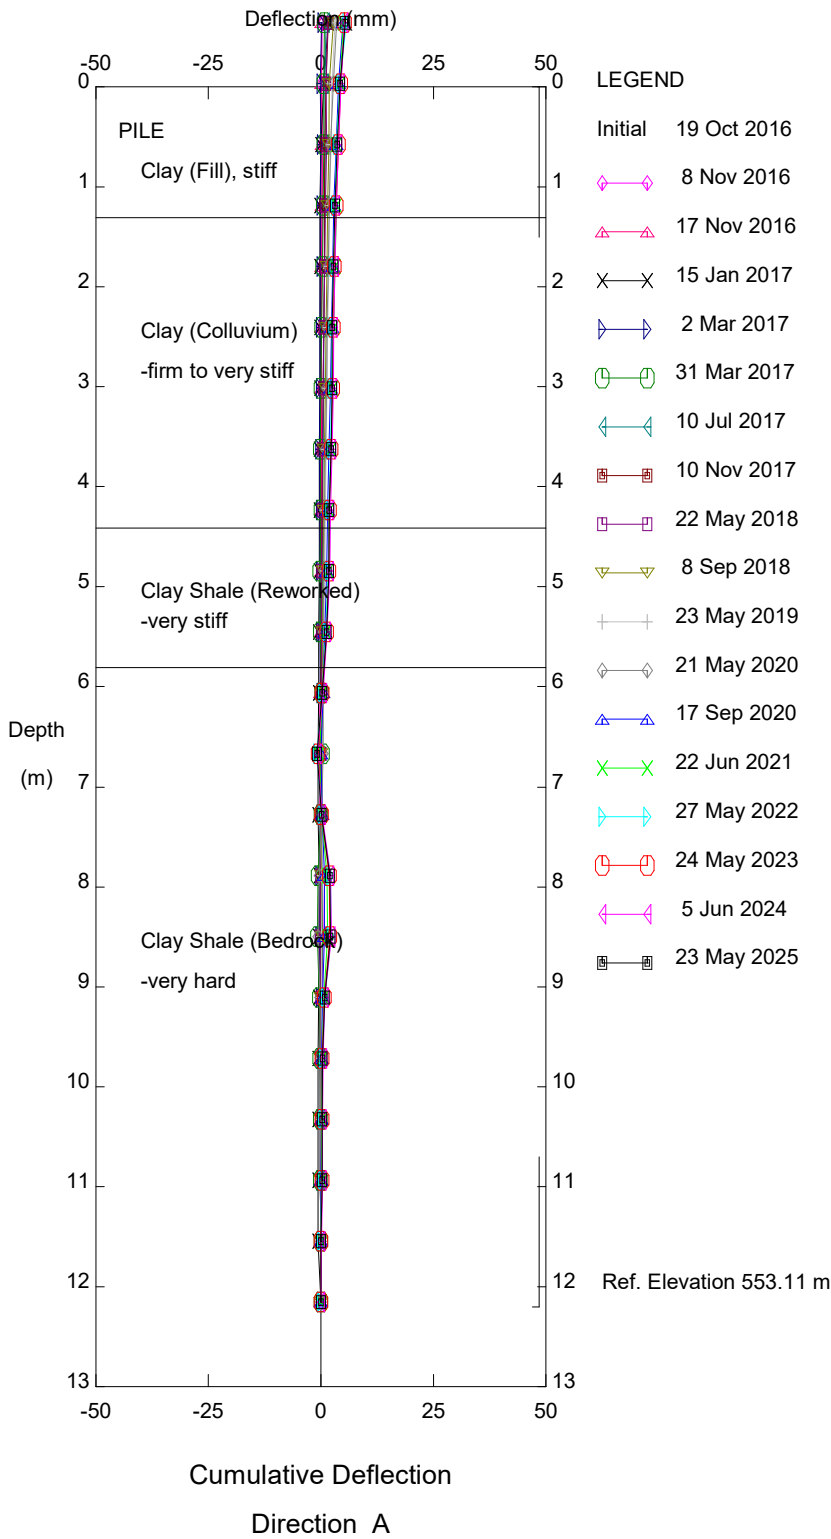
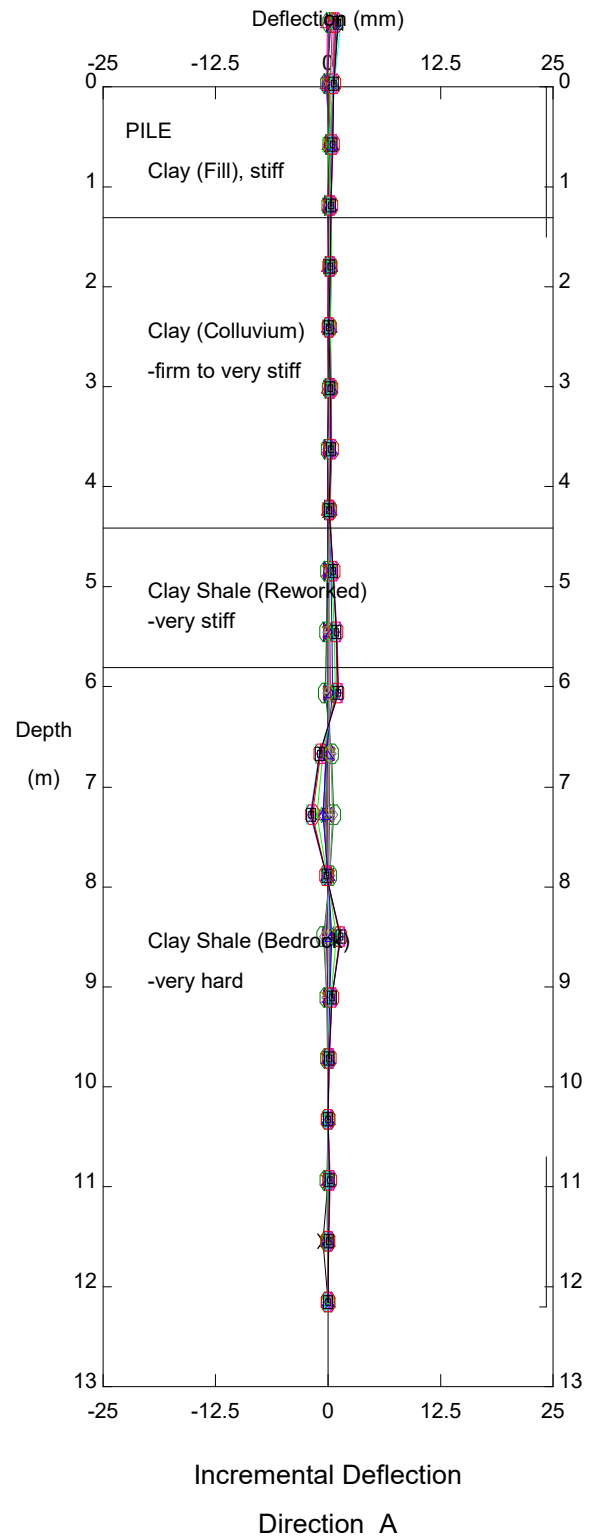
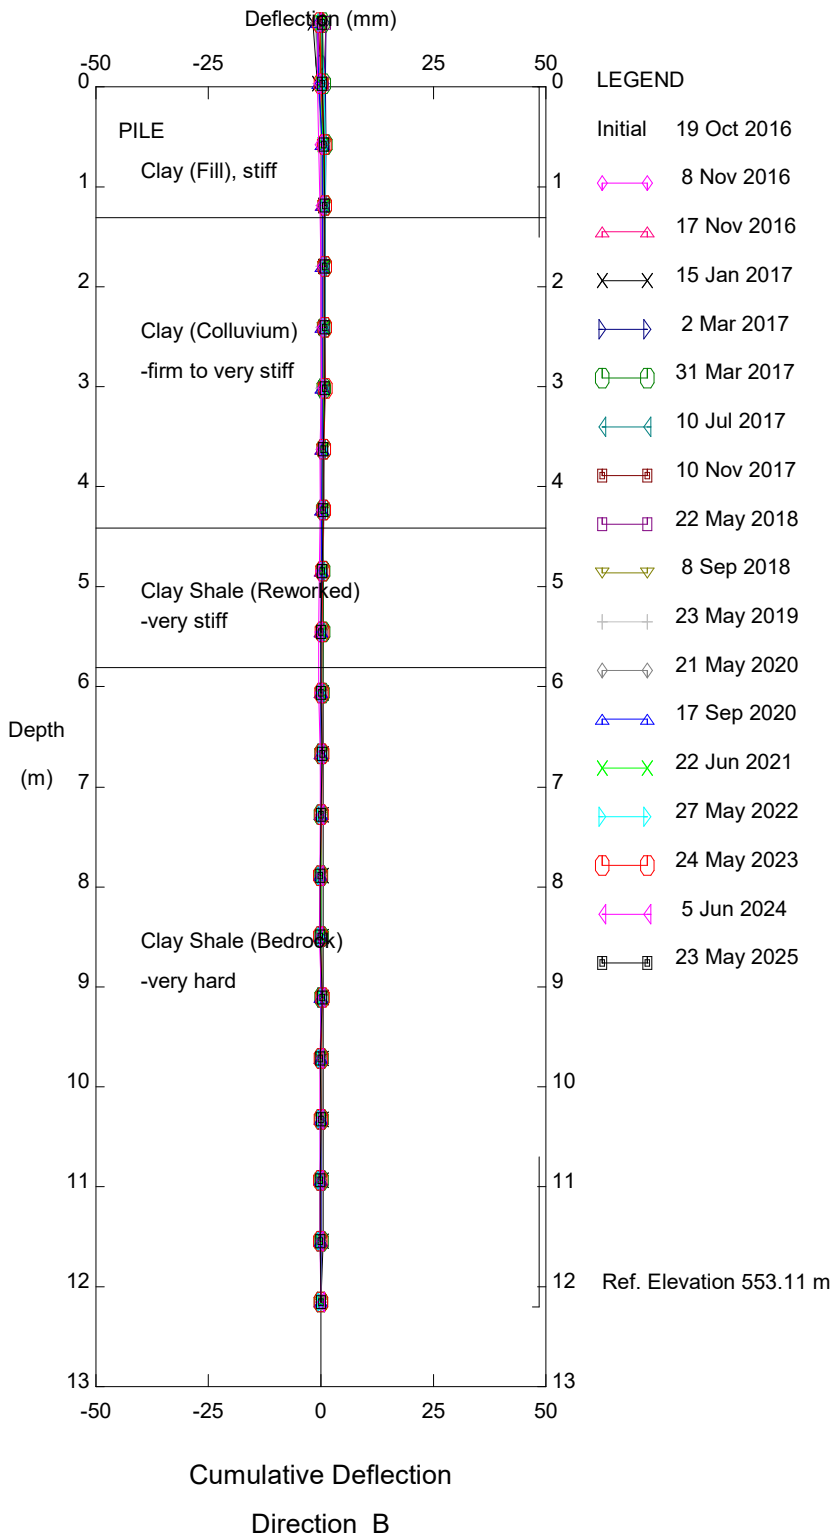
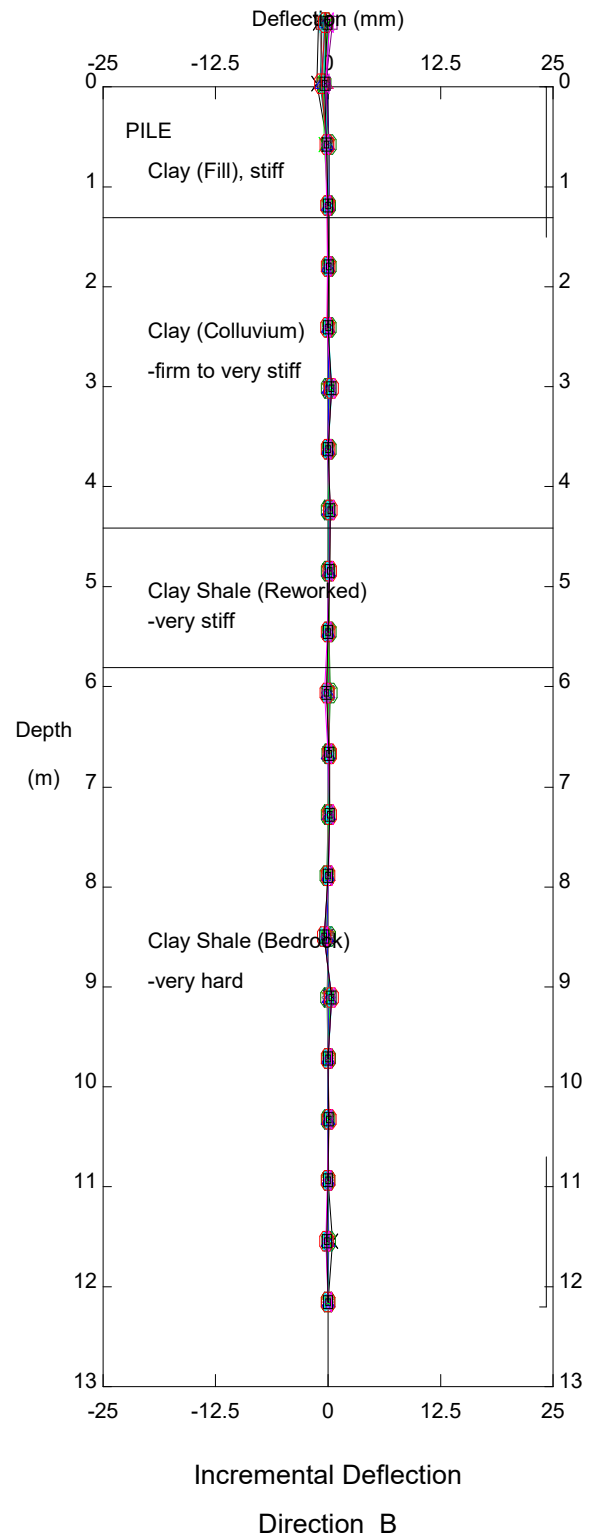
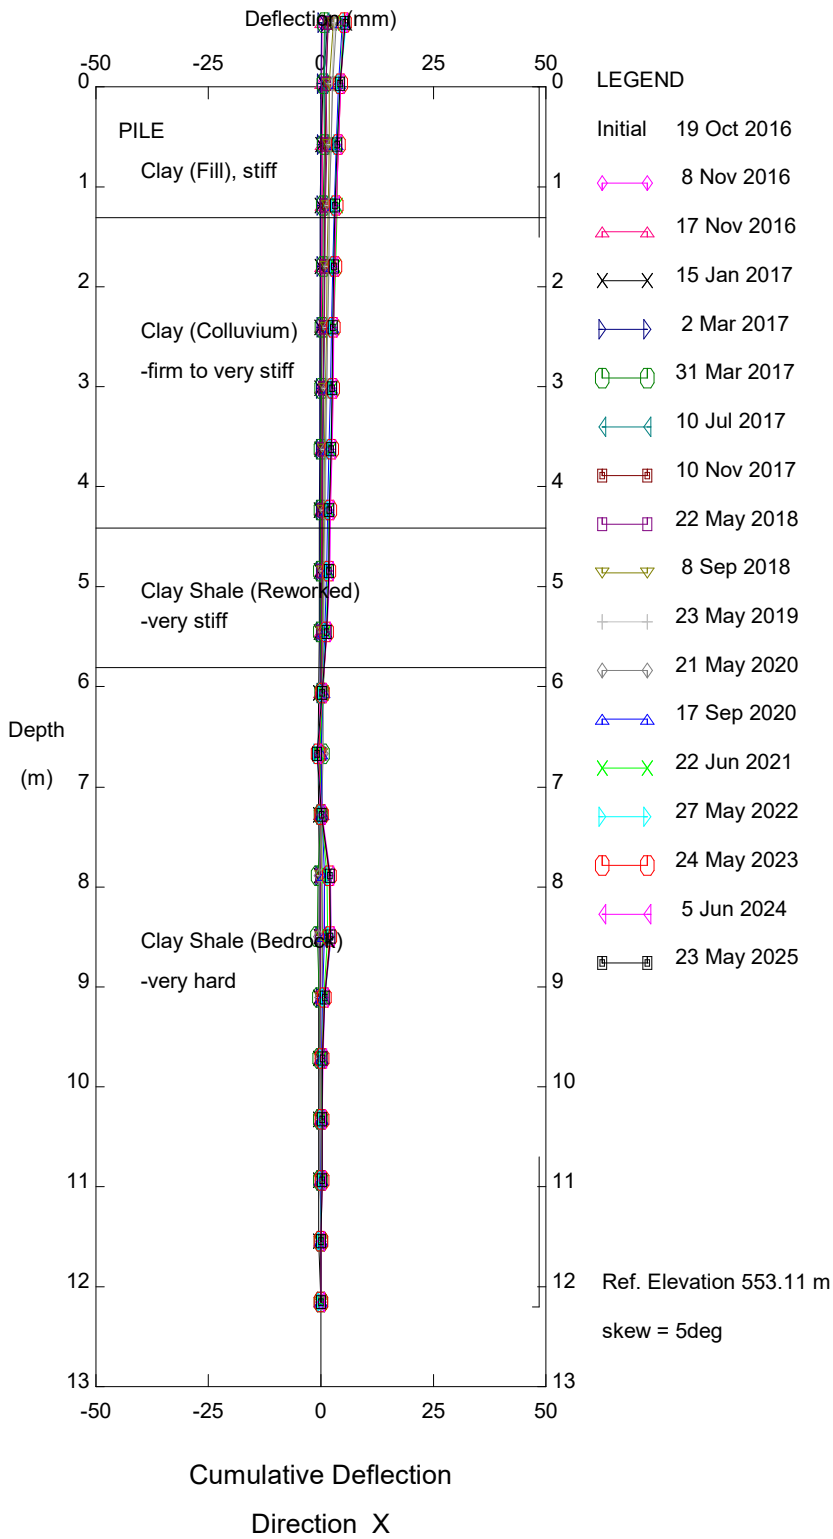
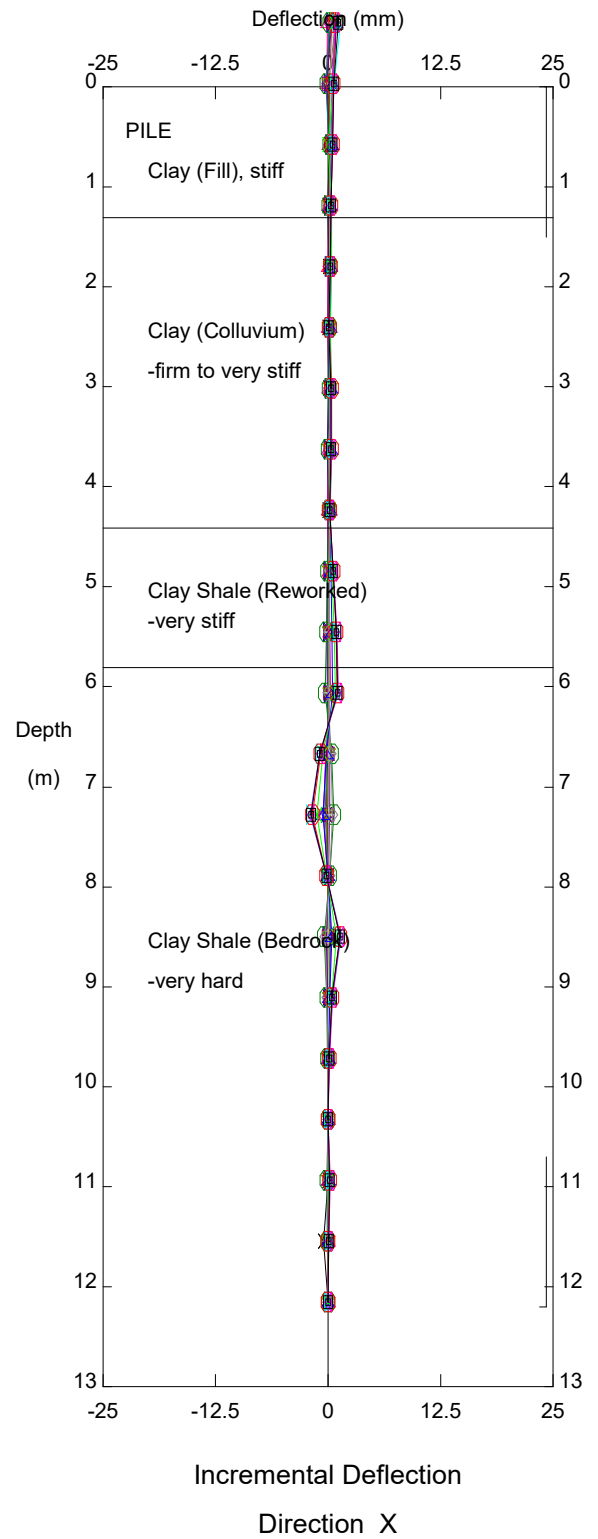
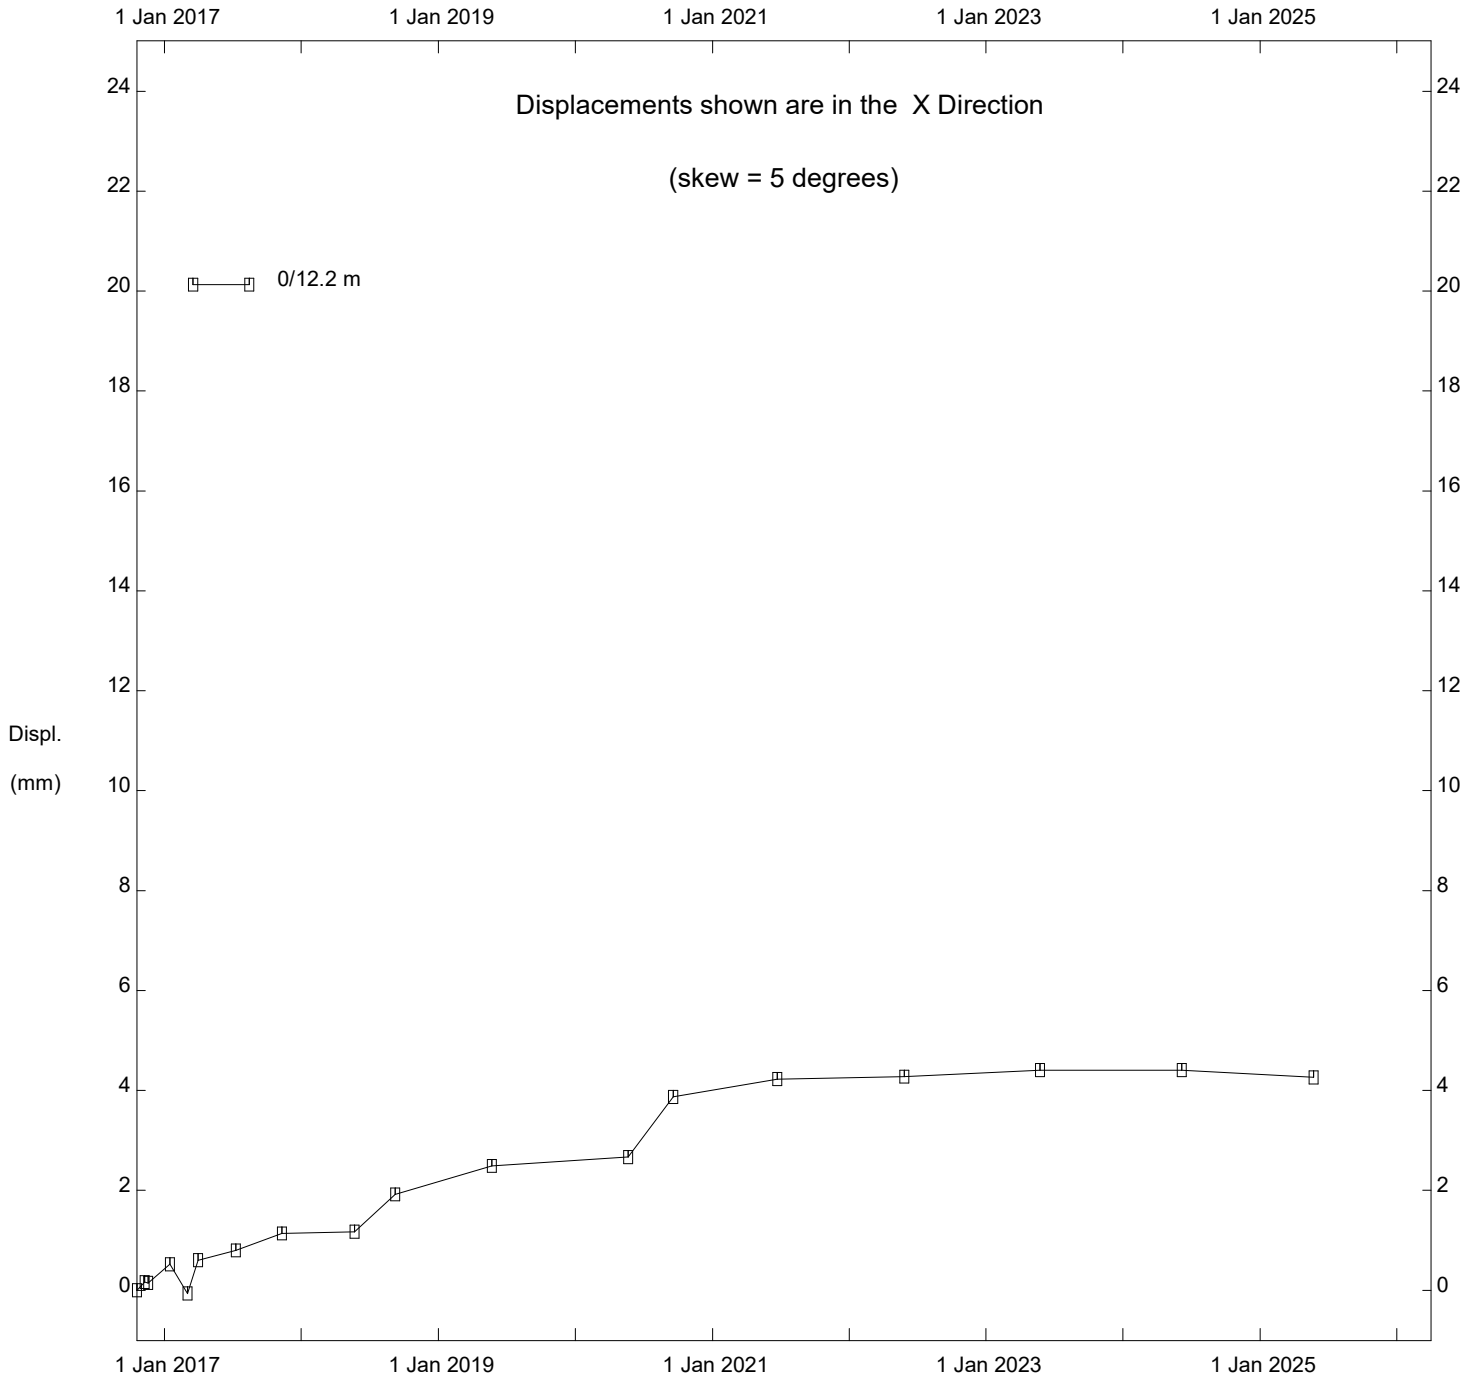
Hwy 41:23 Kehiwin Lake (NC102), Inclinator SI16-1 (P04)

| INSTRUMENT # | DATE INITIALIZED | TOTAL CUMULATIVE RESULTANT MOVEMENT AND DEPTH OF MOVEMENT TO DATE (mm) | MAXIMUM RATE OF MOVEMENT (mm/yr) | CURRENT STATUS OF SI | DATE OF PREVIOUS READING | INCREMENTAL MOVEMENT SINCE PREVIOUS READING (mm) | CURRENT RATE OF MOVEMENT (mm/yr) | CHANGE IN RATE OF MOVEMENT SINCE PREVIOUS READING (mm/yr) |
|---|---|---|---|---|---|---|---|---|
| SI16-1 (P04) | October 19, 2016 | 4.3 over 0.0 to 12.2 m depth in 308° direction | 9.2 in March 2017 | Operational | June 5, 2024 | No discernible movement | N/A | -0.1 |

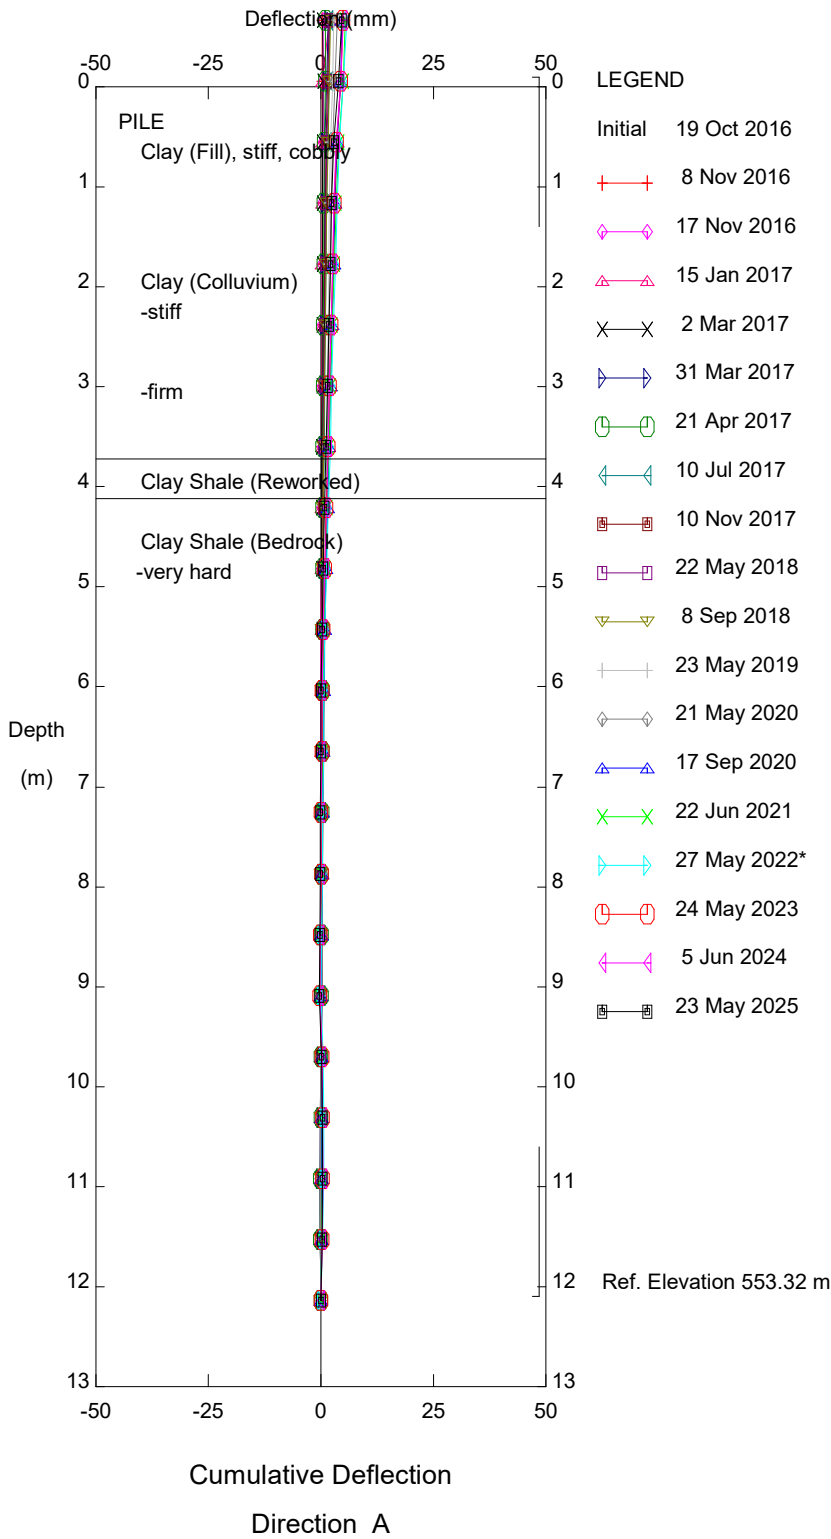
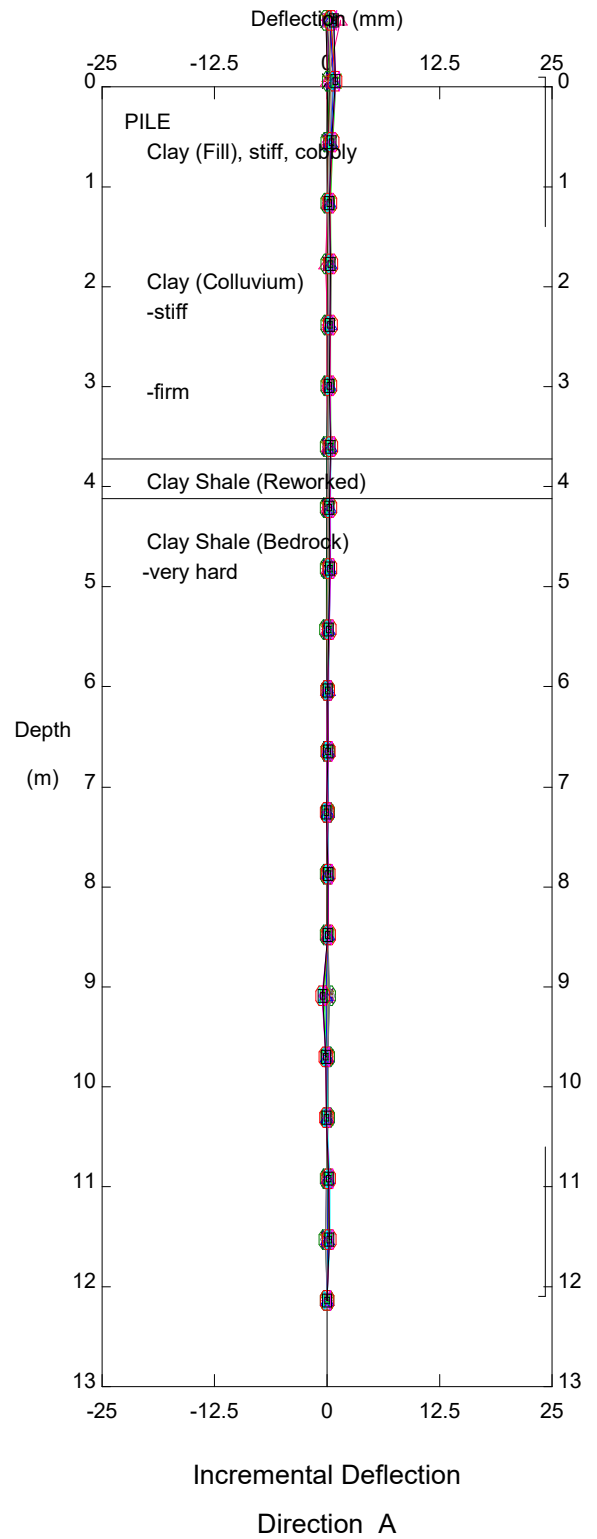
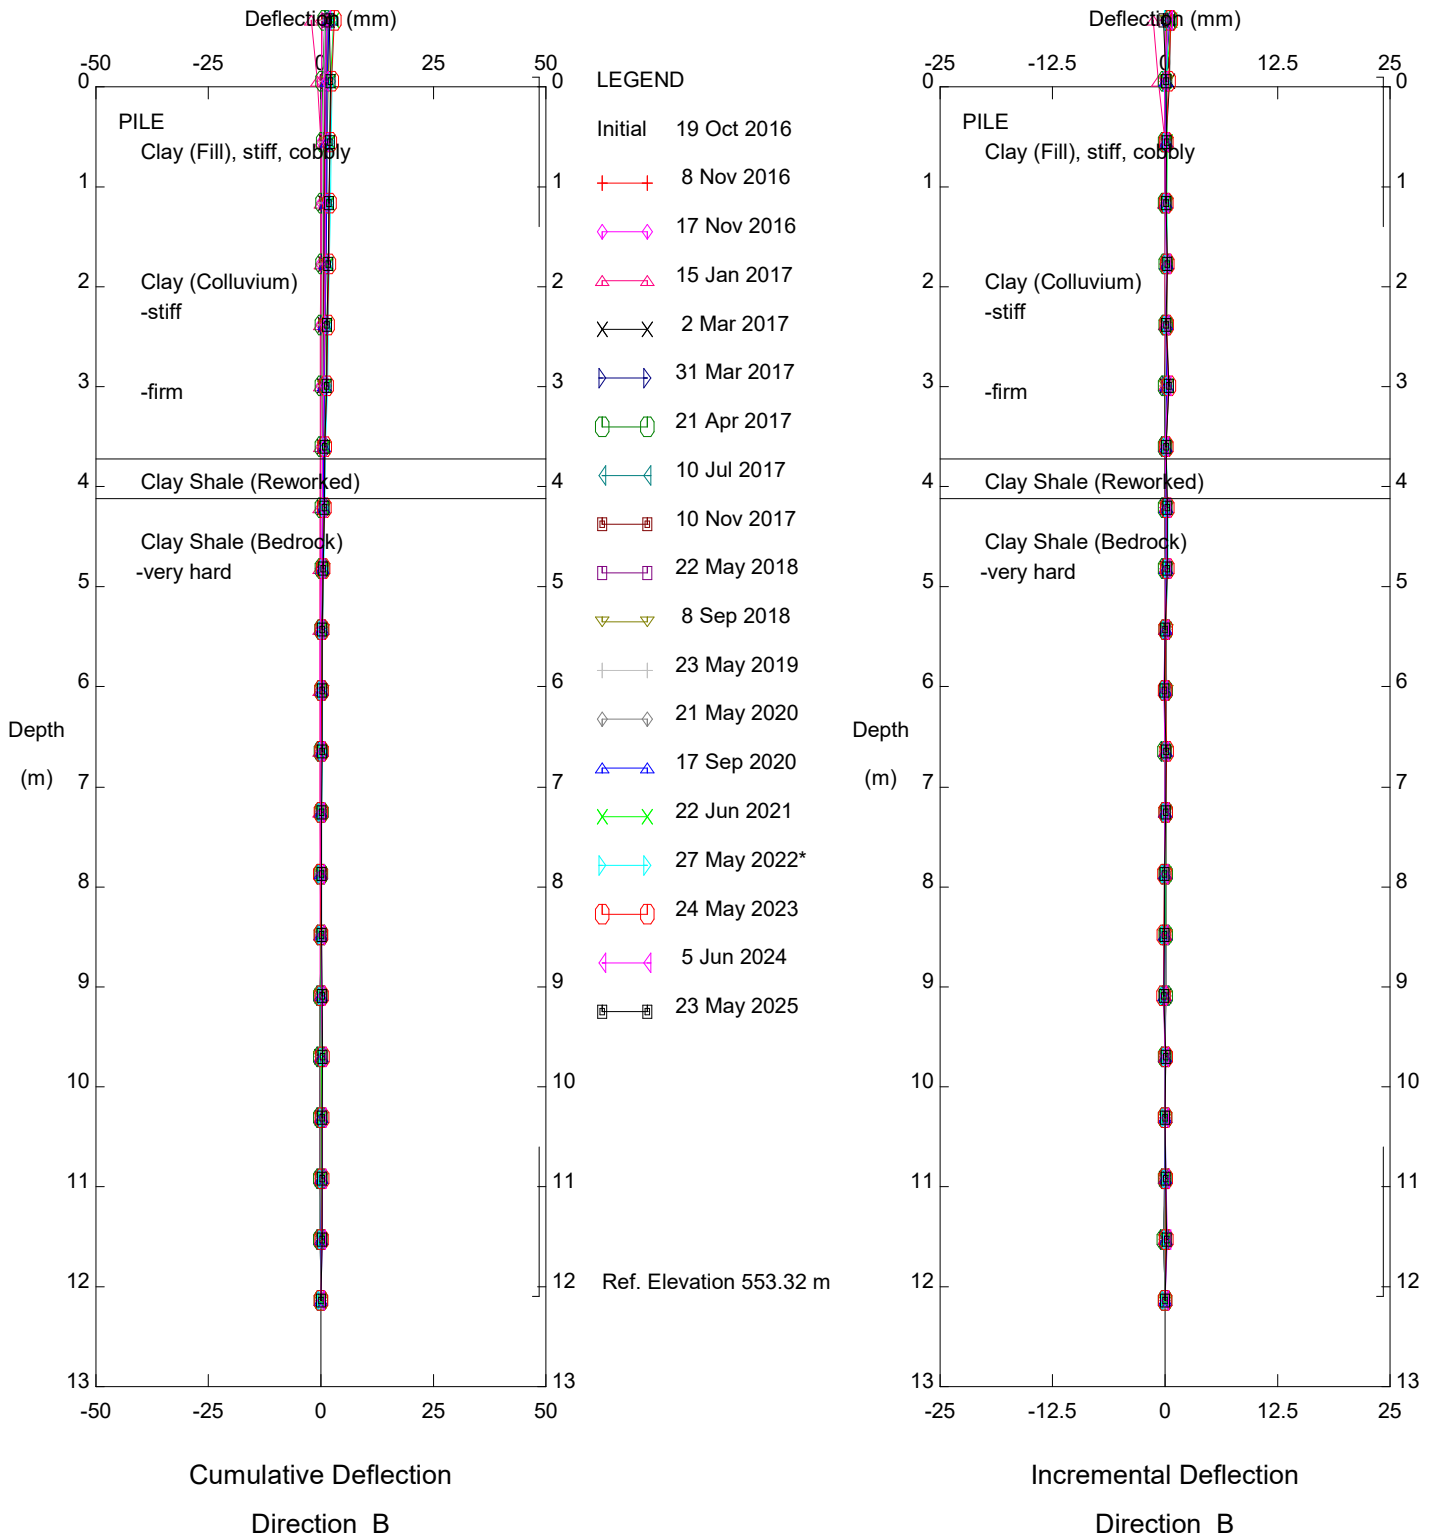
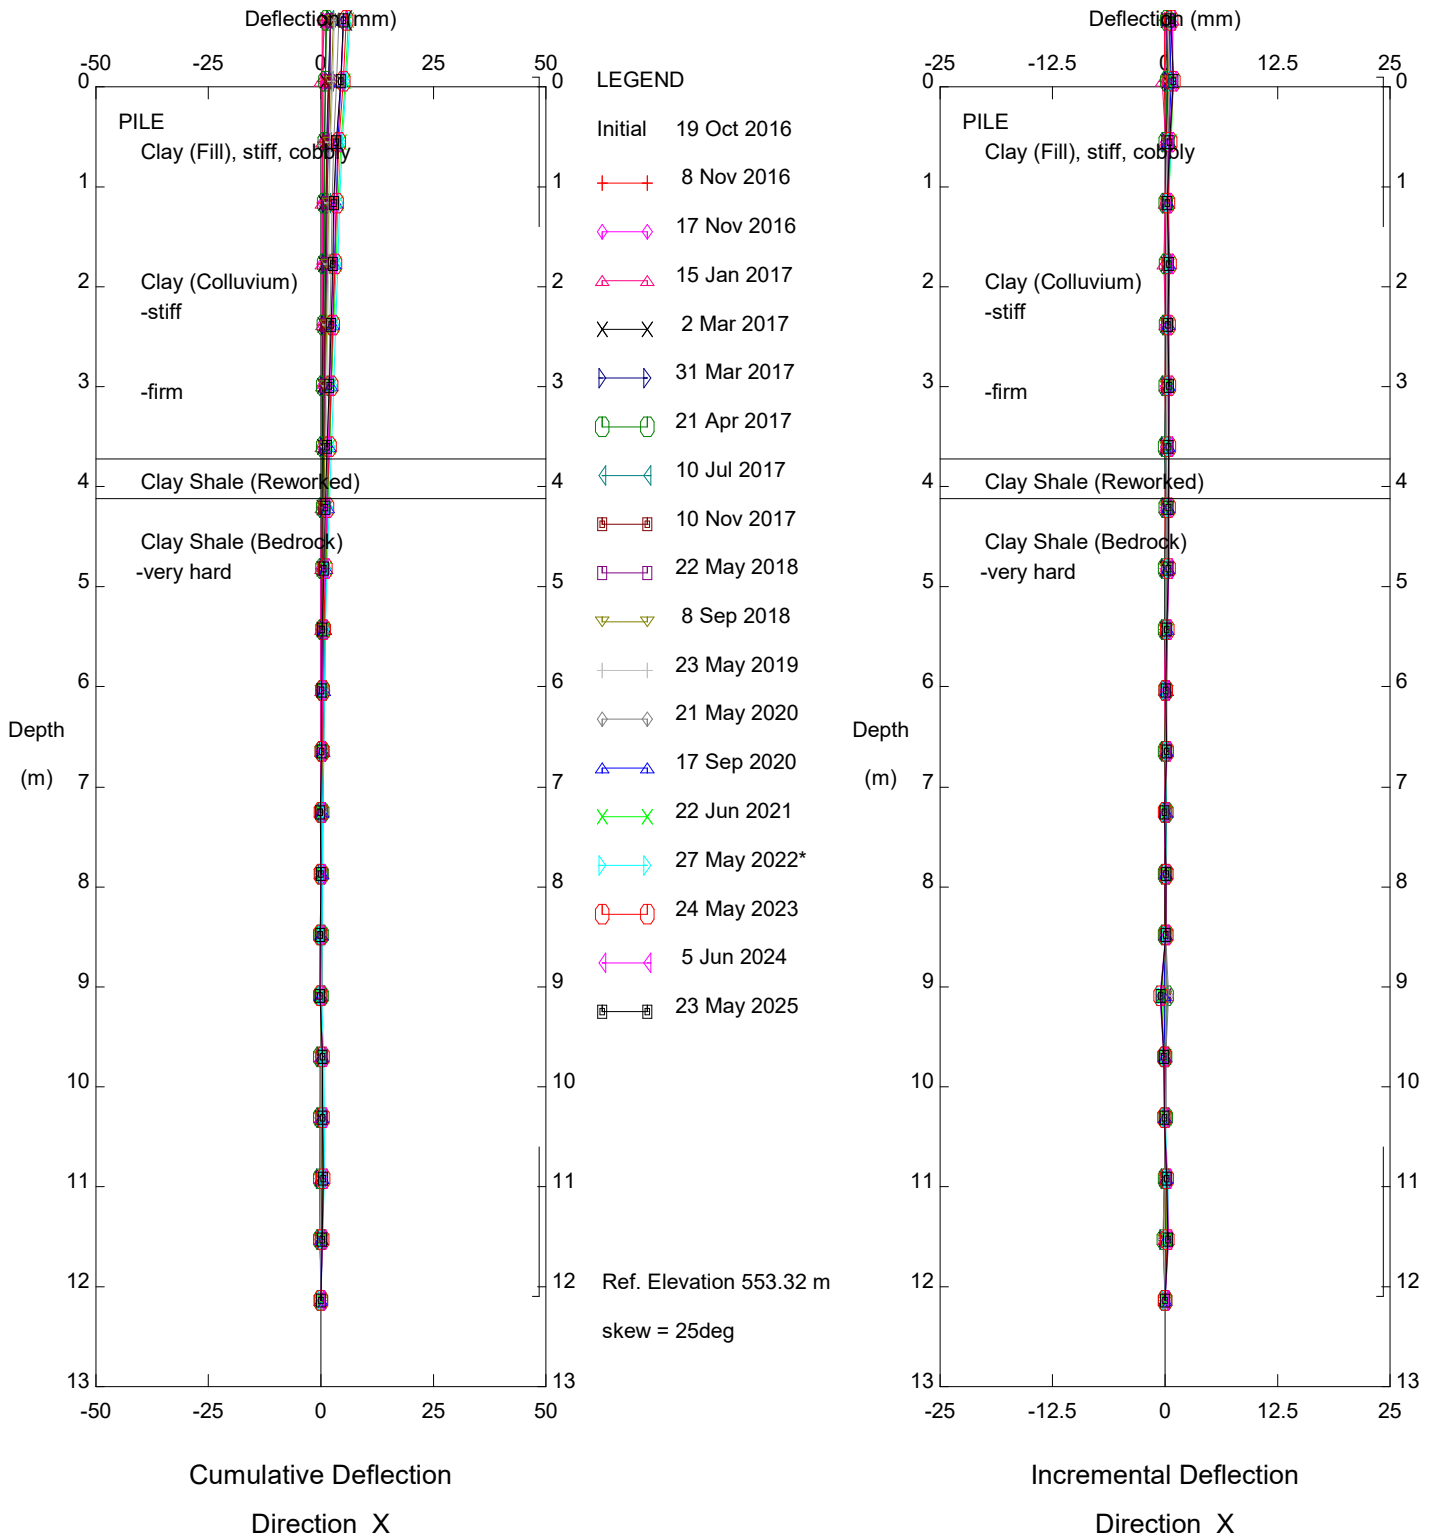
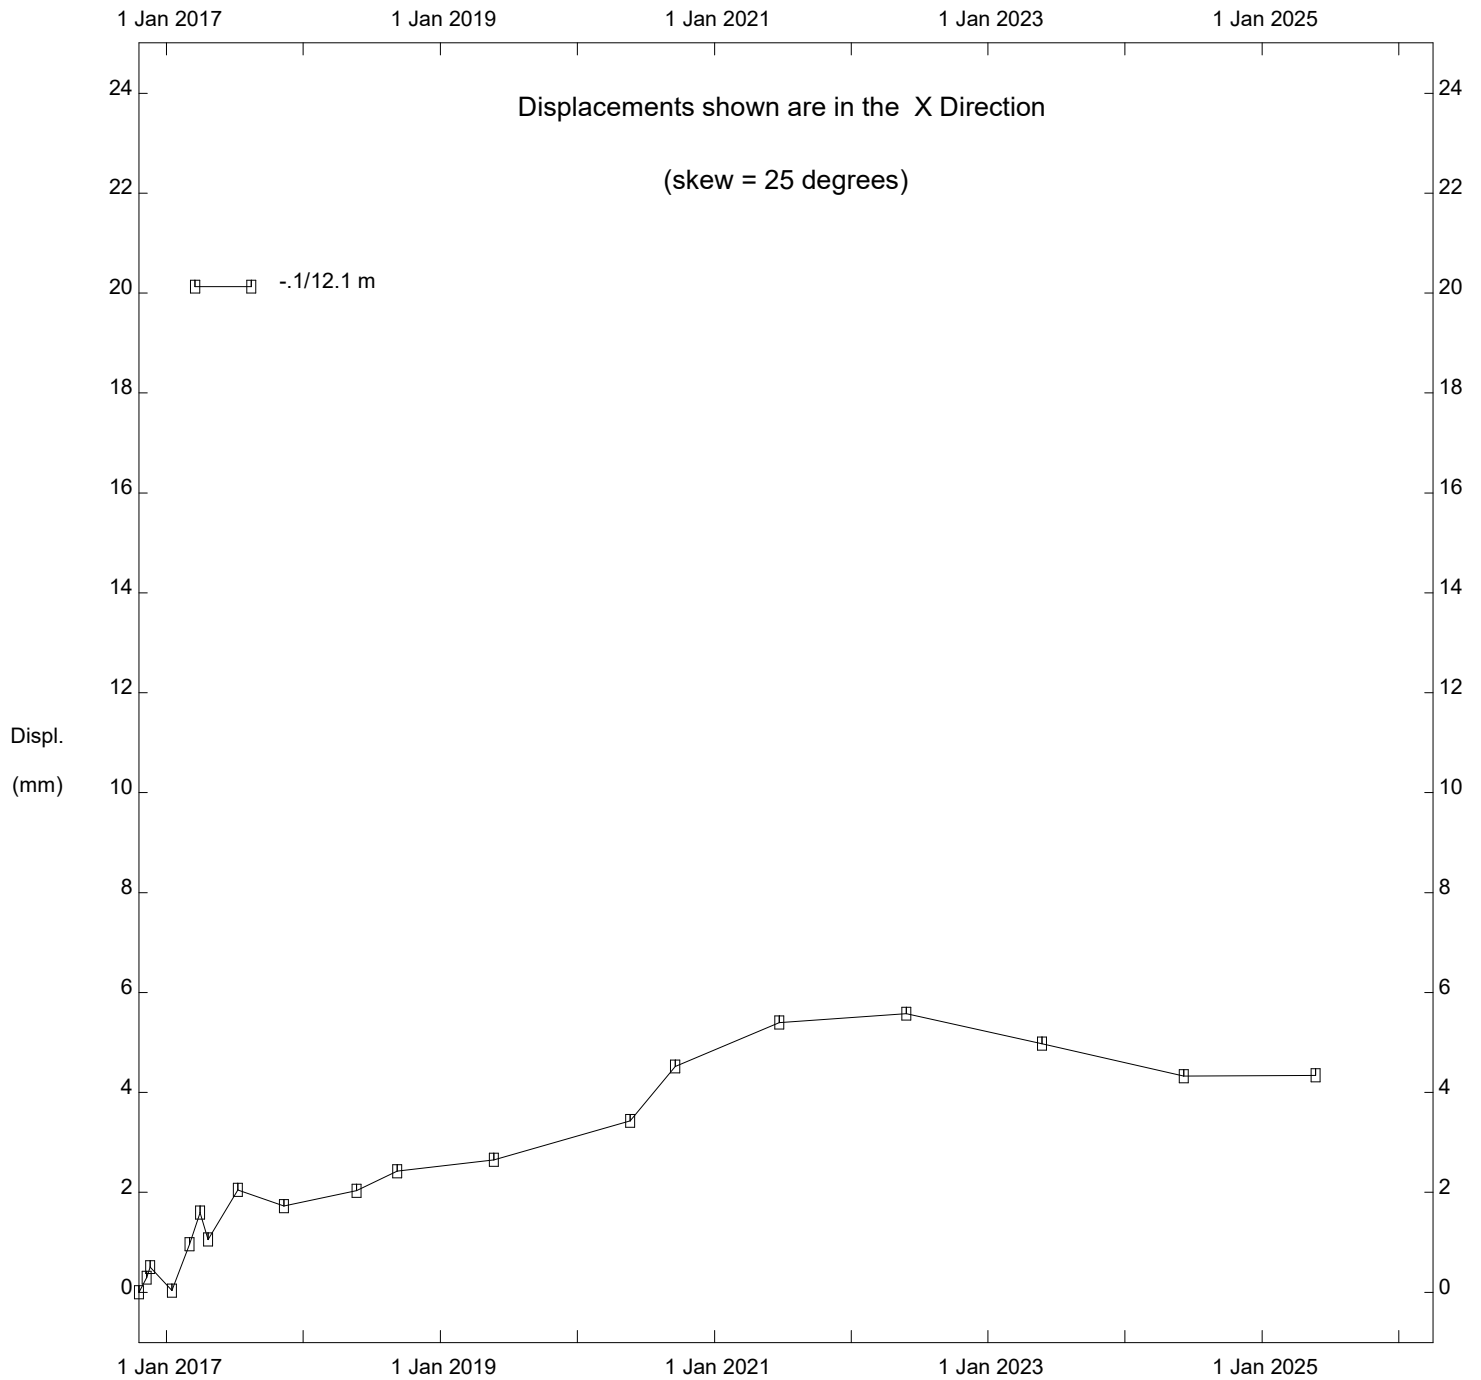
Hwy 41:23 Kehiwin Lake (NC102), Inclinometer SI16-2 (P08)

| INSTRUMENT # | DATE INITIALIZED | TOTAL CUMULATIVE RESULTANT MOVEMENT AND DEPTH OF MOVEMENT TO DATE (mm) | MAXIMUM RATE OF MOVEMENT (mm/yr) | CURRENT STATUS OF SI | DATE OF PREVIOUS READING | INCREMENTAL MOVEMENT SINCE PREVIOUS READING (mm) | CURRENT RATE OF MOVEMENT (mm/yr) | CHANGE IN RATE OF MOVEMENT SINCE PREVIOUS READING (mm/yr) |
|---|---|---|---|---|---|---|---|---|
| SI16-2 (P08) | October 19, 2016 | 4.3 over 0.0 to 12.2 m depth in 323° direction | 8.9 in November 2016 | Operational | June 5, 2024 | <0.1 | <0.1 | 0.7 |

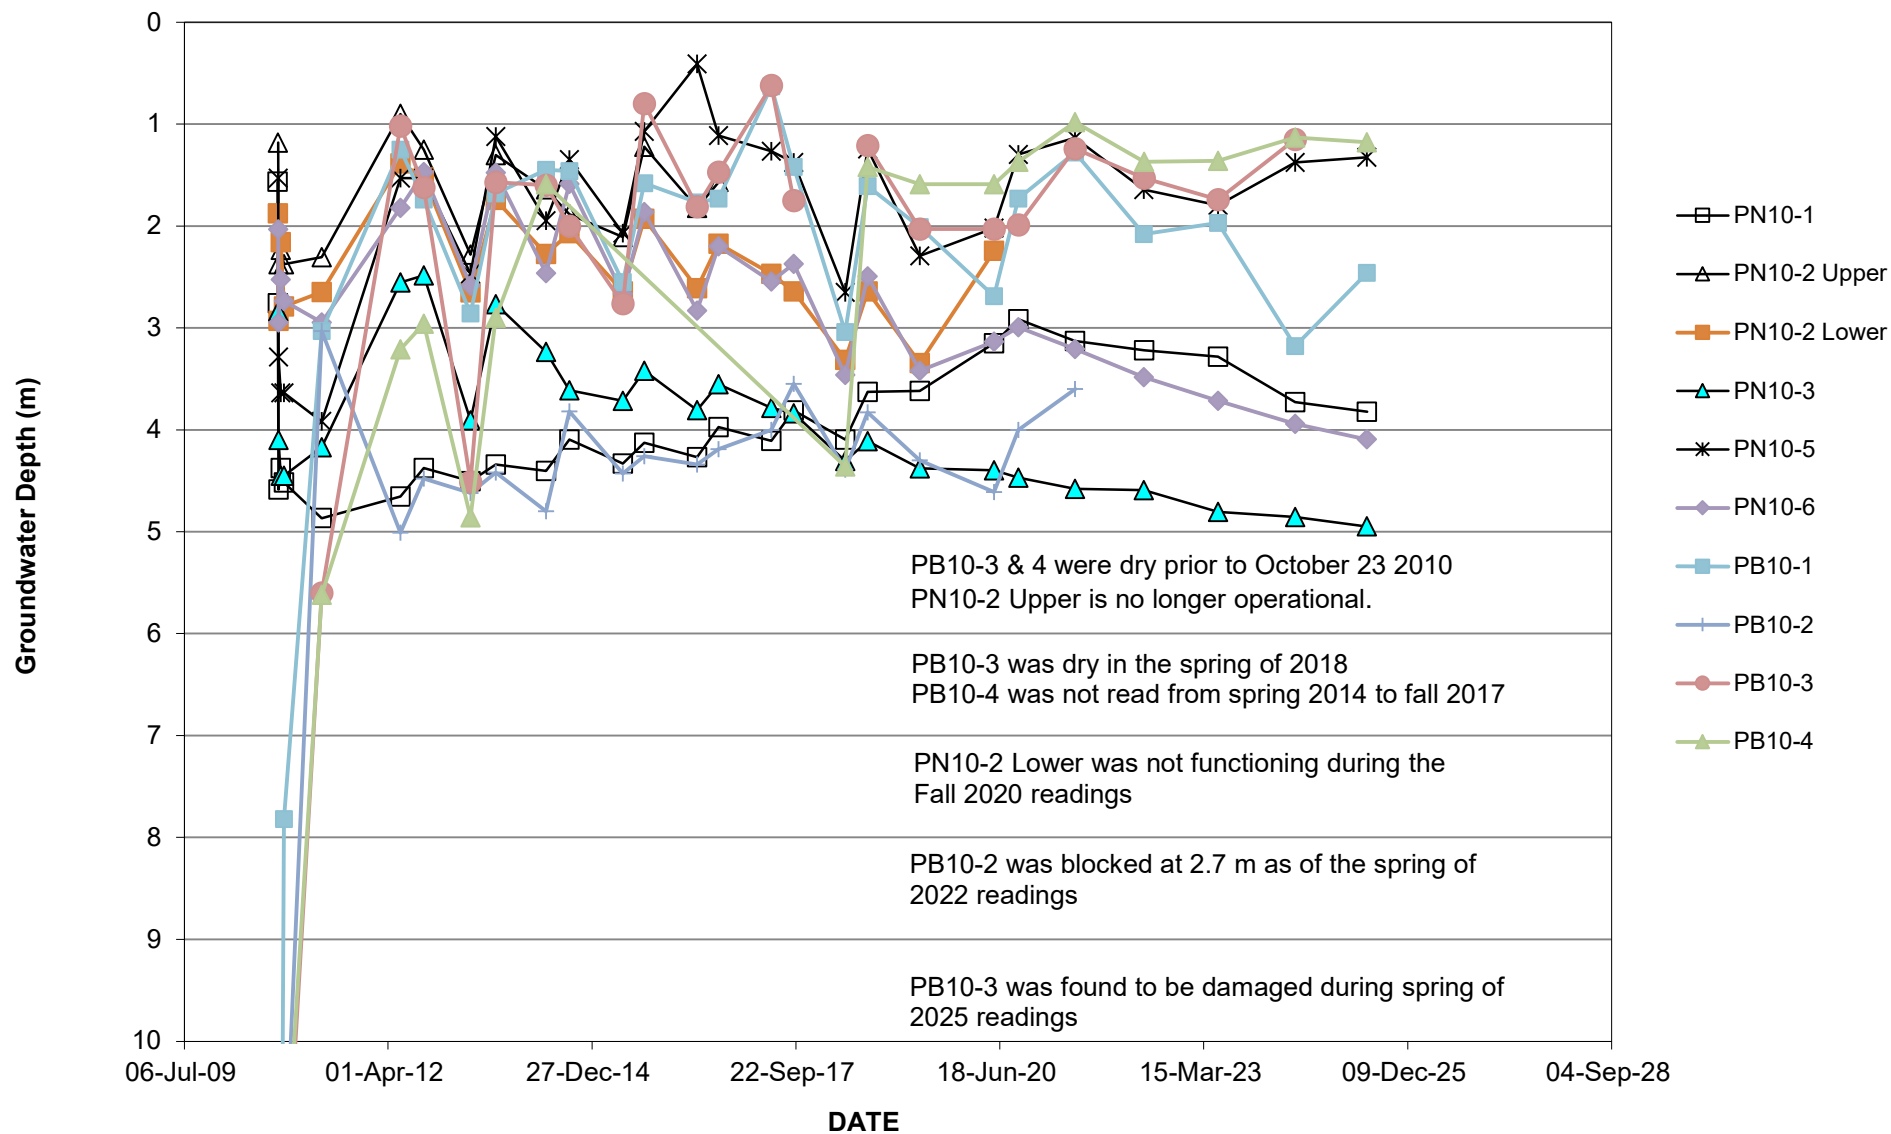
**FIGURE NC102-1**  
**PIEZOMETER DATA (2010 INSTRUMENTS) FOR NC024-2, KEHIWIN LAKE, km 8.89**

| INSTRUMENT # | DATE INITIALIZED | TIP DEPTH (m) | GROUND ELEV. (m) | CURRENT STATUS | HIGHEST MEASURED GROUNDWATER LEVEL BGS (m) | MEASURED PORE PRESSURE (kPa) | CURRENT GROUNDWATER LEVEL BGS (m) | PREVIOUS GROUNDWATER LEVEL BGS (m) | CHANGE IN WATER LEVEL SINCE PREVIOUS READING (m) |
|---|---|---|---|---|---|---|---|---|---|
| PN10-1 | October 7, 2010 | 5.9 | - | Active | 2.76 on October 8, 2010 | 20.6 | 3.82 | 3.73 | -0.09 |
| PN10-3 | October 10, 2010 | 10.0 | - | Active | 2.48 on September 24, 2012 | 49.6 | 4.95 | 4.86 | -0.09 |
| PN10-5 | October 9, 2010 | 4.8 | - | Active | 0.41 on May 26, 2016 | 33.7 | 1.33 | 1.38 | 0.05 |
| PN10-6 | October 9, 2010 | 9.9 | - | Active | 1.48 on September 12, 2013 | 57.0 | 4.09 | 3.94 | -0.15 |

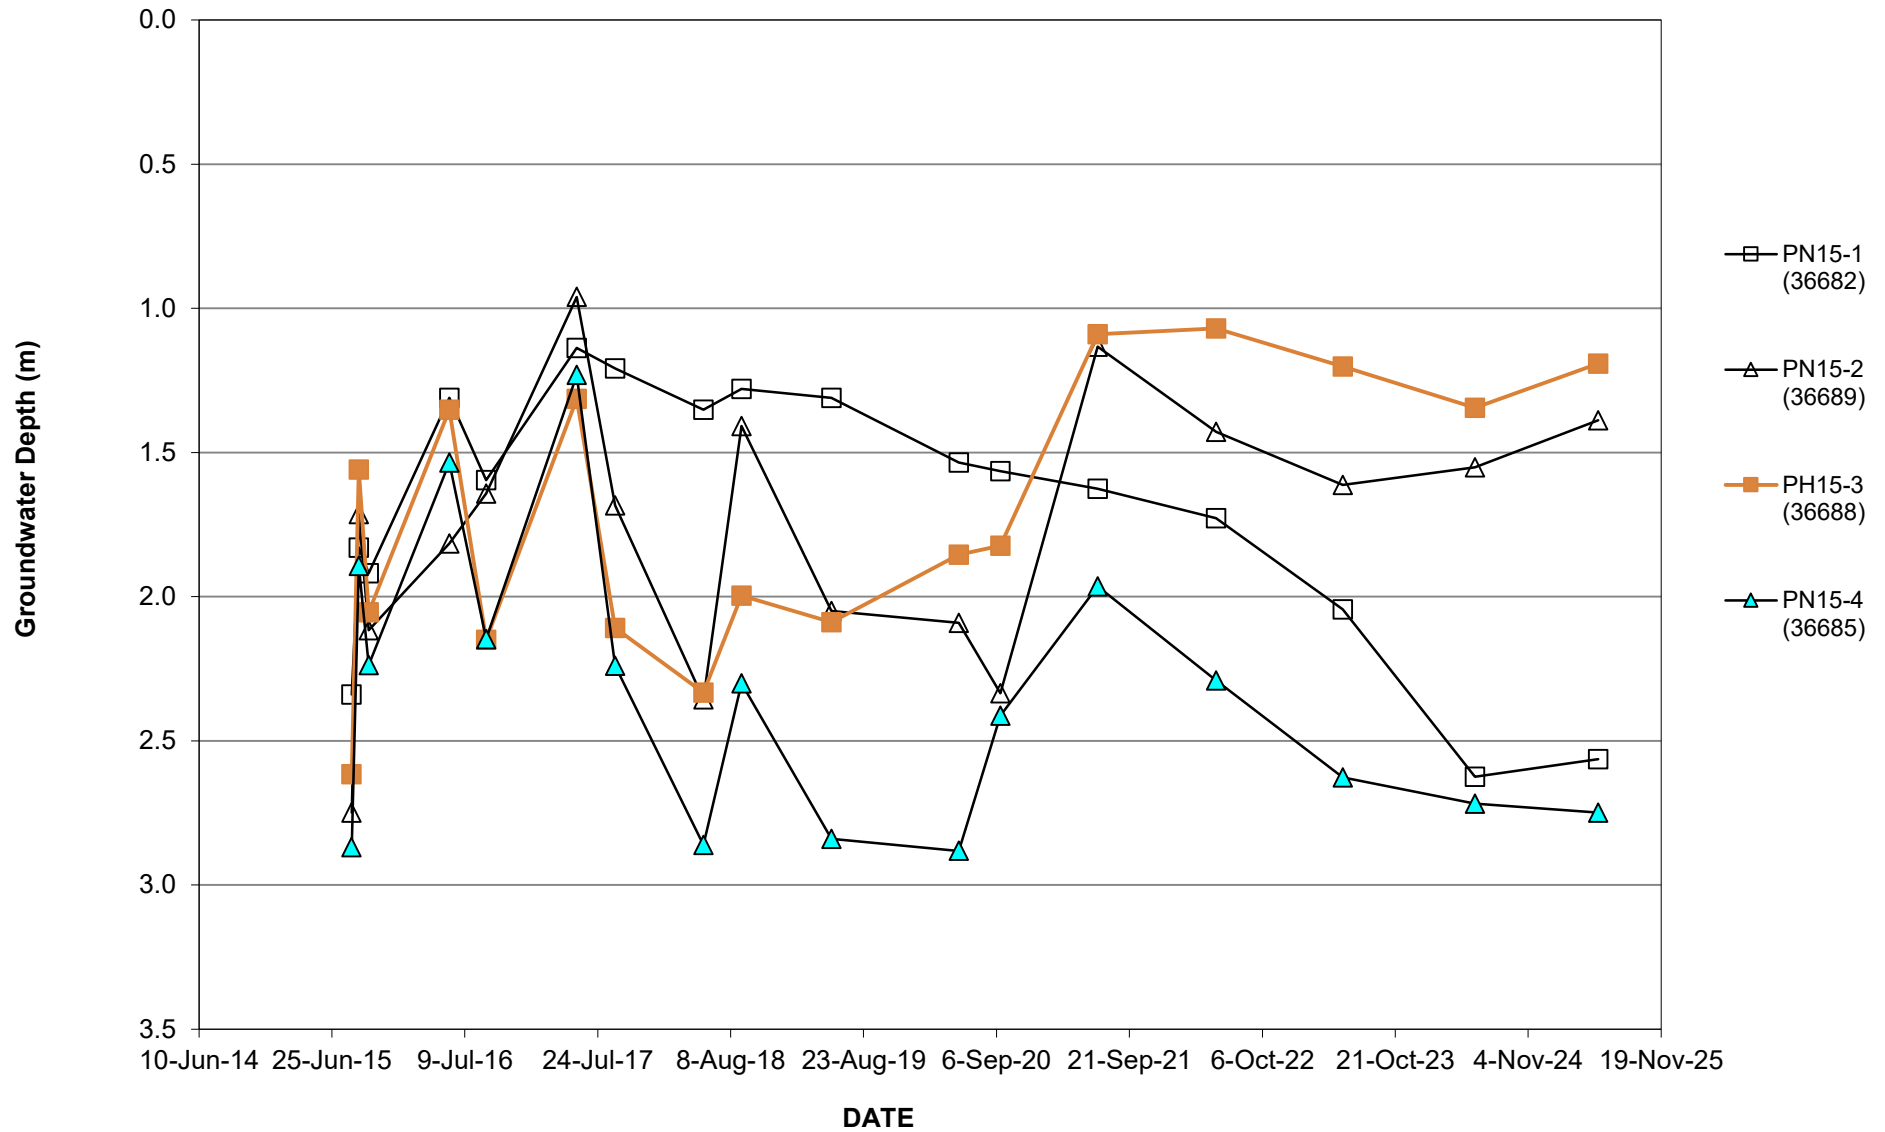
**FIGURE NC102-2**  
**PIEZOMETER DATA (2015 INSTRUMENTS) FOR NC024-2, KEHIWIN LAKE, km 8.89**

| INSTRUMENT # | DATE INITIALIZED | TIP DEPTH (m) | GROUND ELEV. (m) | CURRENT STATUS | HIGHEST MEASURED GROUNDWATER LEVEL BGS (m) | MEASURED PORE PRESSURE (kPa) | CURRENT GROUNDWATER LEVEL BGS (m) | PREVIOUS GROUNDWATER LEVEL BGS (m) | CHANGE IN WATER LEVEL SINCE PREVIOUS READING (m) |
|---|---|---|---|---|---|---|---|---|---|
| PN15-1 | August 20, 2015 | 8.4 | - | Active | 1.14 on May 25, 2017 | 57.1 | 2.56 | 2.62 | 0.06 |
| PN15-2 | August 20, 2015 | 9.1 | - | Active | 0.96 on May 25, 2017 | 76.1 | 1.39 | 1.55 | 0.16 |
| PN15-3 | August 20, 2015 | 3.8 | - | Active | 1.07 on May 27, 2022 | 25.7 | 1.19 | 1.34 | 0.15 |
| PN15-4 | August 20, 2015 | 6.1 | - | Active | 1.23 on May 25, 2017 | 32.9 | 2.75 | 2.72 | -0.03 |
