**ALBERTA TRANSPORTATION AND  
ECONOMIC CORRIDORS GRMP  
NORTH CENTRAL (ATHABASCA AND FORT  
McMURRAY DISTRICTS)  
INSTRUMENTATION MONITORING - FALL 2025**

| Site Number | Location | Name | Hwy | km |
|---|---|---|---|---|
| NC103<br>(NC024-3) | HWY 41:23 C1 7.89 | Kehiwin Lake | 41:23 | km 7.8 |

**SITE NC103**

**NORTH CENTRAL  
(ATHABASCA AND FORT MCMURRAY DISTRICTS)  
NC103: HWY41:23 KEHIWIN LAKE (km 7.8)  
SITE PLAN SHOWING APPROXIMATE  
INSTRUMENT LOCATIONS**

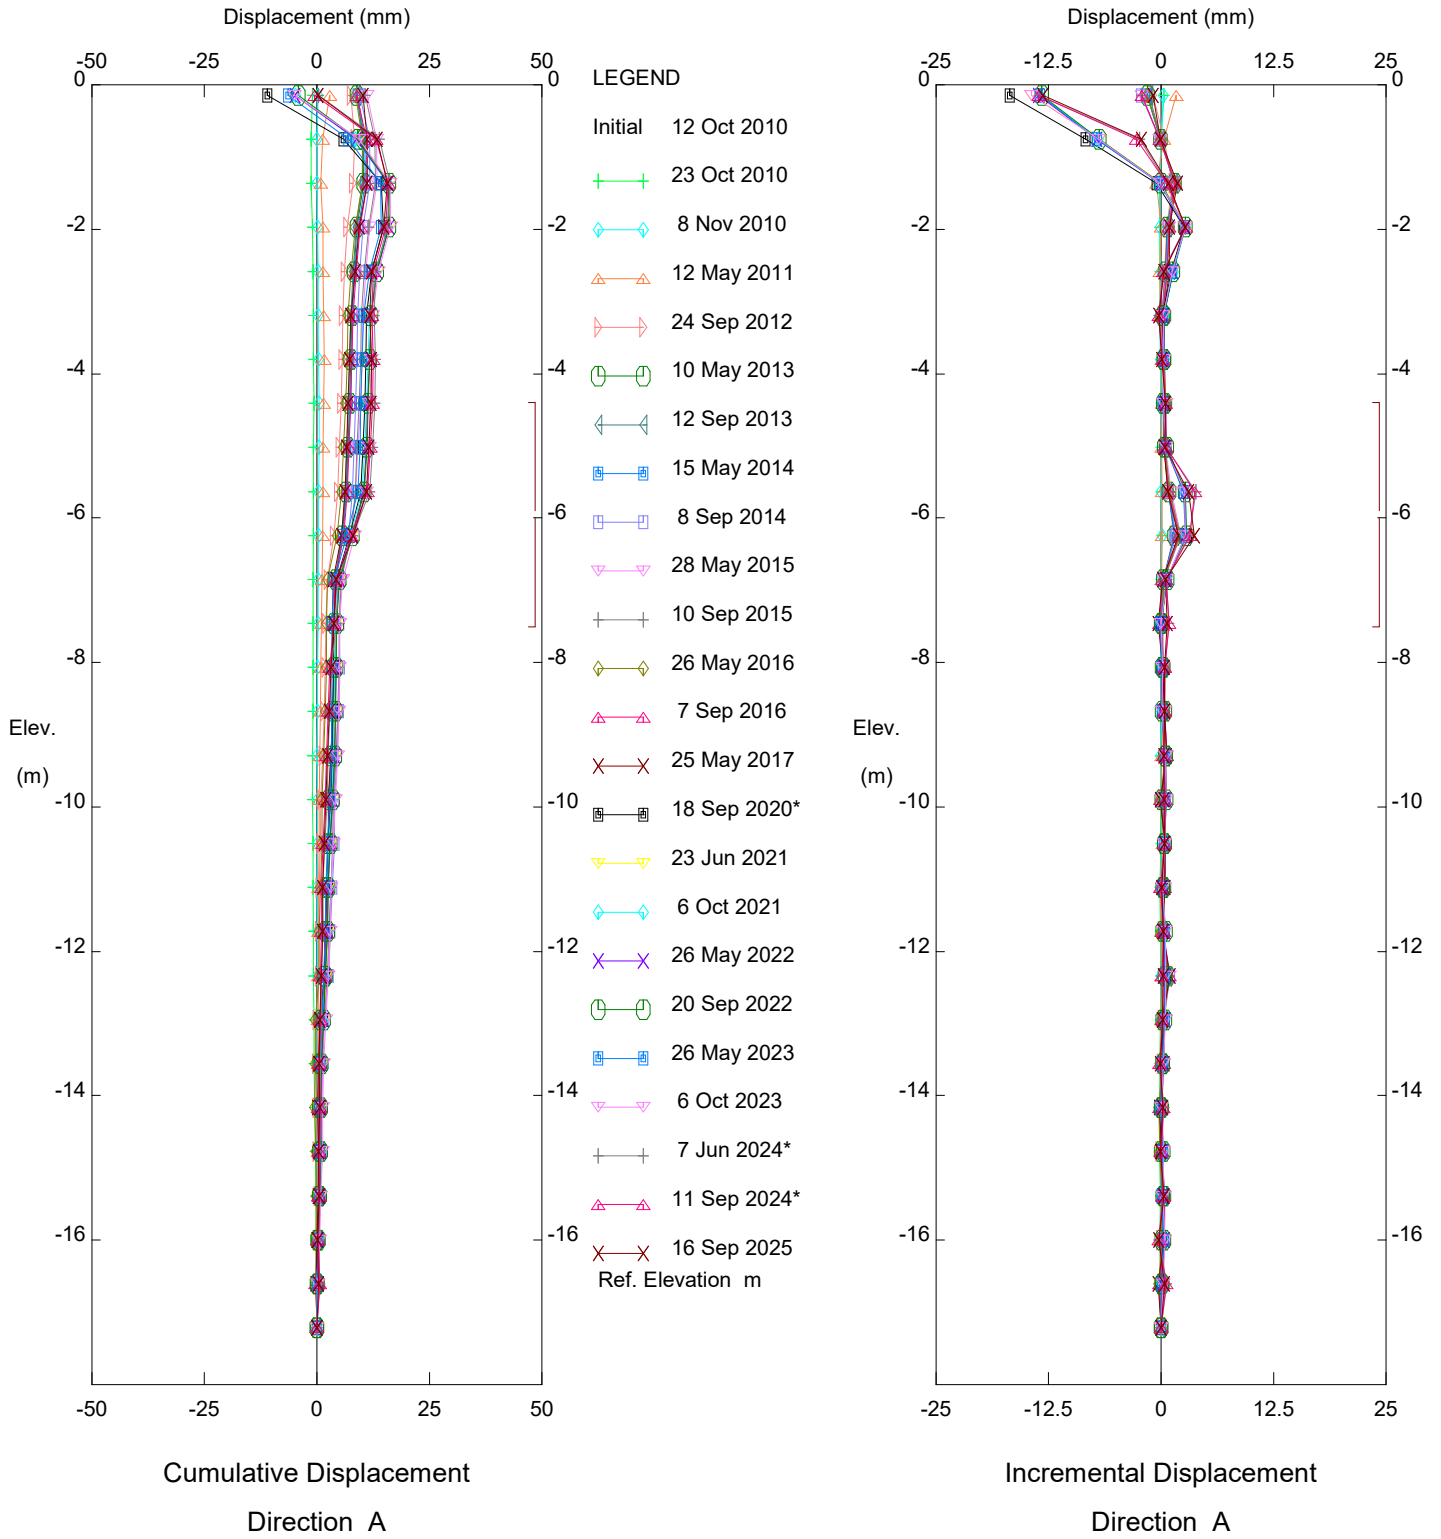
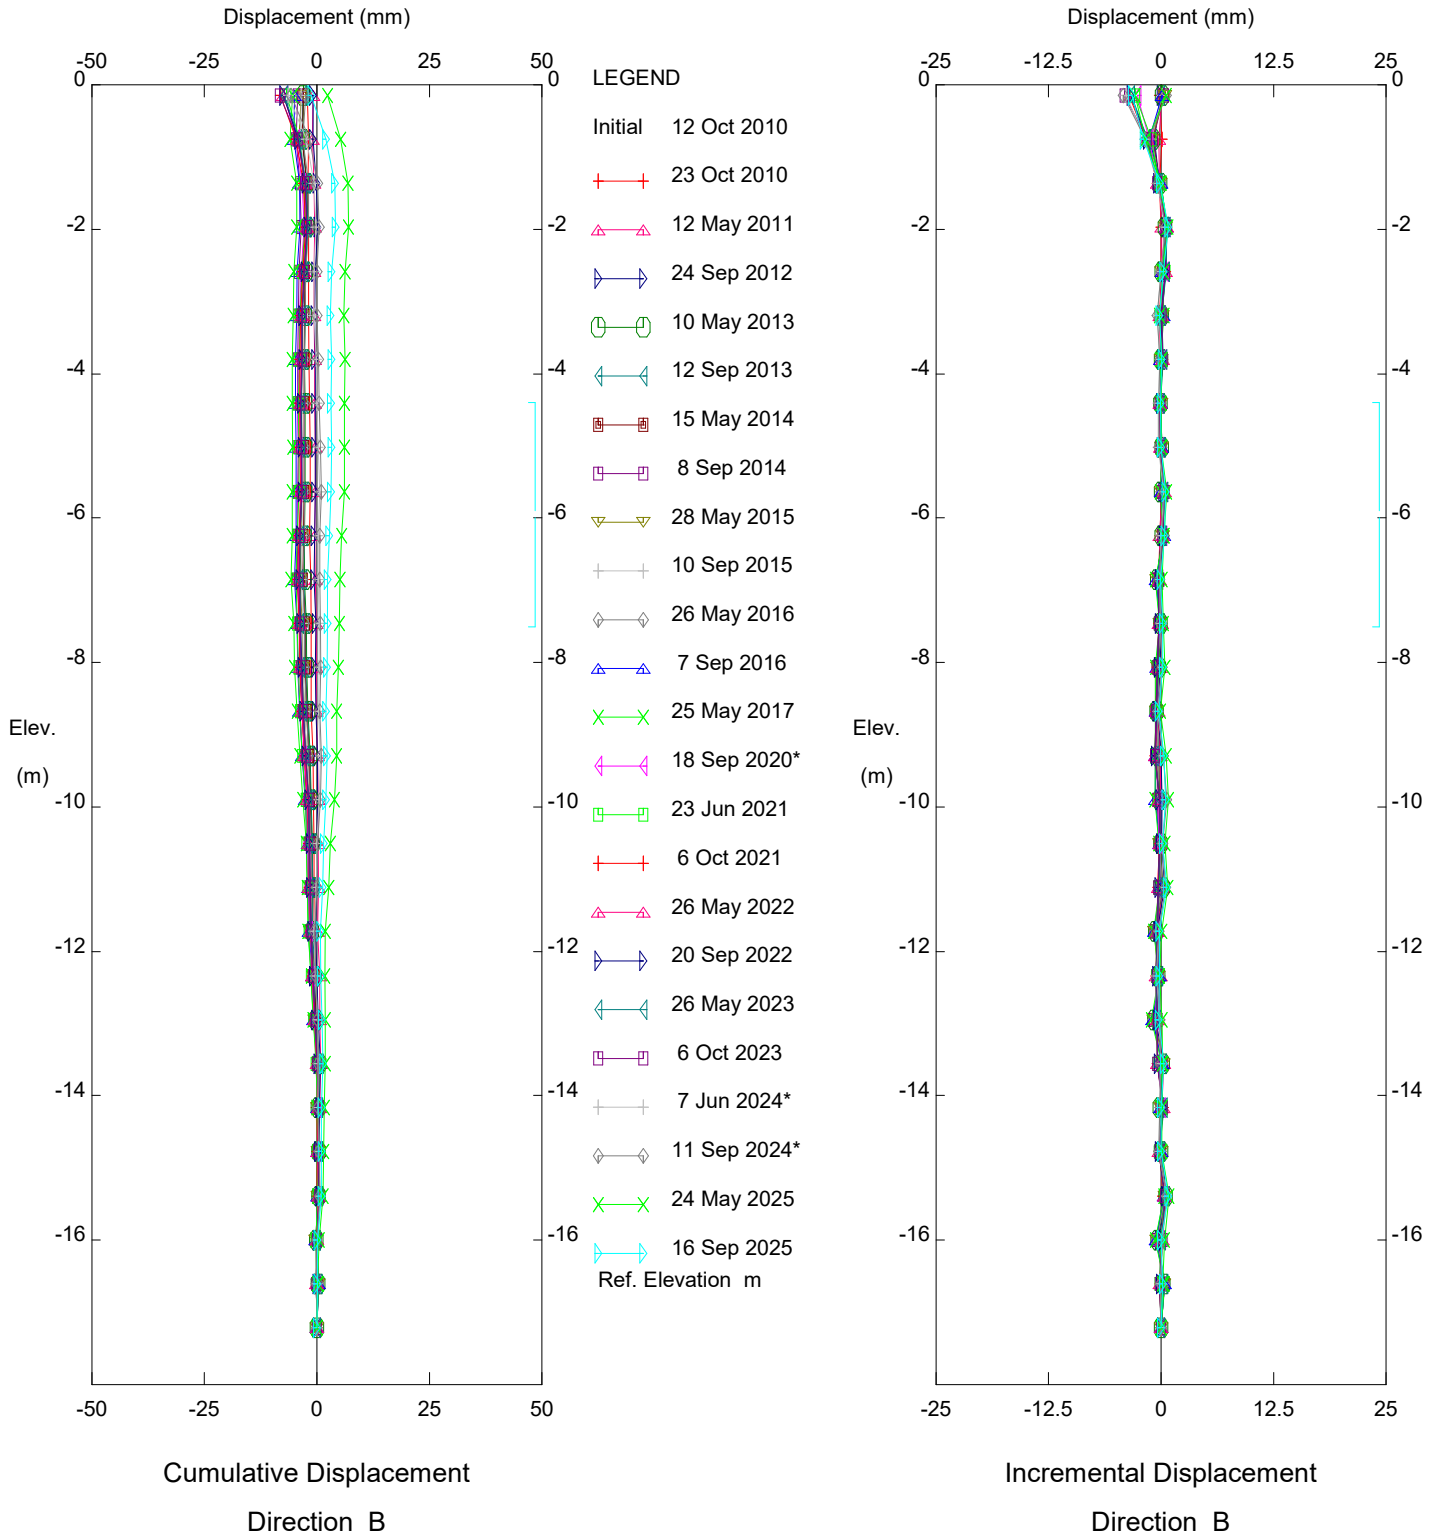
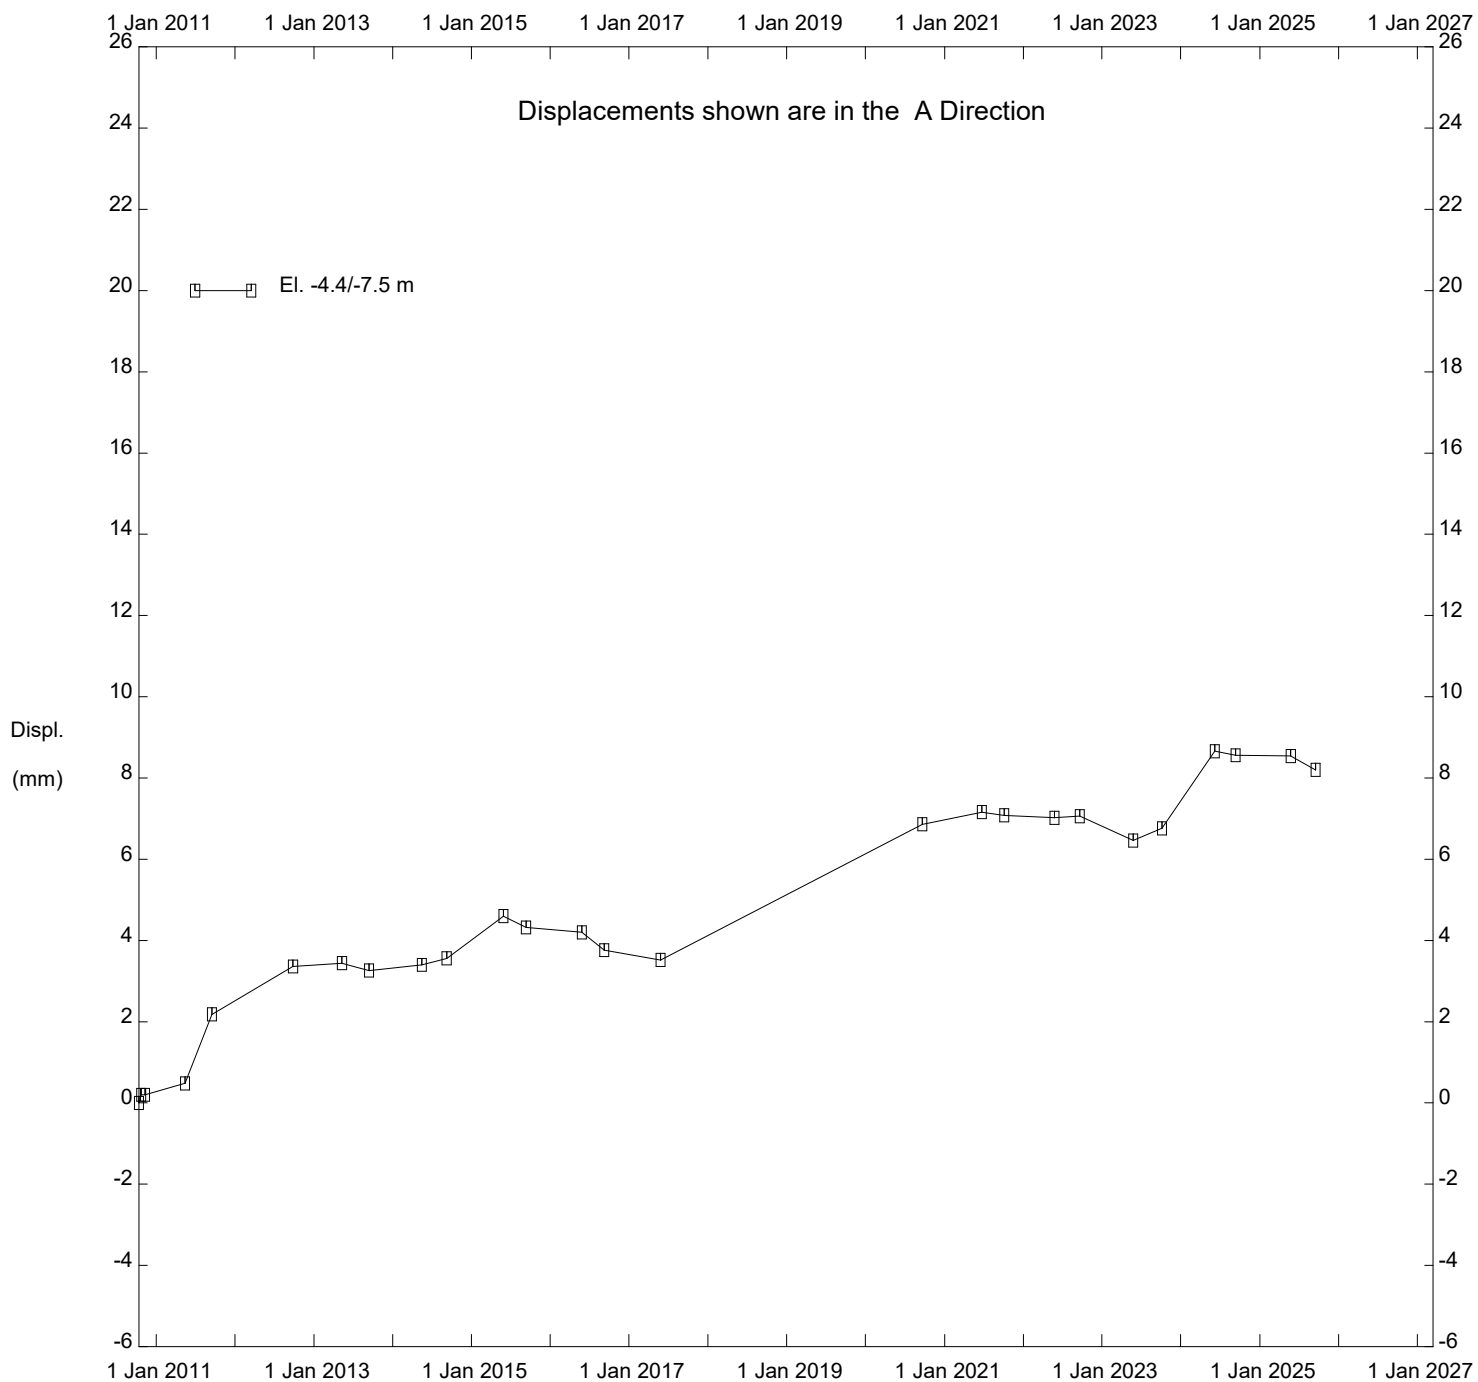
Hwy 41:23 Kehewin Lake (NC103), Inclinometer SI10-1

| INSTRUMENT # | DATE INITIALIZED | TOTAL CUMULATIVE RESULTANT MOVEMENT AND DEPTH OF MOVEMENT TO DATE (mm) | MAXIMUM RATE OF MOVEMENT (mm/yr) | CURRENT STATUS OF SI | DATE OF PREVIOUS READING | INCREMENTAL MOVEMENT SINCE PREVIOUS READING (mm) | CURRENT RATE OF MOVEMENT (mm/yr) | CHANGE IN RATE OF MOVEMENT SINCE PREVIOUS READING (mm/yr) |
|---|---|---|---|---|---|---|---|---|
| SI10-1 | Oct. 12, 2010 | 8.2 over 4.4 m to 7.5 m depth in 308° direction | 7.6 on Oct. 23, 2010 | Operational | May 24, 2025 | No discernible movement | N/A | -1.0 |

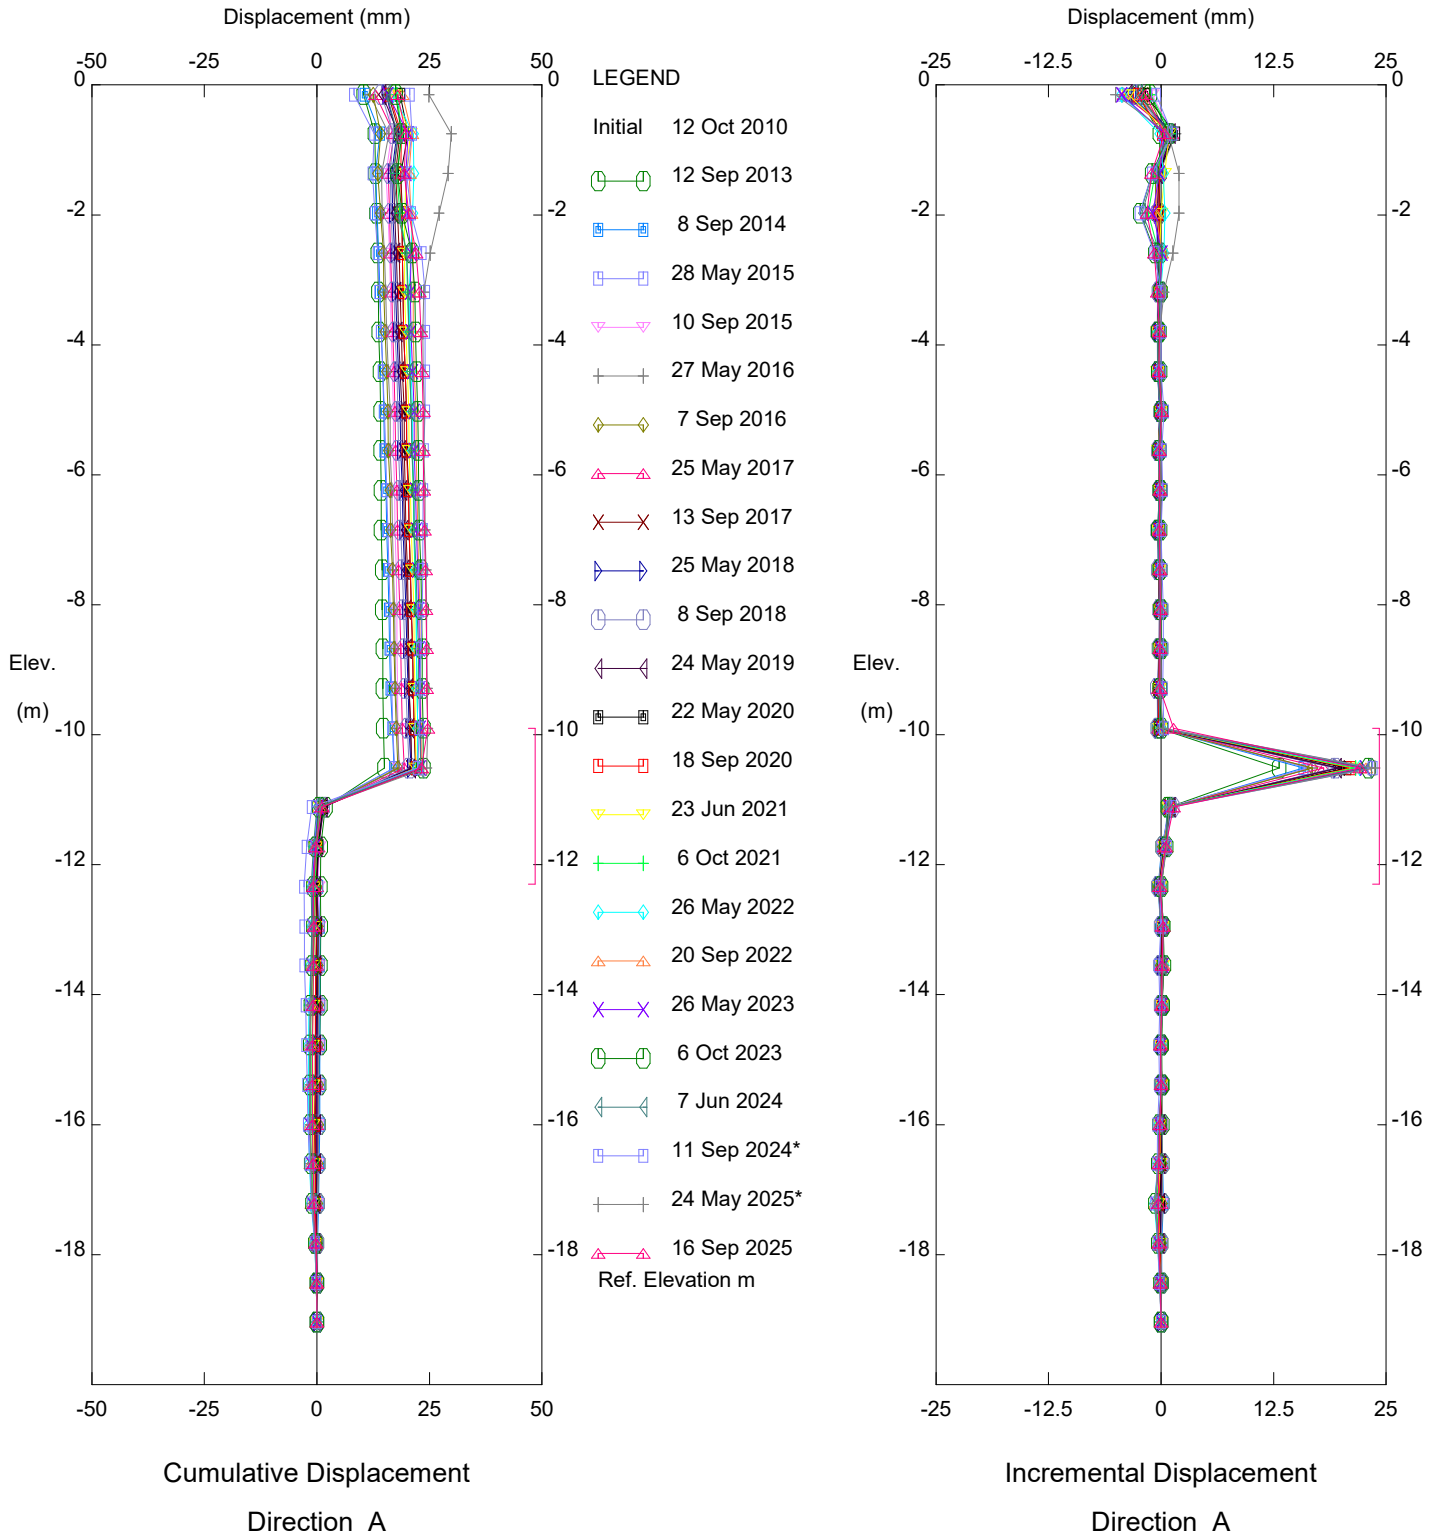
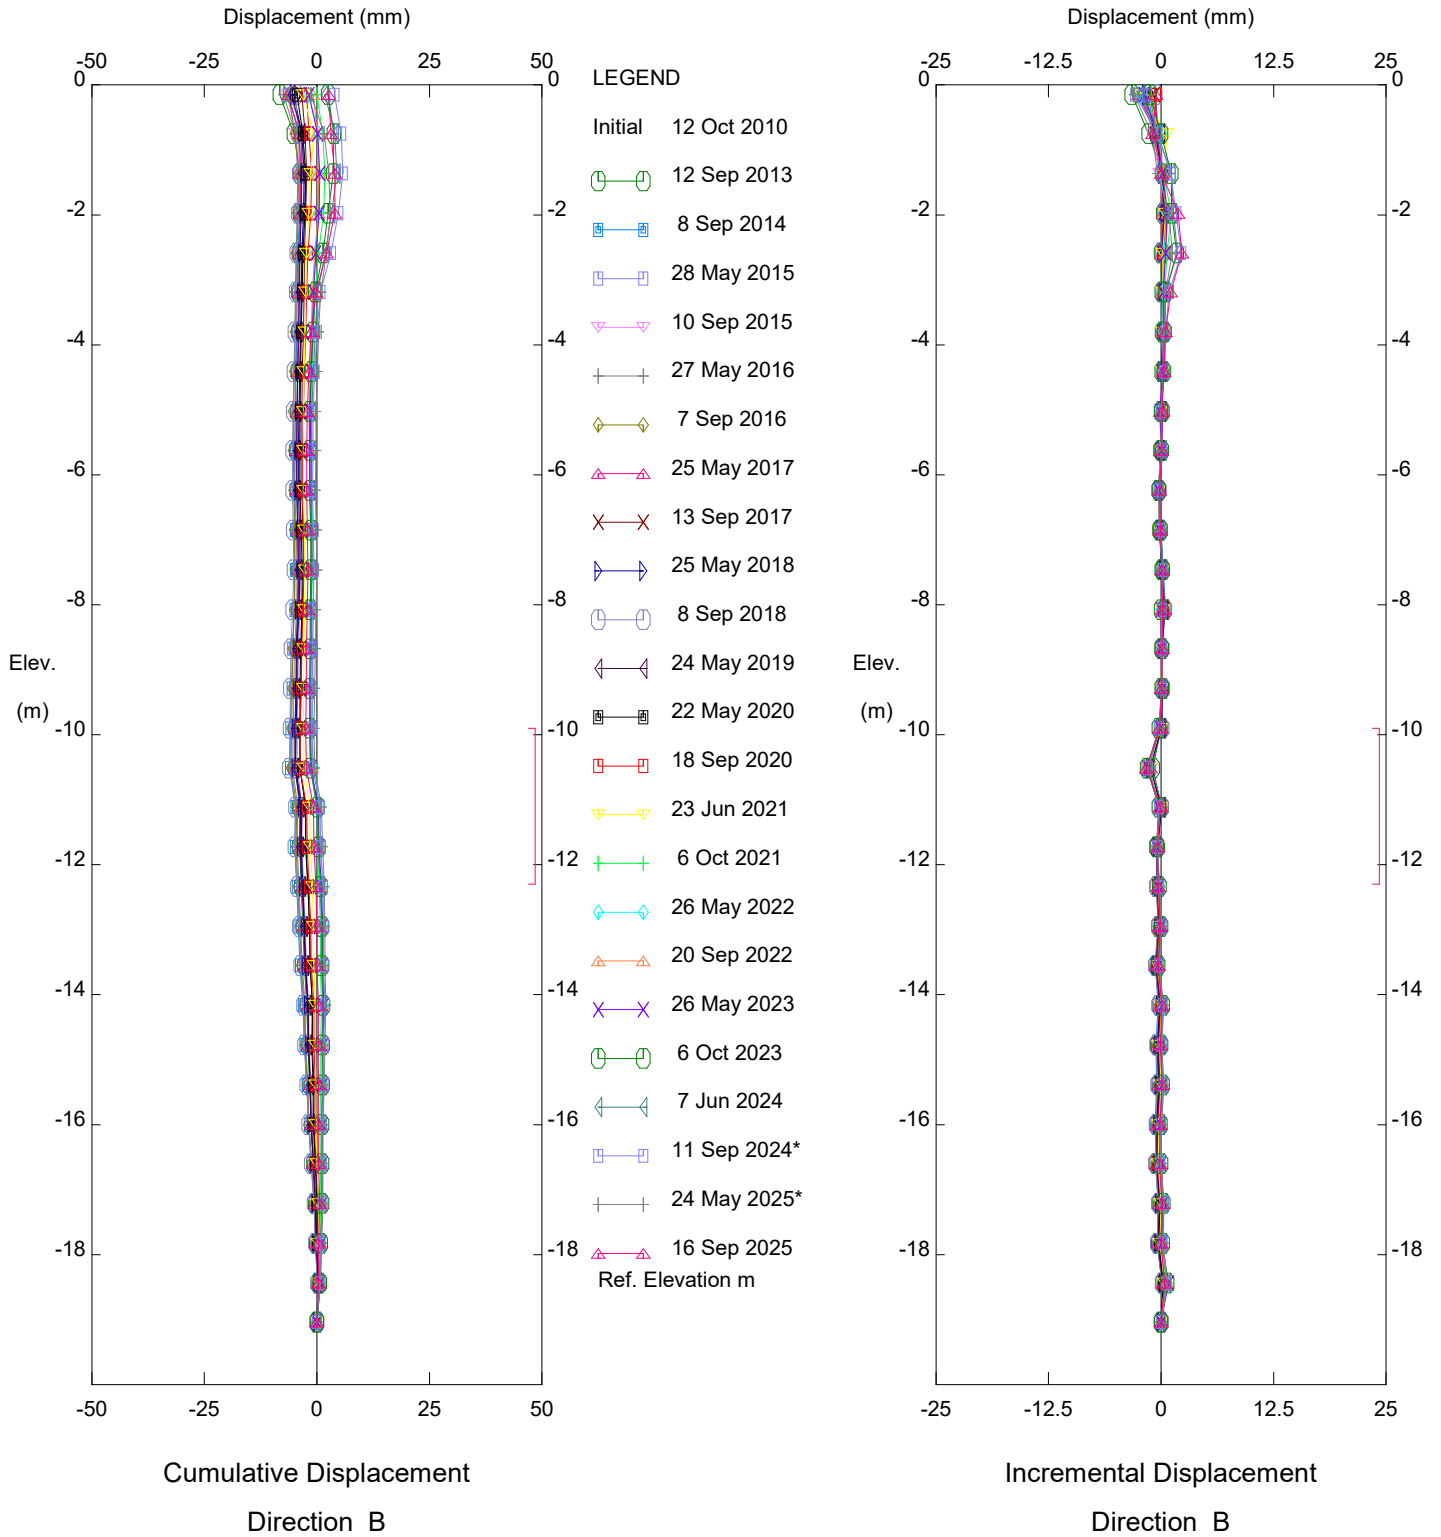
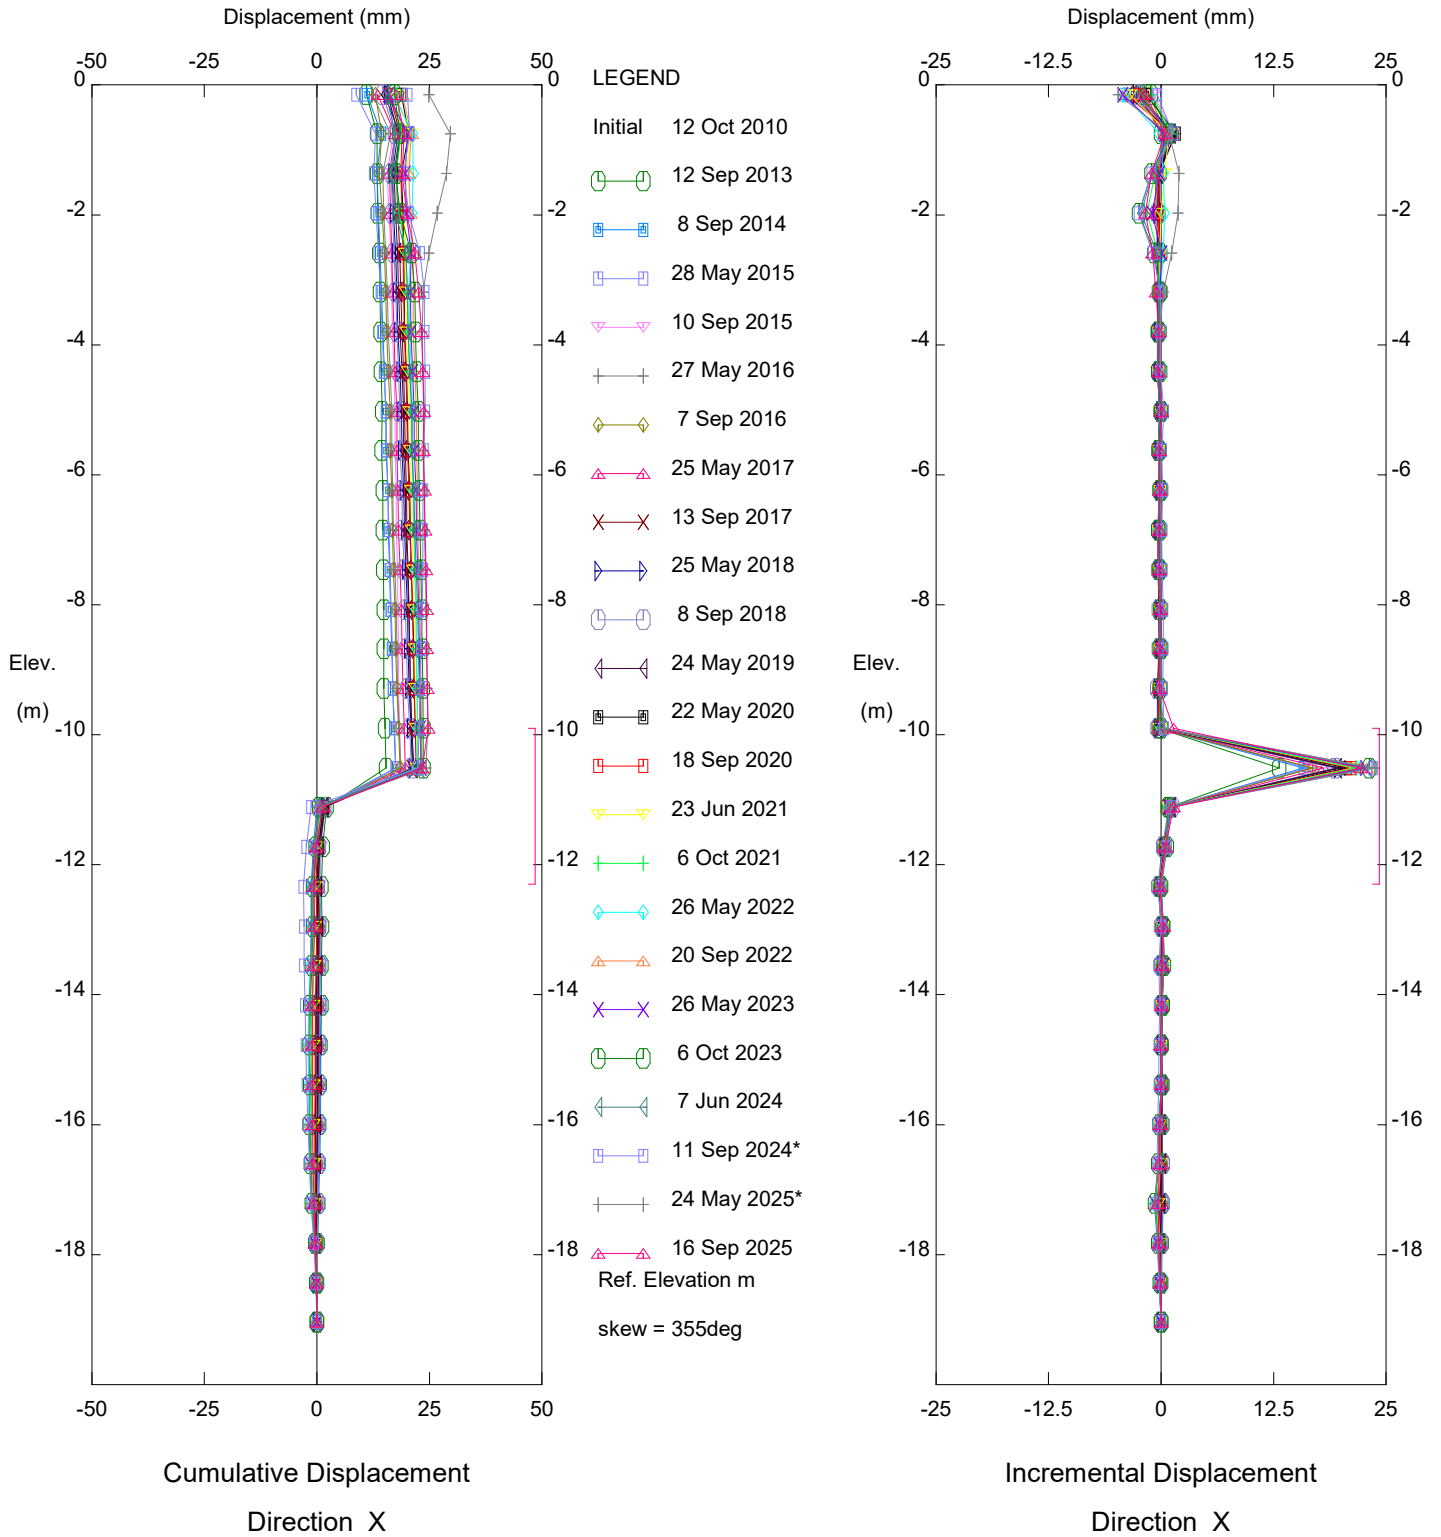
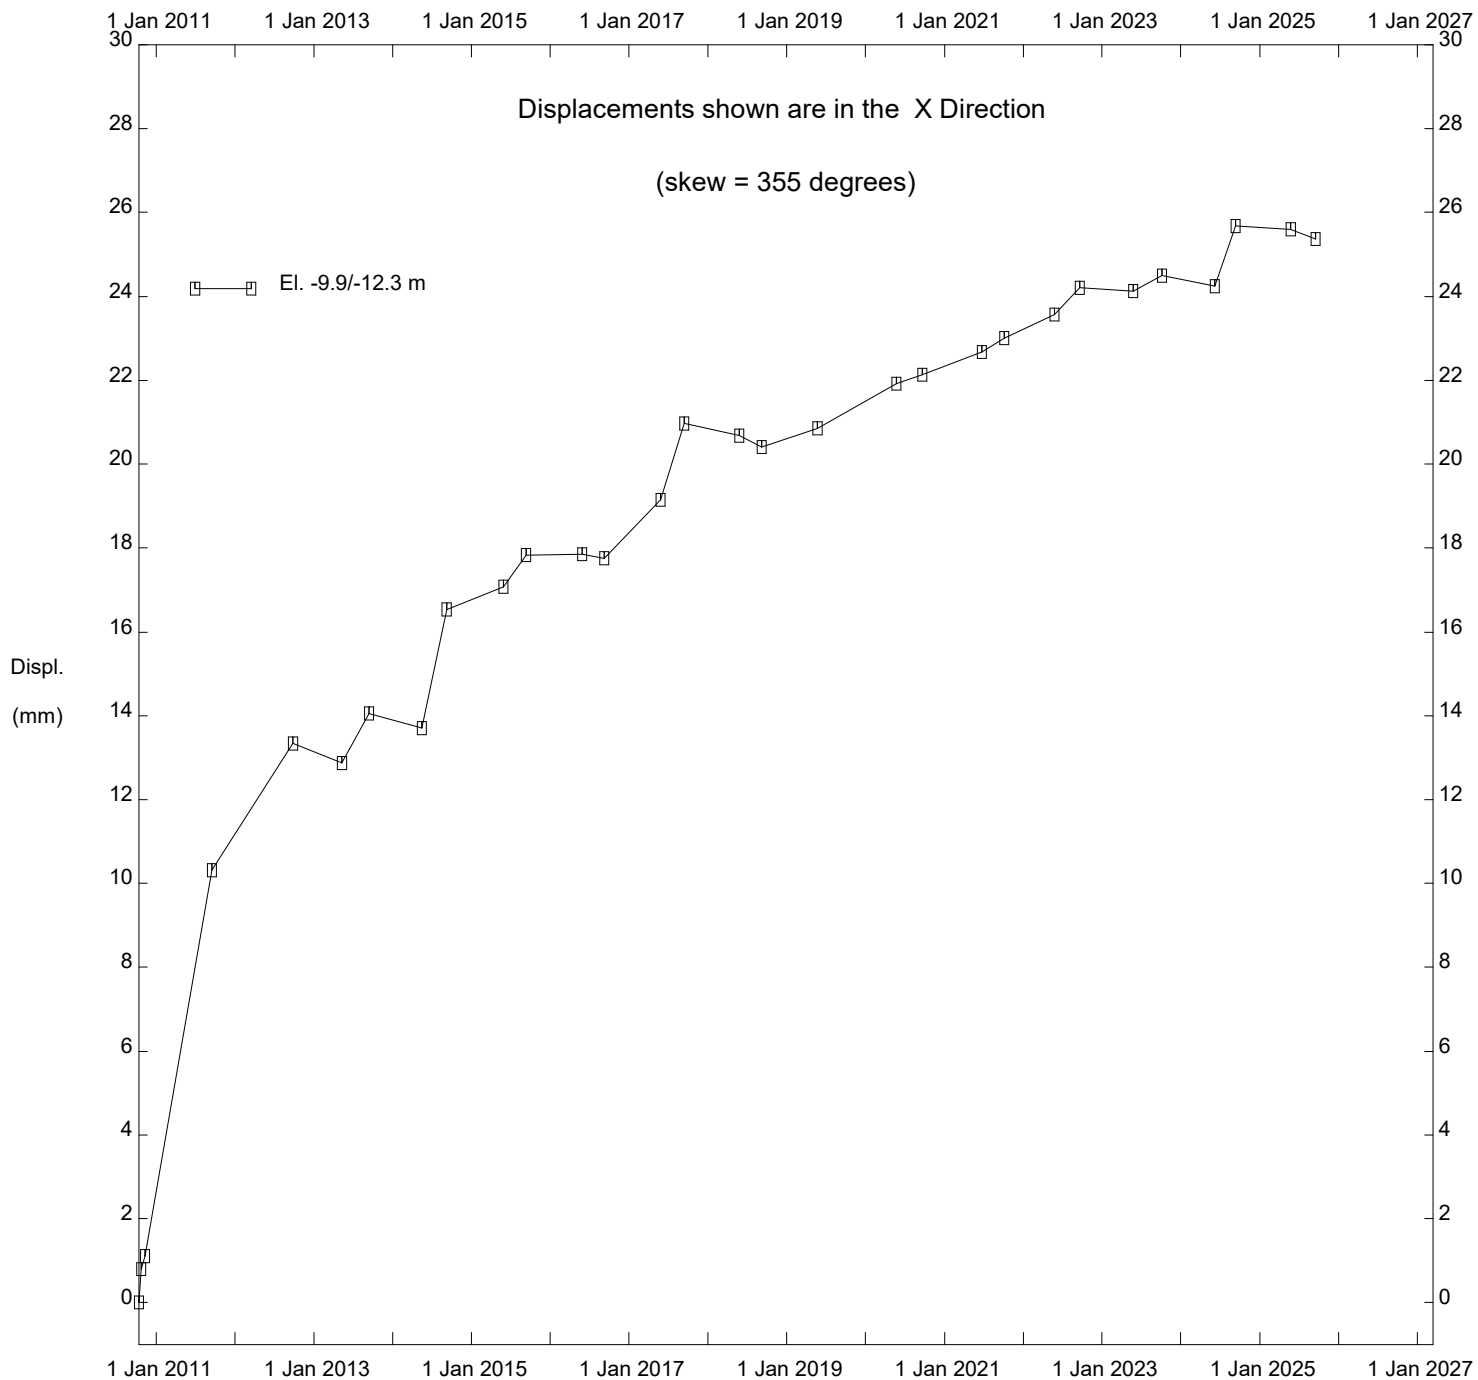
Hwy 41:23 Kehiwin Lake (NC103), Inclinometer SI10-3

| INSTRUMENT # | DATE INITIALIZED | TOTAL CUMULATIVE RESULTANT MOVEMENT AND DEPTH OF MOVEMENT TO DATE (mm) | MAXIMUM RATE OF MOVEMENT (mm/yr) | CURRENT STATUS OF SI | DATE OF PREVIOUS READING | INCREMENTAL MOVEMENT SINCE PREVIOUS READING (mm) | CURRENT RATE OF MOVEMENT (mm/yr) | CHANGE IN RATE OF MOVEMENT SINCE PREVIOUS READING (mm/yr) |
|---|---|---|---|---|---|---|---|---|
| SI10-3 | Oct. 12, 2010 | 25.4 over 9.9 m to 12.3 m depth in 291° direction | 26.5 on Oct. 23, 2010 | Operational | May 24, 2025 | No discernible movement | N/A | -0.6 |
