**ALBERTA TRANSPORTATION AND  
ECONOMIC CORRIDORS GRMP  
NORTH CENTRAL (ATHABASCA AND FORT  
McMURRAY DISTRICTS)  
INSTRUMENTATION MONITORING - FALL 2025**

| Site Number | Location | Name | Hwy | km |
|---|---|---|---|---|
| NC103<br>(NC024-3) | HWY 41:23 C1 7.89 | Kehiwin Lake | 41:23 | km 7.8 |

**SITE NC103**

**NORTH CENTRAL  
(ATHABASCA AND FORT MCMURRAY DISTRICTS)  
NC103: HWY41:23 KEHIWIN LAKE (km 7.8)  
SITE PLAN SHOWING APPROXIMATE  
INSTRUMENT LOCATIONS**

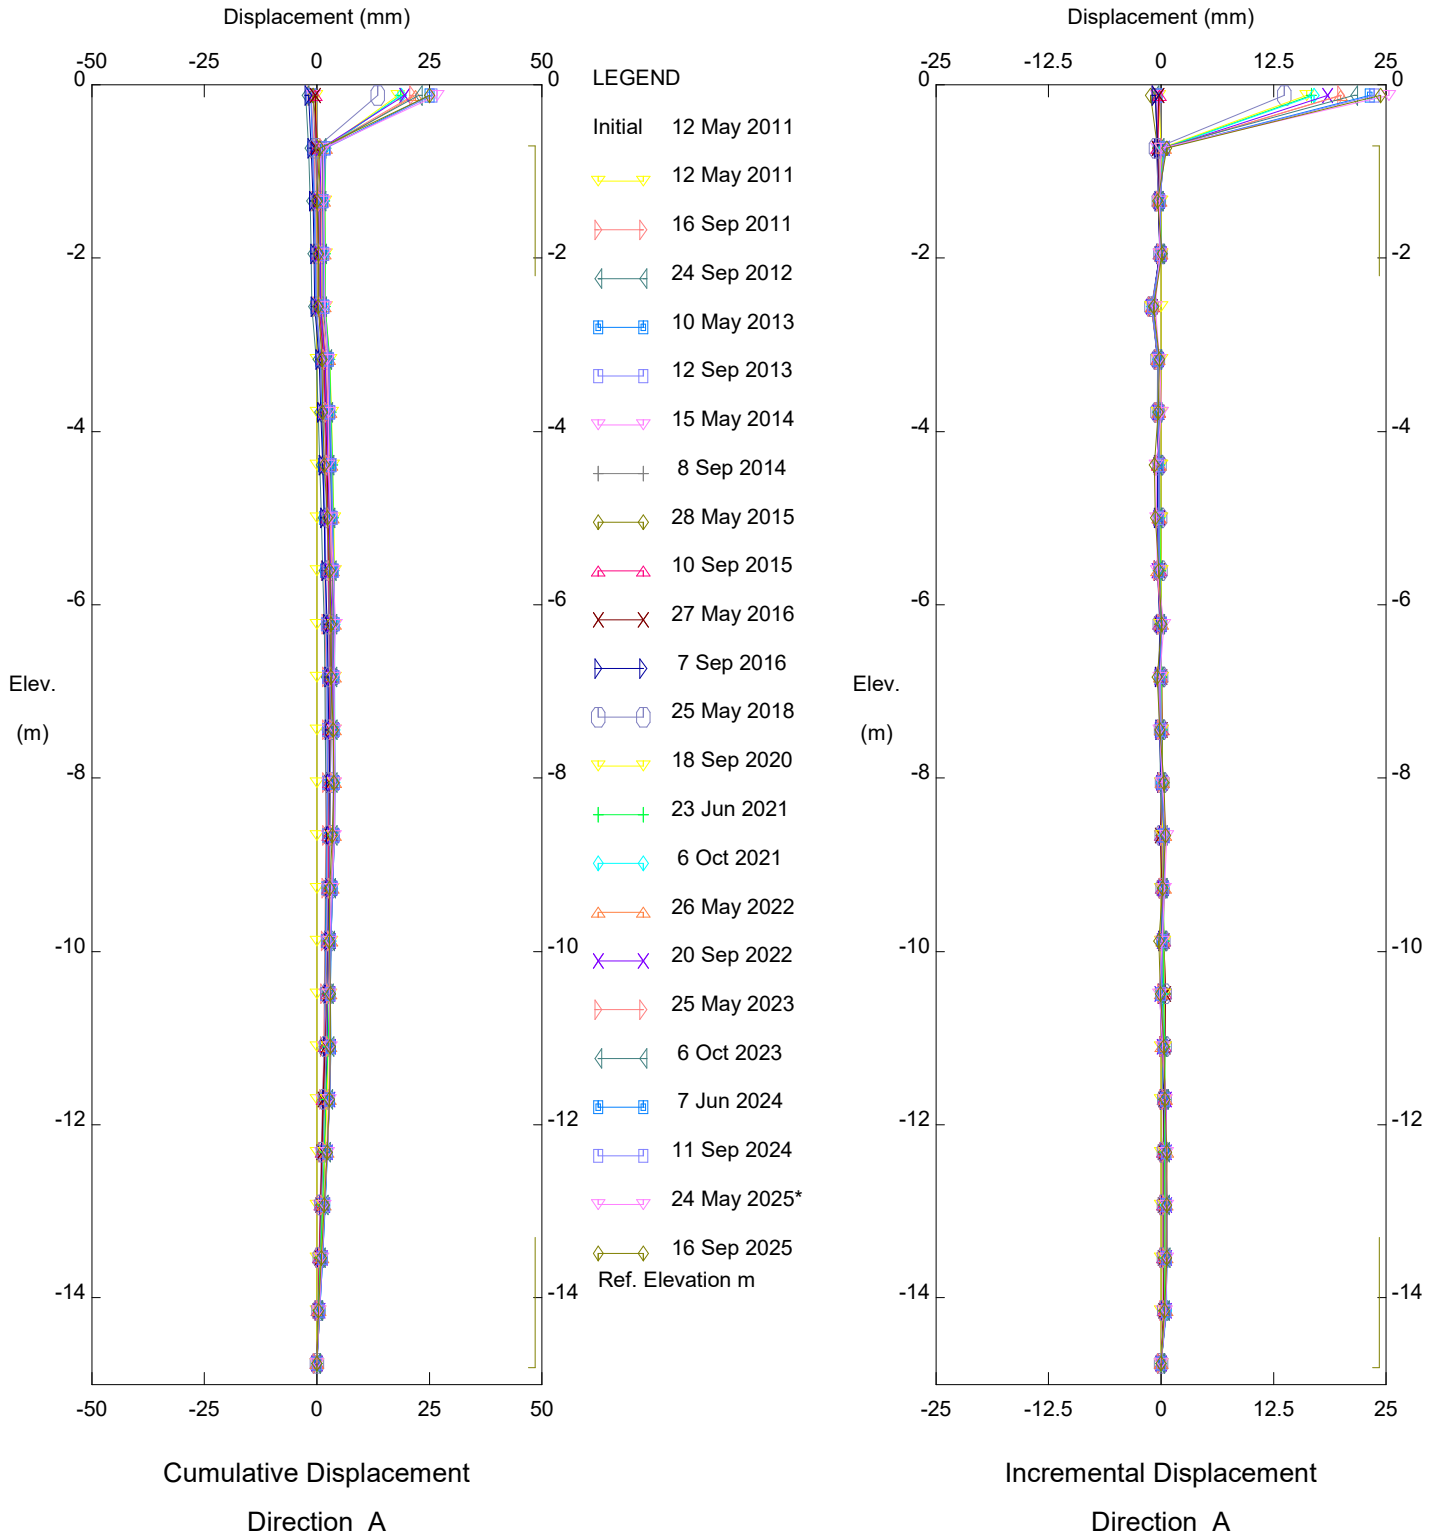
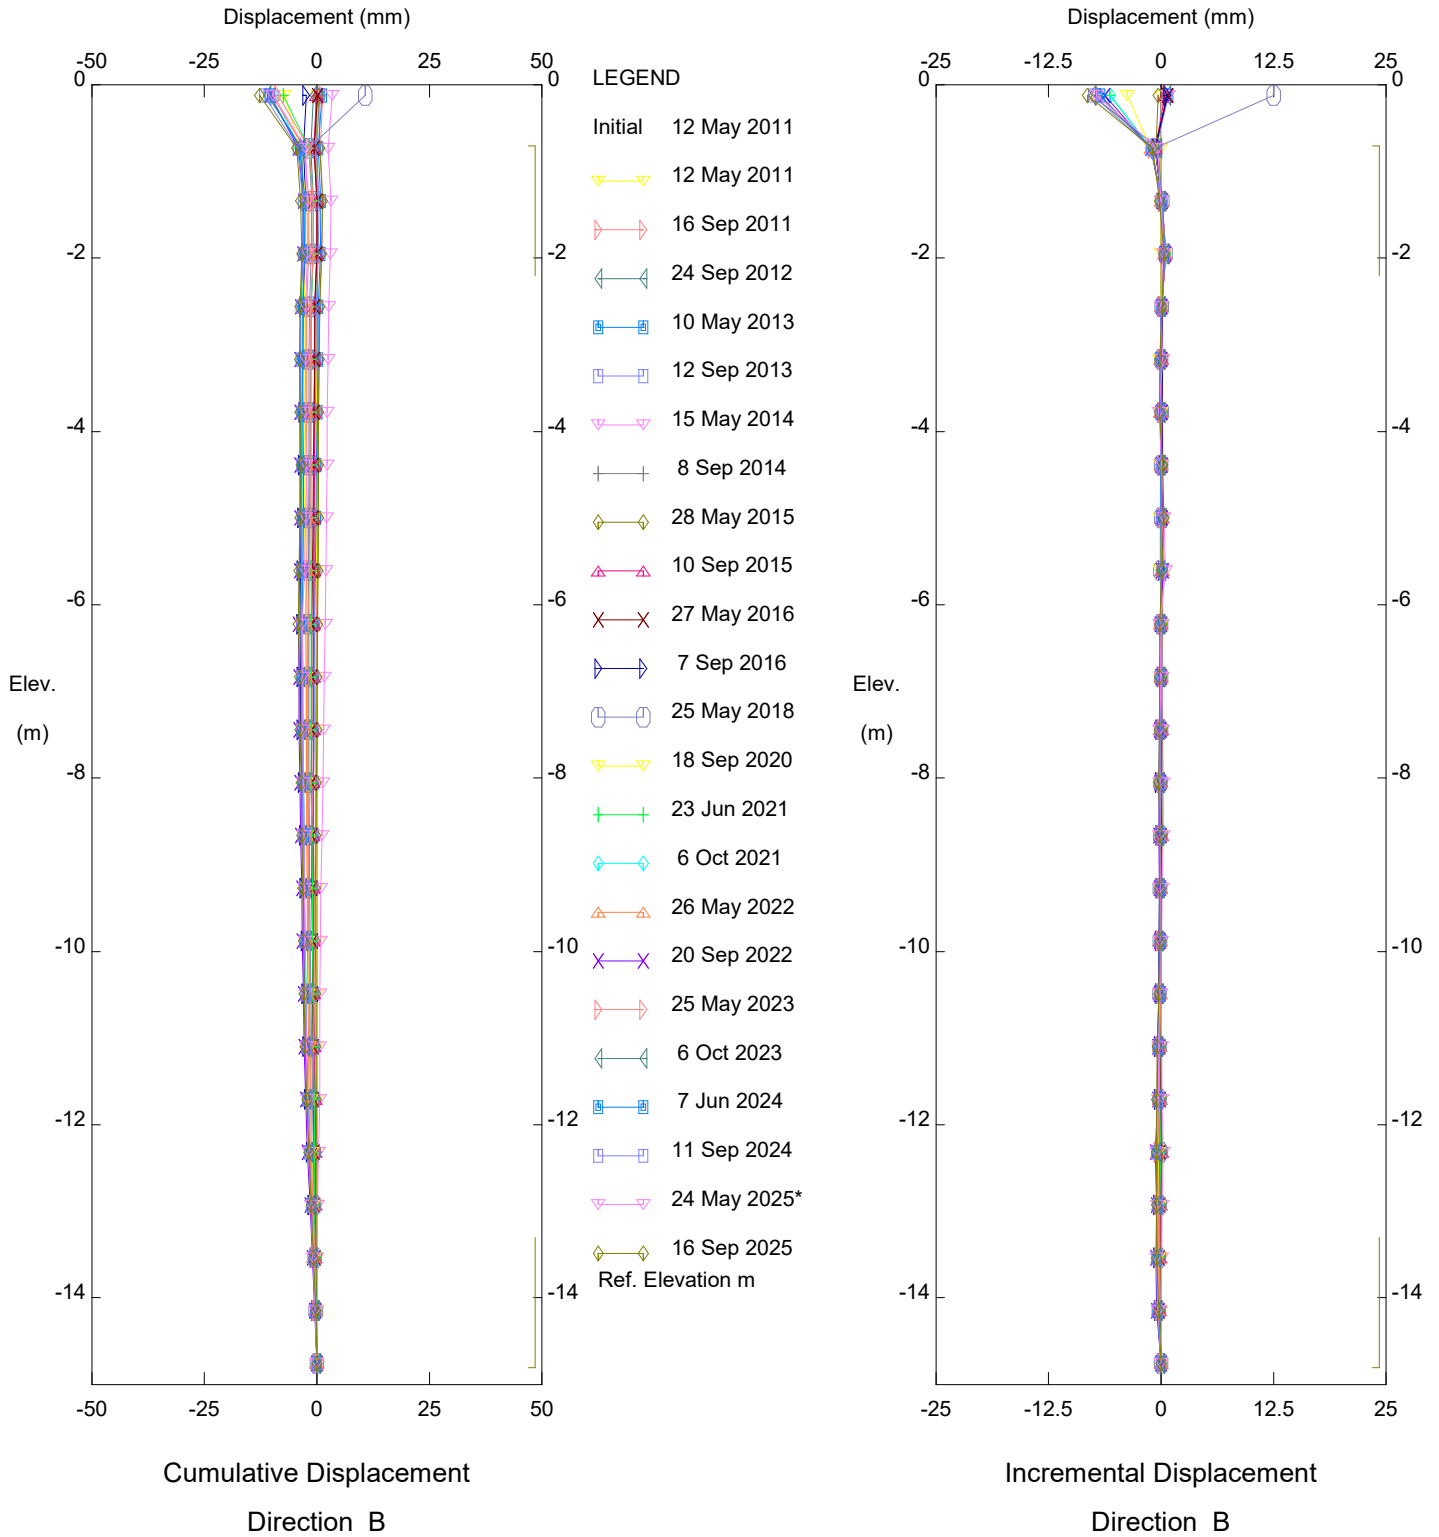
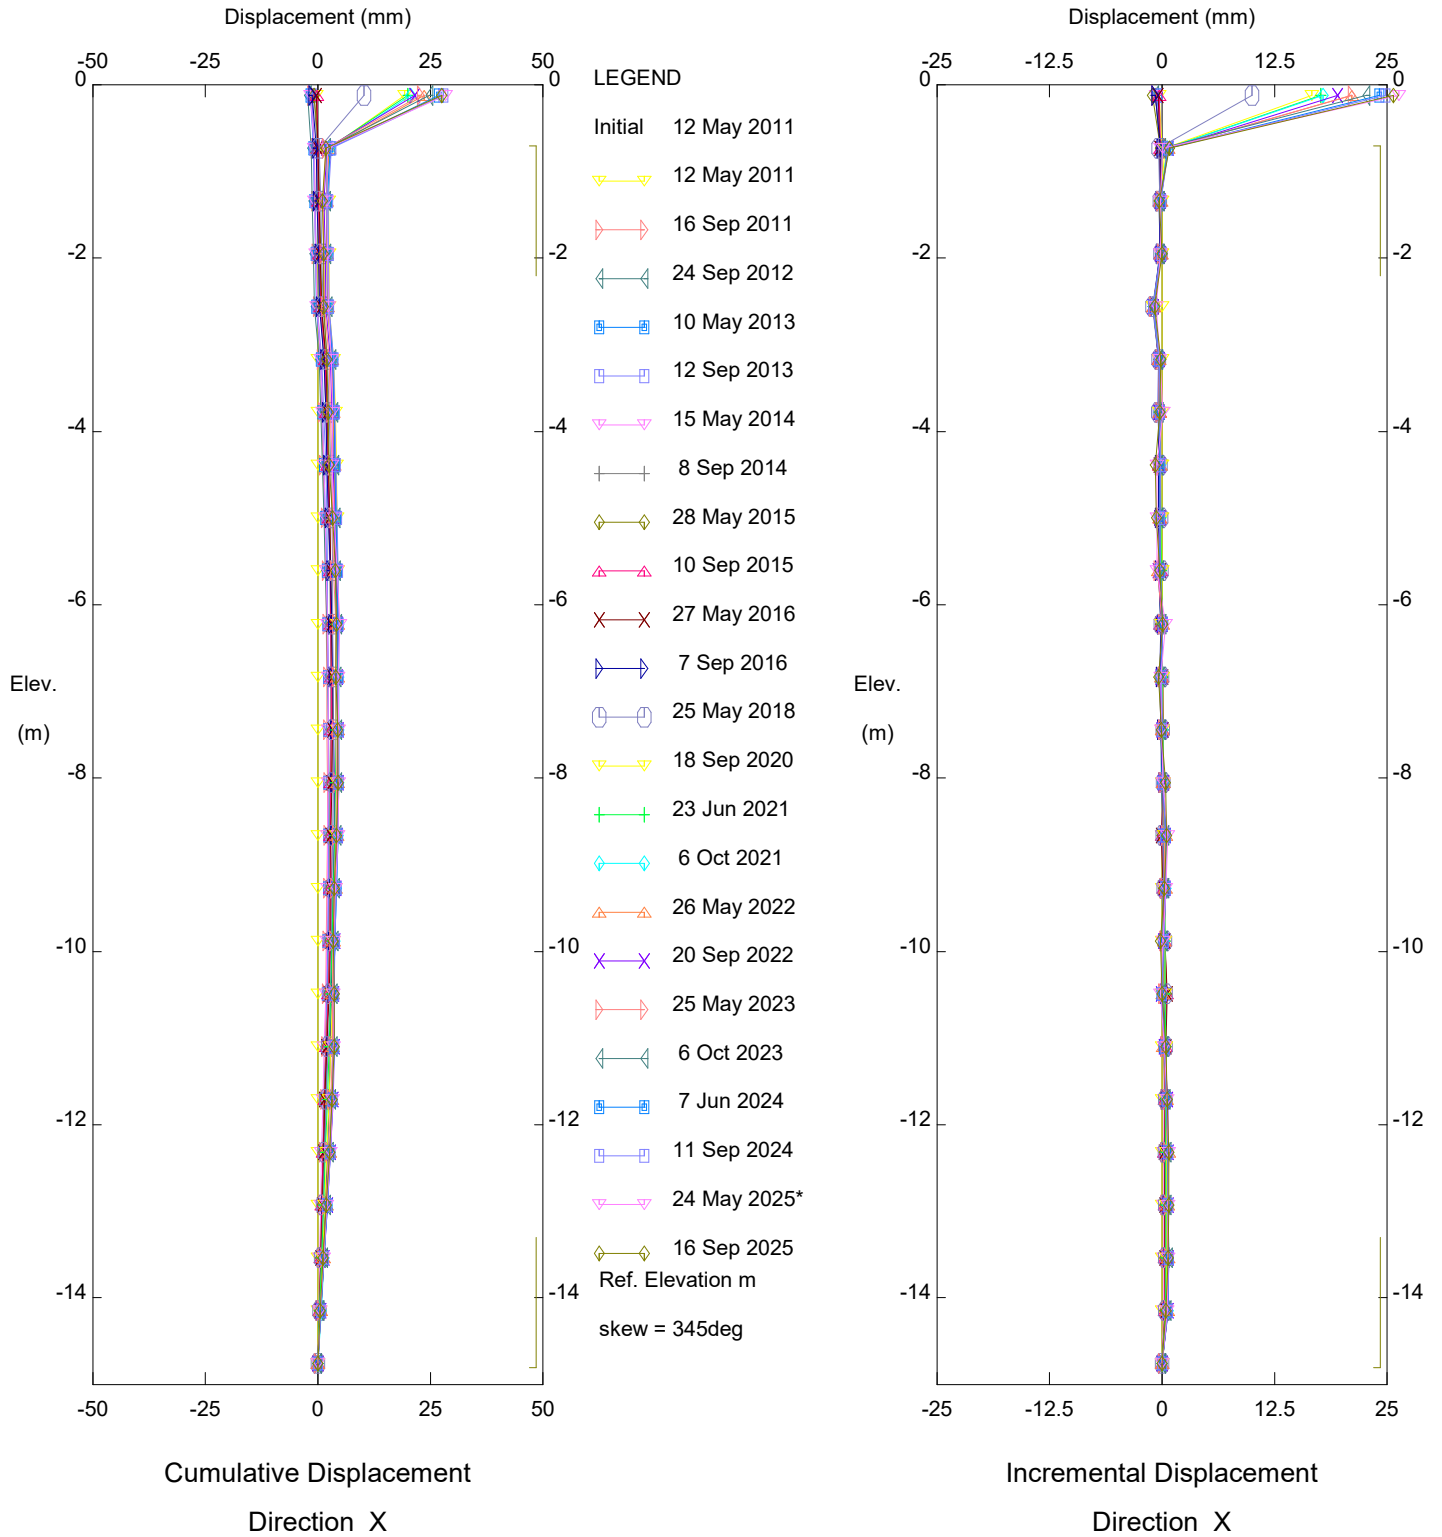
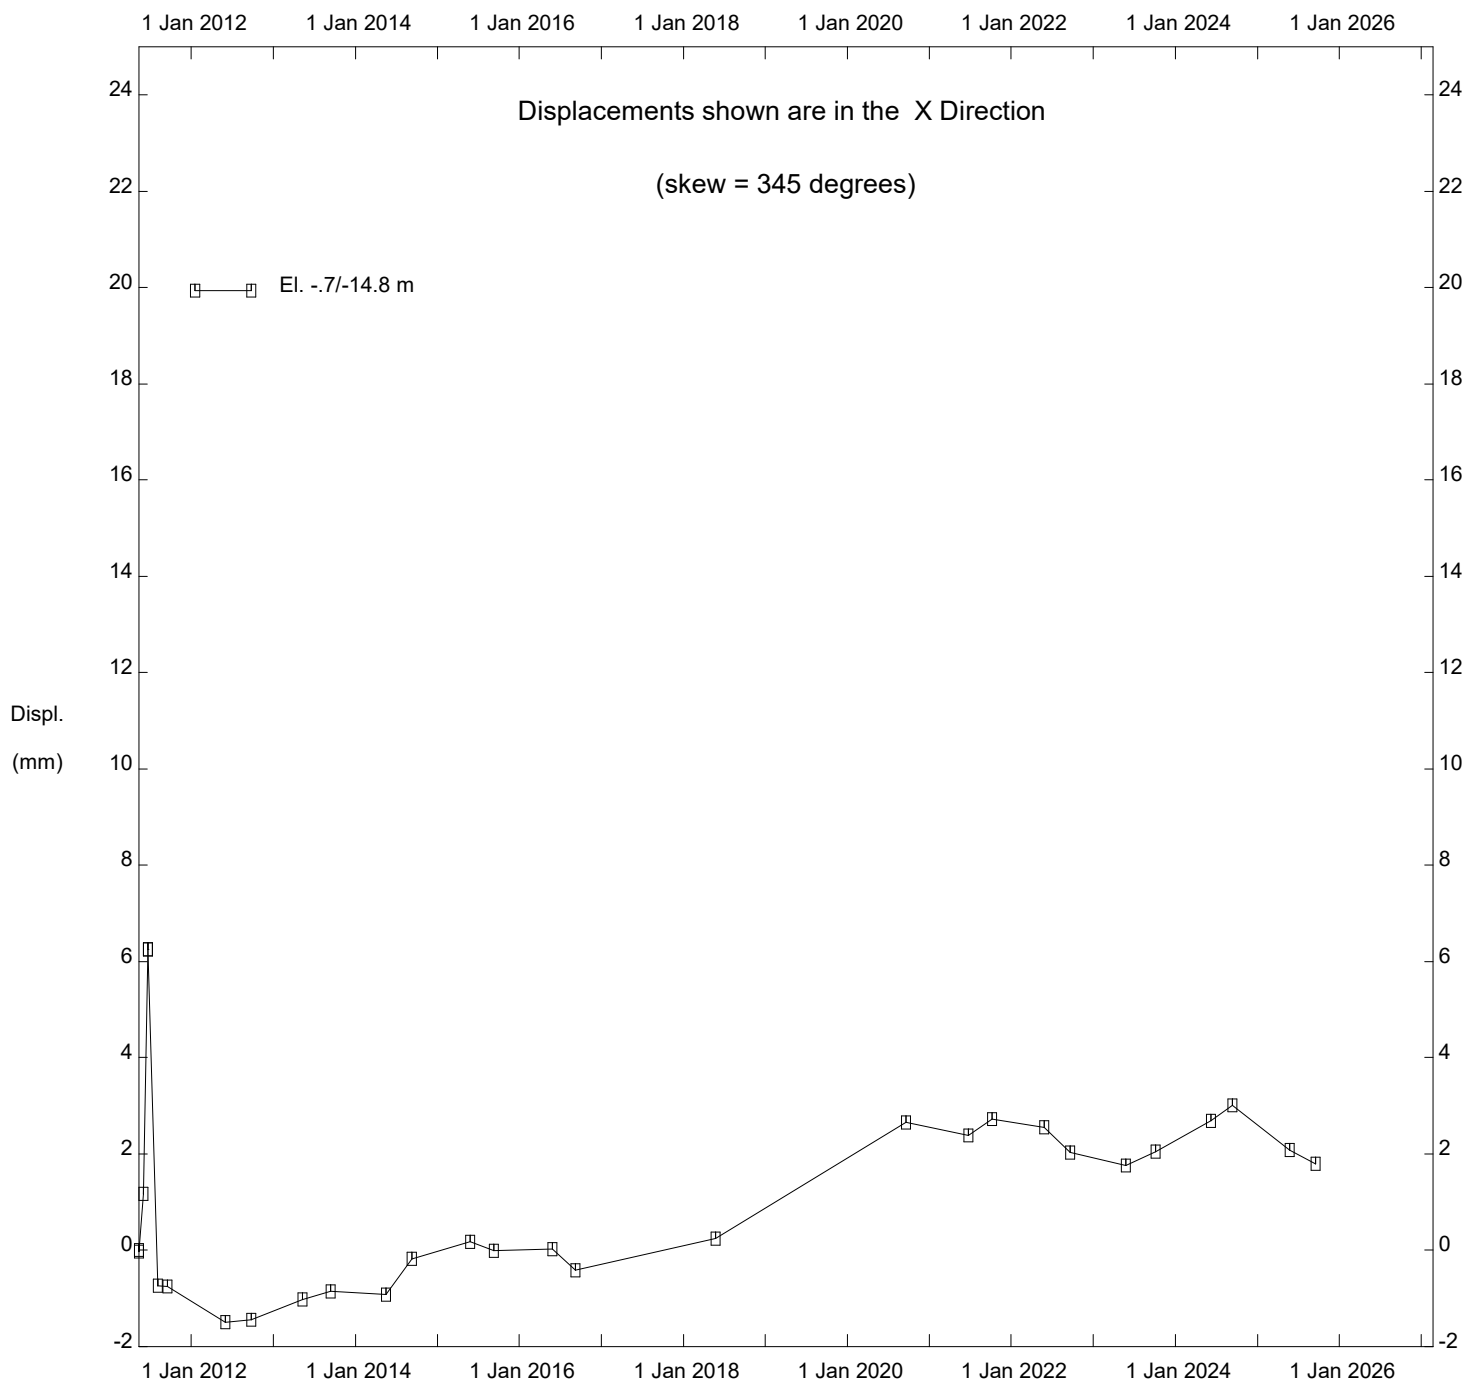
Hwy 41:23 Kehewin Lake (NC103), Inclinometer SI11-1(P9)

| INSTRUMENT # | DATE INITIALIZED | TOTAL CUMULATIVE RESULTANT MOVEMENT AND DEPTH OF MOVEMENT TO DATE (mm) | MAXIMUM RATE OF MOVEMENT (mm/yr) | CURRENT STATUS OF SI | DATE OF PREVIOUS READING | INCREMENTAL MOVEMENT SINCE PREVIOUS READING (mm) | CURRENT RATE OF MOVEMENT (mm/yr) | CHANGE IN RATE OF MOVEMENT SINCE PREVIOUS READING (mm/yr) |
|---|---|---|---|---|---|---|---|---|
| SI11-1 (Pile 9) | May 12, 2011 | 1.8 over 0.7 m to 14.8 m depth in 308° direction | 87.6 on June 21, 2011 | Operational | May 24, 2025 | No discernible movement | N/A | 0.4 |

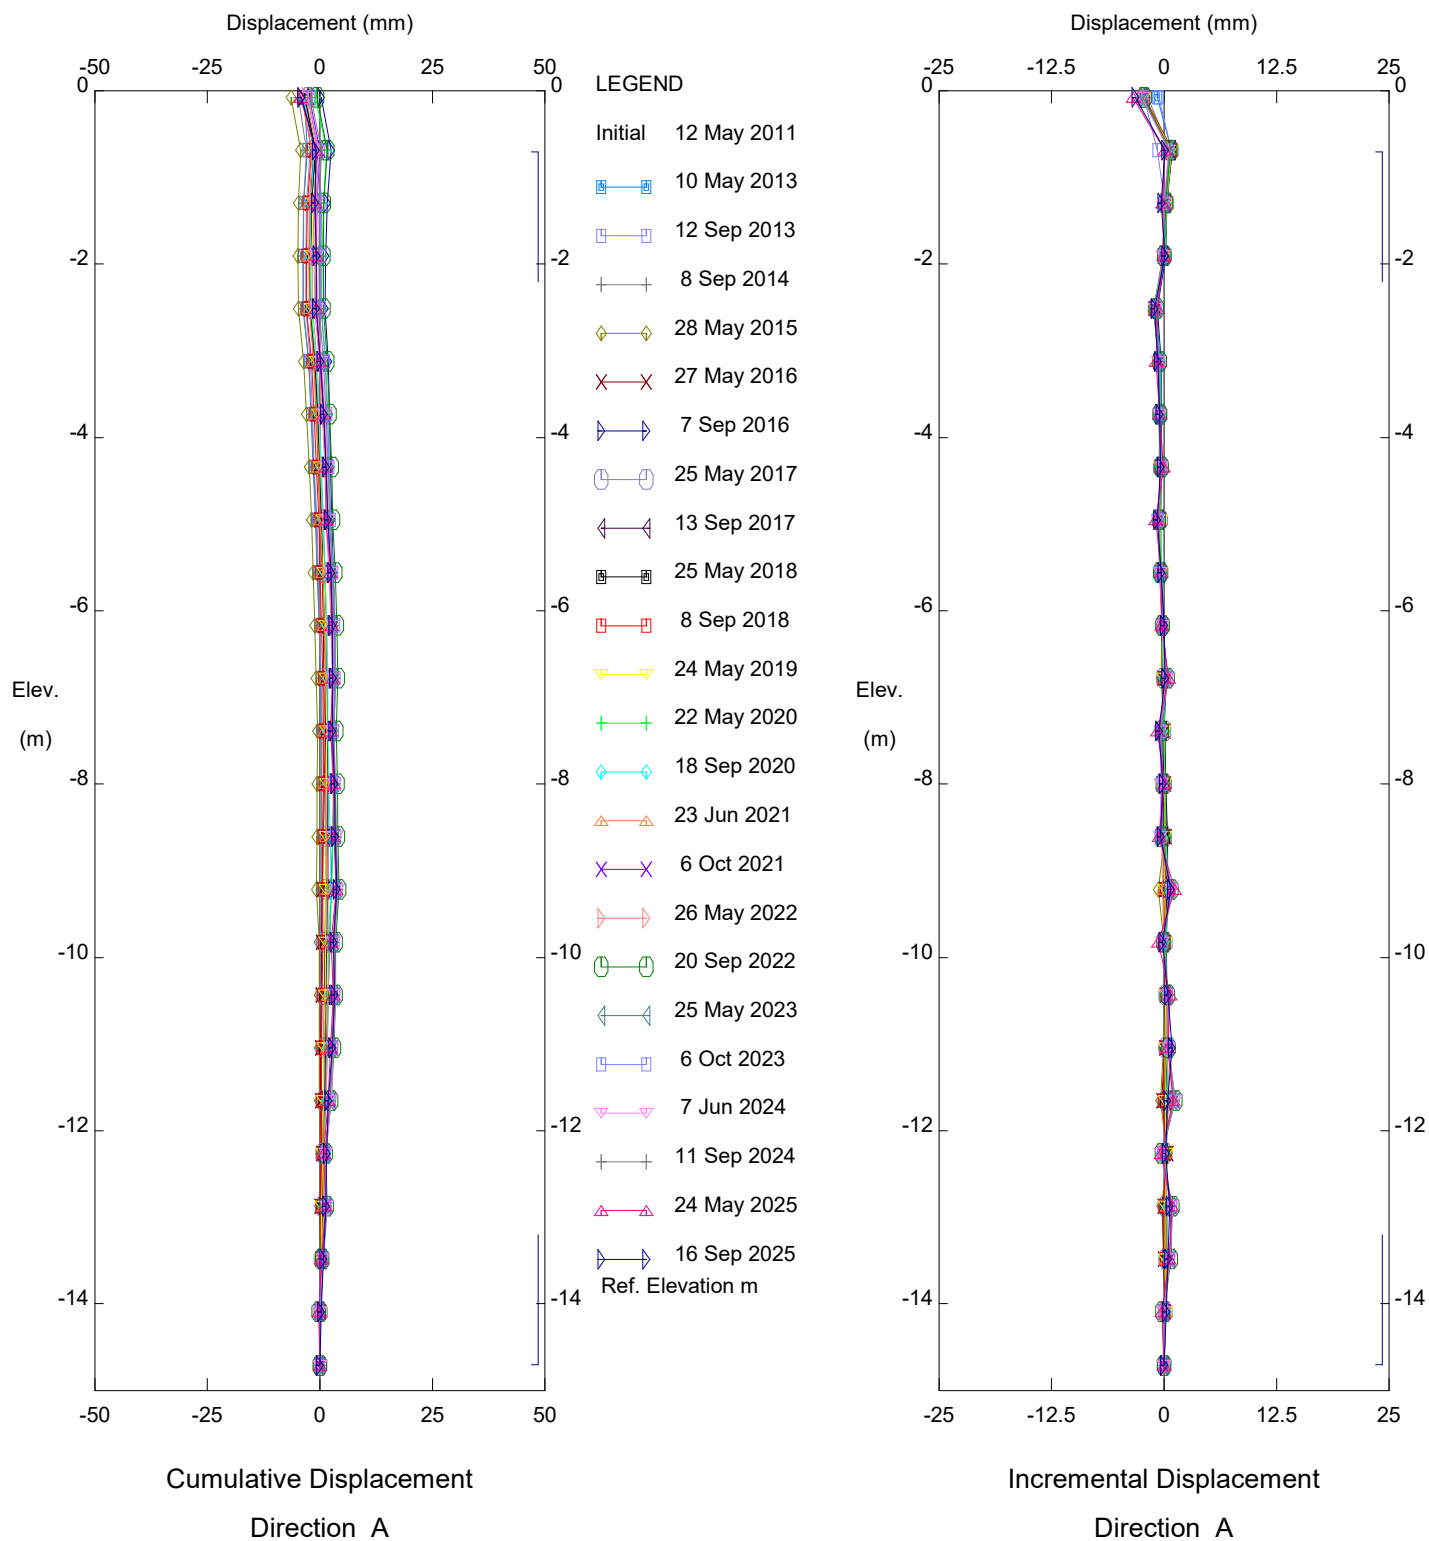
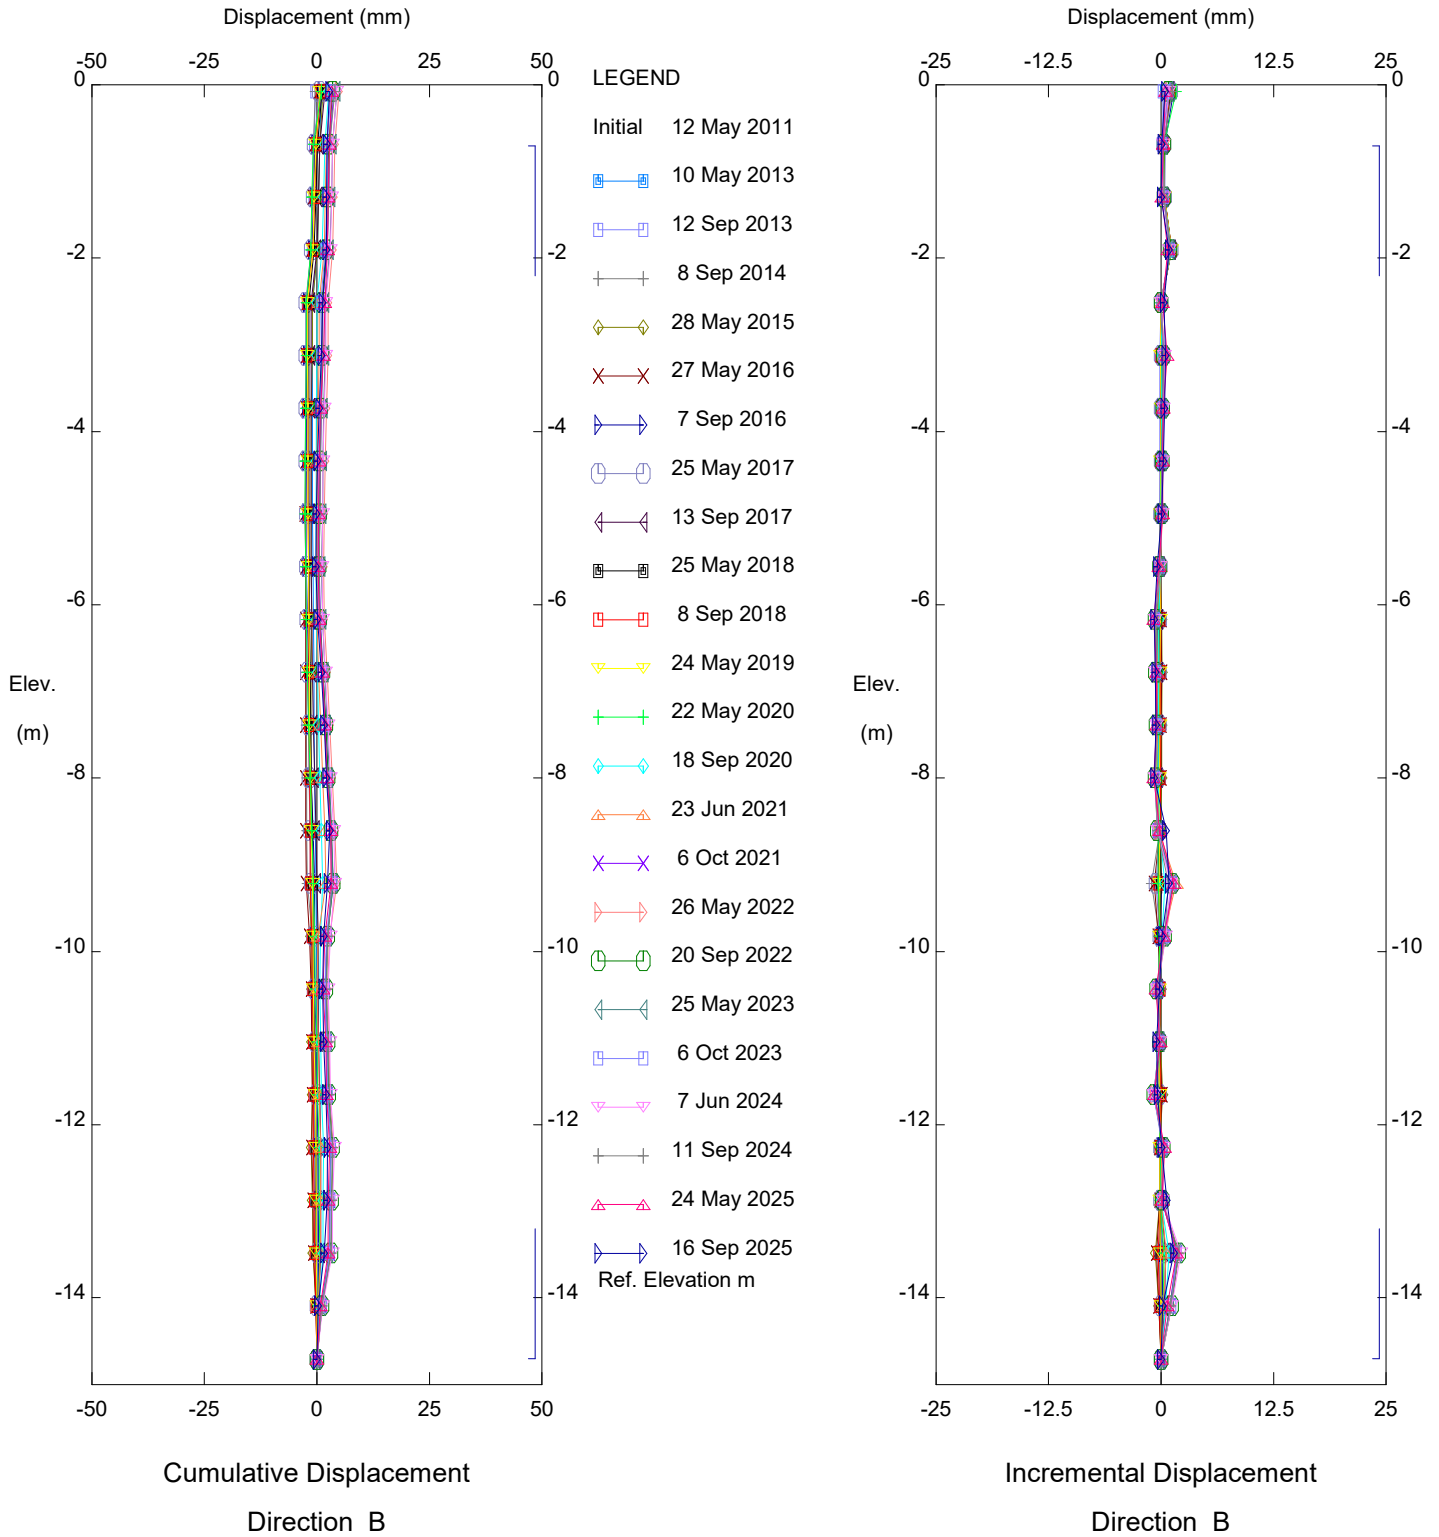
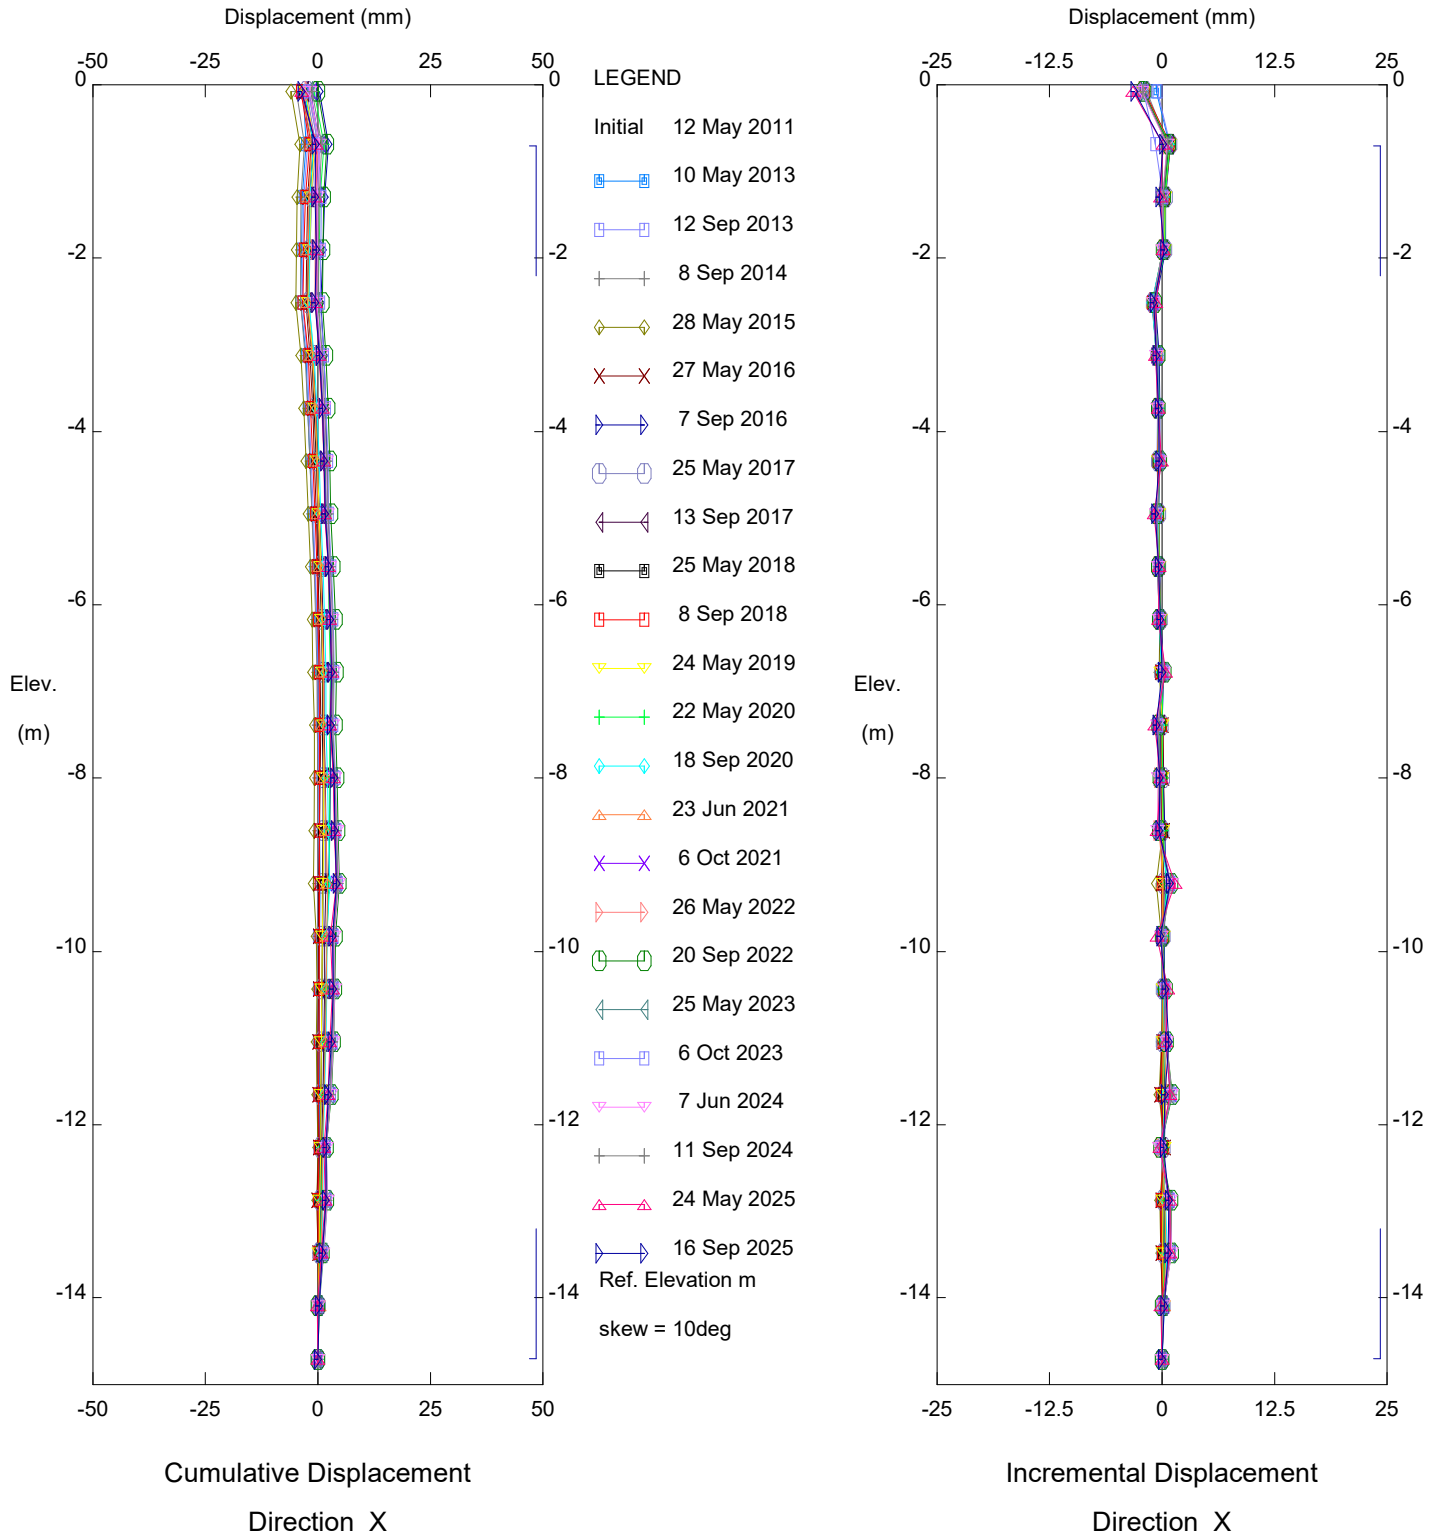
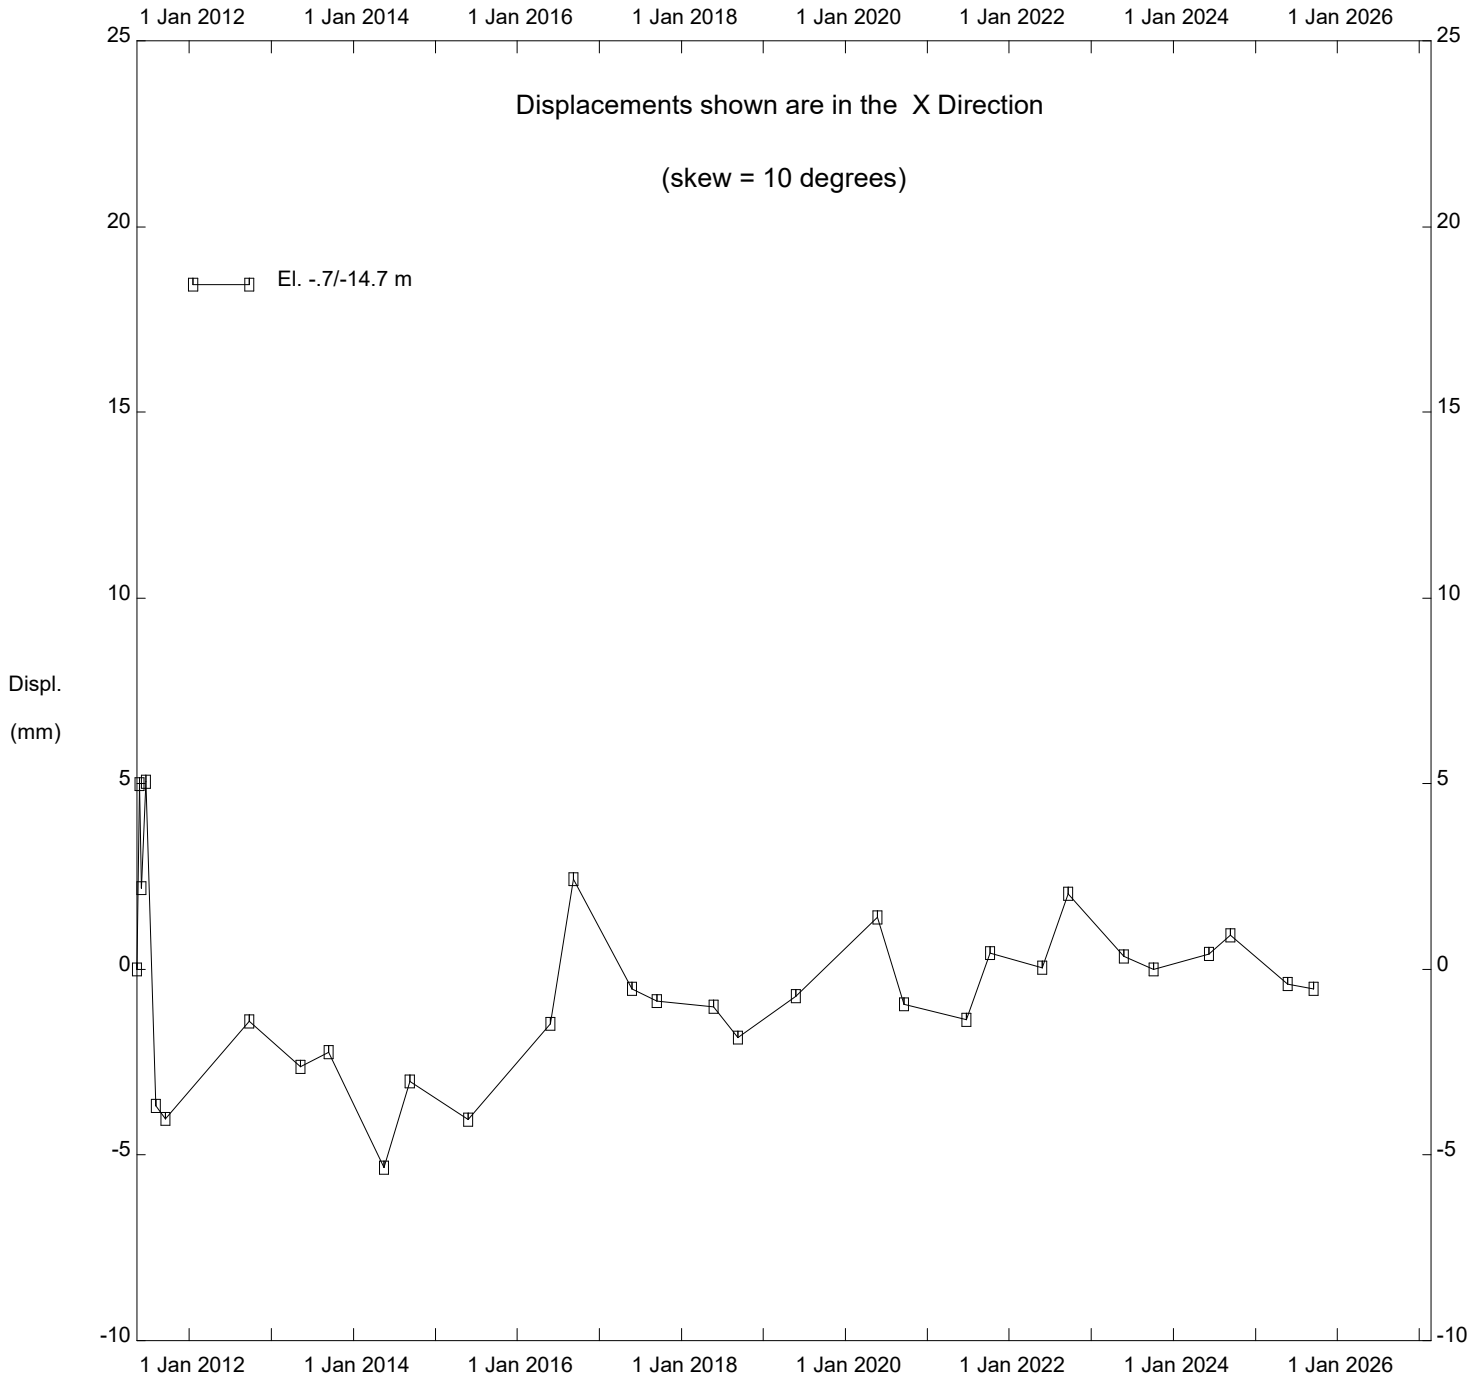
Hwy 41:23 Kehiwin Lake (NC103), Inclinometer SI11-2 (P27)

| INSTRUMENT # | DATE INITIALIZED | TOTAL CUMULATIVE RESULTANT MOVEMENT AND DEPTH OF MOVEMENT TO DATE (mm) | MAXIMUM RATE OF MOVEMENT (mm/yr) | CURRENT STATUS OF SI | DATE OF PREVIOUS READING | INCREMENTAL MOVEMENT SINCE PREVIOUS READING (mm) | CURRENT RATE OF MOVEMENT (mm/yr) | CHANGE IN RATE OF MOVEMENT SINCE PREVIOUS READING (mm/yr) |
|---|---|---|---|---|---|---|---|---|
| SI11-2 (Pile 27) | May 12, 2011 | -0.5 over 0.7 m to 14.7 m depth in 306° direction | 146.6 on May 25, 2011 | Operational | May 24, 2025 | No discernible movement | N/A | 1.5 |
