**ALBERTA TRANSPORTATION AND  
ECONOMIC CORRIDORS GRMP  
NORTH CENTRAL (ATHABASCA AND FORT  
McMURRAY DISTRICTS)  
INSTRUMENTATION MONITORING - FALL 2025**

| Site Number | Location | Name | Hwy | km |
|---|---|---|---|---|
| NC103<br>(NC024-3) | HWY 41:23 C1 7.89 | Kehiwin Lake | 41:23 | km 7.8 |

**SITE NC103**

**NORTH CENTRAL  
(ATHABASCA AND FORT MCMURRAY DISTRICTS)  
NC103: HWY41:23 KEHIWIN LAKE (km 7.8)  
SITE PLAN SHOWING APPROXIMATE  
INSTRUMENT LOCATIONS**

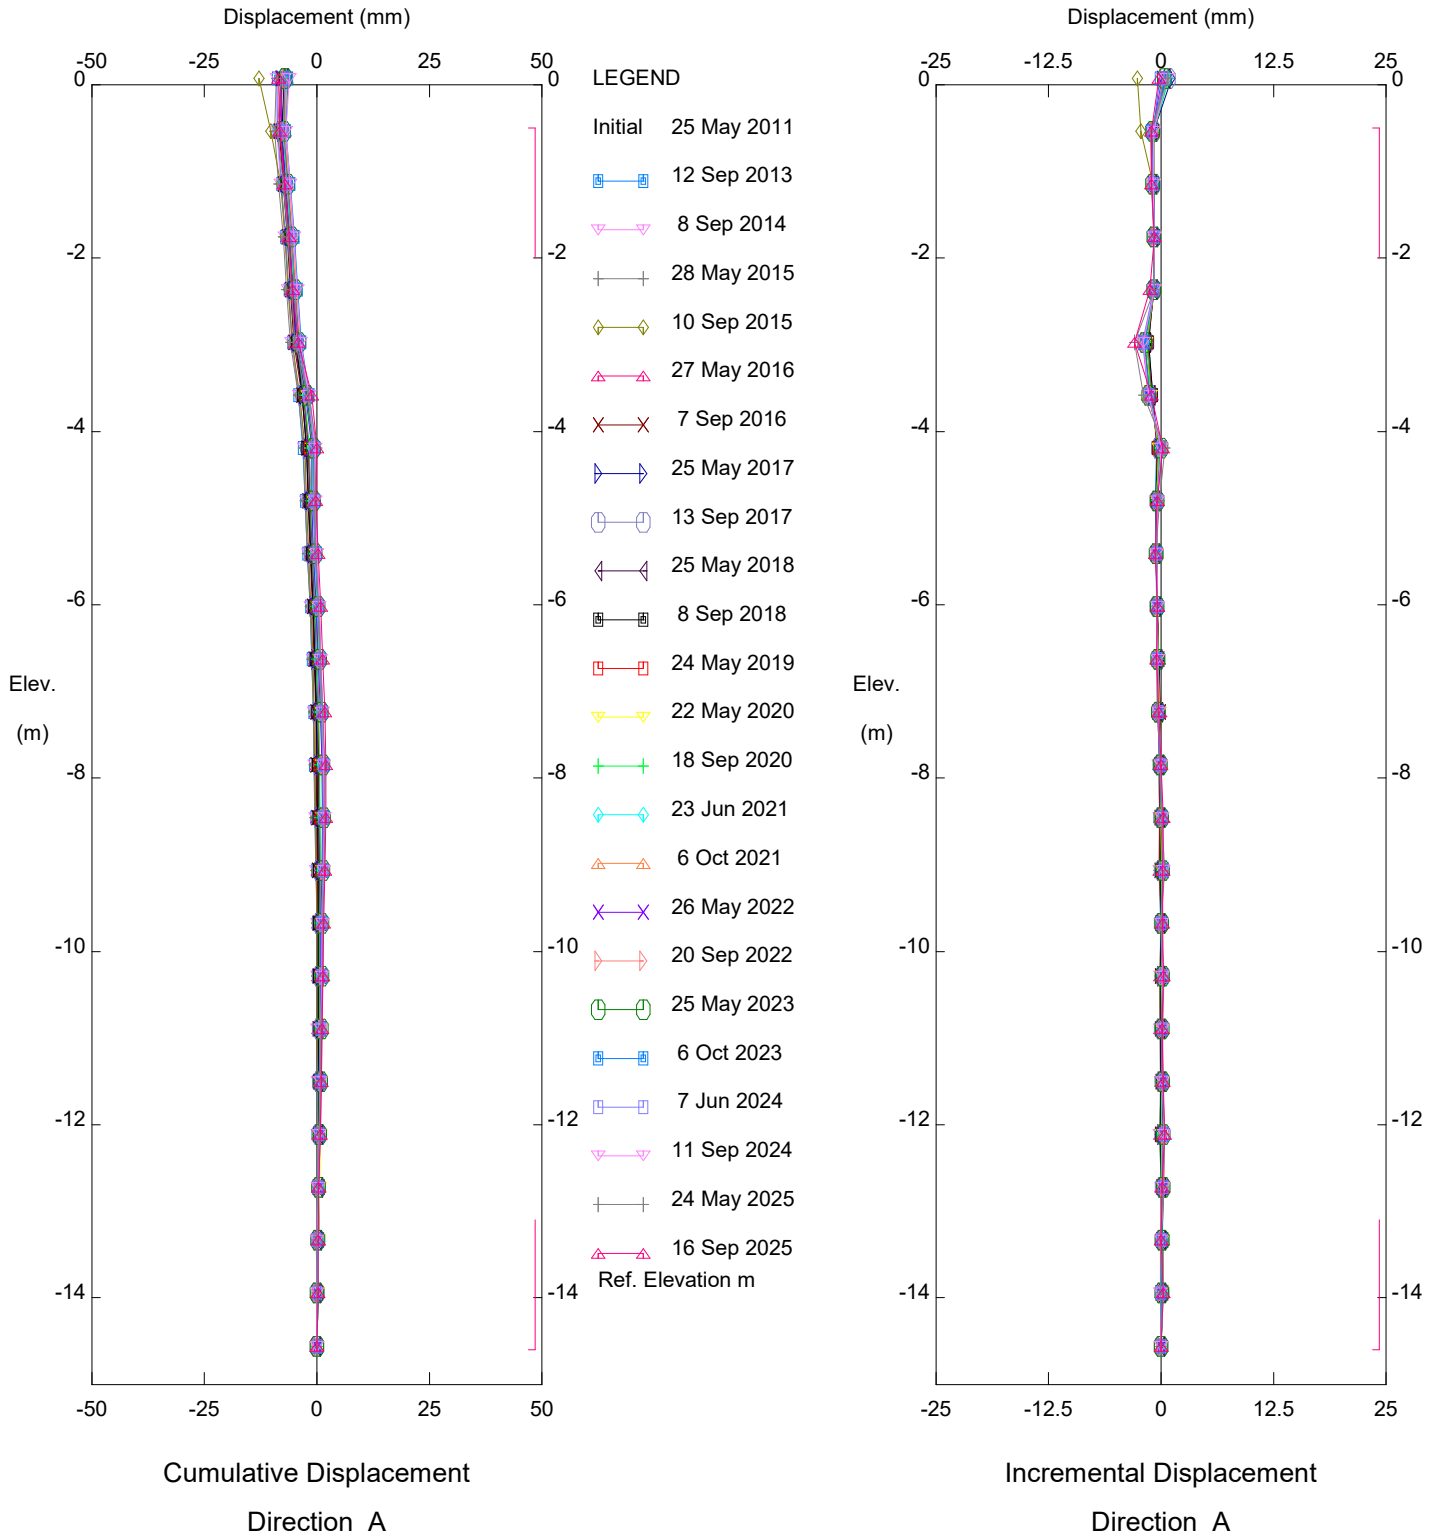
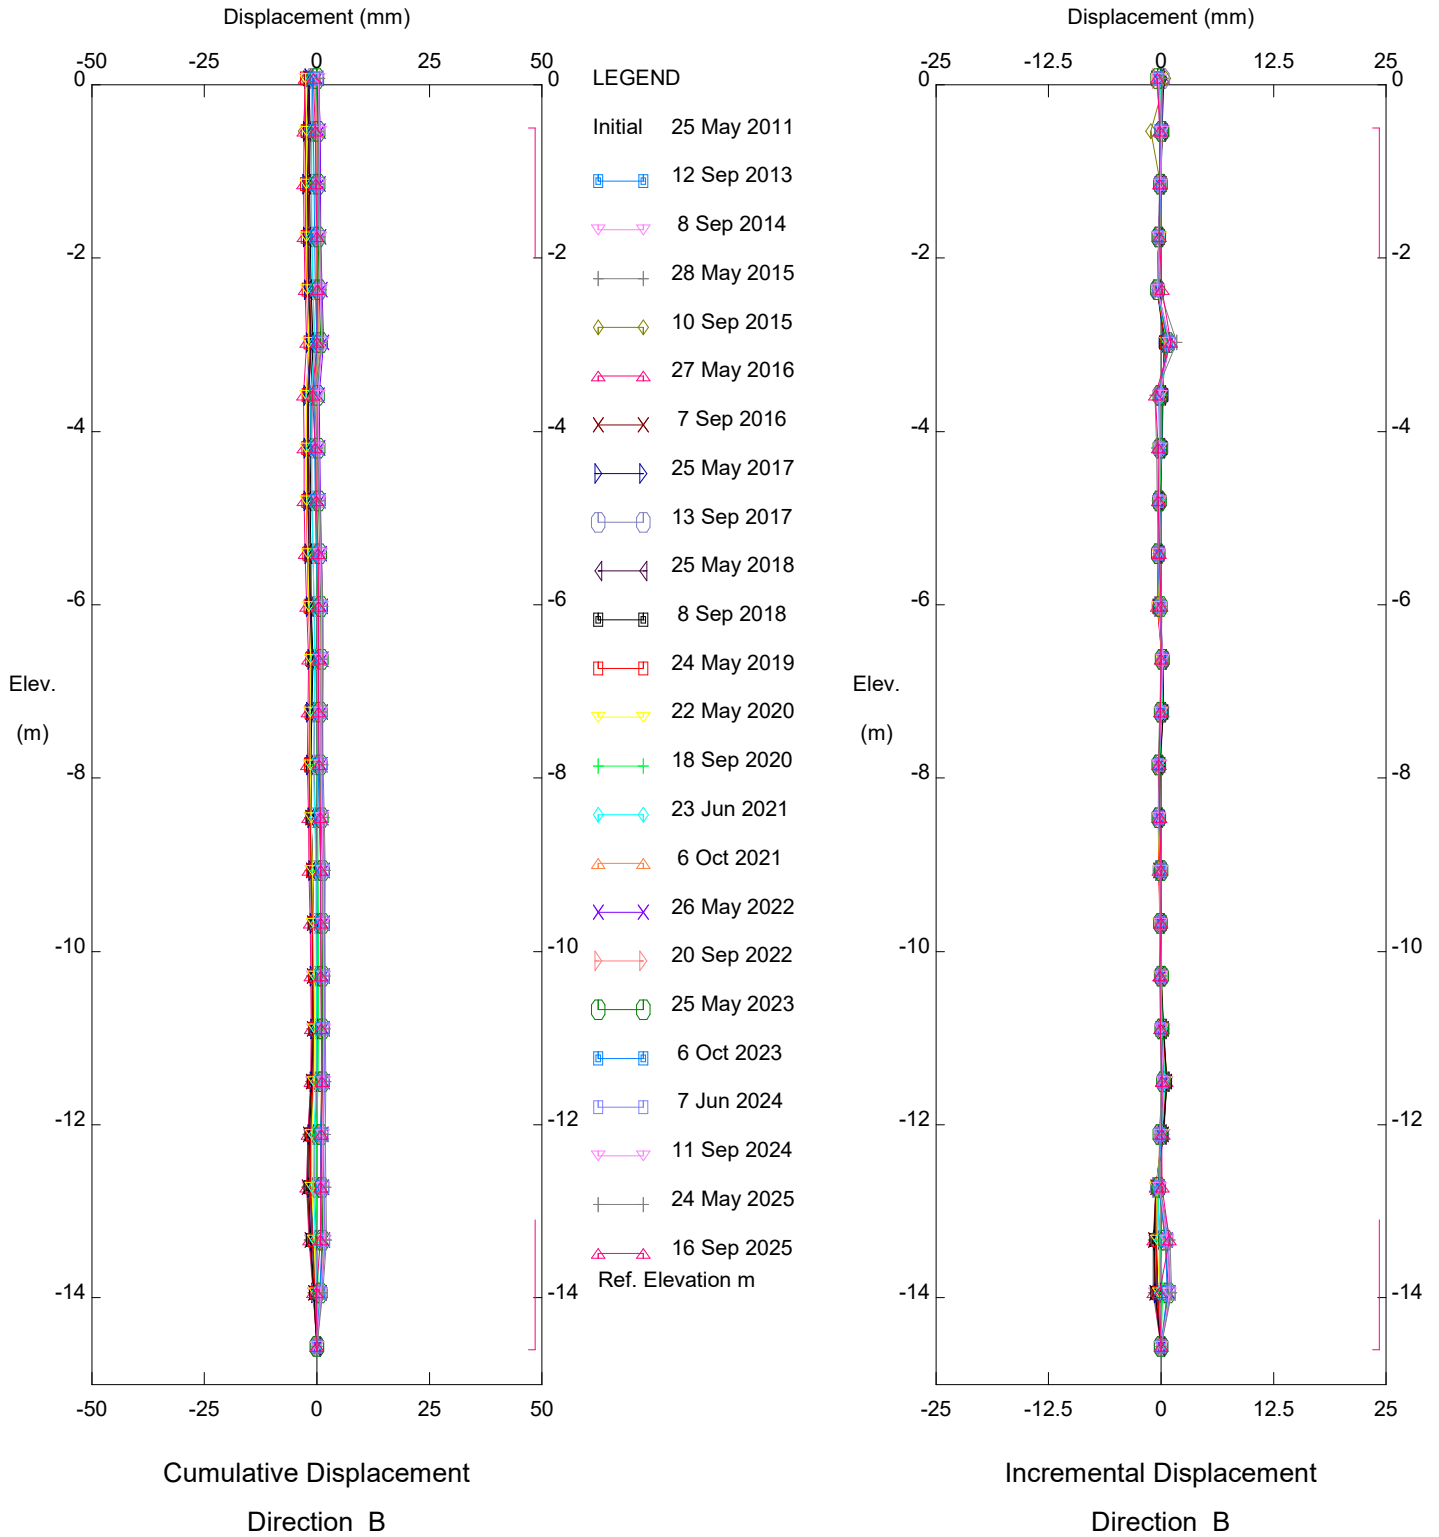
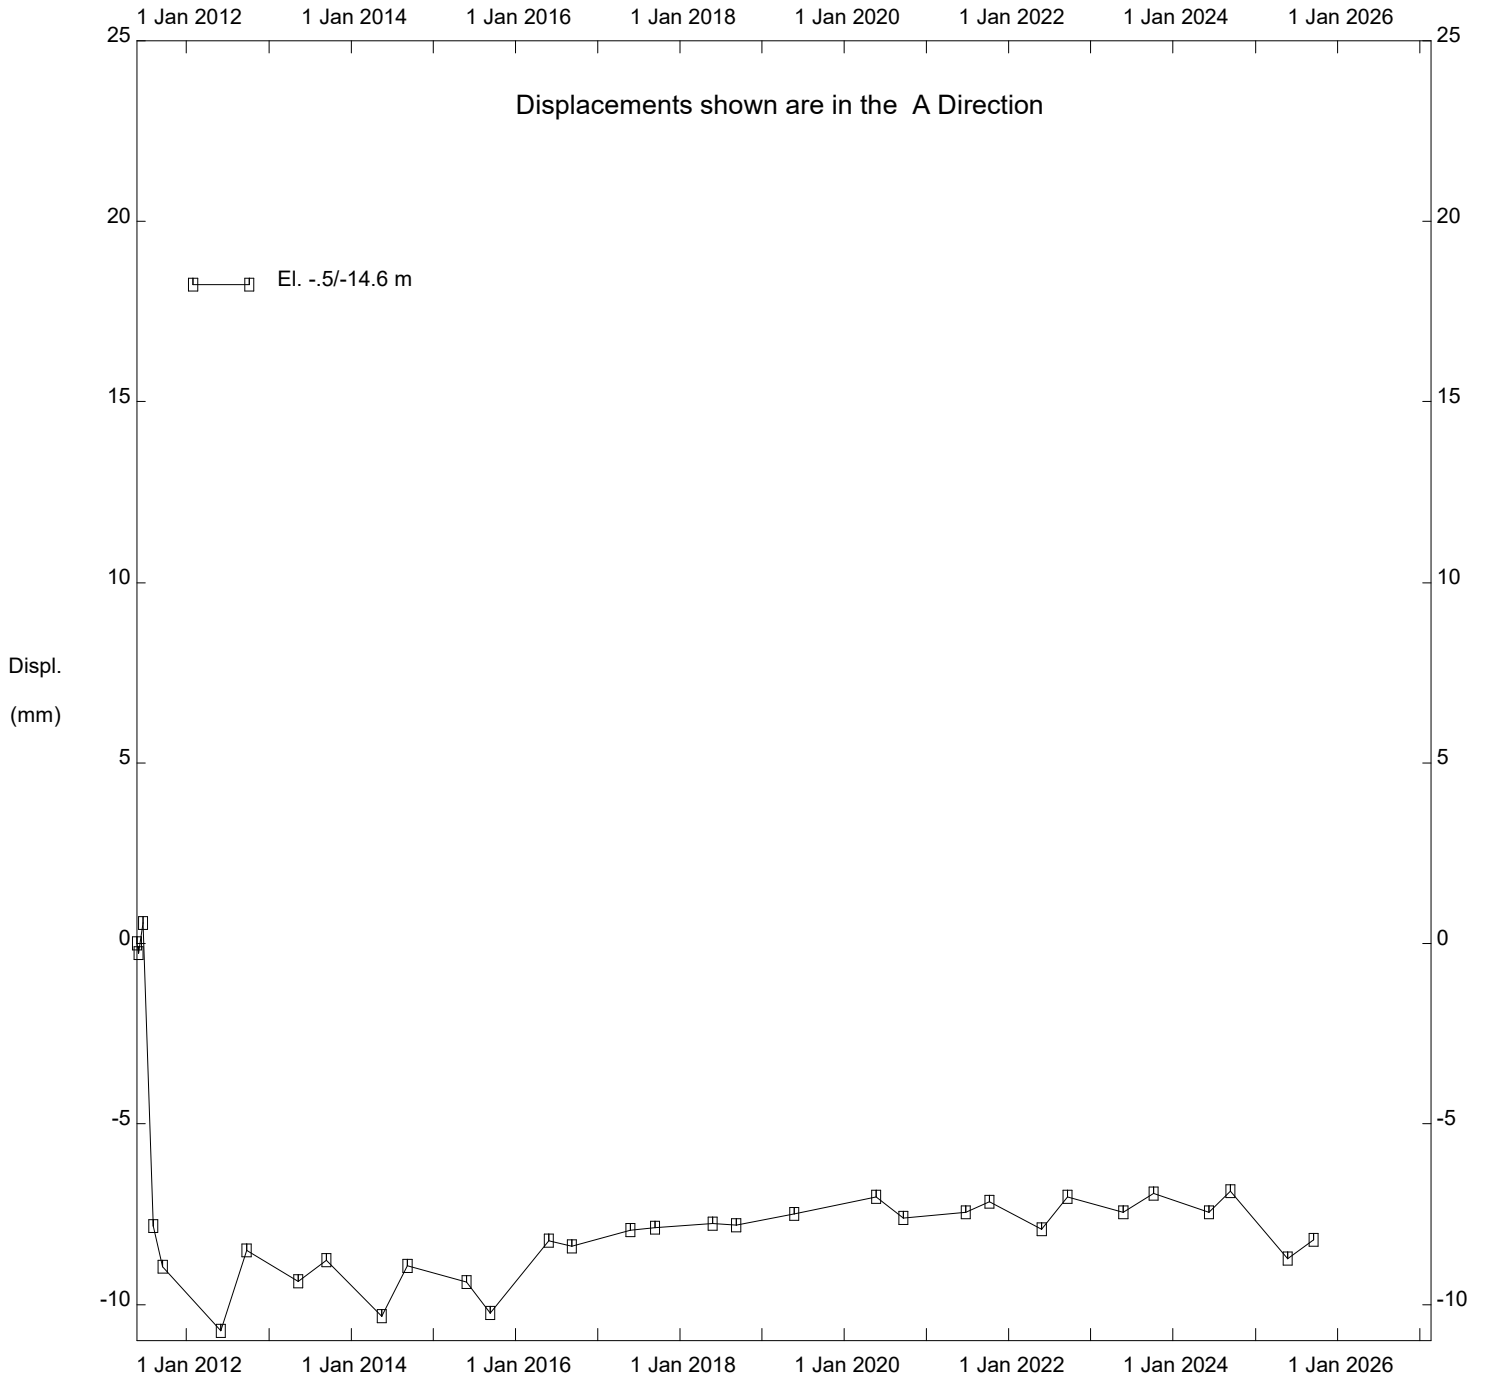
Hwy 41:23 Kehiwin Lake (NC103), Inclinometer SI11-3(P45)

| INSTRUMENT # | DATE INITIALIZED | TOTAL CUMULATIVE RESULTANT MOVEMENT AND DEPTH OF MOVEMENT TO DATE (mm) | MAXIMUM RATE OF MOVEMENT (mm/yr) | CURRENT STATUS OF SI | DATE OF PREVIOUS READING | INCREMENTAL MOVEMENT SINCE PREVIOUS READING (mm) | CURRENT RATE OF MOVEMENT (mm/yr) | CHANGE IN RATE OF MOVEMENT SINCE PREVIOUS READING (mm/yr) |
|---|---|---|---|---|---|---|---|---|
| SI11-3 (Pile 45) | May 25, 2011 | -8.2 over 0.5 m to 14.6 m depth in 308° direction | 14.2 on June 21, 2011 | Operational | May 24, 2025 | 0.5 | 1.7 | 4.4 |

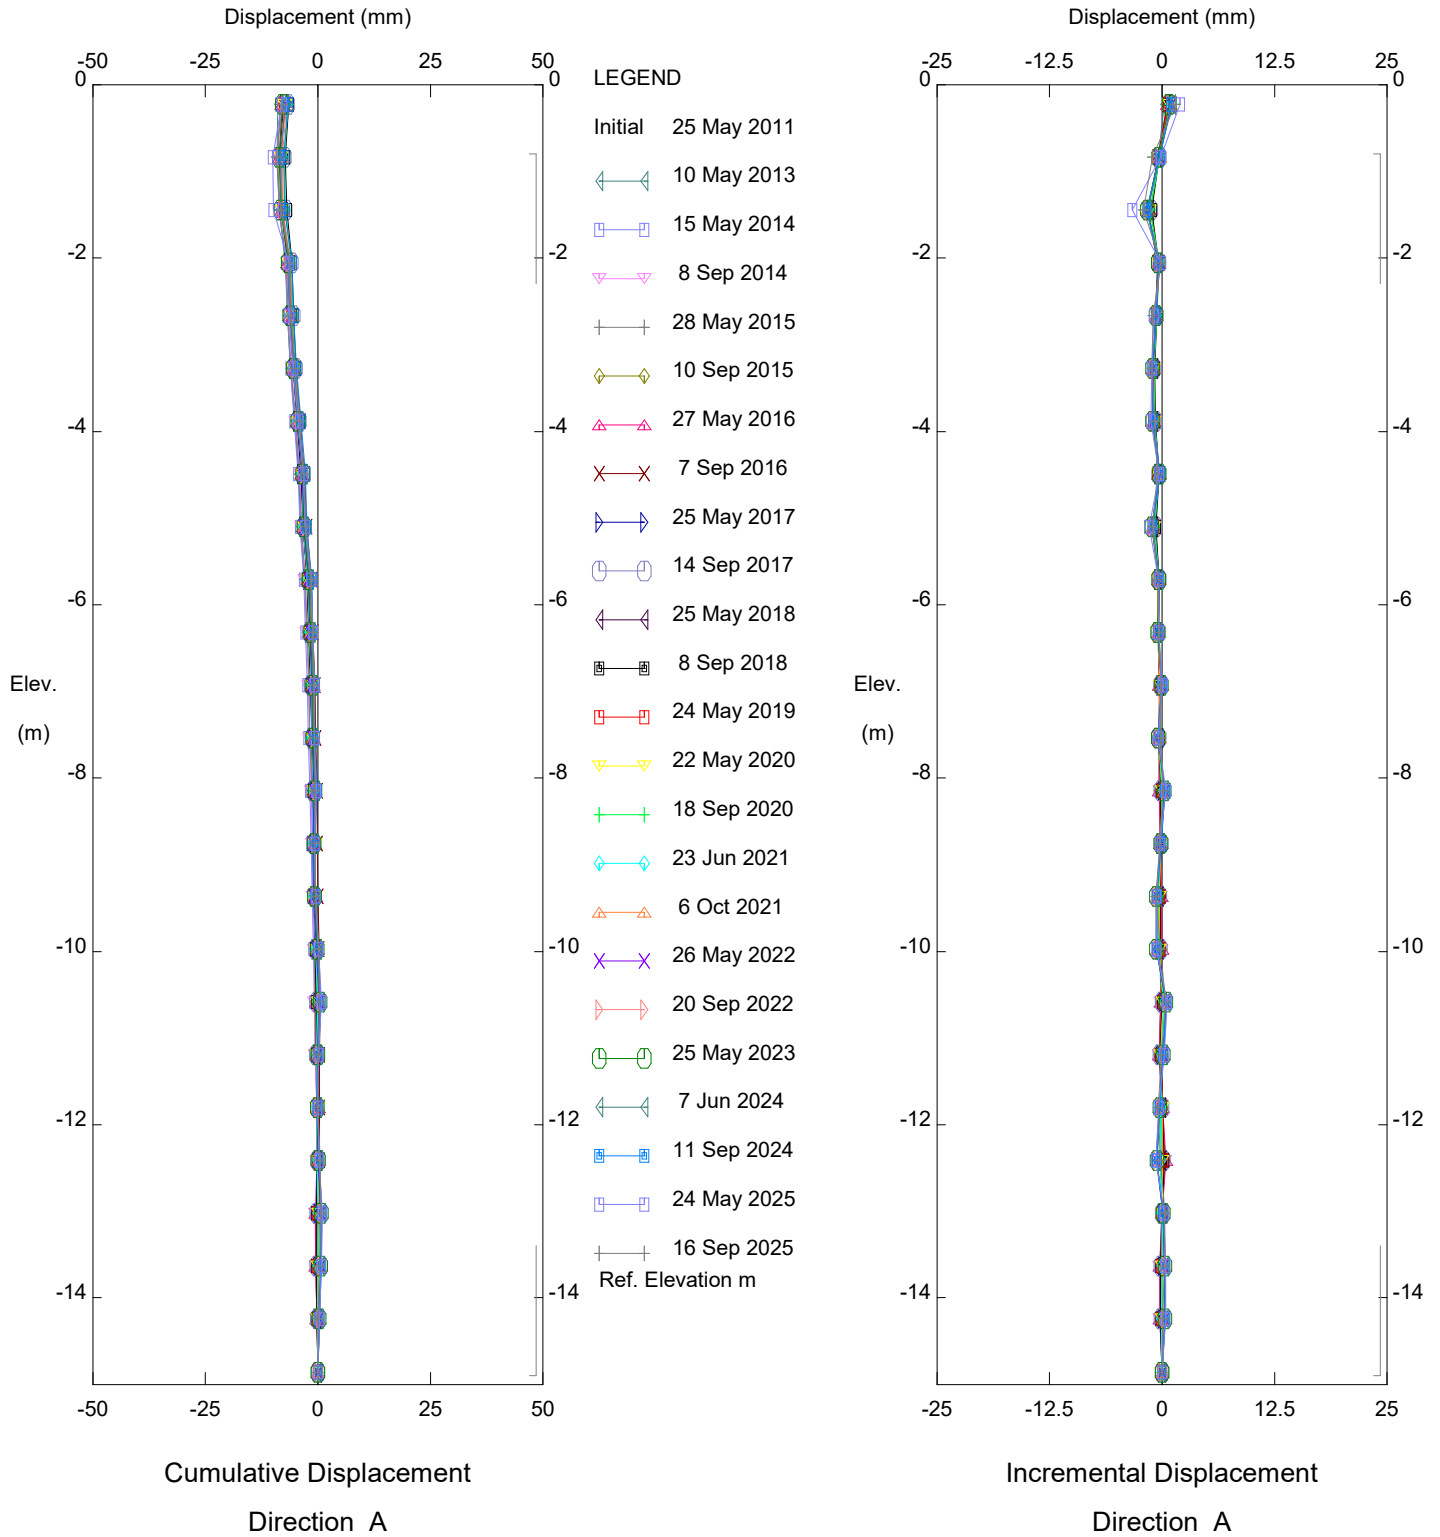
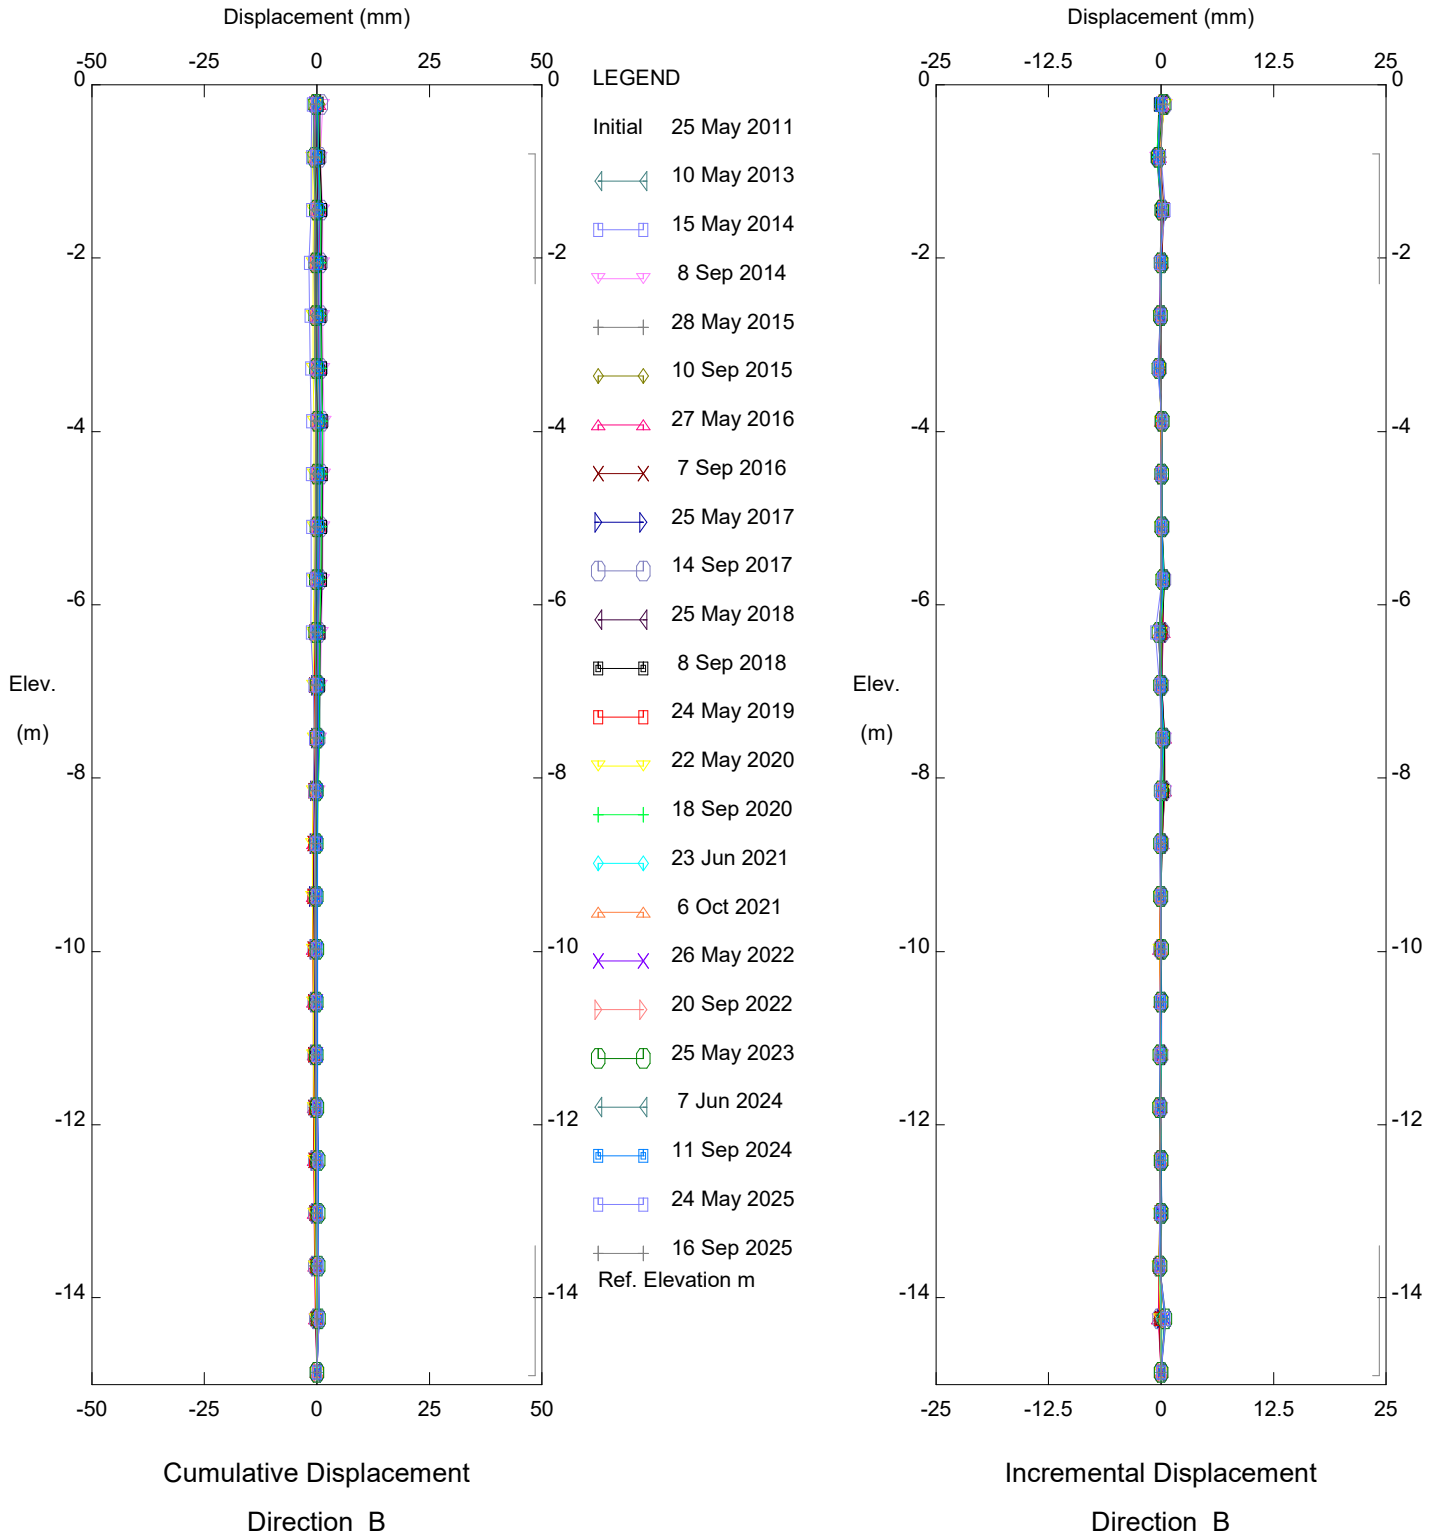
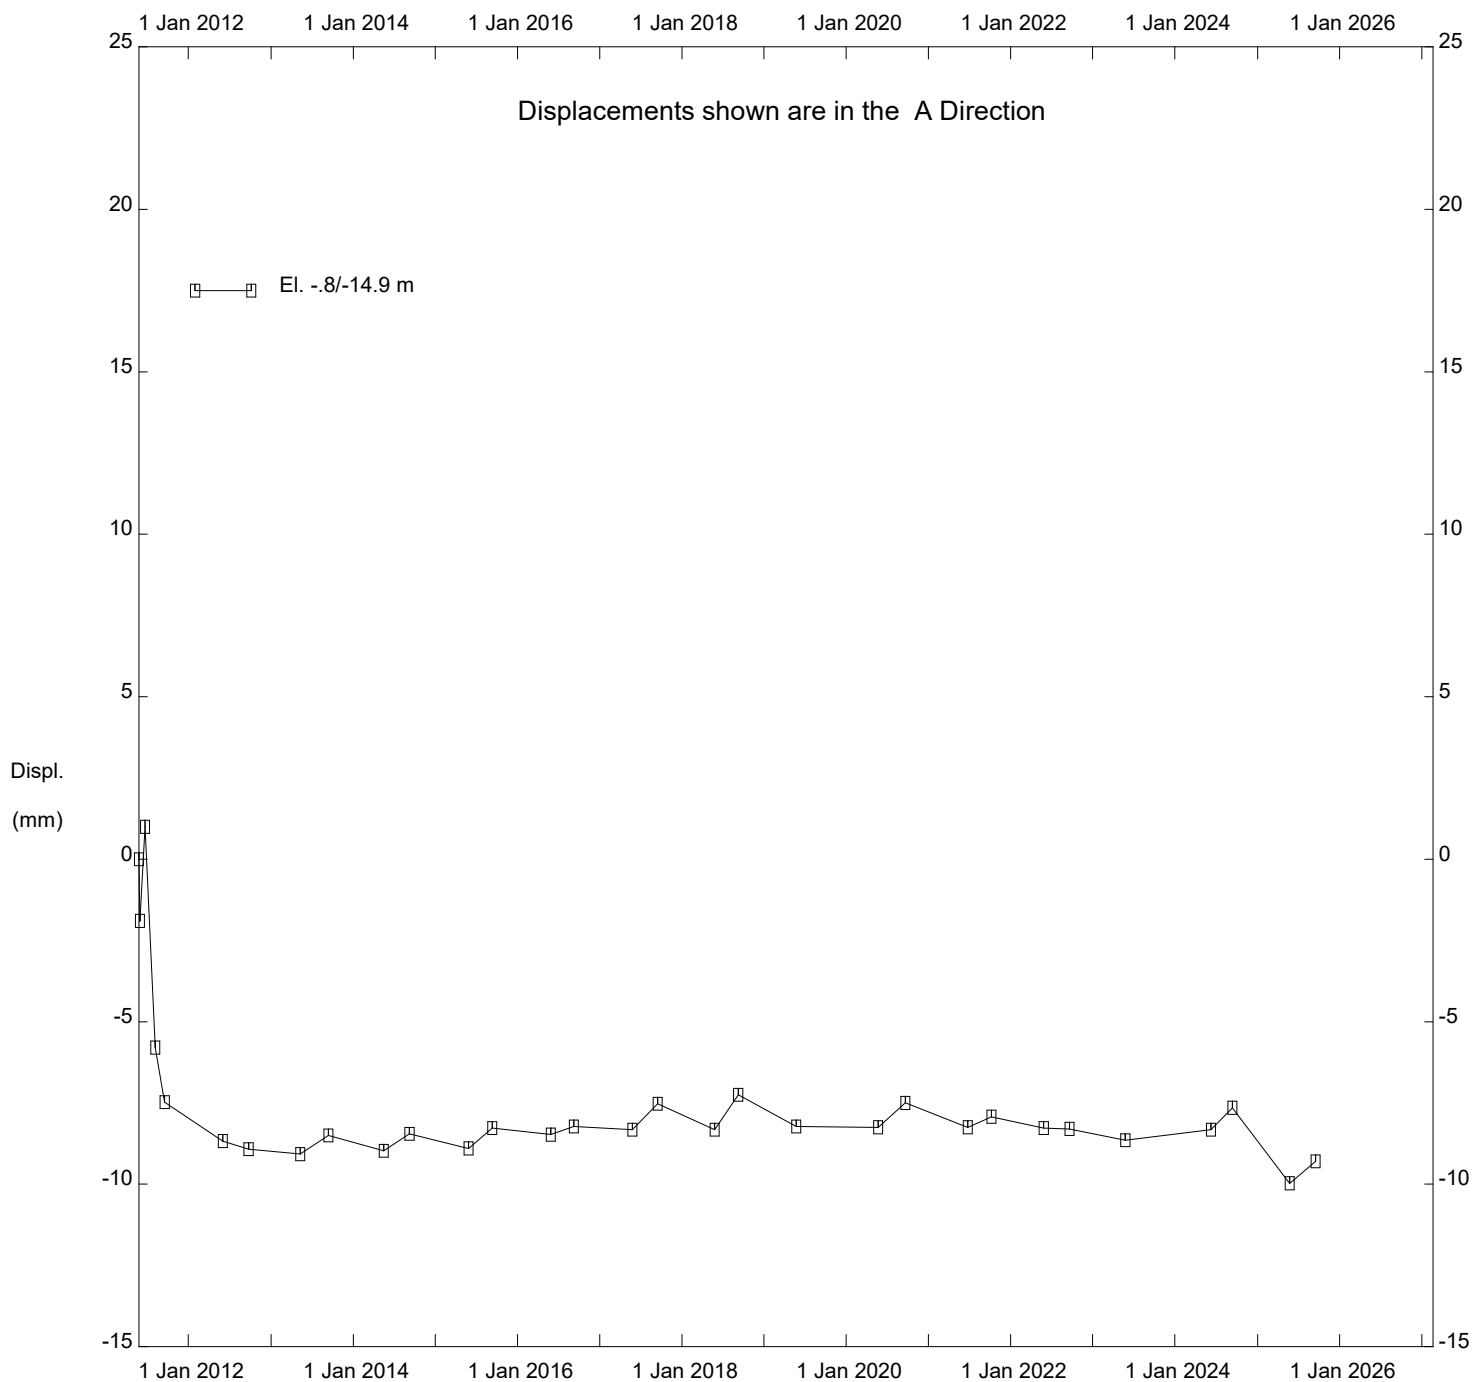
Hwy 41:23 Kehiwin Lake (NC103), Inclinometer SI11-4 (P60)

| INSTRUMENT # | DATE INITIALIZED | TOTAL CUMULATIVE RESULTANT MOVEMENT AND DEPTH OF MOVEMENT TO DATE (mm) | MAXIMUM RATE OF MOVEMENT (mm/yr) | CURRENT STATUS OF SI | DATE OF PREVIOUS READING | INCREMENTAL MOVEMENT SINCE PREVIOUS READING (mm) | CURRENT RATE OF MOVEMENT (mm/yr) | CHANGE IN RATE OF MOVEMENT SINCE PREVIOUS READING (mm/yr) |
|---|---|---|---|---|---|---|---|---|
| SI11-4 (Pile 60) | May 25, 2011 | -9.3 over 0.8 m to 14.9 m depth in 349° direction | 48.5 on June 21, 2011 | Operational | May 24, 2025 | 0.7 | 2.2 | 5.5 |

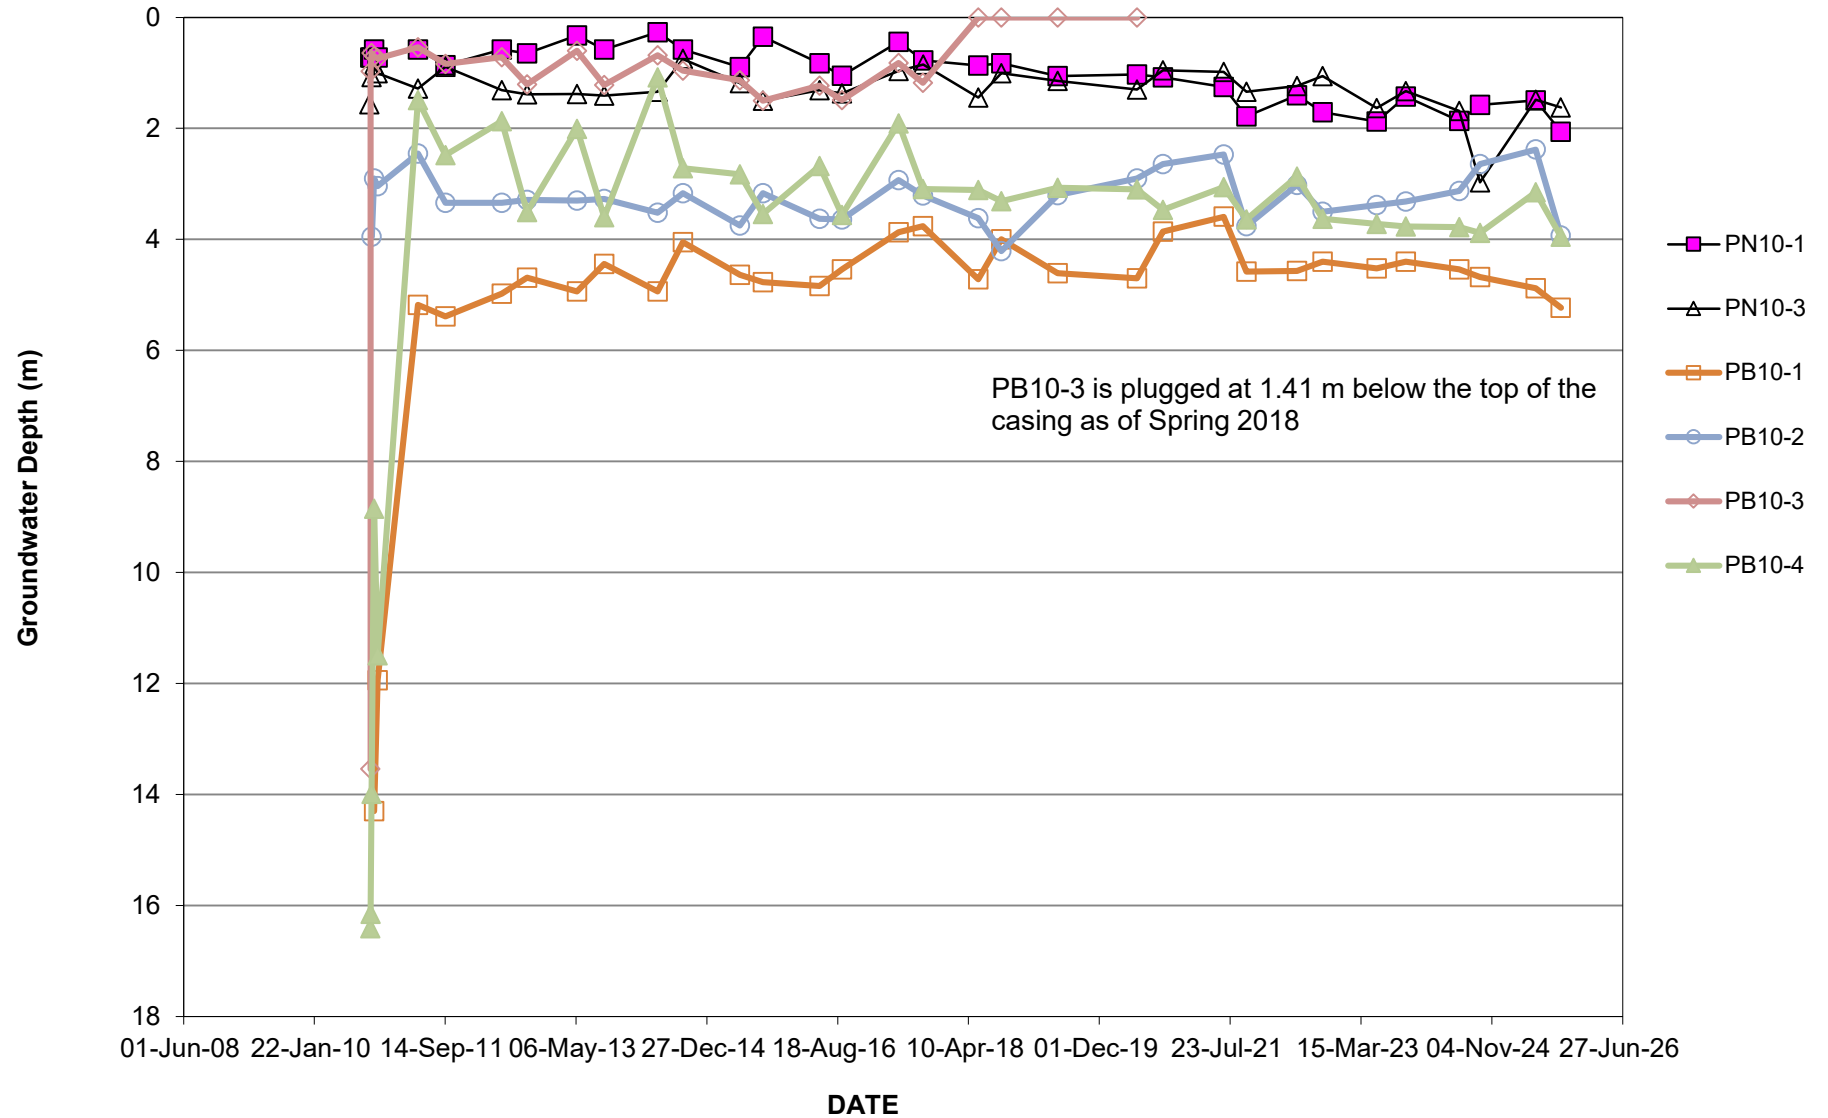
**FIGURE NC103-1**  
**PIEZOMETER DATA FOR HWY 41:23, KEHIWIN LAKE (KM 7.8)**

| | <p>Pneumatic piezometers PN10-1 and PN10-3 showed decreases in groundwater levels of 0.56 m and 0.14 m, respectively, since the spring of 2025 readings.</p> <p>Standpipe piezometer PB10-1, PB10-2, and PB10-4 showed decreases in groundwater level of 0.35 m, 1.55 m, and 0.80 m, respectively, since the spring of 2025 readings.</p> <p>Load cells VC1706, VC1707, VC1708, VC1709, VC1712, and VC1713 showed decreases in measured loads of 7.74 kN, 13.23 kN, 0.62 kN, 1.13 kN, 4.67 kN, and 3.53 kN, respectively since the spring of 2025 readings. Load cell VC1714 showed an increase in the measured load by 1.85 kN.</p> <p>The operational load cells have shown decreases in measured loads, when compared to the lock off load, ranging from 10.0 percent to 38.6 percent. However, the load cells with the largest variations in load values have lost one or more vibrating wire channels over several reading cycles. In addition, the reductions in the loads have not been consistent with the observed movement patterns of the walls, based on the slope inclinometer readings.</p> <p>If significant reductions in anchor loads occur in the future in response to the wall deflection towards west, the anchors will need to be restressed to maintain the wall's lateral deflection within the design limit.</p> |
