ALBERTA TRANSPORTATION AND  
ECONOMIC CORRIDORS GRMP  
NORTH CENTRAL (ATHABASCA AND FORT  
McMURRAY DISTRICTS)  
INSTRUMENTATION MONITORING - SPRING 2025

| Site Number | Location | Name | Hwy | km |
| NC103<br>(NC024-3) | HWY 41:23 C1 7.89 | Kehiwin Lake | 41:23 | km 7.8 |

| <b>Current Monitoring:</b> | 24-May-2025 | <b>Previous Monitoring</b> | 11-Sep-2024 |

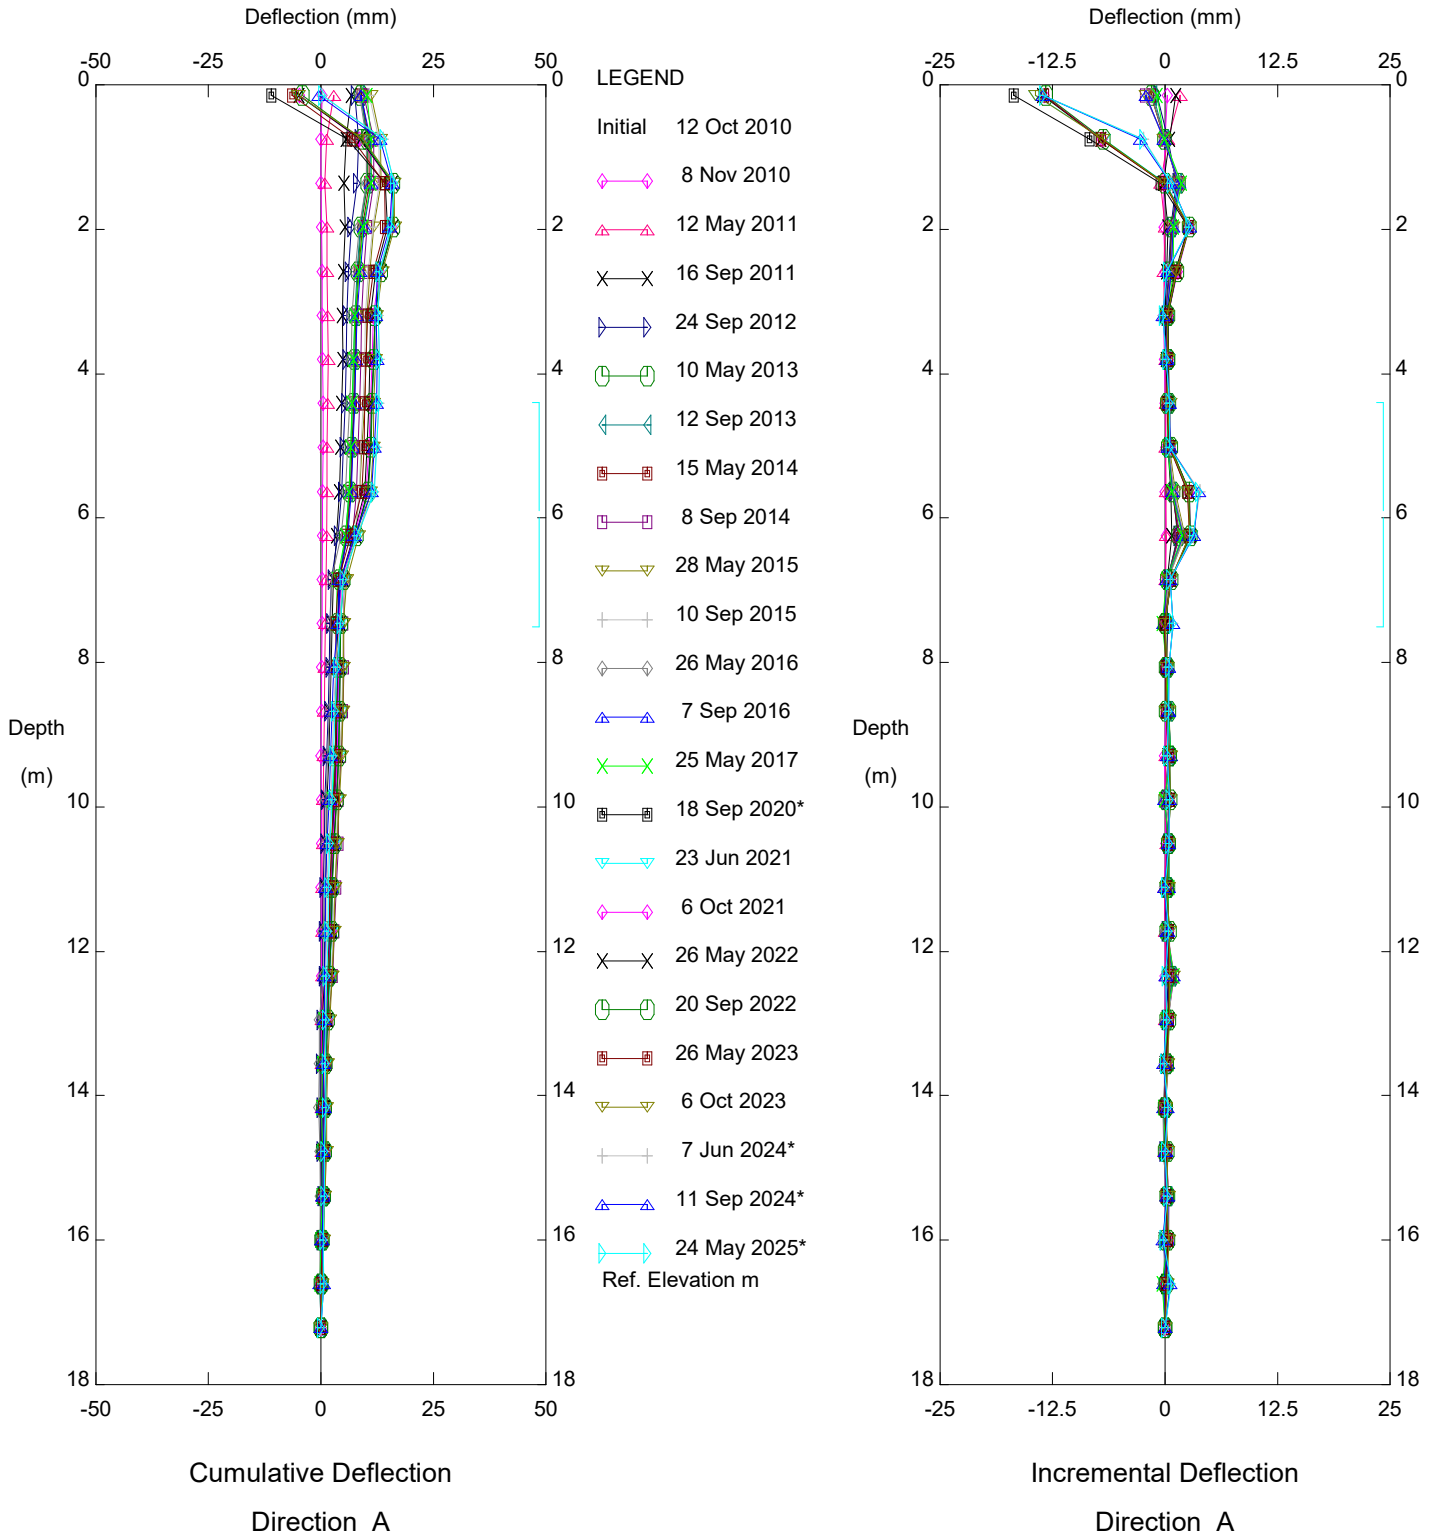
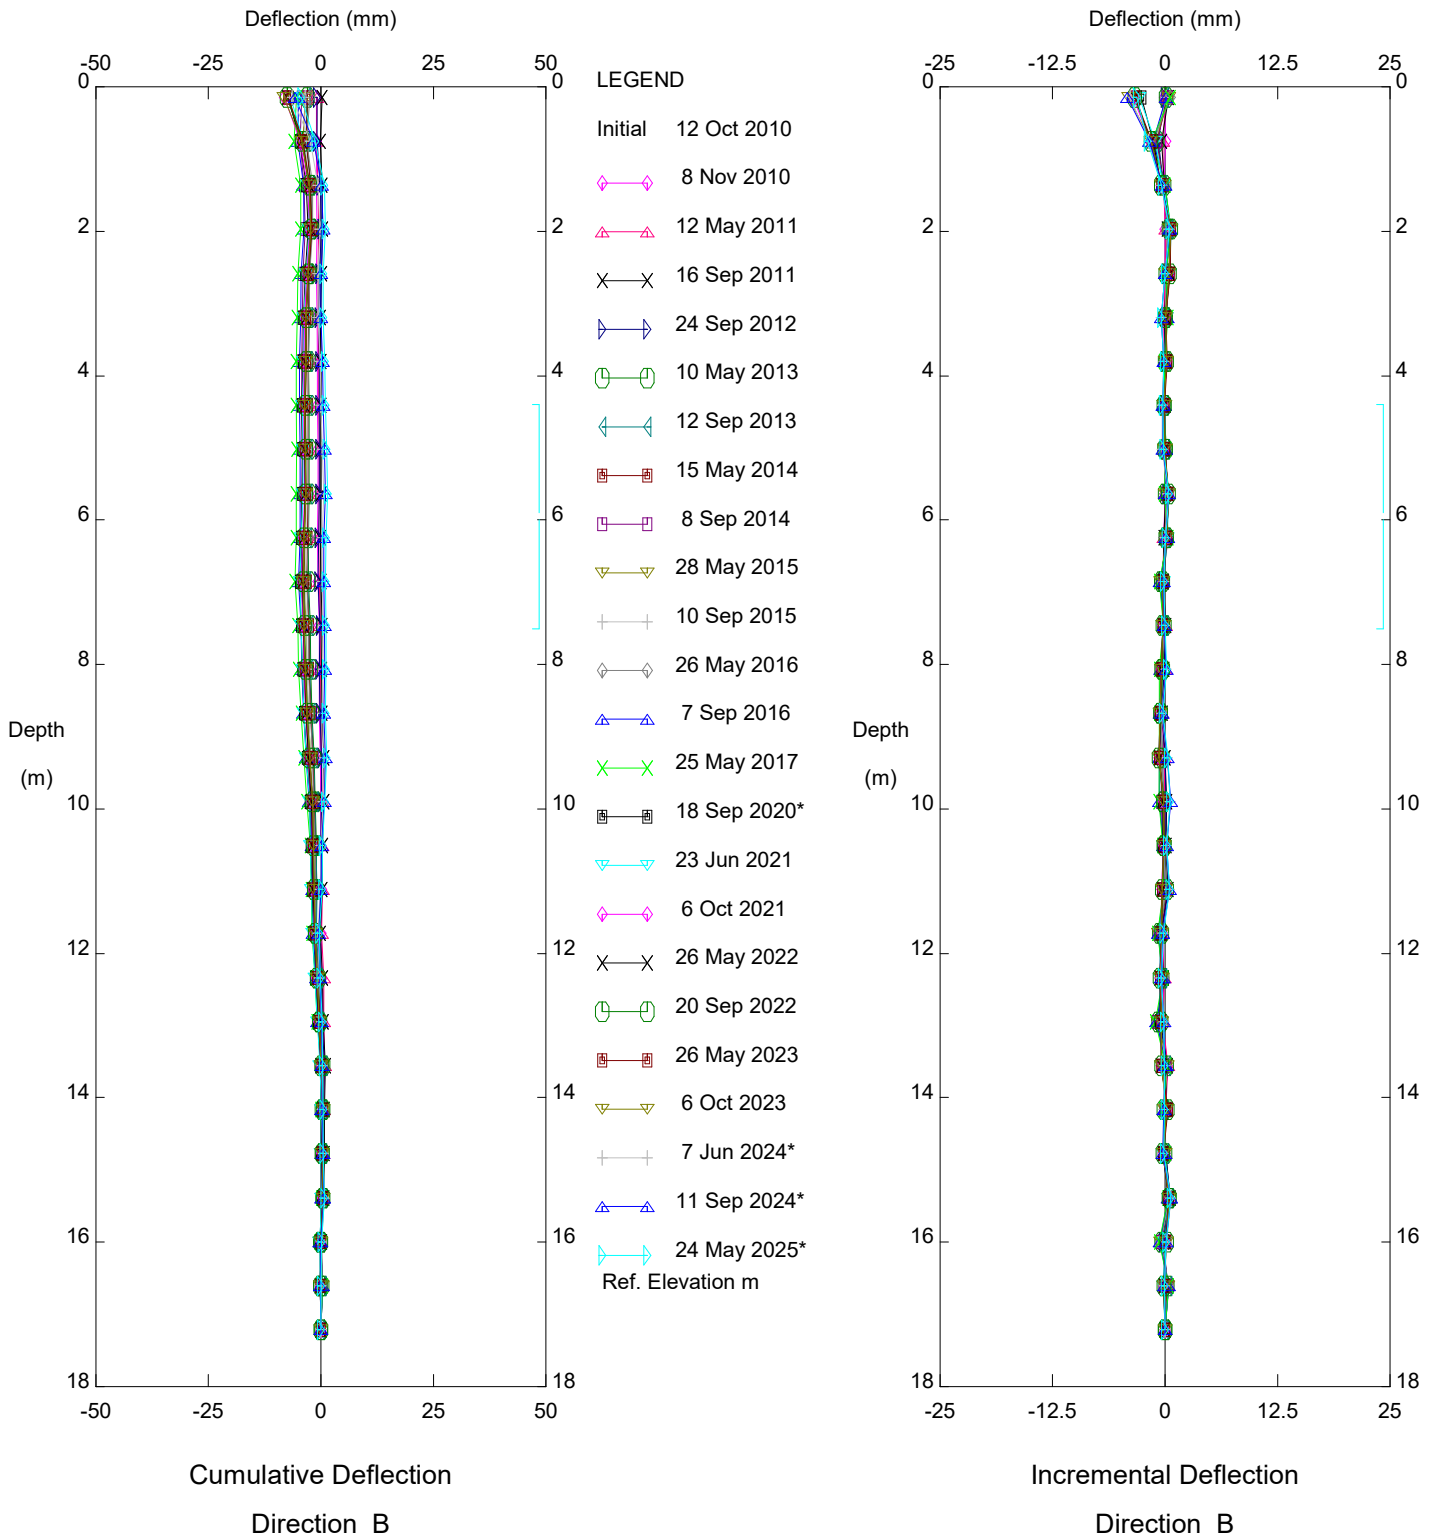
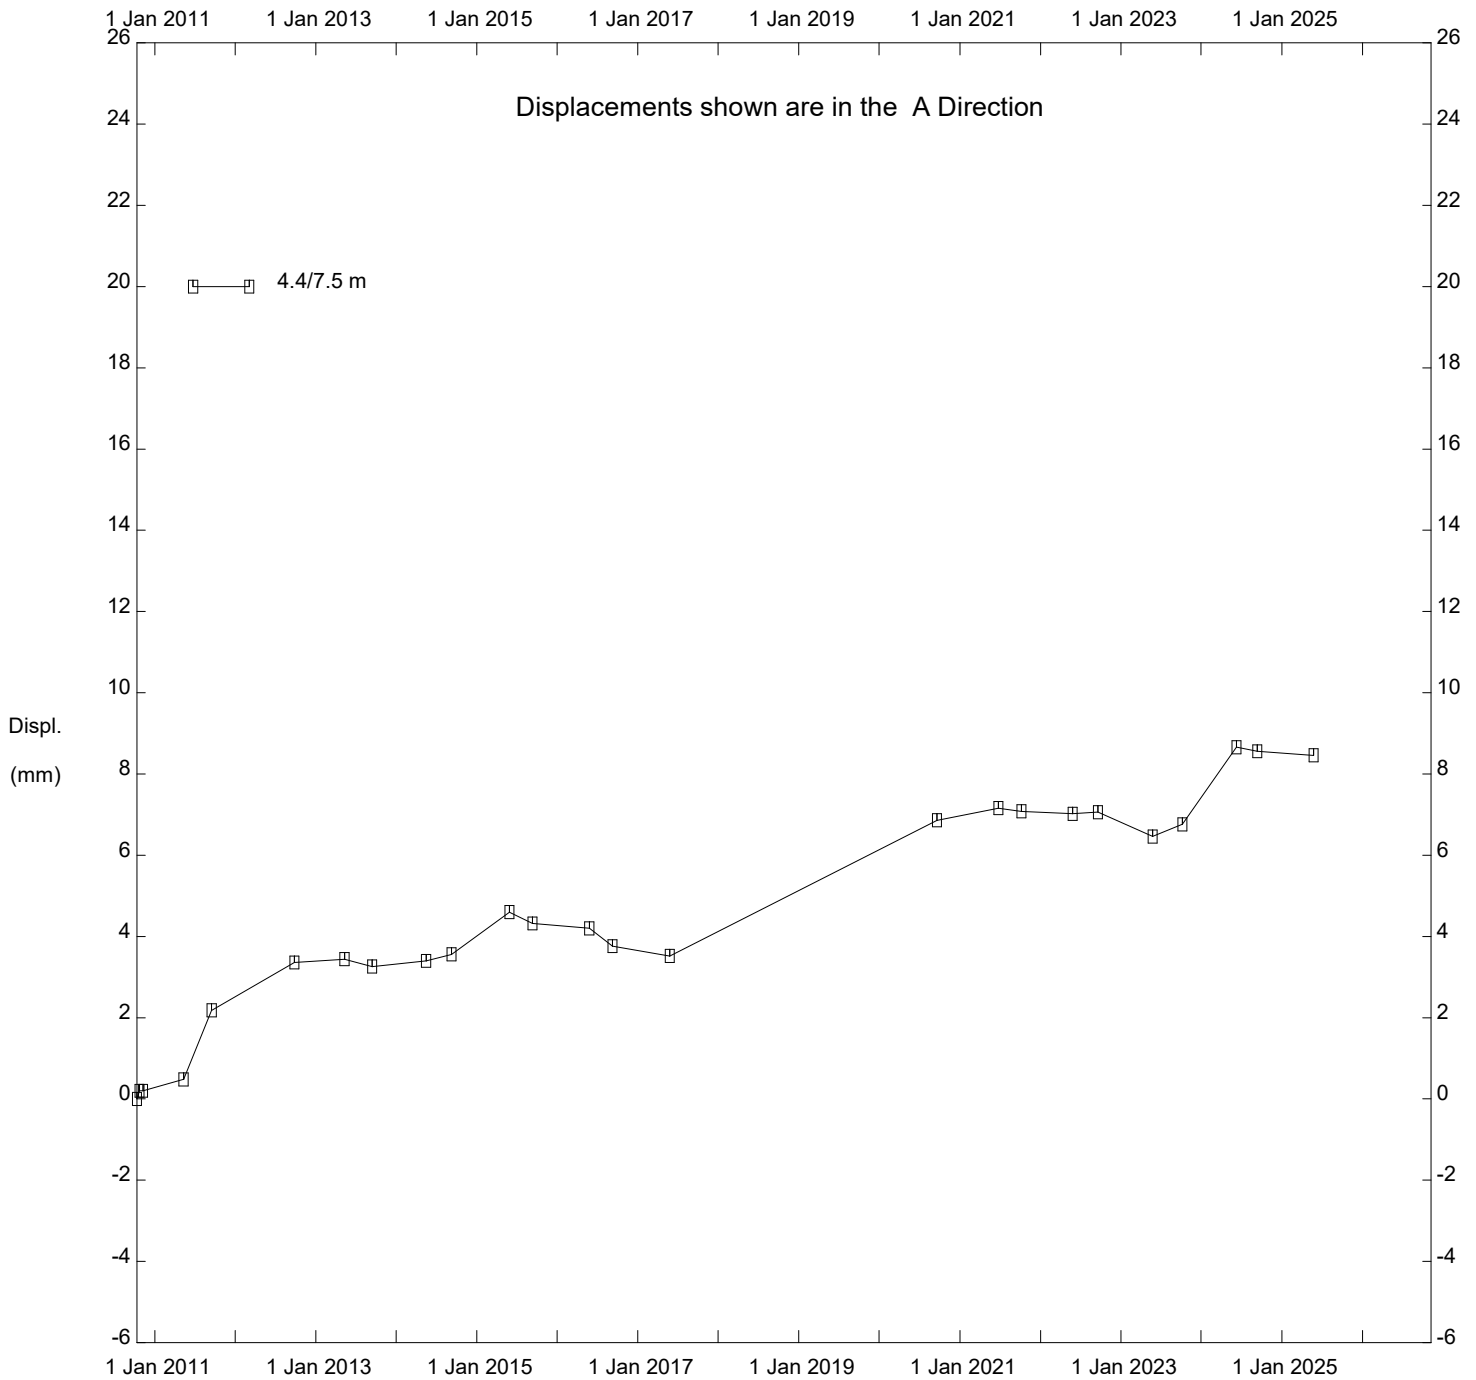
Hwy 41:23 Kehewin Lake (NC103), Inclinometer SI10-1

| INSTRUMENT # | DATE INITIALIZED | TOTAL CUMULATIVE RESULTANT MOVEMENT AND DEPTH OF MOVEMENT TO DATE (mm) | MAXIMUM RATE OF MOVEMENT (mm/yr) | CURRENT STATUS OF SI | DATE OF PREVIOUS READING | INCREMENTAL MOVEMENT SINCE PREVIOUS READING (mm) | CURRENT RATE OF MOVEMENT (mm/yr) | CHANGE IN RATE OF MOVEMENT SINCE PREVIOUS READING (mm/yr) |
|---|---|---|---|---|---|---|---|---|
| SI10-1 | Oct. 12, 2010 | 8.5 over 4.4 m to 7.5 m depth in 308° direction | 7.6 on Oct. 23, 2010 | Operational | September 11, 2024 | No discernible movement | N/A | 0.3 |

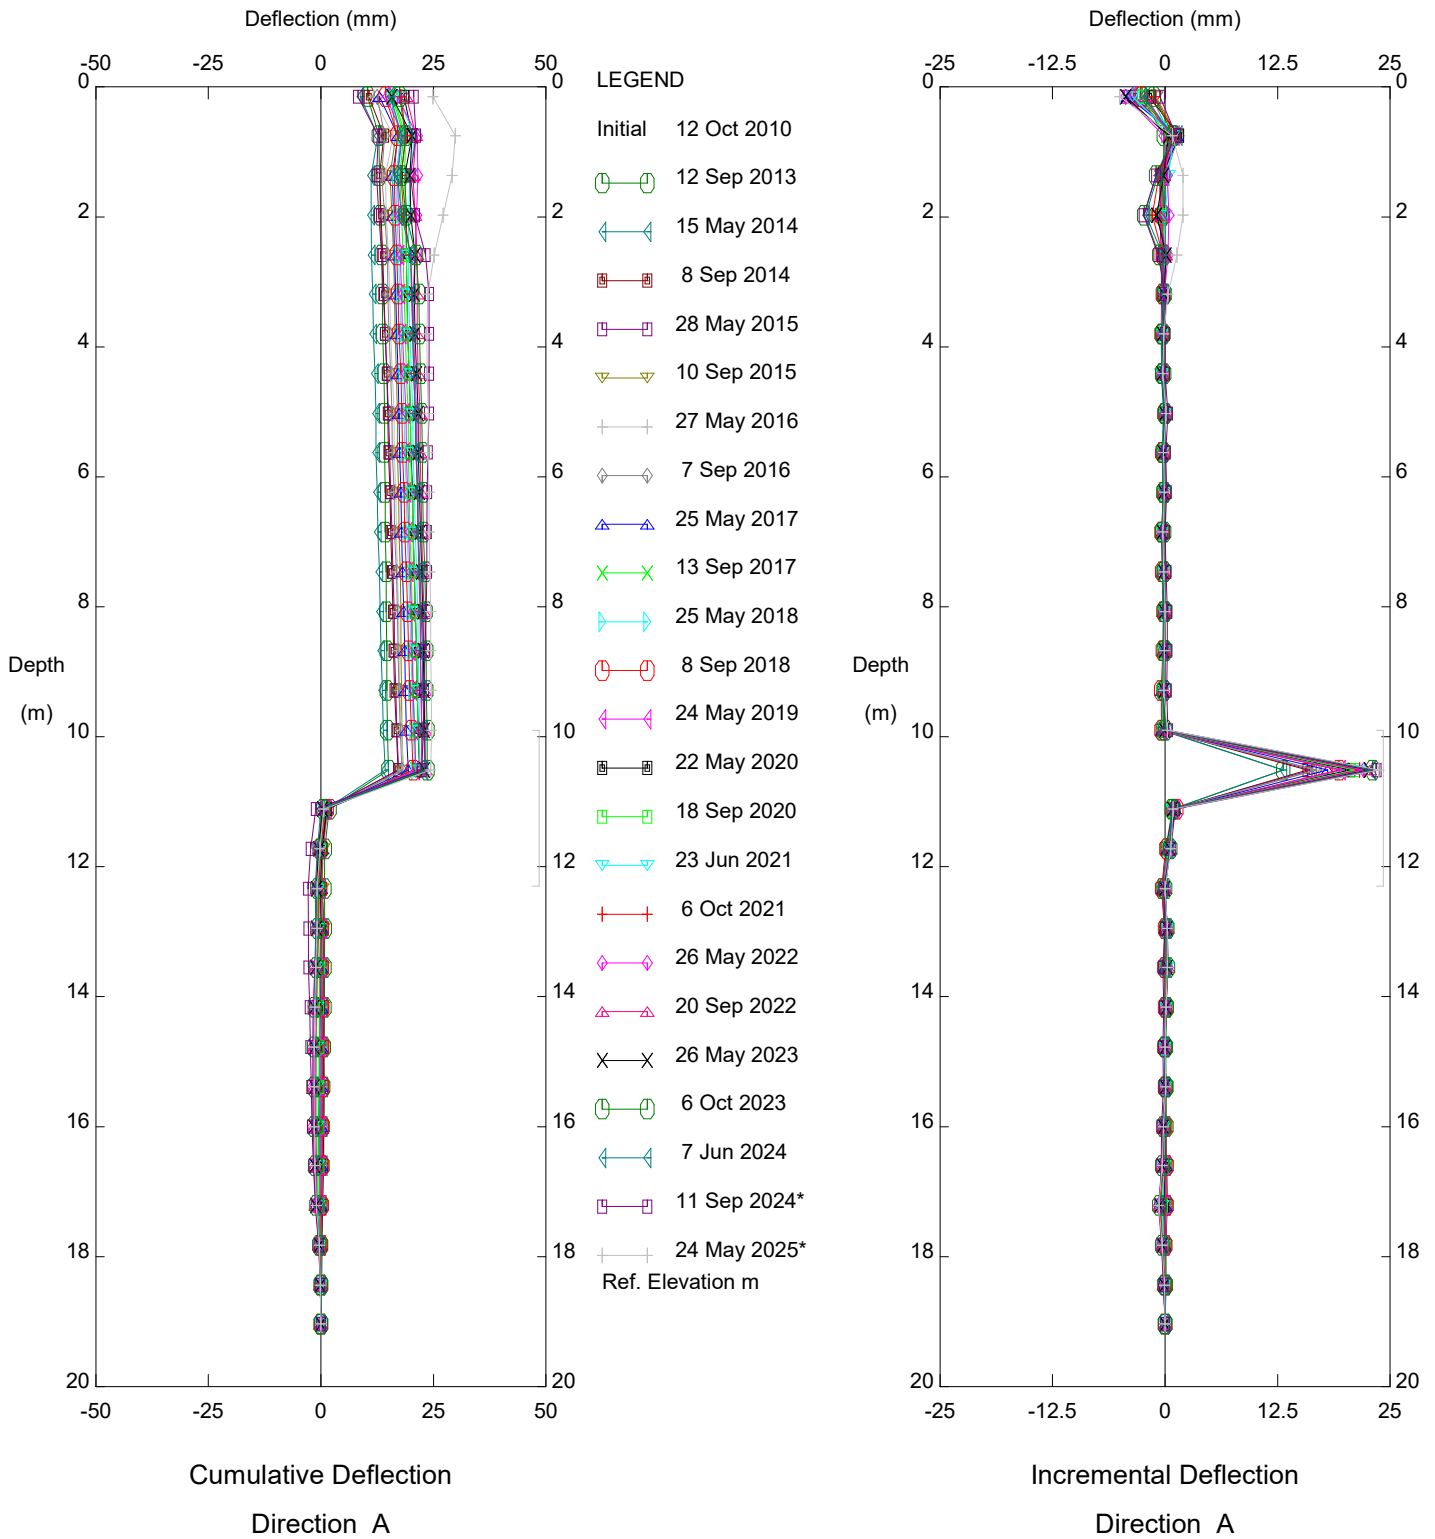
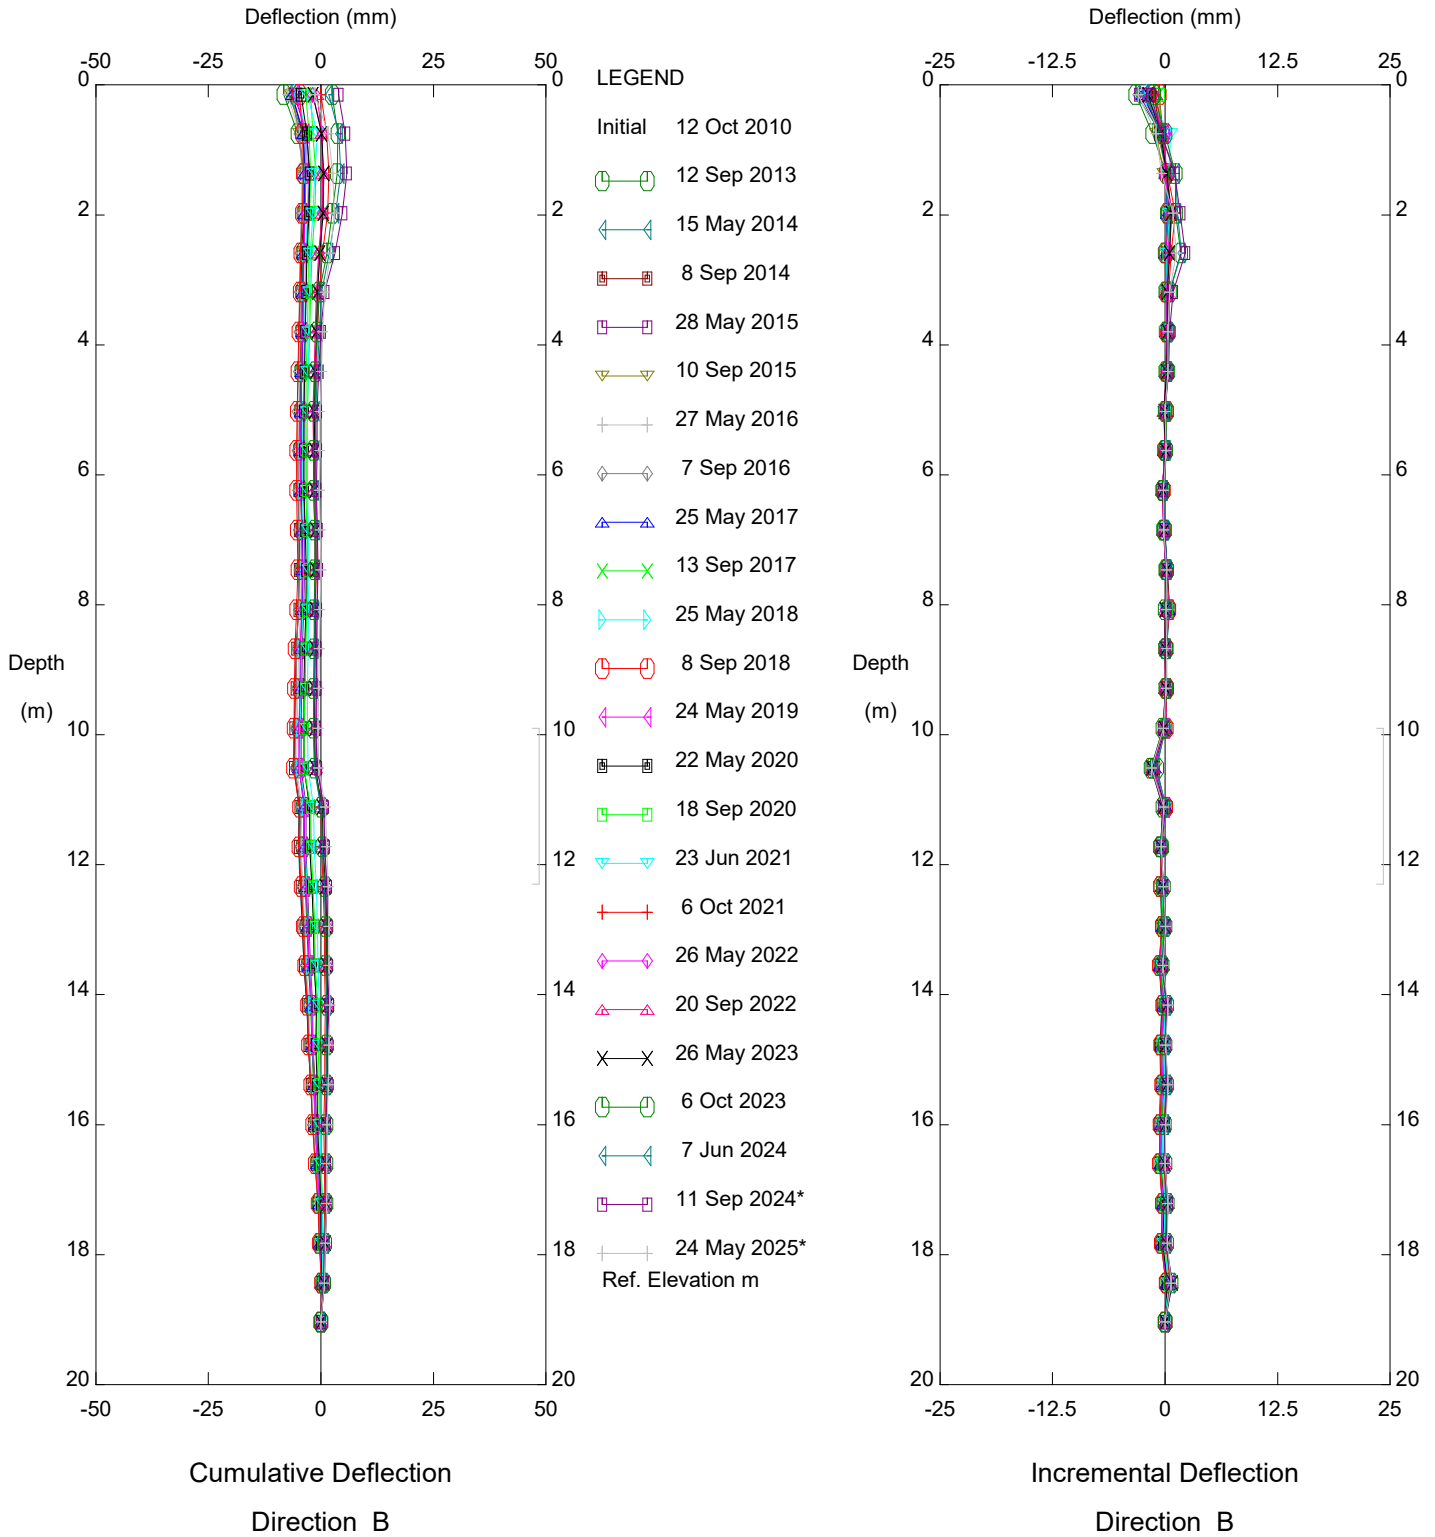
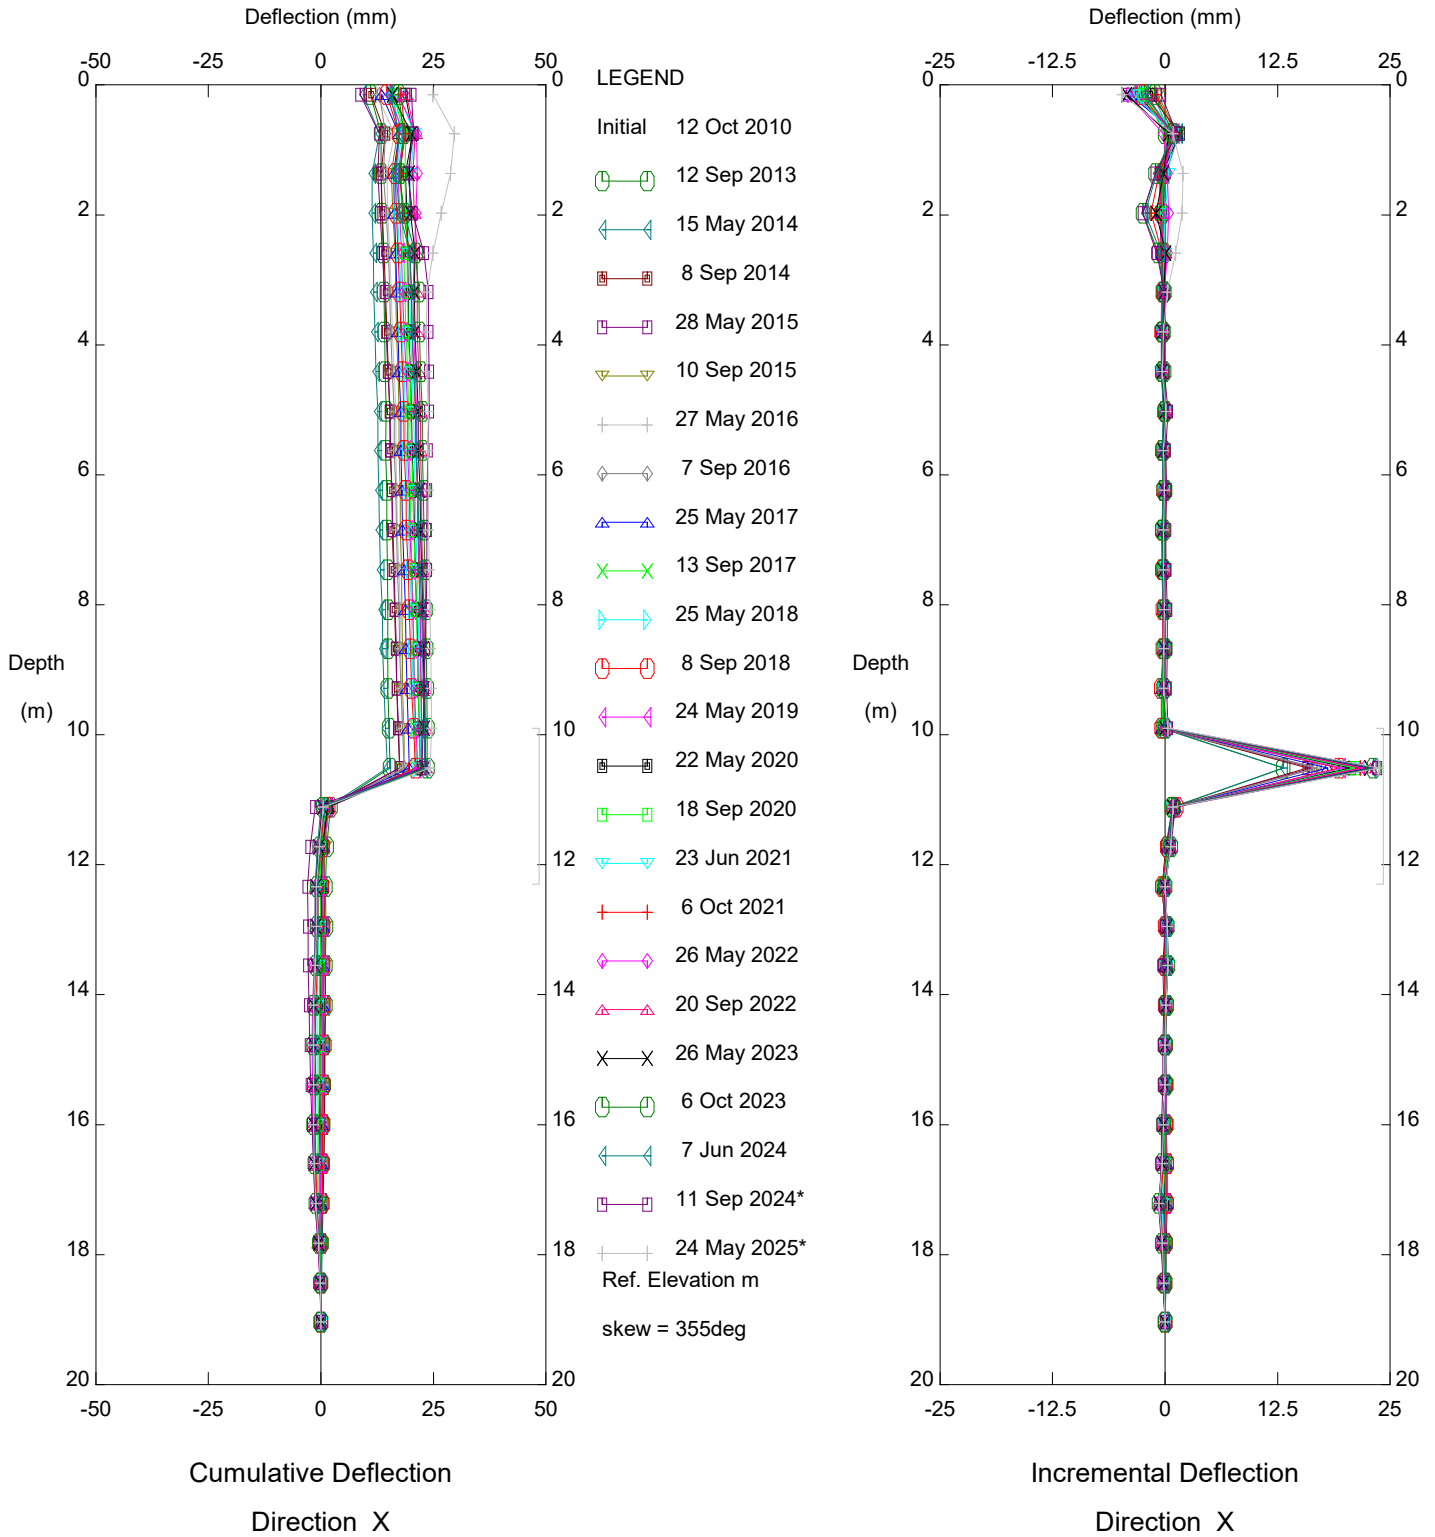
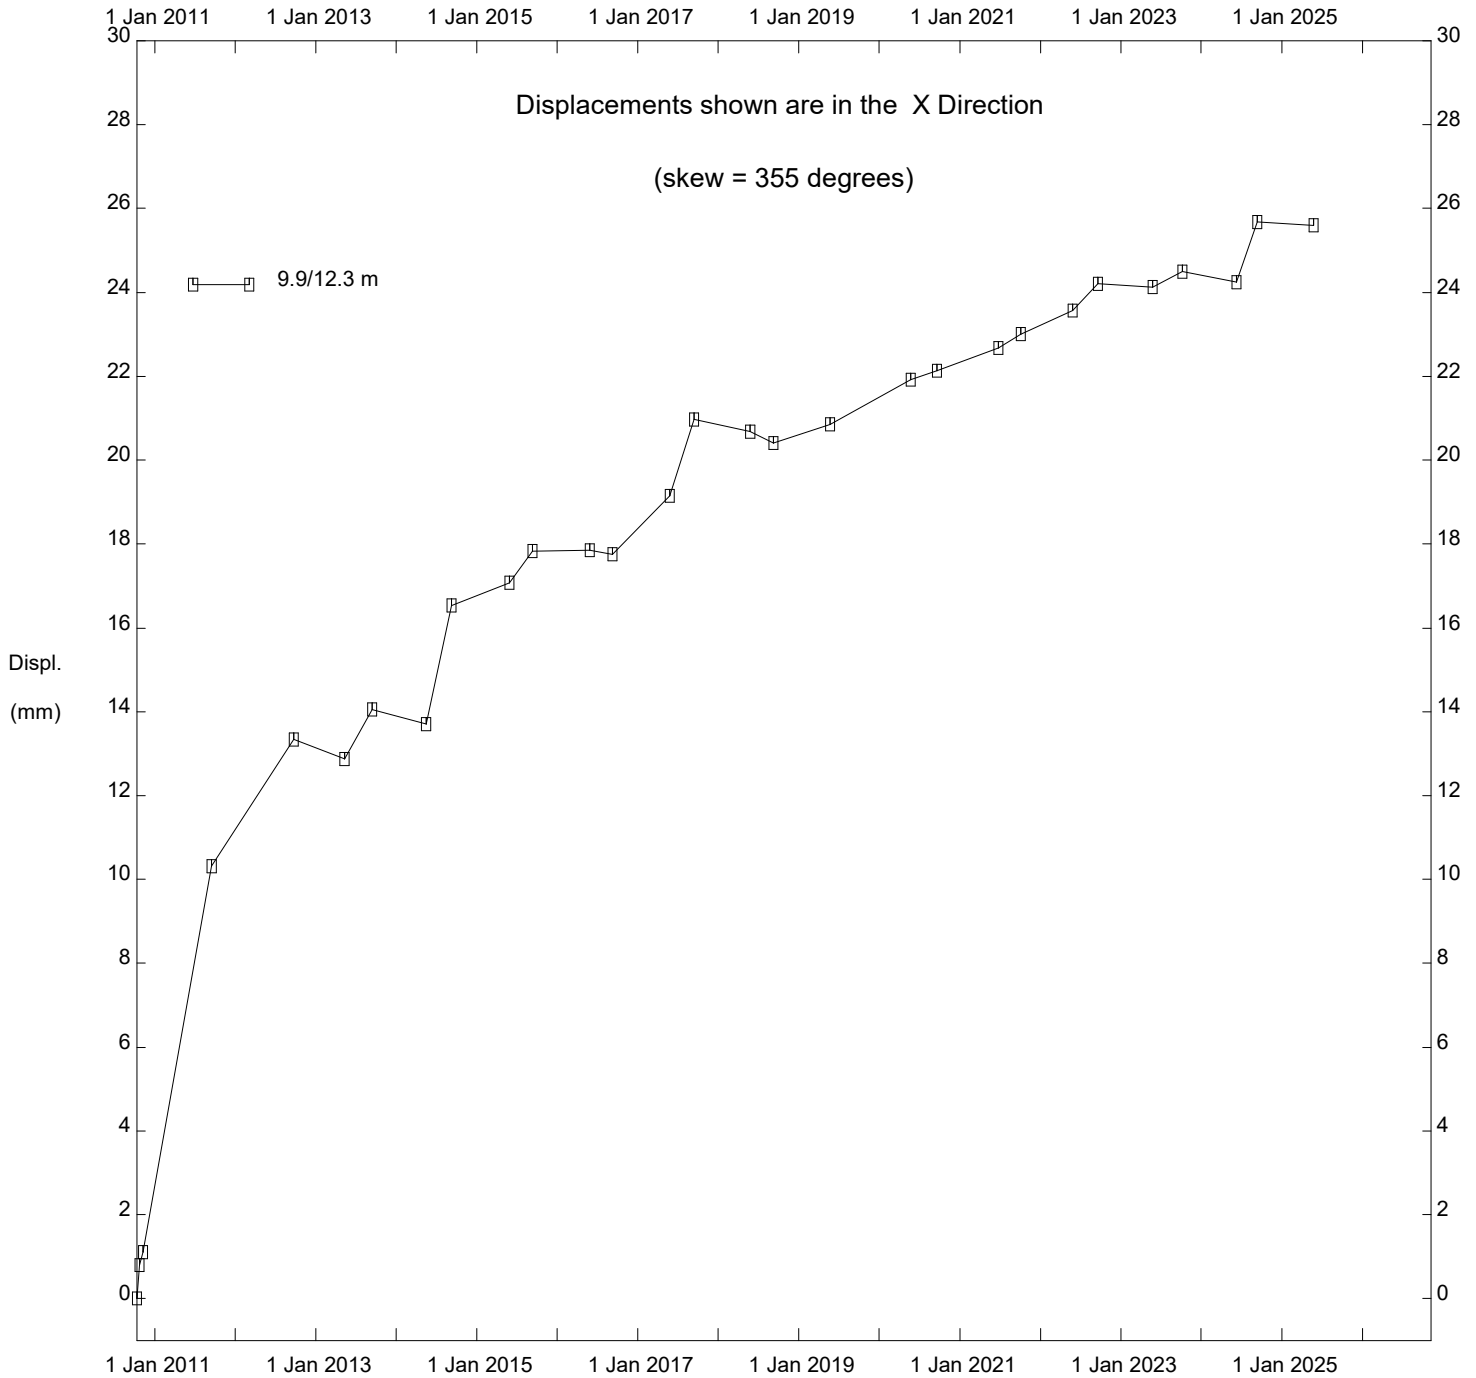
Hwy 41:23 Kehiwin Lake (NC103), Inclinator SI10-3

| INSTRUMENT # | DATE INITIALIZED | TOTAL CUMULATIVE RESULTANT MOVEMENT AND DEPTH OF MOVEMENT TO DATE (mm) | MAXIMUM RATE OF MOVEMENT (mm/yr) | CURRENT STATUS OF SI | DATE OF PREVIOUS READING | INCREMENTAL MOVEMENT SINCE PREVIOUS READING (mm) | CURRENT RATE OF MOVEMENT (mm/yr) | CHANGE IN RATE OF MOVEMENT SINCE PREVIOUS READING (mm/yr) |
|---|---|---|---|---|---|---|---|---|
| SI10-3 | Oct. 12, 2010 | 25.6 over 9.9 m to 12.3 m depth in 291° direction | 26.5 on Oct. 23, 2010 | Operational | September 11, 2024 | No discernible movement | N/A | -5.6 |
