ALBERTA TRANSPORTATION AND  
ECONOMIC CORRIDORS GRMP  
NORTH CENTRAL (ATHABASCA AND FORT  
McMURRAY DISTRICTS)  
INSTRUMENTATION MONITORING - SPRING 2025

| Site Number | Location | Name | Hwy | km |
| NC103<br>(NC024-3) | HWY 41:23 C1 7.89 | Kehiwin Lake | 41:23 | km 7.8 |

| <b>Current Monitoring:</b> | 24-May-2025 | <b>Previous Monitoring</b> | 11-Sep-2024 |

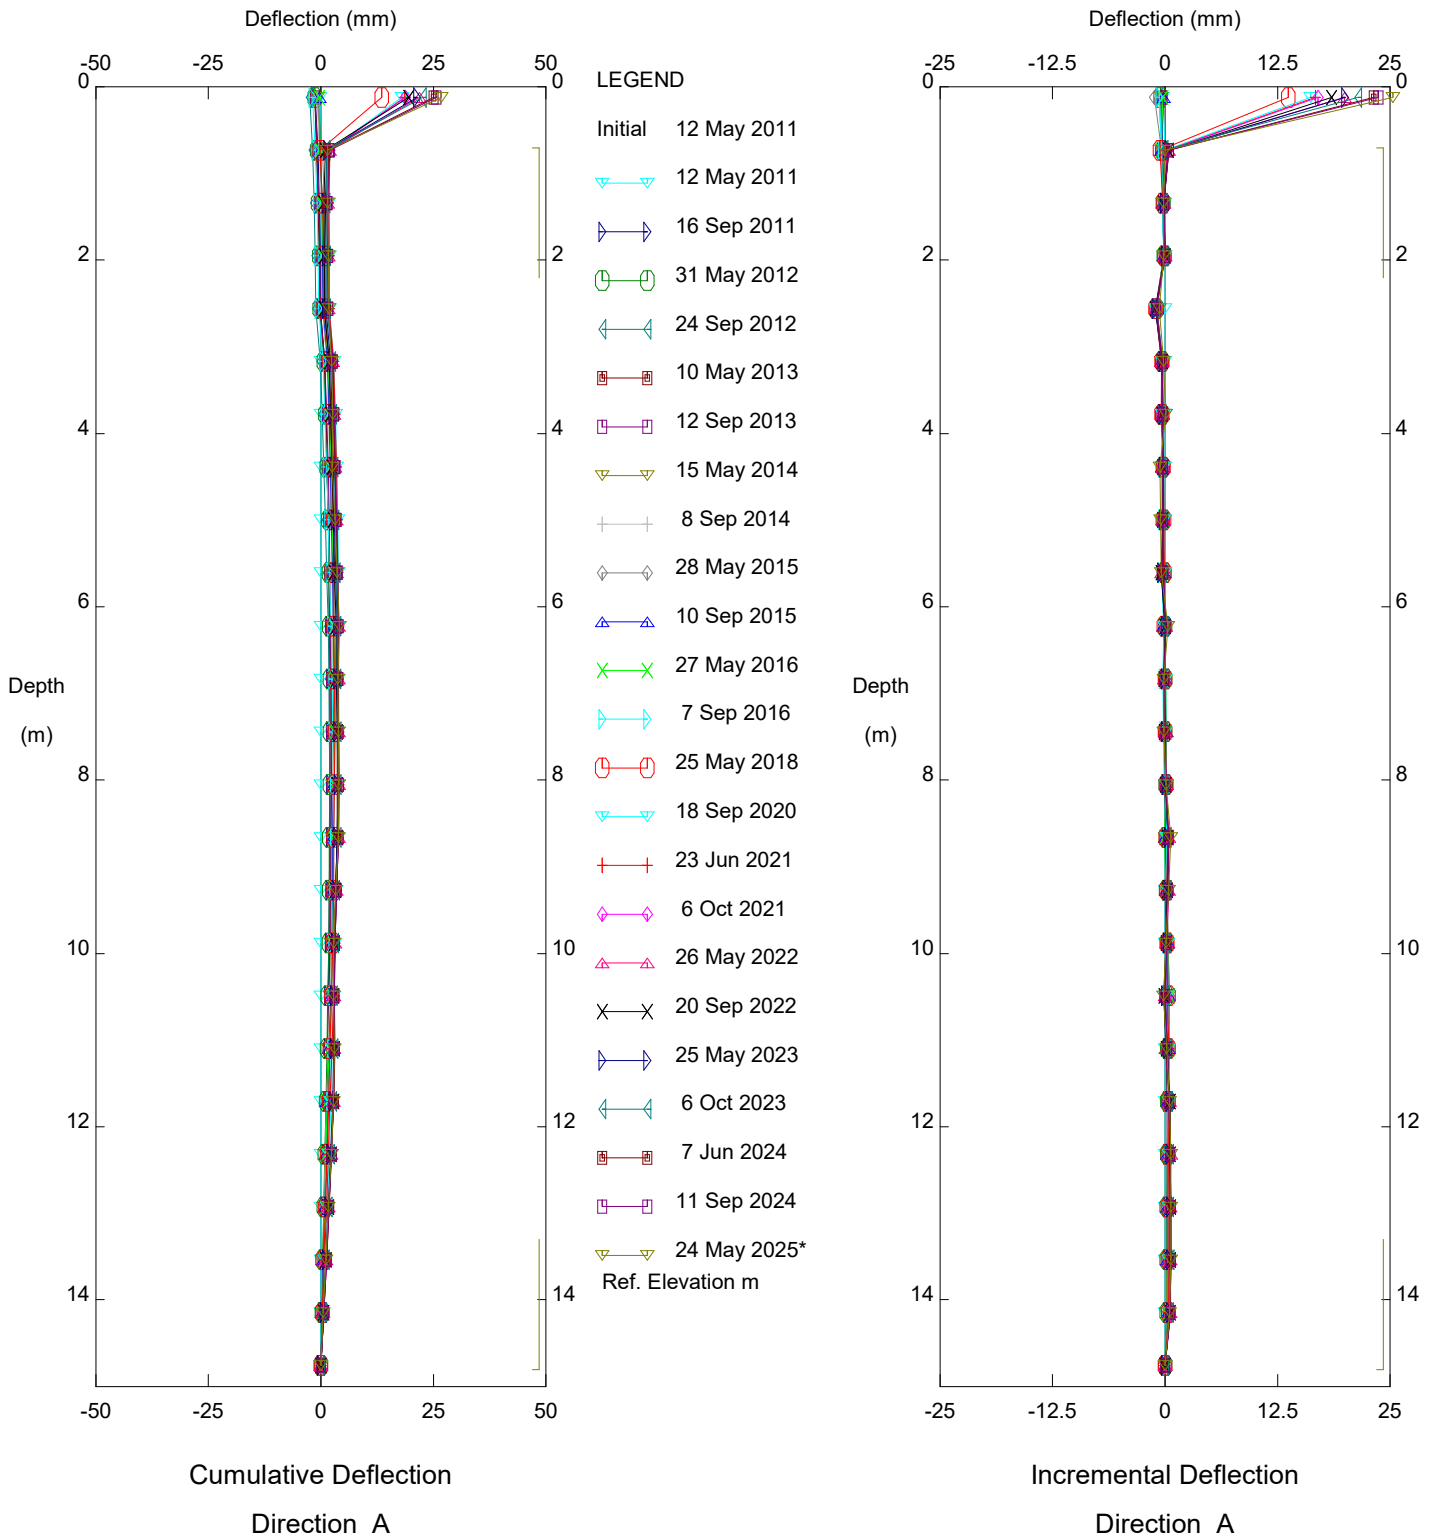
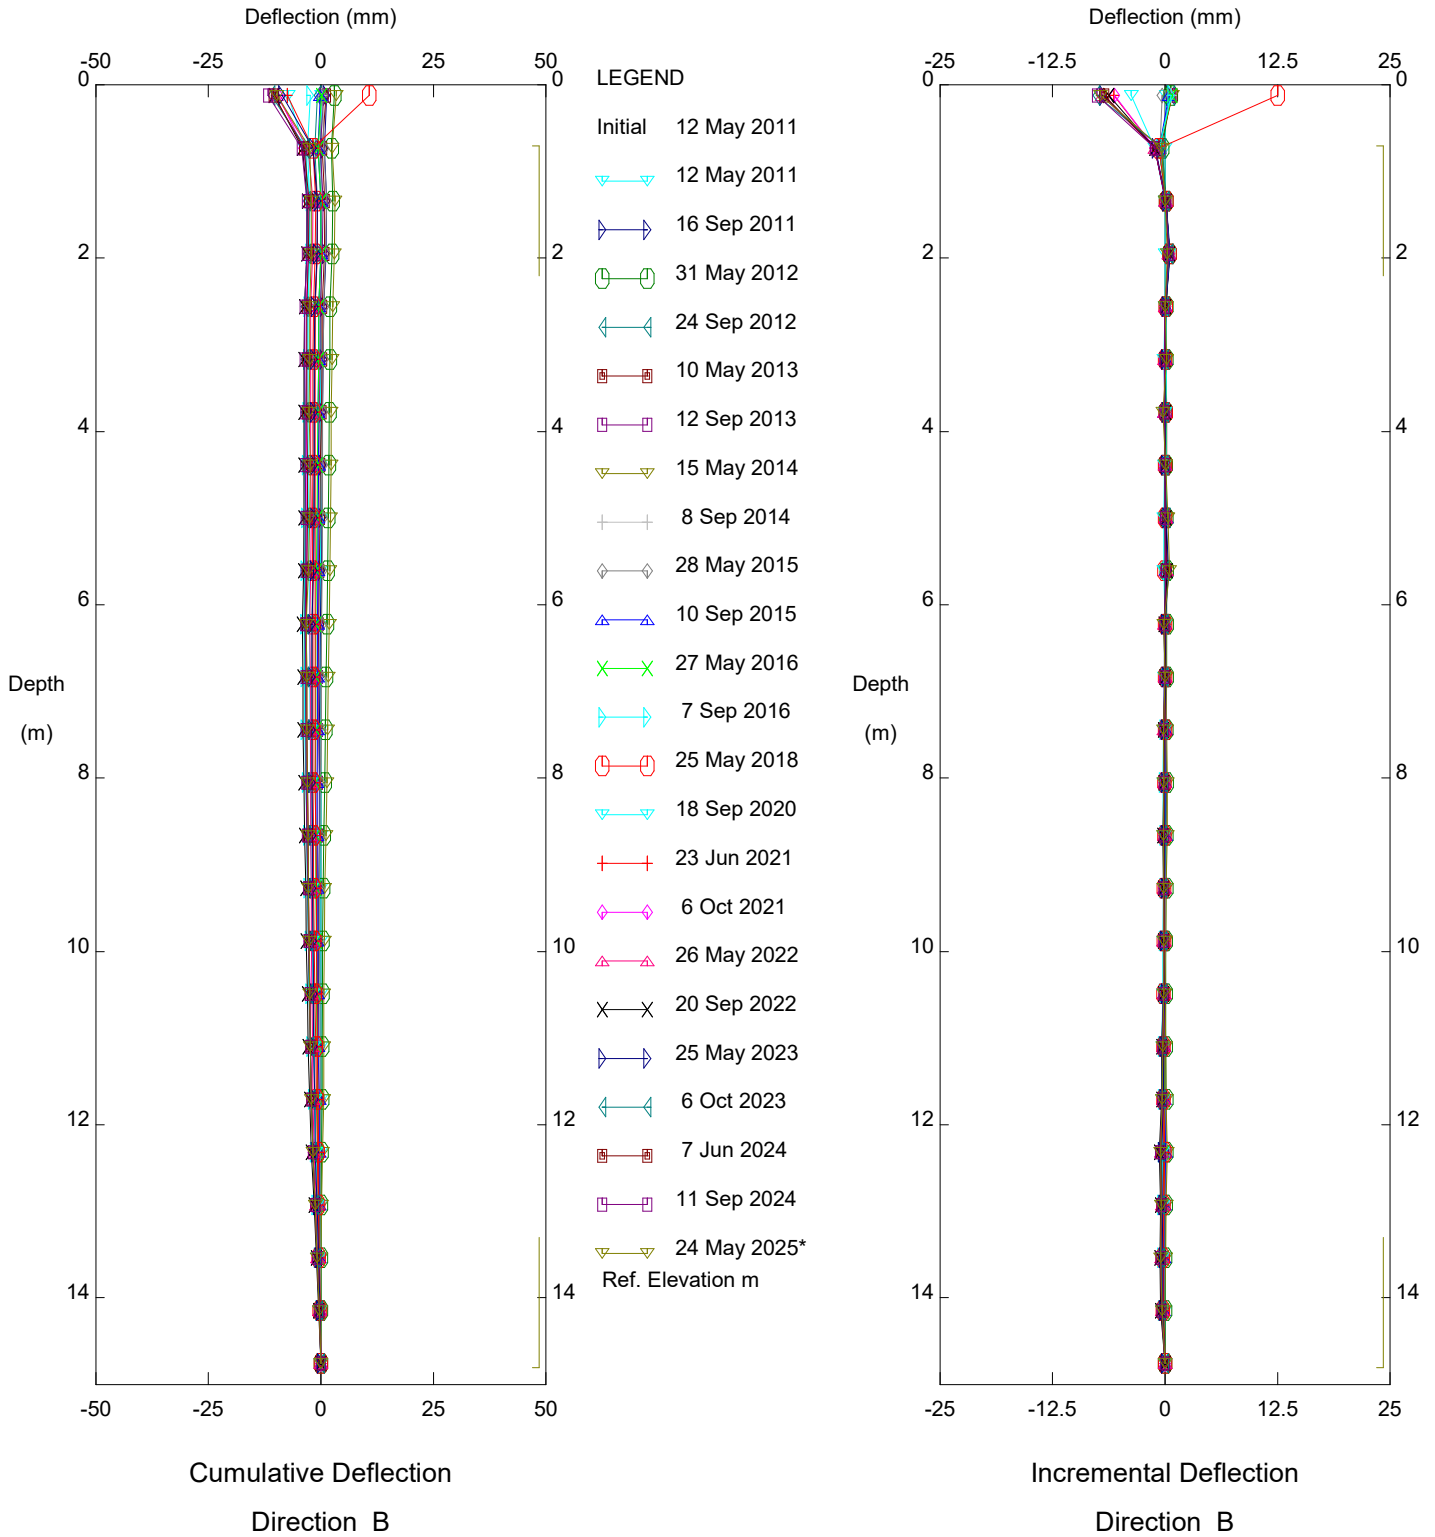
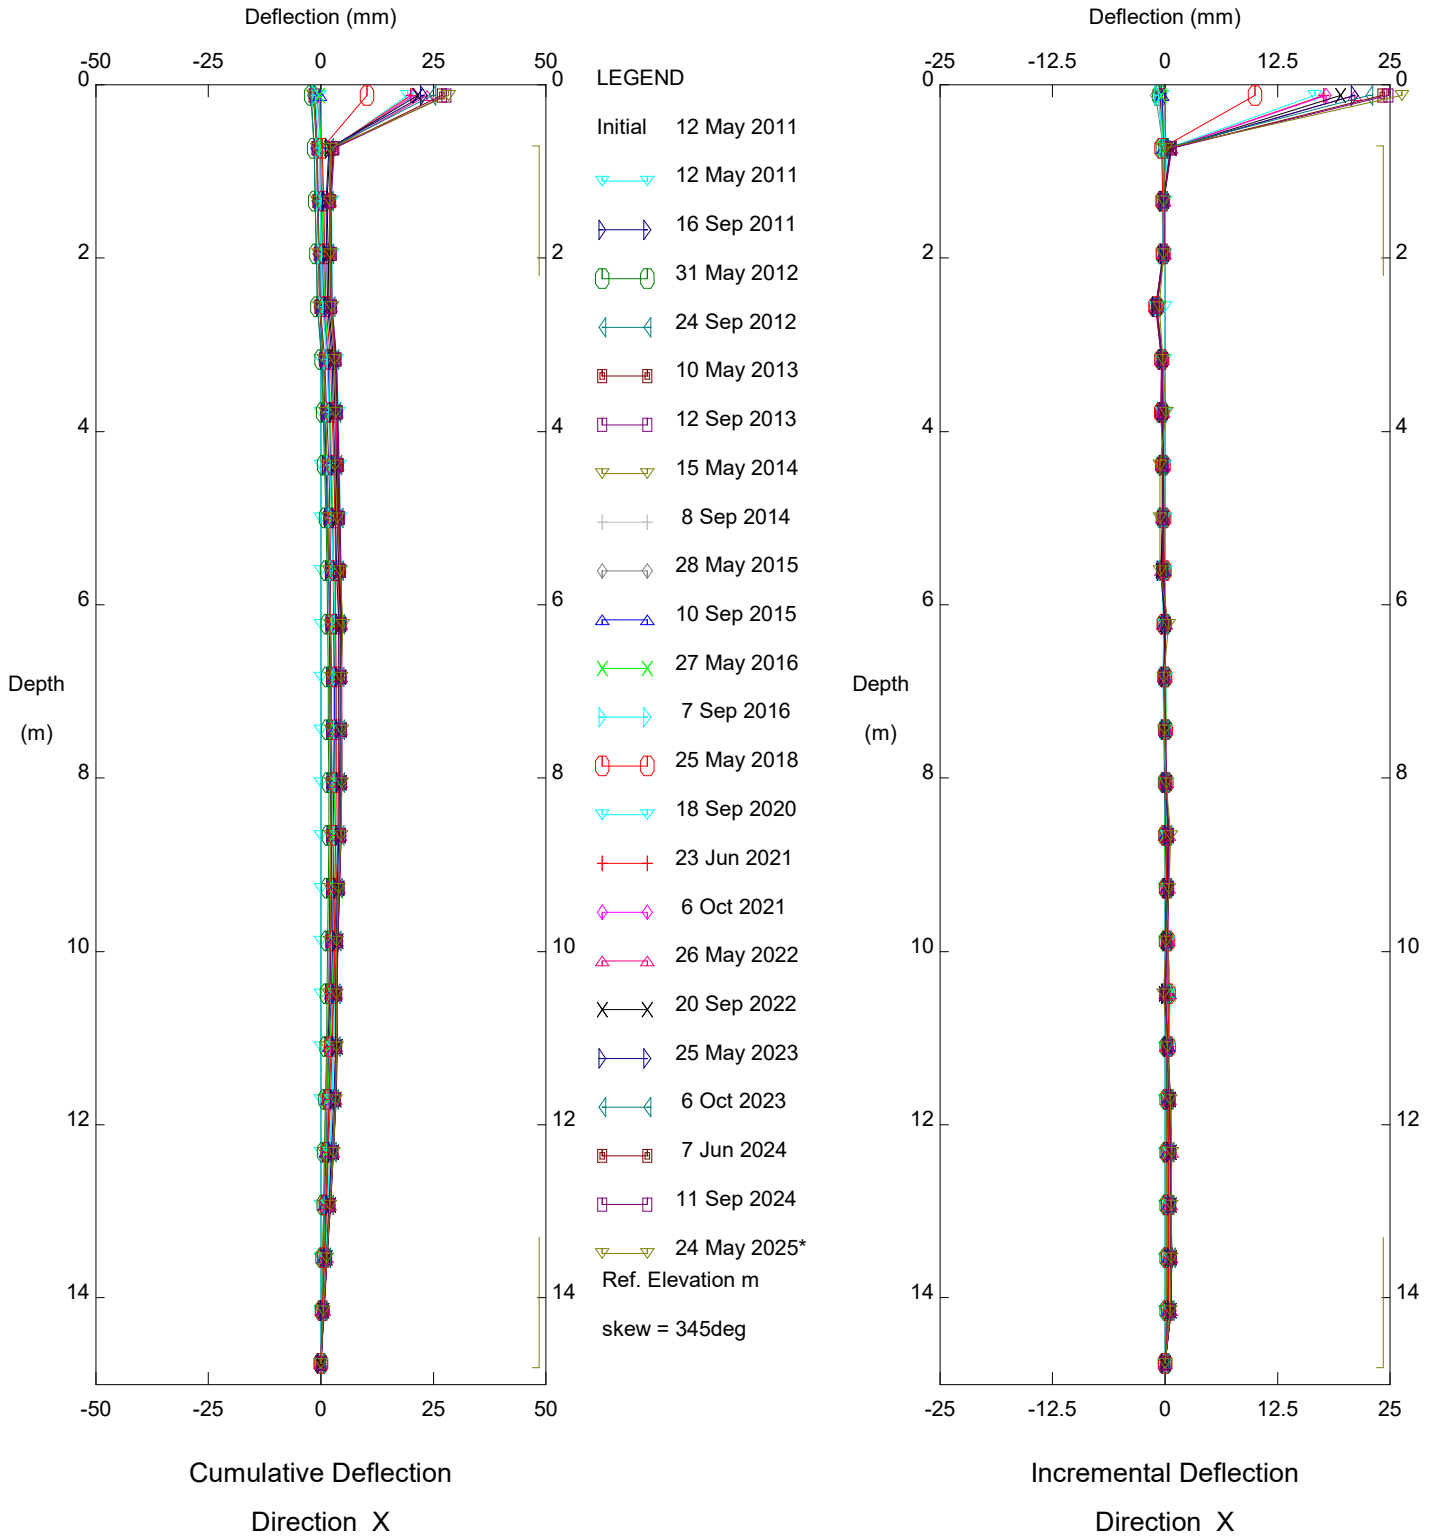
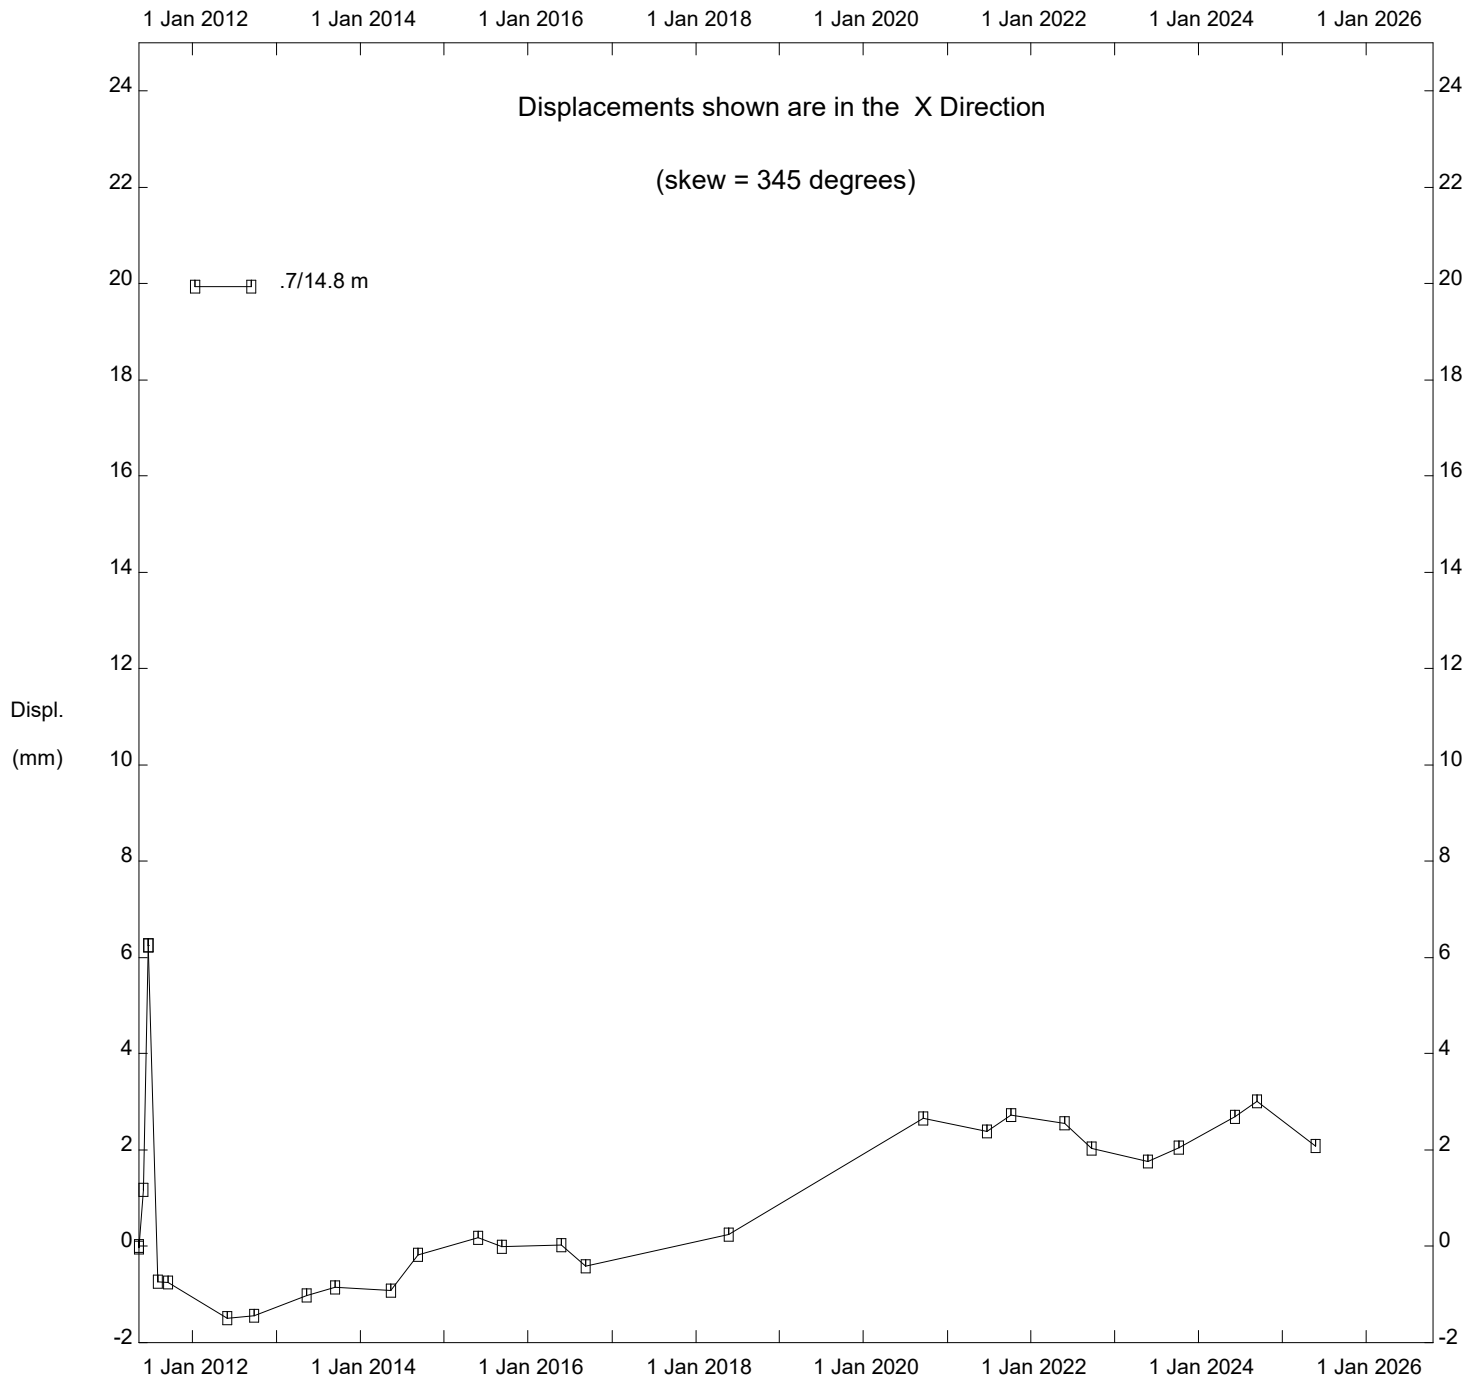
Hwy 41:23 Kehewin Lake (NC103), Inclinometer SI11-1(P9)

| INSTRUMENT # | DATE INITIALIZED | TOTAL CUMULATIVE RESULTANT MOVEMENT AND DEPTH OF MOVEMENT TO DATE (mm) | MAXIMUM RATE OF MOVEMENT (mm/yr) | CURRENT STATUS OF SI | DATE OF PREVIOUS READING | INCREMENTAL MOVEMENT SINCE PREVIOUS READING (mm) | CURRENT RATE OF MOVEMENT (mm/yr) | CHANGE IN RATE OF MOVEMENT SINCE PREVIOUS READING (mm/yr) |
|---|---|---|---|---|---|---|---|---|
| SI11-1 (Pile 9) | May 12, 2011 | 2.1 over 0.7 m to 14.8 m depth in 308° direction | 87.6 on June 21, 2011 | Operational | September 11, 2024 | No discernible movement | N/A | -5.6 |

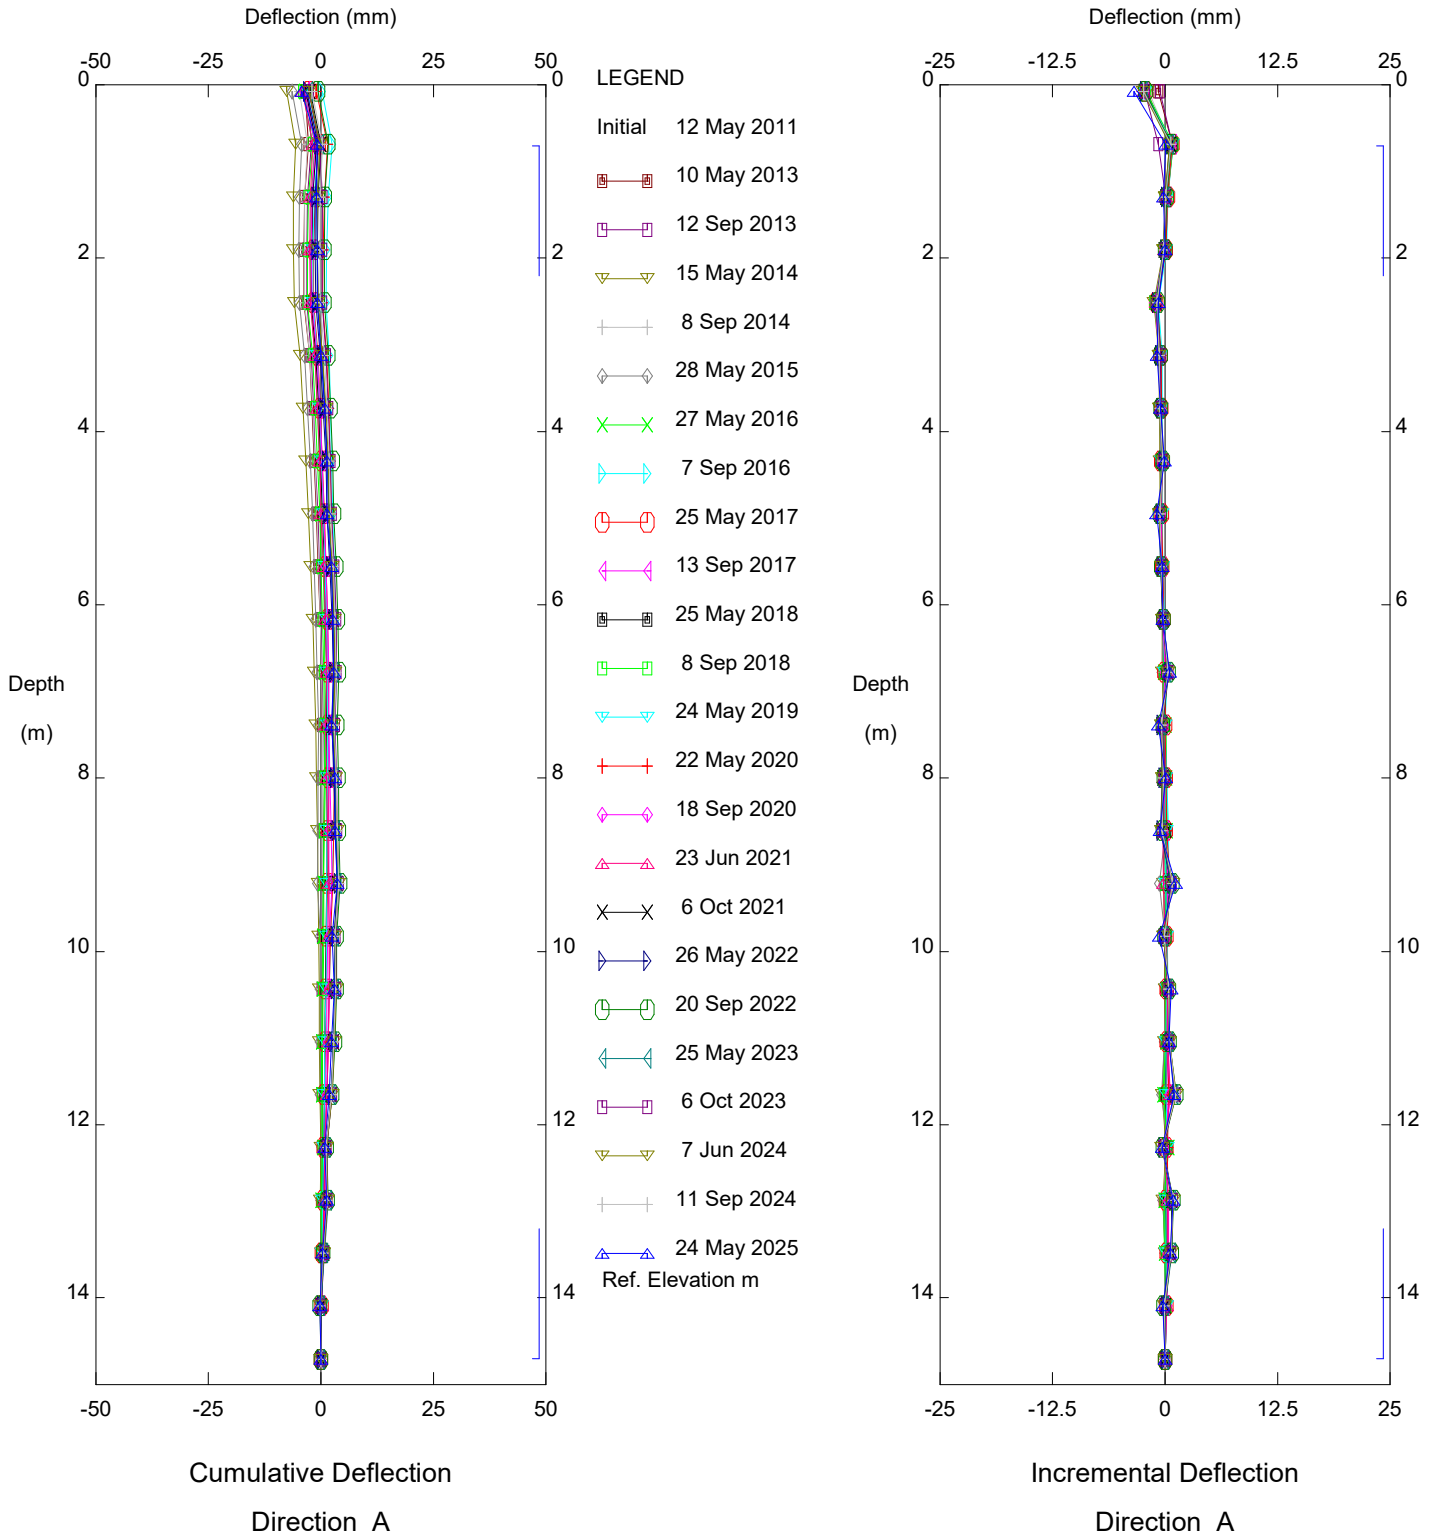
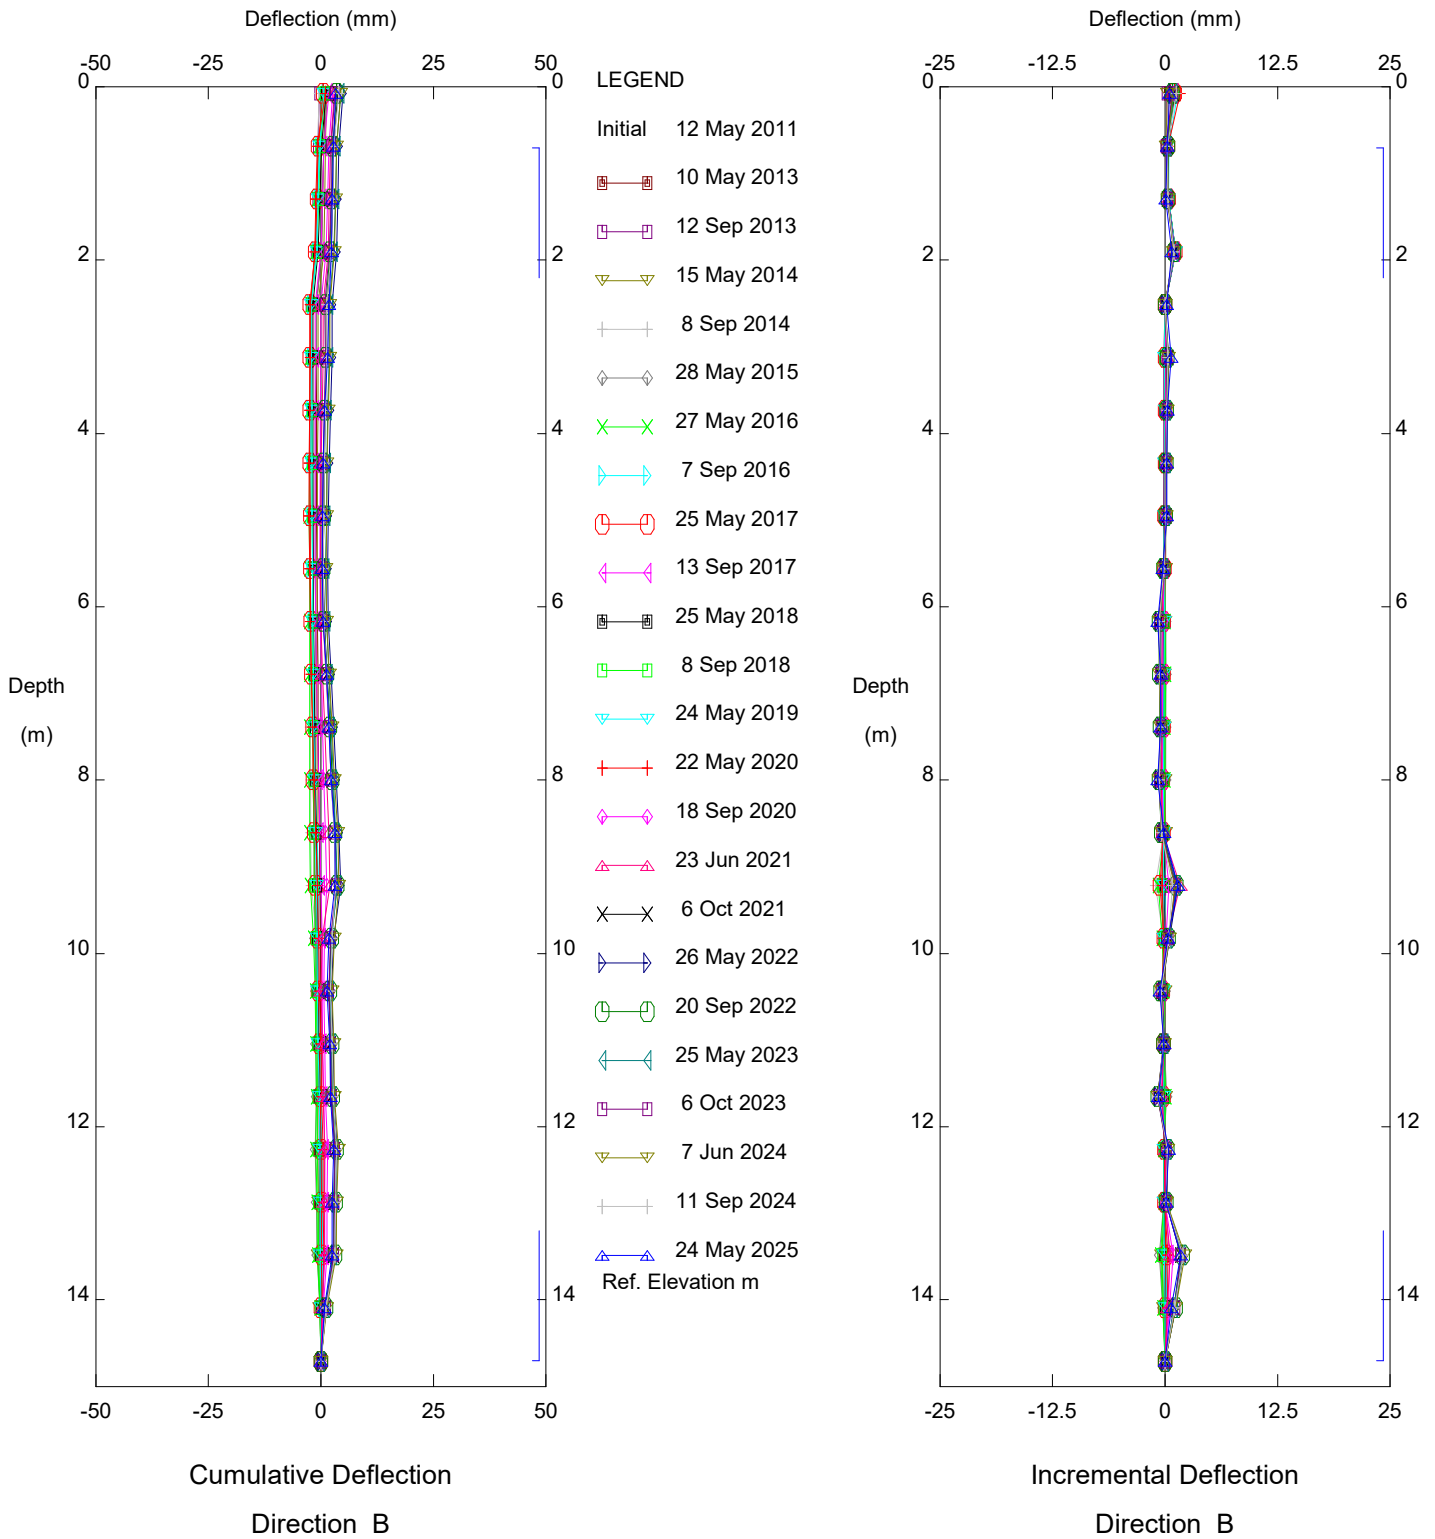
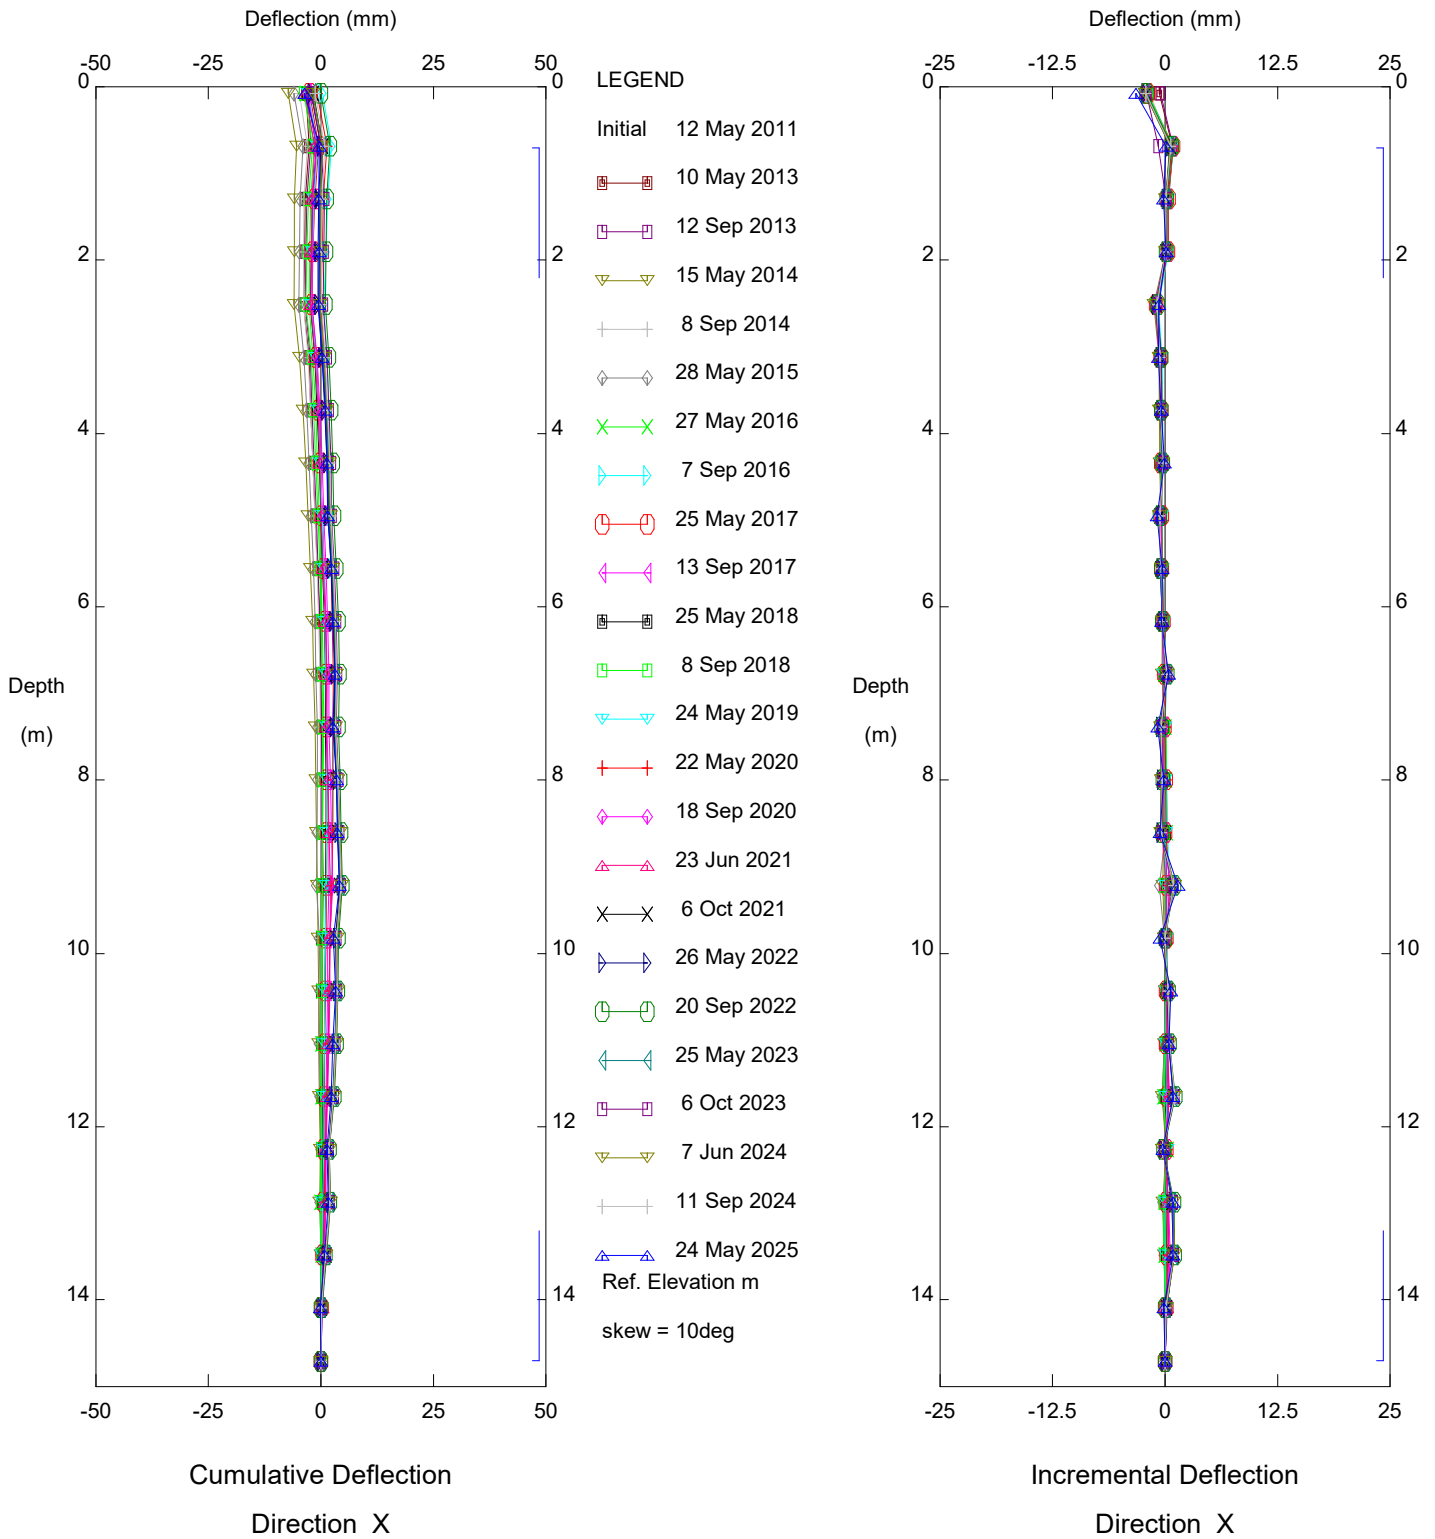
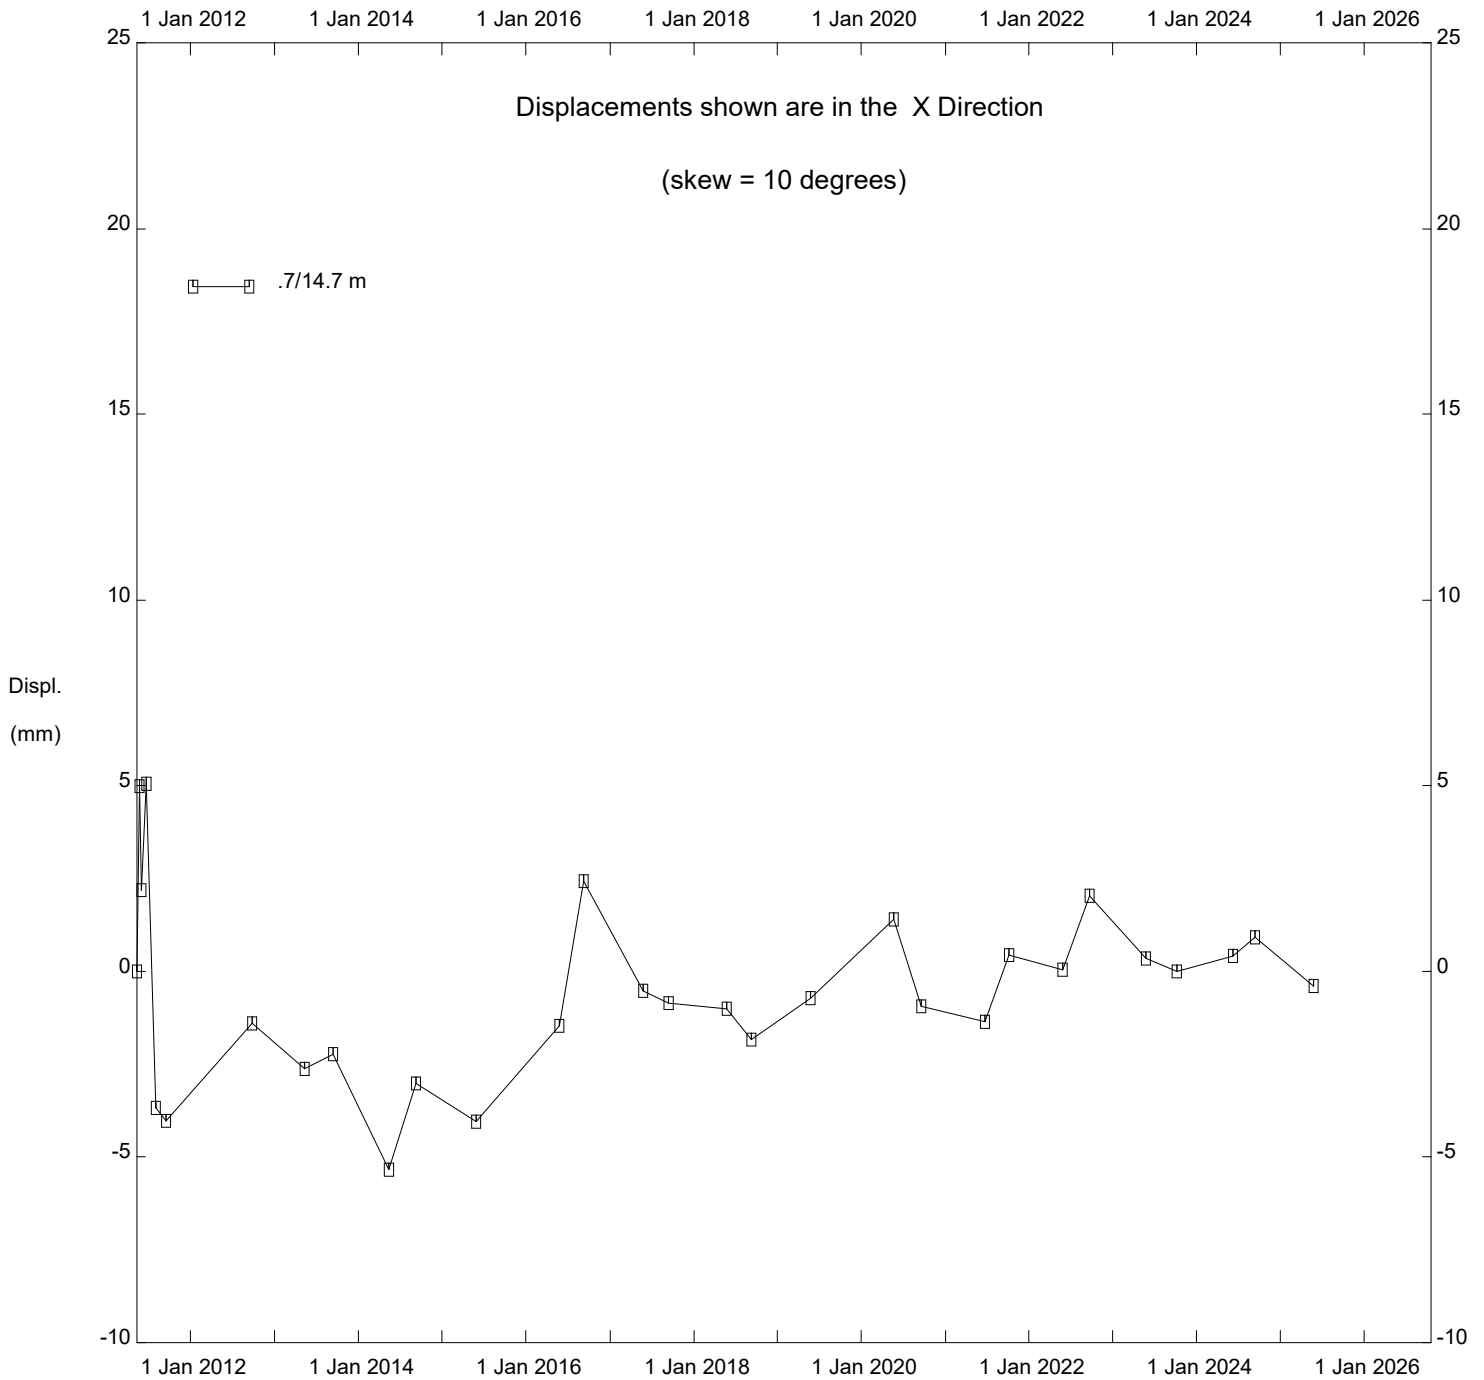
Hwy 41:23 Kehiwin Lake (NC103), Inclinometer SI11-2 (P27)

| INSTRUMENT # | DATE INITIALIZED | TOTAL CUMULATIVE RESULTANT MOVEMENT AND DEPTH OF MOVEMENT TO DATE (mm) | MAXIMUM RATE OF MOVEMENT (mm/yr) | CURRENT STATUS OF SI | DATE OF PREVIOUS READING | INCREMENTAL MOVEMENT SINCE PREVIOUS READING (mm) | CURRENT RATE OF MOVEMENT (mm/yr) | CHANGE IN RATE OF MOVEMENT SINCE PREVIOUS READING (mm/yr) |
|---|---|---|---|---|---|---|---|---|
| SI11-2 (Pile 27) | May 12, 2011 | -0.4 over 0.7 m to 14.7 m depth in 306° direction | 146.6 on May 25, 2011 | Operational | September 11, 2024 | No discernible movement | N/A | -3.7 |
