ALBERTA TRANSPORTATION AND  
ECONOMIC CORRIDORS GRMP  
NORTH CENTRAL (ATHABASCA AND FORT  
McMURRAY DISTRICTS)  
INSTRUMENTATION MONITORING - SPRING 2025

| Site Number | Location | Name | Hwy | km |
| NC103<br>(NC024-3) | HWY 41:23 C1 7.89 | Kehiwin Lake | 41:23 | km 7.8 |

| <b>Current Monitoring:</b> | 24-May-2025 | <b>Previous Monitoring</b> | 11-Sep-2024 |

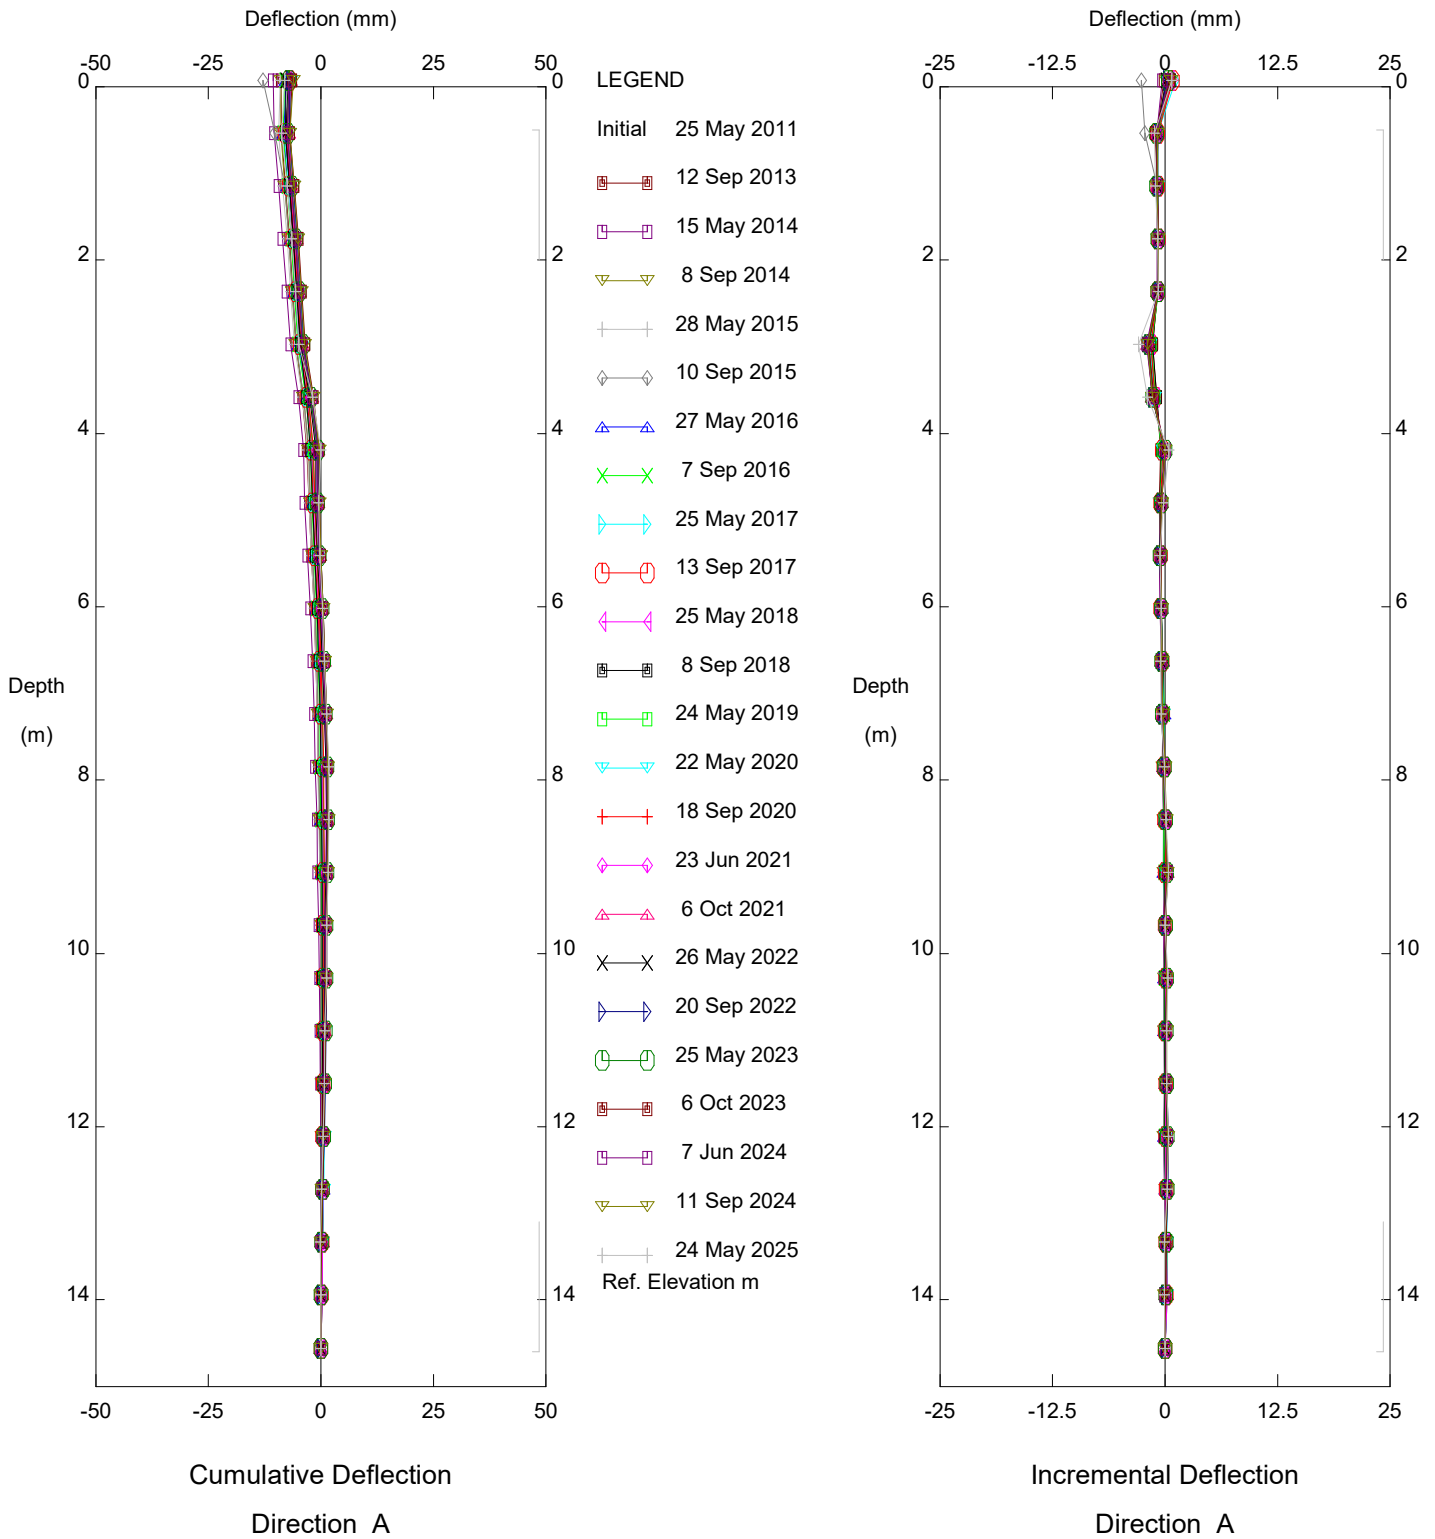
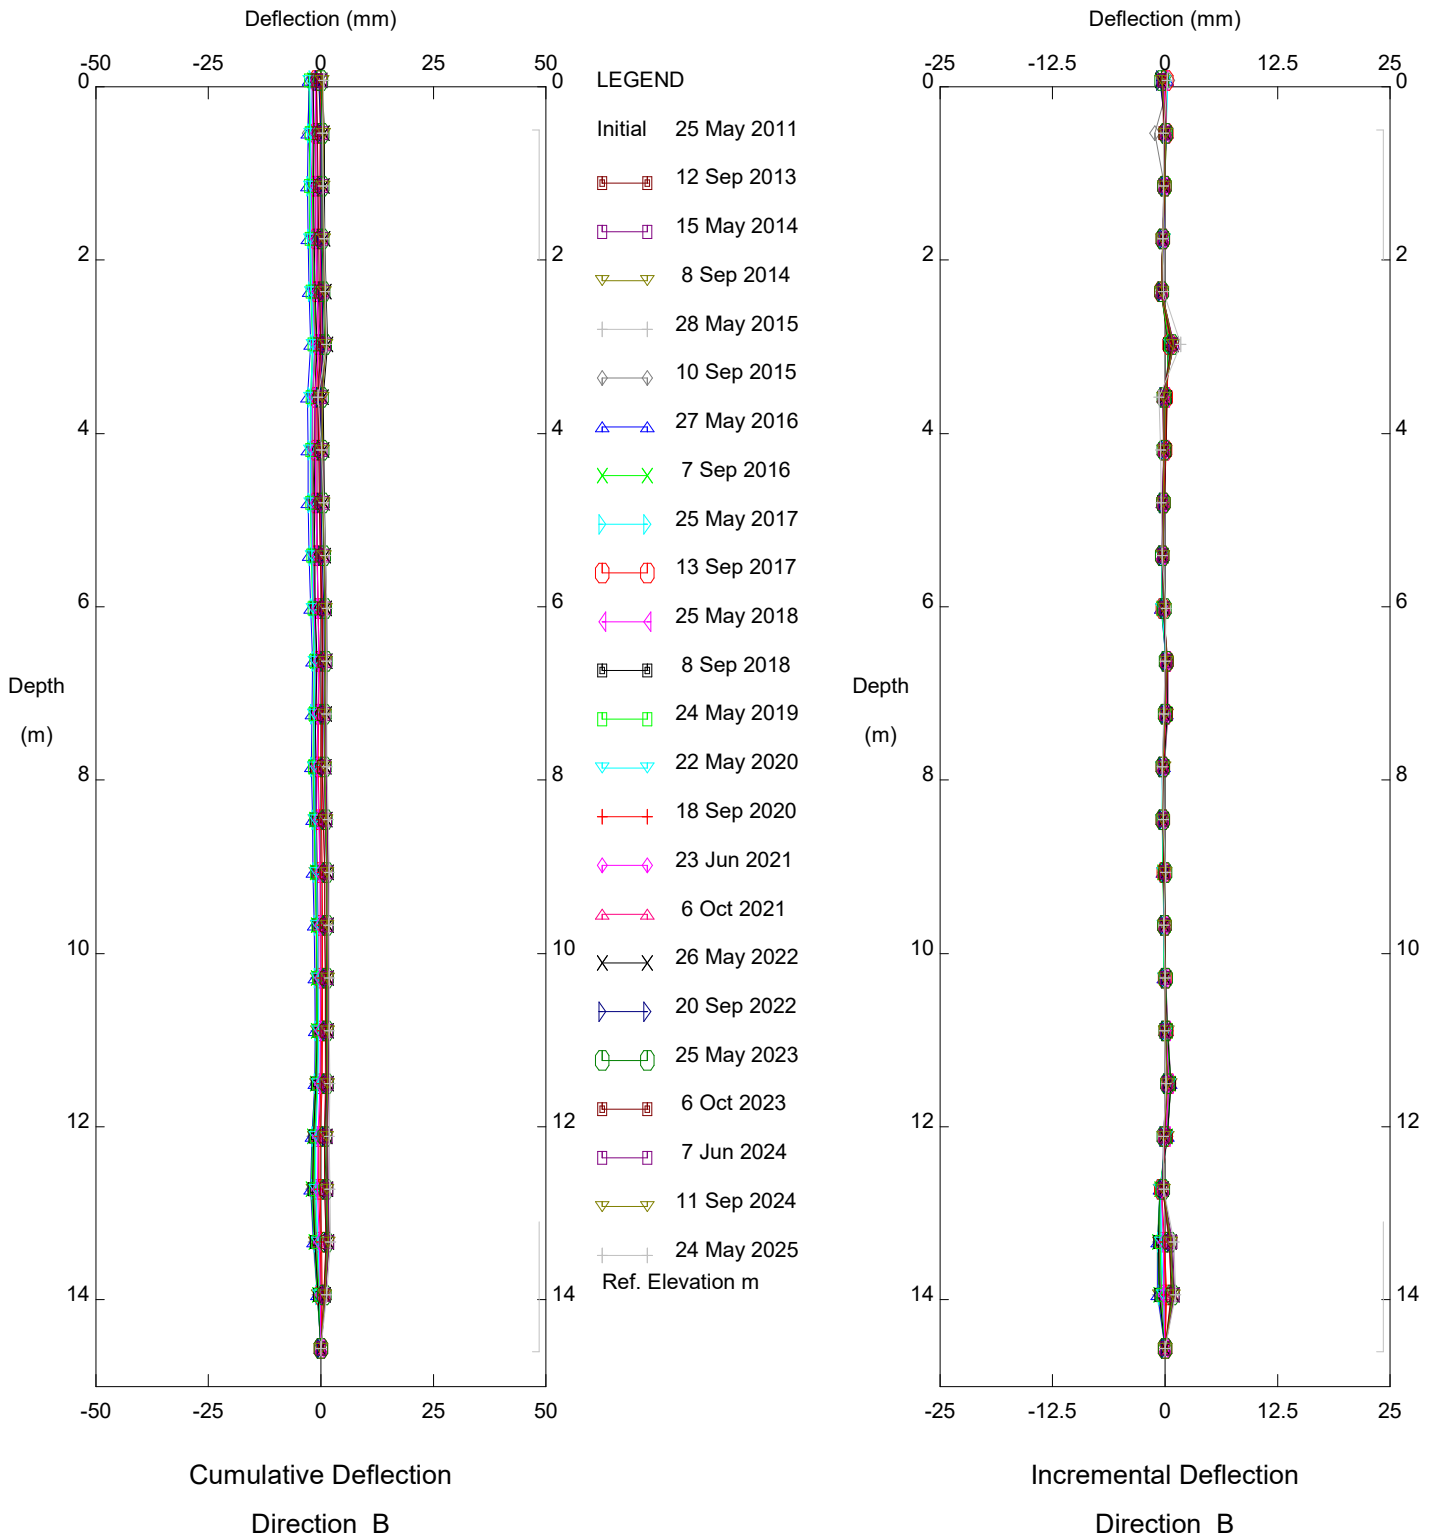
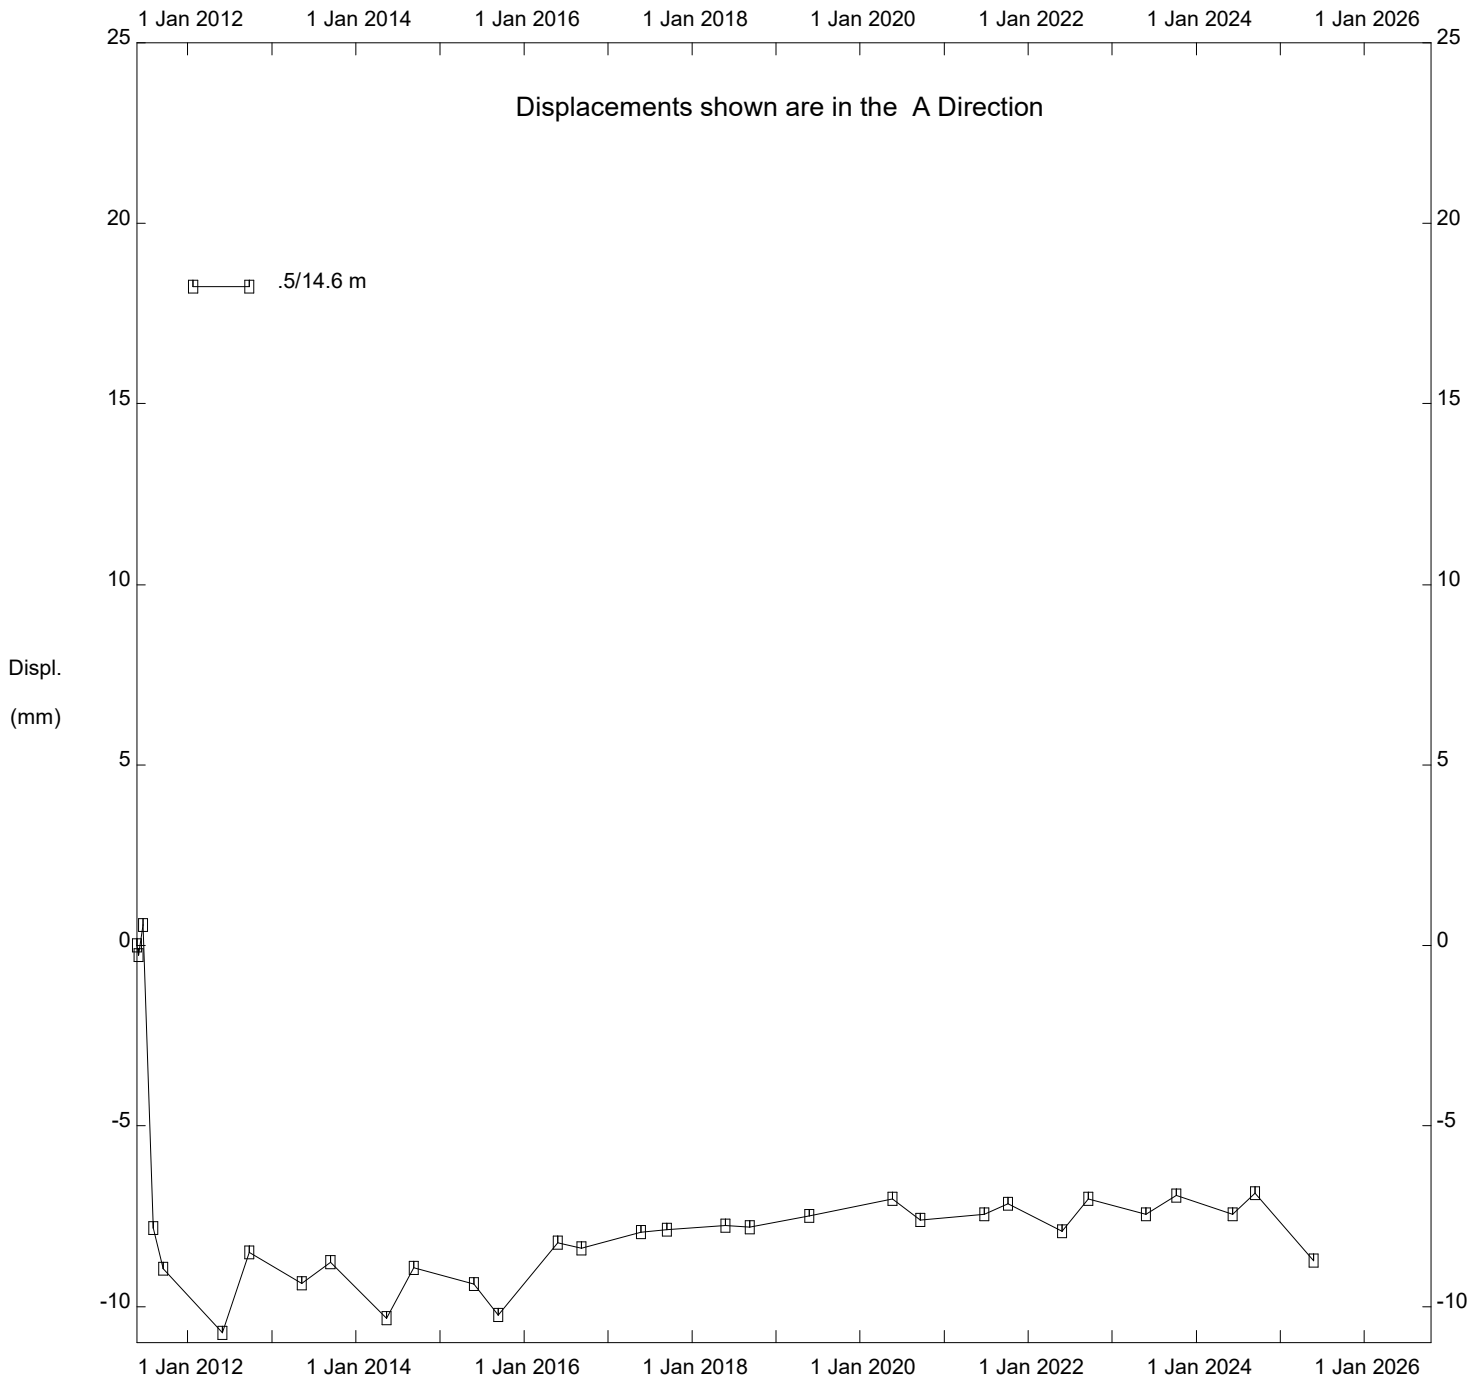
Hwy 41:23 Kehiwin Lake (NC103), Inclinator SI11-3(P45)

| INSTRUMENT # | DATE INITIALIZED | TOTAL CUMULATIVE RESULTANT MOVEMENT AND DEPTH OF MOVEMENT TO DATE (mm) | MAXIMUM RATE OF MOVEMENT (mm/yr) | CURRENT STATUS OF SI | DATE OF PREVIOUS READING | INCREMENTAL MOVEMENT SINCE PREVIOUS READING (mm) | CURRENT RATE OF MOVEMENT (mm/yr) | CHANGE IN RATE OF MOVEMENT SINCE PREVIOUS READING (mm/yr) |
|---|---|---|---|---|---|---|---|---|
| SI11-3 (Pile 45) | May 25, 2011 | -8.7 over 0.5 m to 14.6 m depth in 308° direction | 14.2 on June 21, 2011 | Operational | September 11, 2024 | No discernible movement | N/A | -4.9 |

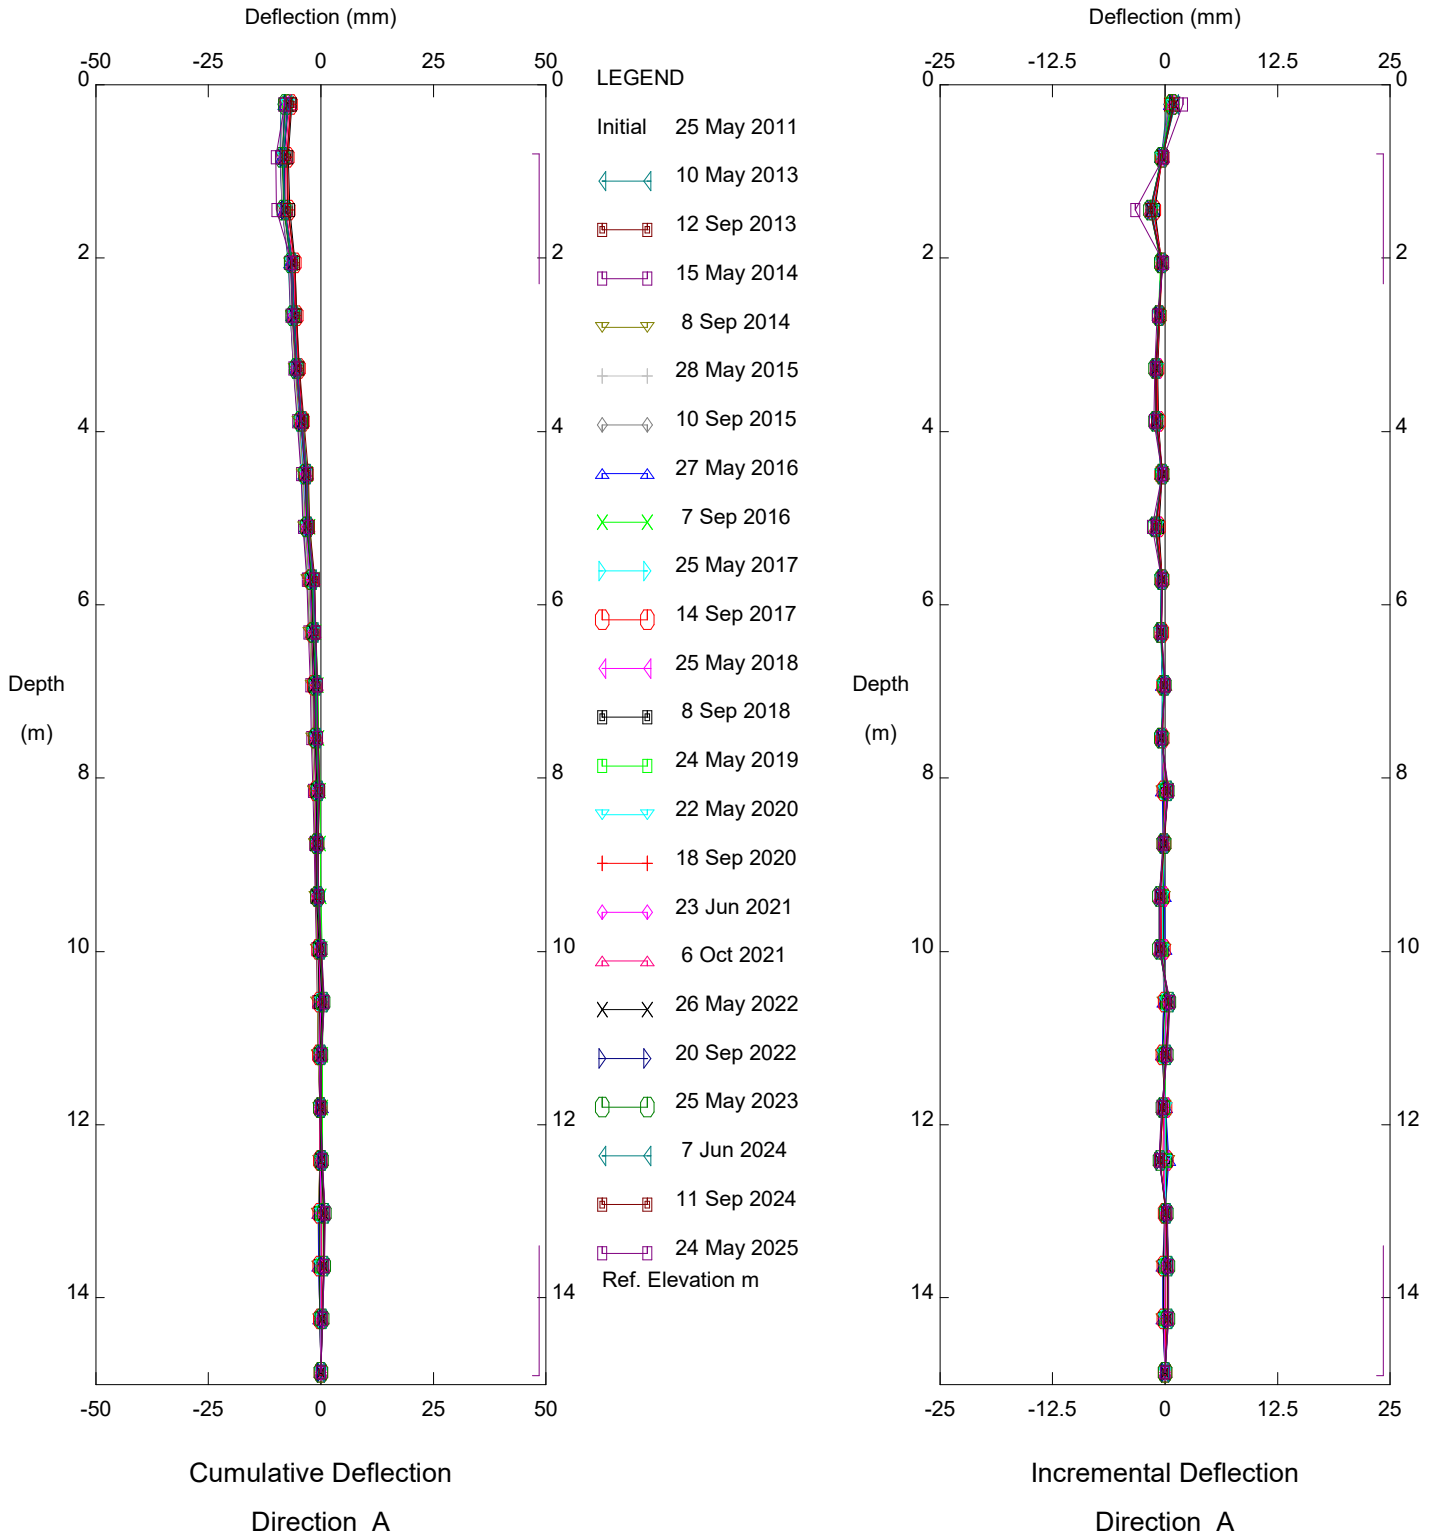
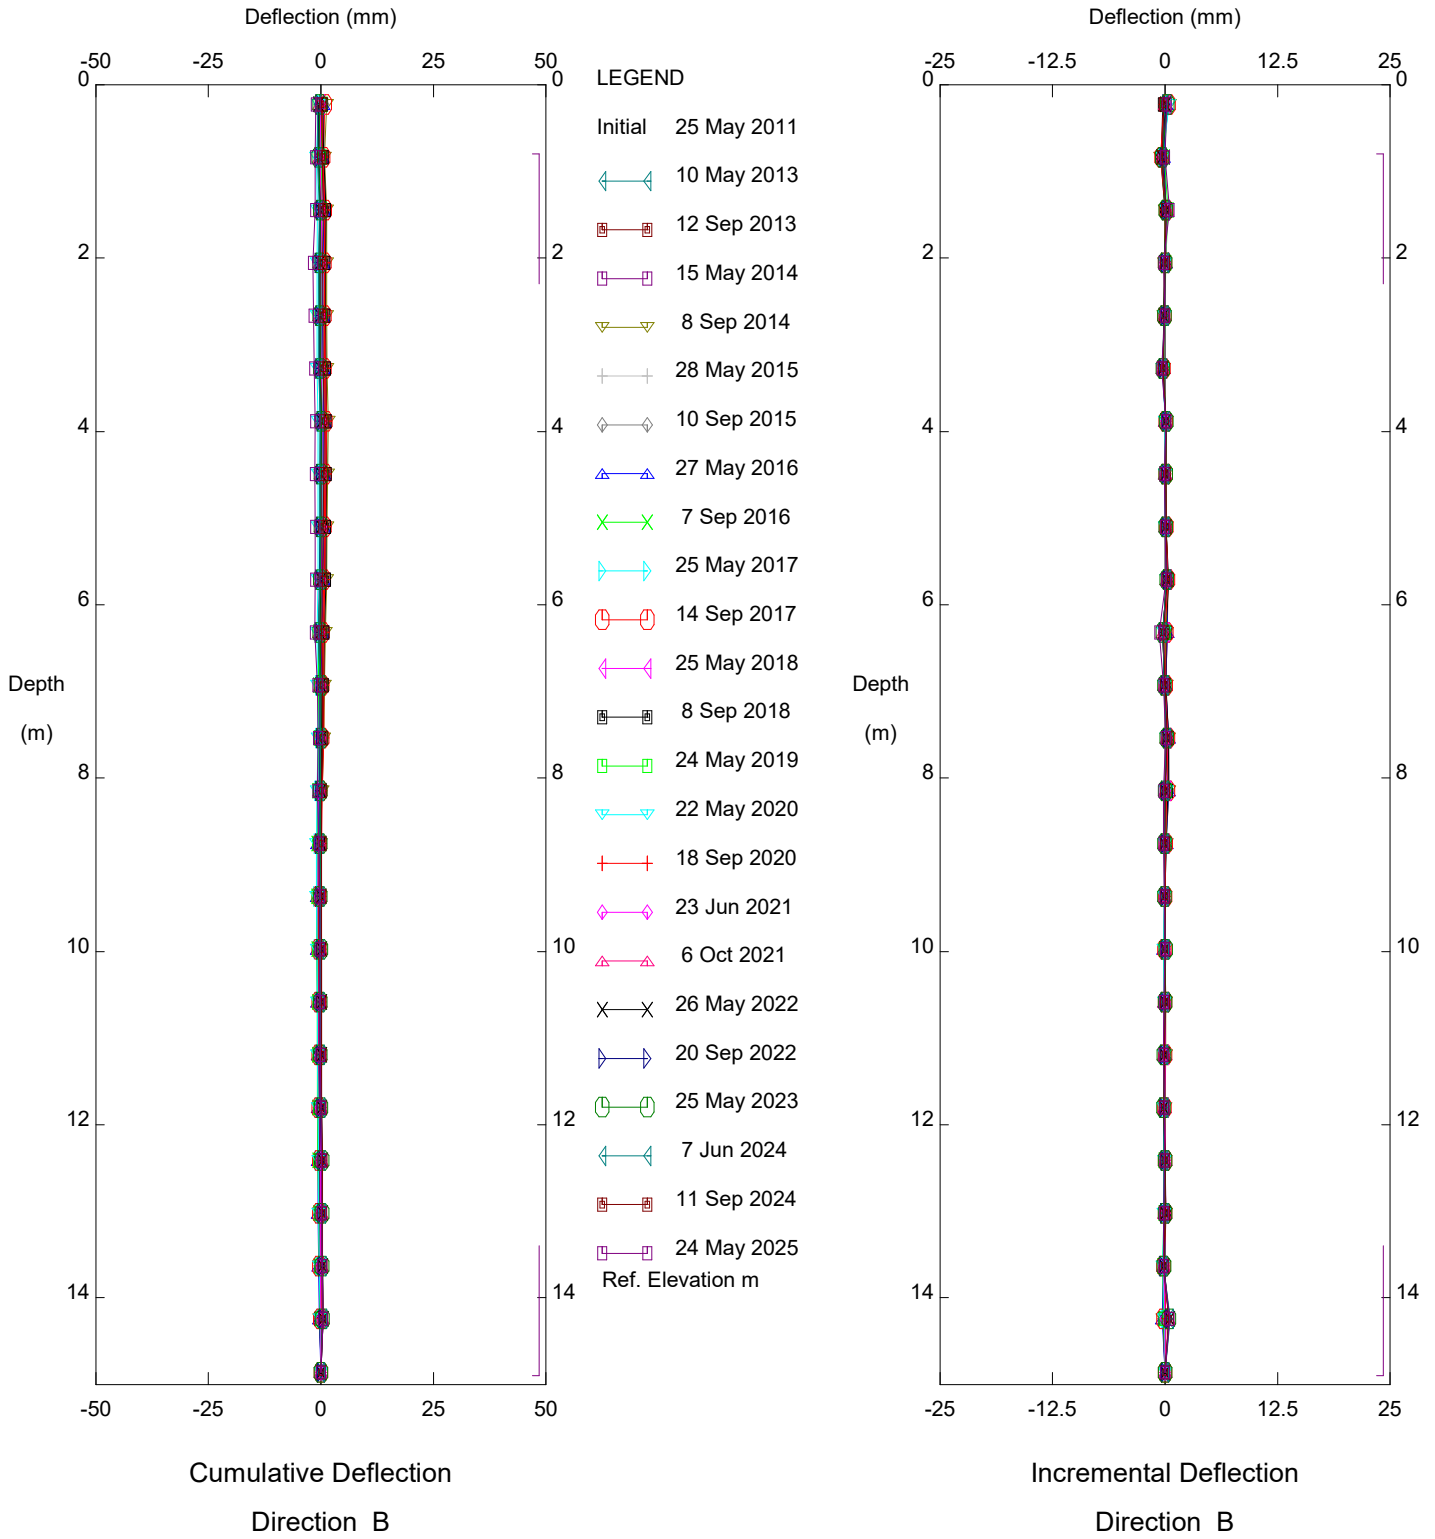
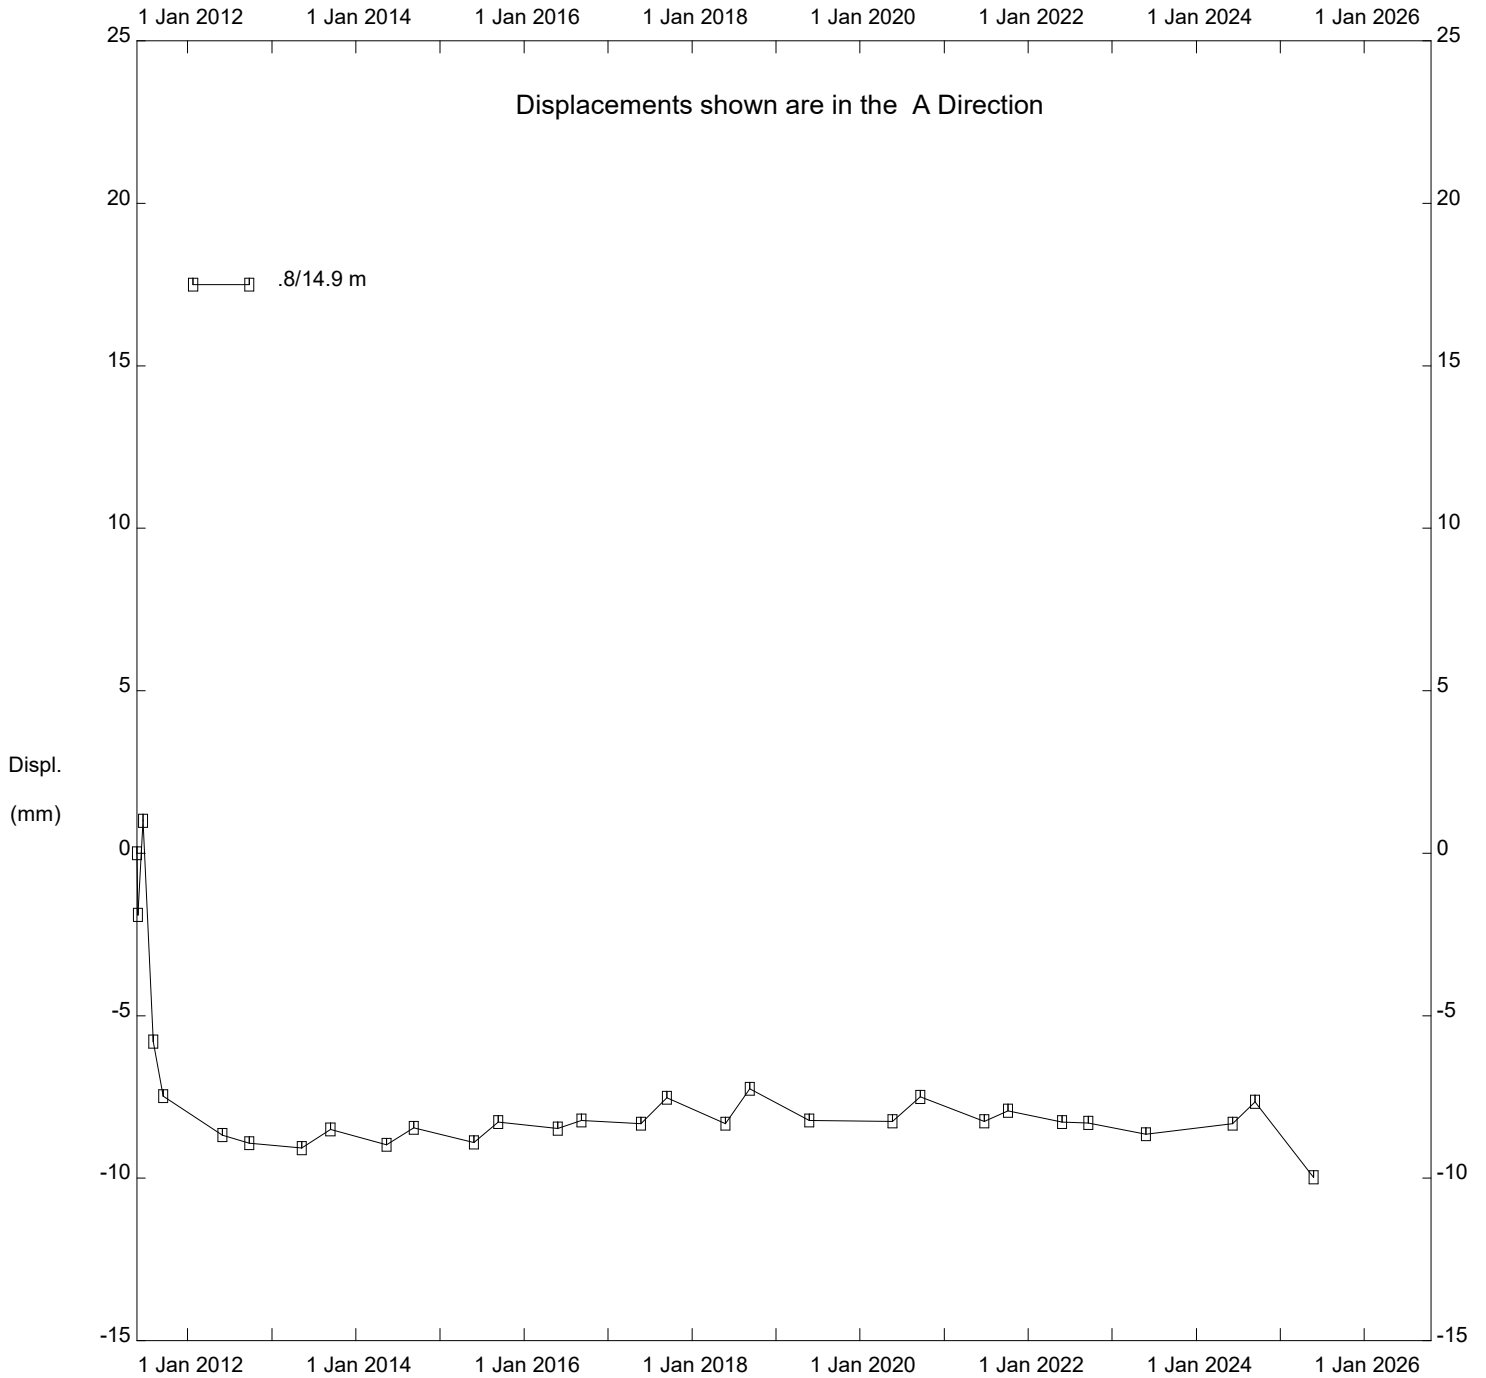
Hwy 41:23 Kehiwin Lake (NC103), Inclinometer SI11-4 (P60)

| Discussion | |
|---|---|
| <b>Interpretation of Monitoring Results:</b> | <p>SI10-1, installed in the east highway ditch, showed no discernible movement since the fall of 2024 readings. SI10-3, installed at the bottom of the slope downslope of the pile wall location, showed no discernible movement since the fall of 2024 readings. SI11-1 through SI11-4 showed no discernible movement since the fall of 2024 readings.</p> <p>The cumulative movements in the SIs installed in the piles were as follows:</p> <ul style="list-style-type: none"> <li>SI11-1 = 2.1 mm pile head movement over 0.7 to 14.8 m depth</li> <li>SI11-2 = 0.4 mm pile head movement over 0.7 to 14.7 m depth in the upslope direction.</li> <li>SI11-3 = -8.7 mm pile head movement over 0.5 to 14.6 m depth in the upslope direction.</li> <li>SI11-4 = -9.9 mm pile head movement over 0.8 m to 14.9 m depth in the upslope direction.</li> </ul> |

| INSTRUMENT # | DATE INITIALIZED | TOTAL CUMULATIVE RESULTANT MOVEMENT AND DEPTH OF MOVEMENT TO DATE (mm) | MAXIMUM RATE OF MOVEMENT (mm/yr) | CURRENT STATUS OF SI | DATE OF PREVIOUS READING | INCREMENTAL MOVEMENT SINCE PREVIOUS READING (mm) | CURRENT RATE OF MOVEMENT (mm/yr) | CHANGE IN RATE OF MOVEMENT SINCE PREVIOUS READING (mm/yr) |
|---|---|---|---|---|---|---|---|---|
| SI11-4 (Pile 60) | May 25, 2011 | -9.9 over 0.8 m to 14.9 m depth in 349° direction | 48.5 on June 21, 2011 | Operational | September 11, 2024 | No discernible movement | N/A | -5.9 |

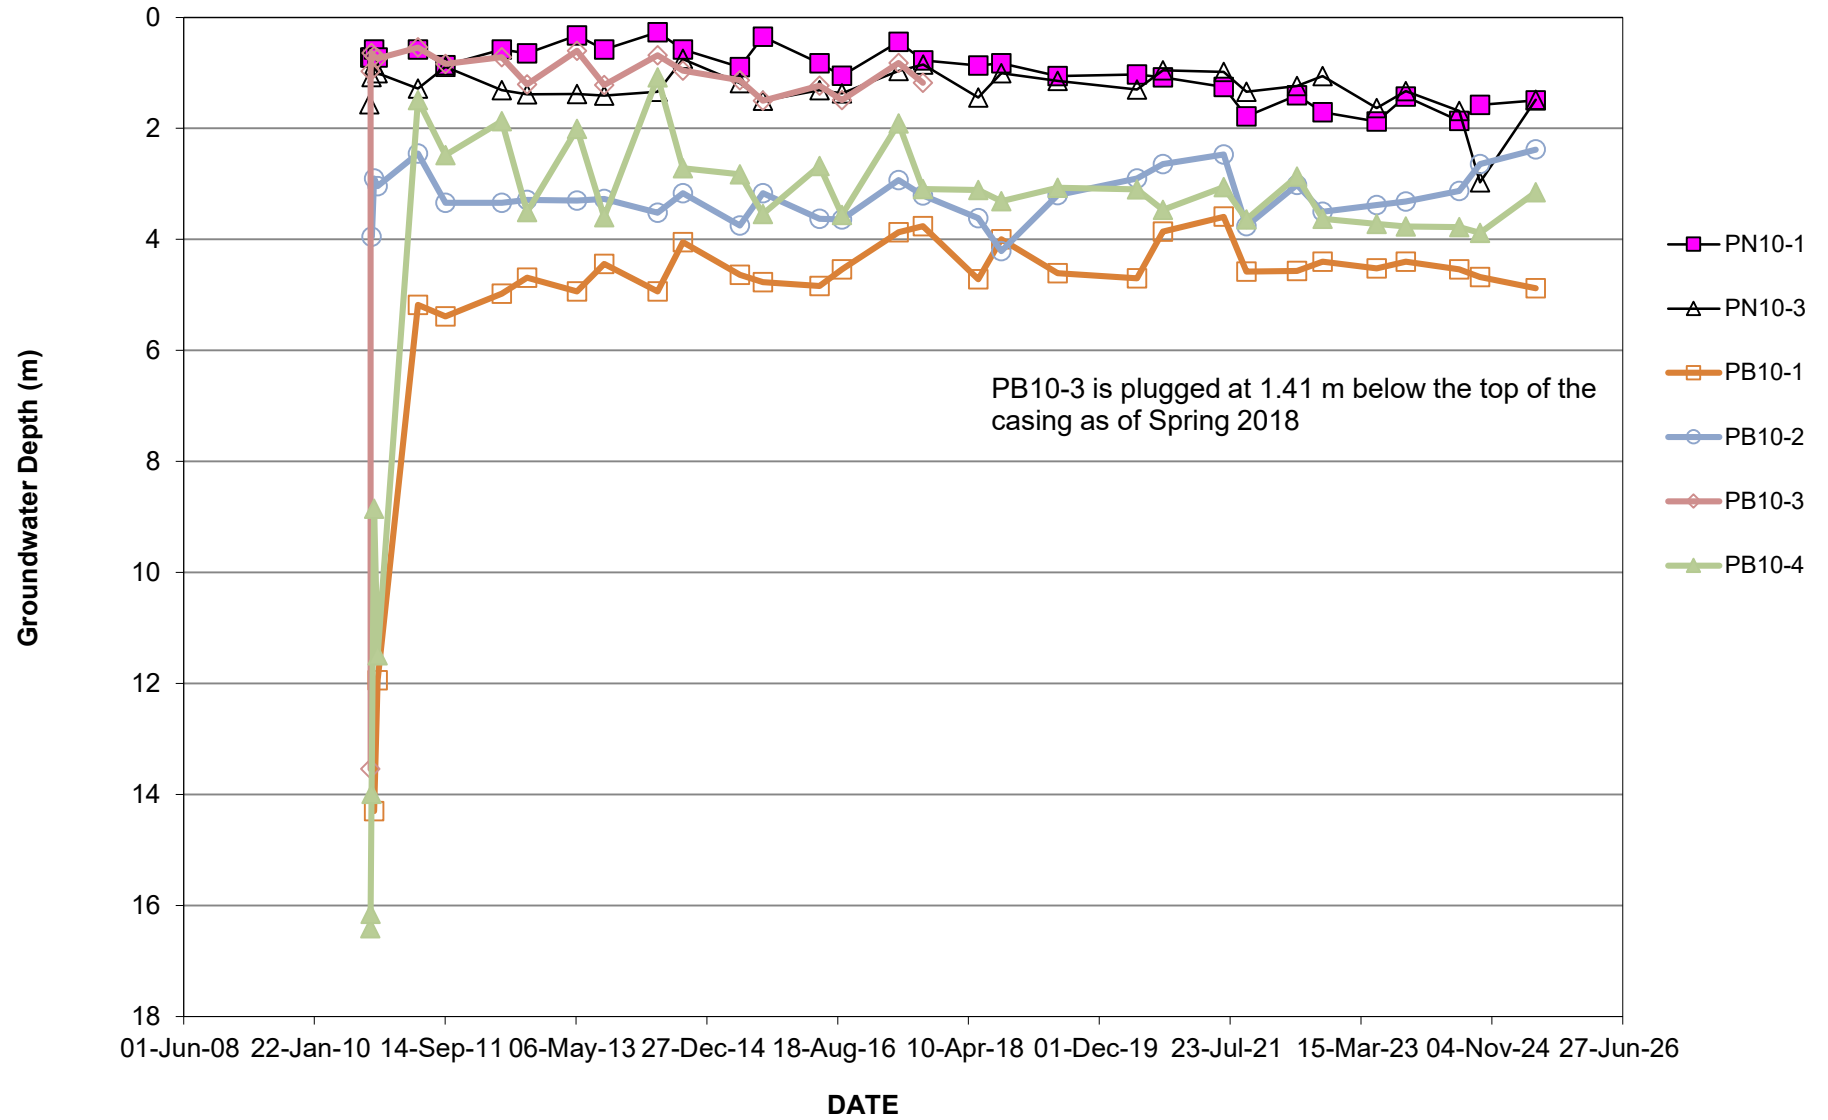
**FIGURE NC103-1  
PIEZOMETER DATA FOR HWY 41:23, KEHIWIN LAKE (KM 7.8)**

| | <p>Pneumatic piezometers PN10-1 and PN10-3 showed increases in groundwater levels of 0.08 m and 1.49 m, respectively, since the fall of 2024 readings.</p> <p>Standpipe piezometer PB10-1 showed a decrease in groundwater level of 0.20 m since the fall of 2024 readings. Standpipe piezometers PB10-2 and PB10-4 showed increases in groundwater level of 0.26 m and 0.73 m, respectively, since the fall of 2024 readings.</p> <p>Load cells VC1706, VC1707, VC1708, VC1712, and VC1713 showed increases in the measured load of 2.45 kN, 0.91 kN, 1.52 kN, 4.42 kN, and 2.15 kN, respectively since the fall of 2024 readings. Load cells VC1709 and VC1714 showed decreases in measured loads by 5.89 kN and 1.64 kN, respectively.</p> <p>The operational load cells have shown decreases in measured loads, when compared to the lock off load, ranging from 10.0 percent to 38.6 percent. However, the load cells with the largest variations in load values have lost one or more vibrating wire channels over several reading cycles. In addition, the reductions in the loads have not been consistent with the observed movement patterns of the walls, based on the slope inclinometer readings.</p> <p>If significant reductions in anchor loads occur in the future in response to the wall deflection towards west, the anchors will need to be restressed to maintain the wall's lateral deflection within the design limit.</p> |

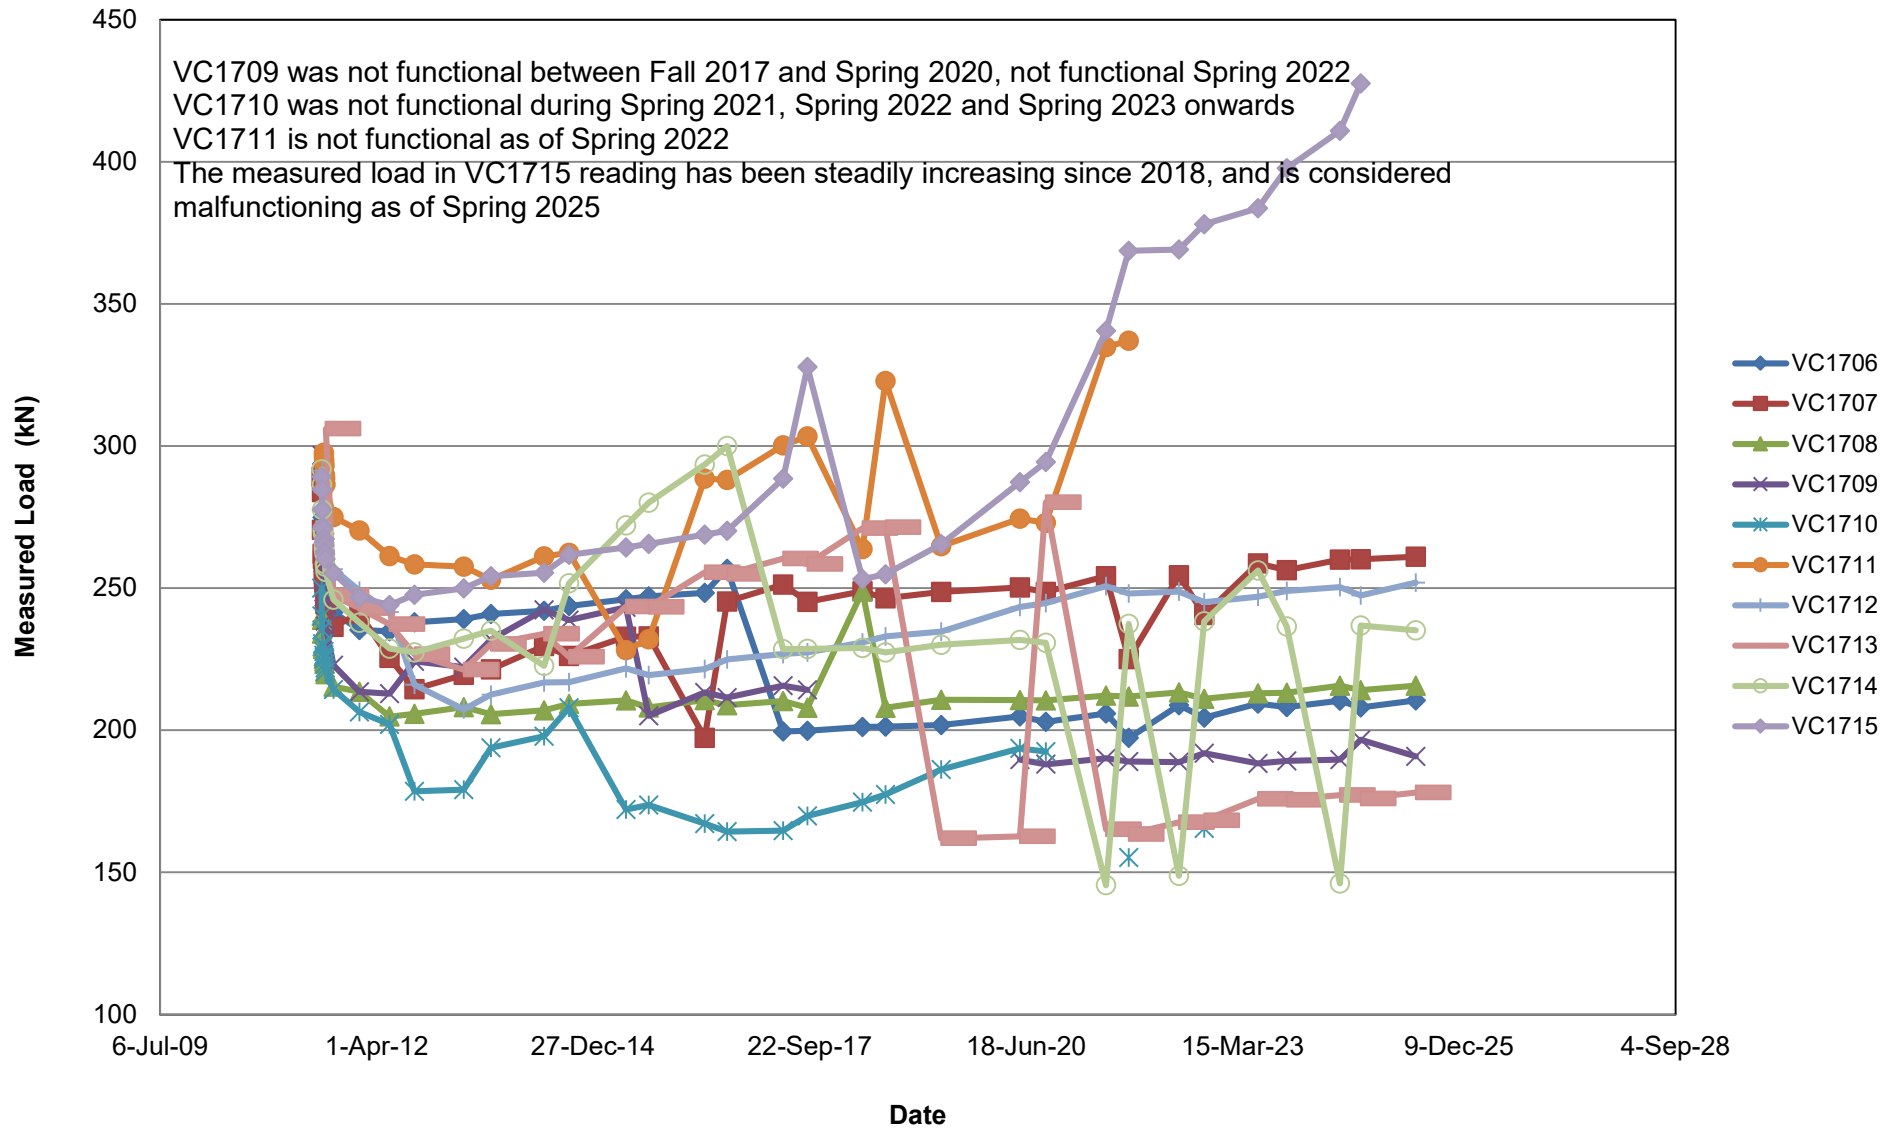
**FIGURE NC103-2**  
**VIBRATING WIRE LOAD CELL DATA FOR**  
**HWY 41:23, KEHIWIN LAKE (km 7.8)**

| Readout Equipment Used | | | |
|---|---|---|---|
| <b>Notes:</b> - The single remaining vibrating wire in Load Cell VC1715 has shown continued dropping readings since 2018 and is considered likely to be malfunctioning. | | | |

| <b>Future Work:</b> | The instruments should be read again in the fall of 2025. Load cell VC1715 has shown a trend of gradually increasing loads for several reading cycles, indicating the load cell may be malfunctioning. Load cell VC1715 should be removed from future reading cycles. |
