**ALBERTA TRANSPORTATION AND  
ECONOMIC CORRIDORS GRMP  
NORTH CENTRAL (ATHABASCA AND FORT  
McMURRAY DISTRICTS)  
2025 SITE INSPECTION**

| Site Number | Location | Name | Hwy | km |
|---|---|---|---|---|
| NC104 | Approximately 7.7 km north of Hwy 29 (North of Elk Point) | Kehiwin Lake | 41.23 | 7.7 |

| | Date | PF | CF | Total |
|---|---|---|---|---|
| Current Inspection: | May 15, 2025 | 11 | 4 | 44 |

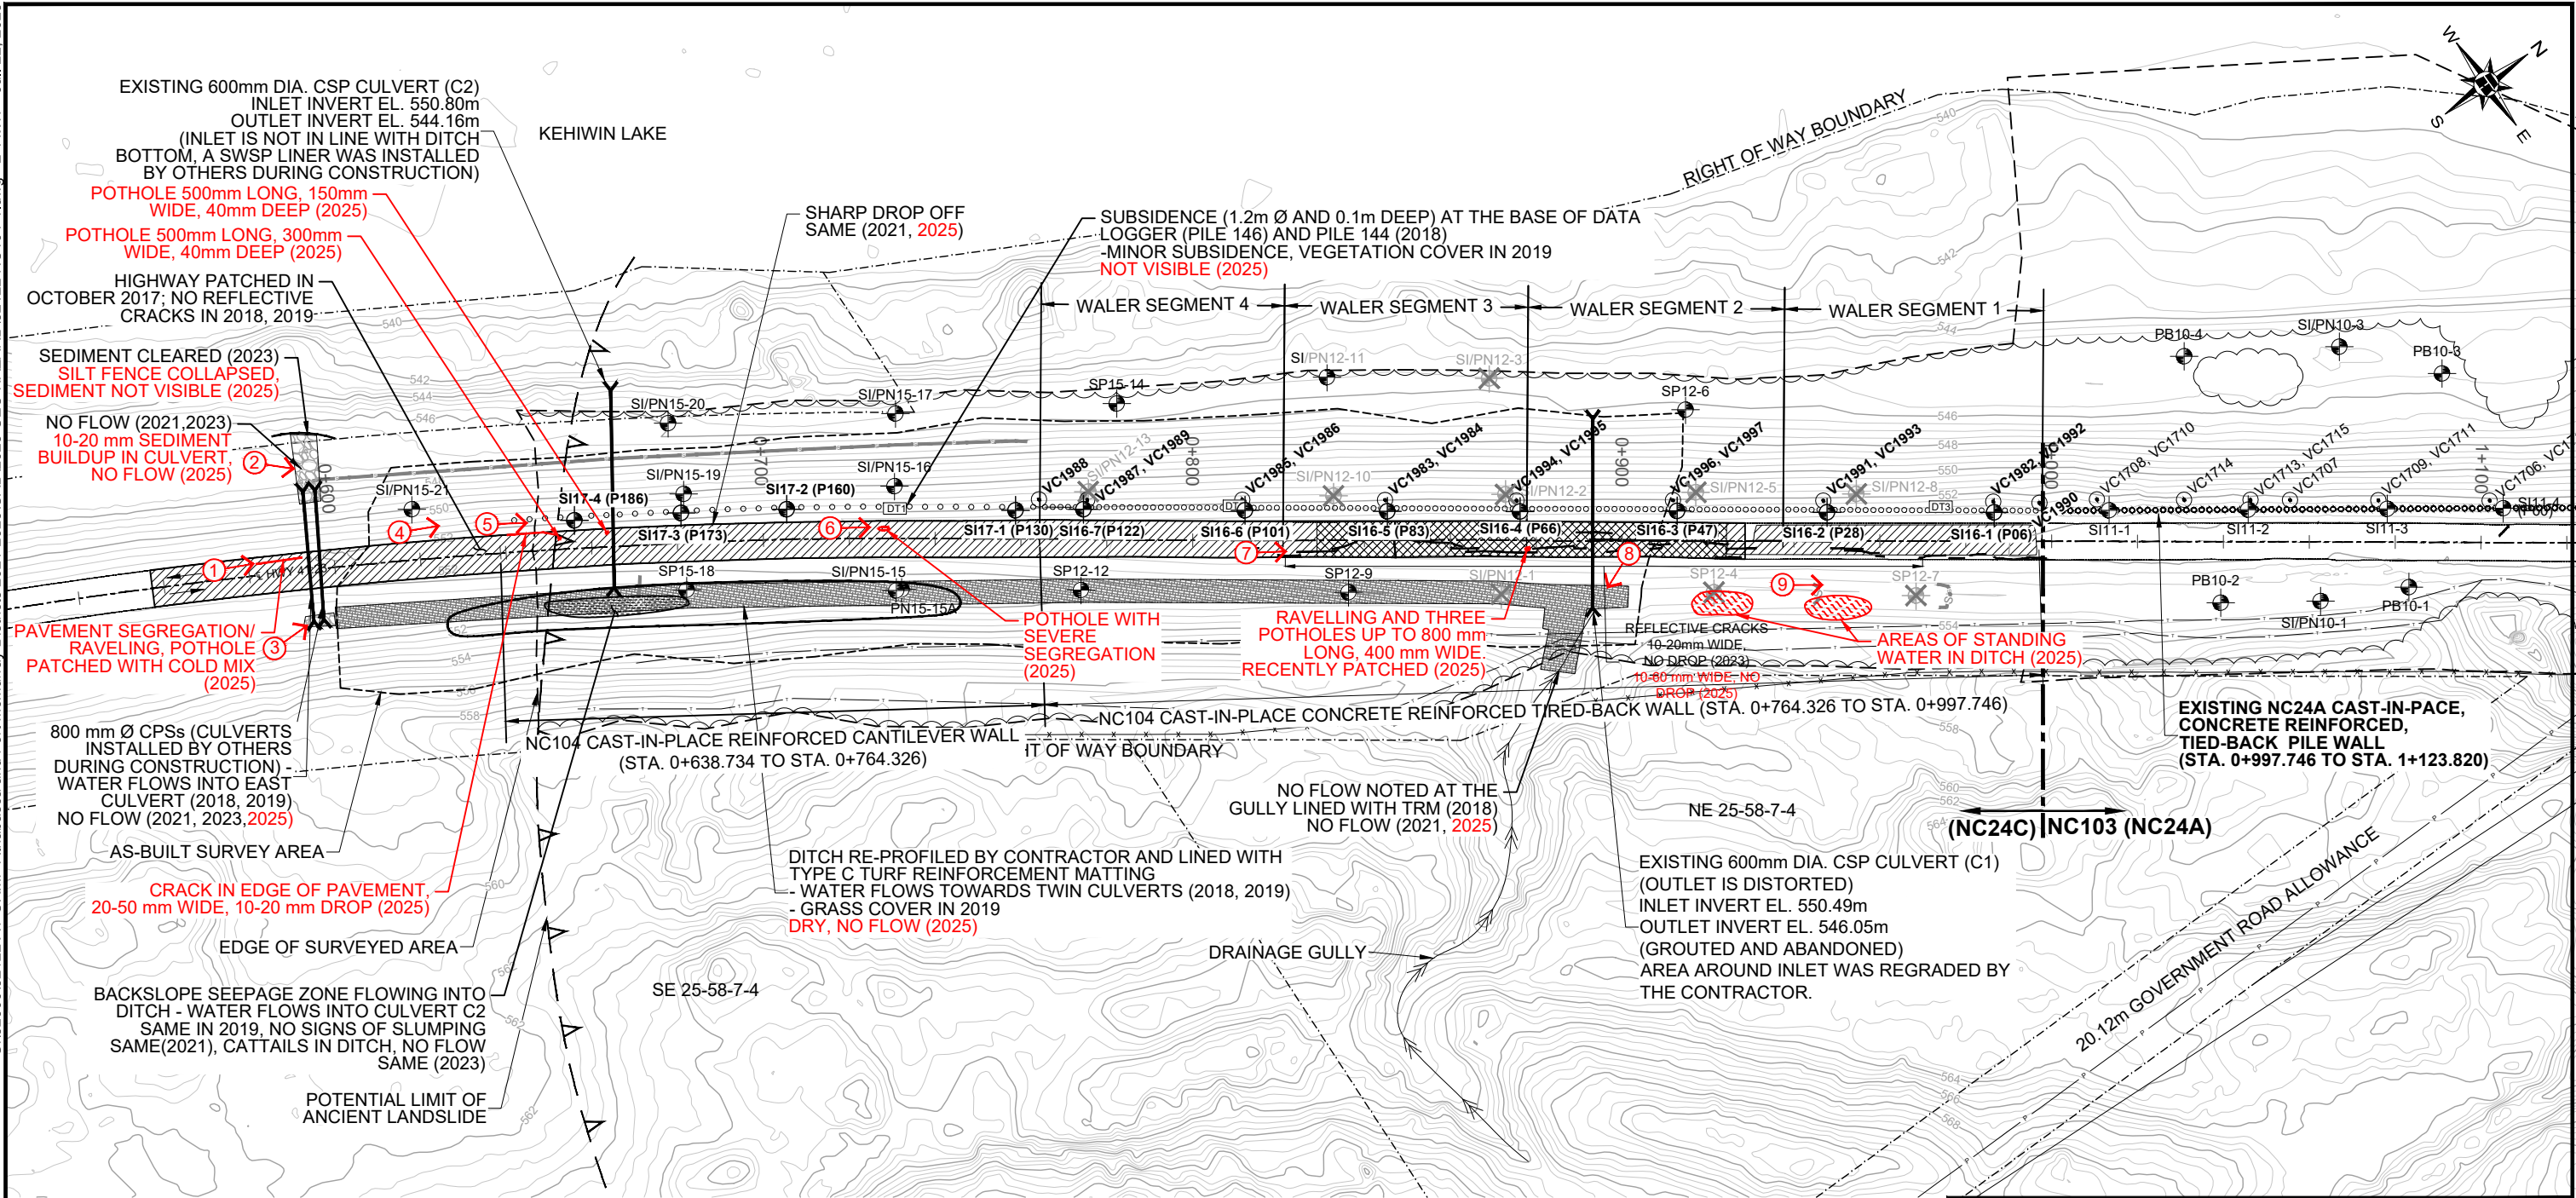
DWG NO. 32122-NC104-1

NC104: HWY 41:23 LANDSLIDE (km 7.7)  
SITE PLAN SHOWING SITE FEATURES AND  
INSTRUMENT LOCATIONS

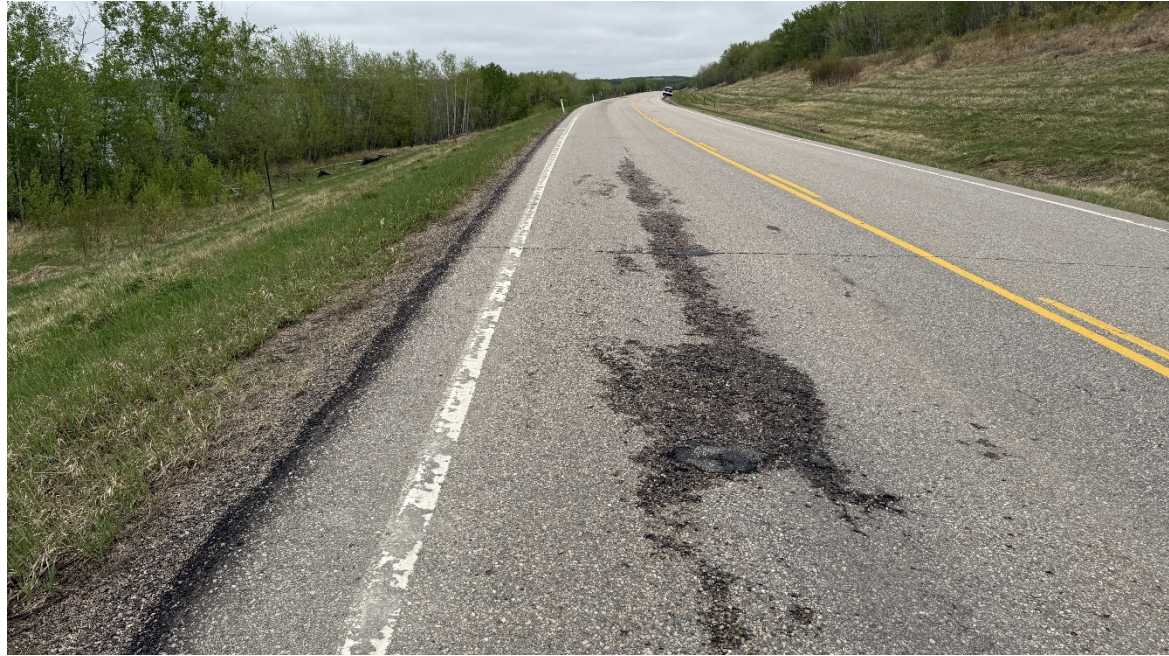
**Photo 1. Looking north at highway surface from the south end of site. Segregation and raveling of pavement have worsened since the 2023 inspection. Some cold mix asphalt was placed in 2025.**

The local MCI should watch closely for the development of new cracks or widening or existing cracks in the highway surface. Open cracks should generally be sealed to reduce surface water infiltration into the landslide mass.

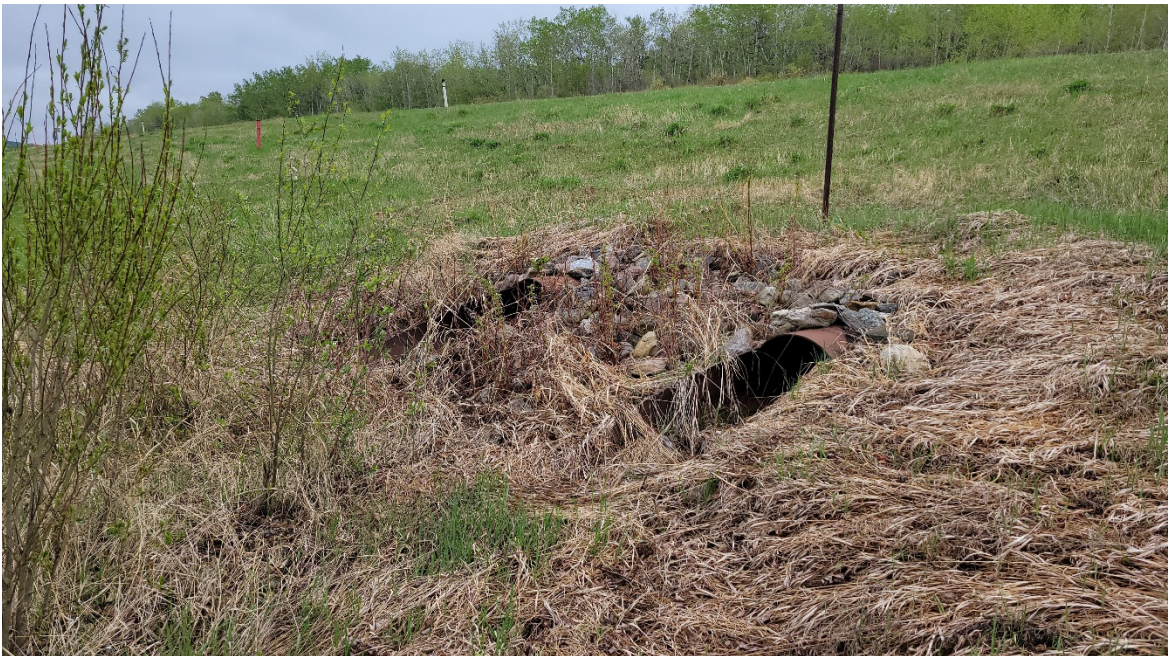
**Photo 2. Looking northeast at the twin culvert outlets. 10-20 mm of sediment has accumulated at the outlets of the culverts since the 2023 inspection.**

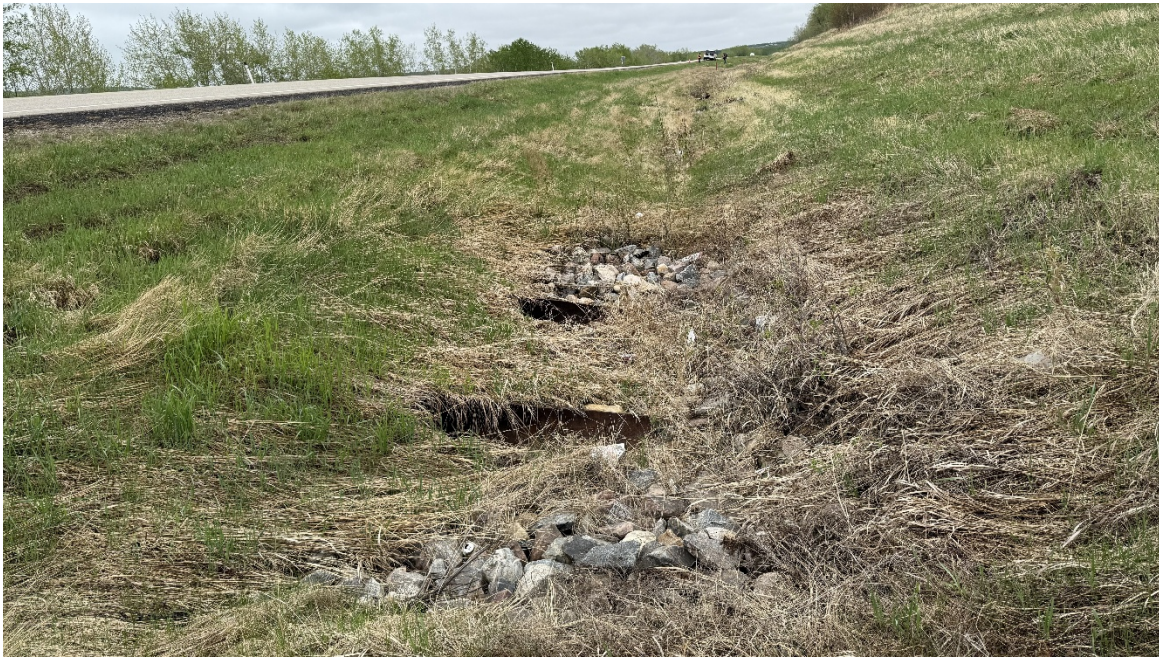
**Photo 3. Looking north at the inlets of the twin culverts. No flow noted during current inspection.**

The local MCI should also check whether the south ditch is draining towards the C2 pipe and the twin culverts. Consideration should be given to re-grading the ditch, within the areas of standing water, to promote positive drainage.

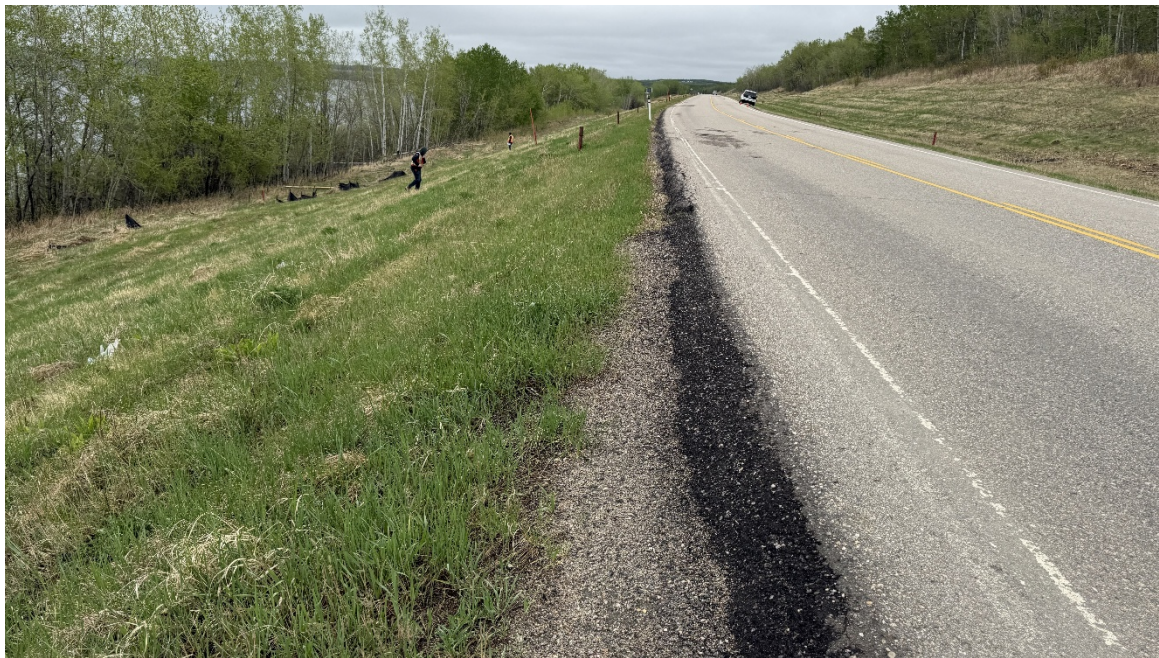
The existing sharp drop off near the edge of pavement still constitutes a safety hazard to runaway vehicles.

**Photo 4. Looking north at sharp drop at shoulder of pavement on the southbound lane.**

Consideration should also be given for placing the least amount of fill off the highway surface to smoothen the existing sharp drop off and eliminate the existing hazard. Otherwise, sharp shoulders warning signs should be erected to warn the motorists of the existing hazard.

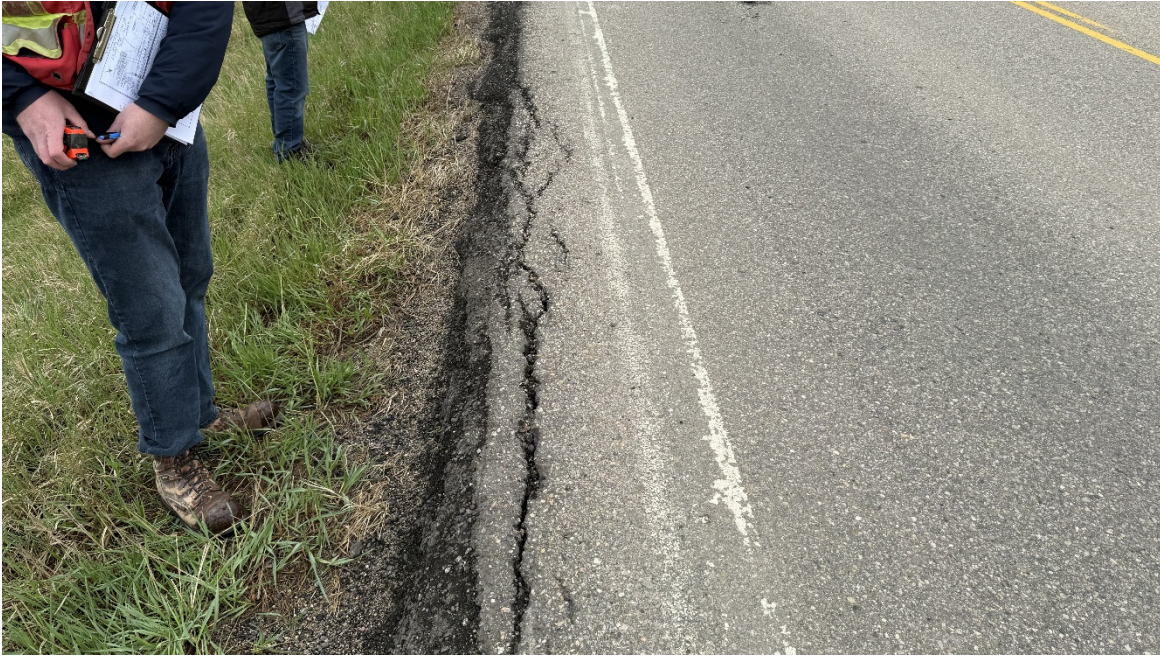
**Photo 5. Pavement stress cracks noted on southbound lane shoulder near south end of NC104 pile wall extension. Cracks were 20-50 mm wide with a 10-20 mm drop.**

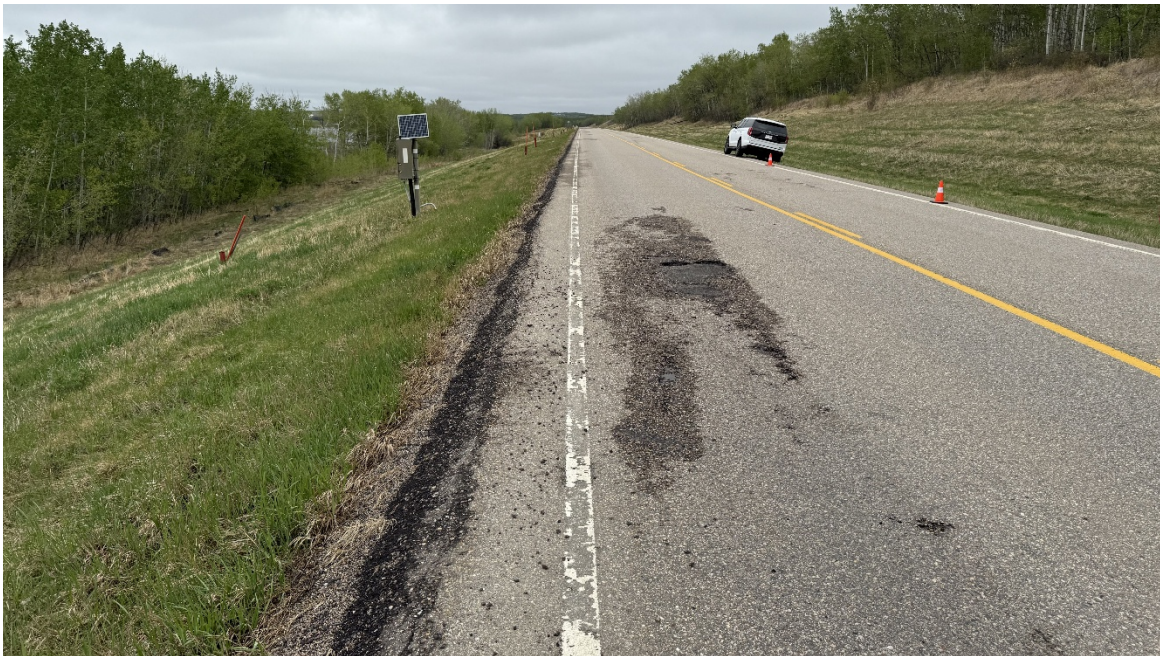
**Photo 6. Looking at datalogger DT1 installed at the pile P146 location in the NC104 pile wall extension. New pothole with segregation developed in 2025.**

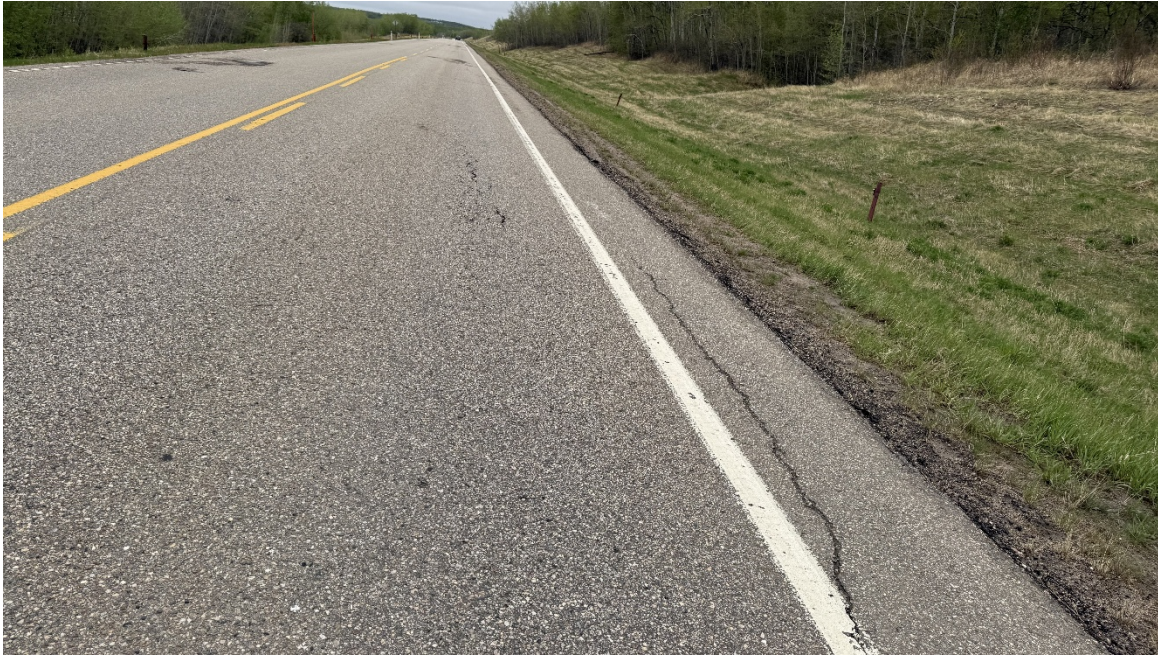
The site observations and instrumentation readings indicate that implemented remedial measures have been effective in stabilizing the landslide mass. Reflective highway surface cracks may however get wider over time until the pile wall mobilizes the full magnitude of the stabilizing force.

**Photo 7. Looking north at reflective cracks, 10 to 60 mm wide with no drop, in the northbound lane.**

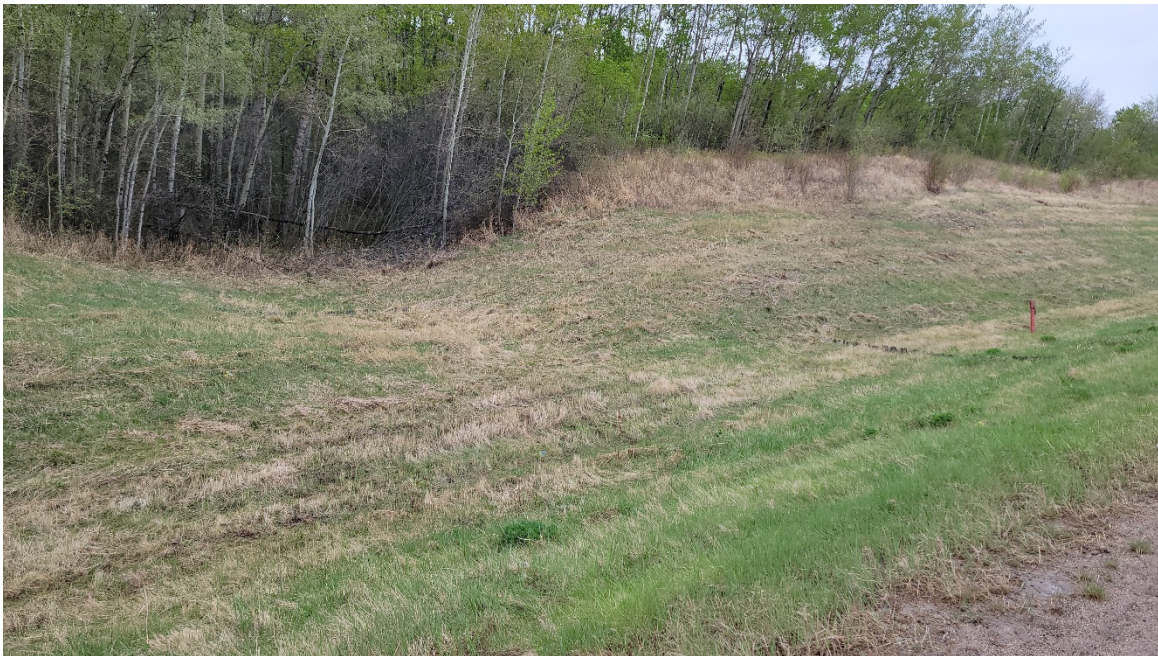
**Photo 8. Looking southeast at TRM lined gully and ditch area. No flow was noted in the gully.**

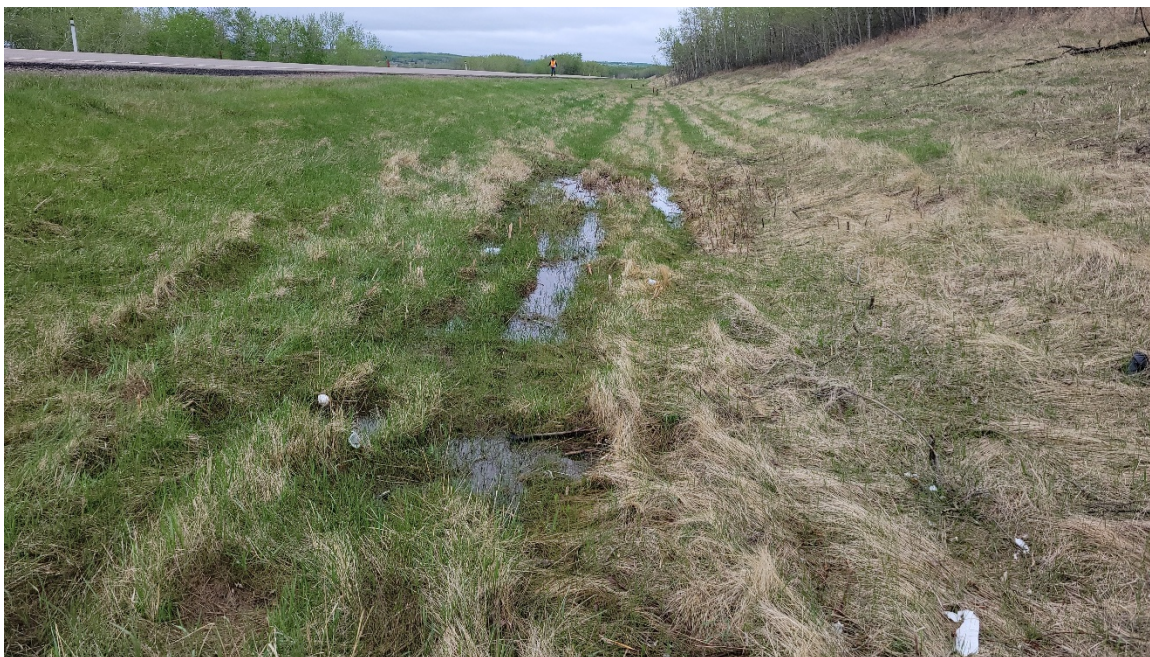
There were areas of standing water visible in the south east highway ditch, which indicate poor surface drainage. These areas previously contained cattails which were mowed after the previous inspection. Poor drainage, and possibly water ponding, in the ditch can result in elevated groundwater levels and an accelerated landside movement at the interim pile wall location.

**Photo 9. Looking north at ponding water in the east highway ditch. |**
