**ALBERTA TRANSPORTATION AND  
ECONOMIC CORRIDORS GRMP  
NORTH CENTRAL (ATHABASCA AND FORT  
McMURRAY DISTRICTS)  
INSTRUMENTATION MONITORING - SPRING 2025**

| Site Number | Location | Name | Hwy | km |
|---|---|---|---|---|
| NC104<br>(NC024-4) | HWY 41:23 C1 7.66 | Kehiwin Lake | 41:23 | Km 7.7 |

| <b>Current Monitoring:</b> | 23-May-2025 to<br>24-May-2025 | <b>Previous Monitoring</b> | 6-June-2024 |

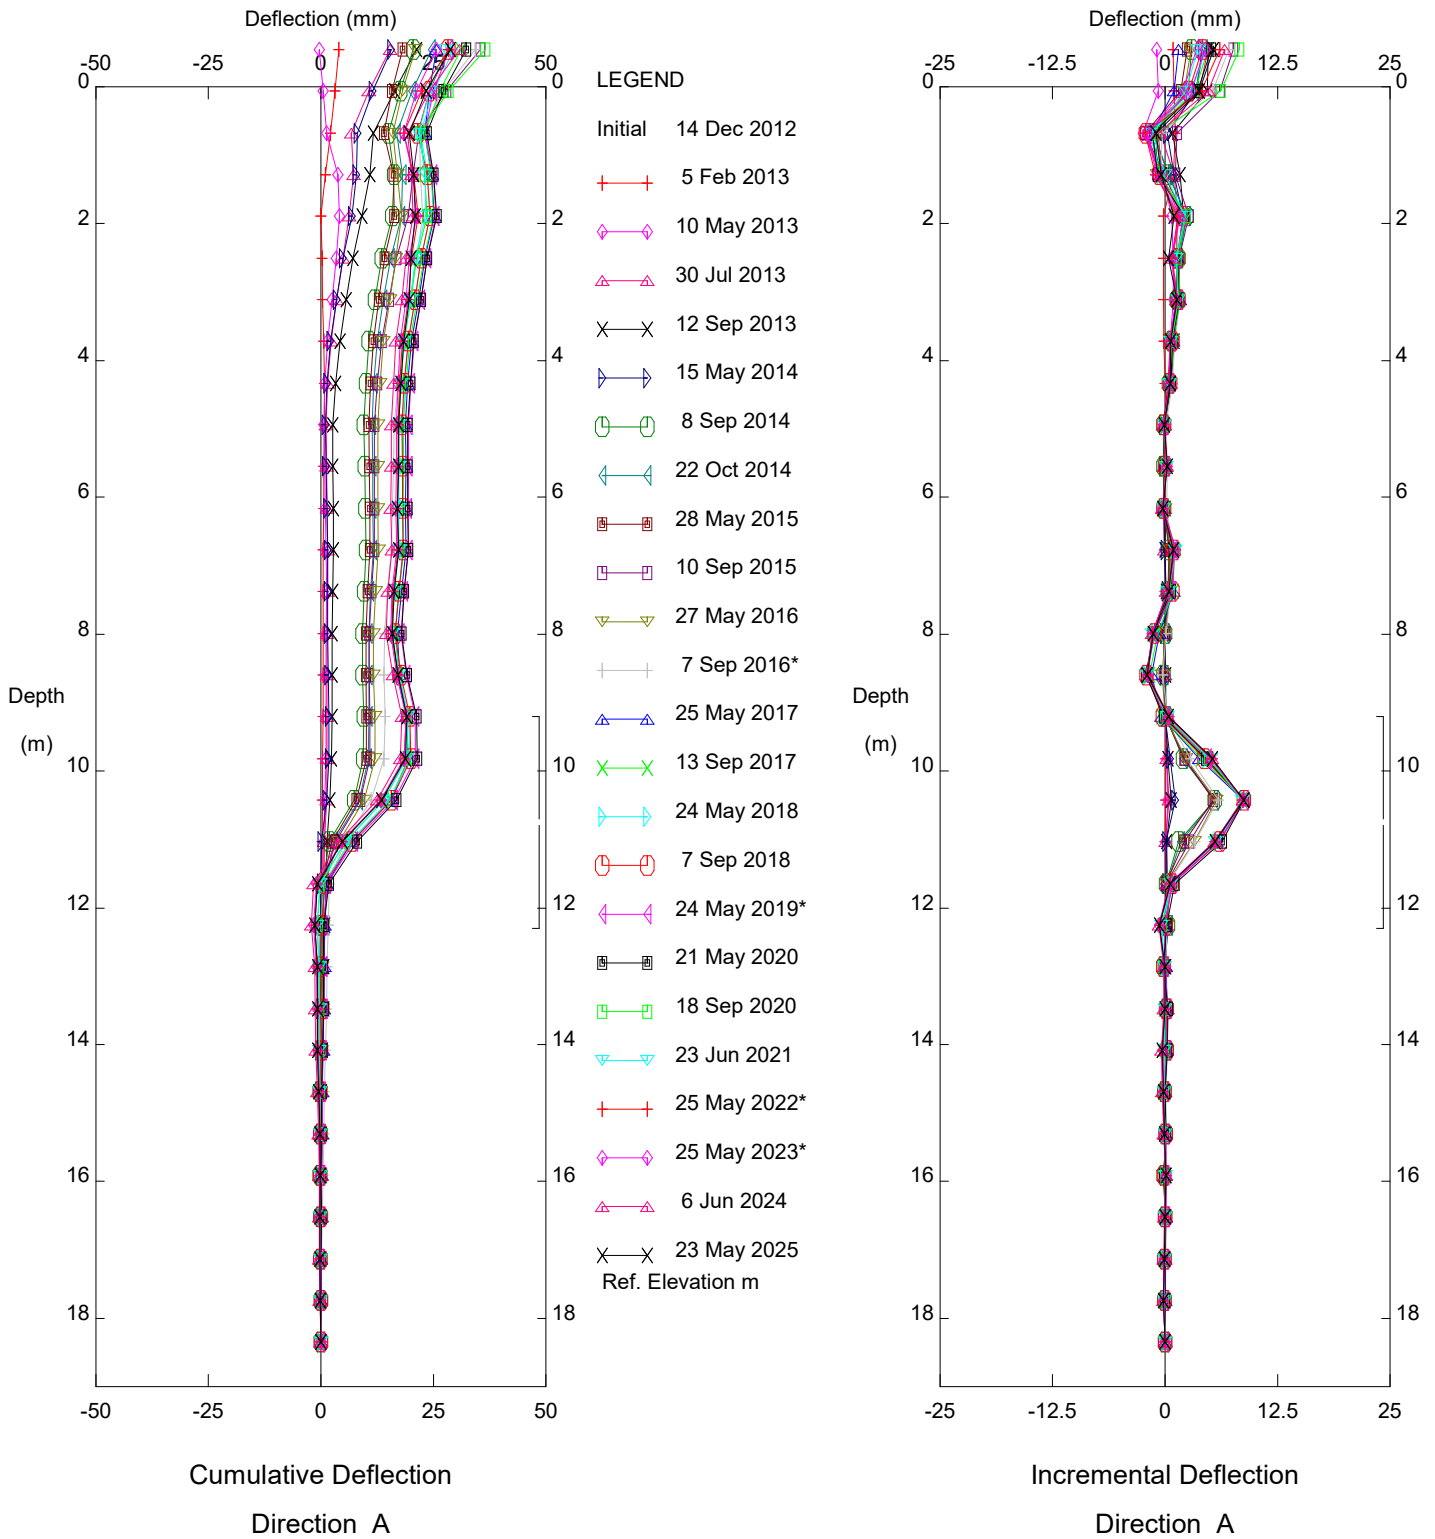
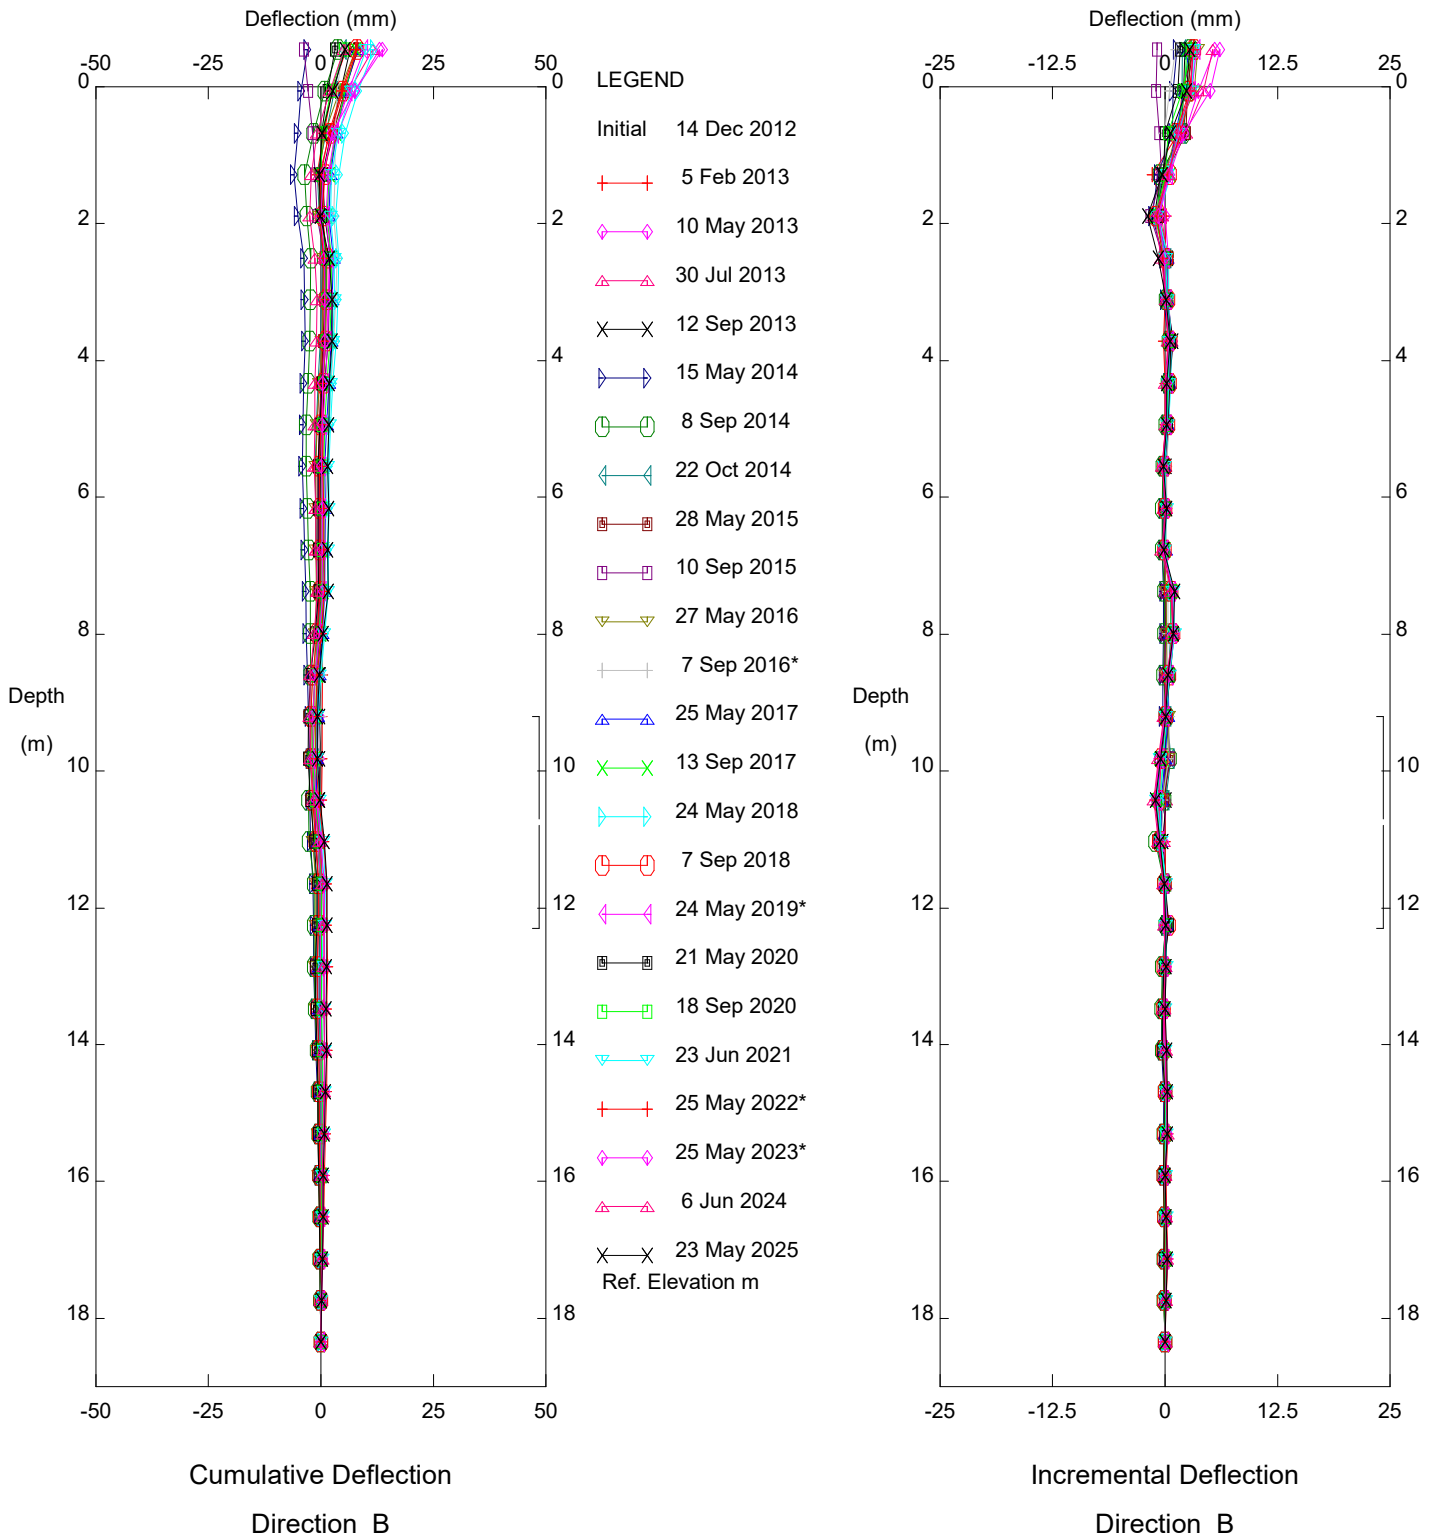
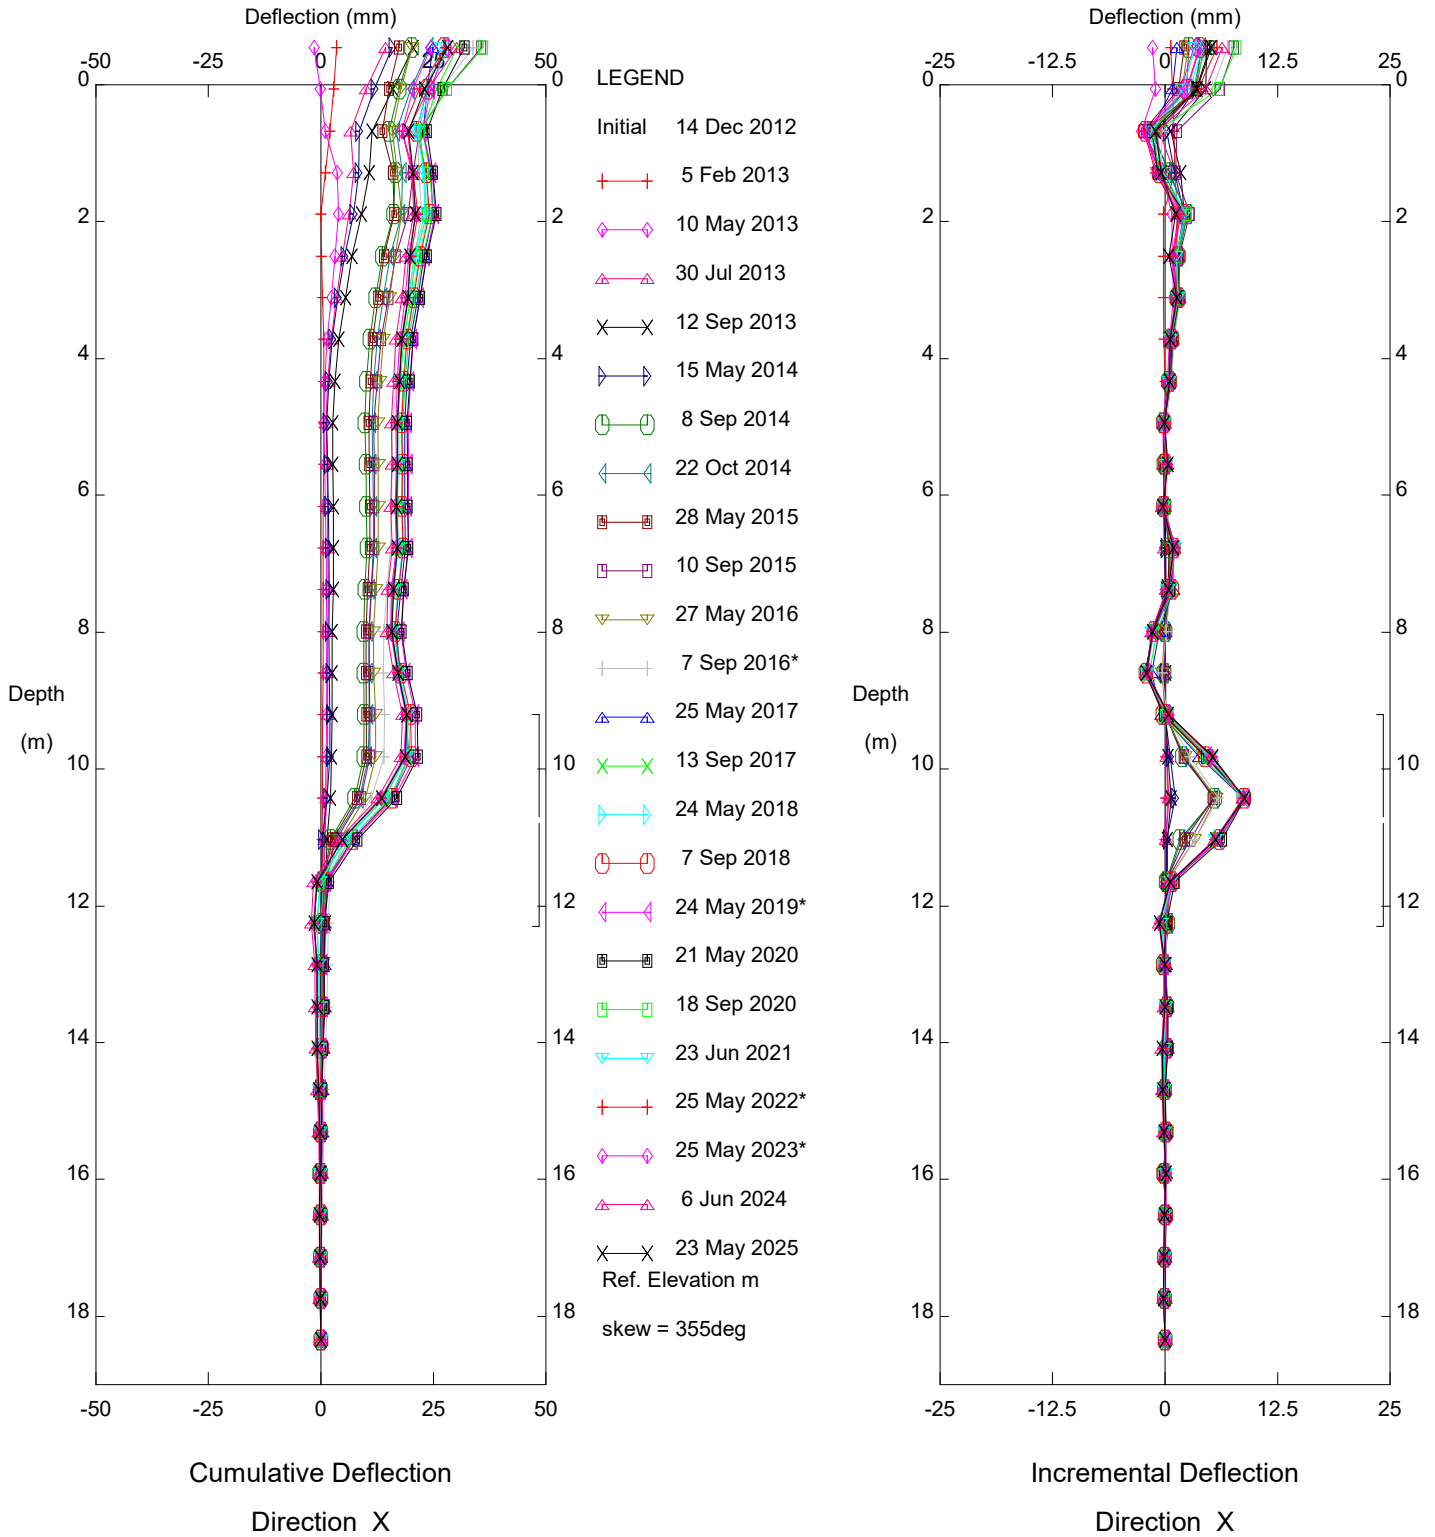
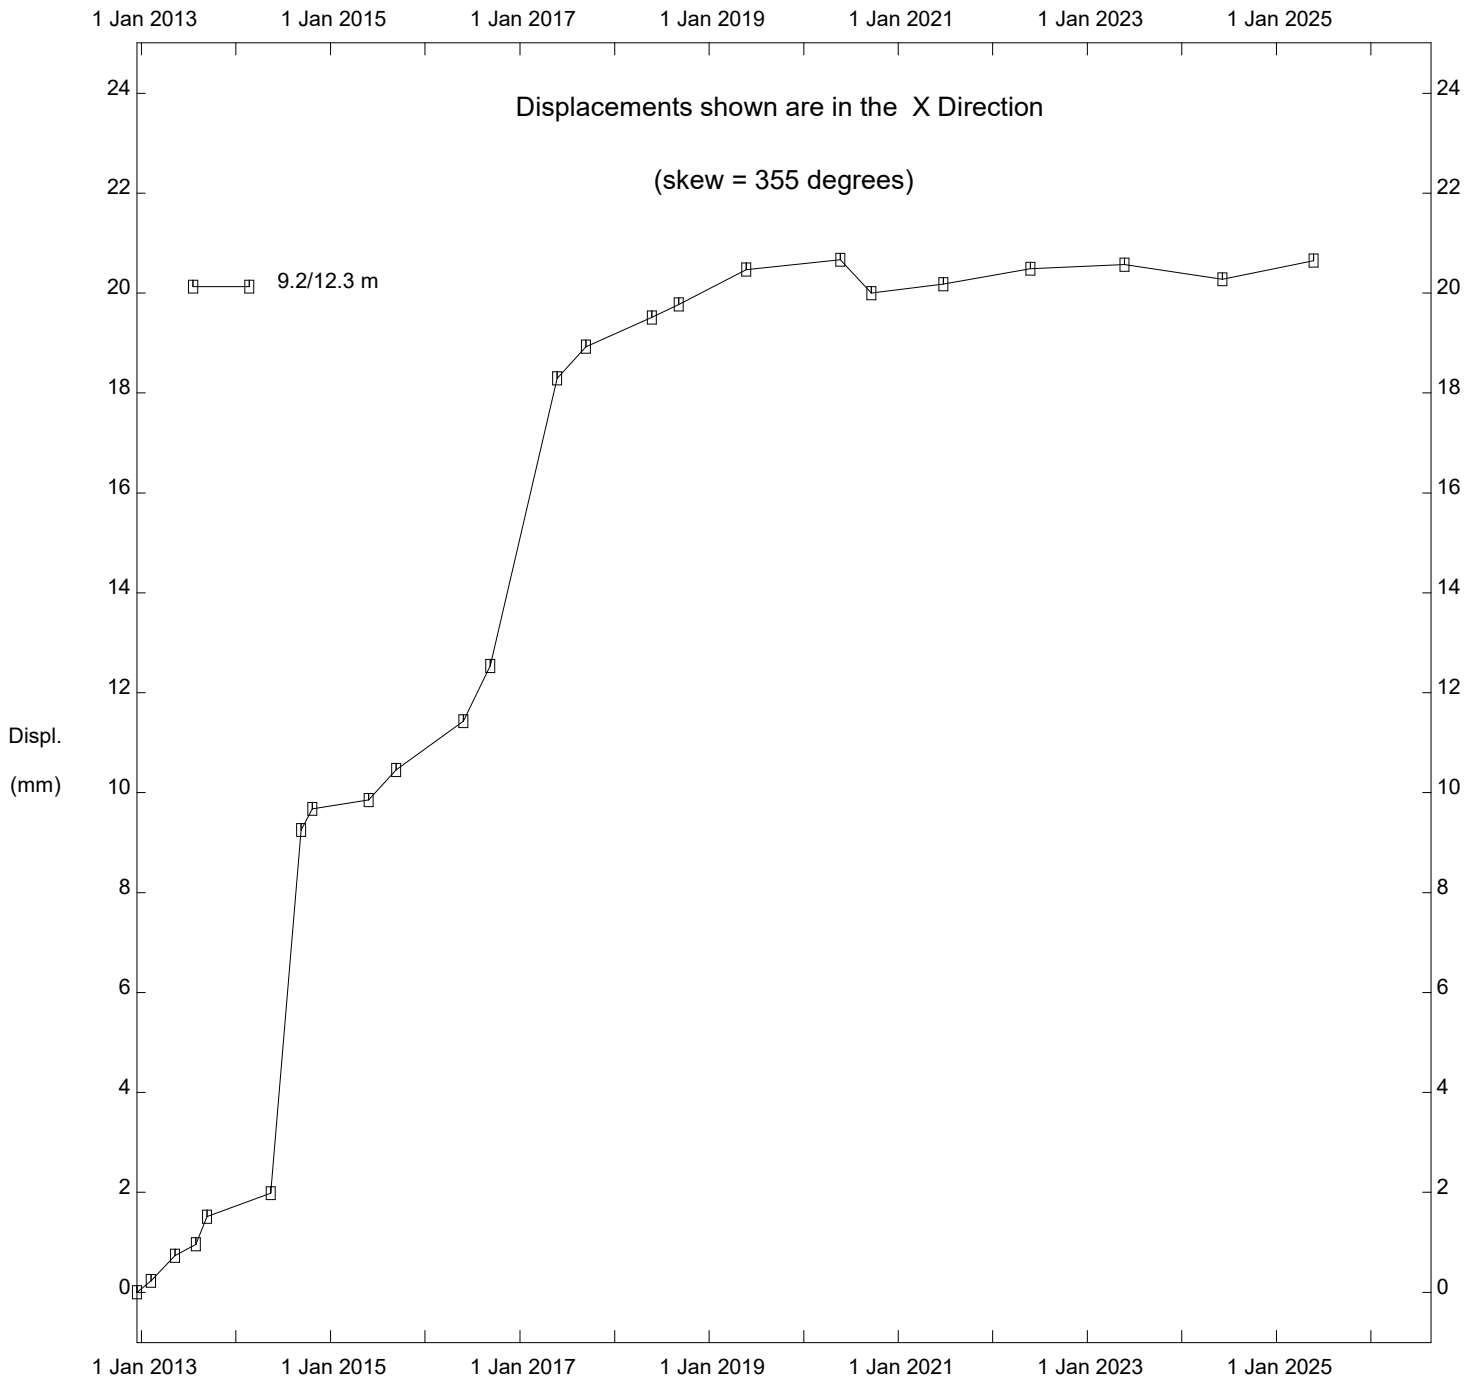
Hwy 41:23 Kehiwin Lake (NC104), Inclinometer SI12-11

| | <p>11.5 m depth and 0.5 mm/yr over 8.5 m to 10.4 m depth, respectively, since the spring of 2024 readings.</p> <p>Slope inclinometer SI12-11, installed at the bottom of the slope, showed a rate of movement of 0.4 mm/yr over 9.2 m to 12.3 m depth since the spring of 2024 readings. SI15-17 installed at the bottom of the slope showed a rate of movement of 1.2 mm/yr over 9.2 m to 11.0 m depth. SI15-20, also installed at the bottom of the slope, showed a rate of movement of 0.9 mm/yr over 8.6 m to 10.4 m depth since the spring of 2024 readings.</p> <p>For the tied-back pile wall, SI16-1, SI16-2, SI16-3, and SI16-5 have shown total pile head movements in the upslope direction of 8.3 mm, 3.7 mm, 2.7 mm, and 0.2 mm, respectively. SI16-6 has shown a total pile head movement of 4.5 mm in the downslope direction. SI16-7 has not shown any discernible movement since it was reinitialized on September 18, 2020.</p> <p>For the interim cantilever pile wall, SI17-1, SI17-2, and SI17-4 showed rates of movement over the length of their respective piles of less than 0.1 mm/yr, 0.7 mm/yr, and 0.8 mm/yr, respectively, since the spring of 2024 readings. SI17-3 showed no discernible movement over the length of the pile. SI17-1, SI17-2, SI17-3, and SI17-4 have shown total pile head movements of 6.2 mm, 8.9 mm, 16.0 mm and 11.7 mm, respectively, since they were initialized.</p> <p>Overall, the current rates of movement shown in the SIs were comparable to those observed in the SIs over the past several years, since the completion of pile wall construction.</p> <p>SAA17-1, installed in pile P146 of the NC104-4 wall extension (i.e., interim pile wall), showed an average rate of movement of 0.2 mm/yr since the spring of 2024 readings. SAA17-1 has shown a total pile head movement of 1.7 mm in the downslope direction since it was installed.</p> <p>The strain gauges installed at 6.35 m below the top of the pile on both the upslope and downslope pile faces were not functioning during the readings, and the strain gauge installed at 0.8 m on the upslope pile face was functioning intermittently. Overall, the strain gauges showed relatively small changes in micro-strain since the previous readings in the spring of 2024, except for the 0.8 m depth upslope strain gauge, which showed a decrease in total microstrain of 22.4 <math>\mu\epsilon</math>. This may be due to it not functioning correctly.</p> <p>The pneumatic piezometers showed changes in groundwater level ranging from an increase 0.25 m in PN15-16 to a decrease of 0.22 m in PN15-21 since the spring of 2024 readings.</p> <p>Standpipe piezometers SP12-6, SP12-9, and SP15-18 showed increases in groundwater levels of 0.01 m, 0.08 m, and 0.45 m, respectively since the spring of 2024. SP15-14 is still dry.</p> <p>The north load cell datalogger has been operating intermittently since November 20, 2023, so the most recent reading recorded was on May 13, 2025.</p> <p>The south load cell datalogger battery died on October 20, 2024, and was replaced on May 23, 2025. The readings were downloaded on May 24, 2025.</p> <p>The Load cells showed relatively small changes in measured load since the spring of 2024 readings. The change in load ranged from a</p> |

| INSTRUMENT # | DATE INITIALIZED | TOTAL CUMULATIVE RESULTANT MOVEMENT AND DEPTH OF MOVEMENT TO DATE (mm) | MAXIMUM RATE OF MOVEMENT (mm/yr) | CURRENT STATUS OF SI | DATE OF PREVIOUS READING | INCREMENTAL MOVEMENT SINCE PREVIOUS READING (mm) | CURRENT RATE OF MOVEMENT (mm/yr) | CHANGE IN RATE OF MOVEMENT SINCE PREVIOUS READING (mm/yr) |
|---|---|---|---|---|---|---|---|---|
| SI12-11 | December 14, 2012 | 20.7 over 9.2 m to 12.3 m depth in 286° direction | 22.8 in September 2014 | Operational | June 6, 2024 | 0.4 | 0.4 | 3.0 |

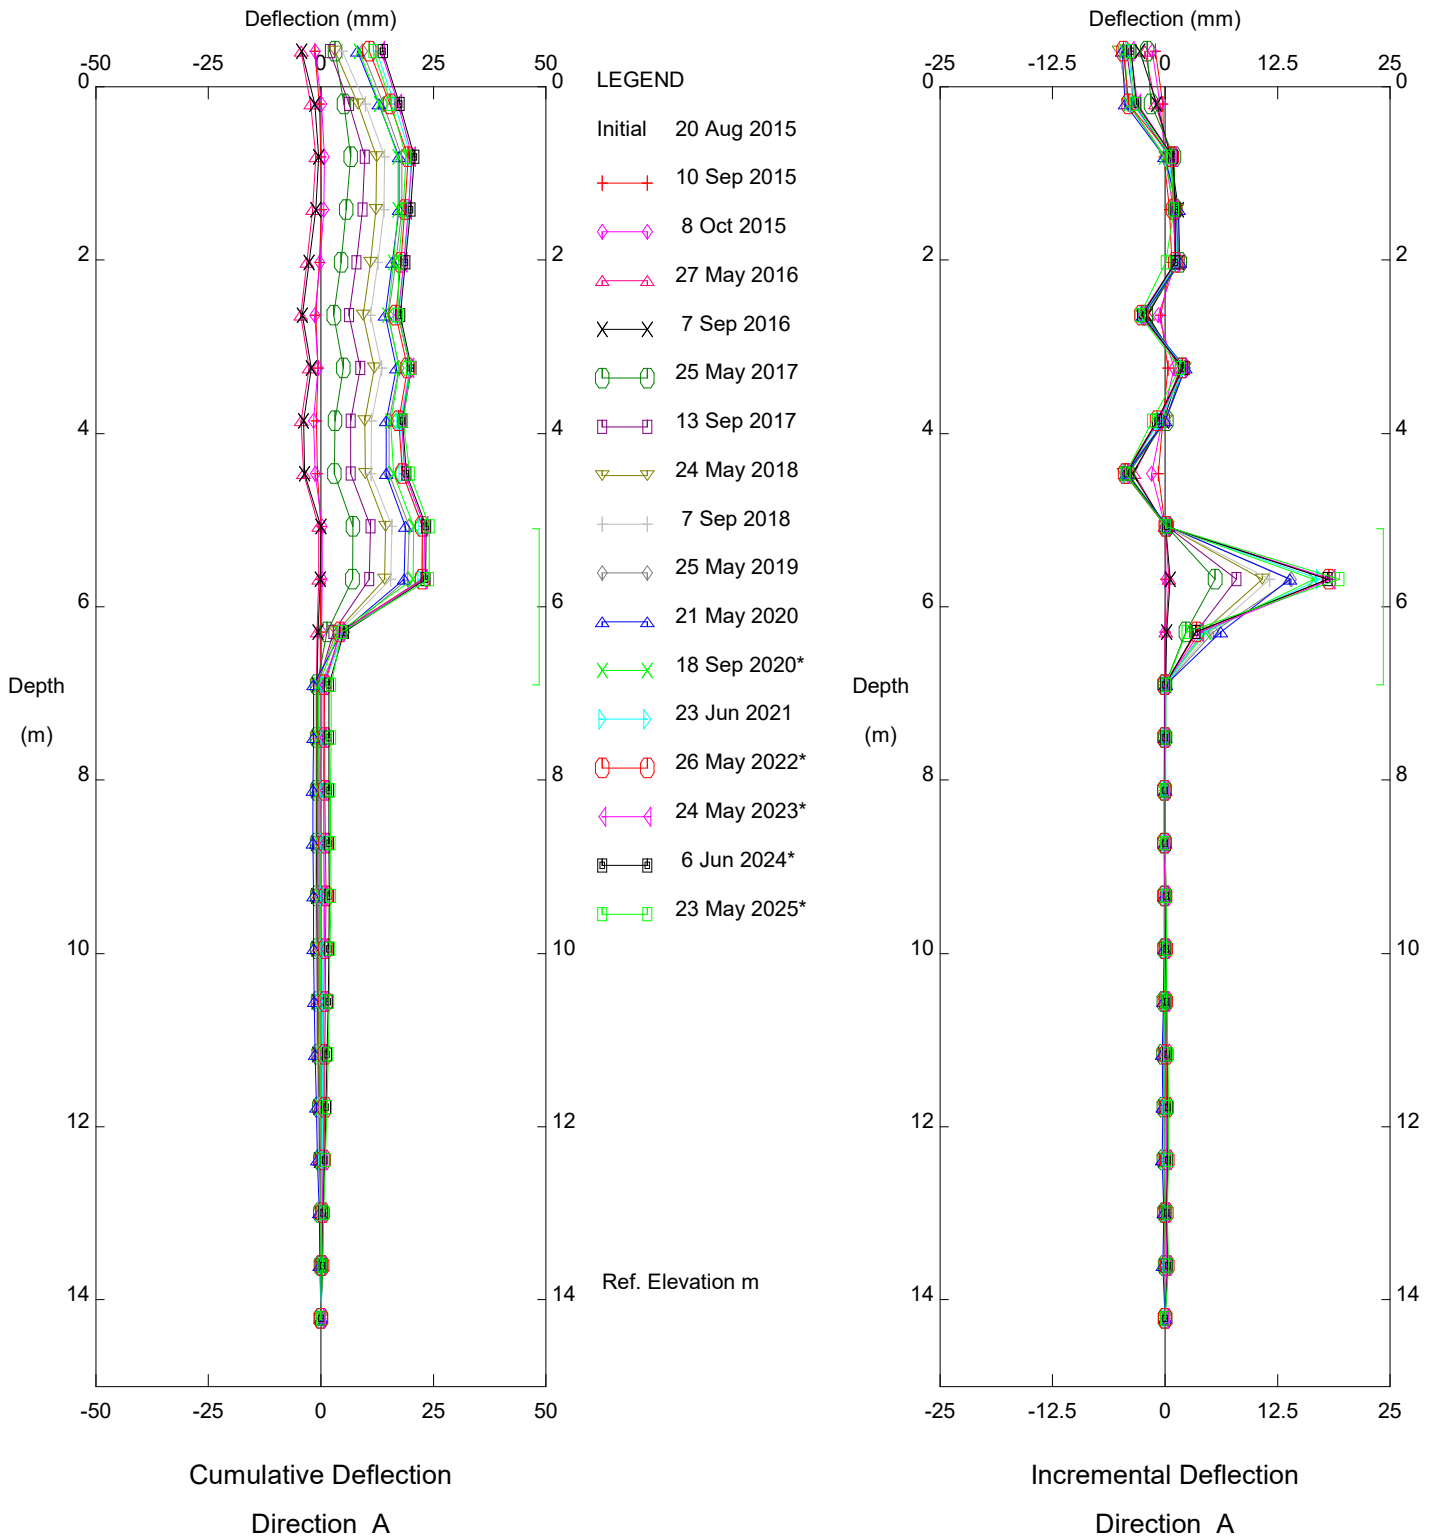
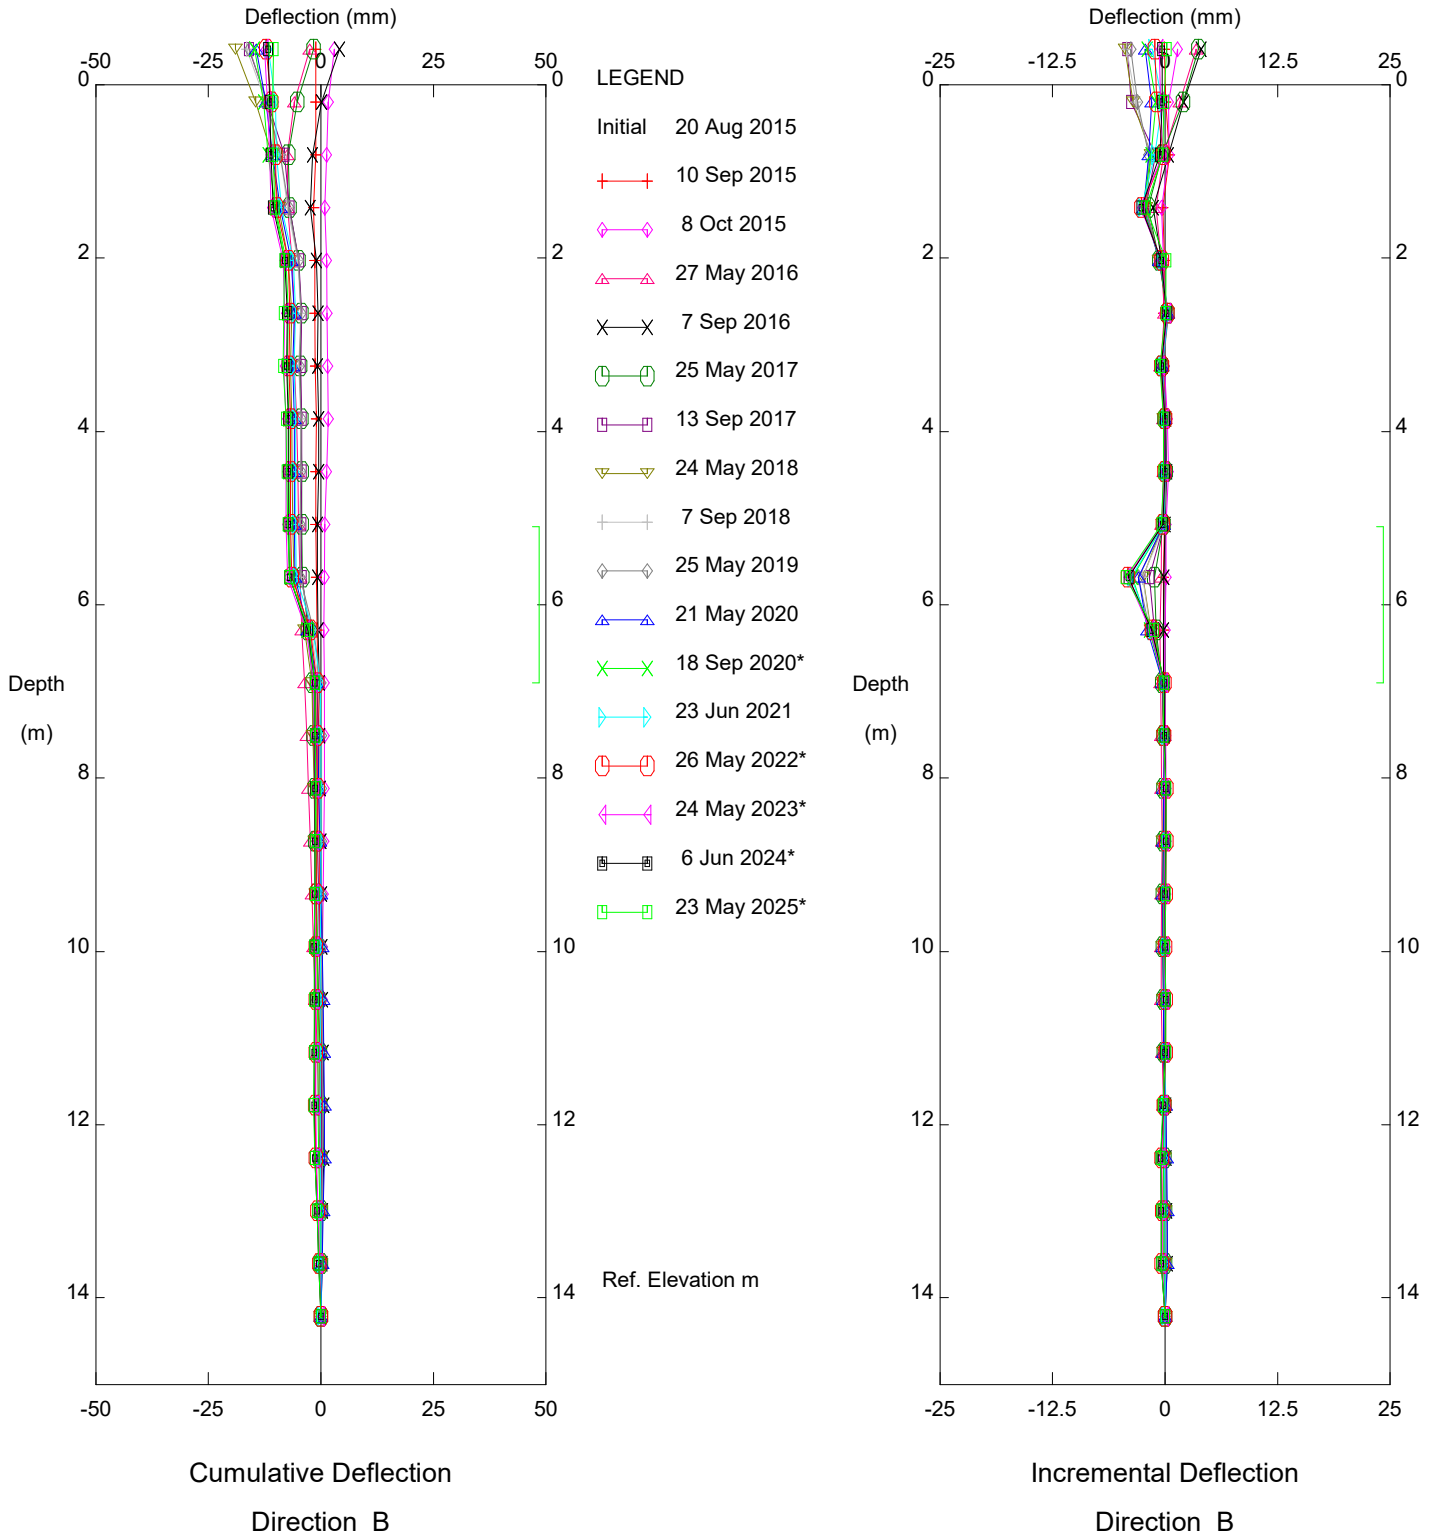
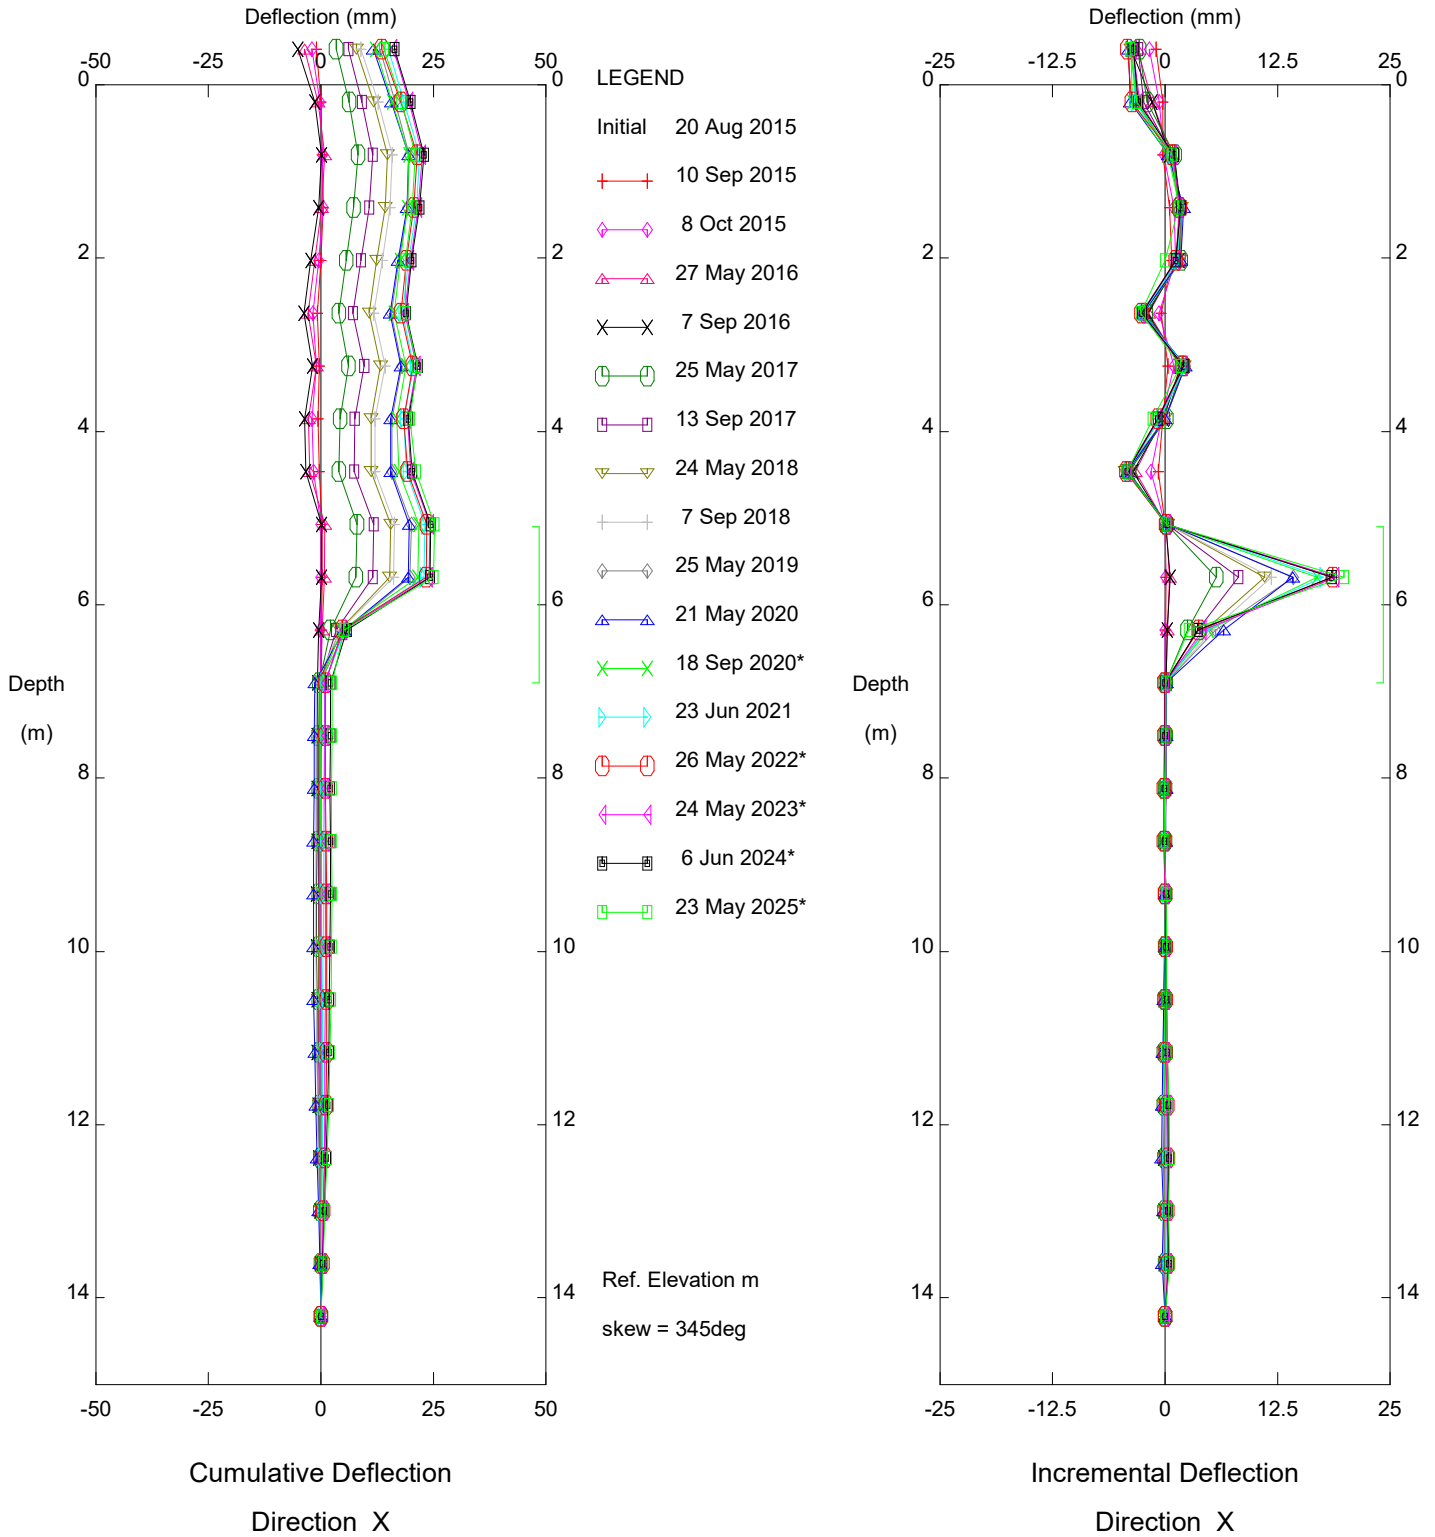
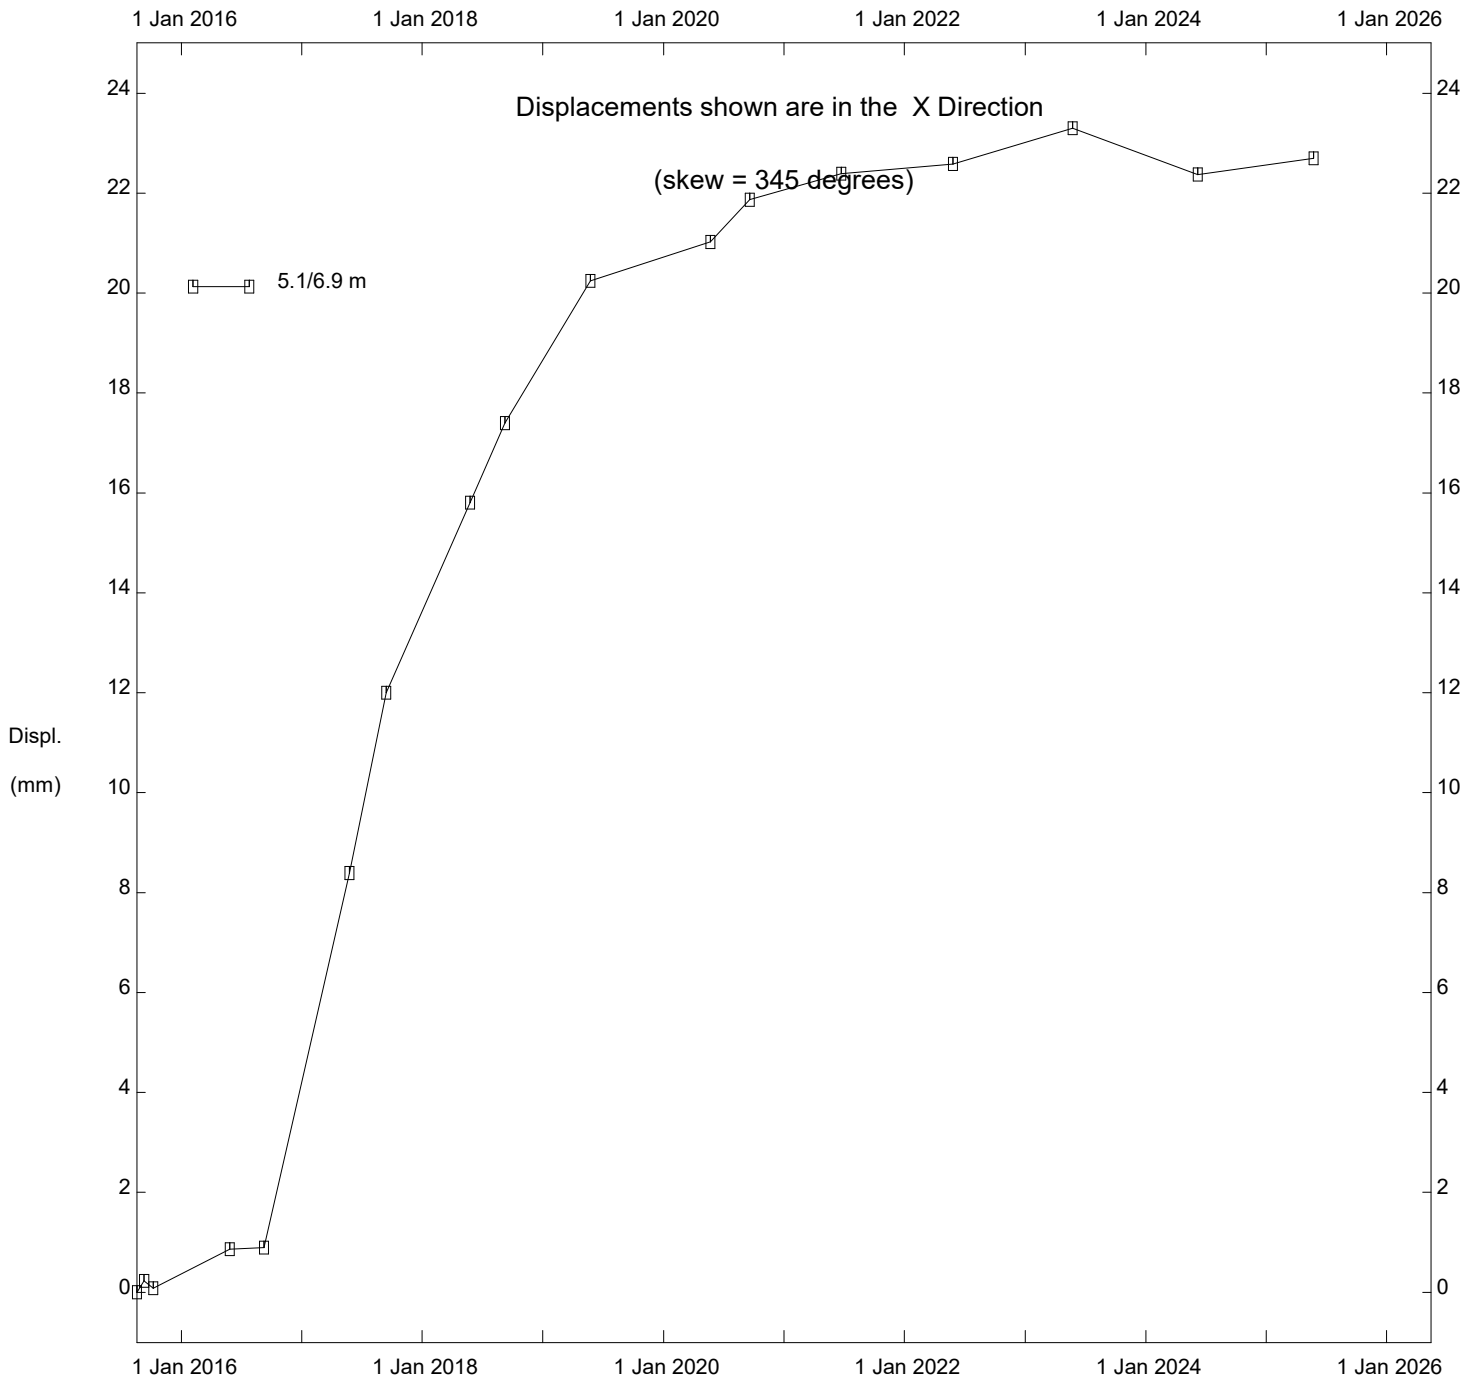
Hwy 41:23 Kehiwin Lake (NC104), Inclinator SI15-15

| Discussion | |
|---|---|
| <b>Interpretation of Monitoring Results:</b> | <p>Slope inclinometer SI15-15, installed in the highway east ditch within the southern limit of the site, showed a rate of movement of 0.3 mm/yr over 5.1 m to 6.9 m depth since the spring of 2024 readings.</p> <p>Slope inclinometers SI15-16 and SI15-21, installed along the west edge of the highway, showed a rate of movement of 0.6 mm/yr over 9.7 m to</p> |

| INSTRUMENT # | DATE INITIALIZED | TOTAL CUMULATIVE RESULTANT MOVEMENT AND DEPTH OF MOVEMENT TO DATE (mm) | MAXIMUM RATE OF MOVEMENT (mm/yr) | CURRENT STATUS OF SI | DATE OF PREVIOUS READING | INCREMENTAL MOVEMENT SINCE PREVIOUS READING (mm) | CURRENT RATE OF MOVEMENT (mm/yr) | CHANGE IN RATE OF MOVEMENT SINCE PREVIOUS READING (mm/yr) |
|---|---|---|---|---|---|---|---|---|
| SI15-15 | August 20, 2015 | 22.7 over 5.1 m to 6.9 m depth in 297° direction | 11.9 in September, 2017 | Operational | June 6, 2024 | 0.3 | 0.3 | 1.2 |
