**ALBERTA TRANSPORTATION AND  
ECONOMIC CORRIDORS GRMP  
NORTH CENTRAL (ATHABASCA AND FORT  
McMURRAY DISTRICTS)  
INSTRUMENTATION MONITORING - SPRING 2025**

| Site Number | Location | Name | Hwy | km |
|---|---|---|---|---|
| NC104<br>(NC024-4) | HWY 41:23 C1 7.66 | Kehiwin Lake | 41:23 | Km 7.7 |

| <b>Current Monitoring:</b> | 23-May-2025 to<br>24-May-2025 | <b>Previous Monitoring</b> | 6-June-2024 |

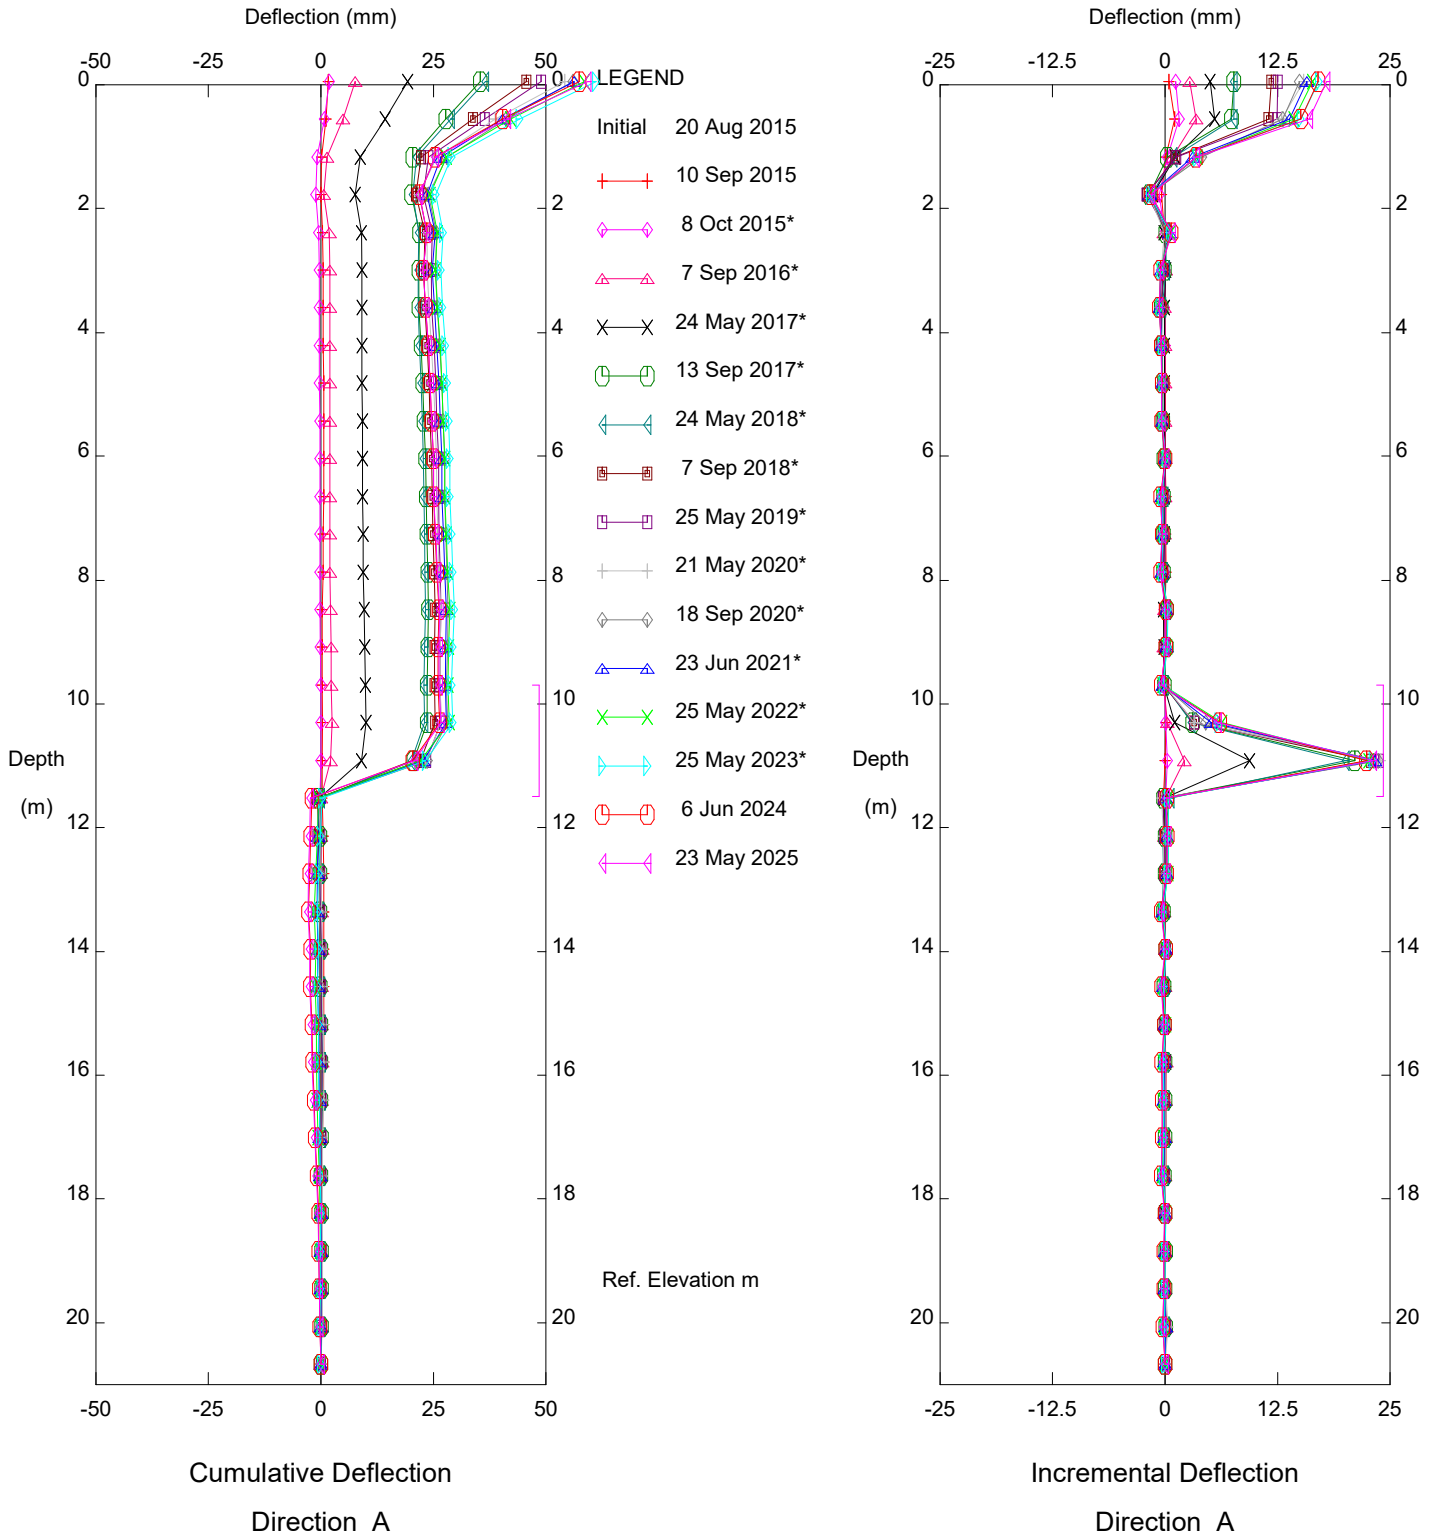
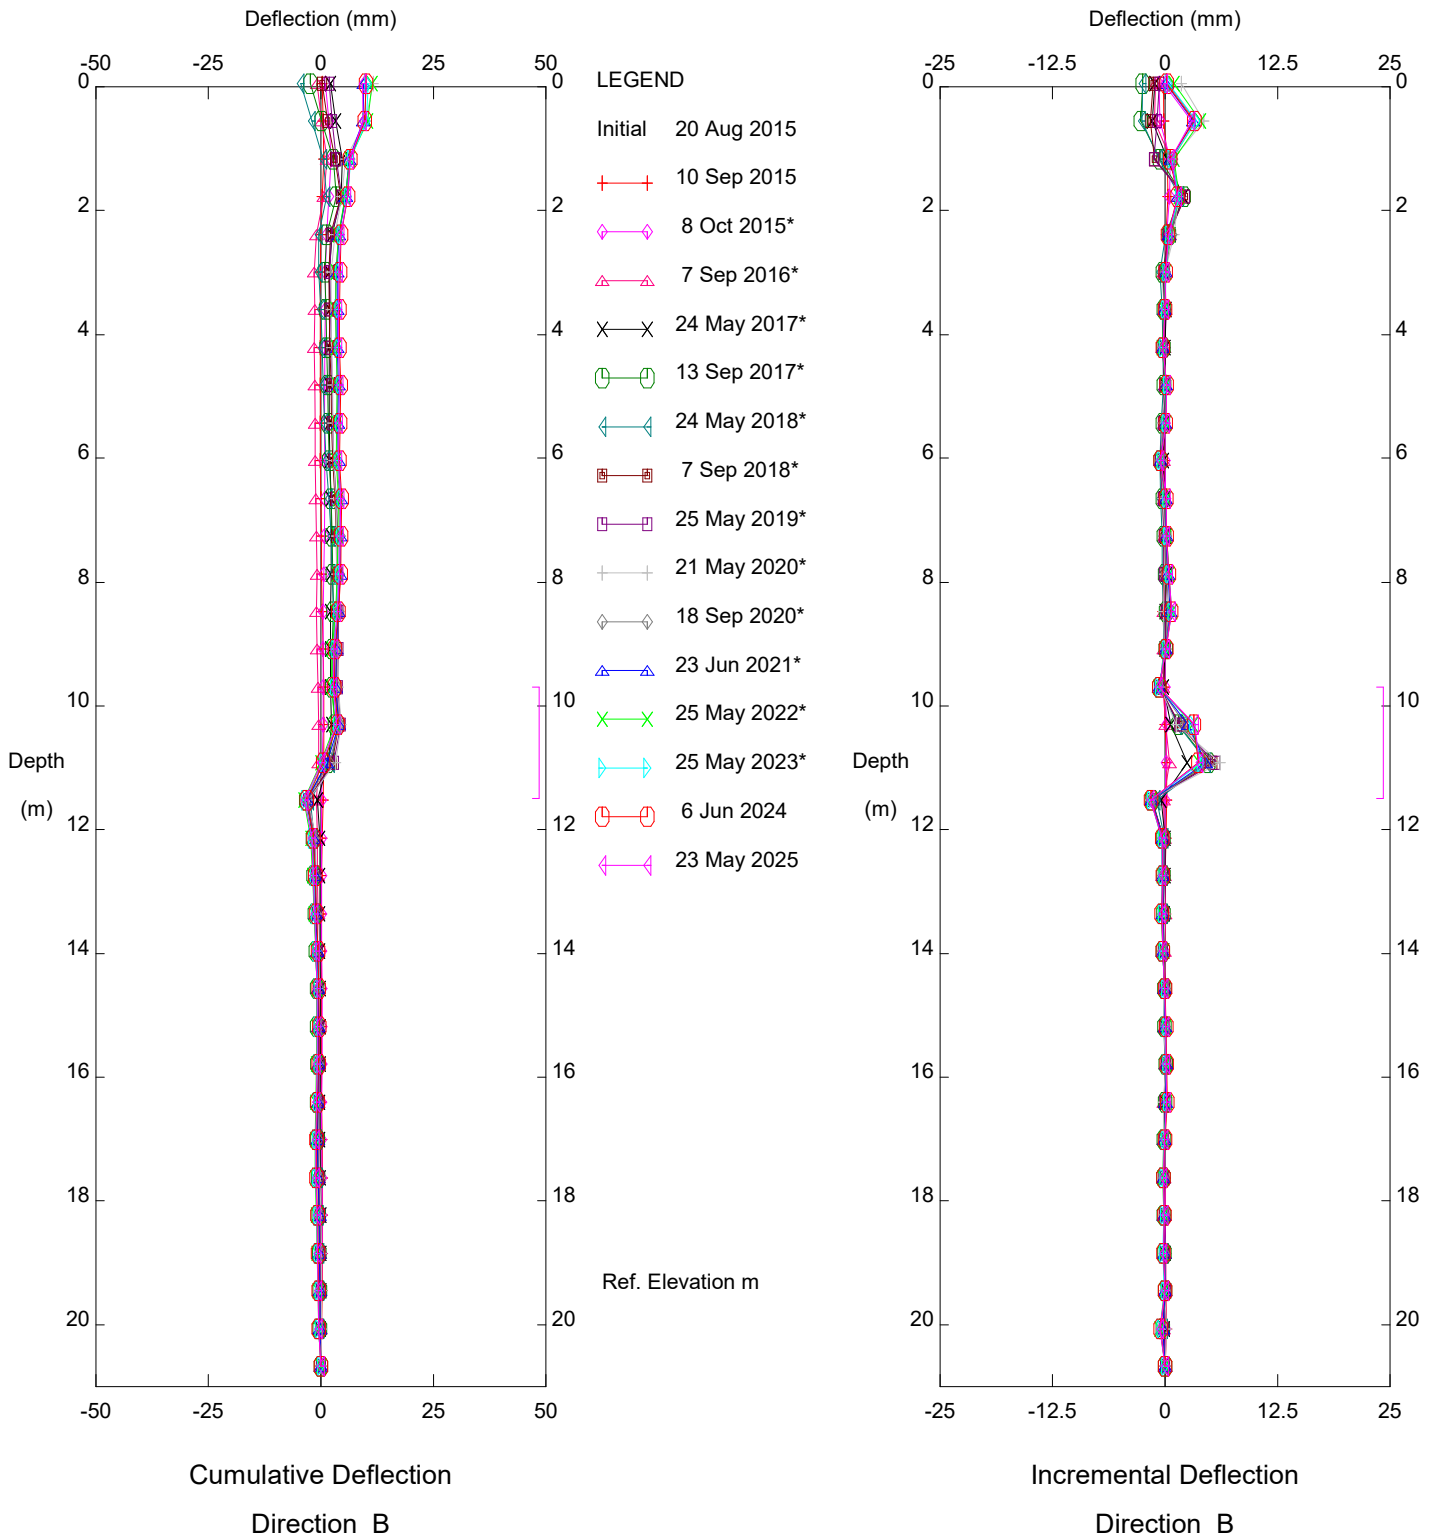
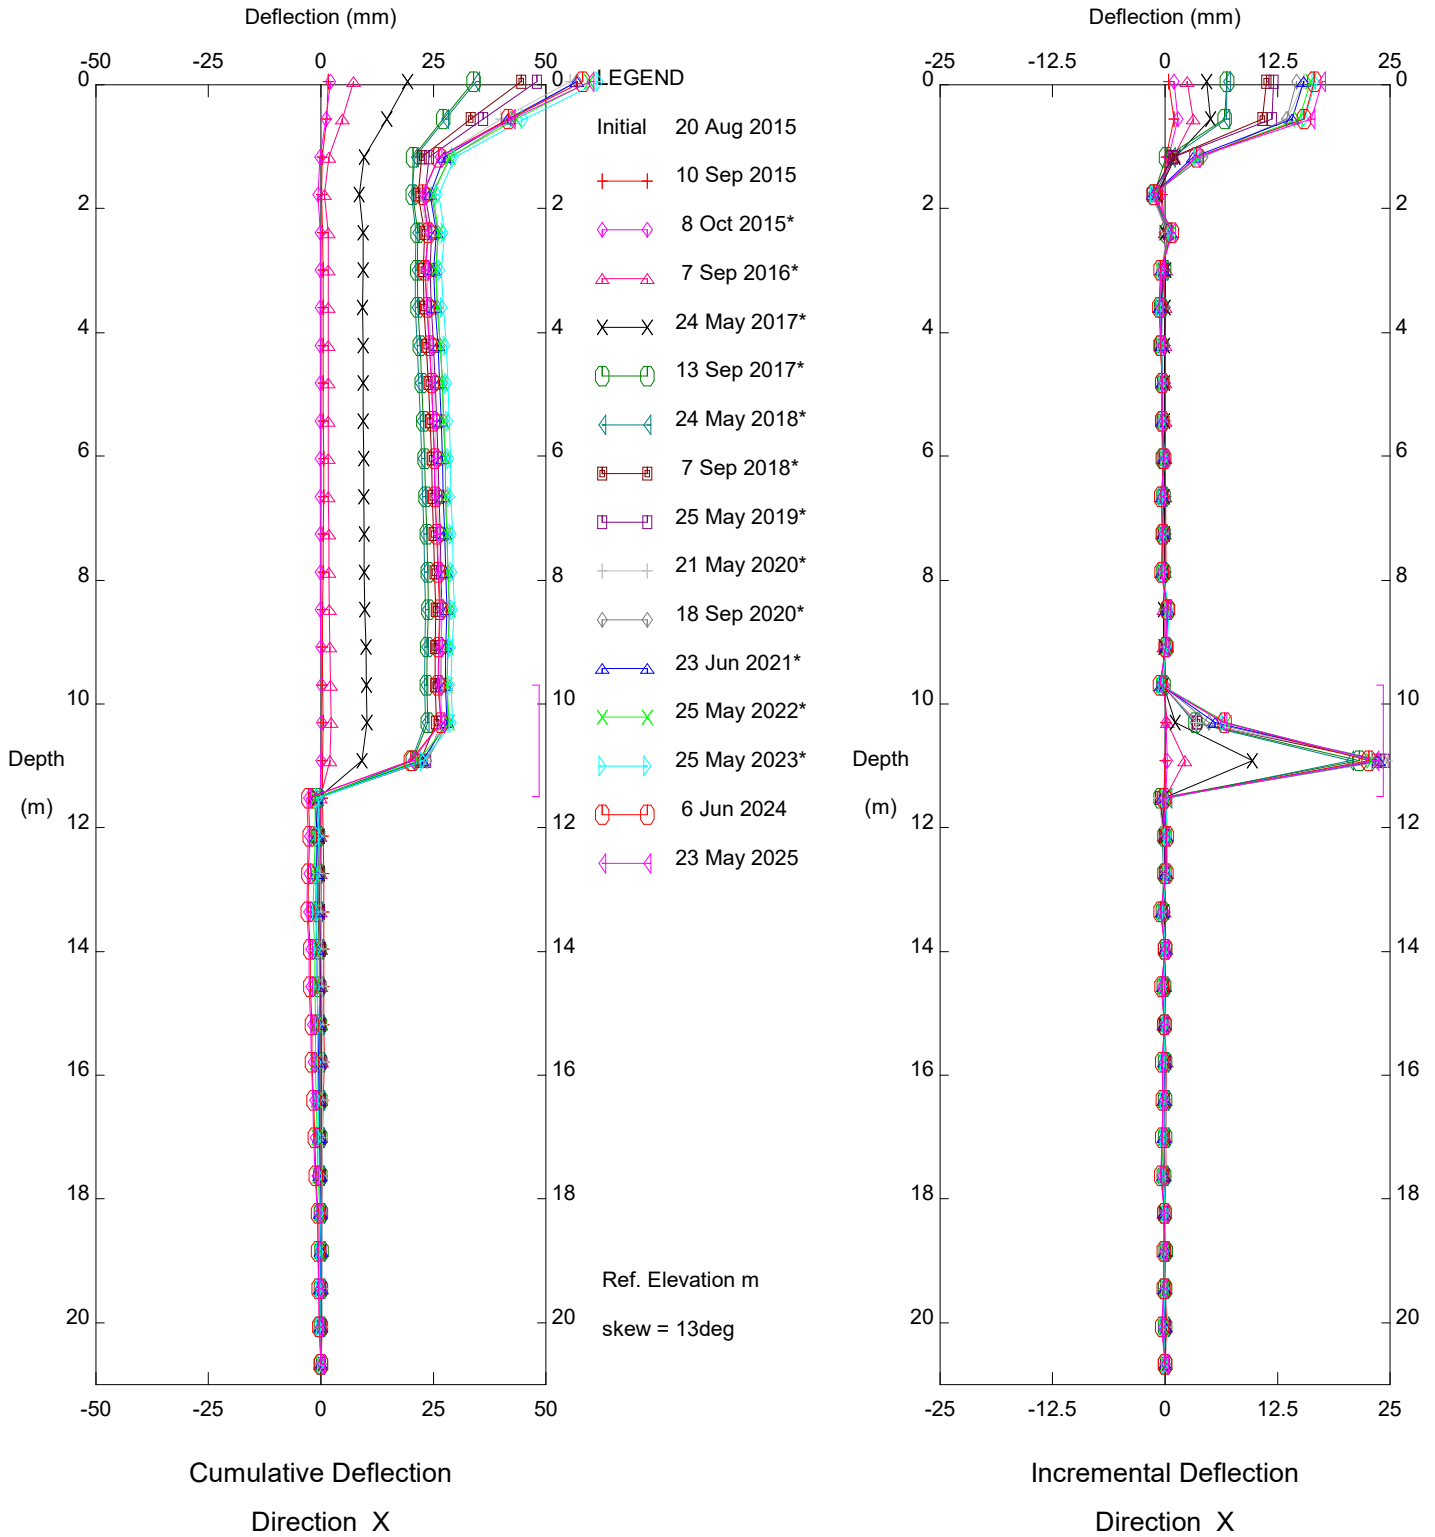
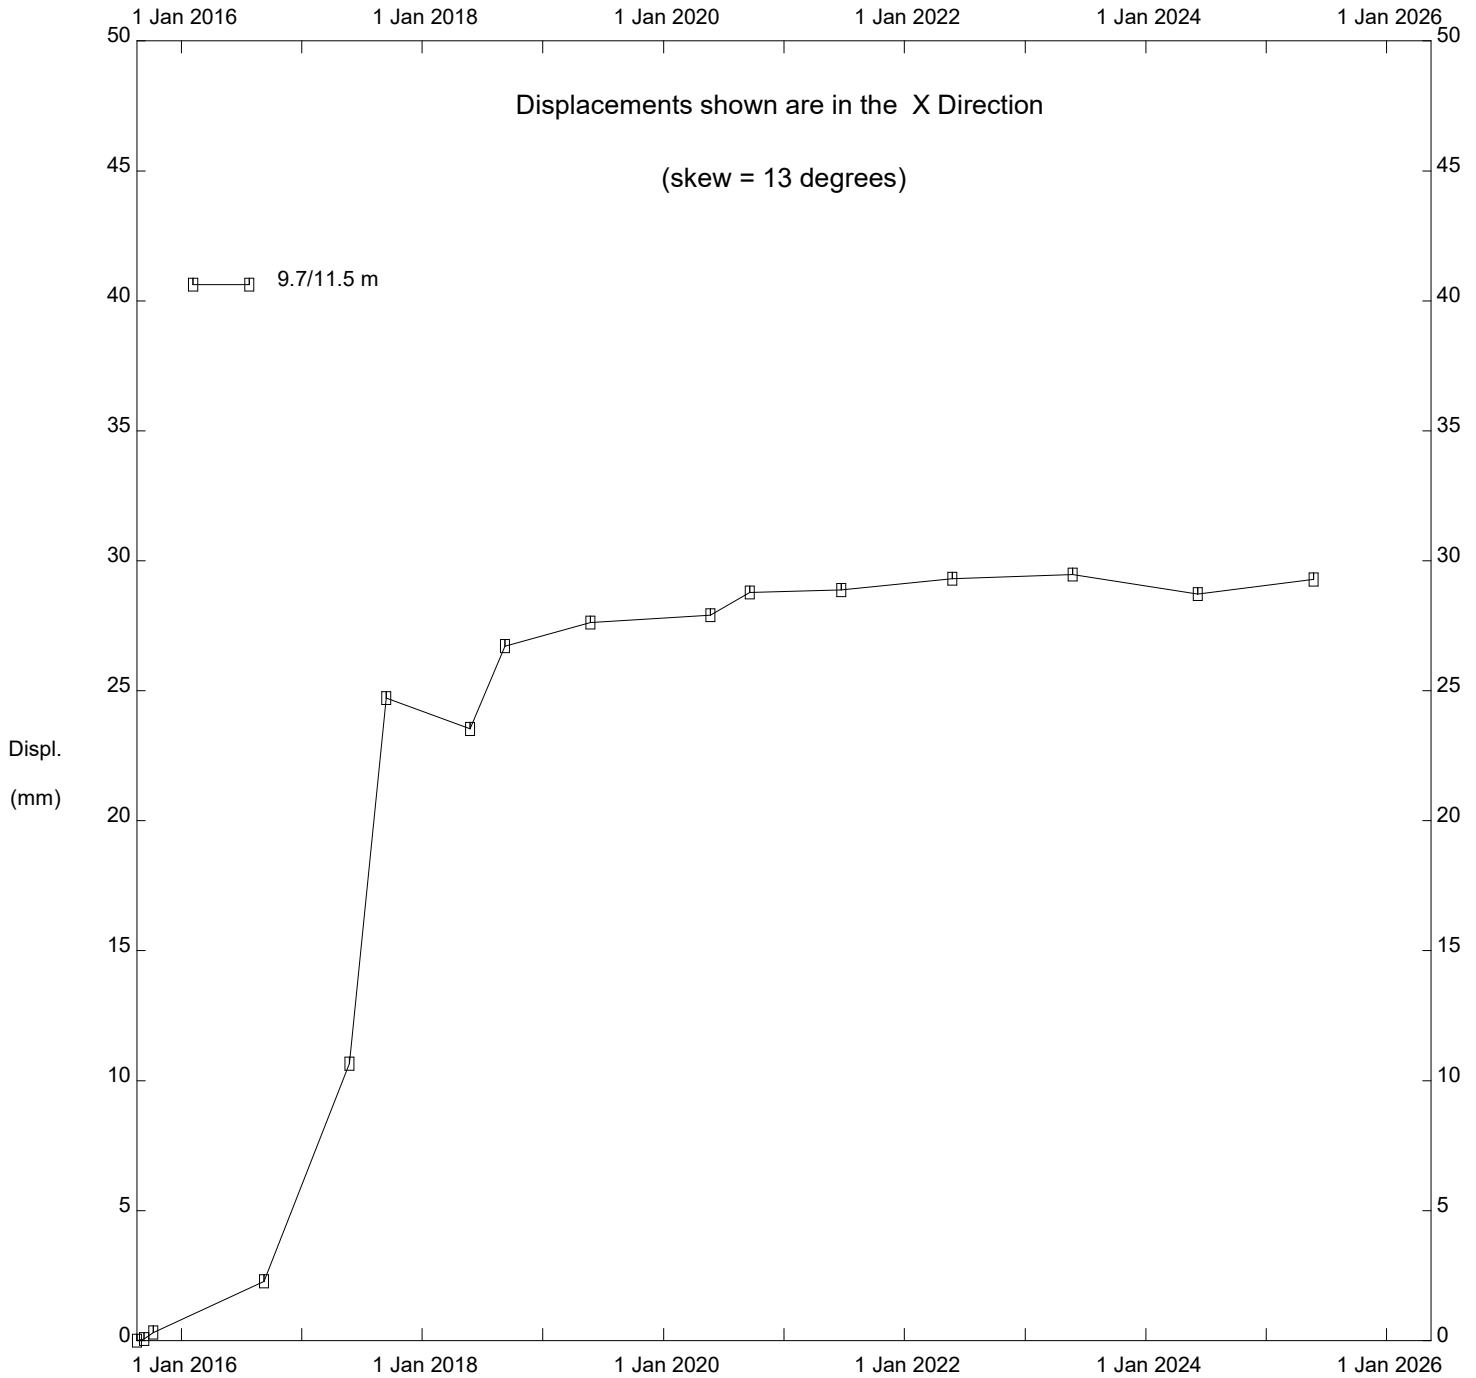
Hwy 41:23 Kehiwin Lake (NC104), Inclinometer SI15-16

| INSTRUMENT # | DATE INITIALIZED | TOTAL CUMULATIVE RESULTANT MOVEMENT AND DEPTH OF MOVEMENT TO DATE (mm) | MAXIMUM RATE OF MOVEMENT (mm/yr) | CURRENT STATUS OF SI | DATE OF PREVIOUS READING | INCREMENTAL MOVEMENT SINCE PREVIOUS READING (mm) | CURRENT RATE OF MOVEMENT (mm/yr) | CHANGE IN RATE OF MOVEMENT SINCE PREVIOUS READING (mm/yr) |
|---|---|---|---|---|---|---|---|---|
| SI15-16 | August 20, 2015 | 29.3 over 9.7 m to 11.5 m depth in 299° direction | 45.9 in September, 2017 | Operational | June 6, 2024 | 0.6 | 0.6 | 1.3 |

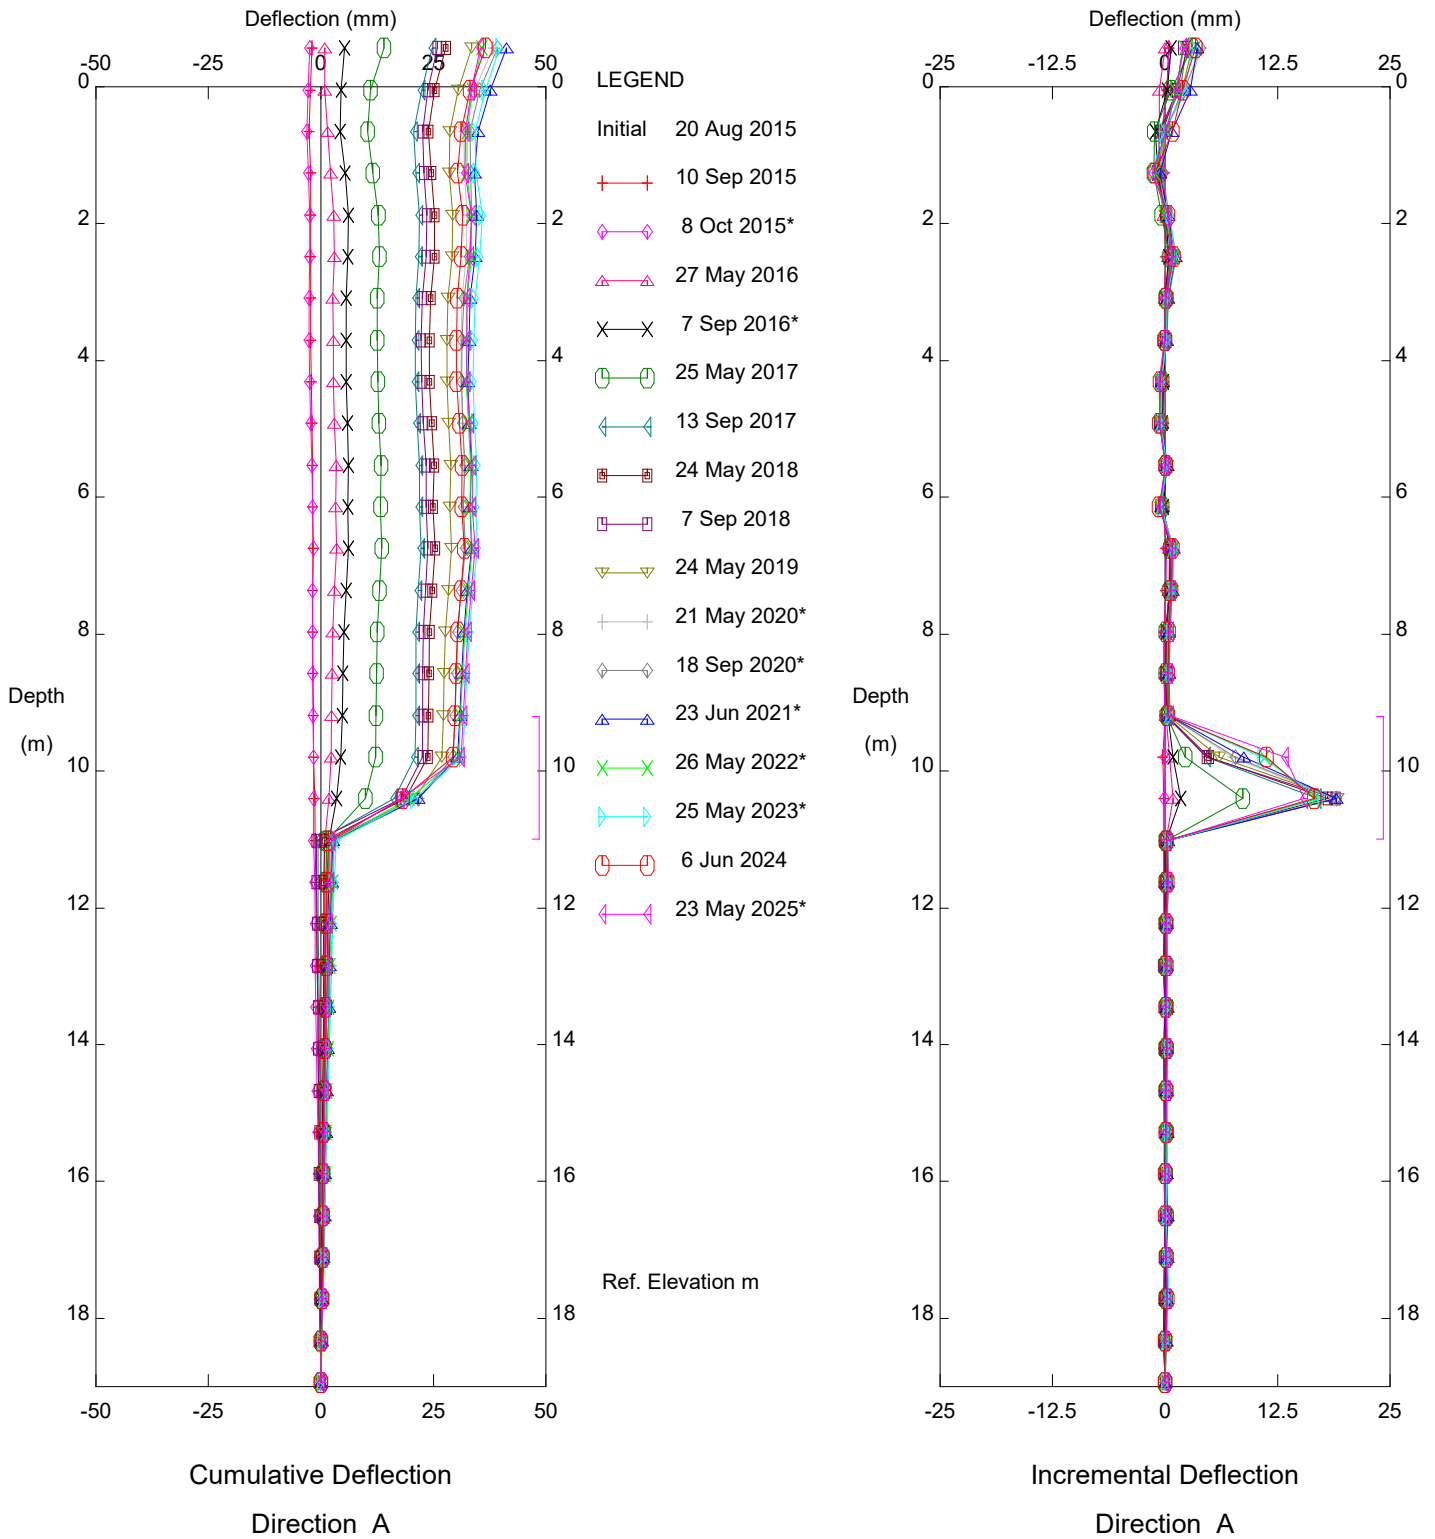
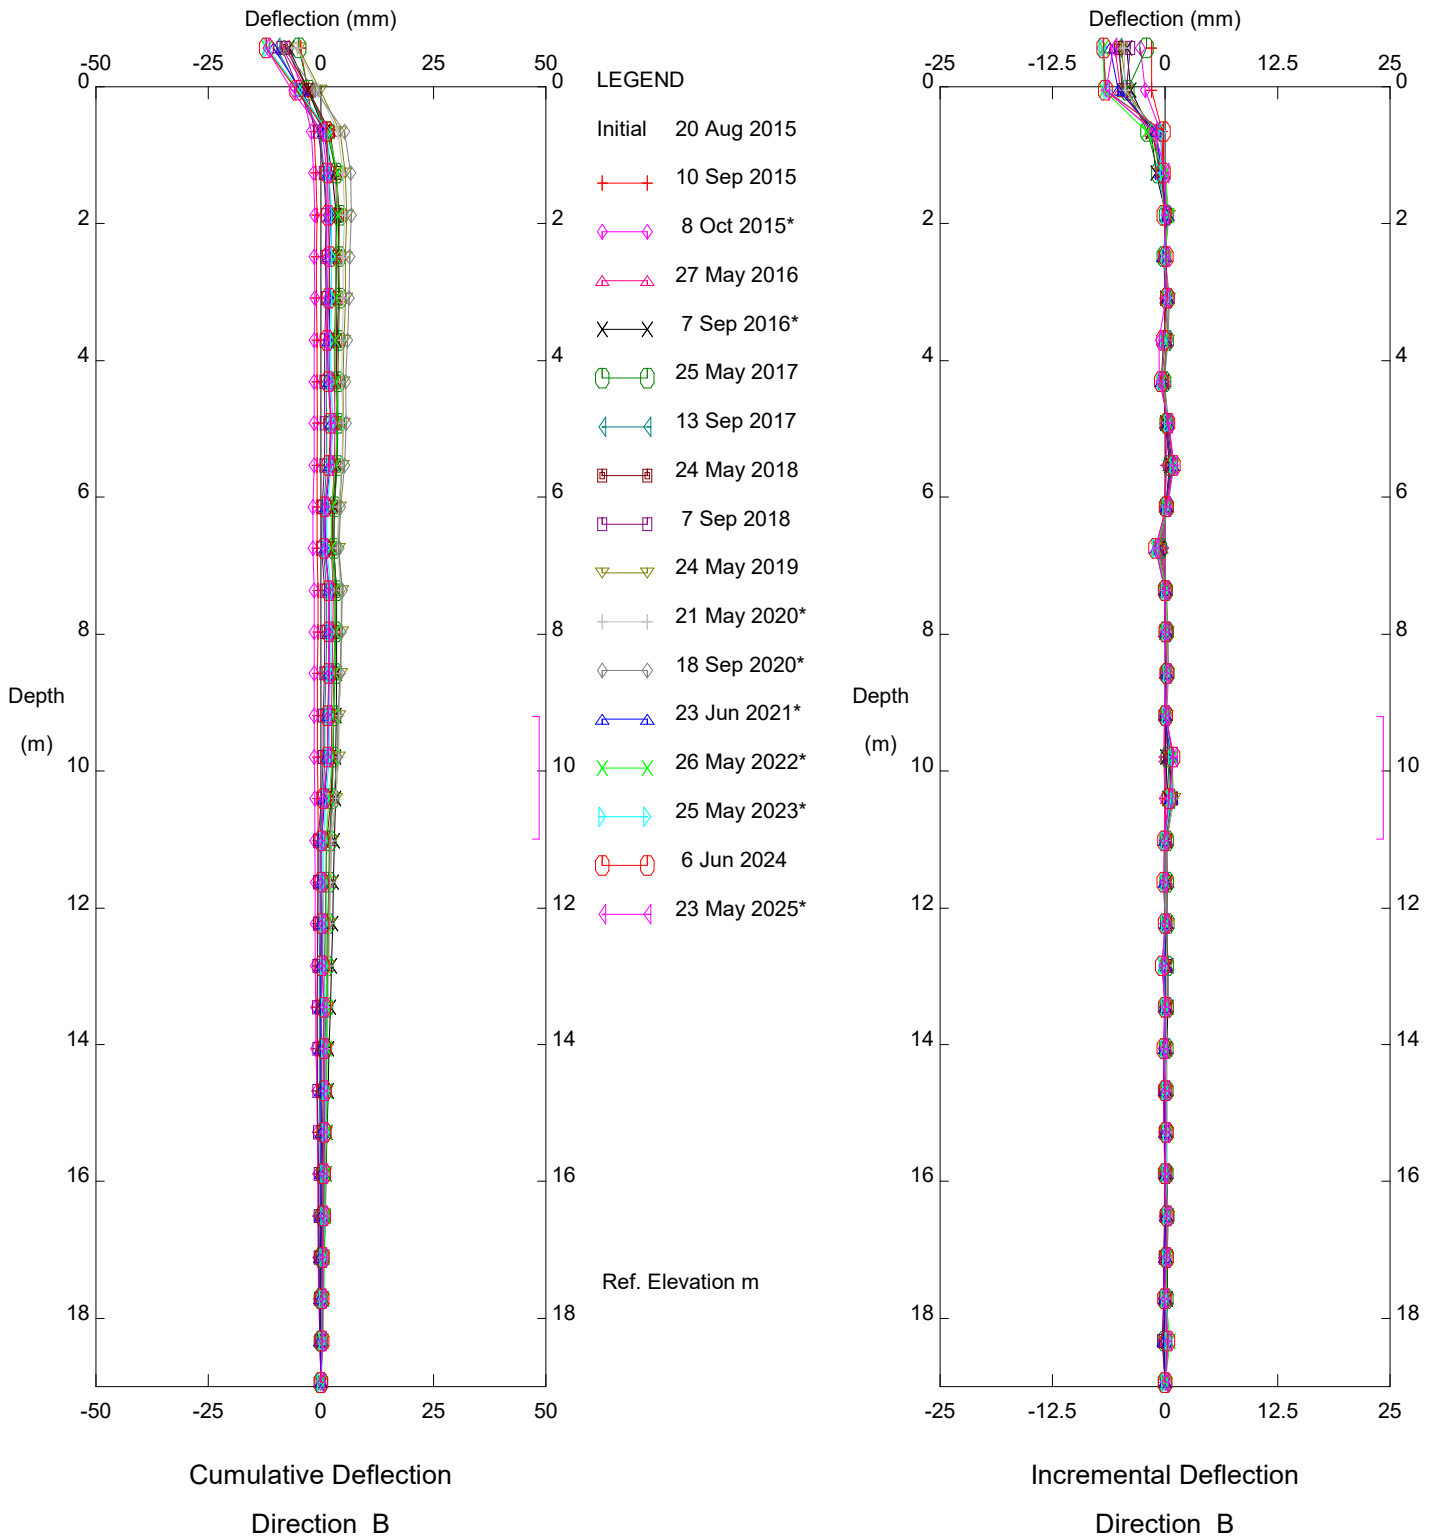
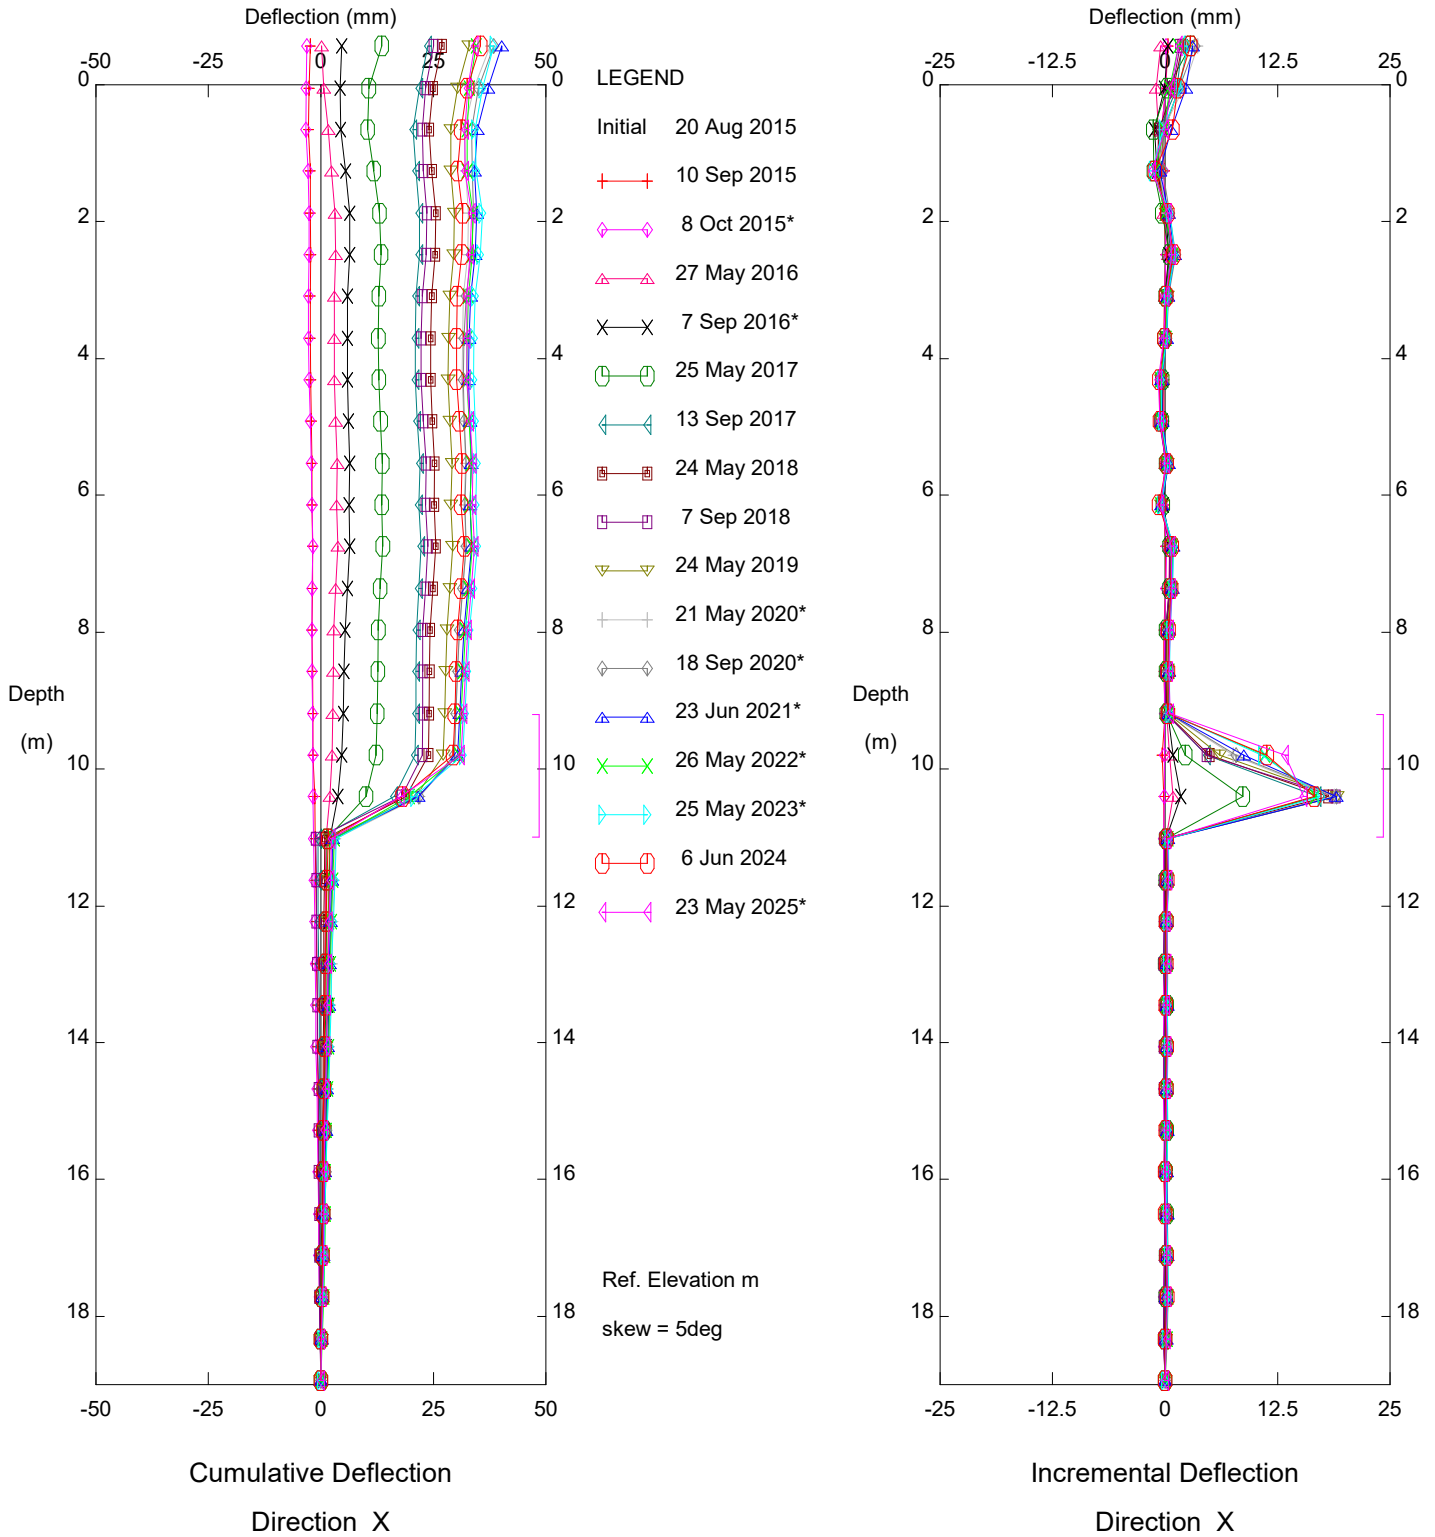
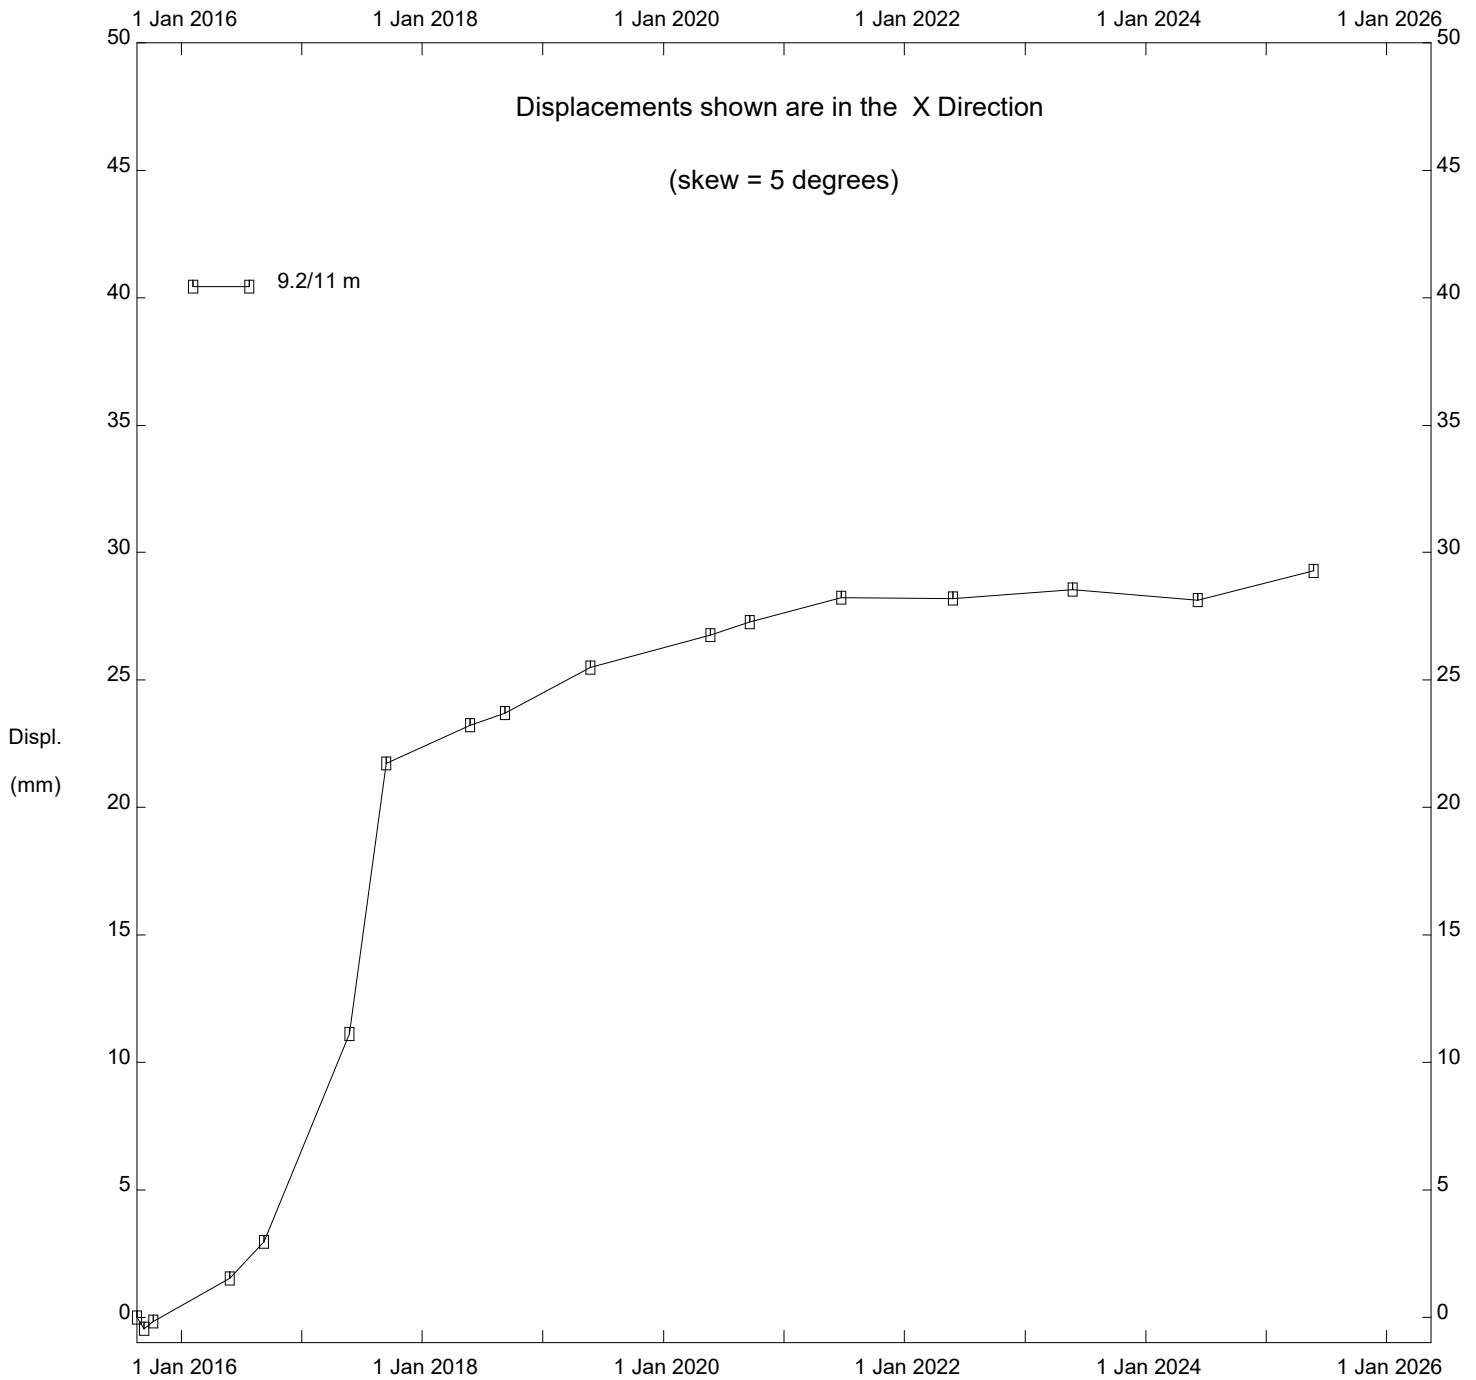
Hwy 41:23 Kehiwin Lake (NC104), Inclinometer SI15-17

| INSTRUMENT # | DATE INITIALIZED | TOTAL CUMULATIVE RESULTANT MOVEMENT AND DEPTH OF MOVEMENT TO DATE (mm) | MAXIMUM RATE OF MOVEMENT (mm/yr) | CURRENT STATUS OF SI | DATE OF PREVIOUS READING | INCREMENTAL MOVEMENT SINCE PREVIOUS READING (mm) | CURRENT RATE OF MOVEMENT (mm/yr) | CHANGE IN RATE OF MOVEMENT SINCE PREVIOUS READING (mm/yr) |
|---|---|---|---|---|---|---|---|---|
| SI15-17 | August 20, 2015 | 29.3 over 9.2 m to 11.0 m depth in 275° direction | 35.0 in September, 2017 | Operational | June 6, 2024 | 1.1 | 1.2 | 1.6 |
