**ALBERTA TRANSPORTATION AND  
ECONOMIC CORRIDORS GRMP  
NORTH CENTRAL (ATHABASCA AND FORT  
McMURRAY DISTRICTS)  
INSTRUMENTATION MONITORING - SPRING 2025**

| Site Number | Location | Name | Hwy | km |
|---|---|---|---|---|
| NC104<br>(NC024-4) | HWY 41:23 C1 7.66 | Kehiwin Lake | 41:23 | Km 7.7 |

| <b>Current Monitoring:</b> | 23-May-2025 to<br>24-May-2025 | <b>Previous Monitoring</b> | 6-June-2024 |

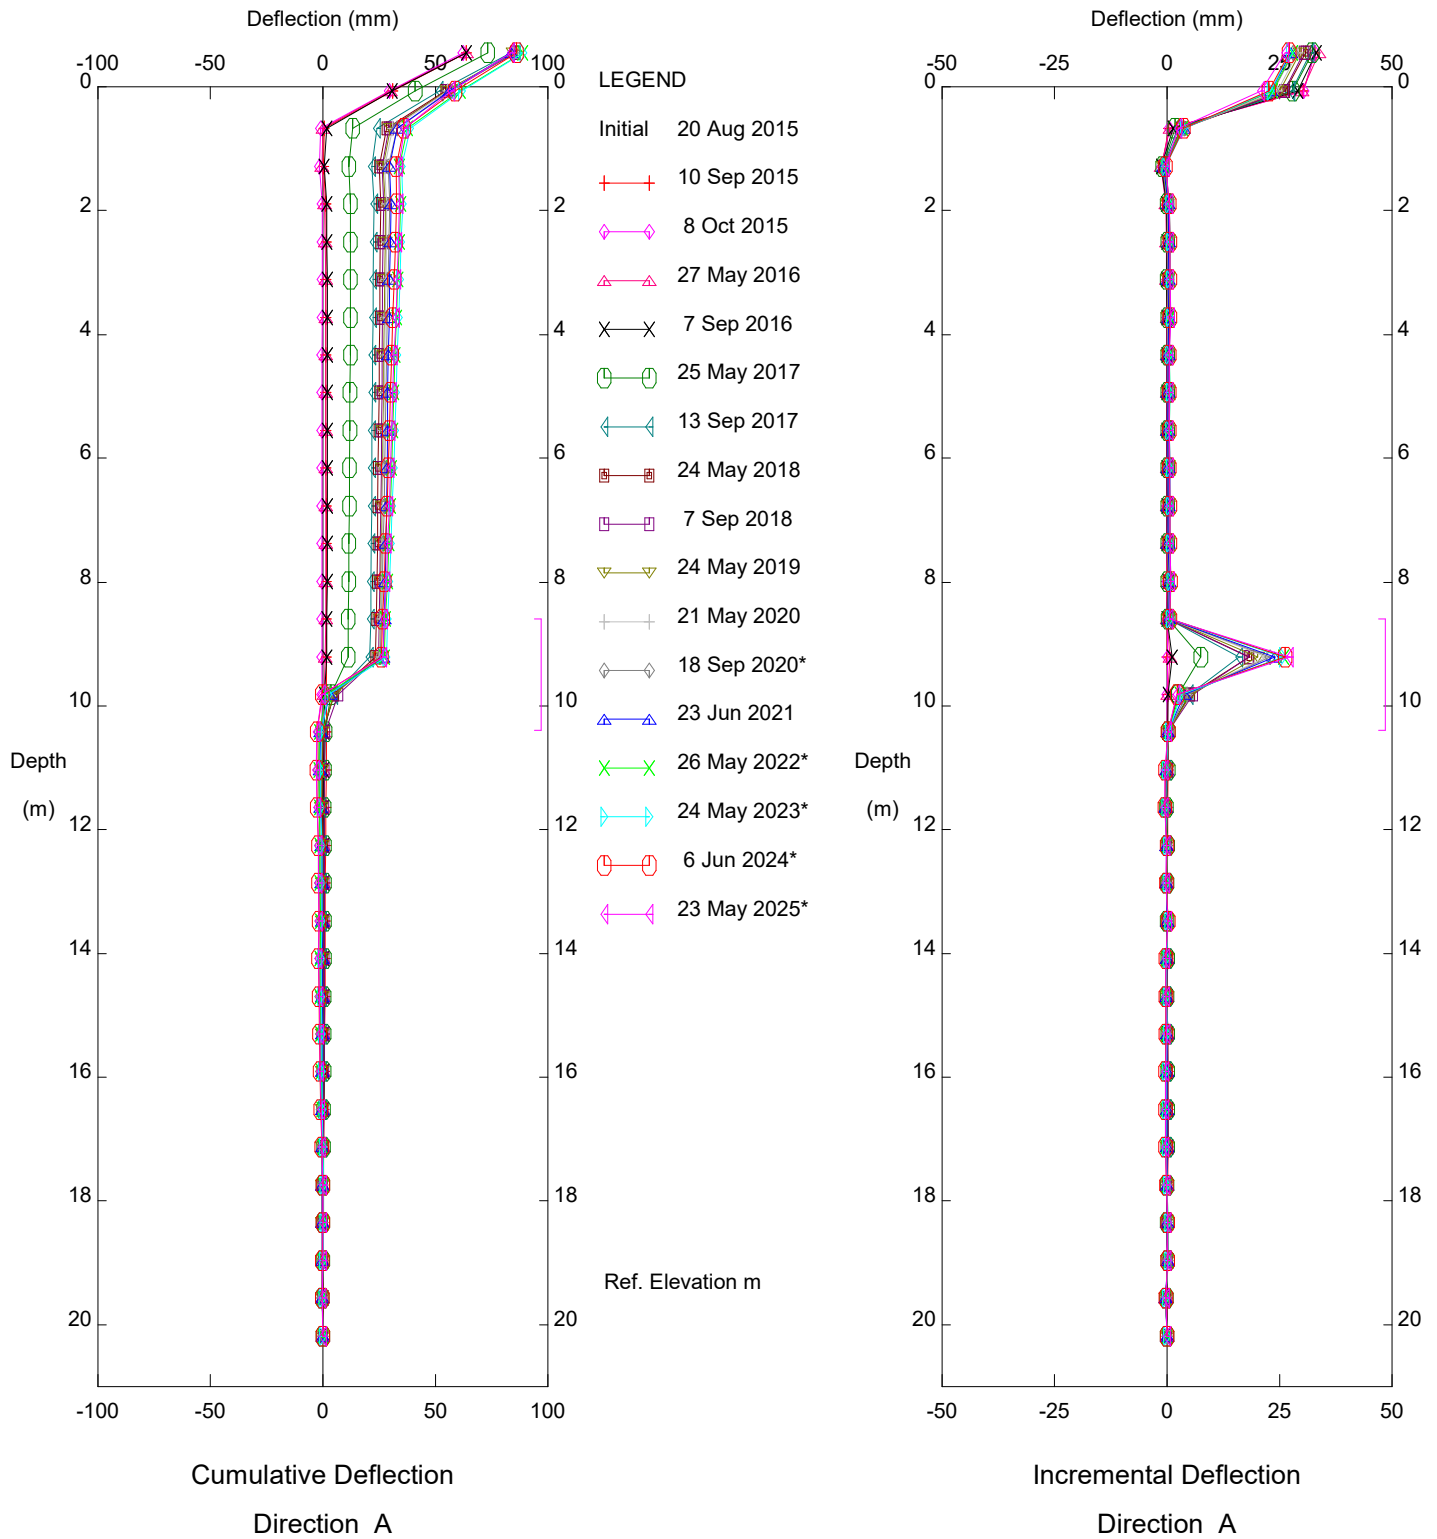
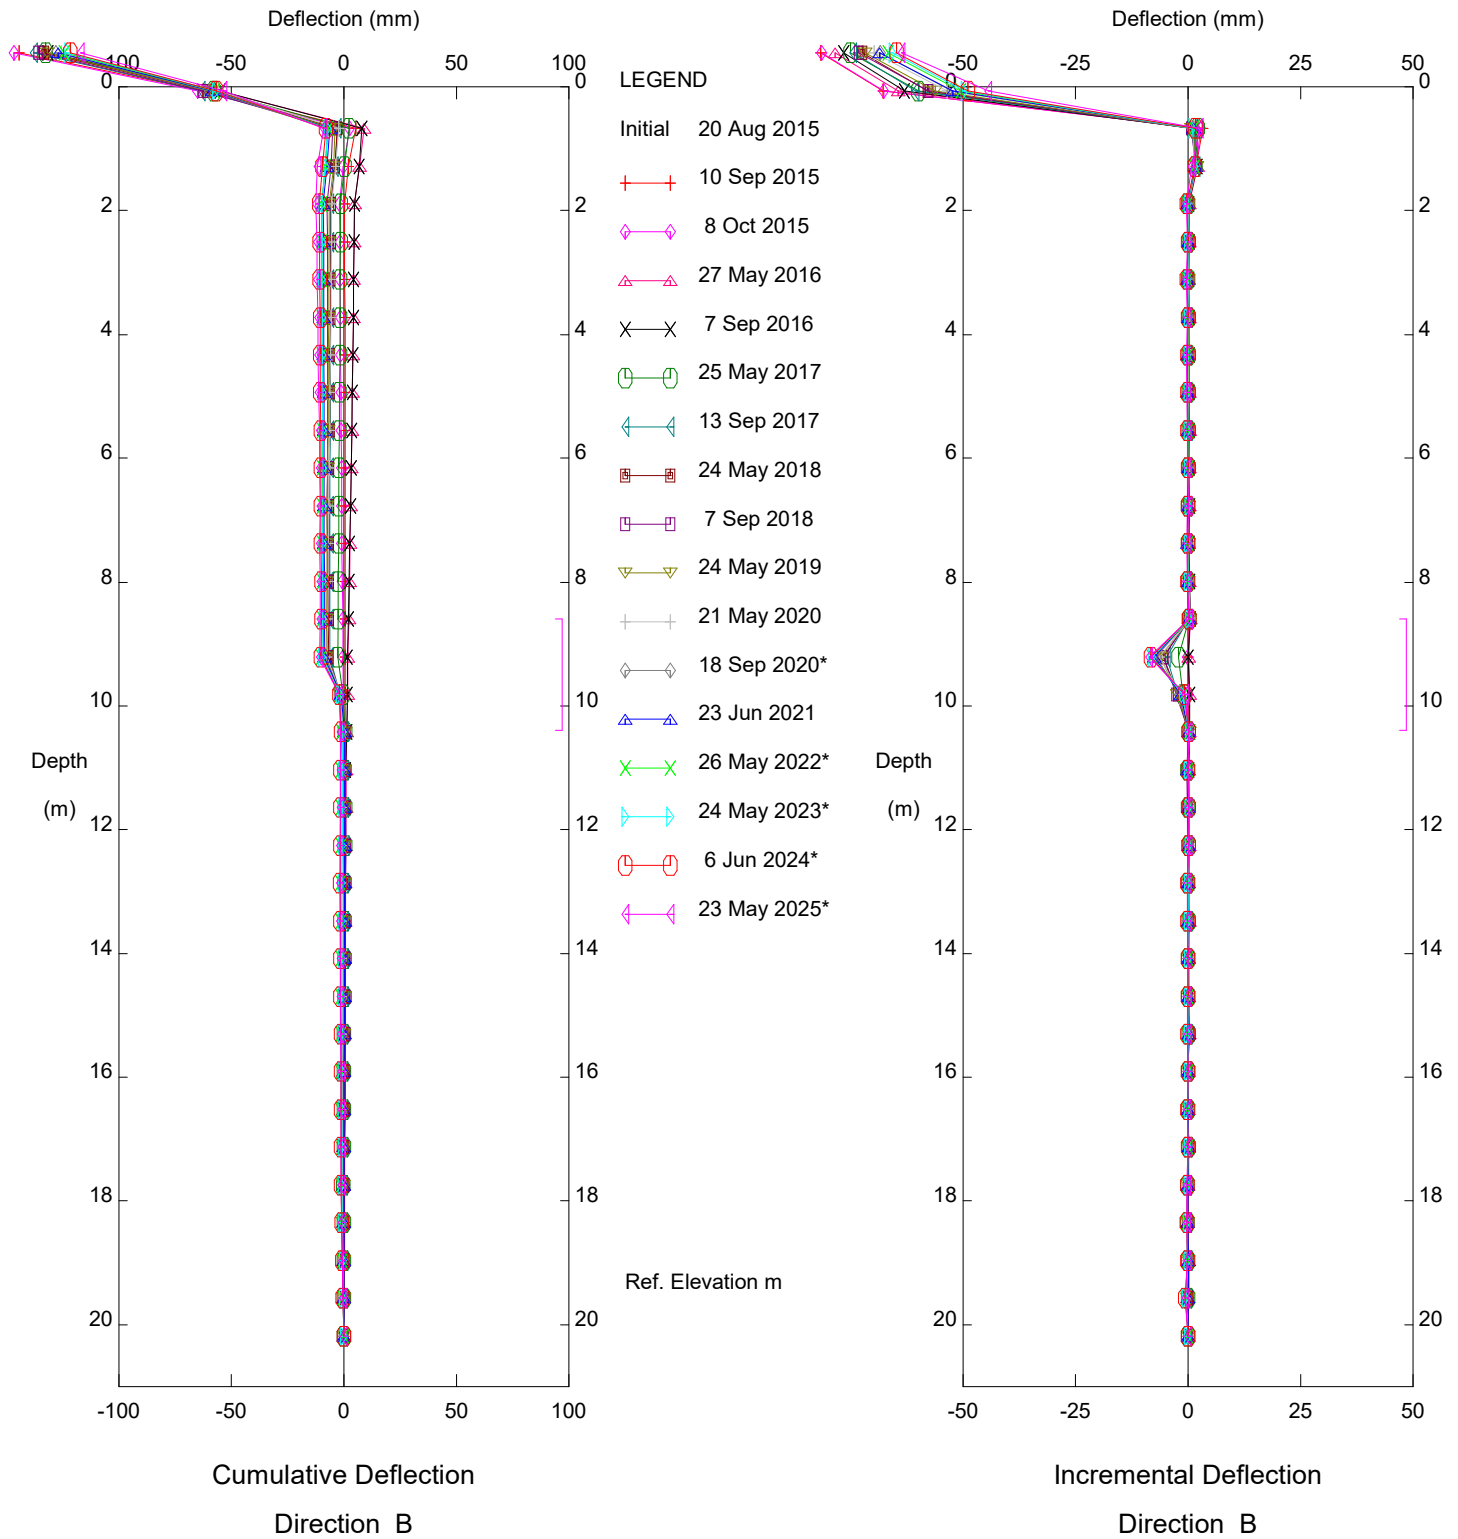
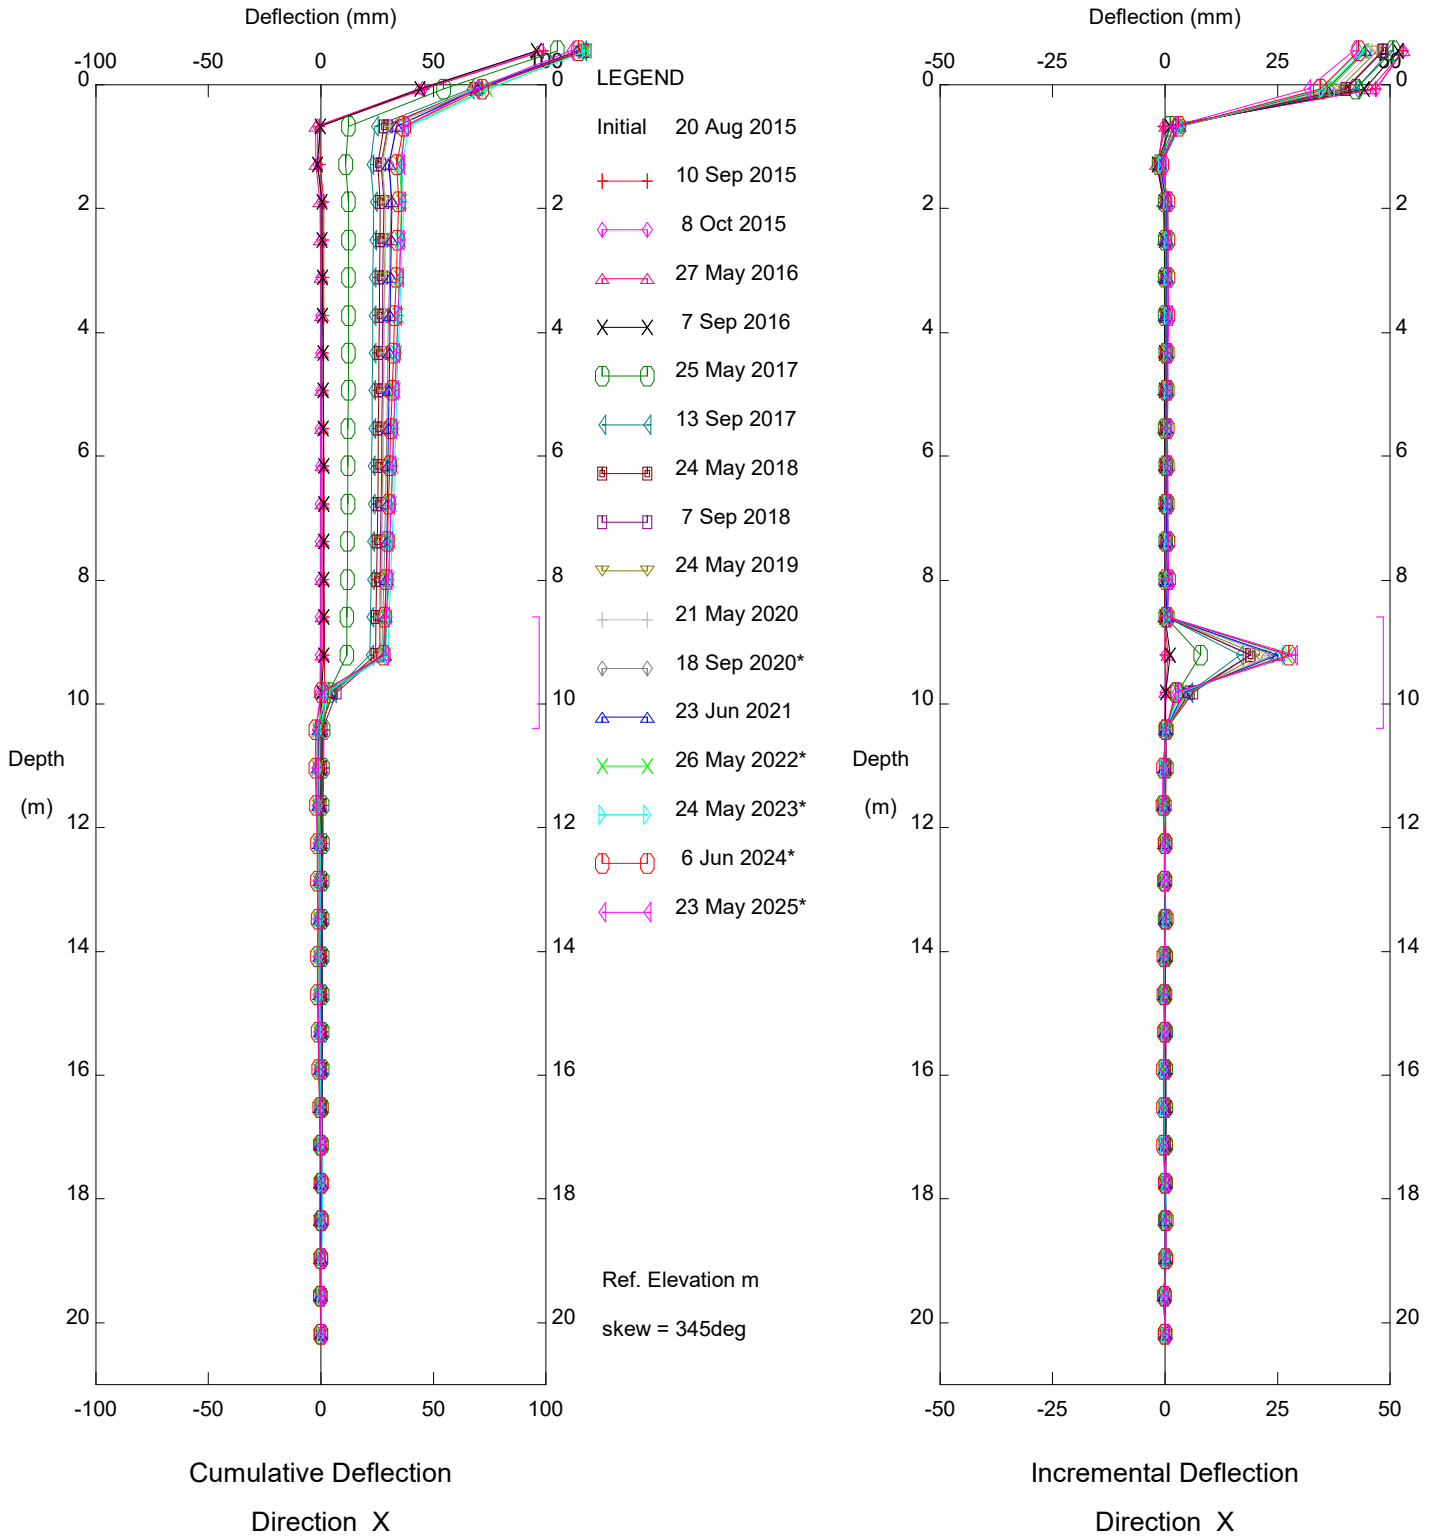
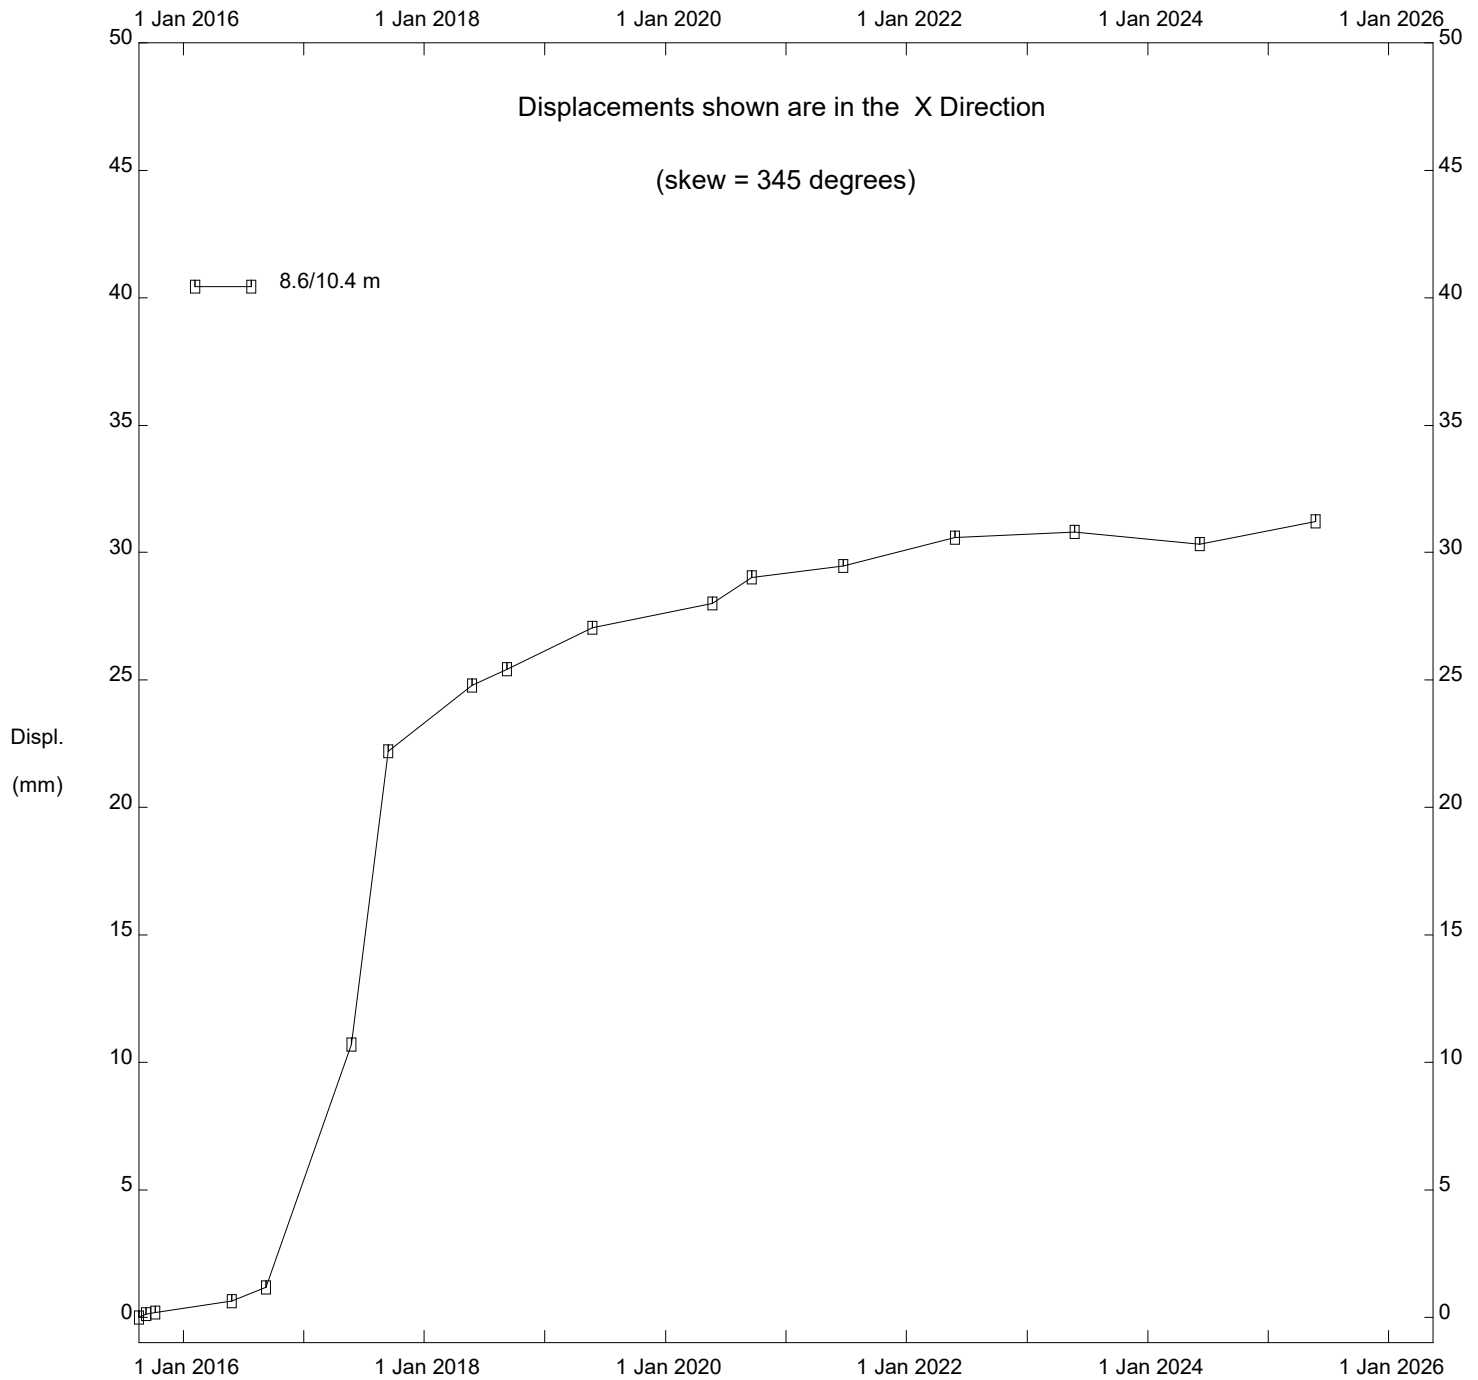
Hwy 41:23 Kehiwin Lake (NC104), Inclinometer SI15-20

| INSTRUMENT # | DATE INITIALIZED | TOTAL CUMULATIVE RESULTANT MOVEMENT AND DEPTH OF MOVEMENT TO DATE (mm) | MAXIMUM RATE OF MOVEMENT (mm/yr) | CURRENT STATUS OF SI | DATE OF PREVIOUS READING | INCREMENTAL MOVEMENT SINCE PREVIOUS READING (mm) | CURRENT RATE OF MOVEMENT (mm/yr) | CHANGE IN RATE OF MOVEMENT SINCE PREVIOUS READING (mm/yr) |
|---|---|---|---|---|---|---|---|---|
| SI15-20 | August 20, 2015 | 31.2 over 8.6 m to 10.4 m depth in 270° direction | 37.9 in September, 2017 | Operational | June 6, 2024 | 0.9 | 0.9 | 1.4 |

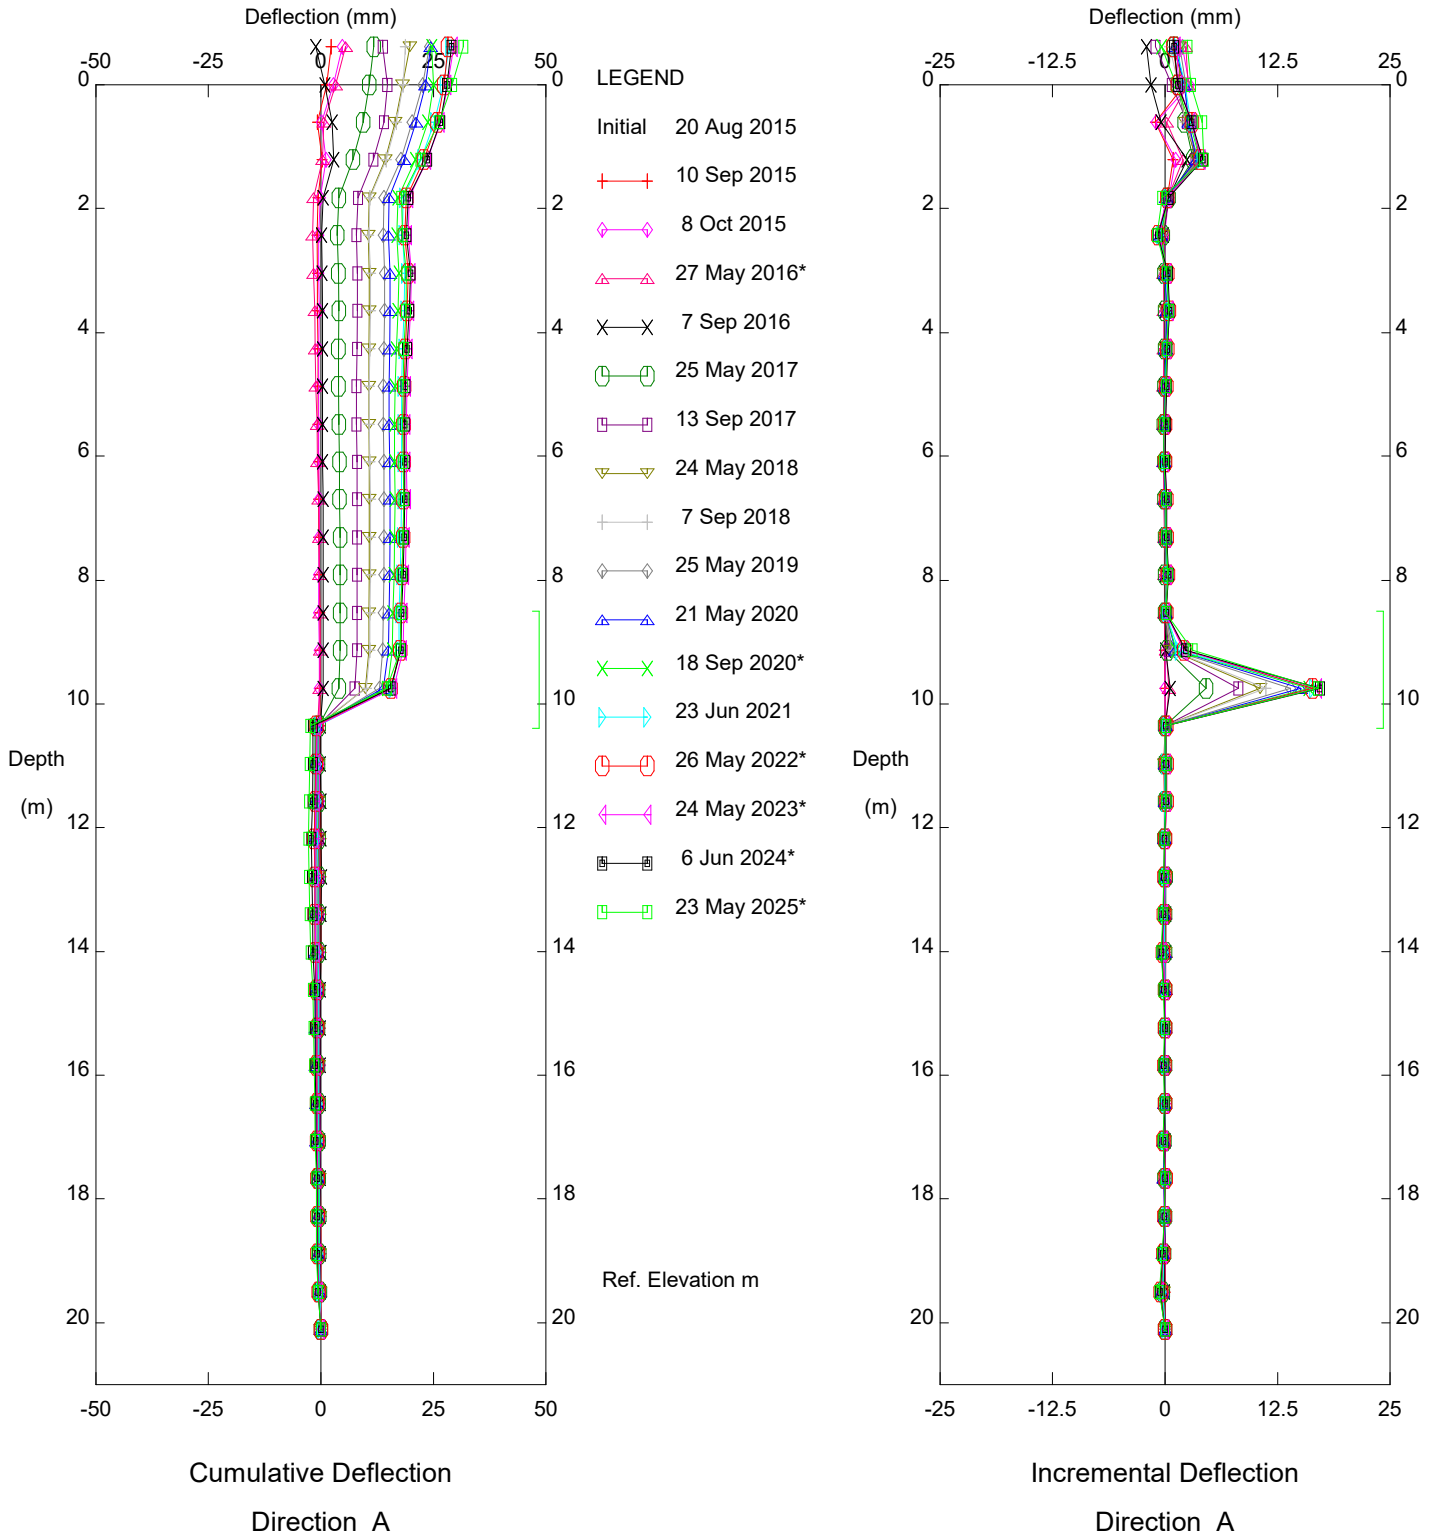
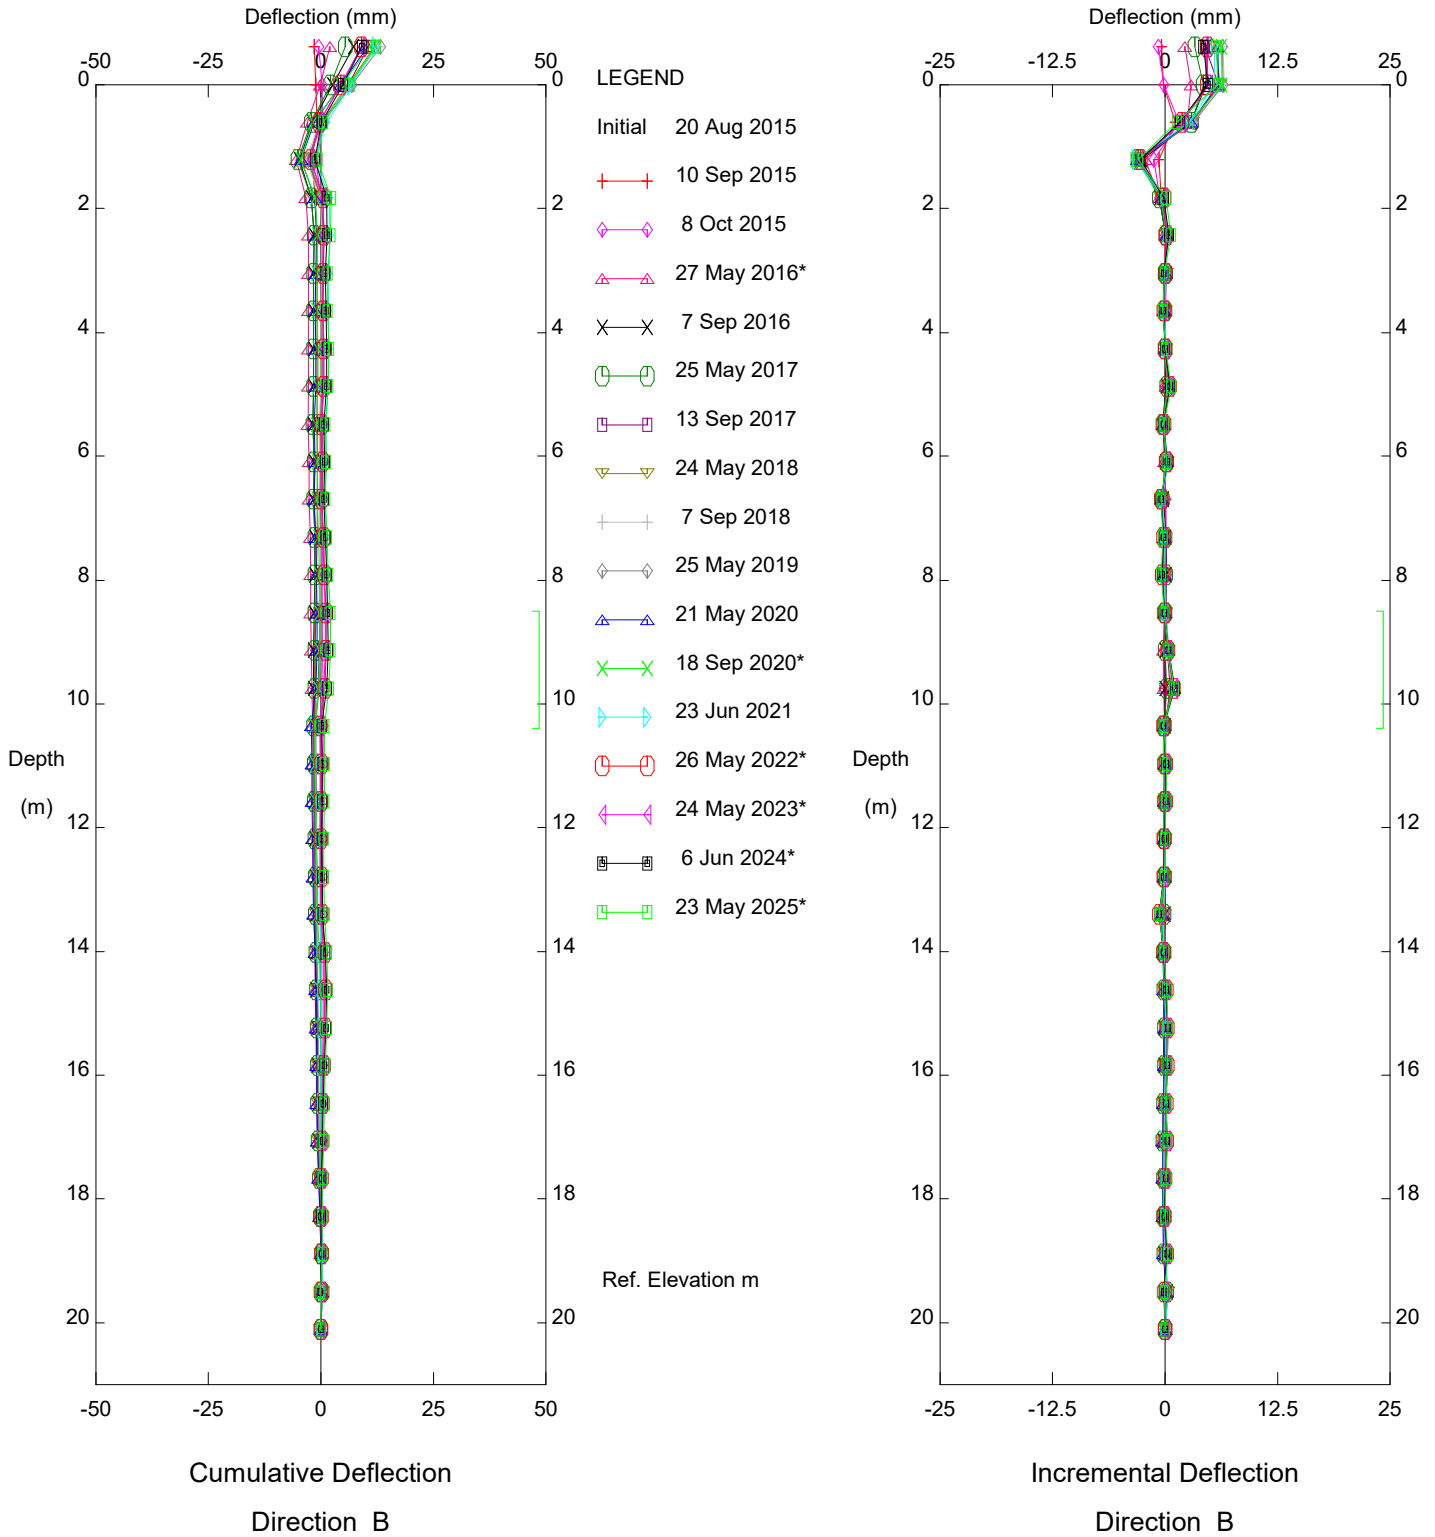
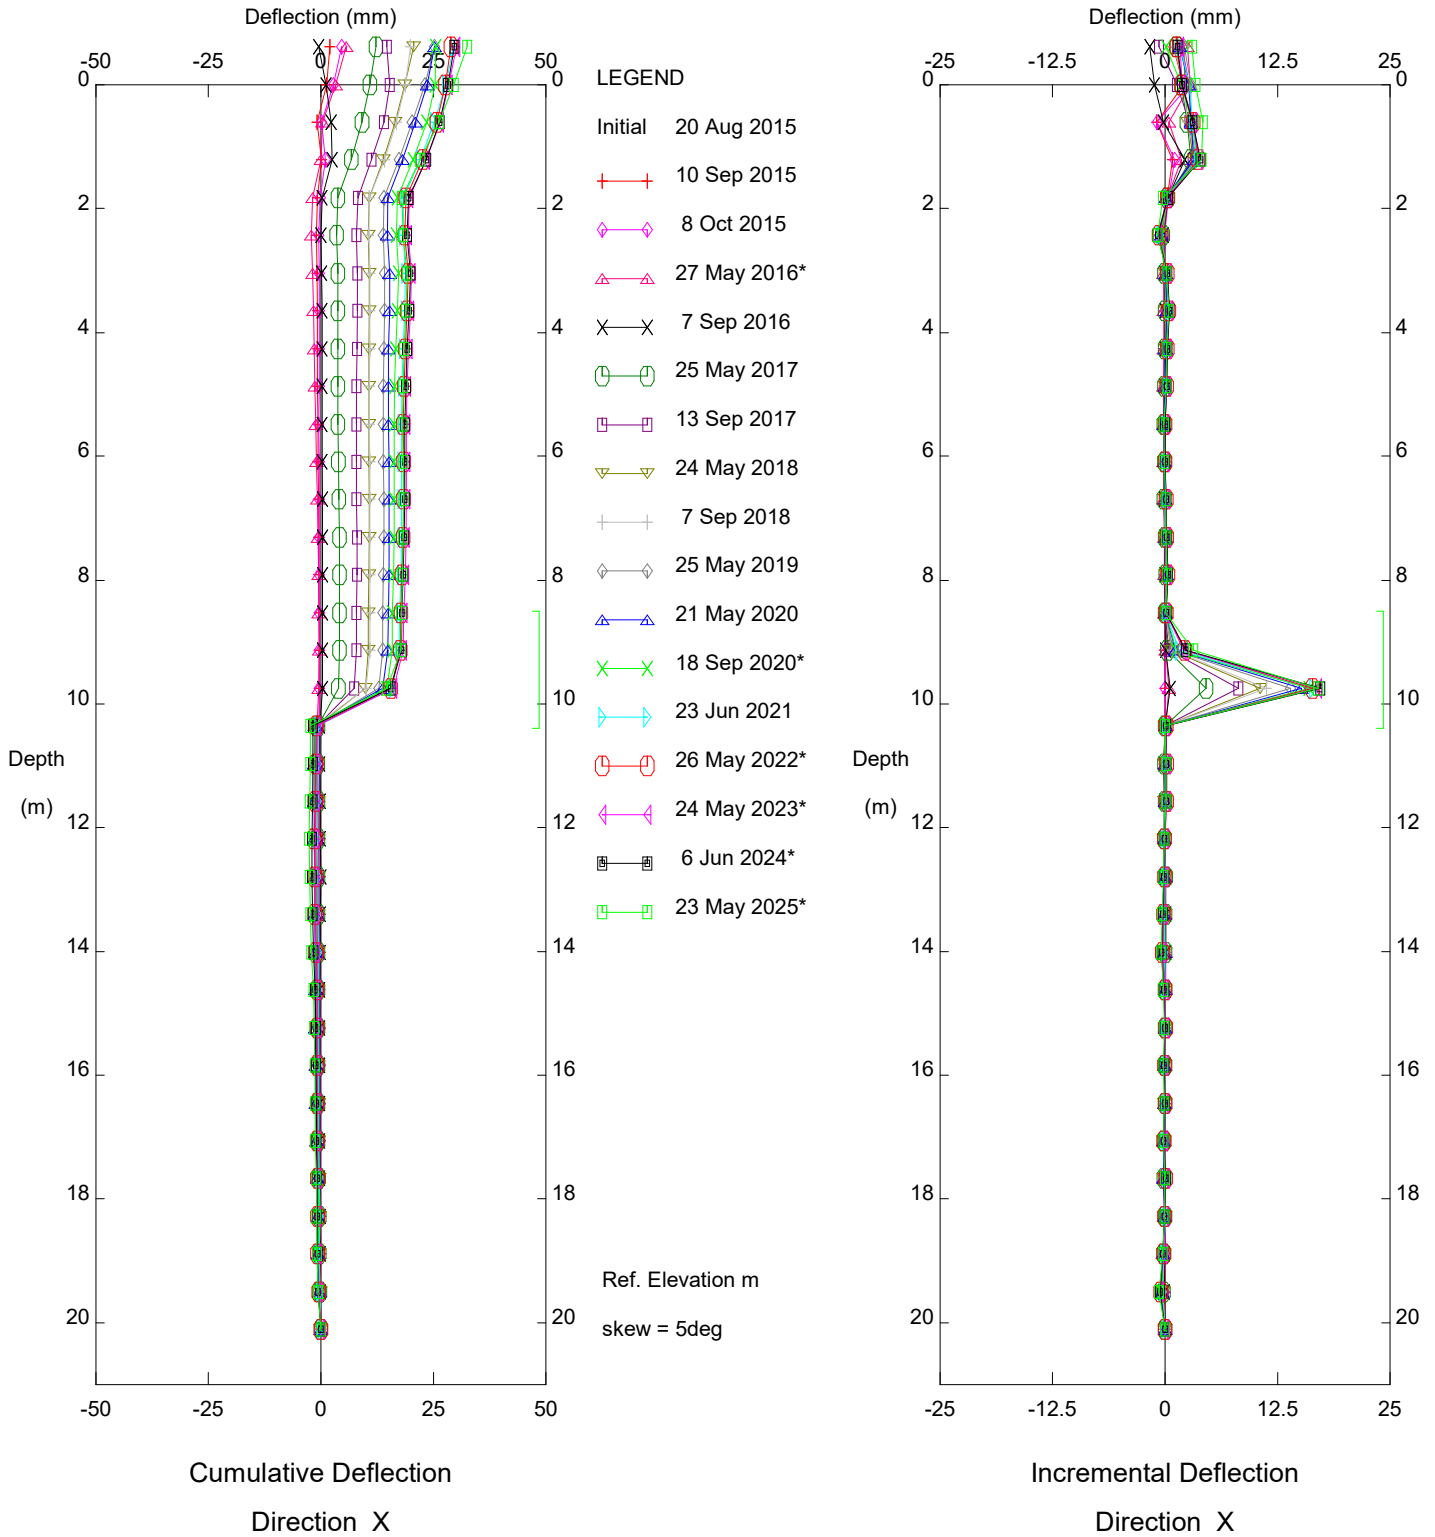
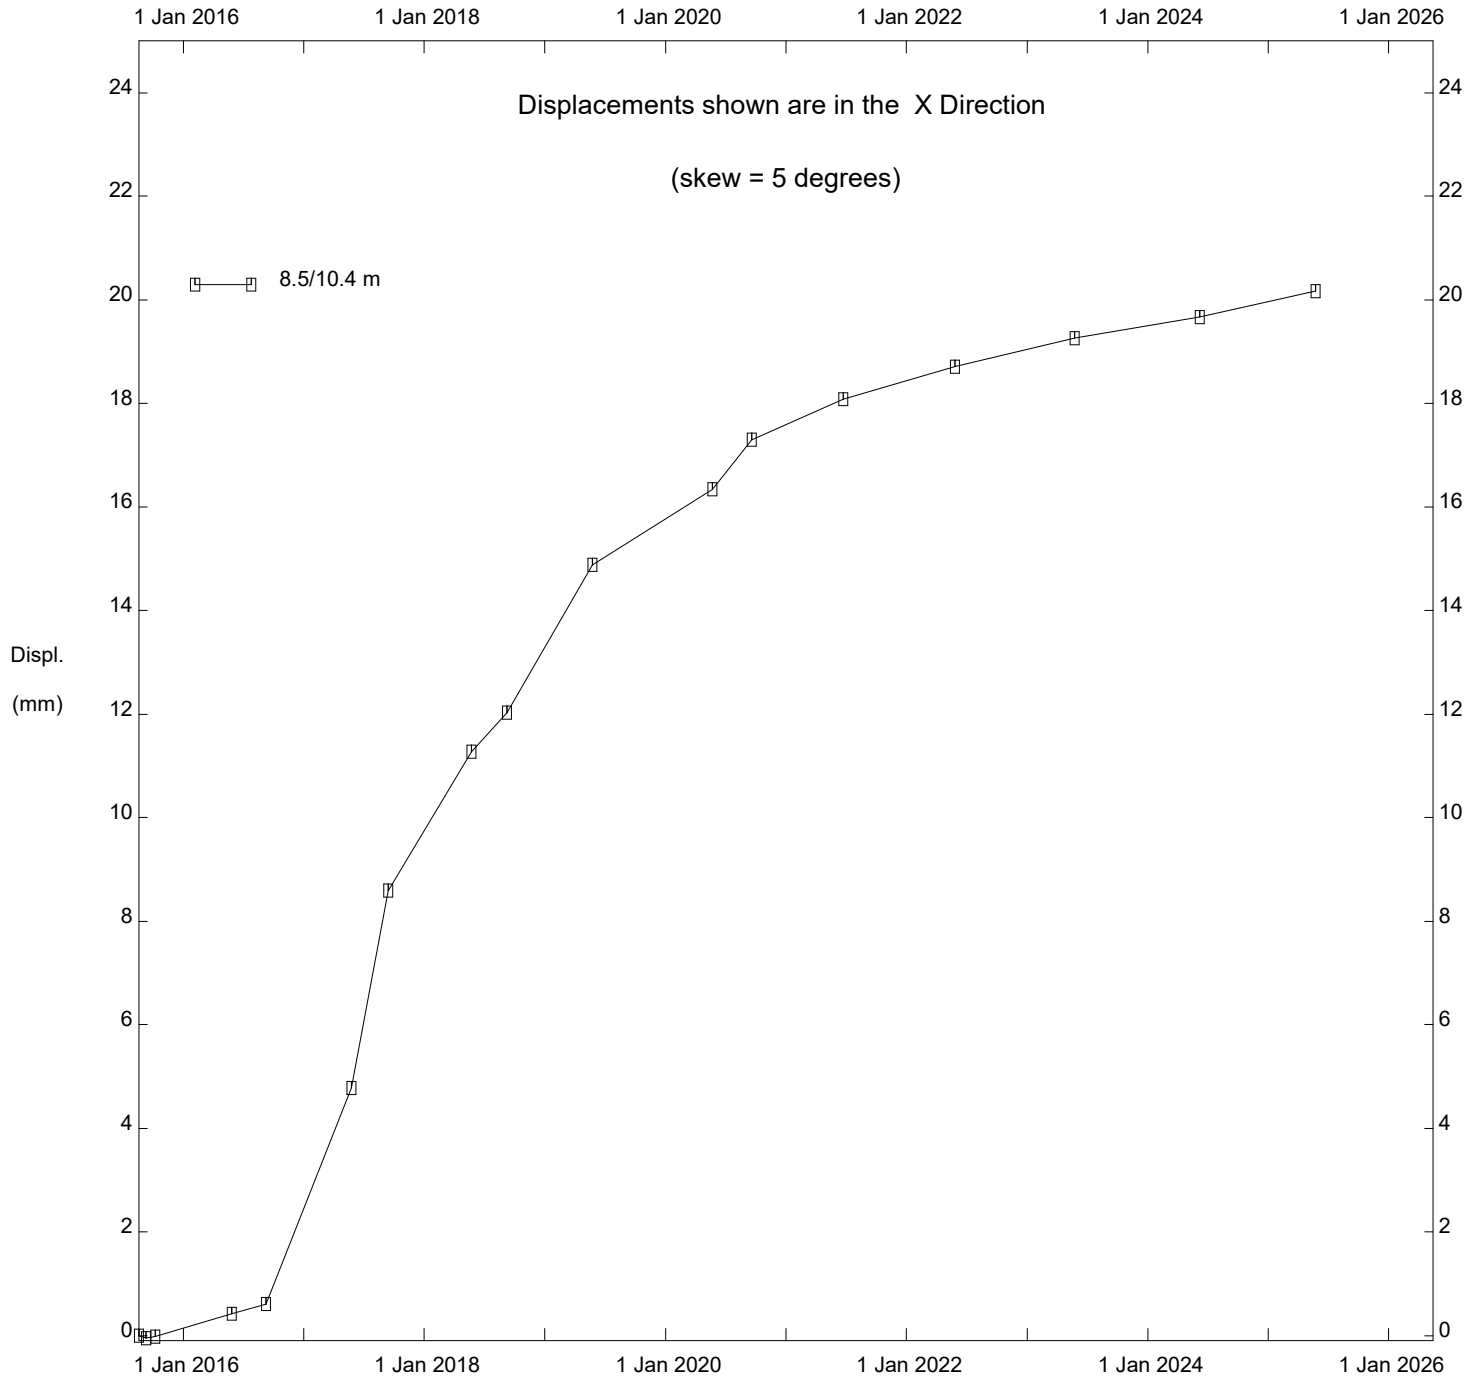
Hwy 41:23 Kehiwin Lake (NC104), Inclinometer SI15-21

| INSTRUMENT # | DATE INITIALIZED | TOTAL CUMULATIVE RESULTANT MOVEMENT AND DEPTH OF MOVEMENT TO DATE (mm) | MAXIMUM RATE OF MOVEMENT (mm/yr) | CURRENT STATUS OF SI | DATE OF PREVIOUS READING | INCREMENTAL MOVEMENT SINCE PREVIOUS READING (mm) | CURRENT RATE OF MOVEMENT (mm/yr) | CHANGE IN RATE OF MOVEMENT SINCE PREVIOUS READING (mm/yr) |
|---|---|---|---|---|---|---|---|---|
| SI15-21 | August 20, 2015 | 20.2 over 8.5 m to 10.4 m depth in 323° direction | 12.6 in September, 2017 | Operational | June 6, 2024 | 0.5 | 0.5 | 0.1 |

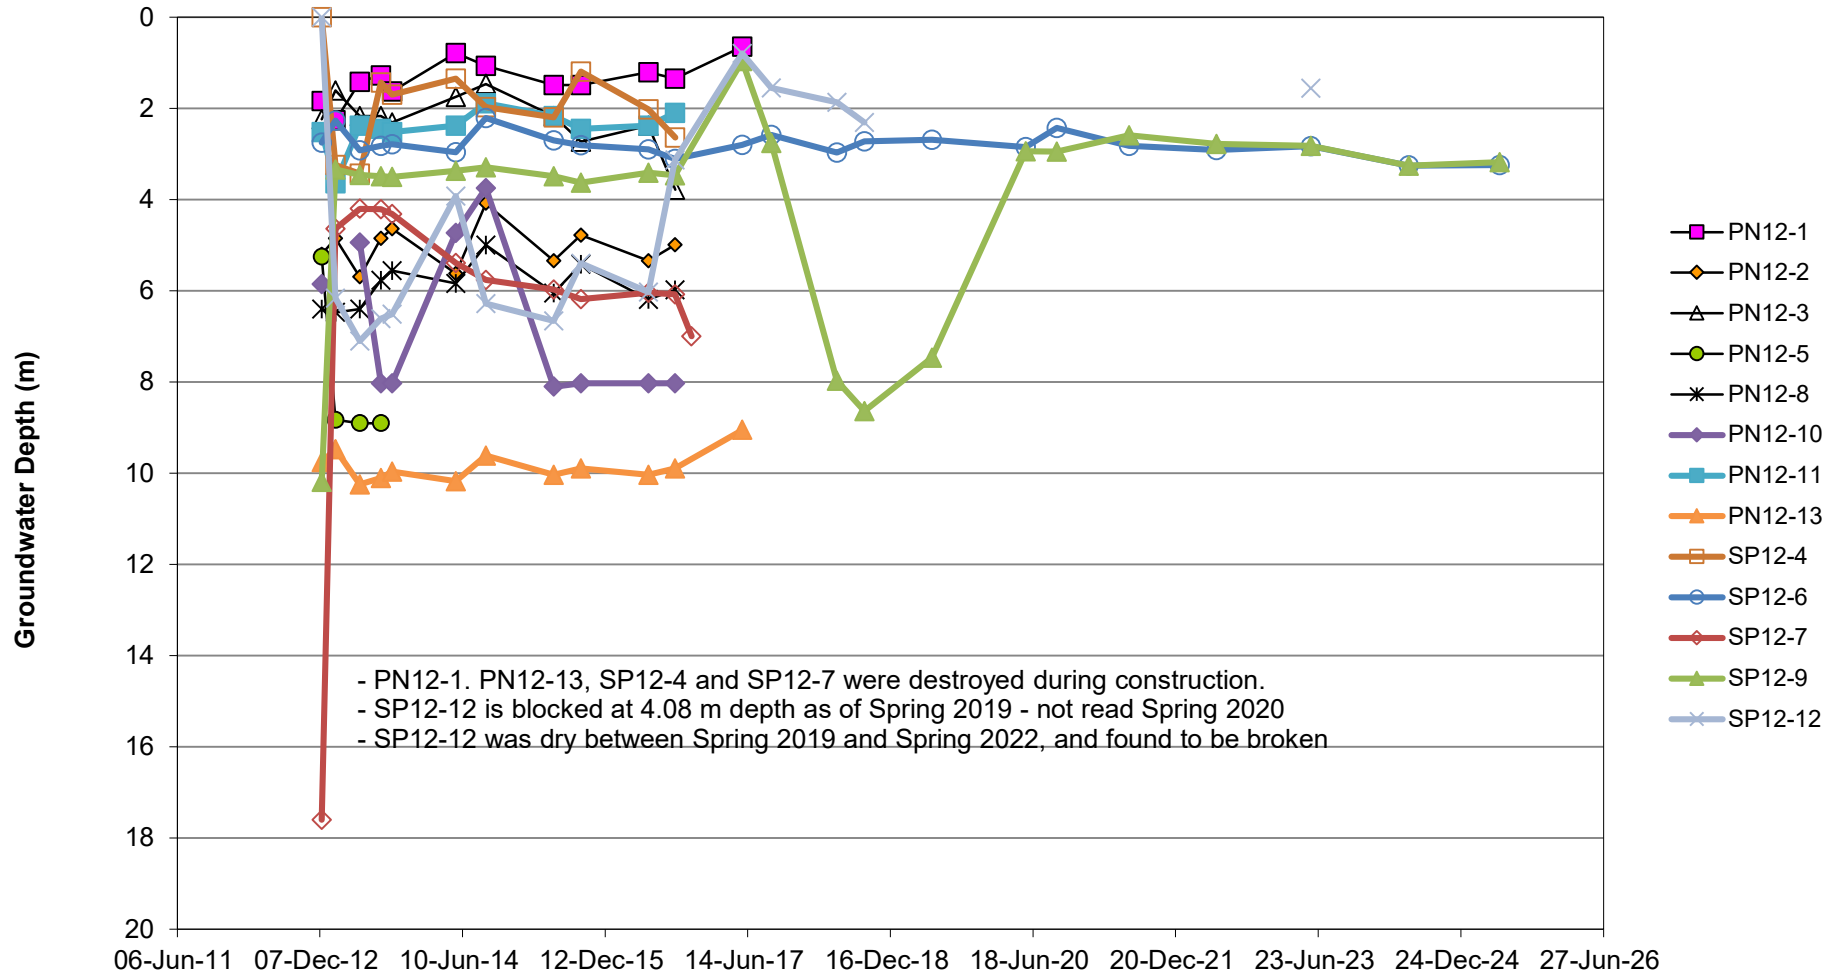
- PN12-1, PN12-13, SP12-4 and SP12-7 were destroyed during construction.  
 - SP12-12 is blocked at 4.08 m depth as of Spring 2019 - not read Spring 2020  
 - SP12-12 was dry between Spring 2019 and Spring 2022, and found to be broken

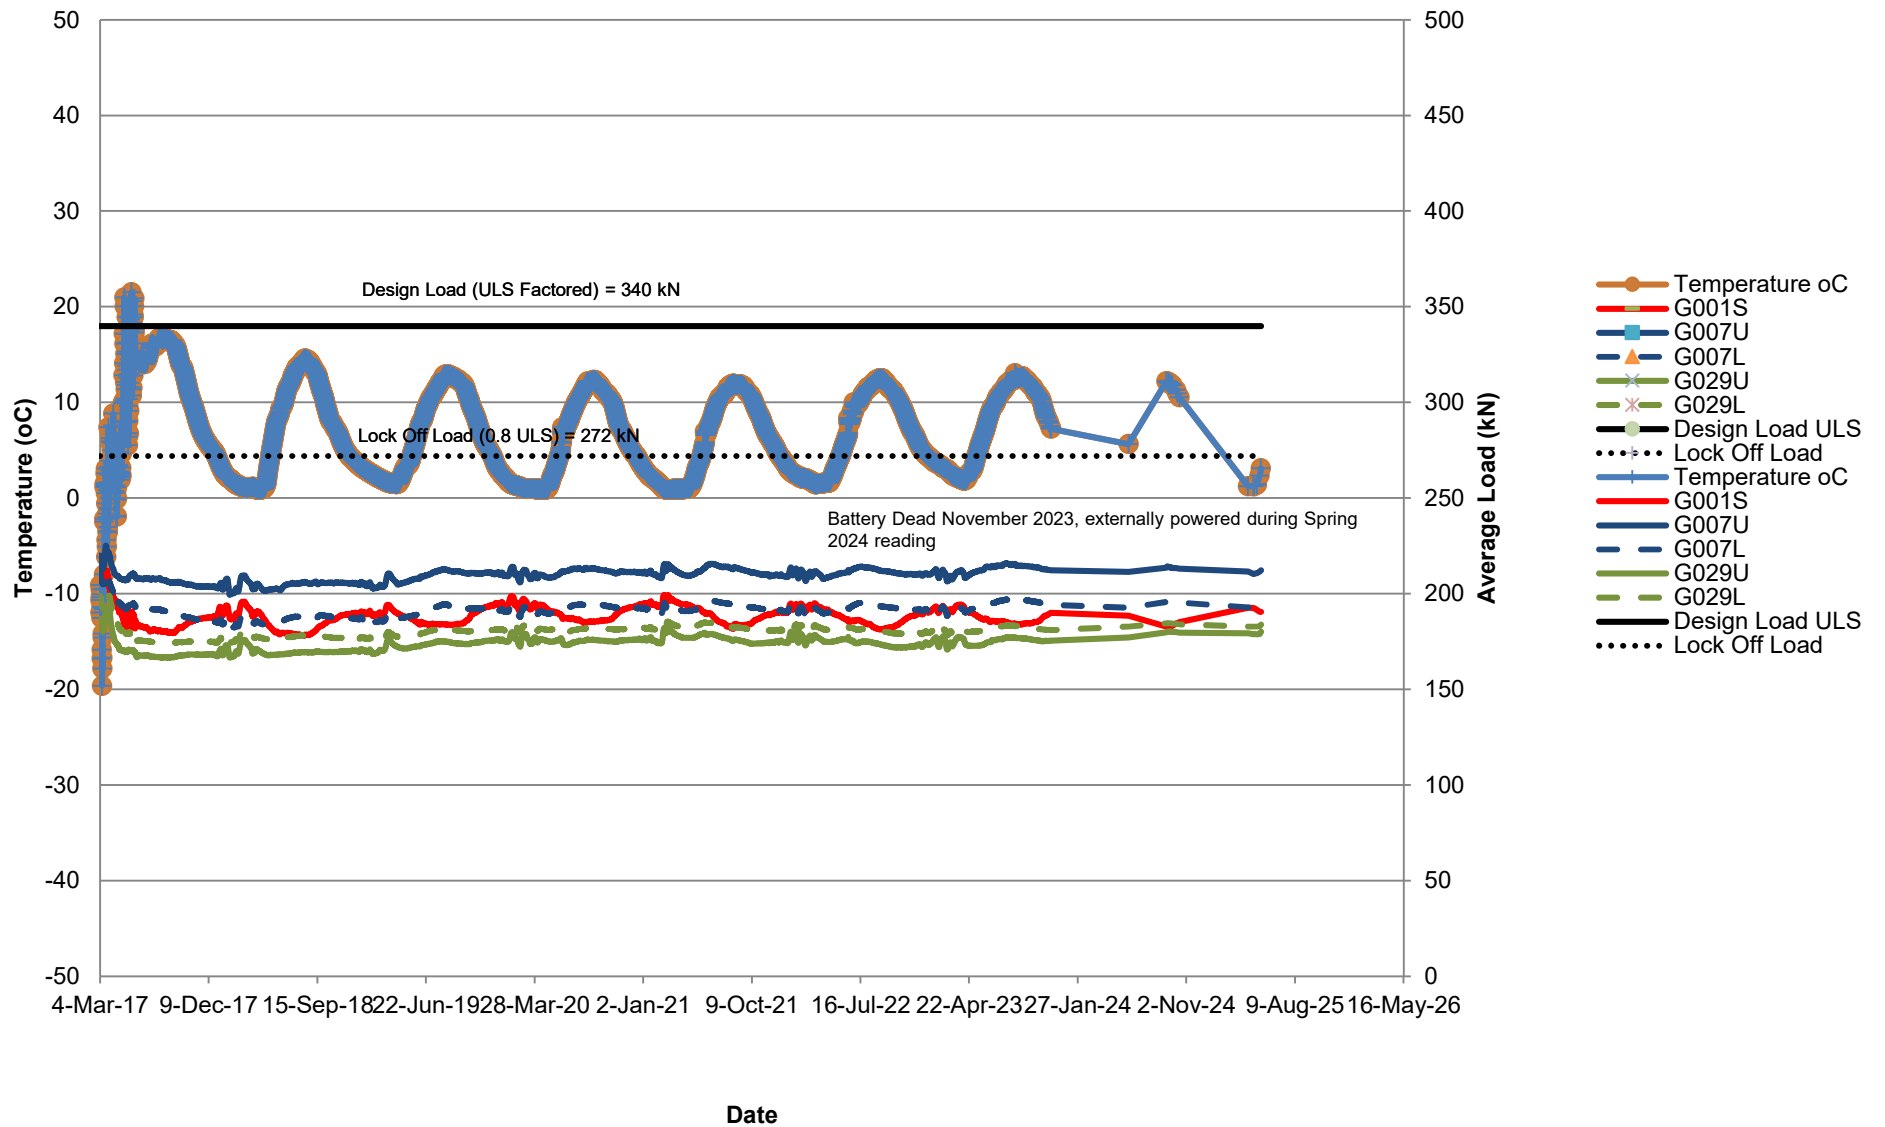
**FIGURE NC104-5**  
**LOAD CELL DATA FOR HWY 41:23, KEHIWIN LAKE (KM 7.7) - WALL SEGMENT 1**

| | <p>decrease in measured load by 1.82 kN in VC1985 to an increase in measured load by 2.96 kN in VC1993.</p> <p>Load cells VC1996 and VC1985 currently have only two vibrating wire channels properly functioning, and hence the readings for these instruments are somewhat skewed when compared to the previous readings.</p> <p>Overall, the load cells are currently registering a trend of stable to slowly increasing measured loads, with seasonably higher loads measured during the winter months.</p> <p>Overall, the instrument readings show that the pile walls constructed in 2016-2017 have been effective in stabilizing the landslide movements. However, the readings of the interim pile wall instruments should be checked at least once a year and compared to the warning threshold values.</p> |

| <b>Instrumentation Repairs:</b> | <p>The battery of the north load cell datalogger should be tested, and the datalogger and wires should also be inspected to confirm the source of the ongoing issue. If it is a battery related issue, the battery should be replaced to enable readings to continue after the spring of 2024. If it isn't the battery or the wires, consideration should be given to replacing the datalogger.</p> <p>Consideration should be given to replacing the modem in the SAA and strain gauge datalogger, to allow for remote download.</p> |
