ALBERTA TRANSPORTATION AND  
ECONOMIC CORRIDORS GRMP  
NORTH CENTRAL (ATHABASCA AND FORT  
McMURRAY DISTRICTS)  
INSTRUMENTATION MONITORING - SPRING 2025

| Site Number | Location | Name | Hwy | km |
|---|---|---|---|---|
| NC069 | HWY 63:02 L1 32.020 | South of Wandering River | 63:02 | Km 32 |

**SITE NC069: HWY 63:02 SLOPE REPAIR SOUTH OF WANDERING RIVER**

**NC069: HWY 63:02 (km 13) SOUTH OF  
WANDERING RIVER SLIDE REPAIR**

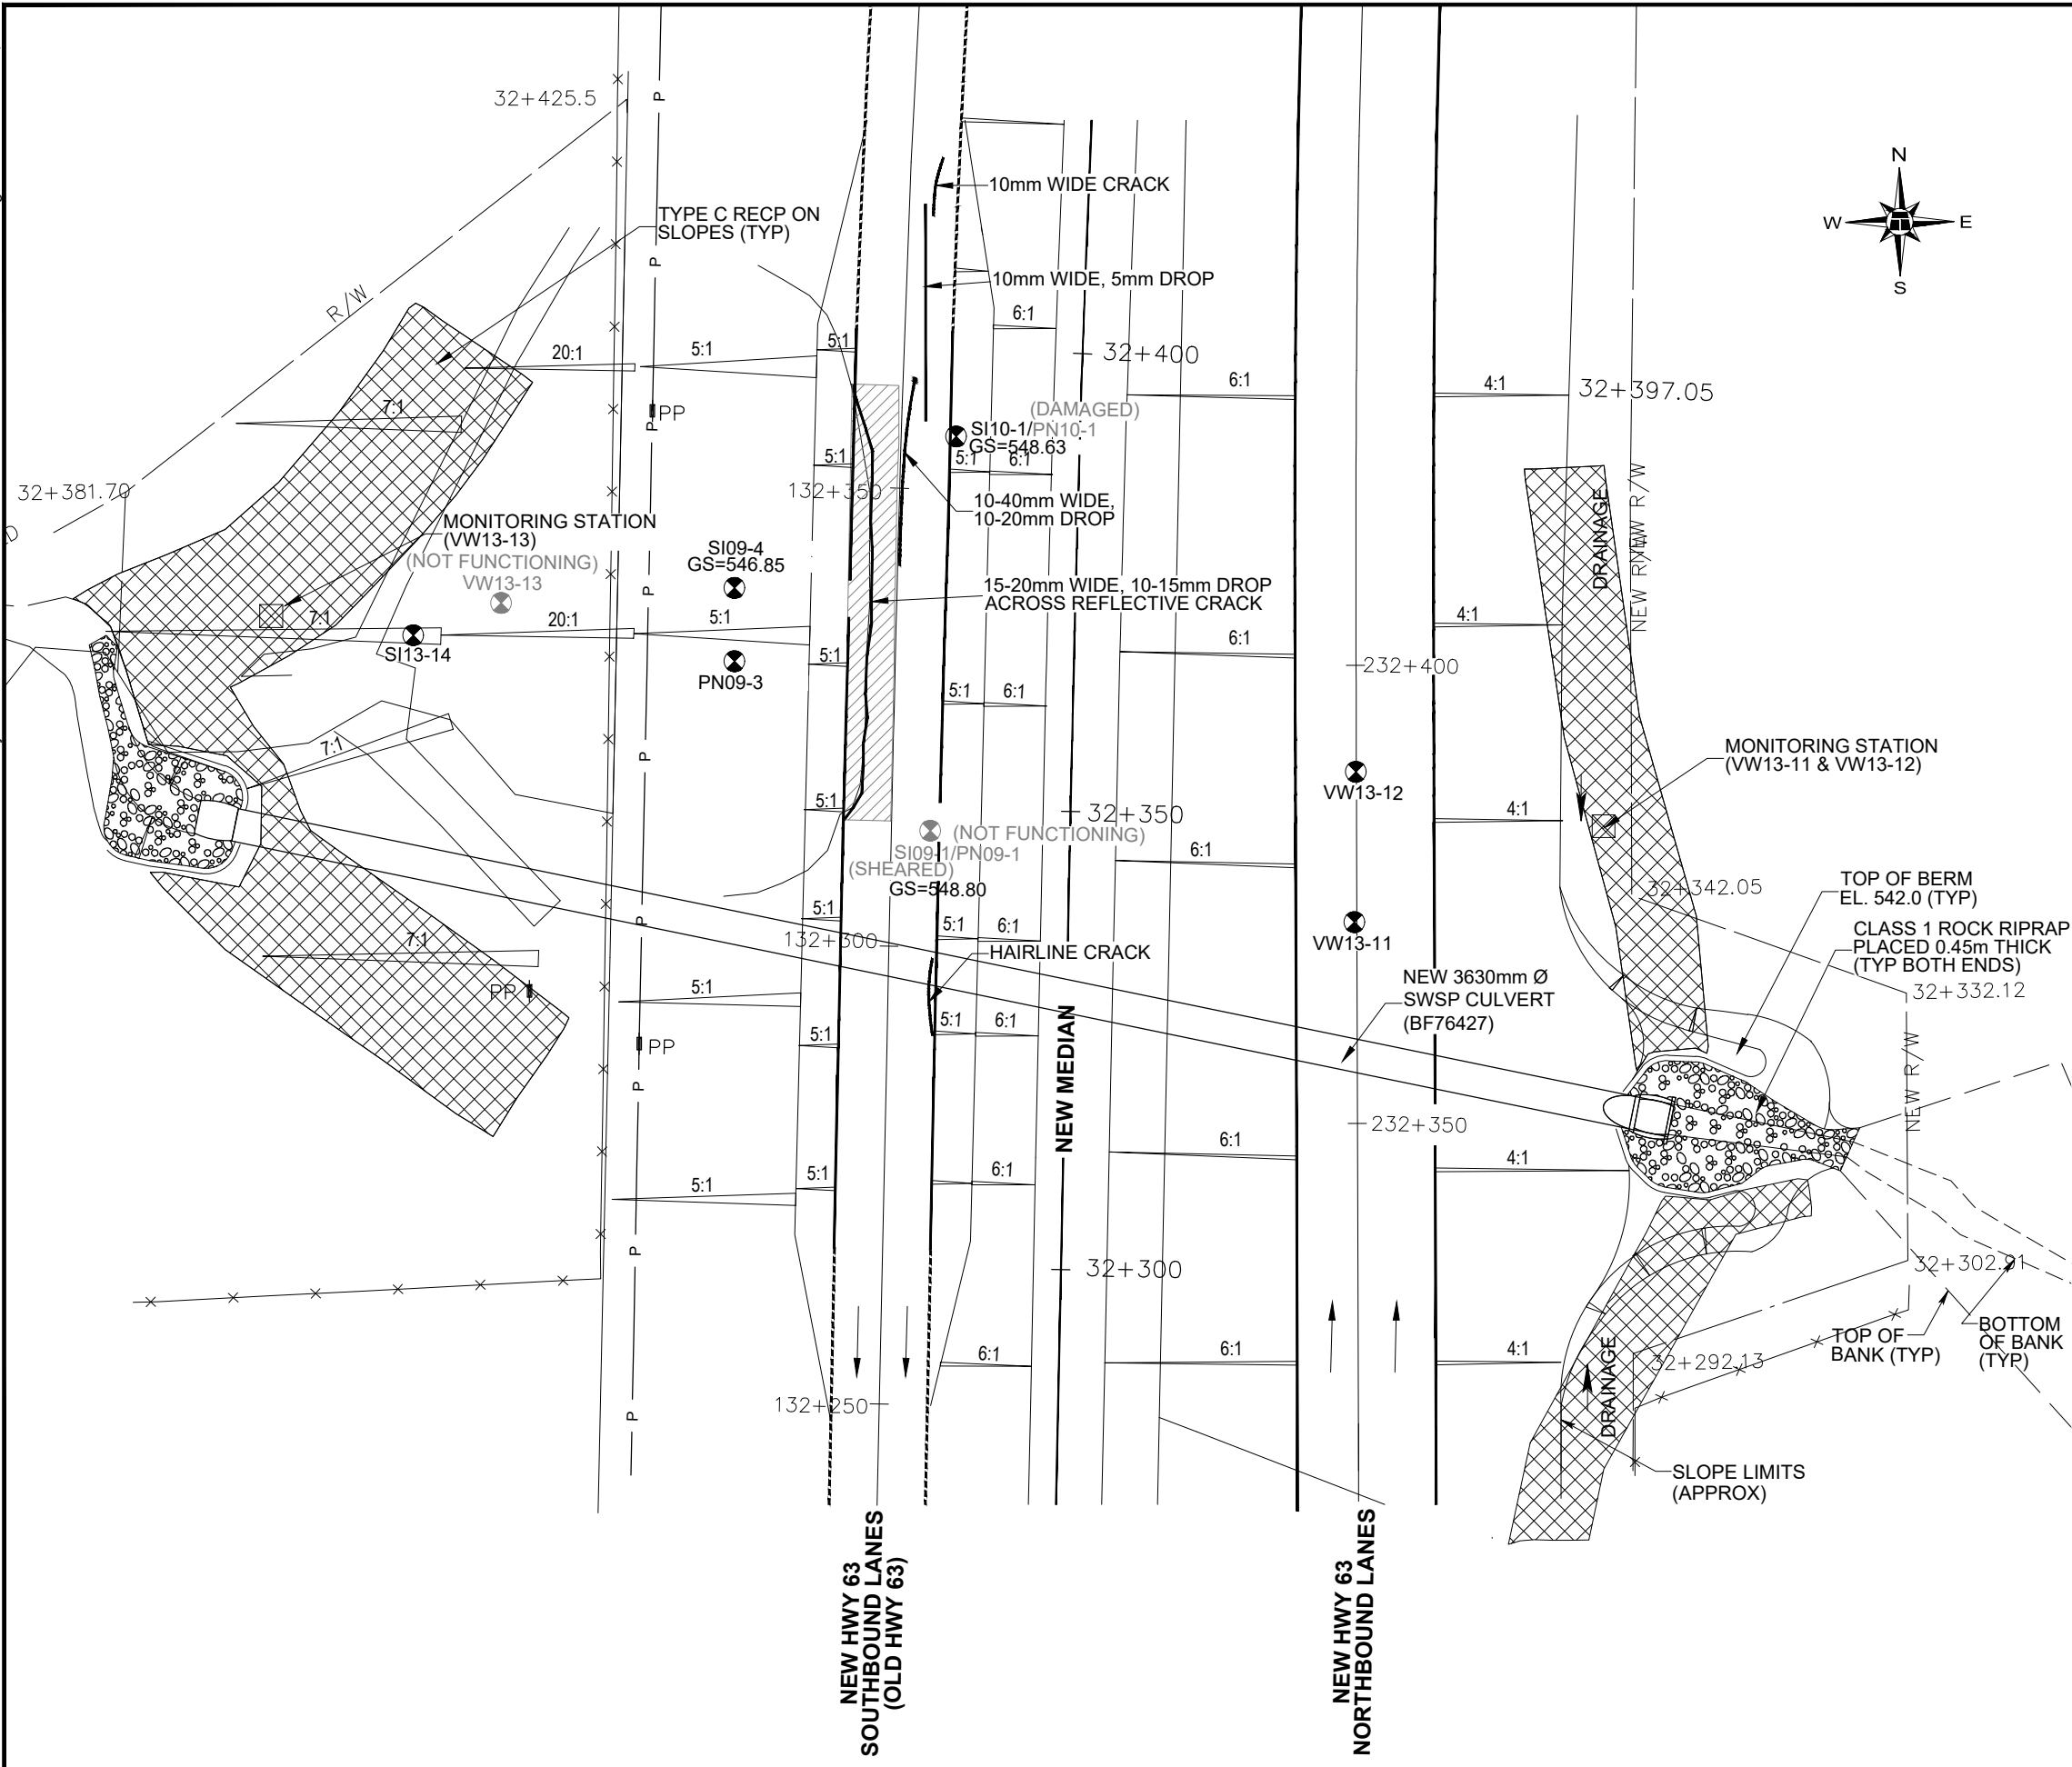
**DWG No. 32122-NC069**

| SI10-1 casing breaking apart @ 10 ft. use dummy probe/ camera for next reading. |
| PN10-1 cut off damaged since the Spring 2023 readings, requires mechanical excavation |

| Discussion | |
|---|---|
| <b>Instrumentation Repairs:</b> | Pneumatic piezometer PN10-1 could be repaired during the spring of 2026 readings. However, this instrument will require mechanical or |

| | hydrovac excavation to repair, as it is placed inside a steel flush mount protector. Additionally, traffic accommodation would be required to complete this instrument repair. |

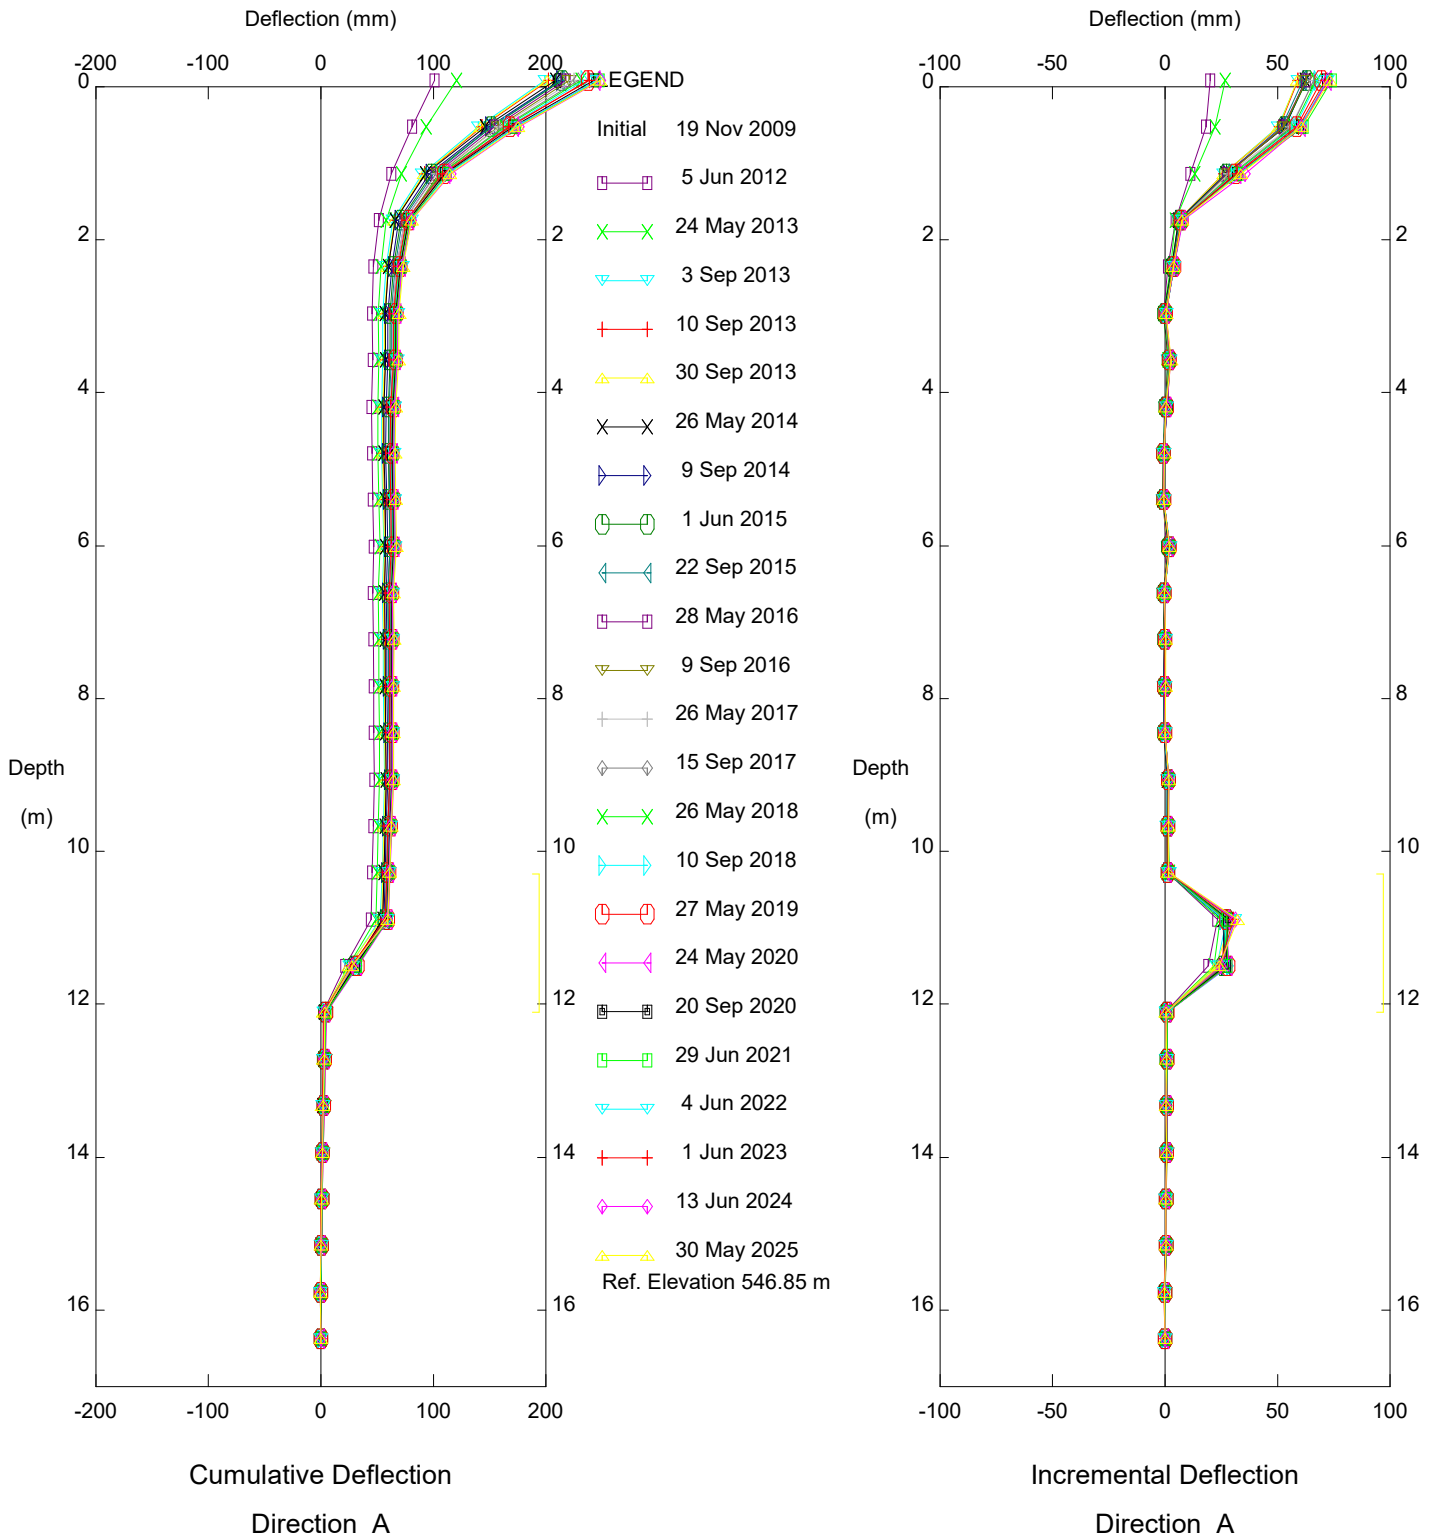
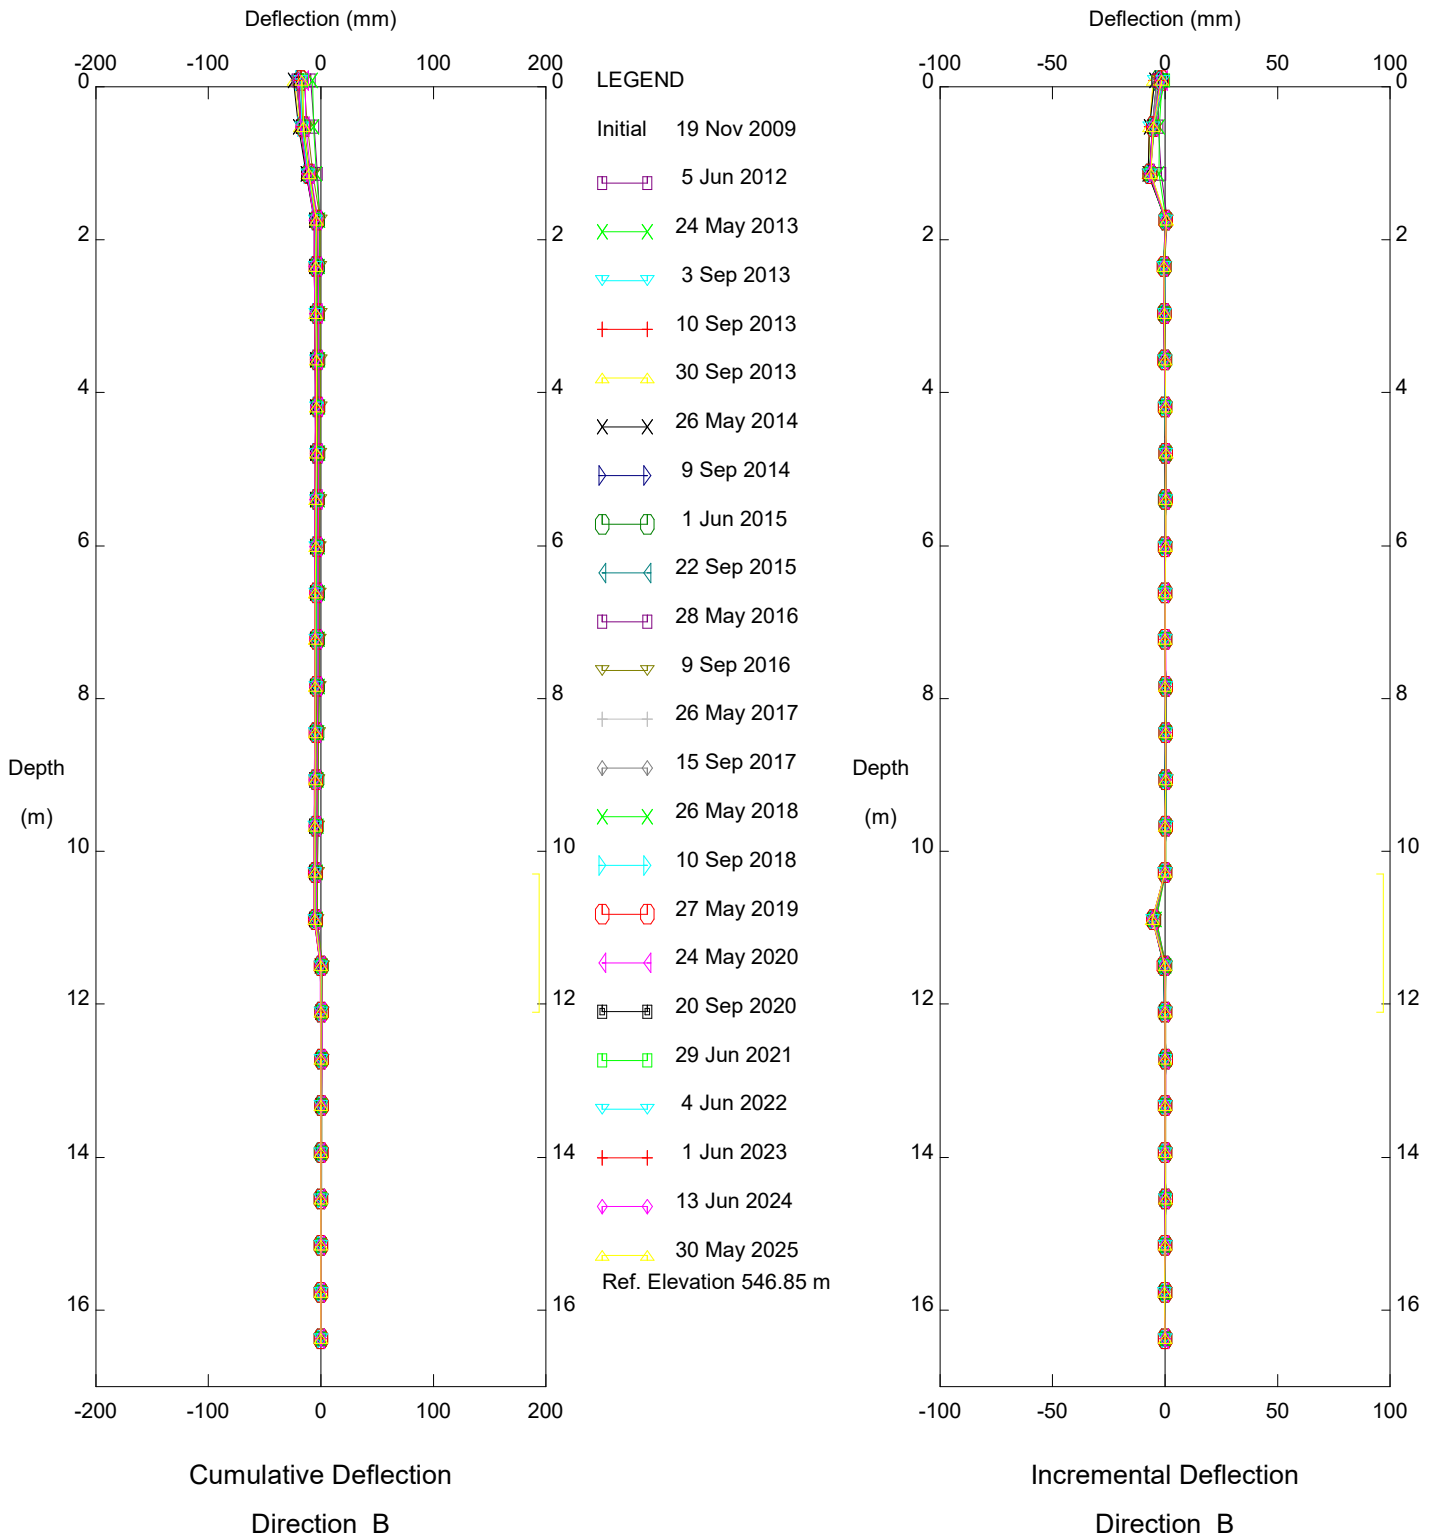
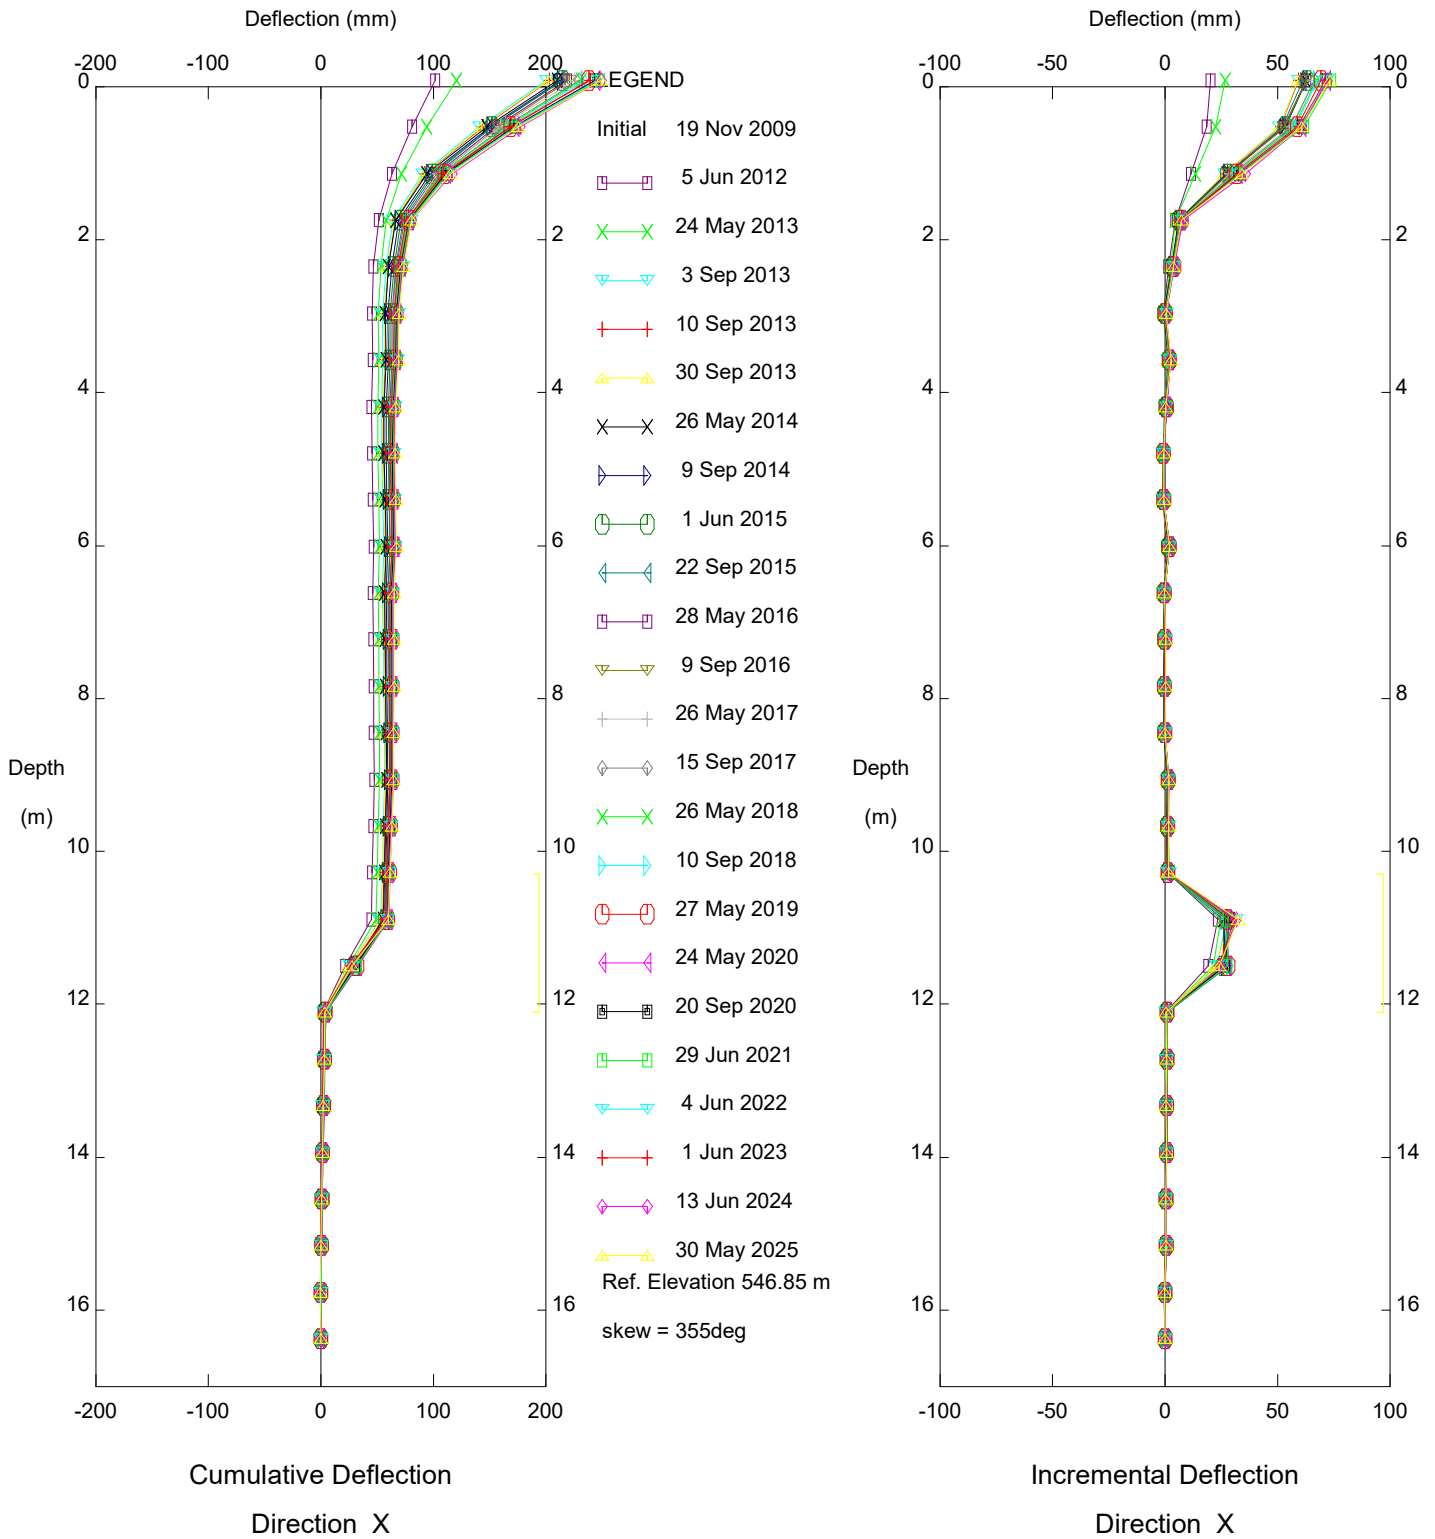
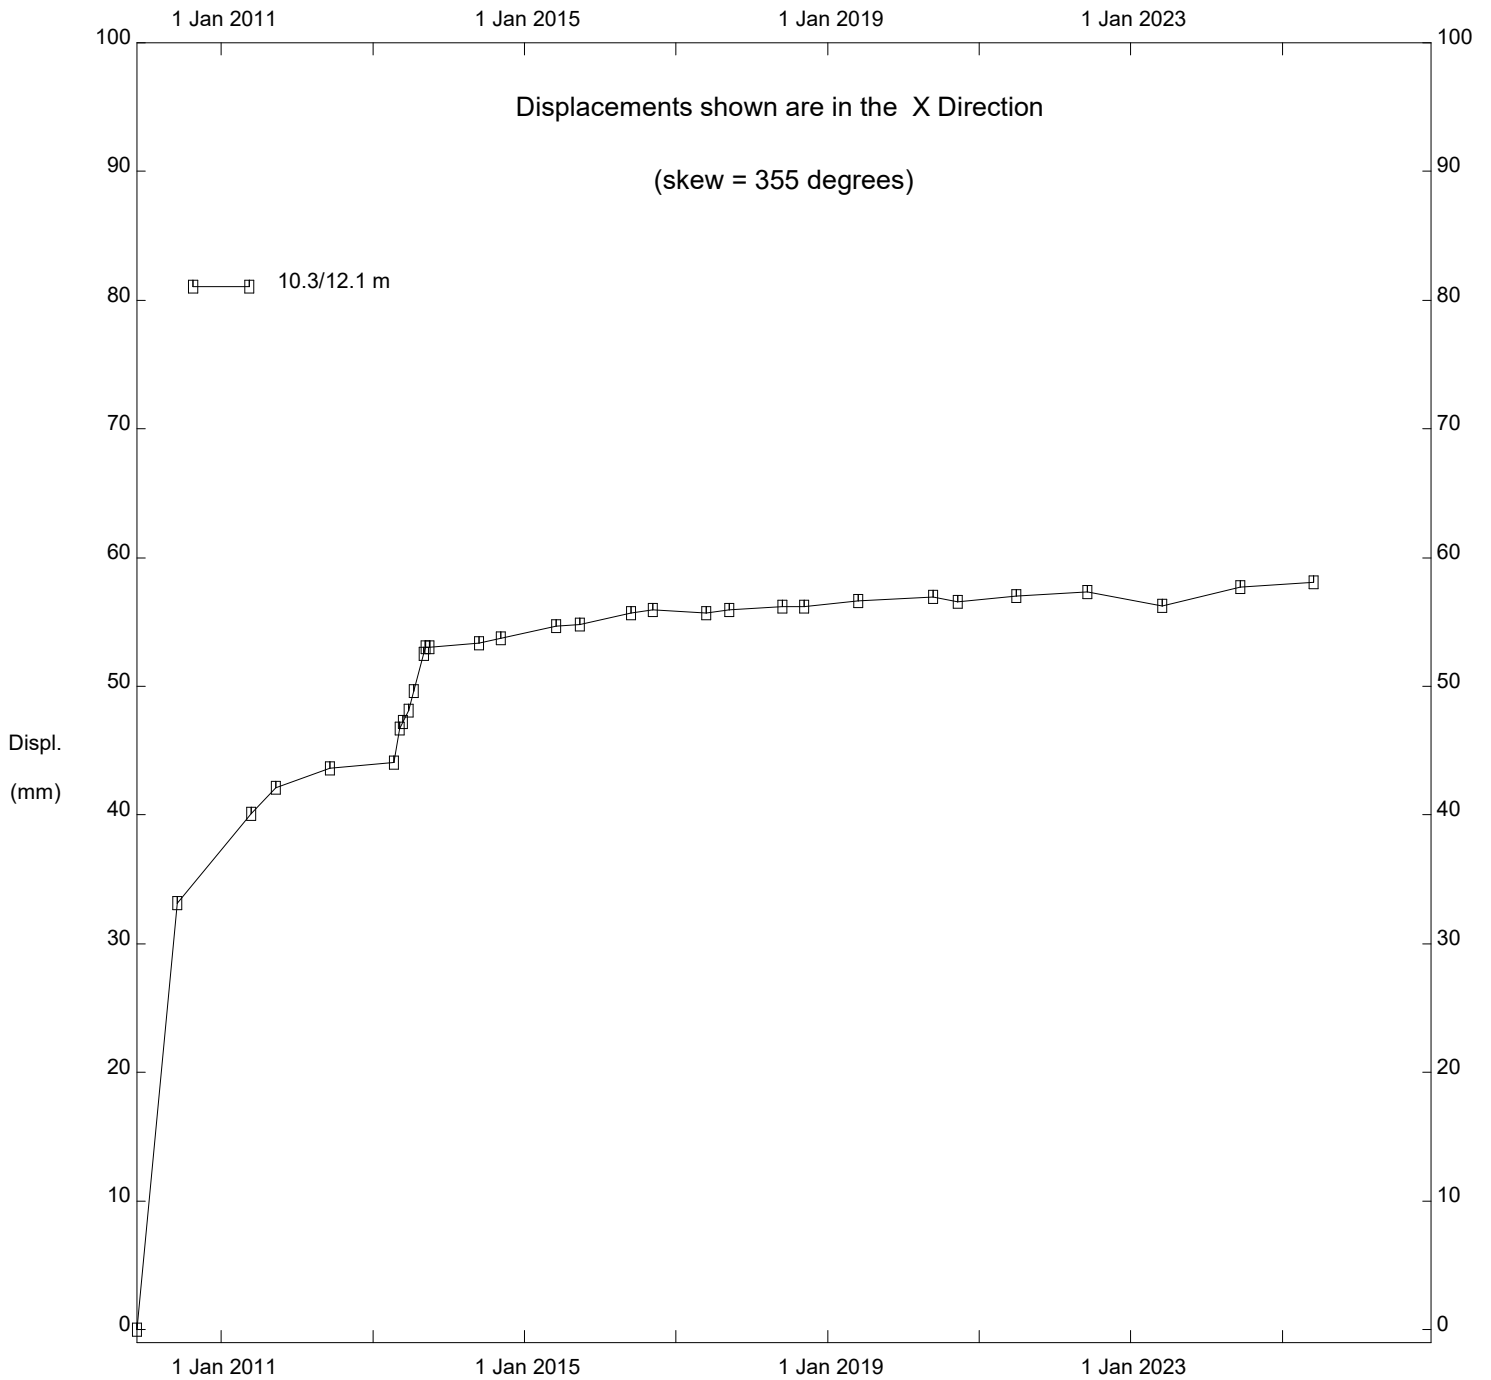
HWY 63:02 South of Wandering River, Inclinometer SI09-4

| INSTRUMENT # | DATE INITIALIZED | TOTAL CUMULATIVE RESULTANT MOVEMENT AND DEPTH OF MOVEMENT TO DATE (mm) | MAXIMUM RATE OF MOVEMENT (mm/yr) | CURRENT STATUS OF SI | DATE OF PREVIOUS READING | INCREMENTAL MOVEMENT SINCE PREVIOUS READING (mm) | CURRENT RATE OF MOVEMENT (mm/yr) | CHANGE IN RATE OF MOVEMENT SINCE PREVIOUS READING (mm/yr) |
|---|---|---|---|---|---|---|---|---|
| SI09-4 | November 19, 2009 | 58.1 over 10.3 m to 12.1 m depth in 331° direction | 1505.1 on November 21, 2009 | Operational | June 13, 2024 | 0.4 | 0.4 | -0.9 |

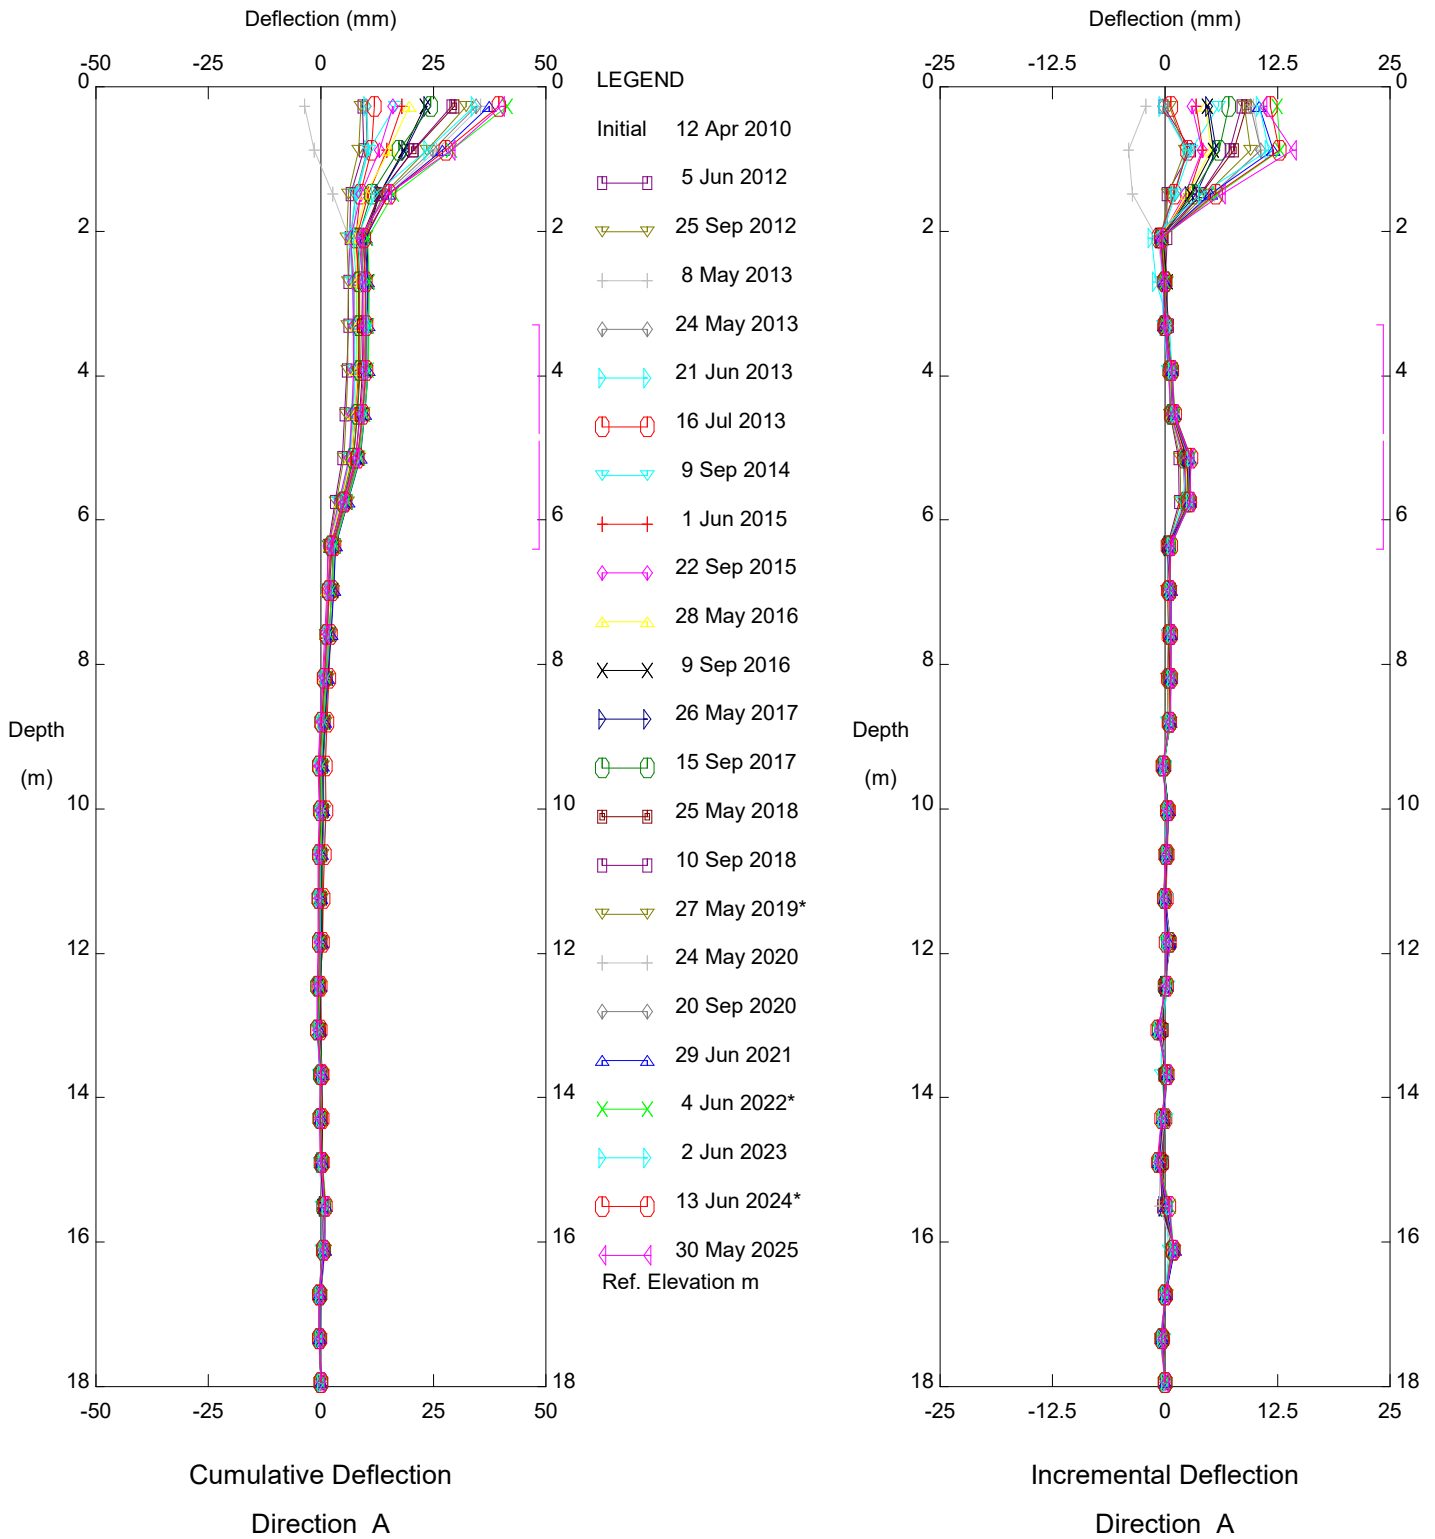
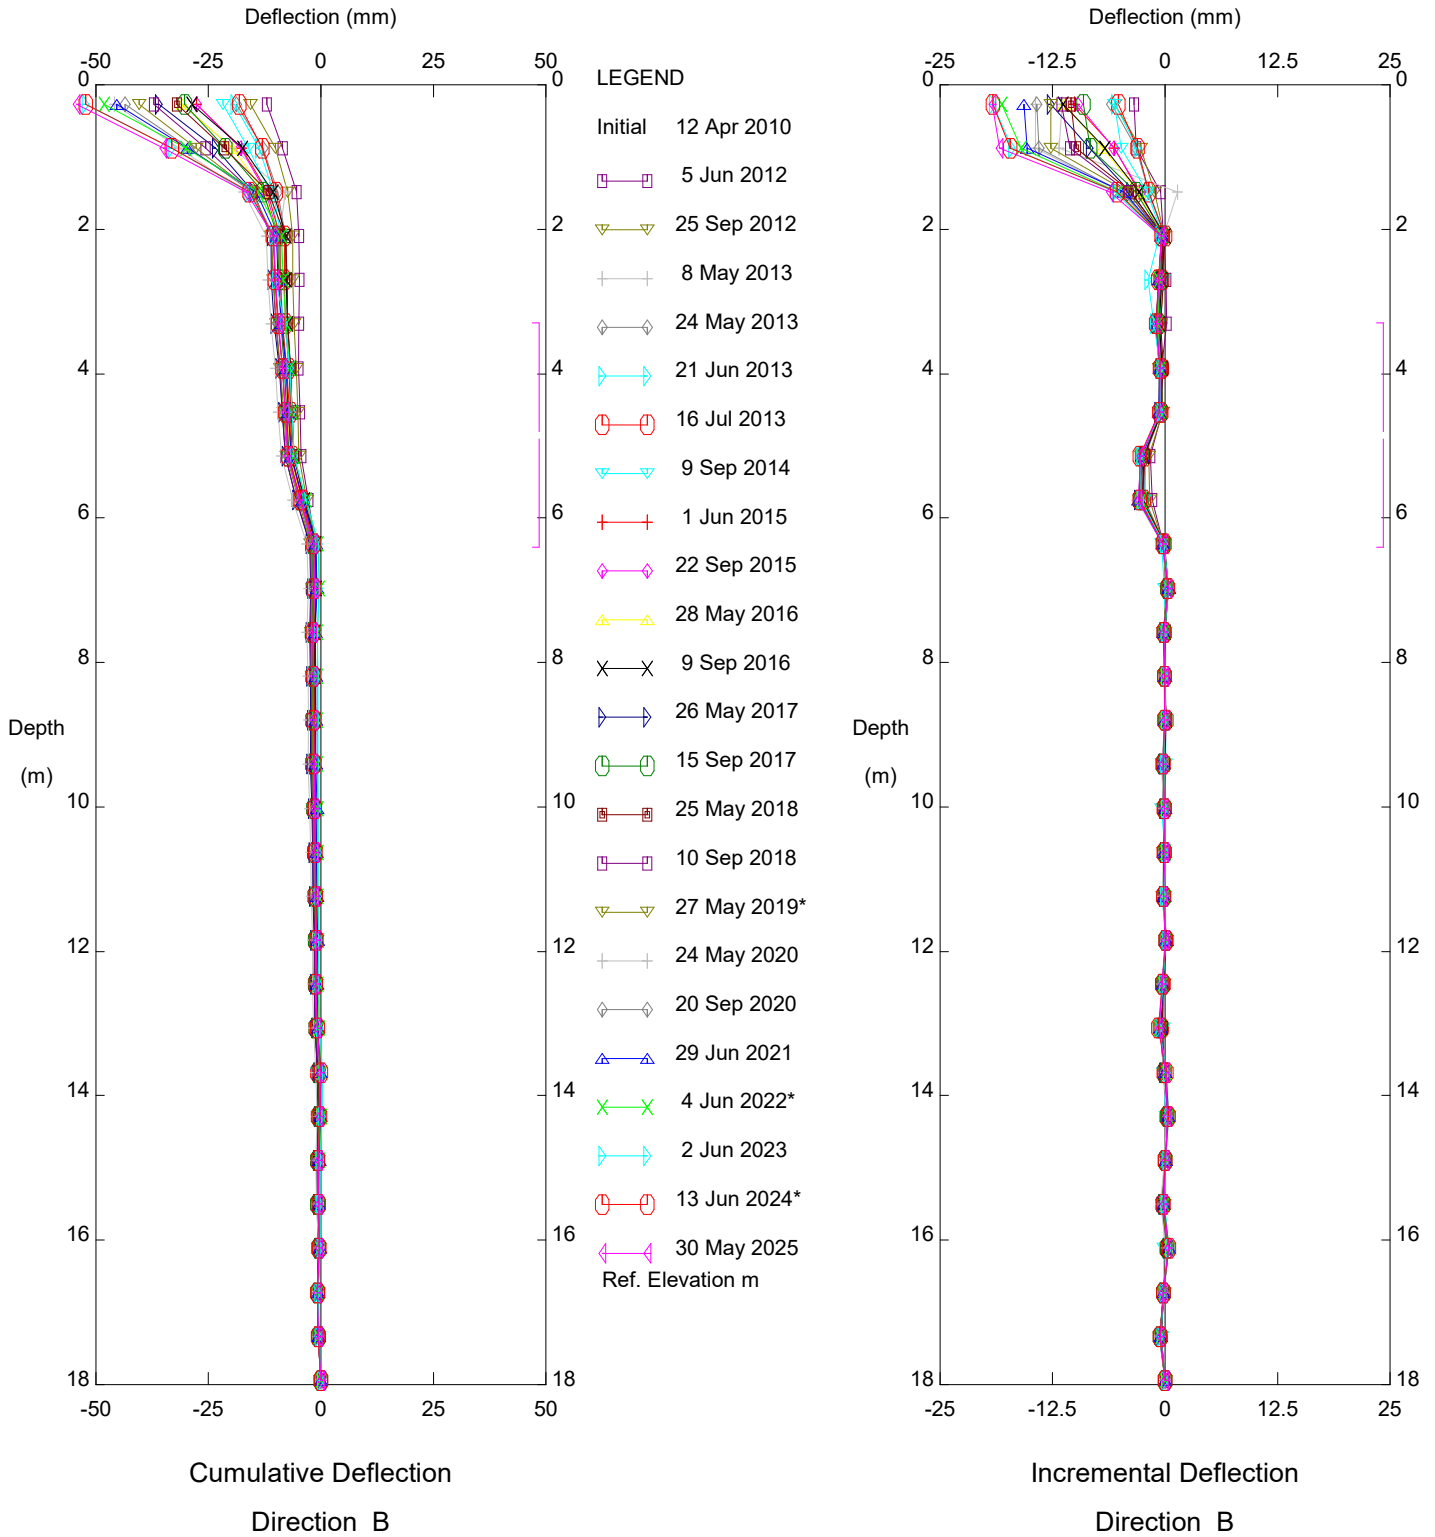
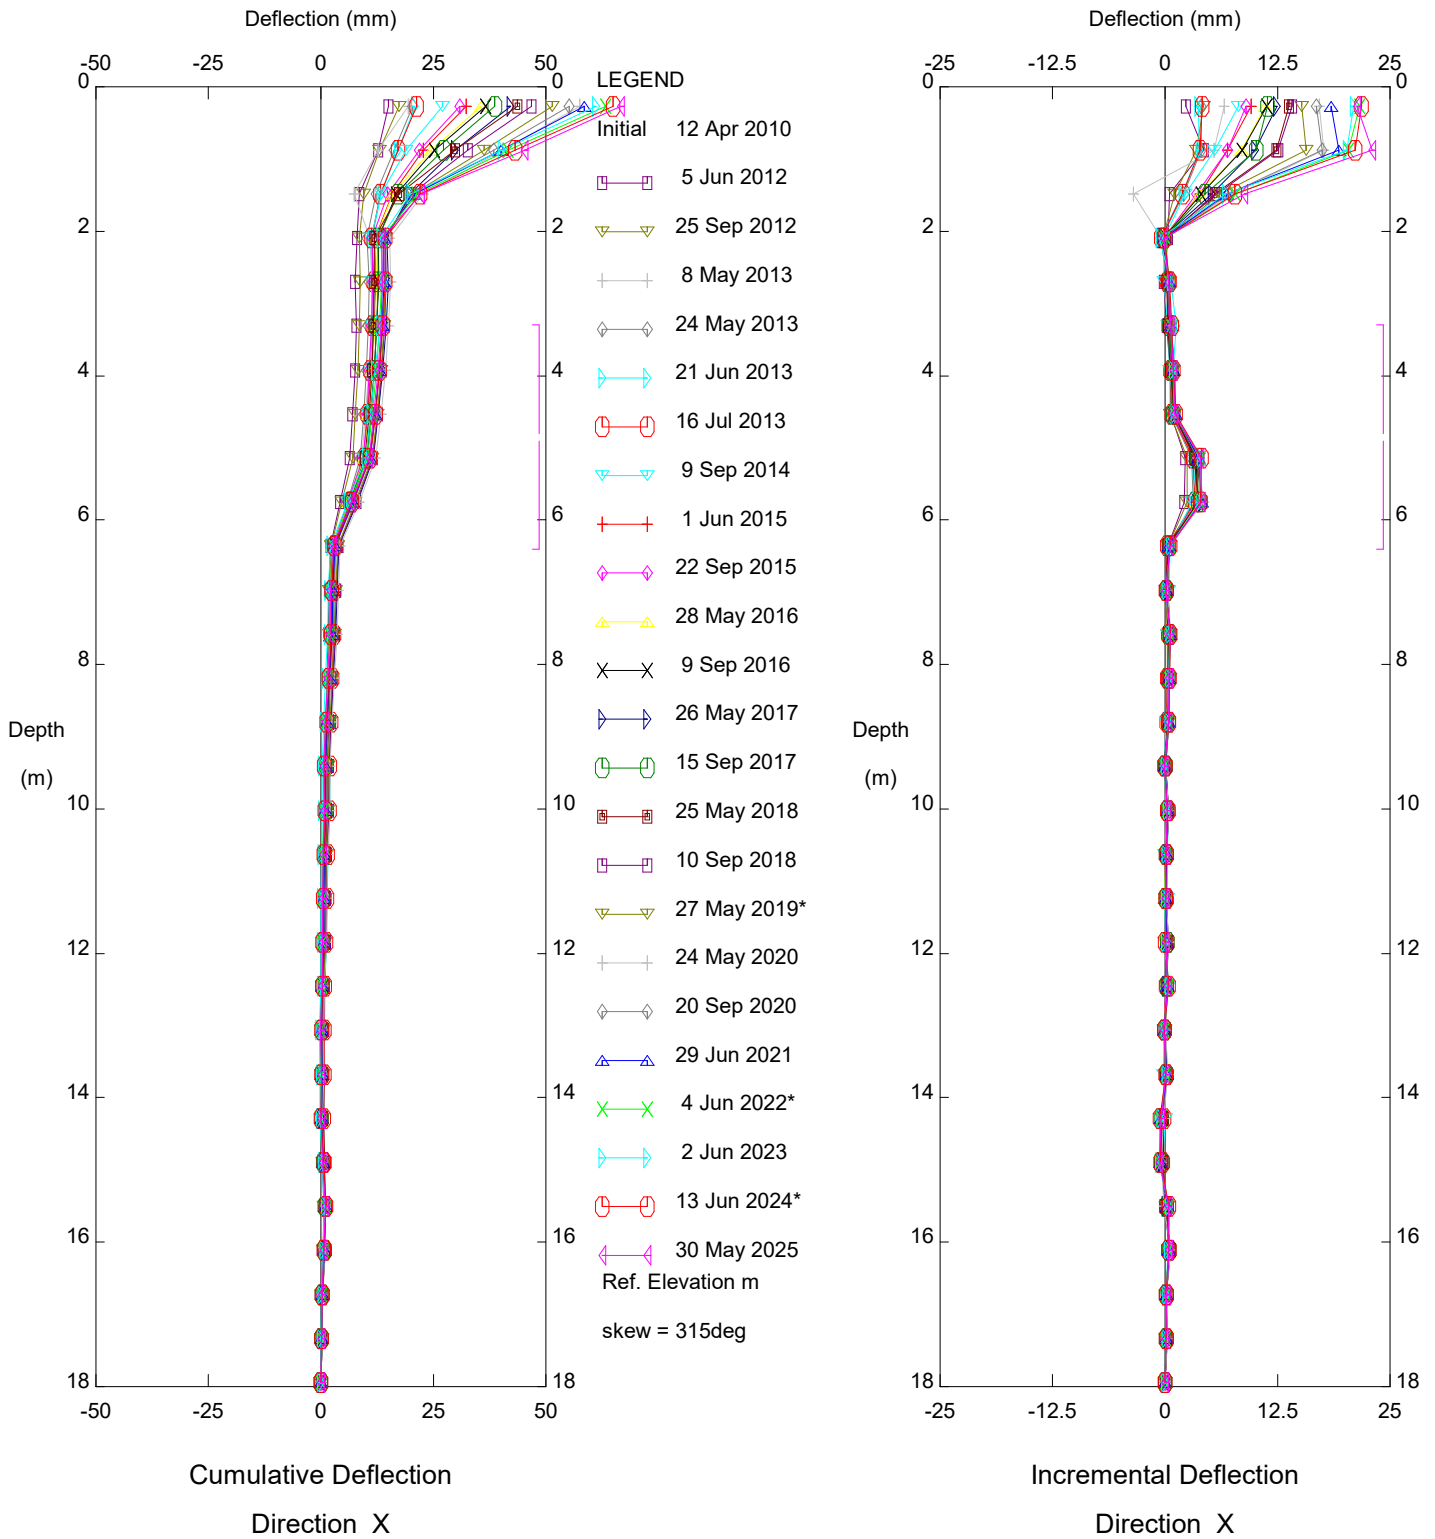
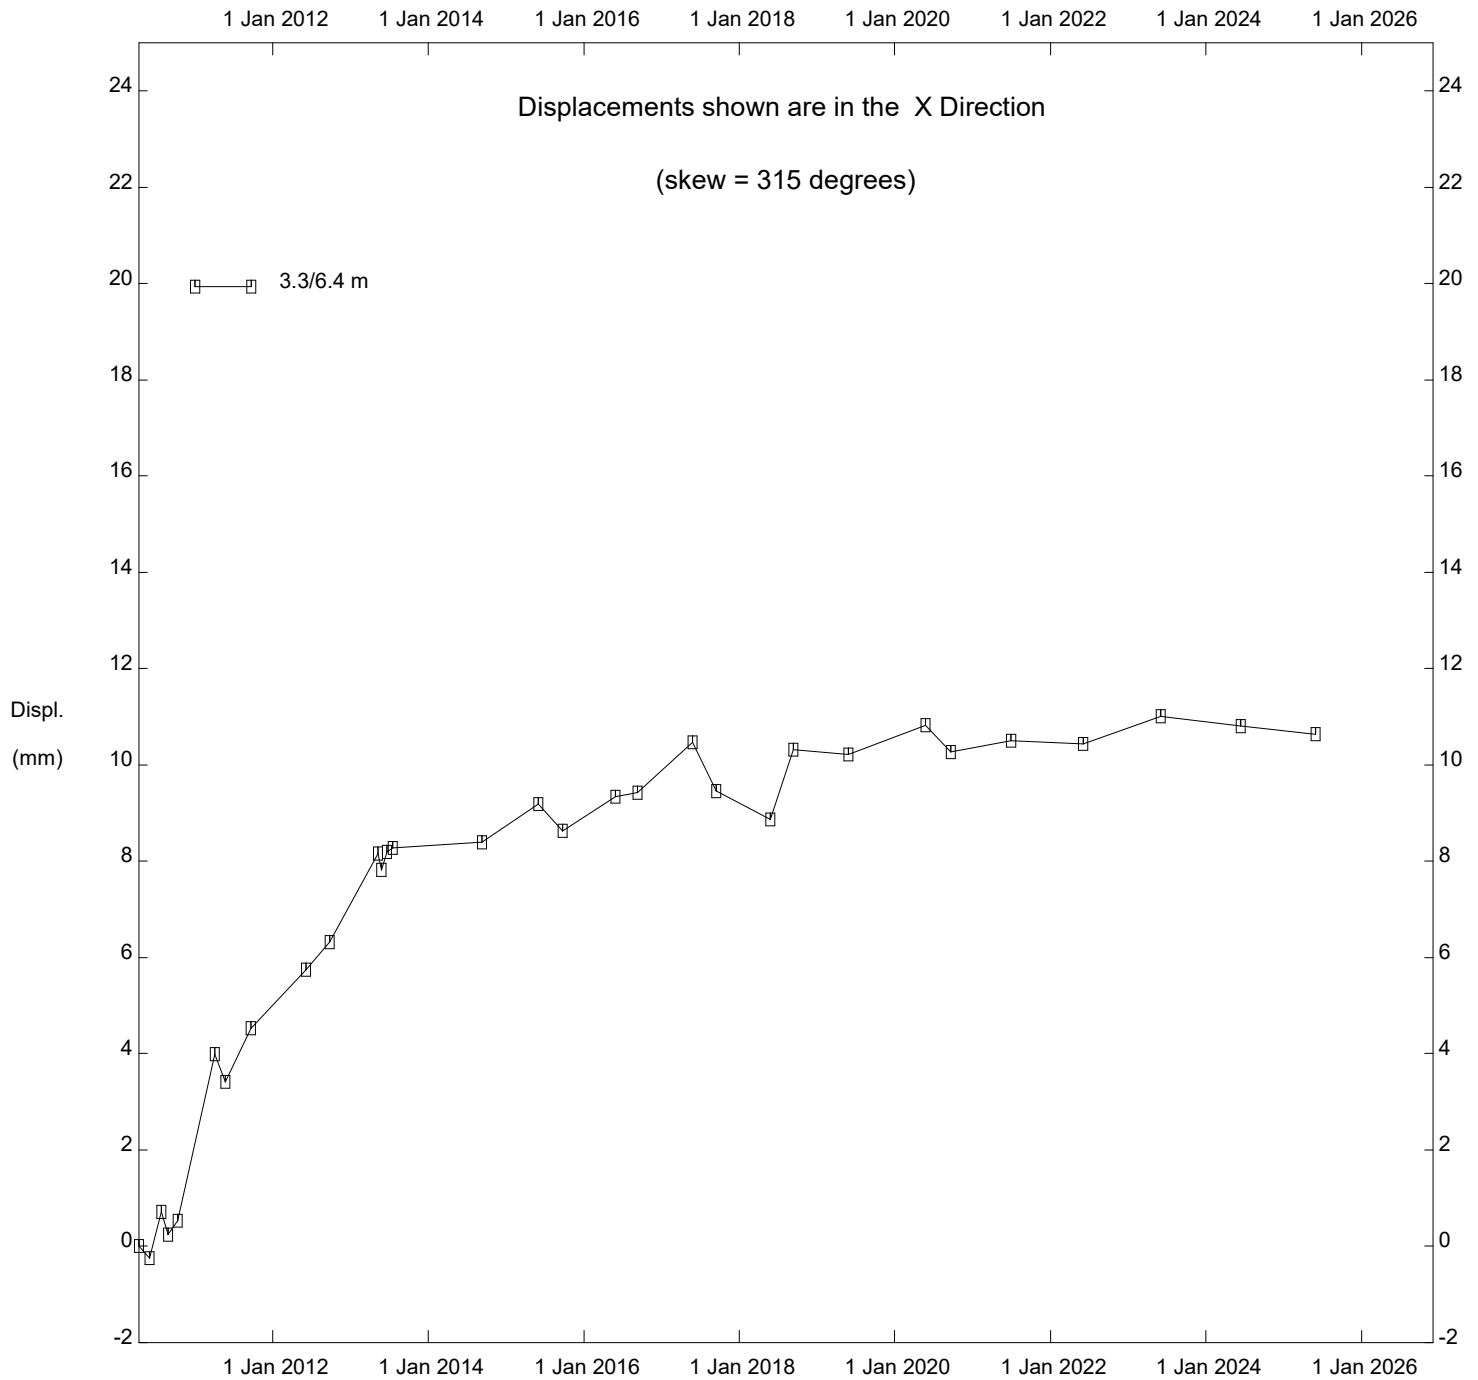
HWY 63:02 South of Wandering River, Inclinator SI10-1

| INSTRUMENT # | DATE INITIALIZED | TOTAL CUMULATIVE RESULTANT MOVEMENT AND DEPTH OF MOVEMENT TO DATE (mm) | MAXIMUM RATE OF MOVEMENT (mm/yr) | CURRENT STATUS OF SI | DATE OF PREVIOUS READING | INCREMENTAL MOVEMENT SINCE PREVIOUS READING (mm) | CURRENT RATE OF MOVEMENT (mm/yr) | CHANGE IN RATE OF MOVEMENT SINCE PREVIOUS READING (mm/yr) |
|---|---|---|---|---|---|---|---|---|
| SI10-1 | April 12, 2010 | 10.6 over 3.3 m to 6.4 m depth in 91° direction | 7.3 on April 4, 2011 | Operational | June 13, 2024 | No discernible movement | N/A | 0 |
