ALBERTA TRANSPORTATION AND  
ECONOMIC CORRIDORS GRMP  
NORTH CENTRAL (ATHABASCA AND FORT  
McMURRAY DISTRICTS)  
INSTRUMENTATION MONITORING - SPRING 2025

| Site Number | Location | Name | Hwy | km |
|---|---|---|---|---|
| NC069 | HWY 63:02 L1 32.020 | South of Wandering River | 63:02 | Km 32 |

**SITE NC069: HWY 63:02 SLOPE REPAIR SOUTH OF WANDERING RIVER**

**NC069: HWY 63:02 (km 13) SOUTH OF  
WANDERING RIVER SLIDE REPAIR**

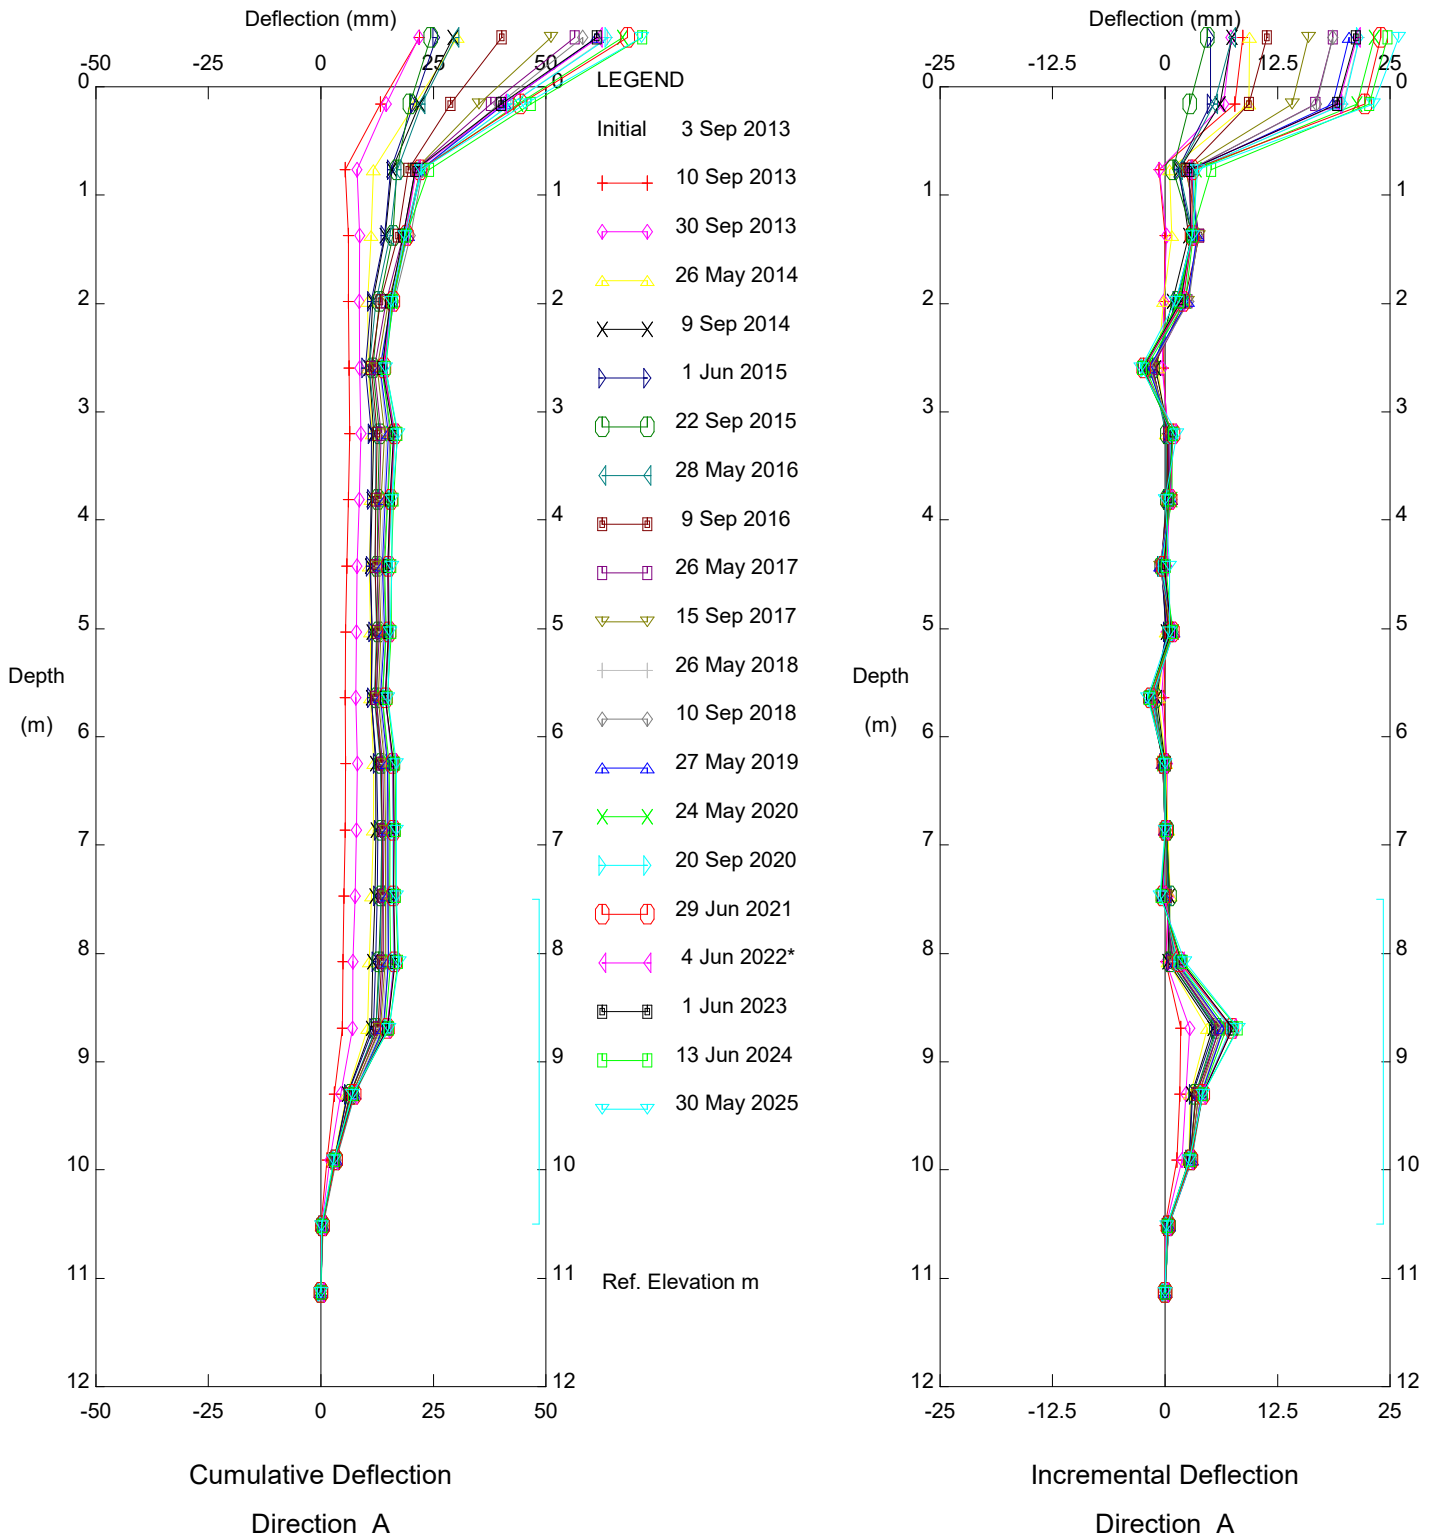
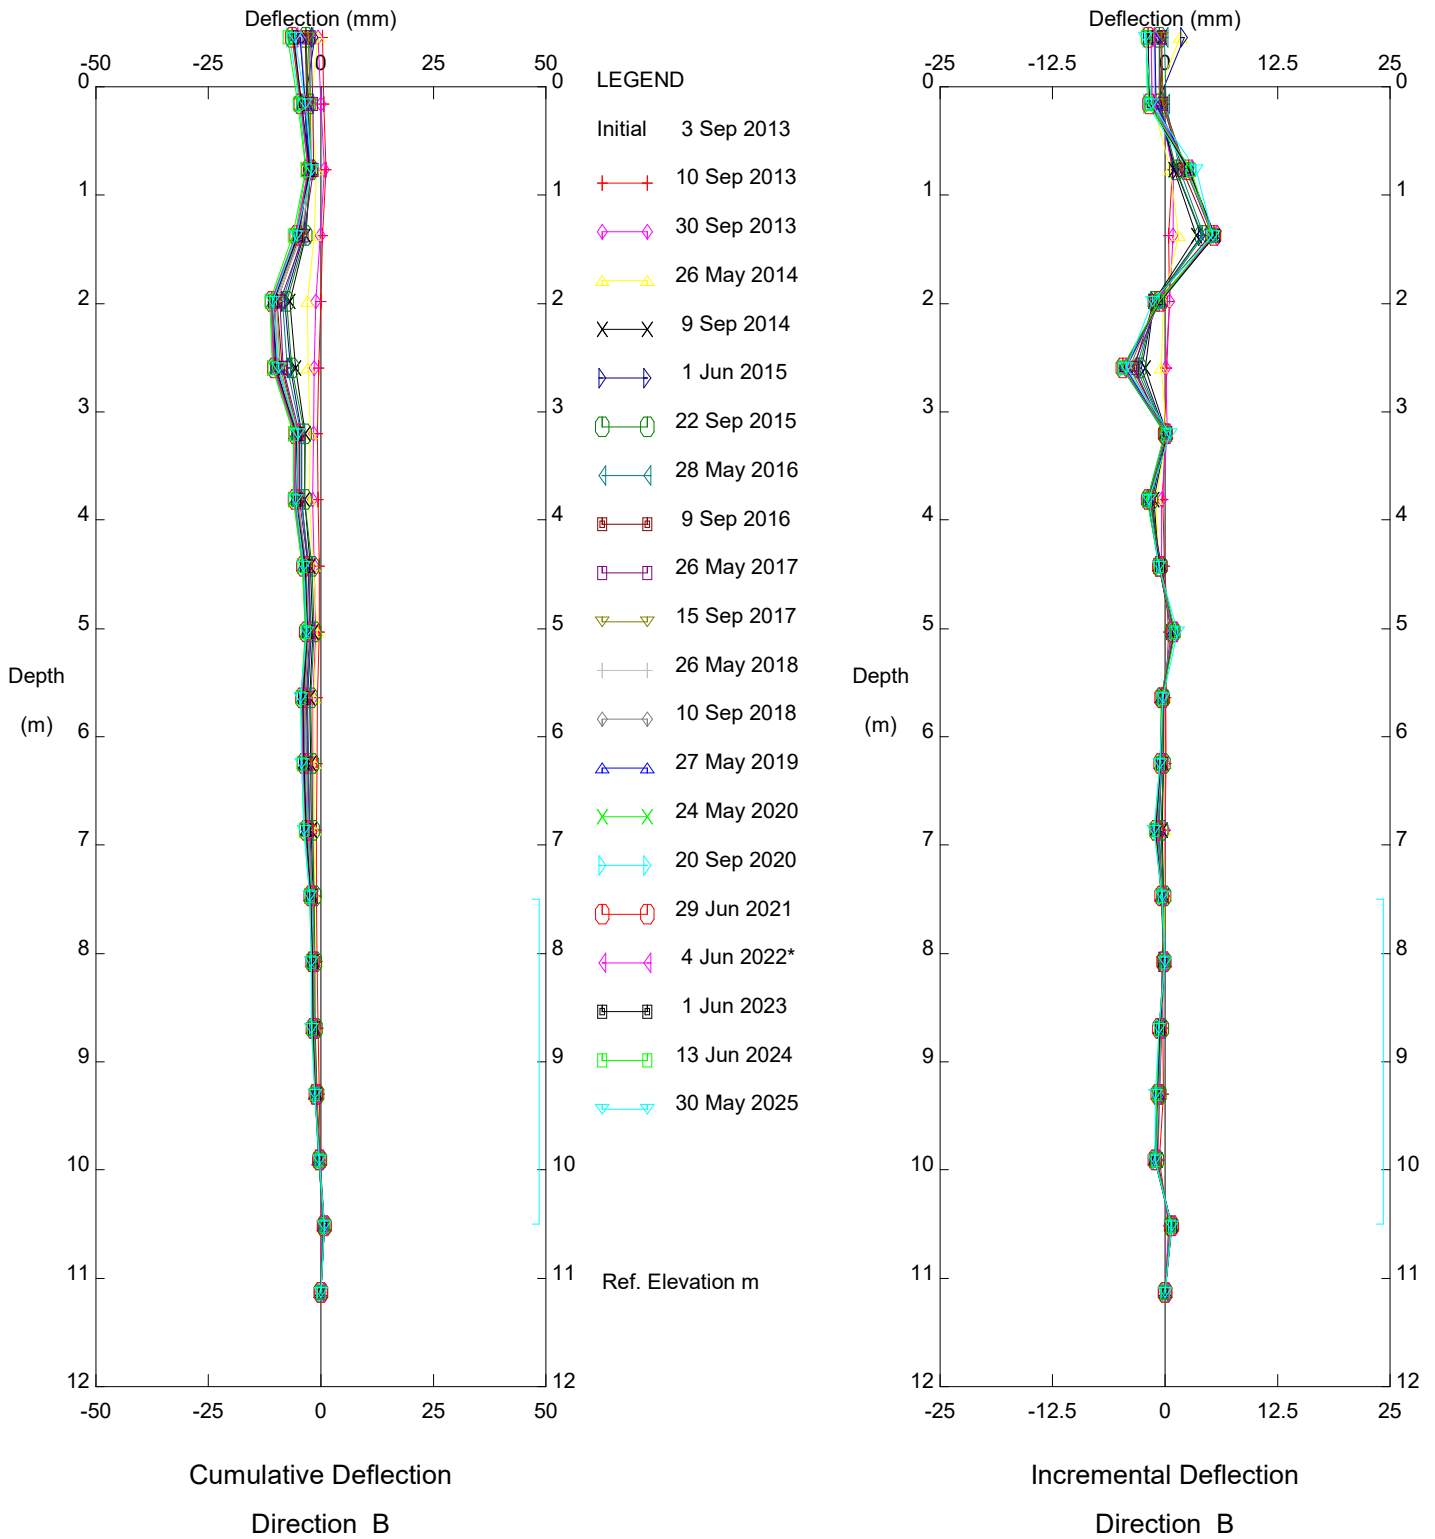
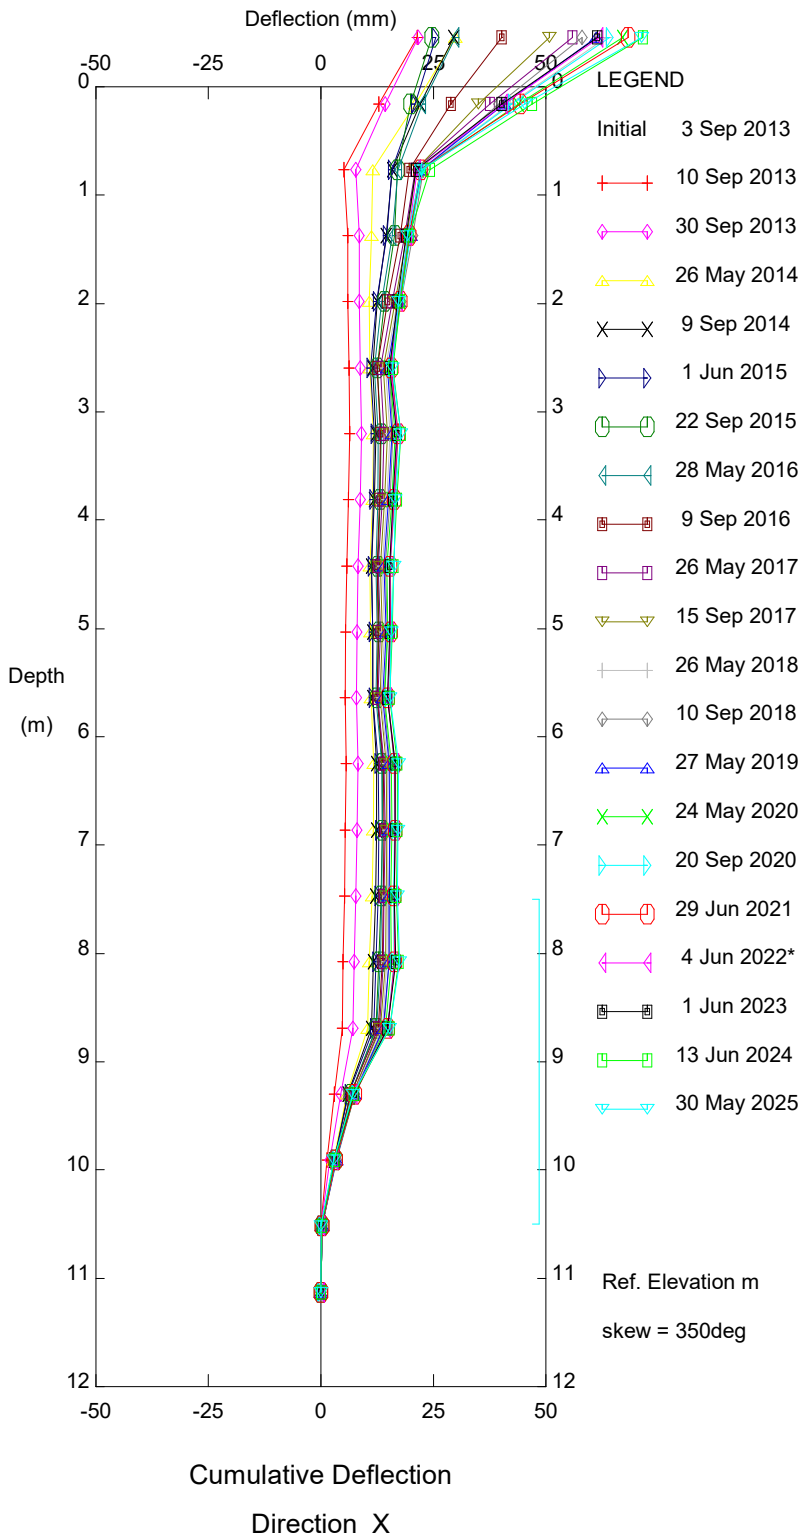
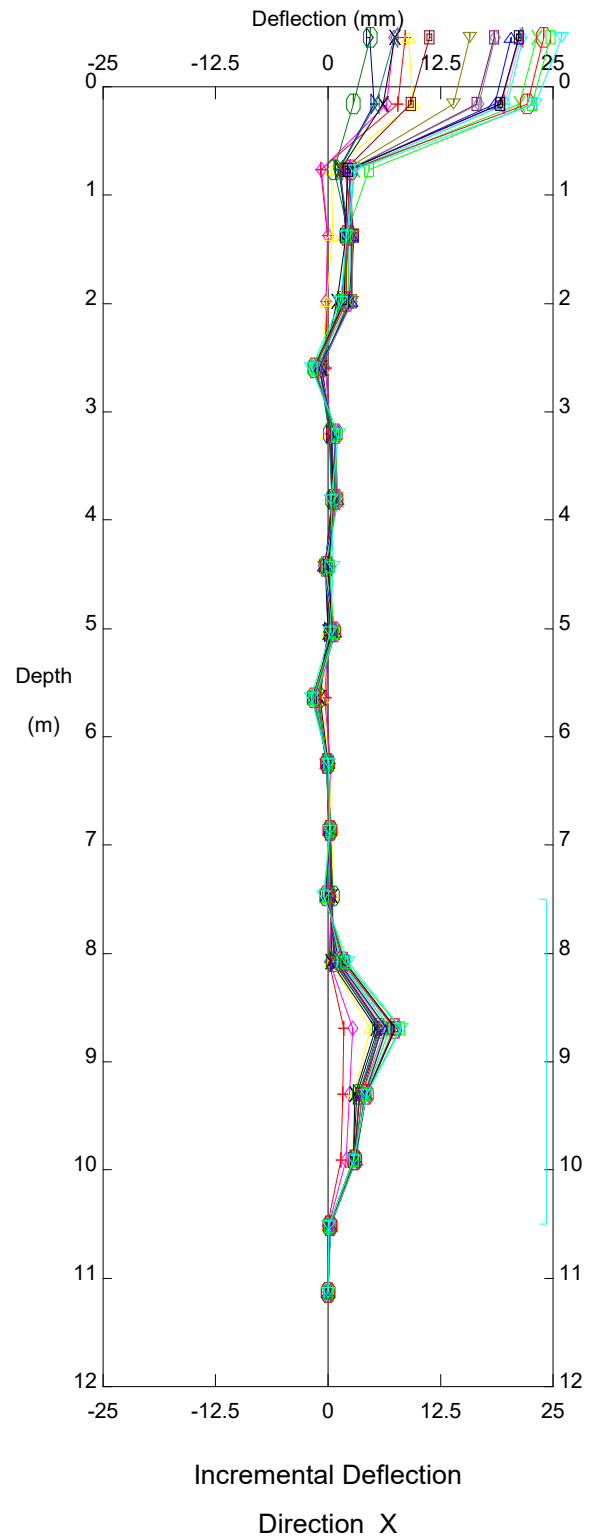
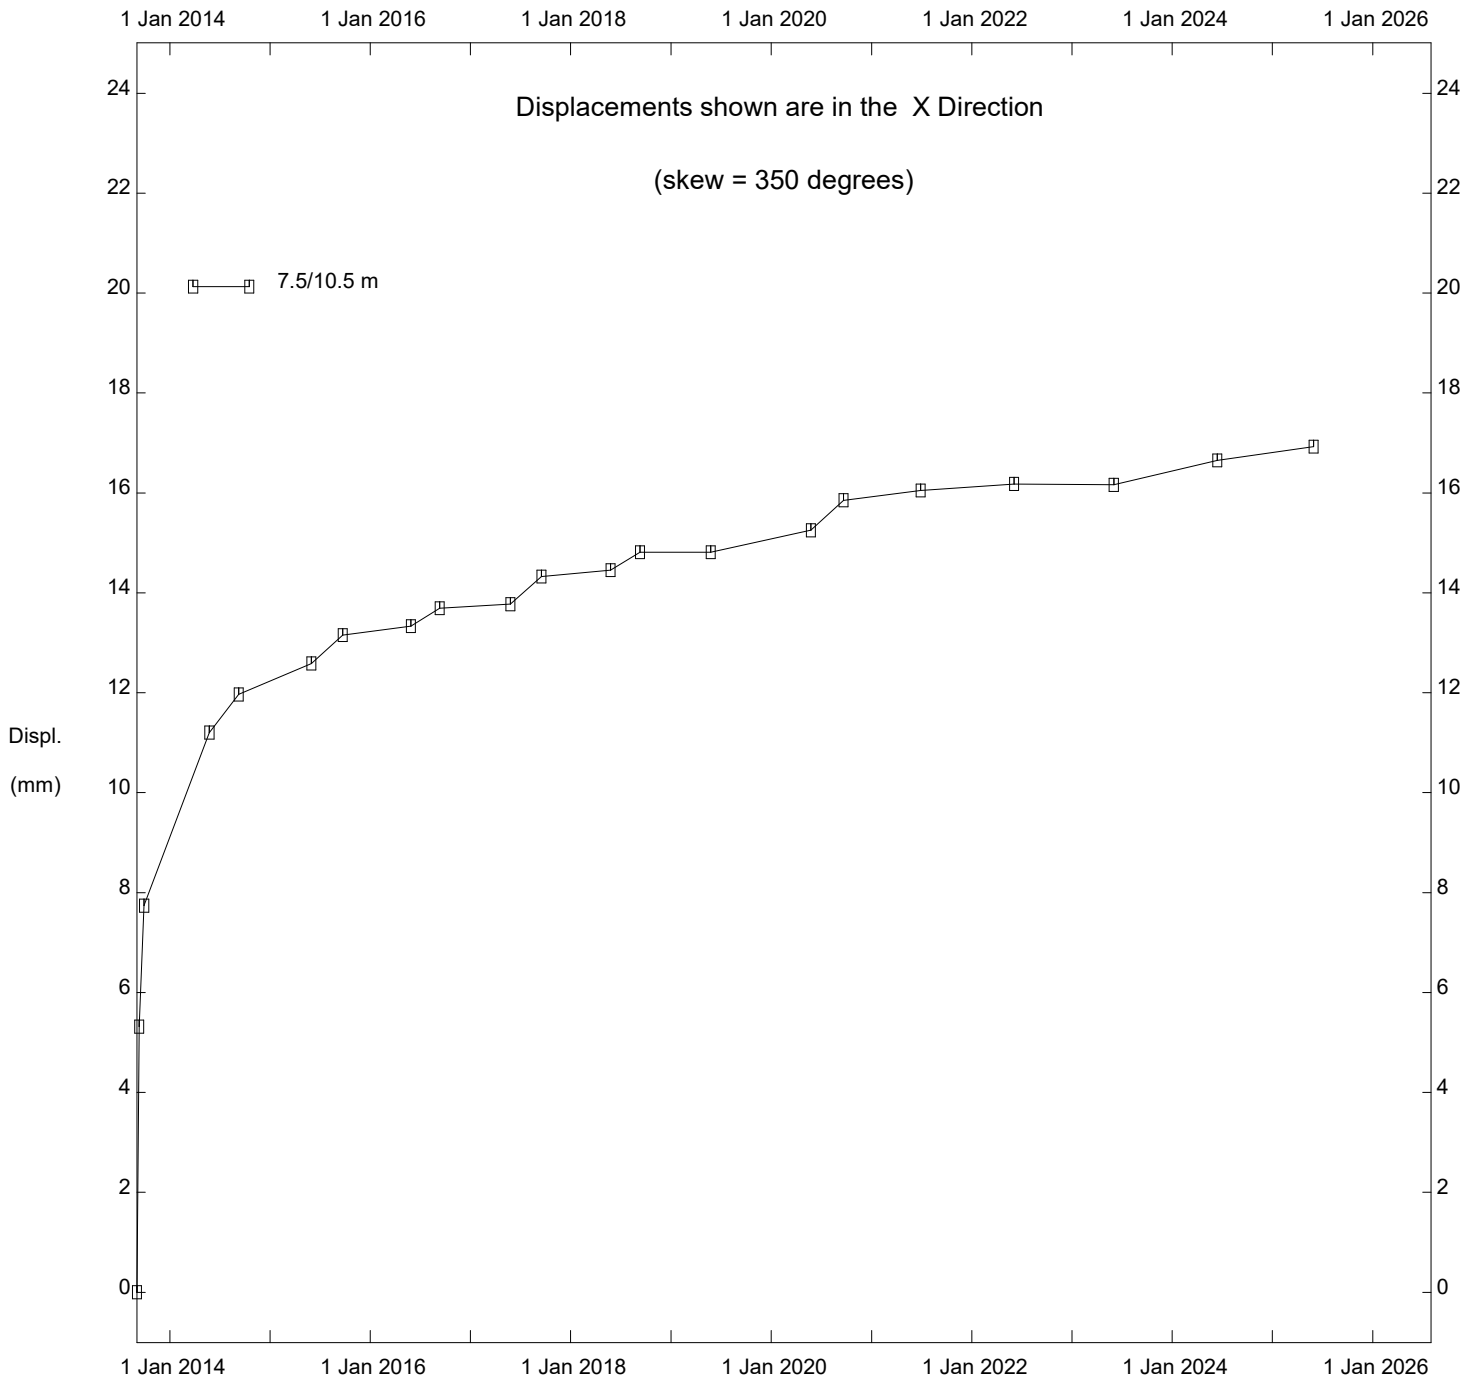
HWY 63:02 South of Wandering River, Inclinometer SI13-14

| INSTRUMENT # | DATE INITIALIZED | TOTAL CUMULATIVE RESULTANT MOVEMENT AND DEPTH OF MOVEMENT TO DATE (mm) | MAXIMUM RATE OF MOVEMENT (mm/yr) | CURRENT STATUS OF SI | DATE OF PREVIOUS READING | INCREMENTAL MOVEMENT SINCE PREVIOUS READING (mm) | CURRENT RATE OF MOVEMENT (mm/yr) | CHANGE IN RATE OF MOVEMENT SINCE PREVIOUS READING (mm/yr) |
|---|---|---|---|---|---|---|---|---|
| SI13-14 | September 3, 2013 | 16.9 over 7.5 m to 10.5 m depth in 333° direction | 284.3 on September 10, 2013 | Operational | June 13, 2024 | 0.3 | 0.3 | -0.2 |
