**ALBERTA TRANSPORTATION AND  
ECONOMIC CORRIDORS GRMP  
NORTH CENTRAL (ATHABASCA AND FORT  
McMURRAY DISTRICTS)  
INSTRUMENTATION MONITORING - FALL 2025**

| Site Number | Location | Name | Hwy | km |
|---|---|---|---|---|
| NC008 | HWY 63:02 L1 15.635 | North of La Biche River | 63:02 | km 15.6 |

**ALBERTA TRANSPORTATION AND ECONOMIC CORRIDORS GRMP (CON0022163)  
NORTH CENTRAL (ATHABASCA AND FORT McMURRAY DISTRICTS)  
INSTRUMENTATION MONITORING RESULTS**

**SITE NC008: HWY 63:02 NORTH OF LA BICHE RIVER**

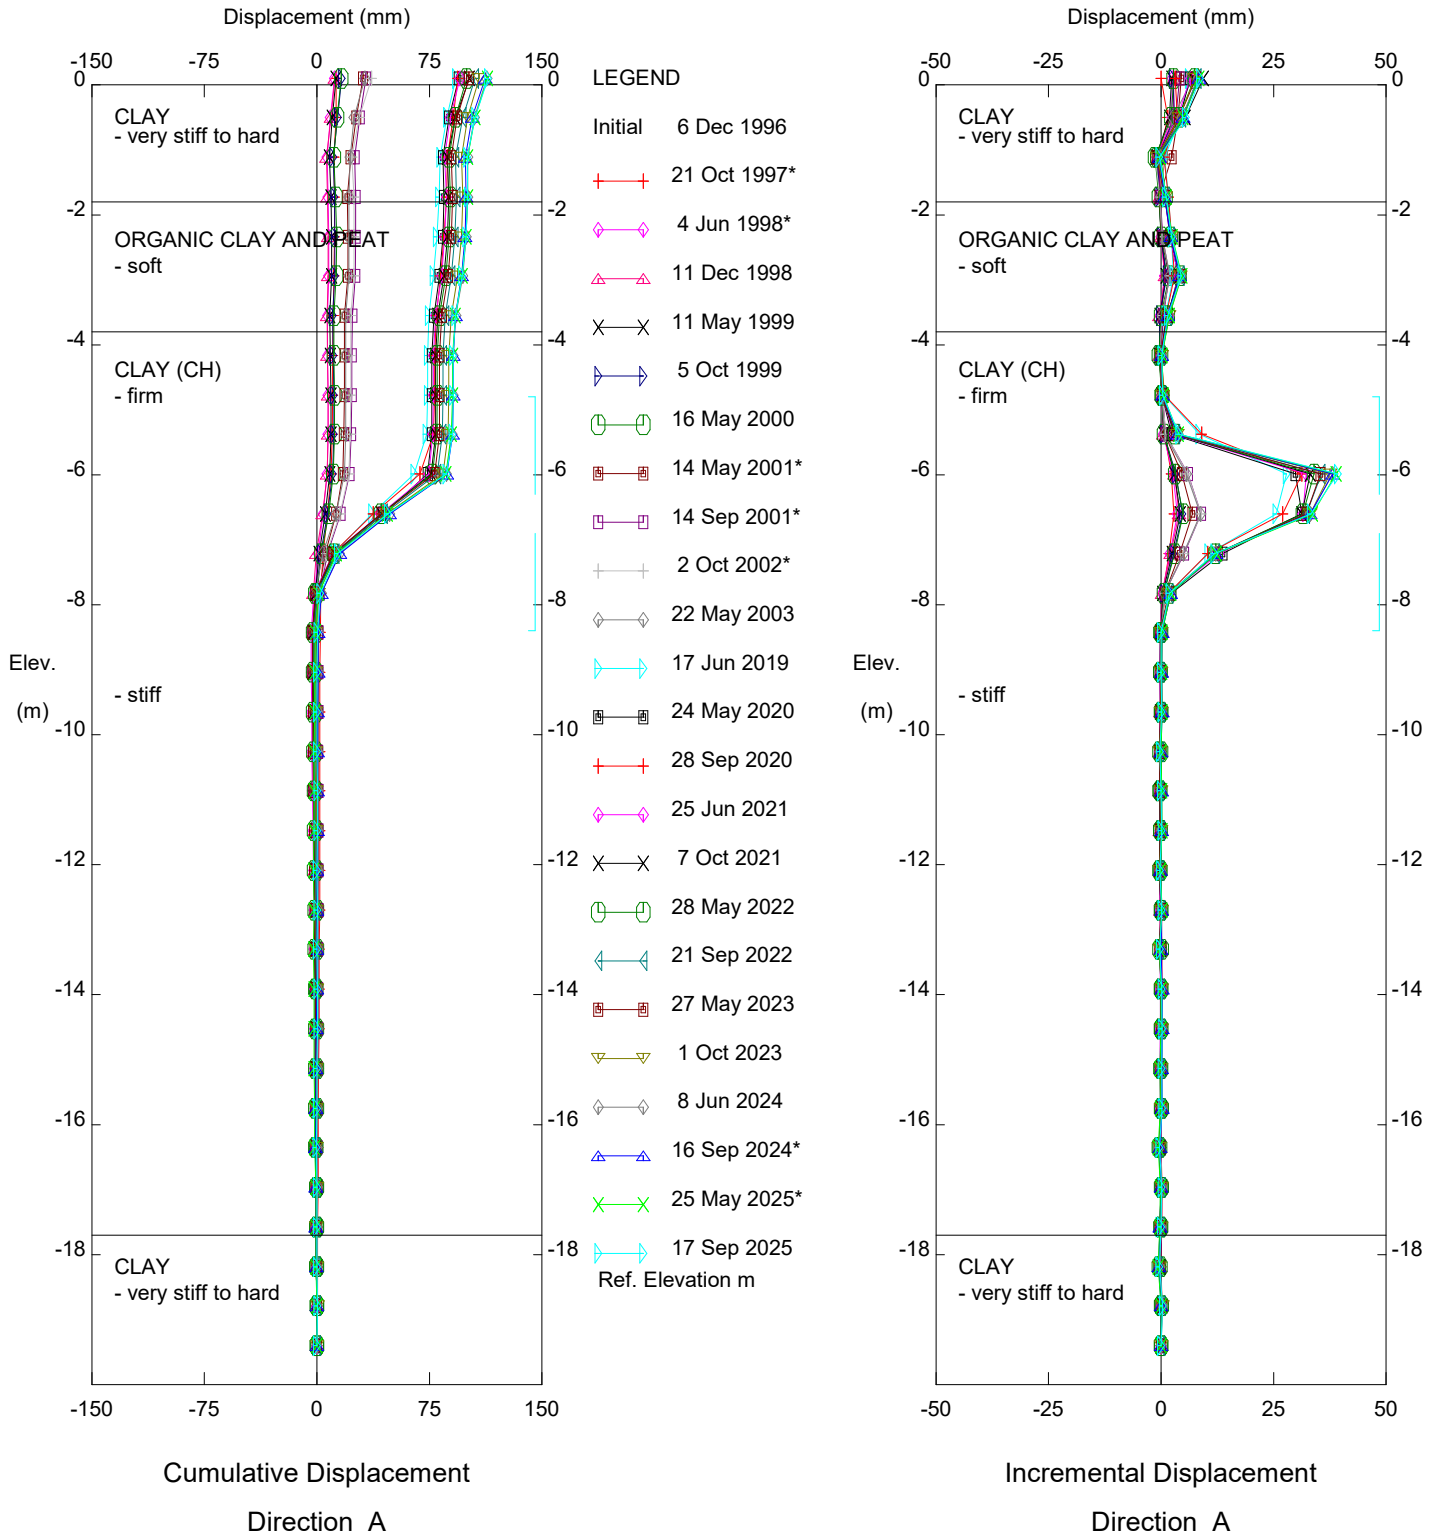
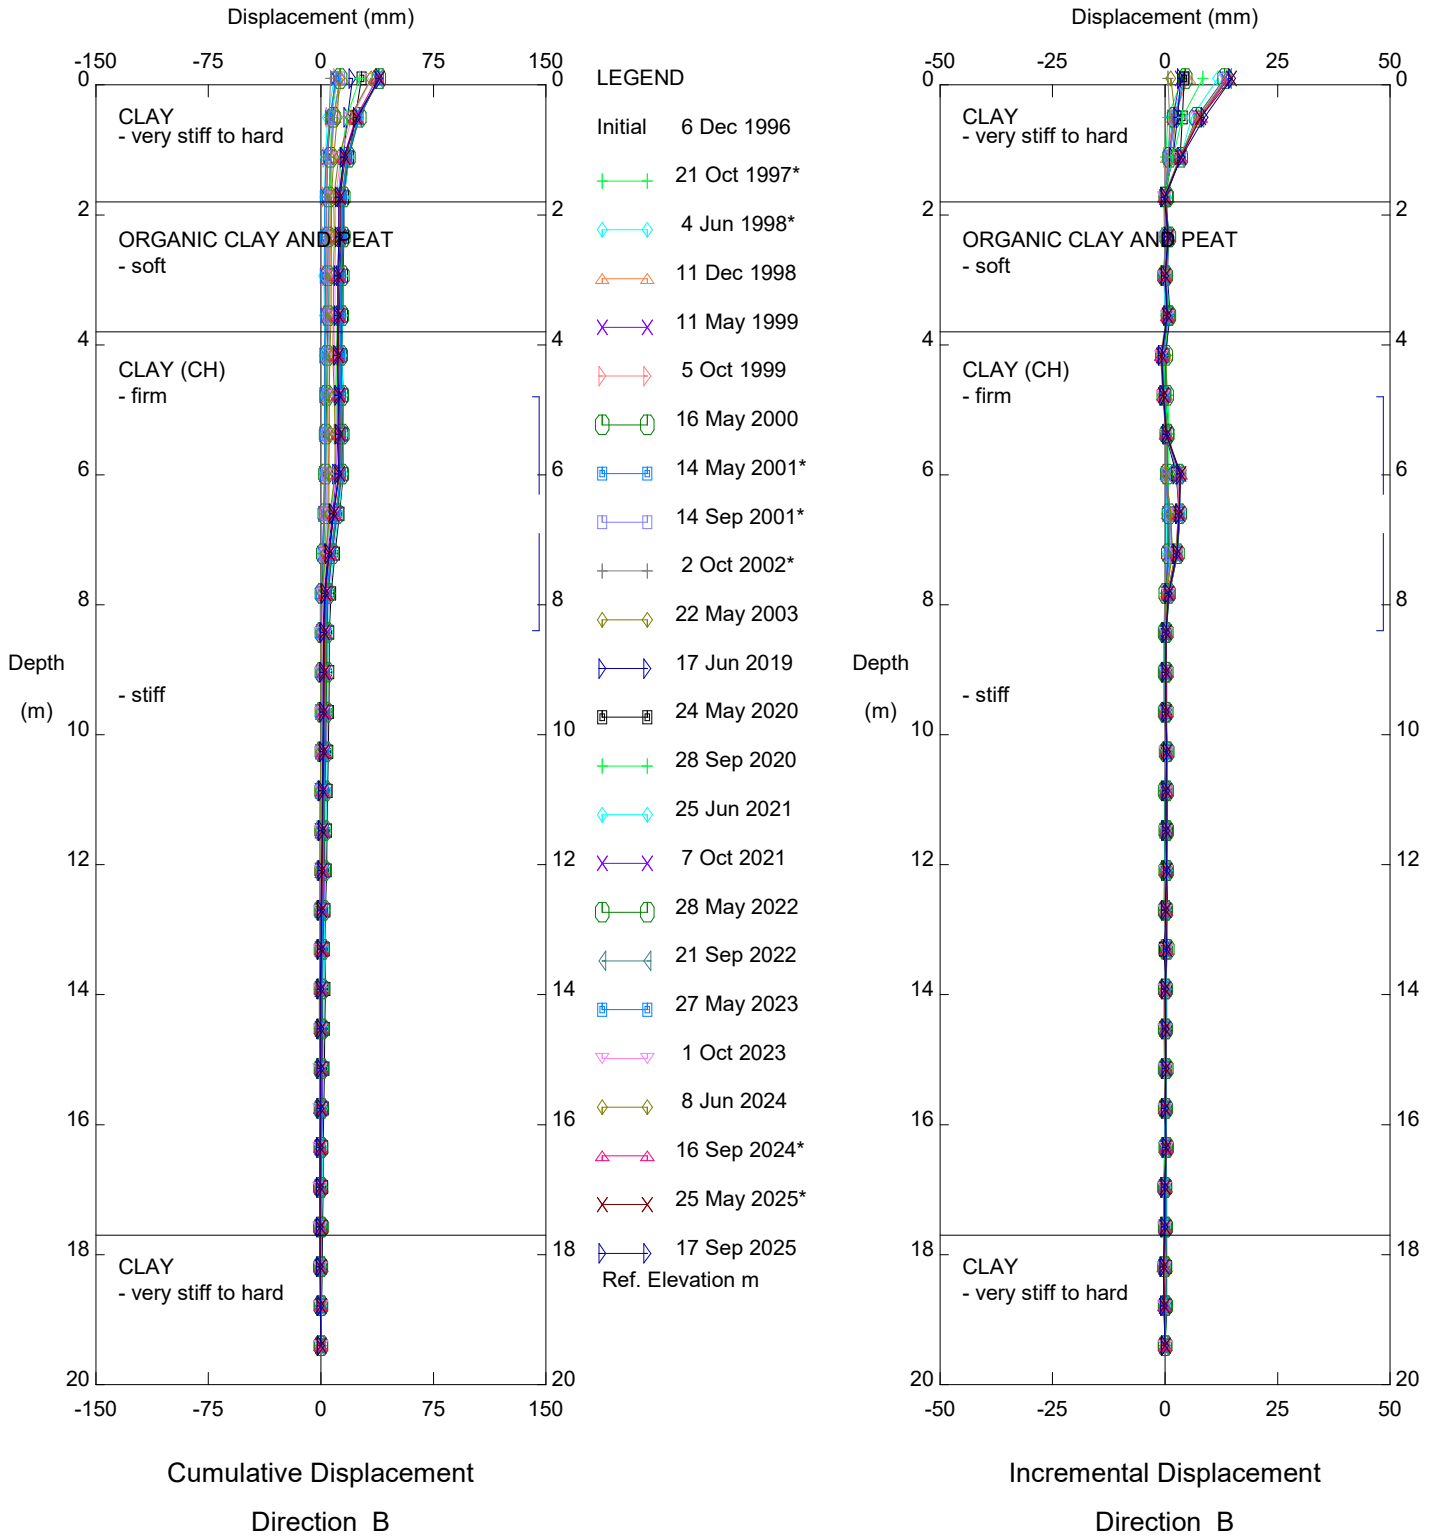
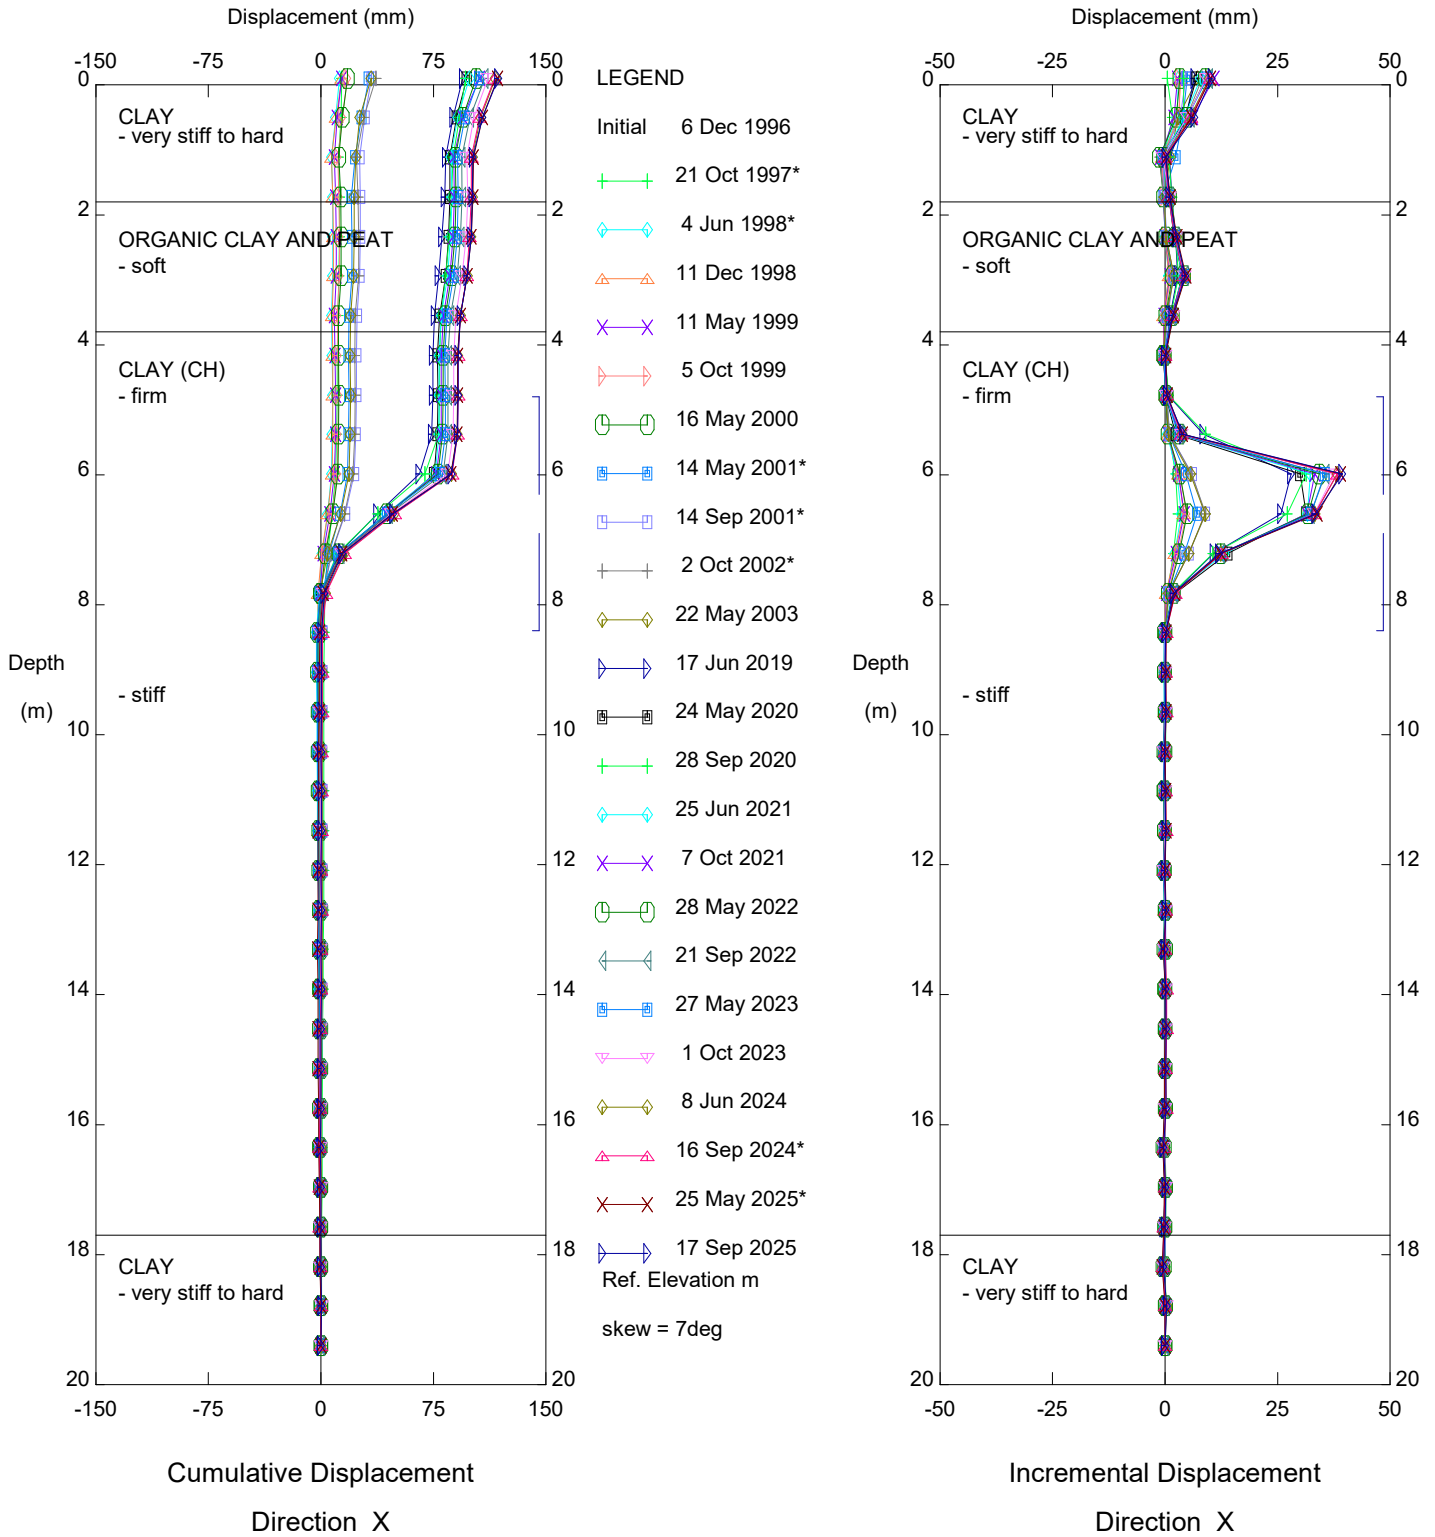
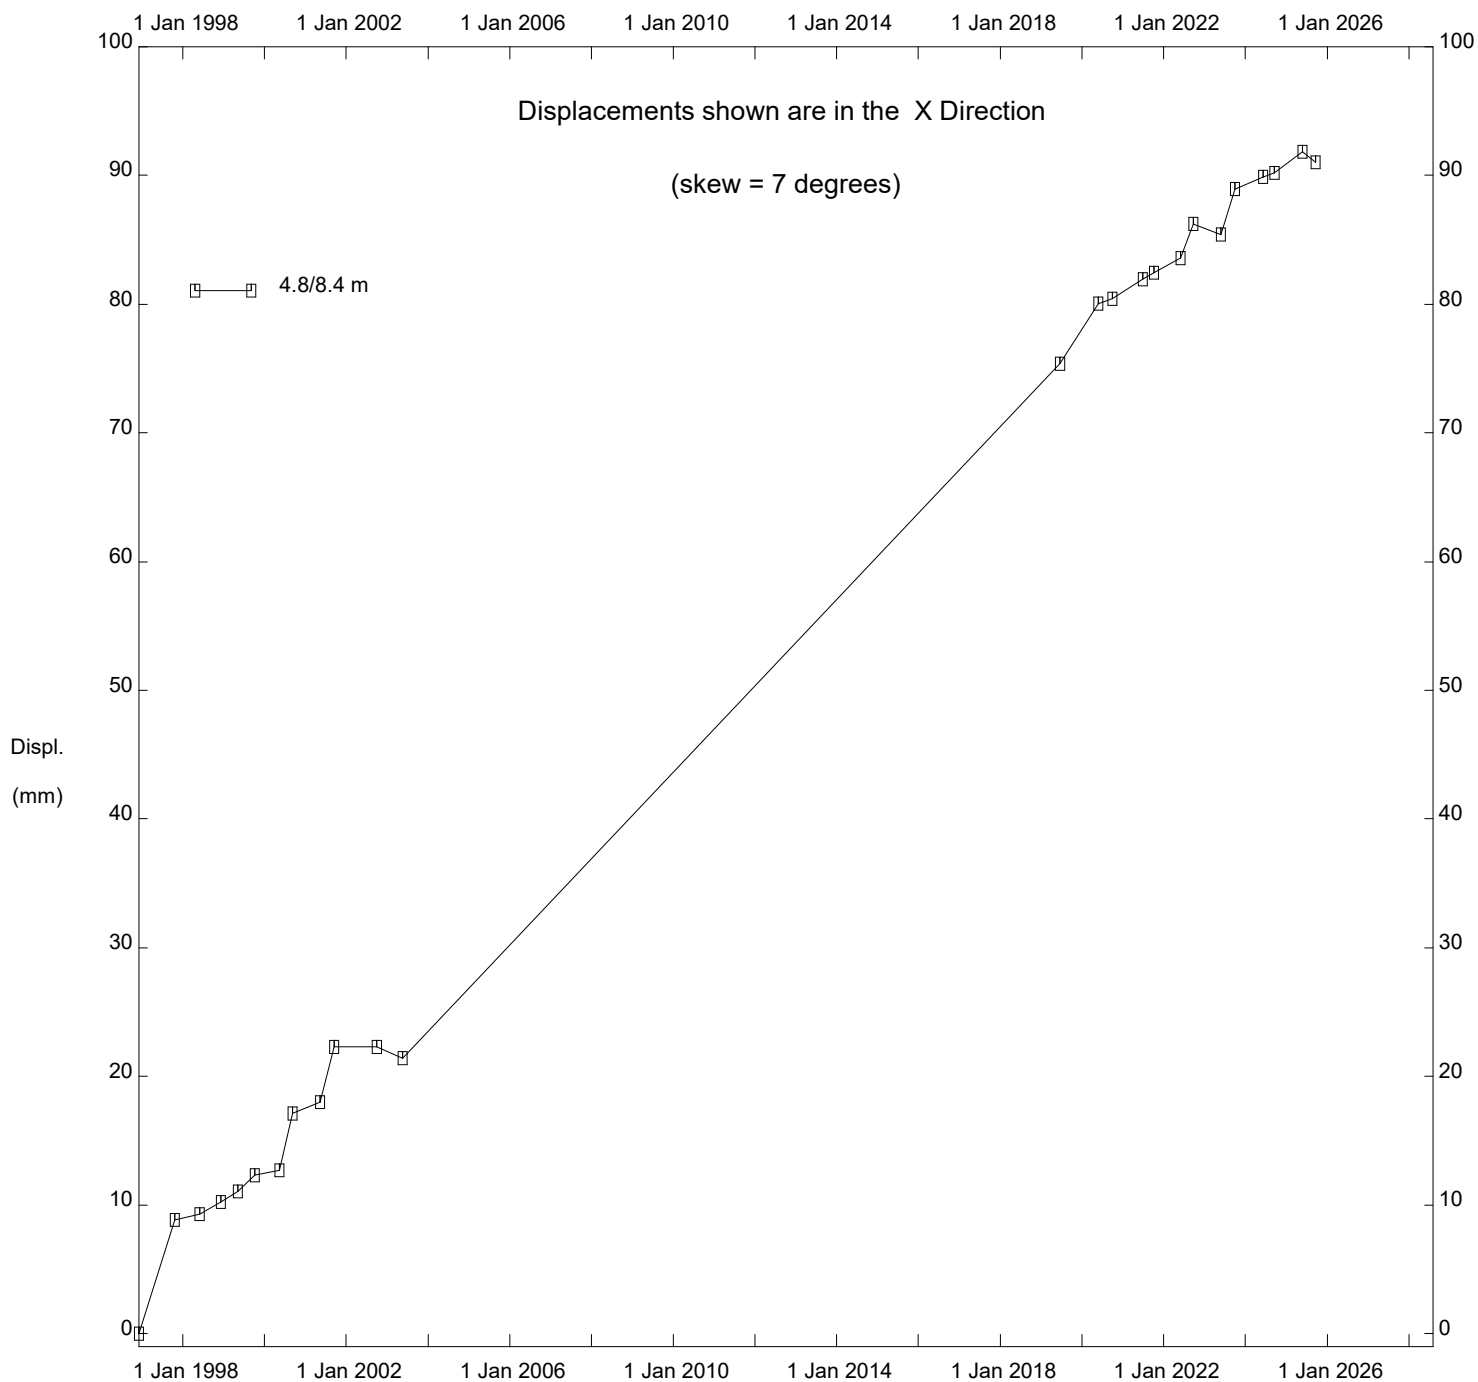
Labiche River, Inclinator SI#1B

| Discussion | |
|---|---|
| <b>Interpretation of Monitoring Results:</b> | SI1B showed no discernable movement over 4.8 m to 8.4 m since the spring of 2025 readings.<br><br>Standpipe piezometer SP20-1 showed a increase in groundwater level of 0.06 m compared to the spring of 2025 readings. |

| Discussion | |
|---|---|
| <b>Future Work:</b> | The instruments should be read again in the spring of 2026. |
