**ALBERTA TRANSPORTATION AND  
ECONOMIC CORRIDORS GRMP  
NORTH CENTRAL (ATHABASCA AND FORT  
MCMURRAY DISTRICTS)  
2025 SITE INSPECTION**

| Site # | Location | Name | Hwy | km |
|---|---|---|---|---|
| NC008 | 15.6 Km North of Hwy 63 & 55 Intersection | La Biche River (0.8 to 0.9 km North of Bridge) | 63:02 | 15.6 |

| | Date | PF | CF | Total |
|---|---|---|---|---|
| Current Inspection: | May 14, 2025 | 11 | 4 | 44 (New Landslide) |

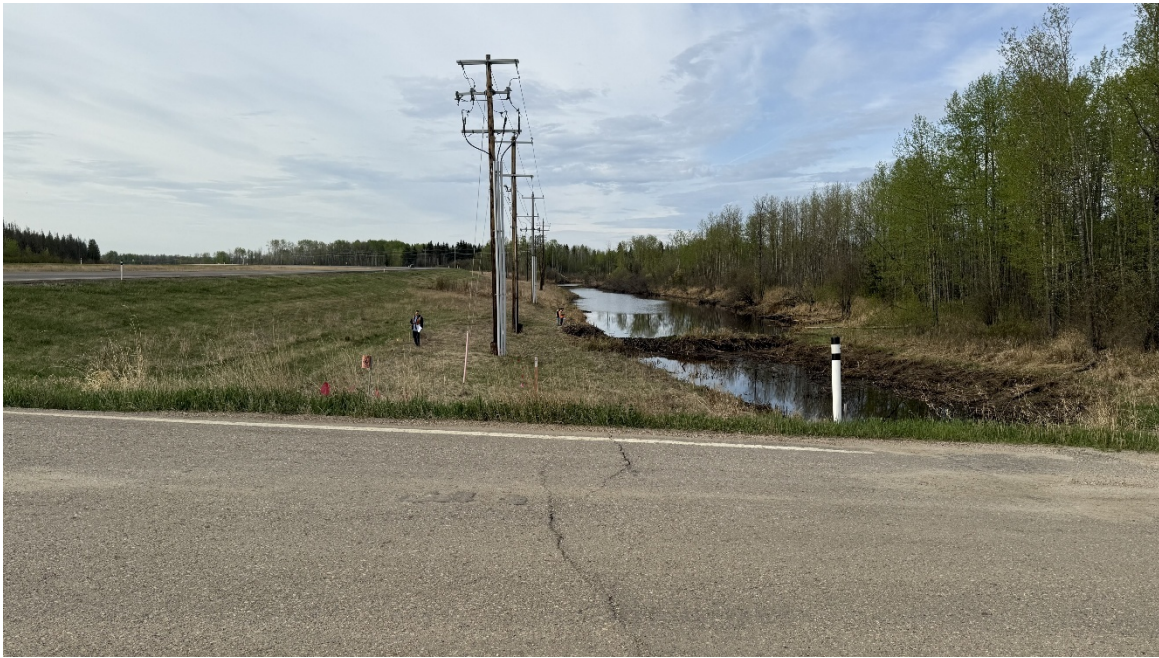
**Photo 1. Looking south at Oxbow Lake. Beaver Dam 2 visible towards center of photo. Water levels behind and in front of the dam appear similar to levels noted in the 2024 inspection.**

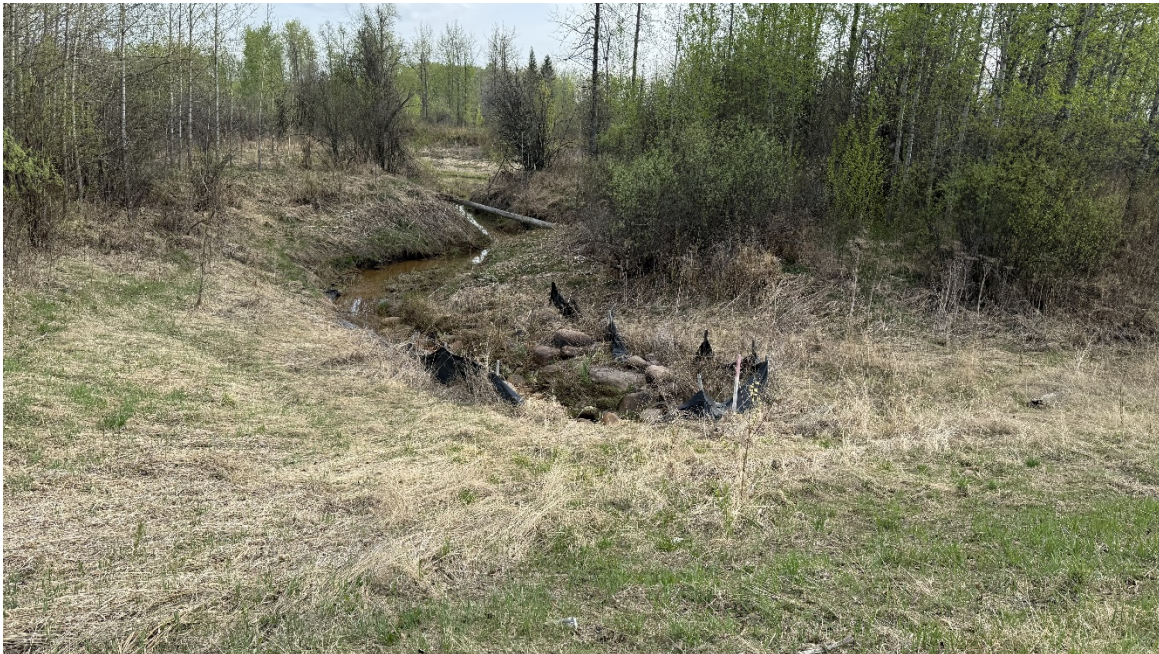
**Photo 2. Looking north at Culvert C1 outlet. Water is freely flowing through the culvert and along the channel.**

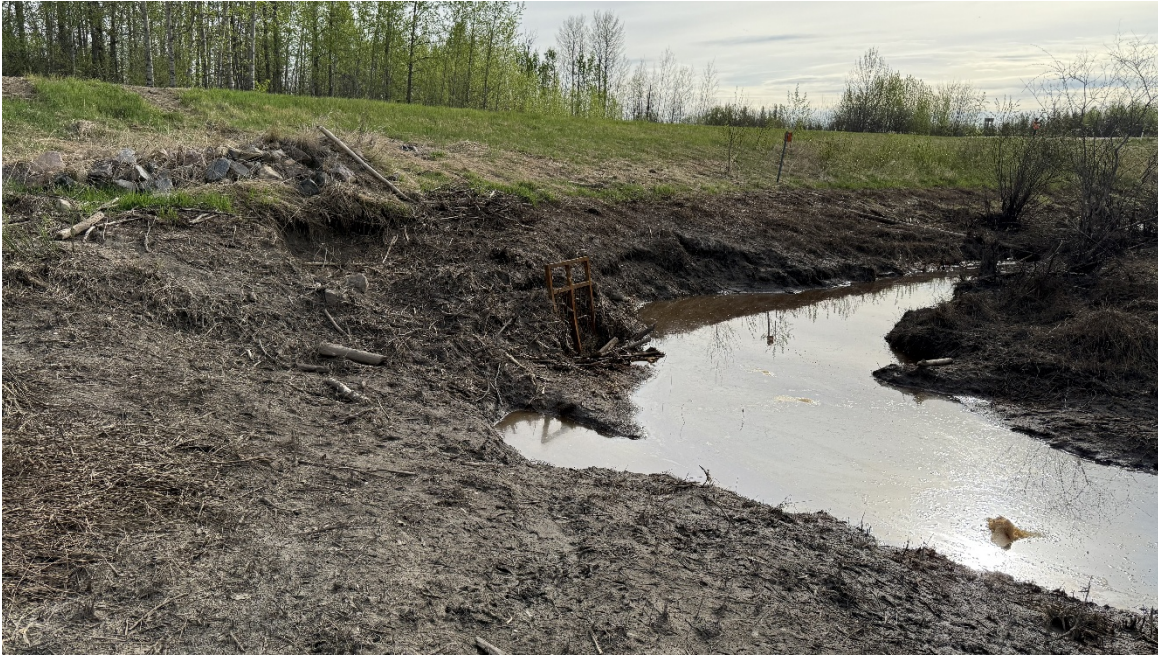
**Photo 3. Looking northeast towards the inlet of CSP Culvert C1. Debris has been removed from the culvert inlet since the 2024 inspection.**

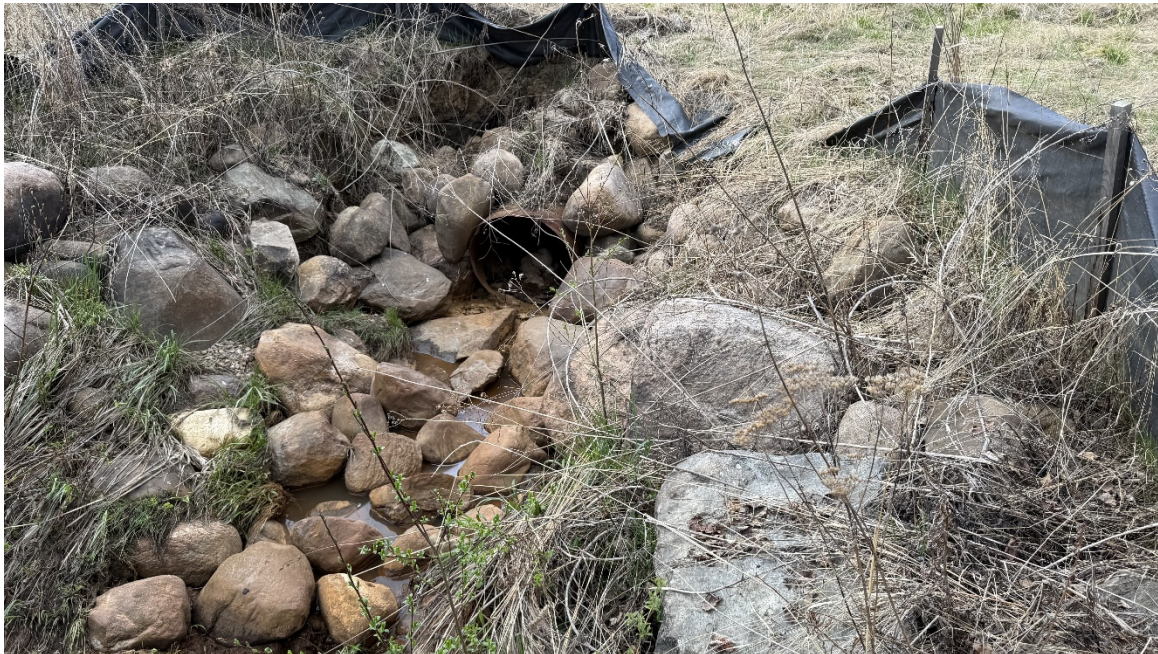
**Photo 4. Steady water flow from Culvert C1 outlet (though noticeably less than during 2024 inspection). Bottom of culvert barrel is severely corroded at outlet.**

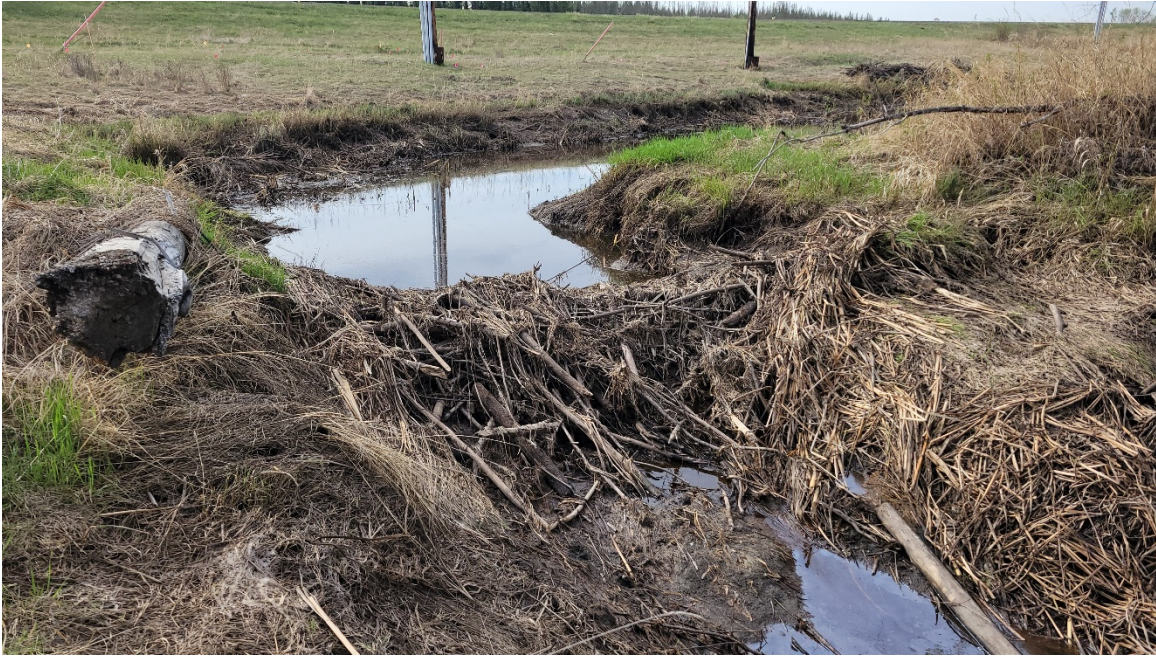
| <input checked="" type="checkbox"/> Other | Three beaver dams were previously noted within the Oxbow Lake. Beaver Dam 1 was cleared in 2020; Beaver rebuilt NE corner of Dam 2 after 2023 inspection. Beaver Dam 3 has been exposed since 2022. A new beaver dam (Dam 1A) was noted near the start of the east-west running drainage channel at the north end of the oxbow lake. | <input type="checkbox"/> |

**Photo 5. New beaver dam 1A at north end of Oxbow Lake**

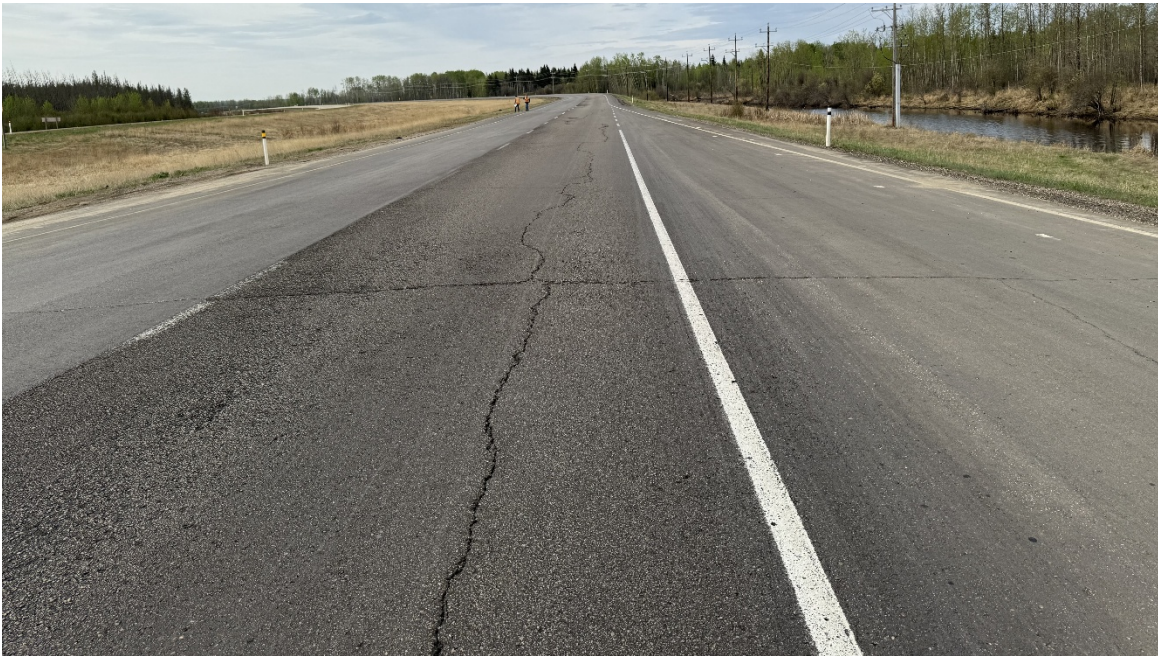
**Photo 6. Looking south at highway within the limits of the area repaired in 1997 (previously known as NC08-1). Highway was overlaid in September 2024, but reflective cracks (10-100 mm wide, no drop) are visible through the new ACP.**

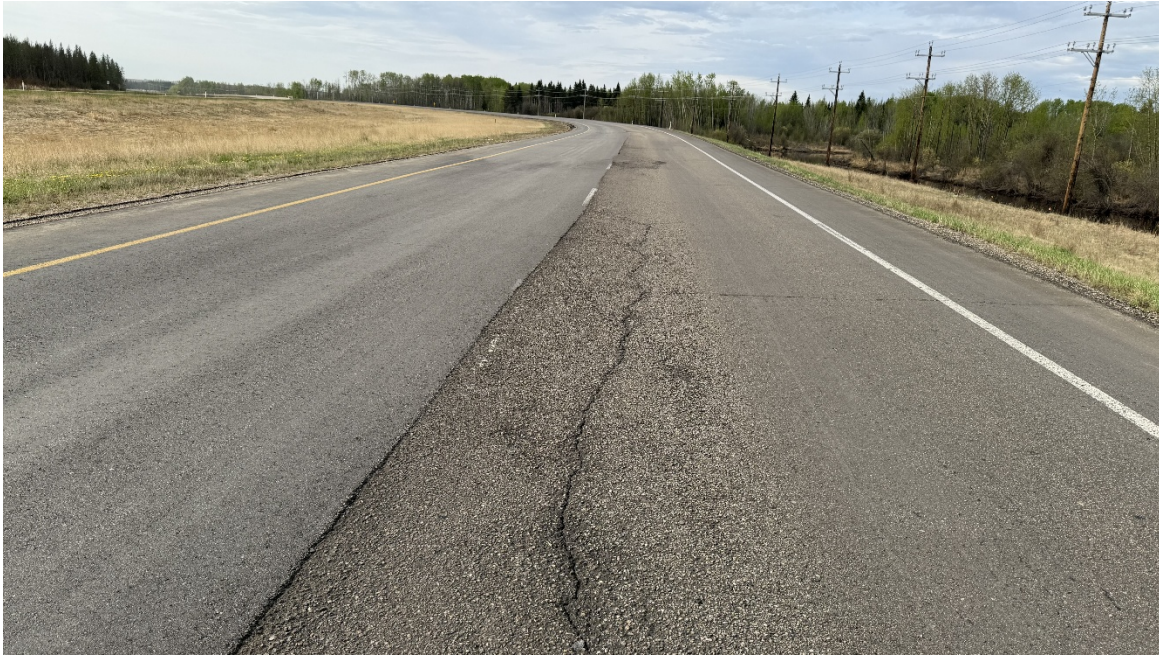
**Photo 7. Looking south at highway within the limits of the NC08-1 repaired area. Reflective cracks are visible through the ACP overlay area.**

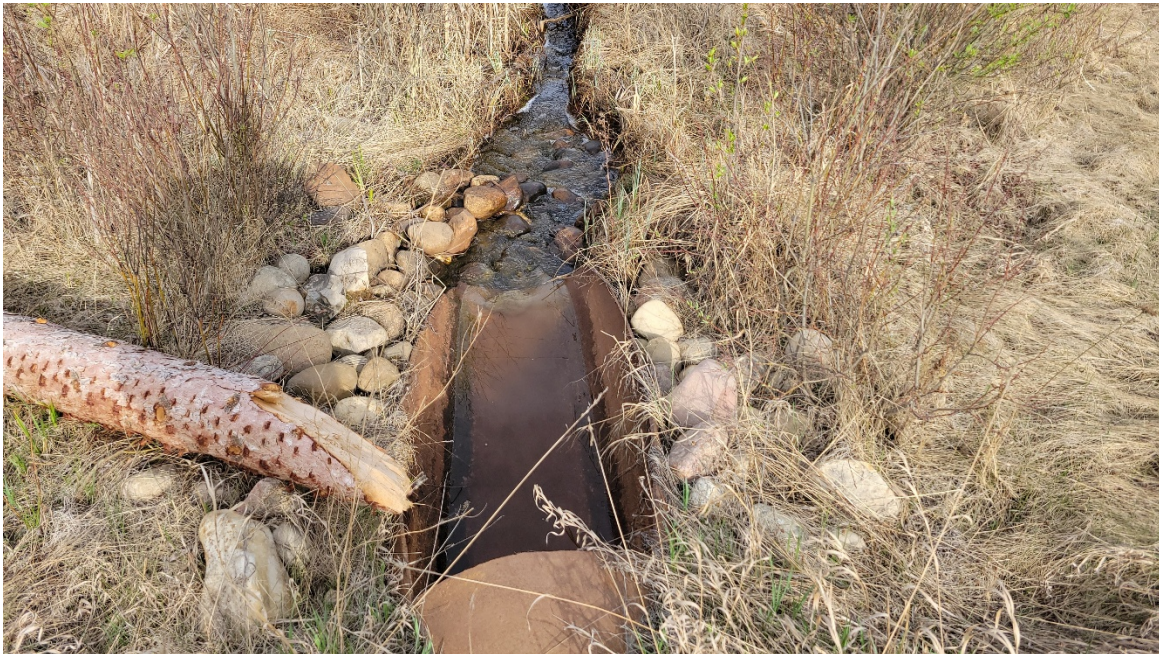
**Photo 8. Looking at the outlet of the 900 mm SWSP C2 Culvert outlet. Lighter flow than noted in the 2024 inspection.**

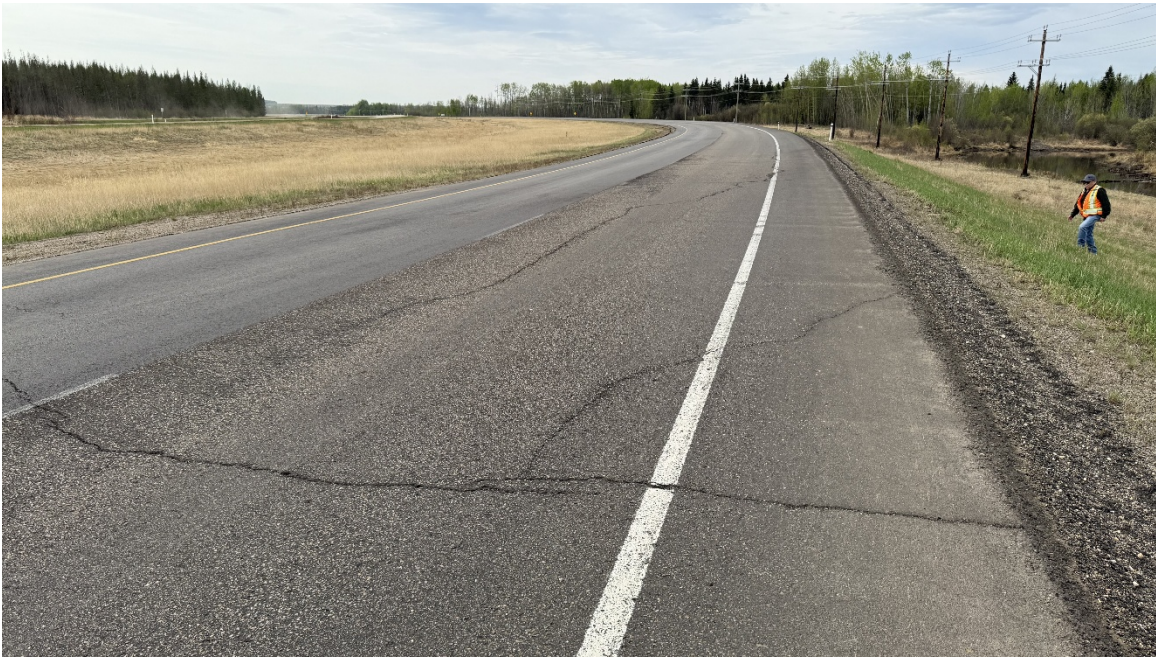
**Photo 9. Looking south at the southern flank cracks of the NC08-1 repaired landslide.**

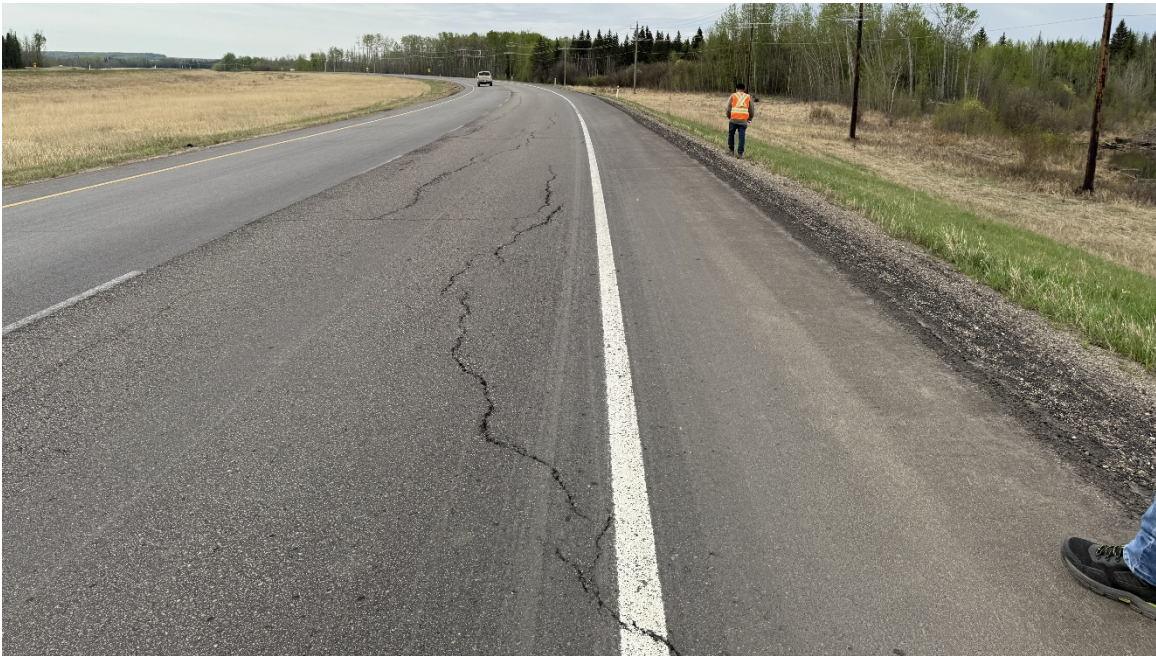
| <input checked="" type="checkbox"/> Pavement Distress | New landslide (NC008-2): reflective landslide cracks through the ACP overlay up to 40 mm wide in the middle portion of the highway southbound lane. No drop noticeable in the slide area after the placement of the 2024 ACP overlay. | <input type="checkbox"/> |

**Photo 10. Looking at the northern flank of the new landslide (NC08-2). Previous ACP patch is no longer visible (new ACP overlay completed September 2024). Reflective cracks 10-20 mm wide are visible in the ACP overlay.**

- (a) Monitor the highway surface periodically for signs of distress and watch closely for the development of additional cracks and highway dip (particularly after prolonged rainfall events). The highway surface cracks at NC008-2 location should be sealed to prevent surface water infiltration into the landslide mass.
- (b) Consider removing all beaver dams within the oxbow lake to further reduce water levels within the highway embankment.

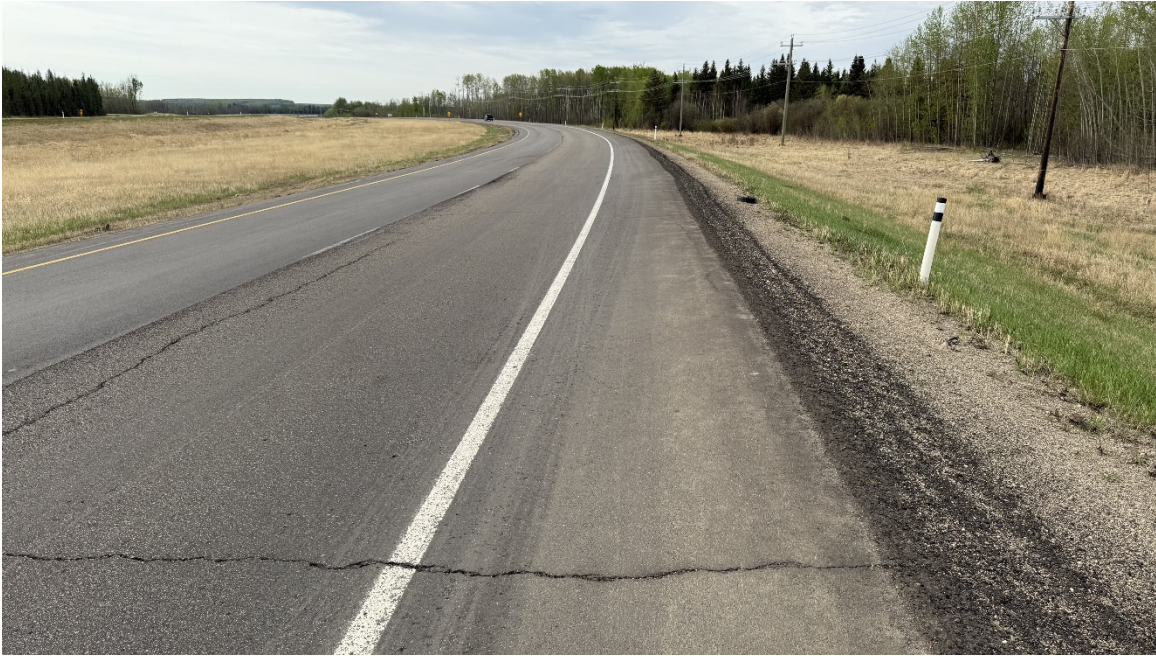
**Photo 11. Looking south at middle section of the NC08-2 landslide. Reflective cracks 5-10 mm wide are visible in the recent ACP overlay.**

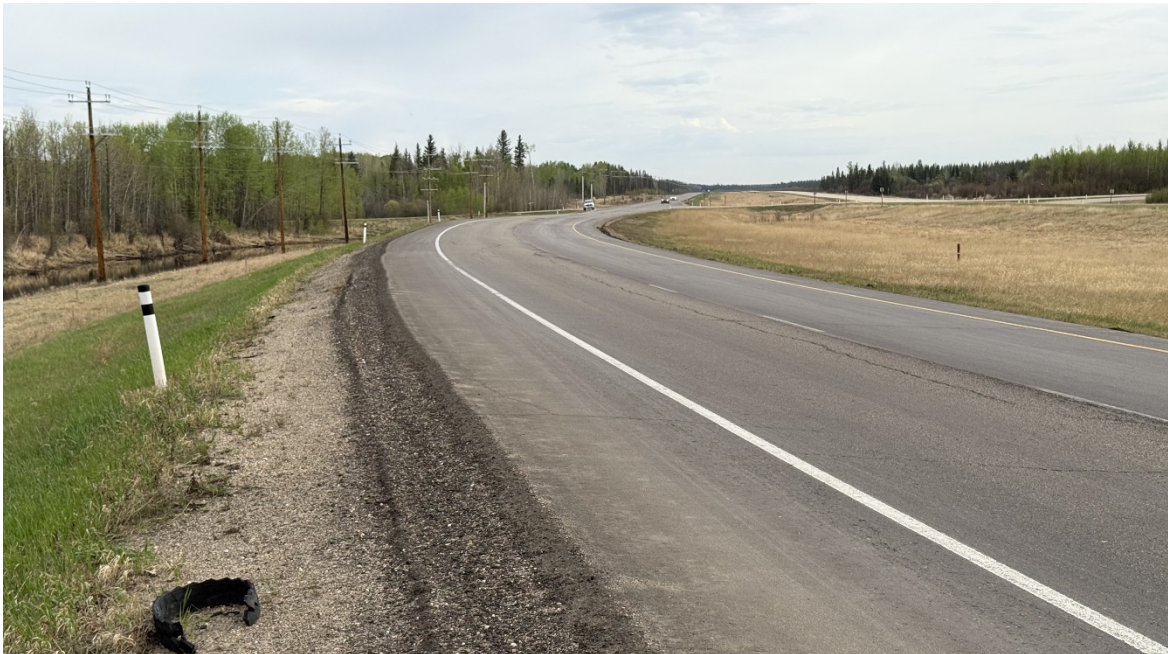
**Photo 12. Looking north at southern flank of NC08-2 landslide. Hairline cracks are visible through the recent ACP overlay.**

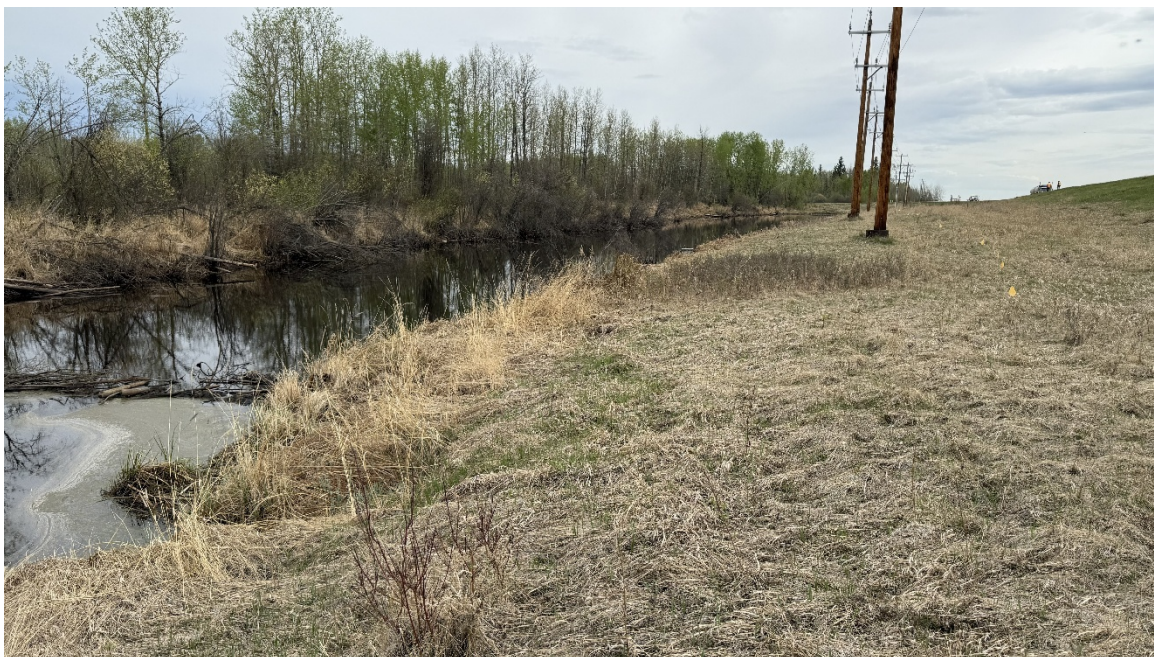
| <input checked="" type="checkbox"/> Slope Movement | New landslide (NC008-2): Multiple reflective head scarp cracks reappeared shortly after the 2022 ACP patch; toe bulge in the oxbow lake continues to narrow the oxbow lake at the landslide location. A new crack or settlement area 100 mm wide, 150 mm deep and approximately 20 m long was noted within the northern portion of the slide mass during the current inspection. | <input type="checkbox"/> |

**Photo 13. Looking north at landslide toe bulge. Beaver Dam 3 is visible at the left of the photo.**
