ALBERTA TRANSPORTATION AND  
ECONOMIC CORRIDORS GRMP  
NORTH CENTRAL (ATHABASCA AND FORT  
McMURRAY DISTRICTS)  
INSTRUMENTATION MONITORING - SPRING 2025

| Site Number | Location | Name | Hwy | km |
|---|---|---|---|---|
| NC008 | HWY 63:02 L1 15.635 | North of La Biche River | 63:02 | km 15.6 |

| <b>Current Monitoring:</b> | 25-May-2025 | <b>Previous Monitoring</b> | 16-Sep-2024 |

**SITE NC008: HWY 63:02 NORTH OF LA BICHE RIVER**

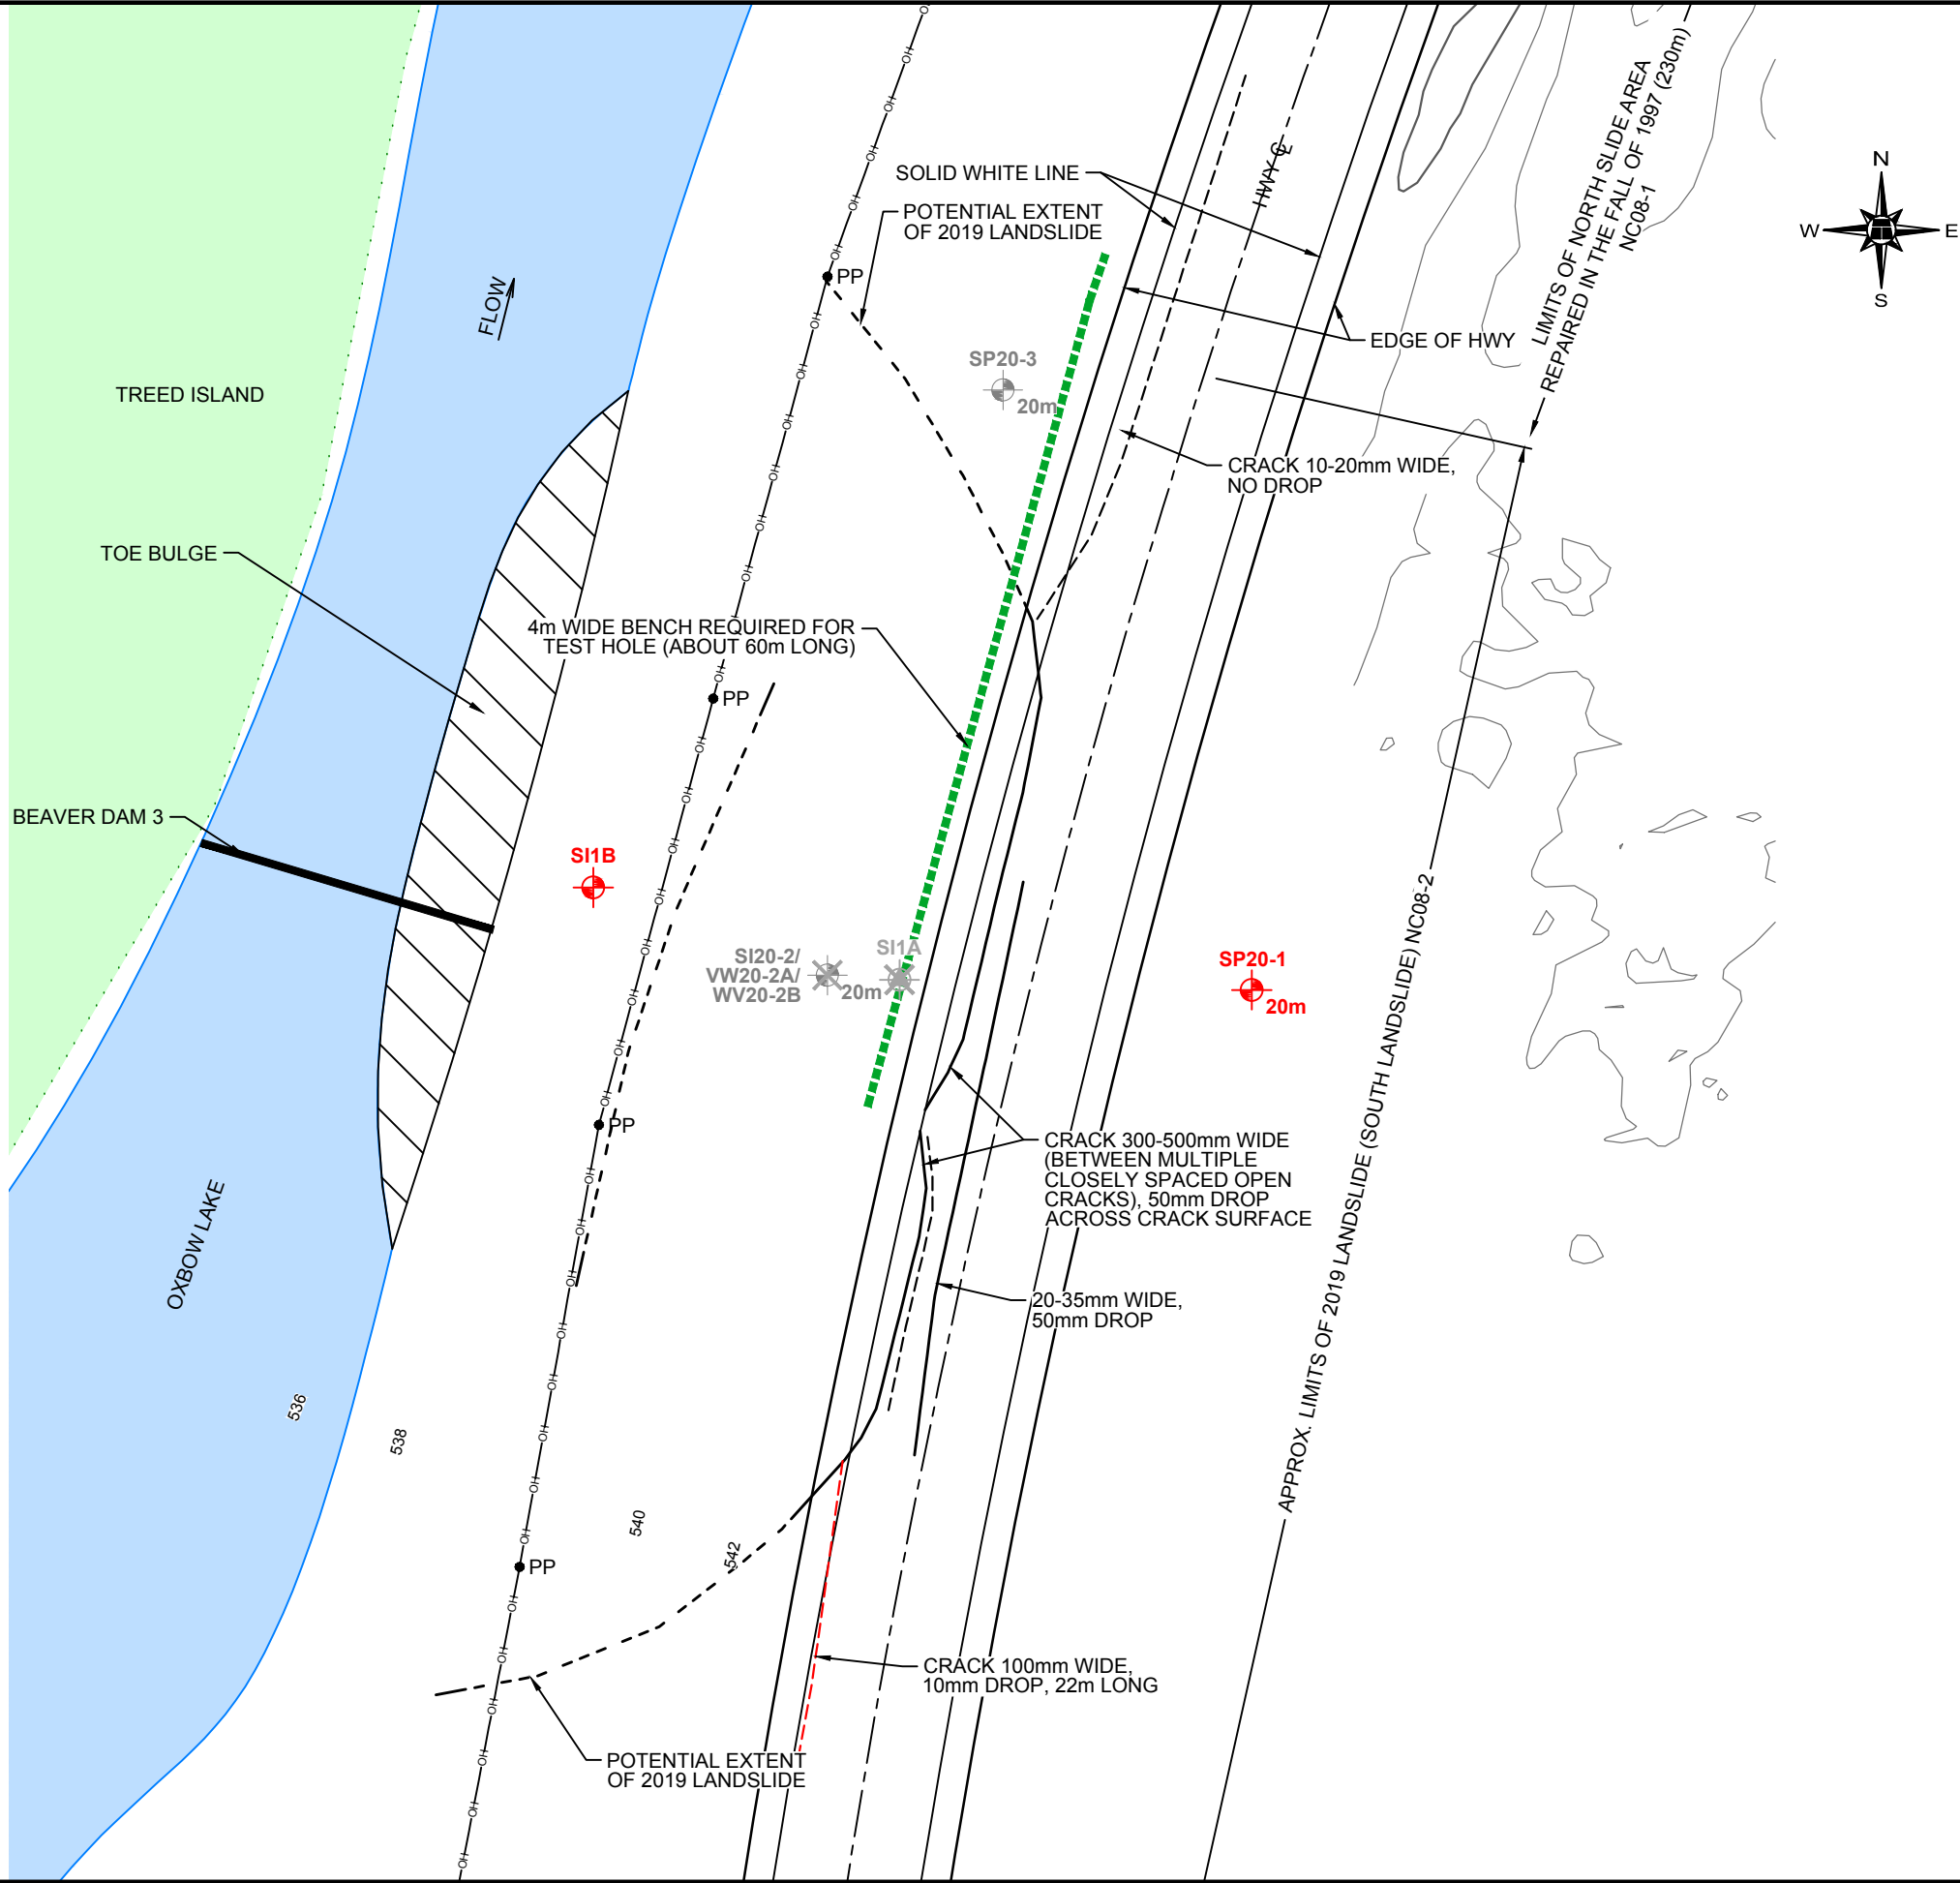
DWG No. 32122-NC008

| SI20-2 stickup protector bent and damaged. Repair needed will have to dig down atleast 3-4 ft to find cut off wire and splice. SI is bent and broken along grooves, need splice |

| Discussion | |
|---|---|
| <b>Instrumentation Repairs:</b> | SI20-2, VW20-2A and VW20-2B are critical instruments and consideration should be given to repairing these instruments in the fall of 2025. |

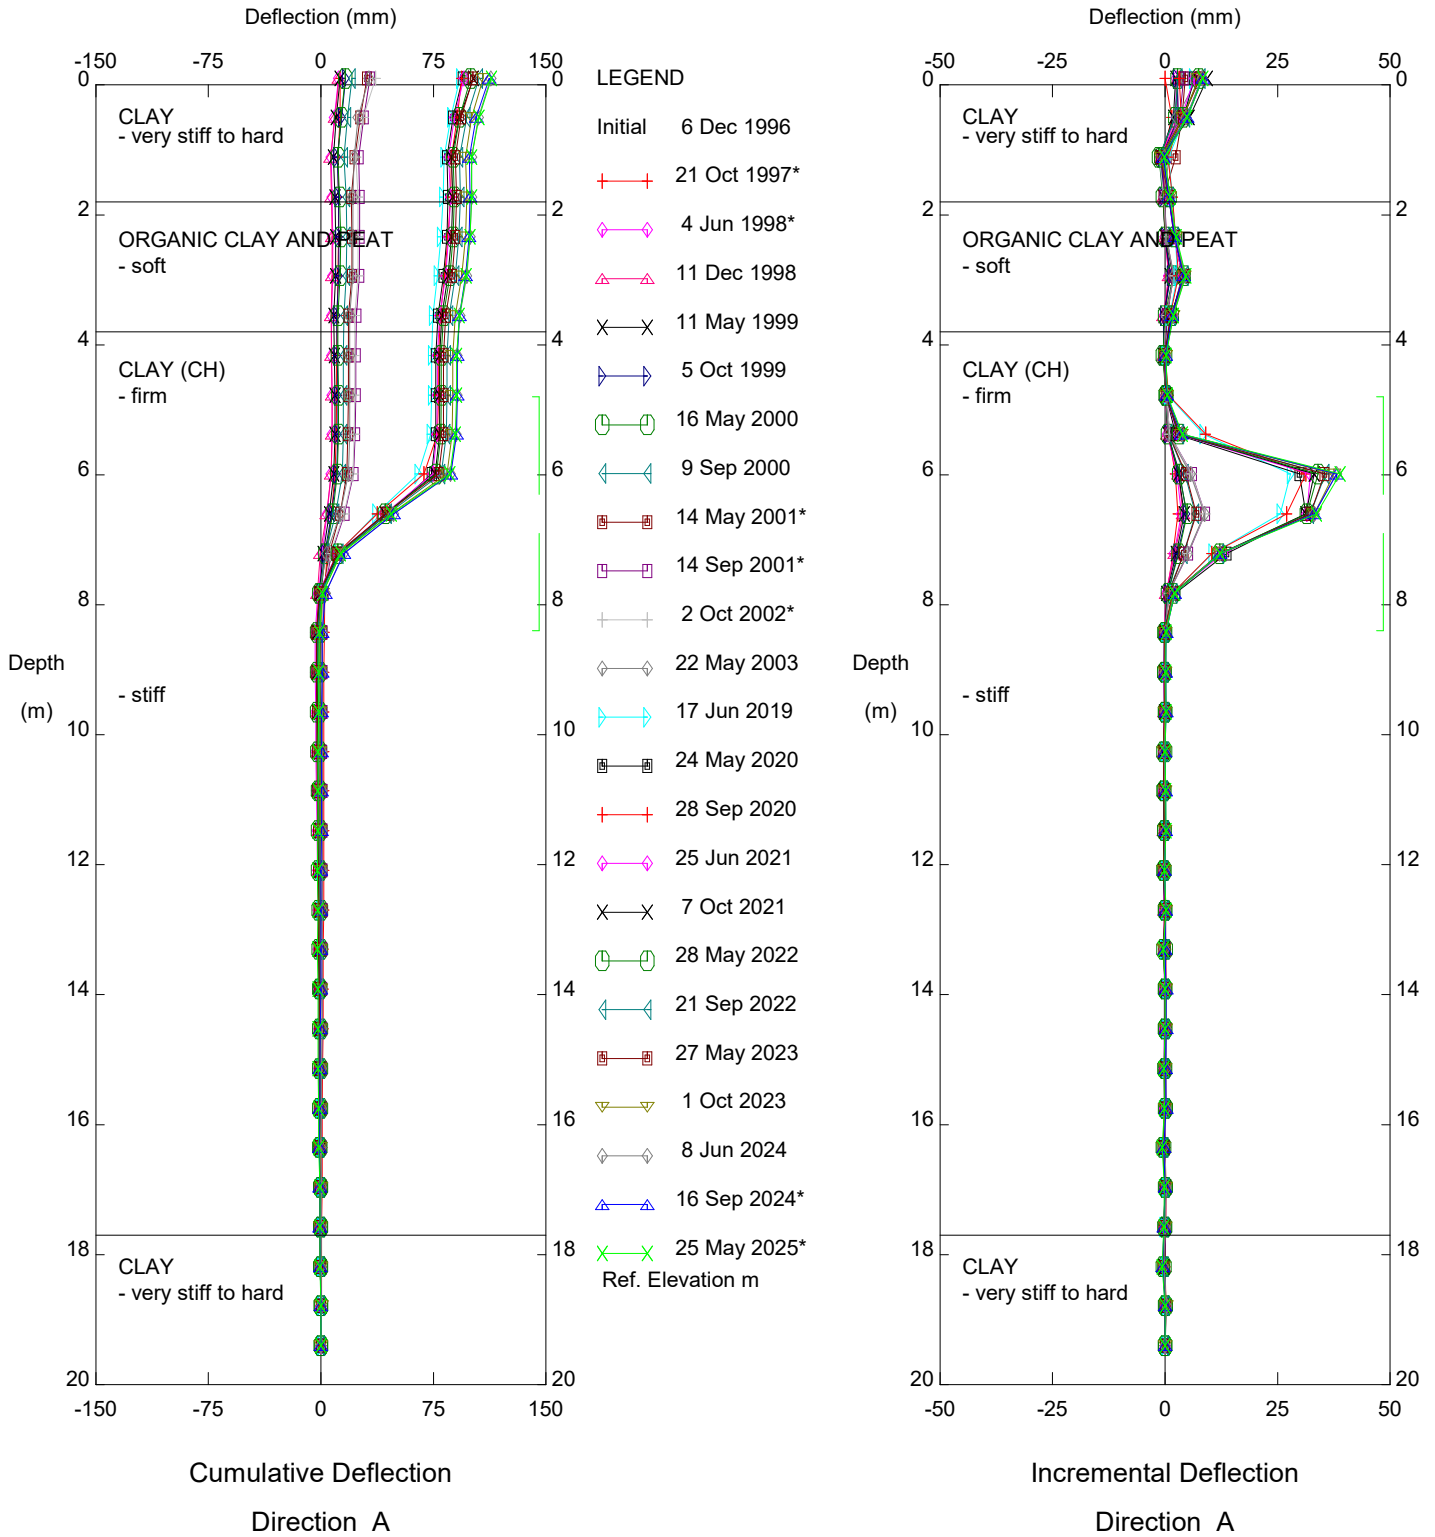
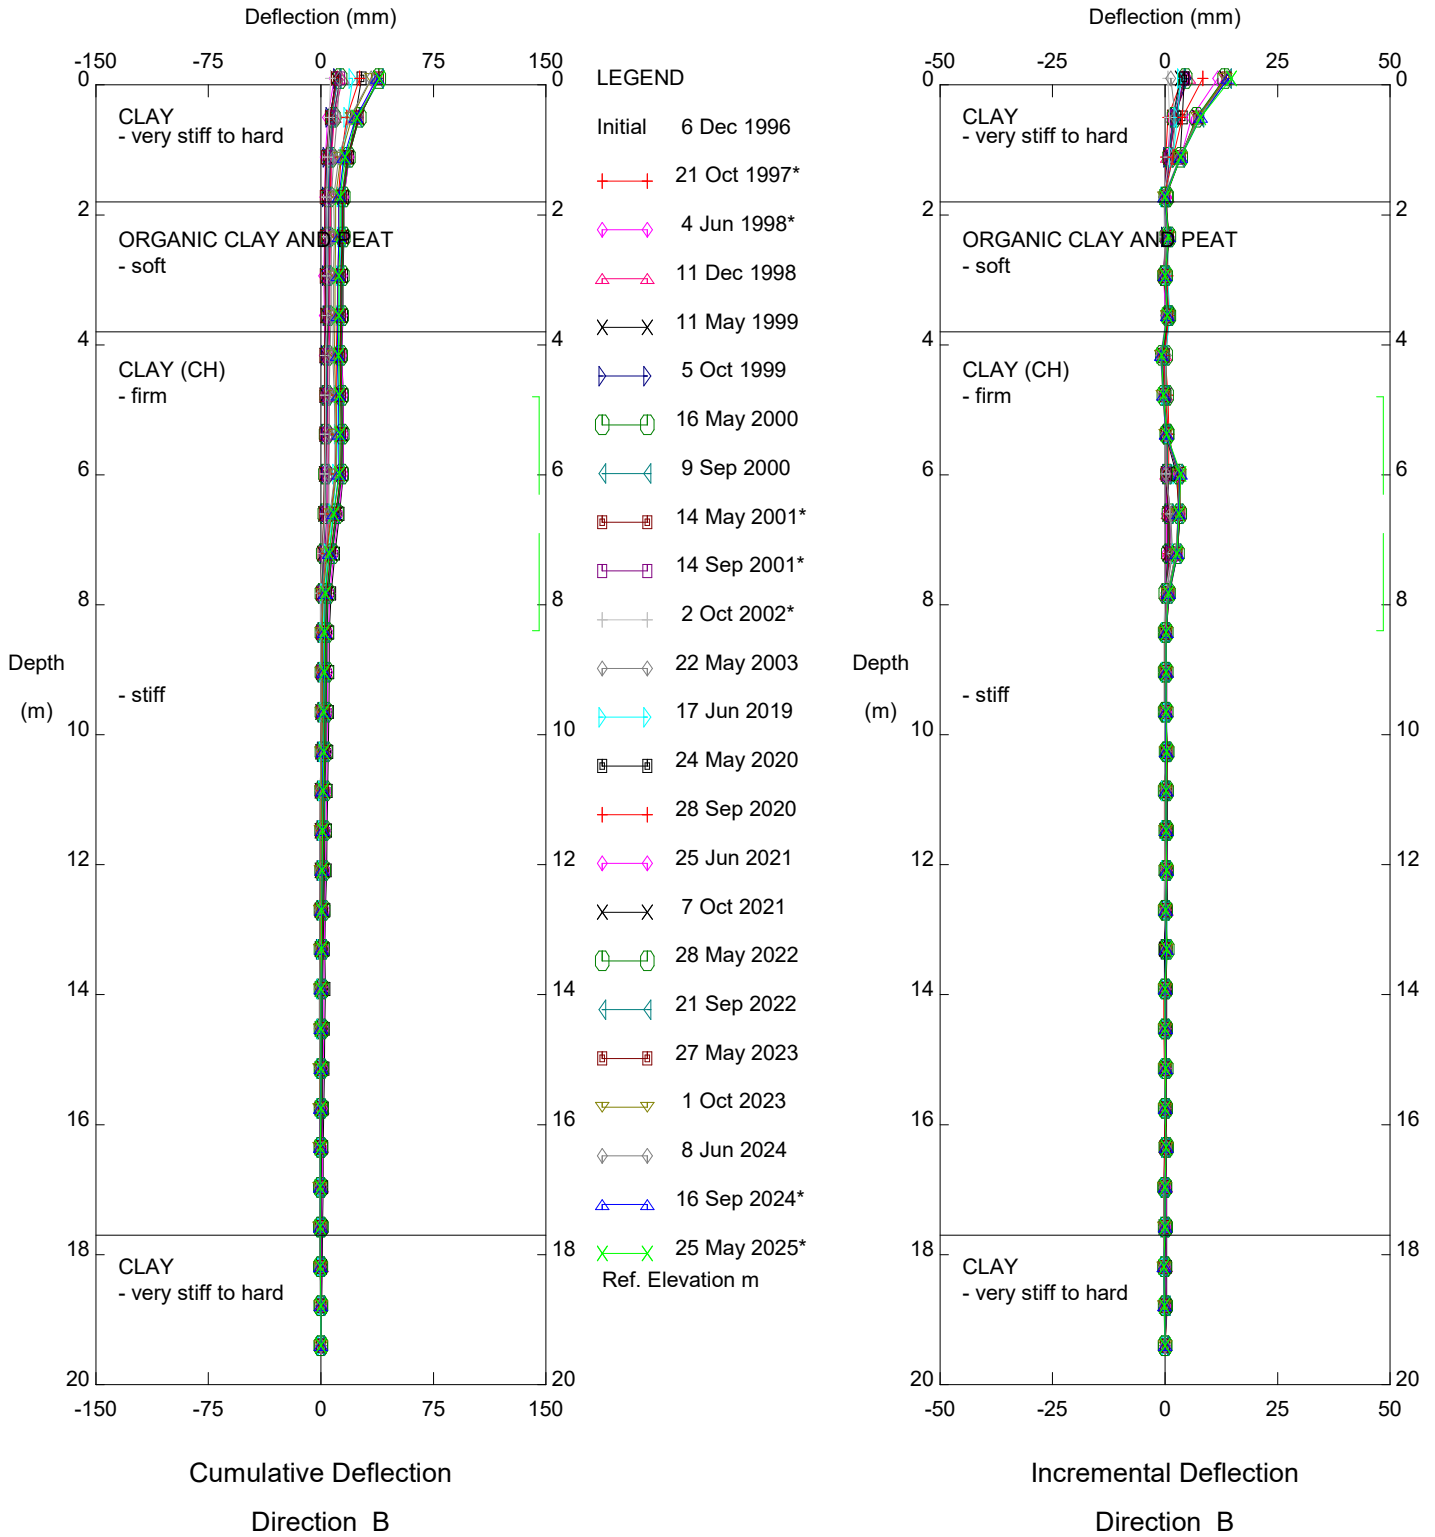
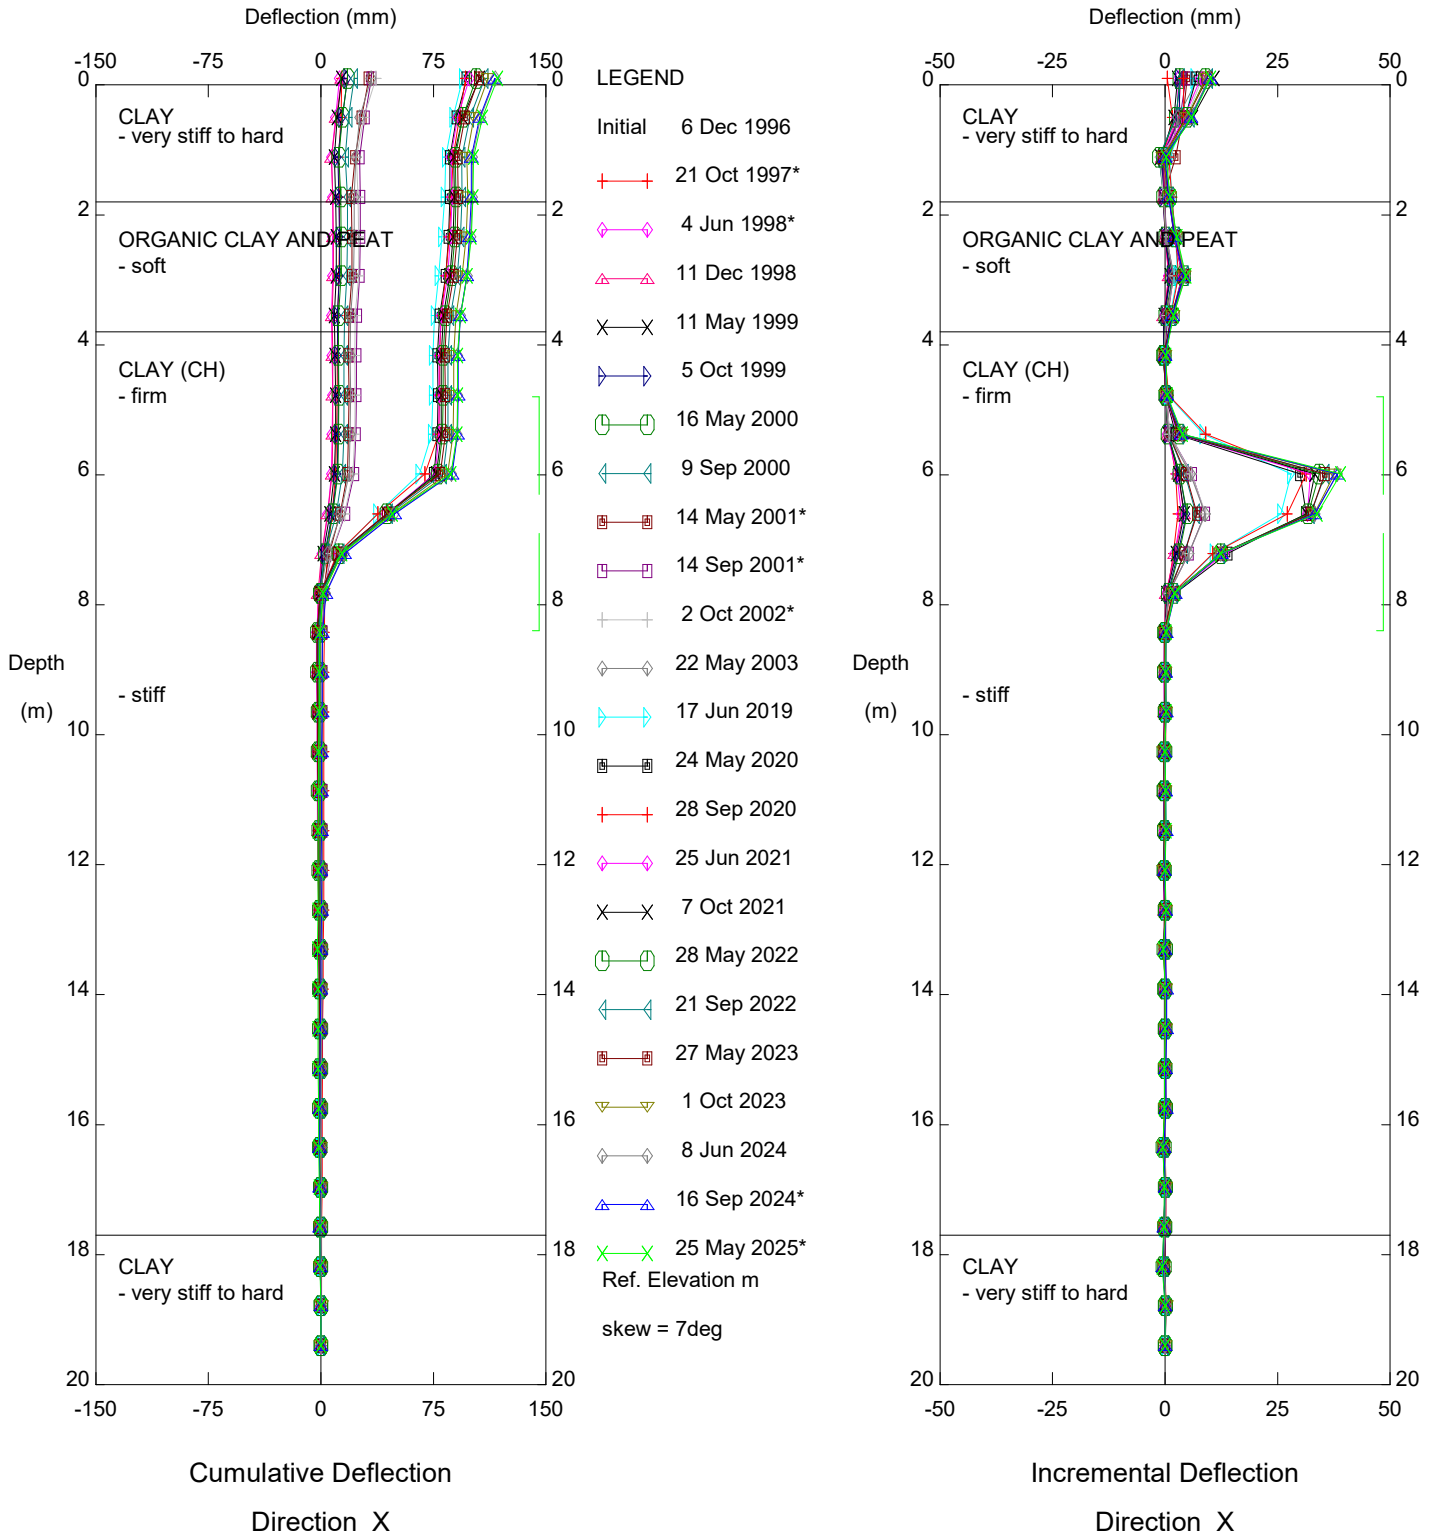
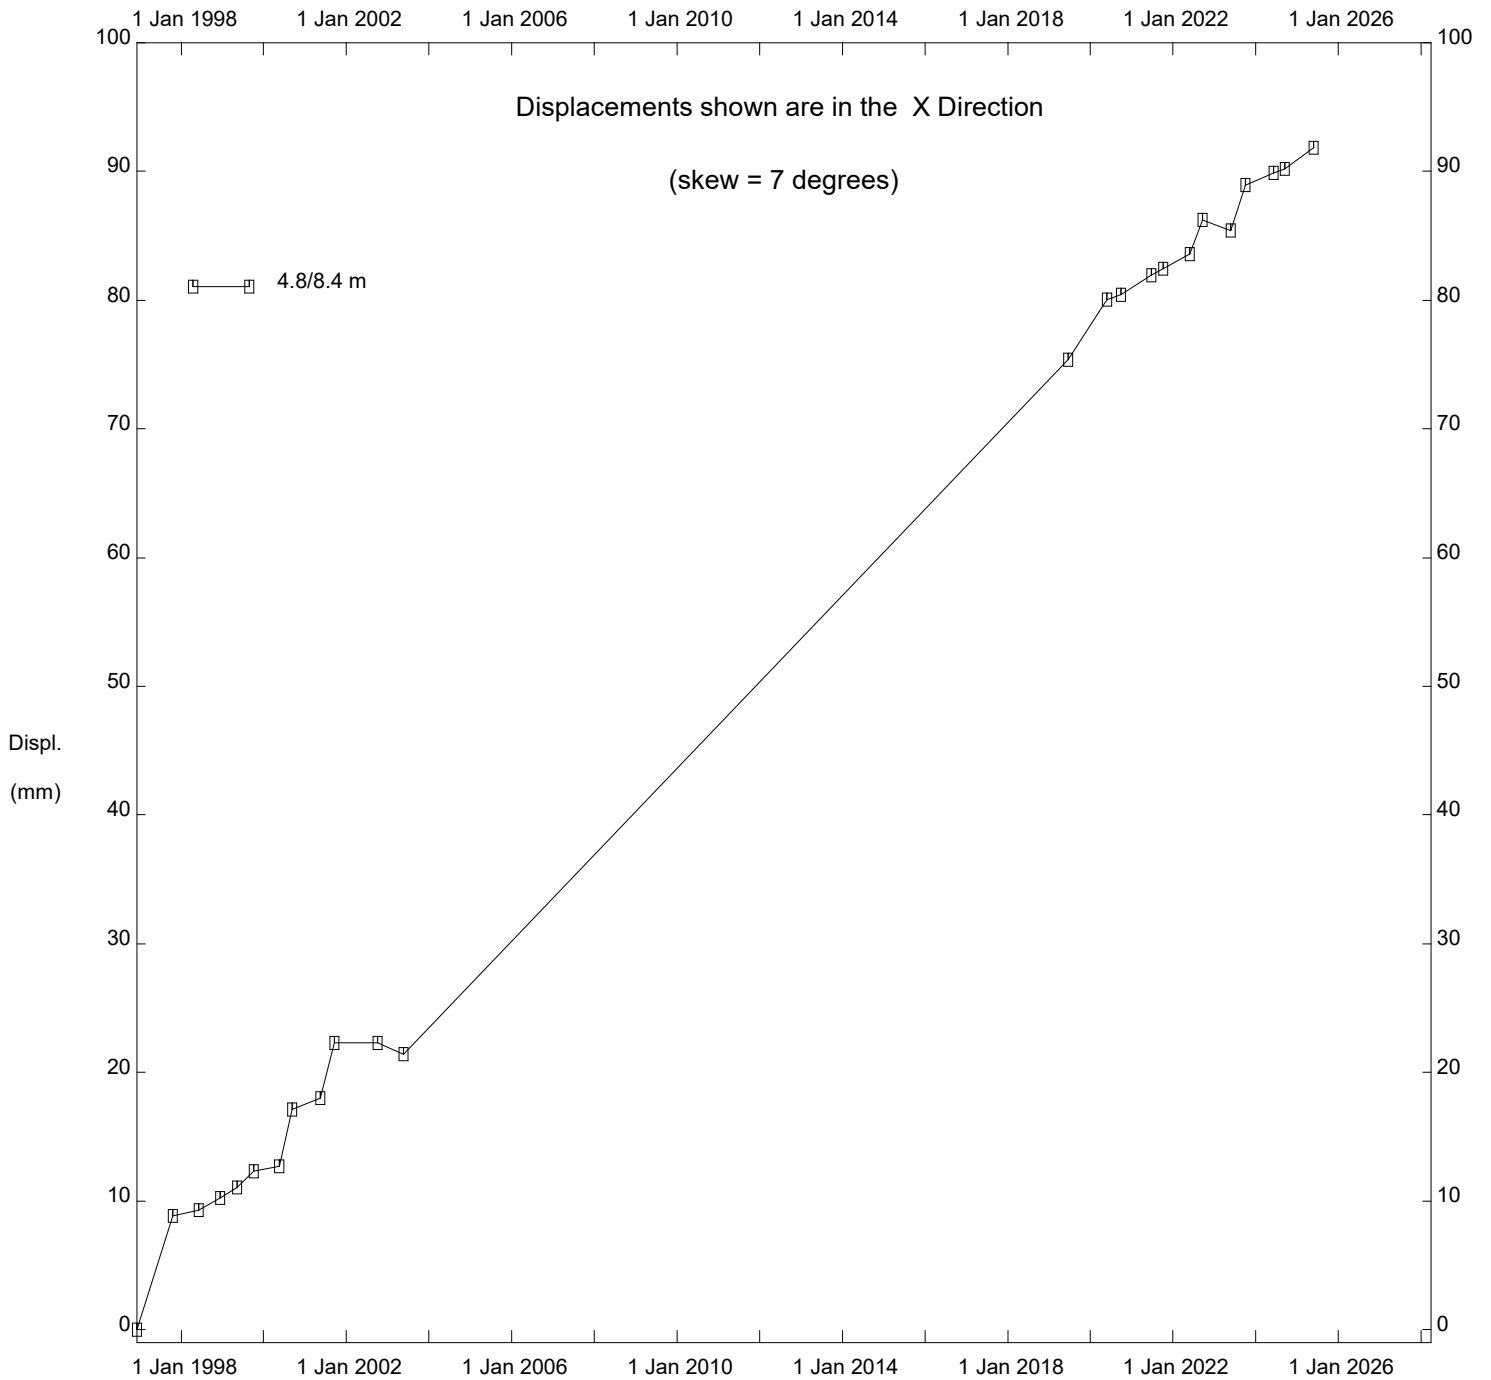
Labiche River, Inclinator SI#1B

| Discussion | |
|---|---|
| <b>Interpretation of Monitoring Results:</b> | SI1B showed a rate of movement of 2.4 mm/yr over 4.8 m to 8.4 m since the fall of 2024 readings. This corresponds to an increase in the rate of movement by 1.4 mm/yr.<br><br>Standpipe piezometer SP20-1 showed a decrease in groundwater level of 0.22 m compared to the fall of 2024 readings. |

| Discussion | |
|---|---|
| <b>Future Work:</b> | The instruments should be read again in the fall of 2025. |
