ALBERTA TRANSPORTATION AND  
ECONOMIC CORRIDORS GRMP  
NORTH CENTRAL (ATHABASCA AND FORT  
McMURRAY DISTRICTS)  
INSTRUMENTATION MONITORING - FALL 2025

| Site Number | Location | Name | Hwy | km |
|---|---|---|---|---|
| NC087 | HWY 63:02 | Fischer Trail | 63:02 | km 20.67 |

**ALBERTA TRANSPORTATION AND ECONOMIC CORRIDORS GRMP (CON0022163)  
NORTH CENTRAL (ATHABASCA AND FORT McMURRAY DISTRICTS)  
INSTRUMENTATION MONITORING RESULTS**

**SITE NC087: HWY 63:02 FISCHER TRAIL (km 20.67)**

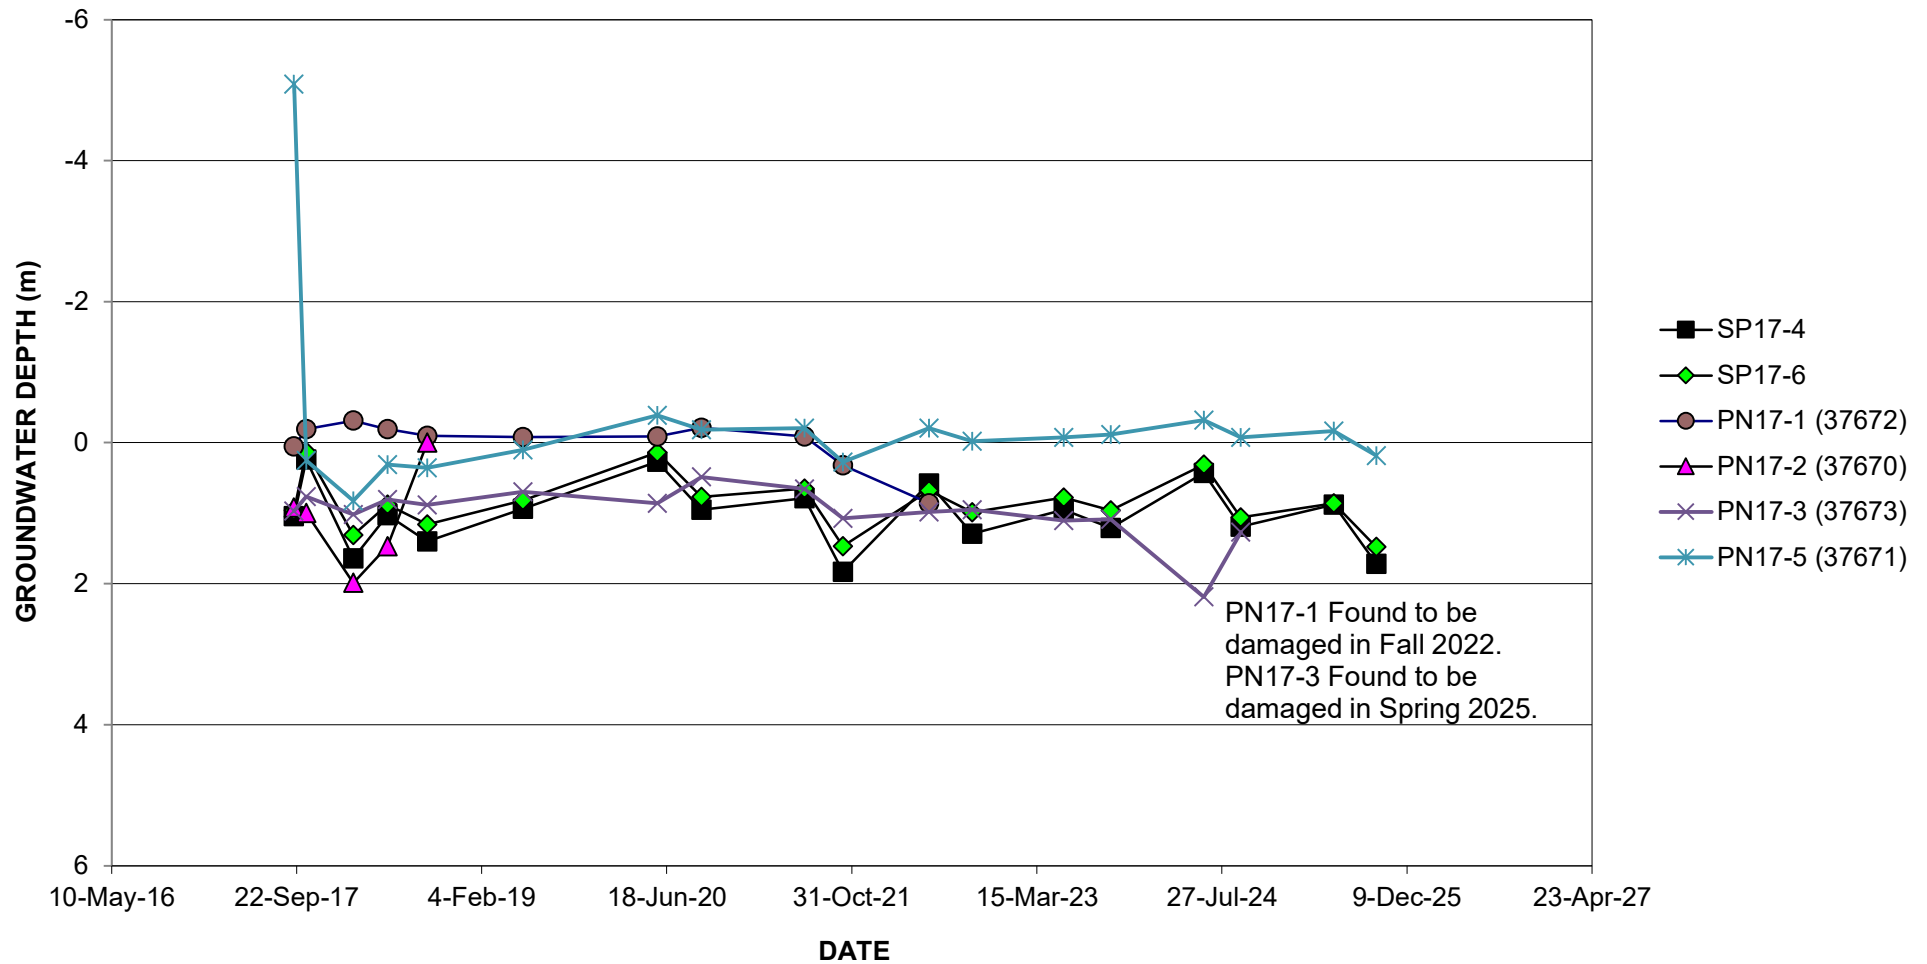
**FIGURE NC087-1**  
**PIEZOMETER DATA FOR HWY 63:02 - FISCHER TRAIL**

| Discussion | |
|---|---|
| <b>Interpretation of Monitoring Results:</b> | PN17-5 showed a decrease in groundwater level of 0.34 m since the spring of 2025 readings.<br><br>Standpipe piezometers SP17-4 and SP17-6 showed decreases in groundwater level of 0.84 m and 0.62 m, respectively, since the spring of 2025 readings. |
