**ALBERTA TRANSPORTATION AND  
ECONOMIC CORRIDORS GRMP  
NORTH CENTRAL (ATHABASCA AND FORT  
McMURRAY DISTRICTS)  
2025 SITE INSPECTION**

| Site Number | Location | Name | Hwy | km |
|---|---|---|---|---|
| NC087 | Hwy 63, 20.75 km north of Hwy 55 | Fischer Trail Slide | 63:02 | 20.75 |

**NORTH CENTRAL REGION  
(ATHABASCA AND FORT MCMURRAY DISTRICTS)  
2025 GEOHAZARD ASSESSMENT**

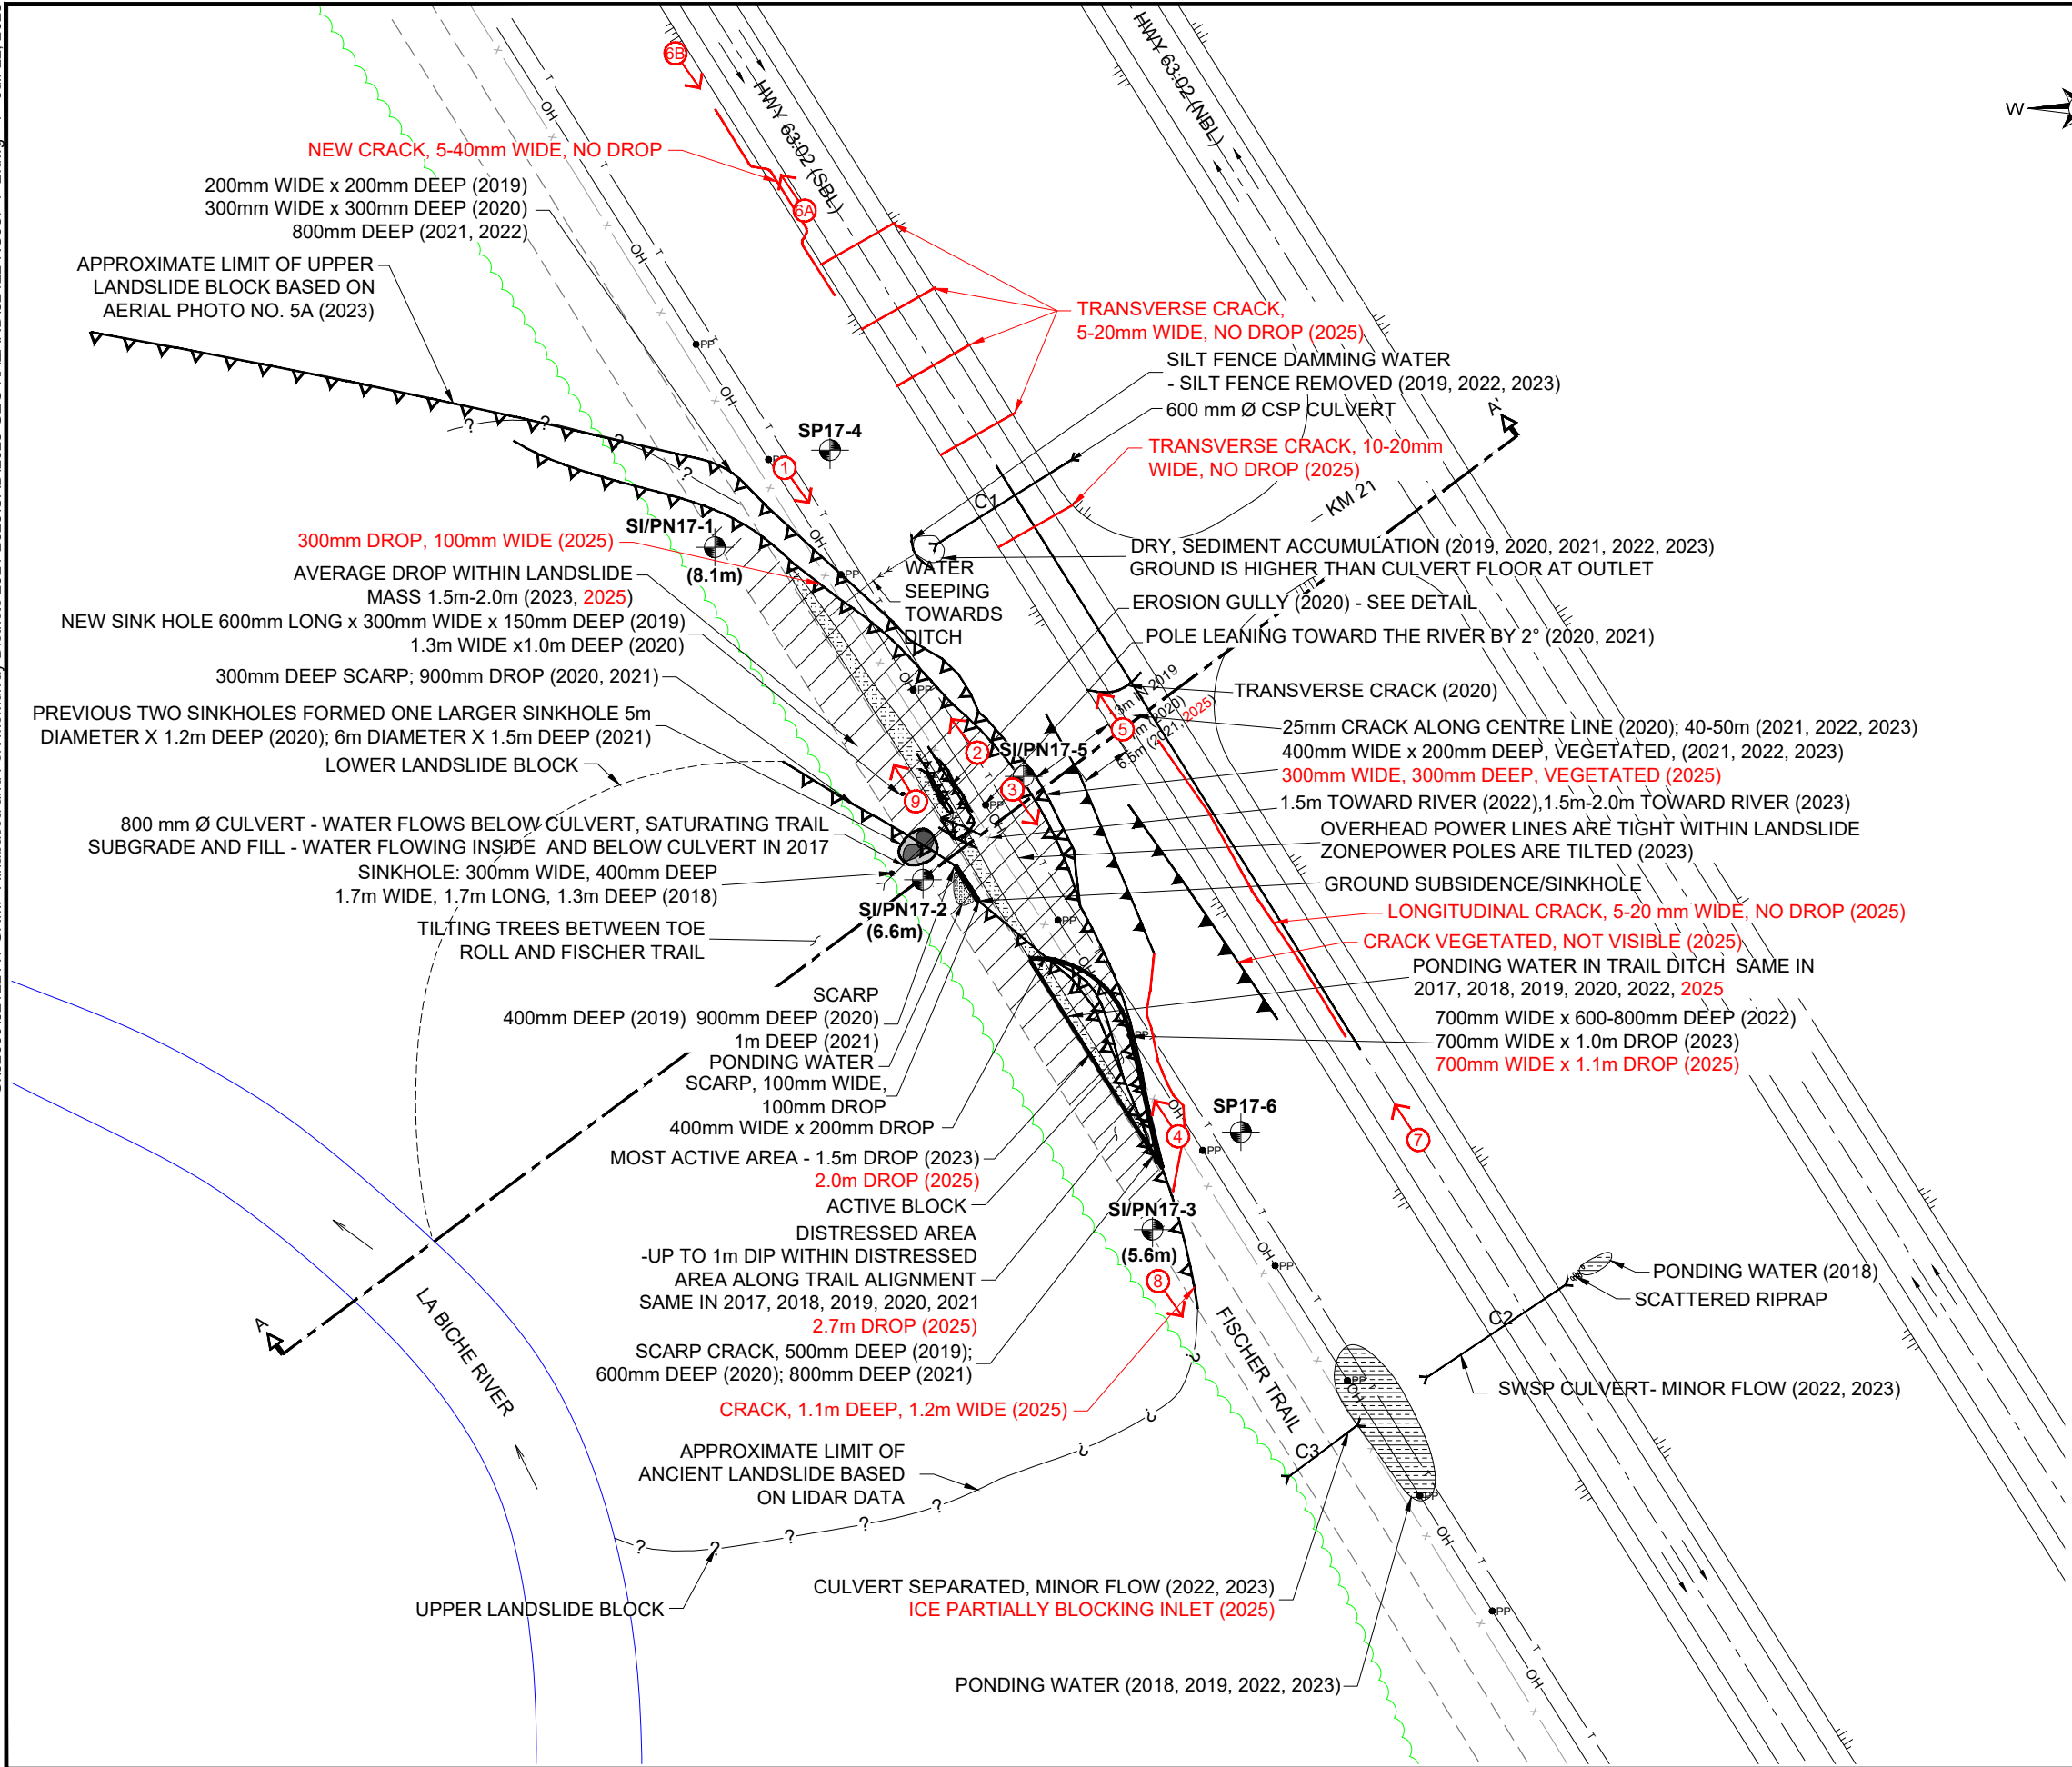
**FIGURE 1**

| <input checked="" type="checkbox"/> Slope Movement | Tension crack within 6.5 m from the edge of the highway; open head scarp cracks within the upper and lower landslide blocks (100 to 700 mm wide, and 100 mm to 2.0 m drop); leaning/tilting trees between the west edge of the trail and the pronounced toe roll area. Overall drop within Fischer trail area up to 2.7 m. | <input checked="" type="checkbox"/> |

**NC087- HWY 63:02 FISCHER TRAIL SLIDE (km 20.7)  
SITE SKETCH SHOWING LANDSLIDE FEATURES**

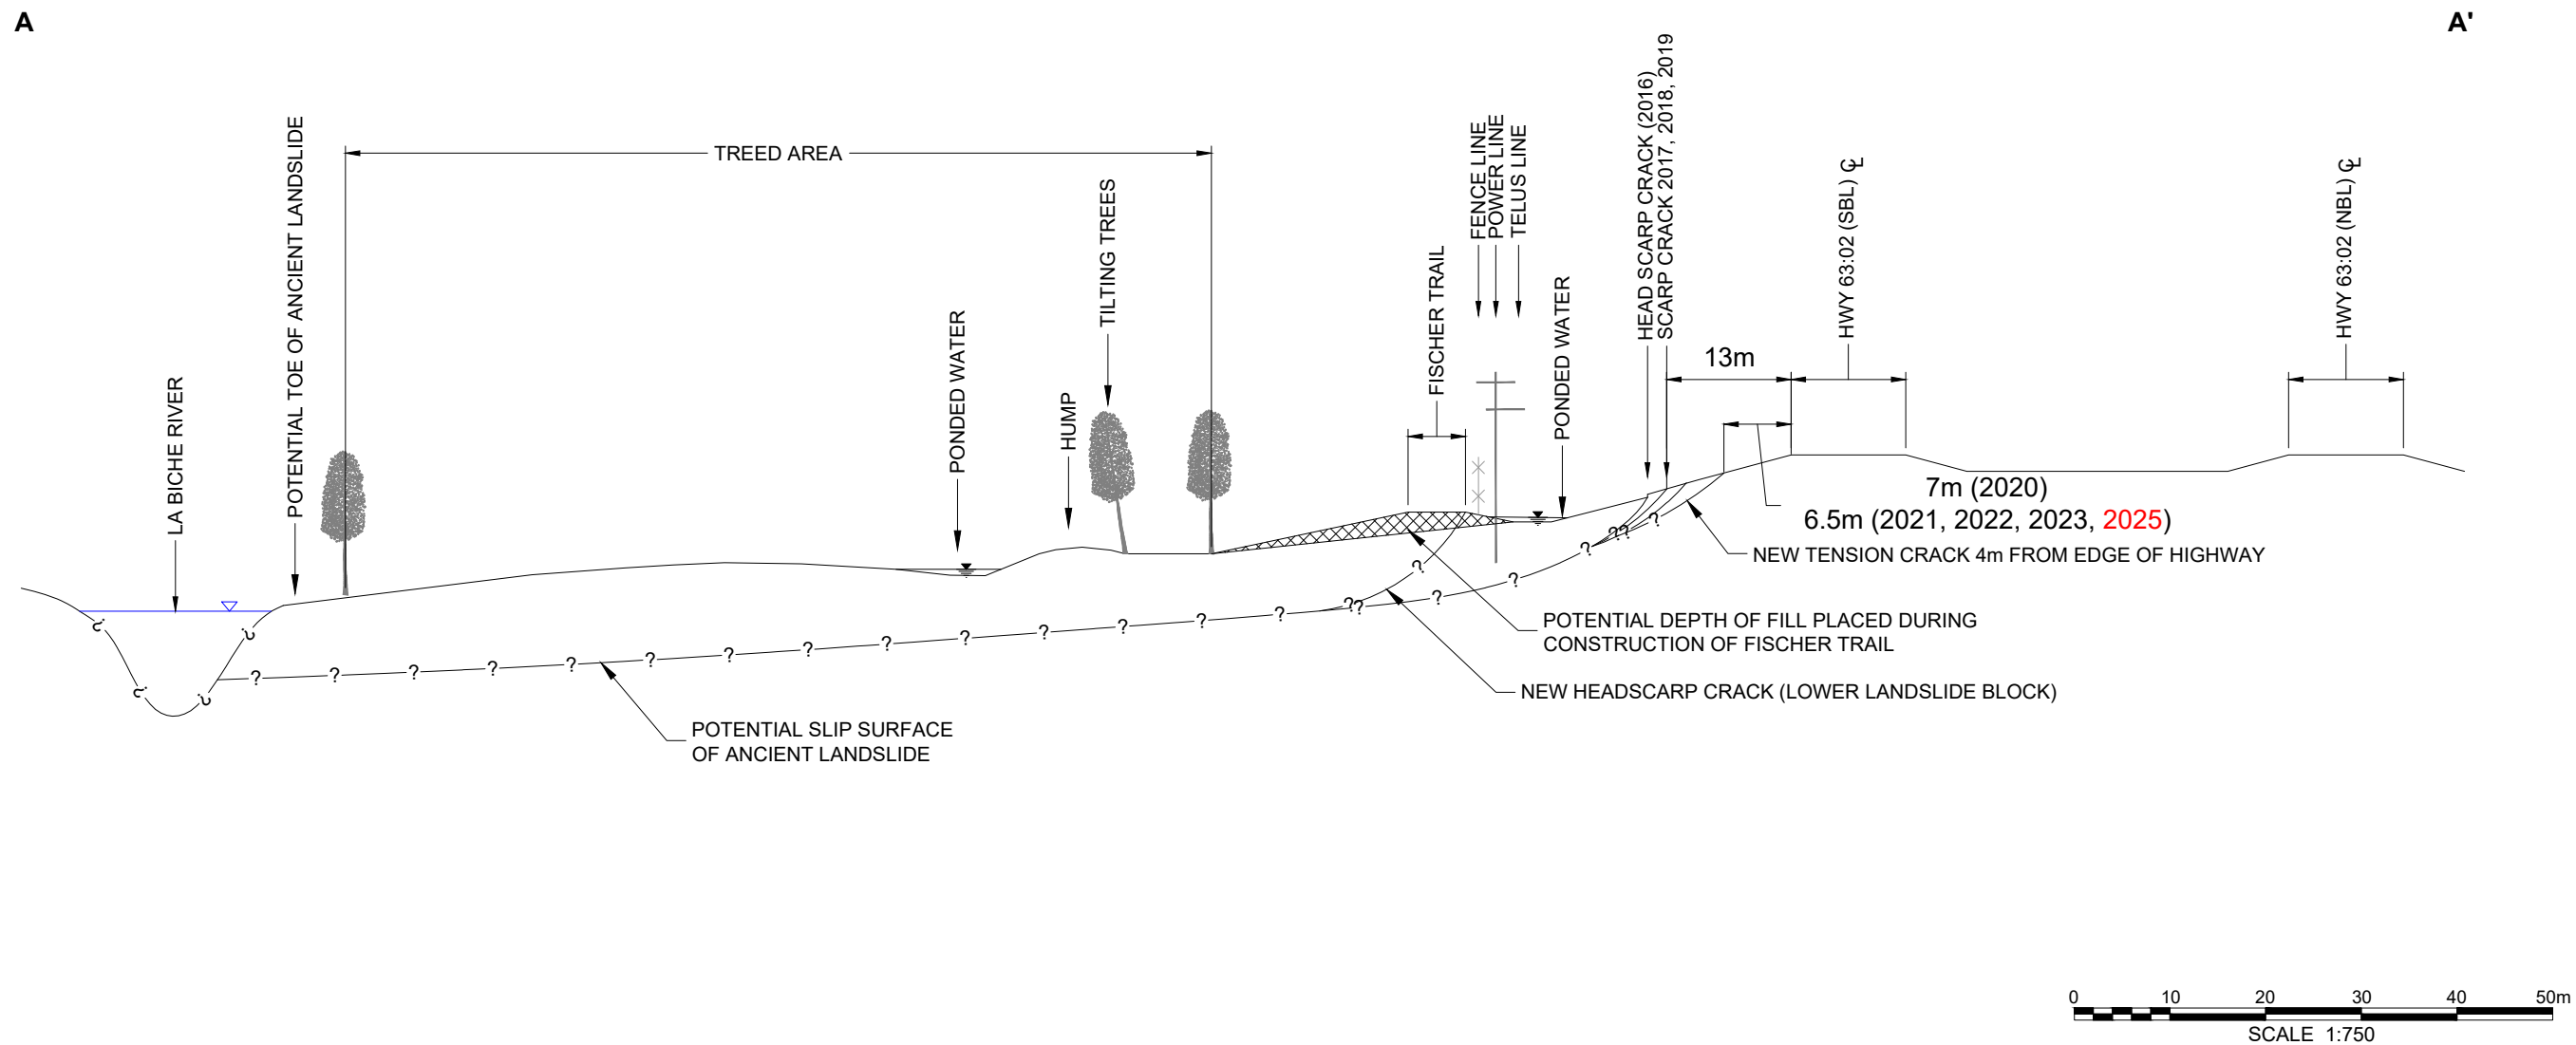
**FIGURE 2**

**NC087- HWY 63:02 FISCHER TRAIL SLIDE (km 20.7)  
CROSS-SECTION A-A'**

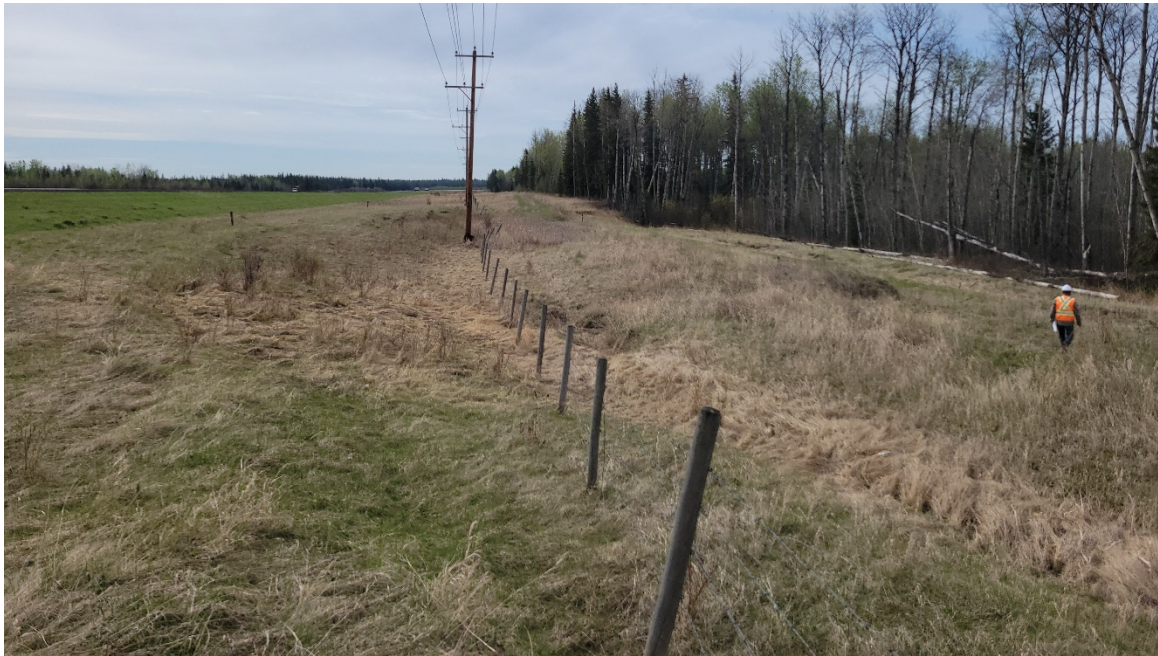
**Photo 1. Looking south at head scarp crack of upper landslide block**

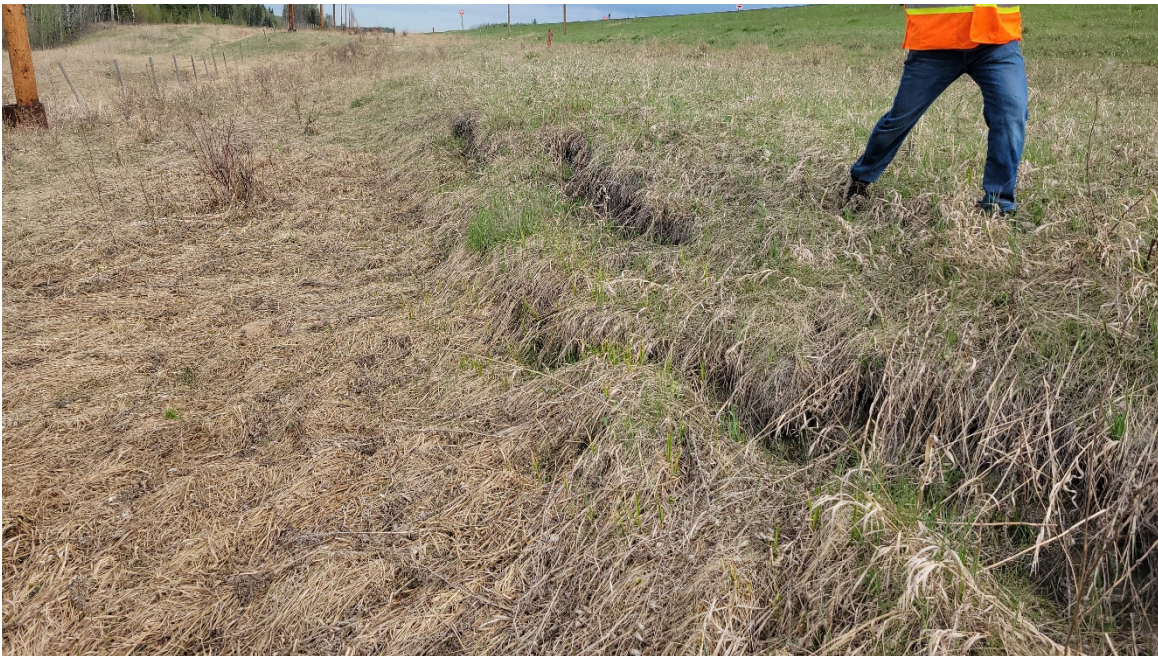
**Photo 2. Looking north at slide backscarp crack (300 mm wide, up to 200 mm deep).**

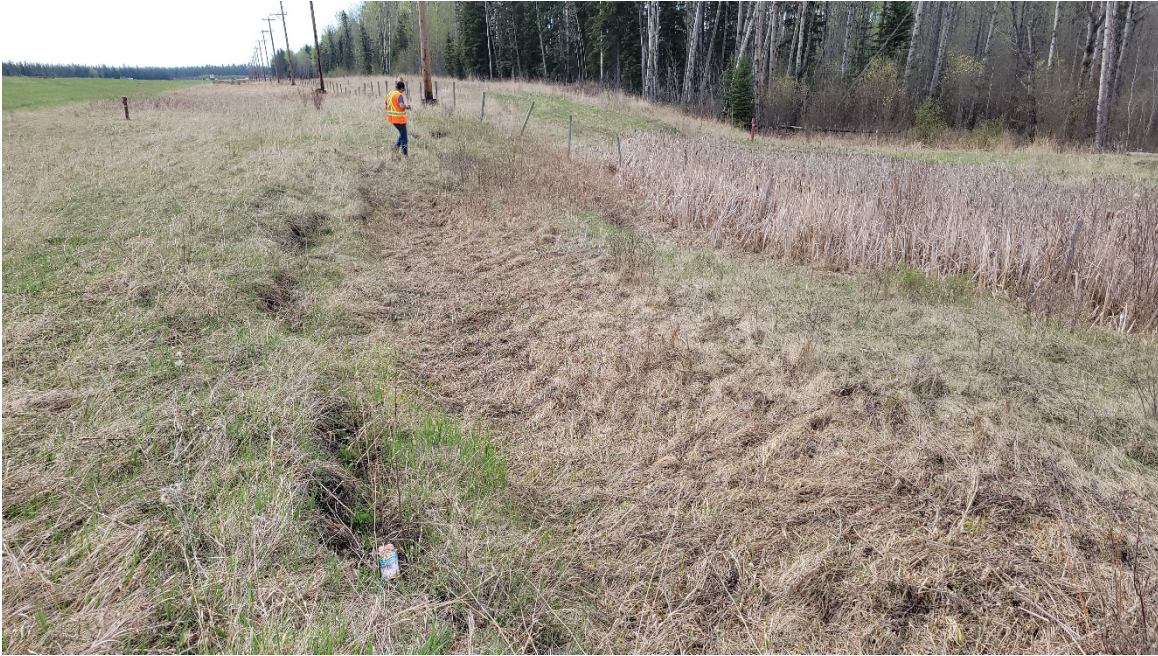
**Photo 3. Looking south towards the southern flank of the landslide (700 mm wide cracks, up to 1.1 m drop). Water is ponding along the ditch between the trail and the fence (note the cat tails in this area).**

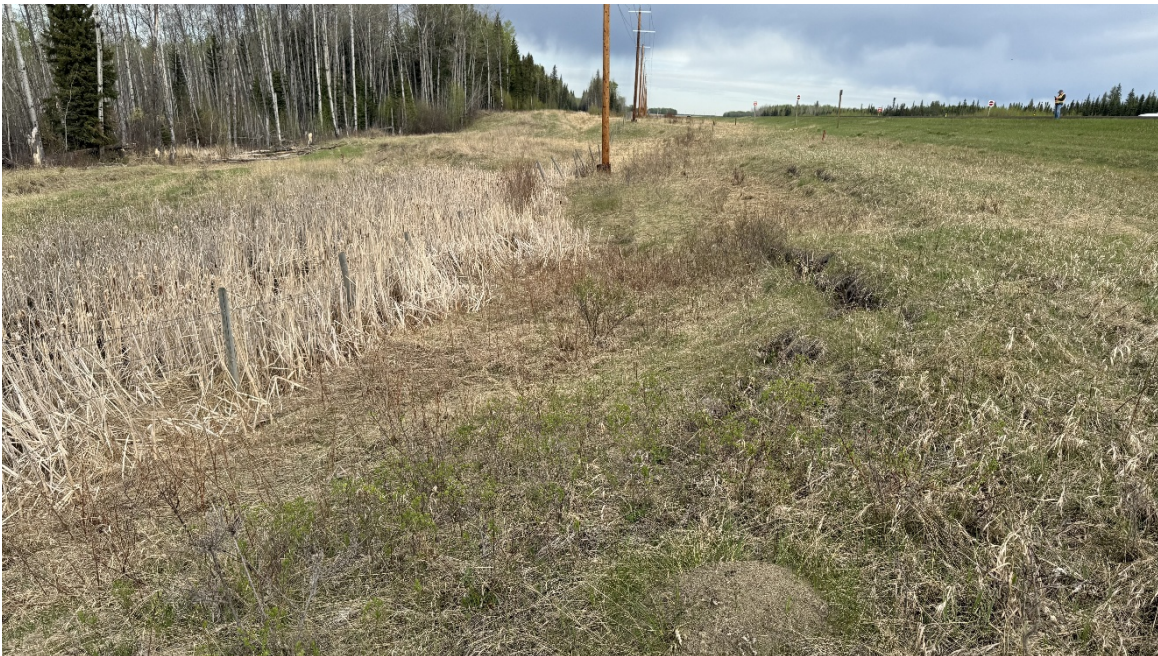
**Photo 4. Looking north at the southern flank of upper and lower landslide blocks; note standing water within the flank and lateral shifting of fence. Landslide is well vegetated.**

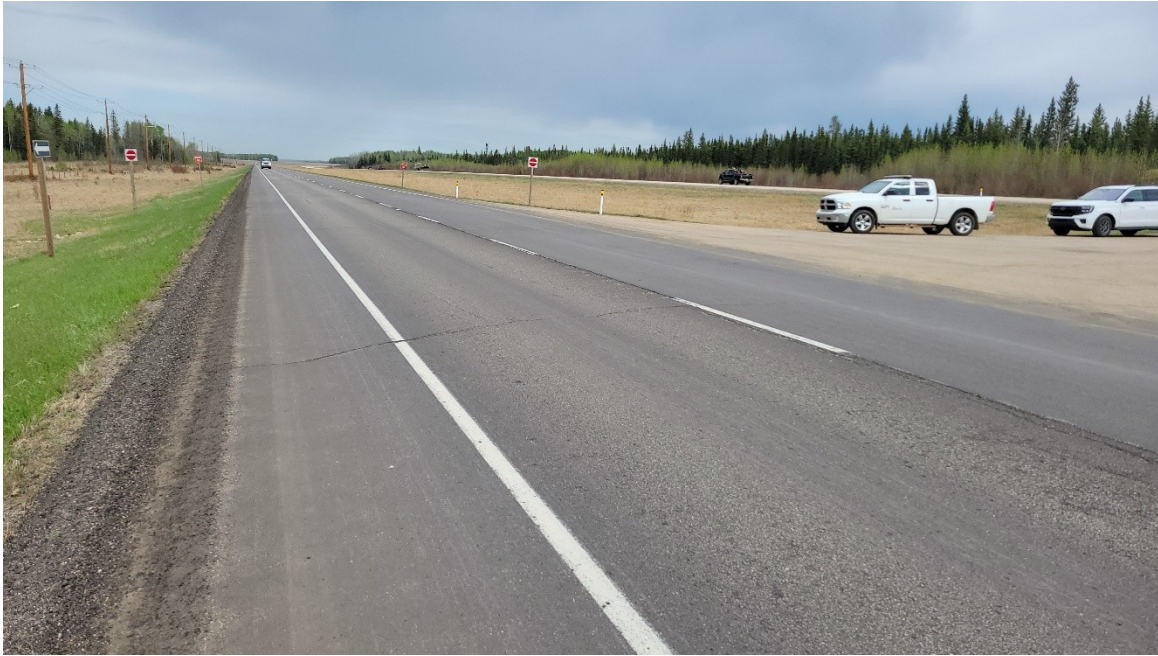
**Photo 5. Looking north at highway southbound lanes. Landslide is currently not impacting the highway surface; head scarp crack is about 6.5 m from the edge of pavement (same as 2023 inspection).**

- TEC should contact the County, the trail owner, and utility companies to let them know about existing hazard(s).
- The local MCI should periodically monitor the head scarp crack for further opening or drop and measure the distance between the head scarp crack and the edge of the highway. Open cracks on the highway surface should also be sealed to prevent surface water infiltration into the landslide mass.
- Clear sedimentation and regrade the ground surface near culvert C1 outlet; inspect and maintain culverts C2 and C3 as needed to prevent further ponding of water in the highway west ditch and water flow under C3.

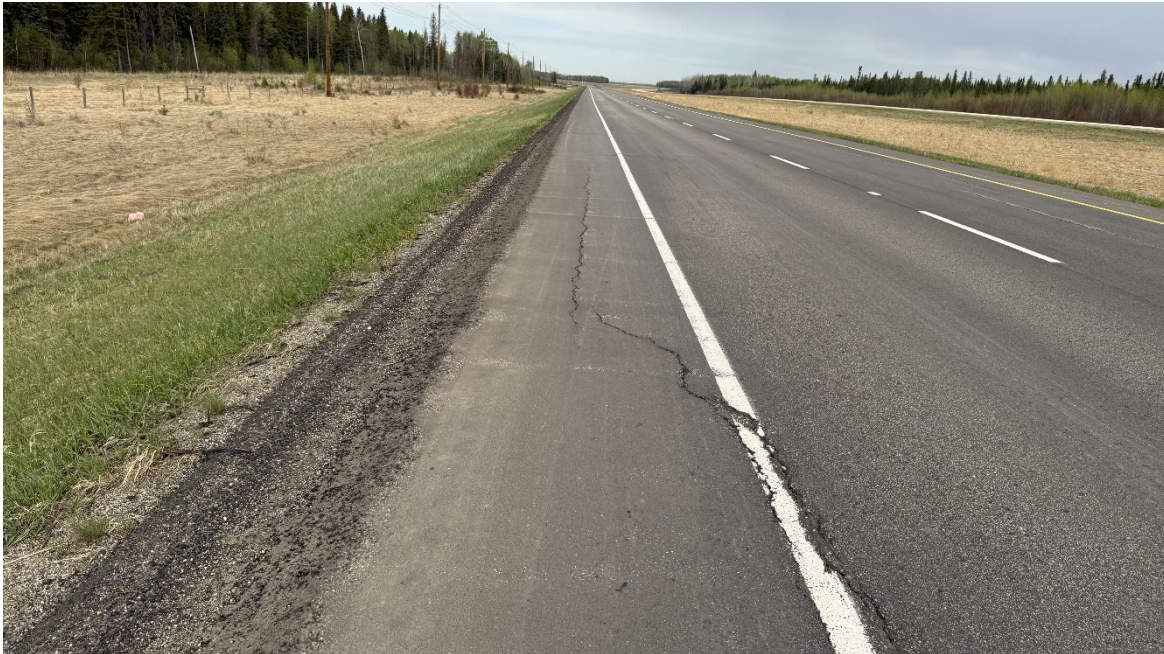
The new longitudinal and diagonal cracks on the highway surface above the southern half of the landslide and north of the north flank of the landslide, respectively, may or may not reflect the retrogression of the landslide into the highway lanes. This should be confirmed during future inspections.

**Photo 6A. Looking north at the diagonal crack appearing through the 2024 ACP overlay north of the landslide north flank. Crack is 10-20 mm wide with no drop.**

Due to the appearance of a new longitudinal and diagonal cracks on the highway surface above and north of the landslide, it is recommended to visit this site again in the spring of 2026.

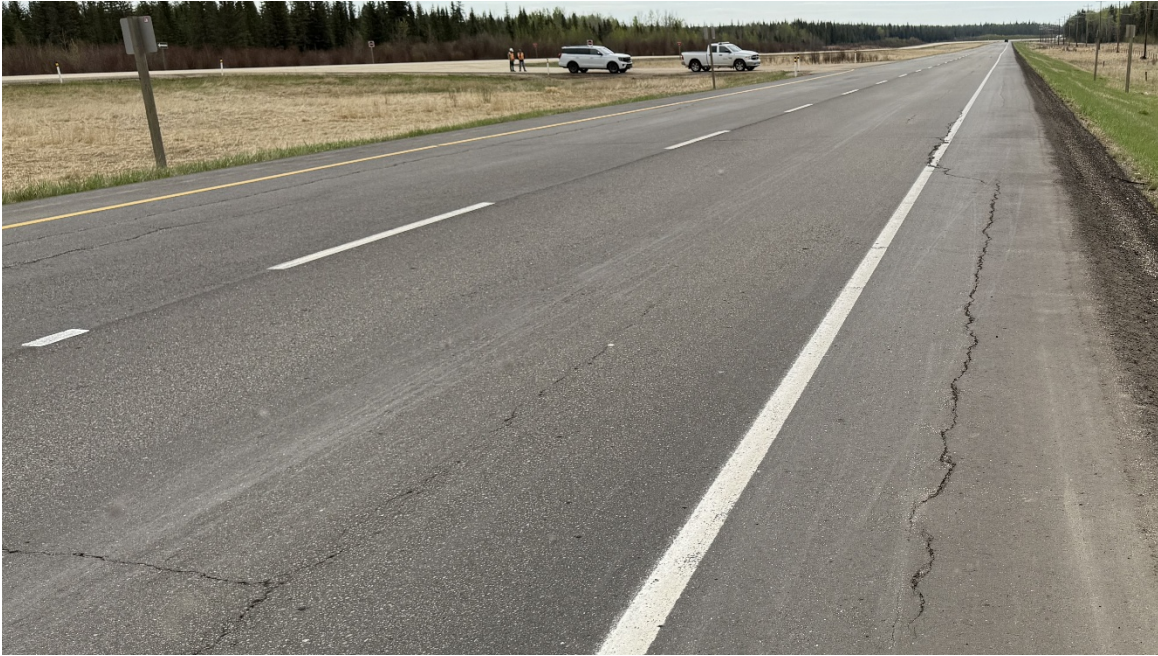
**Photo 6B. Looking south at diagonal crack appearing through the 2024 ACP overlay north of the landslide north flank. Crack is 10-20 mm wide with no drop).**

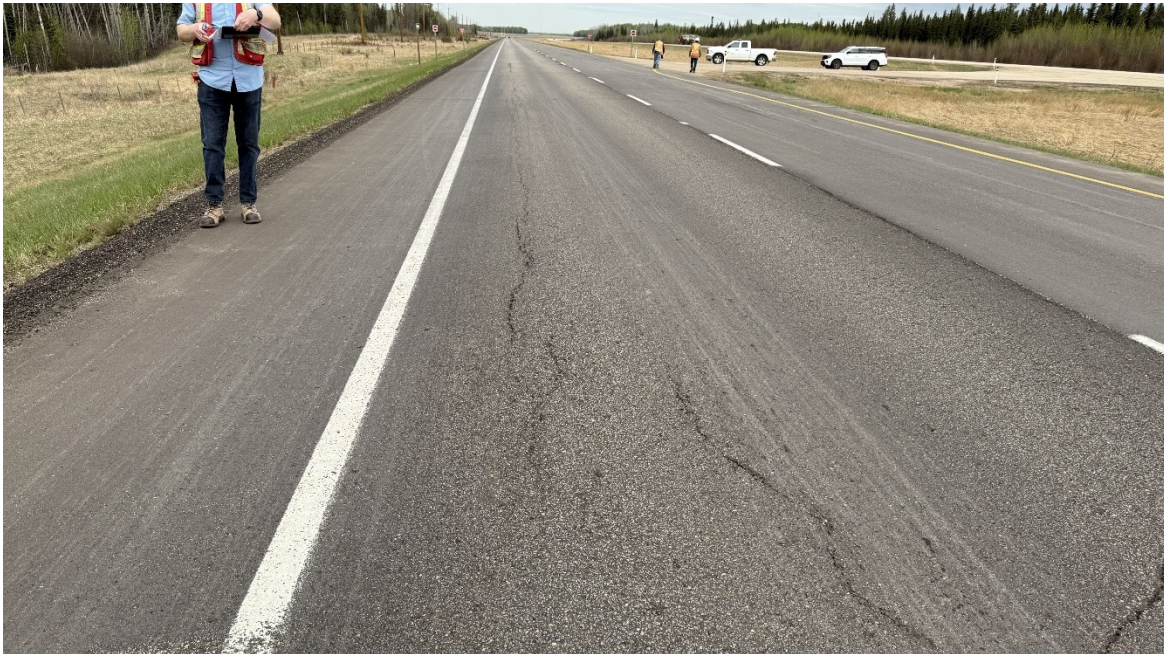
**Photo 7. Looking north at cracking in southbound lane near landslide southern flank. Cracks are 5-10 mm wide with no drop.**

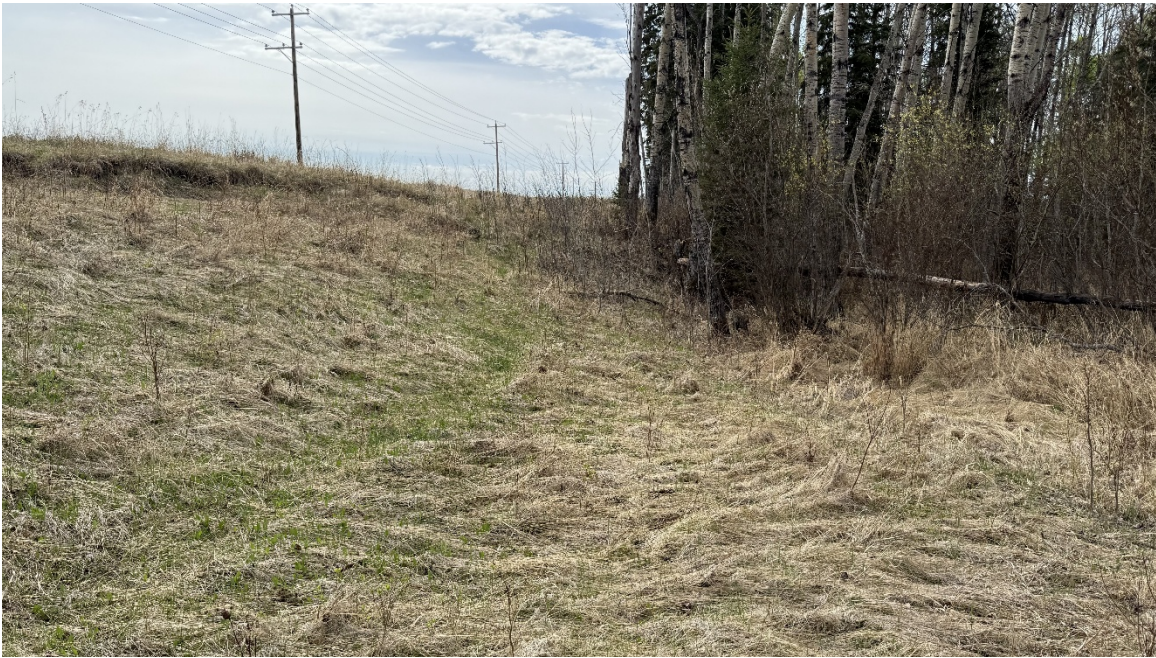
**Photo 8. Looking south at the landslide south flank. Backscarp crack is 1.1 m deep and 1.2 m wide.**

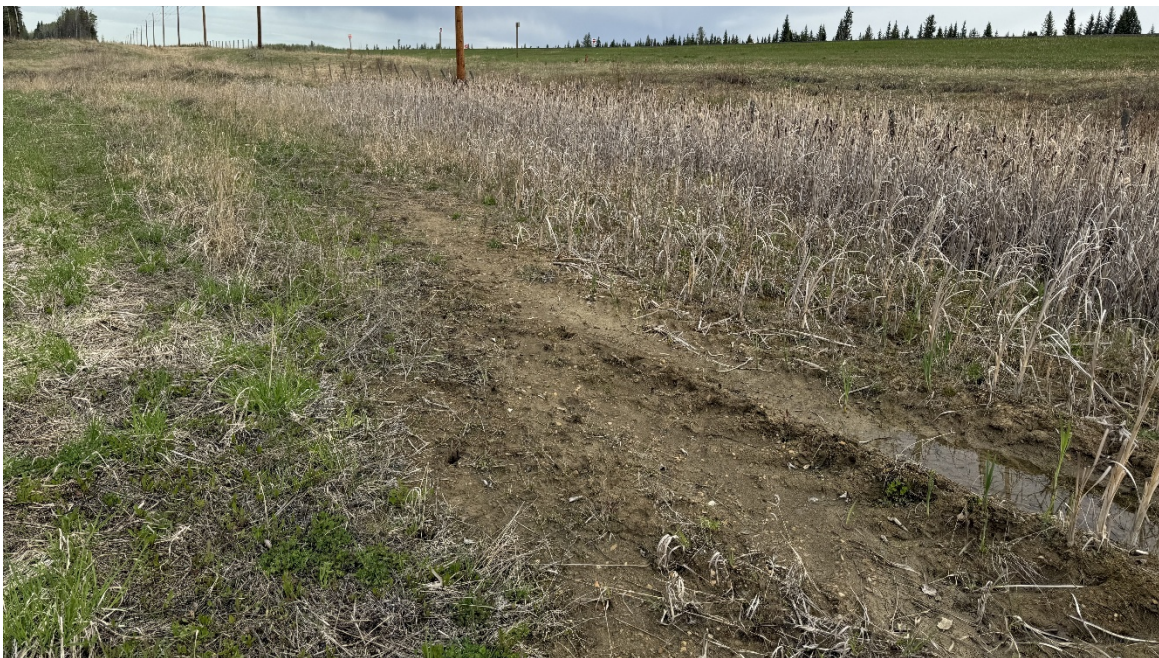
**Photo 9. Looking north at the landslide's north flank. Average drop of 1.5 m to 2.0 m within landslide mass.**
