ALBERTA TRANSPORTATION AND  
ECONOMIC CORRIDORS GRMP  
NORTH CENTRAL (ATHABASCA AND FORT  
McMURRAY DISTRICTS)  
INSTRUMENTATION MONITORING - SPRING 2025

| Site Number | Location | Name | Hwy | km |
|---|---|---|---|---|
| NC087 | HWY 63:02 | Fischer Trail | 63:02 | km 20.67 |

**SITE NC087: HWY 63:02 FISCHER TRAIL (km 20.67)**

**NC087: HWY 63:02 FISCHER TRAIL SLIDE  
SITE PLAN SHOWING APPROXIMATE  
INSTRUMENT LOCATIONS**

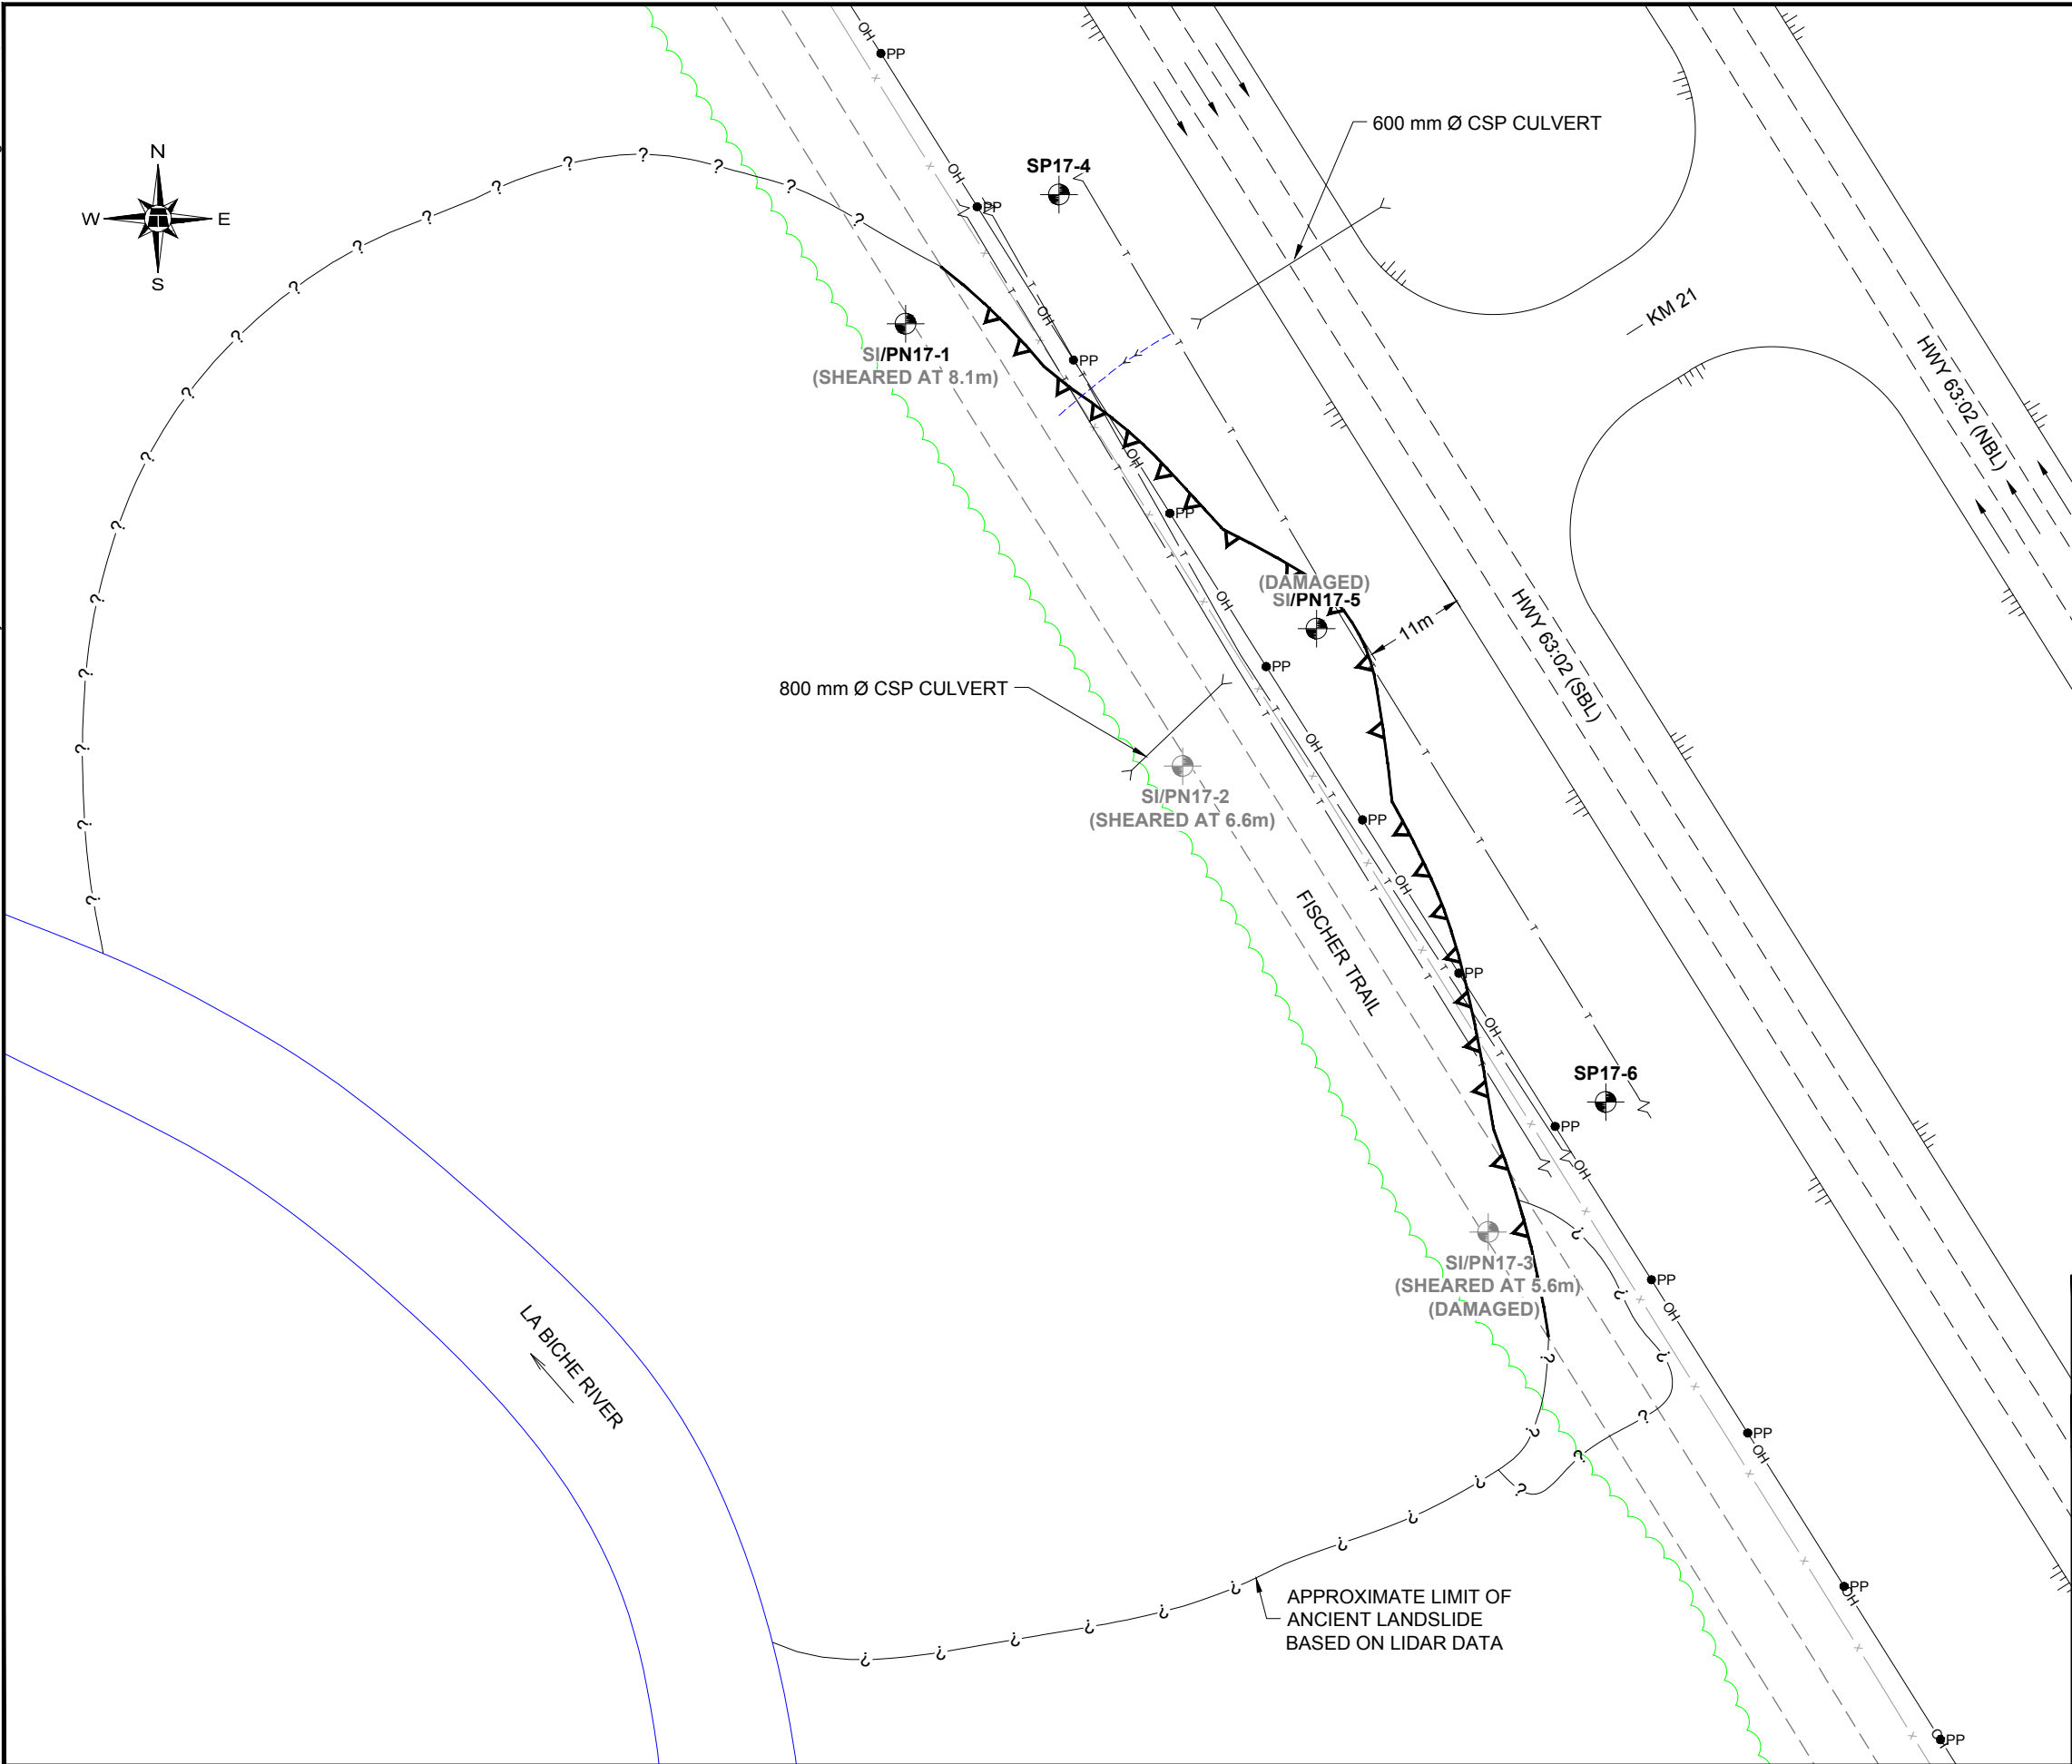
**DWG No. 32122-NC087**

Drawing 32122-NC087 in Appendix A provides a sketch of the approximate location of the monitoring instrumentation for this site.

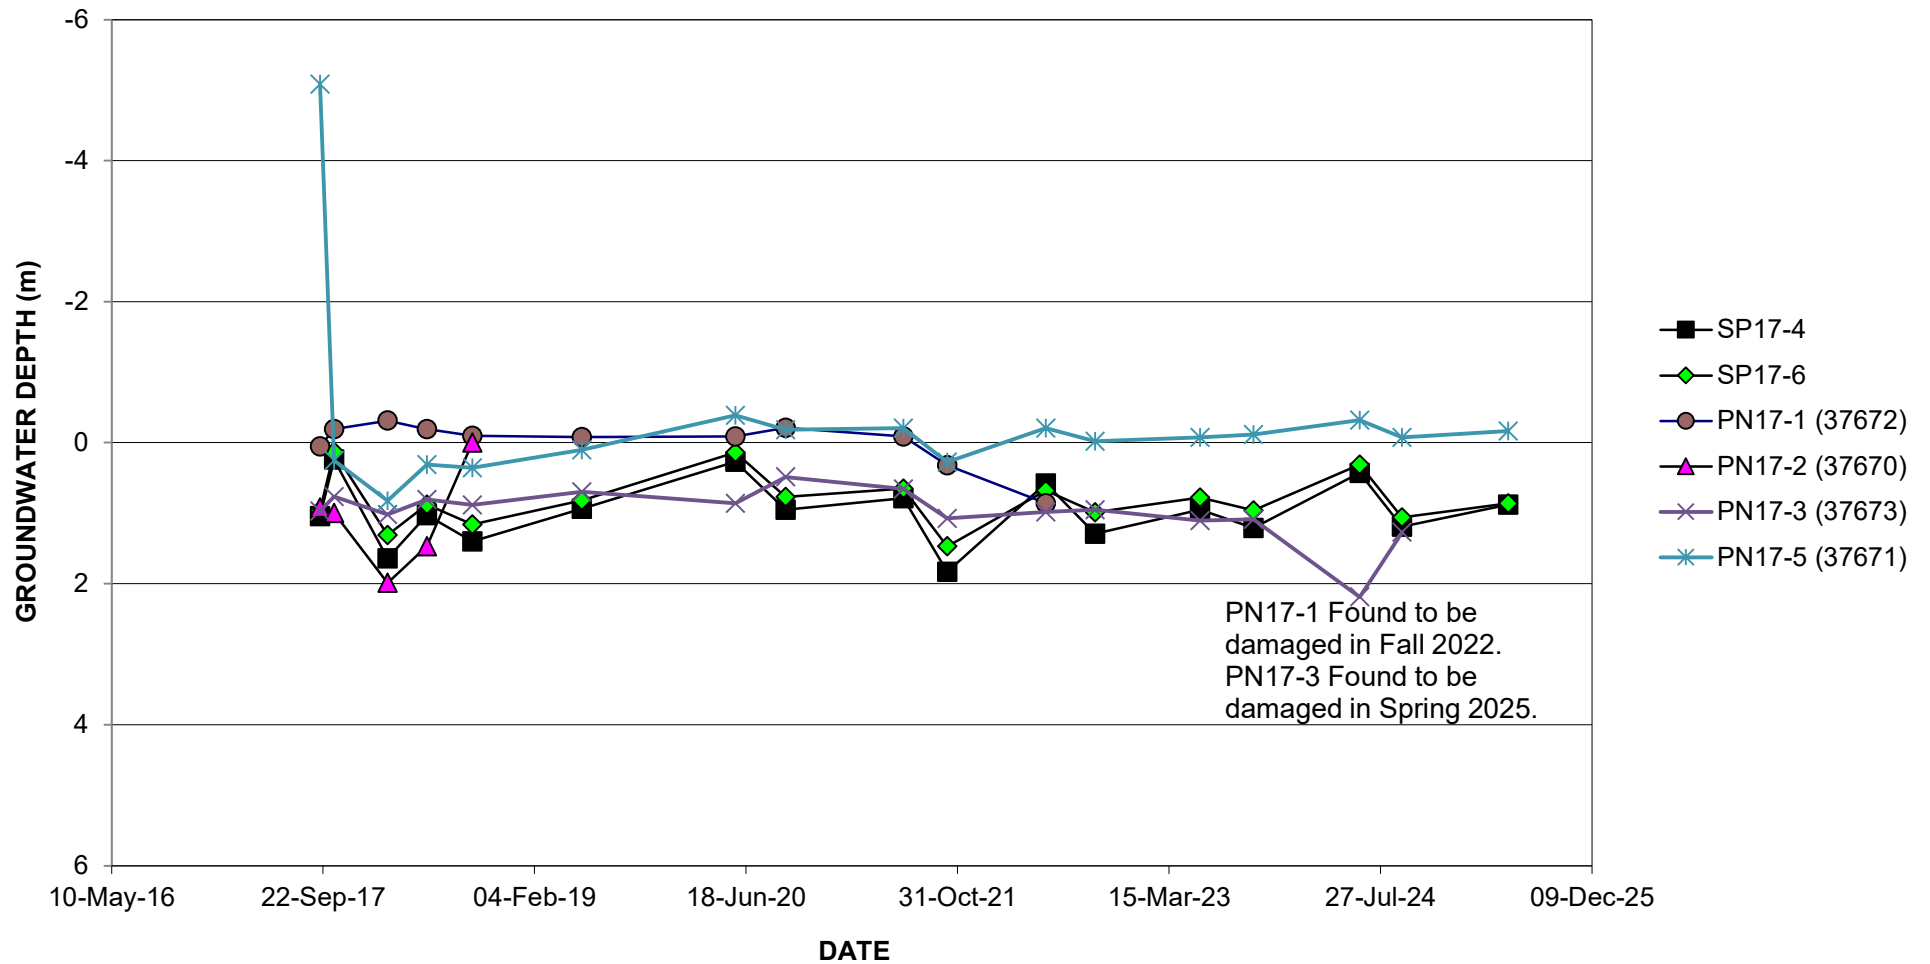
**FIGURE NC087-1**  
**PIEZOMETER DATA FOR HWY 63:02 - FISCHER TRAIL**

| Discussion | |
|---|---|
| <b>Interpretation of Monitoring Results:</b> | PN17-5 showed an increase in groundwater level of 0.09 m since the fall of 2024 readings, corresponding to an above-ground (artesian) groundwater level of 0.16 m.<br><br>Standpipe piezometers SP17-4 and SP17-6 showed increases in groundwater level of 0.31 m and 0.20 m, respectively, since the fall of 2024 readings. |
