**ALBERTA TRANSPORTATION AND  
ECONOMIC CORRIDORS GRMP  
NORTH CENTRAL (ATHABASCA AND FORT  
MCMURRAY DISTRICTS)  
2025 SITE INSPECTION**

| Site # | Location | Name | Hwy | km |
|---|---|---|---|---|
| NC091-1 | NBL - 5 to 6 Km south of Wandering | HWY 63:02 Backslope | 63:02 | 39.27 and |

**NC091-1: HWY 63:02 KM 39.35 - BACKSLOPE SLUMP  
SKETCH SHOWING SITE FEATURES**

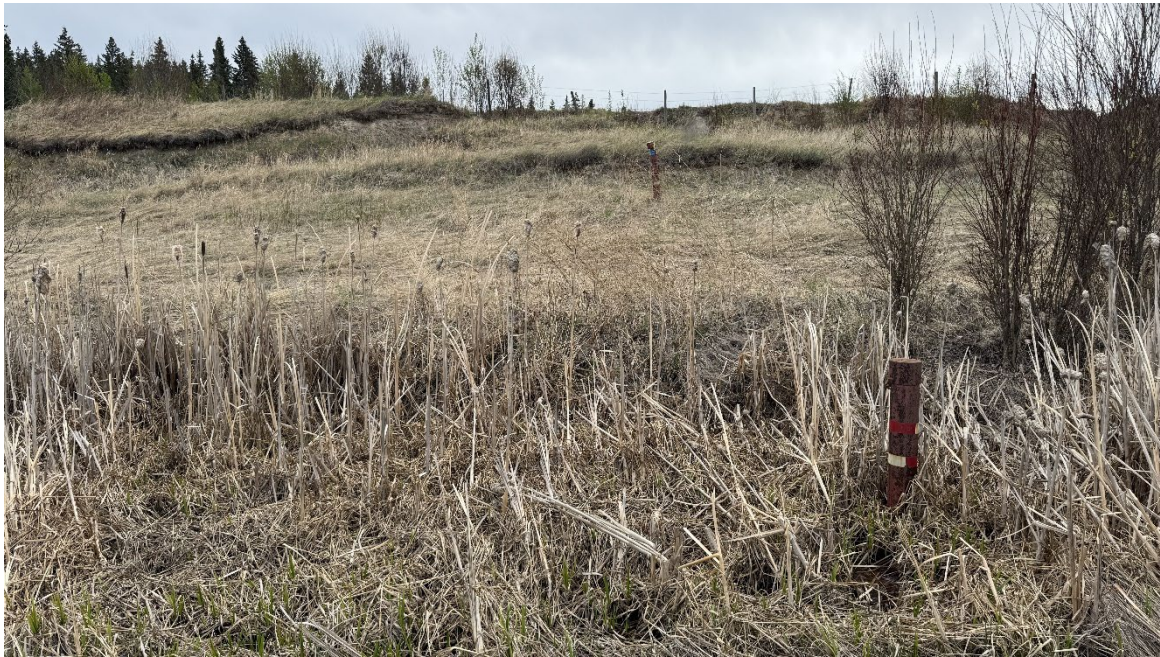
| <input checked="" type="checkbox"/> Slope Movement | <p><b>NC091-1:</b> Up to 2.5 m high head scarp crack in the farmer's field; eight fence posts hanging. Multiple tension cracks within the slide mass, up to 800 mm wide and 600 mm deep between SI18-2 and the head scarp. The toe roll is partially blocking the ditch, and it is about 1 m high. Some retrogression of the head scarp crack noted in 2025.</p> <p><b>NC091-2:</b> Head scarp crack showed some retrogression during the 2025 inspection. Tension cracks are visible up to 2 m wide and 800 mm deep in the middle of the landslide mass, 14 m south of SI18-4. The toe of the landslide is about 1.5 m high, and it is partially blocking the ditch.</p> | <input checked="" type="checkbox"/> | |

**Photo 1. NC091-1: Looking east at the landslide mass.**

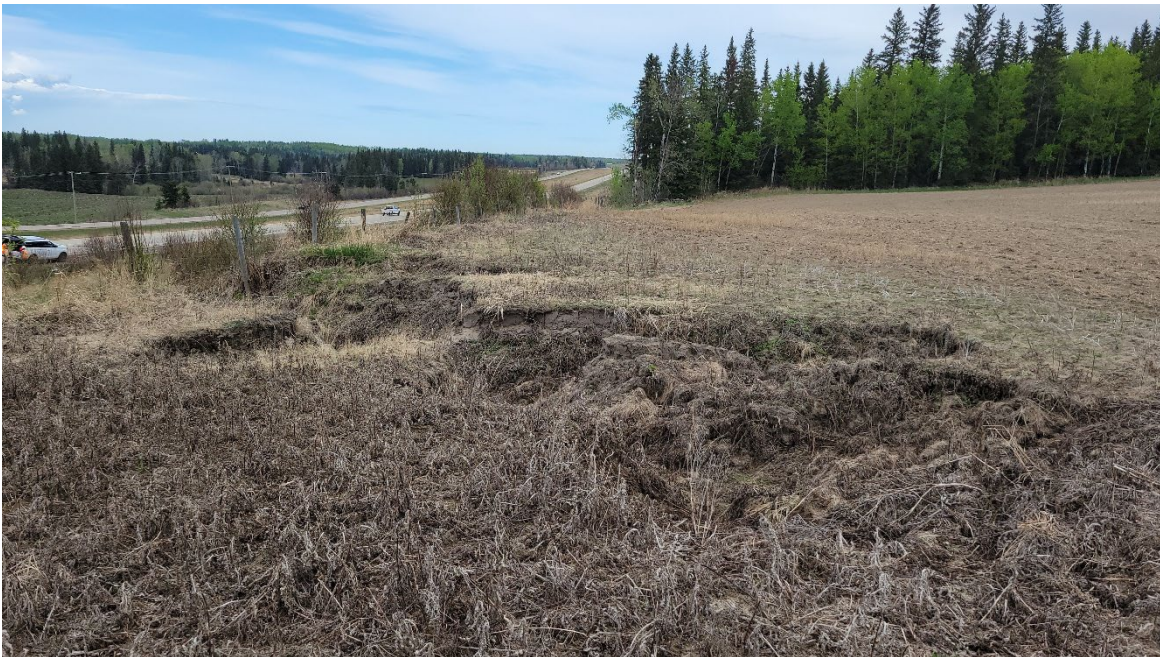
| ☒ Other | <b>NC091-1:</b> A severe erosion gully developed within the farmer's field; the gully is about 16 m long, 8 m wide with 1.5 m drop at the deepest location.<br><b>NC091-2:</b> Severe erosion around the half pipe and the riprap apron; erosion extended to the south of the catch water ditch into private land; half pipe got completely separated from culvert near the top of the slope. Erosion into private land has worsened since 2024 inspection. | ☒ |

The presence of open wide cracks and erosion gullies within lands currently being farmed is a safety concern. In addition, based on information provided by Mr. Arthur Kavulok of TEC, the farmer has reached out and ask TEC to address the slumping as they continue to lose farmland as a result of the ongoing erosion and landslide retrogression.

**Photo 2. NC091-1: Looking northwest at the erosion gulley developed within the farmer's field.  
Erosion has worsened since 2024 inspection.**

(c) place a snow fence around areas impacted by the landslide within the private lands or backfill these areas to eliminate existing hazard. However, this can only take place after consultation with the landowner(s).

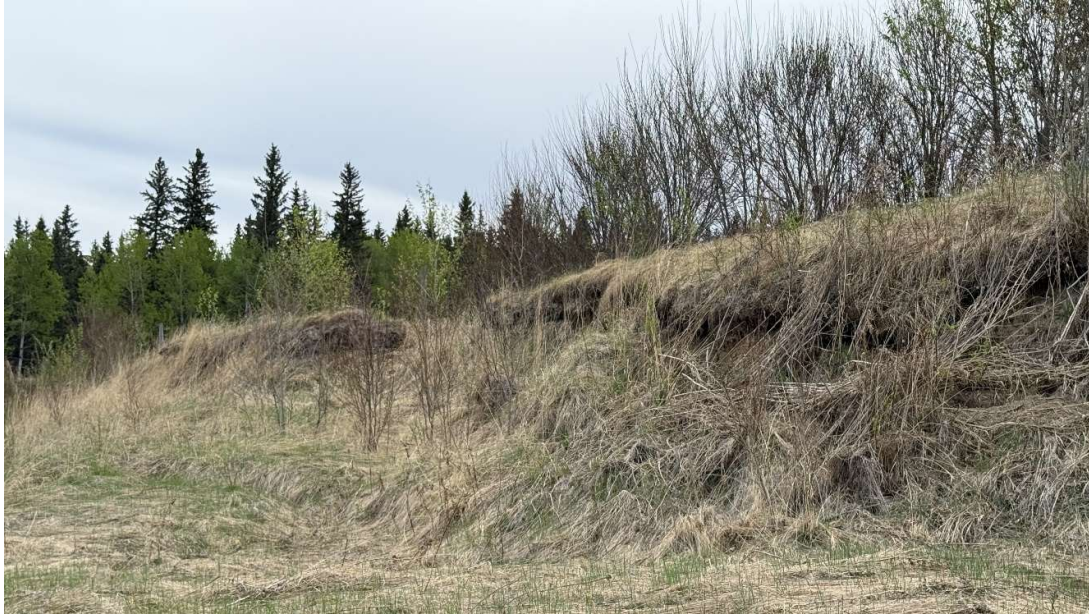
**Photo 3. NC091-1: Looking north at landslide backscarp crack showing a 2.4 m drop approximately 5 m west of the upslope ditch.**

(b) seal open cracks in the slope surface to reduce surface water infiltration into the slide mass. A small track mounted equipment could be used to smoothen the slope surface and fill in any dips without causing significant changes in grade, and

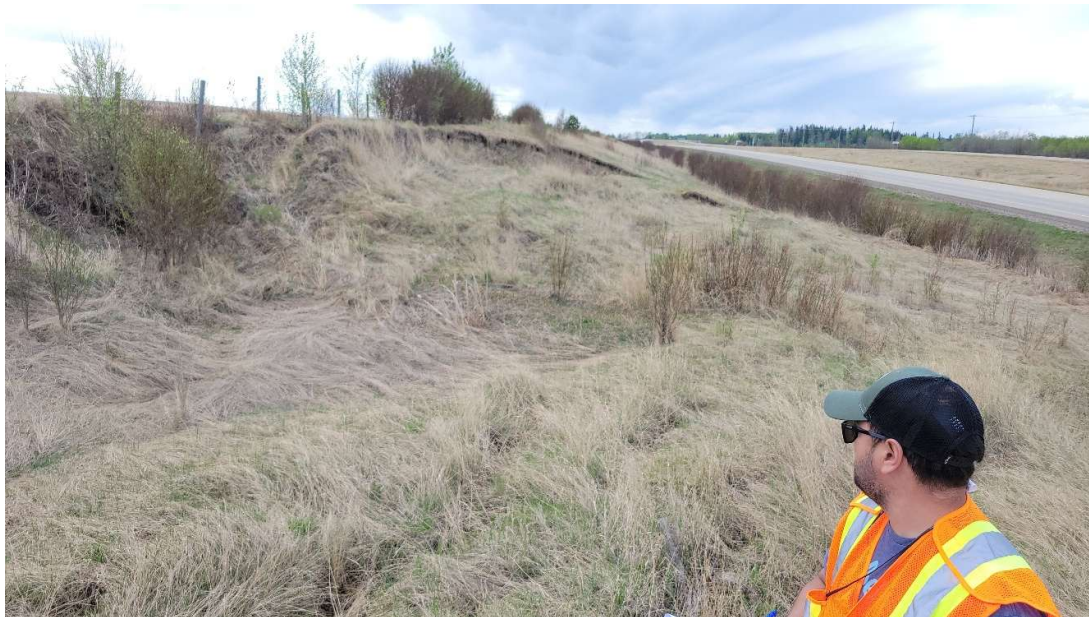
**Photo 4. NC091-1: Looking south at landslide mass. The retrogression of the backscarp crack into the farmer's field is visible on the left of the photo. Eight barbed if it got wire posts were hanging in 2025.**

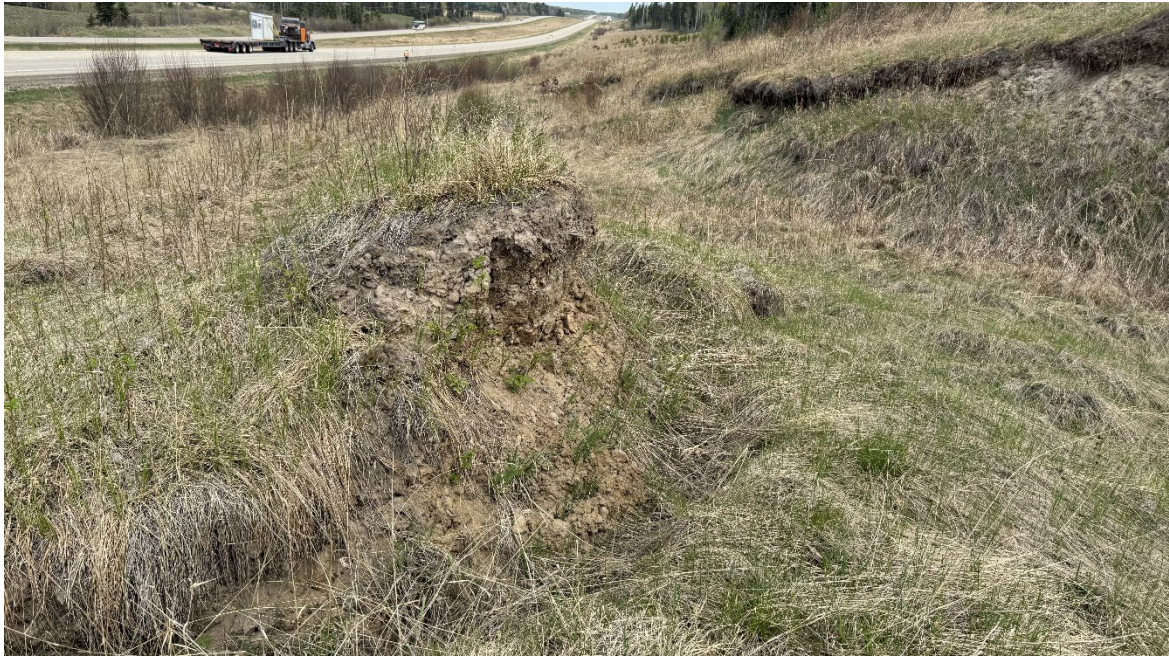
**Photo 5. NC091-1: Looking northwest at graben feature developed in the middle of the landslide mass.**

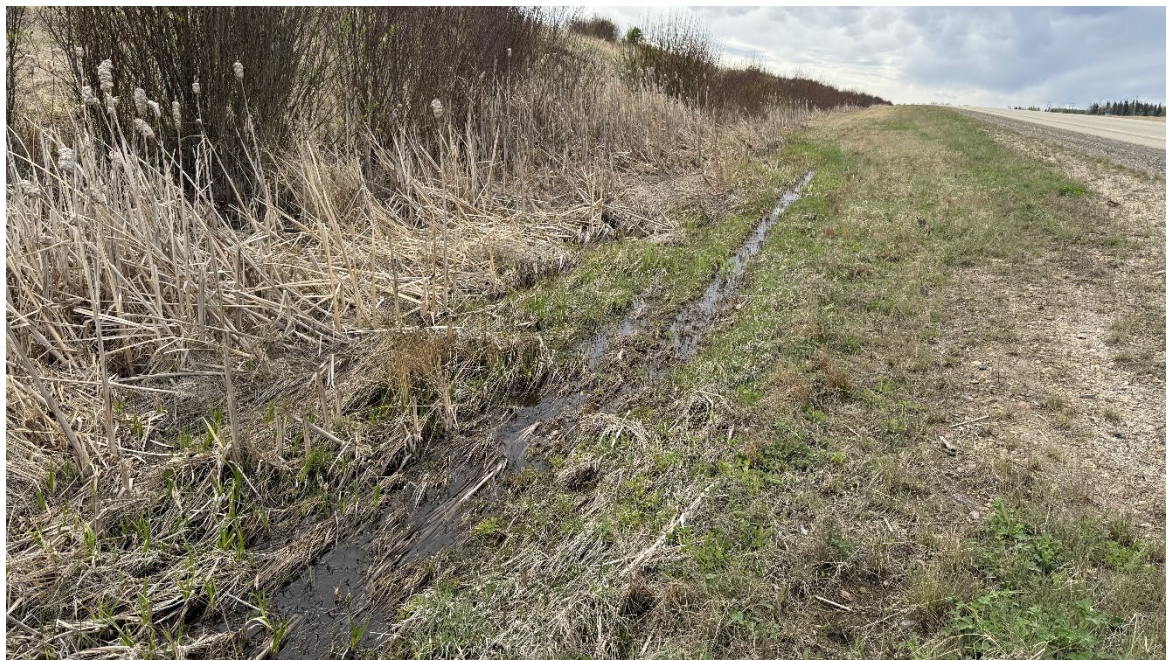
The landslide debris is partially blocking the highway ditch at both locations and hence impeding surface drainage in the highway ditch. This may result in elevated groundwater levels in the highway embankment and potential instabilities in the future.

**Photo 6. NC091-1: Looking south at flow in the highway ditch.**

(a) undertake slight grading of the highway ditch at the slump locations, as needed, to promote surface drainage. Excavated material from the ditch should be pushed back against the toe of the slope. Excessive removal of landslide debris from the toe of the slope could result in accelerated movement,

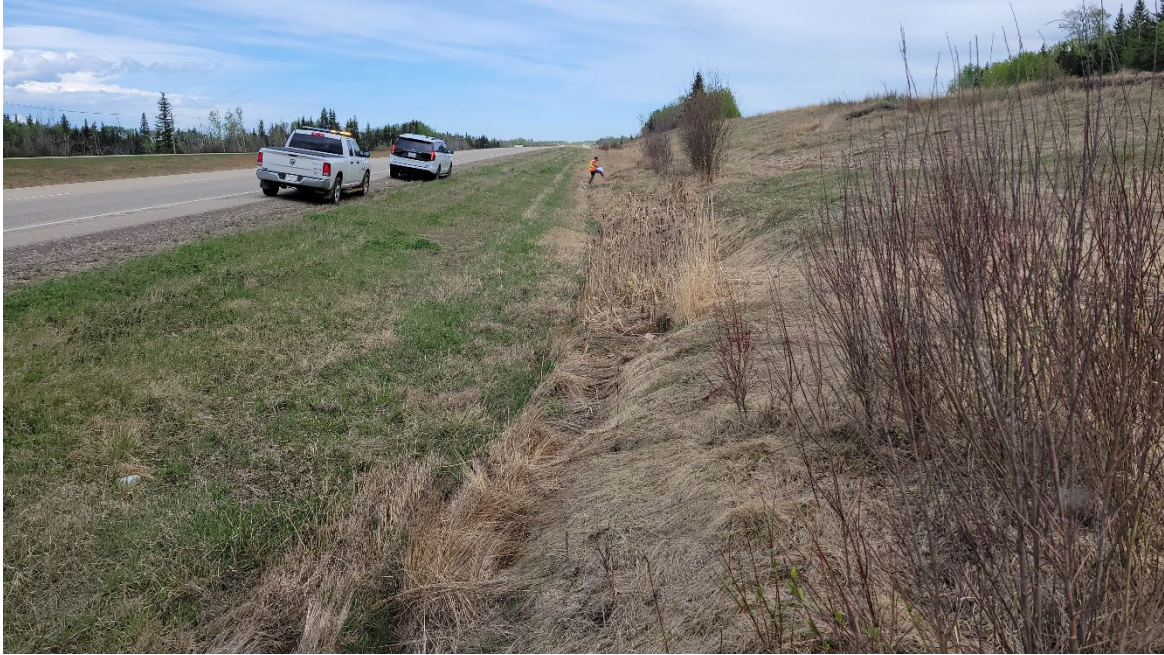
**Photo 7. NC091-2: Looking north near the southern flank of the landslide; note the presence of a distinct toe roll in the ditch.**

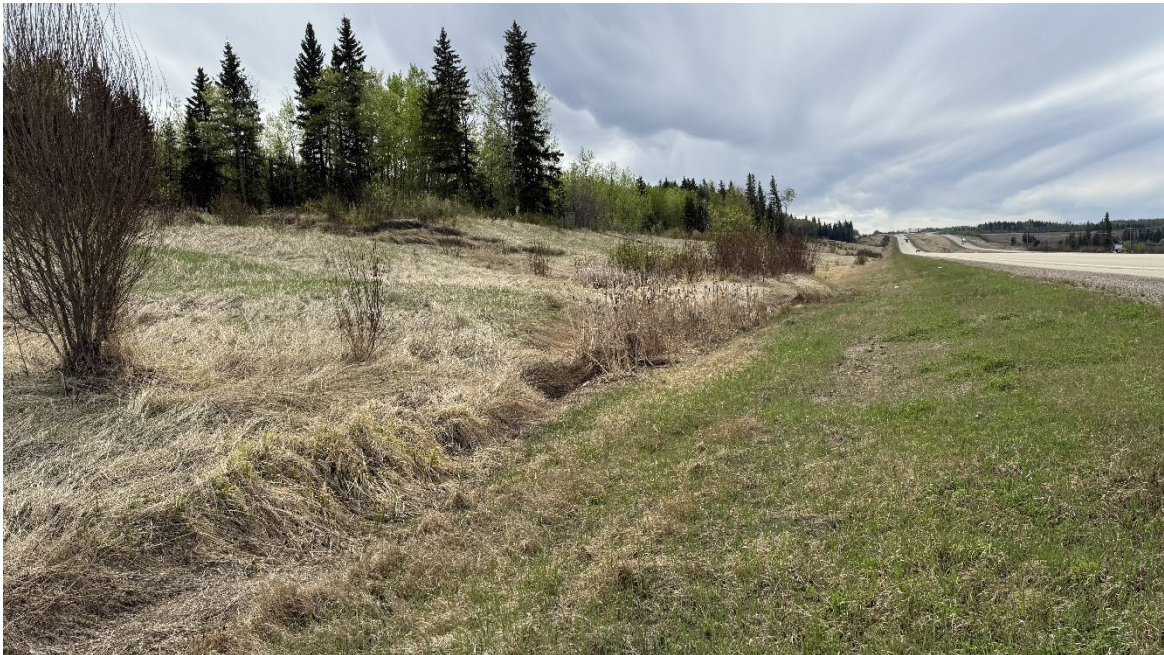
**Photo 8. NC091-2: Looking south at the landslide mass; note the distinct toe roll in the ditch and the presence of multiple tension cracks within the backslope.**

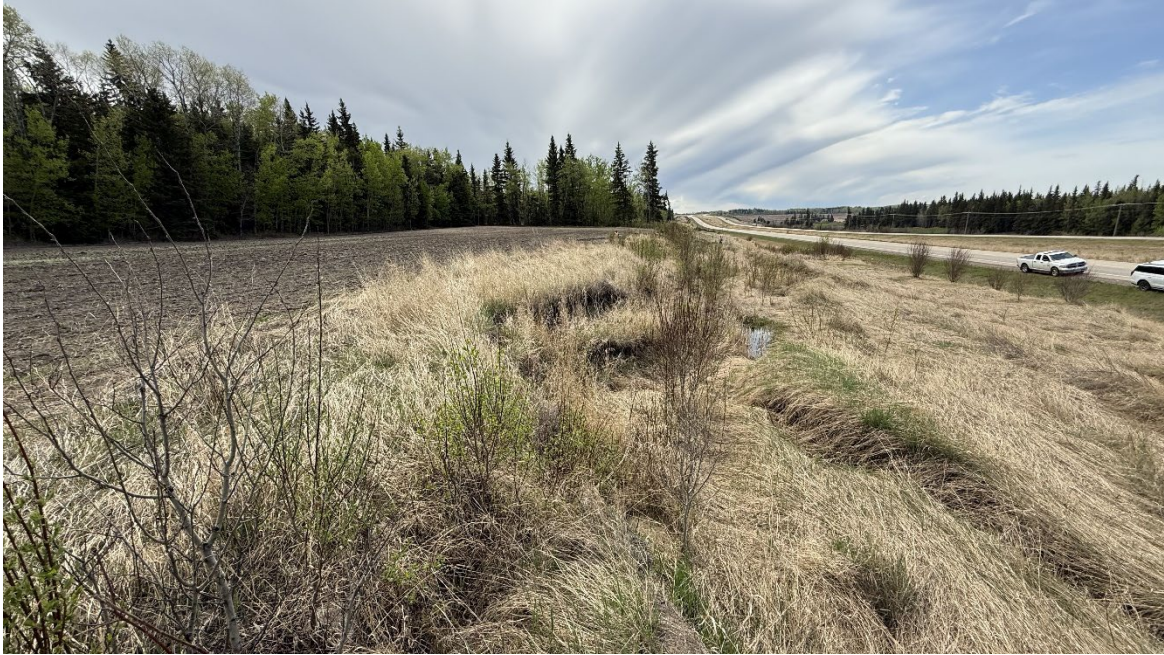
**Photo 9. NC091-2: Looking south at a scarp crack developed within the crest of the backslope.**

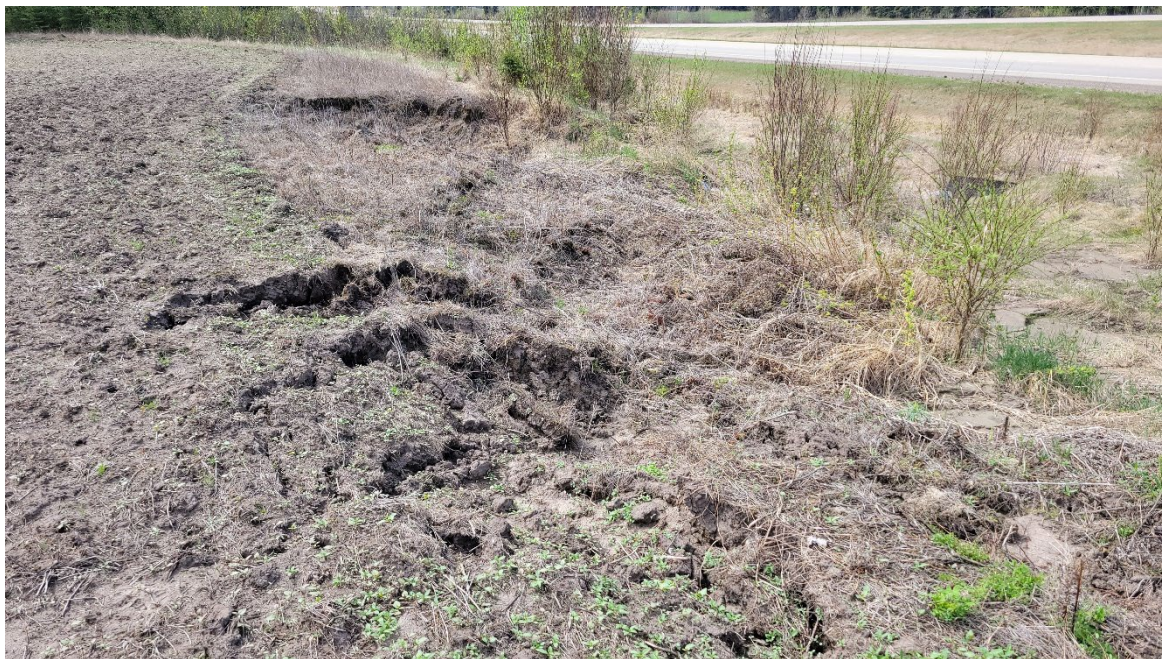
**Photo 10. NC091-2: Looking southwest at erosion near the scarp crest which has retrogressed into the farmer's field.**

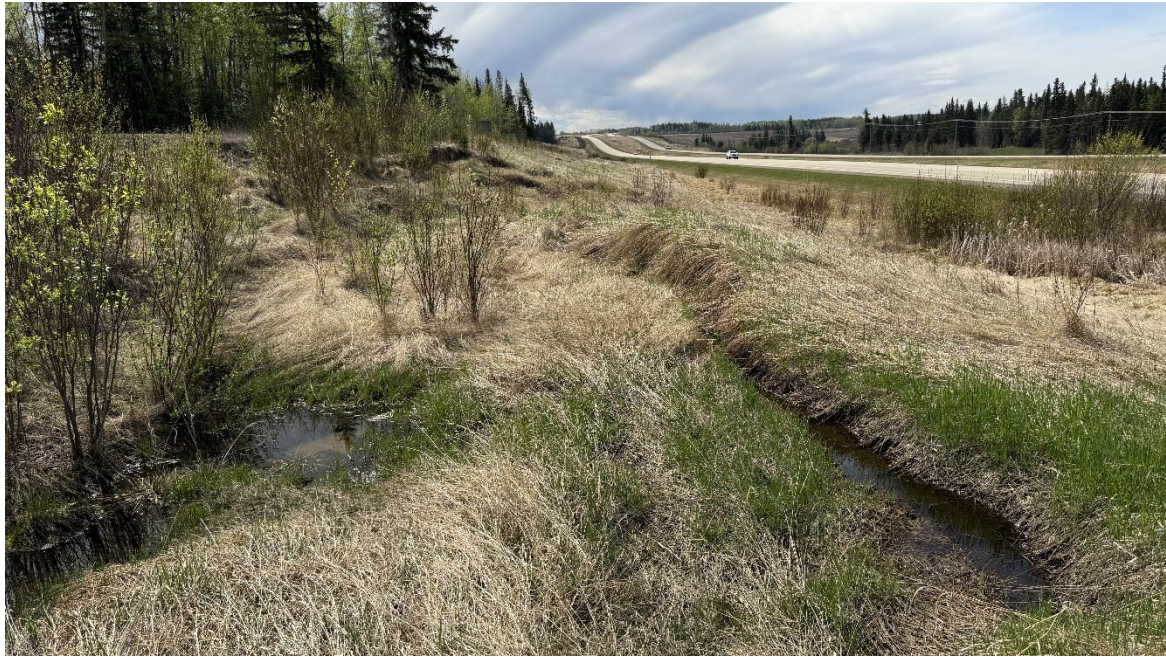
| ☒ Seepage | <b>NC091-1 and NC091-2:</b> wet landslide mass; ponding water within a few locations of the landslide mass; toe roll partially blocking water flow along the ditch; catch water ditch near the crest of both slides was impacted by the landslide movement and water from the catch water ditch saturated the landslides. | ☒ |

**Photo 11. NC091-2: Looking south at water pooled within the landslide mass.**

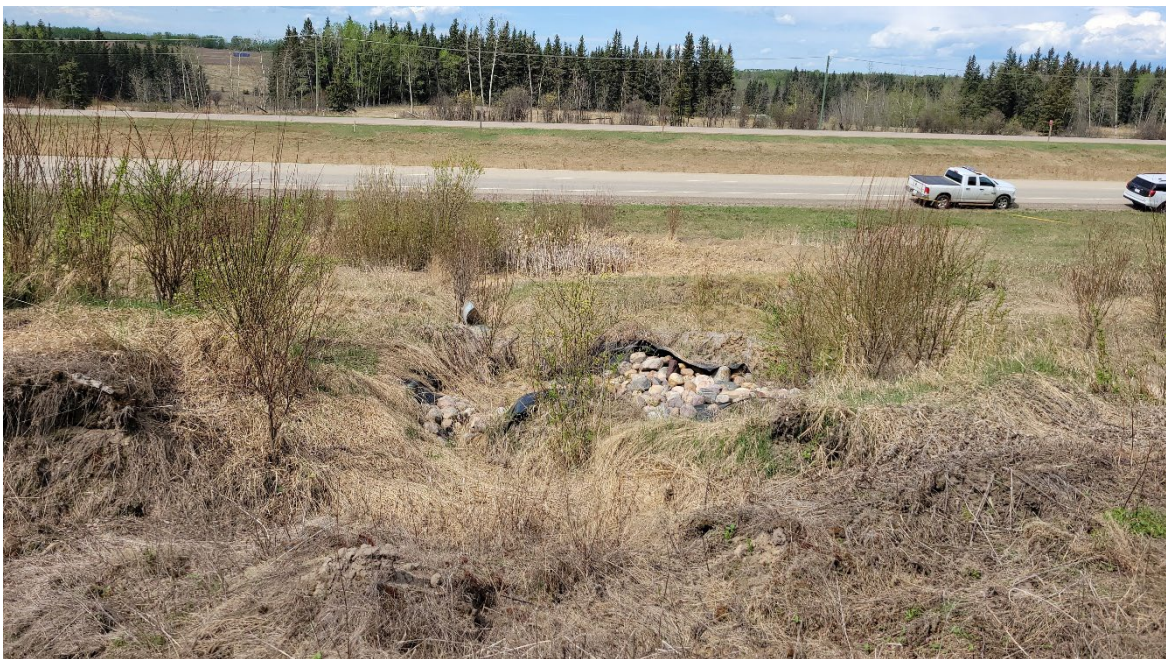
**Photo 12. NC091-2: Looking west at the failed riprap apron and half-pipe culvert.**

At both sites, the catch water ditch will need to be reconstructed using low to medium plastic clay, realigned to be a few meters away from the top of the slope in the vicinity of the landslides, and lined with an impervious barrier to prevent further erosion and saturation of the slopes. At NC091-2, it is possible to re-grade the catch water ditch to drain towards a centerline culvert located south of the site at approximate km 40.090. During construction, the catch water ditch flow will need to be temporarily diverted away from the slope repair area.
