ALBERTA TRANSPORTATION AND  
ECONOMIC CORRIDORS GRMP  
NORTH CENTRAL (ATHABASCA AND FORT  
McMURRAY DISTRICTS)  
INSTRUMENTATION MONITORING - SPRING 2025

| Site Number | Location | Name | Hwy | km |
|---|---|---|---|---|
| NC091 | HWY 63:02 | Backslope Slumps | 63:02 | Km 39.4<br>and Km 40.4 |

| <b>Current Monitoring:</b> | 25-May-2025 | <b>Previous Monitoring</b> | 08-June-2024 |

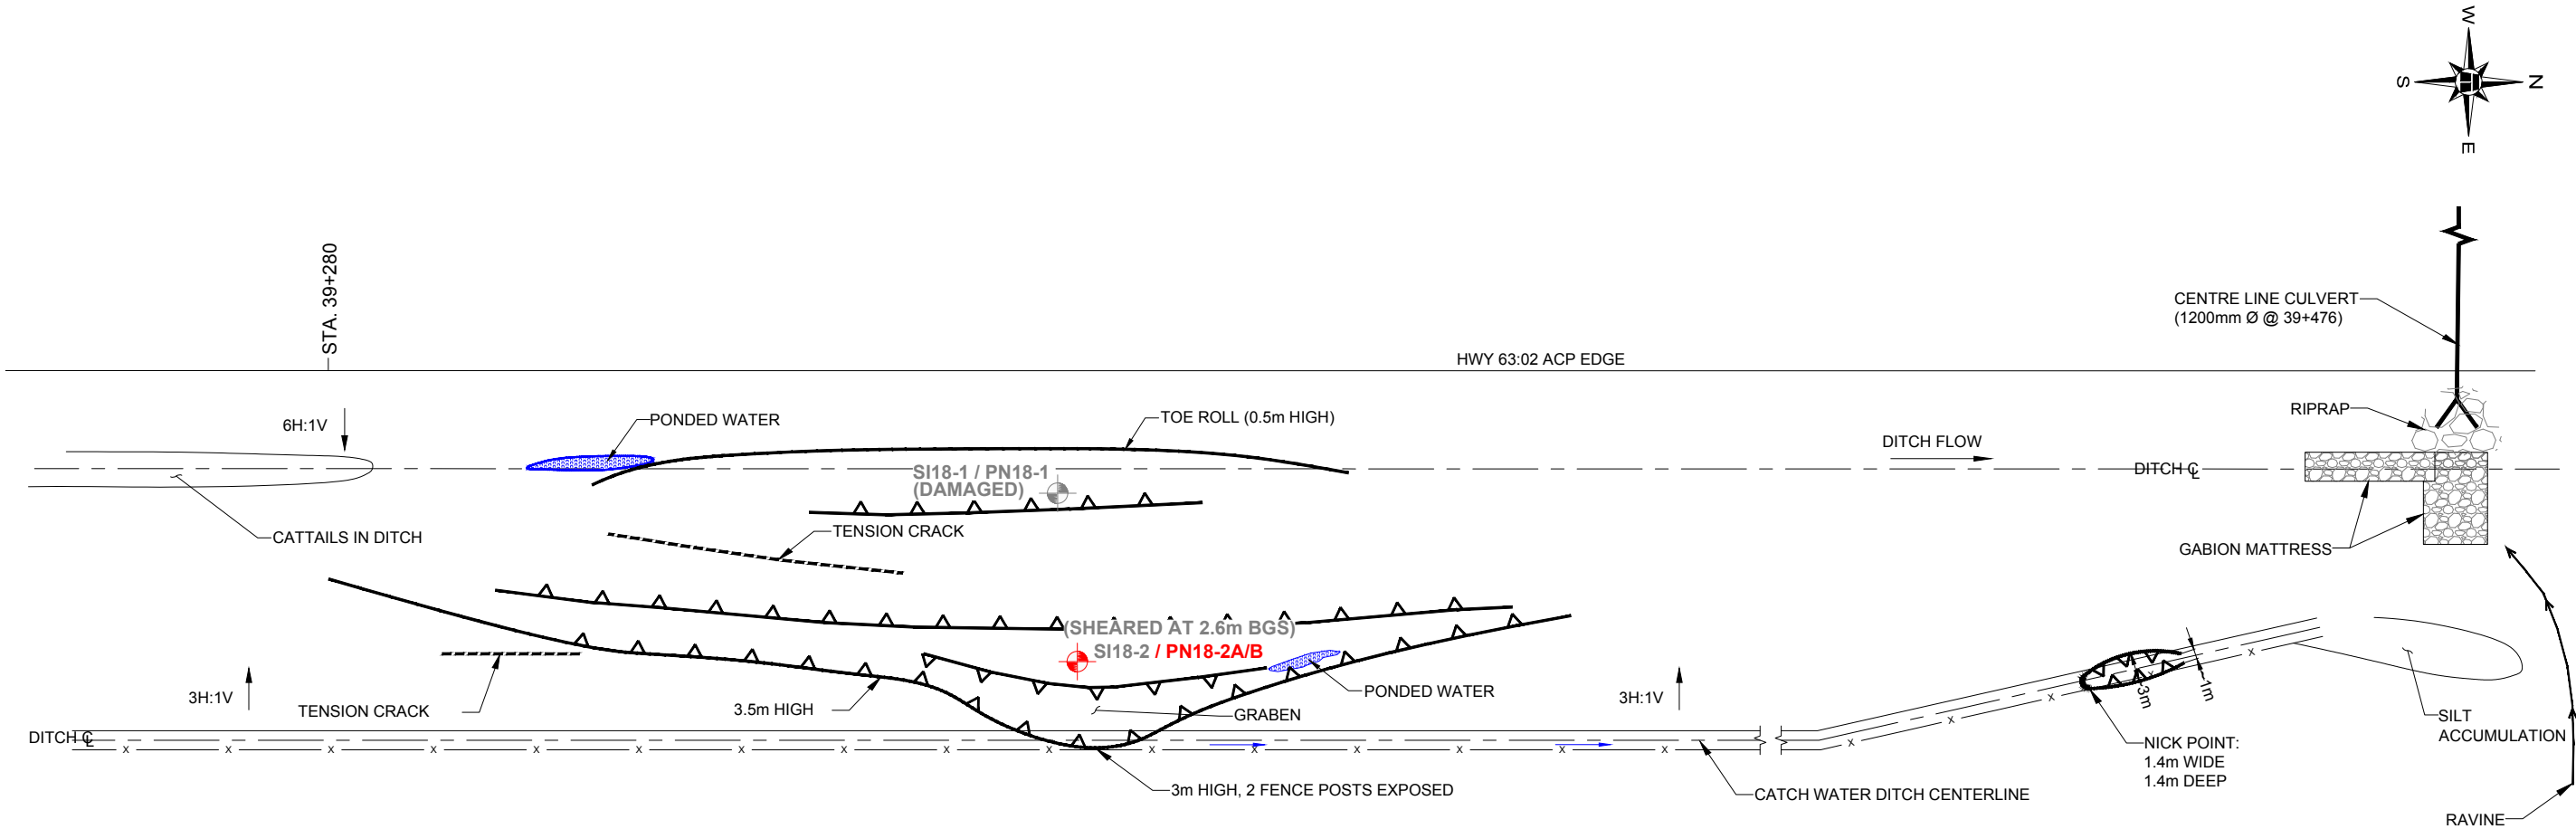
**DWG No. 32122-NC091-1**

| Discussion | |
|---|---|
| <b>Interpretation of Monitoring Results:</b> | <b>NC091-1 (km 39.35)</b><br>The groundwater level in PN18-2B decreased by 0.01 m since the spring of 2024 readings.<br><b>NC091-2 (km 40.37)</b><br>The groundwater level decreased in PN18-4A by 0.31 m and increased in PN18-4B by 0.01 m since the spring of 2024 readings. |

**NORTH CENTRAL  
(ATHABASCA AND FORT MCMURRAY DISTRICTS)  
NC091: HWY 63:02 km 39.35 - BACKSLOPE SLUMP  
SITE PLAN SHOWING APPROXIMATE  
INSTRUMENT LOCATIONS**

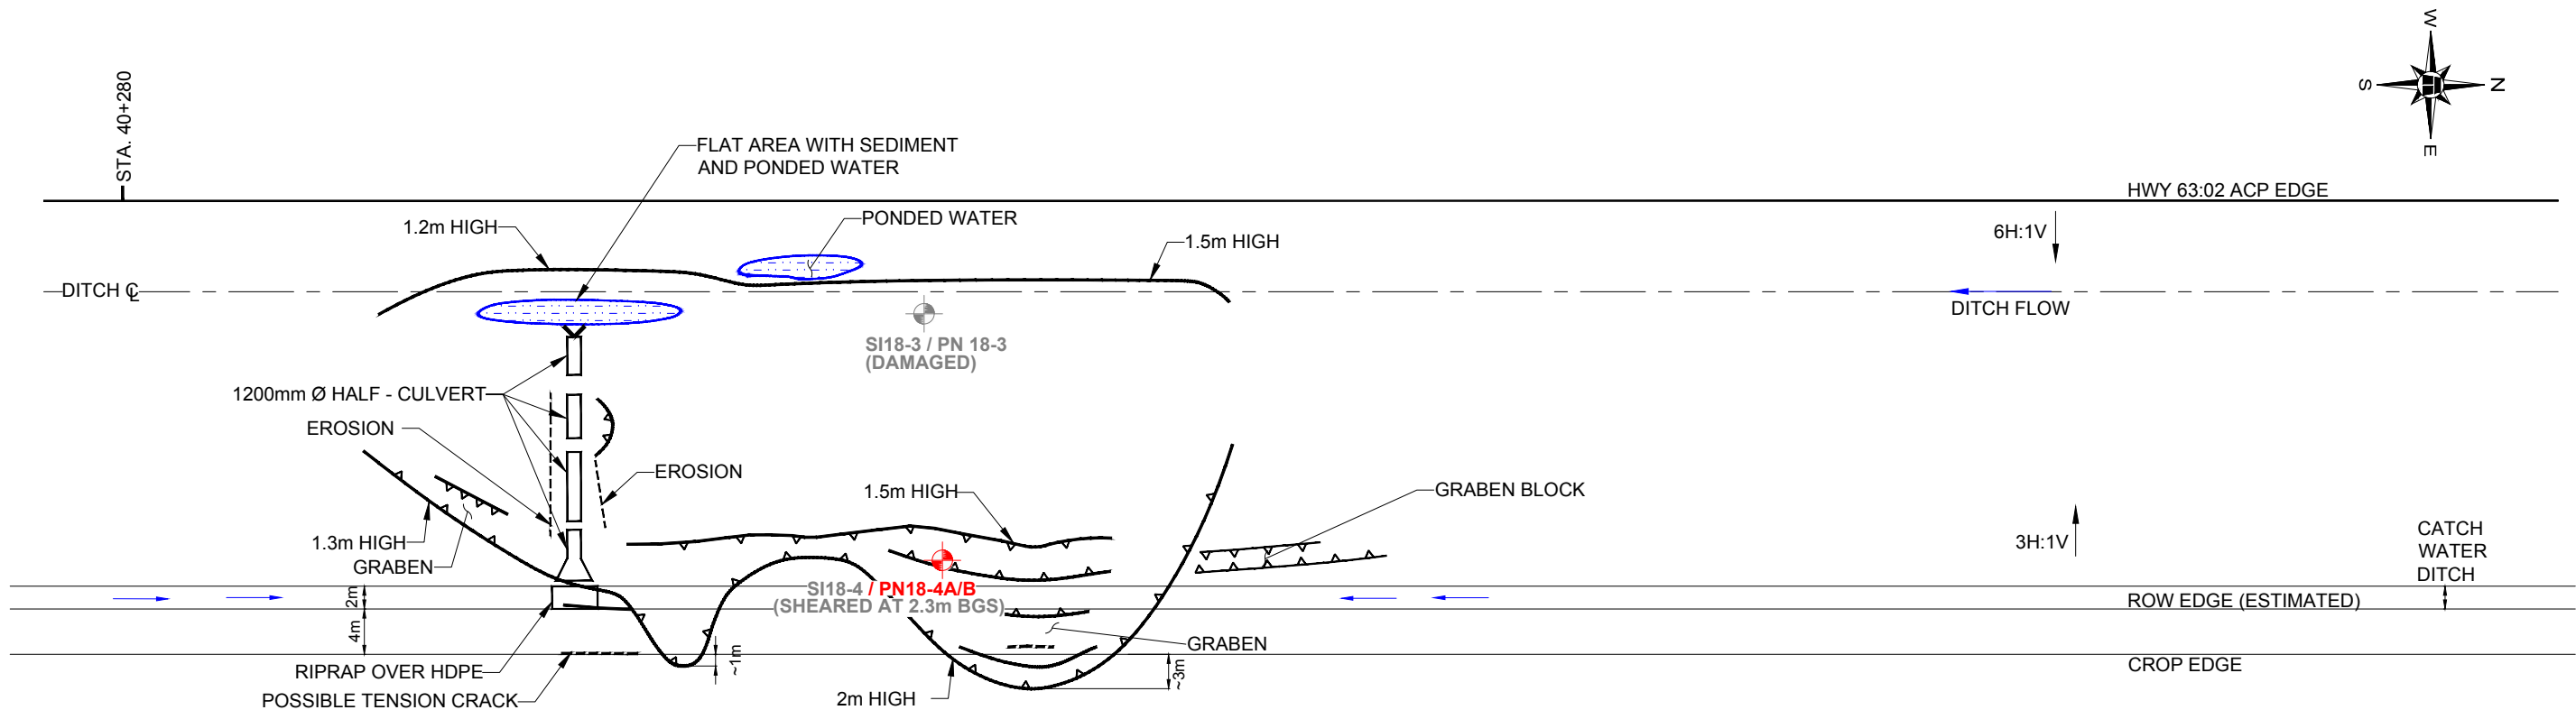
**DWG No. 13357-NC091-2**

**NORTH CENTRAL  
(ATHABASCA AND FORT MCMURRAY DISTRICTS)  
NC091: HWY 63:02 km 40.37 - BACKSLOPE SLUMP  
SITE PLAN SHOWING APPROXIMATE  
INSTRUMENT LOCATIONS**

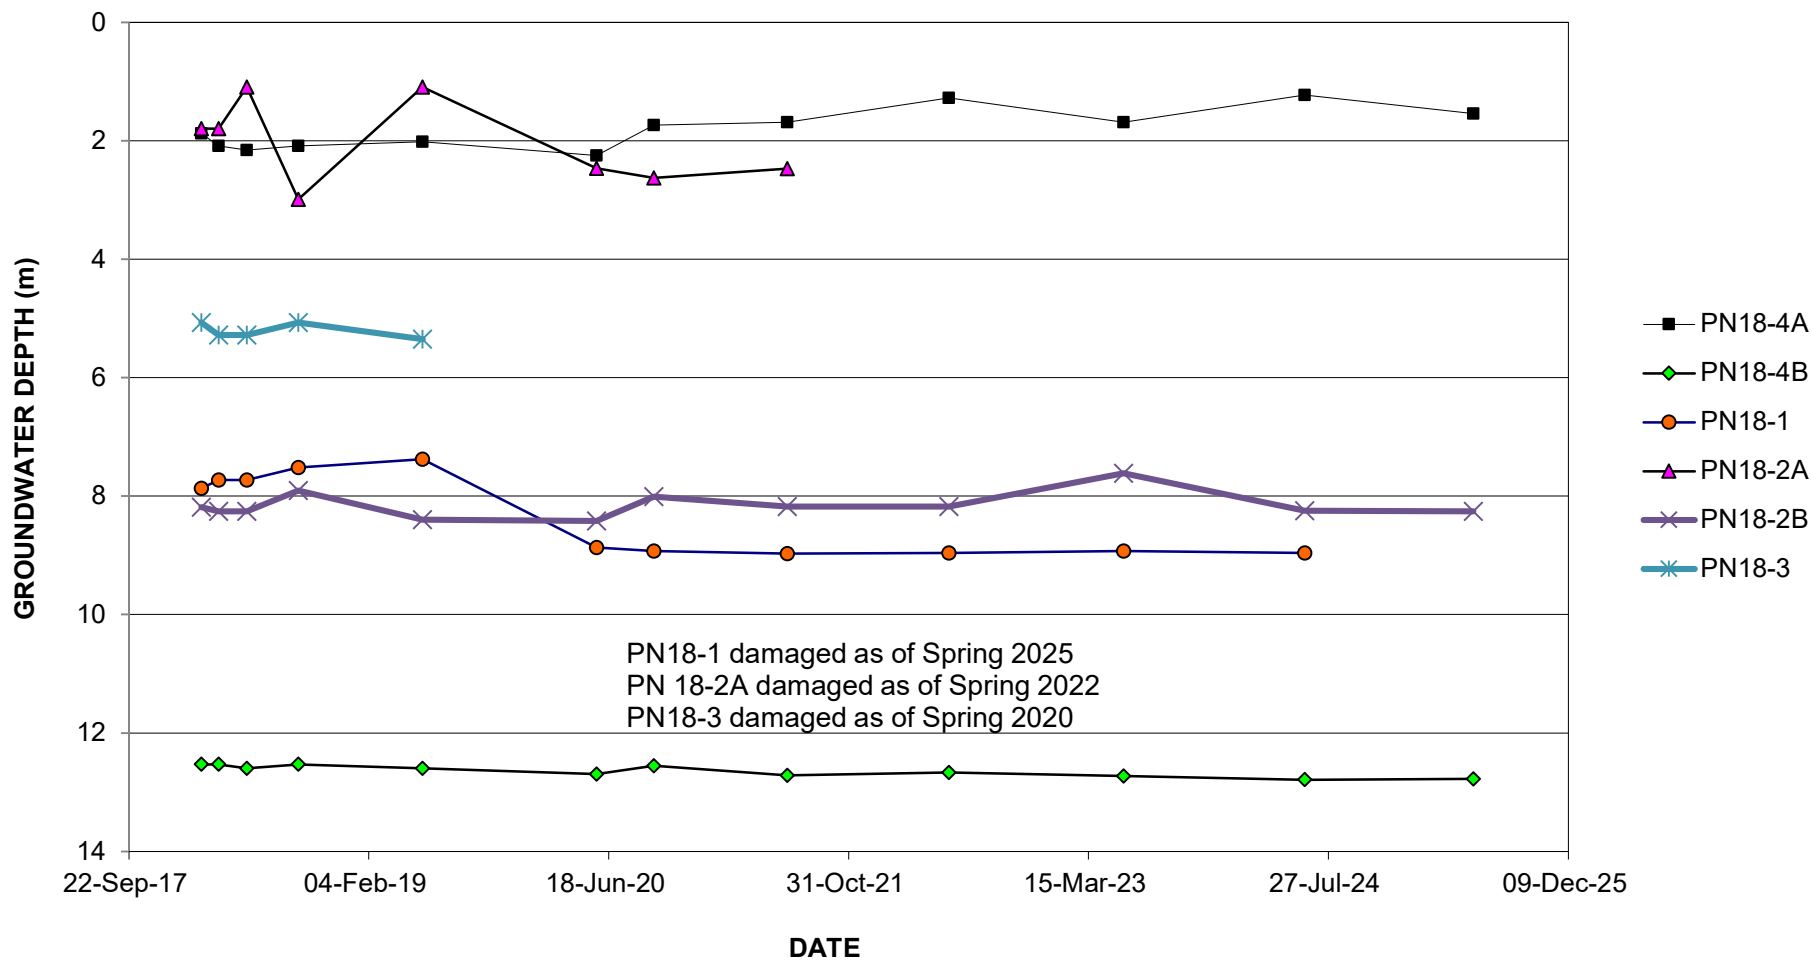
**FIGURE NC091-1  
PIEZOMETER DATA FOR HWY 63:02 BACKSLOPE SLUMPS**

| Readout Equipment Used | | | |
|---|---|---|---|
| <b>Notes:</b><br>- PN18-1 was found to be damaged; reading rising when bypass is open. | | | |

| Discussion | |
|---|---|
| <b>Instrumentation Repairs:</b> | PN18-1 is damaged and should be removed from future reading cycles. |
