ALBERTA TRANSPORTATION AND  
ECONOMIC CORRIDORS GRMP  
NORTH CENTRAL (ATHABASCA AND FORT  
MCMURRAY DISTRICTS)  
2025 SITE INSPECTION

| Site # | Location | Name | Hwy | km |
|---|---|---|---|---|
| NC096 | 13 Km north of Wandering River | Wandering River Bridge (75731N) | 63:04 | 2.85 |

| | Date | PF | CF | Total |
|---|---|---|---|---|
| Current Inspection: | May 14, 2025 | 15 | 5 | 75 |

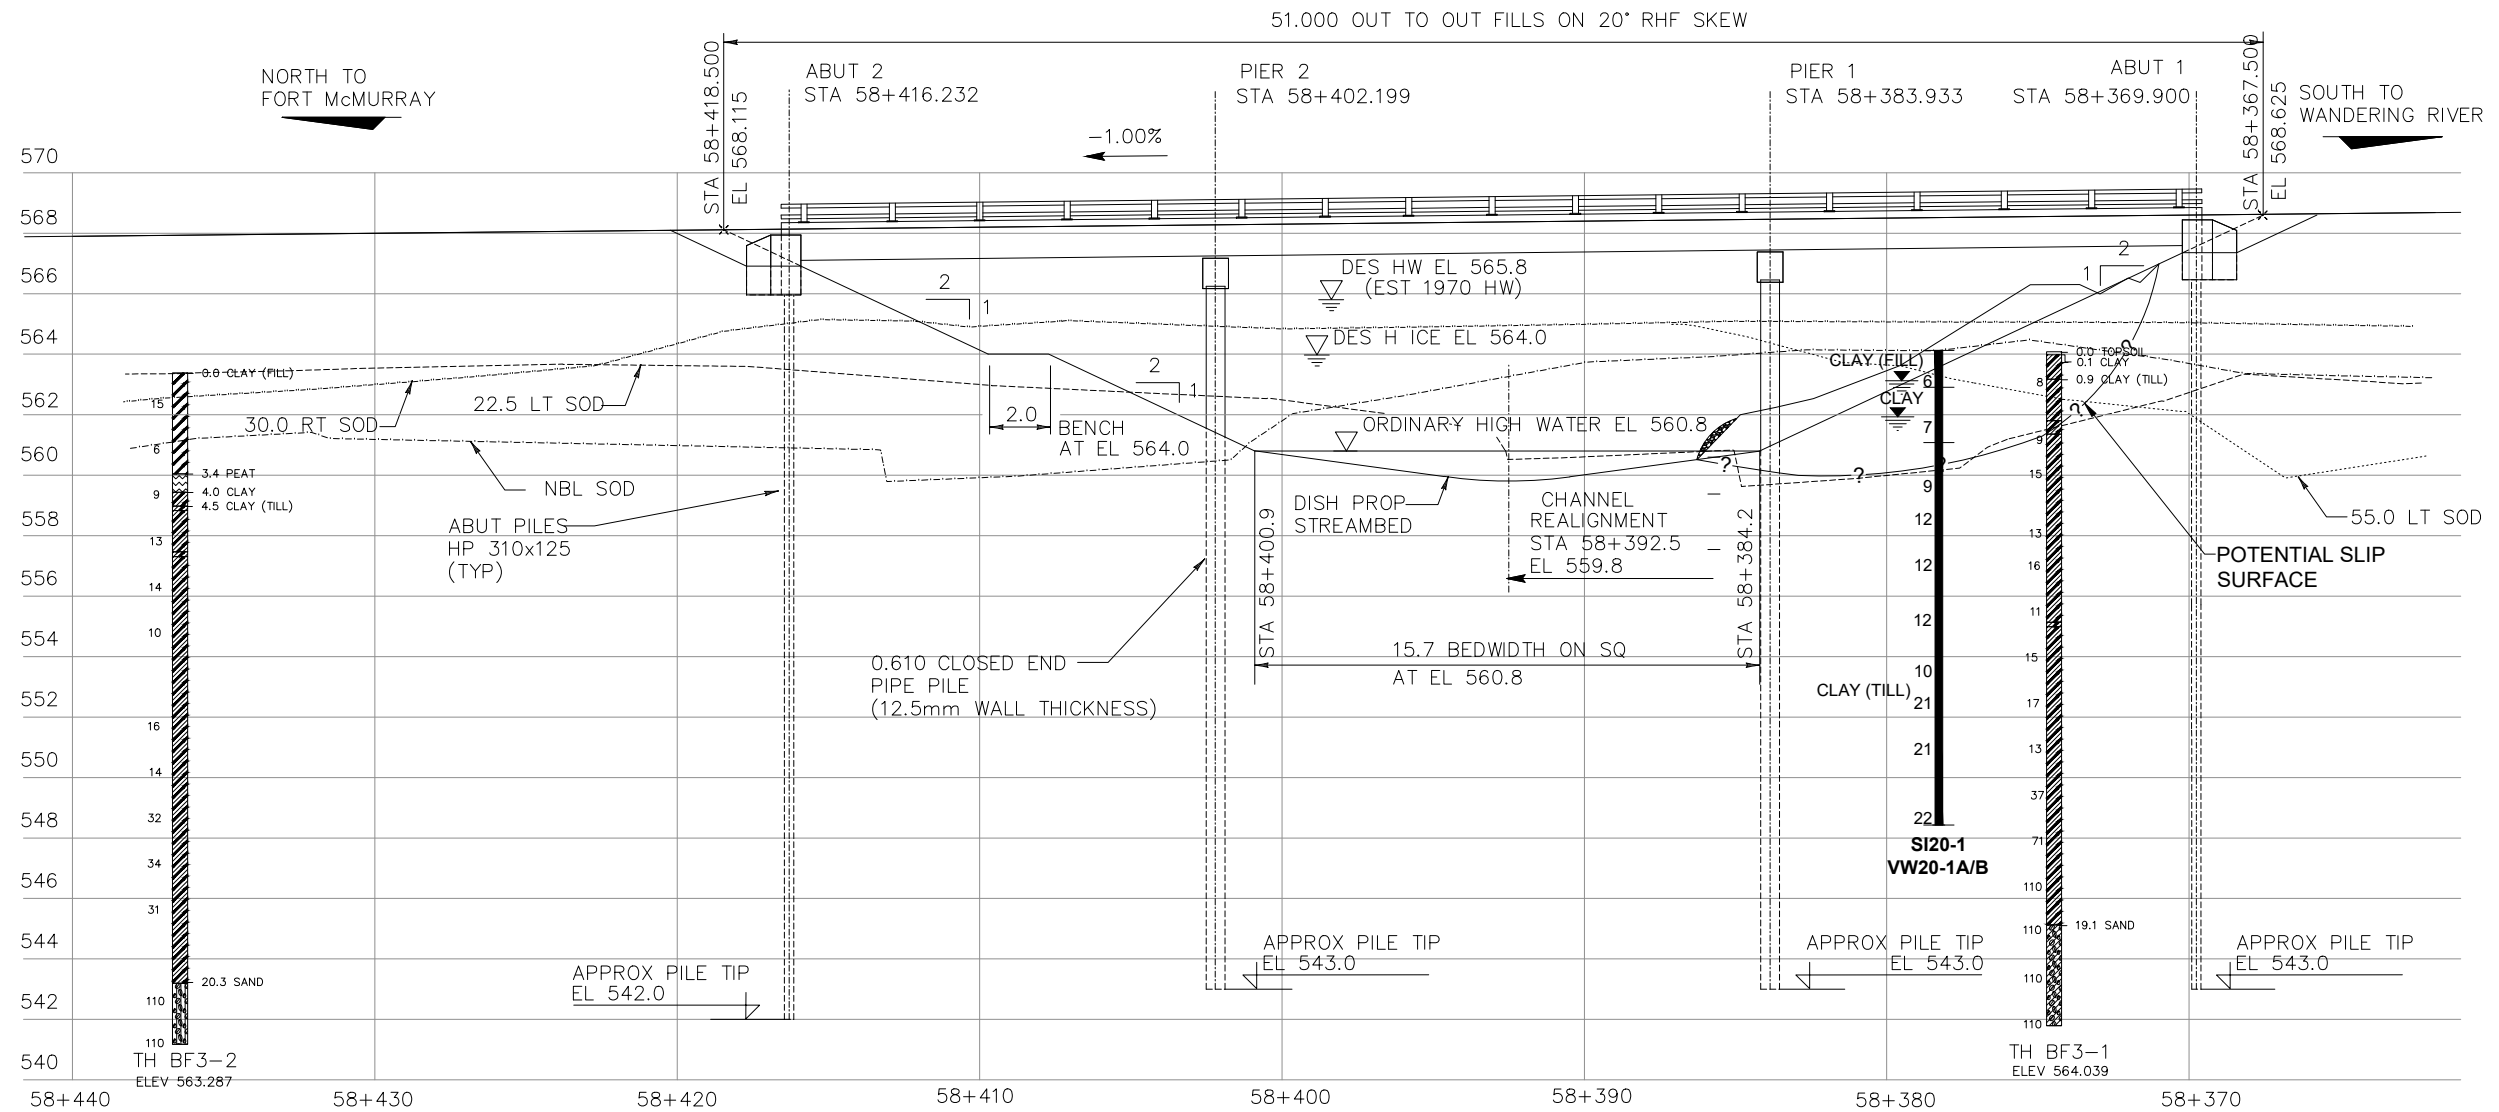
**FIGURE 2**

- NOTES:
- MAY 14, 2025 OBSERVATIONS ARE SHOWN IN RED.
  - SLUMP 1 IS WITHIN THE RIVERBANK SLOPE TO THE EAST OF THE BRIDGE HEADSLOPE.

**CROSS - SECTION A - A'  
SHOWING SLUMP 1 - EAST OF BRIDGE HEADSLOPE**

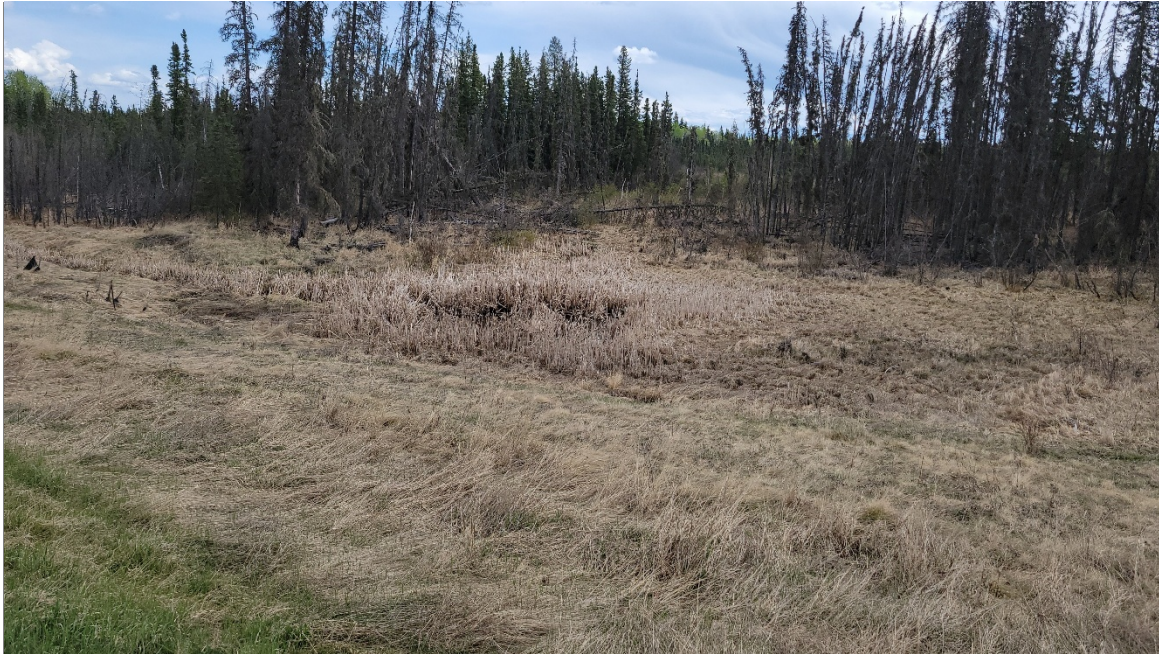
| <input checked="" type="checkbox"/> Seepage | Ground surface within Slumps was soft and wet (particularly at Slump 2 location); a steady flow in the highway east ditch originating from the low-lying area located to the south of the bridge location; subdrain pipe near west flank of Slump 1 was dry. | <input type="checkbox"/> |

**Photo 1. Looking east at the low-lying area south of the bridge.**

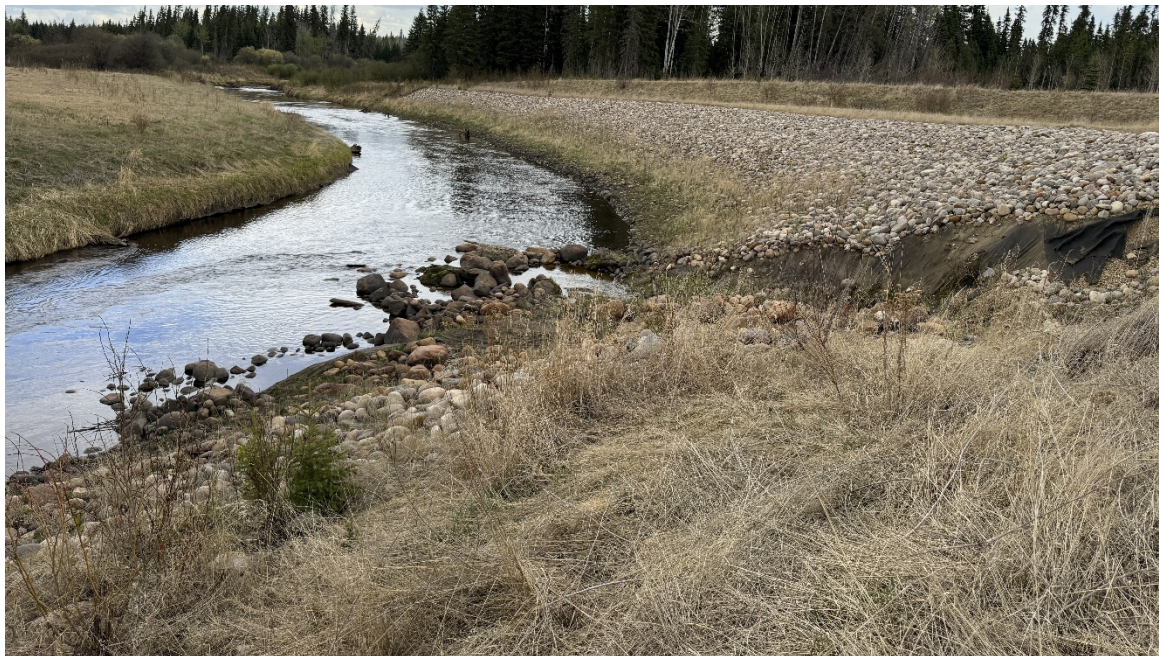
**Photo 2. Looking northeast at the north facing riprap channel to the east of the bridge location.**

- Place heavy rock riprap (Min. Class 1) at the base of the slumps (near the river location) to provide additional buttress and erosion protection.
- Reshape the failed riprap-lined channel within the east ditch and add heavy rock riprap (Min Class 2) to armor the re-graded channel. This should prevent future accumulation of sediment in the river channel and reduce the probability of further loss of land/trees to the east of the gully location.

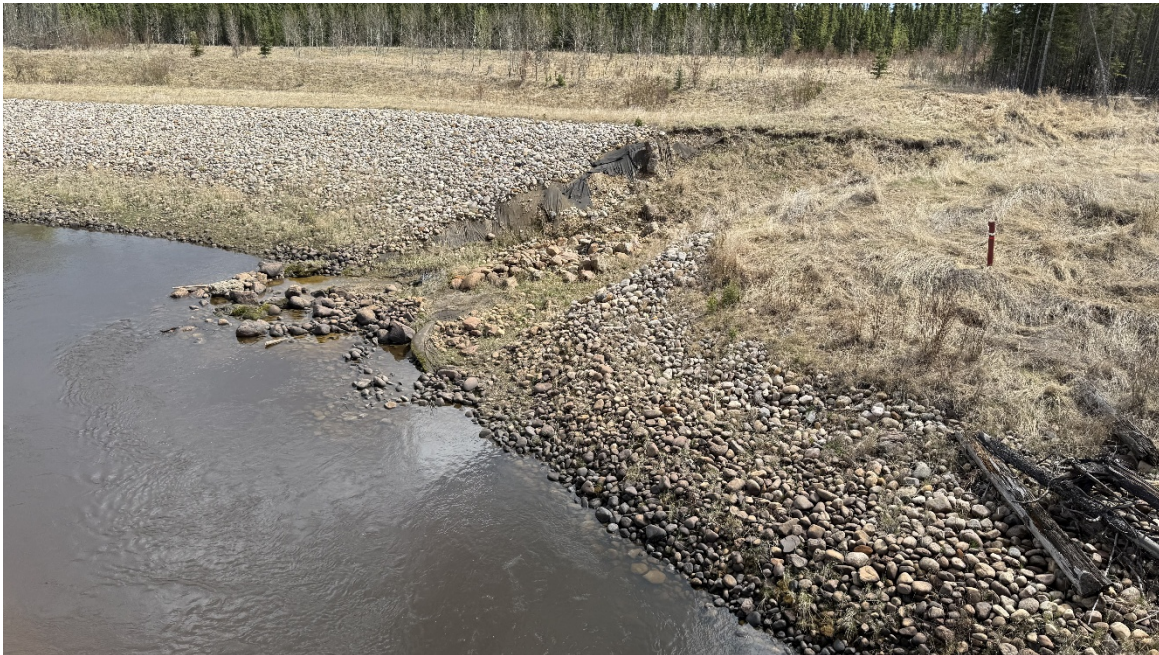
| <input checked="" type="checkbox"/> Erosion | Erosion developed east of Slump 1 at the mouth of the north facing riprap lined channel. Erosion is at least 3.5 m deep and has distorted the existing riprap within the channel. Scattered and subdued riprap areas along the outside bend of the river channel | <input type="checkbox"/> |

The existing erosion gully was similar to the 2024 inspection. It appears that the east ditch was not properly designed to carry the current flow. It is anticipated that the gully will continue get deeper and wider with time, resulting in more sediment accumulation in the stream and loss of land/trees to the east of the gully.

**Photo 3. Looking southeast at mouth of the severe erosion channel.**

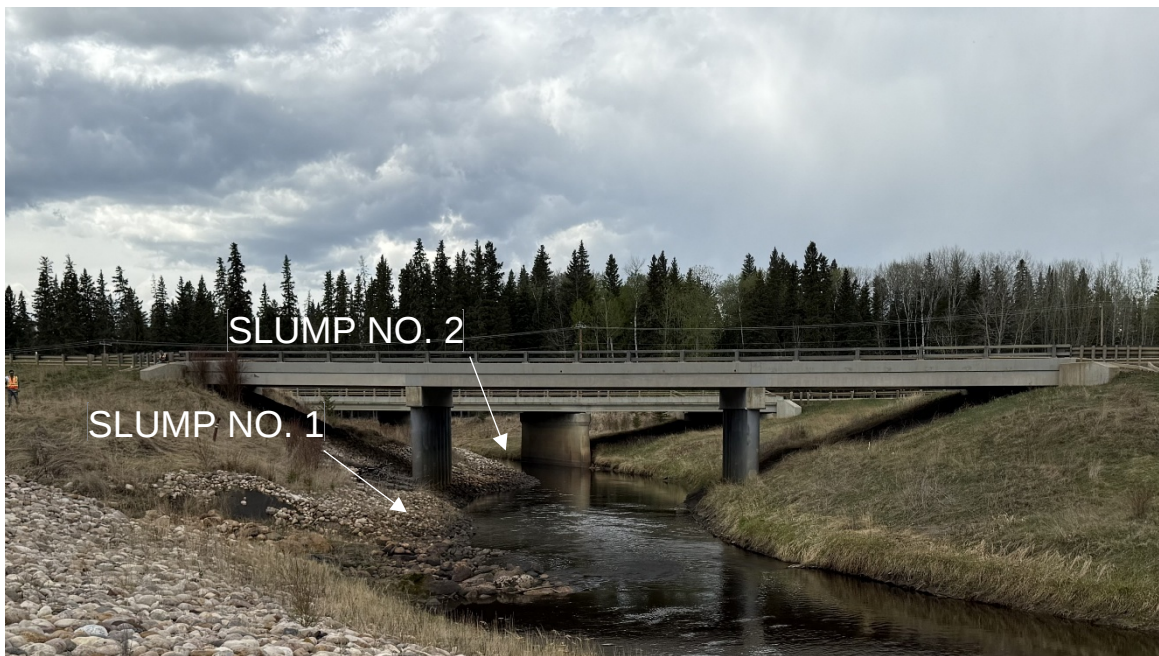
| <input checked="" type="checkbox"/> Slope Movement | A slump developing on each side of the bridge headslope. Slump 1 on the east side of the highway: head scarp cracks up to 1.5 deep and 1.5 m wide. Slump 2 on the west side of the highway: head scarp cracks up to 4 m deep and 1 m wide; multiple tension cracks within the Slump 2 slide area. The eastern flank of Slump 2 extends under the bridge by at least 2 m and has exposed the underside of the wingwall. Slump 2 sheared off existing 150 mm diameter subdrain pipe and developed a 200 mm gap under the southwest wing wall. Slumps 1 and 2 are both well vegetated. Both slumps 1 and 2 are toeing out into the river channel and are narrowing the river channel by approximately 1.2 m; Open, wide cracks noted within the bridge headslope downslope of the abutment seat location and cracks were noted to be similar to last inspection. | <input type="checkbox"/> |

The placement of relatively steeply inclined deep high plastic clay fill (i.e., 2H:1V), elevated groundwater levels within the slope, potential winter construction of embankment fills, and ongoing toe erosion by the river are likely the triggering factors for the observed slumps. In addition, the existing riprap (mainly Class 1M) along the riverbank is relatively smaller in size than what is typically used to armour riverbanks in similar bridge projects.

The approach fill slumps, to the east and the west of the bridge headslope, are very active, moving at very high rates and will continue to grow bigger in size. Future erosion of the toe of the landslides at the river location and/or rise in groundwater levels within the landslides may result in (a) failure of the majority of the headslope under the bridge deck, and (b) distress of the wing walls and exposure of abutment seat and a few of the pile supports (particularly at Slump 2 location). In addition, the complete failure of these closely spaced slumps, if occurs with time, could significantly restrict the width of the river channel and (a) cause flooding of areas located upstream of the site and/or (b) result in the development of additional slumps above the restricted channel width on the north side of the bridge.

**Photo 4. Slumping within the riverbank to the east of the Hwy (slump no. 1) and to the west of the Hwy (slump no. 2). Note distinct toe rolls in the river channel.**

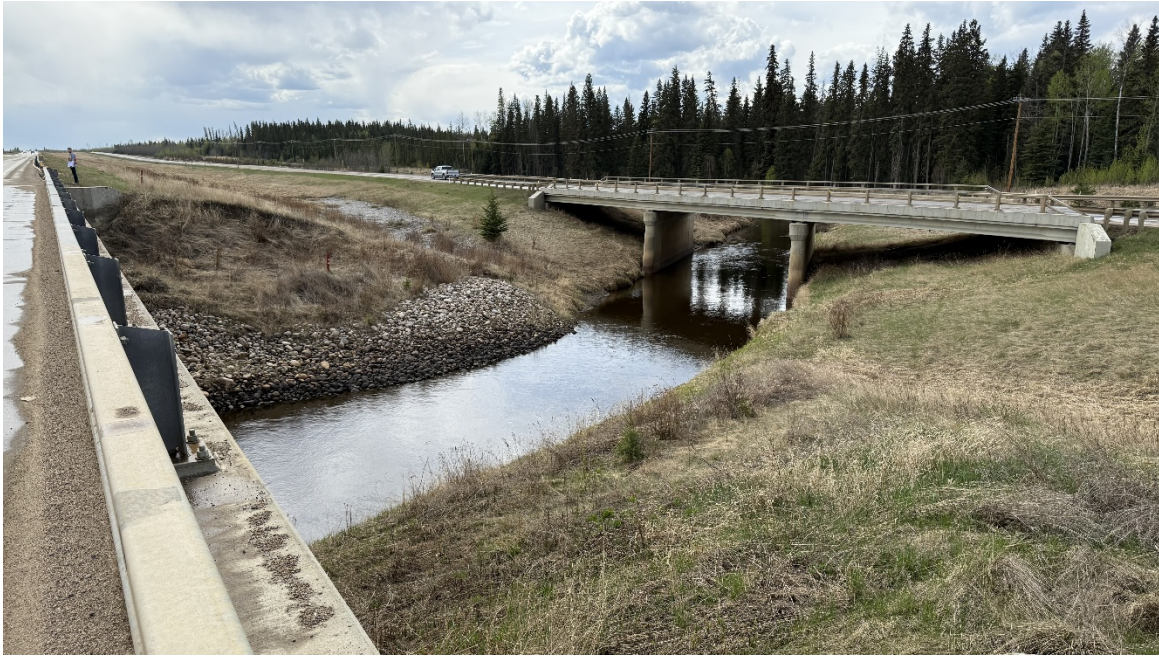
| <input checked="" type="checkbox"/> Other | Both slumps restricted the river channel width; sediment accumulation within the stream at the mouth of the erosion gully; more vegetation within Slump 2 mass. | <input type="checkbox"/> |

**Photo 5. Looking southwest at slump no. 2 area. Slump area is well vegetated.**

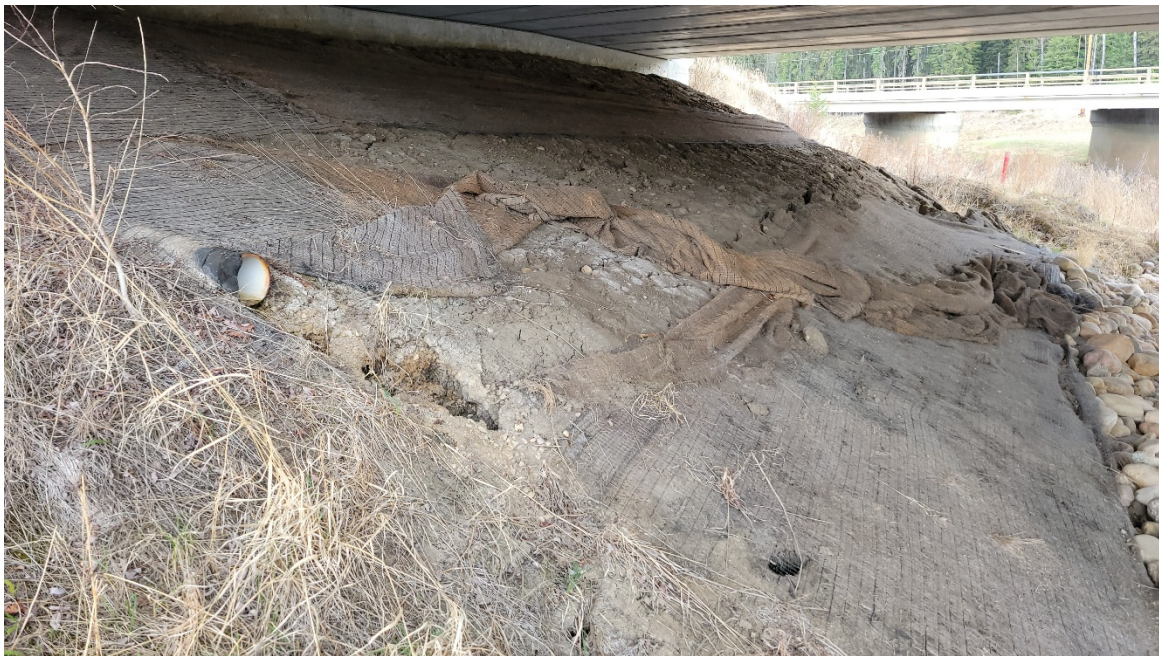
The bridge headslope, between the two slumps, is likely in a meta-stable condition and the complete failure of the headslope may take place abruptly similar to the currently active slumps. The observed cracks within the headslope may reflect a slope movement. The dip noted on the highway approach slab could be a reflection of the headslope movement.

**Photo 6. Looking at crack on headslope extending to the subdrain on the east side of the bridge. Crack is 5 mm wide at the subdrain and 700 mm at 10 m west of the subdrain.**

- Monitor the highway periodically for signs of distress and watch closely for the development of new cracks or widening of existing cracks.
- Monitor existing cracks under the bridge headslope and check for signs of movement of the headslope.

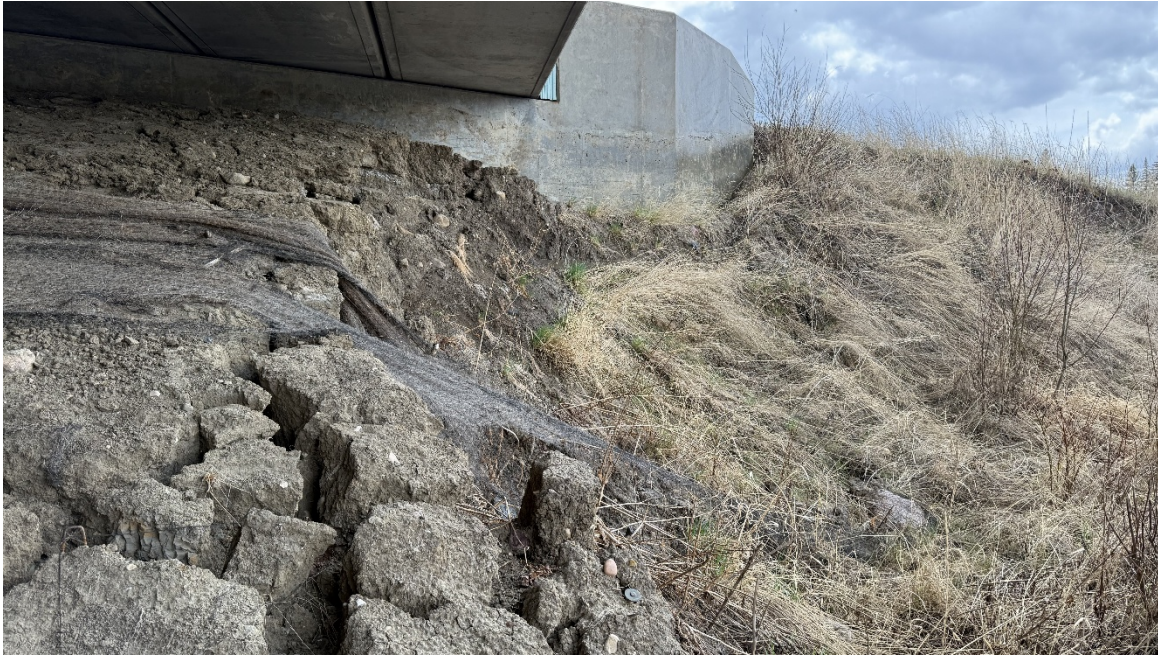
The slumps within the south approach fills, on each side of the bridge, did not appear to have yet impacted the integrity of the bridge and the highway. However, Slump 2 has exposed the base of the NW wing wall, and its flank extended below the headslope of the bridge downslope of the abutment location.

**Photo 7. Looking southwest at slump no. 2 flank. There is a 0.65 m drop from the original fill height at the abutment (shown as the soil staining in the photo).**

- Undertake slight grading to seal open cracks within landslide masses.
- Insert a flexible HDPE pipe into the void below the NW wing wall to convey as much flow as possible from the location of the sheared off subdrain pipe to the river channel.

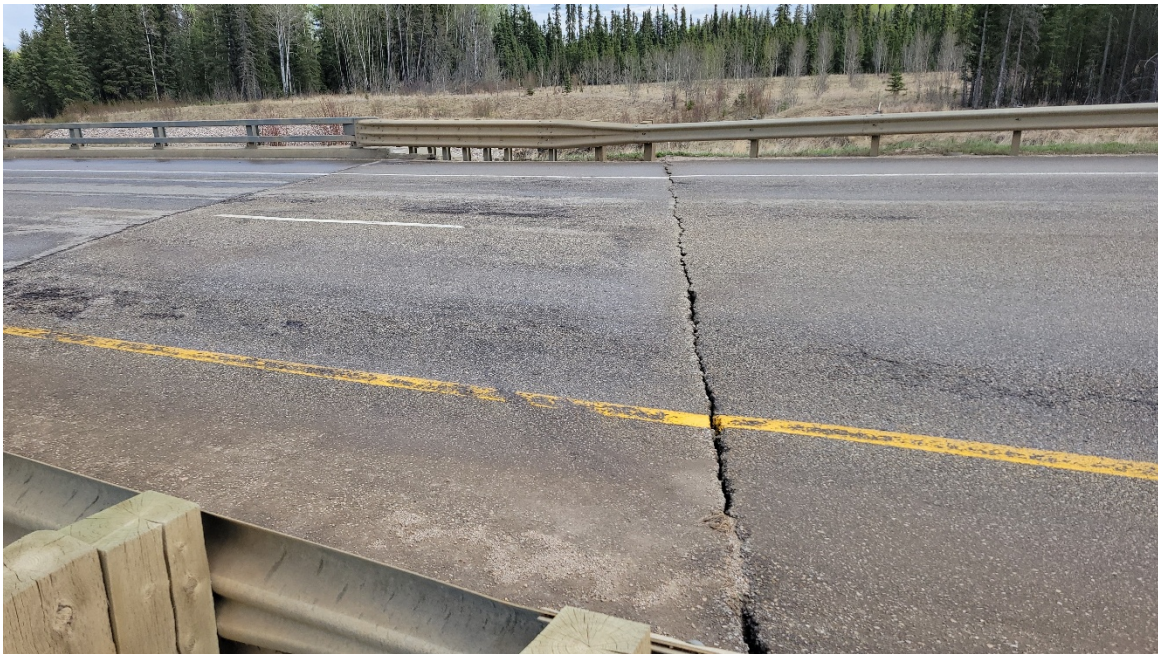
| <input checked="" type="checkbox"/> Pavement Distress | 25 to 30 mm dip on the south approach slab with a 40 to 70 mm wide crack. | <input checked="" type="checkbox"/> |

**Photo 8. Dip (25 mm to 30 mm) at the bridge south approach slab. Crack is 40-70 mm wide.**
