ALBERTA TRANSPORTATION AND  
ECONOMIC CORRIDORS GRMP  
NORTH CENTRAL (ATHABASCA AND FORT  
McMURRAY DISTRICTS)  
INSTRUMENTATION MONITORING - SPRING 2025

| Site Number | Location | Name | Hwy | km |
|---|---|---|---|---|
| NC088 | km 108 Settlement | HWY 63:06 km 108 Settlement | 63:06 | km 108 |

| <b>Current Monitoring:</b> | 26-May-2025 | <b>Previous Monitoring</b> | 16-Sep-2024 |

**SITE NC088: HWY 63:06 km 108 SETTLEMENT**

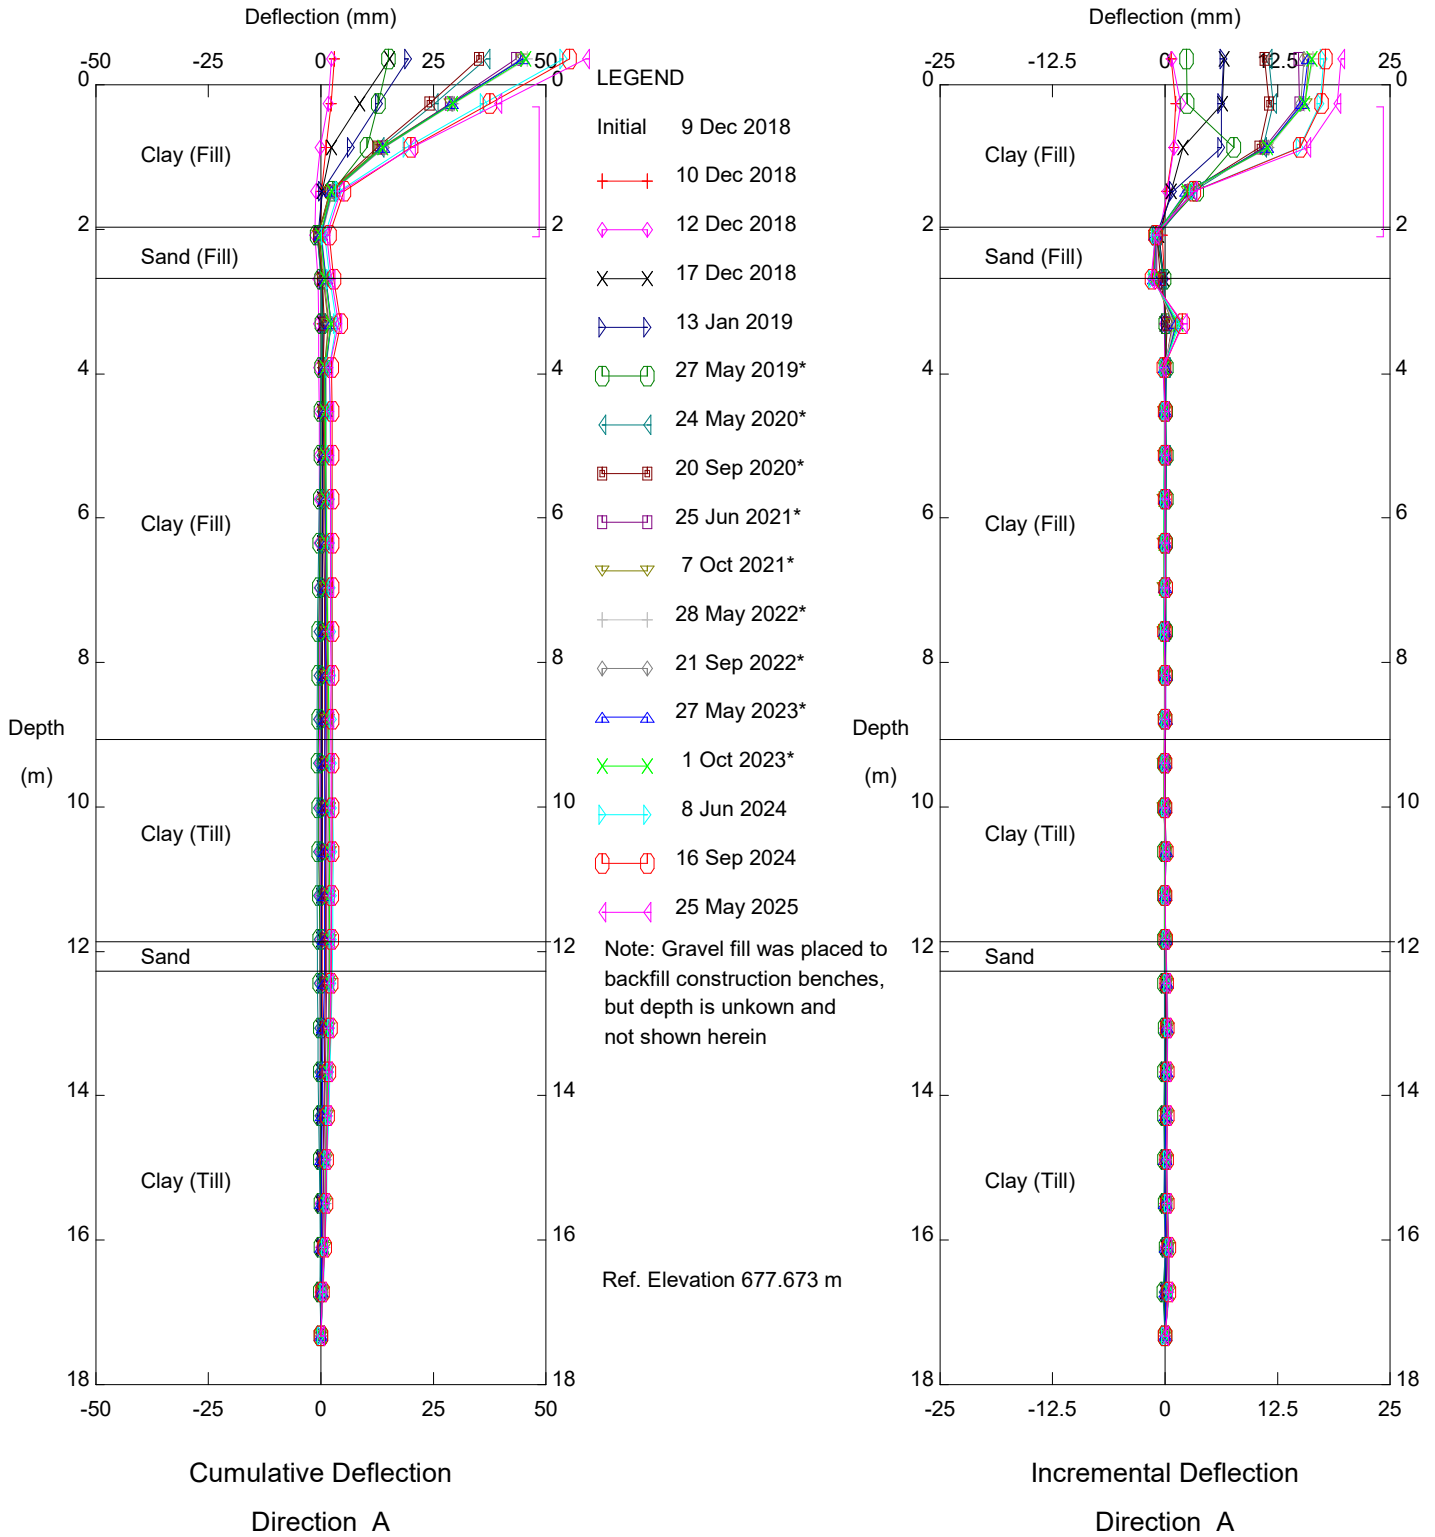
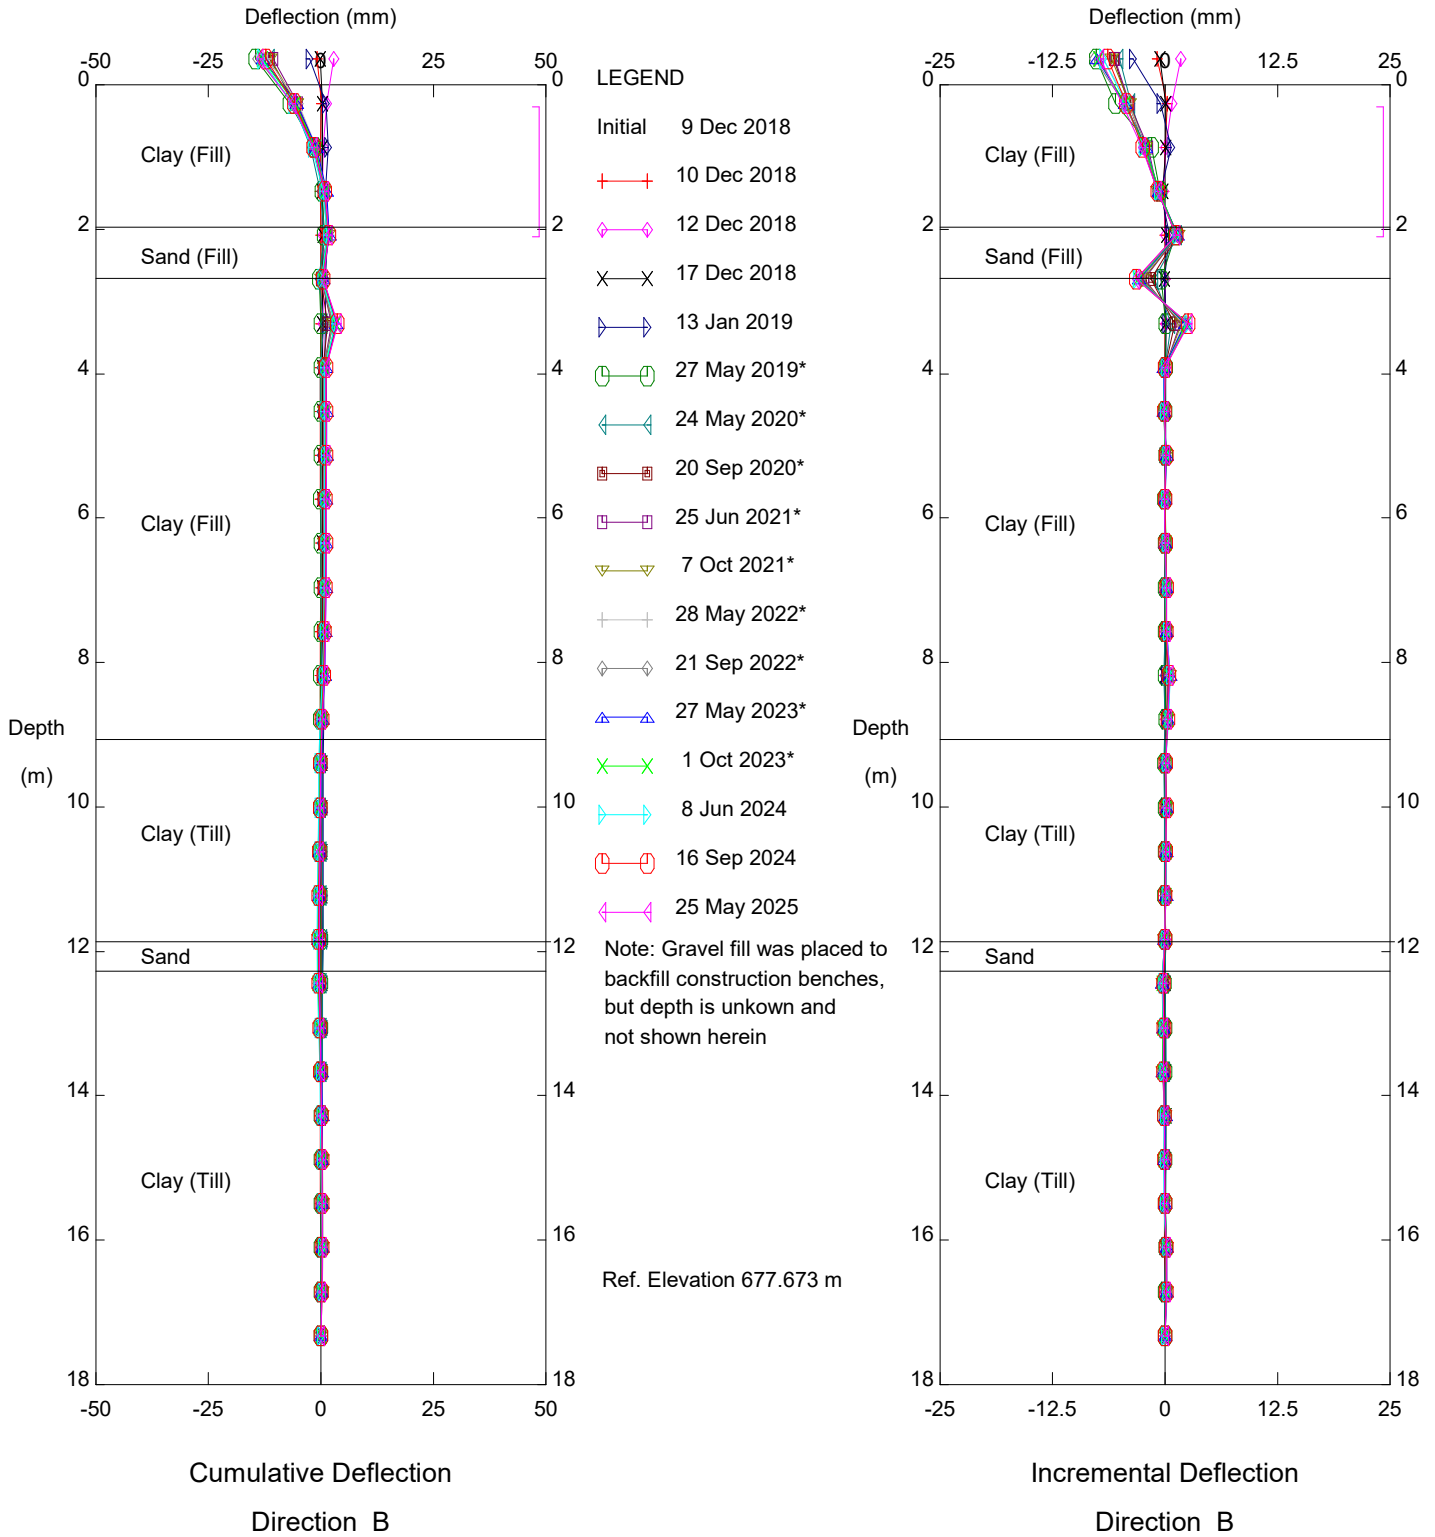
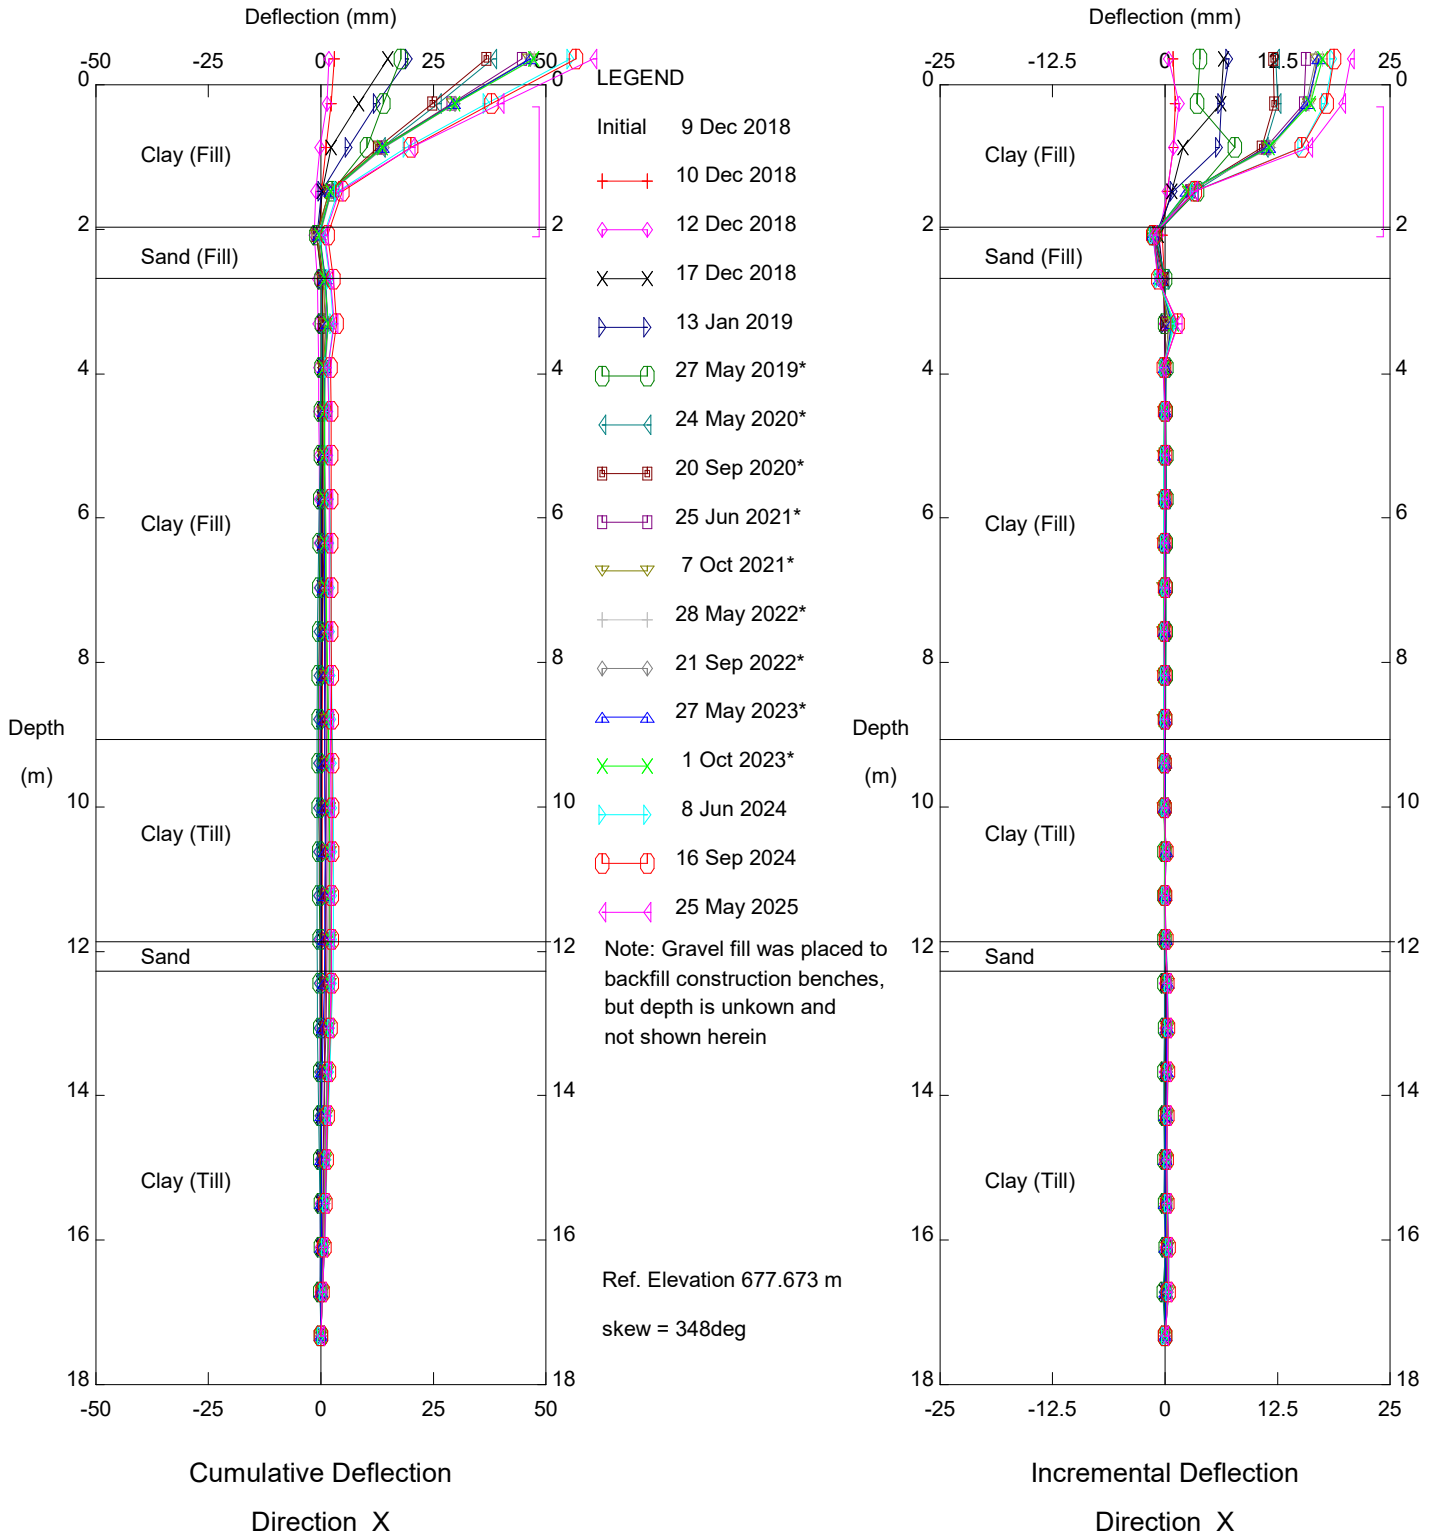
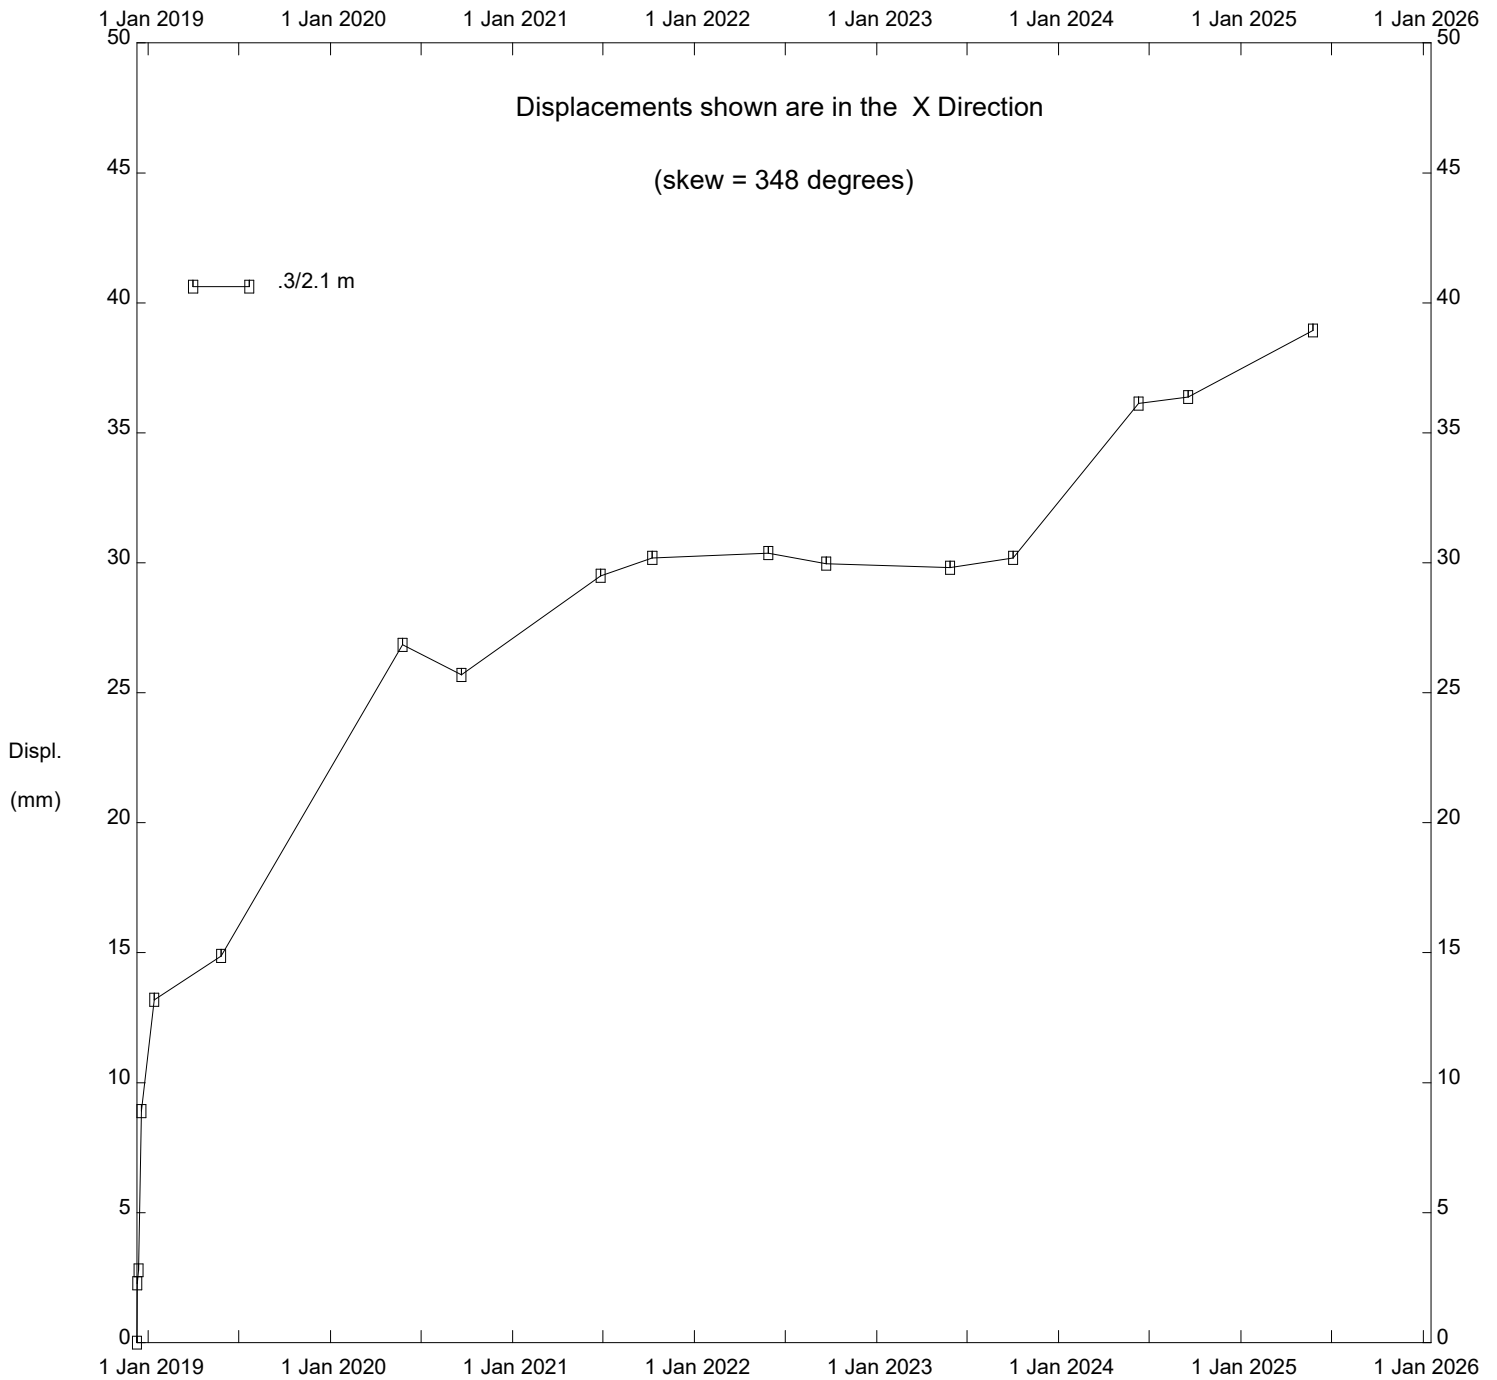
NC088 - West Embankment, Inclinator SI18-4

| Discussion | |
|---|---|
| <b>Interpretation of Monitoring Results:</b> | SI18-4 showed a rate of movement of 3.8 mm/yr over 0.3 m to 2.1 m depth since the fall of 2024 readings, which corresponds to an increase of 2.8 mm/yr since the fall of 2024 readings.<br><br>Pneumatic piezometers PN18-3A, PN18-3B, PN14-4A, and PN18-4B showed decreases in groundwater levels of 0.55 m, 0.64 m, 0.09 m, and 0.20 m, respectively, since the fall of 2024 readings. |

| INSTRUMENT # | DATE INITIALIZED | TOTAL CUMULATIVE RESULTANT MOVEMENT AND DEPTH OF MOVEMENT TO DATE (mm) | MAXIMUM RATE OF MOVEMENT (mm/yr.) | CURRENT STATUS OF SI | DATE OF PREVIOUS READING | INCREMENTAL MOVEMENT SINCE PREVIOUS READING (mm) | CURRENT RATE OF MOVEMENT (mm/yr.) | CHANGE IN RATE OF MOVEMENT SINCE PREVIOUS READING (mm/yr.) |
|---|---|---|---|---|---|---|---|---|
| SI18-4 | December 9, 2018 | 39.0 over 0.3 to 2.1 m depth in 272° direction | 729.4 on December 10, 2018 | Operational | September 16, 2024 | 2.6 | 3.8 | 2.8 |

| Discussion | |
|---|---|
| <b>Future Work:</b> | The instruments should be read again in the fall of 2025. |
