ALBERTA TRANSPORTATION AND  
ECONOMIC CORRIDORS GRMP  
NORTH CENTRAL (ATHABASCA AND FORT  
McMURRAY DISTRICTS)  
INSTRUMENTATION MONITORING - SPRING 2025

| Site Number | Location | Name | Hwy | km |
|---|---|---|---|---|
| NC089 | HWY 63:12 | Beacon Hill Backslope Slide | 63:12 | Km 8.7 |

| <b>Current Monitoring:</b> | 28-May-2025 | <b>Previous Monitoring</b> | 11-June-2024 |

**SITE NC089: HWY 63:12 BEACON HILL BACKSLOPE SLIDE (km 8.7)**

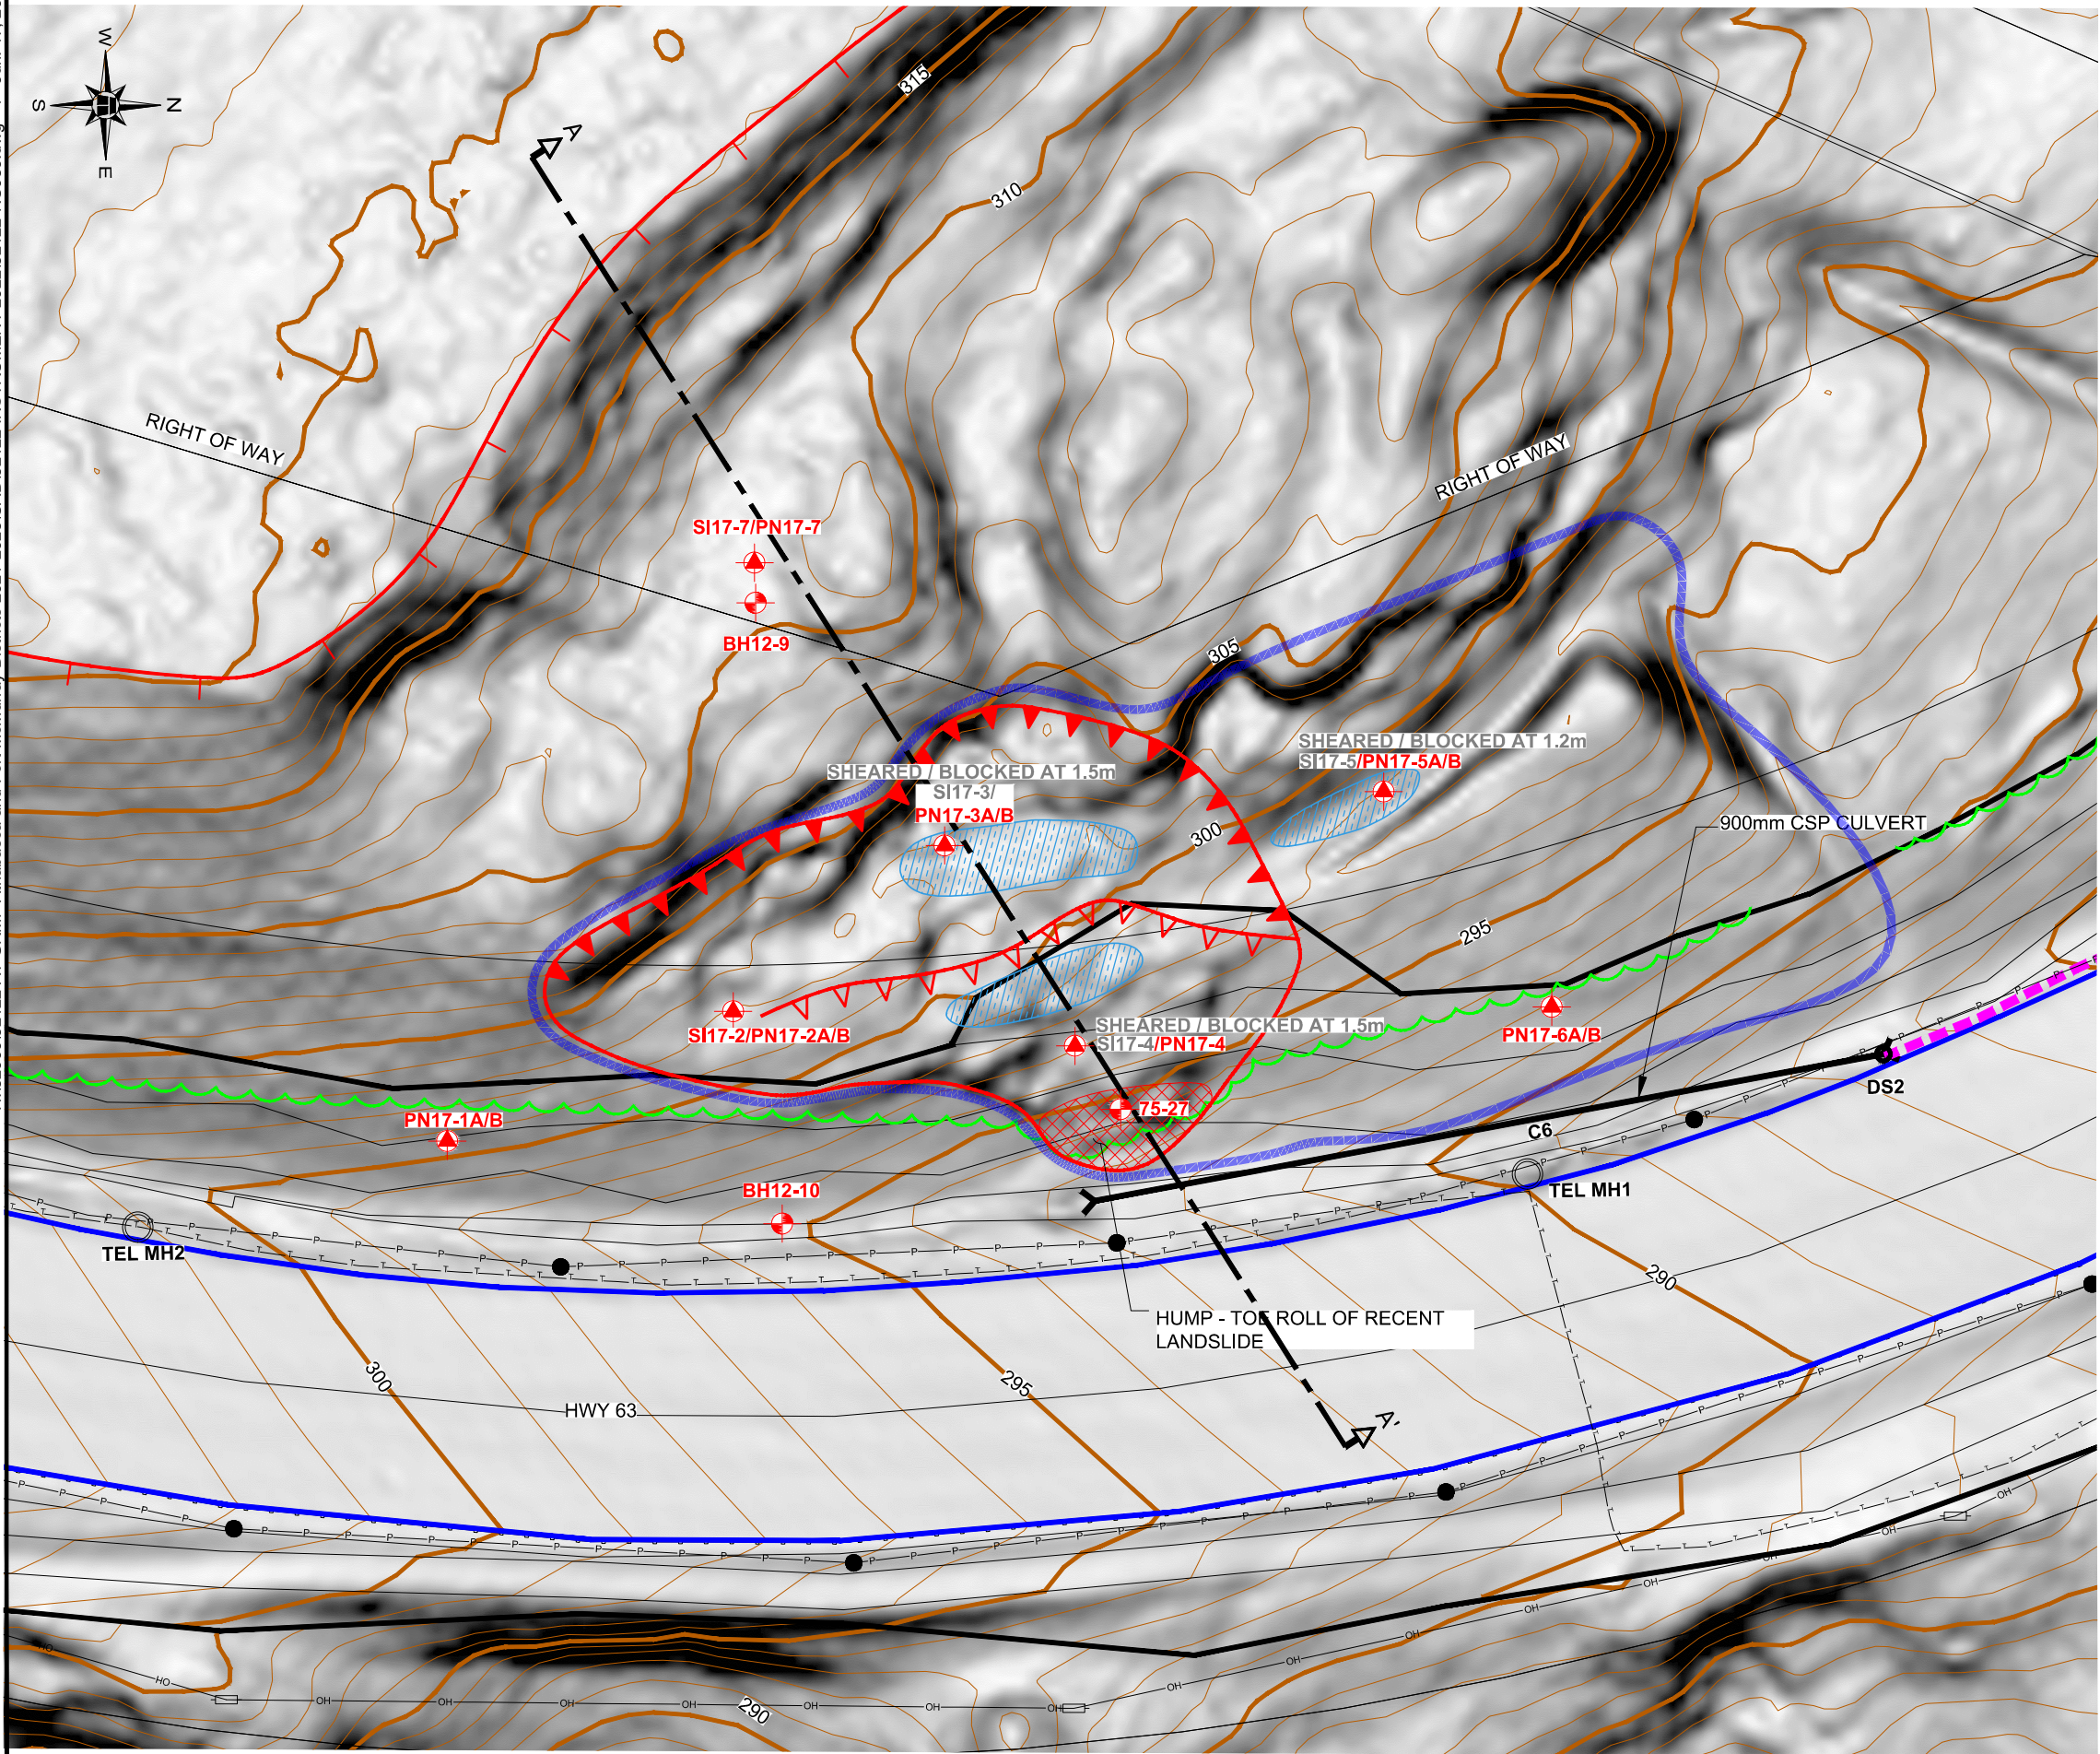
**DWG No. 32122-NC089**

| * Clear SI17-4, Water seepage and running down the slope. |

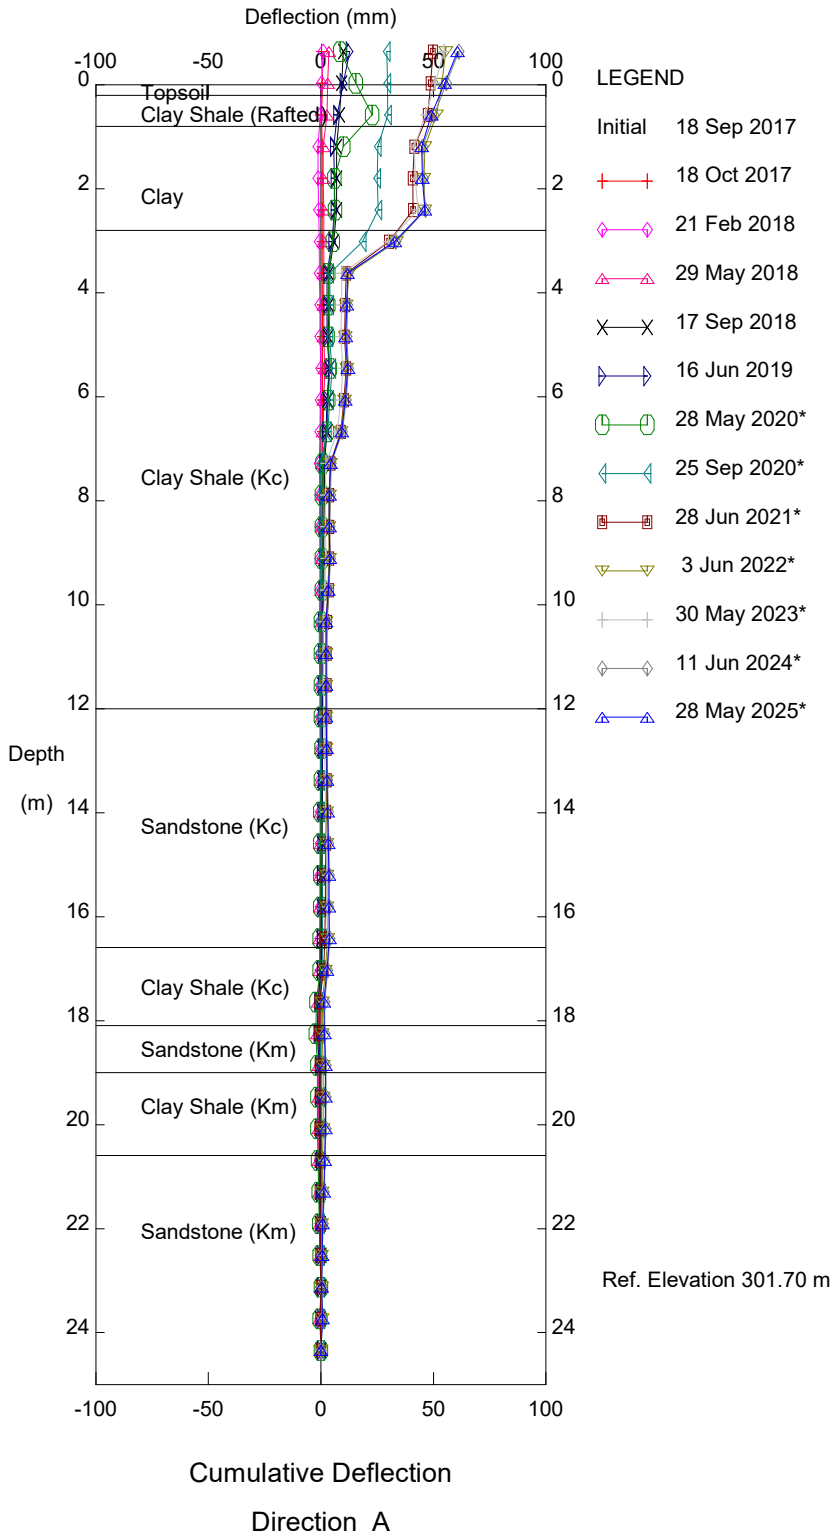
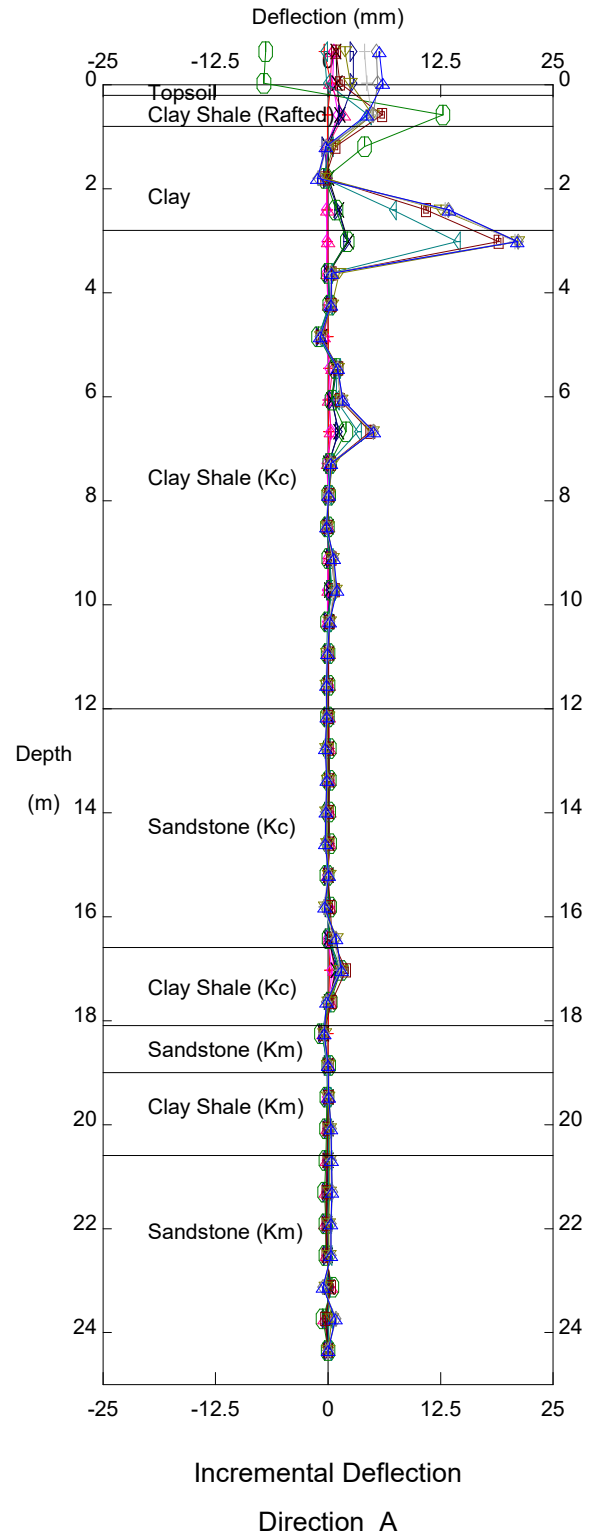
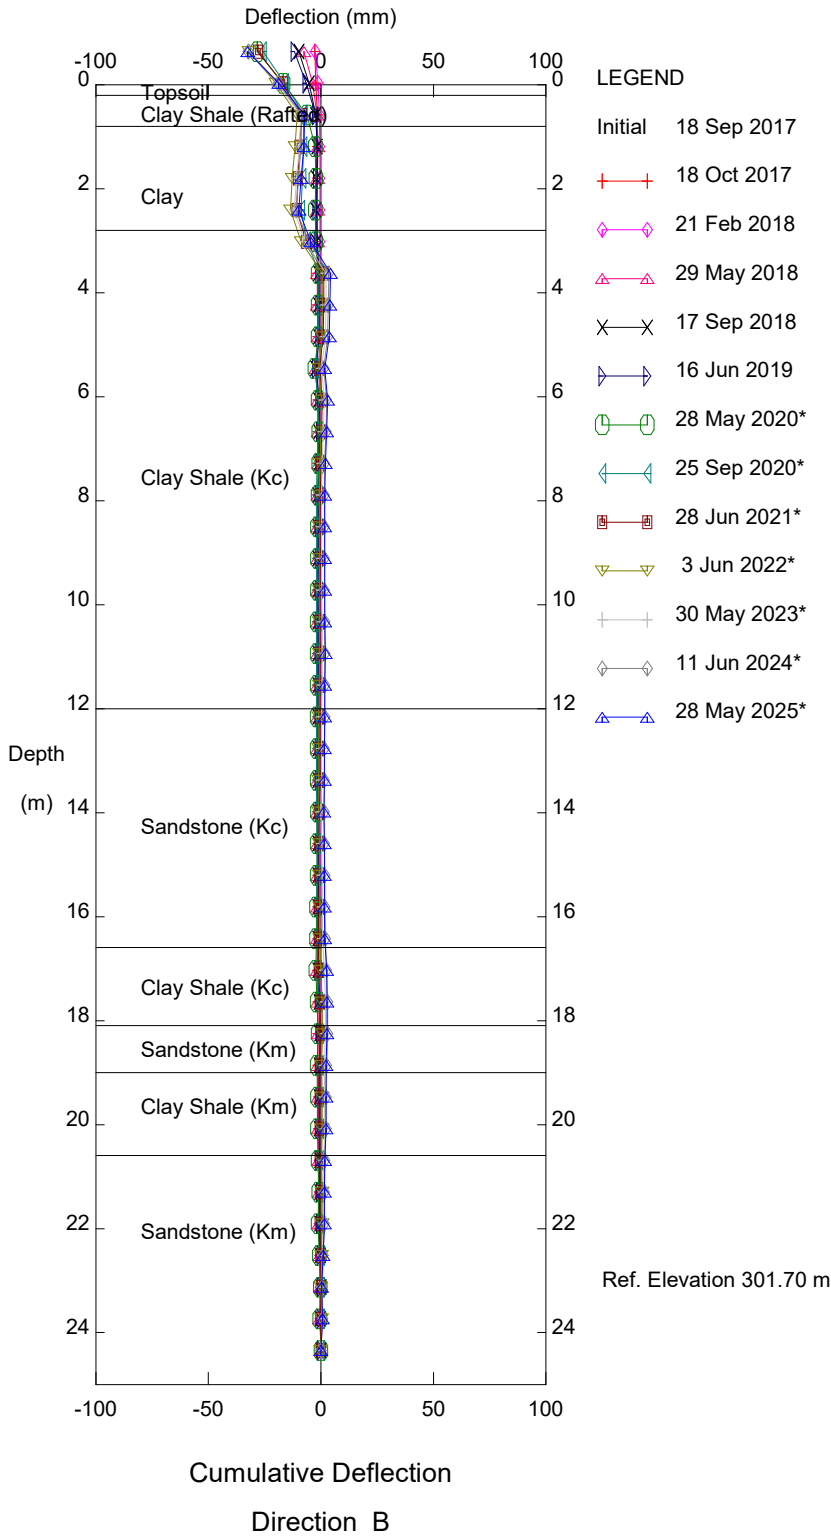
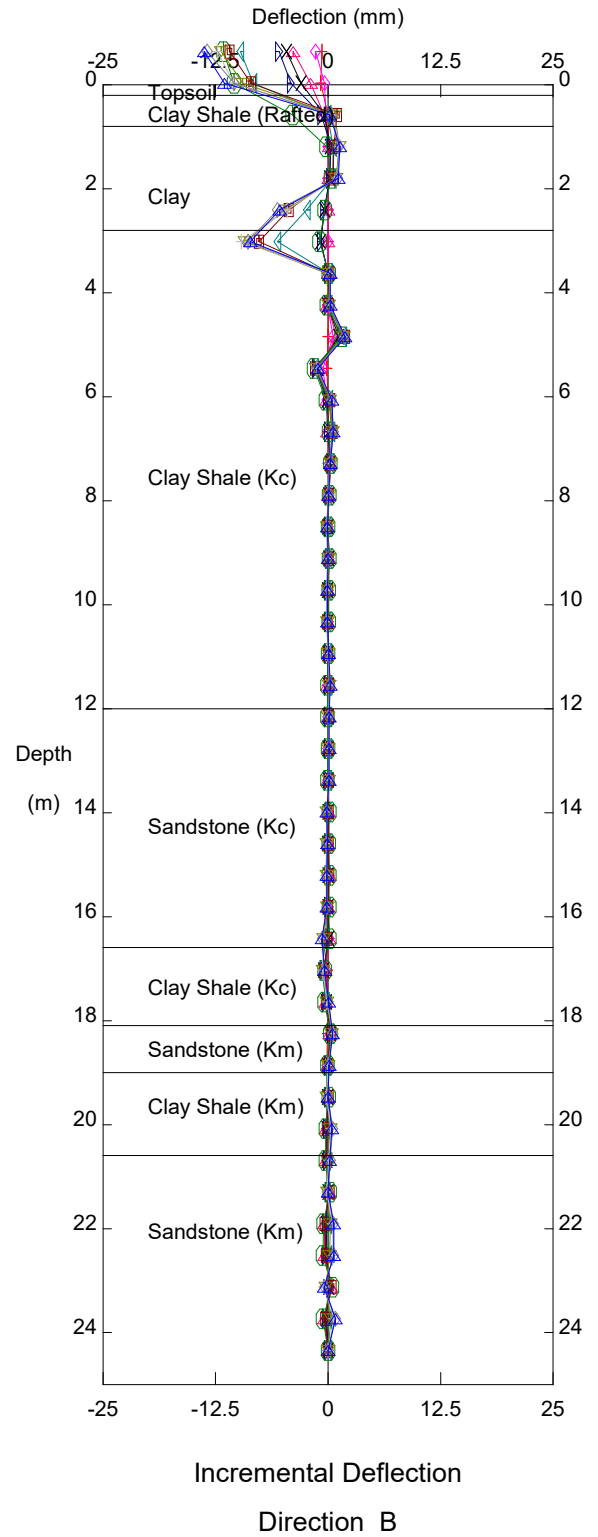
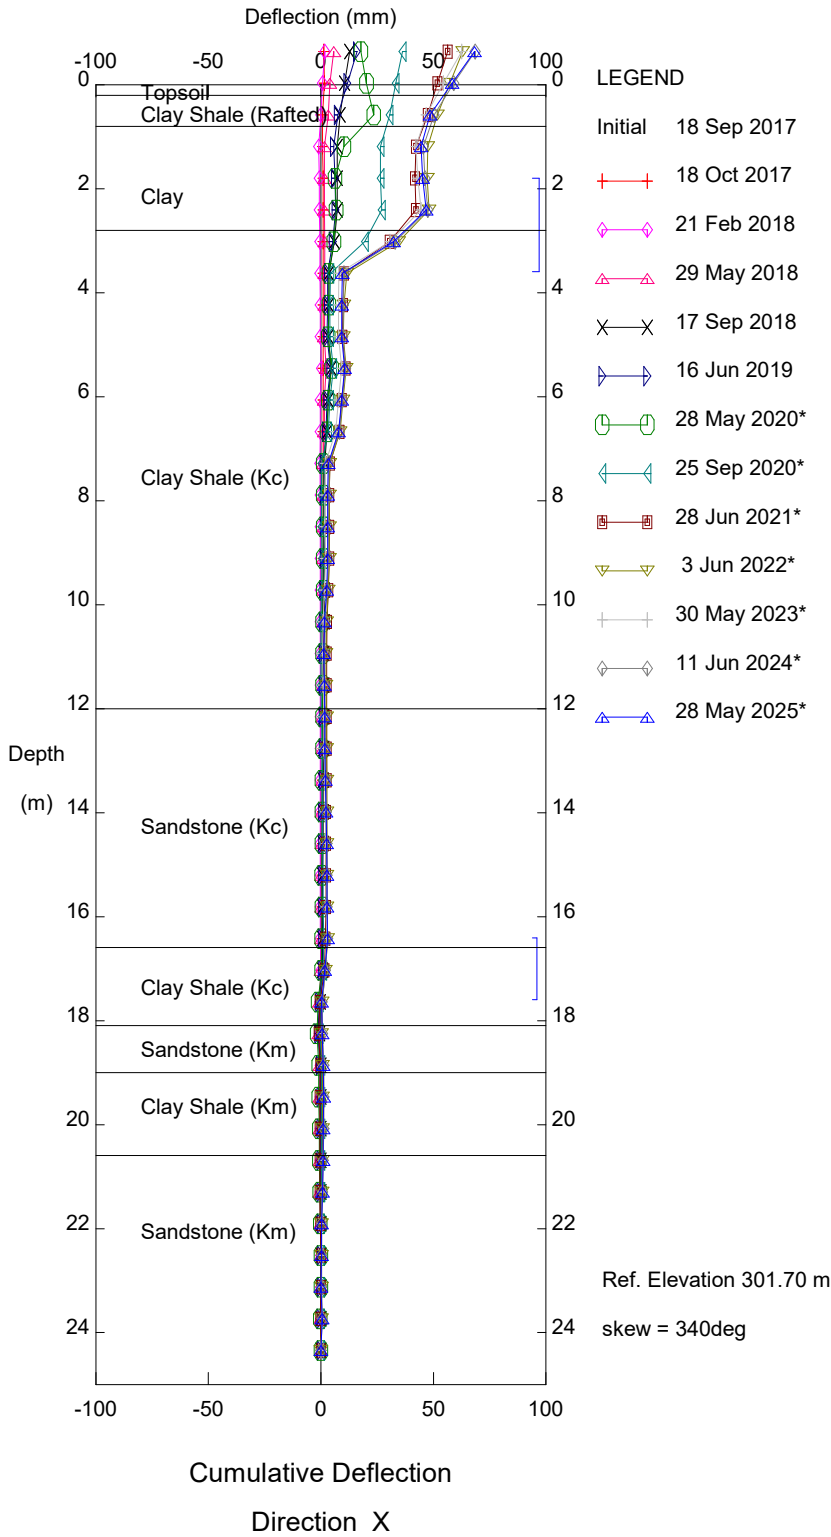
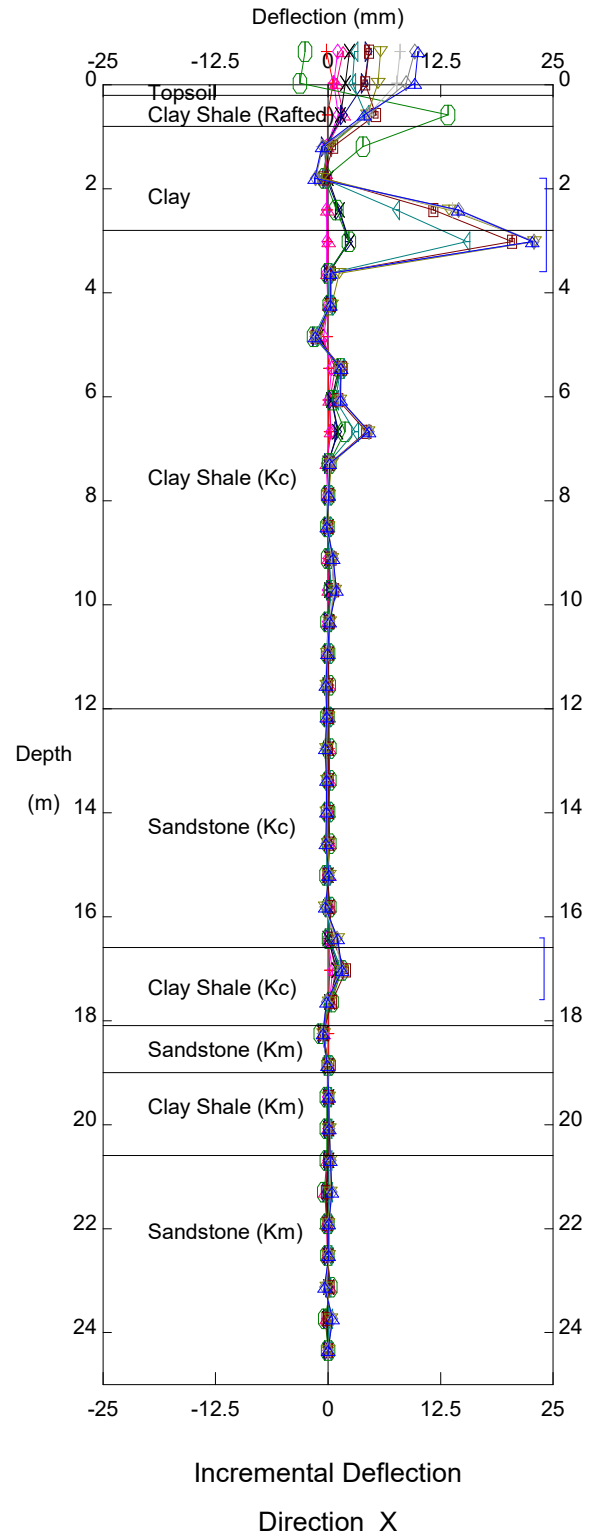
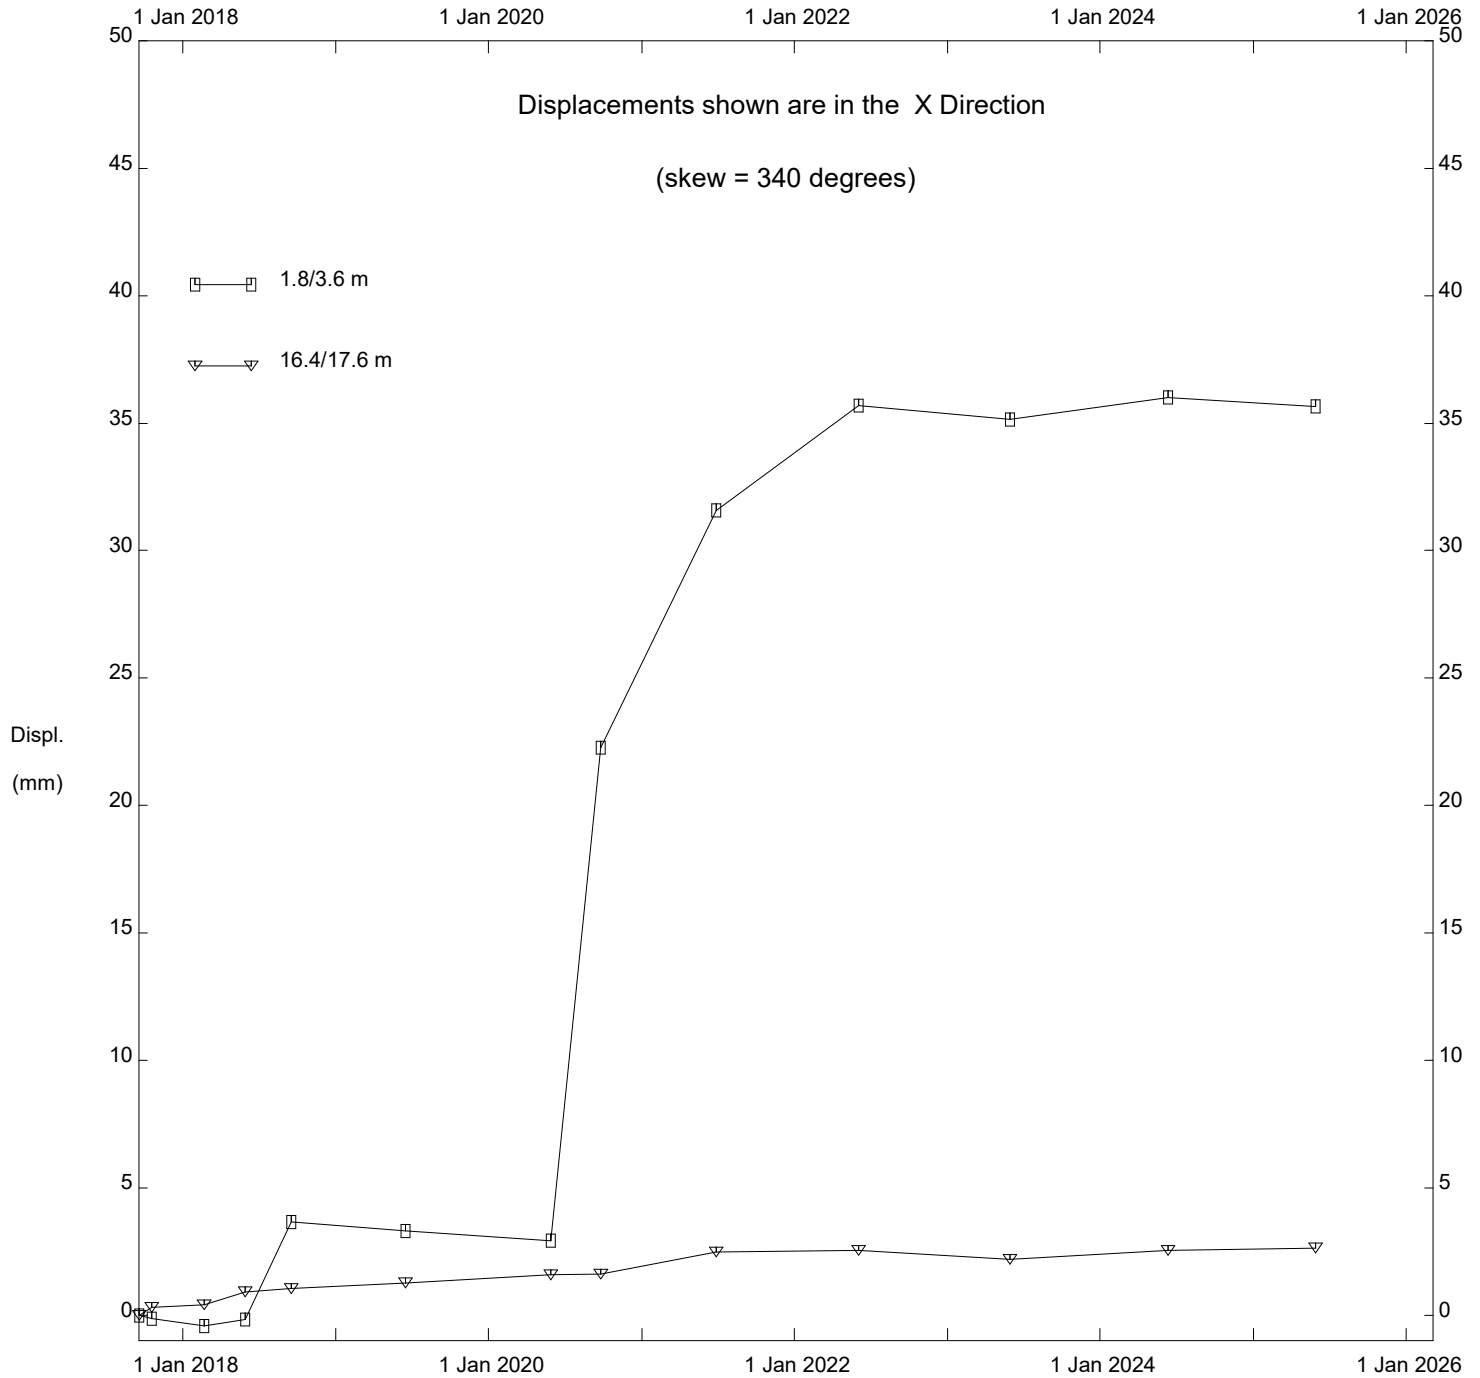
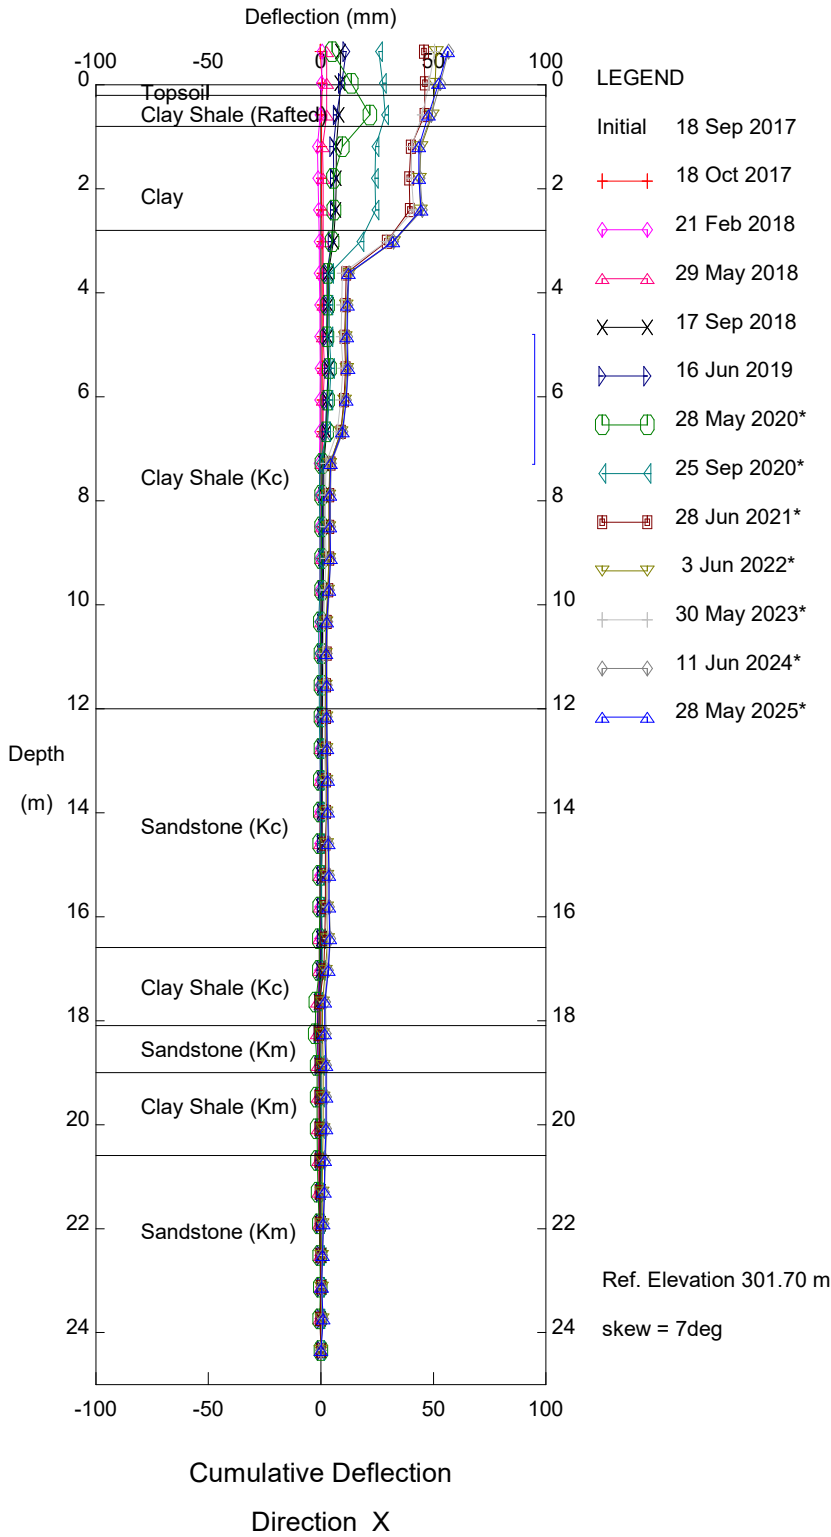
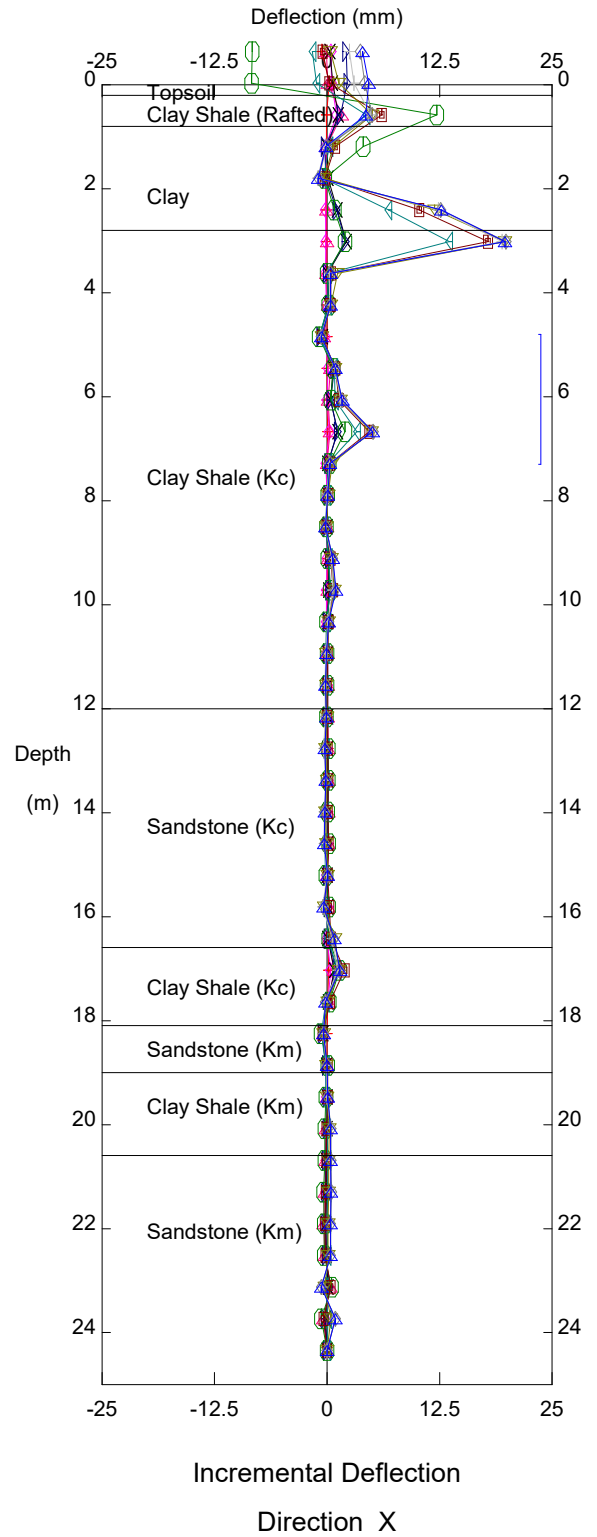
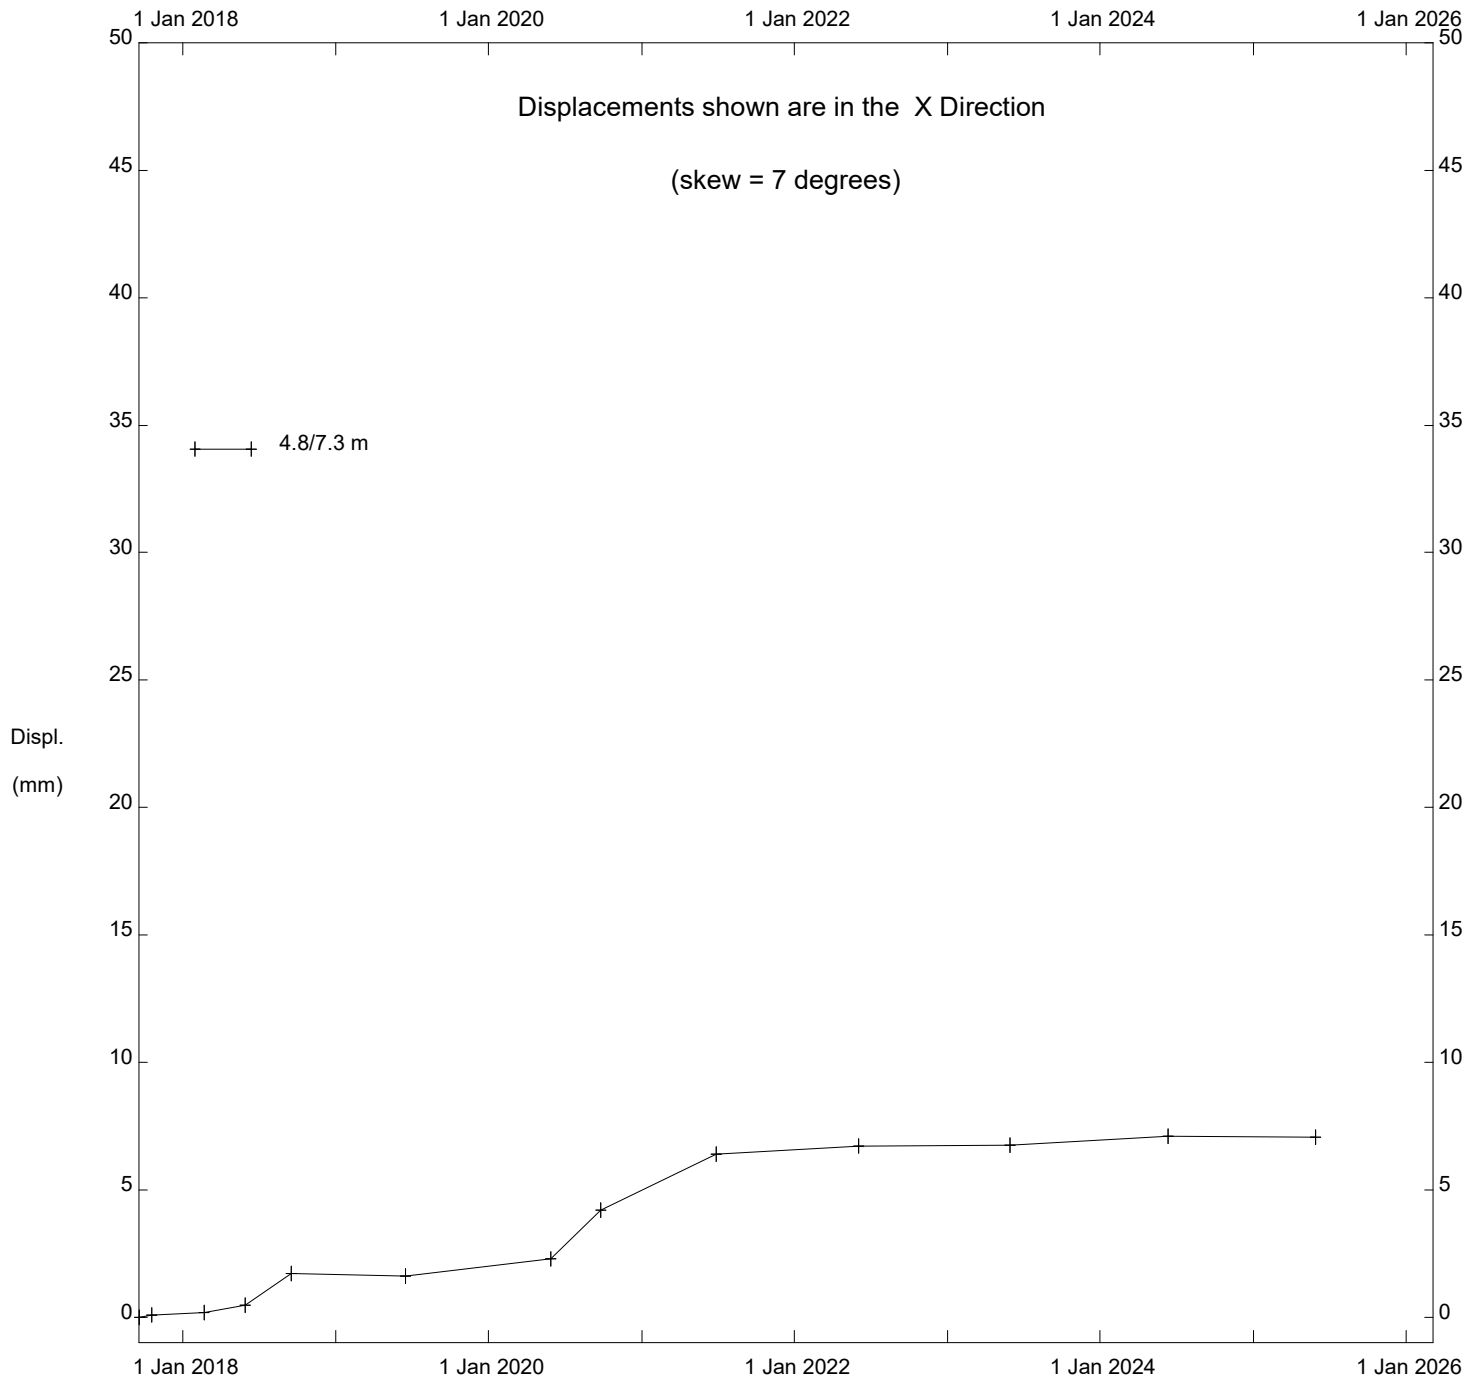
NC089 - Beacon Hill Backslope Slide, Inclinometer SI17-2

| Discussion | |
|---|---|
| <b>Interpretation of Monitoring Results:</b> | <p>SI17-2 showed no discernible movement over 1.8 m to 3.6 m depth, no discernible moment over 4.8 m to 7.3 m depth, and a rate of movement of 0.1 mm/yr over 16.4 to 17.6 m of depth since the spring of 2024 readings. SI17-7 showed a rate of movement of less than 1 mm/yr over 1.6 m to 3.4 m depth and 22.9 m to 24.1 m depth since the spring of 2024 readings.</p> <p>Pneumatic piezometers PN17-1A, PN17-1B, PN17-2A, PN17-2B, PN17-3A, PN17-3B, PN17-4, PN17-5B, PN17-6A, PN17-6B, PN17-7A and PN17-7B showed decreases in groundwater levels ranging from 0.01 m in PN17-7B to 0.57 m in PN17-7A since the spring of 2024 readings. PN17-5A and PN17-7C showed increases in groundwater levels of 0.10 m and 0.04 m, respectively, since the spring of 2024 readings. The groundwater level recorded in PN17-5A was 8.77 m</p> |

| INSTRUMENT # | DATE INITIALIZED | TOTAL CUMULATIVE RESULTANT MOVEMENT AND DEPTH OF MOVEMENT TO DATE (mm) | MAXIMUM RATE OF MOVEMENT (mm/yr) | CURRENT STATUS OF SI | DATE OF PREVIOUS READING | INCREMENTAL MOVEMENT SINCE PREVIOUS READING (mm) | CURRENT RATE OF MOVEMENT (mm/yr) | CHANGE IN RATE OF MOVEMENT SINCE PREVIOUS READING (mm/yr) |
|---|---|---|---|---|---|---|---|---|
| SI17-2 | September 18, 2017 | 35.6 mm over 1.8 to 3.6 m depth in 53° direction | 58.9 on September 25, 2020 | Operational | June 11, 2024 | No Discernible Movement | N/A | -1.2 |
| | | 7.1 mm over 4.8 to 7.3 m of depth in 80° direction | 5.8 on September 25, 2020 | | | No Discernible Movement | N/A | -0.3 |
| | | 2.6 mm over 16.4 to 17.6 m depth in 53° direction | 3.6 on October 18, 2017 | | | 0.1 | 0.1 | -0.2 |
