ALBERTA TRANSPORTATION AND  
ECONOMIC CORRIDORS GRMP  
NORTH CENTRAL (ATHABASCA AND FORT  
McMURRAY DISTRICTS)  
INSTRUMENTATION MONITORING - SPRING 2025

| Site Number | Location | Name | Hwy | km |
|---|---|---|---|---|
| NC089 | HWY 63:12 | Beacon Hill Backslope Slide | 63:12 | Km 8.7 |

| <b>Current Monitoring:</b> | 28-May-2025 | <b>Previous Monitoring</b> | 11-June-2024 |

**SITE NC089: HWY 63:12 BEACON HILL BACKSLOPE SLIDE (km 8.7)**

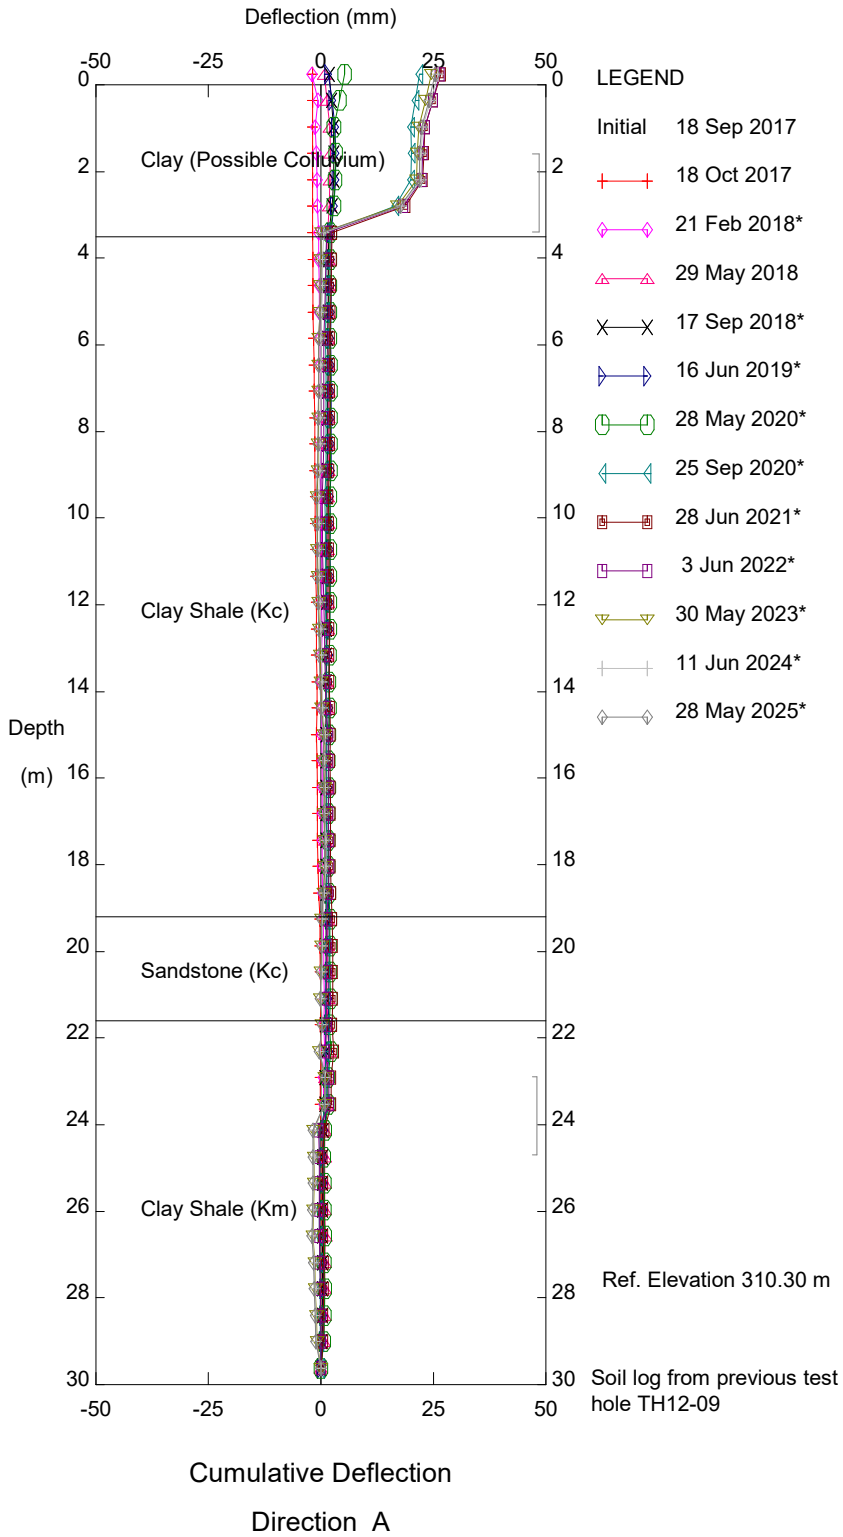
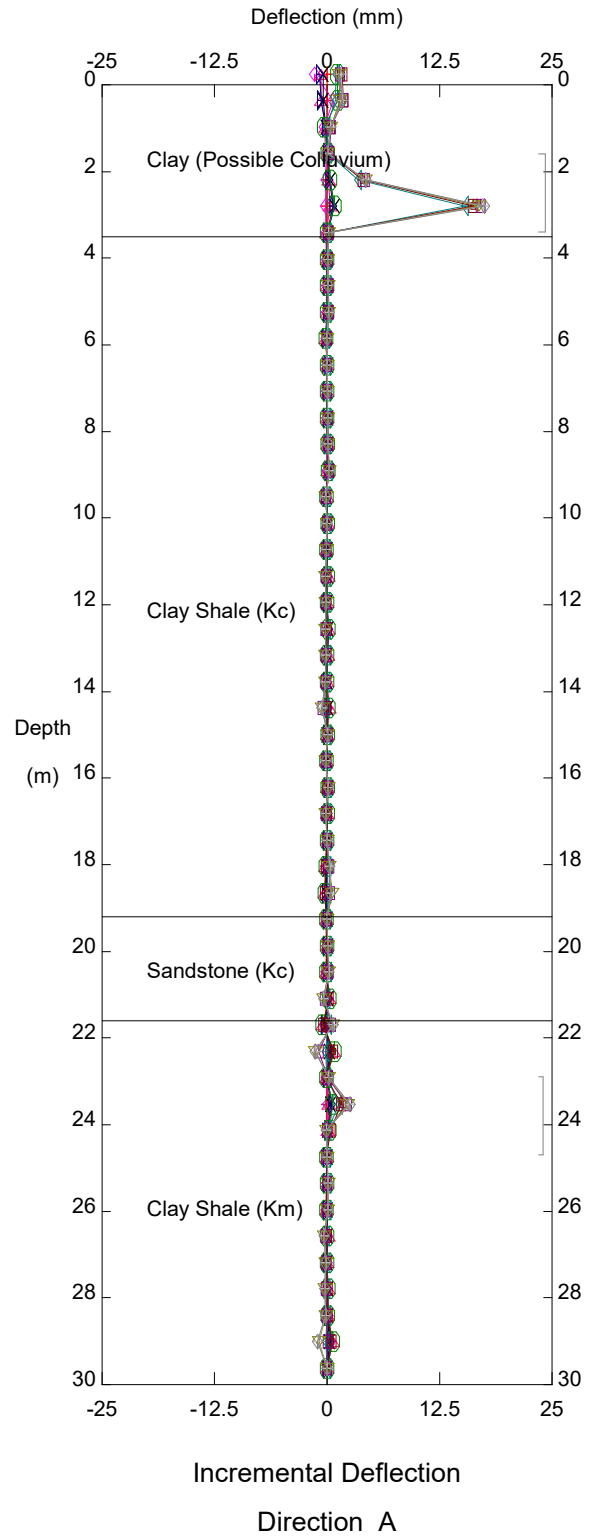
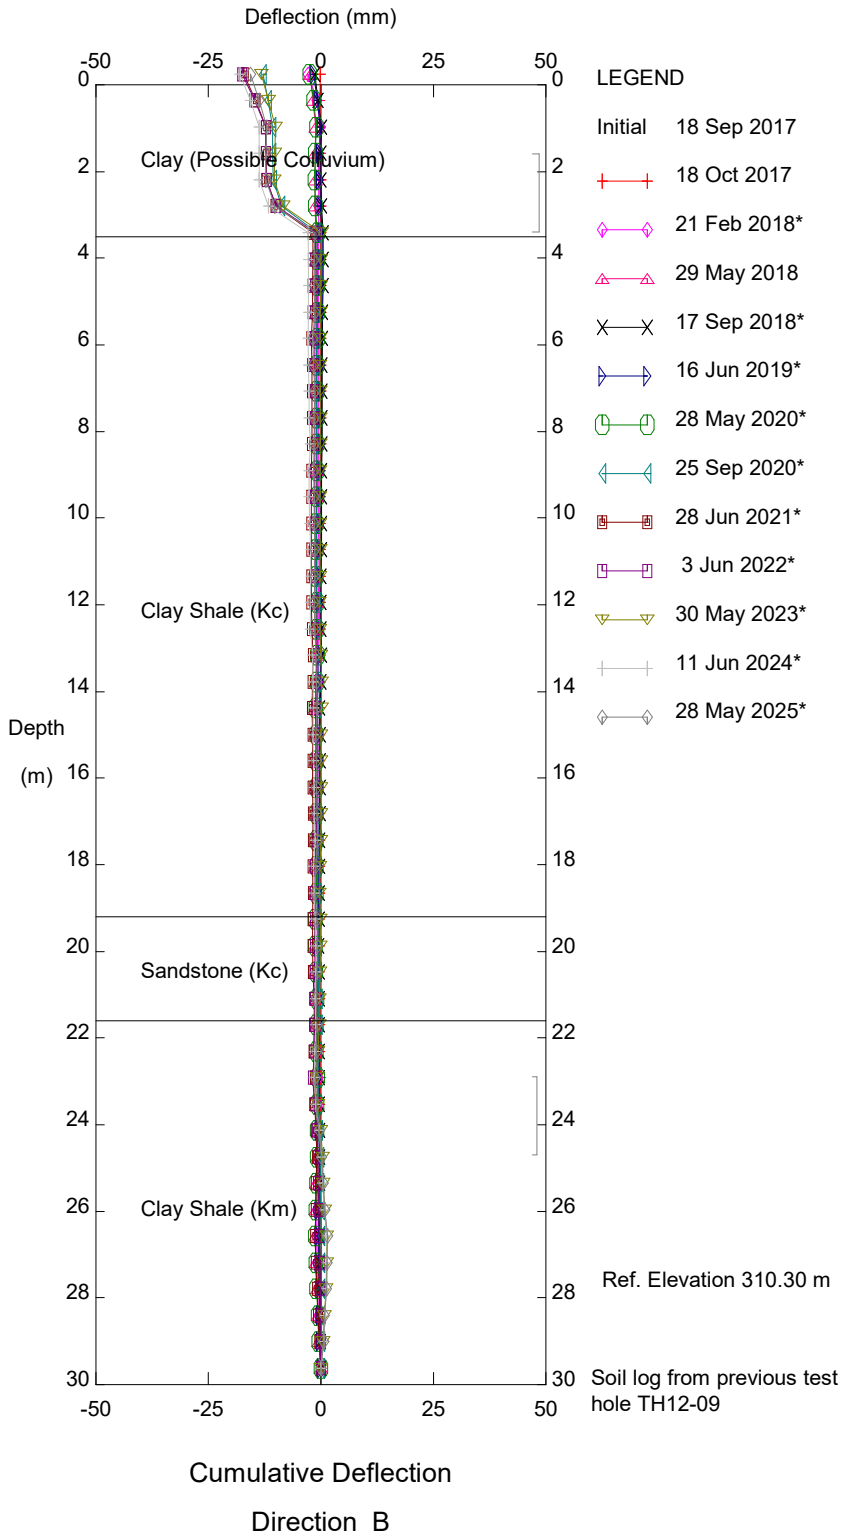
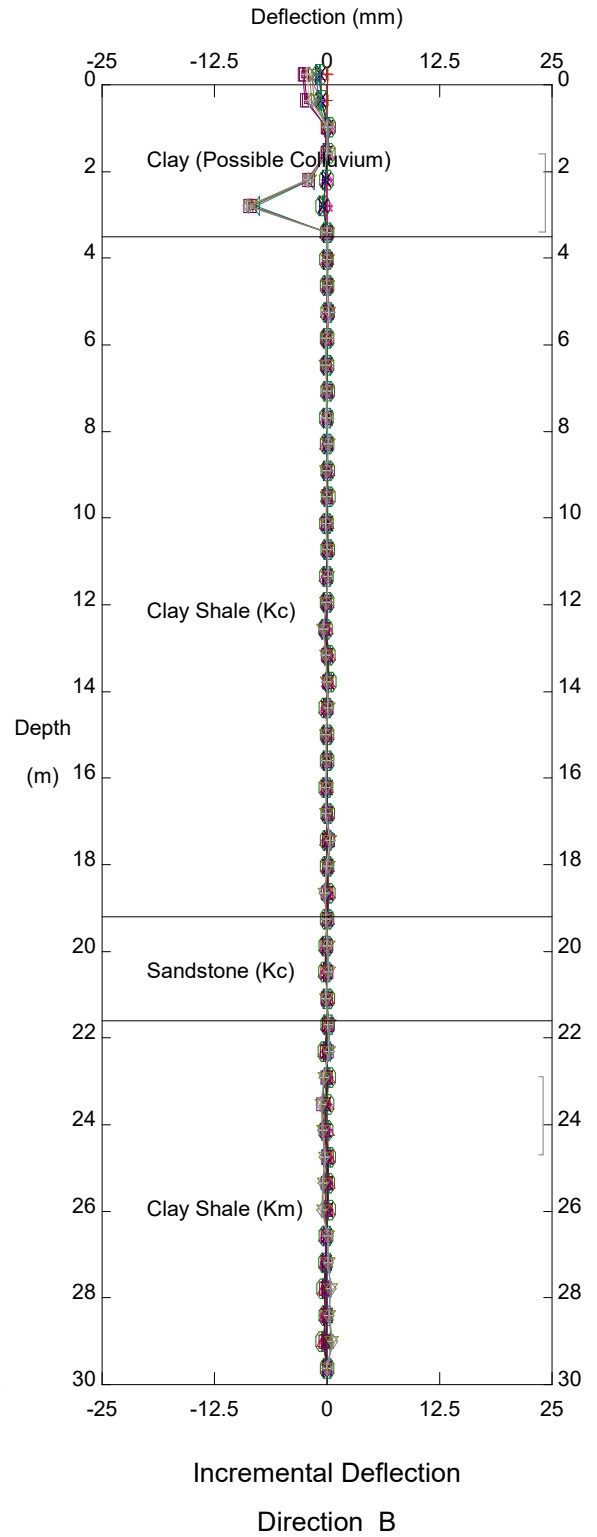
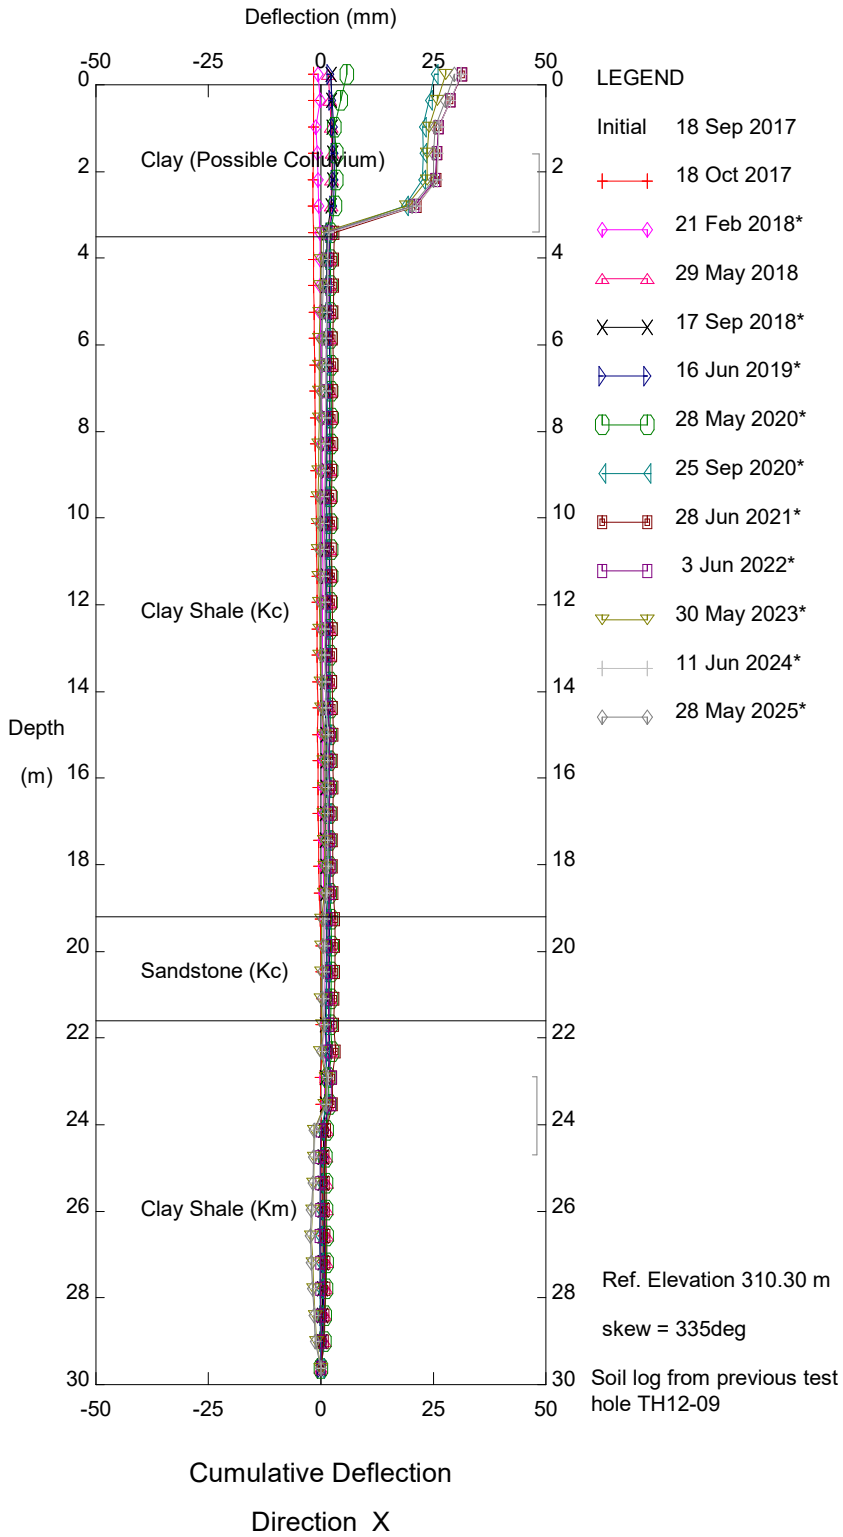
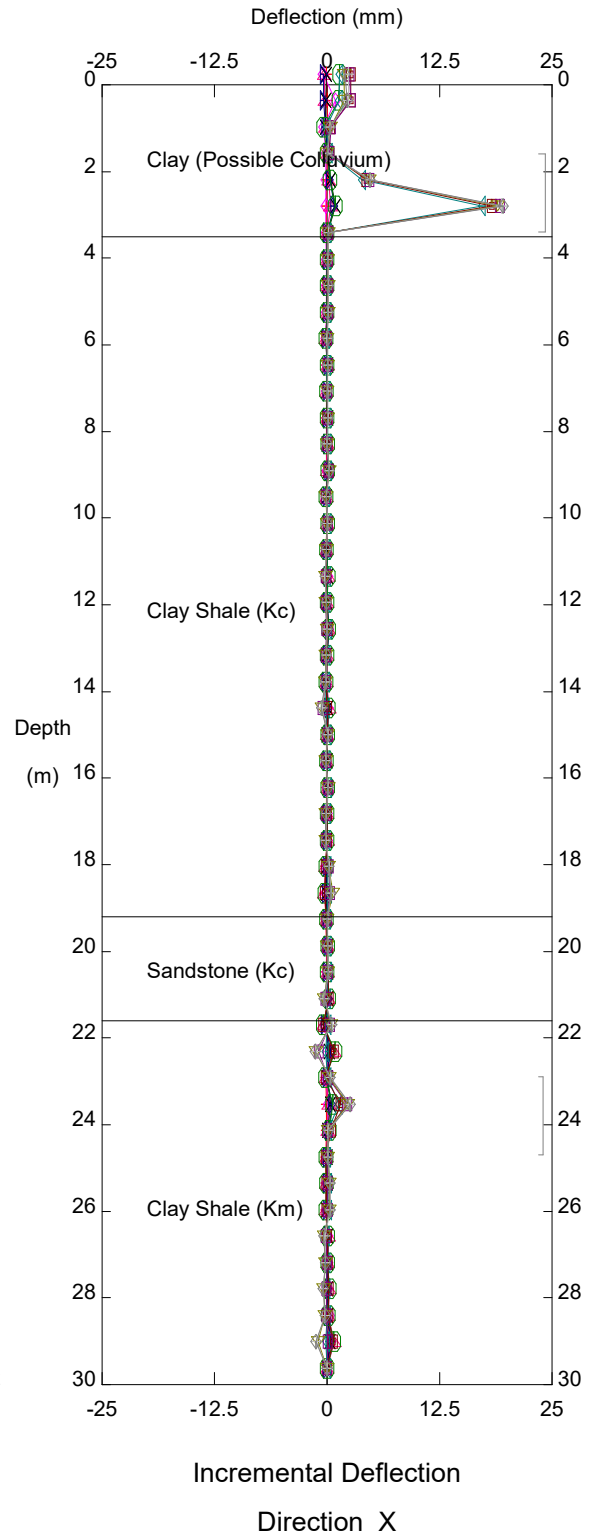
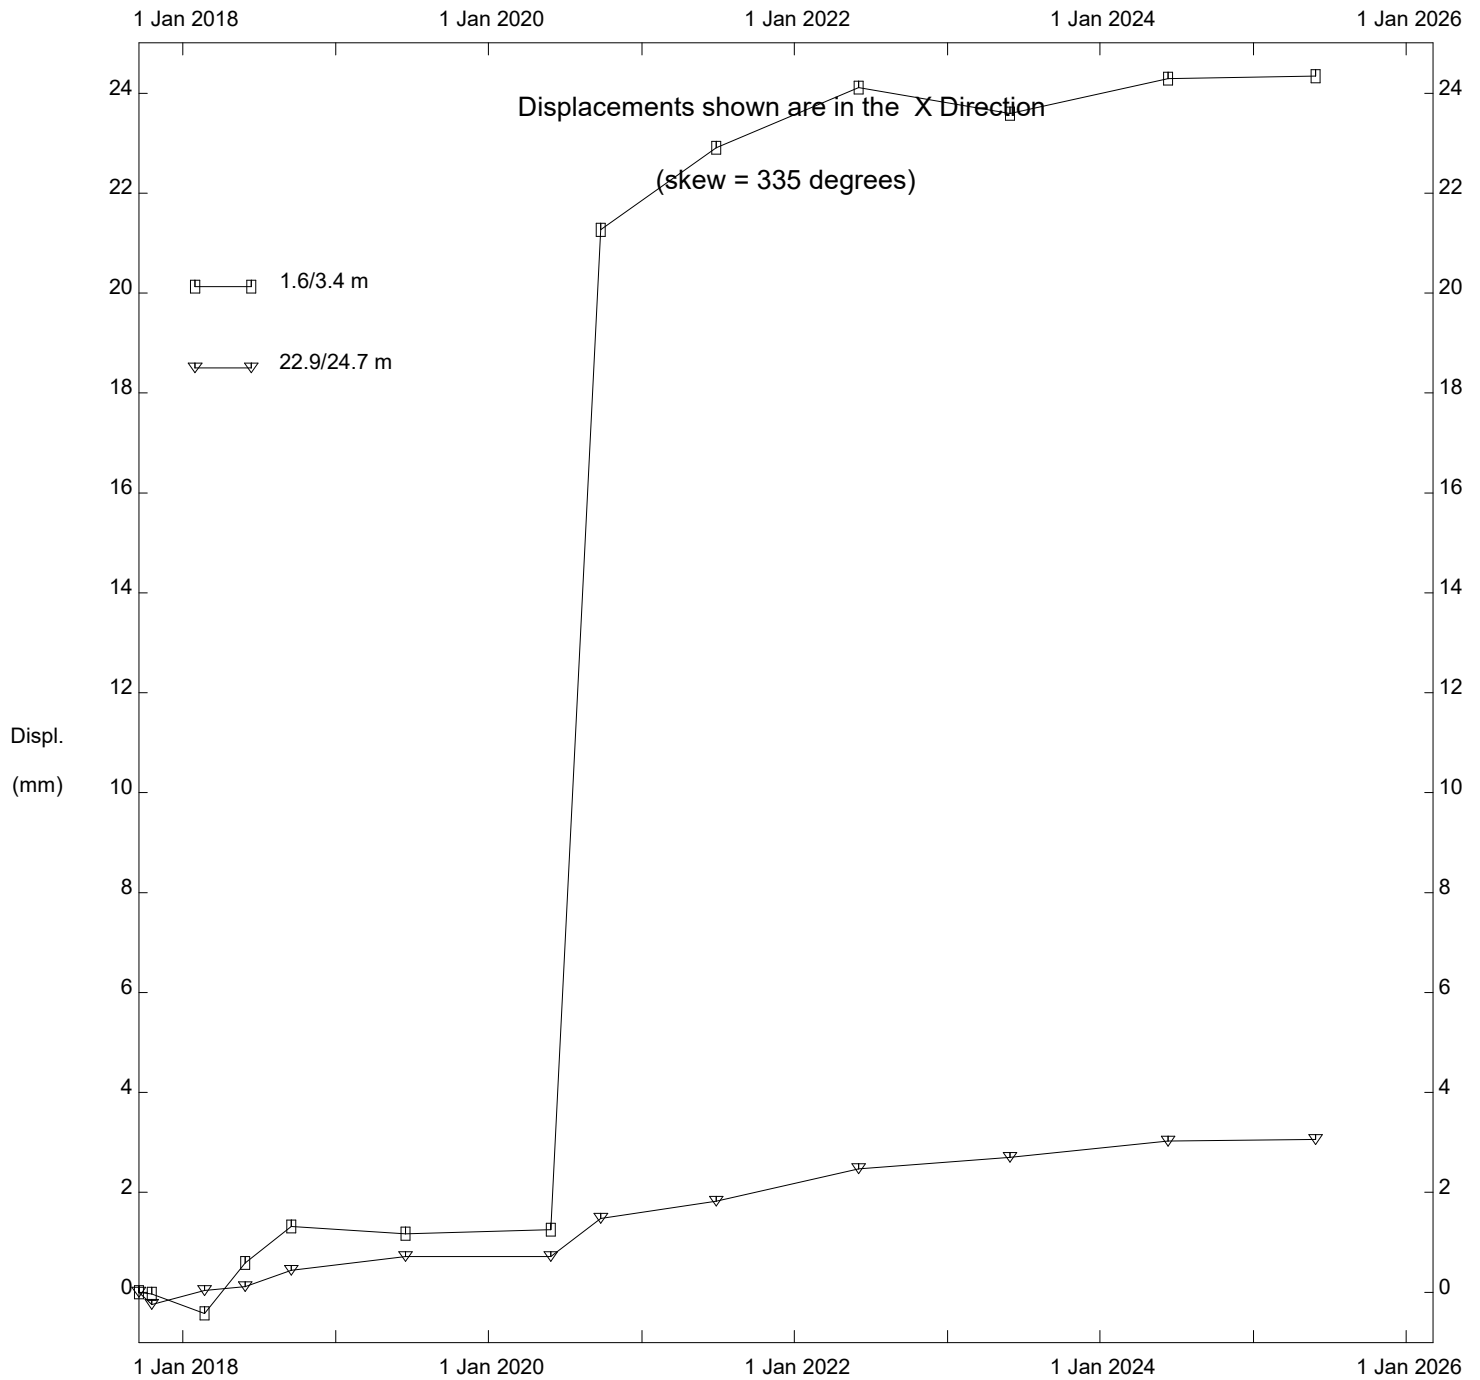
NC089 - Beacon Hill Backslope Slide, Inclinometer SI17-7

| INSTRUMENT # | DATE INITIALIZED | TOTAL CUMULATIVE RESULTANT MOVEMENT AND DEPTH OF MOVEMENT TO DATE (mm) | MAXIMUM RATE OF MOVEMENT (mm/yr) | CURRENT STATUS OF SI | DATE OF PREVIOUS READING | INCREMENTAL MOVEMENT SINCE PREVIOUS READING (mm) | CURRENT RATE OF MOVEMENT (mm/yr) | CHANGE IN RATE OF MOVEMENT SINCE PREVIOUS READING (mm/yr) |
|---|---|---|---|---|---|---|---|---|
| SI17-7<br>(Replacement for SI12-09) | September 18, 2017 | 24.3 mm over 1.6 to 3.4 m depth in 28° direction | 60.8 in September 2020 | Operational | June 11, 2024 | <0.1 | <0.1 | -0.6 |
| | | 3.1 mm over 22.9 to 24.1 m depth in 28° direction | 2.3 in September 2020 | | | <0.1 | <0.1 | -0.3 |

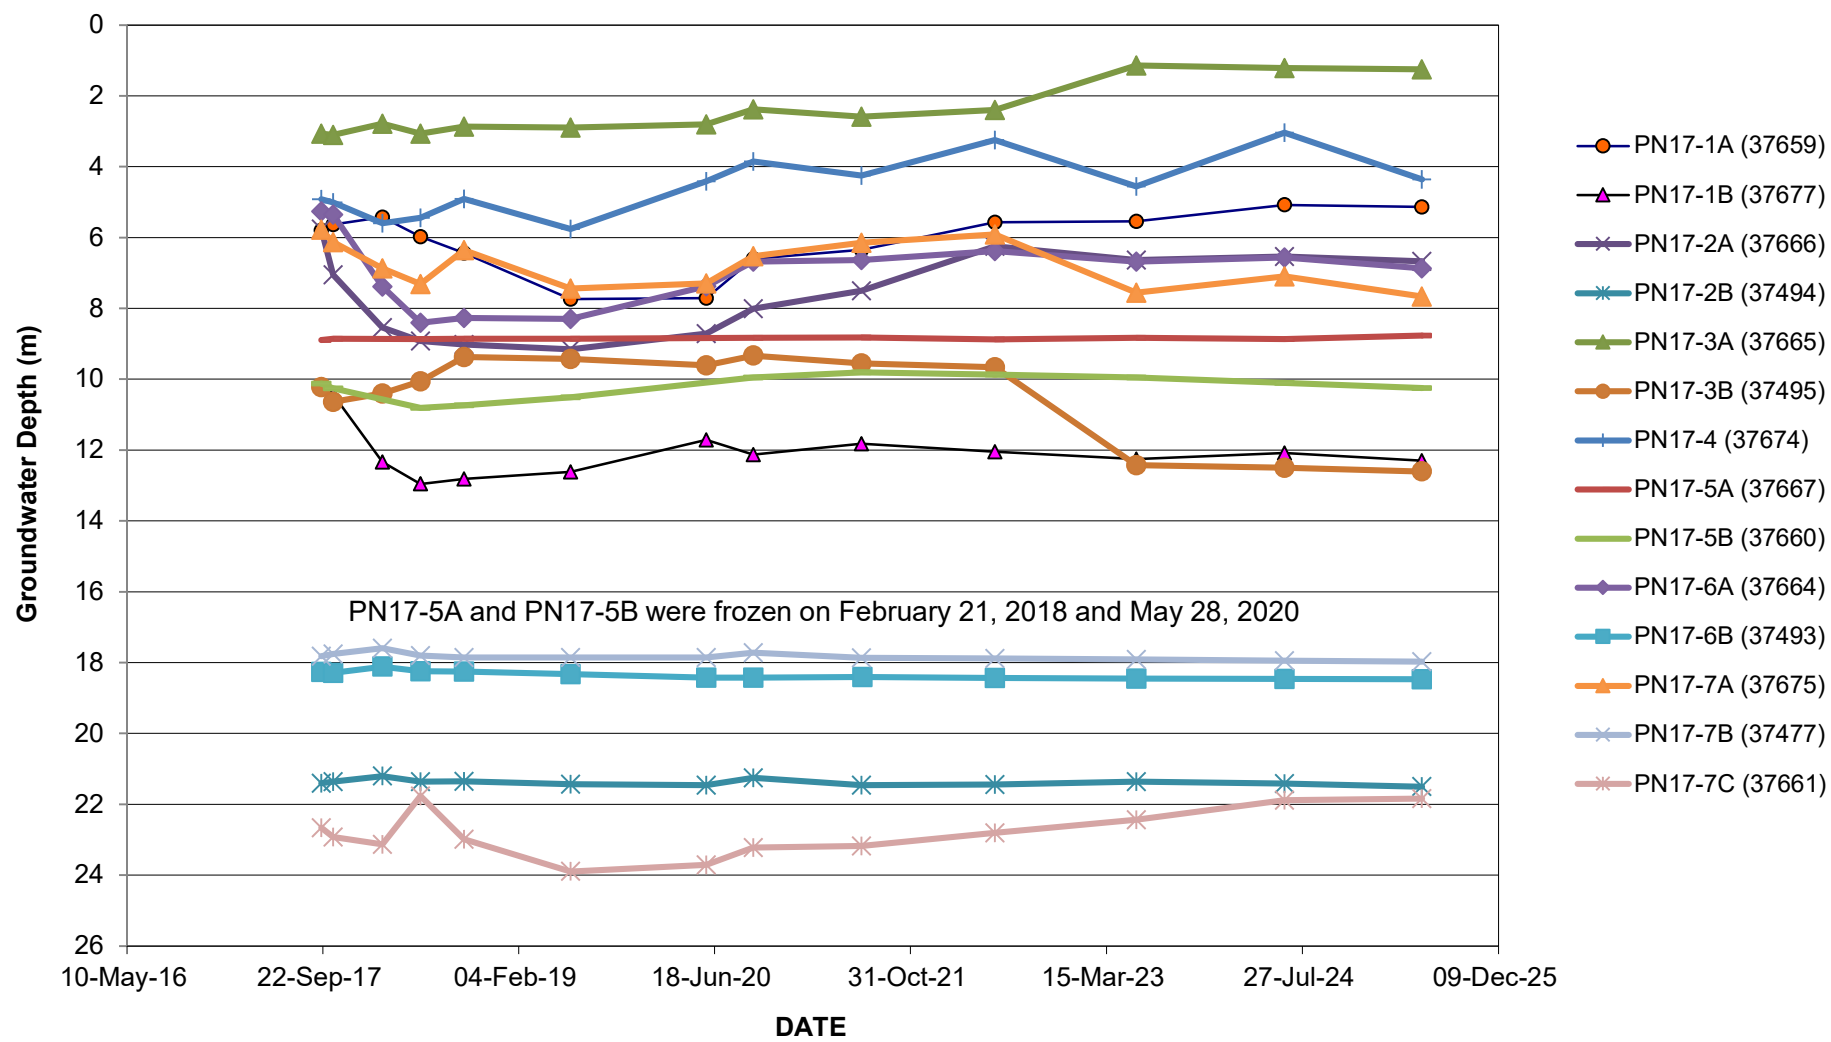
**FIGURE NC089-1**  
**PIEZOMETER DATA FOR HWY 63:12 BEACON HILL**

| | below ground surface which is the highest recorded reading in the instrument since initialization. |

| INSTRUMENT # | DATE INITIALIZED | TIP DEPTH (m) | CURRENT STATUS | HIGHEST MEASURED GROUNDWATER DEPTH (m) | MEASURED PORE PRESSURE (kPa) | CURRENT GROUNDWATER DEPTH (m) | PREVIOUS GROUNDWATER DEPTH (m) | CHANGE IN WATER LEVEL SINCE PREVIOUS READING (m) |
|---|---|---|---|---|---|---|---|---|
| PN17-5A (37667) | September 18, 2017 | 8.9 | Operational | 8.77 on May 28, 2025 | 1.3 | 8.77 | 8.87 | 0.10 |
