**ALBERTA TRANSPORTATION AND  
ECONOMIC CORRIDORS GRMP  
NORTH CENTRAL (ATHABASCA AND FORT  
McMURRAY DISTRICTS)  
2025 SITE INSPECTION**

| Site Number | Location | Name | Hwy | km |
|---|---|---|---|---|
| NC071 | 1 km east of Colinton | Little Pine Creek Slide | 663:04 | 6.98 |

| | Date | PF | CF | Total |
|---|---|---|---|---|
| Current Inspection | May 13, 2025 | 11 | 5 | 55 (for highway) |

**NC071: HWY 663:04 LITTLE PINE CREEK SLIDE (km 6.98)**

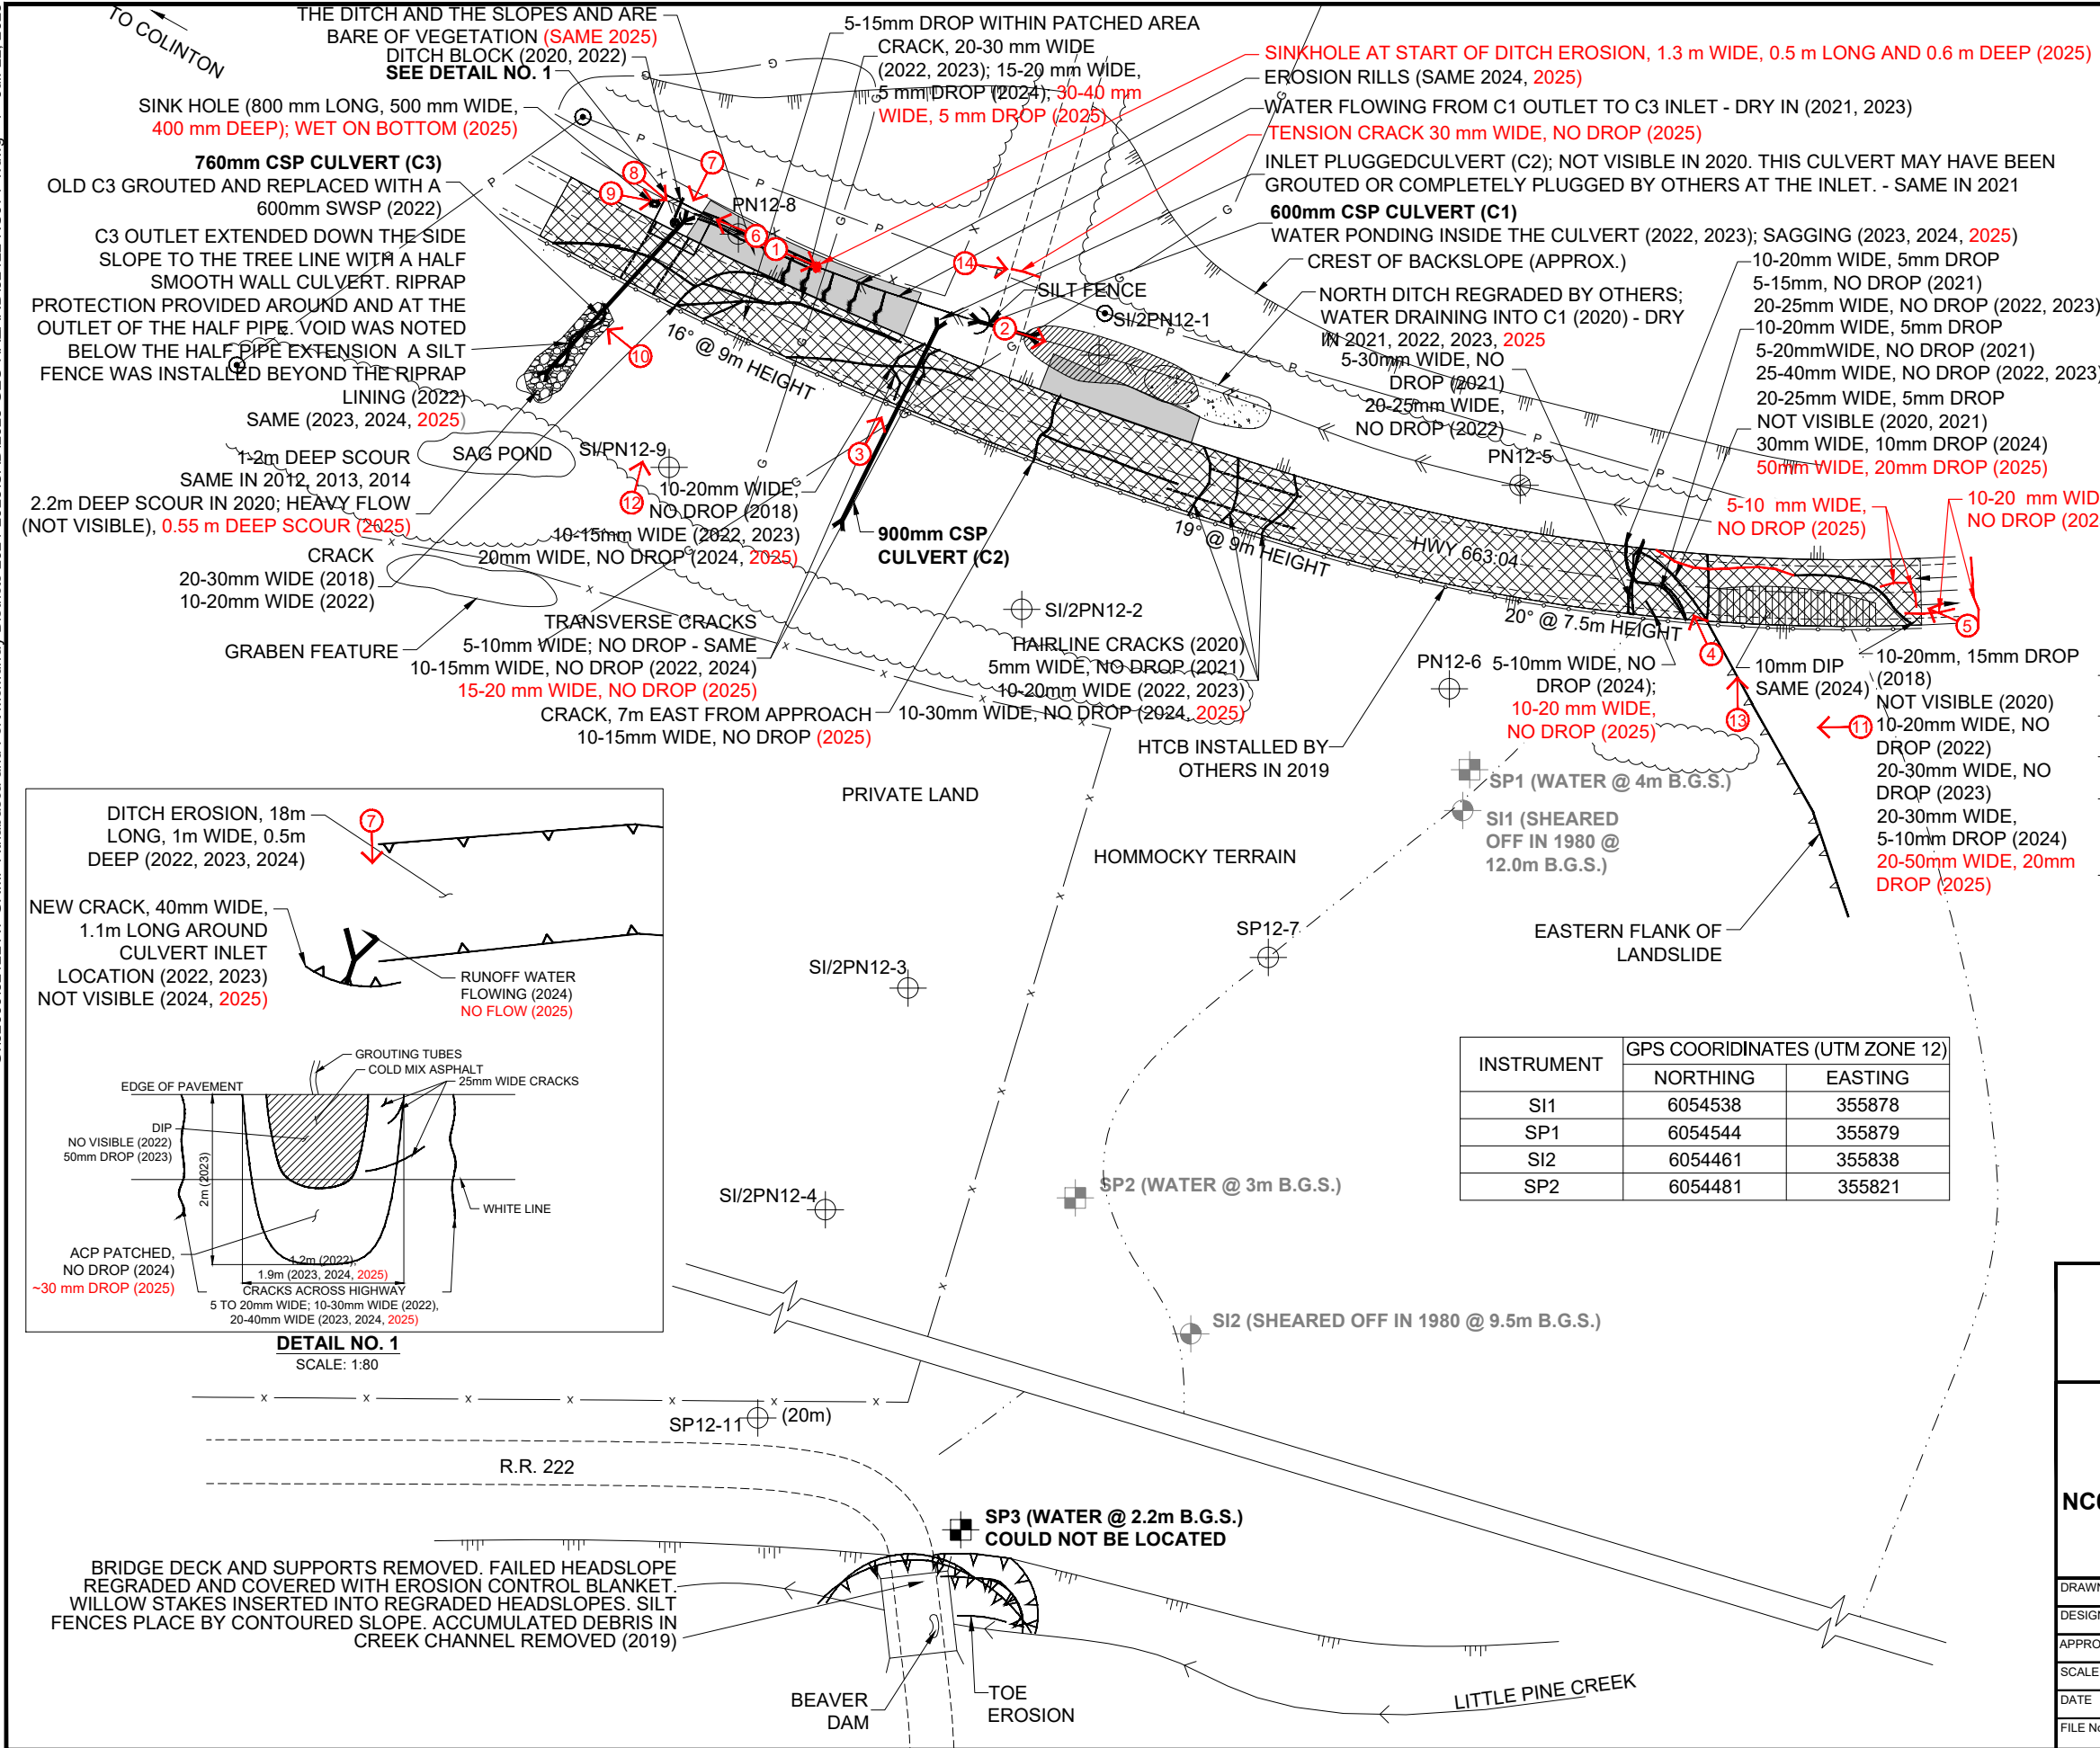
**DWG NO. 32122-NC071-1**

1. WATER LEVELS IN STANDPIPE PIEZOMETERS ARE BASED ON THE AVAILABLE INFORMATION PROVIDED BY TRANS
2. MAY 13, 2025 SITE OBSERVATIONS ARE SHOWN IN RED.

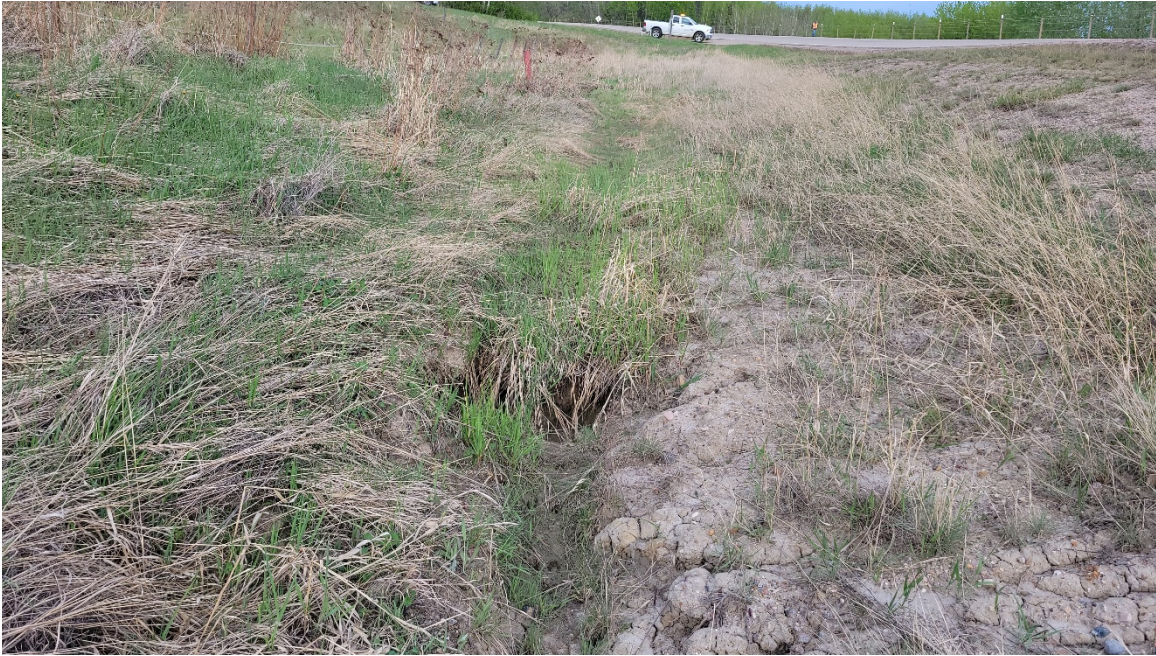
| Observations: | Description | Worse? |
|---|---|---|
| <input checked="" type="checkbox"/> Erosion | Erosion gully (18 m long x 1 m wide x 0.5 m deep) which developed in 2022 within the north ditch upstream of culvert C3 remains unchanged; sinkhole 0.5 m long, 1.3 m wide and 0.6 m deep was noted at east end of the erosion gully during current inspection; erosion rills along the highway side slope to the west of the access road; sink hole (800 mm long x 500 mm wide x 400 mm deep) to the west of C3 inlet location was wet on the bottom (partially filled with sediment since the last inspection). | <input type="checkbox"/> |

**Photo 1. Looking east at a sinkhole that has developed at the start of the erosion gully in the highway north ditch. The sinkhole is 1300 mm wide, 500 mm long and 600 mm deep.**

- The north ditch to the west of the access road should be properly graded to eliminate the erosion gully. The side slope should also be track-packed to fill erosion rills. After the ditch/side slope repairs are completed, all disturbed areas within the north ditch should be topsoiled and seeded. The ditch bottom and side slopes should be covered with Type C TRM to reduce future erosion potential.

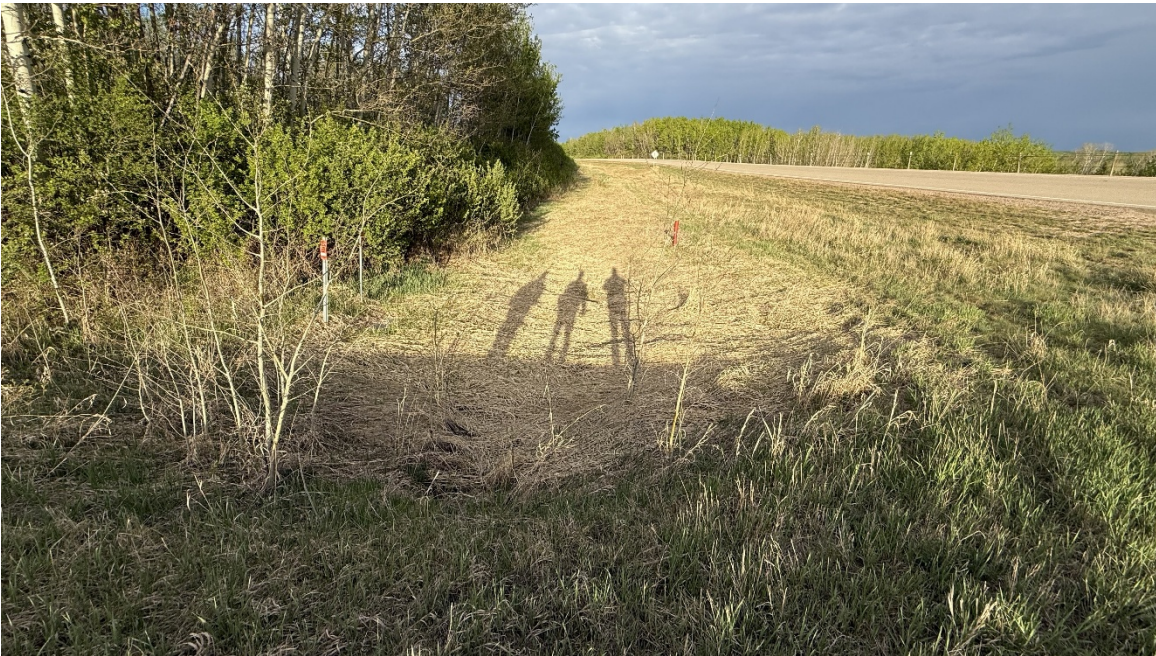
**Photo 2. Highway north ditch east of the approach (facing east).**

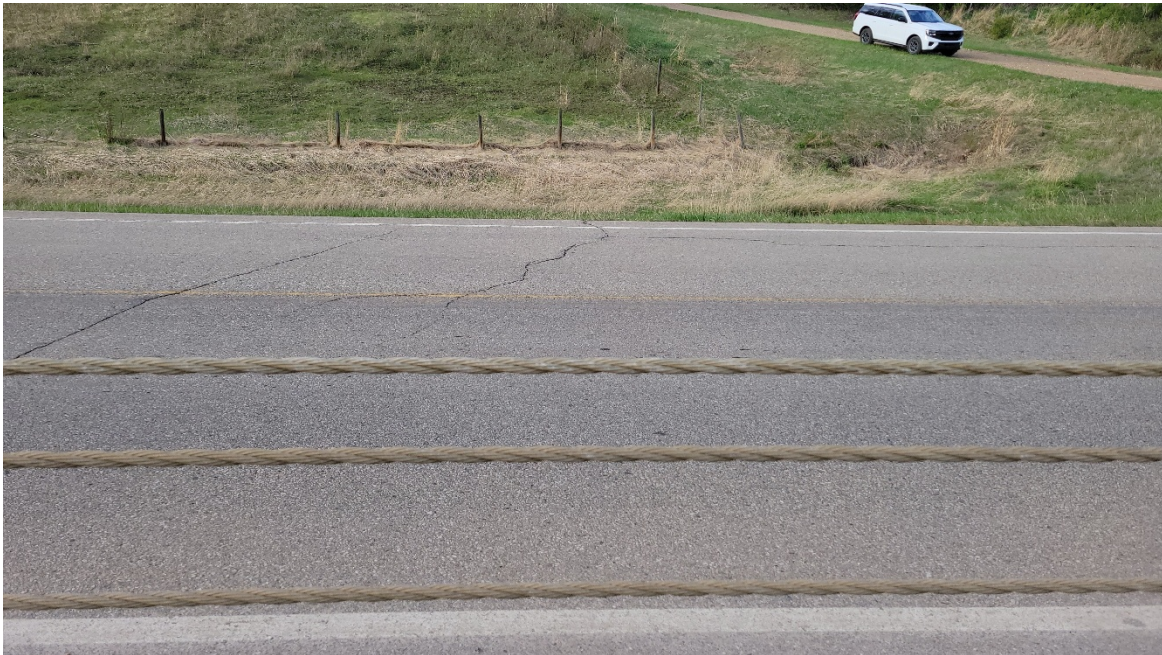
**Photo 3. Looking north at a transverse crack (15-20 mm wide with no drop).**

The local MCI should continue to monitor the site (particularly between the spring and the fall seasons) and seal any open cracks to reduce surface water infiltration into the highway fill. Consideration should be given in the future to placing an ACP patch near the flanks of the landslide to provide a smooth ride to motorists.

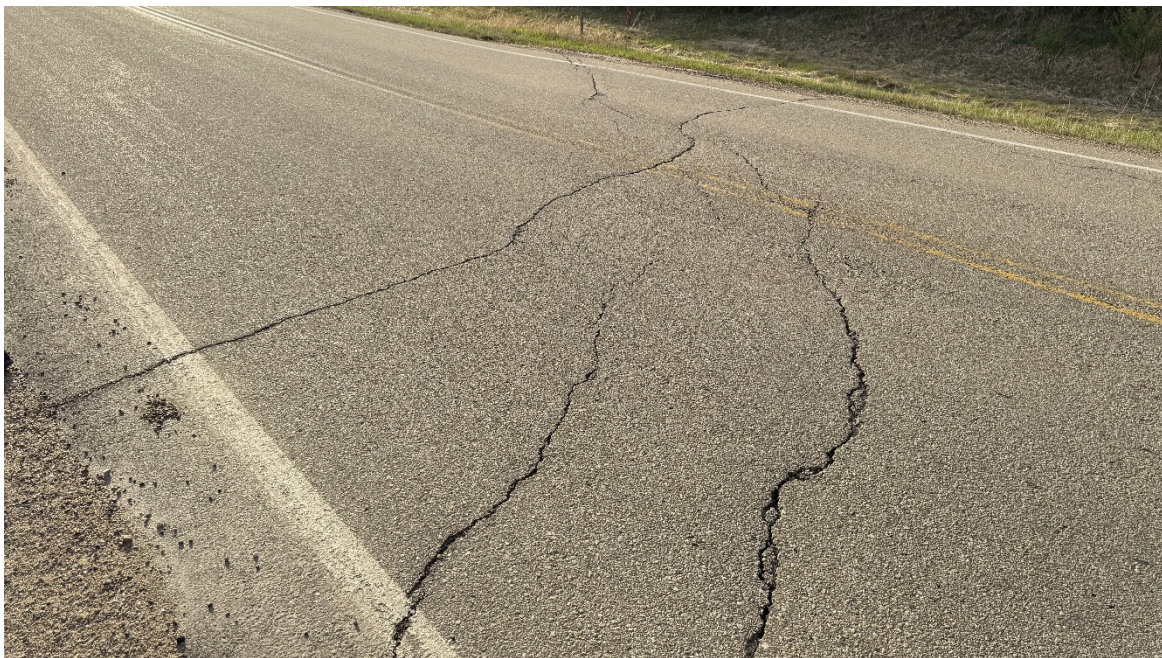
| Observations: | Description | Worse? |
|---|---|---|
| <input checked="" type="checkbox"/> Slope Movement | Western flank crack is showing reflective cracks 30 to 40 mm wide, 5 mm drop; 10 to 30 mm wide cracks within the middle section of the landslide; eastern flank cracks are up to 50 mm wide with a 20 mm drop, and a new tension crack 10-20 mm in width has opened at the east side of the site; a 30 mm wide tension crack has also developed in the access road near the intersection with the highway. | <input checked="" type="checkbox"/> |

**Photo 4. Looking northwest at the eastern flank reflective diagonal cracks (up to 50 mm wide with 20 mm drop).**

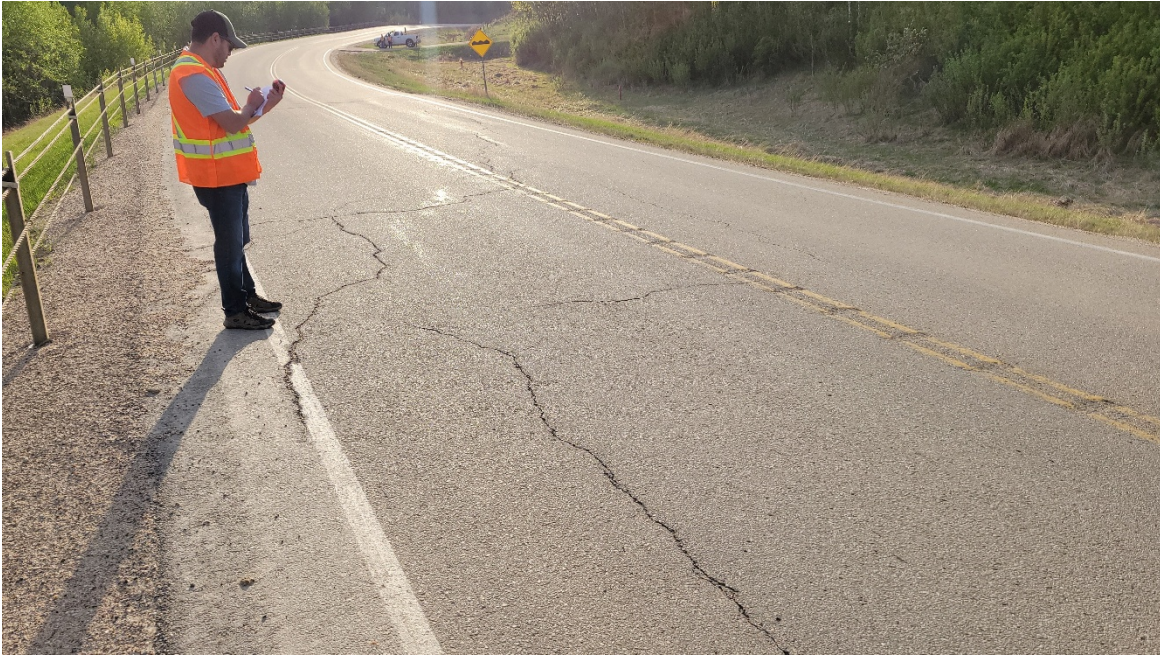
**Photo 5. Looking northwest at diagonal cracks about 15 m east of the landslide eastern flank (up to 50 mm wide with 20 mm drop).**

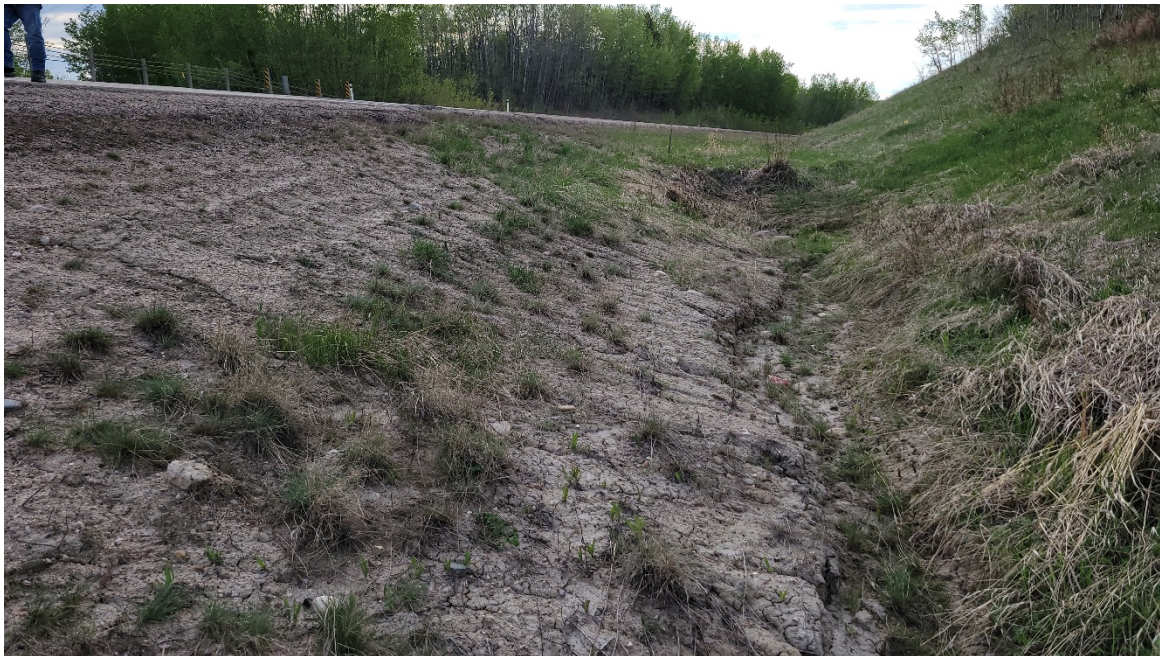
**Photo 6. Looking west at the section of the north ditch regraded in 2019; side slopes and sections of the ditch bottom are still bare of vegetation; note the presence of erosion rills along the side slope and a deep erosion gully in the ditch.**

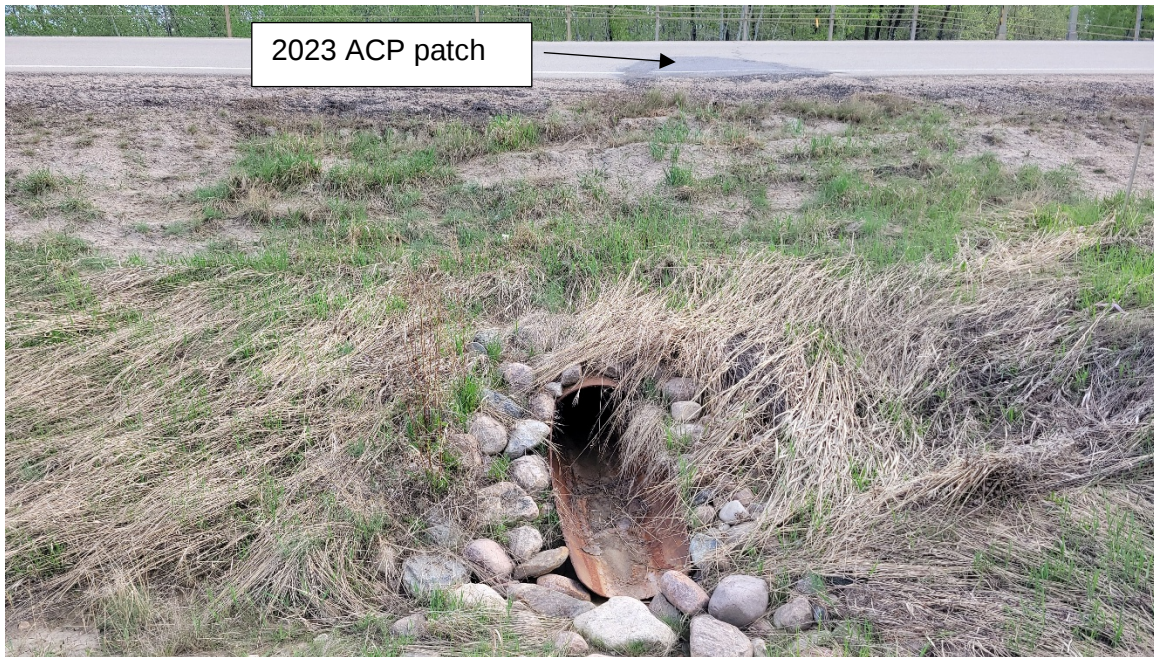
It is suspected that a void exists below the highway's WBL/shoulder and the north side slope surface upslope of the C3 culvert inlet location. Inadequate grouting of old pipe is likely the main cause of the void and the previously dip noted in the highway surface. The ACP patch placed by TEC between 2023 and 2024 to eliminate the dip on the highway surface above the void is an interim measure. It is anticipated that the dip will re-occur and become worse with time, due to the progressive collapse of the existing void, and this may cause a severe future distress on the highway WBL surface.

**Photo 7. Looking south at the inlet of culvert C3 – No flow noted in 2025. The 1.9 m wide ACP patch on the highway surface dropped by 30 mm.**

- The distressed area above C3 culvert should be excavated to properly fill the existing void in this area. Care should be taken during the excavation to avoid damaging the new culvert. An excavator with a ripper tooth attachment may be needed to complete the excavation. Once the void is located, the base of the excavation should be inspected to remove damaged/collapsed section of the old pipe, debris, and soft /loose materials. Attempts should be made to re-grout the old pipe if the inspection reveals that the exposed section of the pipe has not been filled with grout. The excavation should then be backfilled with compacted crushed gravel to ground surface to re-build the highway surface and the side slope. The side slope should be capped with at least 300 mm of clay at ground surface. The closure of the highway WBL will likely be required to complete this repair.

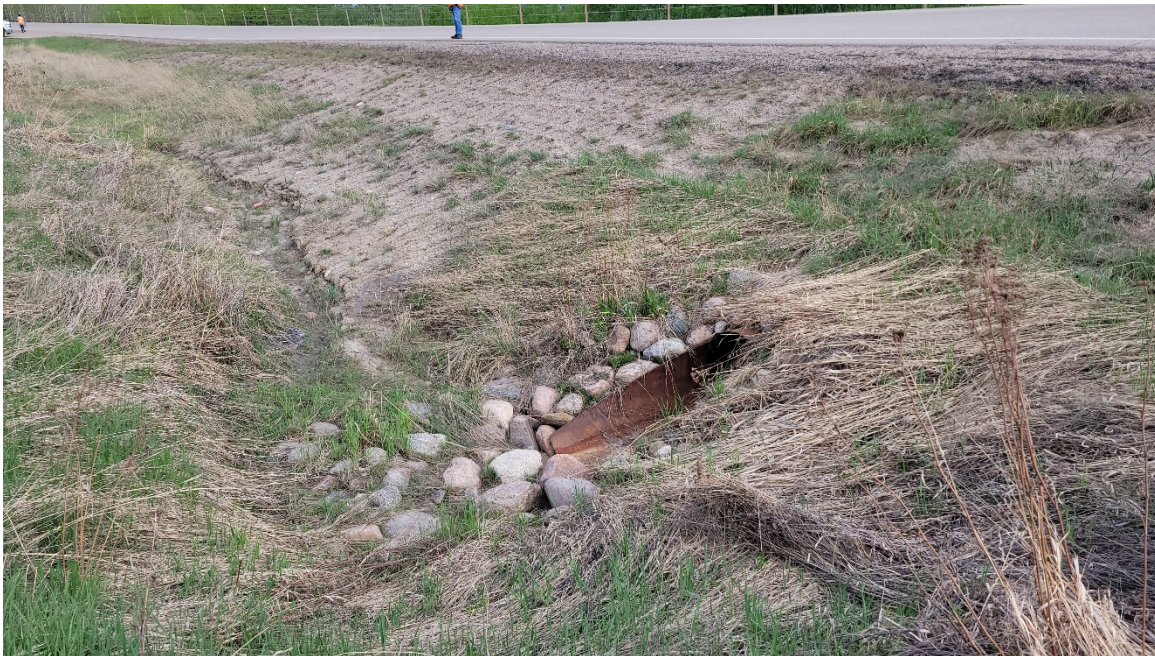
**Photo 8. C3 inlet; side slope still is bare of vegetation; erosion developing upstream of the inlet within the ditch.**

- The area around Culvert C3 inlet should also be scarified, repacked, and contoured to eliminate the existing crack, and the sinkhole to the west of the culvert should be backfilled with compacted fill.

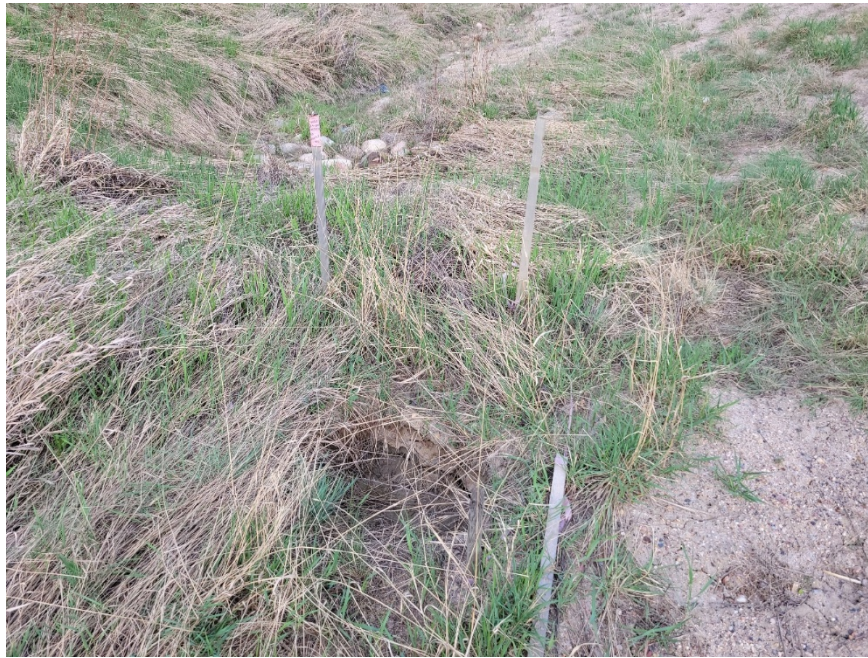
**Photo 9. Sinkhole (800 mm long x 500 mm wide x 400 mm deep) west of the C3 culvert inlet.**

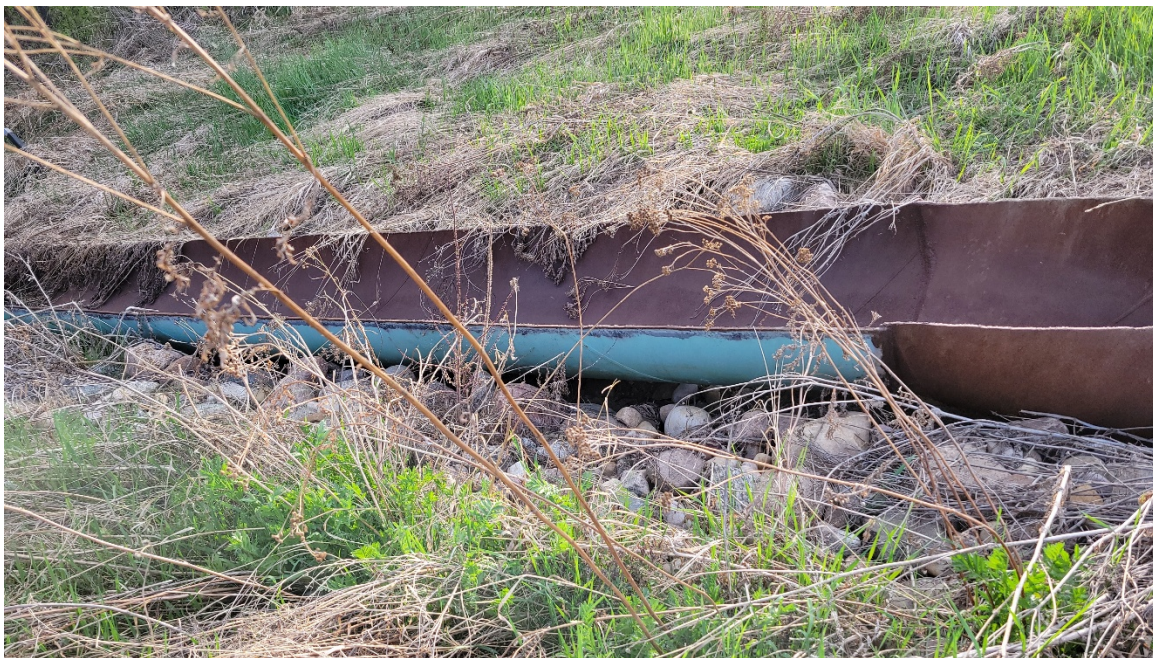
The void below the half pipe downstream of C3 outlet location is due to improper subgrade preparation. The surface flow around the pipe may undermine the subgrade, potentially resulting in the development of a severe erosion gully below and around the extension pipe.

**Photo 10. Outlet of culvert C3, installed in 2021. There is a void below the half pipe extension piece.**

- The void below the half pipe culvert, downstream of the outlet of the C3 culvert, should be filled with fillcrete.

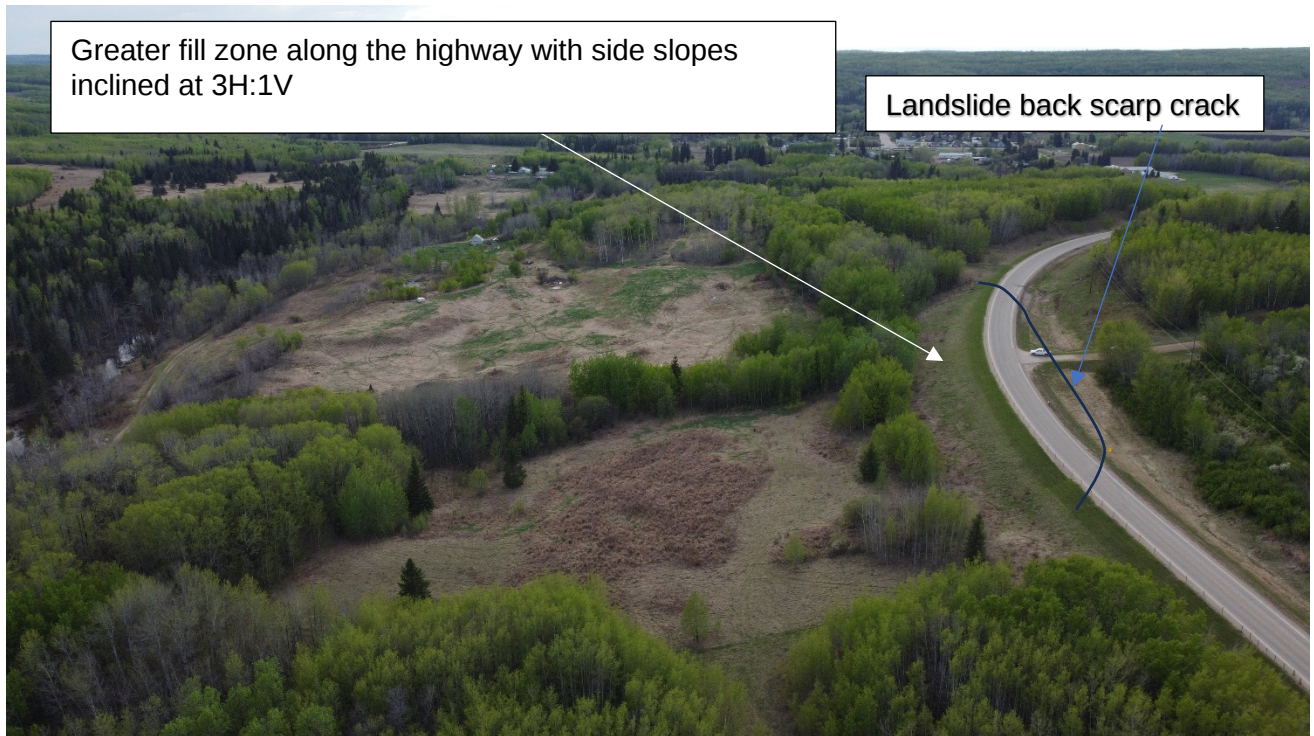
**Photo 11 (drone shot).** Looking west from beyond the eastern limits of the landslide. Little Pine Creek is visible on the left side of the photo. Hummocky terrain is visible downslope of the highway. Note fill section along the highway notably higher within landslide area.

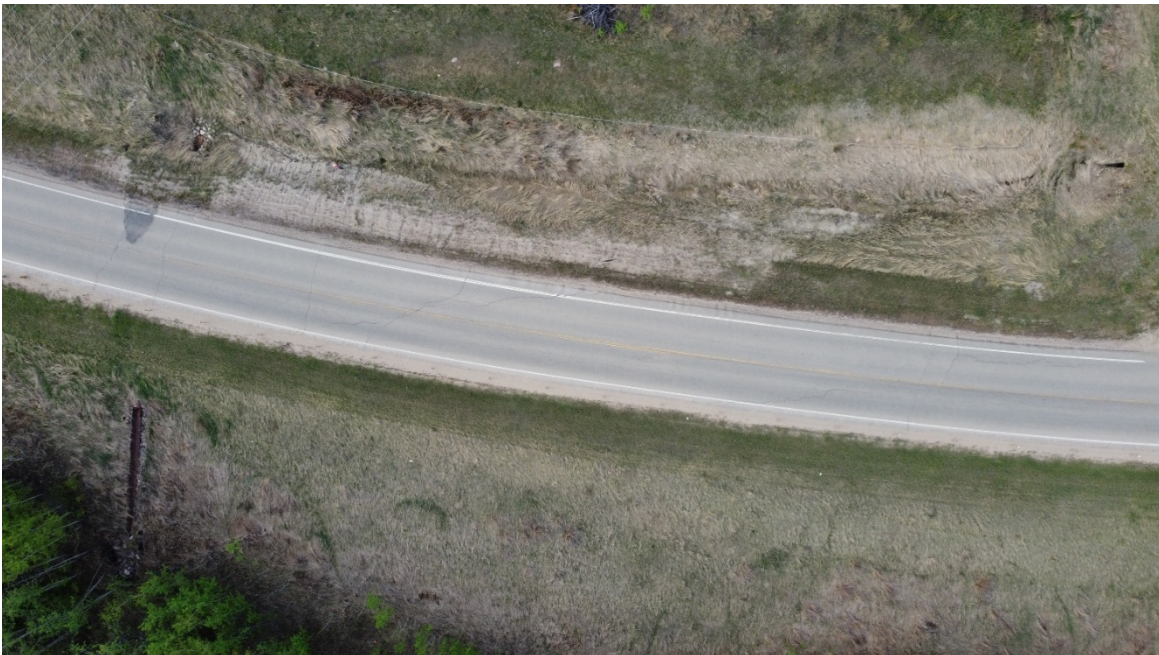
**Photo 12 (drone shot).** Highway west of access road. Erosion on the ditch slope is visible. Inlet of culvert C3, sinkhole area and ACP patch, and C3 culvert outlet and half pipe extension is visible on the left of the photo.

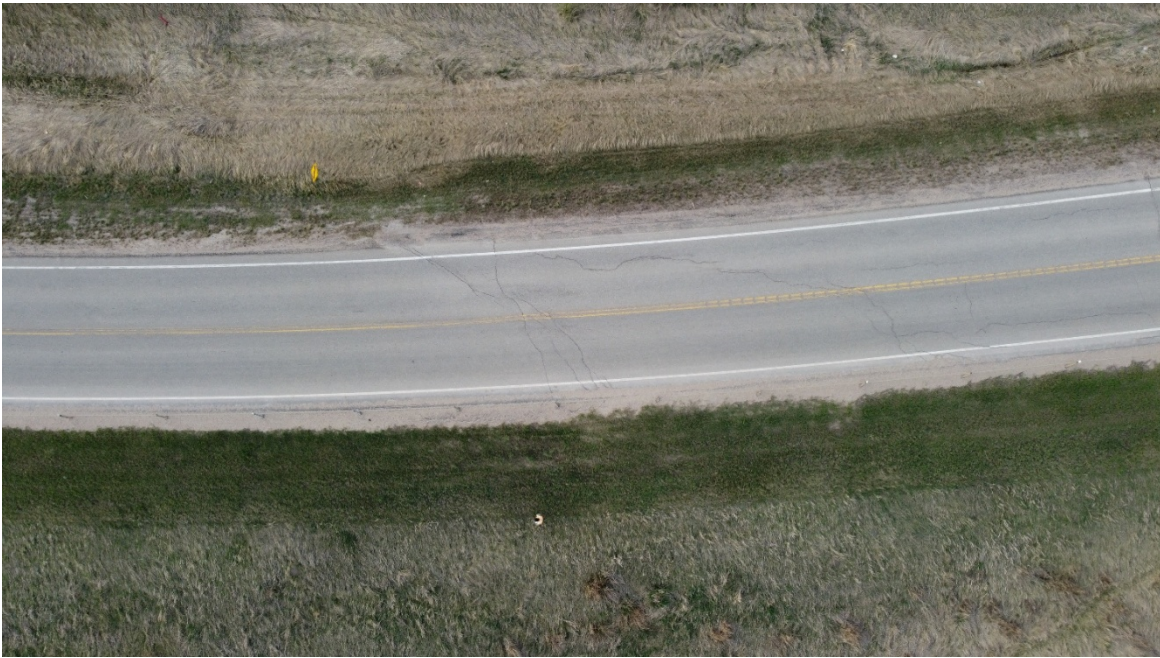
**Photo 13 (drone shot). Highway east of access road showing the eastern flank of the highway and cracking pattern in the ACP.**

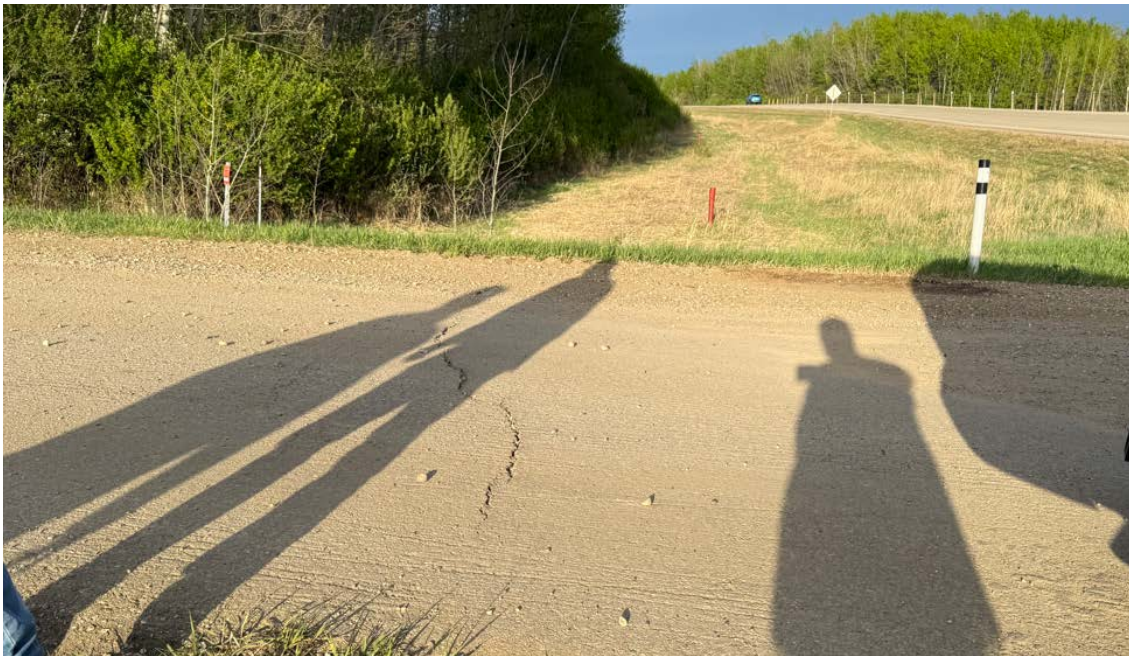
**Photo 14. Possible backscarp crack 30 mm wide, no drop**
