ALBERTA TRANSPORTATION AND  
ECONOMIC CORRIDORS GRMP  
NORTH CENTRAL (ATHABASCA AND FORT  
McMURRAY DISTRICTS)  
INSTRUMENTATION MONITORING – FALL 2025

| Site Number | Location | Name | Hwy | km |
|---|---|---|---|---|
| NC097 | HWY 63:12 L1 0.093 | Parsons Creek Interchange | 63:12 | km 0.09 |

**SITE NC097: HWY 63:12 PARSONS CREEK INTERCHANGE**

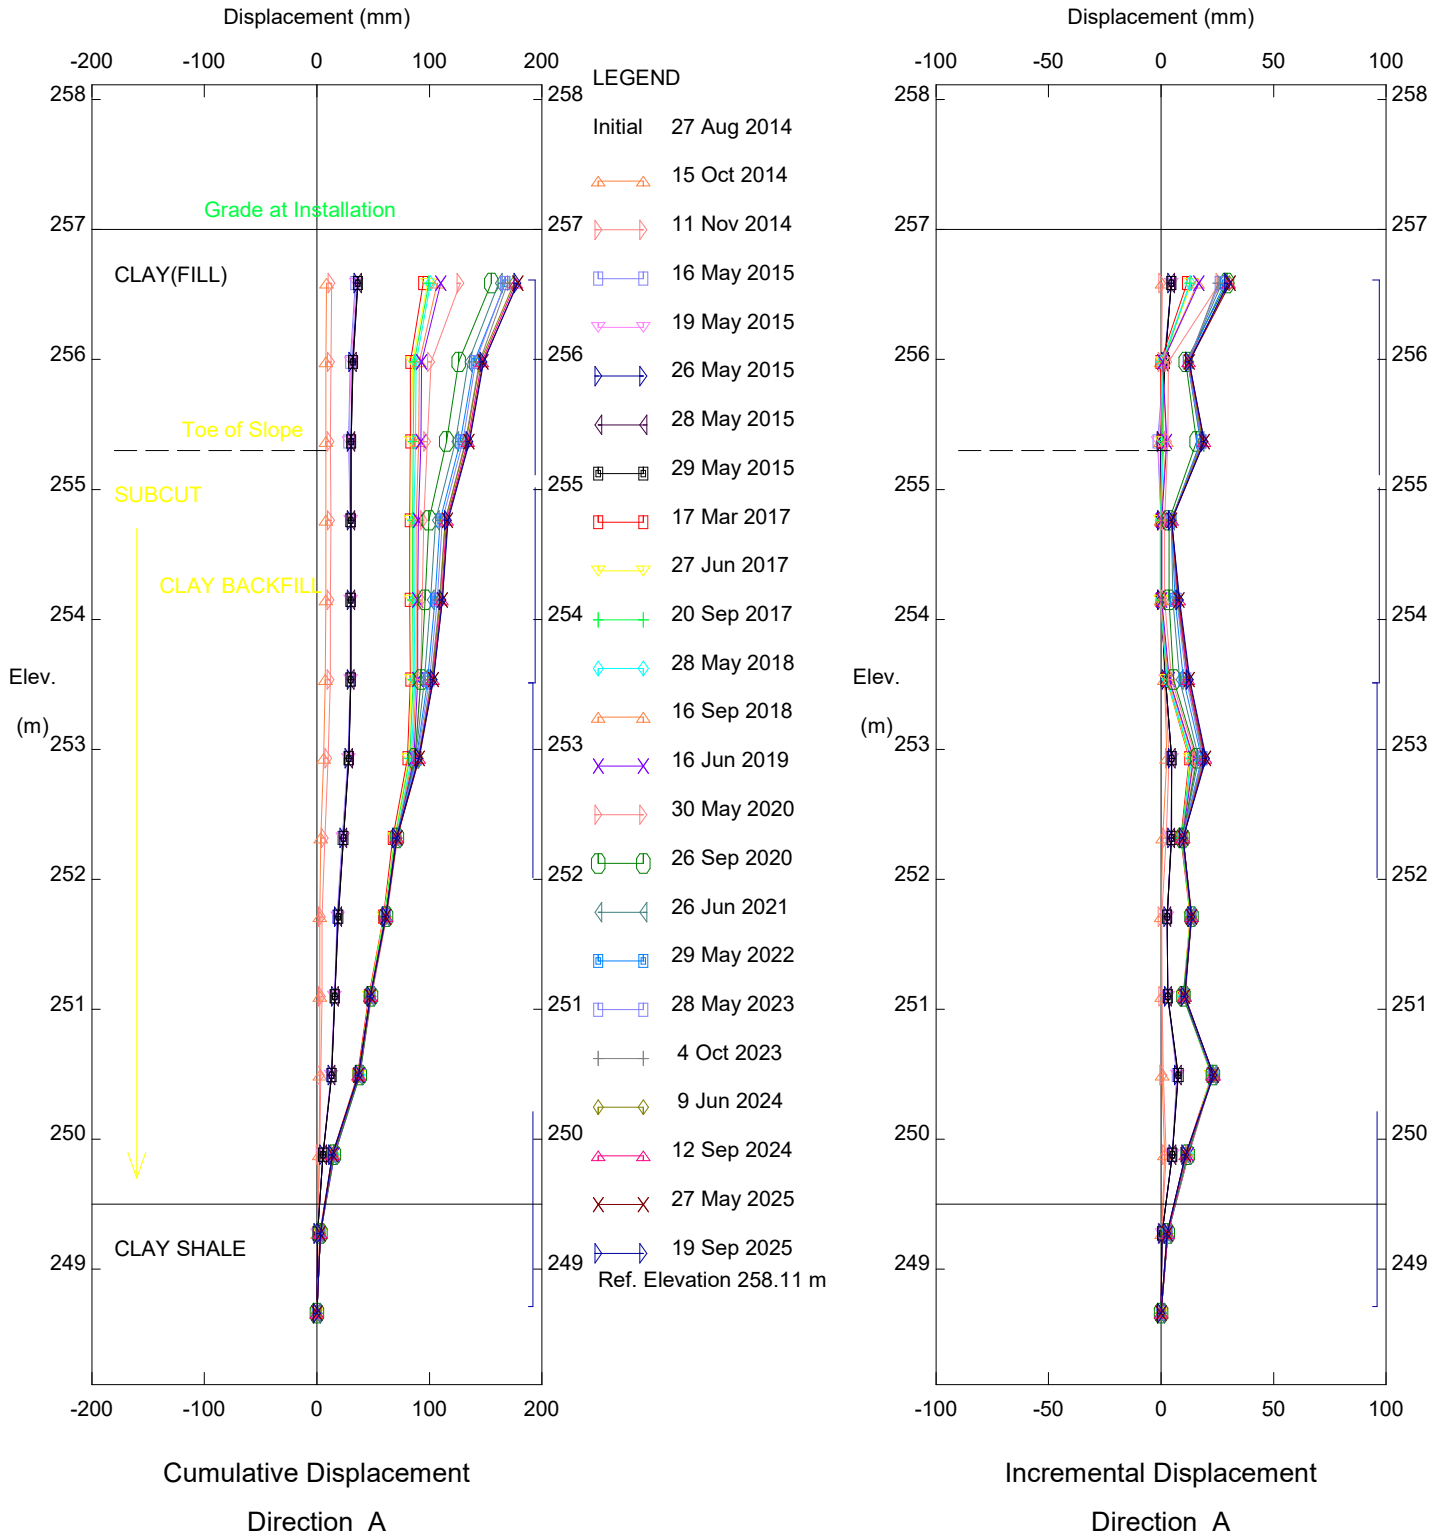
Hwy 686, 49+833.7 o/s +6.6m, Inclinometer SI14-05

| Discussion | |
|---|---|
| <b>Interpretation of Monitoring Results:</b> | <p><b><u>Parsons Interchange:</u></b></p> <p>Slope inclinometer SI14-05, installed near the west headslope of the bridge, showed no discernable movement over 1.5 m to 4.6 m depth and a rate of movement of 0.2 mm/yr over 4.6 m to 9.4 m depth since the spring of 2025 readings.</p> <p>PZ14-15, PZ14-19, and PZ14-20 showed increases in groundwater level of 1.41 m, 0.13 m, and 0.01 m respectively since respectively, since they were last read in the spring of 2025.</p> <p>Settlement cells SC14-09 and SC14-12 showed increases in settlement by 3.57 mm and 12.54 mm respectively, compared to the spring of 2025 readings.</p> |
